Your Ref: TP/IP/56223/2021  
Our Ref : CI/TPD22002075/N

9 March 2022

**Fatal Accident Investigation Team**

**INSPECTION REPORT OF PERSONAL MOBILITY AID PMA  
TRAFFIC POLICE POUND REPORT NO. 3986/21**

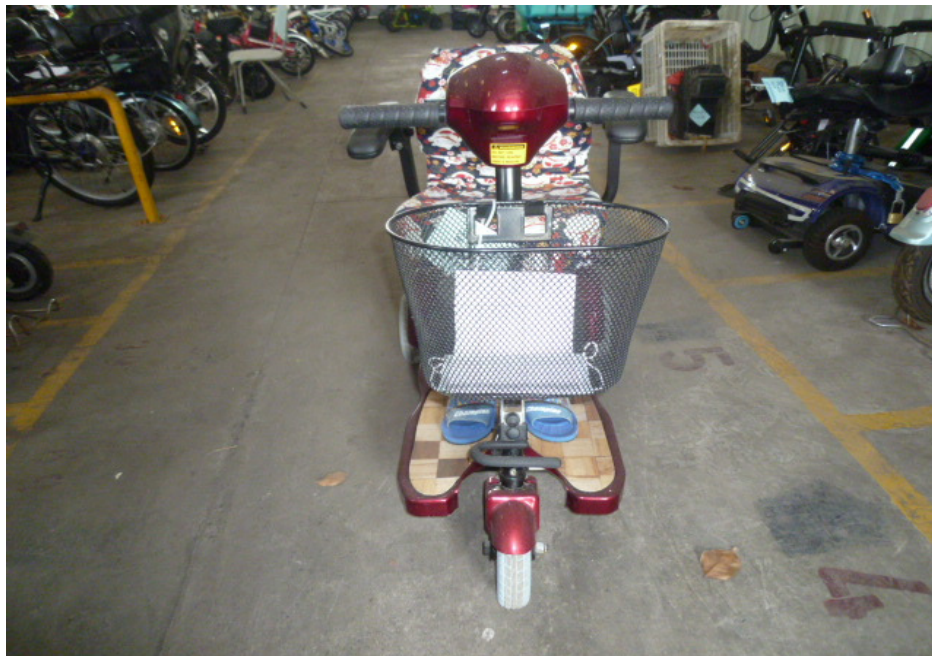
**Photo 2** shows a general view of the frontal portion of the PMA at the time of our inspection. The PMA was observed to have sustained damages at its right body.

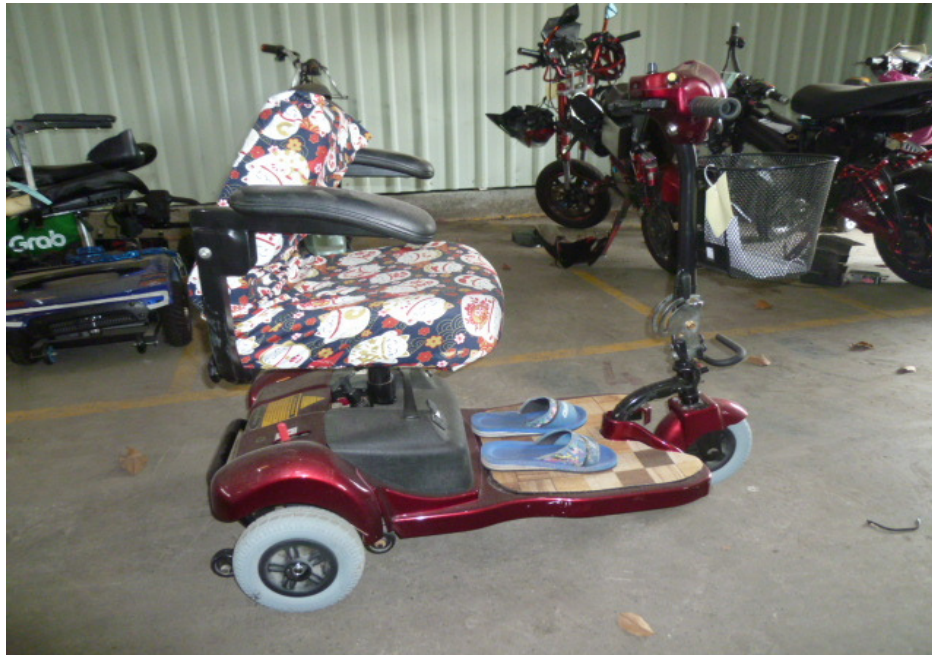
**Photo 3** shows a general view of the right body of the PMA at the time of our inspection. The PMA was observed to have sustained damages at its right body.

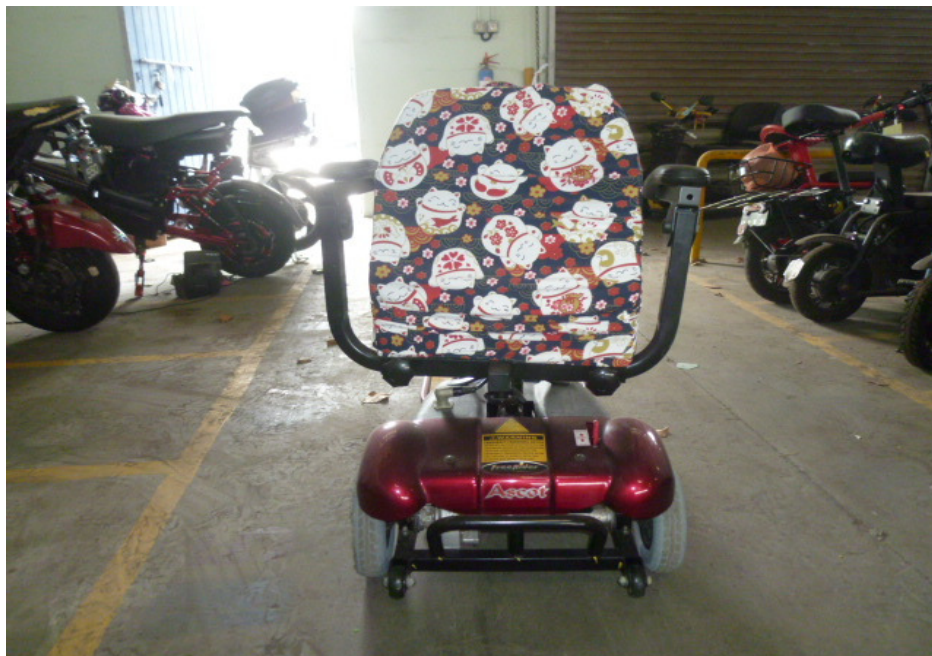
4. The PMA was observed to have sustained damages at its right body. The body parts that were found to have been damaged include its right handlebar grip, right bottom cowling and right armrest, amongst others as a result of the accident. See photos 1 – 7 below.

**Photo 4** shows a general view of the rear portion of the PMA at the time of our inspection. The PMA was observed to have sustained damages at its right body. The body parts that were found to have been damaged include its right handlebar grip, right bottom cowling and right armrest, amongst others as a result of the accident.

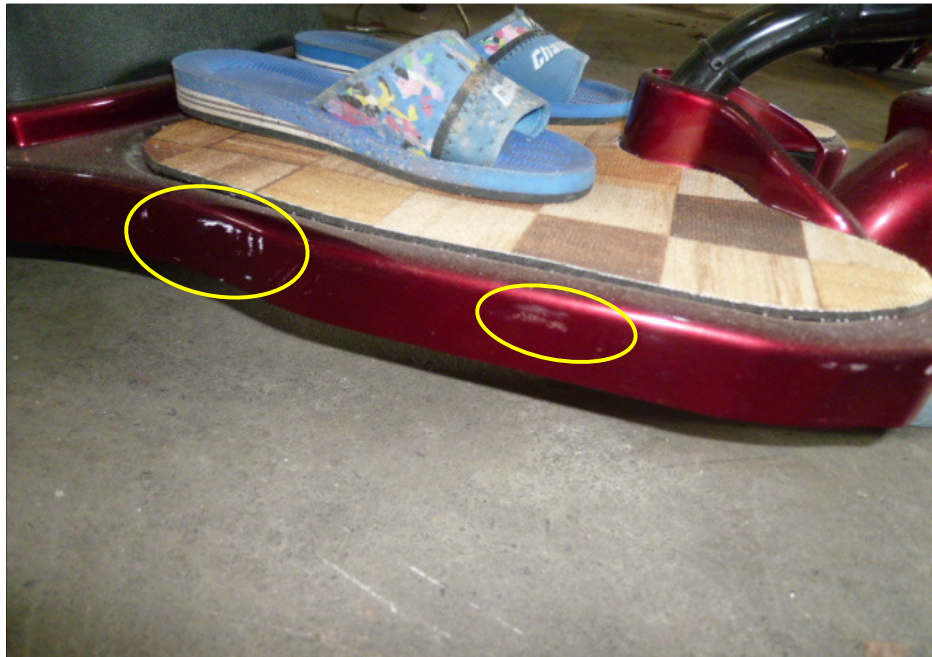
**Photo 5** shows a closer view of the right bottom cowling (circled) of the PMA which was observed to be damaged due to the accident.

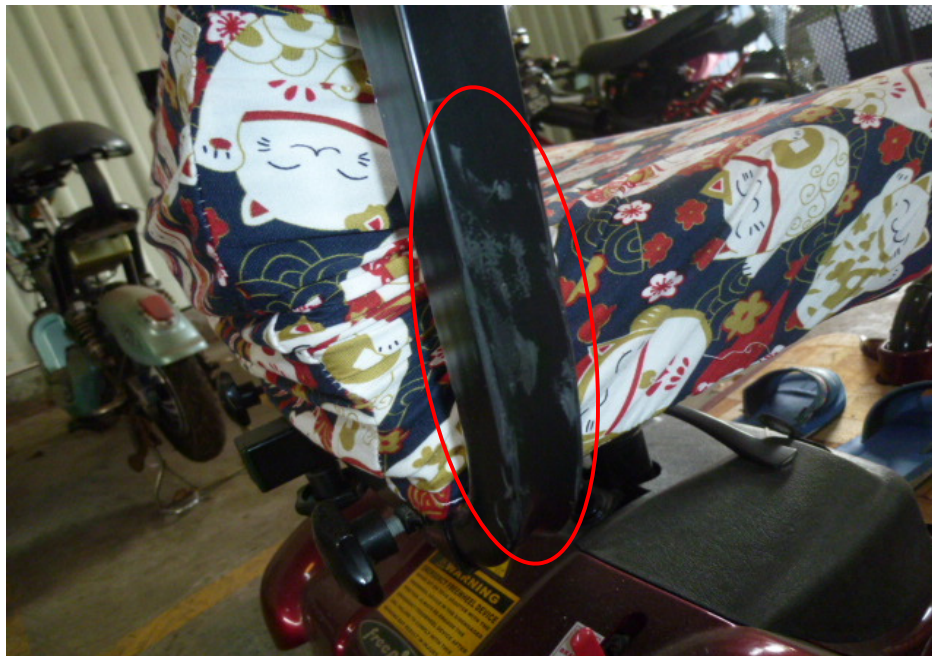
**Photo 6** shows a closer view of the grazed right armrest (circled) of the PMA as a result of the accident.

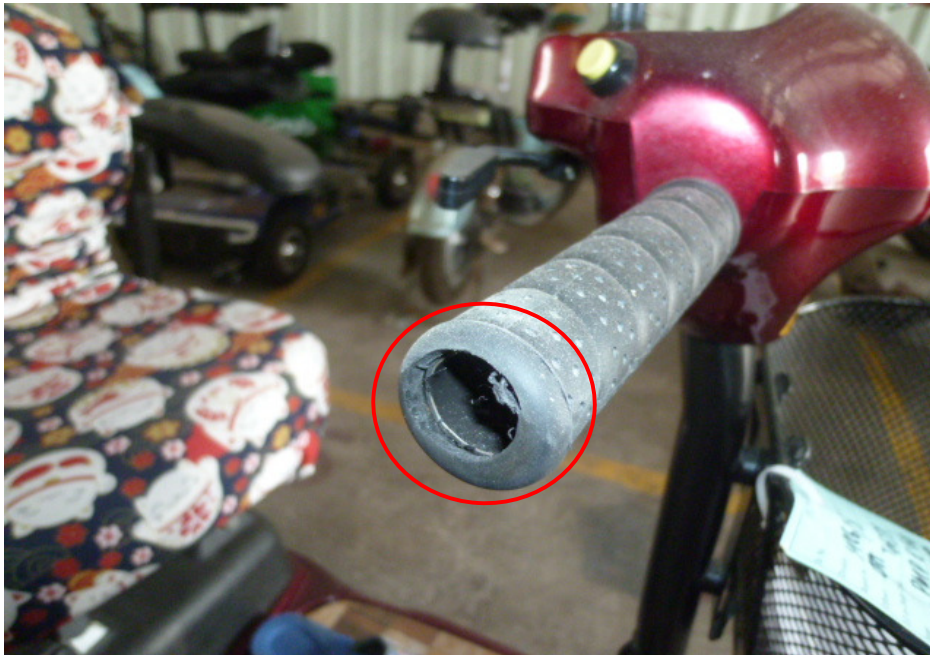
**Photo 7** shows a closer view of the right handlebar grip (circled) of the PMA which were observed to be damaged due to the accident

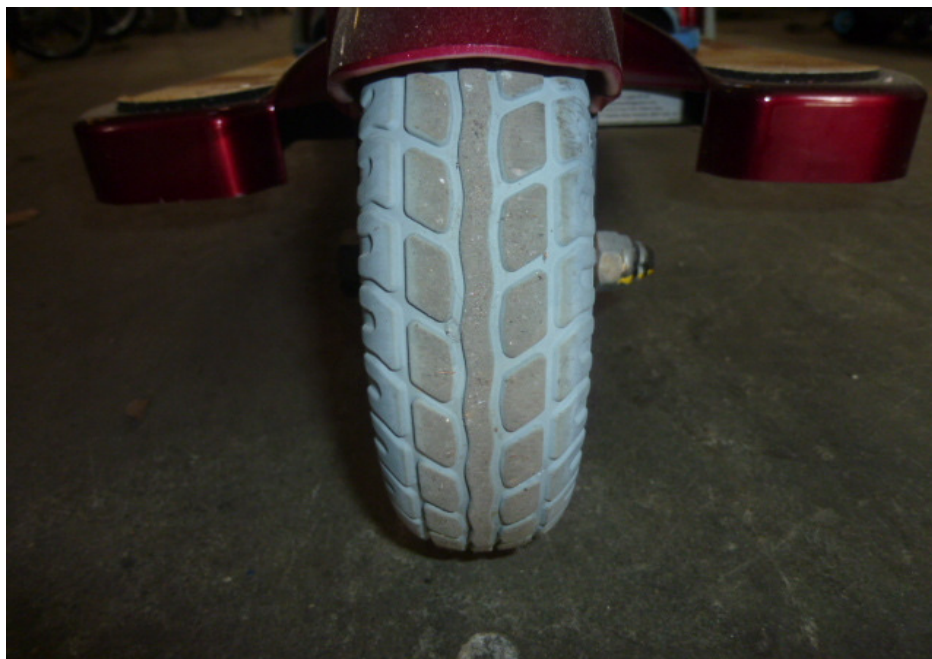
**Photo 8** shows the condition of the PMA's front tyre. The front tyre was observed to be in serviceable condition with remaining tread depth of approximately 3mm. There was no tear, burst mark(s) and/or punctured hole(s) on the sidewalls as well as across the tread of the front tyre.

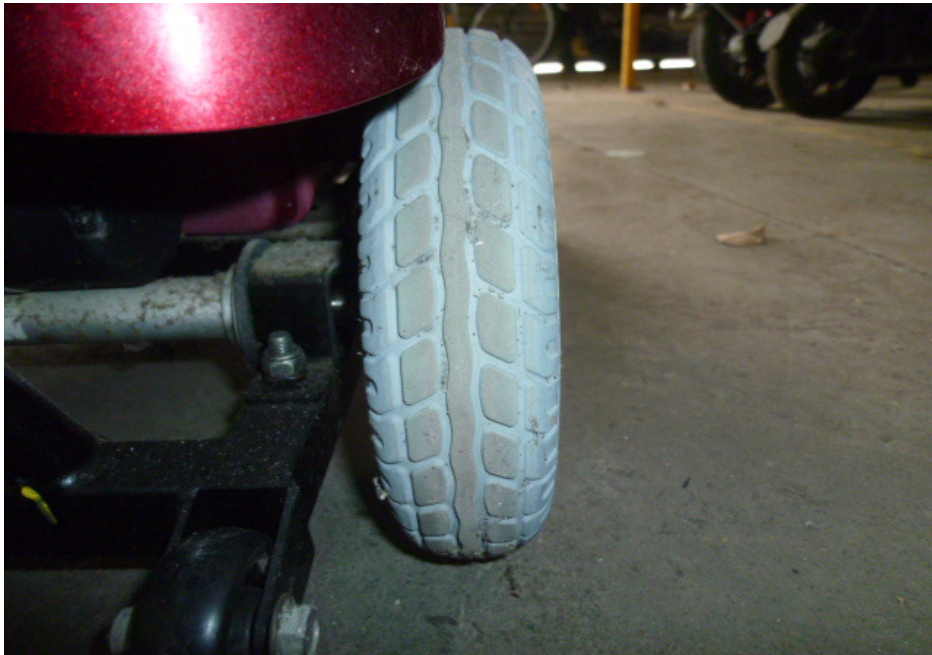
**Photo 9** shows the condition of the PMA's right rear tyre. The right rear tyre was observed to be in serviceable condition with remaining tread depth of approximately 3mm. There was no tear, burst mark(s) and/or punctured hole(s) on the sidewalls as well as across the tread of the right rear tyre.

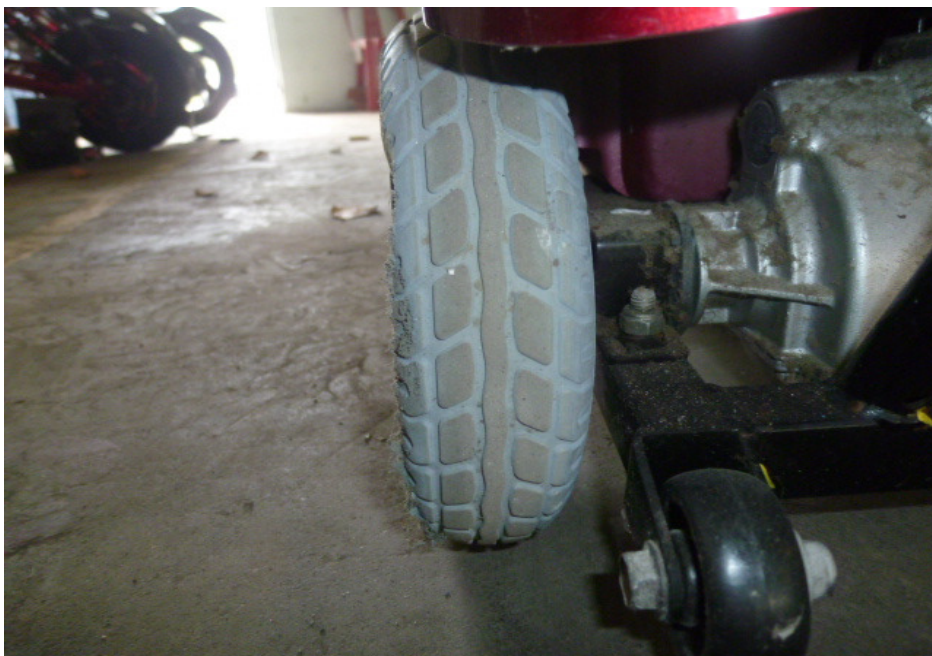
5. The PMA's 3 Polyurethane (PU) solid tyres were observed to be in serviceable condition. The tread pattern of the 3 tyres was clearly visible. We did not observe any tear, burst mark(s) and/or punctured hole(s) on the sidewalls as well as across the tread of the 3 tyres. However we found the left sidewall of the left rear tyre to be grazed. The tyre size and remaining tread depth of the 3 tyres were recorded as follows:-

**Photo 10** shows the condition of the PMA's left rear tyre. The left rear tyre was observed to have remaining tread depth of approximately 3mm. The left rear tyre was also observed to be sufficiently inflated for vehicular operation. However we found the left sidewall of the left rear tyre to be grazed.

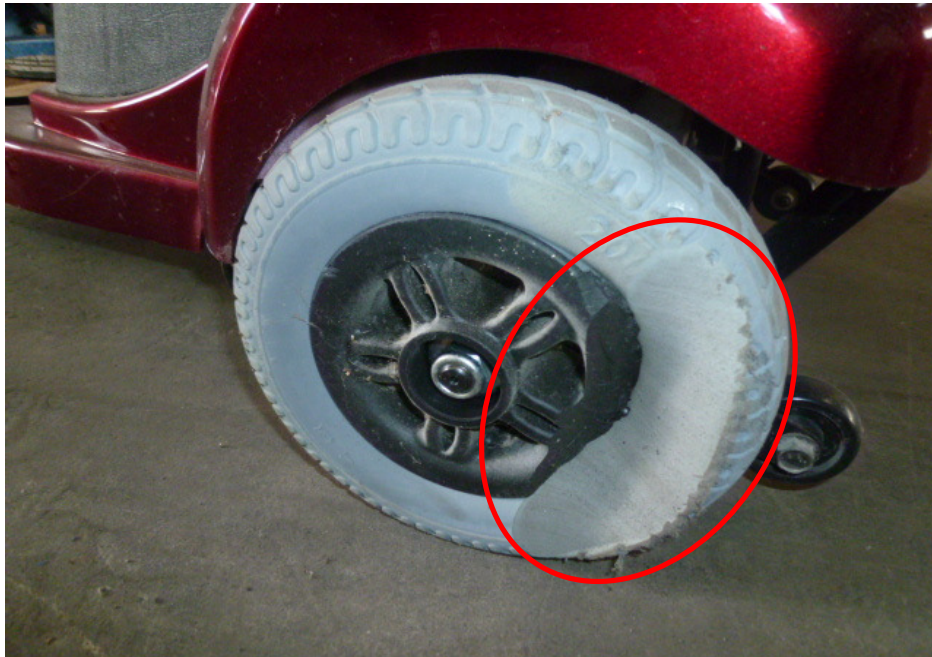
6. The 3 tyres were wrapped around plastic wheel rims. At the time of our inspection, we did not observe any visible damage on the front wheel rim and right rear wheel rim of the PMA. However we found marks of grazing nature on the left rear wheel rim of the PMA. See photos 8 - 11 below.

**Photo 11** shows the left rear wheel rim and tyre of the PMA at the time of our inspection. Marks of grazing nature were observed on the left rear wheel rim and left sidewall of the left rear tyre of the PMA (circled).

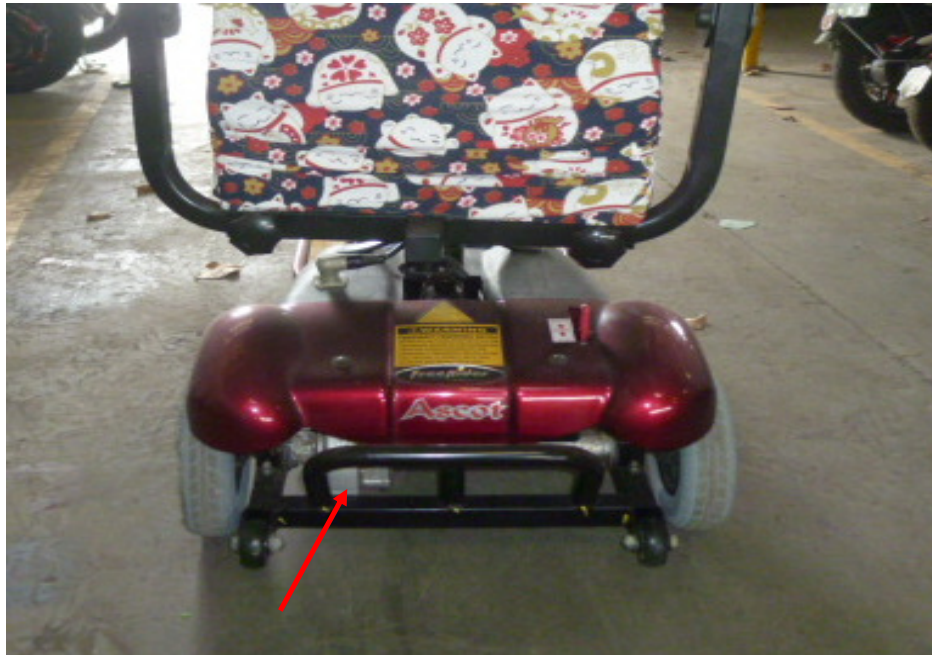
7. The PMA is controlled by an electric drive motor which is powered by a wireless battery pack to drive the rear tyres. The motor was originally installed on the rear portion of the rear tyres & found adequately acceptable. The motor of the PMA was found to be intact without any misalignment or damages. It was also observed to be in operational condition. The wireless battery pack of the PMA was also found to be intact without any misalignment. See photos 12 & 13 below.

**Photo 12** shows the general view of the electric drive motor (arrowed) of the PMA which was observed to be intact with no misalignment or damages. It was also observed to be in operational condition.

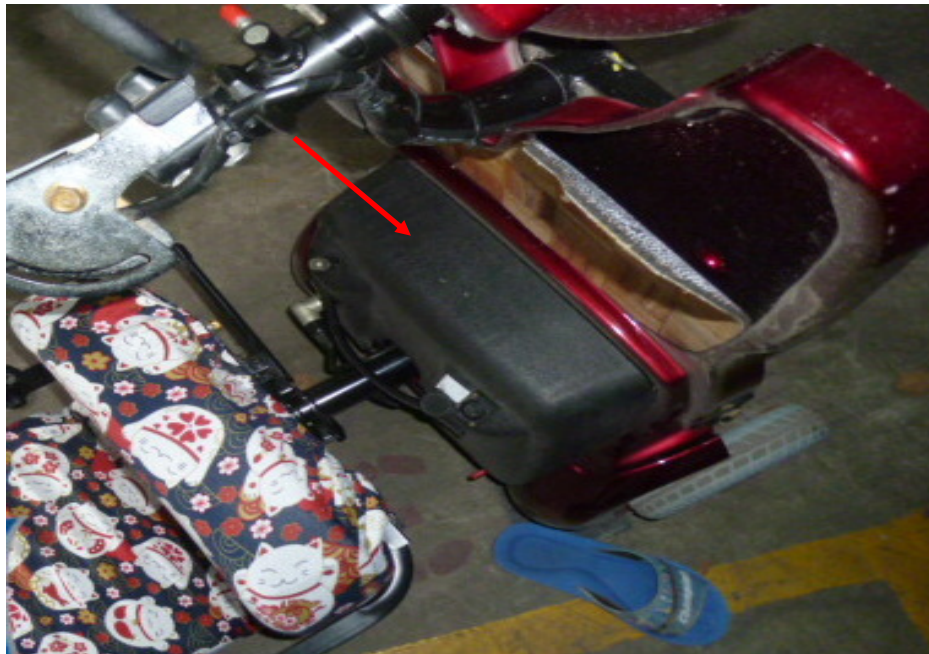
**Photo 13** shows the wireless battery pack of the PMA (arrowed) which was found to be intact without any misalignment.

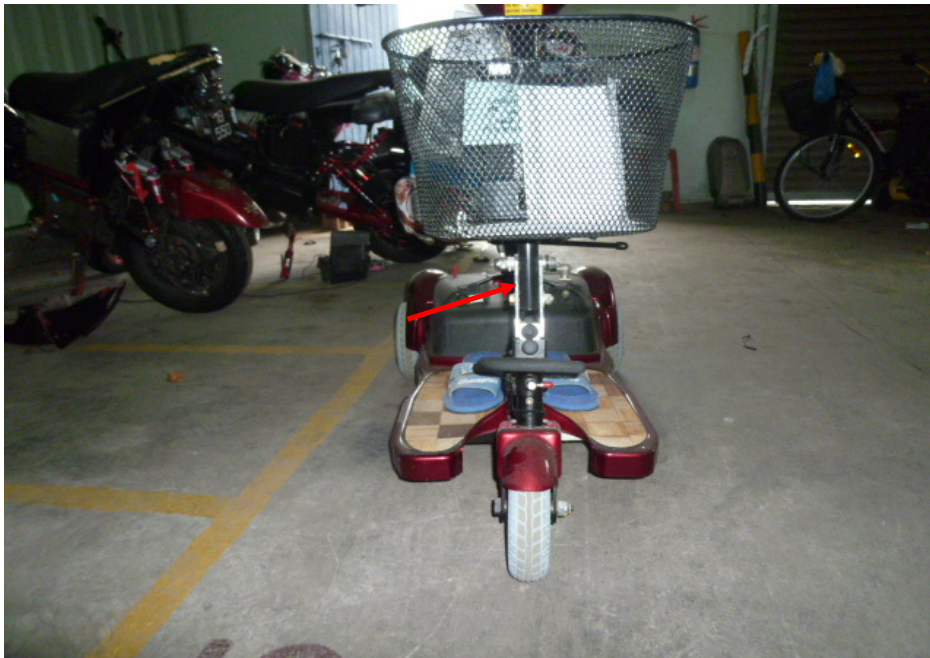
8. Our checks on the various steering components of the PMA revealed that its steering system was in serviceable condition. Its steering handlebar was found to be intact and undamaged. Turning the handle bar towards the left and right did not produce any abnormal free play and/or resistance.

**Photo 14** shows the steering handlebar (arrowed) of the PMA. The steering handlebar of the PMA was found to be intact and undamaged. Turning the PMA's steering handlebar towards the left and right did not produce any abnormal free play. The steering system of the PMA was in serviceable condition at the time of our inspection.

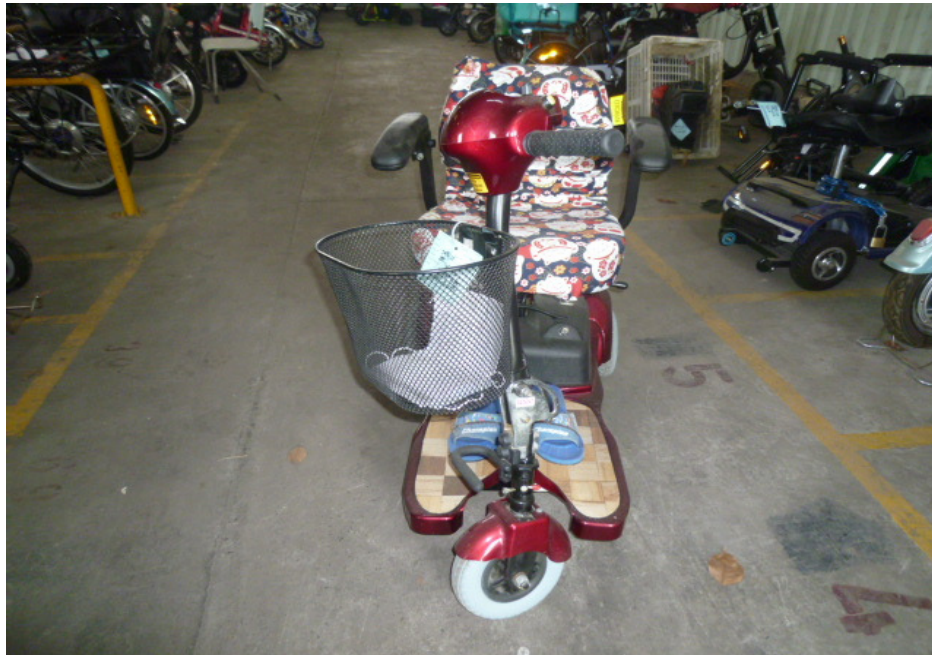
**Photo 15** shows the front wheel of the PMA turned towards its full right. Turning the PMA's steering handlebar towards the right did not produce any abnormal free play and/or resistance. This would indicate that the steering system of the PMA was in serviceable condition at the time of our inspection.

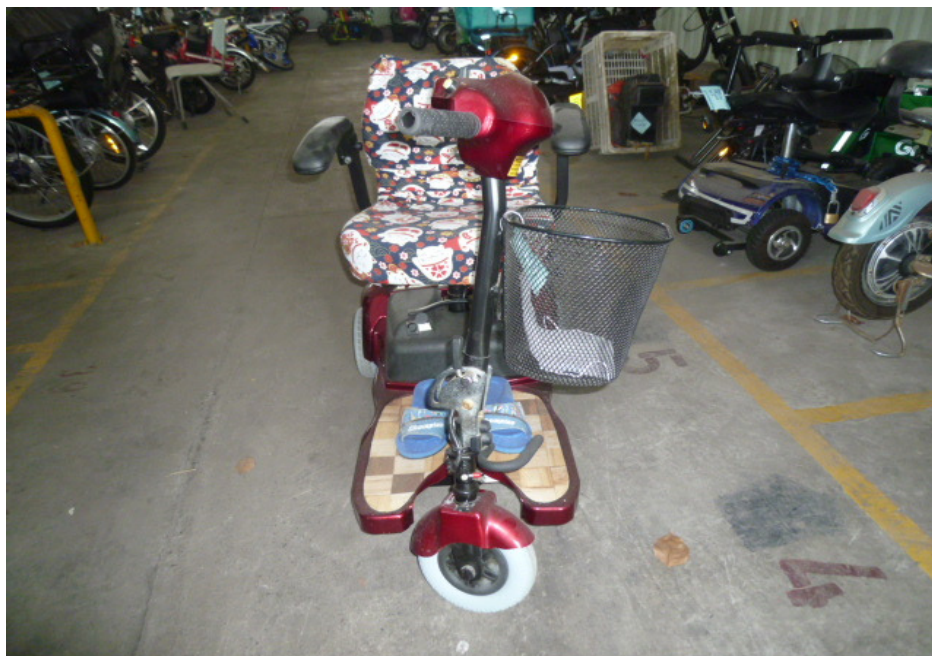
**Photo 16** shows the front wheel of the PMA turned towards its full left. Turning the PMA's steering handlebar towards the left did not produce any abnormal free play and/or resistance. This would indicate that the steering system of the PMA was in serviceable condition at the time of our inspection.

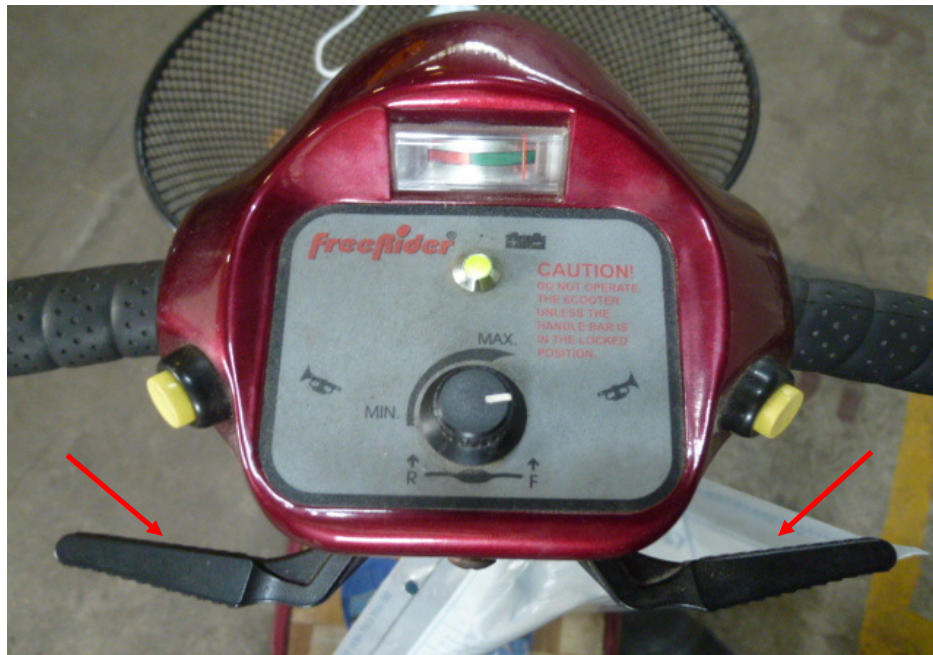
**Photo 17** shows a close up view of the forward control lever and reverse control lever of the PMA (arrowed), which are all part of the components in the regenerative braking system of the PMA. Our visual checks of these various components had revealed all to be intact with no visible damage.

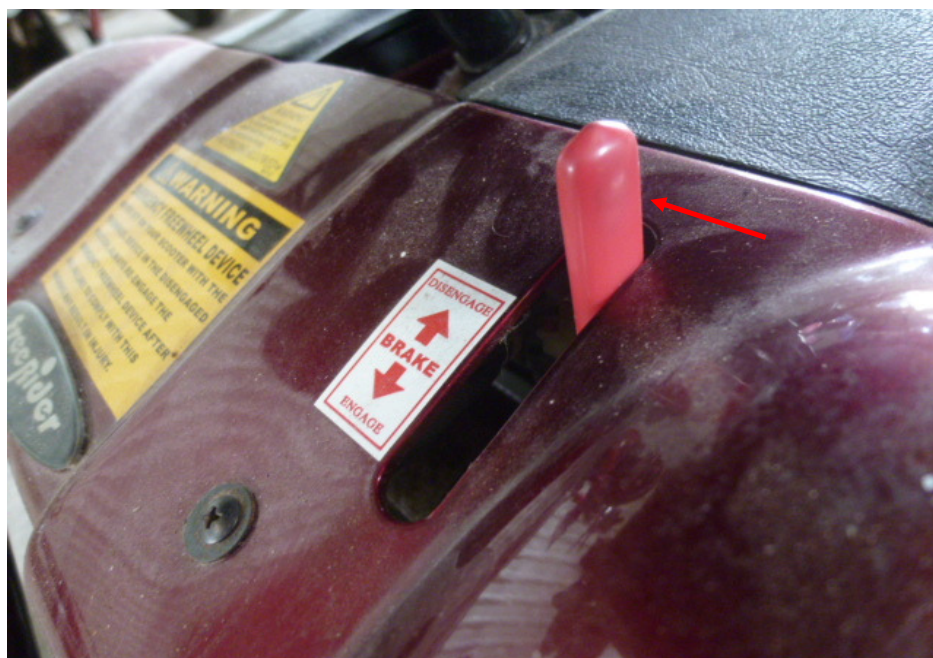
**Photo 18** shows a close up view of the electric/mechanical disc park brake lever (arrowed) of the PMA. Our visual check of this component had revealed it to be intact with no visible damage.

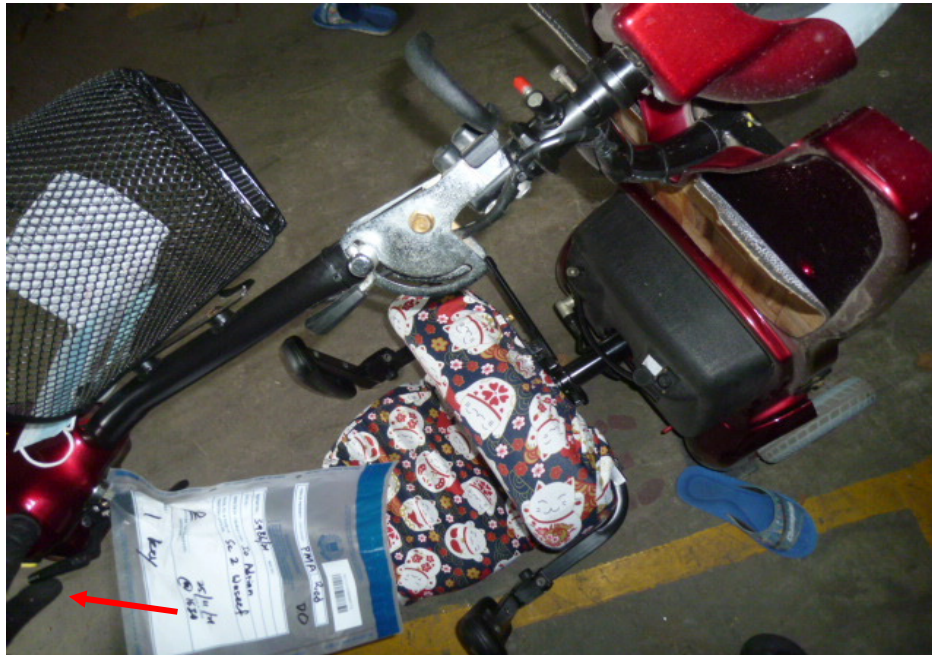
11. A static brake test was conducted on the PMA's forward braking system. The test was conducted by lifting the rear wheels above ground. The PMA was switched on and the forward control lever (right hand lever) was pushed to rotate the rear wheels in a forward motion. The forward control lever was then released in order to stop the spinning rear tyres. The result was satisfactory. It stopped after the forward control lever returned to the centre (neutral drive) position.

**Photo 19** shows a static brake test conducted on the PMA's forward braking system. The test was conducted by lifting the rear wheels above ground. The PMA was switched on and the forward control lever (right hand lever) was pushed to rotate the rear wheels in a forward motion. The forward control lever was then released in order to stop the spinning rear tyres. The result was satisfactory. It stopped after the forward control lever returned to the centre (neutral drive) position.

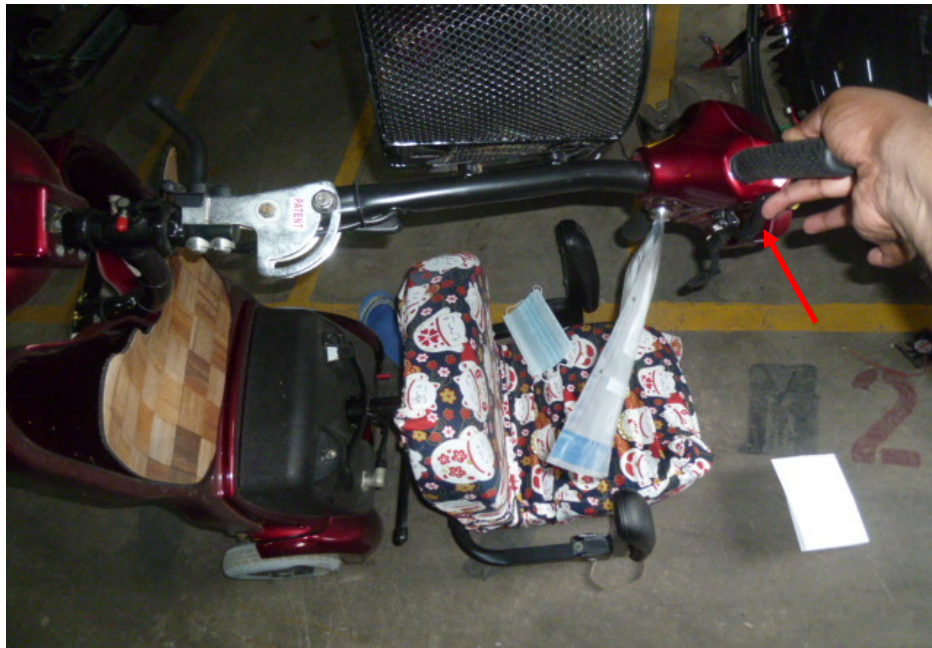
12. A static brake test was conducted on the PMA's reverse braking system. The test was conducted by lifting the rear wheels above ground. The PMA was switched on and the reverse control lever (left hand lever) was pushed to rotate the rear wheels in a reverse motion. The reverse control lever was then released in order to stop the spinning rear tyres. The result was satisfactory. It stopped after the reverse control lever returned to the centre (neutral drive) position.

**Photo 20** shows a static brake test conducted on the PMA's reverse braking system. The test was conducted by lifting the rear wheels above ground. The PMA was switched on and the reverse control lever (left hand lever) was pushed to rotate the rear wheels in a reverse motion. The reverse control lever was then released in order to stop the spinning rear tyres. The result was satisfactory. It stopped after the reverse control lever returned to the centre (neutral drive) position.

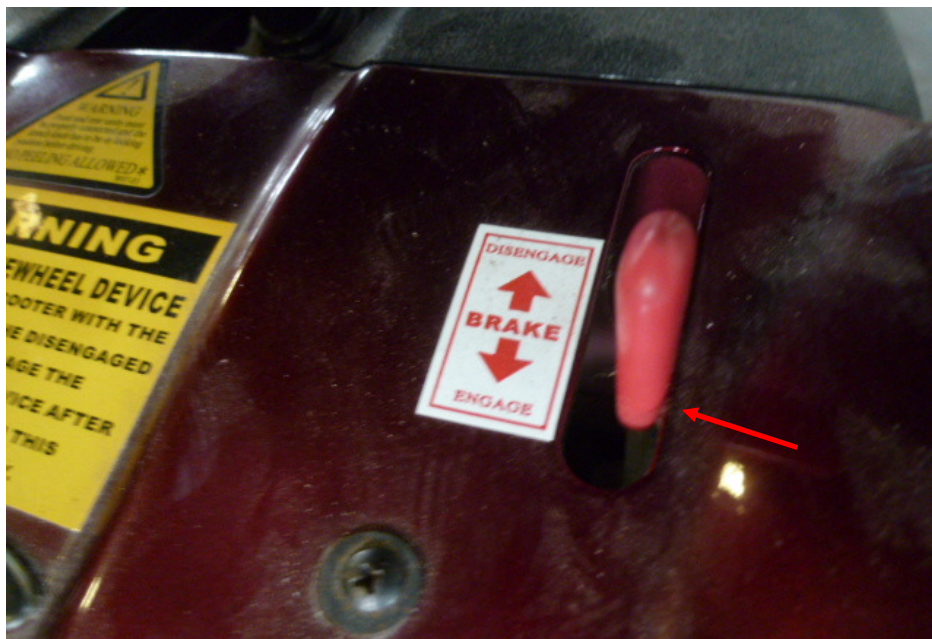
**Photo 21** shows the red handled lever was able to be pulled downwards (arrowed) to engage the electric/mechanical disc park brake for the operational test.
