Your Ref: TP/IP/59028/2021  
Our Ref : CI/TPD22002076/N

**Fatal Accident Investigation Team**

**INSPECTION REPORT OF MOTORCYCLE FBM 9963U**

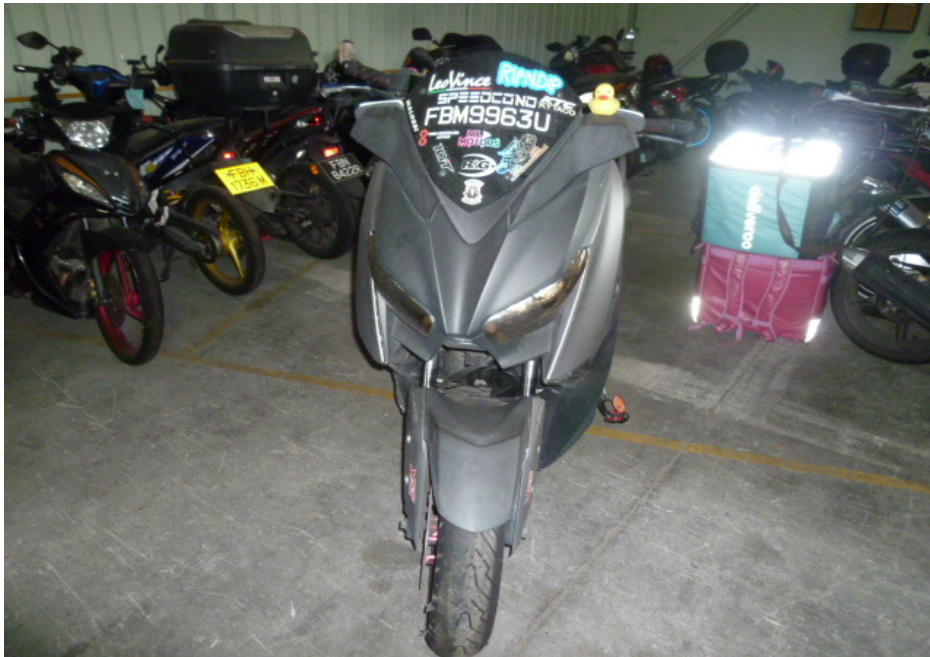
**Photo 1** shows a general view of the frontal portion of the Motorcycle at the time of our inspection. The Motorcycle was observed to have sustained damages all around. The mileage of the Motorcycle could not be recorded at the time of our inspection despite several attempts to jumpstart the battery.

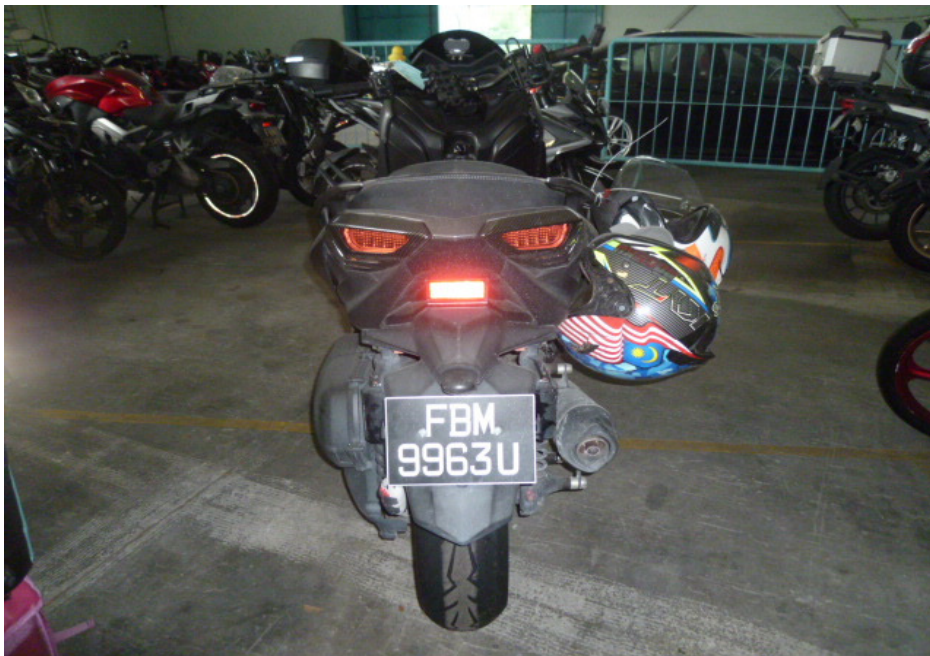
**Photo 2** shows a general view of the rear portion of the Motorcycle at the time of our inspection. The Motorcycle was observed to have sustained damages all around.

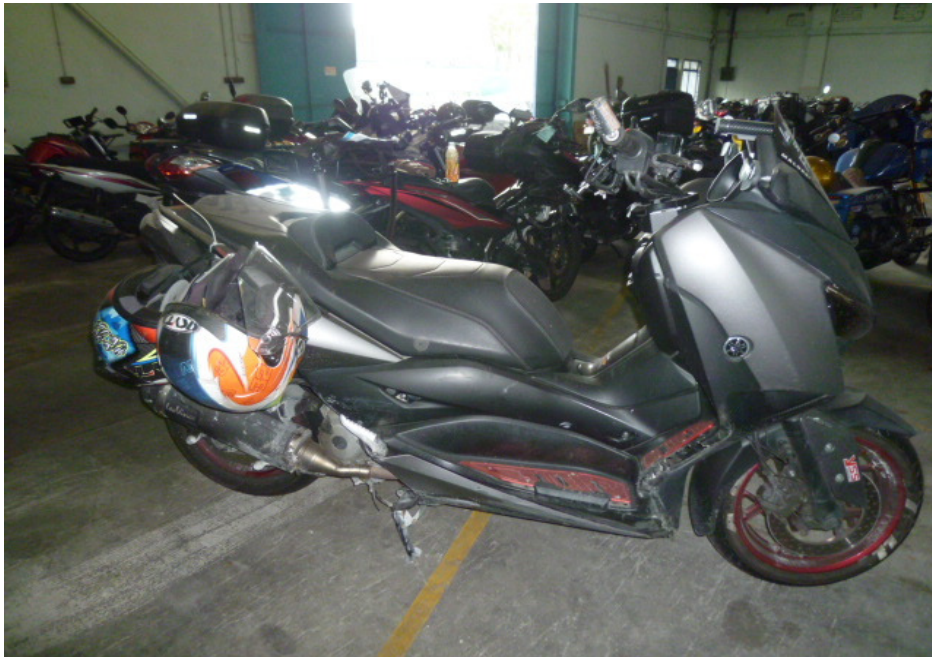
**Photo 3** shows a general view of the right body of the Motorcycle at the time of our inspection. The Motorcycle was observed to have sustained damages all around.

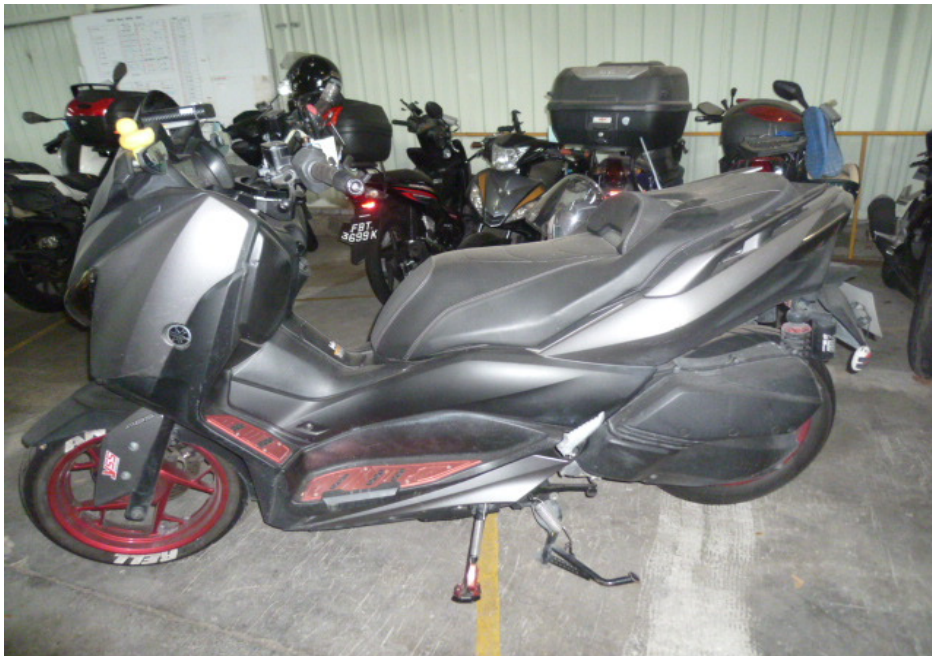
**Photo 4** shows a general view of the left body of the Motorcycle at the time of our inspection. The Motorcycle was observed to have sustained damages all around. The body parts that were found to have been damaged include its front brake lever, right handlebar end, side cowlings, side lower cowlings, pillion footpegs, side stand, rear side covers and exhaust muffler, amongst others as a result of the accident.

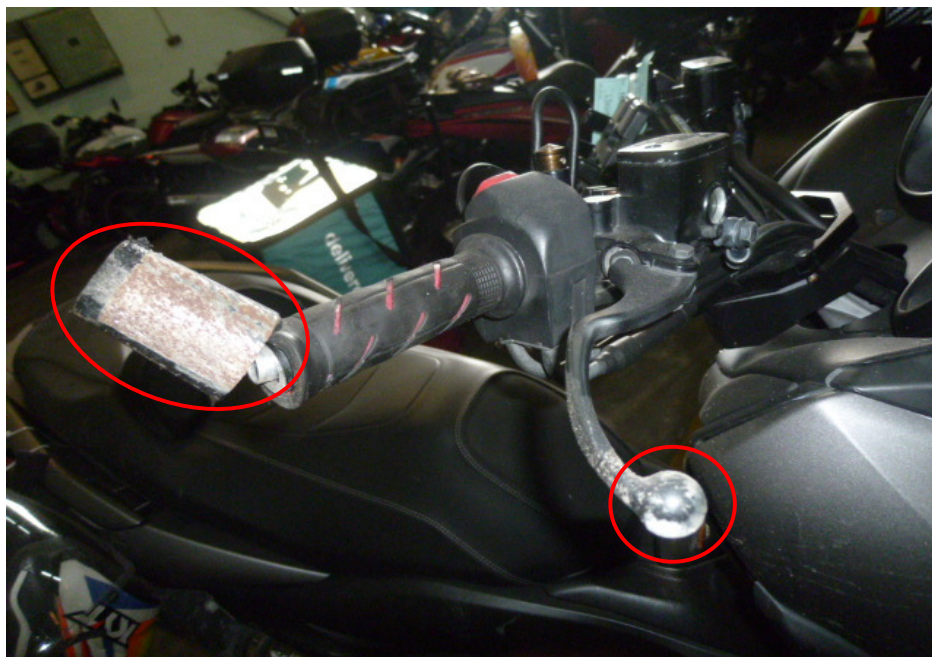
**Photo 5** shows a closer view of the right handlebar end and front brake lever of the Motorcycle which were observed to be damaged due to the accident (circled).

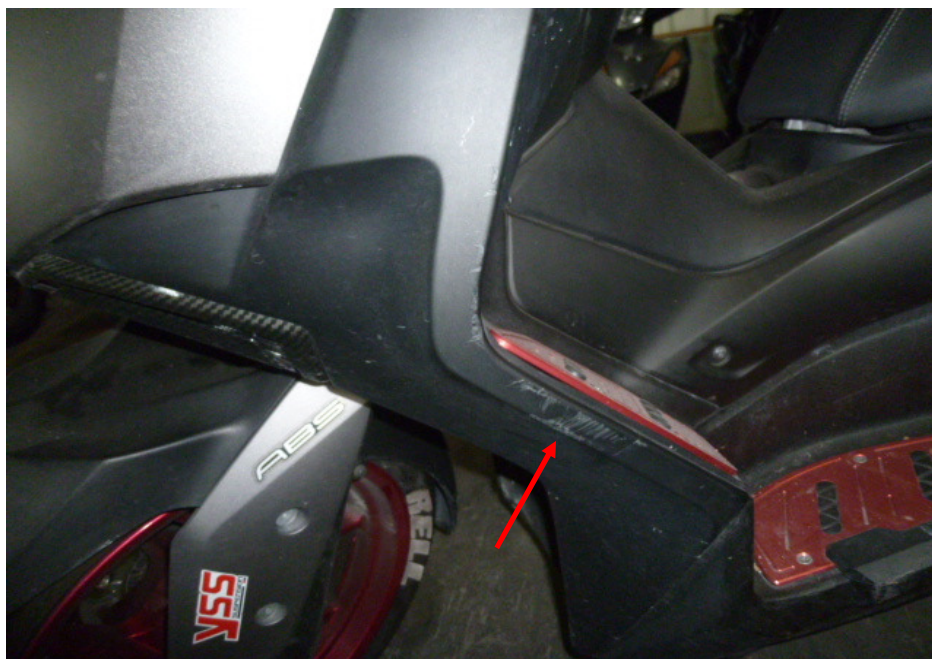
**Photo 6** shows a close-up view of the grazed left side cowling of the Motorcycle at the time of our inspection (arrowed).

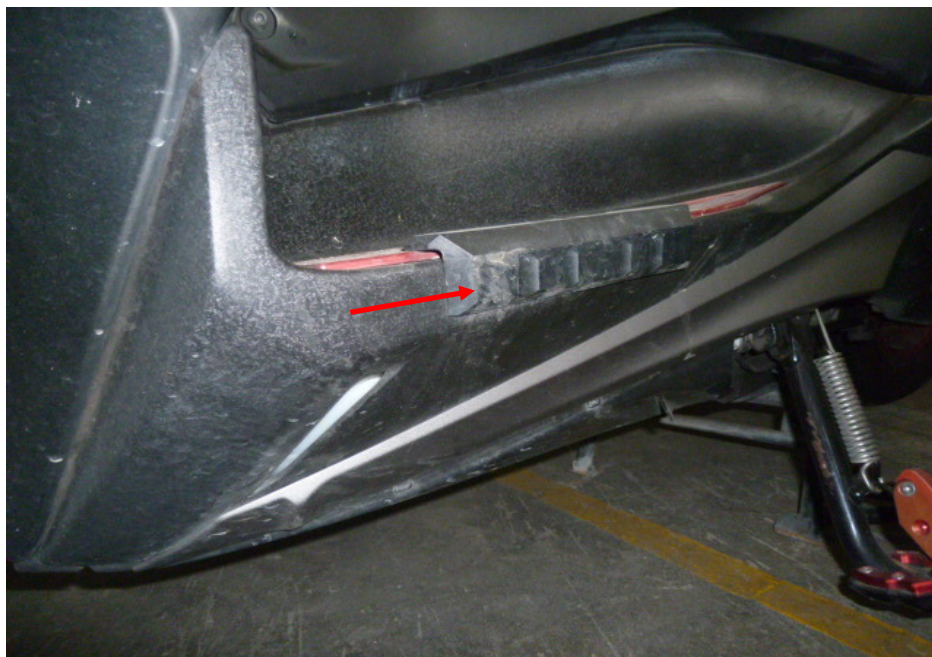
**Photo 7** shows a close-up view of the grazed left lower side cowling of the Motorcycle as a result of the accident (arrowed).

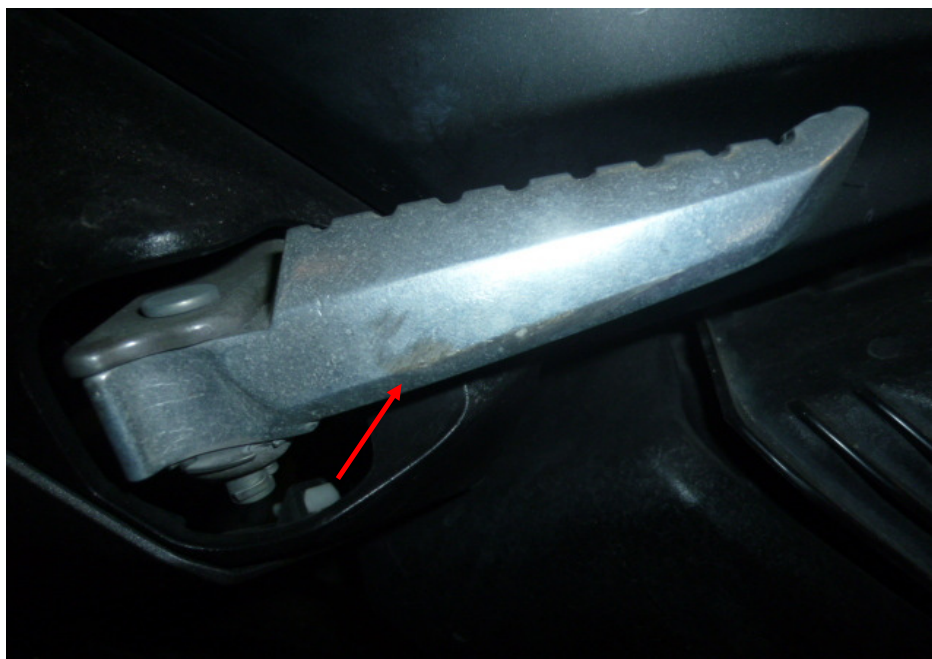
**Photo 8** shows a closer view of the grazed left pillion footpeg (arrowed) of the Motorcycle as a result of the accident.

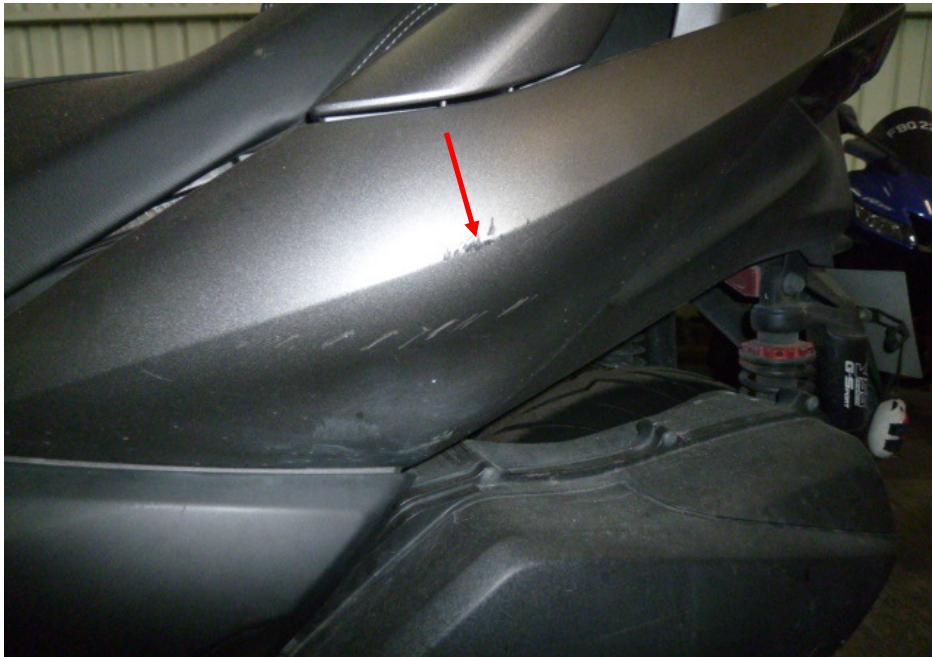
**Photo 9** shows a closer view of the grazed left rear side cover of the Motorcycle as a result of the accident (arrowed).

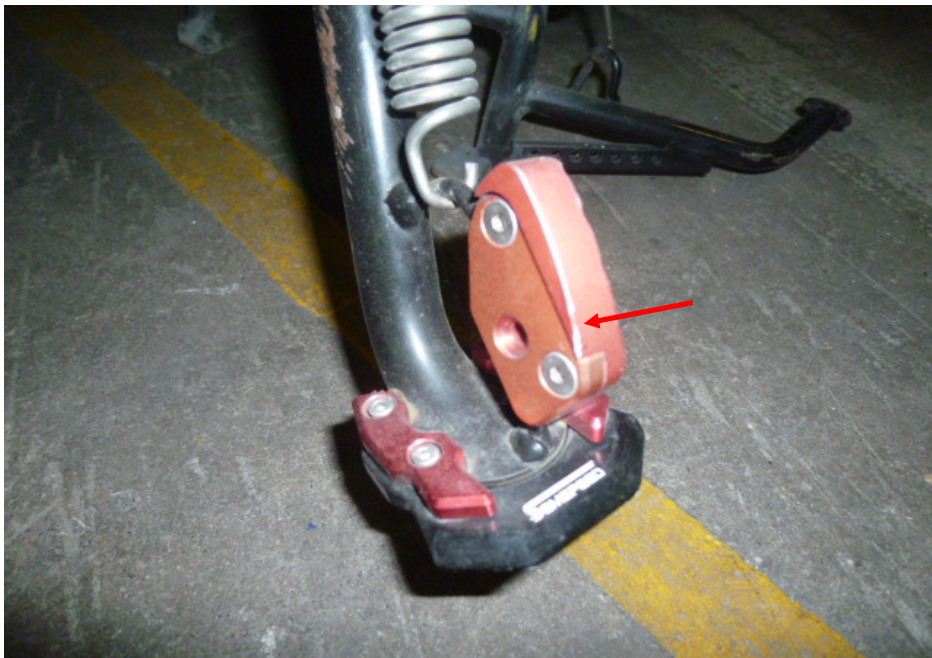
**Photo 10** shows a closer view of the grazed side stand of the Motorcycle as a result of the accident (arrowed).

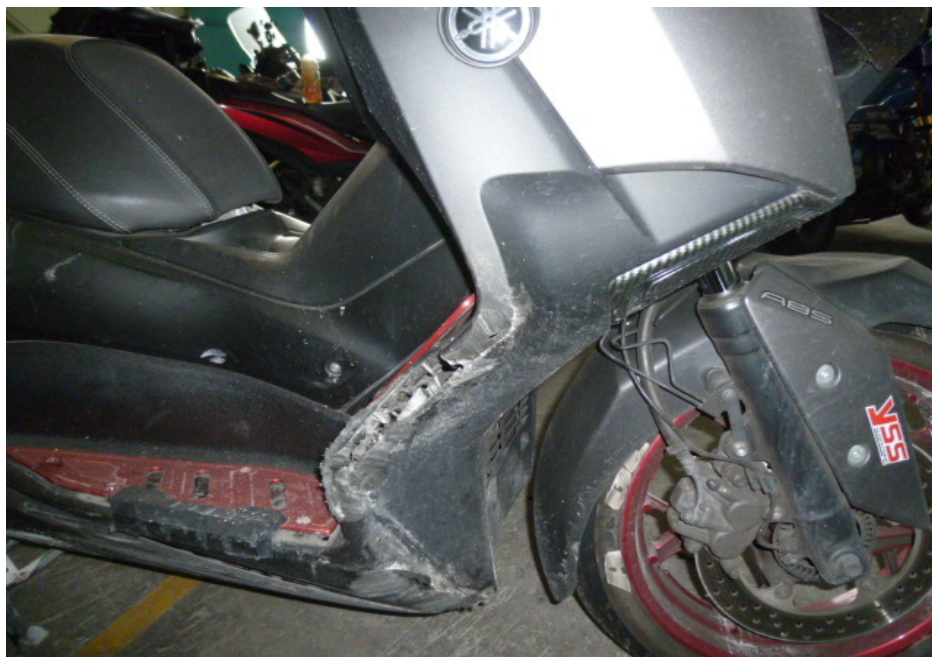
**Photo 11** shows the damaged right side cowling of the Motorcycle as a result of the accident.

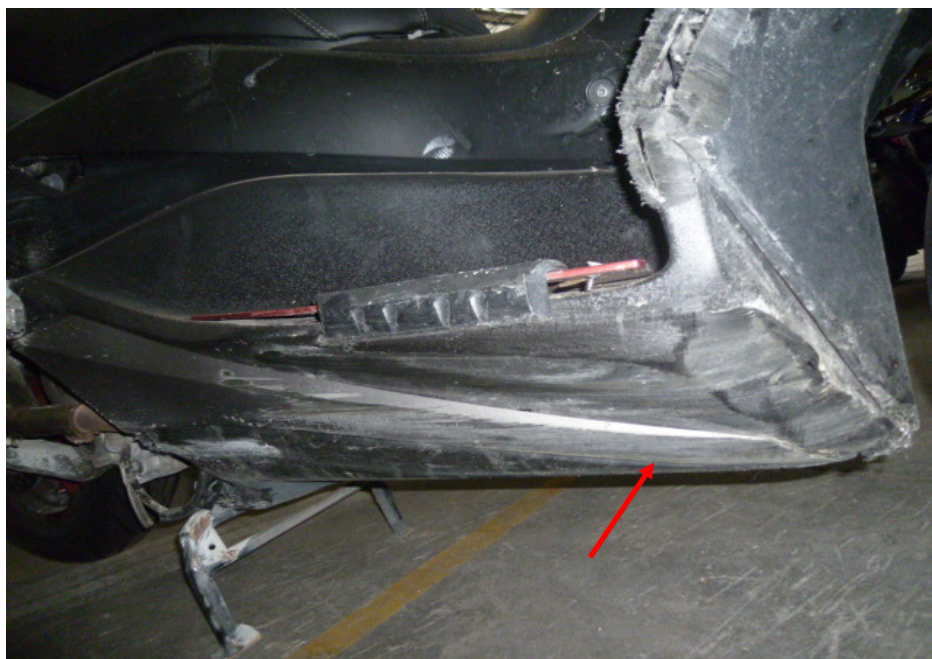
**Photo 12** shows a close-up view of the grazed right lower side cowling of the Motorcycle as a result of the accident.

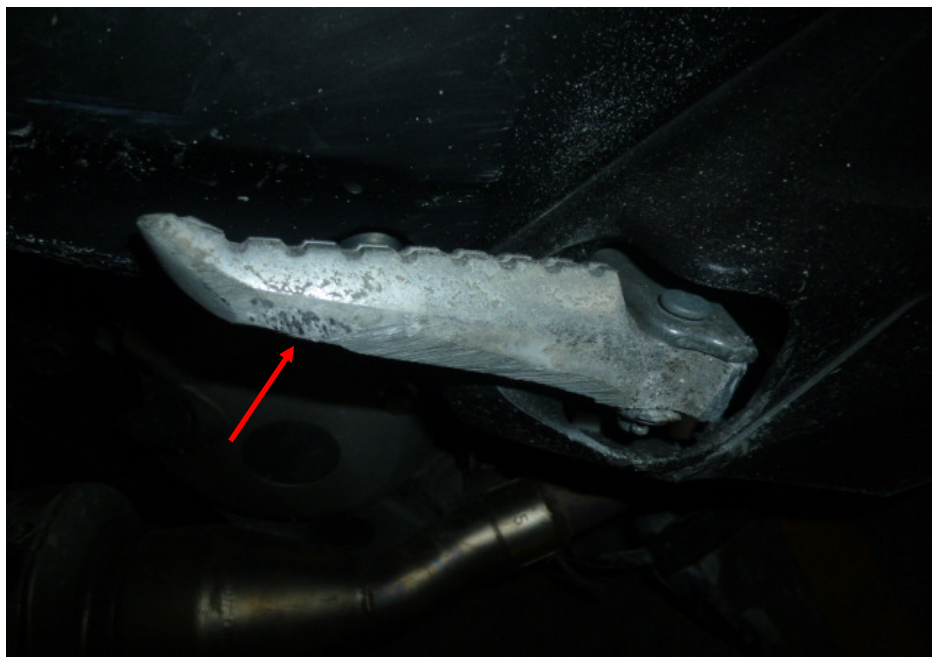
**Photo 13** shows a closer view of the grazed right pillion footpeg (arrowed) of the Motorcycle as a result of the accident.

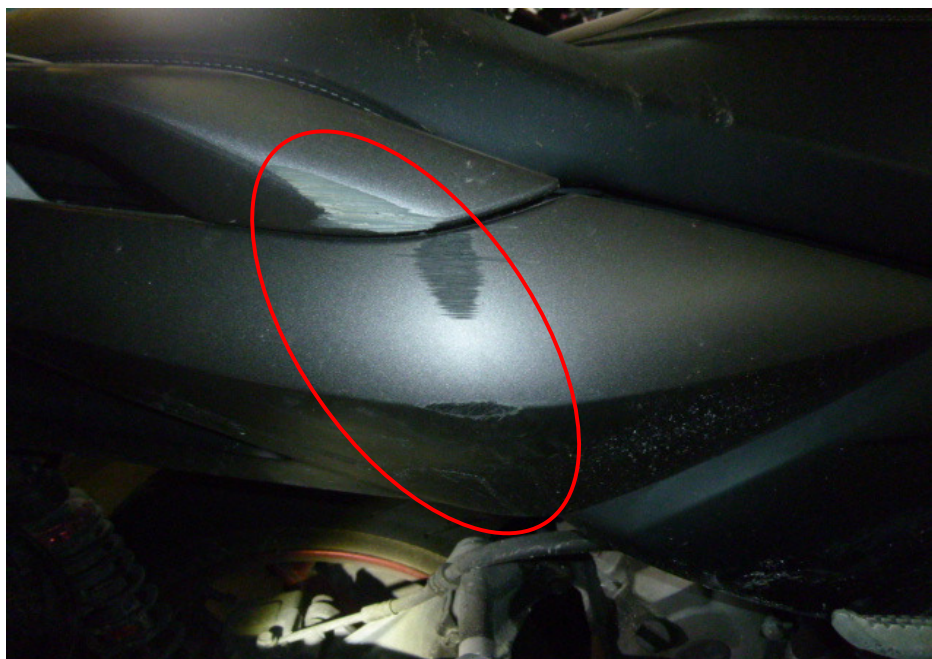
**Photo 14** shows a closer view of the grazed right rear side cover (circled) of the Motorcycle as a result of the accident.

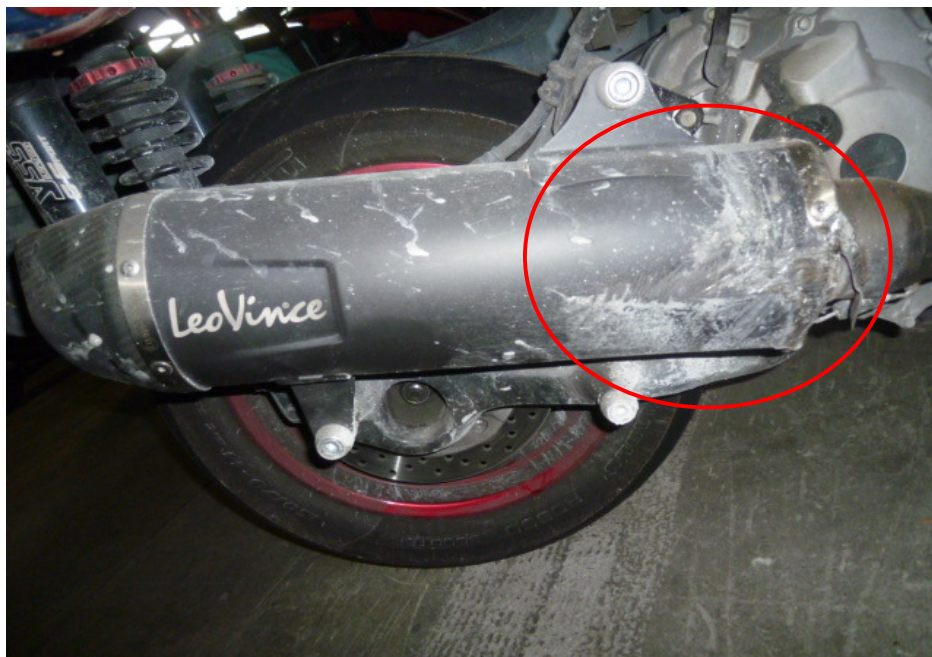
**Photo 15** shows a closer view of the deformed exhaust muffler of the Motorcycle as a result of the accident (circled).

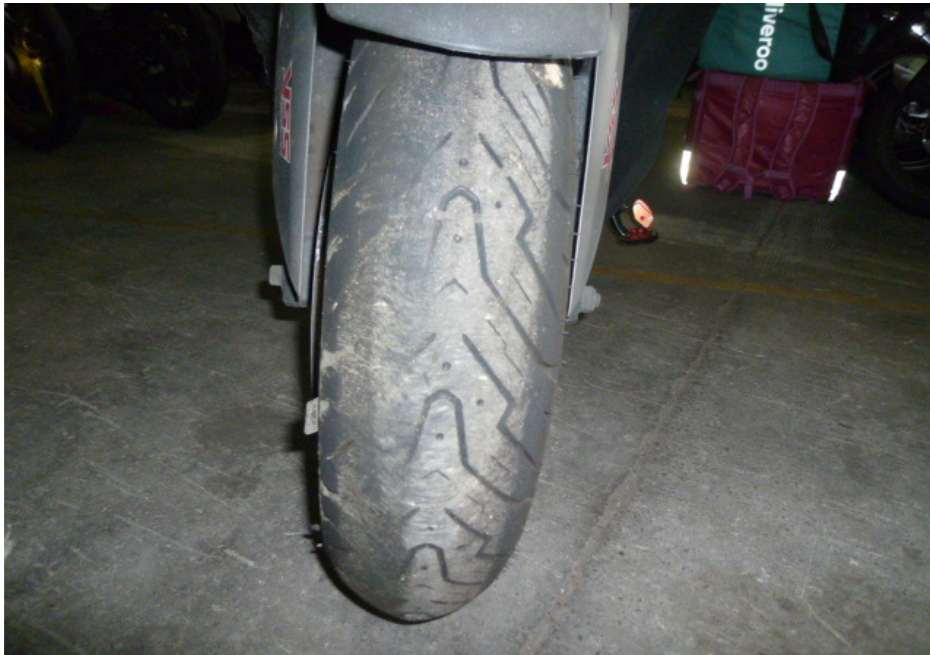
**Photo 16** shows the condition of the Motorcycle's front tyre. The front tyre was observed to be in serviceable condition with remaining tread depth of approximately 2mm. There was no tear, burst mark(s) and/or punctured hole(s) on the sidewalls as well as across the tread of the front tyre.

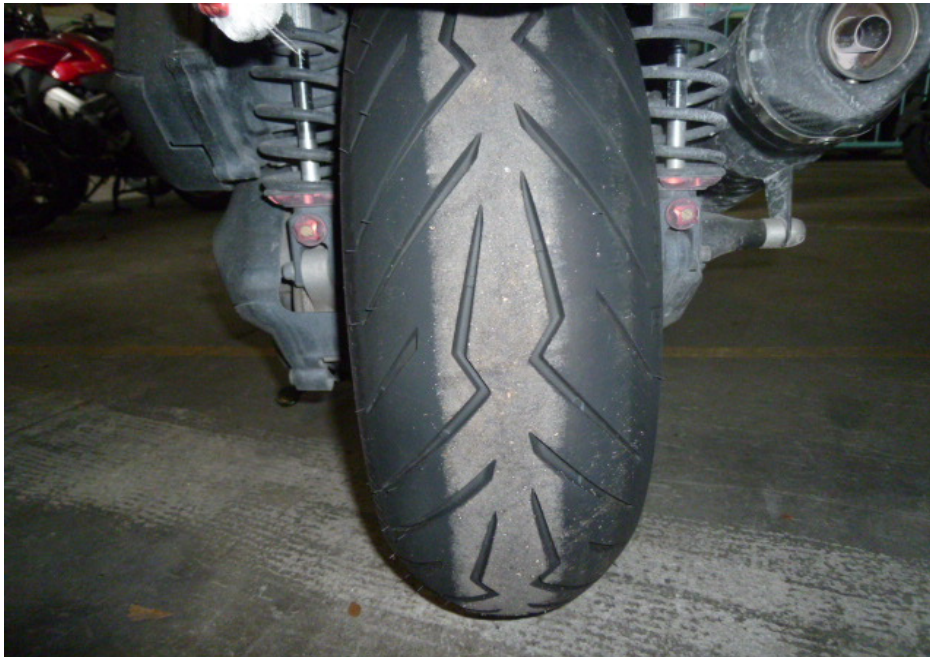
**Photo 17** shows the condition of the Motorcycle's rear tyre. The rear tyre was observed to be in serviceable condition with remaining tread depth of approximately 8mm. The tyre was also observed to be sufficiently inflated for vehicular operation. We did not observe any tear, burst mark(s) and/or punctured hole(s) on the sidewalls as well as across the tread of the rear tyre.

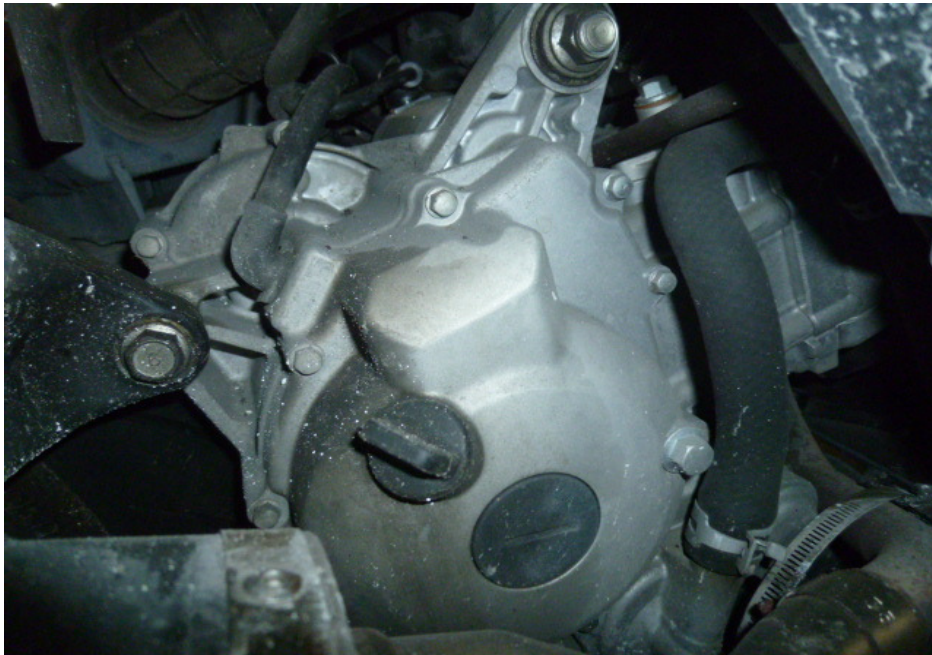
**Photo 18** shows the right side of the engine of the Motorcycle at the time of our inspection. The various engine related parts and components were found to be intact with no visible damage. There was also no sign(s) or indication(s) of fluid leak observed around the right engine area of the Motorcycle.

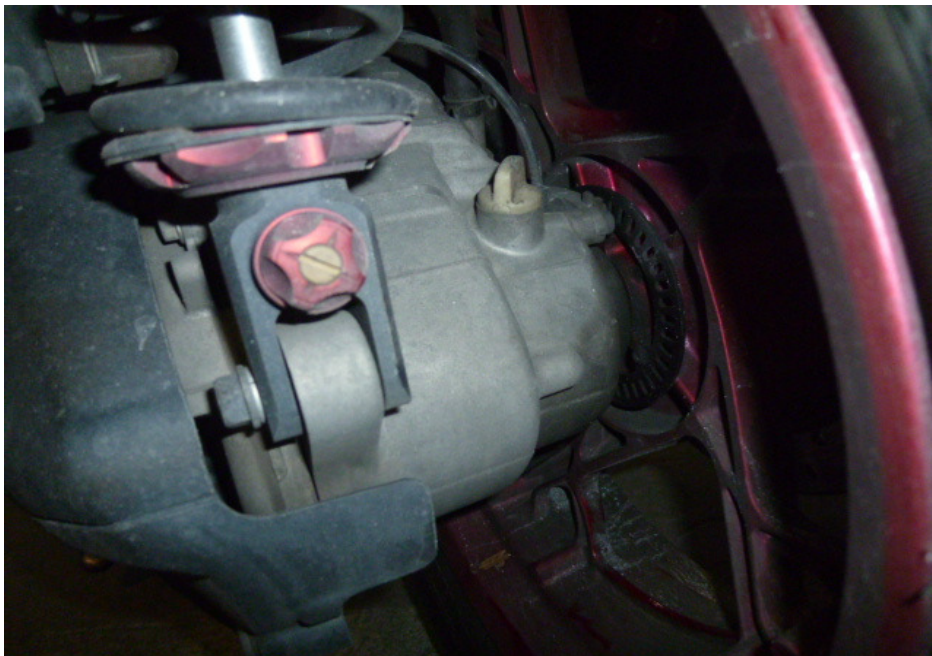
**Photo 19** shows the left side of the engine of the Motorcycle at the time of our inspection. The various engine related parts and components were found to be intact with no visible damage. There was also no sign(s) or indication(s) of fluid leak observed around the left engine area of the Motorcycle.

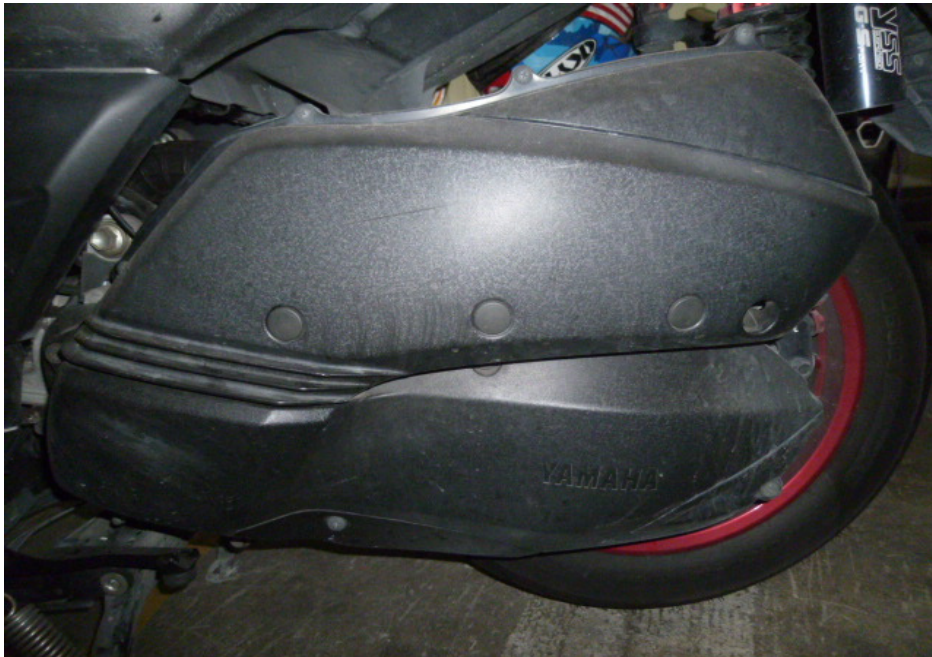
**Photo 20** shows the drive train cover of the Motorcycle which was found to be intact without any misalignment.

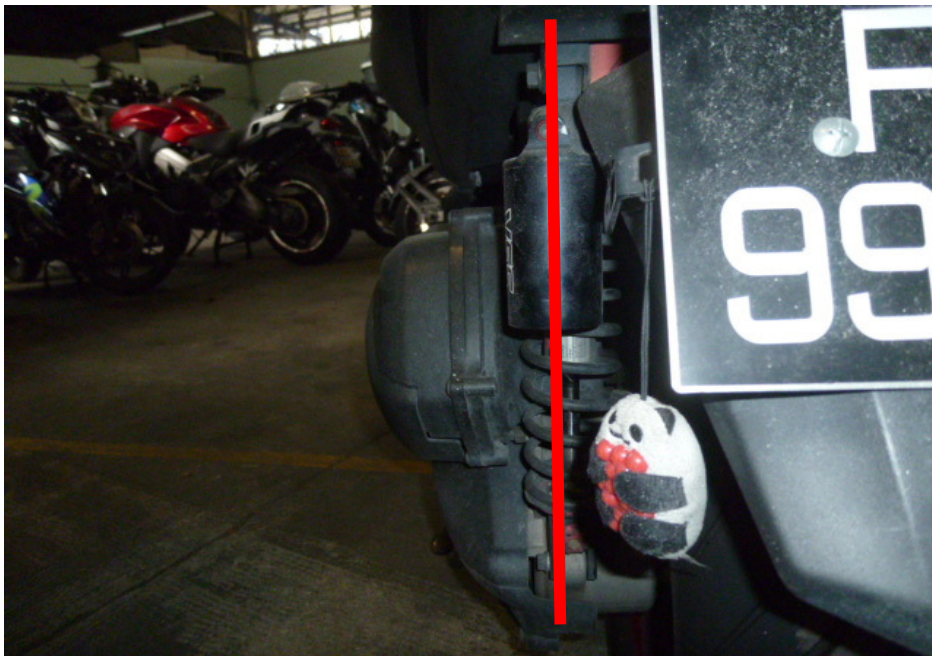
**Photo 21** shows the left shock absorber of the Motorcycle which was found to be intact without any misalignment.

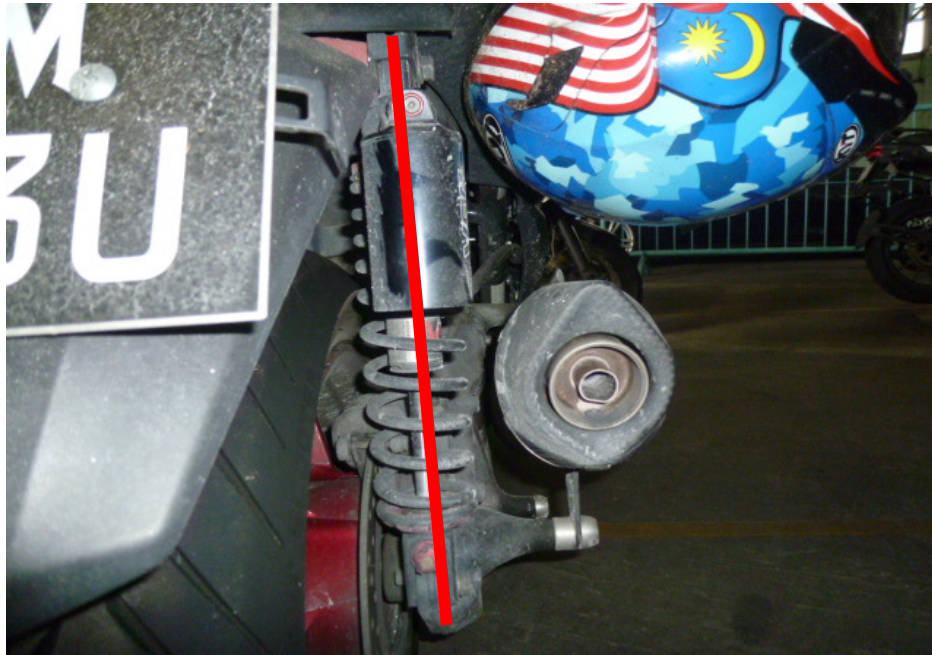
**Photo 22** shows the right shock absorber of the Motorcycle which was found to be intact without any misalignment.

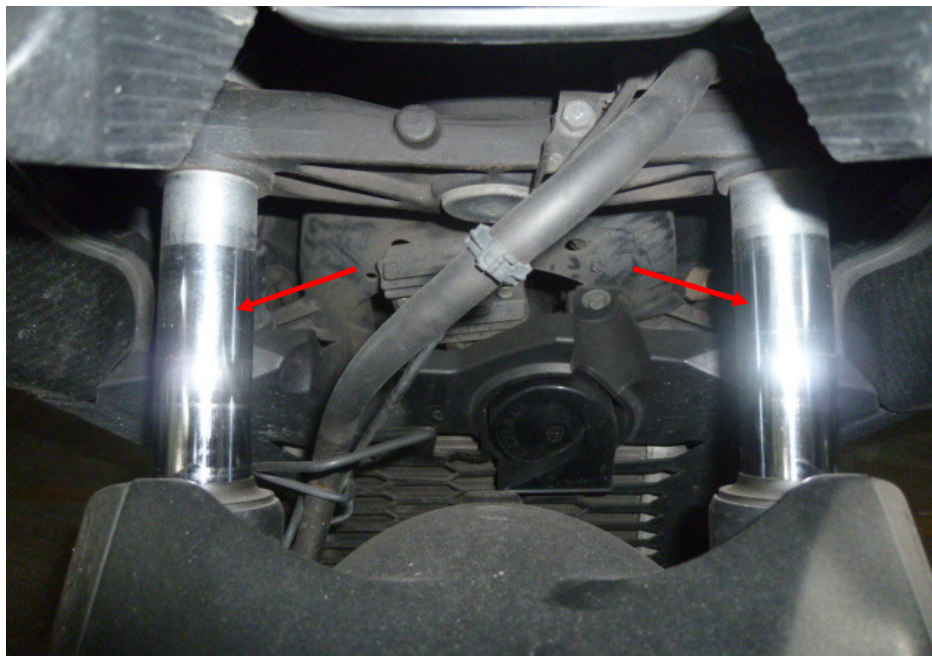
**Photo 23** shows the front forks (arrowed) of the Motorcycle. The front forks and fork brackets of the Motorcycle were both found to be intact and undamaged. Turning the Motorcycle's handle bar towards the left and right did not produce any abnormal free play and/or resistance. The steering system of the Motorcycle was in serviceable condition at the time of our inspection.

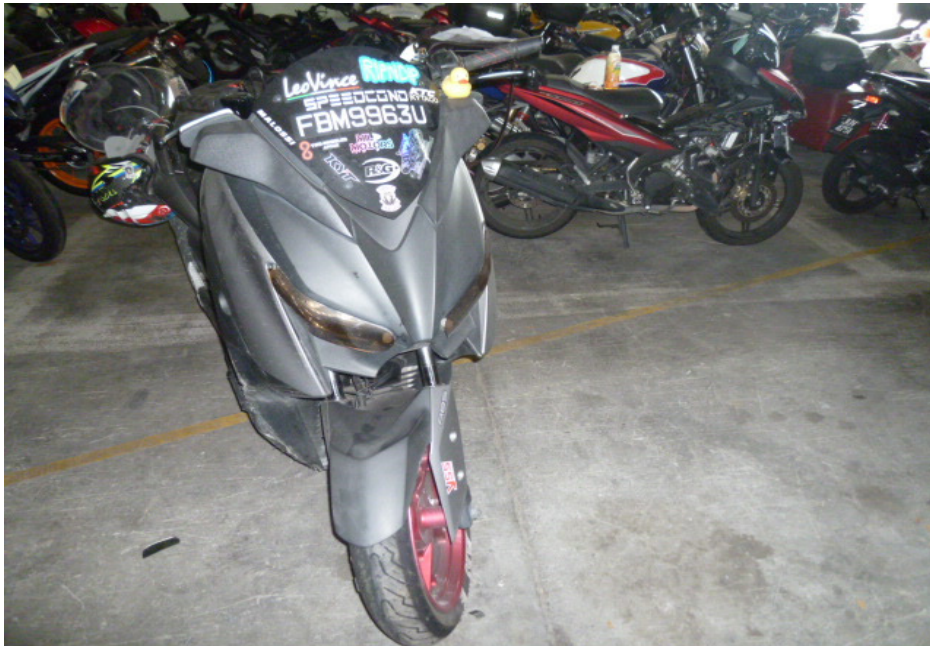
**Photo 24** shows the front wheel of the Motorcycle turned towards its full right. Turning the Motorcycle's handle bar towards the left and right did not produce any abnormal free play and/or resistance. This would indicate that the steering system of the Motorcycle was in serviceable condition at the time of our inspection.

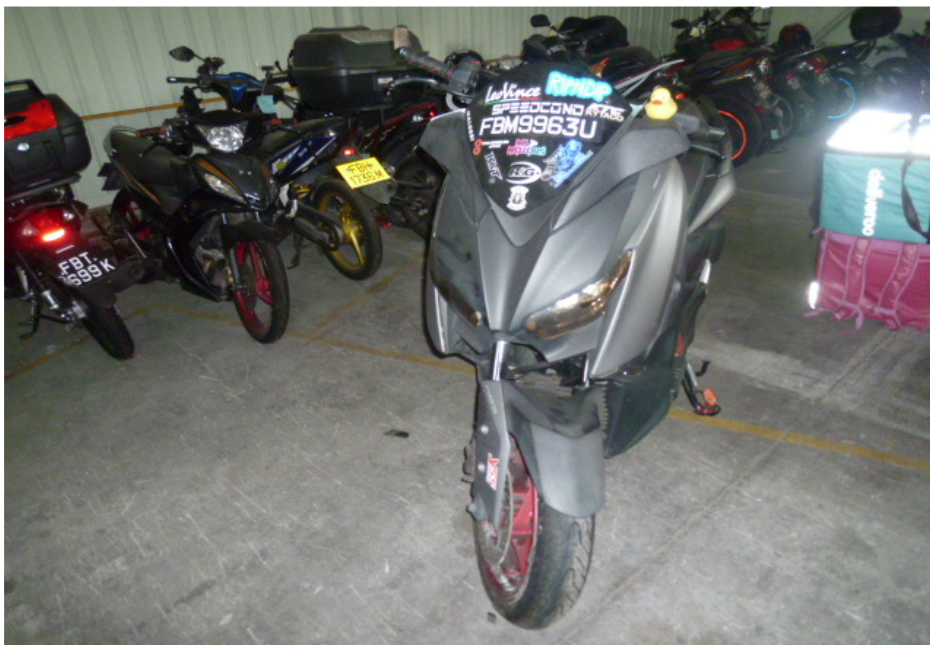
**Photo 25** shows the front wheel of the Motorcycle turned towards its full left. Turning the Motorcycle's handle bar towards the left and right did not produce any abnormal free play and/or resistance. This would indicate that the steering system of the Motorcycle was in serviceable condition at the time of our inspection.

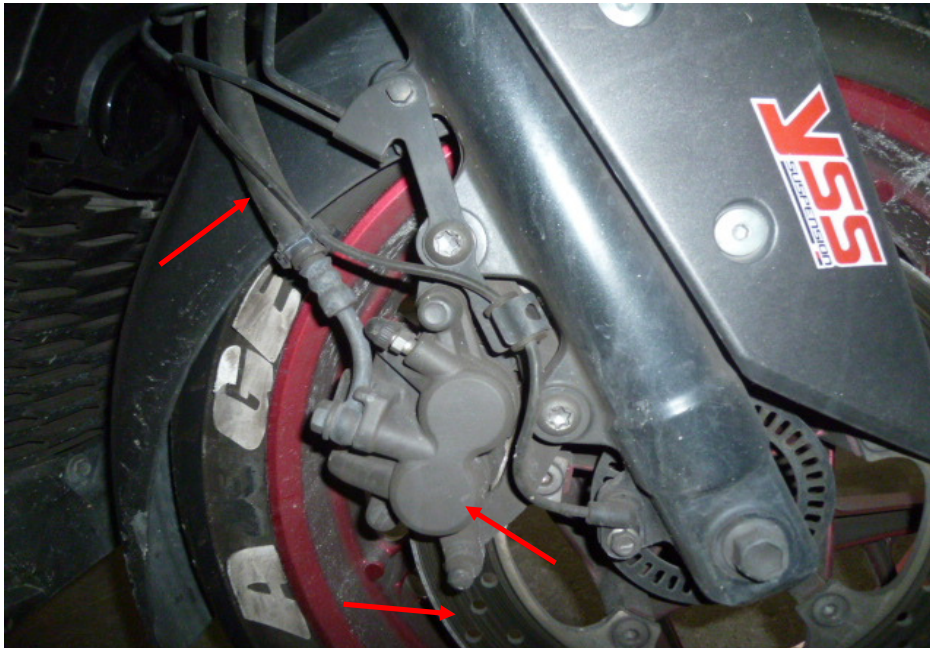
**Photo 26** shows a close up view of the front brake caliper, front brake disc and front brake hose (arrowed) of the Motorcycle, which are all part of the components in the hydraulic front brake system of the Motorcycle. Our visual checks of these various components had revealed all to be intact with no visible damage. No leakage of brake fluid was also observed.

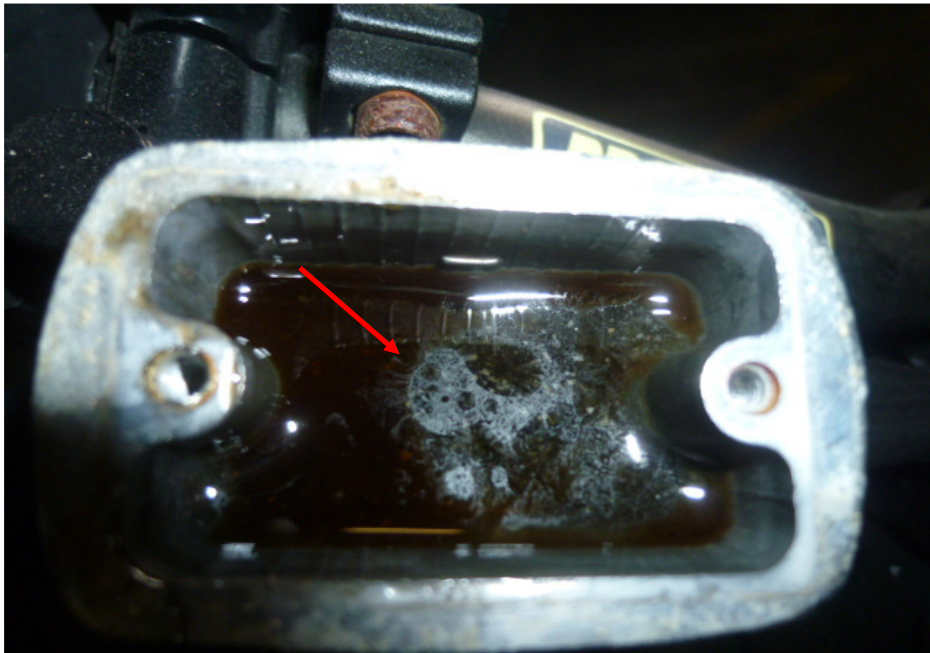
13. Our checks on the front brake fluid had indicated that the front brake fluid was of sufficient level for operational purposes. However it was found to be slightly contaminated. Our checks on the rear brake fluid had also indicated that the rear brake fluid was of sufficient level for operational purposes, and without contamination.

**Photo 27** shows the brake fluid reservoir for the front brake of the Motorcycle. The brake fluid was observed to be of sufficient level for operational purposes. However it was found to be slightly contaminated (arrowed).

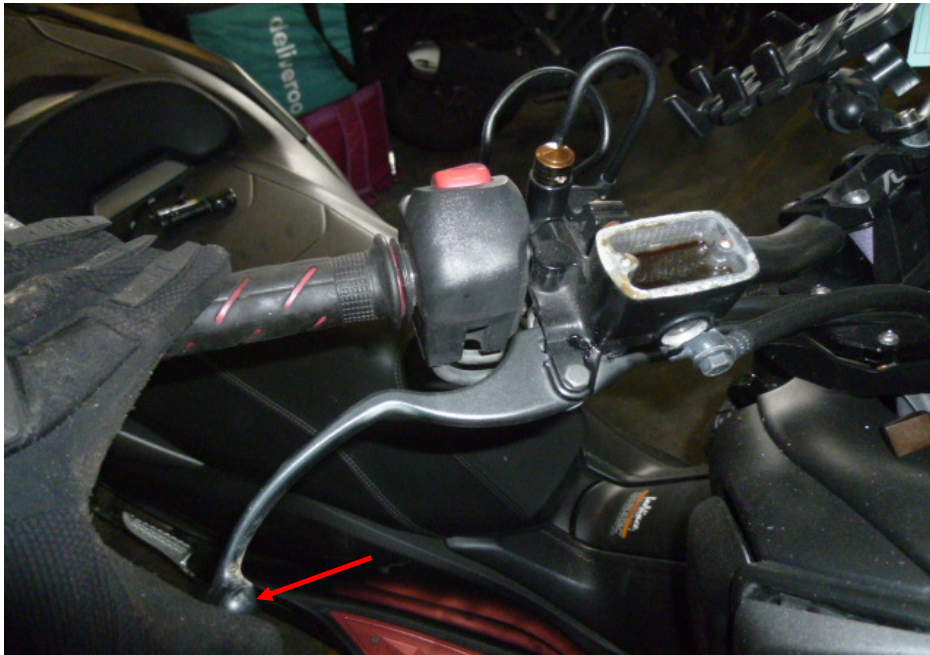
**Photo 28** shows the front brake lever being depressed. There was some resistance felt (spongy like feel) upon pressing the front brake lever (arrowed). This would indicate that there is no leakage of pressure/vacuum in the brake system.

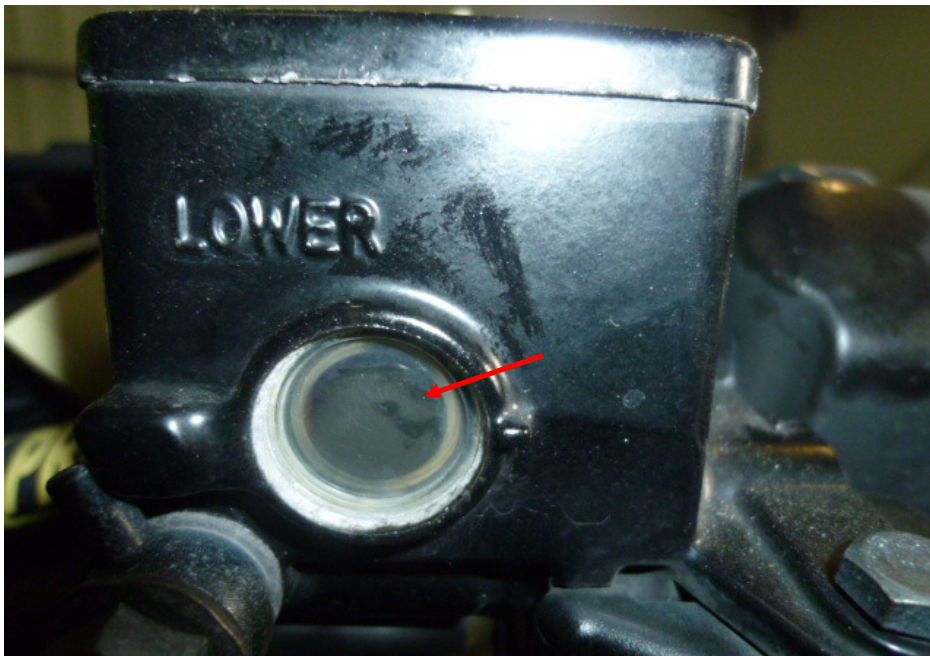
**Photo 29** shows the brake fluid reservoir for the rear brake of the Motorcycle. The brake fluid was observed to be of sufficient level for operational purposes and without contamination (arrowed).

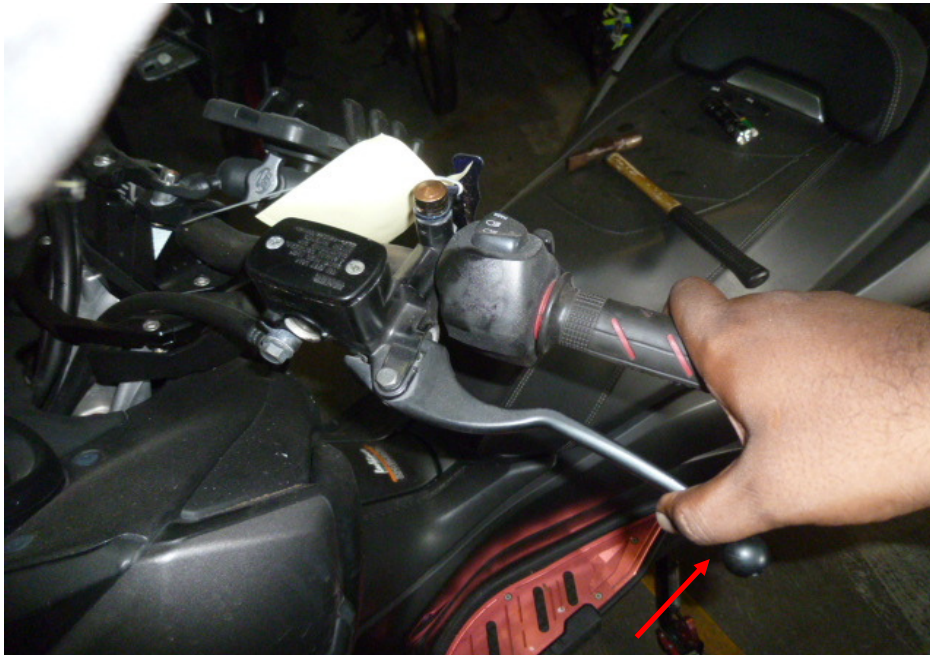
**Photo 30** shows the rear brake lever being depressed. There was some resistance felt (spongy like feel) upon pressing the front brake lever (arrowed). This would indicate that there is no leakage of pressure/vacuum in the brake system.

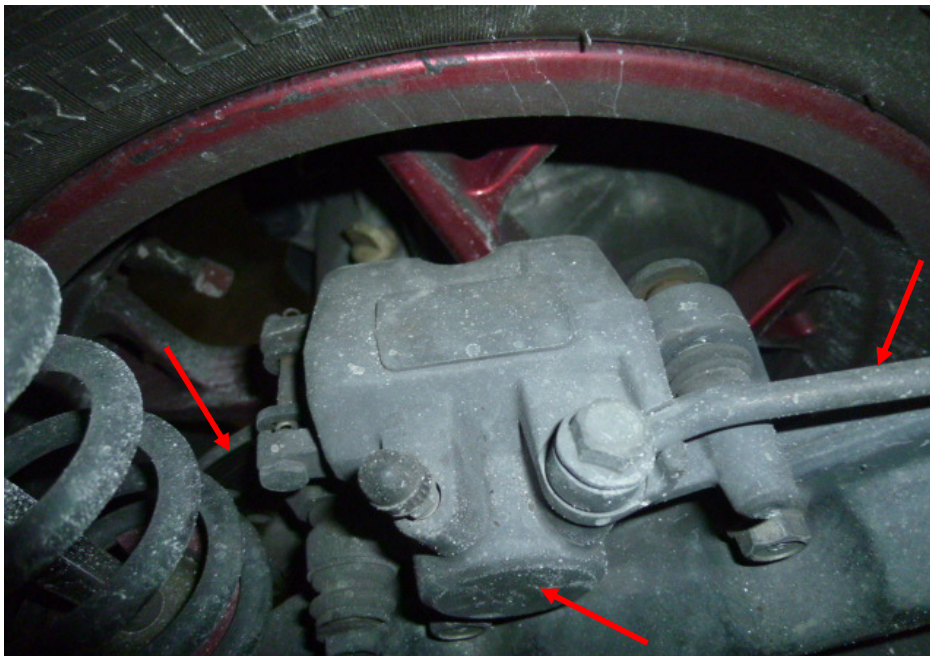
**Photo 31** shows a close up view of the rear brake caliper, rear brake disc and rear brake hose (arrowed) of the Motorcycle, which are all part of the components in the hydraulic rear brake system of the Motorcycle. Our visual checks of these various components revealed all to be intact with no visible damage. No leakage of brake fluid was also observed.
