Your Ref: TP/IP/56095/2021
Our Ref : CI/TPD22002080/N

1 April 2022

Fatal Accident Investigation Team

INSPECTION REPORT OF MOTORCYCLE FBL 6921R

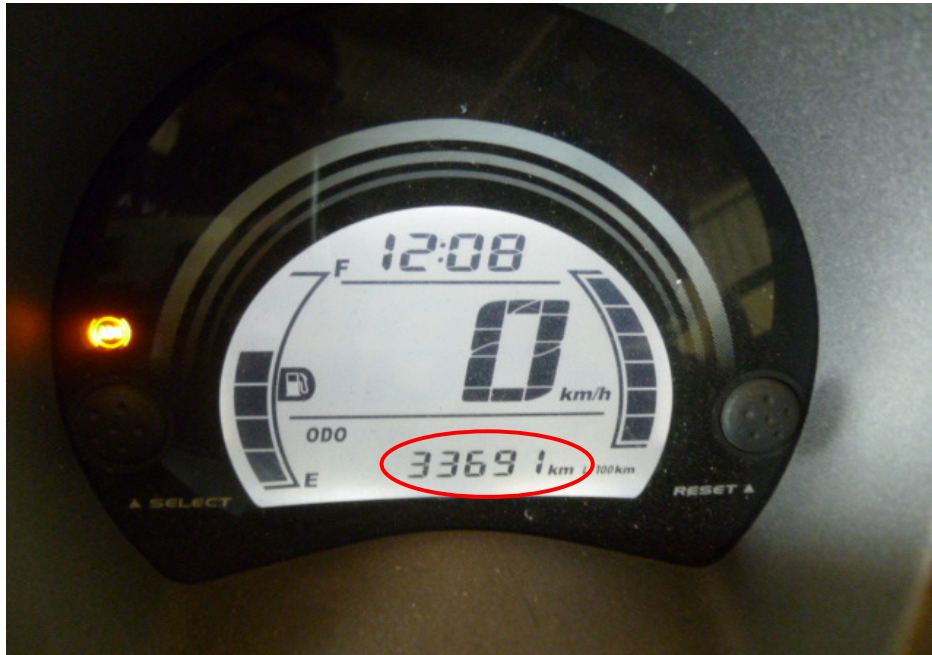
Photo 1 shows the speedometer gauge of the Motorcycle where the mileage recorded at time of our inspection was 33, 691km (circled).

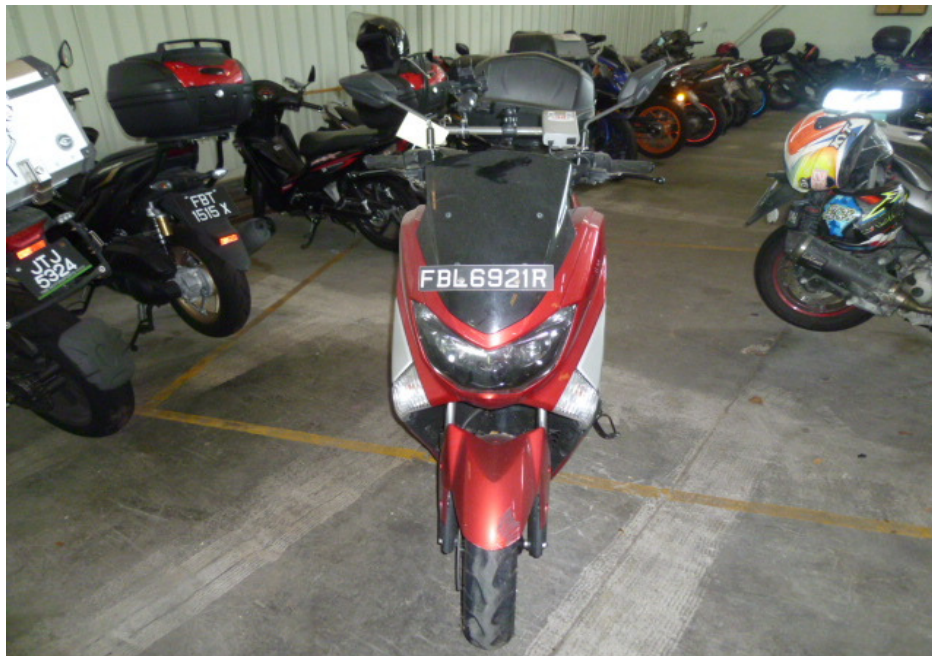
Photo 2 shows a general view of the frontal portion of the Motorcycle at the time of our inspection. The Motorcycle was observed to have sustained damages at its frontal portion and left body.

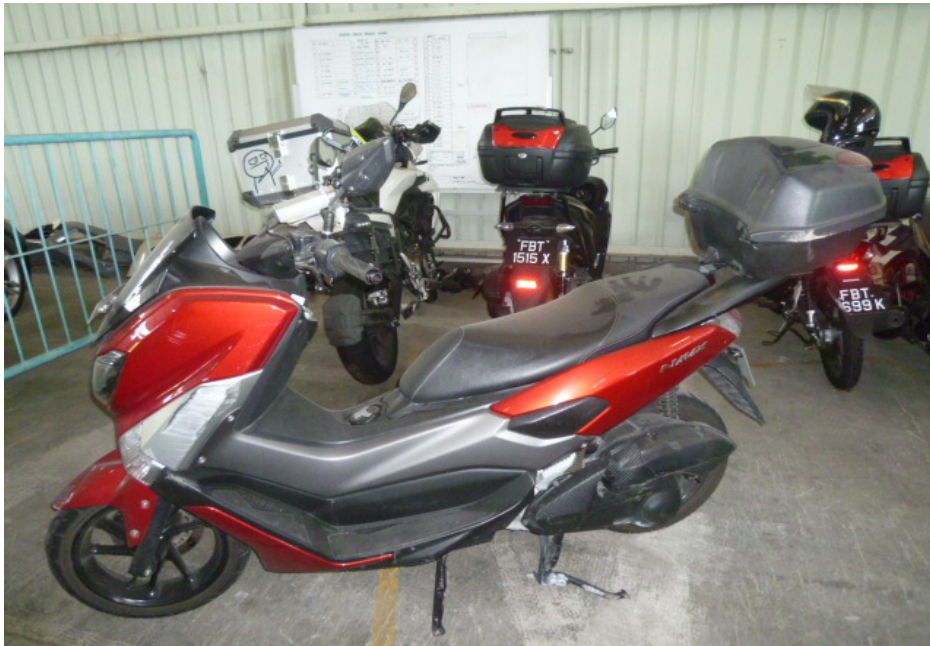
Photo 3 shows a general view of the left body of the Motorcycle at the time of our inspection. The Motorcycle was observed to have sustained damages at its frontal portion and left body.

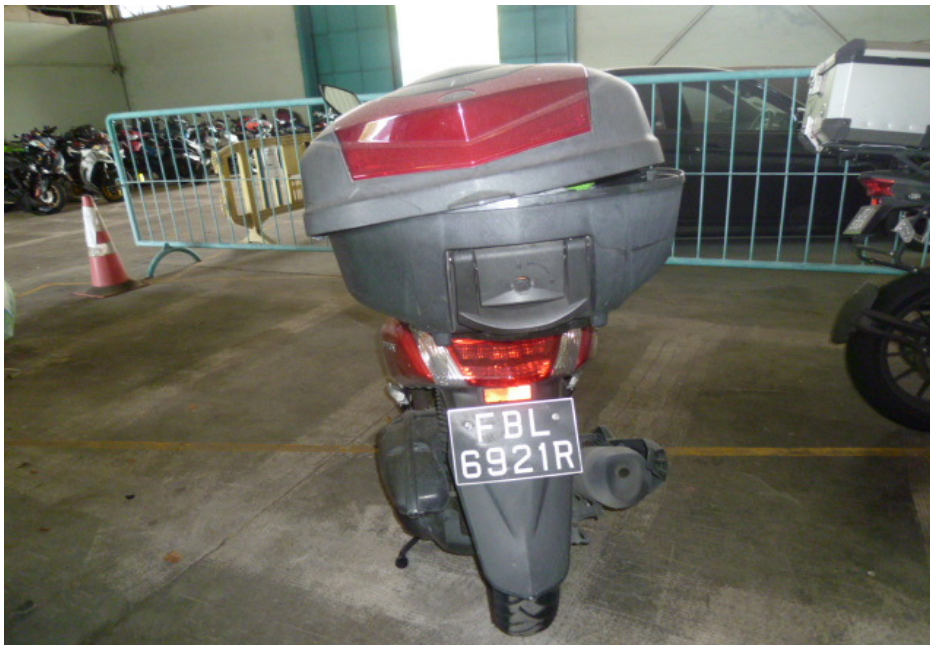
Photo 4 shows a general view of the rear portion of the Motorcycle at the time of our inspection. The Motorcycle was observed to have sustained damages at its frontal portion and left body. The body parts that were found to have been damaged include its front cowling, front mudguard, rear brake lever, left side mirror, left handlebar end, left cowling, left bottom cowling, side stand, main stand, left rear side cover and top box, amongst others as a result of the accident.

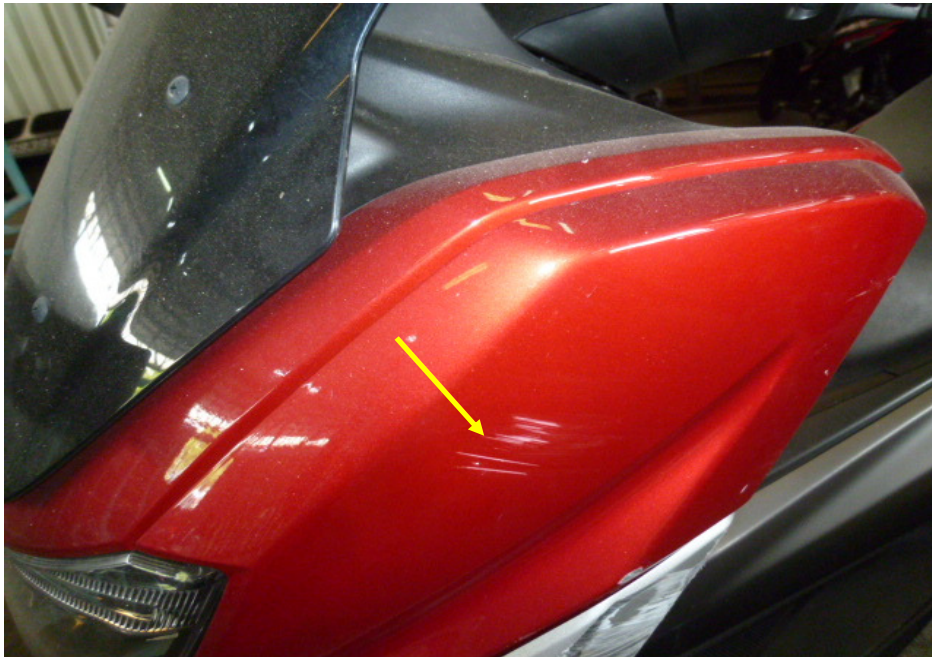
Photo 5 shows a closer view of the grazed front cowling of the Motorcycle at the time of our inspection (arrowed).

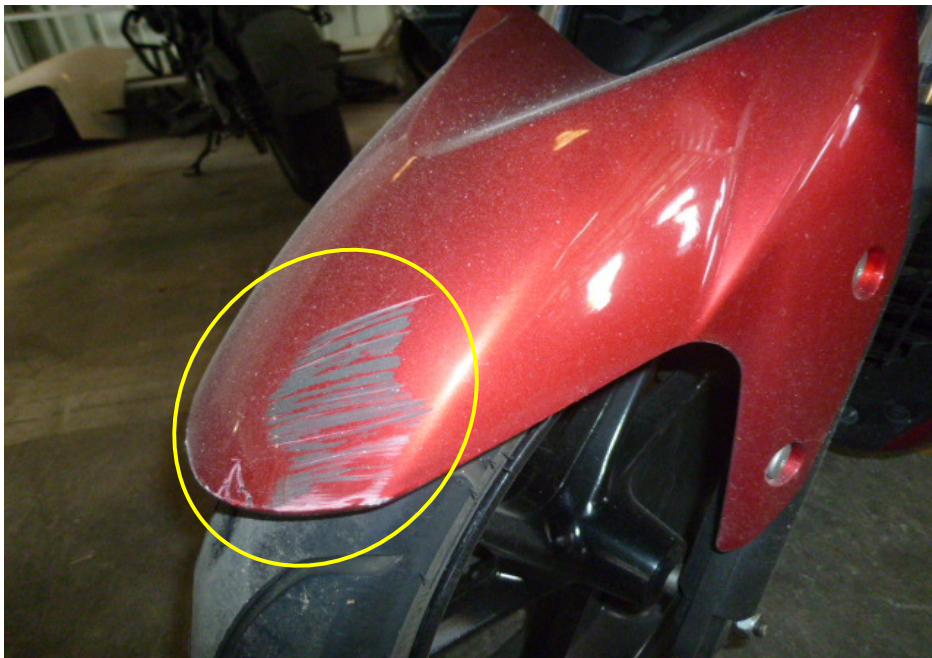
Photo 6 shows a closer view of the front mudguard which was amongst the body parts at the front body of the Motorcycle that had sustained damage as a result of the accident (circled).

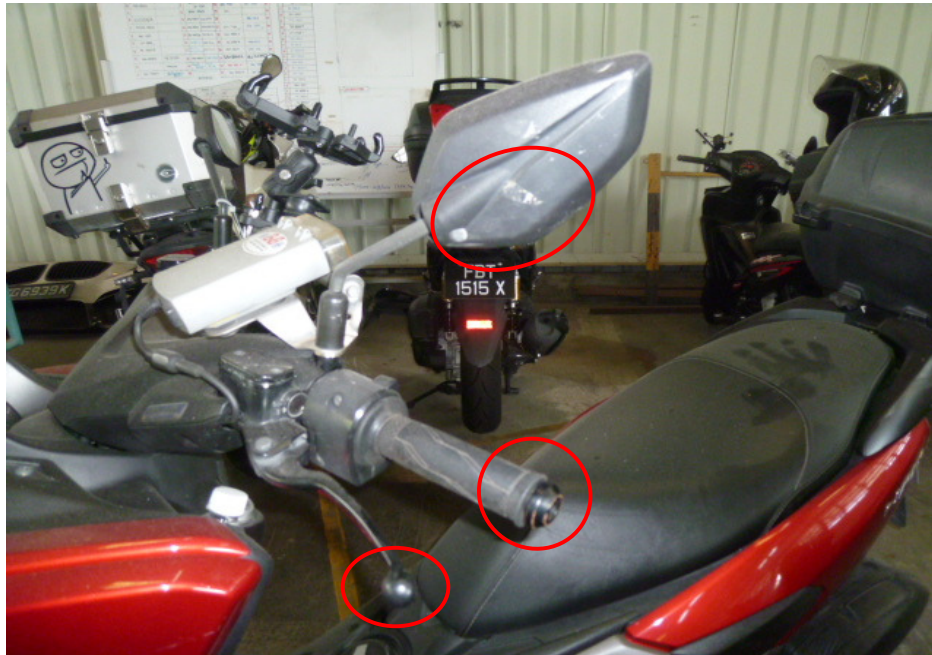
Photo 7 shows a closer view of the left side mirror, left handlebar end and rear brake lever of the Motorcycle which were observed to be damaged due to the accident (circled).

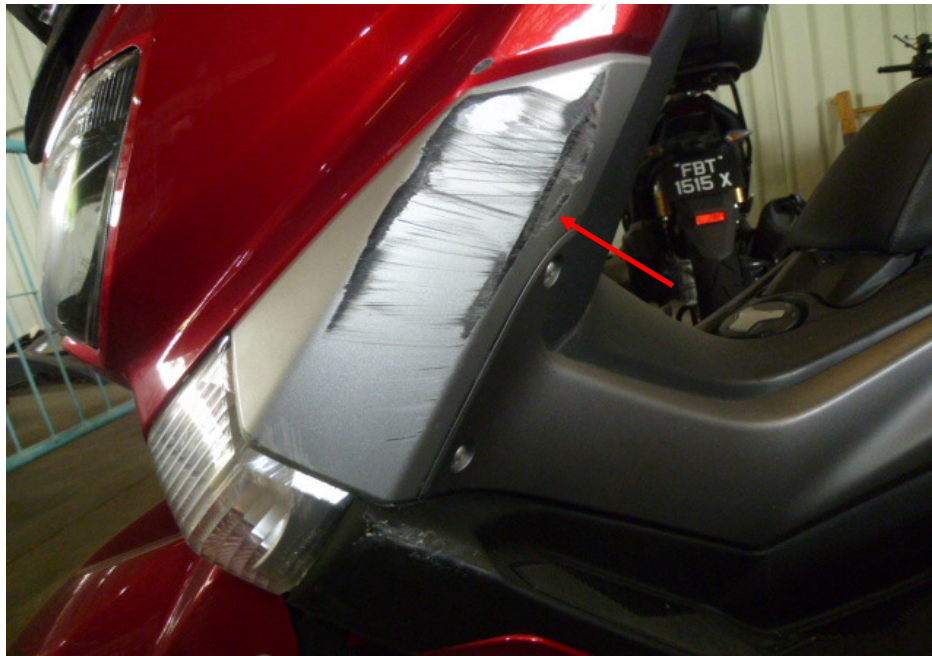
Photo 8 shows a close-up view of the grazed left cowling of the Motorcycle at the time of our inspection (arrowed).

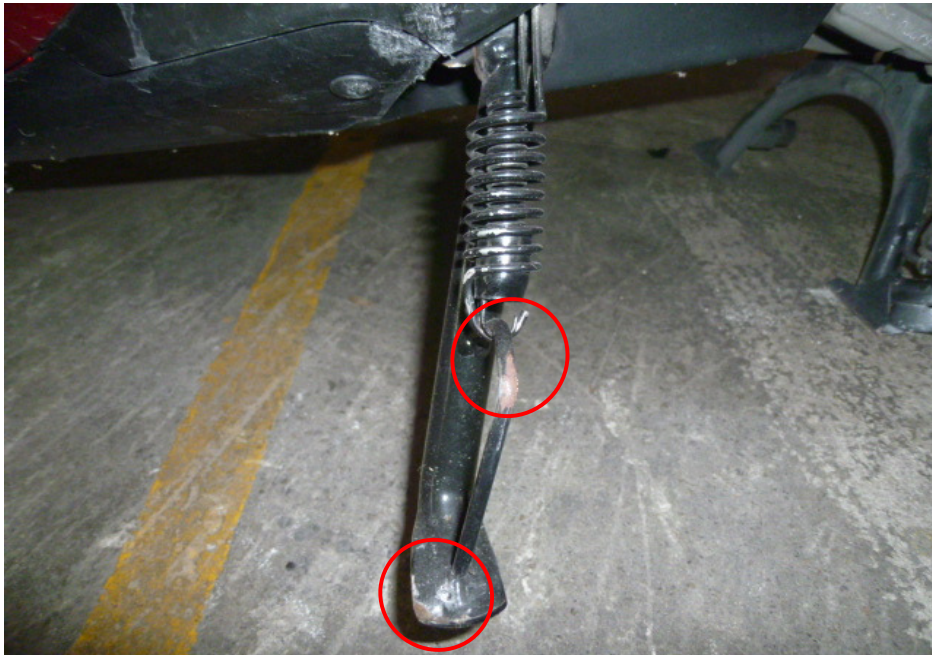
Photo 9 shows the grazed side stand (circled) of the Motorcycle as a result of the accident.

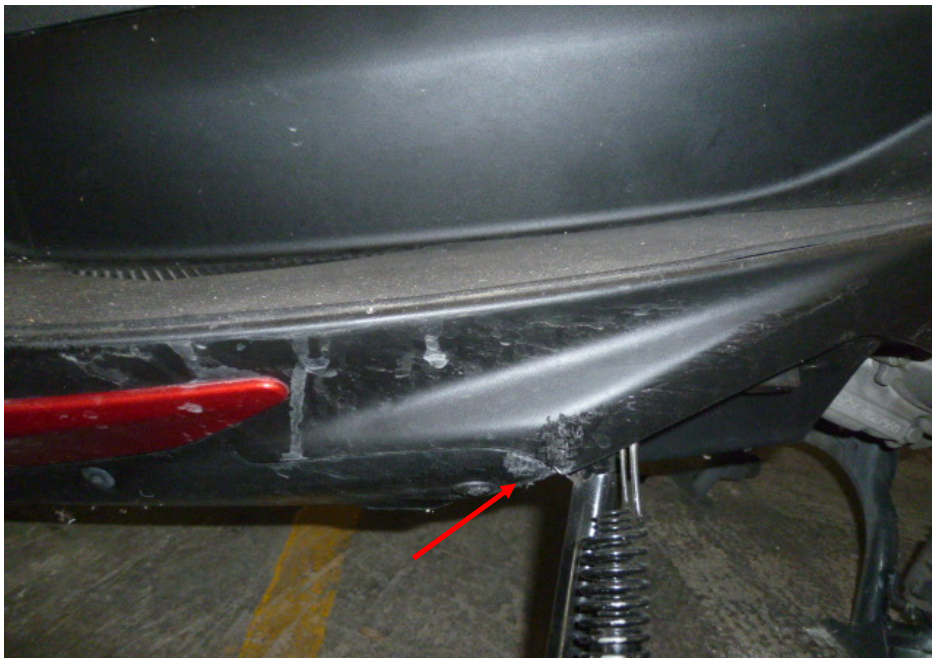
Photo 10 shows a closer view of the grazed left bottom cowling of the Motorcycle as a result of the accident (arrowed).

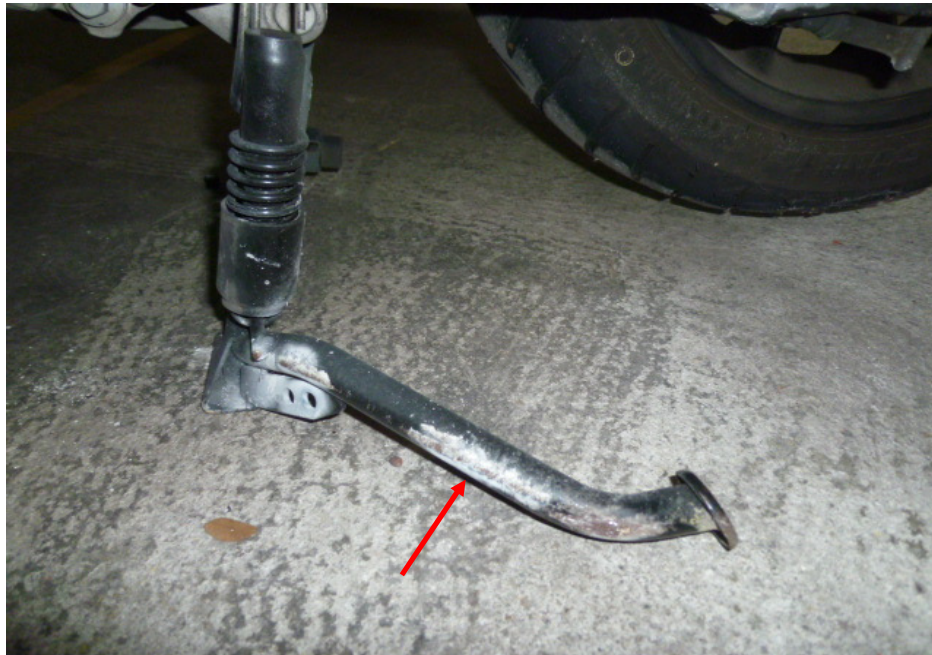
Photo 11 shows a closer view of the grazed main stand (arrowed) of the Motorcycle as a result of the accident.

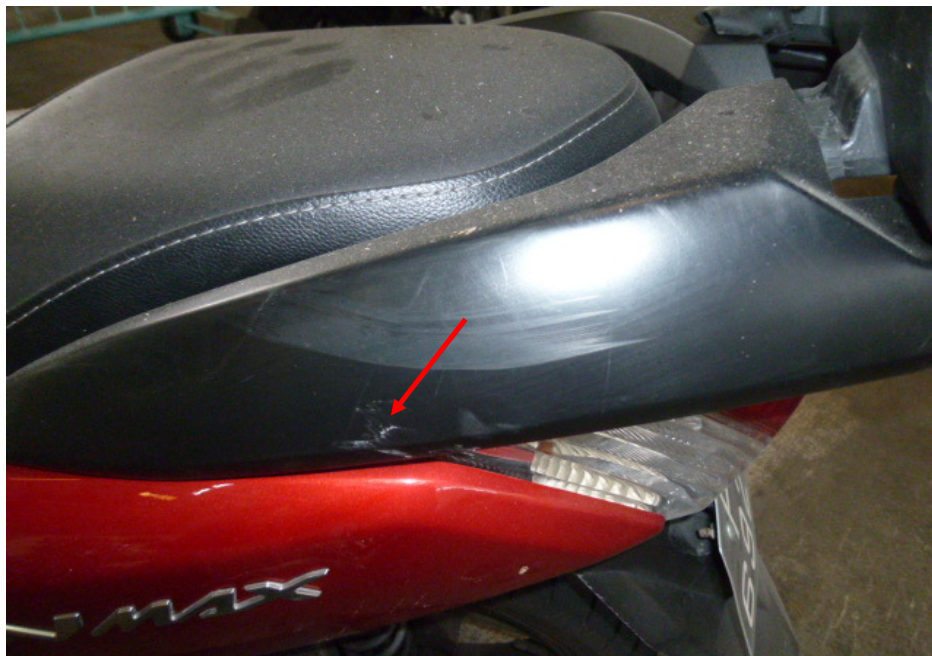
Photo 12 shows a closer view of the grazed left rear side cover of the Motorcycle at the time of our inspection (arrowed).

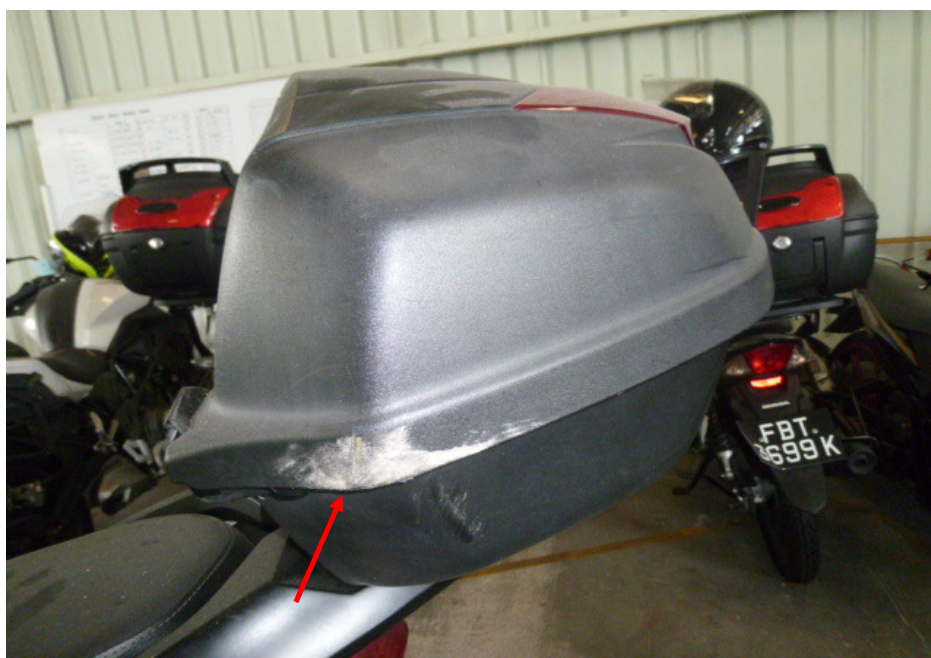
Photo 13 shows a closer view of the grazed top box of the Motorcycle as a result of the accident (arrowed).

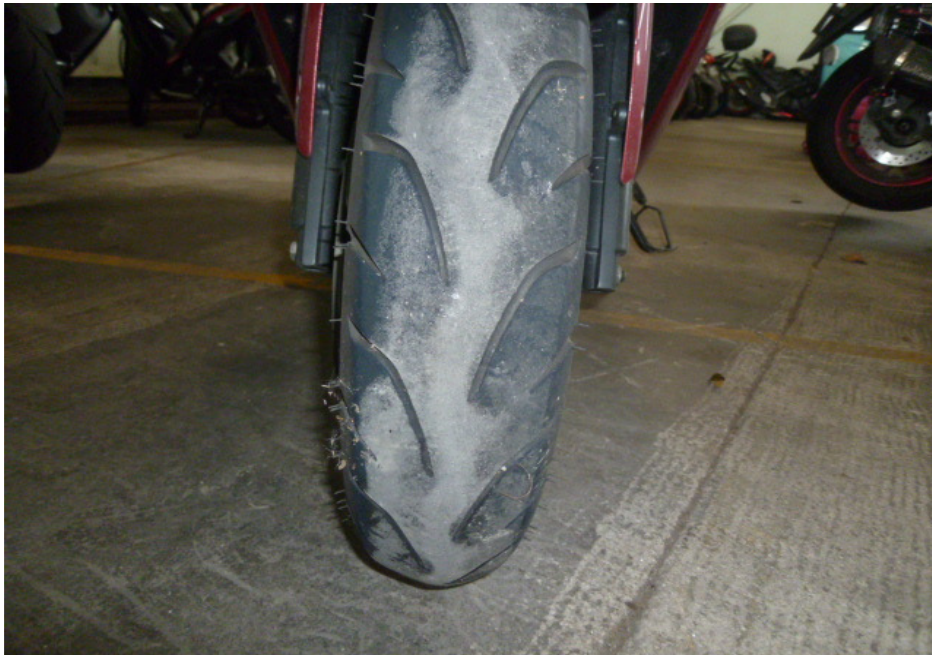
Photo 14 shows the condition of the Motorcycle's front tyre. The front tyre was observed to be in serviceable condition with remaining tread depth of approximately 4mm. There was no tear, burst mark(s) and/or punctured hole(s) on the sidewalls as well as across the tread of the front tyre.

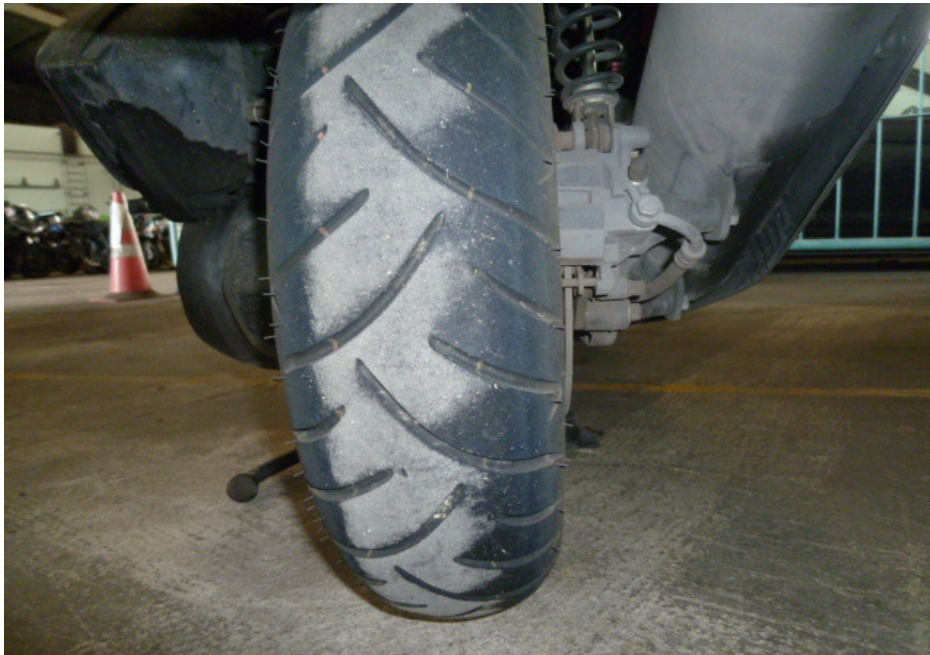
Photo 15 shows the condition of the Motorcycle's rear tyre. The rear tyre was observed to be in serviceable condition with remaining tread depth of approximately 5mm. The tyre was also observed to be sufficiently inflated for vehicular operation. We did not observe any tear, burst mark(s) and/or punctured hole(s) on the sidewalls as well as across the tread of the rear tyre.

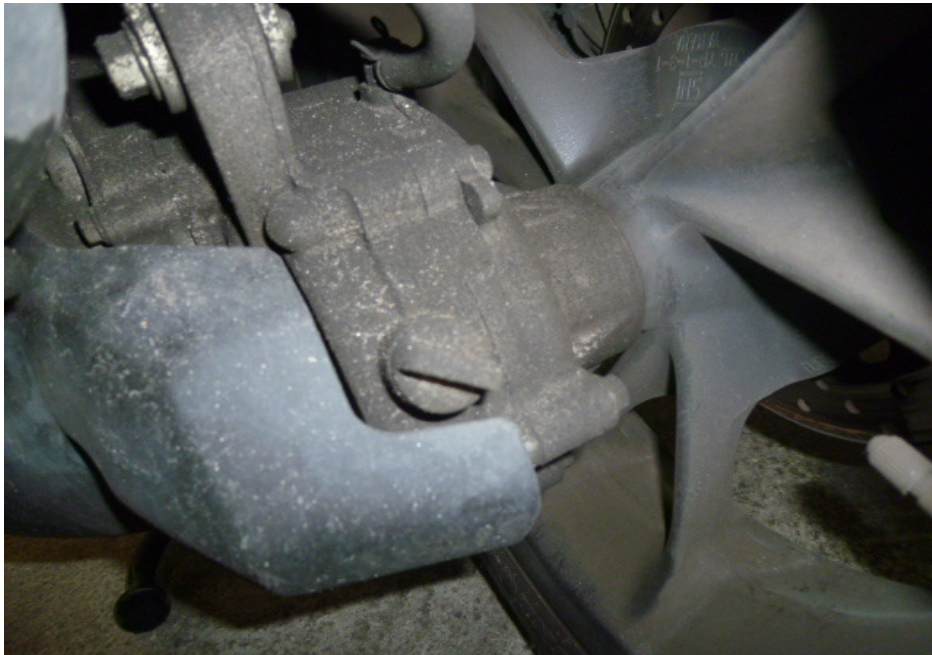
Photo 16 shows the left side of the engine of the Motorcycle at the time of our inspection. The various engine related parts and components were found to be intact with no visible damage. There was also no sign(s) or indication(s) of fluid leak observed around the left engine area of the Motorcycle.

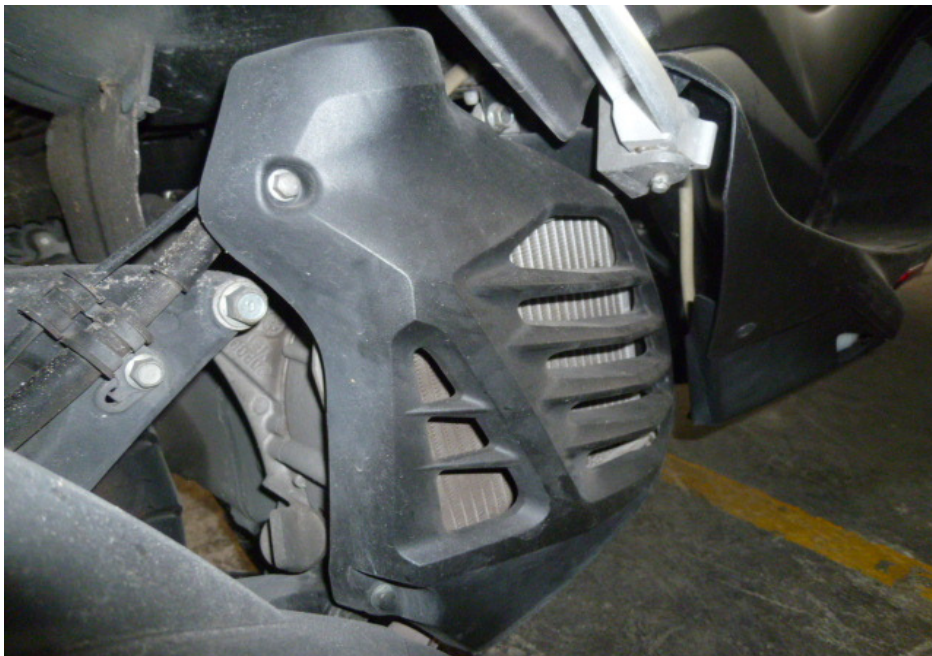
Photo 17 shows the right side of the engine of the Motorcycle at the time of our inspection. The various engine related parts and components were found to be intact with no visible damage. There was also no sign(s) or indication(s) of fluid leak observed around the right engine area of the Motorcycle.

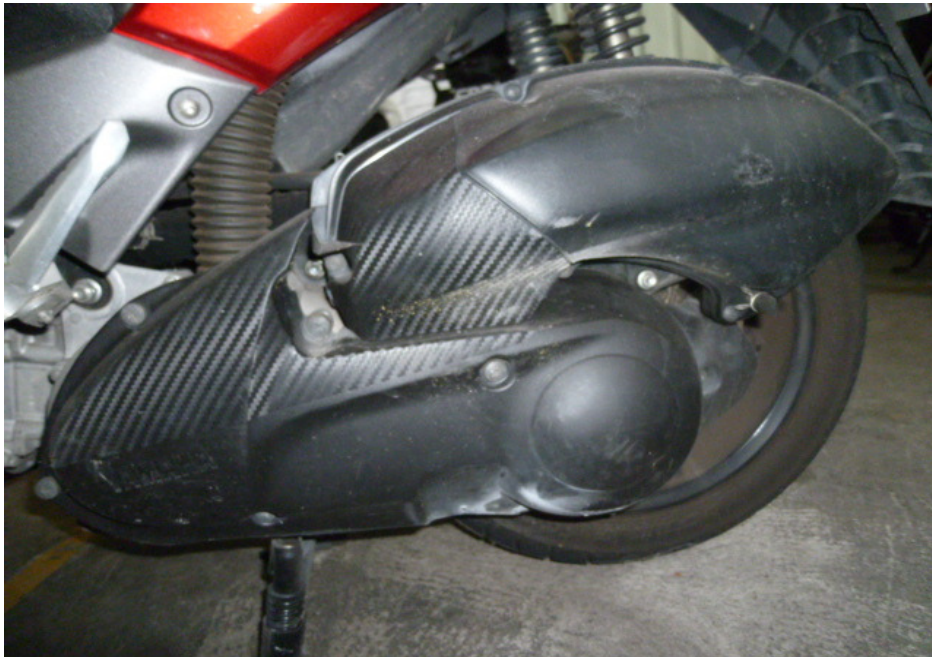
Photo 18 shows the drive train cover of the Motorcycle which was found to be intact without any misalignment. Upon examination of the Motorcycle's engine area, we had observed that the various engine related parts and components were intact with no visible damage. There was also no sign(s) or indication(s) of fluid leak observed around the engine area of the Motorcycle.

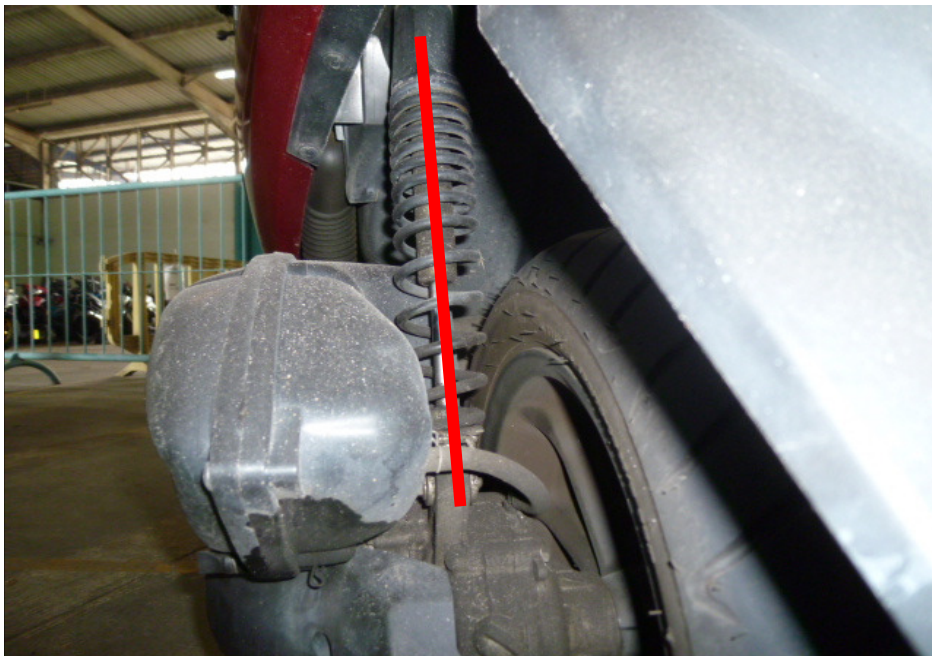
Photo 19 shows the left shock absorber of the Motorcycle which was found to be intact without any misalignment.

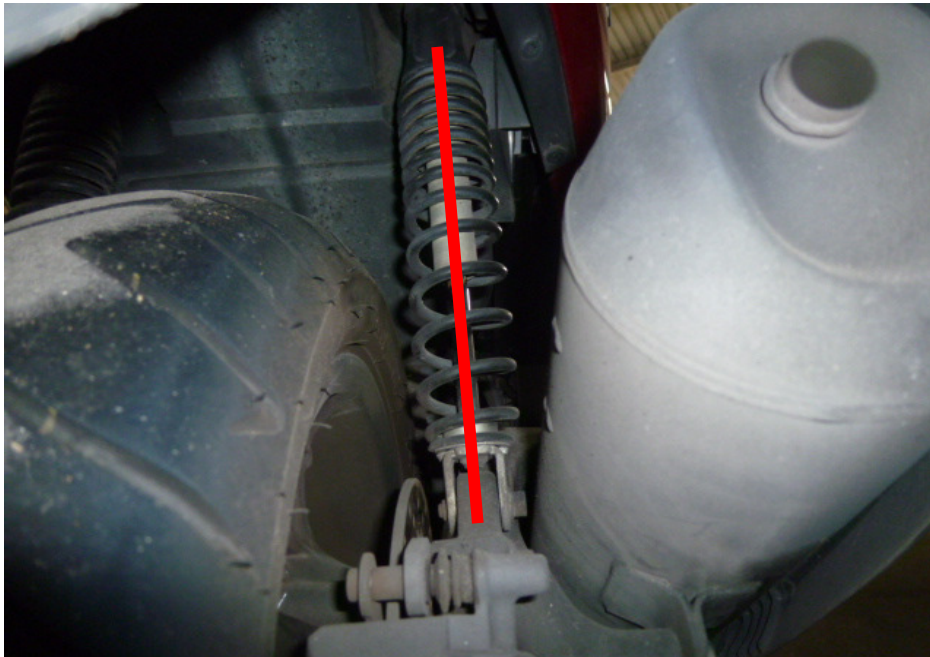
Photo 20 shows the right shock absorber of the Motorcycle which was found to be intact without any misalignment.

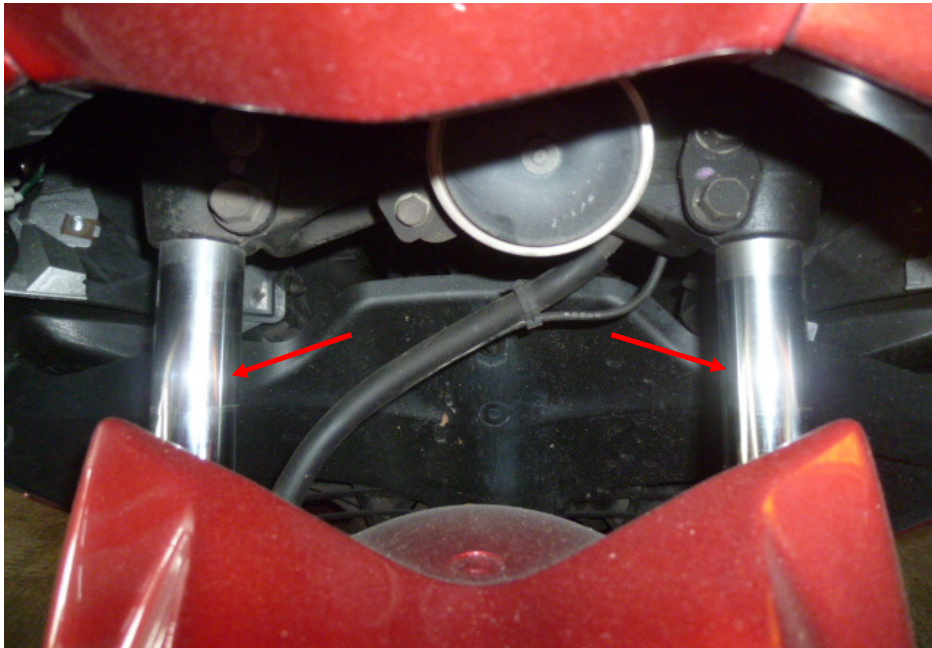
Photo 21 shows the front forks (arrowed) of the Motorcycle. The front forks and fork brackets of the Motorcycle were both found to be intact and undamaged. Turning the Motorcycle's handle bar towards the left and right did not produce any abnormal free play and/or resistance. The steering system of the Motorcycle was in serviceable condition at the time of our inspection.

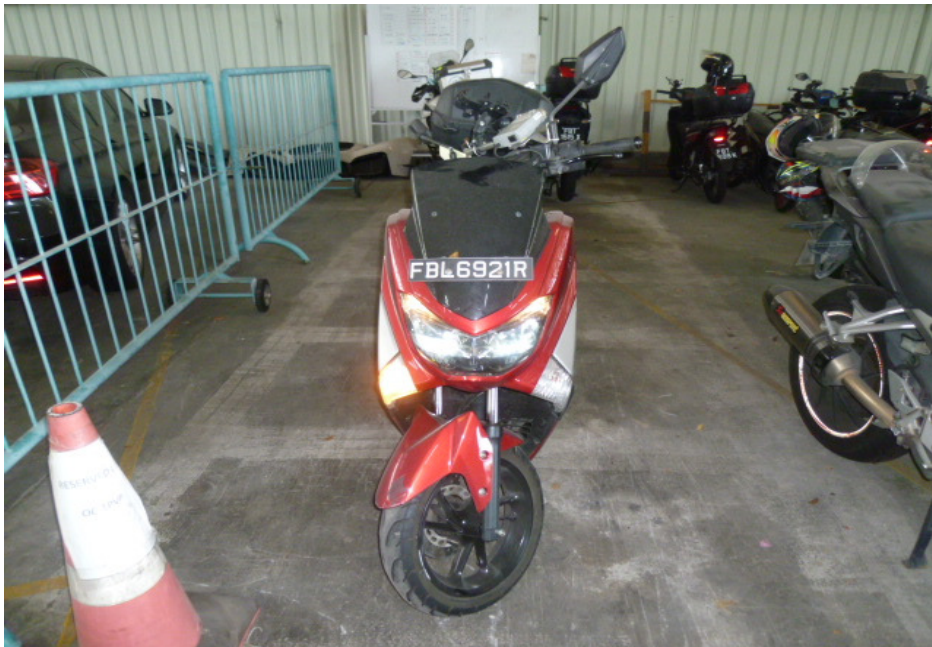
Photo 22 shows the front wheel of the Motorcycle turned towards its full right. Turning the Motorcycle's handle bar towards the left and right did not produce any abnormal free play and/or resistance. This would indicate that the steering system of the Motorcycle was in serviceable condition at the time of our inspection.

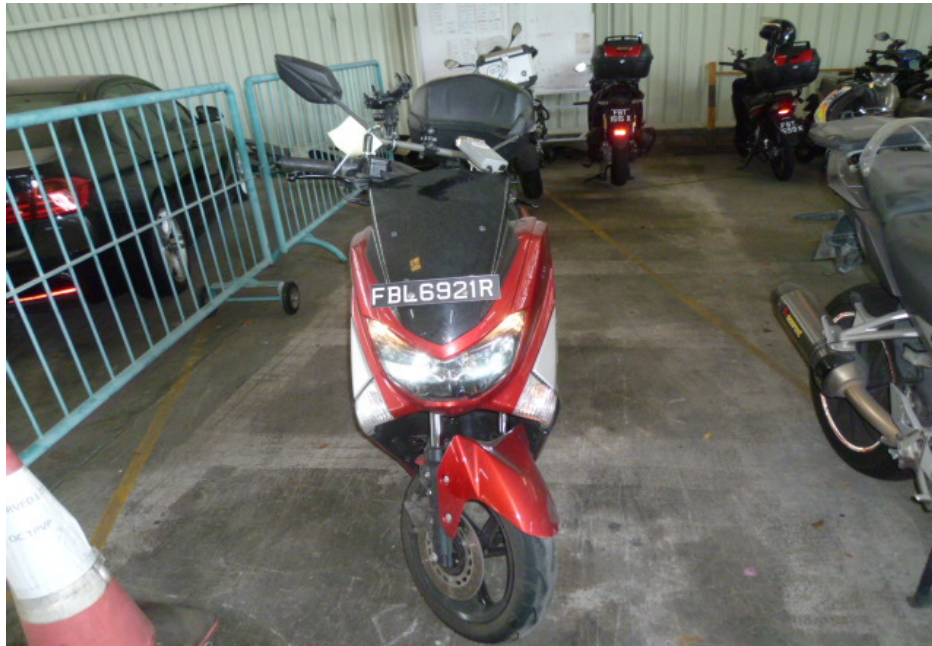
Photo 23 shows the front wheel of the Motorcycle turned towards its full left. Turning the Motorcycle's handle bar towards the left and right did not produce any abnormal free play and/or resistance. This would indicate that the steering system of the Motorcycle was in serviceable condition at the time of our inspection.

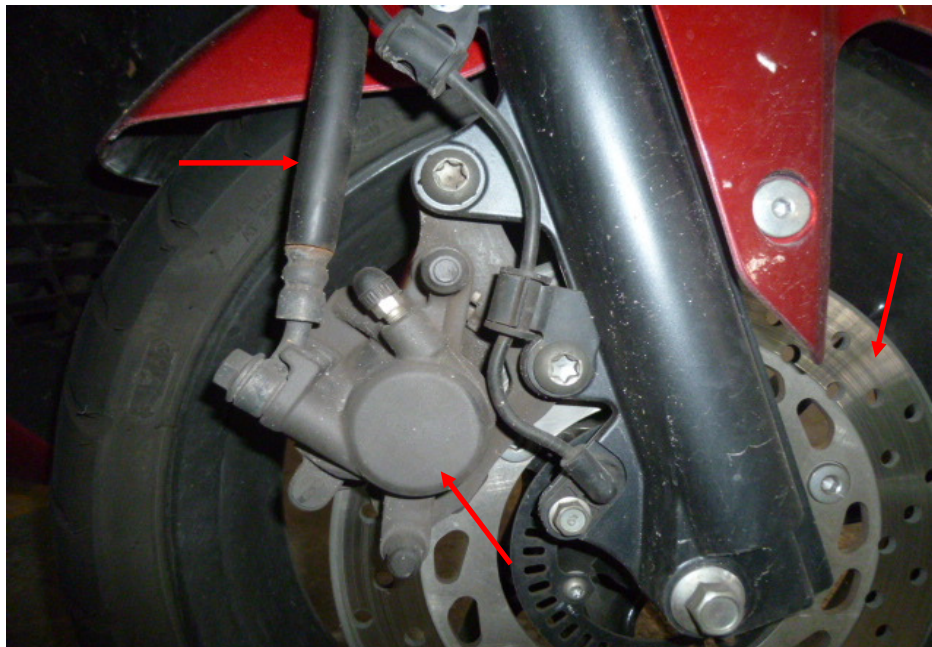
Photo 24 shows a close up view of the front brake caliper, front brake disc and front brake hose (arrowed) of the Motorcycle, which are all part of the components in the hydraulic front brake system of the Motorcycle. Our visual checks of these various components had revealed all to be intact with no visible damage. No leakage of brake fluid was also observed.

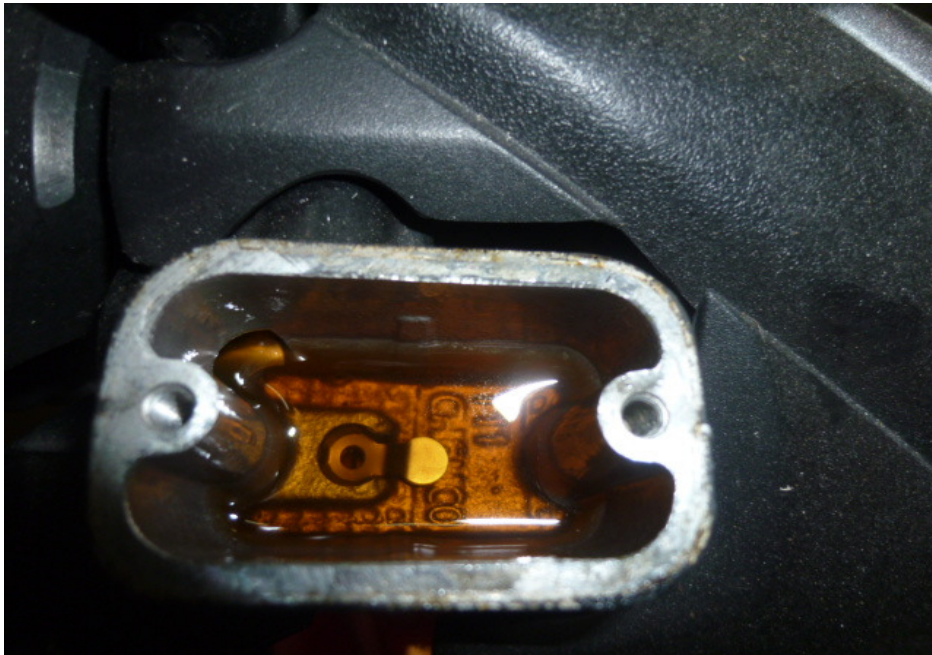
13. Our checks on the front brake fluid had indicated that the front brake fluid was of sufficient level for operational purposes and without any contamination.

Photo 25 shows the brake fluid reservoir for the front brake of the Motorcycle. The brake fluid was observed to be of sufficient level for operational purposes and without any contamination.

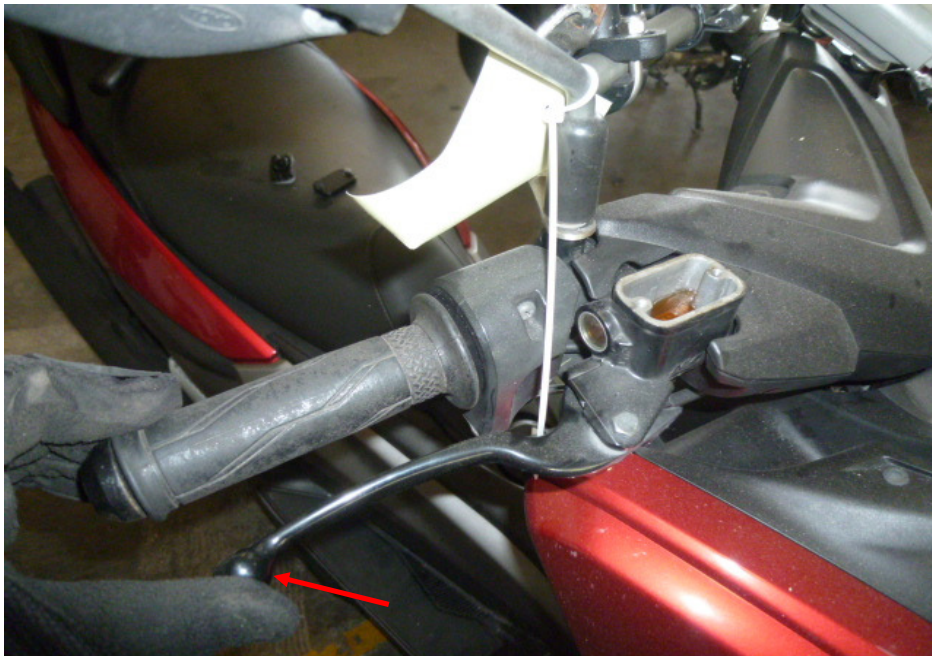
Photo 26 shows the front brake lever being depressed. There was some resistance felt (spongy like feel) upon pressing the front brake lever (arrowed). This would indicate that there is no leakage of pressure/vacuum in the front brake system.

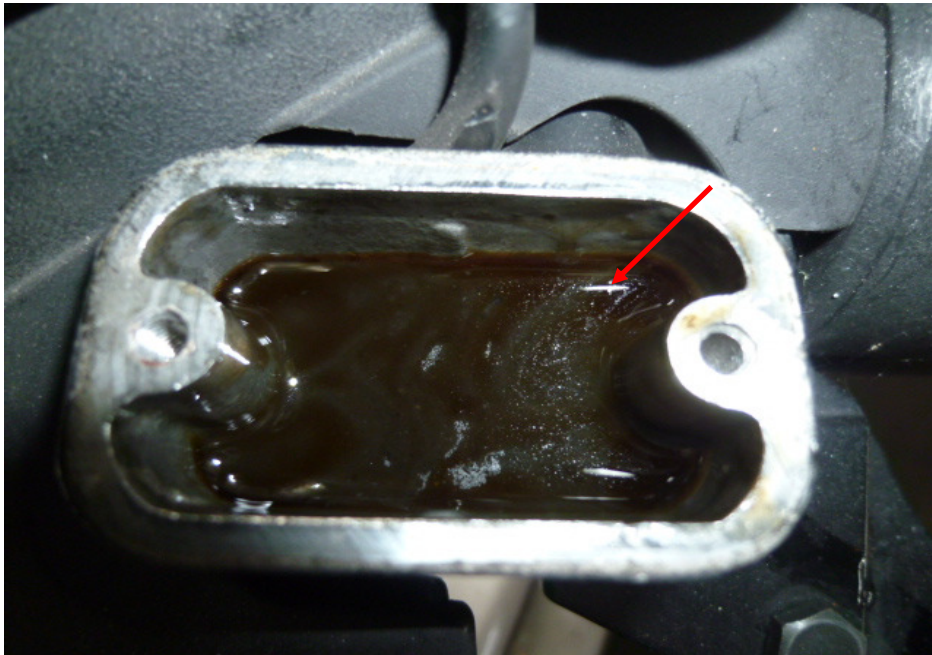
14. Our checks on the rear brake fluid had also indicated that the rear brake fluid was of sufficient level for operational purposes. However the brake fluid for the rear brake was found to be contaminated.

Photo 27 shows the brake fluid reservoir for the rear brake of the Motorcycle. The brake fluid was observed to be of sufficient level for operational purposes. However it was found to be contaminated (arrowed).

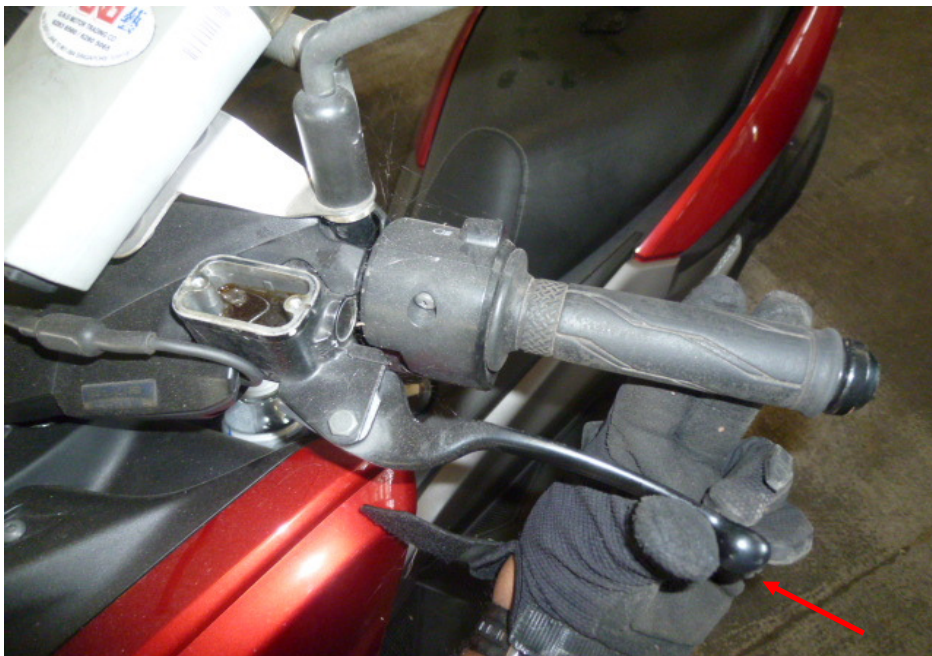
Photo 28 shows the rear brake lever being depressed. There was some resistance felt (spongy like feel) upon pressing the rear brake lever (arrowed). This would indicate that there is no leakage of pressure/vacuum in the rear brake system.

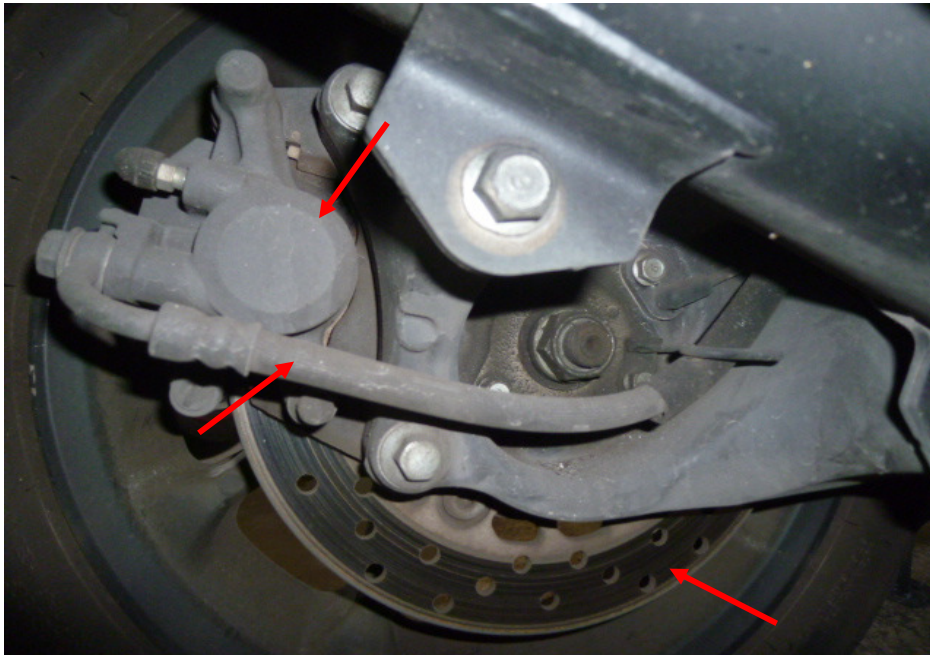
Photo 29 shows a close up view of the rear brake caliper, rear brake disc and rear brake hose (arrowed) of the Motorcycle, which are all part of the components in the hydraulic rear brake system of the Motorcycle. Our visual checks of these various components revealed all to be intact with no visible damage. No leakage of brake fluid was also observed.
