Your Ref: TP/IP/57551/2021  
Our Ref : CI/TPD22002081/N

12 April 2022

**Fatal Accident Investigation Team**

**INSPECTION REPORT OF MOTORCYCLE JSW 1159**

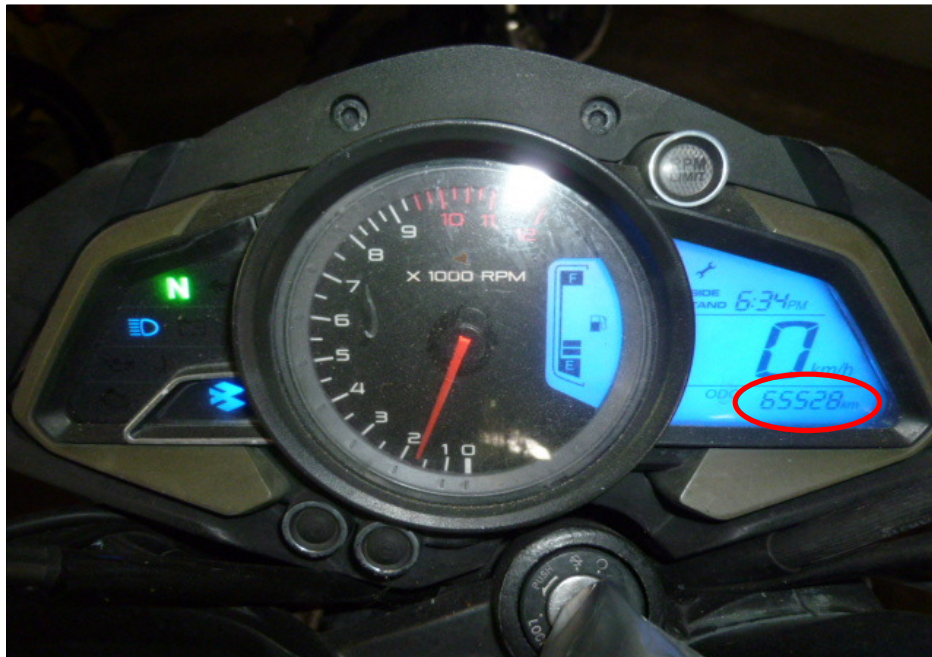
**Photo 1** shows the speedometer gauge of the Motorcycle. The mileage of the Motorcycle at the time of our inspection was 65, 528km (circled).

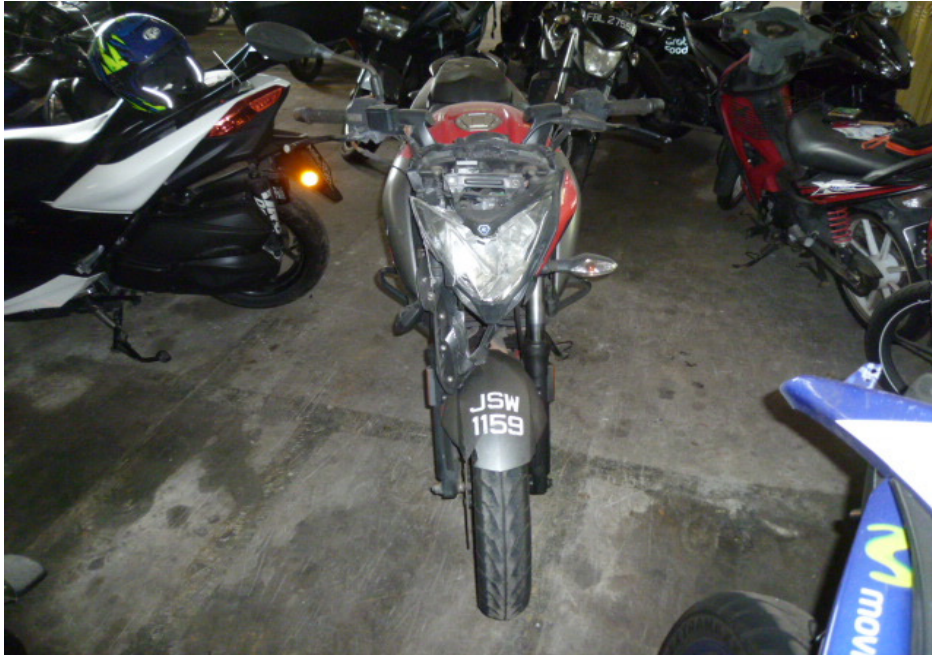
**Photo 2** shows a general view of the frontal portion of the Motorcycle at the time of our inspection. The Motorcycle was observed to have sustained damages all around.

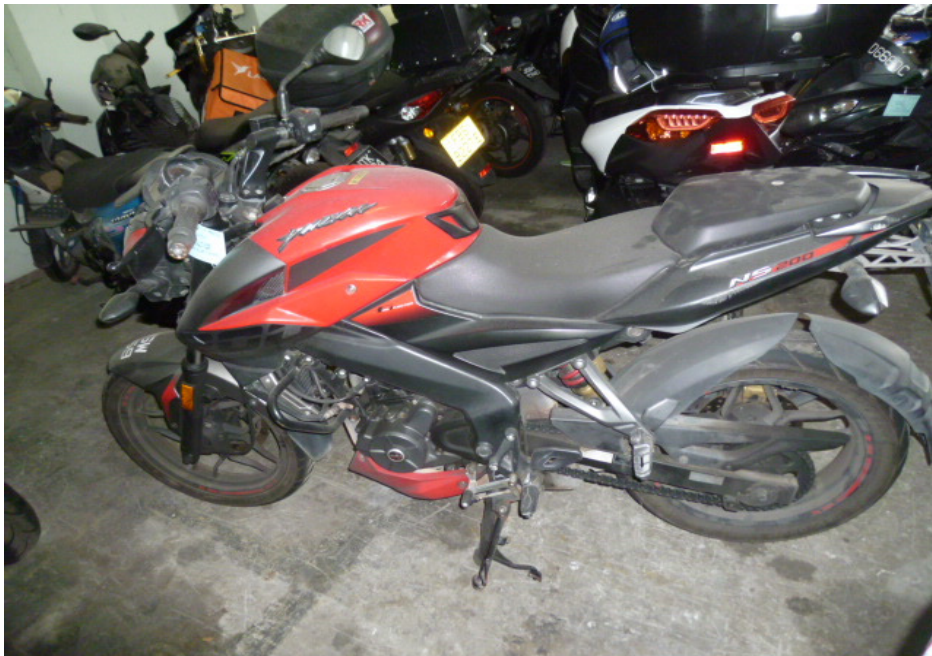
**Photo 3** shows a general view of the left body of the Motorcycle at the time of our inspection. The Motorcycle was observed to have sustained damages all around.

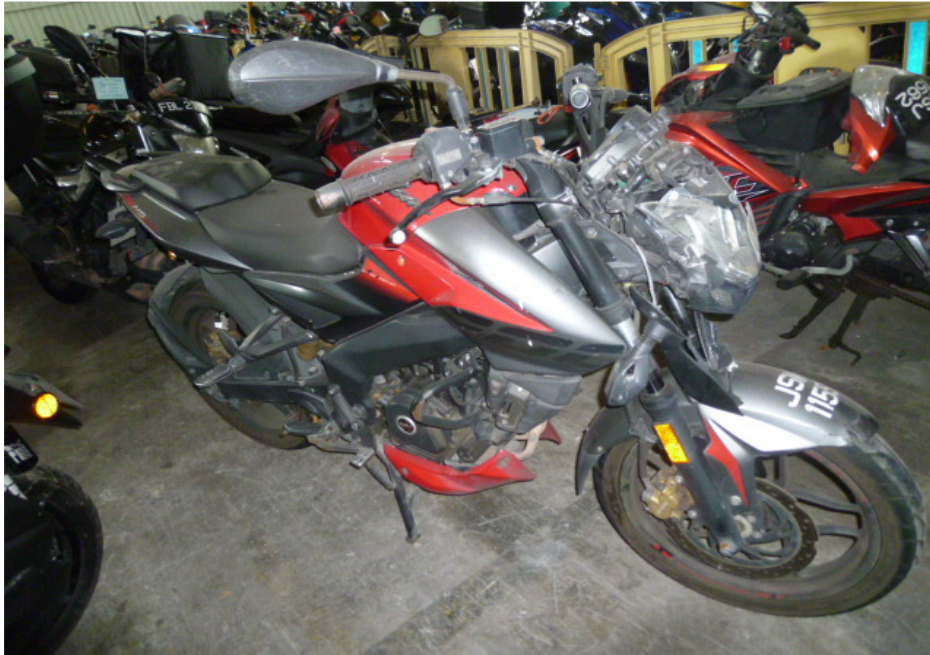
**Photo 4** shows a general view of the right body of the Motorcycle at the time of our inspection. The Motorcycle was observed to have sustained damages all around. The body parts that were found to have been damaged include its head cowl, headlight assembly, front mudguard, left cowl, right side mirror, front brake lever, right engine crashbar, rear brake pedal, right front footrest, rear side covers, rear number plate and rear reflector, amongst others.

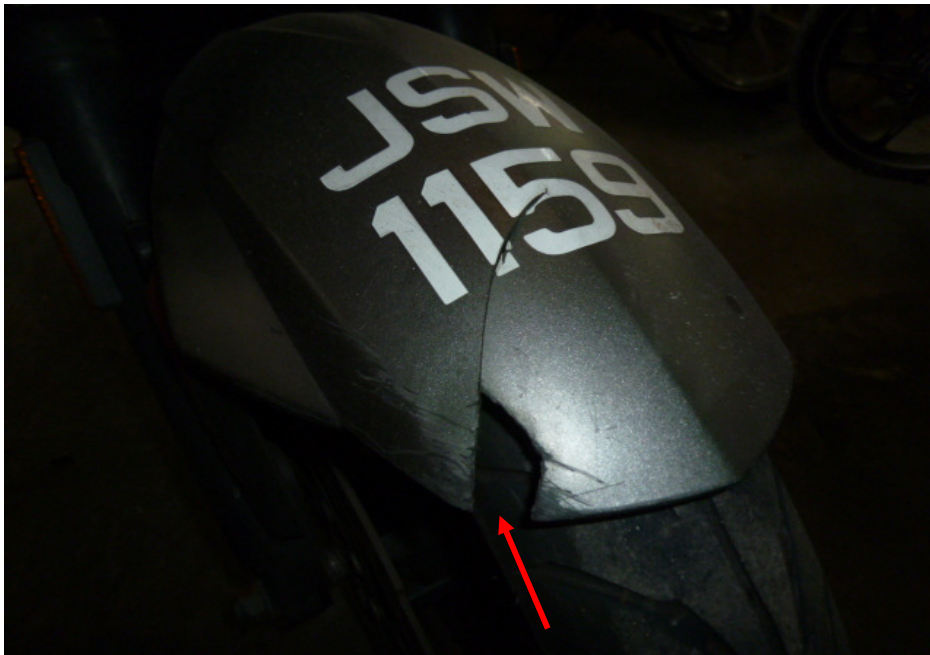
**Photo 5** shows a closer view of the front mudguard (arrowed) which was amongst the body parts of the Motorcycle that had sustained damage as a result of the accident.

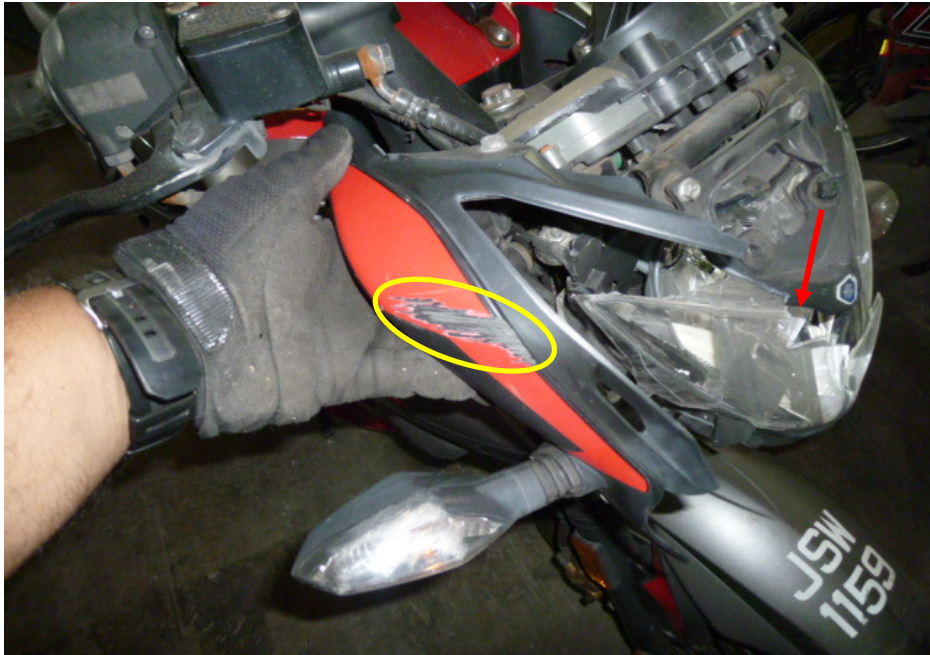
**Photo 6** shows the grazed head cowling (circled) and cracked headlight assembly (arrowed), which were amongst the body parts of the Motorcycle that had sustained damage as a result of the accident.

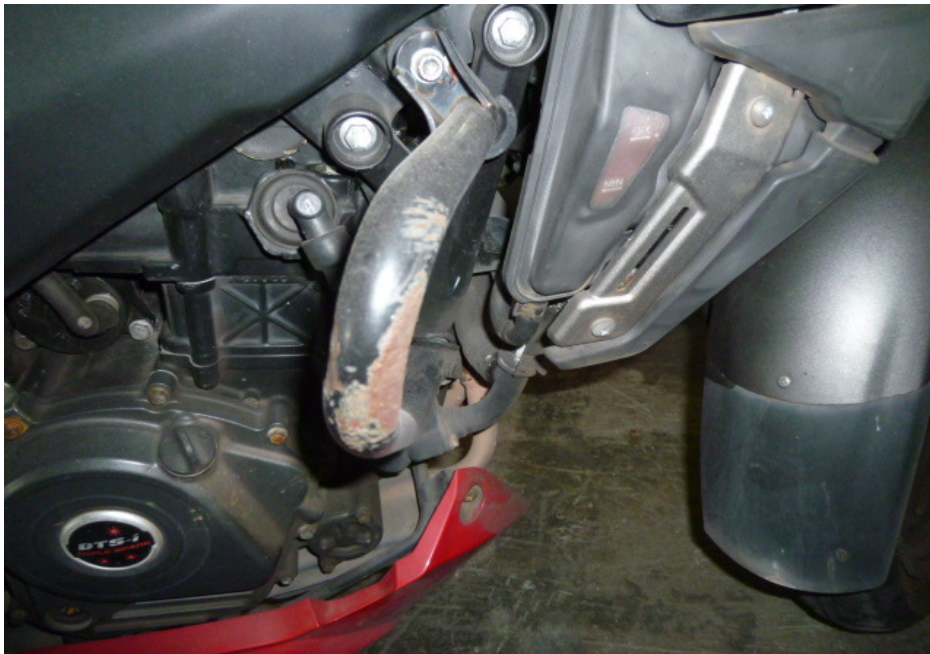
**Photo 7** shows a closer view of the grazed right engine crashbar of the Motorcycle as a result of the accident.

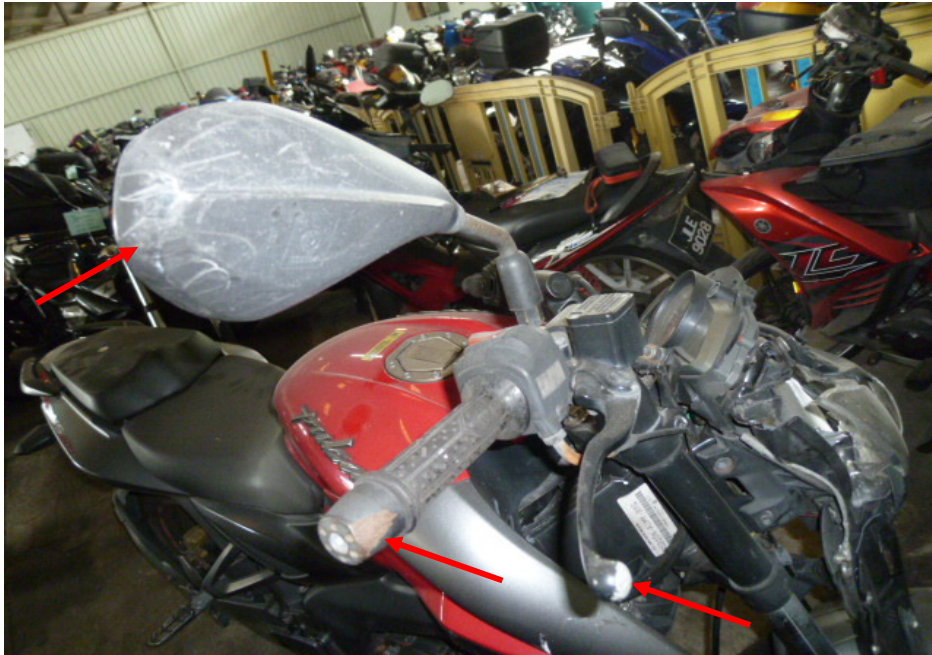
**Photo 8** shows the right handlebar end, front brake lever and right side mirror (arrowed), which were amongst the body parts of the Motorcycle that had sustained damage as a result of the accident.

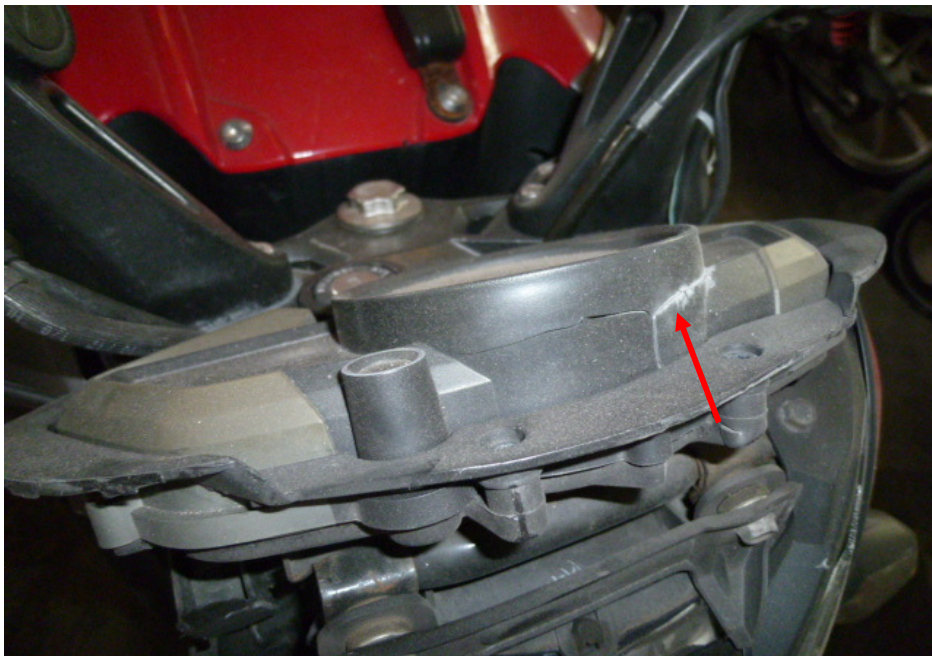
**Photo 9** shows a closer view of the grazed speedometer gauge of the Motorcycle as a result of the accident (arrowed).

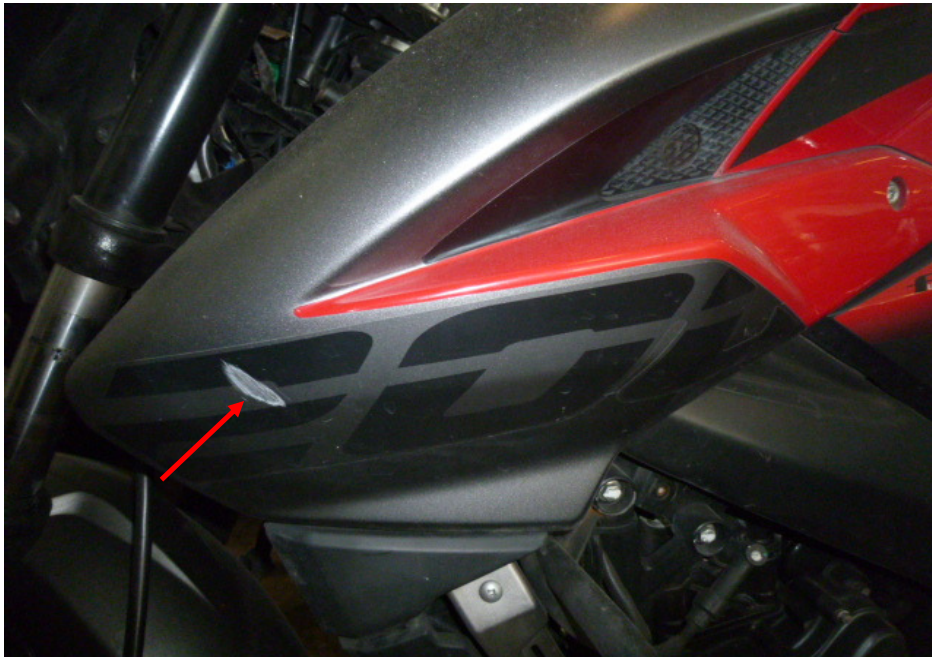
**Photo 10** shows a closer view of the grazed left cowling of the Motorcycle as a result of the accident (arrowed).

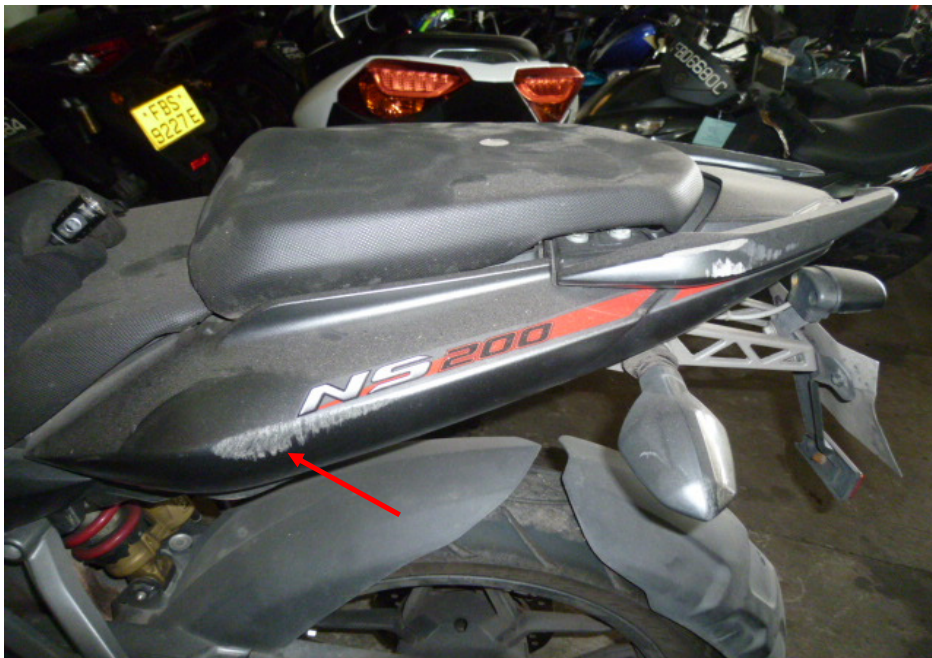
**Photo 11** shows a closer view of the grazed left rear side cover of the Motorcycle as a result of the accident (arrowed).

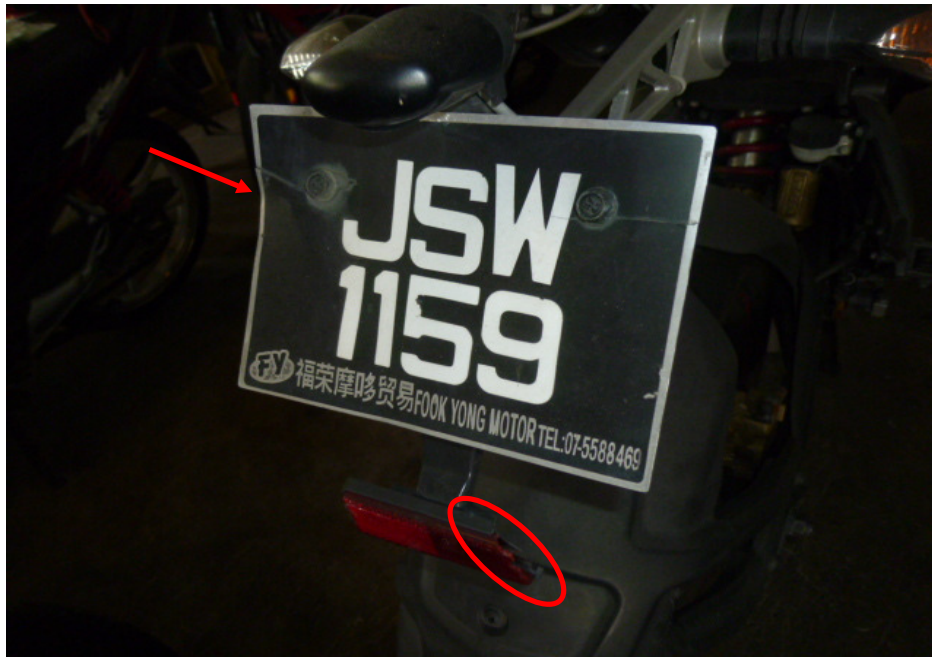
**Photo 12** shows a closer view of the broken rear reflector (circled) and dented rear number plate (arrowed) of the Motorcycle as a result of the accident.

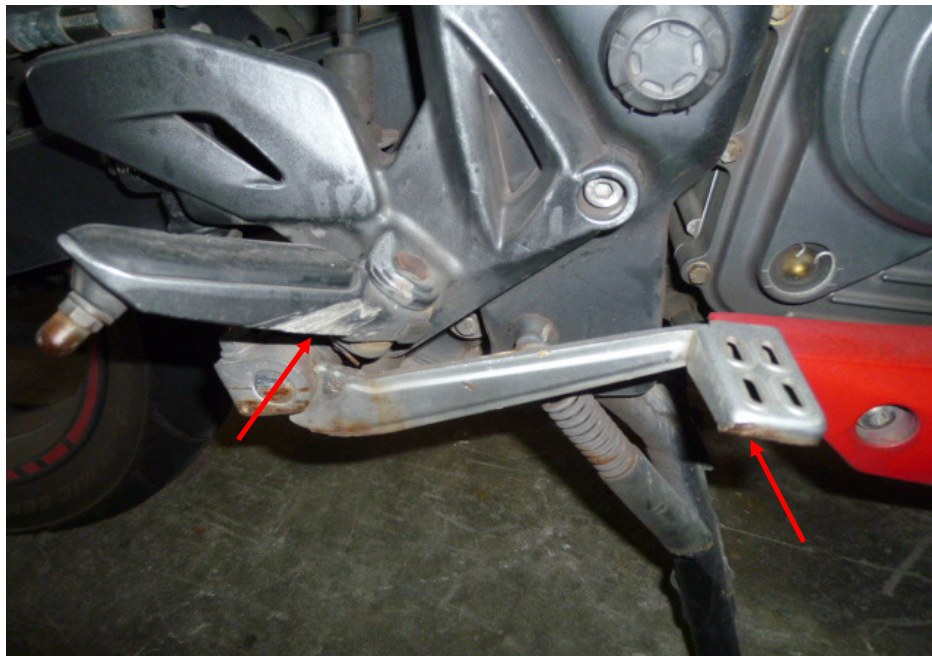
**Photo 13** shows the rear brake pedal and right front footrest of the Motorcycle that had sustained damage as a result of the accident (arrowed).

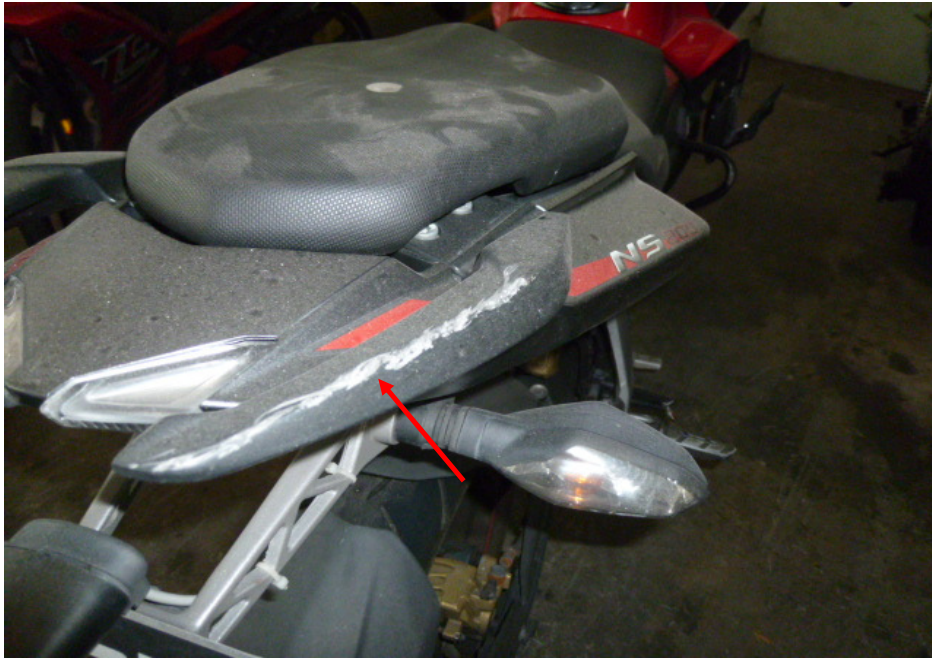
**Photo 14** shows the grazed right rear side cover of the Motorcycle as a result of the accident (arrowed).

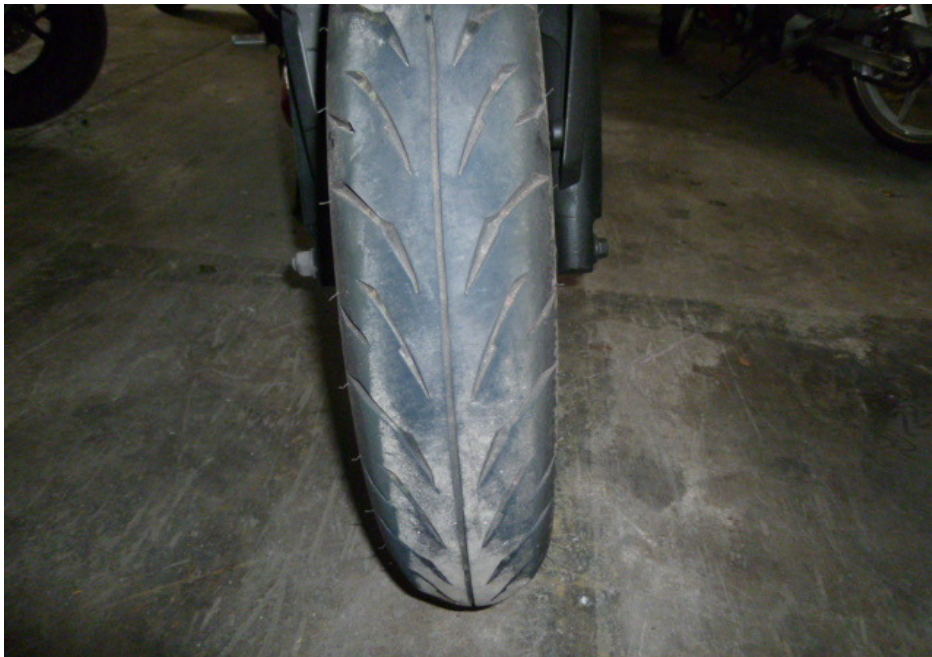
**Photo 15** shows the front tyre of the Motorcycle at the time of our inspection. The front tyre was observed to be in serviceable condition with remaining tread depth of approximately 3mm. The pattern of the tread was also clearly visible. There was no tear, burst mark(s) and/or punctured hole(s) on the sidewalls as well as across the tread of the front tyre.

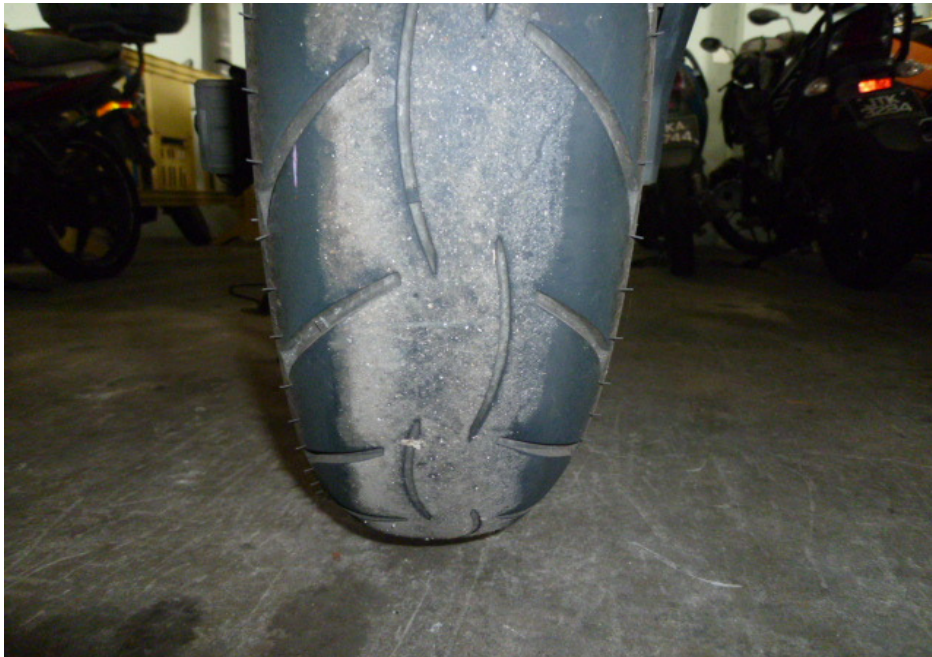
**Photo 16** shows the condition of the Motorcycle's rear tyre. The rear tyre was observed to be in serviceable condition with remaining tread depth of approximately 2mm. The tyre was also observed to be sufficiently inflated for vehicular operation. We did not observe any tear, burst mark(s) and/or punctured hole(s) on the sidewalls as well as across the tread of the rear tyre.

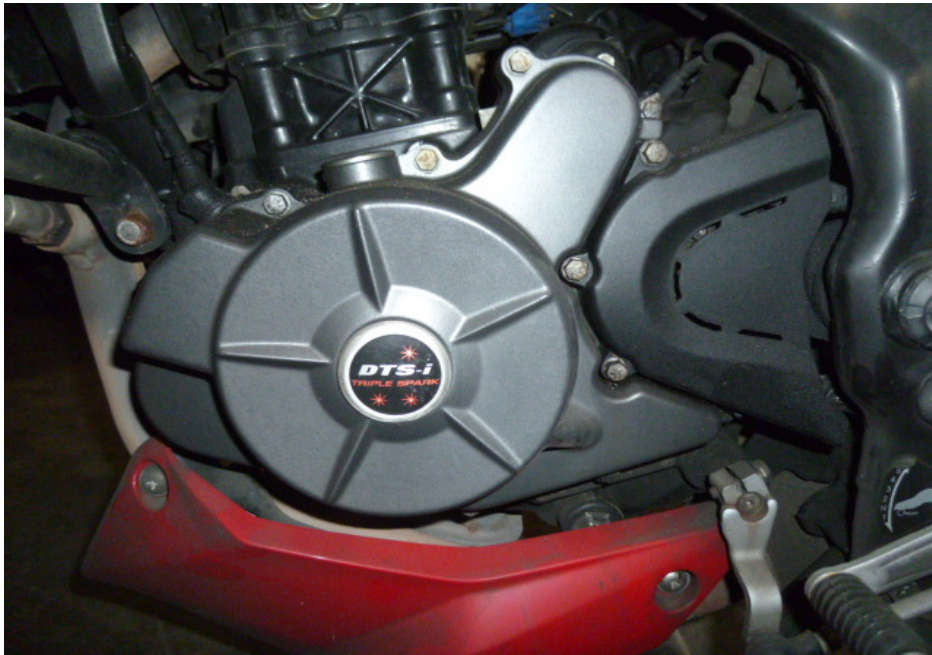
**Photo 17** shows the left side of the engine of the Motorcycle at the time of our inspection. The various engine related parts and components were found to be intact with no visible damage. There was also no sign(s) or indication(s) of fluid leak observed around the left engine area of the Motorcycle.

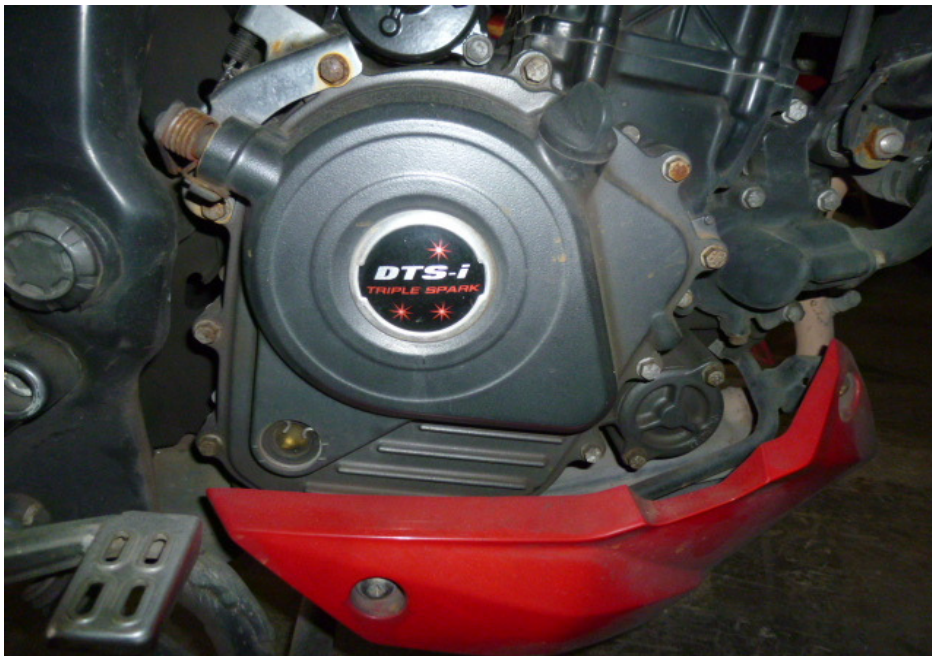
**Photo 18** shows the right side of the engine of the Motorcycle at the time of our inspection. The various engine related parts and components were found to be intact with no visible damage. There was also no sign(s) or indication(s) of fluid leak observed around the right engine area of the Motorcycle.

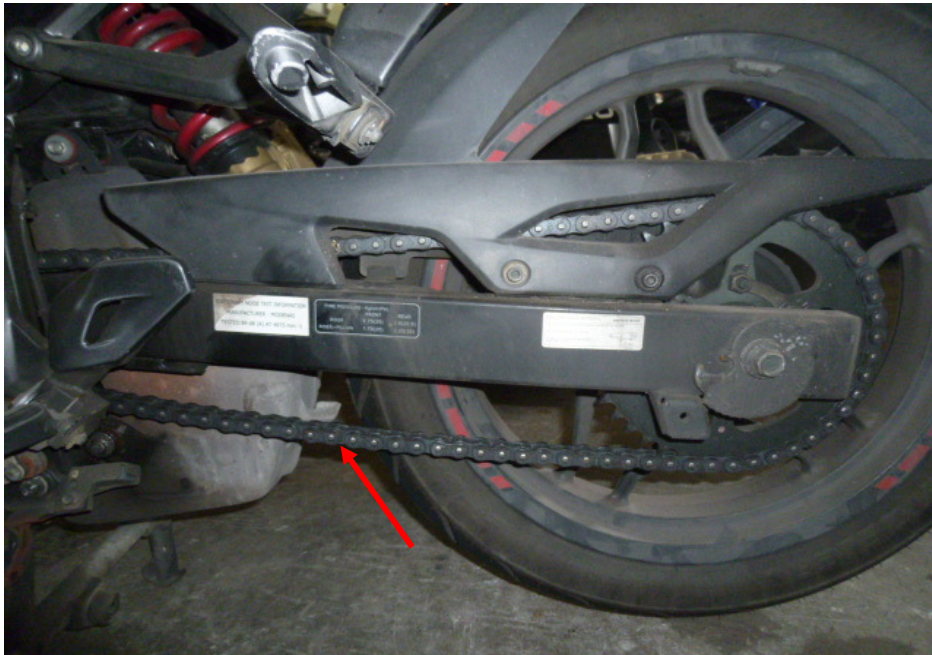
**Photo 19** shows the general view of the gear chain (arrowed) of the Motorcycle, which was observed to be intact with no misalignment. It was also adequately lubricated for operating purposes.

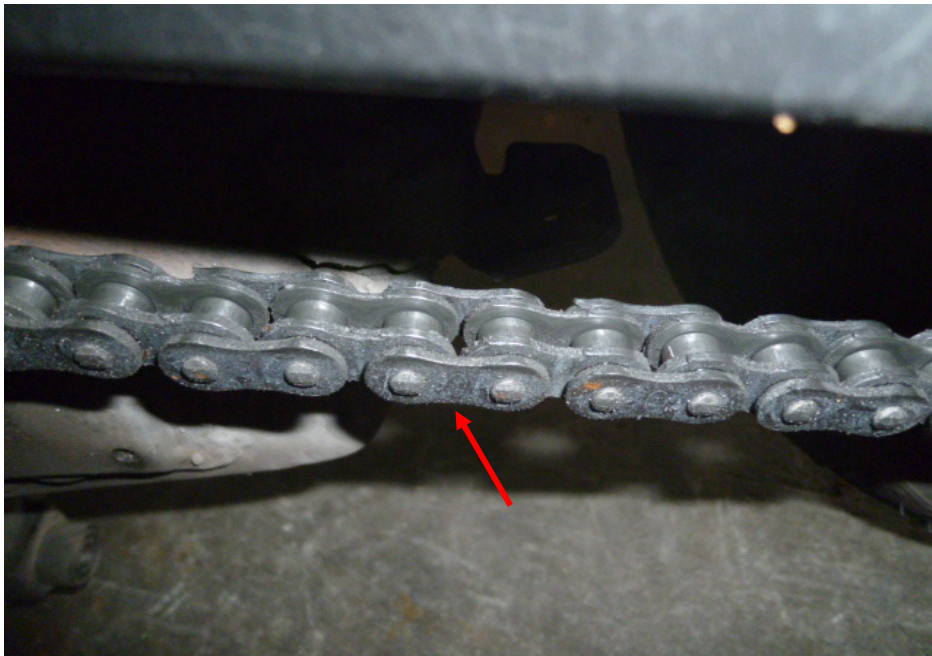
**Photo 20** shows a closer view of the gear chain (arrowed) of the Motorcycle, which was observed to be intact with no misalignment. It was also adequately lubricated for operating purposes.

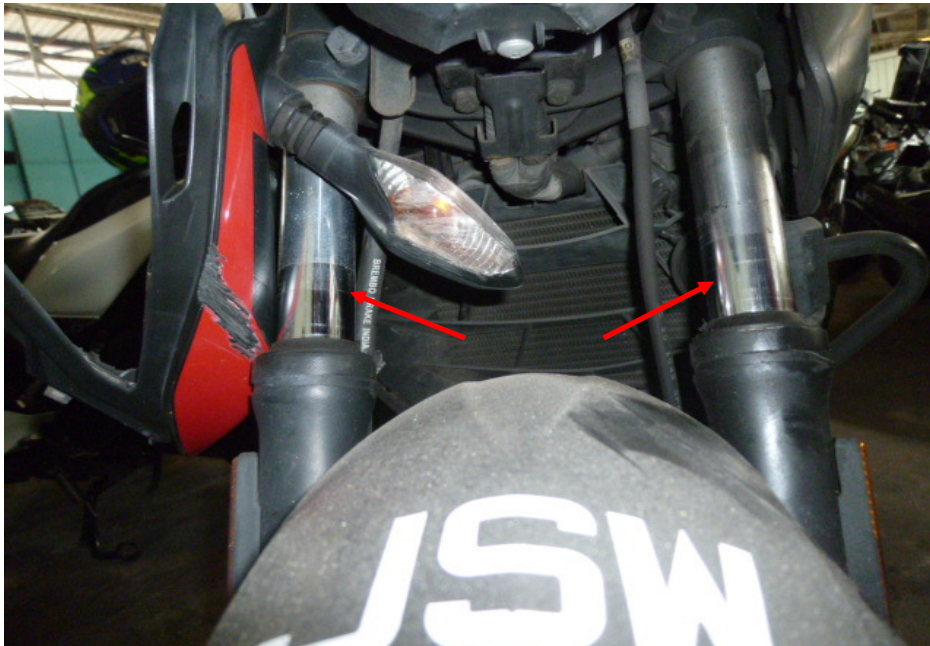
**Photo 21** shows the front forks (arrowed) of the Motorcycle. The front forks and fork bracket of the Motorcycle were both found to be intact and undamaged. Turning the Motorcycle's handle bar towards the left and right did not produce any abnormal free play. The steering system of the Motorcycle was in serviceable condition at the time of our inspection.

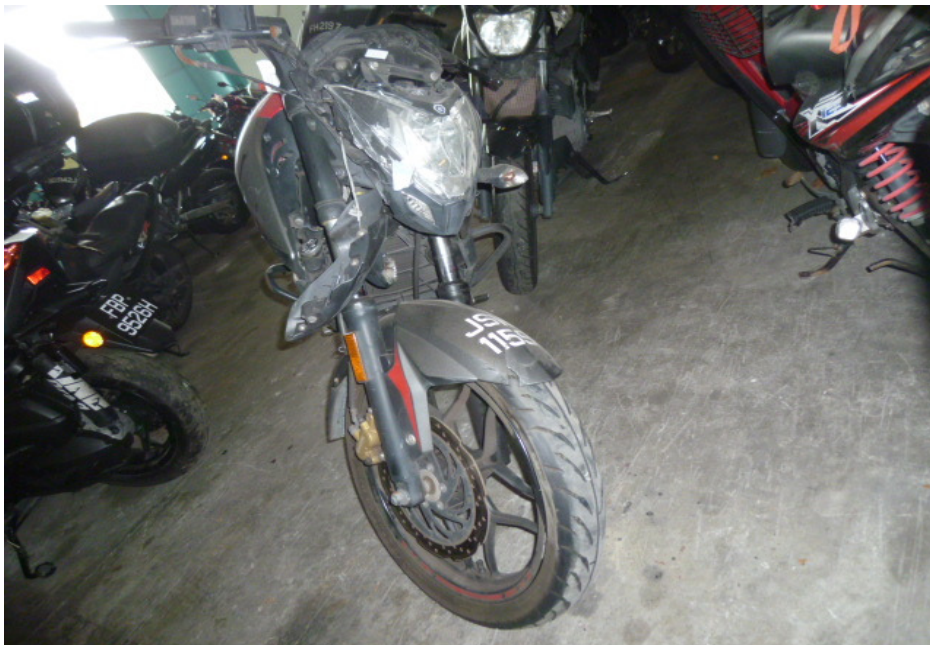
**Photo 22** shows the front wheel of the Motorcycle turned towards its full left. Turning the Motorcycle's handle bar towards the left did not produce any abnormal free play and/or resistance. This would indicate that the steering system of the Motorcycle was in serviceable condition at the time of our inspection.

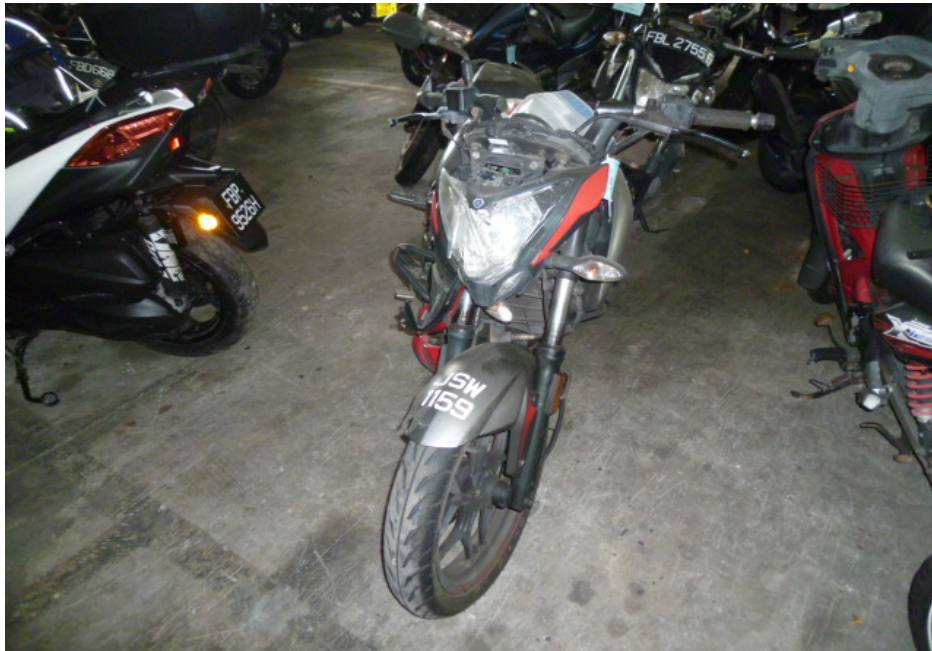
**Photo 23** shows the front wheel of the Motorcycle turned towards its full right. Turning the Motorcycle's handle bar towards the right did not produce any abnormal free play and/or resistance. This would indicate that the steering system of the Motorcycle was in serviceable condition at the time of our inspection.

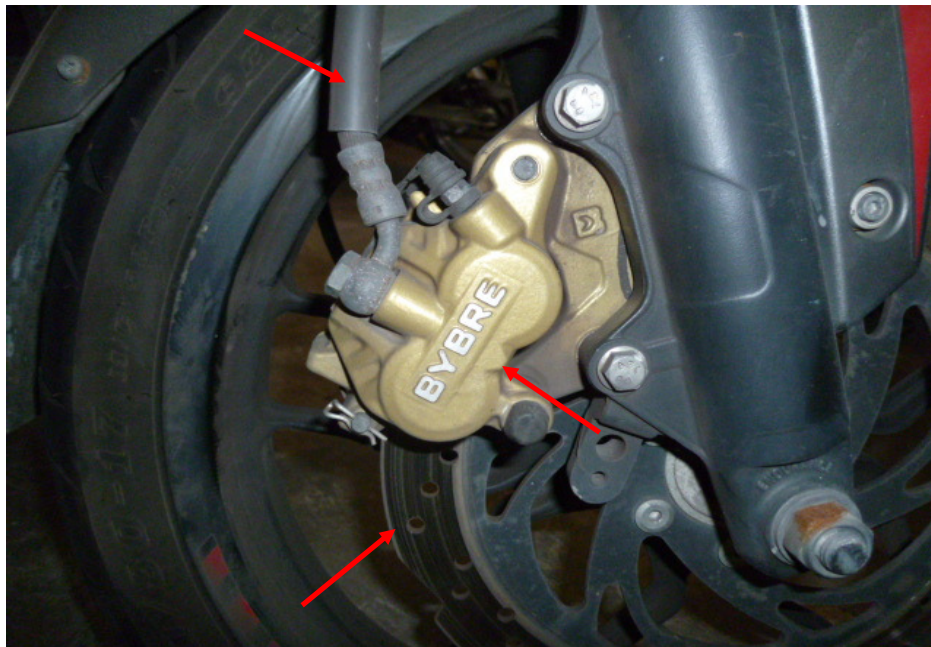
**Photo 24** shows a close up view of the front brake caliper, front brake disc and front brake hose (arrowed) of the Motorcycle, which are all part of the components in the hydraulic front brake system of the Motorcycle. Our visual checks of these various components had revealed all to be intact with no visible damage. No leakage of brake fluid was also observed.

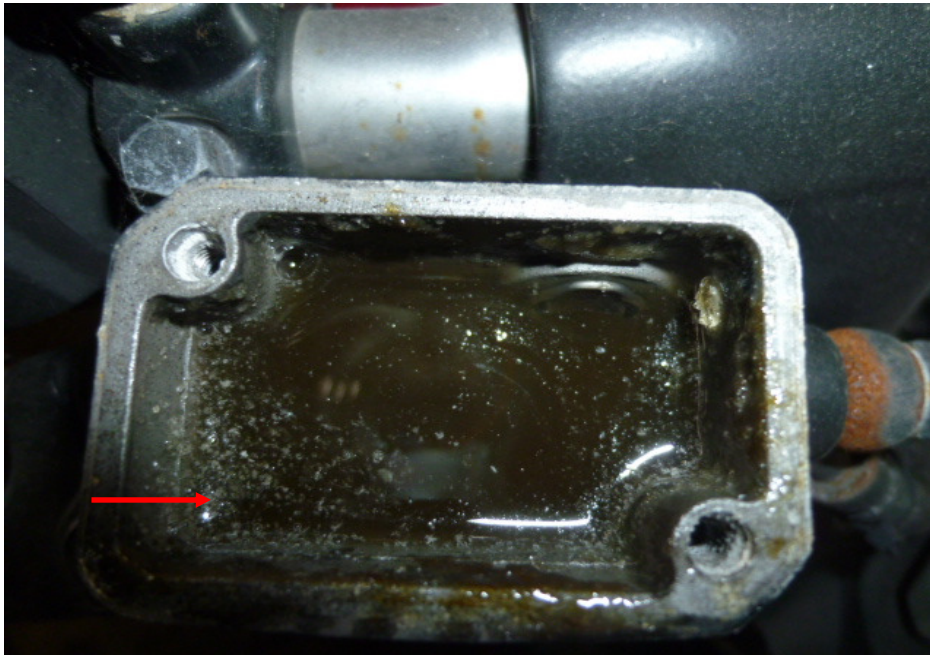
14. The brake fluid for the front brake and rear brake was observed to be of sufficient level for operational purposes. However the brake fluid for the front brake and rear brake was found to be contaminated.

**Photo 25** shows a close up view of the brake fluid reservoir for the front brake of the Motorcycle. The front brake fluid was observed to be of sufficient level for operational purposes. However it was found to be contaminated (arrowed).

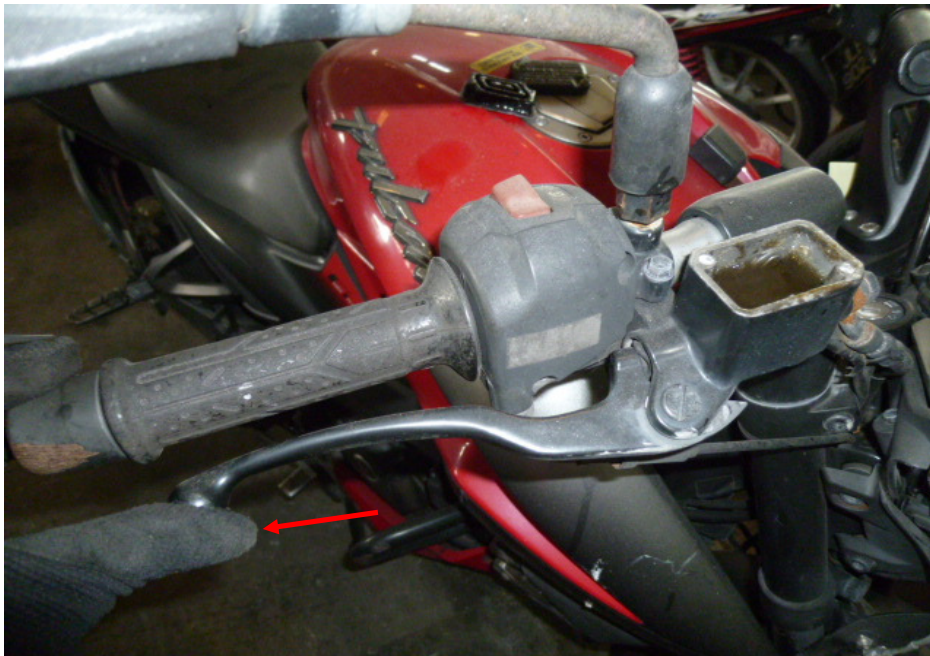
**Photo 26** shows the front brake lever being depressed. There was some resistance felt (spongy like feel) upon pressing the front brake lever (arrowed). This would indicate that there is no leakage of pressure/vacuum in the front brake system.

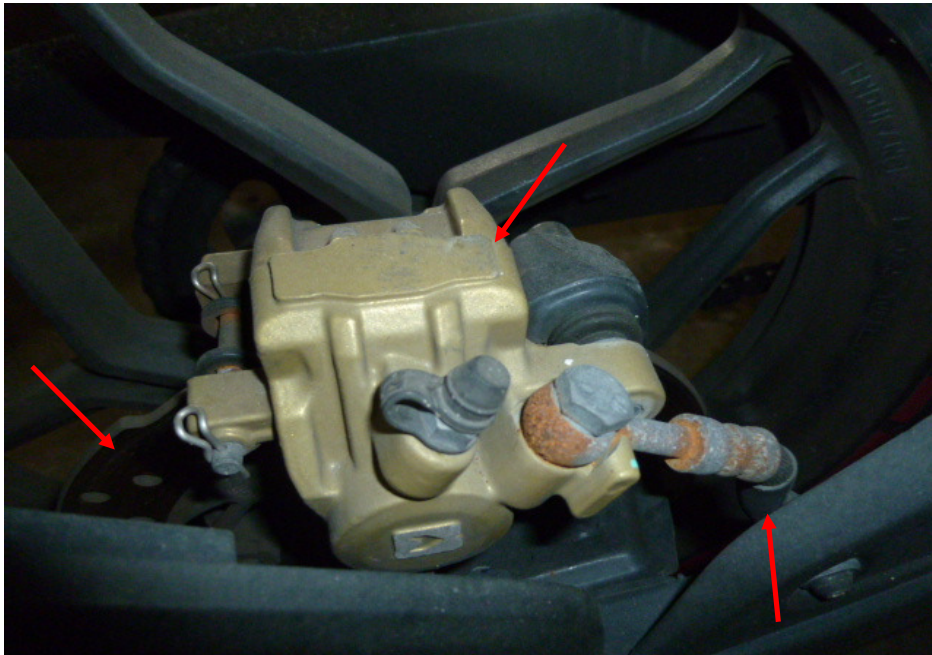
**Photo 27** shows a close up view of the rear brake caliper, rear brake disc and rear brake hose (arrowed) of the Motorcycle, which are all part of the components in the hydraulic rear brake system of the Motorcycle. Our visual checks of these various components had revealed all to be intact with no visible damage. No leakage of brake fluid was also observed.

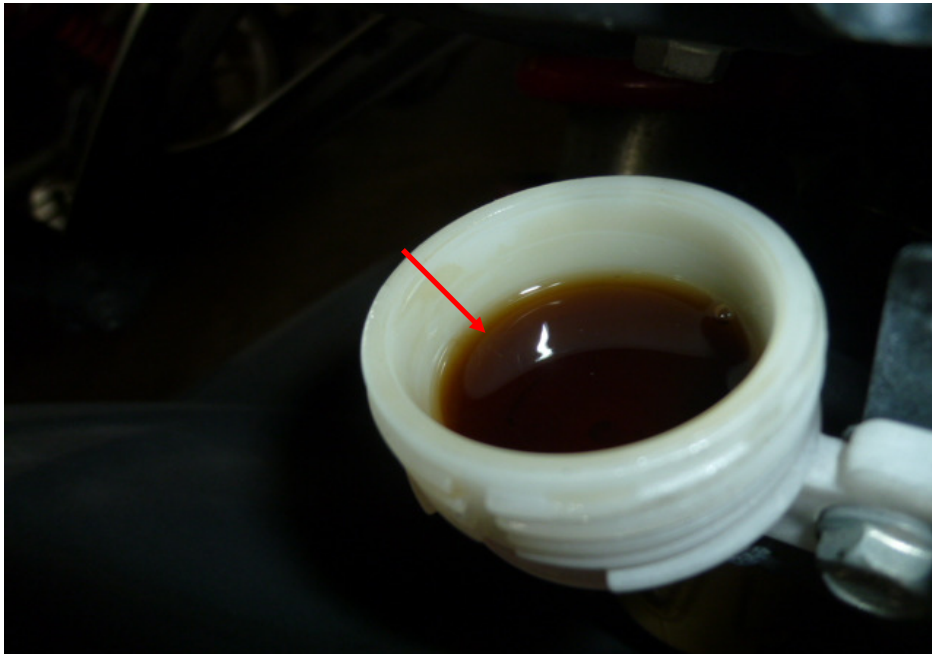
**Photo 28** shows a close up view of the brake fluid reservoir for the rear brake of the Motorcycle. The rear brake fluid was observed to be of sufficient level for operational purposes. However it was found to be contaminated (arrowed).
