Your Ref: TP/IP/57585/2021  
Our Ref : CI/TPD22002082/N

12 April 2022

**Fatal Accident Investigation Team**

**INSPECTION REPORT OF MOTORCYCLE FBQ 2218M**

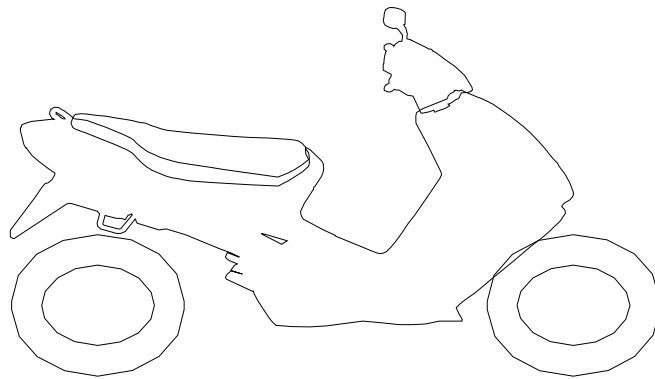
7. The tyre brand, tyre size and remaining tread depth of the 2 tyres were recorded as follows:-

Maxxis 140/70 - 17 (6mm)

Metzeler 110/70 - 17 (4mm)

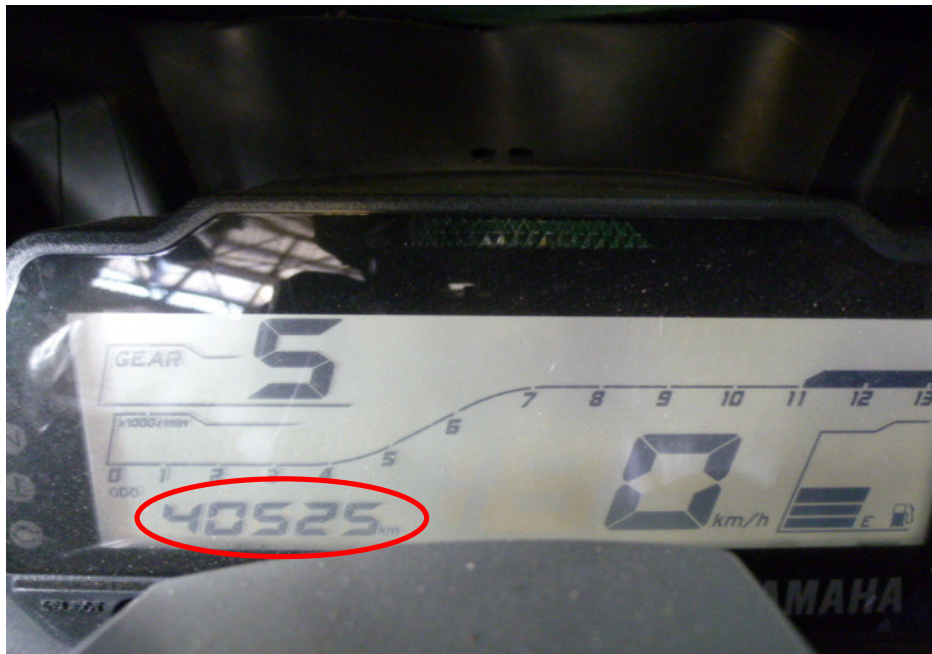
**Photo 1** shows the speedometer gauge of the Motorcycle. The mileage of the Motorcycle at the time of our inspection was 40, 525km (circled).

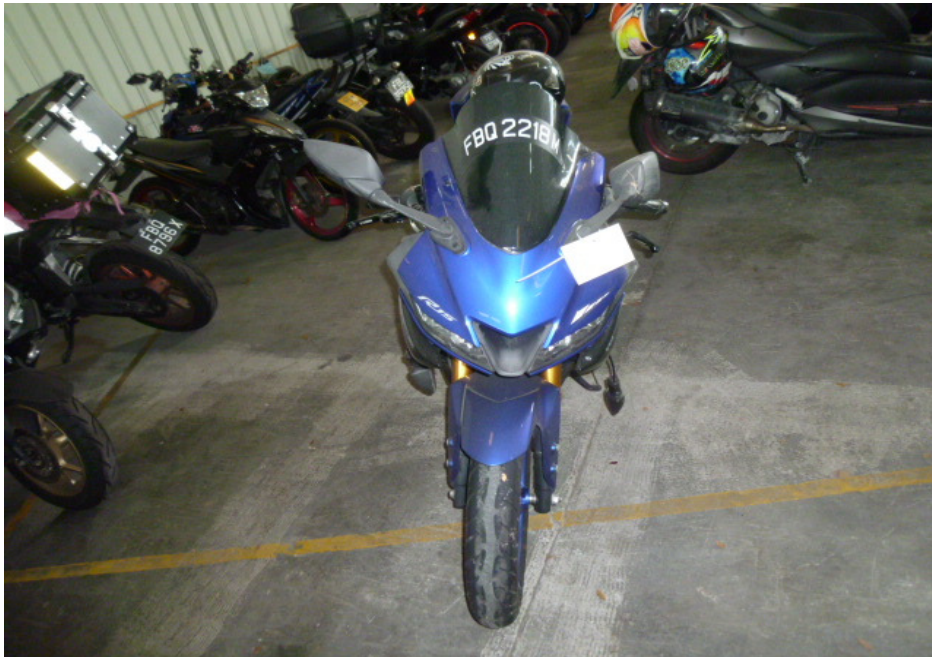
**Photo 2** shows a general view of the frontal portion of the Motorcycle at the time of our inspection. The Motorcycle was observed to have sustained damages all around.

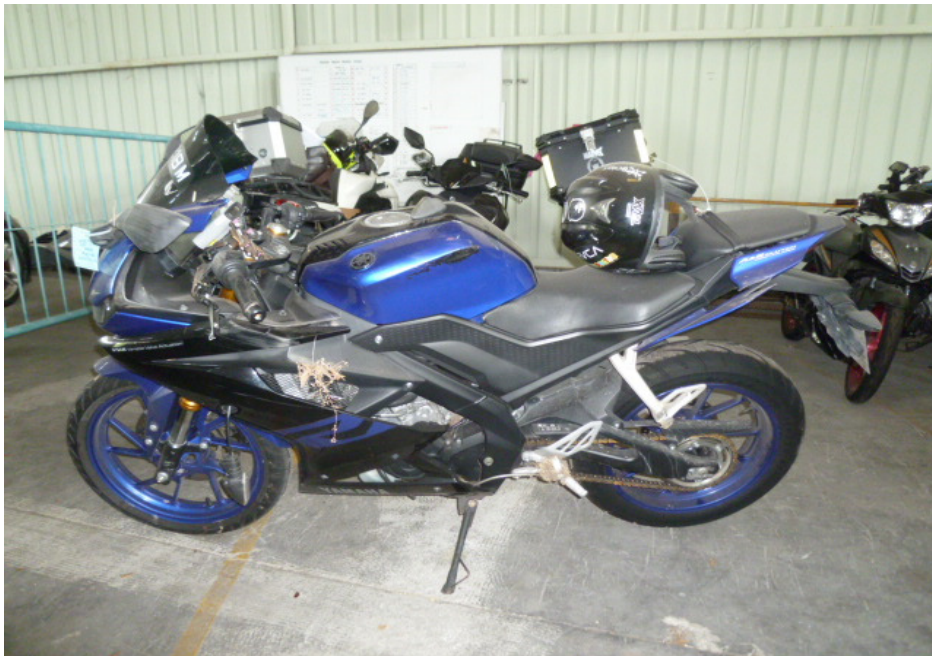
**Photo 3** shows a general view of the left body of the Motorcycle at the time of our inspection. The Motorcycle was observed to have sustained damages all around.

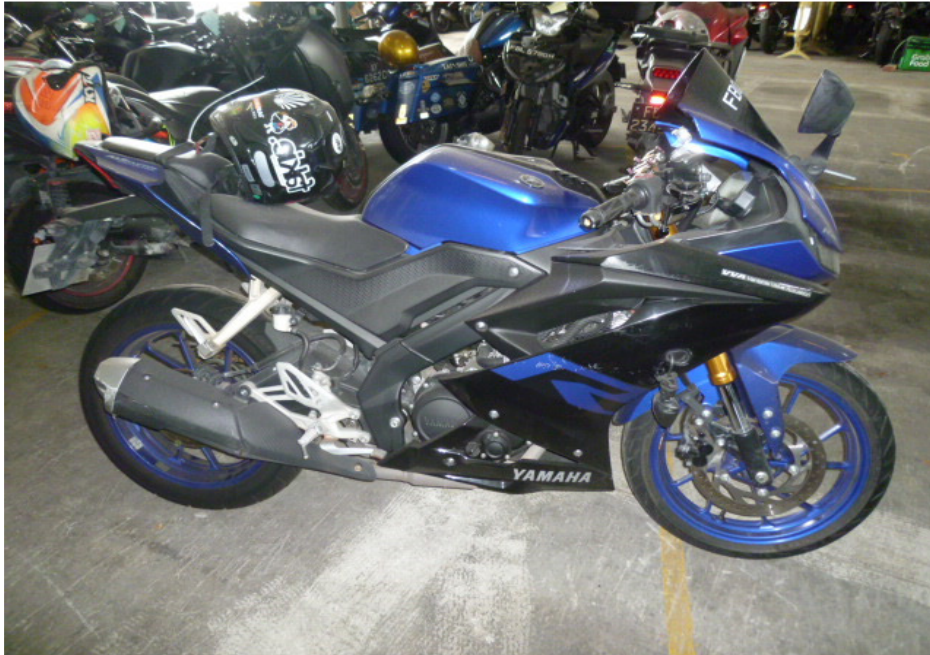
**Photo 4** shows a general view of the right body of the Motorcycle at the time of our inspection. The Motorcycle was observed to have sustained damages all around. The body parts that were found to have been damaged include its front cowling, front mudguard, side cowlings, right side mirror, front brake lever, right handlebar end, petrol tank, gear shift pedal, left front footrest, left rear side cover, right rear signal lamp and exhaust muffler heat shield, amongst others.

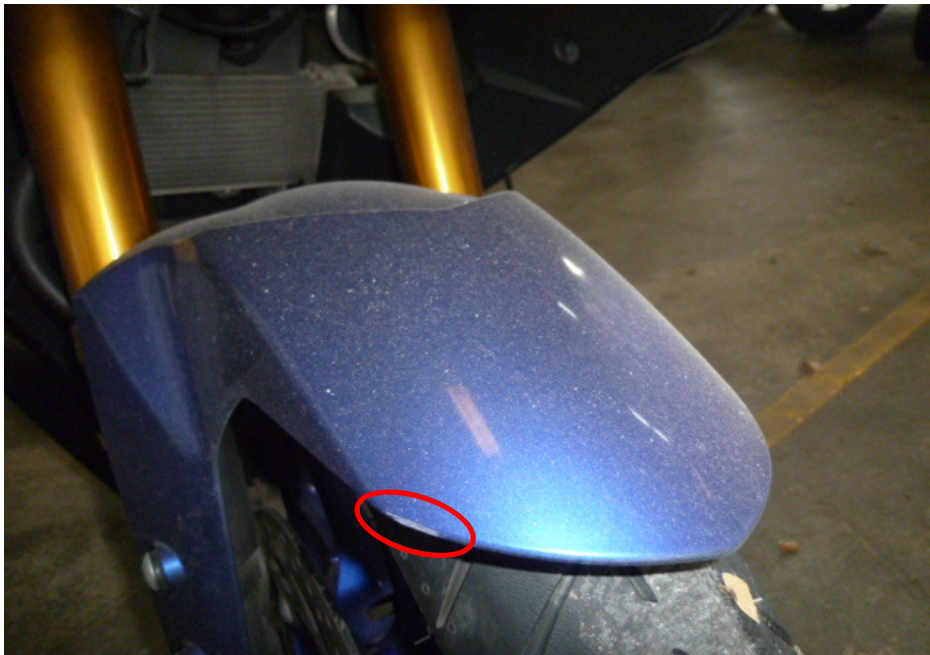
**Photo 5** shows a closer view of the front mudguard (circled) which was amongst the body parts of the Motorcycle that had sustained damage as a result of the accident.

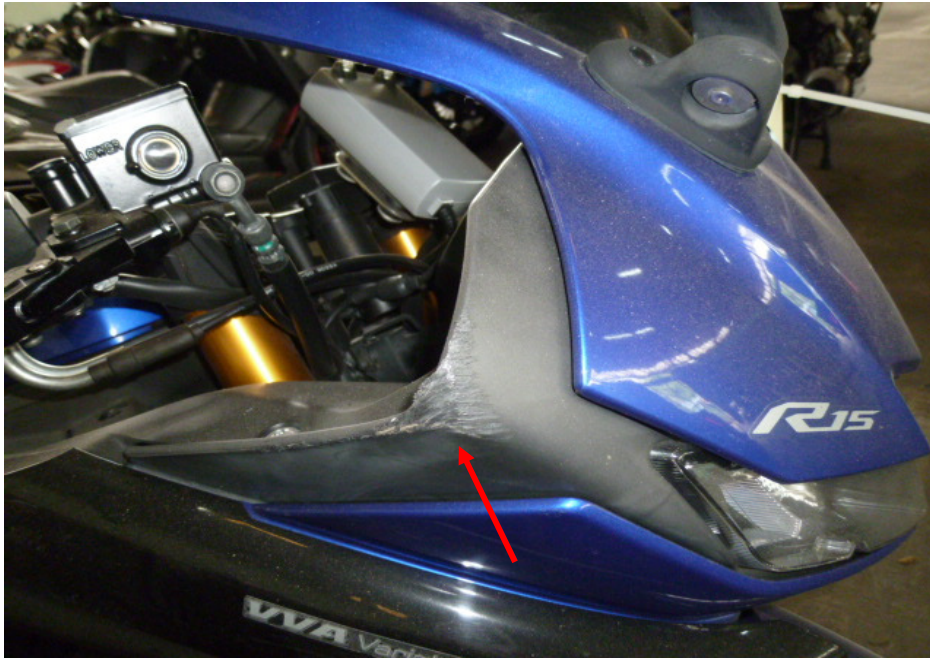
**Photo 6** shows the front cowling (arrowed), which were amongst the body parts of the Motorcycle that had sustained damage as a result of the accident.

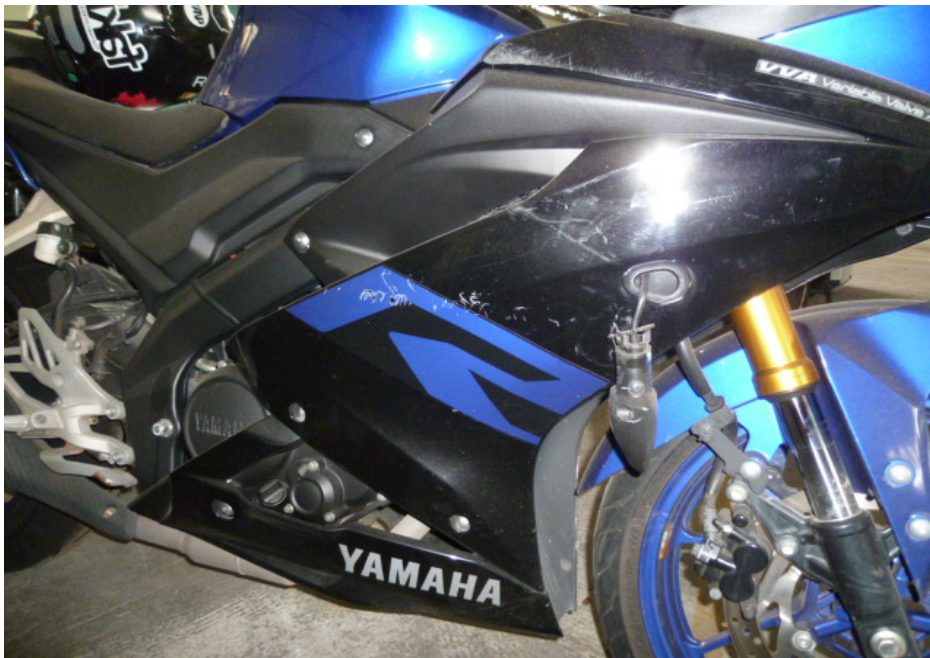
**Photo 7** shows a closer view of the right cowling which was amongst the body parts of the Motorcycle that had sustained damage as a result of the accident.

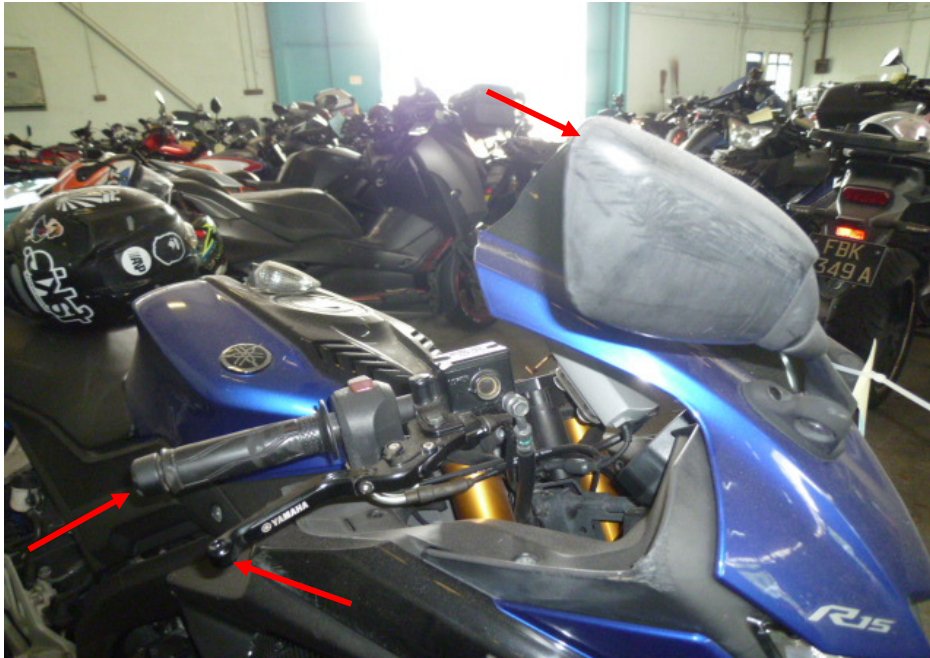
**Photo 8** shows the right handlebar end, front brake lever and right side mirror (arrowed), which were amongst the body parts of the Motorcycle that had sustained damage as a result of the accident.

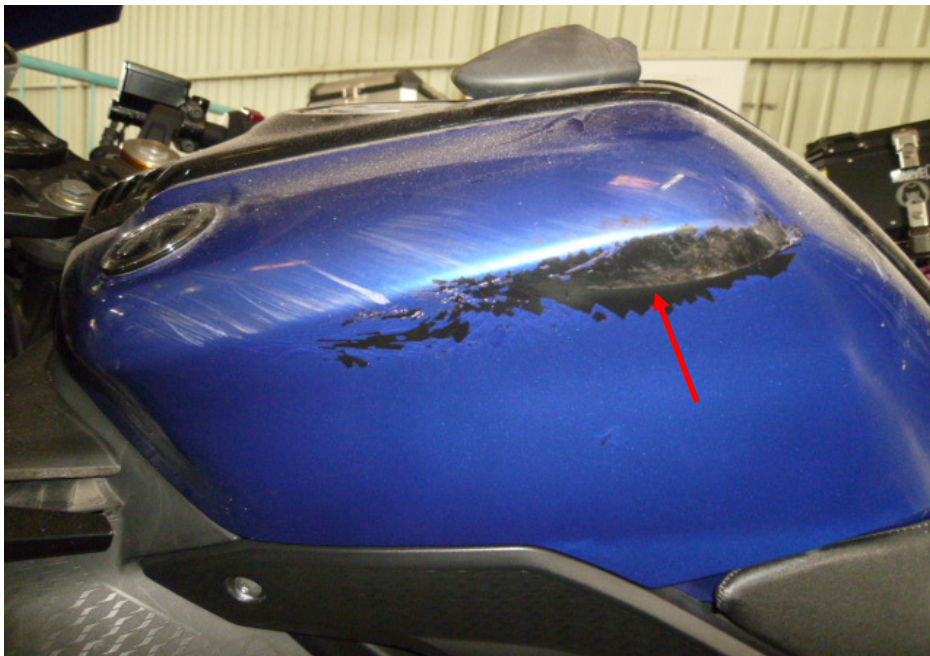
**Photo 9** shows a closer view of the dented petrol tank of the Motorcycle as a result of the accident (arrowed).

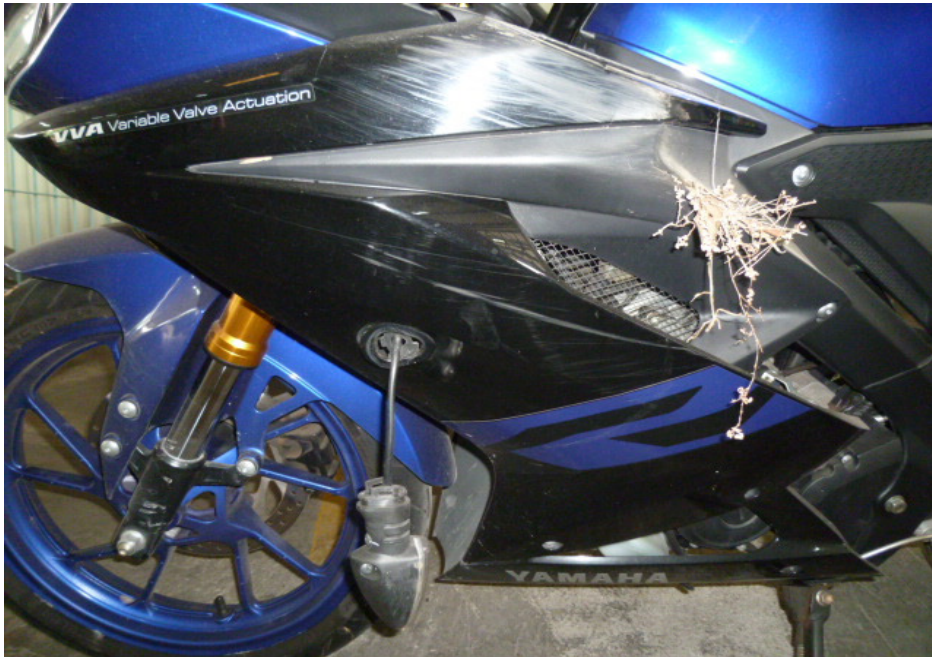
**Photo 10** shows a closer view of the left cowling which was amongst the body parts of the Motorcycle that had sustained damage as a result of the accident.

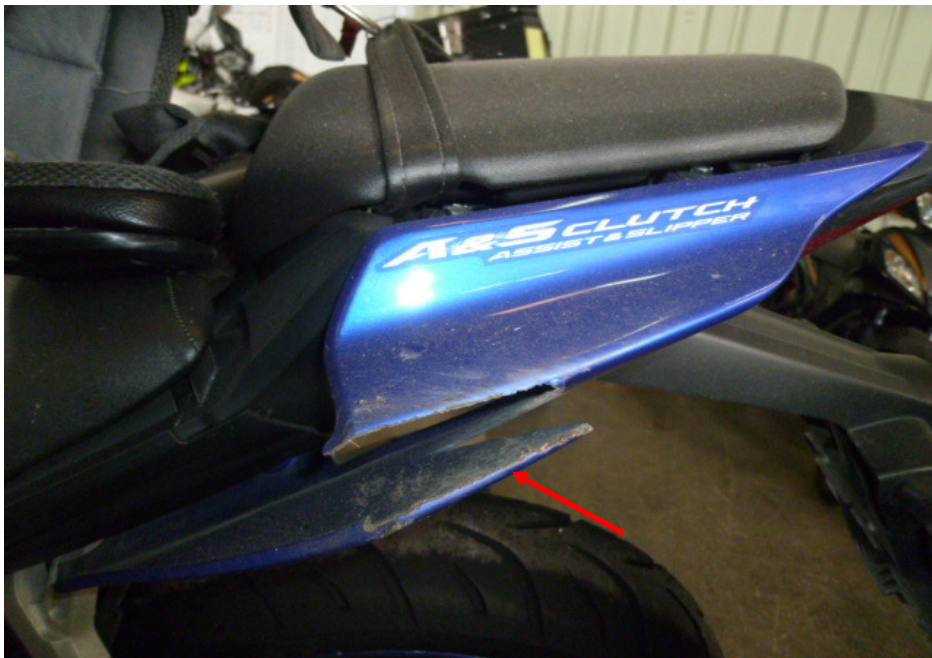
**Photo 11** shows a closer view of the cracked left rear side cover of the Motorcycle as a result of the accident (arrowed).

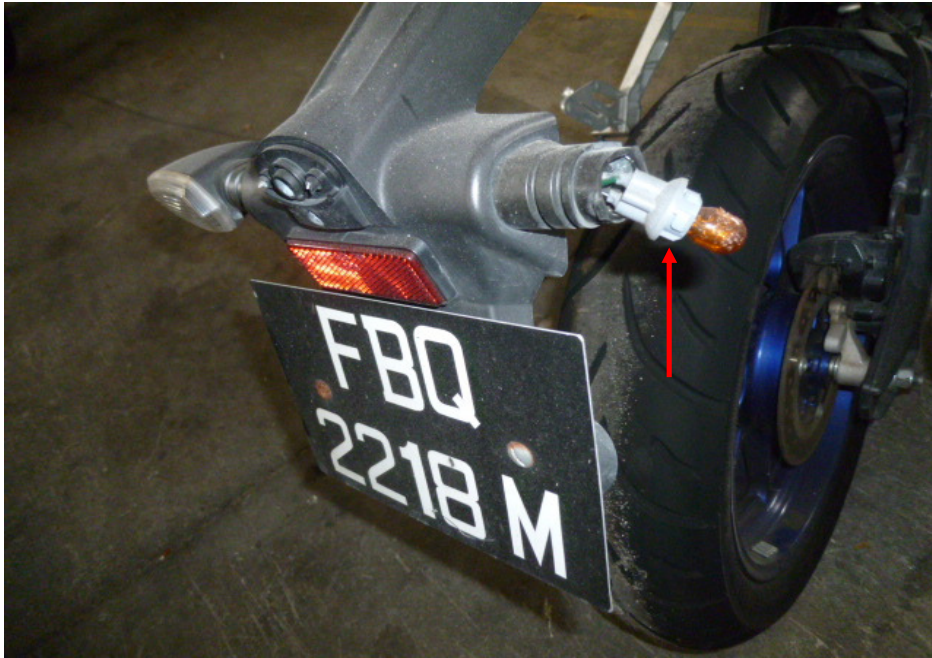
**Photo 12** shows a closer view of the broken right rear signal lamp (arrowed) of the Motorcycle as a result of the accident.

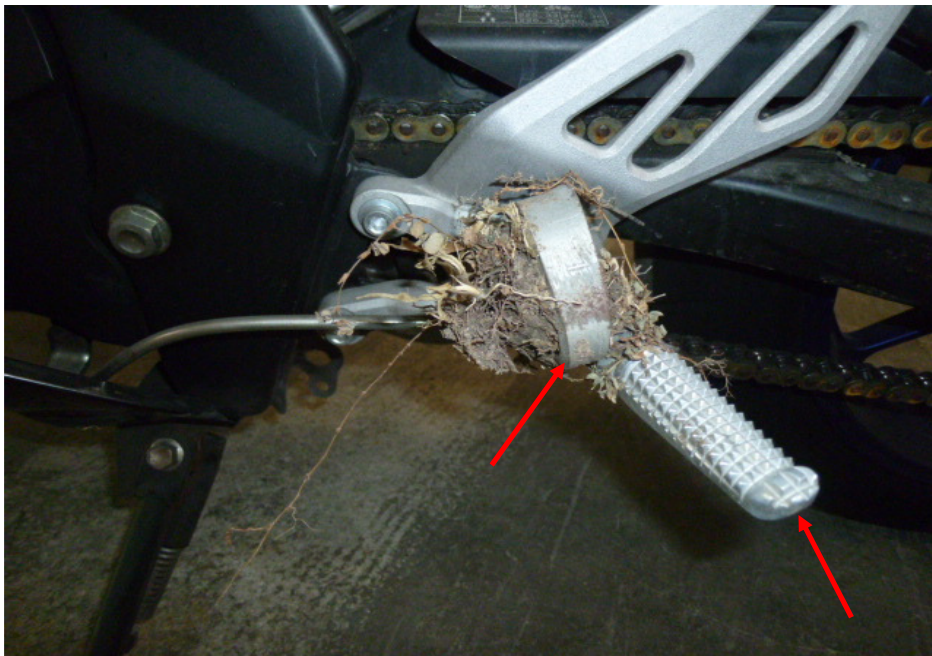
**Photo 13** shows the gear shift pedal and left front footrest of the Motorcycle that had sustained damage as a result of the accident (arrowed).

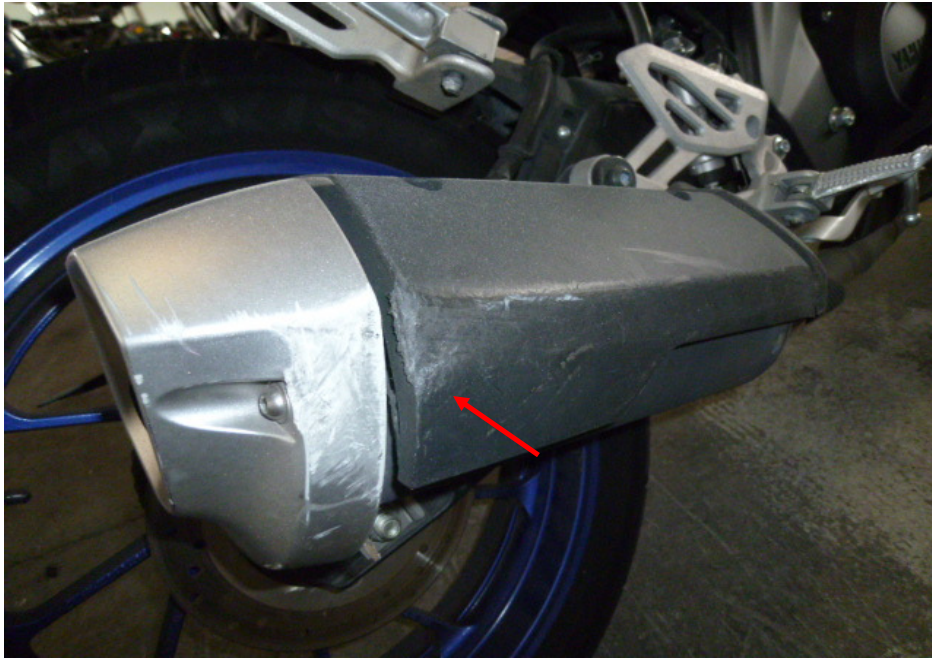
**Photo 14** shows the grazed exhaust muffler heat shield of the Motorcycle as a result of the accident (arrowed).

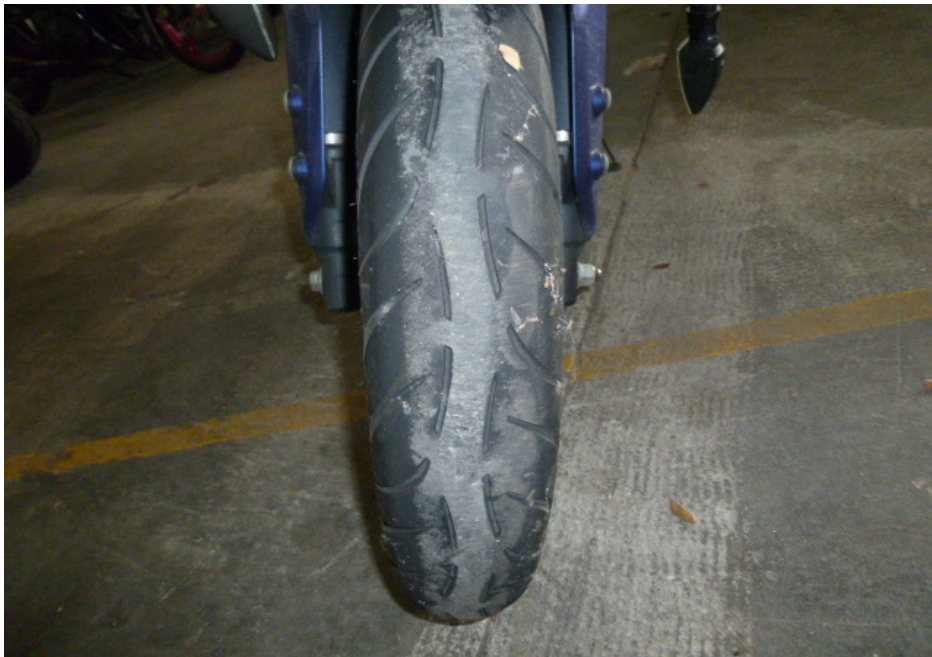
**Photo 15** shows the front tyre of the Motorcycle at the time of our inspection. The front tyre was observed to be in serviceable condition with remaining tread depth of approximately 4mm. The pattern of the tread was also clearly visible. There was no tear, burst mark(s) and/or punctured hole(s) on the sidewalls as well as across the tread of the front tyre.

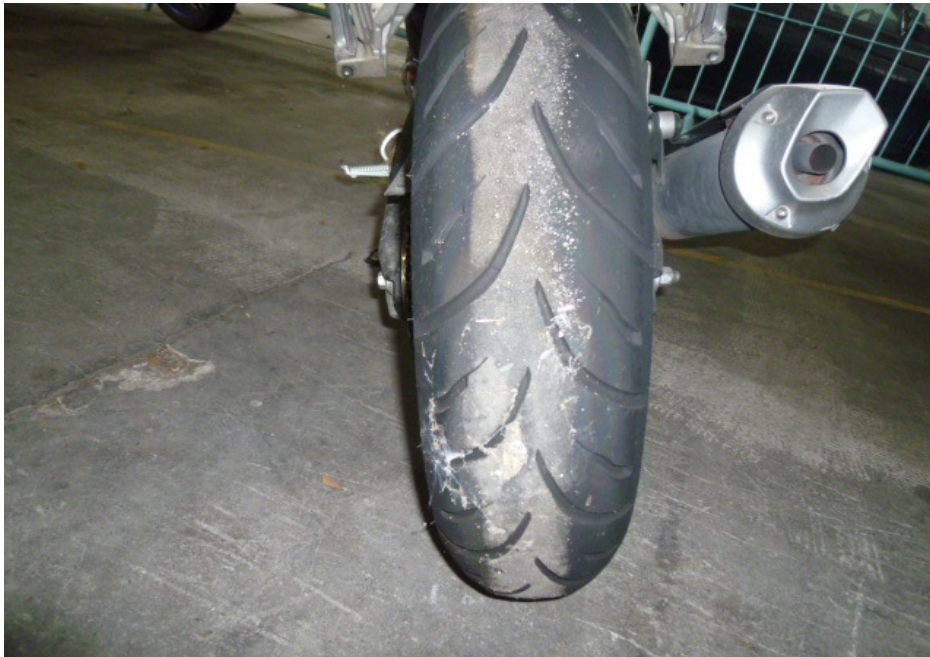
**Photo 16** shows the condition of the Motorcycle's rear tyre. The rear tyre was observed to be in serviceable condition with remaining tread depth of approximately 6mm. The tyre was also observed to be sufficiently inflated for vehicular operation. We did not observe any tear, burst mark(s) and/or punctured hole(s) on the sidewalls as well as across the tread of the rear tyre.

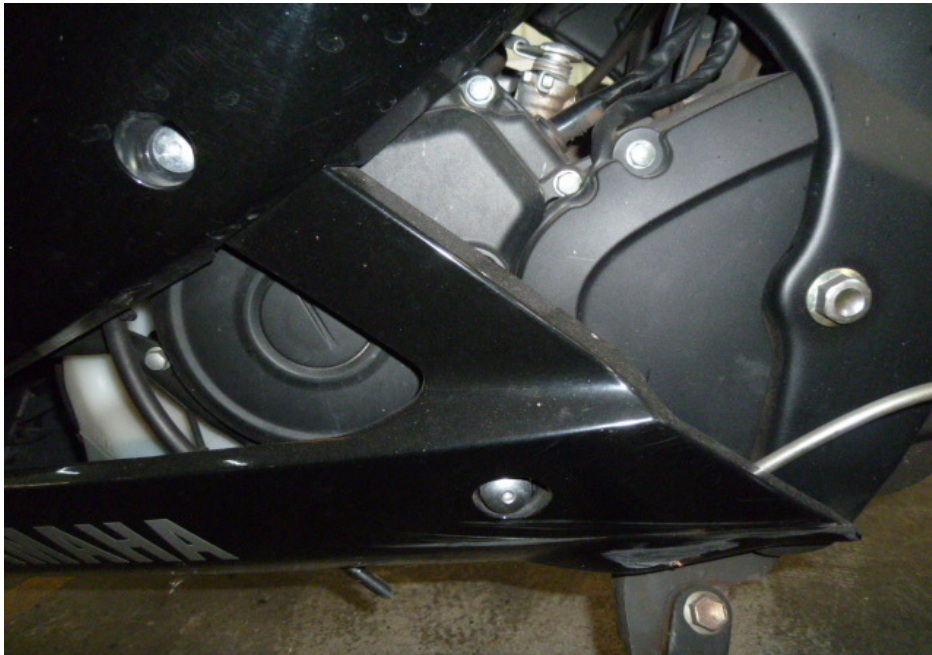
**Photo 17** shows the left side of the engine of the Motorcycle at the time of our inspection. The various engine related parts and components were found to be intact with no visible damage. There was also no sign(s) or indication(s) of fluid leak observed around the left engine area of the Motorcycle.

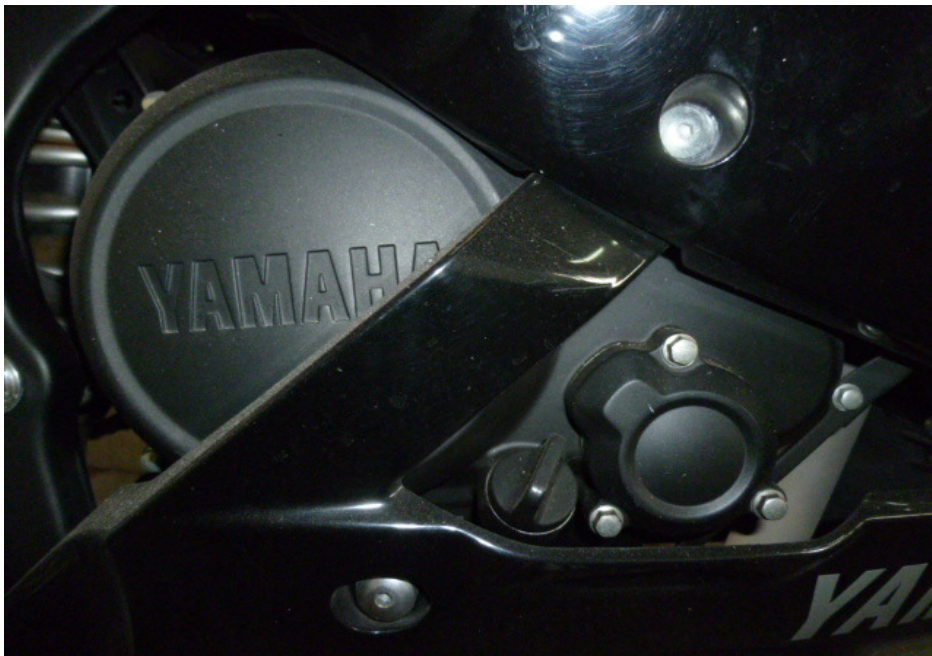
**Photo 18** shows the right side of the engine of the Motorcycle at the time of our inspection. The various engine related parts and components were found to be intact with no visible damage. There was also no sign(s) or indication(s) of fluid leak observed around the right engine area of the Motorcycle.

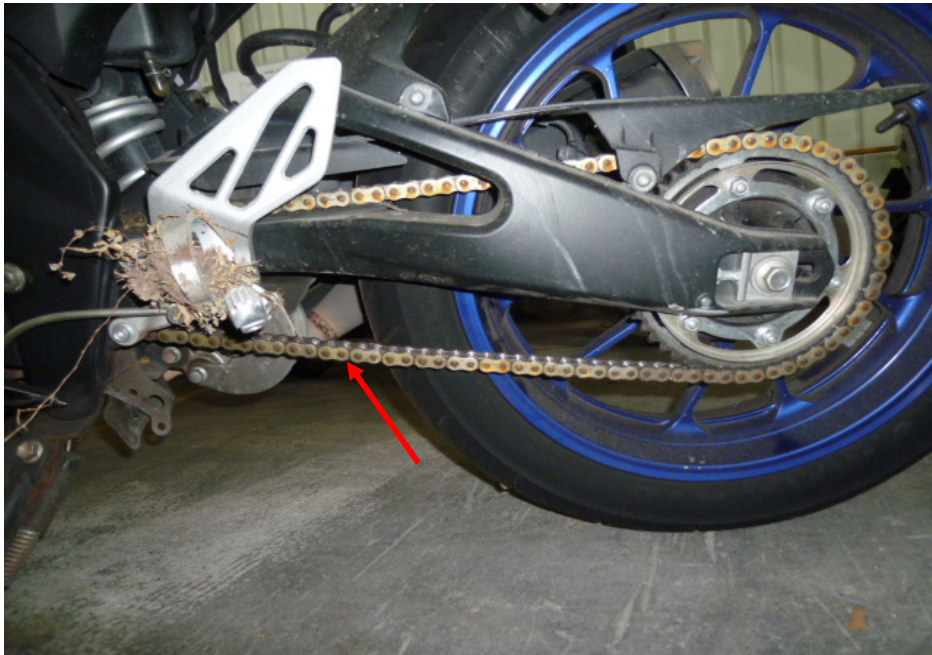
**Photo 19** shows the general view of the gear chain (arrowed) of the Motorcycle, which was observed to be intact with no misalignment. It was also adequately lubricated for operating purposes.

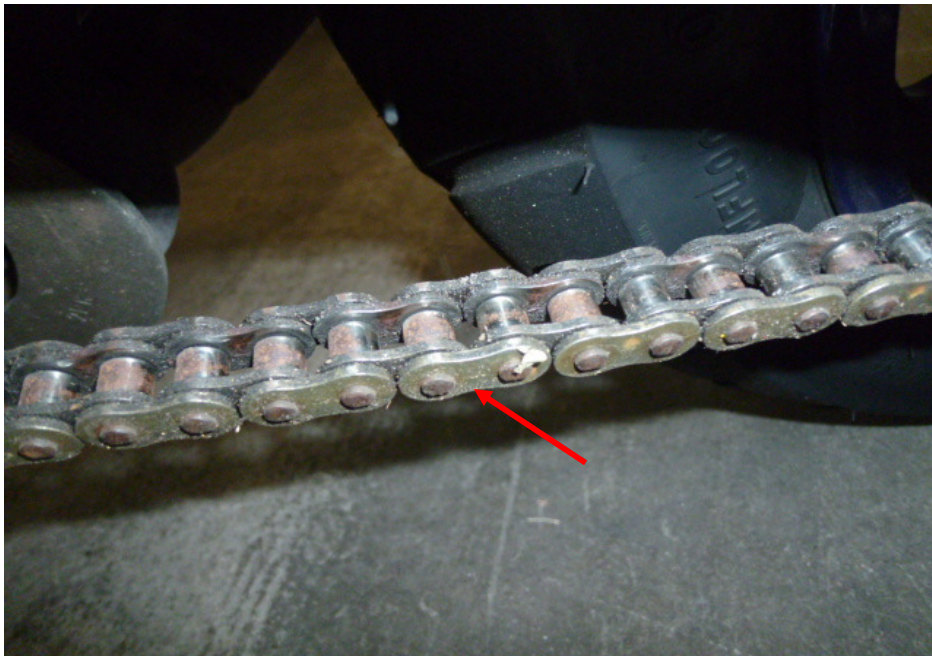
**Photo 20** shows a closer view of the gear chain (arrowed) of the Motorcycle, which was observed to be intact with no misalignment. It was also adequately lubricated for operating purposes.

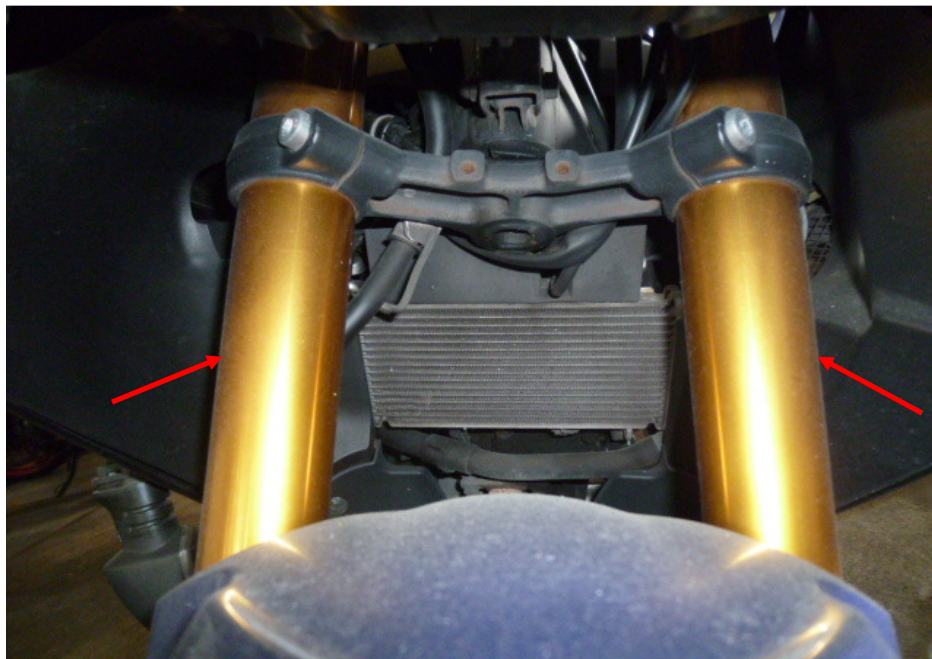
**Photo 21** shows the front forks (arrowed) of the Motorcycle. The front forks and fork bracket of the Motorcycle were both found to be intact and undamaged. Turning the Motorcycle's handle bar towards the left and right did not produce any abnormal free play. The steering system of the Motorcycle was in serviceable condition at the time of our inspection.

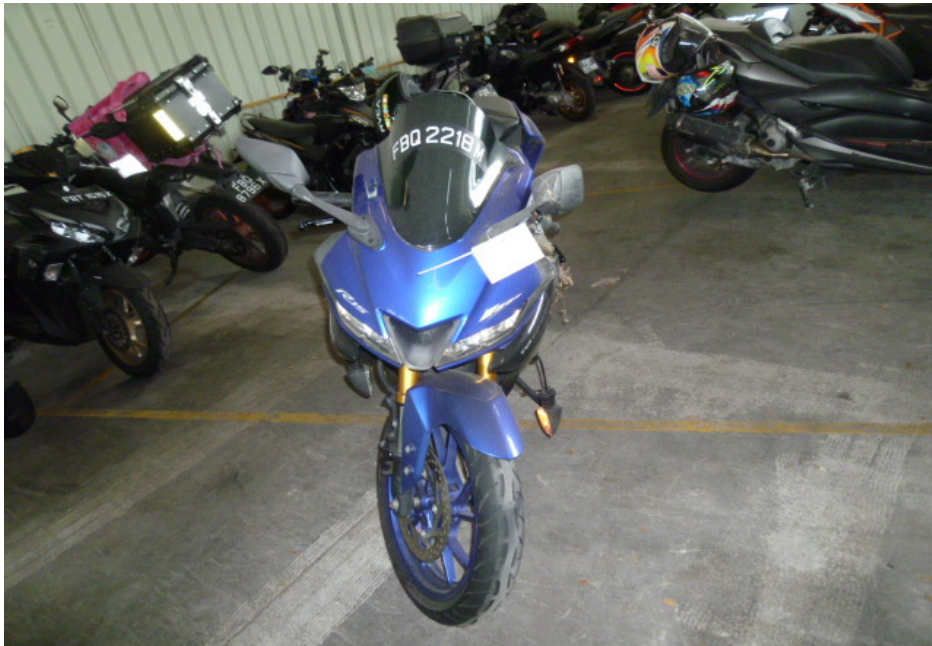
**Photo 22** shows the front wheel of the Motorcycle turned towards its full left. Turning the Motorcycle's handle bar towards the left did not produce any abnormal free play and/or resistance. This would indicate that the steering system of the Motorcycle was in serviceable condition at the time of our inspection.

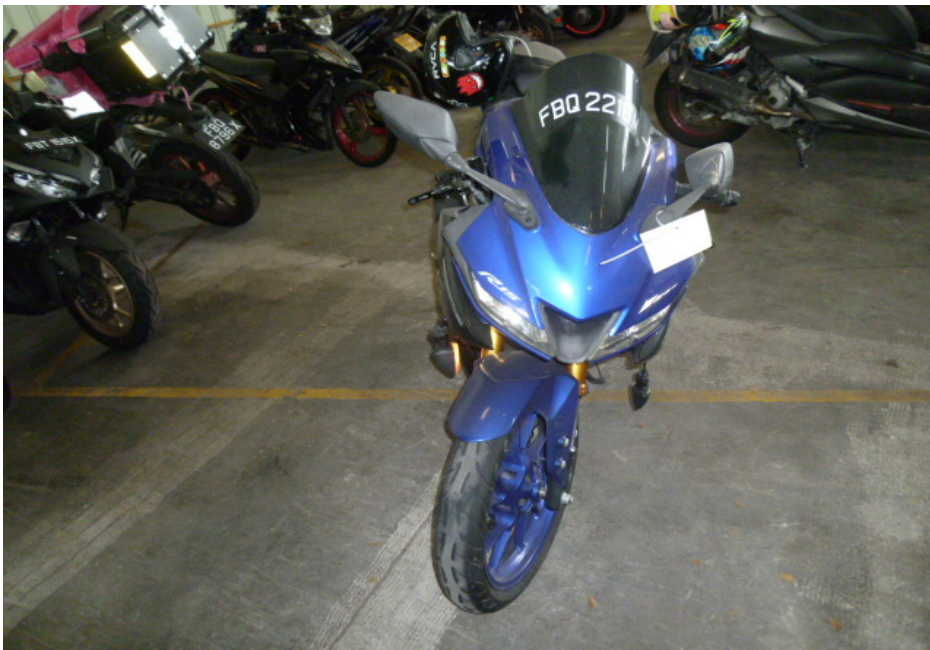
**Photo 23** shows the front wheel of the Motorcycle turned towards its full right. Turning the Motorcycle's handle bar towards the right did not produce any abnormal free play and/or resistance. This would indicate that the steering system of the Motorcycle was in serviceable condition at the time of our inspection.

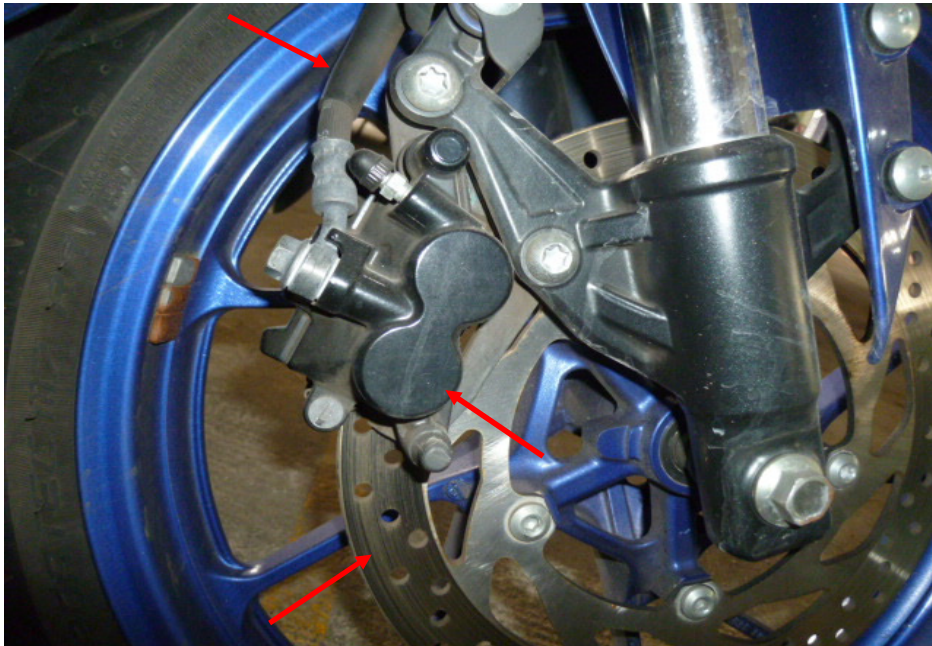
**Photo 24** shows a close up view of the front brake caliper, front brake disc and front brake hose (arrowed) of the Motorcycle, which are all part of the components in the hydraulic front brake system of the Motorcycle. Our visual checks of these various components had revealed all to be intact with no visible damage. No leakage of brake fluid was also observed.

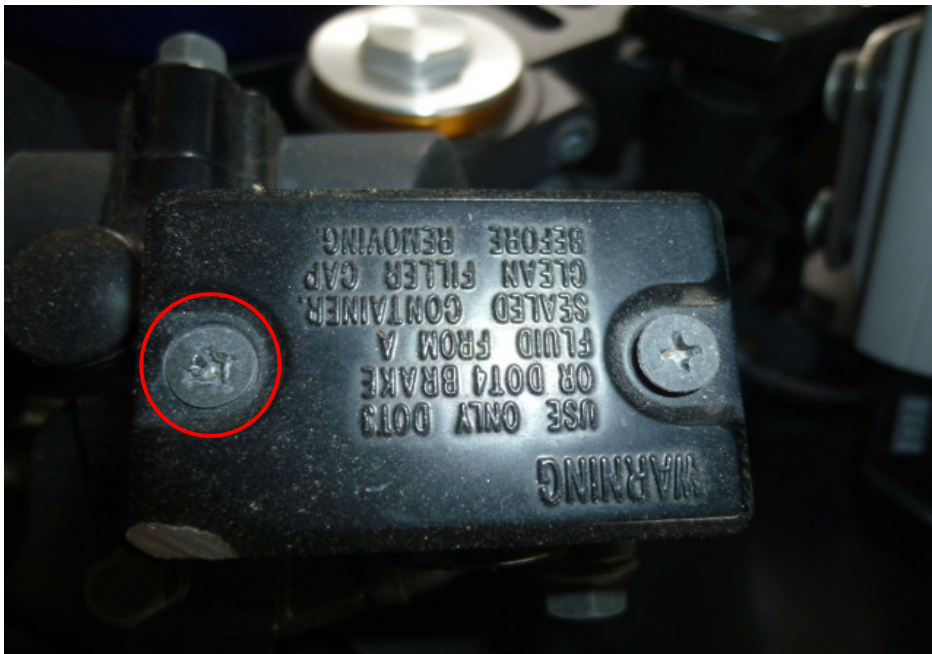
14. The brake fluid for the rear brake was found to be of sufficient level for operational purposes and without any contamination. We were unable to remove the front brake reservoir cover to examine whether the front brake fluid was without contamination due to a worn out screw. However the front brake fluid was observed to be of sufficient level for operational purposes.

**Photo 25** shows the brake fluid reservoir cover for the front brake of the Motorcycle. We were unable to examine whether the front brake fluid was without contamination due to the worn out screw (circled).

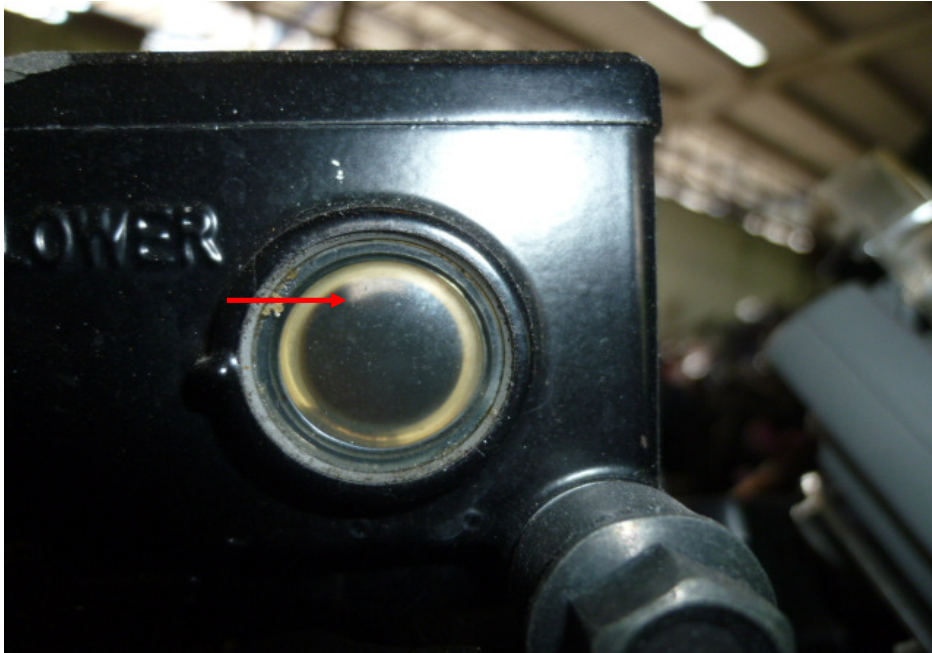
**Photo 26** shows a close up view of the brake fluid reservoir for the front brake of the Motorcycle. The brake fluid was observed to be of sufficient level for operational purposes (arrowed).

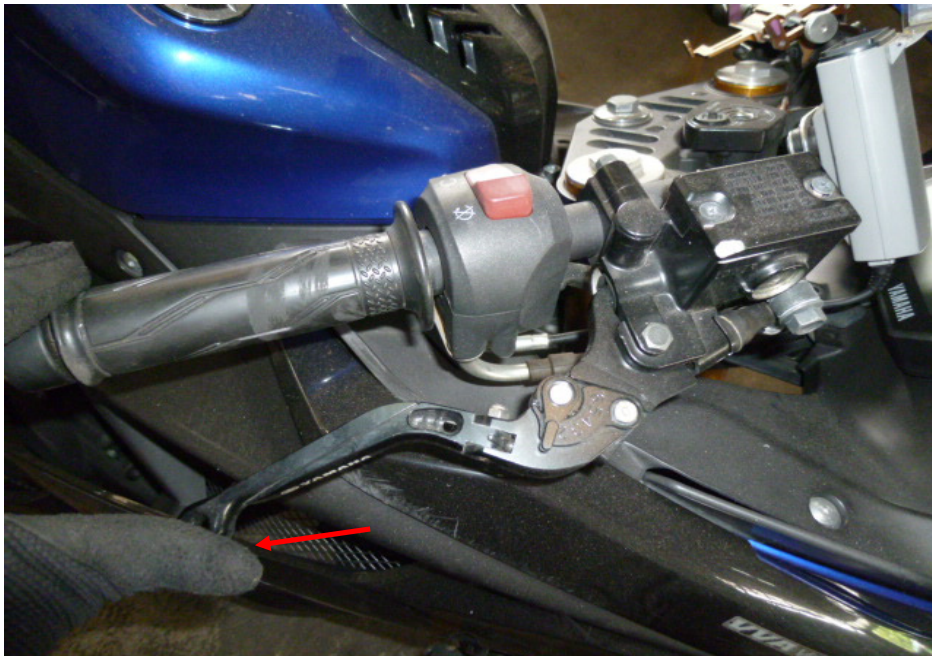
15. Static brake tests conducted on the Motorcycle had appear to indicate that the front braking system of the Motorcycle was in serviceable condition. There was some resistance felt (spongy like feel) upon pressing the brake lever. This would indicate that there was no leakage of pressure/vacuum in the front brake system.

**Photo 27** shows the front brake lever being depressed. There was some resistance felt (spongy like feel) upon pressing the front brake lever (arrowed). This would indicate that there is no leakage of pressure/vacuum in the front brake system.

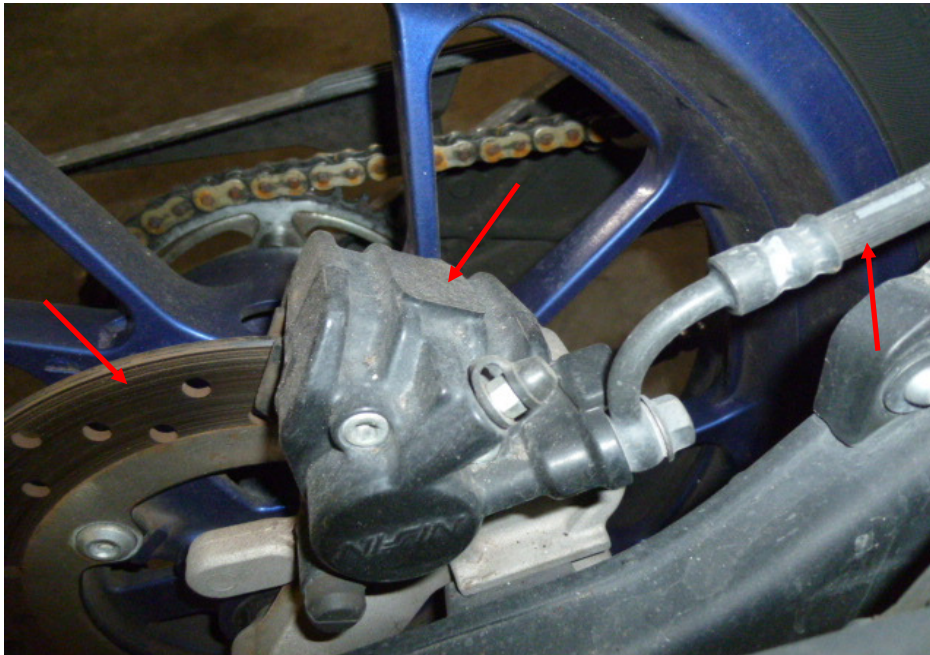
16. Static brake tests conducted on the Motorcycle had appear to indicate that the rear braking system of the Motorcycle was not in serviceable condition. There was no resistance felt (spongy like feel) upon stepping on the brake pedal. This would indicate that there may be a leakage of pressure/vacuum in the rear brake system.

**Photo 28** shows a close up view of the rear brake caliper, rear brake disc and rear brake hose (arrowed) of the Motorcycle, which are all part of the components in the hydraulic rear brake system of the Motorcycle. Our visual checks of these various components had revealed all to be intact with no visible damage. No leakage of brake fluid was also observed.

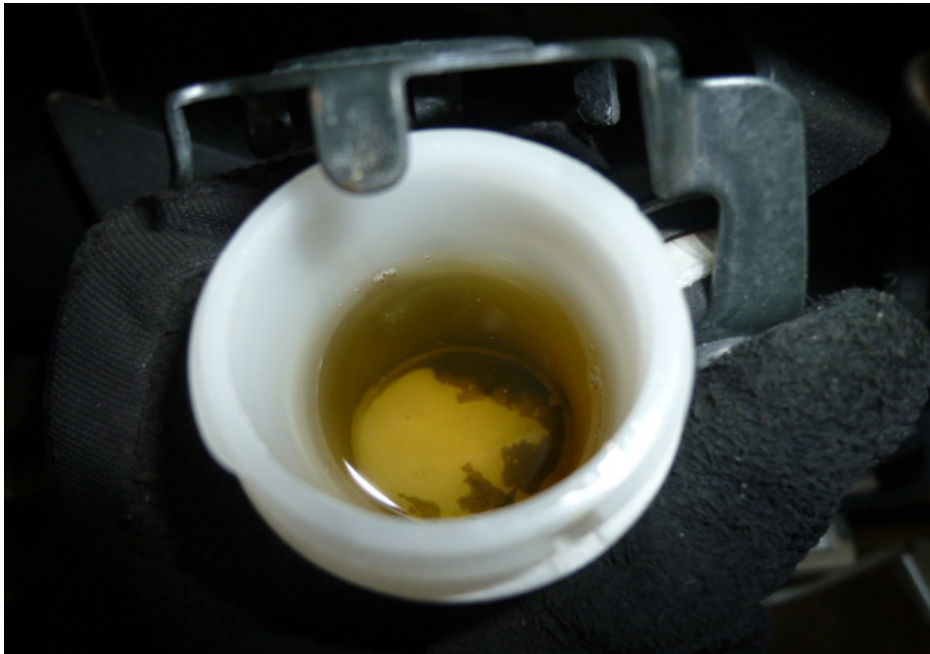
**Photo 29** shows a close up view of the brake fluid reservoir for the rear brake of the Motorcycle. The rear brake fluid was observed to be of sufficient level for operational purposes and without contamination.
