Your Ref: TP/IP/59502/2021  
Our Ref : CI/TPD22002083/N

**Fatal Accident Investigation Team**

**INSPECTION REPORT OF MOTORCYCLE FBT 1515X**

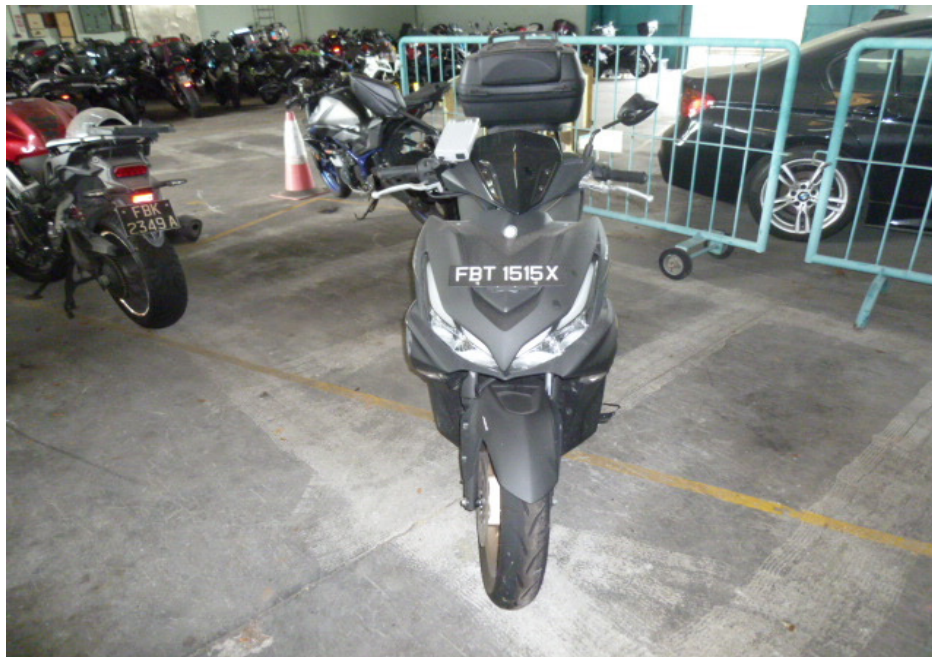
**Photo 1** shows a general view of the frontal portion of the Motorcycle at the time of our inspection. The Motorcycle was observed to have sustained damages at its frontal portion and right body. The mileage of the Motorcycle could not be recorded at the time of our inspection due to the flat battery of the key fob.

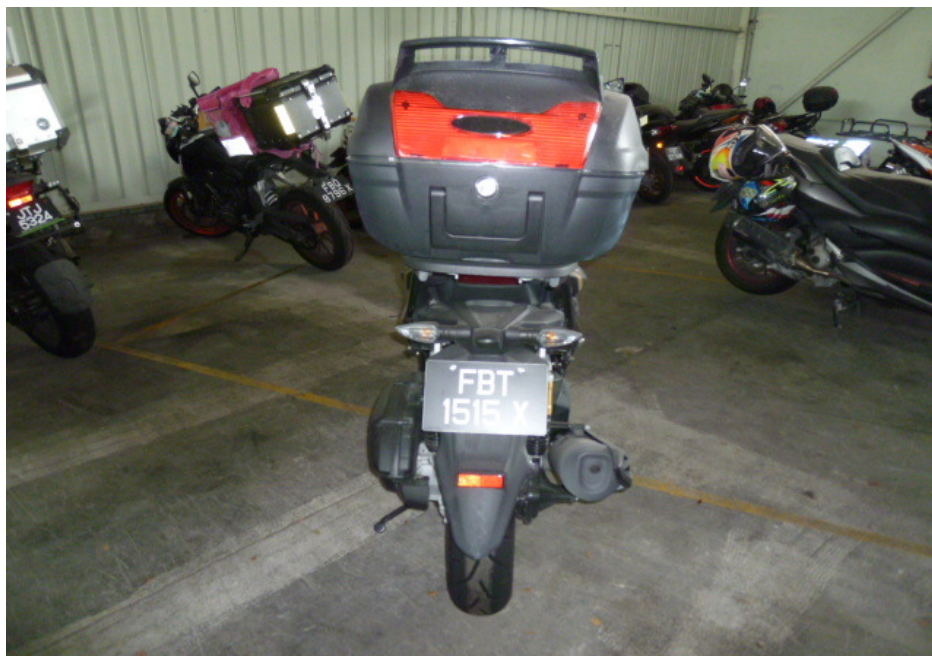
**Photo 2** shows a general view of the rear portion of the Motorcycle at the time of our inspection. The Motorcycle was observed to have sustained damages at its frontal portion and right body.

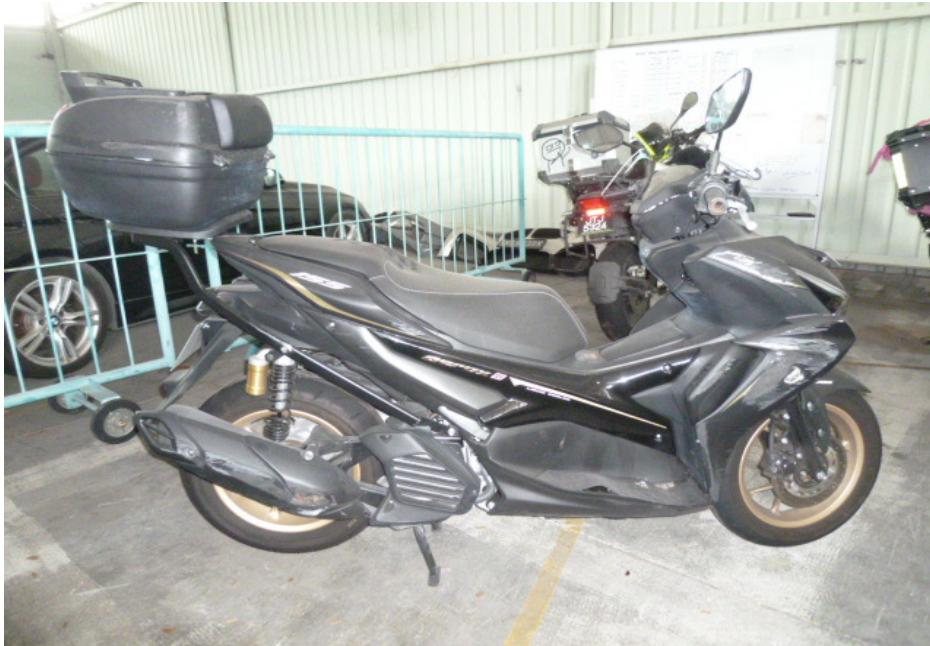
4. The mileage of the Motorcycle could not be recorded at the time of our inspection due to the flat battery of the key fob.
5. The Motorcycle was observed to have sustained damages at its frontal portion and right body. The body parts that were found to have been damaged include its front mudguard, right cowling, right side mirror, front brake lever, right handlebar end, right bottom cowling, right pillion foot peg, right rear side cover, top box rack, exhaust muffler heat shield, exhaust muffler and rear number plate, amongst others as a result of the accident. See photos 1 – 12 below.

**Photo 3** shows a general view of the right body of the Motorcycle at the time of our inspection. The Motorcycle was observed to have sustained damages at its frontal portion and right body. The body parts that were found to have been damaged include its front mudguard, right cowling, right side mirror, front brake lever, right handlebar end, right bottom cowling, right pillion foot peg, right rear side cover, top box rack, exhaust muffler heat shield, exhaust muffler and rear number plate, amongst others as a result of the accident.

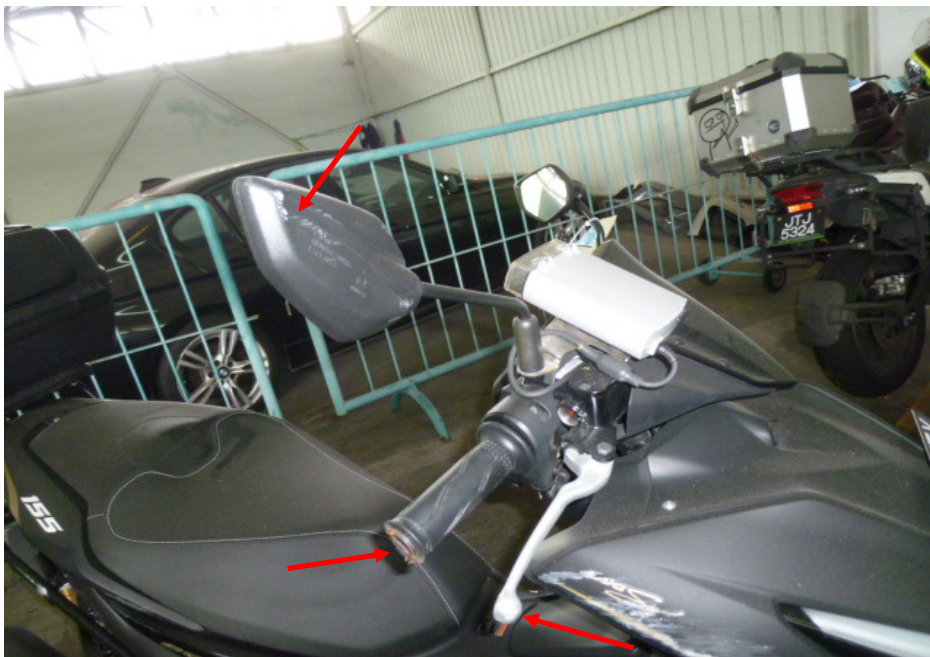
**Photo 4** shows a closer view of the front brake lever, right side mirror and right handlebar end of the Motorcycle which were observed to be damaged due to the accident (arrowed).

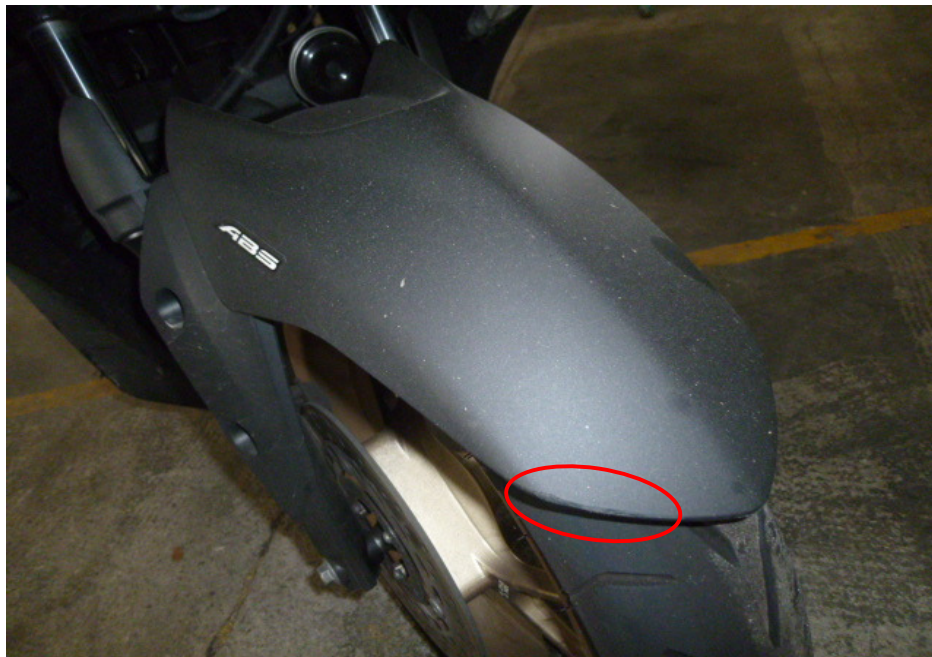
**Photo 5** shows a closer view of the front mudguard (circled) which was amongst the body parts at the front body of the Motorcycle that had sustained damage as a result of the accident.

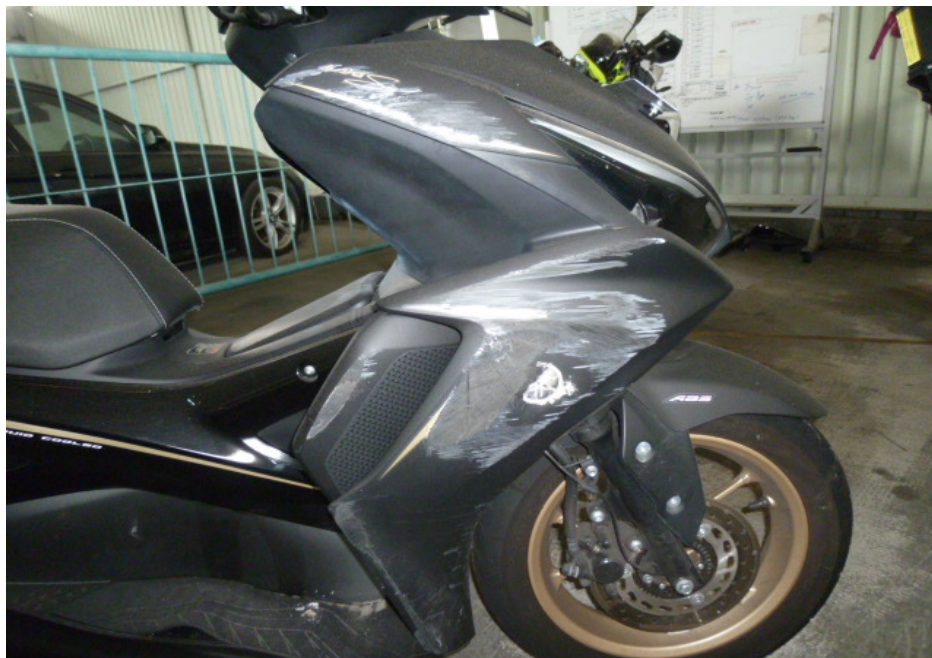
**Photo 6** shows a closer view of the right cowling which was amongst the body parts at the front body of the Motorcycle that had sustained damage as a result of the accident.

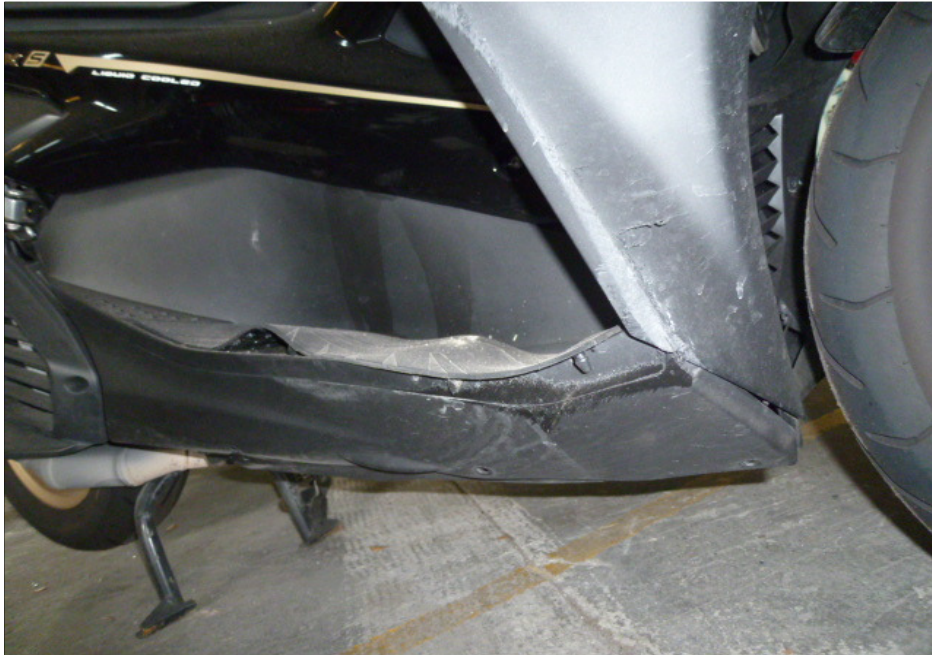
**Photo 7** shows a closer view of the right bottom cowling of the Motorcycle which was observed to be damaged due to the accident.

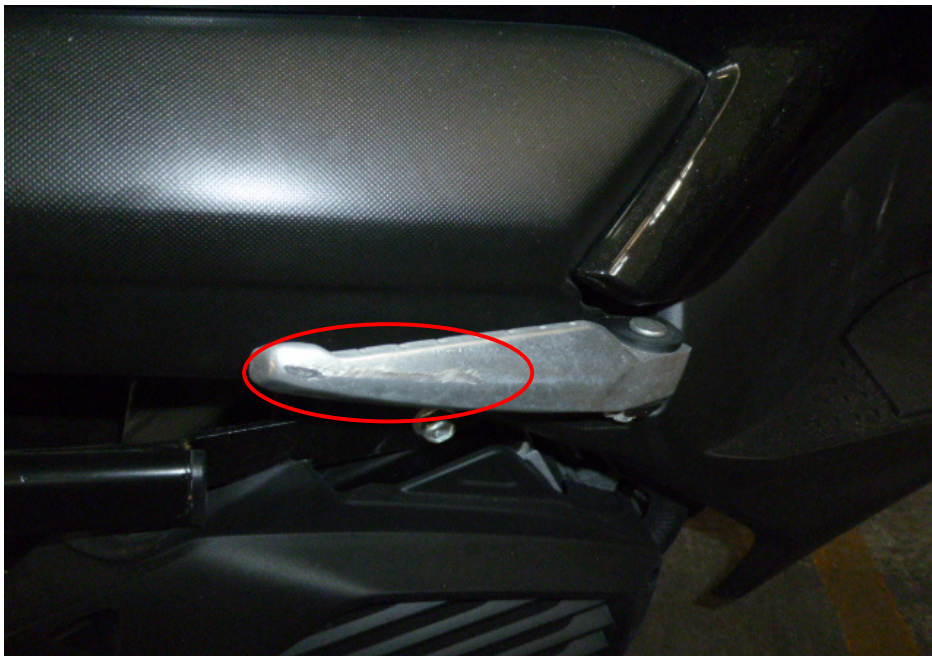
**Photo 8** shows a closer view of the grazed right pillion foot peg (circled) of the Motorcycle at the time of our inspection.

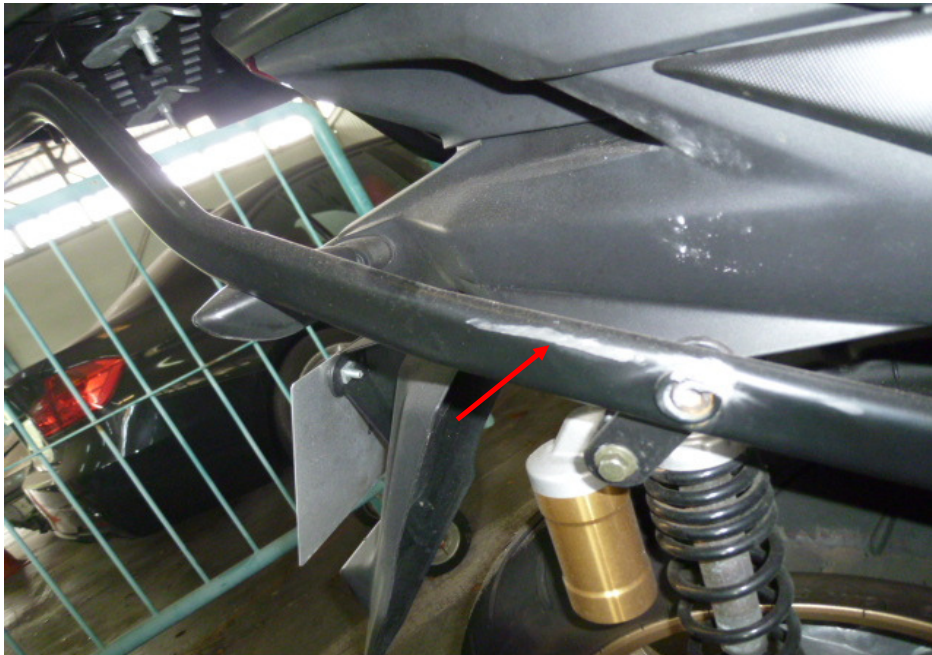
**Photo 9** shows the grazed top box rack (arrowed) of the Motorcycle as a result of the accident.

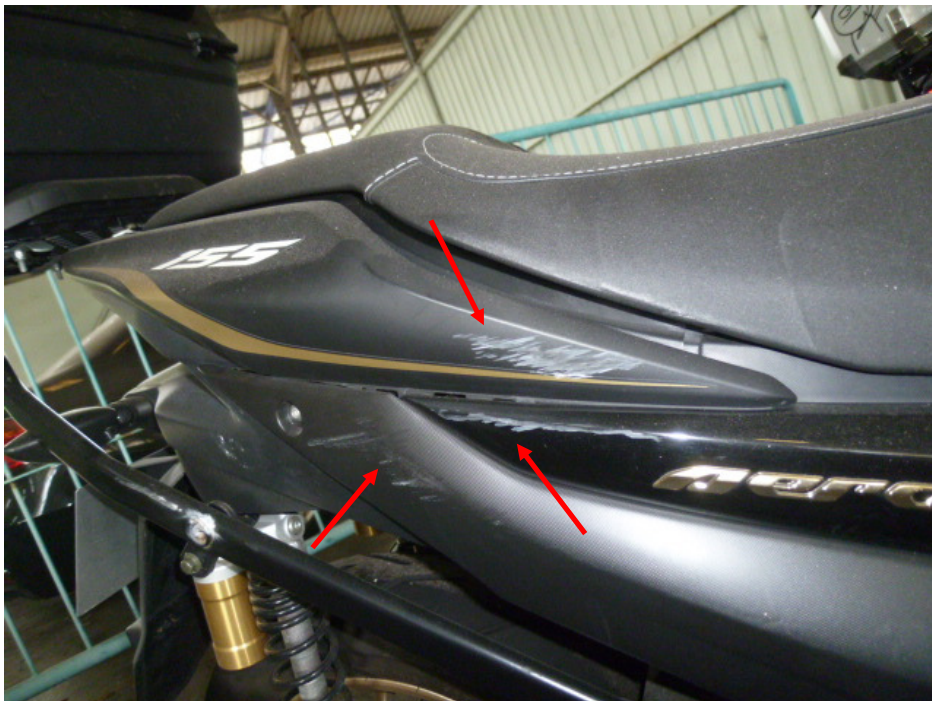
**Photo 10** show a closer view of the right rear side cover of the Motorcycle which was observed to be damaged due to the accident (arrowed).

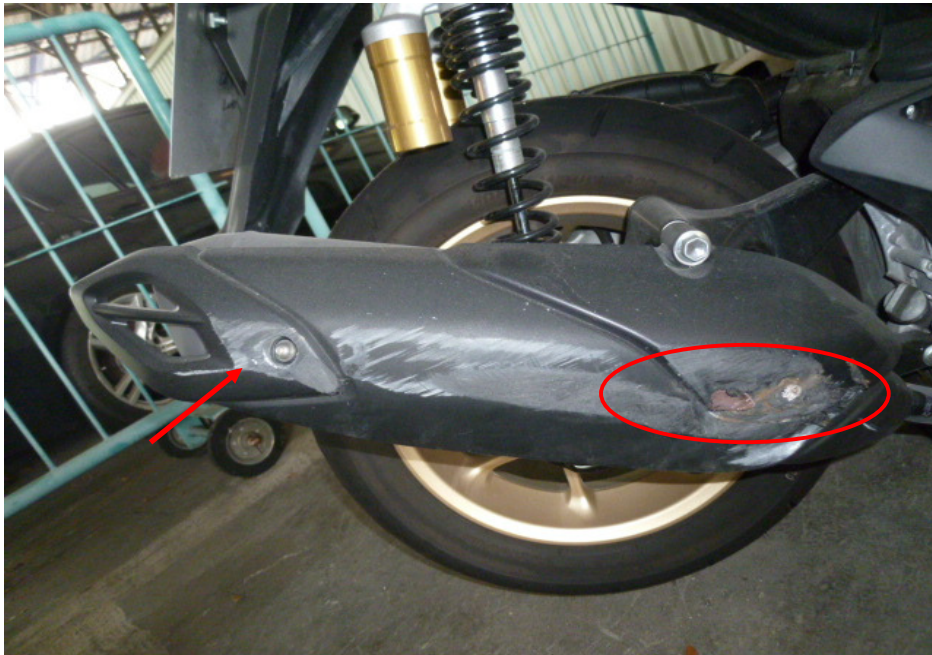
**Photo 11** shows a closer view of the grazed exhaust muffer heat shield (arrowed) and dented exhaust muffer (arrowed) of the Motorcycle as a result of the accident.

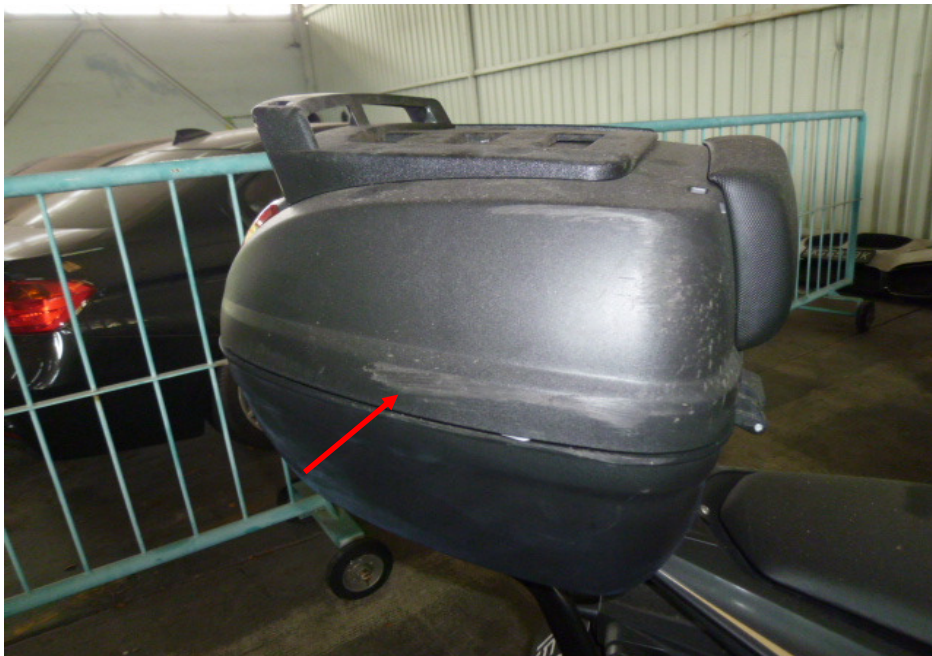
**Photo 12** shows a closer view of the grazed top box (arrowed) of the Motorcycle as a result of the accident.

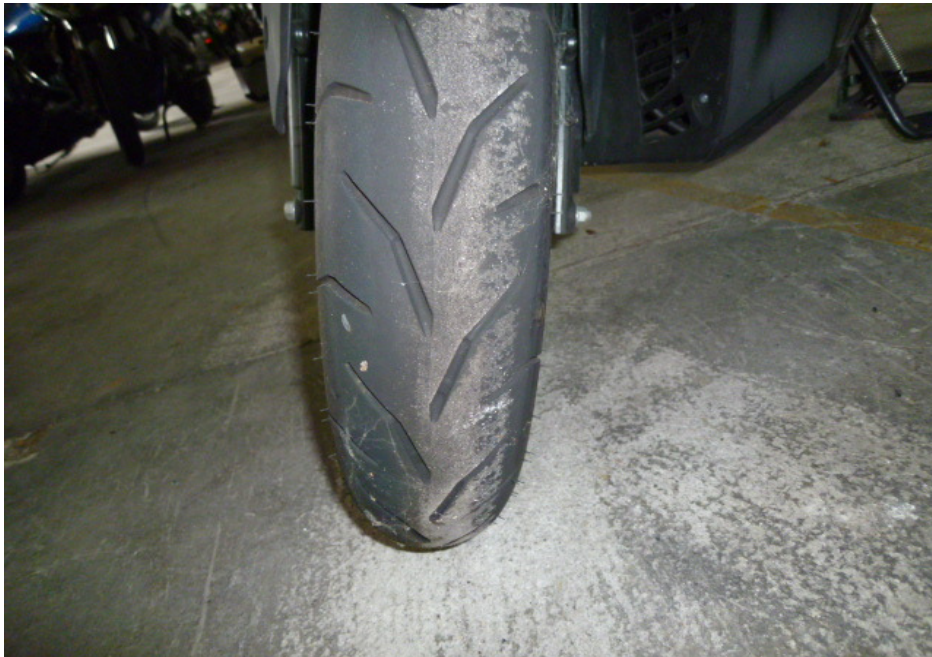
**Photo 13** shows the condition of the Motorcycle's front tyre. The front tyre was observed to be in serviceable condition with remaining tread depth of approximately 6mm. There was no tear, burst mark(s) and/or punctured hole(s) on the sidewalls as well as across the tread of the front tyre.

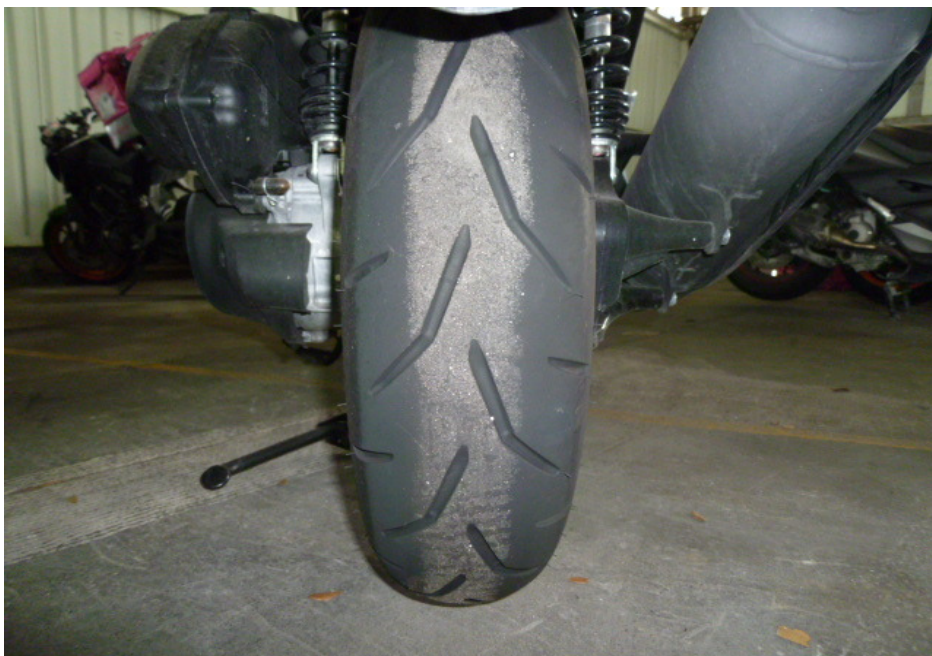
**Photo 14** shows the condition of the Motorcycle's rear tyre. The rear tyre was observed to be in serviceable condition with remaining tread depth of approximately 8mm. The tyre was also observed to be sufficiently inflated for vehicular operation. We did not observe any tear, burst mark(s) and/or punctured hole(s) on the sidewalls as well as across the tread of the rear tyre.

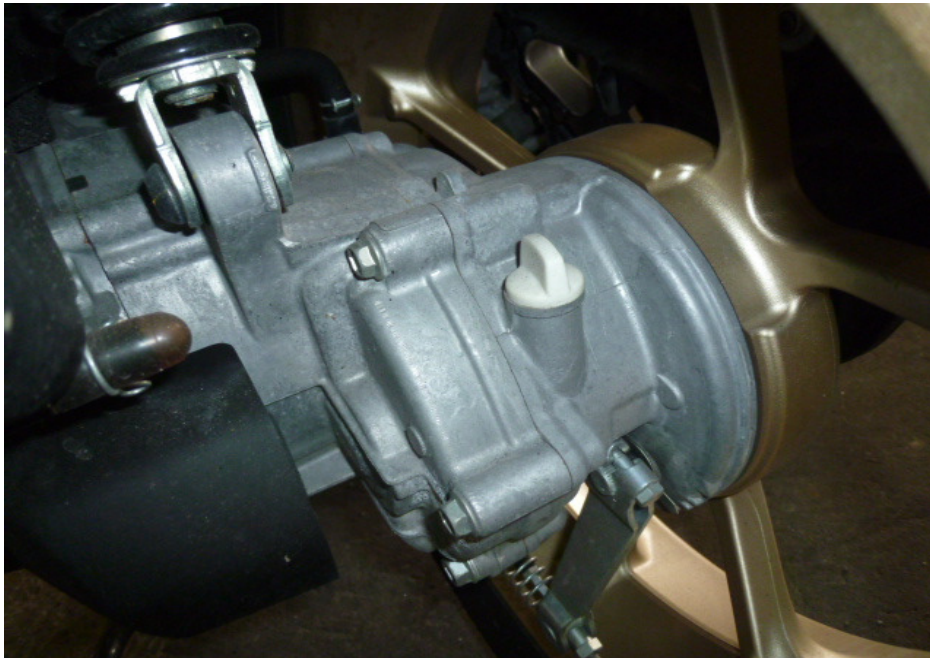
**Photo 15** shows the left side of the engine of the Motorcycle at the time of our inspection. The various engine related parts and components were found to be intact with no visible damage. There was also no sign(s) or indication(s) of fluid leak observed around the left engine area of the Motorcycle.

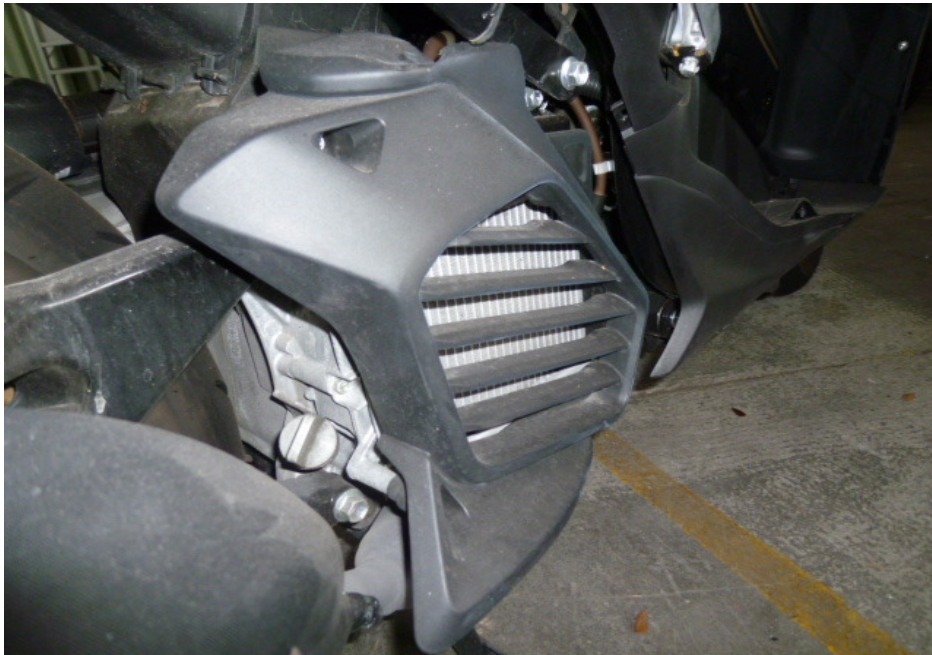
**Photo 16** shows the radiator of the Motorcycle at the time of our inspection. The radiator was found to be intact with no visible damage. There was also no sign(s) or indication(s) of fluid leak observed around the radiator of the Motorcycle.

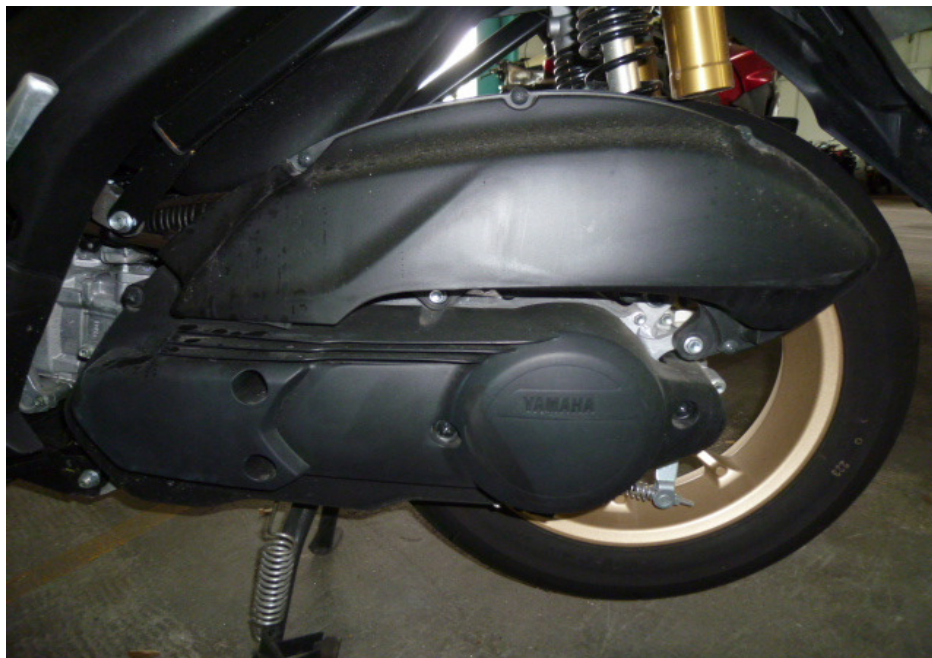
**Photo 17** shows the drive train of the Motorcycle which was found to be intact without any misalignment.

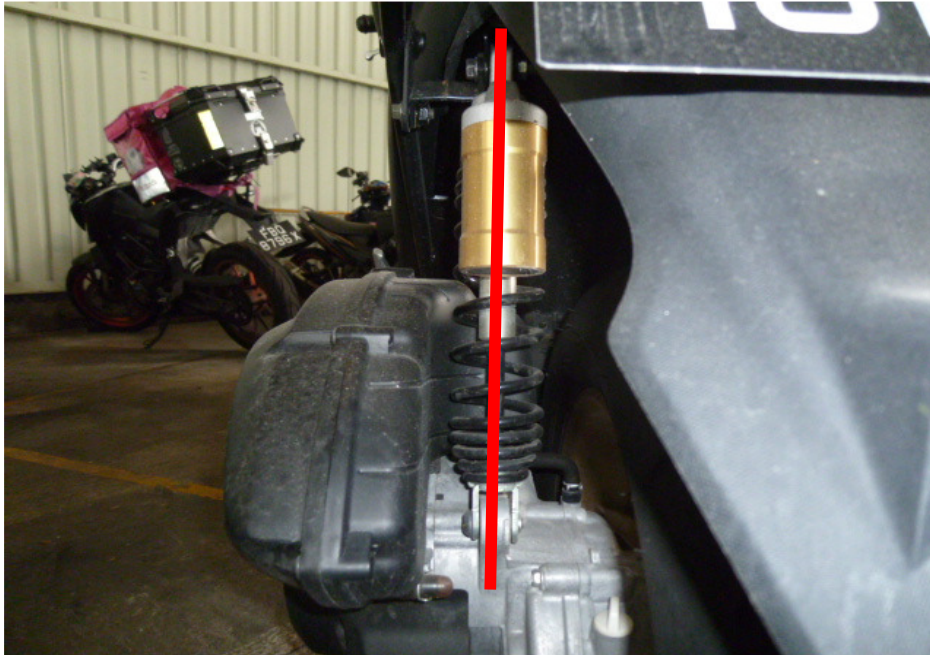
**Photo 18** shows the left shock absorber of the Motorcycle which was found to be intact without any misalignment.

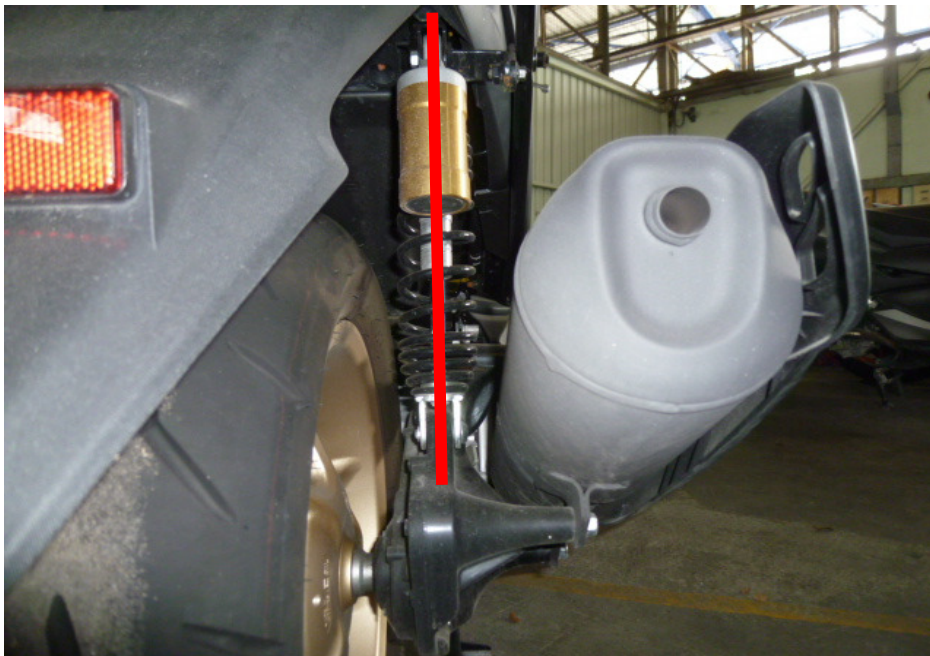
**Photo 19** shows the right shock absorber of the Motorcycle which was found to be intact without any misalignment.

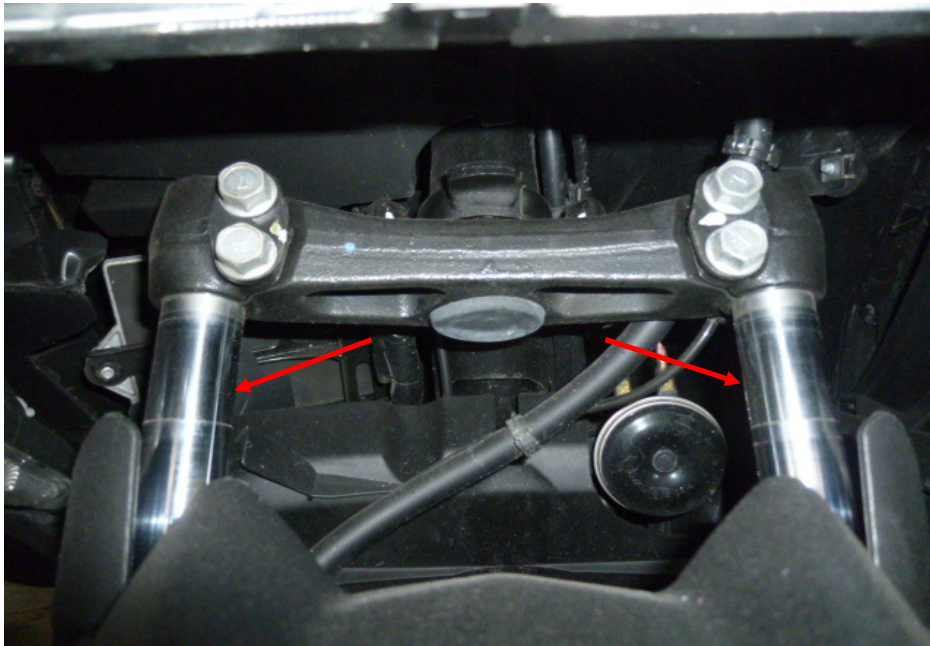
**Photo 20** shows the front forks (arrowed) of the Motorcycle. The front forks and fork brackets of the Motorcycle were both found to be intact and undamaged. Turning the Motorcycle's handle bar towards the left and right did not produce any abnormal free play and/or resistance. The steering system of the Motorcycle was in serviceable condition at the time of our inspection.

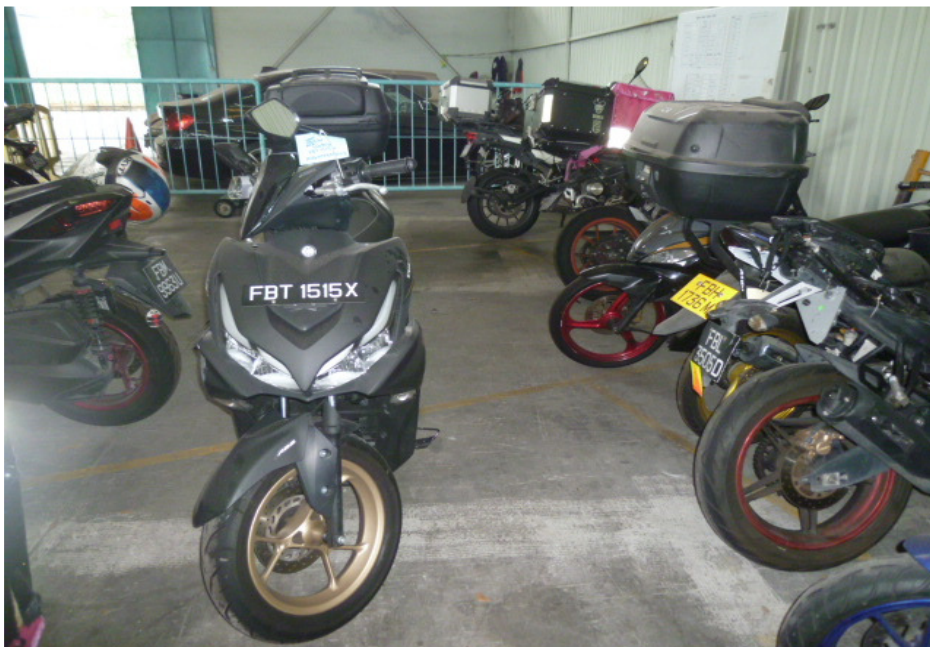
**Photo 21** shows the front wheel of the Motorcycle turned towards its full right. Turning the Motorcycle's handle bar towards the left and right did not produce any abnormal free play and/or resistance. This would indicate that the steering system of the Motorcycle was in serviceable condition at the time of our inspection.

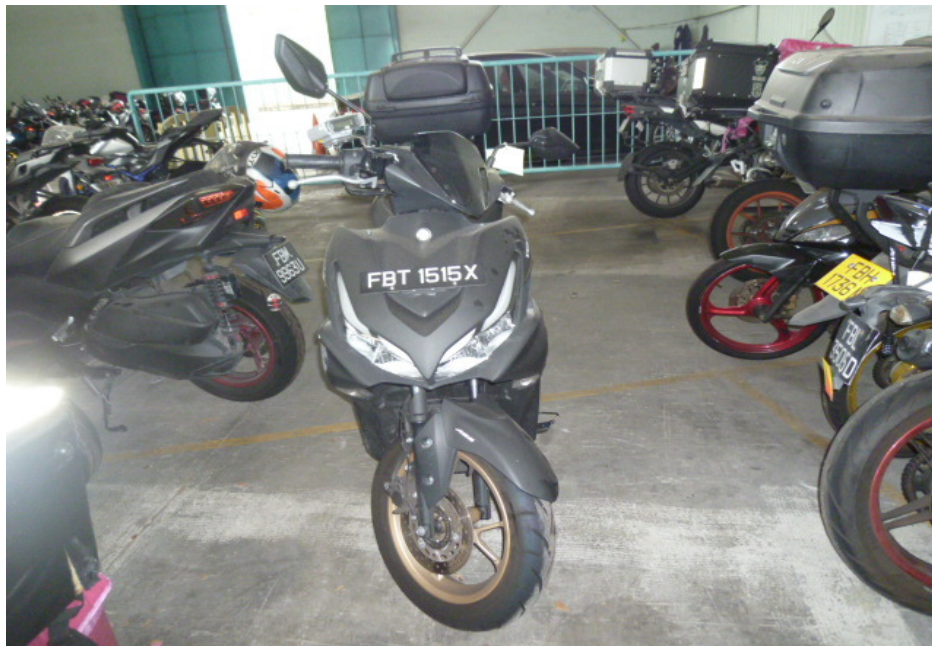
**Photo 22** shows the front wheel of the Motorcycle turned towards its full left. Turning the Motorcycle's handle bar towards the left and right did not produce any abnormal free play and/or resistance. This would indicate that the steering system of the Motorcycle was in serviceable condition at the time of our inspection.

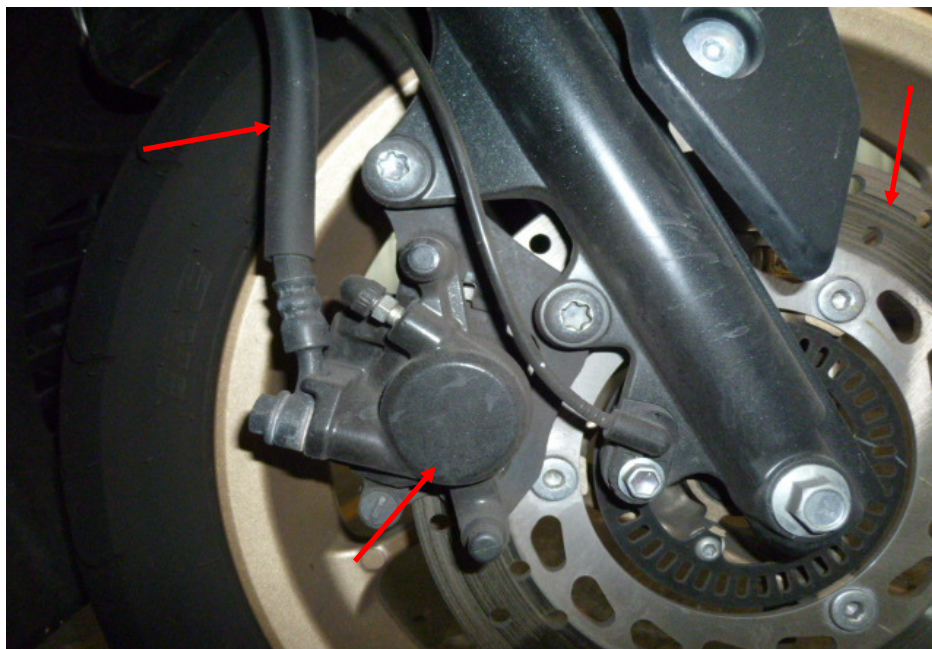
**Photo 23** shows a close up view of the front brake caliper, front brake disc and front brake hose (arrowed) of the Motorcycle, which are all part of the components in the hydraulic front brake system of the Motorcycle. Our visual checks of these various components had revealed all to be intact with no visible damage. No leakage of brake fluid was also observed.

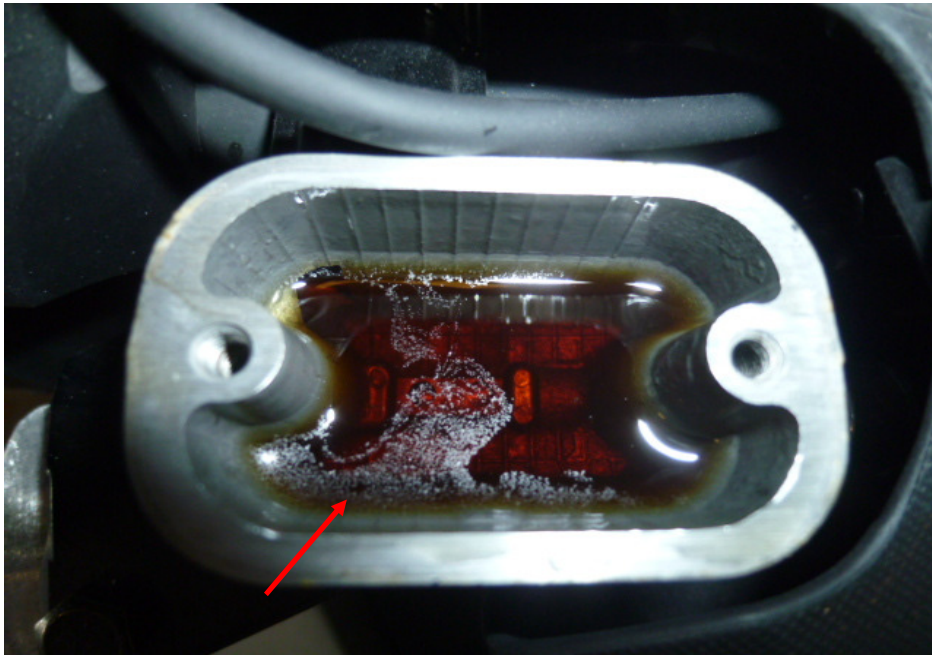
11. The brake system of the Motorcycle was of a semi-hydraulic type, where hydraulic (brake fluid) pressure controls the brake for the front wheel while the brake for the rear wheel is controlled by mechanical means (cables and springs). Our visual examination of the various components in the brake system, like the brake disc, brake caliper, drum and brake levers revealed all to be intact and without damage. There was also no leakage of brake fluid observed along the front brake hose. This was from the respective front brake fluid reservoir to the front brake caliper of the Motorcycle. The brake fluid for the front brake was observed to be of sufficient level for operating purposes. However it was found to be slightly contaminated. There was also no visible tear or cut observed on the connecting hoses and cables.

**Photo 24** shows a close up view of the brake fluid reservoir for the front brake of the Motorcycle. The brake fluid was observed to be of sufficient level for operational purposes. However it was found to be slightly contaminated (arrowed).

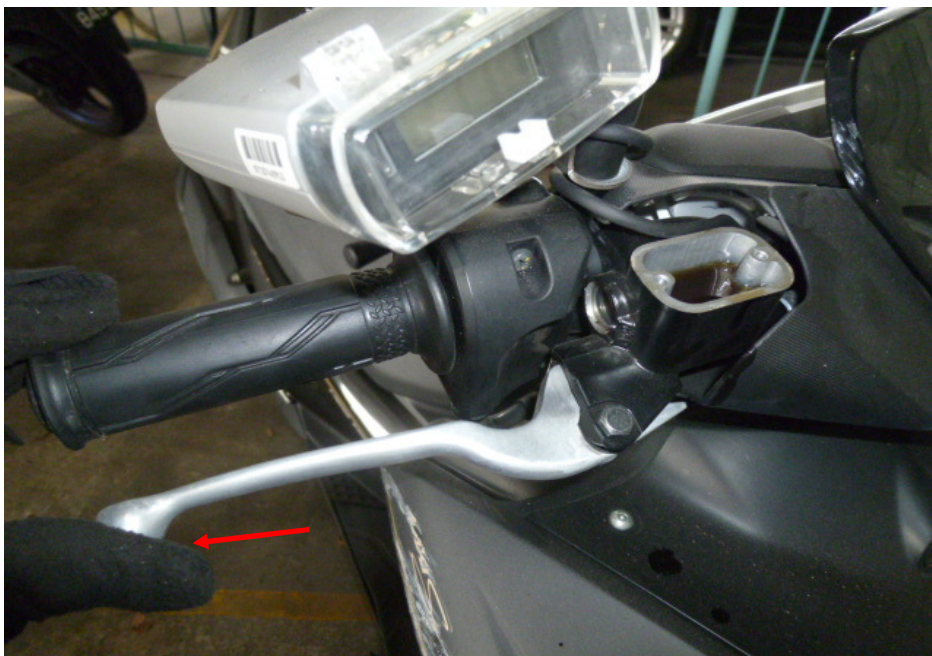
12. Static brake tests conducted on the Motorcycle had appeared to indicate that the brake system of the Motorcycle was in serviceable condition. There was some resistance felt (spongy like feel) upon pressing the front brake lever. This would indicate that there's no leakage of pressure/vacuum in the front brake system.

**Photo 25** shows the front brake lever being depressed. There was some resistance felt (spongy like feel) upon pressing the front brake lever (arrowed). This would indicate that there is no leakage of pressure/vacuum in the front brake system.

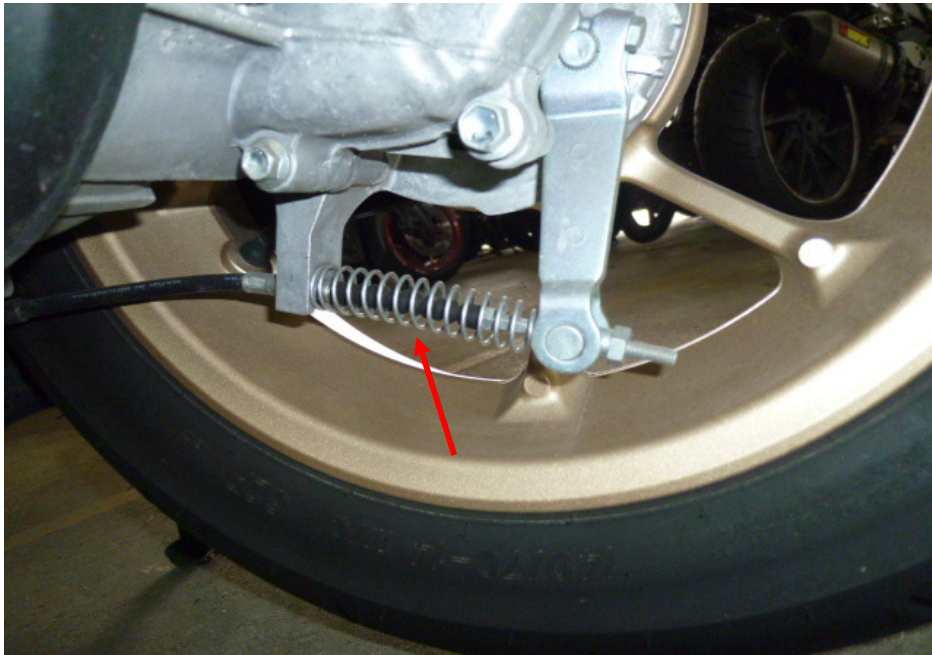
**Photo 26** shows the rear wheel of the Motorcycle. The type of brake system for the rear wheel was of a mechanical type, controlled by the brake foot pedal of the Motorcycle. Our checks of the cable (arrowed), spring and drum which are all part of the components in the rear brake system of the Motorcycle reveal all to be intact and without damage.
