Your Ref: TP IP/52163/2021  
Our Ref : CI/TPD22002087/N

25 May 2023

**Fatal Accident Investigation Team**

**INSPECTION REPORT OF MOTORCYCLE FBR 8606G**

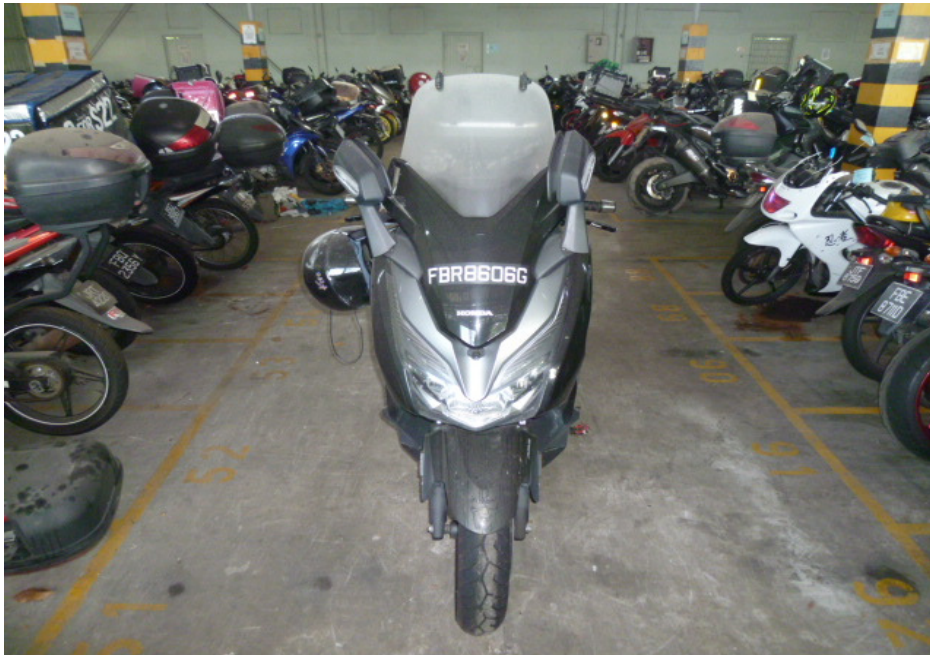
**Photo 1** shows a general view of the frontal portion of the Motorcycle at the time of our inspection. The mileage of the Motorcycle could not be recorded at the time of our inspection due to a flat battery in the smart key remote transponder.

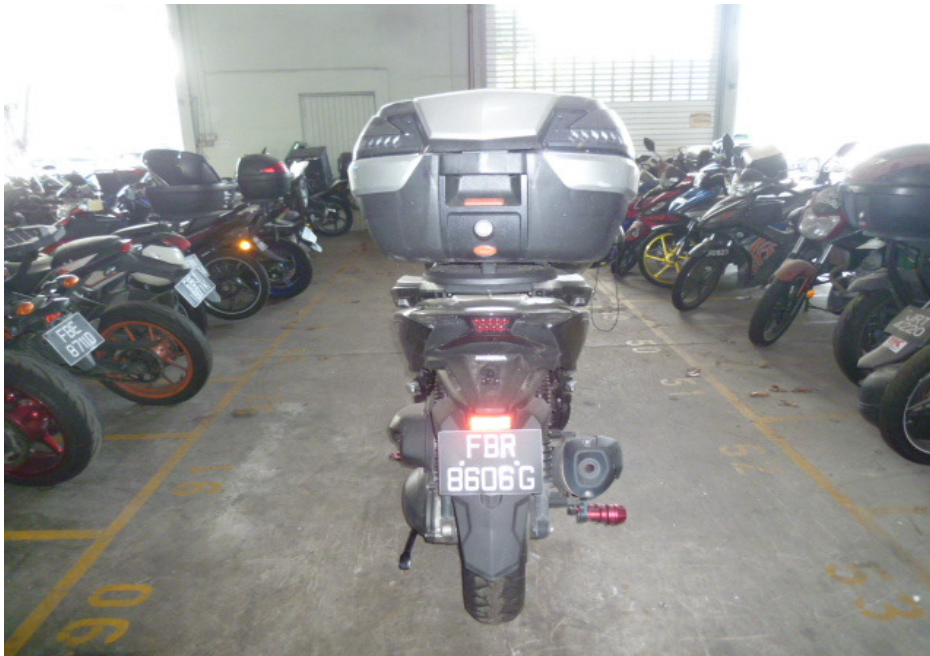
**Photo 2** shows a general view of the rear portion of the Motorcycle at the time of our inspection. The Motorcycle was observed to have sustained damages at its frontal portion and left body.

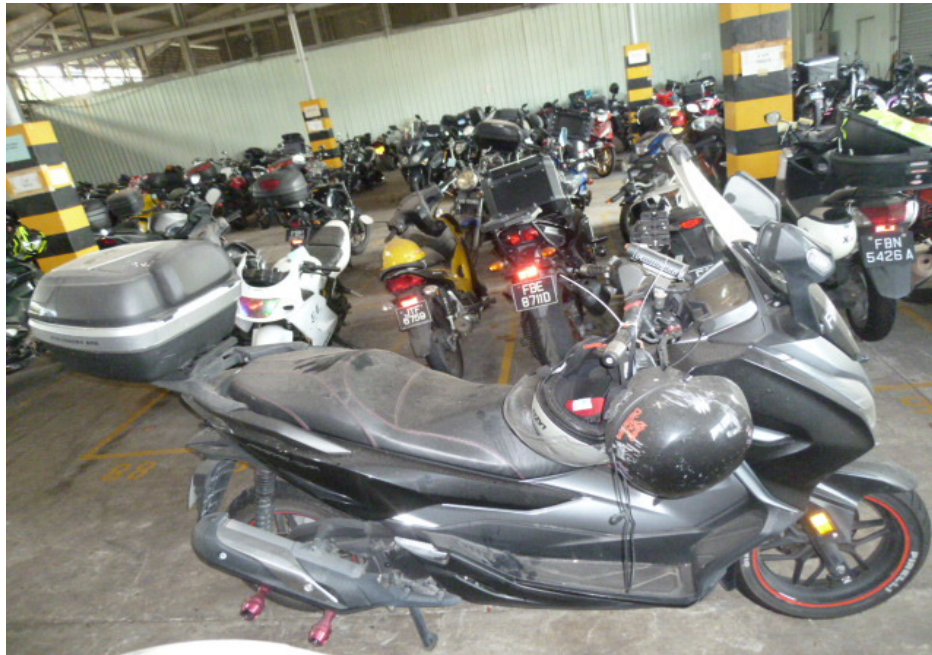
**Photo 3** shows a general view of the right body of the Motorcycle at the time of our inspection. The Motorcycle was observed to have sustained damages at its frontal portion and left body.

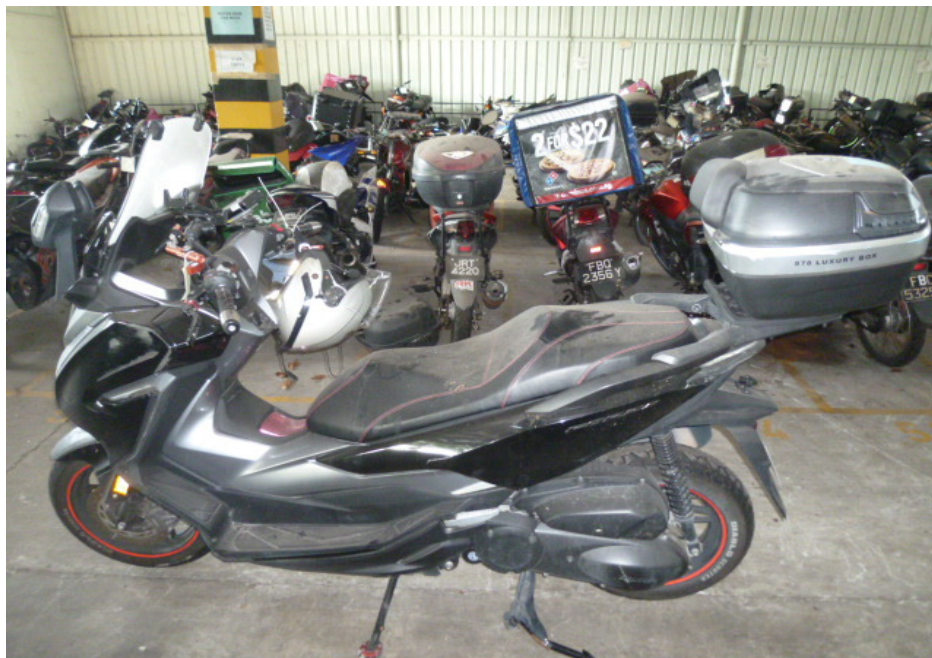
**Photo 4** shows a general view of the left body of the Motorcycle at the time of our inspection. The Motorcycle was observed to have sustained damages at its frontal portion and left body. The body parts that were found to have been damaged include its front mudguard, left side mirror, left handlebar end, rear brake lever, left cowling, left bottom cowling, side stand, main stand, left rear side cover and top box, amongst others as a result of the accident

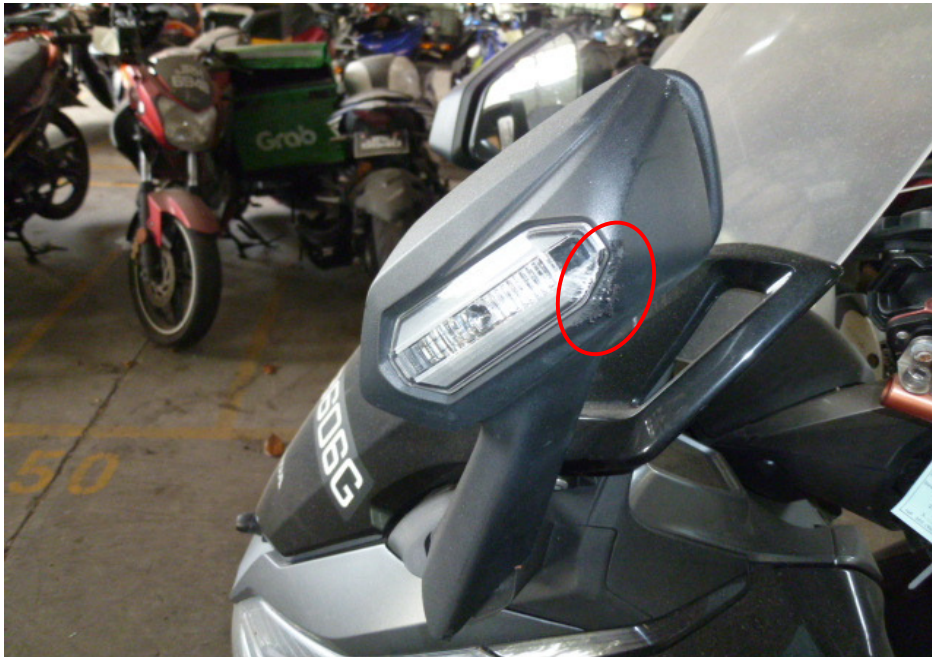
**Photo 5** shows a closer view of the grazed left side mirror of the Motorcycle at the time of our inspection (circled).

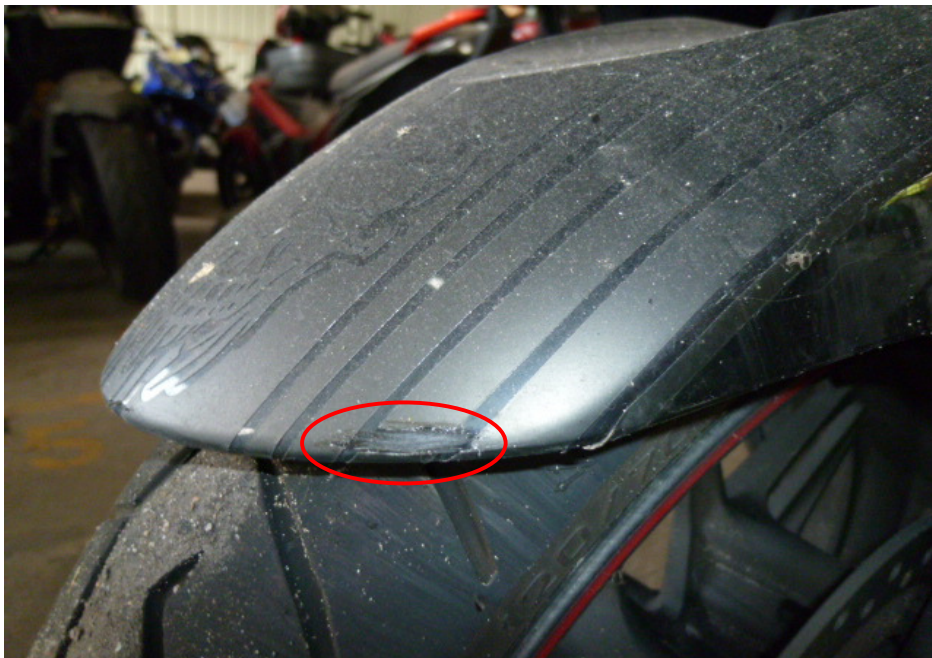
**Photo 6** shows a closer view of the front mudguard which was amongst the body parts at the front body of the Motorcycle that had sustained damage as a result of the accident (circled).

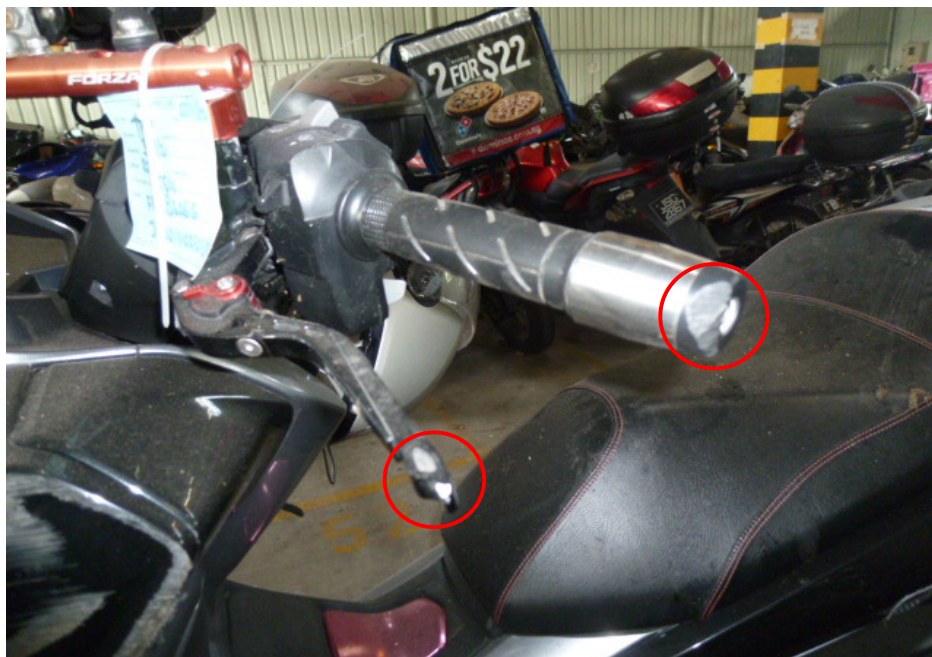
**Photo 7** shows a closer view of the left handlebar end and rear brake lever of the Motorcycle which was observed to be damaged due to the accident (circled).

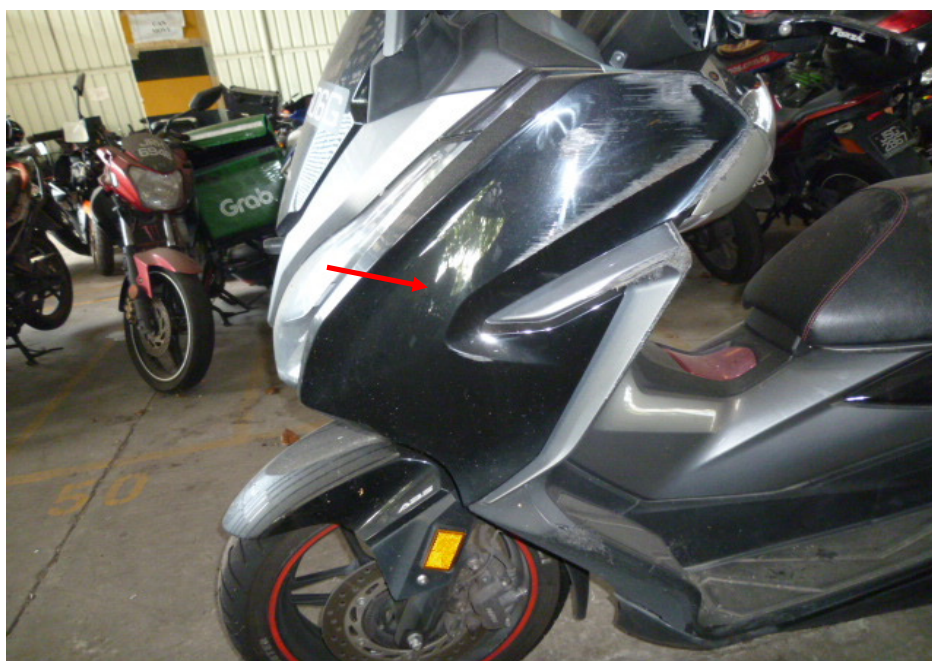
**Photo 8** shows the grazed left side cowling (arrowed) of the Motorcycle as a result of the accident.

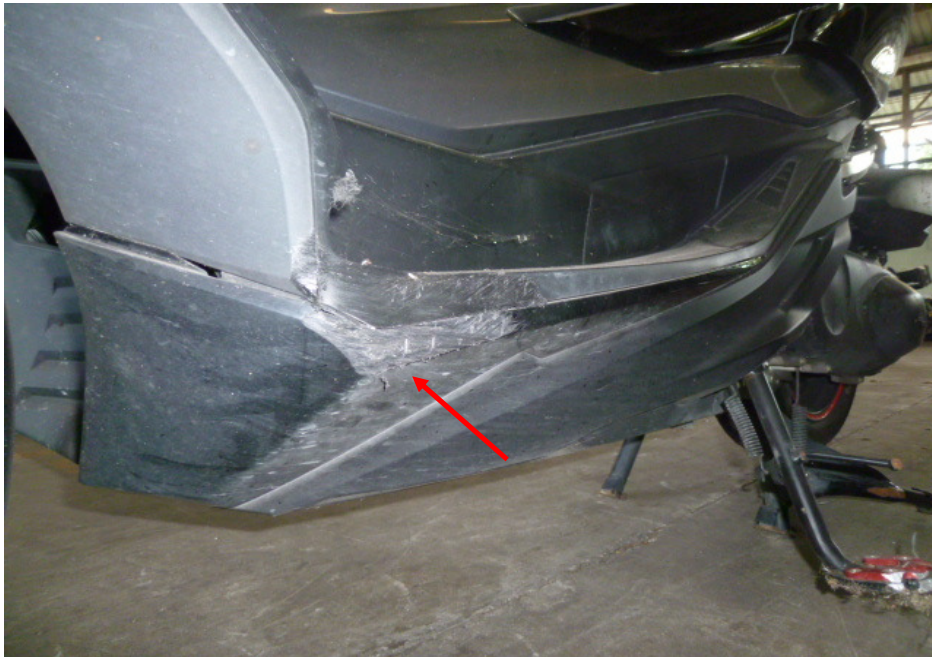
**Photo 9** shows a closer view of the grazed left bottom cowling of the Motorcycle as a result of the accident (arrowed).

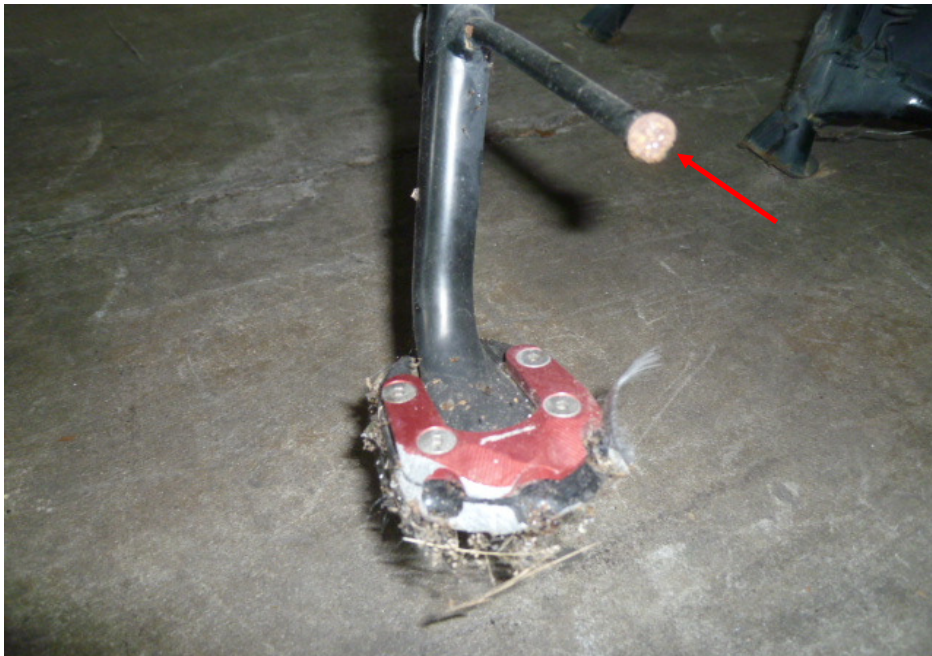
**Photo 10** shows a closer view of the grazed side stand of the Motorcycle at the time of our inspection (arrowed).

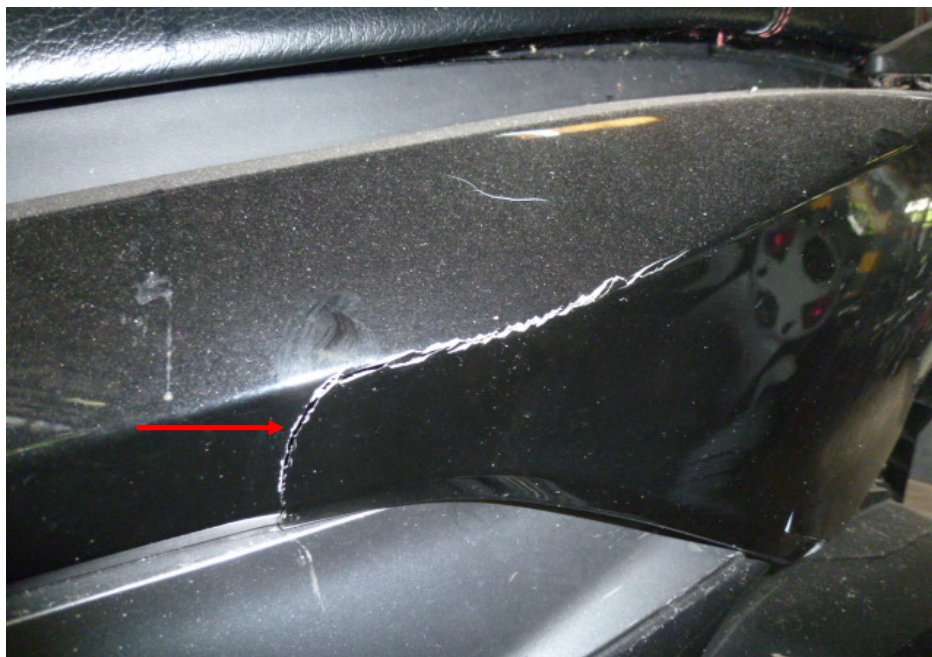
**Photo 11** shows a closer view of the cracked left rear side cover of the Motorcycle as a result of the accident (arrowed).

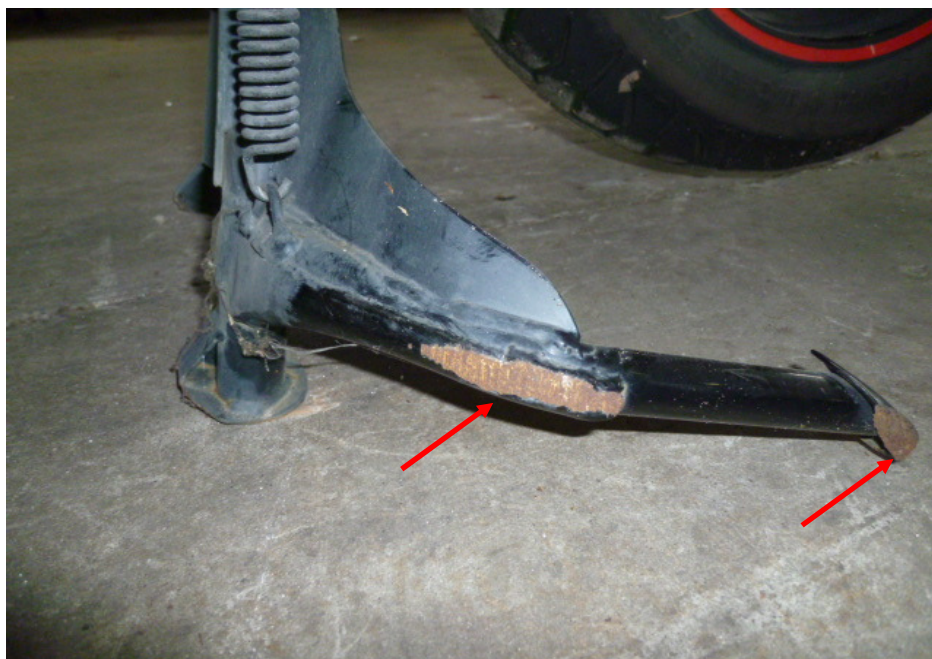
**Photo 12** shows a closer view of the grazed main stand of the Motorcycle as a result of the accident (arrowed).

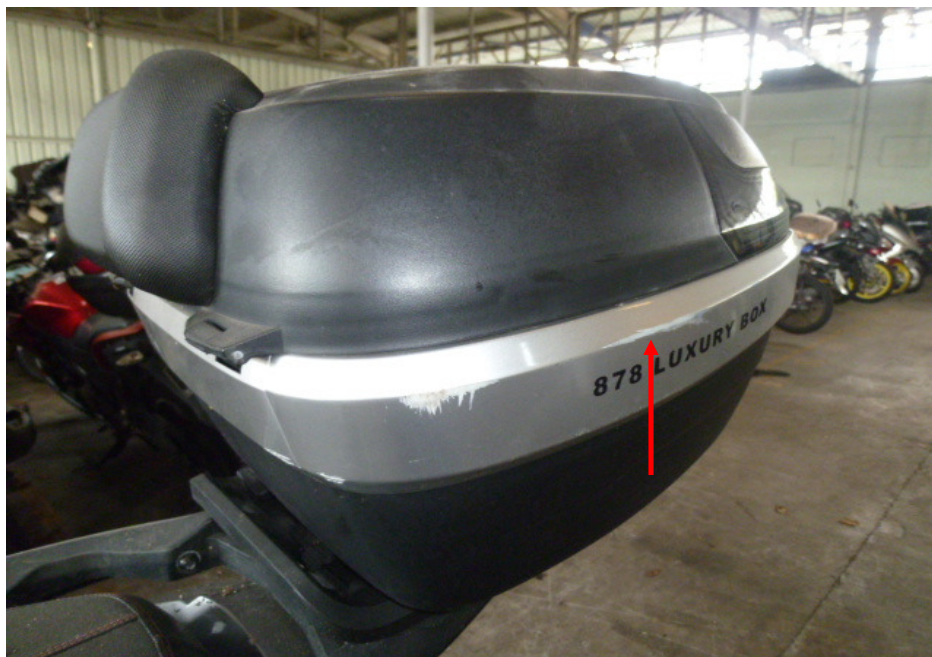
**Photo 13** shows a closer view of the grazed top box of the Motorcycle as a result of the accident (arrowed).

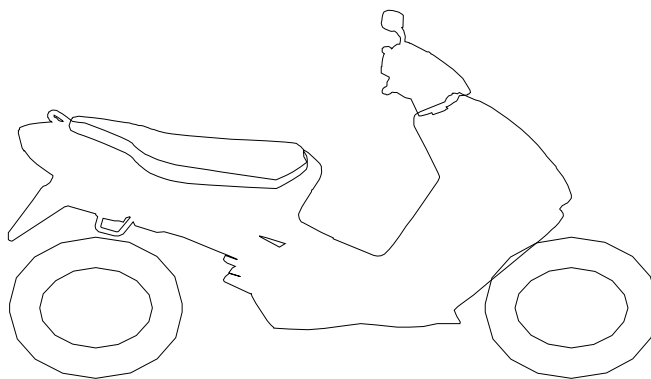
6. The condition of the Motorcycle's 2 tyres was observed to be in serviceable condition. The tread pattern of the 2 tyres was clearly visible. We did not observe any tear, burst mark(s) and/or punctured hole(s) on the sidewalls as well as across the tread of the 2 tyres. The 2 tyres were both observed to be sufficiently inflated for vehicular operation. The tyre brand, tyre size and remaining tread depth of the 2 tyres were recorded as follows:-

Pirelli 140/70 - 14 (3mm)

Pirelli 120/70 - 15 (6mm)

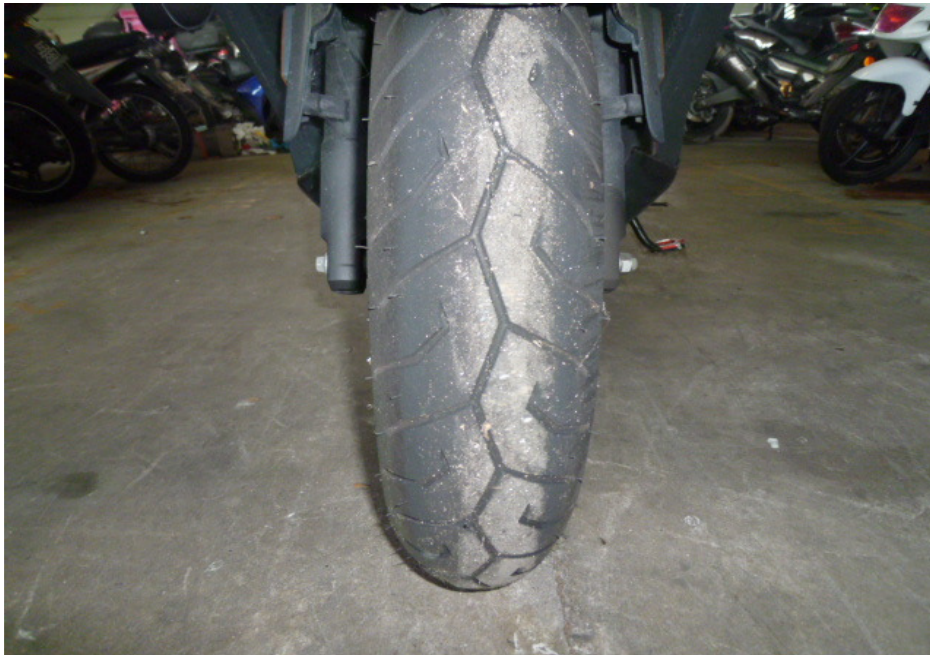
**Photo 14** shows the condition of the Motorcycle's front tyre. The front tyre was observed to be in serviceable condition with remaining tread depth of approximately 3mm. There was no tear, burst mark(s) and/or punctured hole(s) on the sidewalls as well as across the tread of the front tyre.

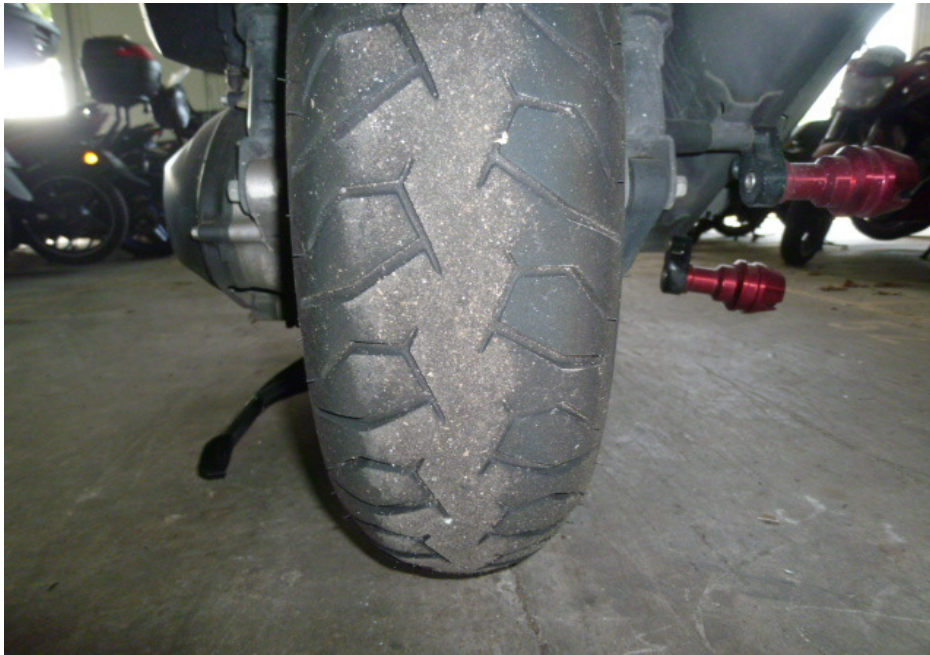
**Photo 15** shows the condition of the Motorcycle's rear tyre. The rear tyre was observed to be in serviceable condition with remaining tread depth of approximately 3mm. The tyre was also observed to be sufficiently inflated for vehicular operation. We did not observe any tear, burst mark(s) and/or punctured hole(s) on the sidewalls as well as across the tread of the rear tyre.

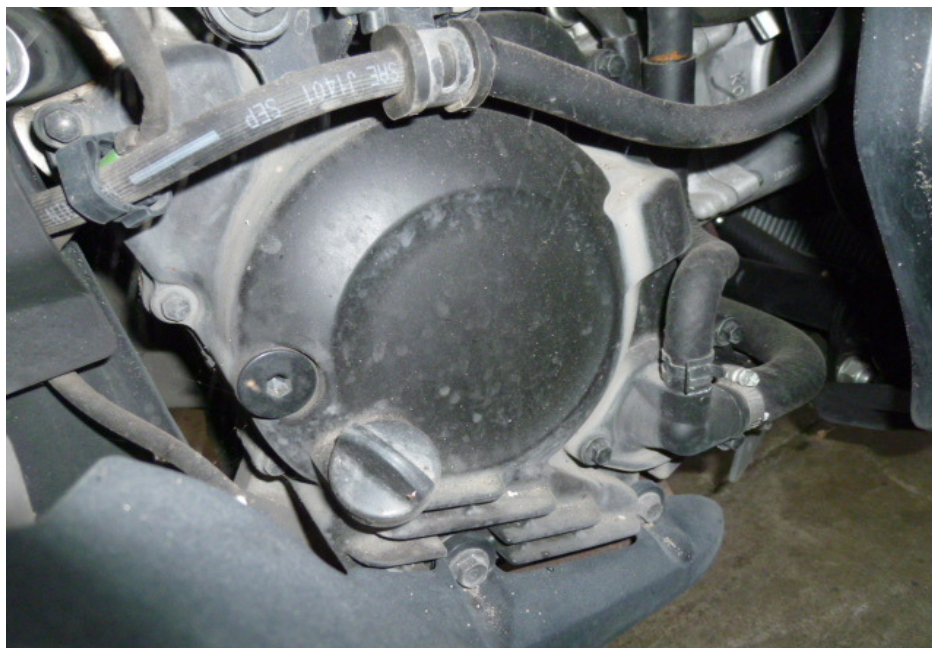
**Photo 16** shows the right side of the engine of the Motorcycle at the time of our inspection. The various engine related parts and components were found to be intact with no visible damage. There was also no sign(s) or indication(s) of fluid leak observed around the right engine area of the Motorcycle.

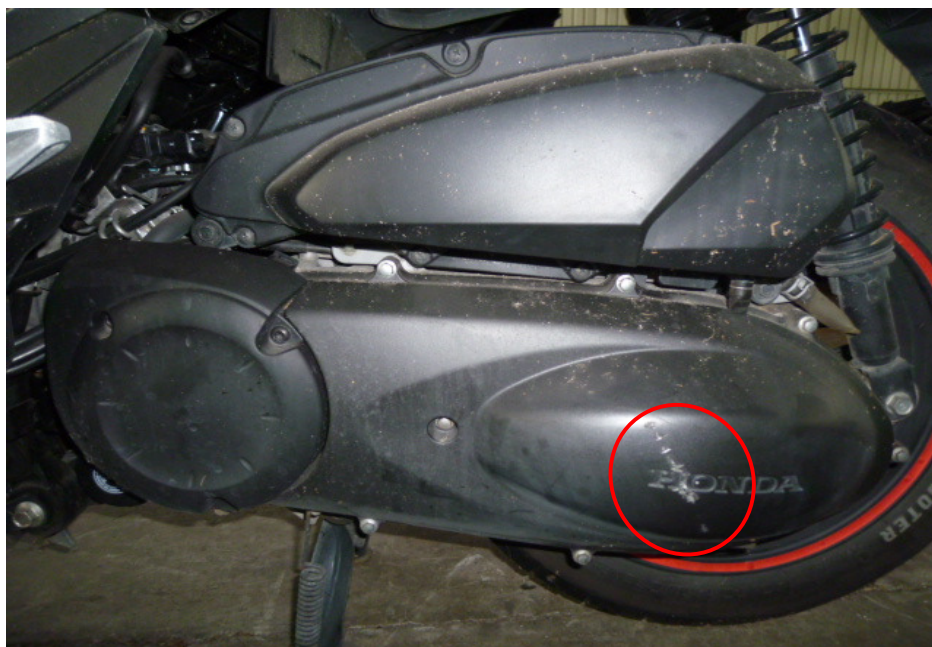
**Photo 17** shows the drive train of the Motorcycle which was found to be intact without any misalignment. However the drive train cover had sustained damages of grazing nature as a result of the accident (circled). Upon examination of the Motorcycle's engine area, we had observed that the various engine related parts and components were intact with no visible damage. There was also no sign(s) or indication(s) of fluid leak observed around the engine area of the Motorcycle.

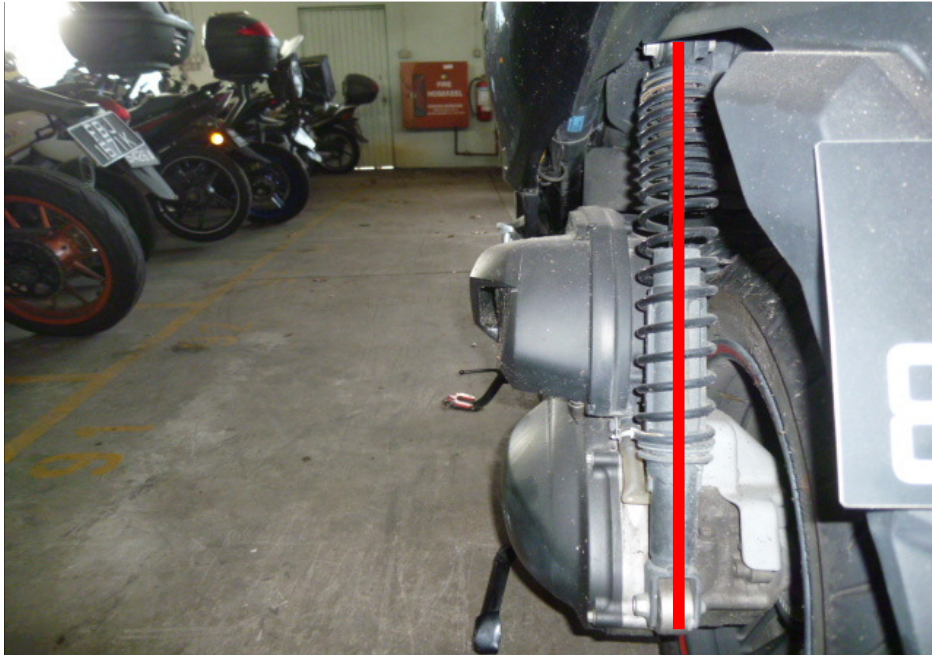
**Photo 18** shows the left shock absorber of the Motorcycle which was found to be intact without any misalignment.

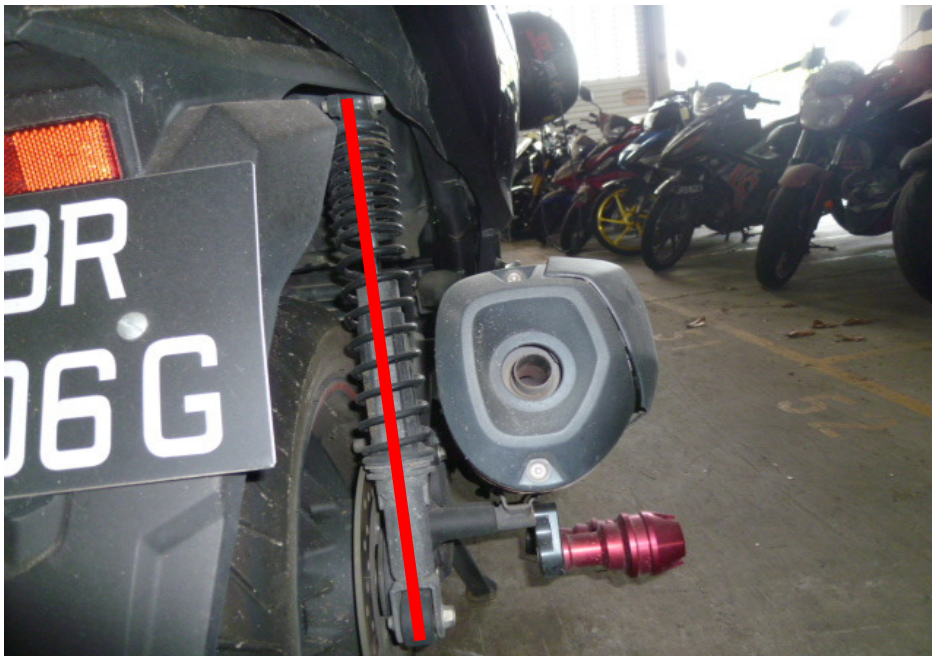
**Photo 19** shows the right shock absorber of the Motorcycle which was found to be intact without any misalignment.

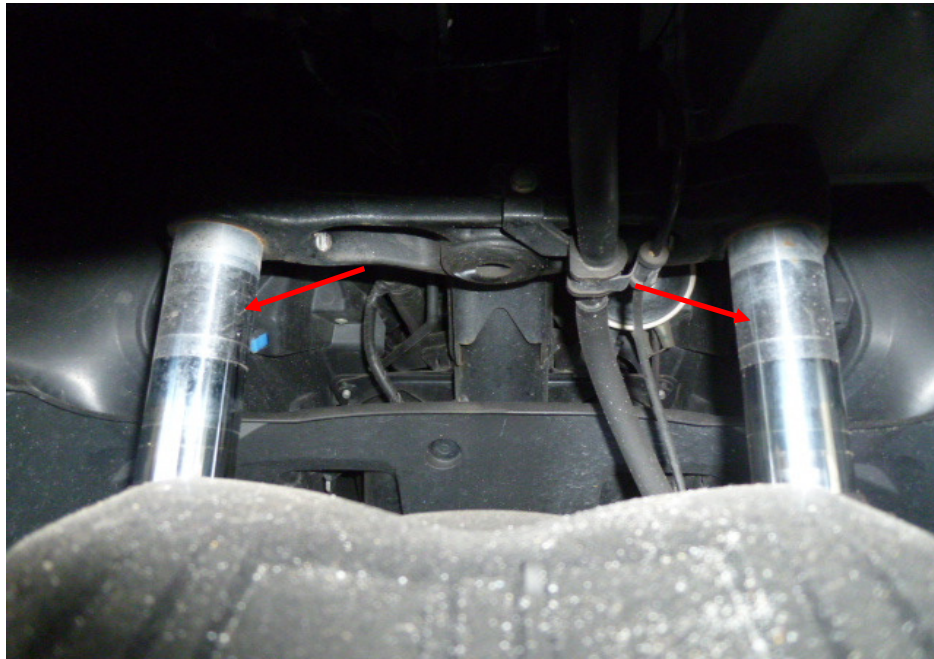
**Photo 20** shows the front forks (arrowed) of the Motorcycle. The front forks and fork brackets of the Motorcycle were both found to be intact and undamaged. Turning the Motorcycle's handle bar towards the left and right did not produce any abnormal free play and/or resistance. The steering system of the Motorcycle was in serviceable condition at the time of our inspection.

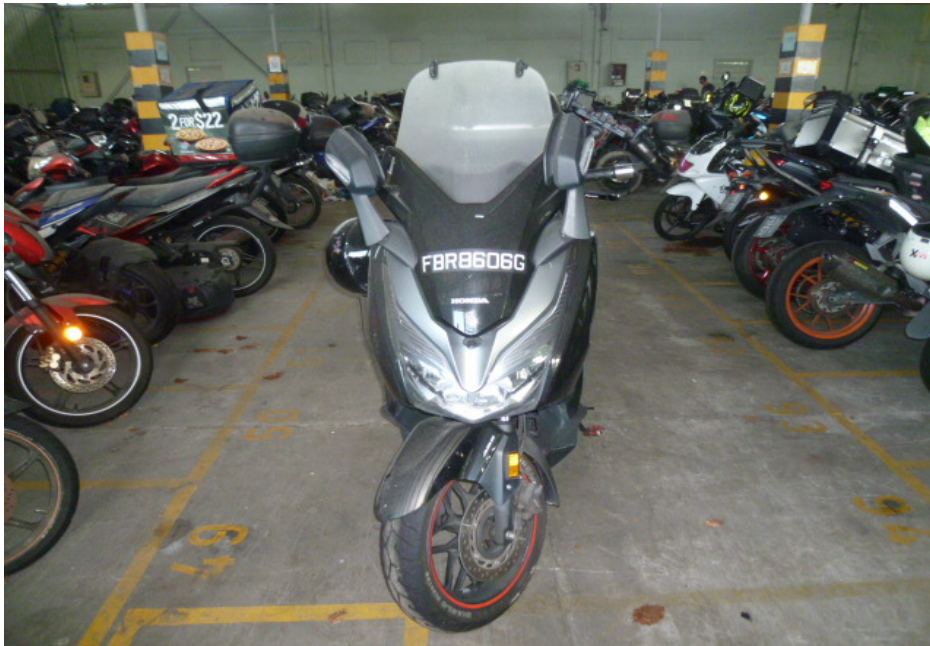
**Photo 21** shows the front wheel of the Motorcycle turned towards its full right. Turning the Motorcycle's handle bar towards the left and right did not produce any abnormal free play and/or resistance. This would indicate that the steering system of the Motorcycle was in serviceable condition at the time of our inspection.

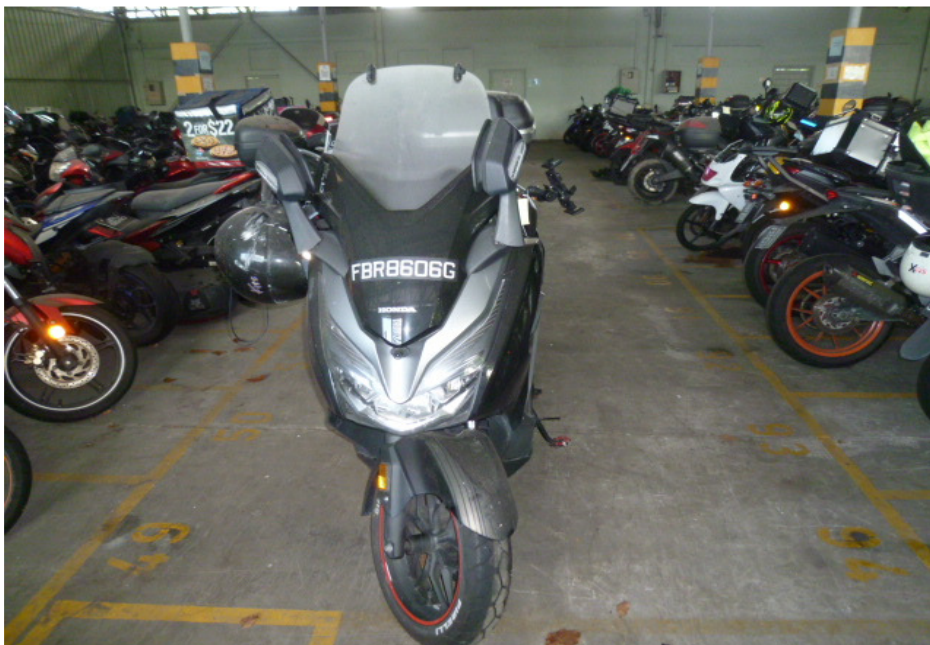
**Photo 22** shows the front wheel of the Motorcycle turned towards its full left. Turning the Motorcycle's handle bar towards the left and right did not produce any abnormal free play and/or resistance. This would indicate that the steering system of the Motorcycle was in serviceable condition at the time of our inspection.

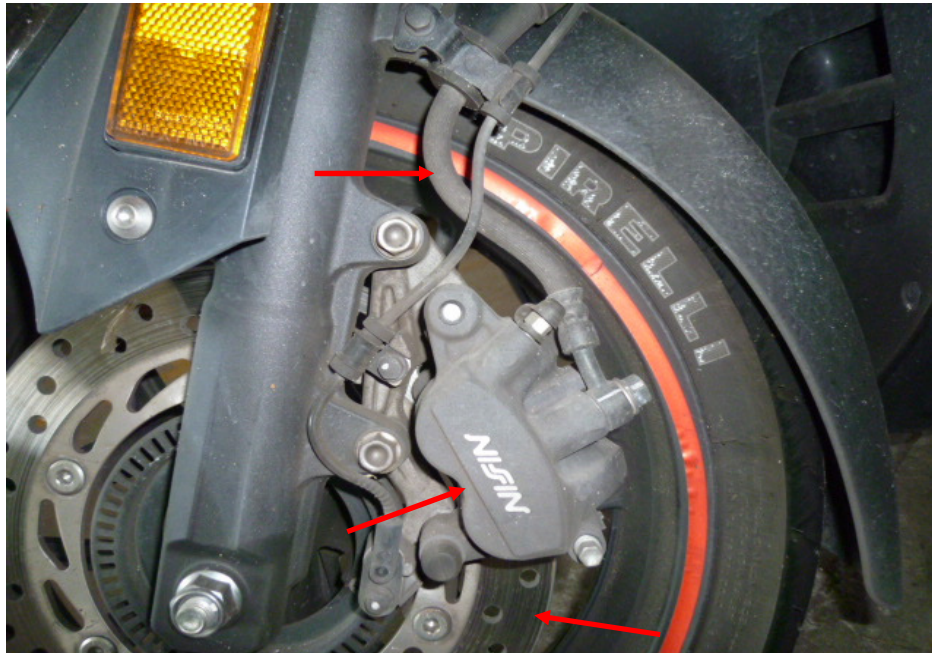
**Photo 23** shows a close up view of the front brake caliper, front brake disc and front brake hose (arrowed) of the Motorcycle, which are all part of the components in the hydraulic front brake system of the Motorcycle. Our visual checks of these various components had revealed all to be intact with no visible damage. No leakage of brake fluid was also observed.

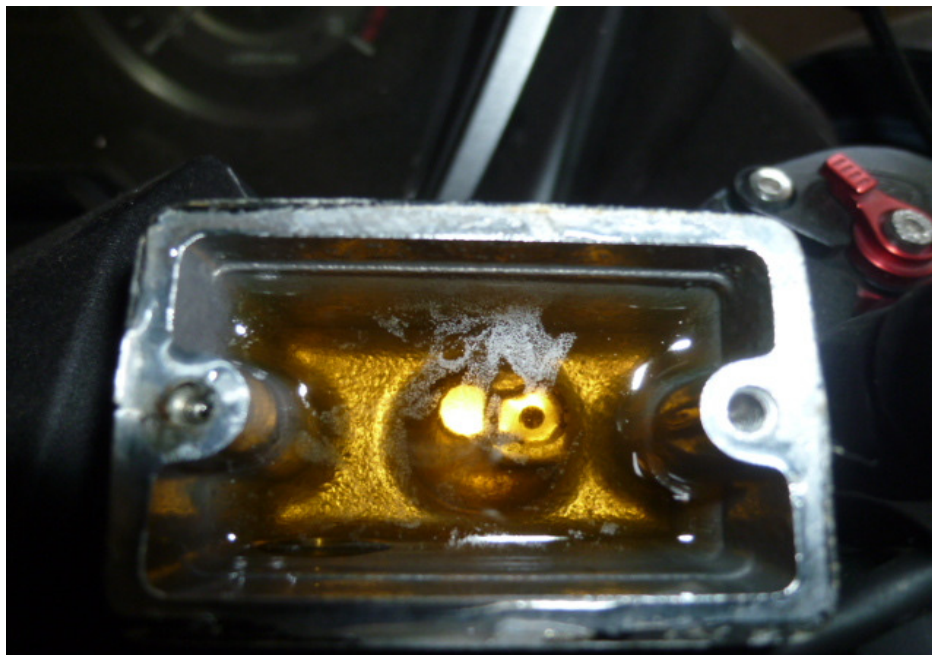
**Photo 24** shows the brake fluid reservoir for the front brake of the Motorcycle. The brake fluid was observed to be of sufficient level for operational purposes and without any contamination.

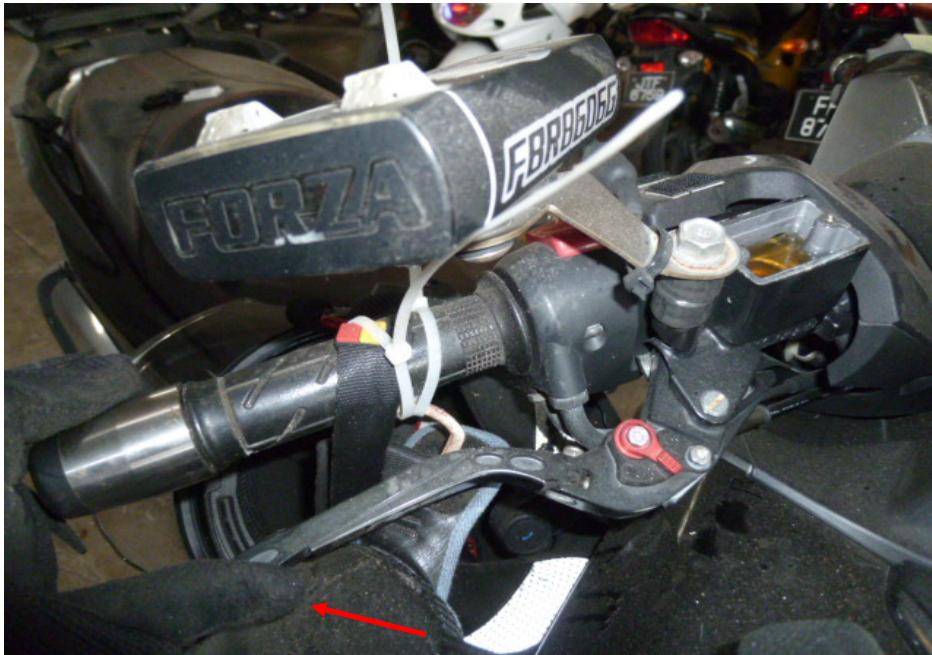
**Photo 25** shows the front brake lever being depressed. There was some resistance felt (spongy like feel) upon pressing the front brake lever (arrowed). This would indicate that there is no leakage of pressure/vacuum in the front brake system.

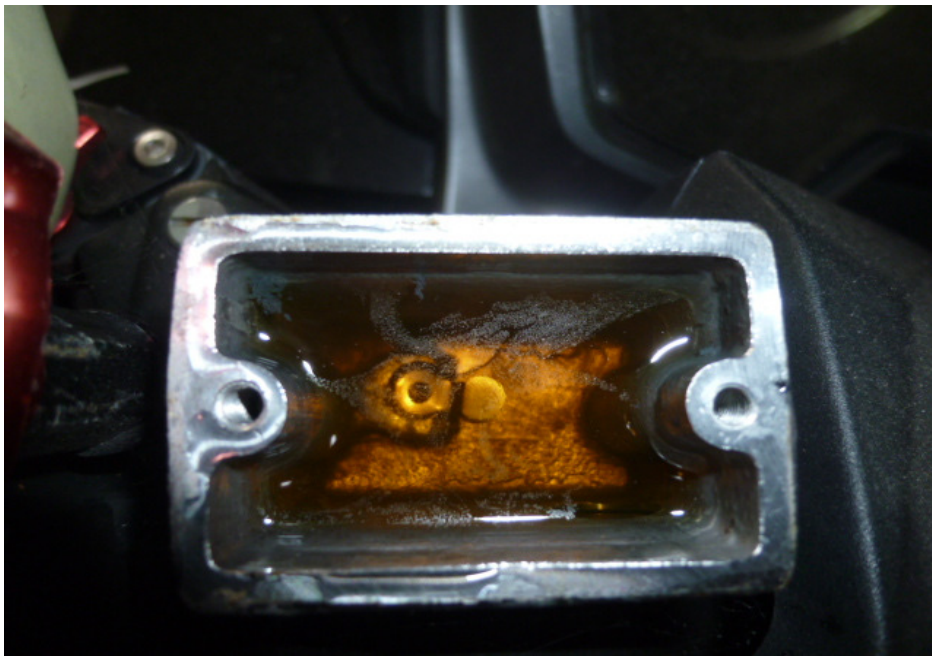
**Photo 26** shows the brake fluid reservoir for the rear brake of the Motorcycle. The brake fluid was observed to be of sufficient level for operational purposes and without any contamination.

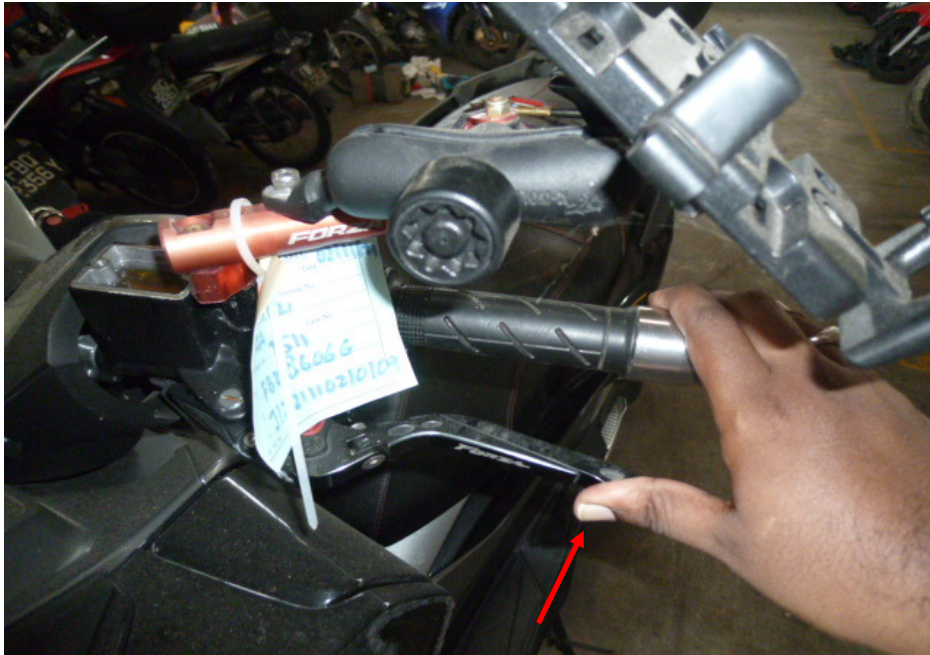
**Photo 27** shows the rear brake lever being depressed. There was some resistance felt (spongy like feel) upon pressing the rear brake lever (arrowed). This would indicate that there is no leakage of pressure/vacuum in the rear brake system.

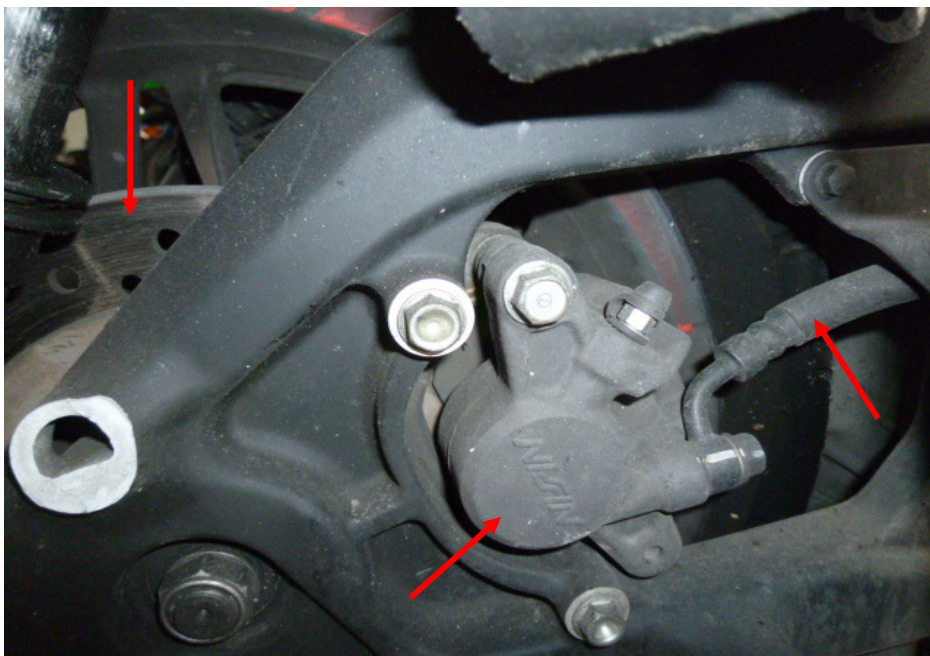
**Photo 28** shows a close up view of the rear brake caliper, rear brake disc and rear brake hose (arrowed) of the Motorcycle, which are all part of the components in the hydraulic rear brake system of the Motorcycle. Our visual checks of these various components revealed all to be intact with no visible damage. No leakage of brake fluid was also observed.
