Your Ref: TP/IP/53185/2021  
Our Ref : CI/TPD22002090/N

**Fatal Accident Investigation Team**

**INSPECTION REPORT OF MOTORCYCLE FBH 956B**

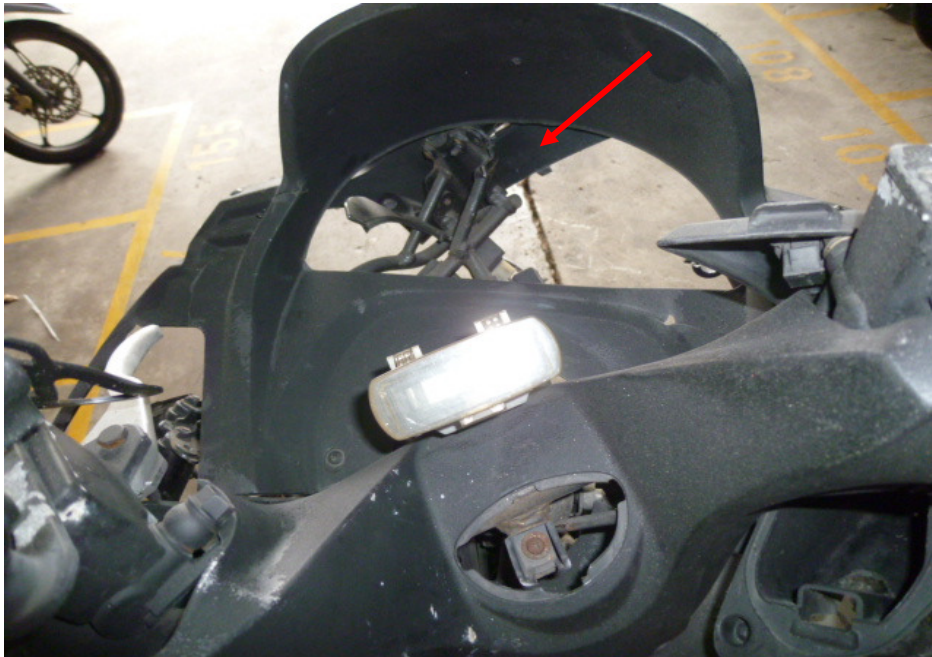
4. The mileage of the Motorcycle could not be recorded at the time of our inspection due to a missing speedometer gauge.
5. The Motorcycle was observed to have sustained damages all around. The body parts that were found to have been damaged include its handlebar, head cowlings, headlight, side cowlings, front brake lever, right handlebar end, radiator, bottom cowlings, pillion foot pegs, rear side covers, top box and exhaust muffler heat shield, amongst others as a result of the accident. See photos 1 – 18 below.

**Photo 1** shows the mileage of the Motorcycle which could not be recorded at the time of our inspection due to a missing speedometer gauge (arrowed).

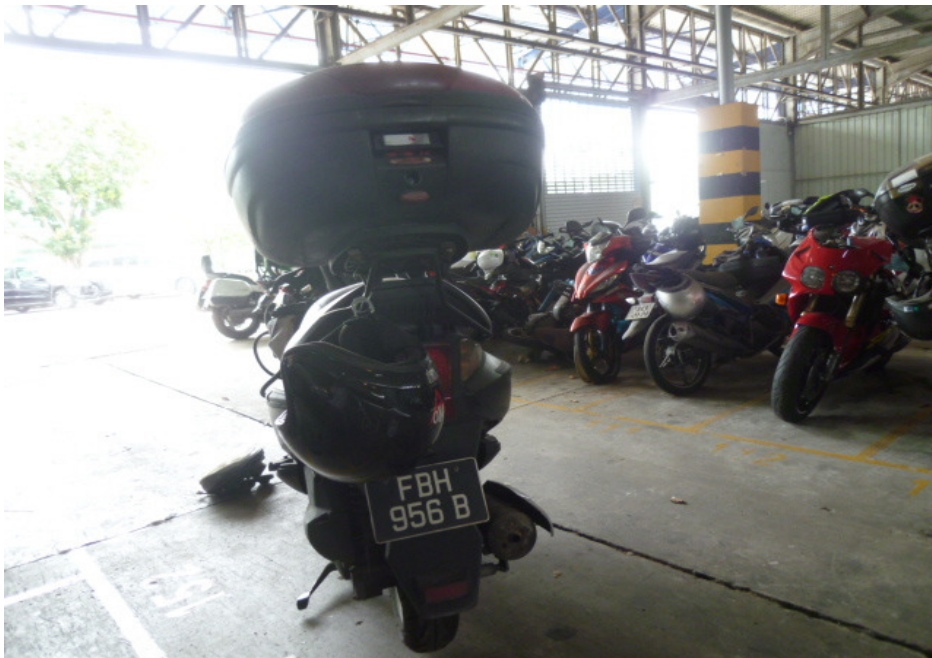
**Photo 2** shows a general view of the rear portion of the Motorcycle at the time of our inspection. The Motorcycle was observed to have sustained damages all around.

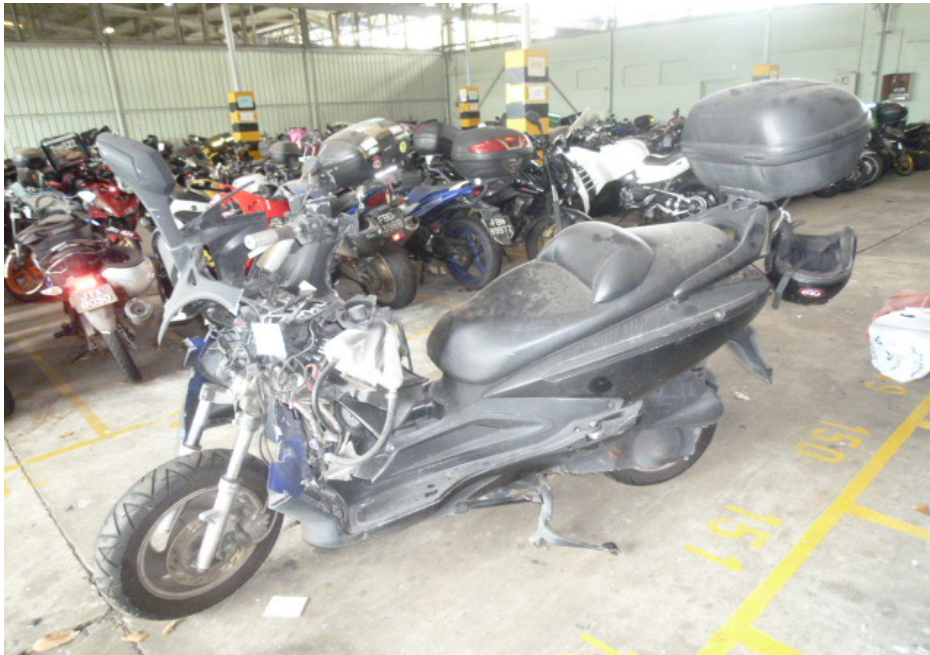
**Photo 3** shows a general view of the left body of the Motorcycle at the time of our inspection. The Motorcycle was observed to have sustained damages all around.

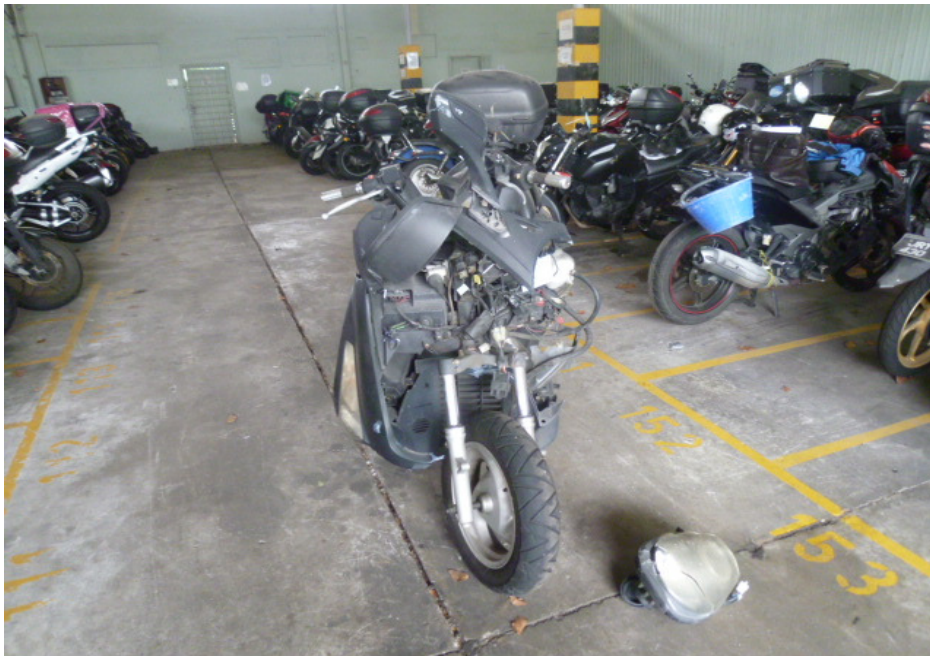
**Photo 4** shows a general view of the frontal portion of the Motorcycle at the time of our inspection. The Motorcycle was observed to have sustained damages all around. The body parts that were found to have been damaged include its handlebar, head cowlings, headlight, side cowlings, front brake lever, right handlebar end, radiator, bottom cowlings, pillion foot pegs, rear side covers, top box and exhaust muffler heat shield, amongst others as a result of the accident.

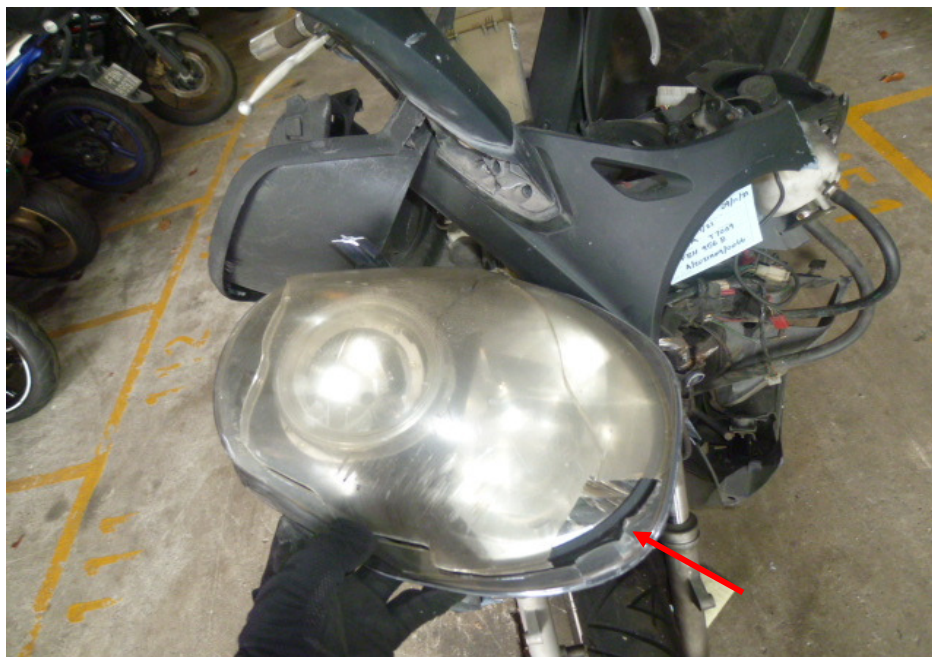
**Photo 5** shows a closer view of the cracked headlight of the Motorcycle at the time of our inspection (arrowed).

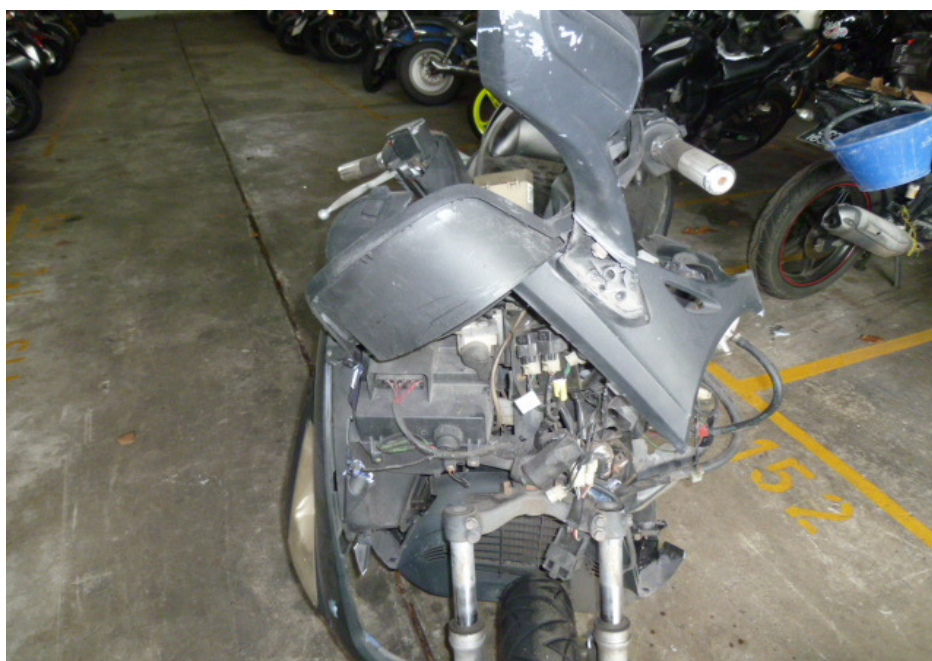
**Photo 6** shows a closer view of the missing head cowl of the Motorcycle as a result of the accident.

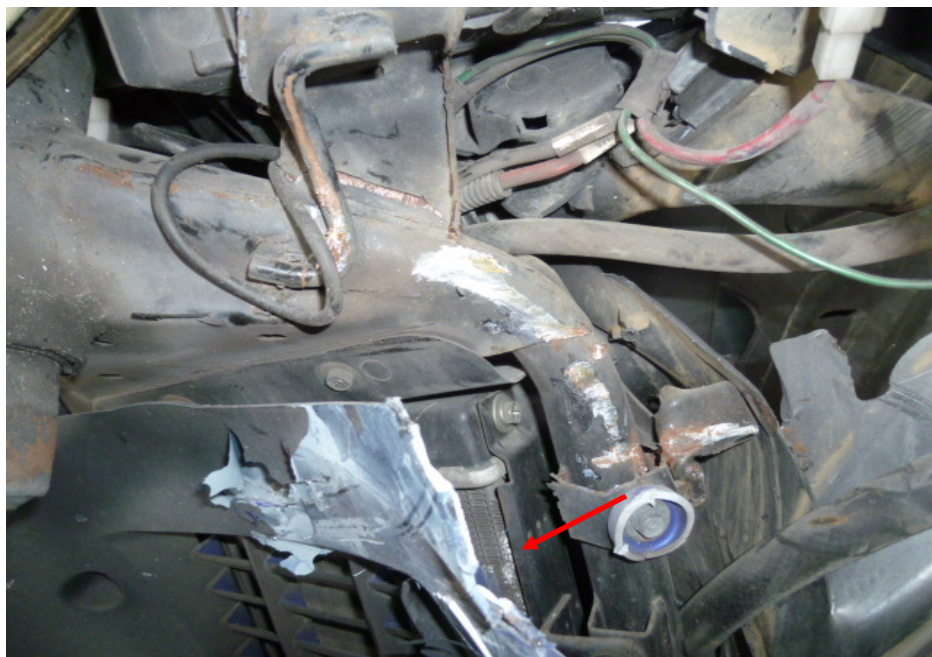
**Photo 7** shows a closer view of the deformed radiator which was amongst the body parts at the front body of the Motorcycle that had sustained damage as a result of the accident (arrowed).

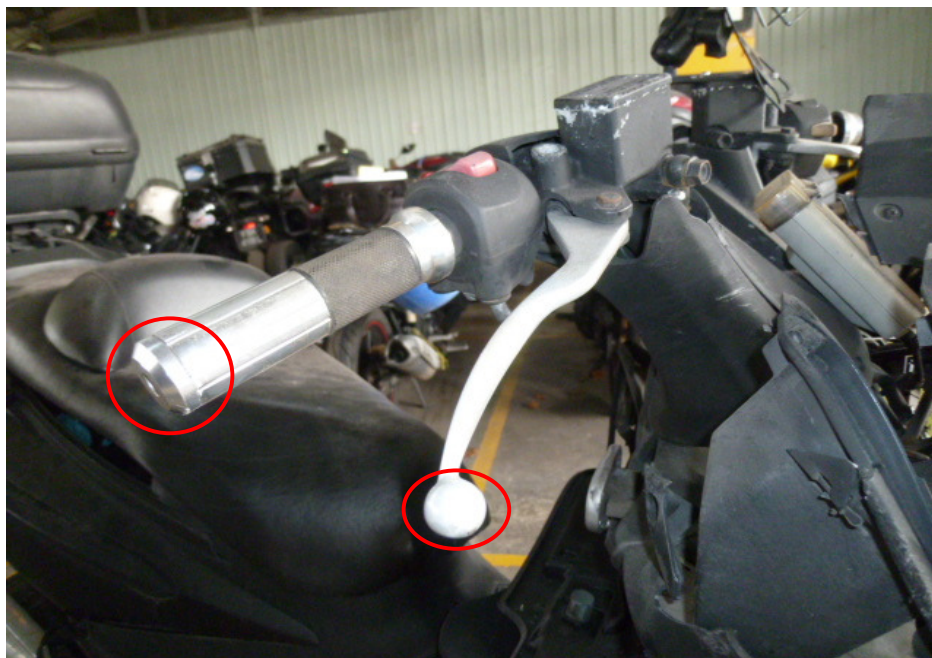
**Photo 8** shows a closer view of the right handlebar end and front brake lever of the Motorcycle which were observed to be damaged due to the accident (circled).

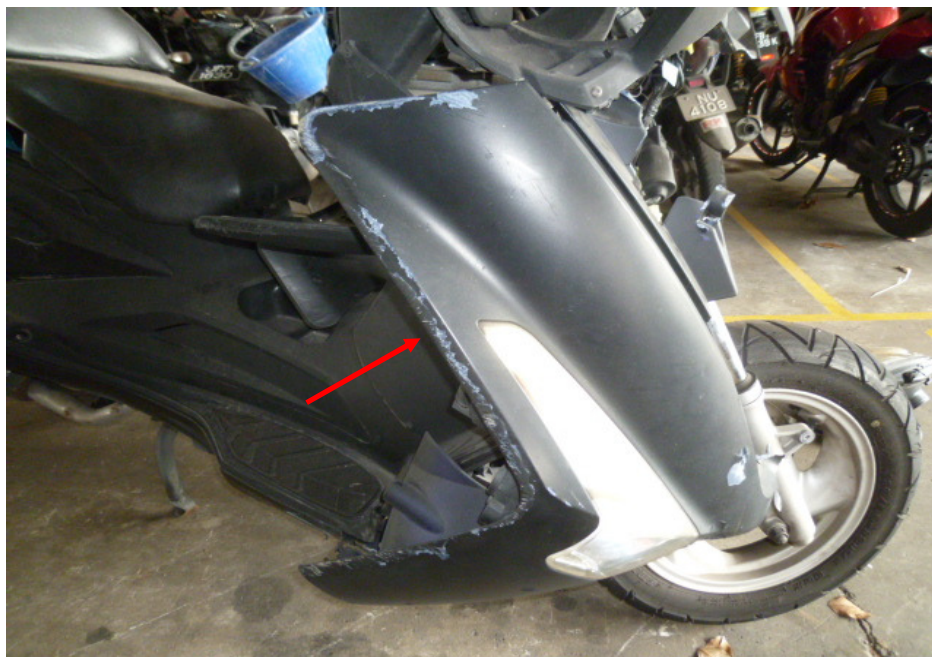
**Photo 9** shows a general view of the grazed right cowling of the Motorcycle as a result of the accident (arrowed).

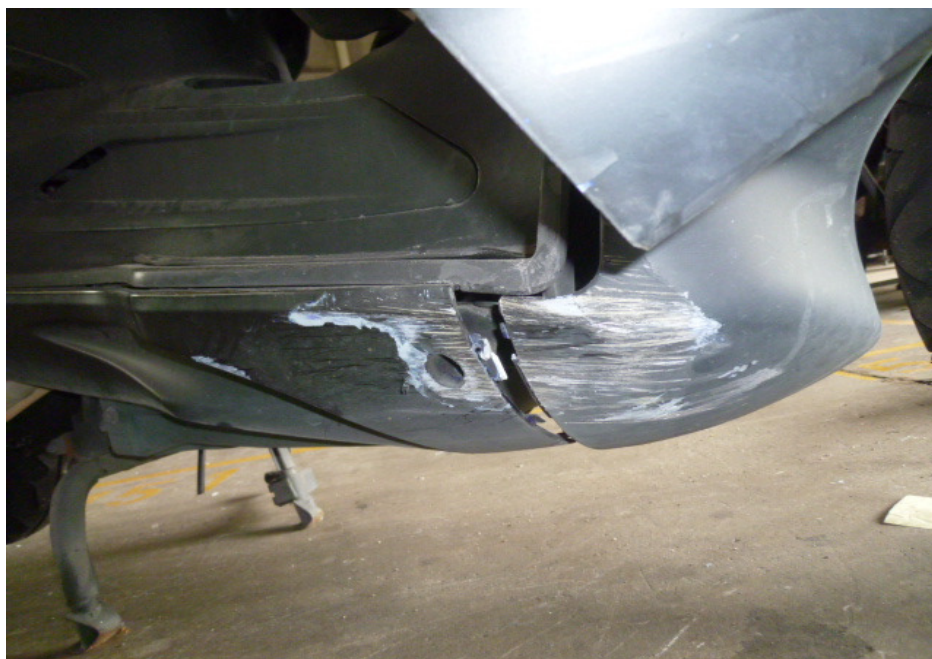
**Photo 10** shows a close-up view of the cracked right bottom cowling of the Motorcycle as a result of the accident.

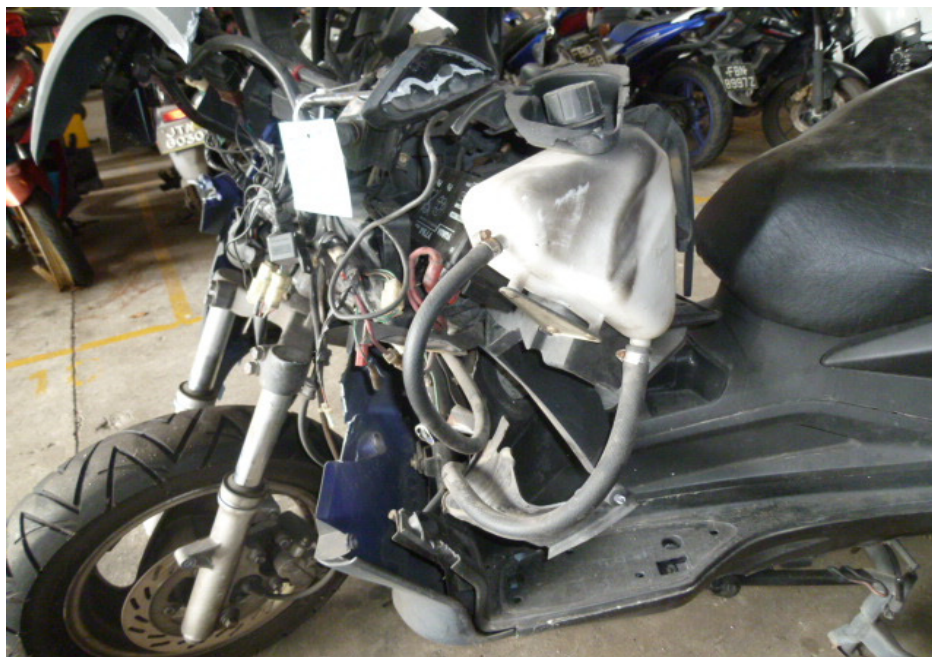
**Photo 11** shows the missing left side cowling of the Motorcycle as a result of the accident.

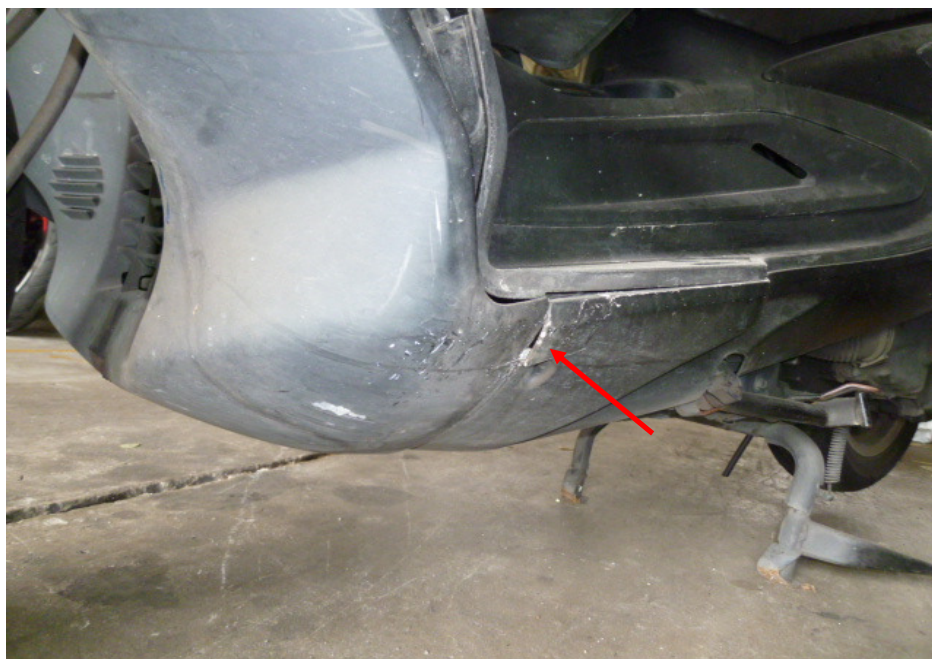
**Photo 12** shows a close-up view of the cracked left bottom cowling of the Motorcycle as a result of the accident (arrowed).

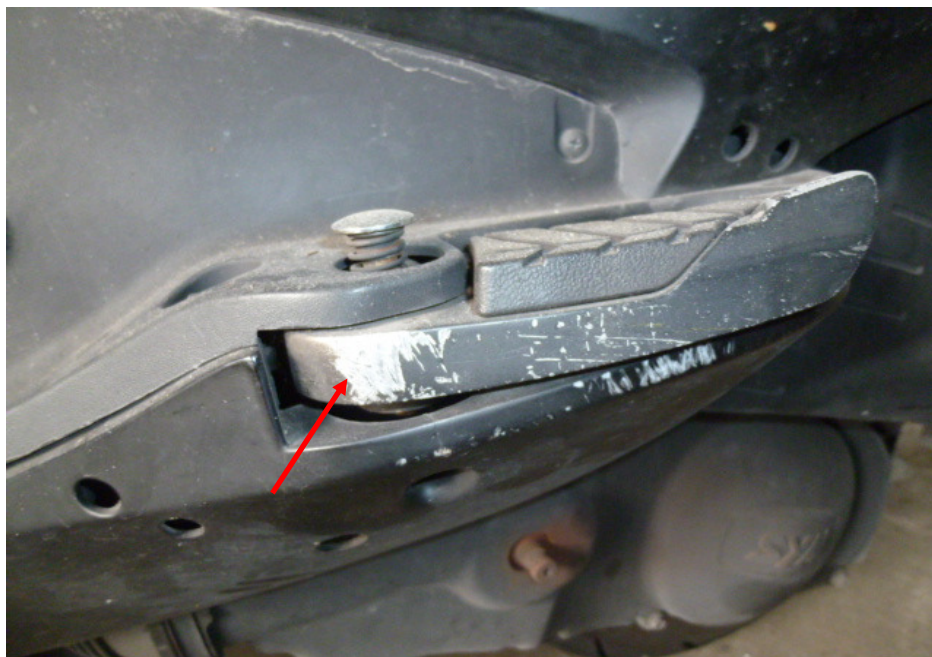
**Photo 13** shows a close-up view of the grazed left pillion foot peg of the Motorcycle as a result of the accident (arrowed).

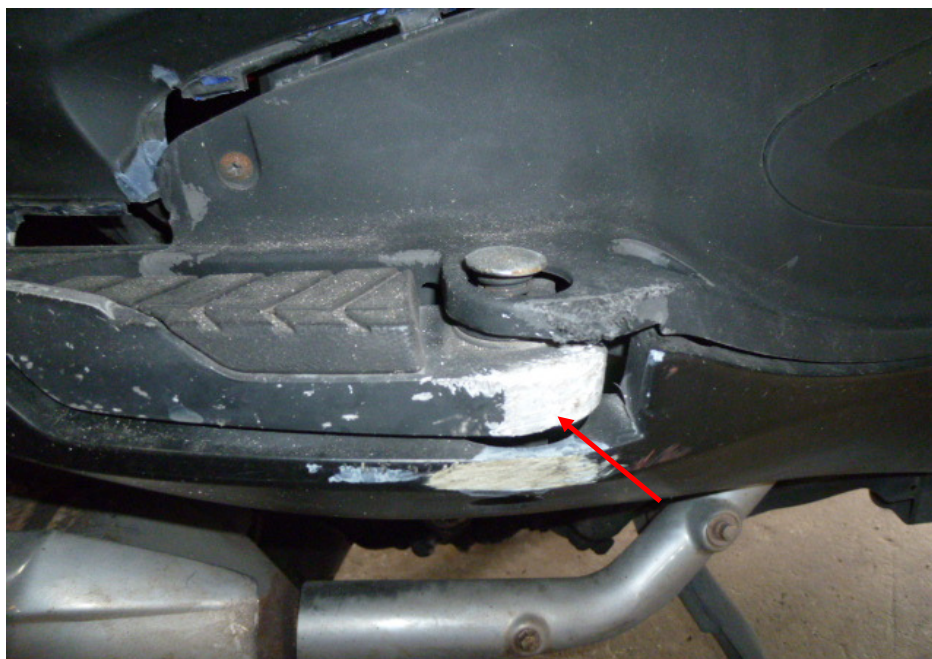
**Photo 14** shows a close-up view of the grazed right pillion foot peg of the Motorcycle as a result of the accident (arrowed).

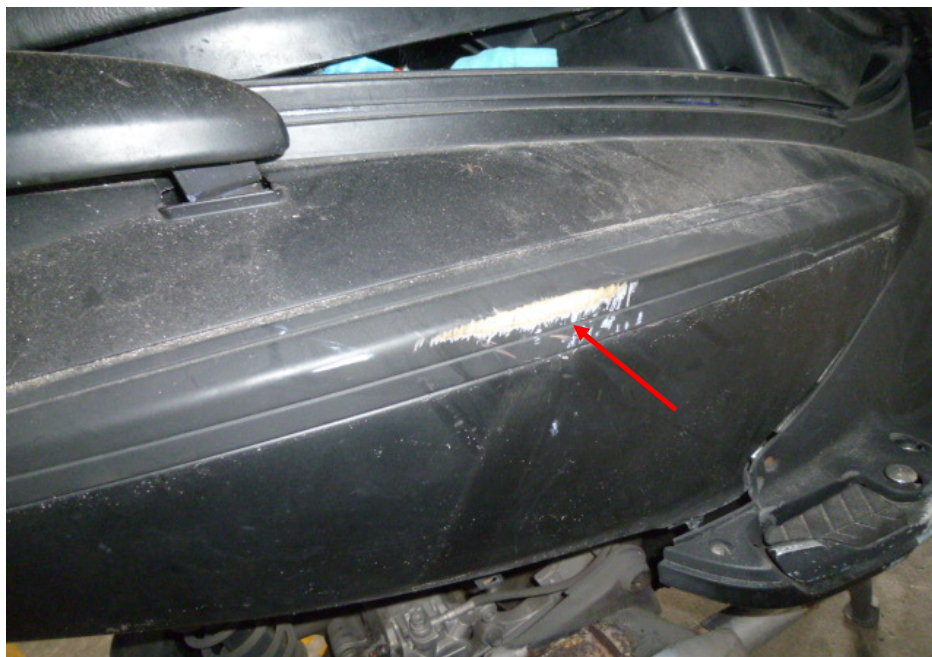
**Photo 15** shows a close-up view of the grazed right rear side cover of the Motorcycle as a result of the accident (arrowed).

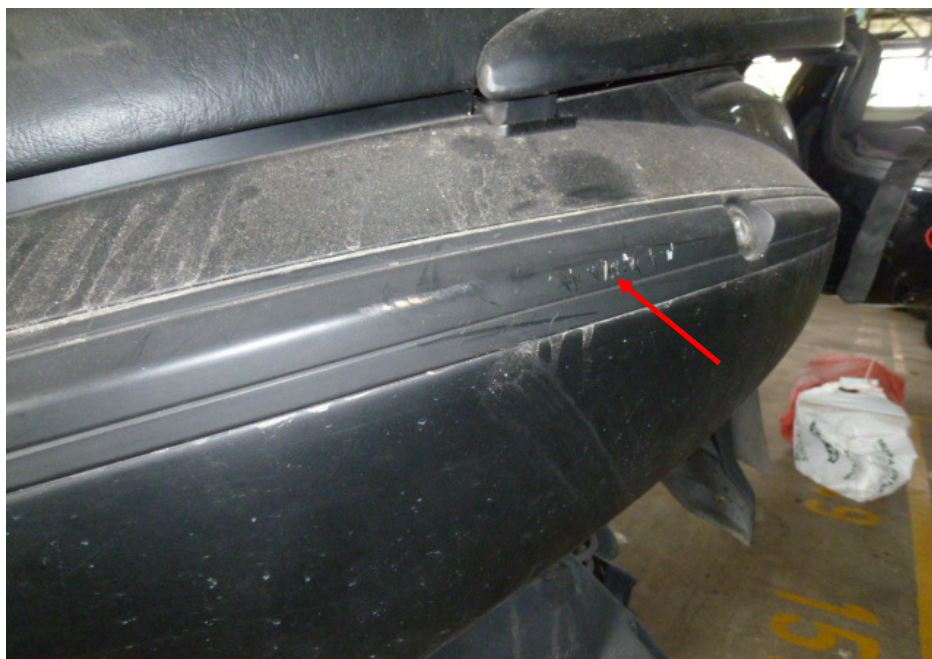
**Photo 16** shows a close-up view of the grazed left rear side cover of the Motorcycle as a result of the accident (arrowed).

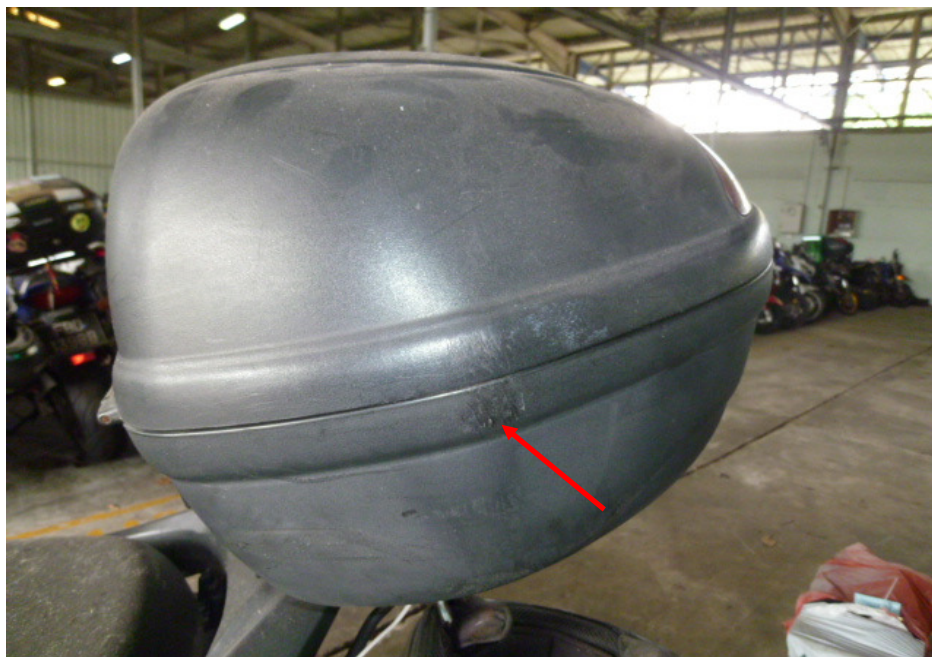
**Photo 17** shows a close-up view of the grazed top box of the Motorcycle as a result of the accident (arrowed).

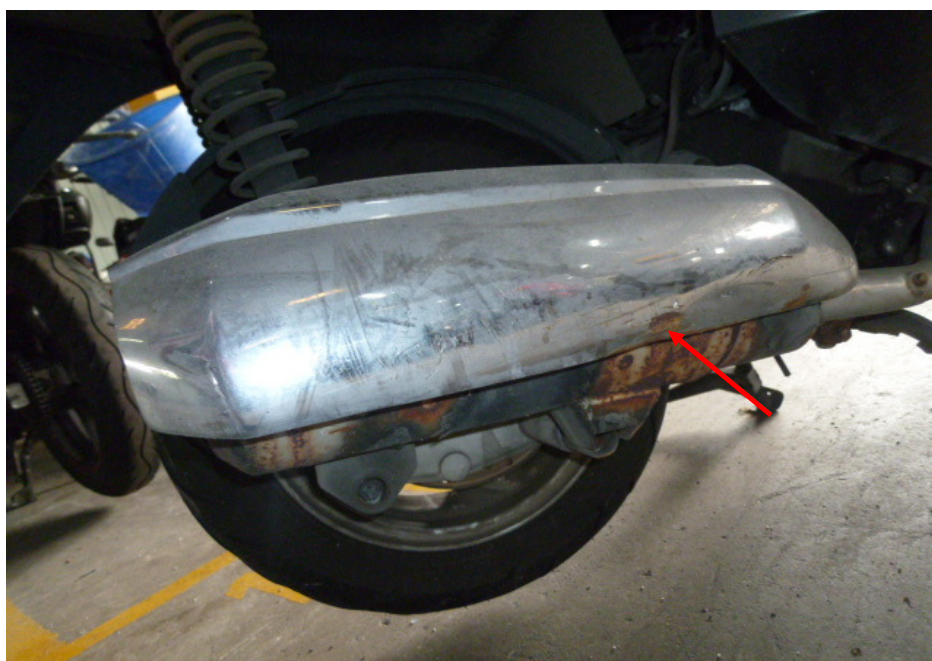
**Photo 18** shows a close-up view of the deformed exhaust muffler heat shield of the Motorcycle as a result of the accident (arrowed).

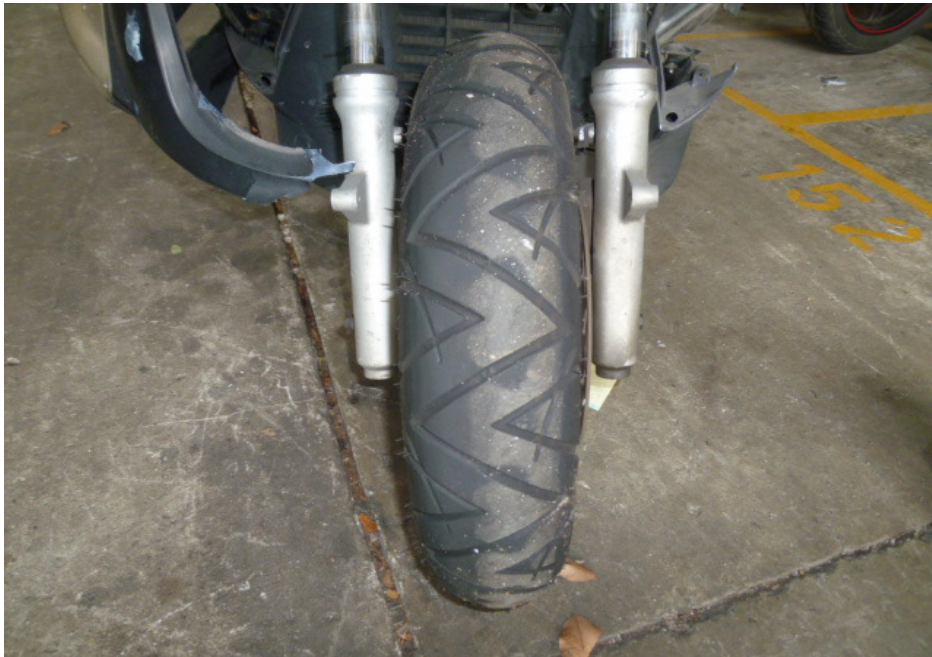
**Photo 19** shows the condition of the Motorcycle's front tyre. The front tyre was observed to be in serviceable condition with remaining tread depth of approximately 6mm. There was no tear, burst mark(s) and/or punctured hole(s) on the sidewalls as well as across the tread of the front tyre.

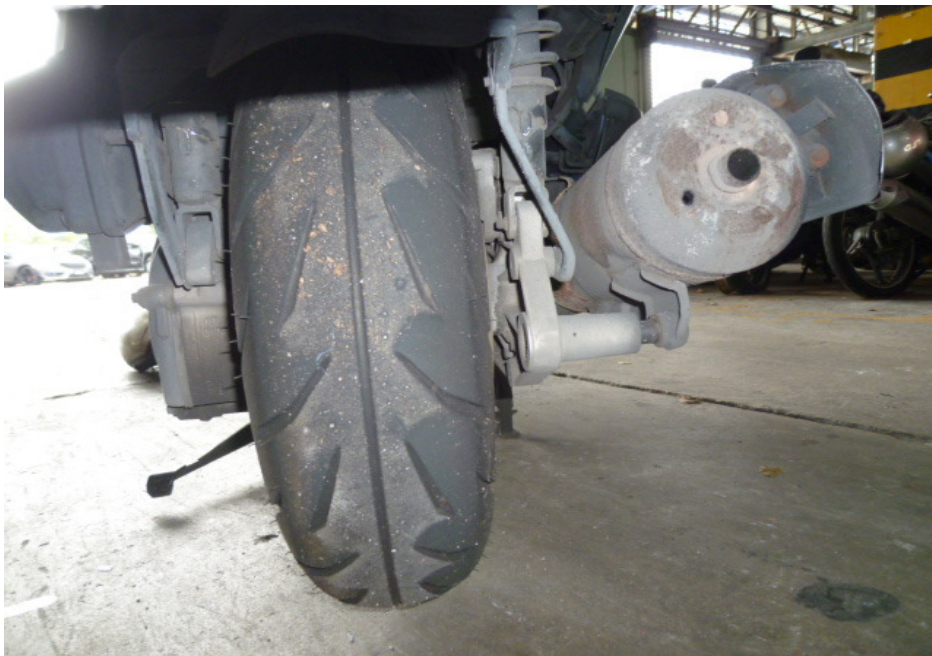
**Photo 20** shows the condition of the Motorcycle's rear tyre. The rear tyre was observed to be in serviceable condition with remaining tread depth of approximately 5mm. The tyre was also observed to be sufficiently inflated for vehicular operation. We did not observe any tear, burst mark(s) and/or punctured hole(s) on the sidewalls as well as across the tread of the rear tyre.

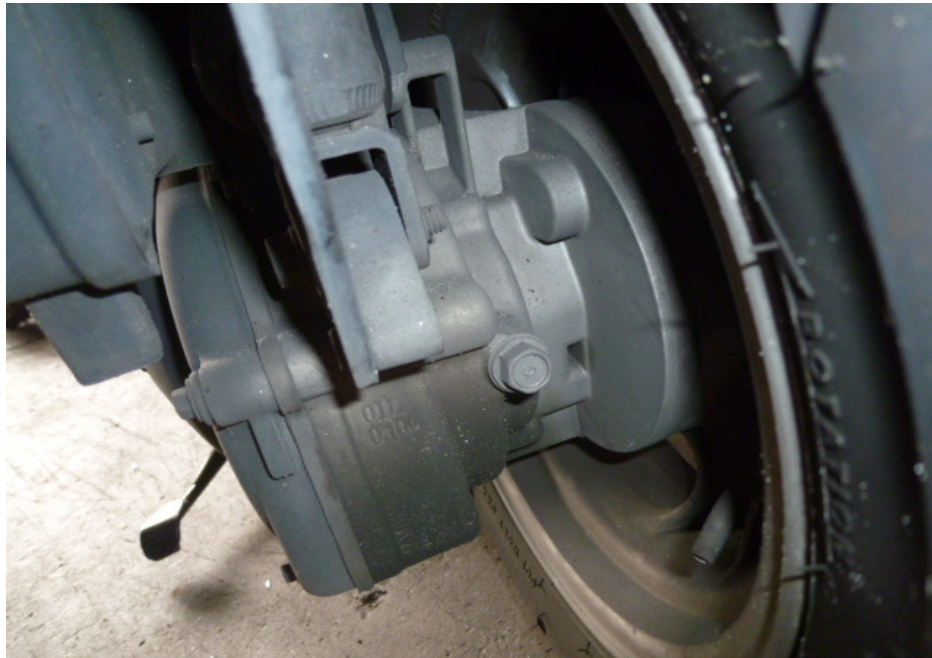
**Photo 21** shows the left side of the engine of the Motorcycle at the time of our inspection. The various engine related parts and components were found to be intact with no visible damage. There was also no sign(s) or indication(s) of fluid leak observed around the left engine area of the Motorcycle.

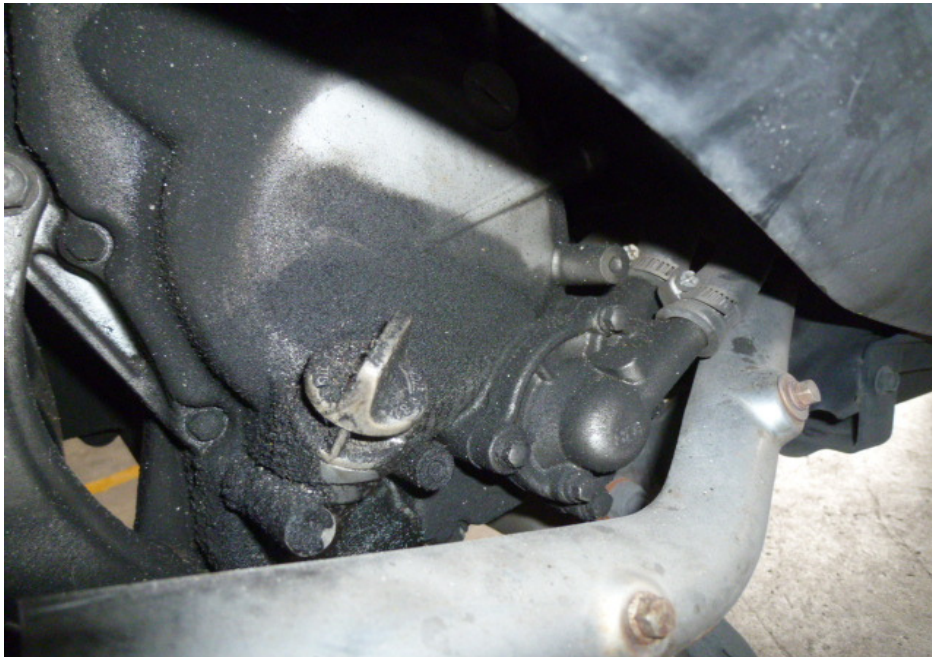
**Photo 22** shows the right side of the engine of the Motorcycle at the time of our inspection. The various engine related parts and components were found to be intact with no visible damage. There was also no sign(s) or indication(s) of fluid leak observed around the right engine area of the Motorcycle.

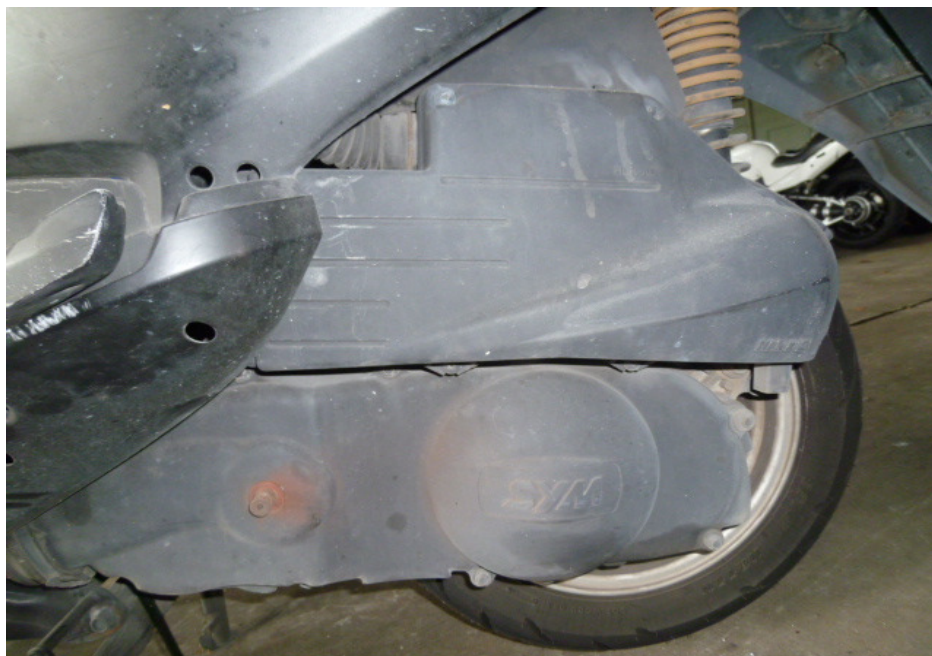
**Photo 23** shows the drive train cover of the Motorcycle which was found to be intact without any misalignment.

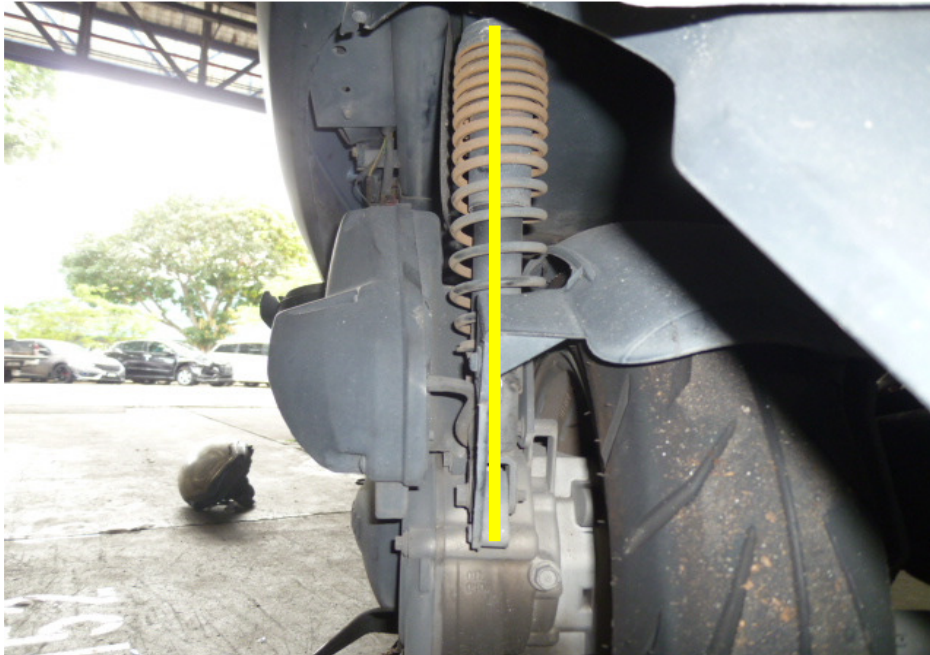
**Photo 24** shows the left shock absorber of the Motorcycle which was found to be intact without any misalignment.

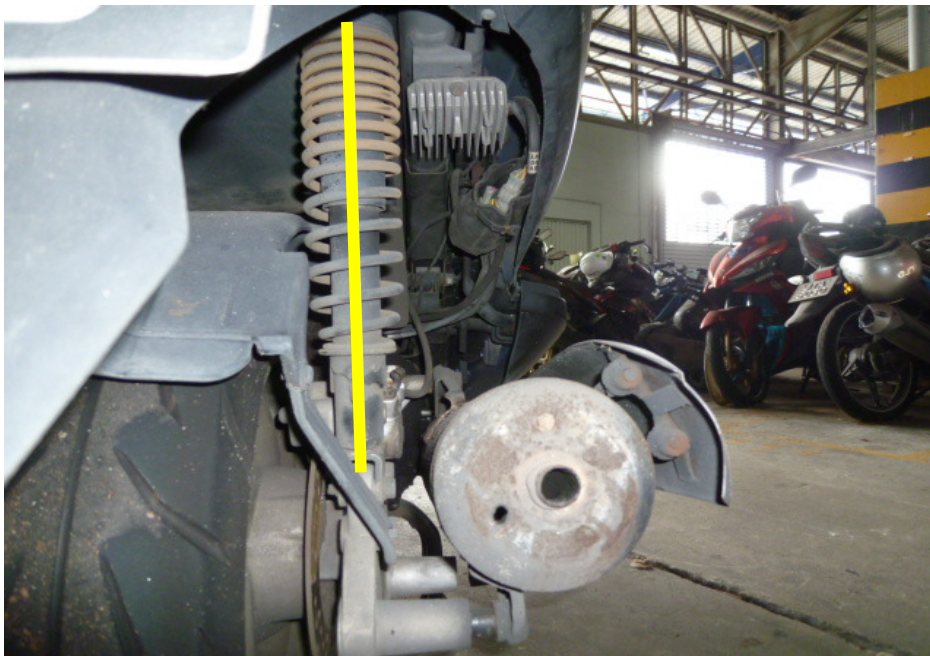
**Photo 25** shows the right shock absorber of the Motorcycle which was found to be intact without any misalignment.

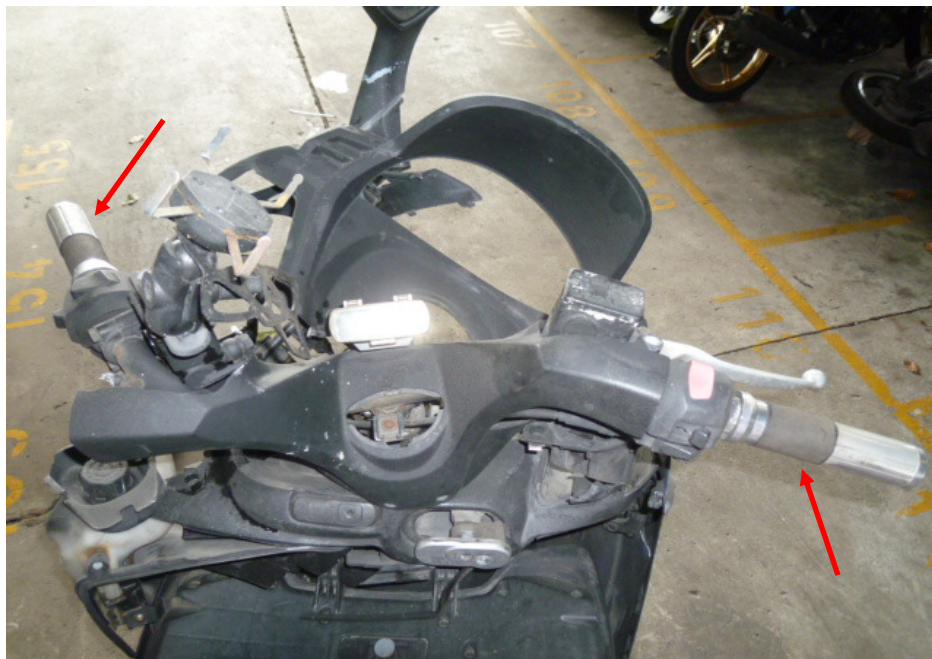
10. For this case, we were not able to conduct any test(s) on the steering system of the Motorcycle due to the damage to its handlebar. The handlebar was found to be bent as a result of the accident.

**Photo 26** shows the handlebar of the Motorcycle. The handlebar was observed to be bent (arrowed) as a result of the accident. We were hence not able to conduct any tests on the steering system of the Motorcycle.

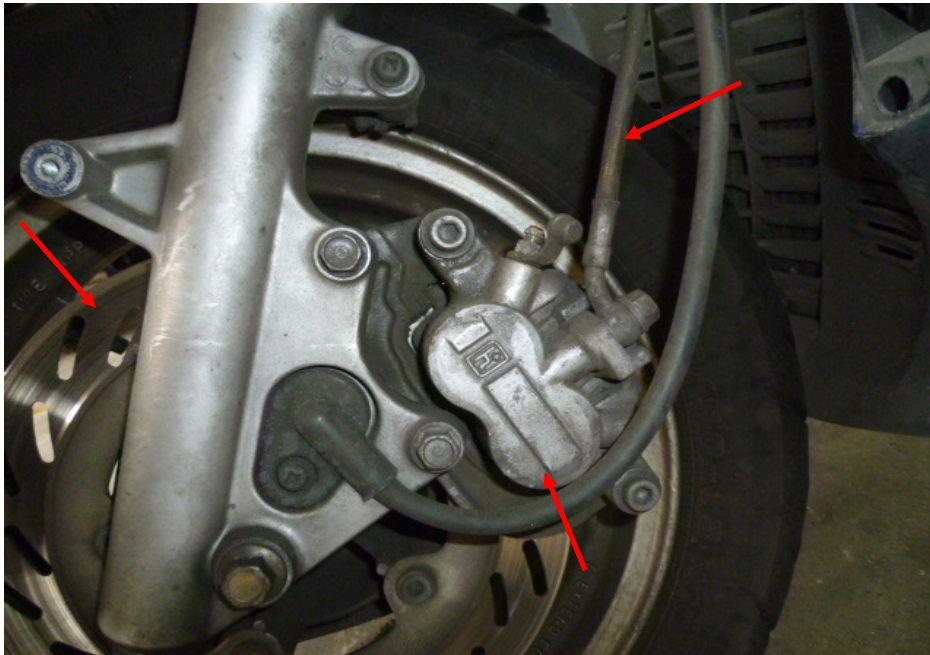
**Photo 27** shows a close up view of the front brake caliper, front brake disc and front brake hose (arrowed) of the Motorcycle, which are all part of the components in the hydraulic front brake system of the Motorcycle. Our visual checks of these various components had revealed all to be intact with no visible damage. No leakage of brake fluid was also observed.

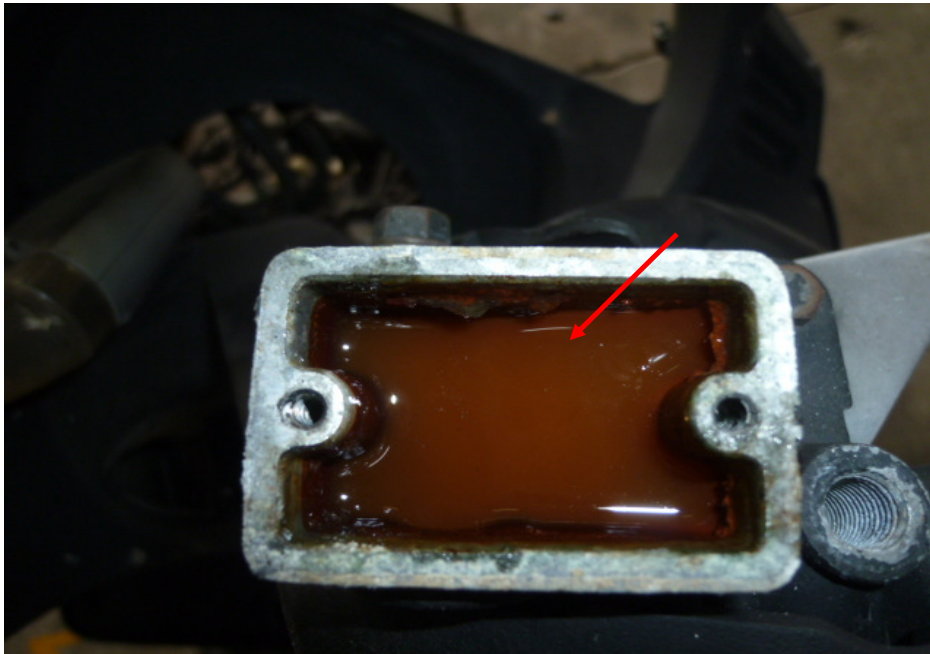
13. Our checks on the front brake fluid had also indicated that the front brake fluid was observed to be of sufficient level for operational purposes. However it was found to be contaminated.

**Photo 28** shows the brake fluid reservoir for the front brake of the Motorcycle. The brake fluid was observed to be of sufficient level for operational purposes. However it was found to be contaminated (arrowed).

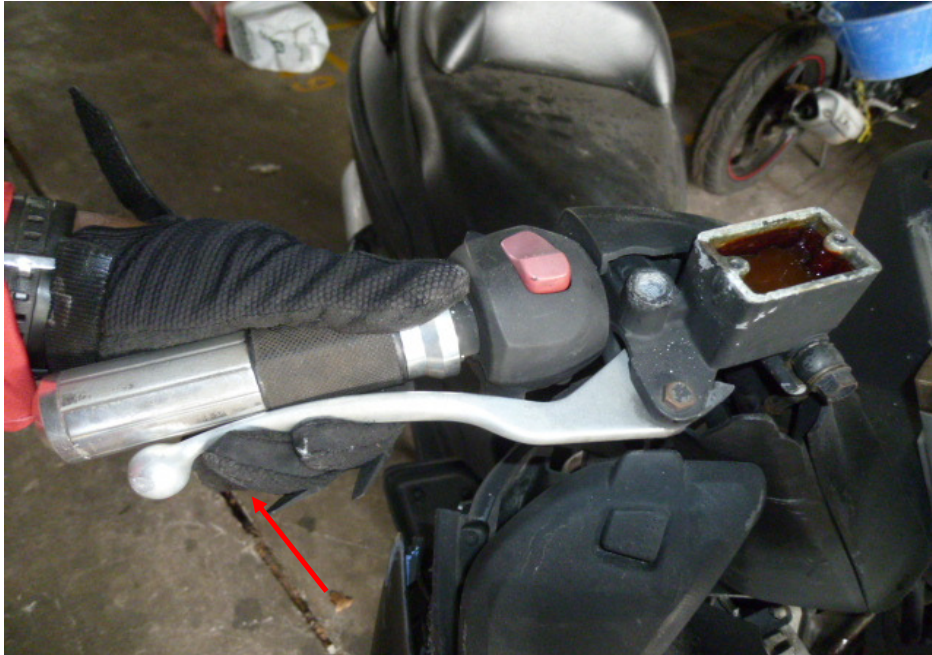
16. Static brake tests conducted on the Motorcycle had appeared to indicate that the front brake system of the Motorcycle was not in serviceable condition. There was no resistance felt (spongy like feel) upon pressing the right hand brake lever. This would indicate that there may be a leakage of pressure/vacuum in the front brake system.

**Photo 29** shows the front brake lever being depressed. There was no resistance felt (spongy like feel) upon pressing the front brake lever (arrowed). This would indicate that there may be a leakage of pressure/vacuum in the front brake system.

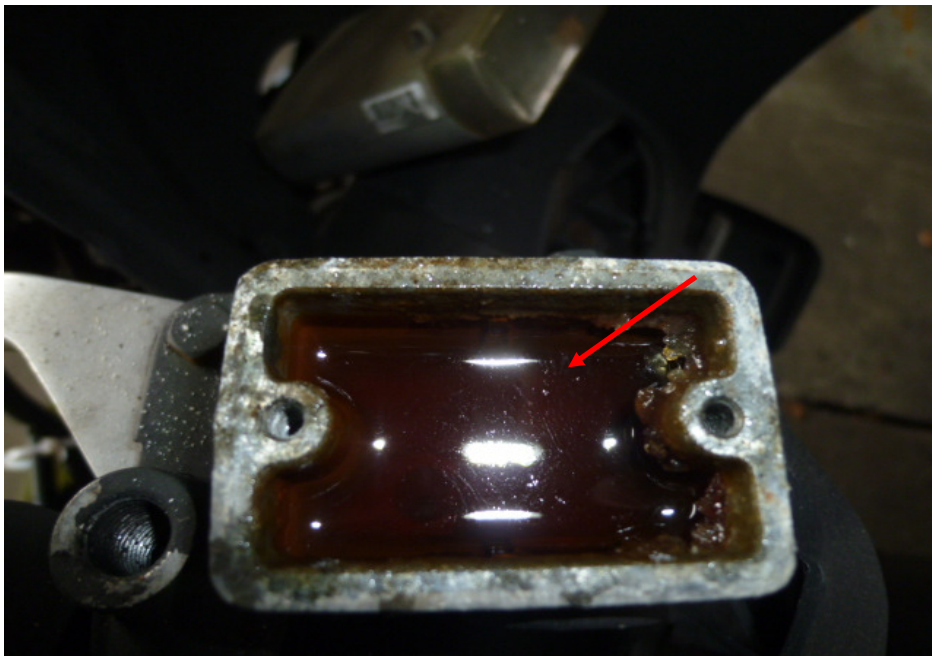
14. Our checks on the rear brake fluid had also indicated that the rear brake fluid was observed to be of sufficient level for operational purposes. However it was found to be slightly contaminated.

**Photo 30** shows the brake fluid reservoir for the rear brake of the Motorcycle. The brake fluid was observed to be of sufficient level for operational purposes. However it was found to be slightly contaminated (arrowed).

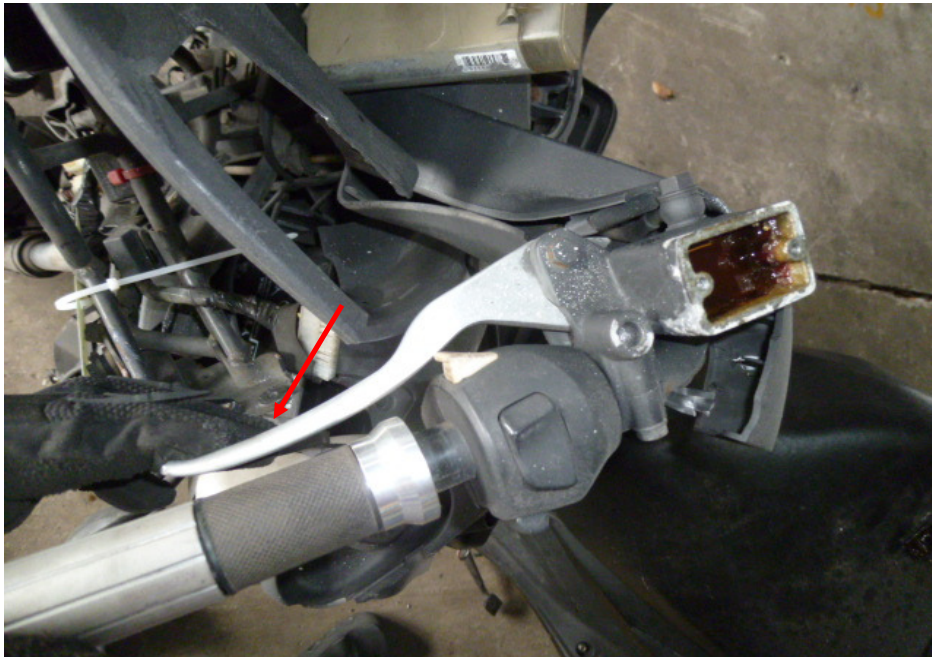
15. Static brake tests conducted on the Motorcycle had appeared to indicate that the rear brake system of the Motorcycle was in serviceable condition. There was some resistance felt (spongy like feel) upon pressing the left hand brake lever. This would indicate that there's no leakage of pressure/vacuum in the rear brake system.

**Photo 31** shows the rear brake lever being depressed. There was some resistance felt (spongy like feel) upon pressing the rear brake lever (arrowed). This would indicate that there is no leakage of pressure/vacuum in the rear brake system.

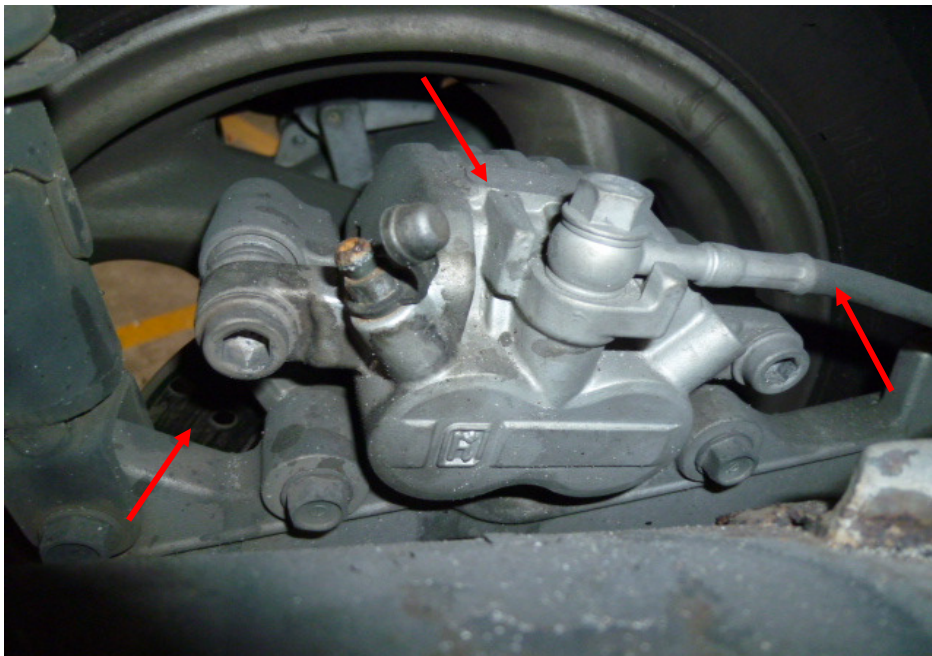
**Photo 32** shows a close up view of the rear brake caliper, rear brake disc and rear brake hose (arrowed) of the Motorcycle, which are all part of the components in the hydraulic rear brake system of the Motorcycle. Our visual checks of these various components revealed all to be intact with no visible damage. No leakage of brake fluid was also observed.
