Your Ref: TP/IP/00007/2022
Our Ref : CI/TPD22002091/N

Fatal Accident Investigation Team

INSPECTION REPORT OF MOTORCYCLE FBL 4923Z

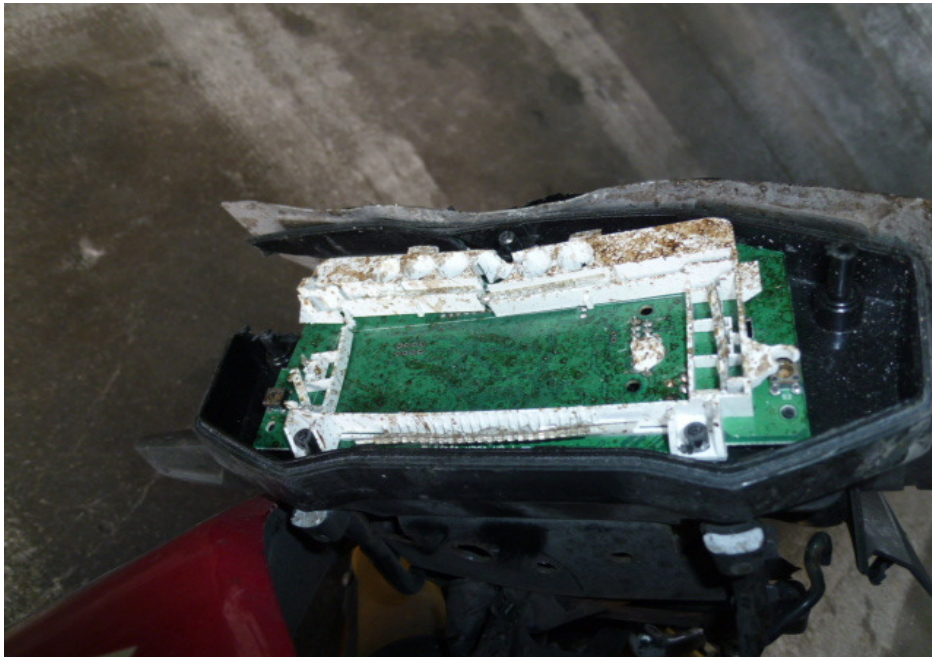
4. The mileage of the Motorcycle could not be recorded at the time of our inspection due to damages sustained to the speedometer gauge.
5. The Motorcycle was observed to have sustained damages all around. The body parts that were found to have been damaged include its speedometer gauge, headlight assembly, front mudguard, front wheel rim, side cowlings, handlebars, side mirrors, front brake lever, petrol tank, rear brake pedal, right front footrest, right rear side cover and top box rack, amongst others.

Photo 1 shows the damages sustained to the speedometer gauge of the Motorcycle as a result of the accident. Hence the mileage could not be recorded at the time of our inspection.

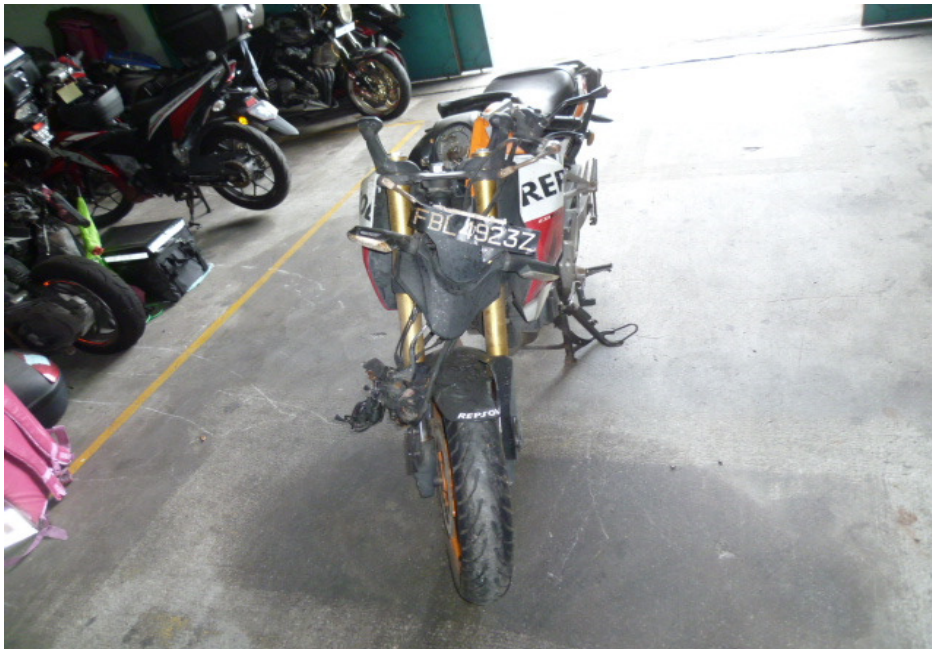
Photo 2 shows a general view of the frontal portion of the Motorcycle at the time of our inspection. The Motorcycle was observed to have sustained damages all around.

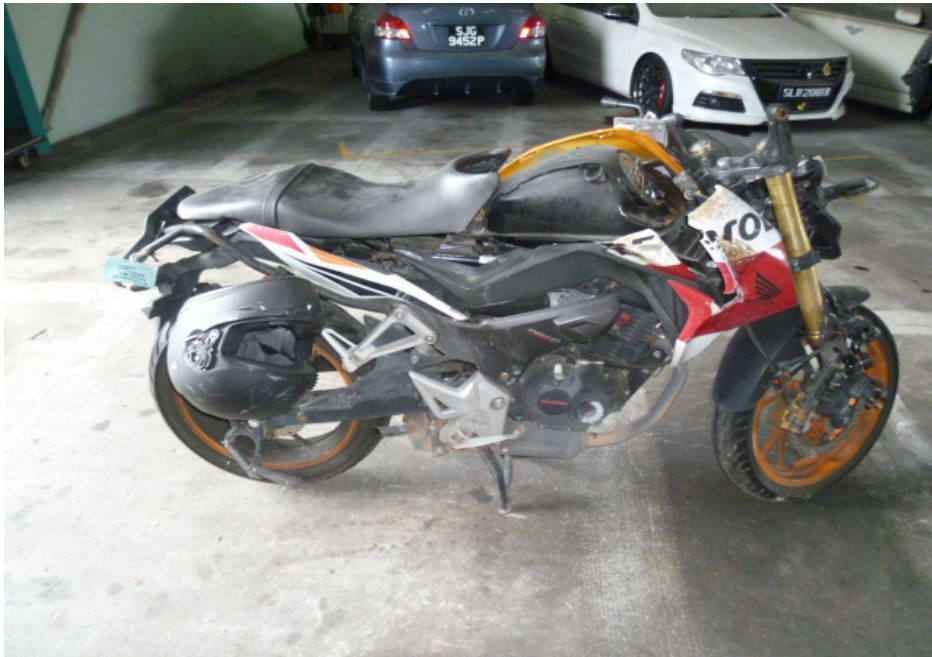
Photo 3 shows a general view of the right body of the Motorcycle at the time of our inspection. The Motorcycle was observed to have sustained damages all around.

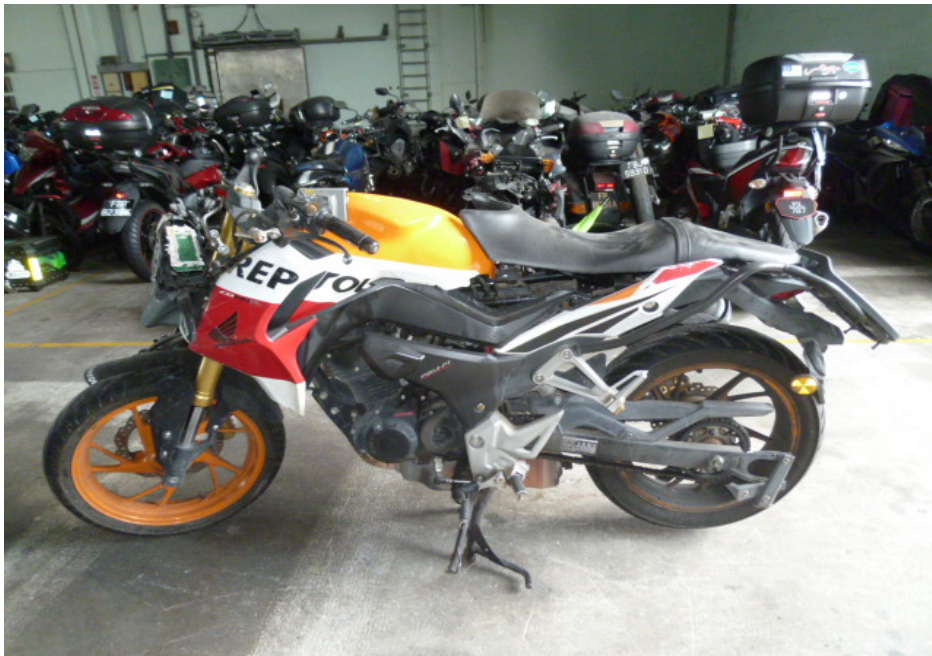
Photo 4 shows a general view of the left body of the Motorcycle at the time of our inspection. The Motorcycle was observed to have sustained damages all around.

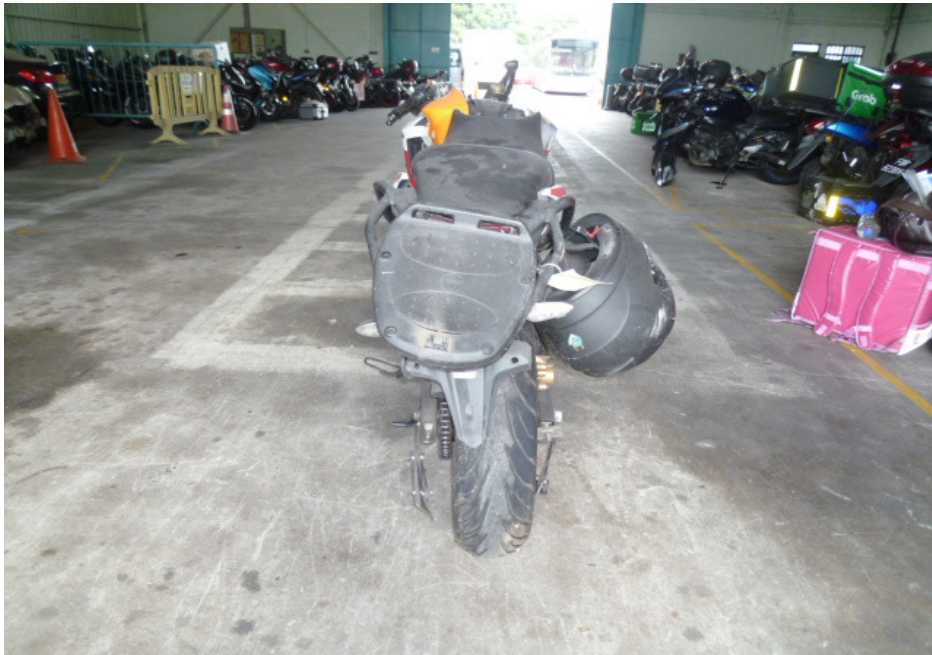
Photo 5 shows a general view of the rear portion of the Motorcycle at the time of our inspection. The Motorcycle was observed to have sustained damages all around. Amongst the body parts that were found to have been damaged include its speedometer gauge, headlight assembly, front mudguard, front wheel rim, side cowlings, handlebars, side mirrors, front brake lever, petrol tank, rear brake pedal, right front footrest, right rear side cover and top box rack, amongst others.

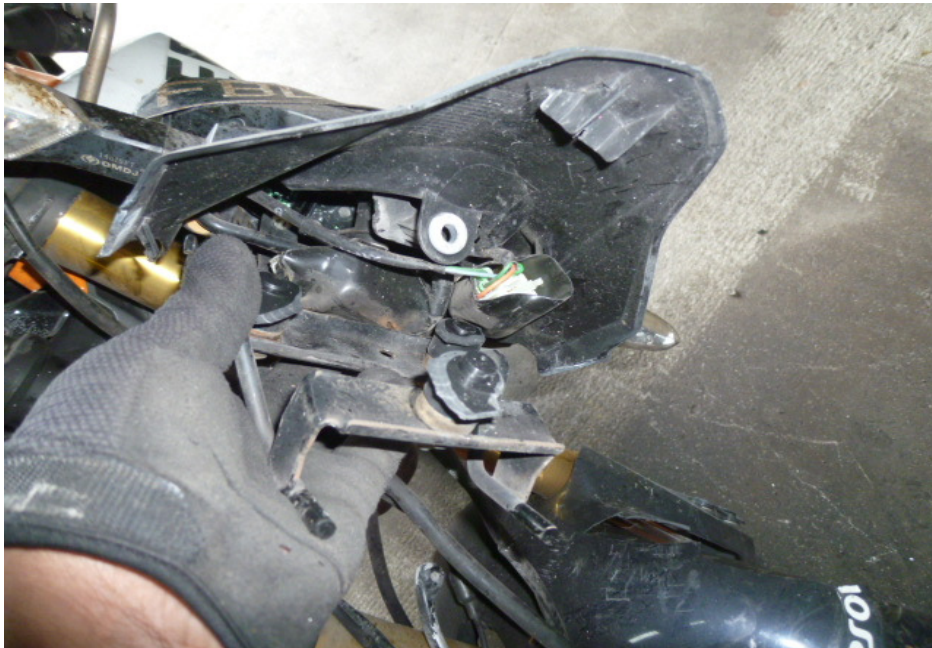
Photo 6 shows a closer view of the missing headlight assembly and head cowling which were amongst the body parts at the front body of the Motorcycle that had sustained damage as a result of the accident.

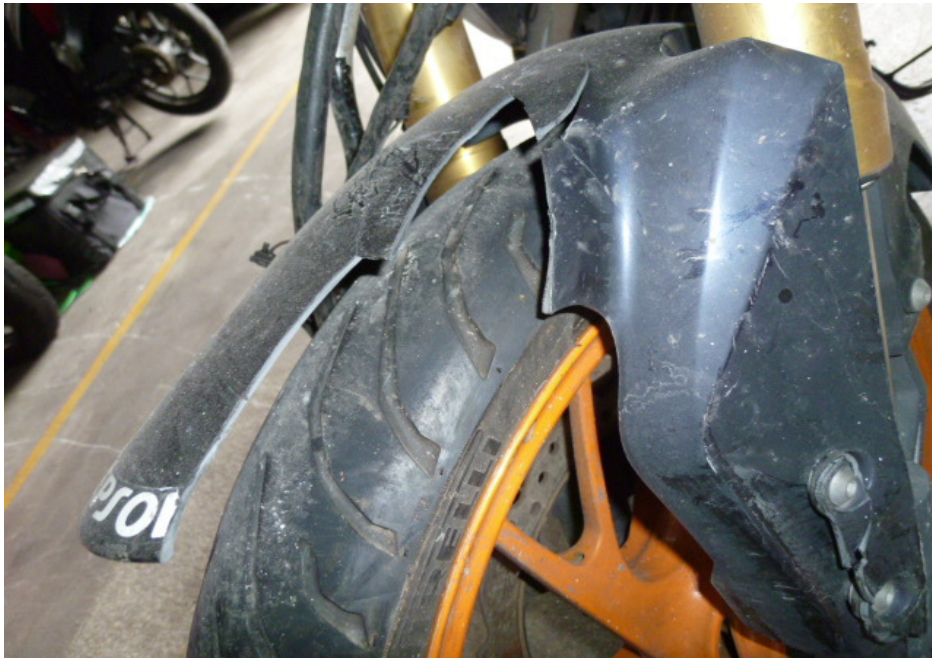
Photo 7 shows a close up view of the cracked front mudguard of the Motorcycle as a result of the accident.

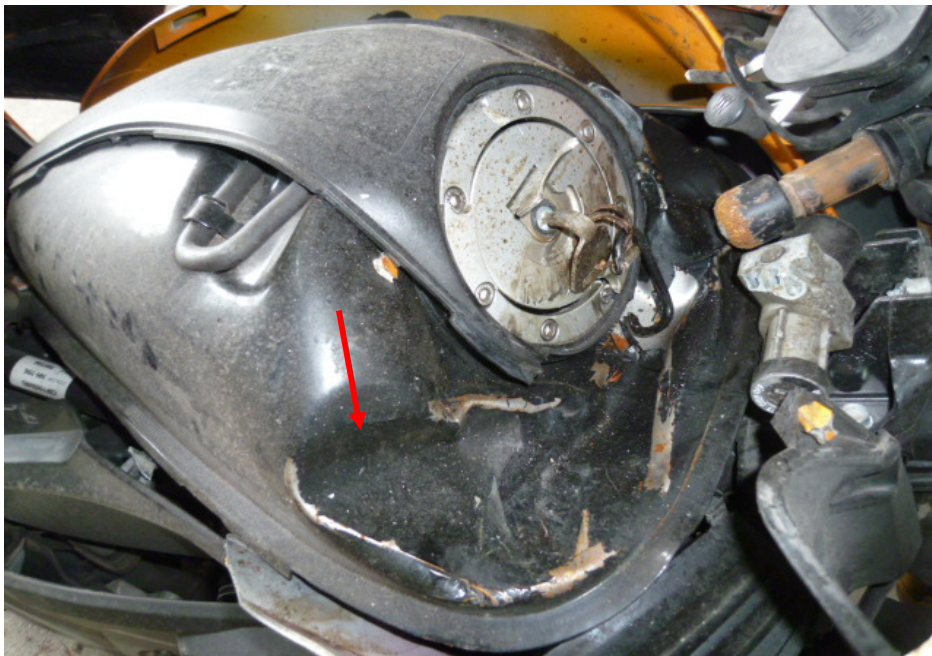
Photo 8 shows a closer view of the dented petrol tank of the Motorcycle as a result of the accident (arrowed).

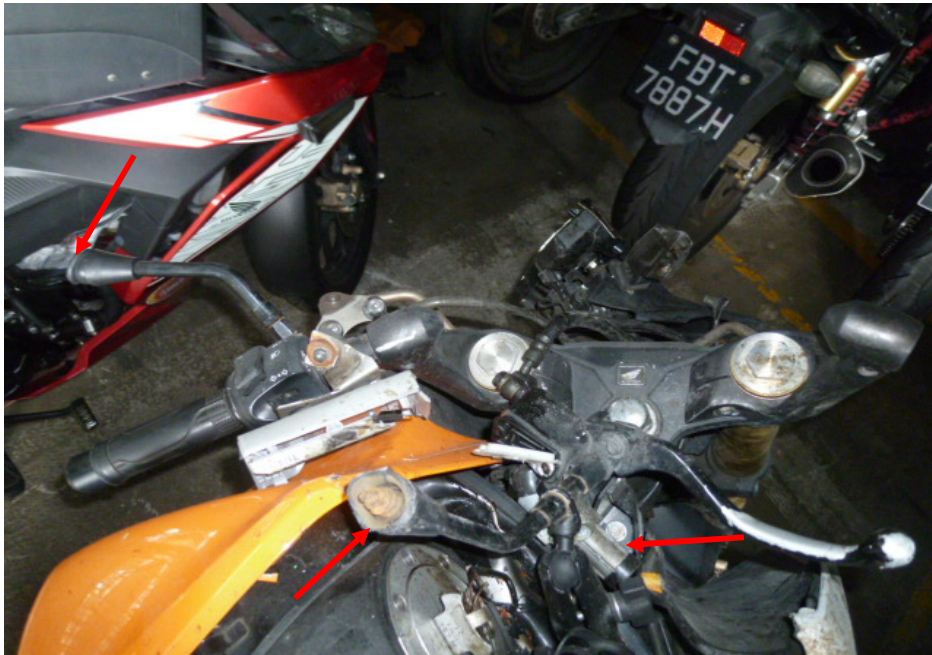
Photo 9 shows a closer view of the handlebars, side mirrors, front brake lever and side mirrors (arrowed) which were amongst the body parts of the Motorcycle that had sustained damage as a result of the accident.

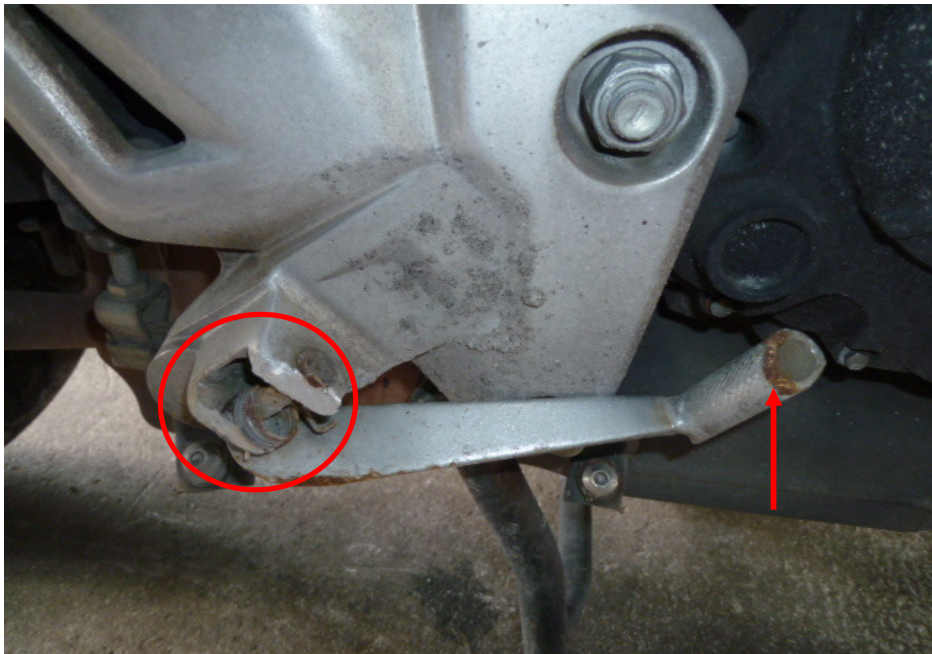
Photo 10 shows a closer view of the bent rear brake pedal (arrowed) and broken right front footrest (circled) which were amongst the body parts of the Motorcycle that had sustained damage as a result of the accident.

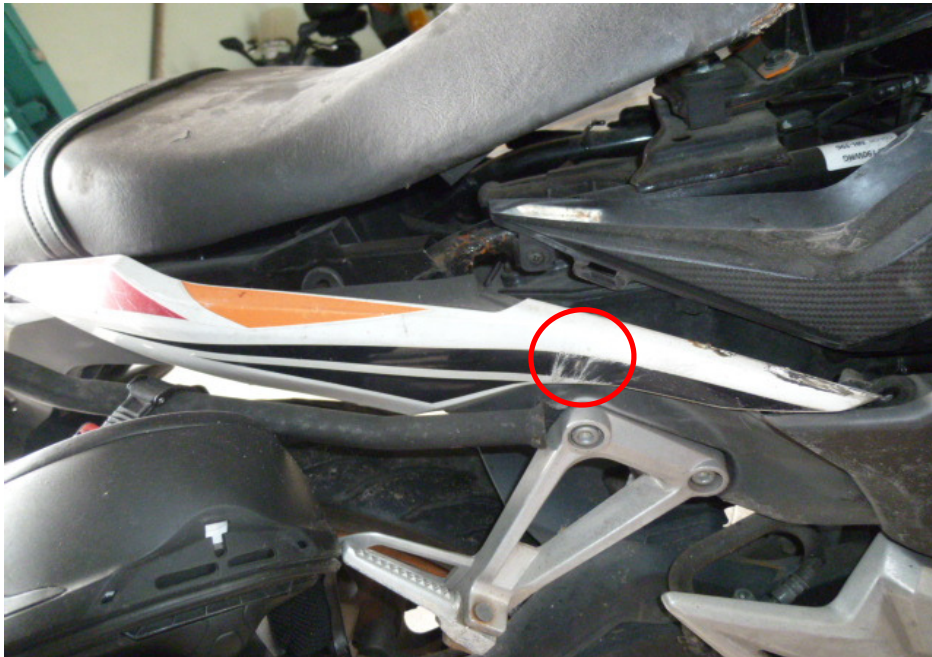
Photo 11 shows the right rear side cover of the Motorcycle which was amongst the body parts of the Motorcycle that had sustained damages of grazing nature as a result of the accident (circled).

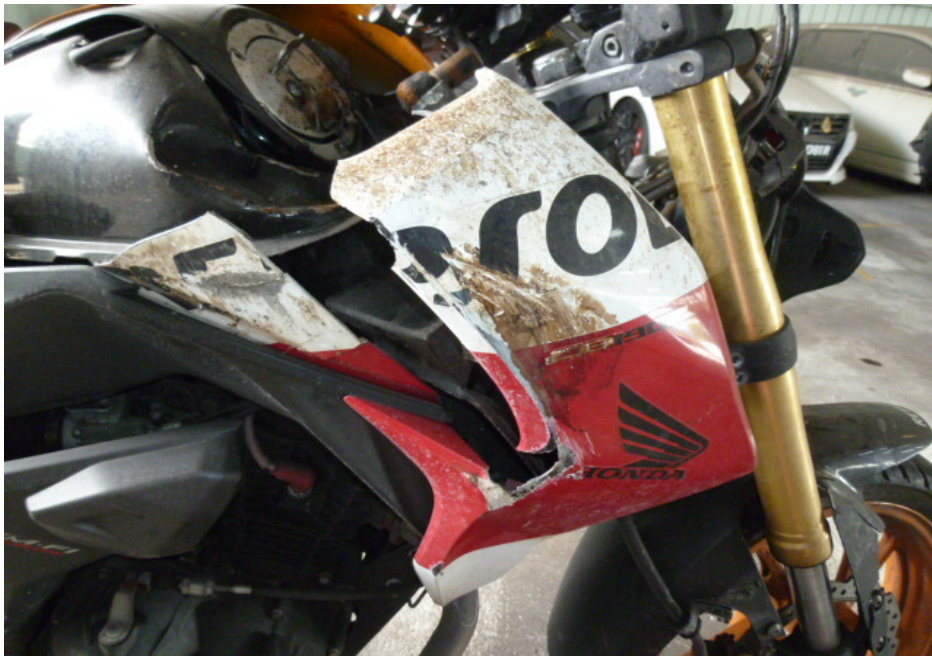
Photo 12 shows a closer view of the cracked right cowling of the Motorcycle as a result of the accident.

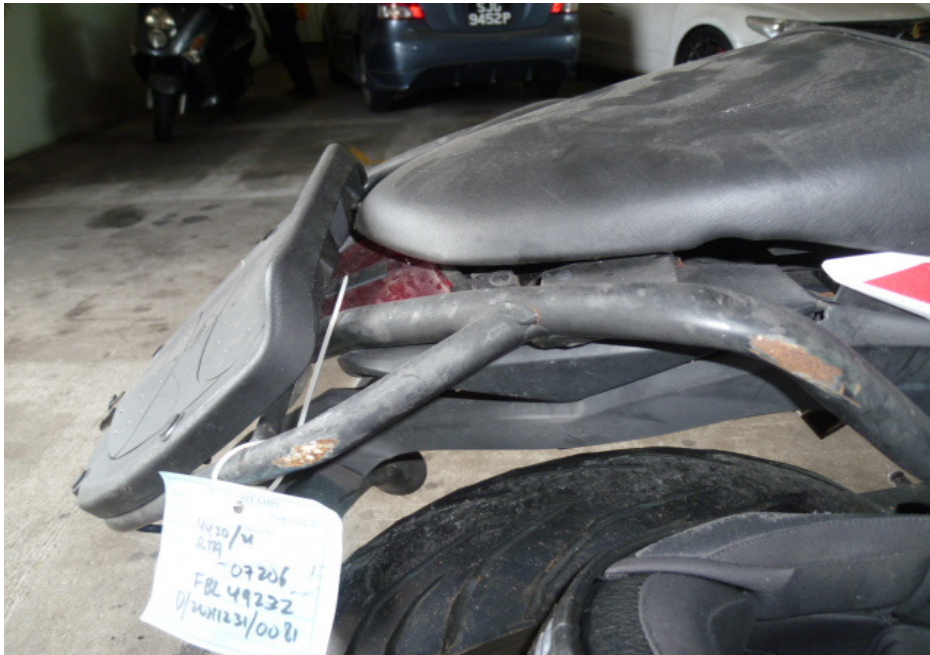
Photo 13 shows a closer view of the deformed top box rack of the Motorcycle as a result of the accident.

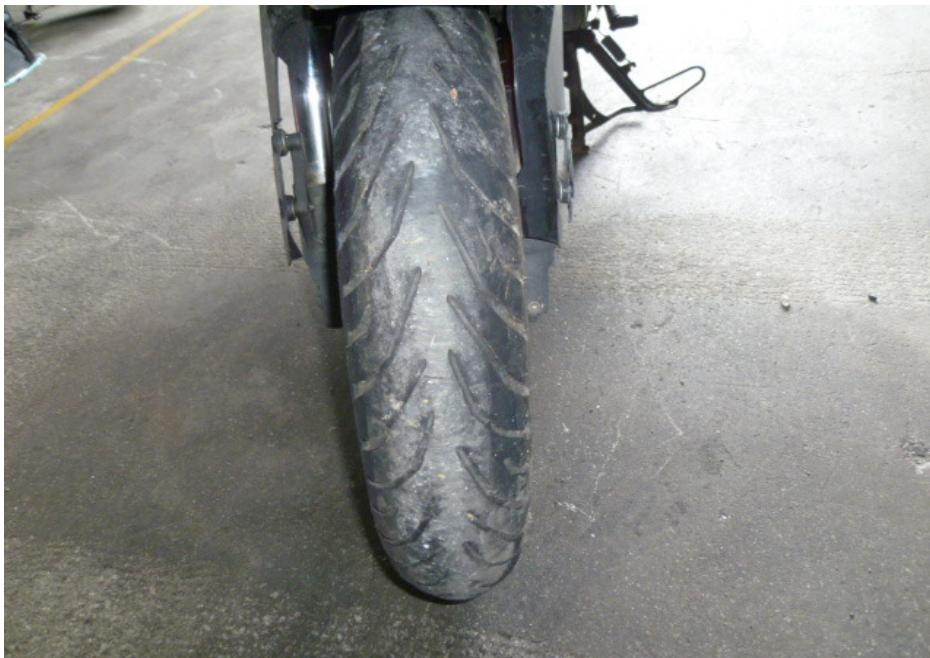
Photo 14 shows the condition of the Motorcycle's front tyre. The front tyre was observed to be in serviceable condition with remaining tread depth of approximately 3mm. There was no tear, burst mark(s) and/or punctured hole(s) on the sidewalls as well as across the tread of the front tyre.

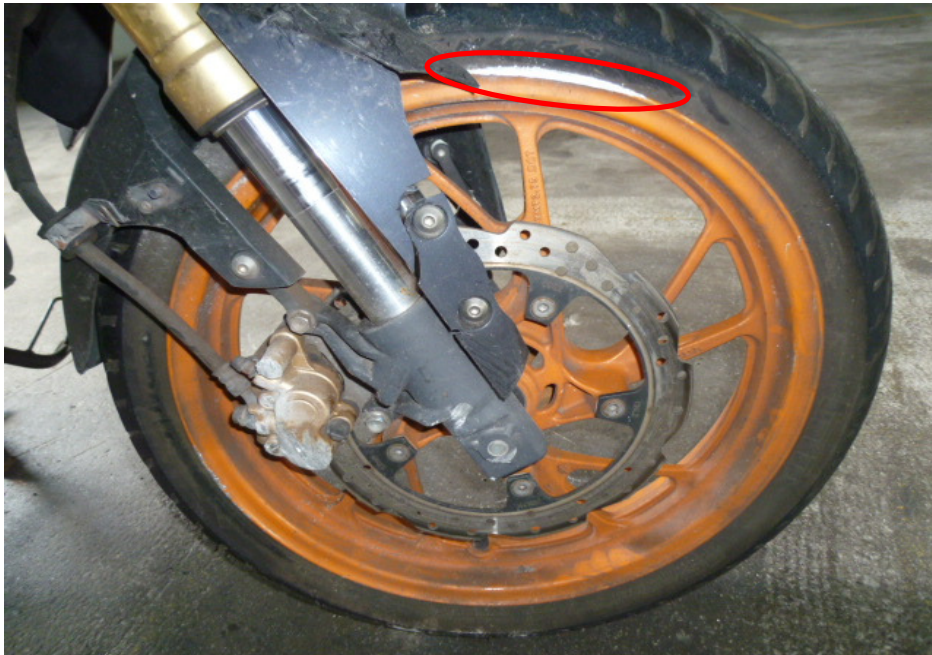
8. At the time of our inspection, we did not observe any visible damage on the rear wheel rim of the Motorcycle. We had however found some relatively minor marks of grazing nature on the edges of the front wheel rim, at the right side of the Motorcycle. See photos 1 – 16 below.

Photo 15 shows the front wheel rim of the Motorcycle at the time of our inspection. Some relatively minor marks of grazing nature were observed on the edges of the front wheel rim (circled), at the right side of the Motorcycle.

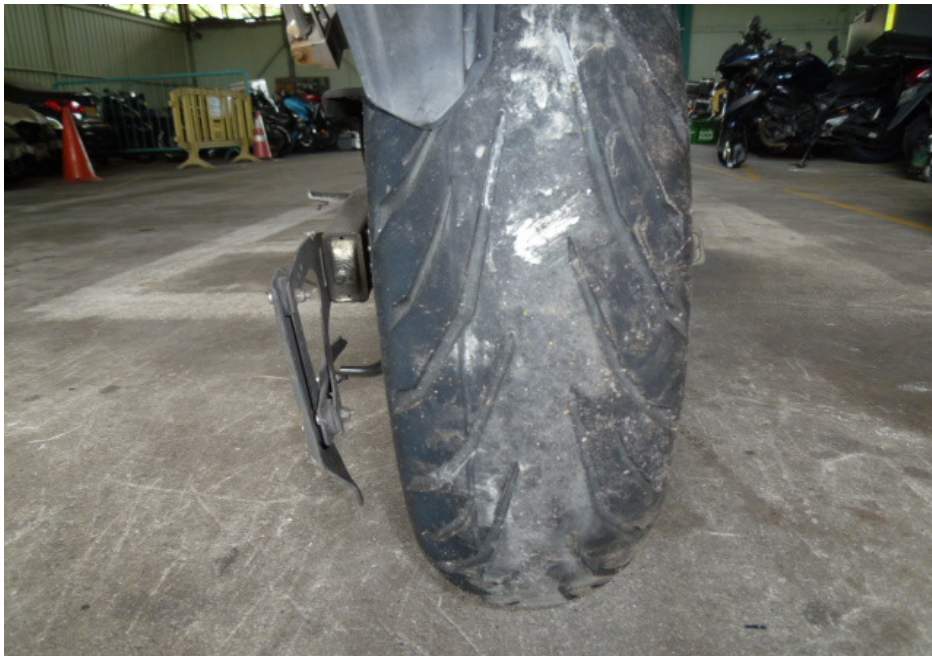
Photo 16 shows the condition of the Motorcycle's rear tyre. The rear tyre was observed to be in serviceable condition with remaining tread depth of approximately 4mm. The tyre was also observed to be sufficiently inflated for vehicular operation. We did not observe any tear, burst mark(s) and/or punctured hole(s) on the sidewalls as well as across the tread of the rear tyre.

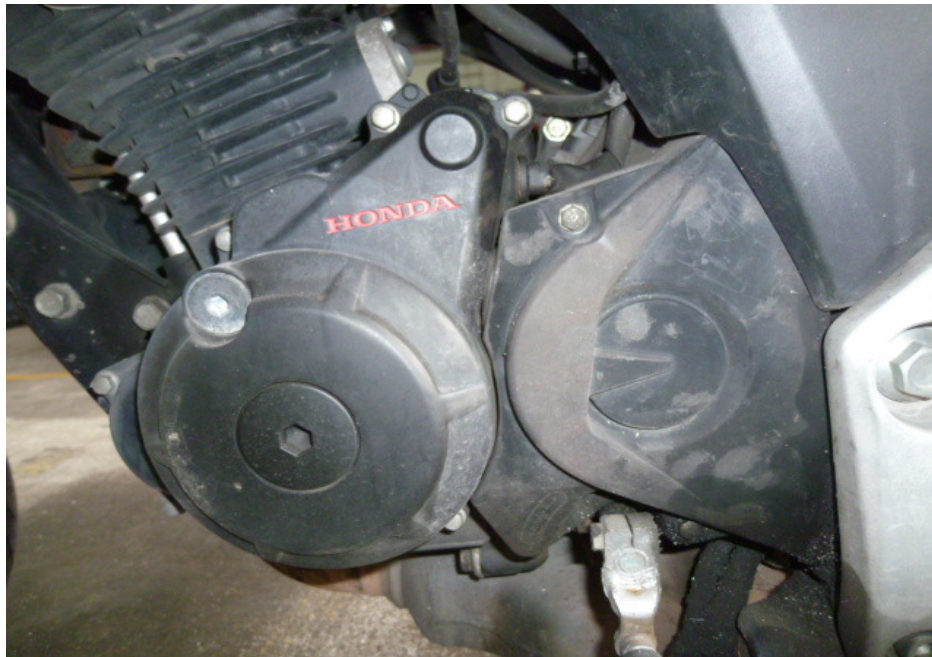
Photo 17 shows the left side of the engine of the Motorcycle at the time of our inspection. The various engine related parts and components were found to be intact with no visible damage. There was also no sign(s) or indication(s) of fluid leak observed around the left engine area of the Motorcycle.

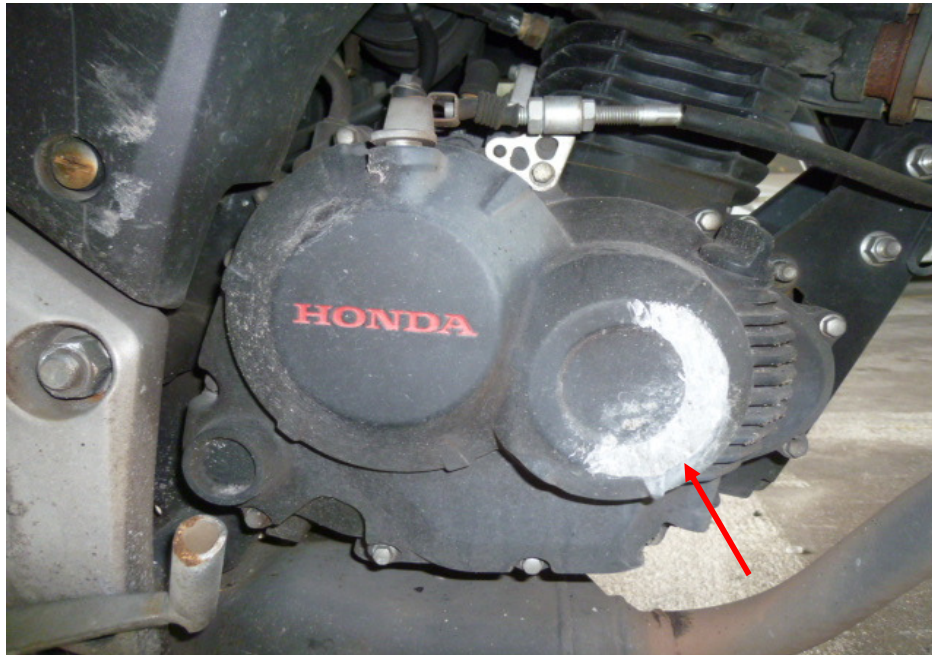
Photo 18 shows the right side of the engine of the Motorcycle at the time of our inspection. The various right engine components had sustained damage of grazing nature as a result of the accident (arrowed) however the engine components were still intact. There was also no fluid leak and/or fluid stain found around the right engine area of the Motorcycle.

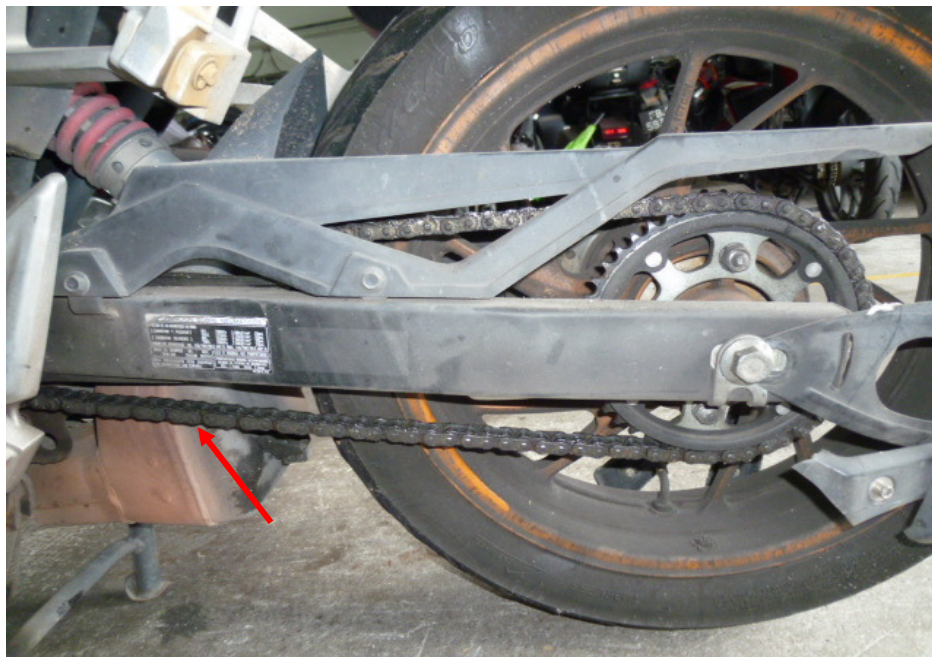
Photo 19 shows the general view of the gear train (arrowed) of the Motorcycle, which was observed to be intact with no misalignment. It was also adequately lubricated for operating purposes.

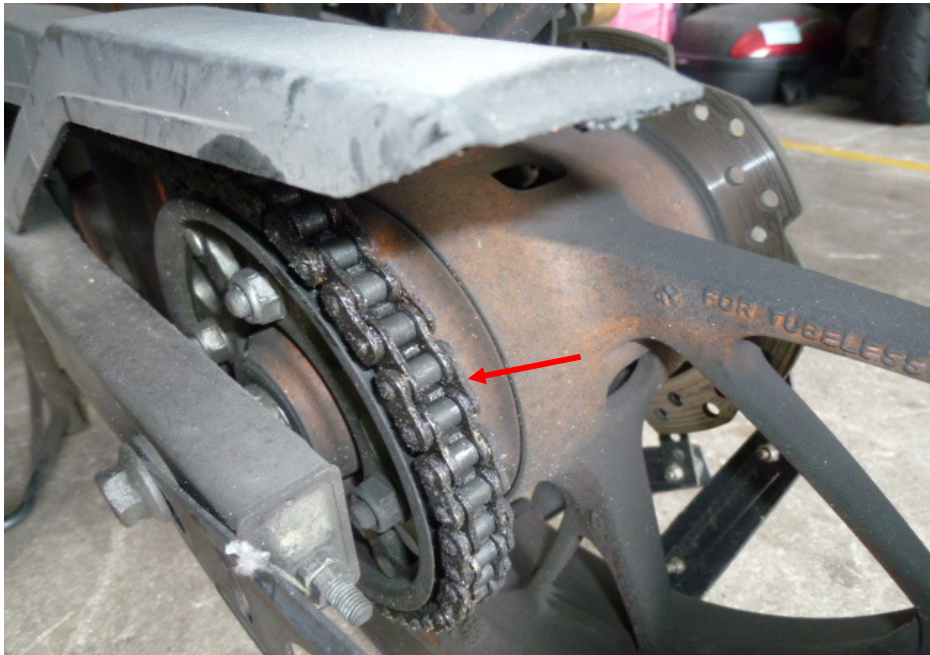
Photo 20 shows a closer view of the gear train (arrowed) of the Motorcycle, which was observed to be intact with no misalignment. It was also adequately lubricated for operating purposes.

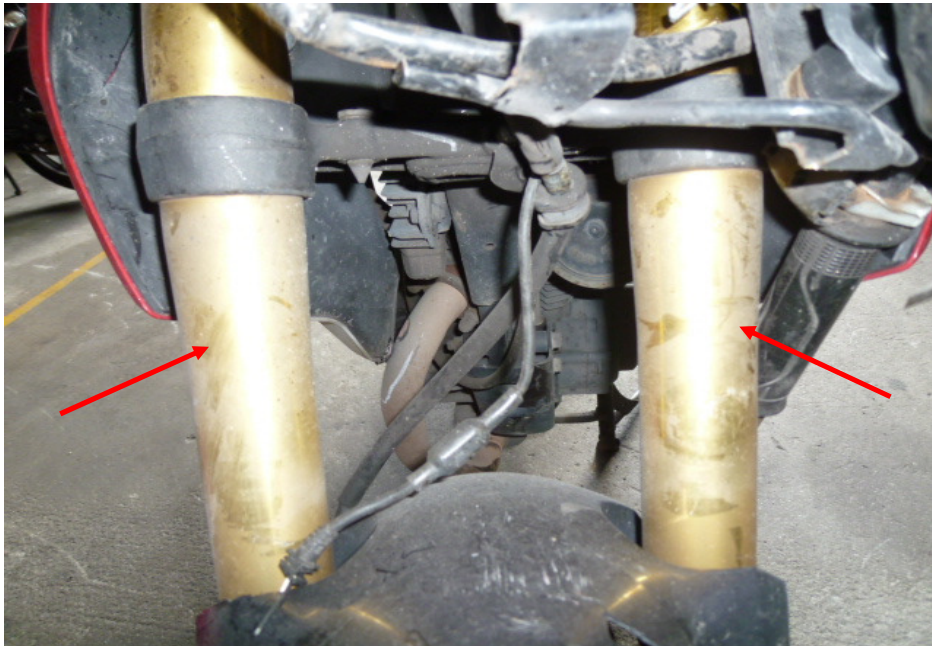
Photo 21 shows the front fork assembly (arrowed) of the Motorcycle. The front fork and fork bracket of the Motorcycle were both found to be intact and undamaged. Turning the Motorcycle's handle bar towards the left and right did not produce any abnormal free play and/or resistance. The steering system of the Motorcycle was in serviceable condition at the time of our inspection.

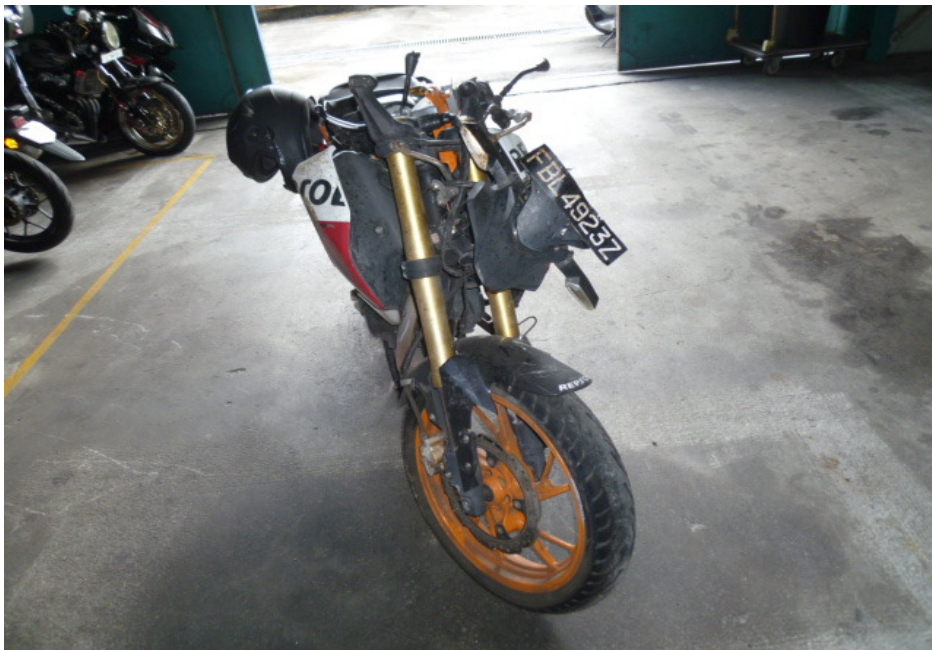
Photo 22 shows the front wheel of the Motorcycle turned towards its full left. Turning the Motorcycle's handle bar towards the left and right did not produce any abnormal free play and/or resistance. This would indicate that the steering system of the Motorcycle was in serviceable condition at the time of our inspection.

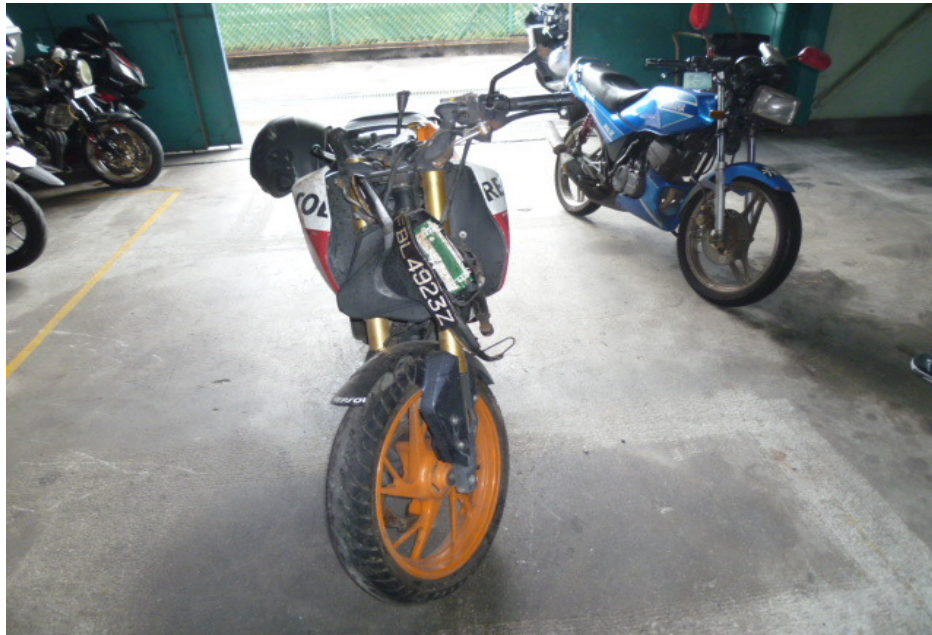
Photo 23 shows the front wheel of the Motorcycle turned towards its full right. Turning the Motorcycle's handle bar towards the left and right did not produce any abnormal free play and/or resistance. This would indicate that the steering system of the Motorcycle was in serviceable condition at the time of our inspection.

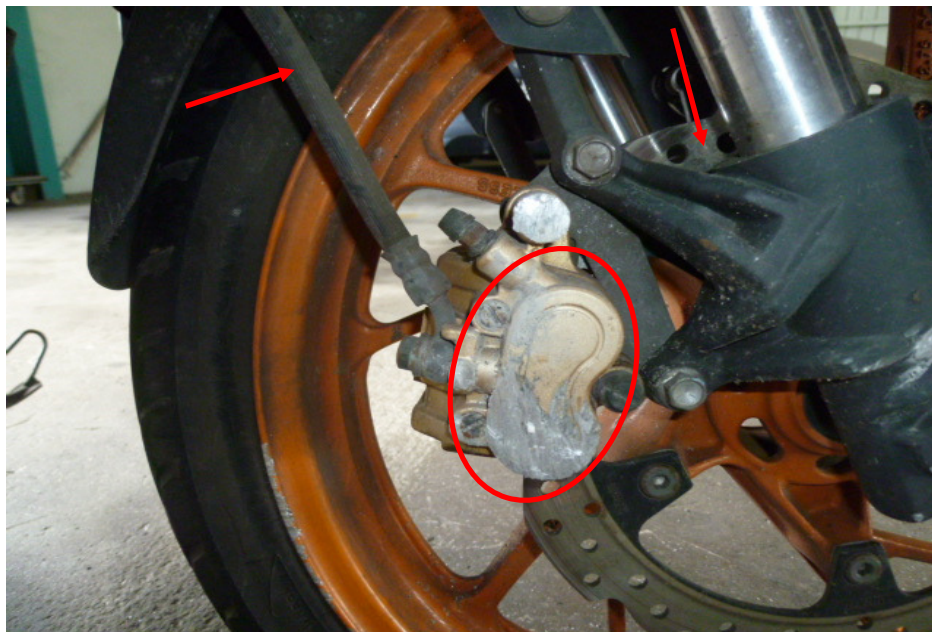
14. However we observed that the front brake caliper had sustained damages of grazing natures as a result of the accident. We also observed that the front brake clamp had broken off as a result of the accident. The front brake reservoir was also observed to be empty due to damages sustained as a result of the accident. Hence static as well as operational brake tests could not be conducted on the Motorcycle's front braking system. We were unable to determine if there was any leakage of pressure/vacuum in the front braking system.

Photo 24 shows a close up view of the front brake disc and front brake hose (arrowed) of the Motorcycle, which are all part of the components in the hydraulic front brake system of the Motorcycle. Our visual checks of these various components had revealed all to be intact with no visible damage. No leakage of brake fluid was also observed. However the front brake caliper had sustained damages of grazing nature as a result of the accident (circled).

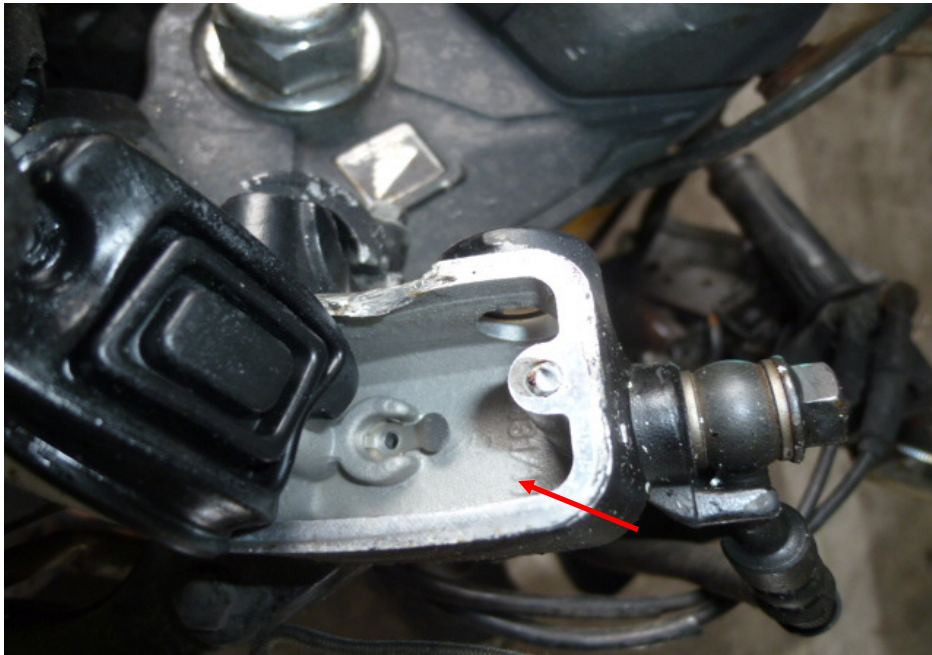
Photo 25 shows the brake fluid reservoir for the front brake of the Motorcycle. The front brake reservoir was observed to be empty (arrowed).

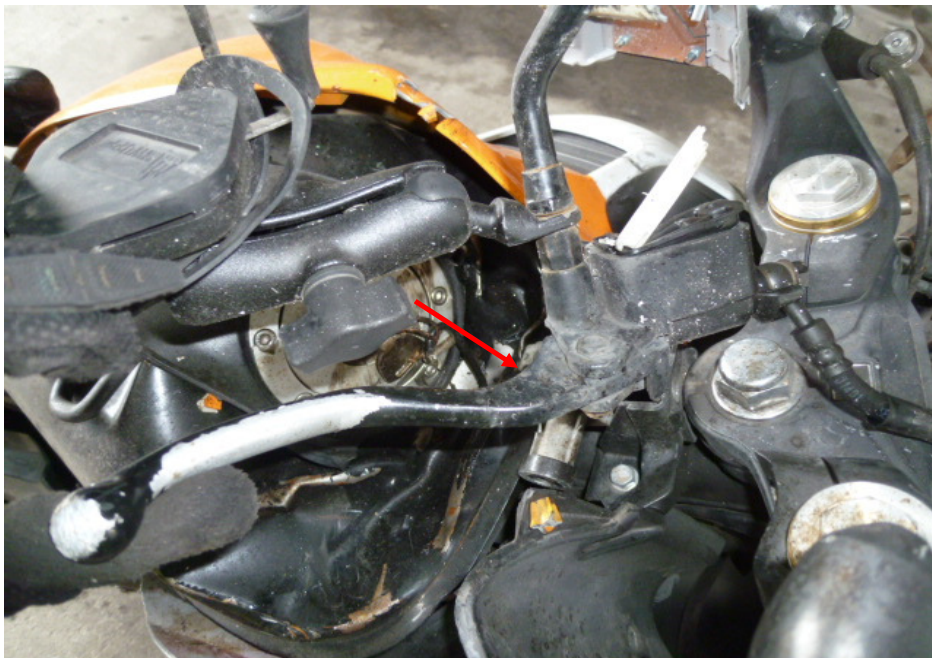
Photo 26 shows the front brake reservoir. We were unable to depress the front brake lever as the front brake clamp had broken off as a result of the accident (arrowed). Hence static as well as operational brake tests could not be conducted on the Motorcycle's front braking system. We were unable to determine if there was any leakage of pressure/vacuum in the front braking system.

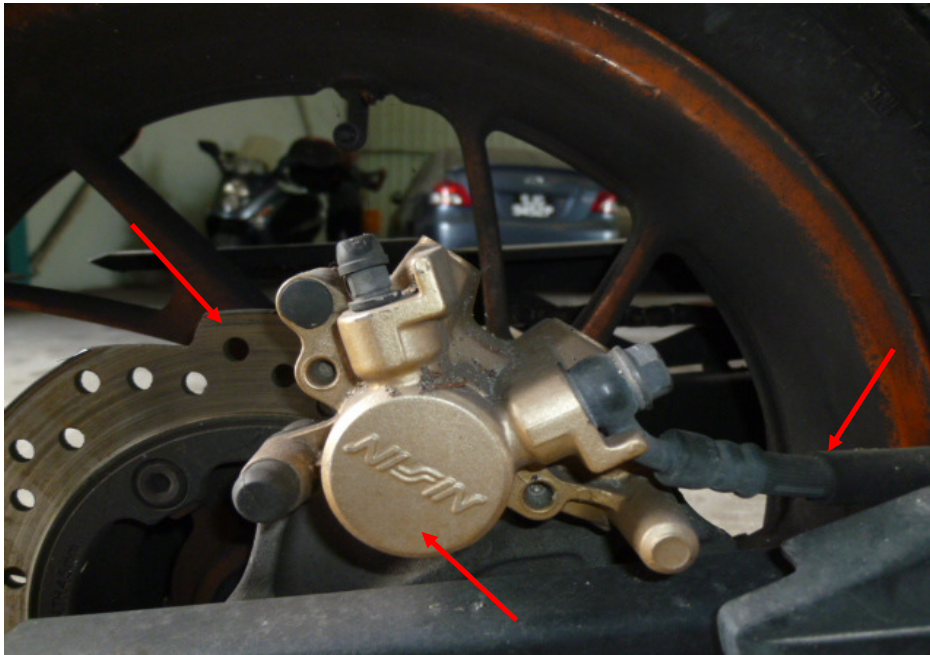
Photo 27 shows a close up view of the rear brake caliper, rear brake disc and rear brake hose (arrowed) of the Motorcycle, which are all part of the components in the hydraulic rear brake system of the Motorcycle. Our visual checks of these various components had revealed all to be intact with no visible damage. No leakage of brake fluid was also observed.

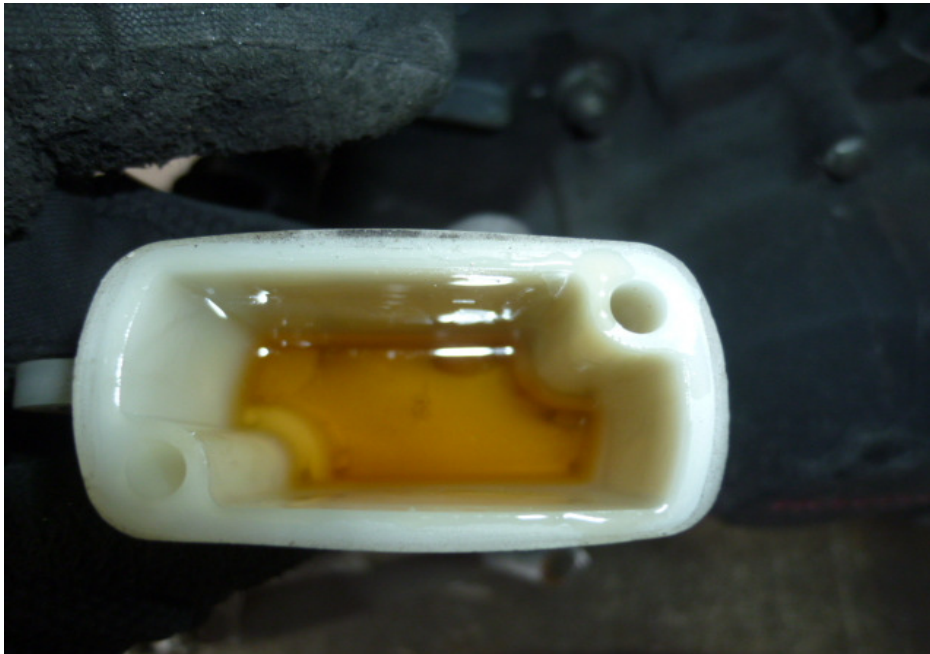
Photo 22 shows the brake fluid reservoir for the rear brake of the Motorcycle. The brake fluid was observed to be of sufficient level for operational purposes and without contamination.
