Your Ref: Porsche Macan GTS  
(chassis number WP1ZZZ95ZLLB60114)  
Our Ref : CI/TP22002092/D

07 March 2022

**INSPECTION REPORT OF AN UNREGISTERED PORSCHE MACAN GTS  
MOTOR CAR WITH CHASSIS NUMBER WP1ZZZ95ZLLB60114**

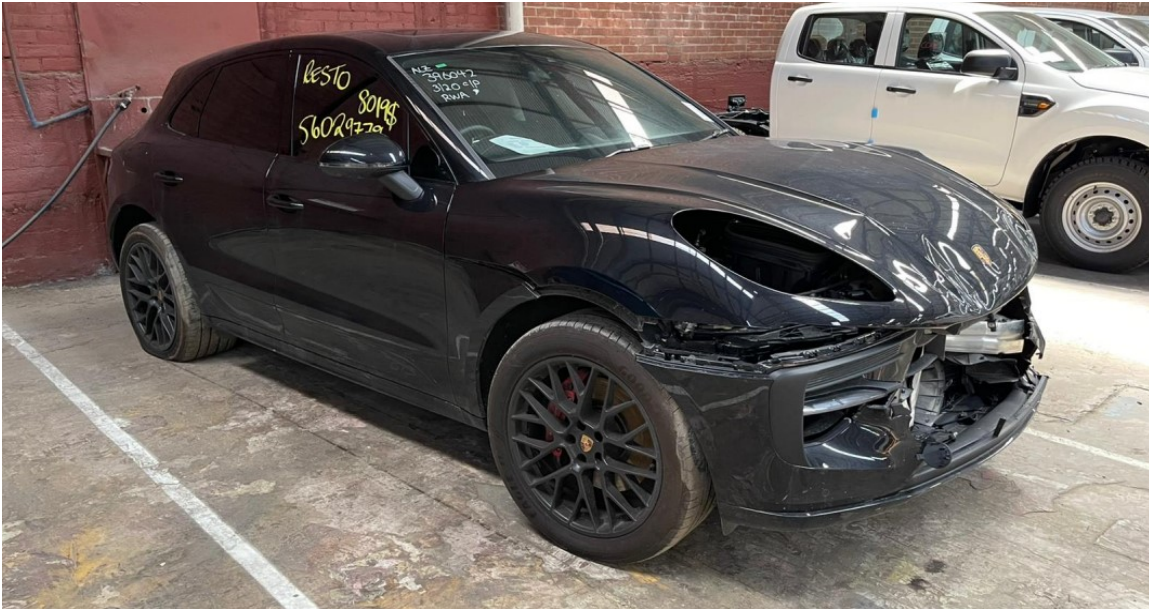
3. The photographs provided to me had showed damage to the Motor Car's frontal portion. Body parts damaged include the front bumper, front bumper centre lower grille, front bumper reinforcement, radiator grille, front bonnet, front bonnet locks, front number plate garnish, front sensor, front support panel, front support panel top garnish, aircon condenser and radiator amongst others. The front right headlamp was also observed to be damaged/dislodge/missing.
4. No physical damage was observed to other areas of the Motor Car. The airbag(s) of the Motor Car was not deployed as seen from the photographs that were provided to me. See photo 1 – 4 below.

**Photo 1** shows the front right body of the Motor Car (photograph provided to me). The Motor Car was observed to have sustained damage at its frontal portion. The front bumper, front bumper centre lower grille, front bumper reinforcement, radiator grille, front bonnet, front bonnet locks, front number plate garnish, front sensor, front support panel, front support panel top garnish, aircon condenser and radiator were amongst the body parts that were observed to have been damaged. The front right headlamp was also observed to be damaged/dislodge/missing.

22. The body parts at the frontal portion of the Motor Car were visually examined and it was noted that the repair/restoration works carried out to the damaged area of the Motor Car (refer to photograph 1 above) were reasonably adequate and in order.

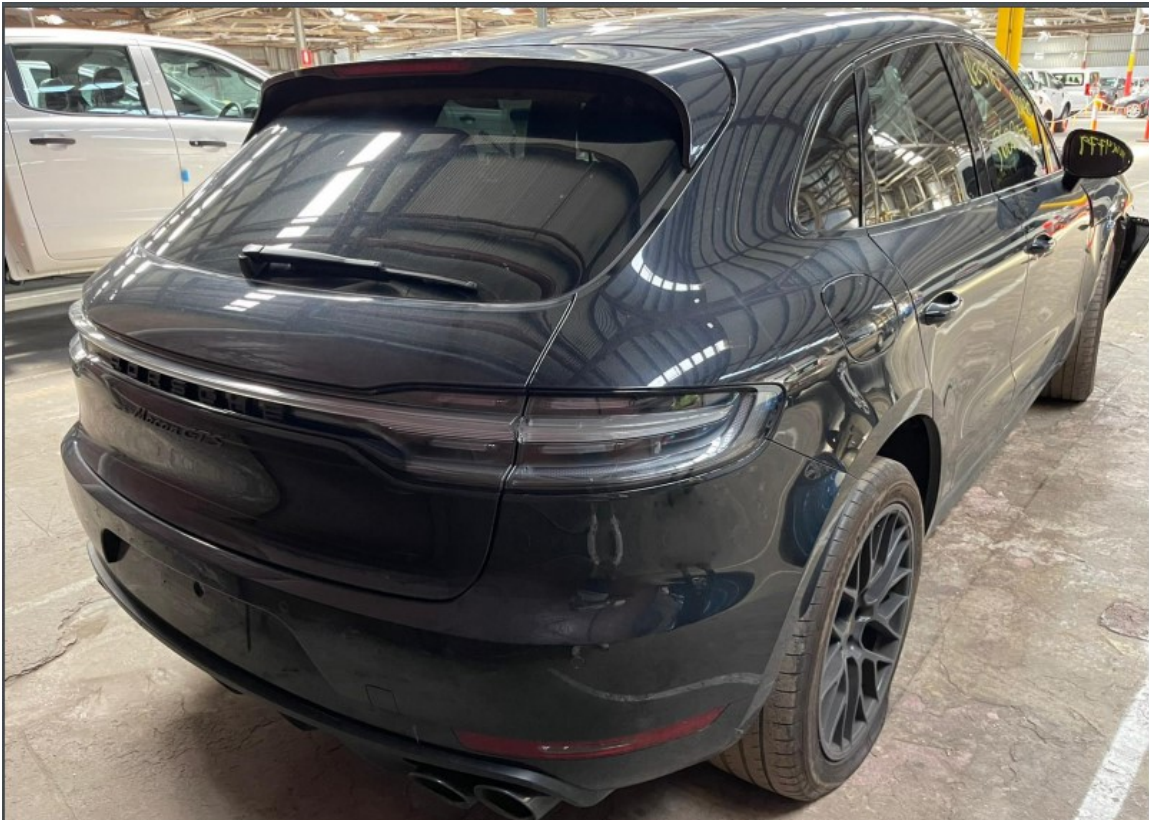
**Photo 2** shows the rear right body of the Motor Car (photograph provided to me). Apart for the frontal portion, there was no physical damage observed to other areas of the Motor Car.

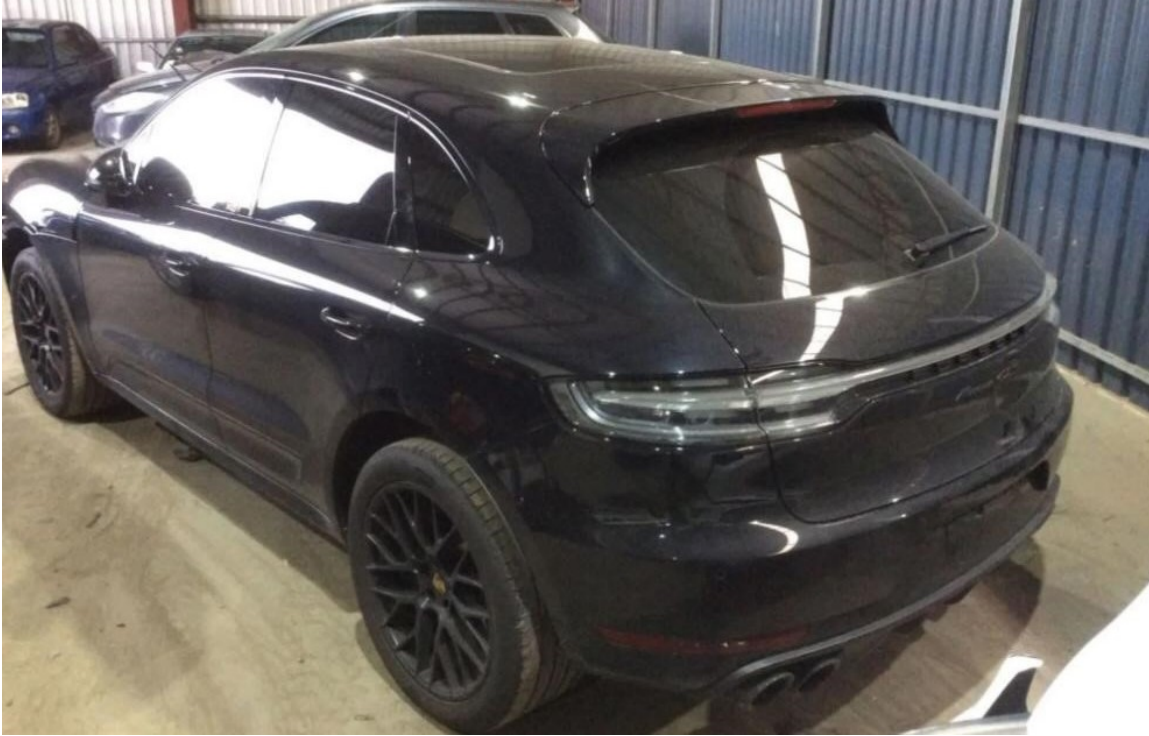
**Photo 3** shows the rear left body of the Motor Car (photograph provided to me). Apart for the frontal portion, there was no physical damage observed to other areas of the Motor Car.

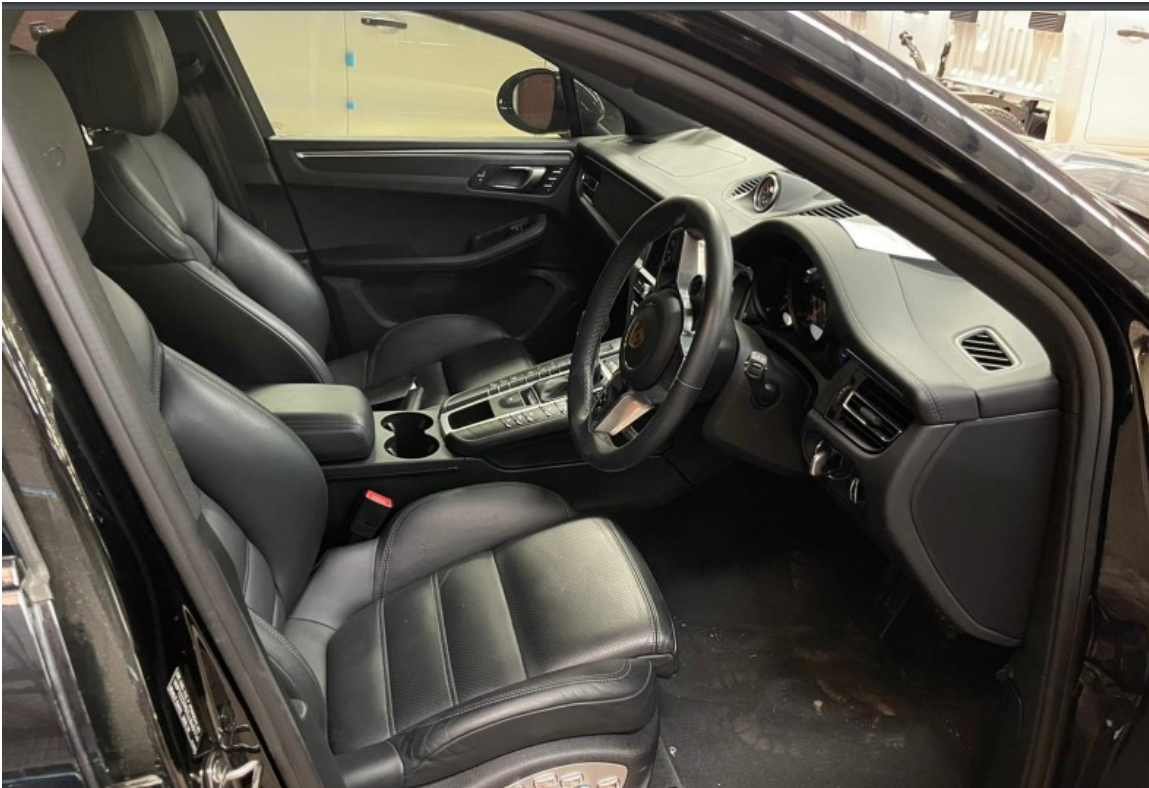
**Photo 4** shows the interior compartment of the Motor Car (photograph provided to me). The various parts and components within the interior compartment were all intact and unaffected. The airbag(s) was not deployed as seen from the photographs that were provided to me.

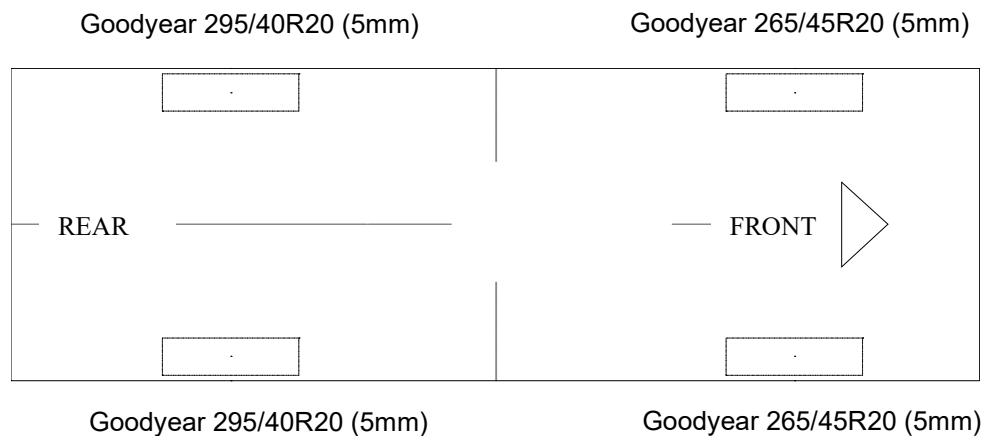
8. It was fitted with 20inch sport wheel rims that were wrapped with tyres that were observed to be of serviceable condition. The tyres were also sufficiently inflated for vehicular operation. The tyre brand, tyre size and approximate remaining tread depth of the 4 tyres of the Motor Car were recorded as follows: -

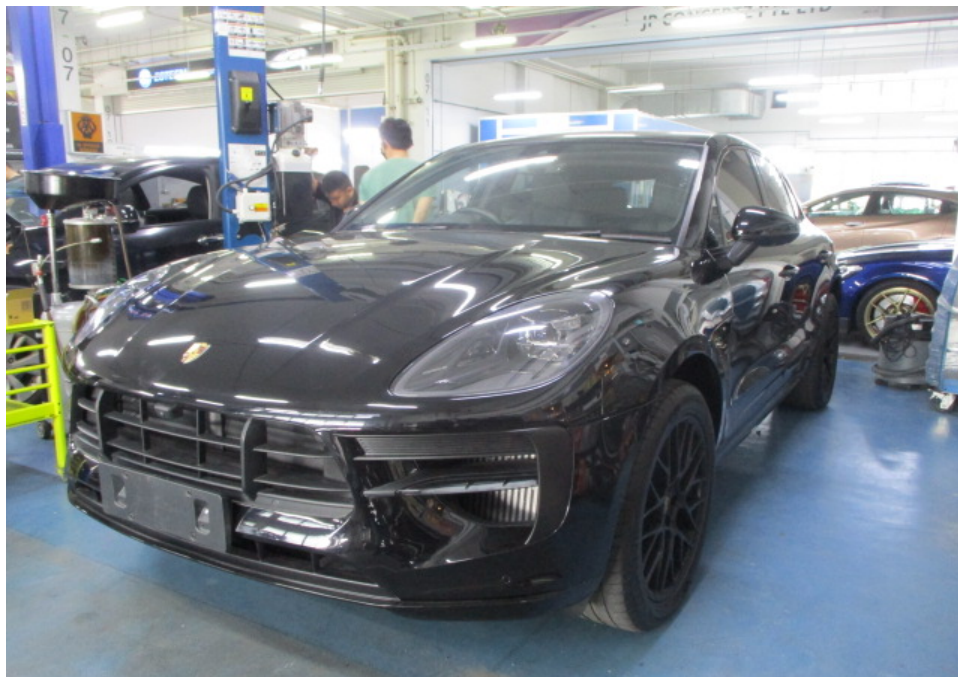
**Photo 5** shows a general view of the front left body of the Motor Car at the time of my inspection. The Motor Car was observed to be in a relatively good general condition with no loose exterior fittings observed. The body parts at the frontal portion of the Motor Car were visually examined and it was observed that the repair/restoration works carried out to the damaged area of the Motor Car (refer to photograph 1 above) were reasonably adequate and in order.

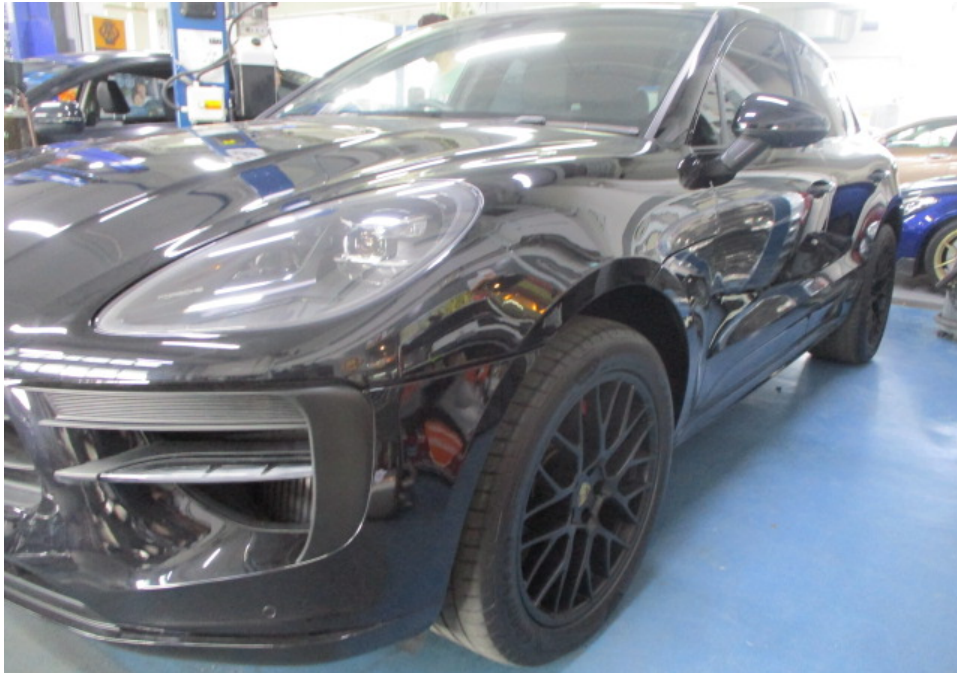
**Photo 6** shows a closer view of the Motor Car's front bonnet, front left headlamp, front left wheel rim, front bumper left grille and front left day light. The body parts at the frontal portion of the Motor Car were visually examined and it was observed that the repair/restoration works carried out to the damaged area of the Motor Car (refer to photograph 1 above) were reasonably adequate and in order.

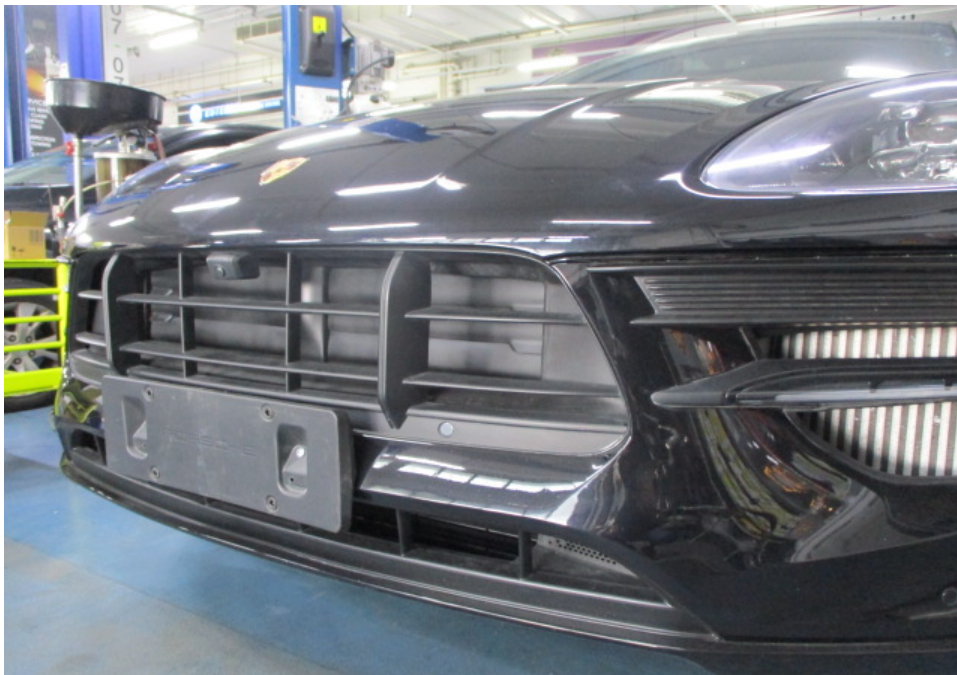
**Photo 7** shows a closer view of the Motor Car's front bumper, front bumper centre lower grille, radiator grille, and front number plate garnish. The body parts at the frontal portion of the Motor Car were visually examined and it was observed that the repair/restoration works carried out to the damaged area of the Motor Car (refer to photograph 1 above) were reasonably adequate and in order.

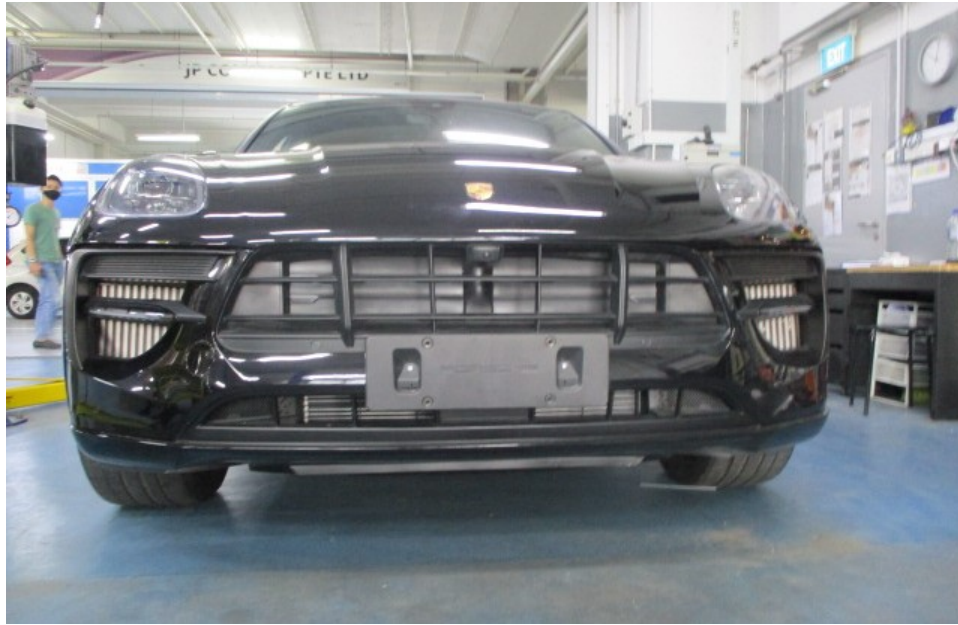
**Photo 8** shows a general view of the frontal body of the Motor Car at the time of my inspection. The Motor Car was observed to be in a relatively good general condition with no loose exterior fittings observed. The body parts at the frontal portion of the Motor Car were visually examined and it was observed that the repair/restoration works carried out to the damaged area of the Motor Car (refer to photograph 1 above) were reasonably adequate and in order.

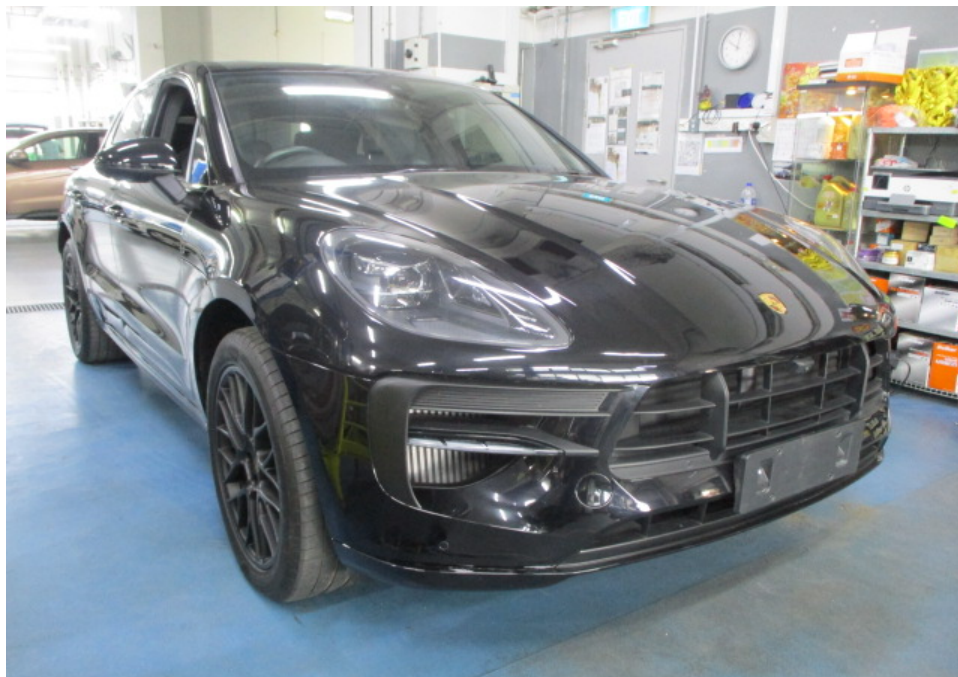
**Photo 9** shows a general view of the front right body of the Motor Car at the time of my inspection. The Motor Car was observed to be in a relatively good general condition with no loose exterior fittings observed. The body parts at the frontal portion of the Motor Car were visually examined and it was observed that the repair/restoration works carried out to the damaged area of the Motor Car (refer to photograph 1 above) were reasonably adequate and in order.

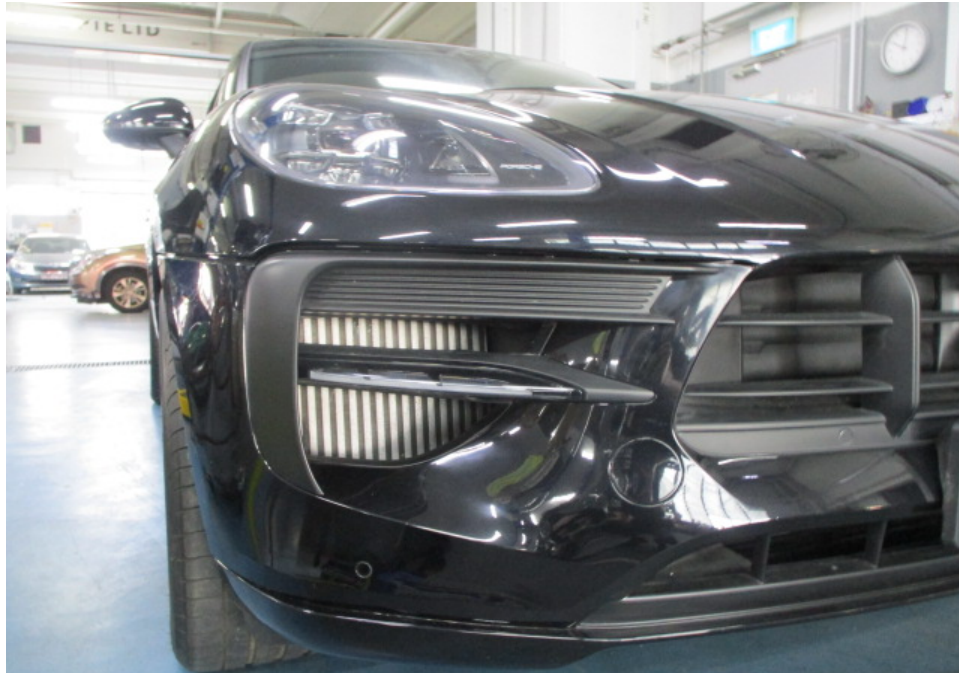
**Photo 10** shows a closer view of the Motor Car's front bumper, front bumper front bumper right grille, front right day light and front right headlamp. The body parts at the frontal portion of the Motor Car were visually examined and it was observed that the repair/restoration works carried out to the damaged area of the Motor Car (refer to photograph 1 above) were reasonably adequate and in order.

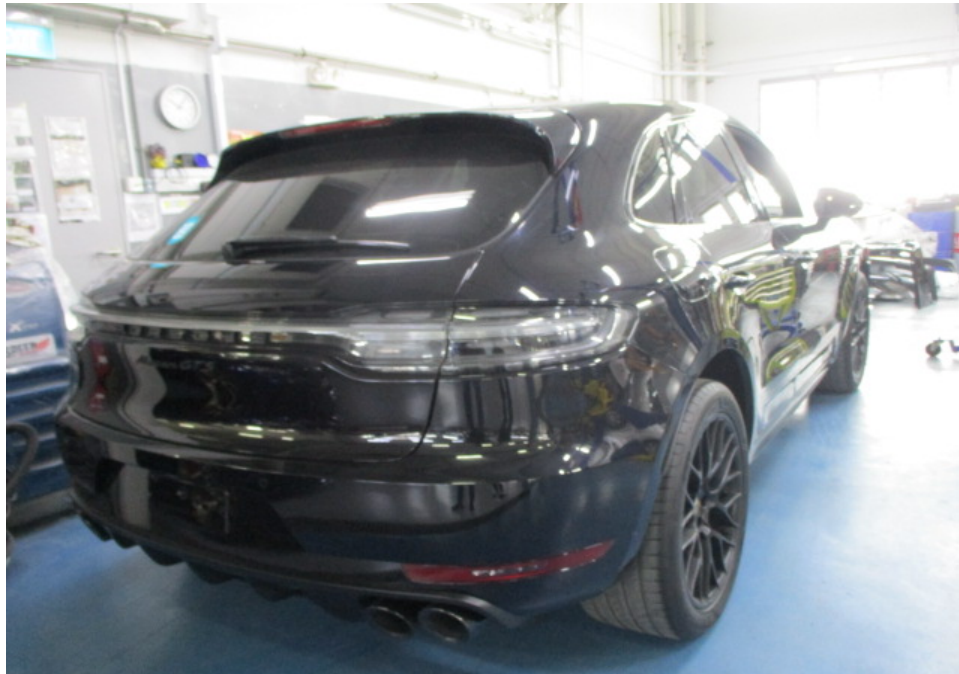
**Photo 11** shows a general view of the rear right body of the Motor Car at the time of my inspection. The Motor Car was observed to be in a relatively good general condition with no loose exterior fittings observed. The mileage of the Motor Car recorded at the time of my inspection was 20,028km.

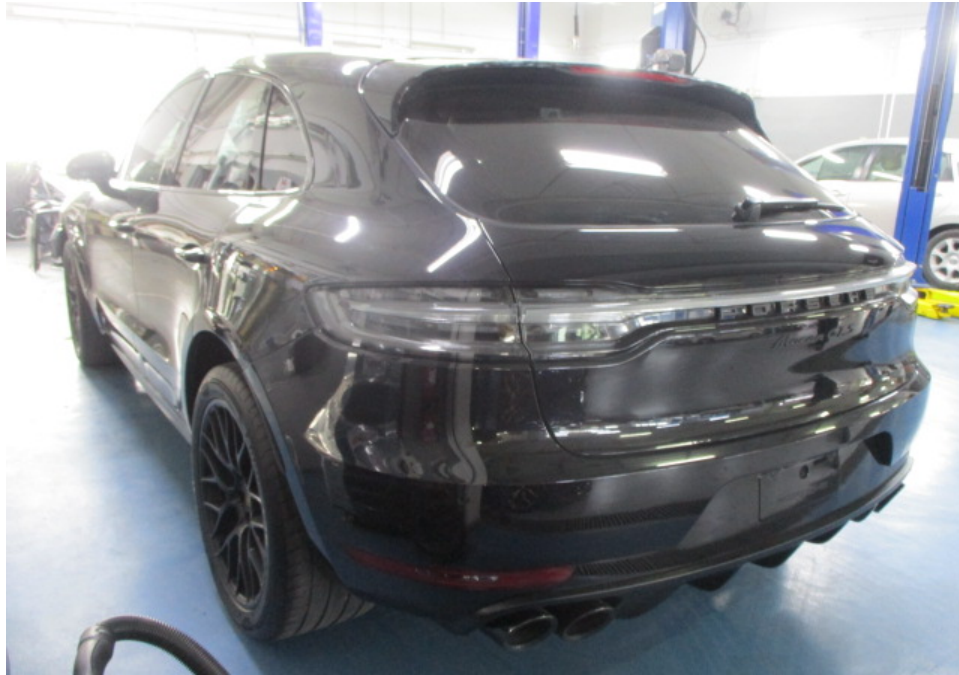
**Photo 12** shows a general view of the rear left body of the Motor Car at the time of my inspection. The Motor Car was observed to be in a relatively good general condition with no loose exterior fittings observed. The mileage of the Motor Car recorded at the time of my inspection was 20,028km.

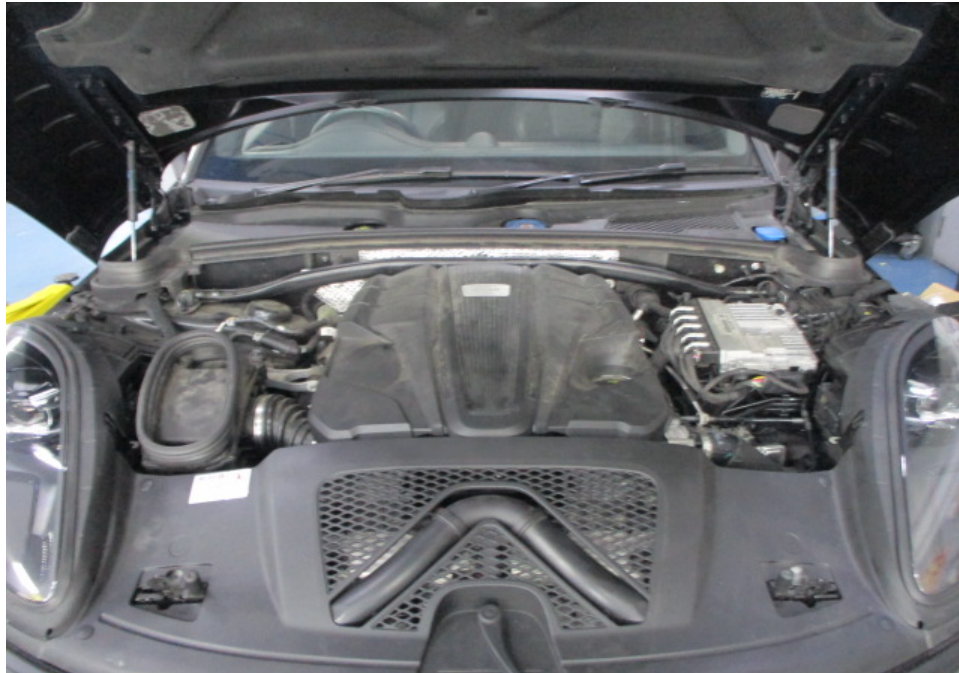
**Photo 14** shows a general view of the engine compartment of the Motor Car at the time of my inspection. The various parts and components inside the engine compartment were all observed to be intact and properly fitted. There was also no sign(s) or indication(s) of fluid leak and/or fluid stain found inside the engine compartment. The repair/restoration works carried out to the various parts within the engine compartment like the front bonnet locks, front support panel, front support panel top garnish, aircon condenser and radiator amongst others were reasonably adequate and in order.

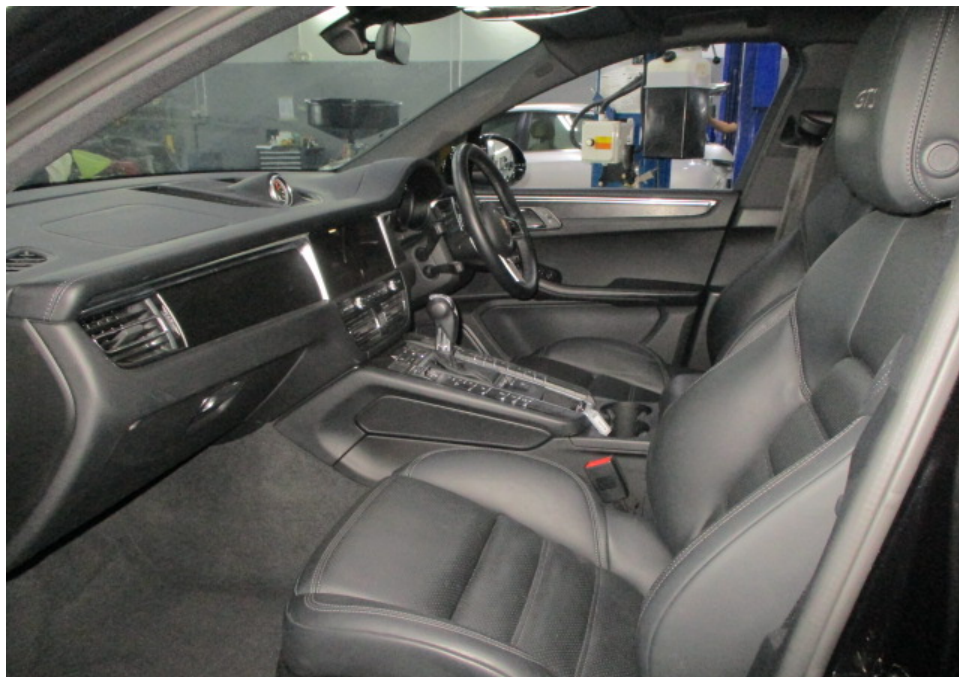
**Photo 15** shows the interior compartment of the Motor Car. The front dashboard, steering wheel, seats, upholstery and trims etc were all observed to be intact and properly fitted.

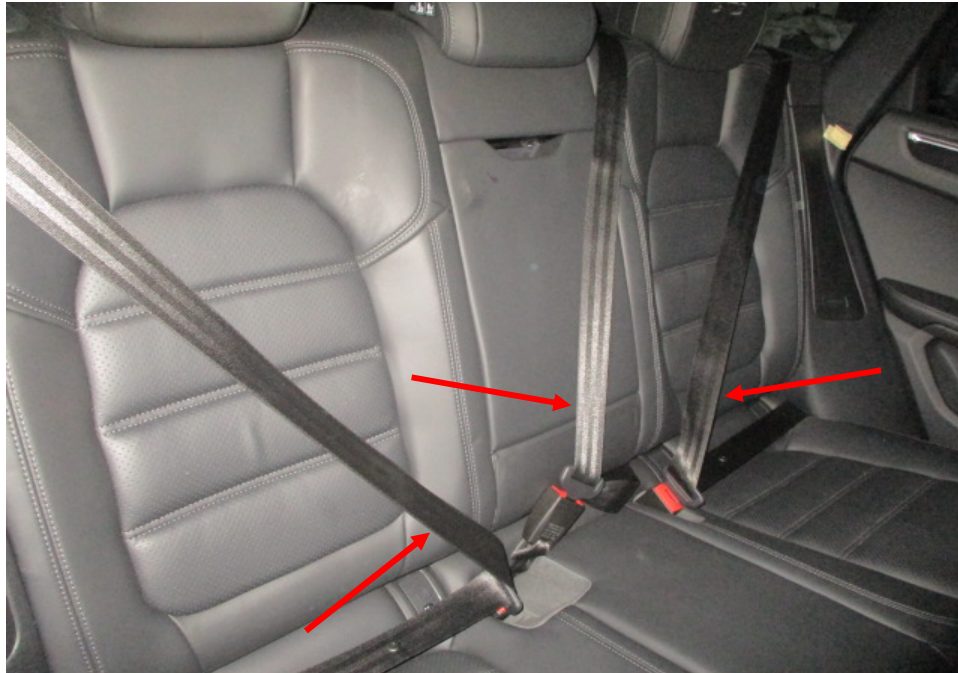
**Photo 16** shows the rear seats of the Motor Car. All the seats of the Motor Car were secured via seat rails to the floorboard. They were also fitted with a retractable seat belt reel and a pre-tensioner. The seat belts (arrowed) were tested and were able to be fastened into the respective pre-tensions that were fitted on the side of each individual seat.

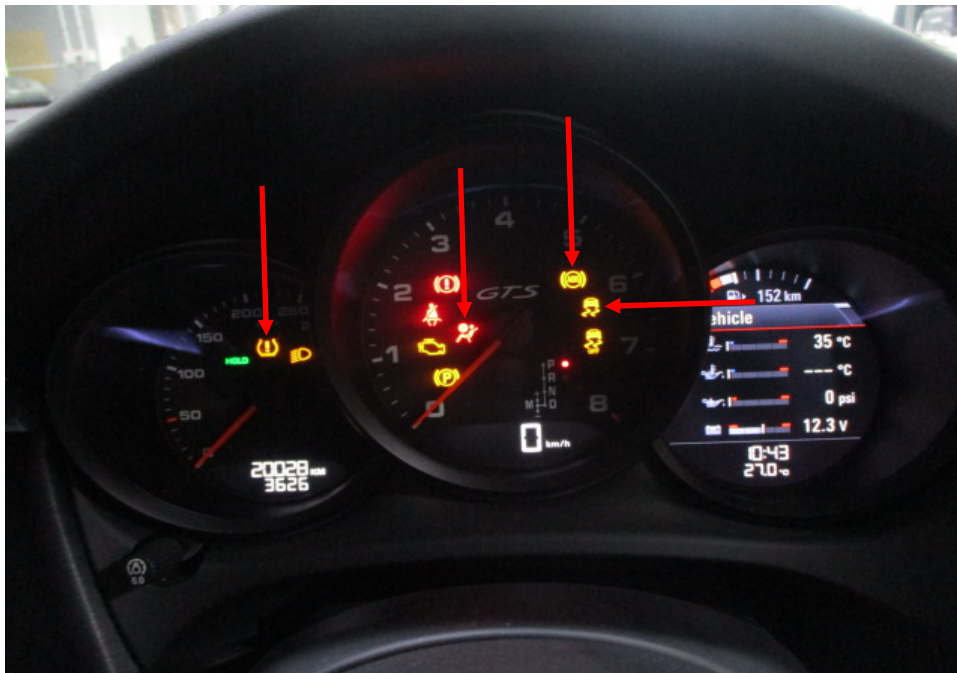
**Photo 17** shows the warning lights for the various electronic safety features appearing on the instrument panel of the Motor Car during its self-test when the engine is cranked, in particular the ABS, SRS, TPM and TCS lights (arrowed).

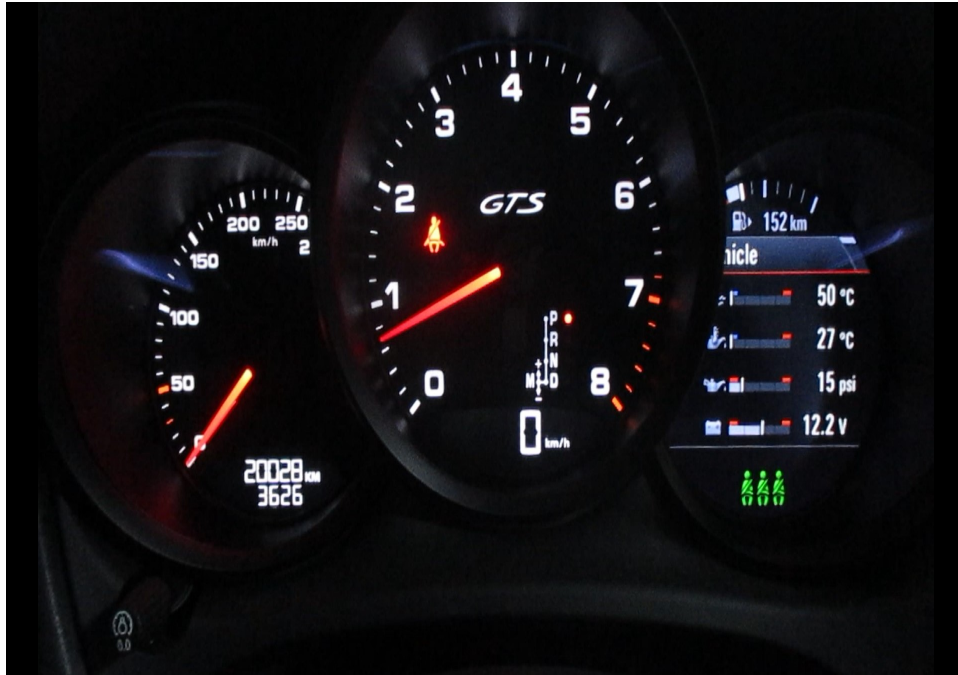
**Photo 18** shows the respective warning lights no longer illuminated, indicating that there is no fault detected to the ABS, SRS, TPM and TCS systems of the Motor Car during the self-test. These electronic systems were hence in working condition at the time of my inspection.

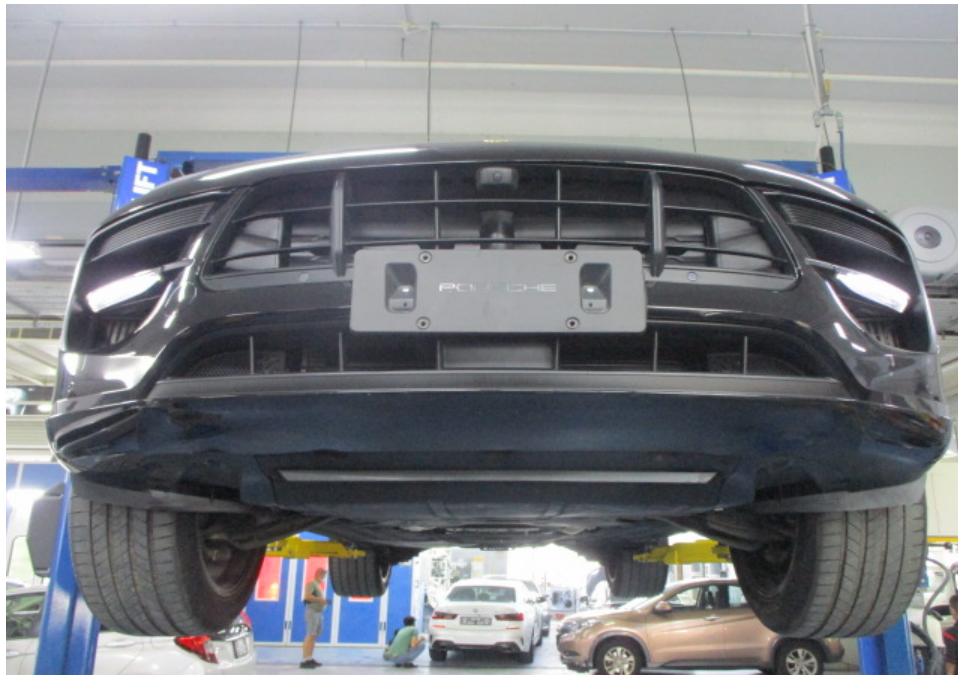
**Photo 19** shows the Motor Car hoisted up for checks on its undercarriage. There was no sign(s) or indication(s) of fluid leakage and/or fluid stain(s) on the underside of the Motor Car. The undercarriage components of the Motor Car were also all observed to be intact and secured in an appropriate manner.

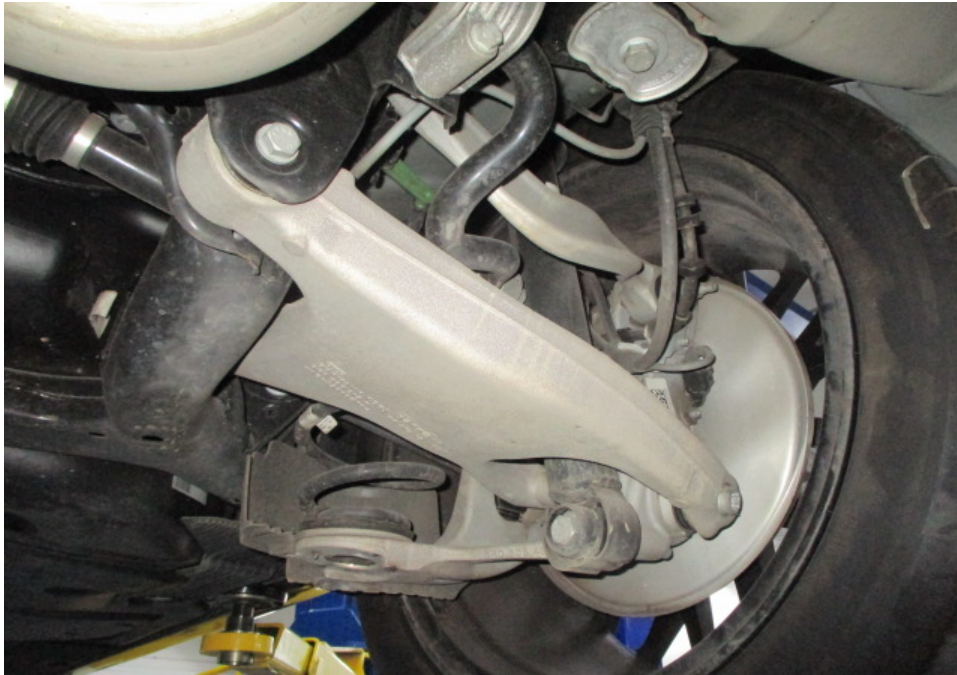
**Photo 20** shows a general view of the control arms and linkages at the rear right wheel of the Motor Car. I did not observe any fluid leak and/or fluid stain on the underside of the Motor Car. All of the Motor Car's undercarriage components were observed to be intact and secured in an appropriate manner.

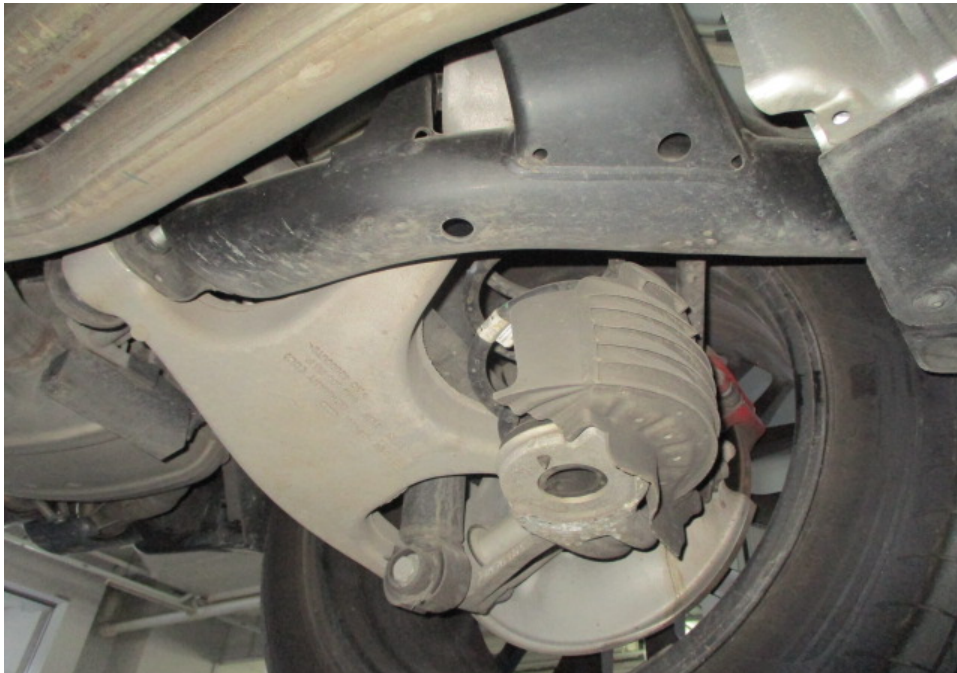
**Photo 21** shows a general view of the control arms and linkages at the rear left wheel of the Motor Car. I did not observe any fluid leak and/or fluid stain on the underside of the Motor Car. All of the Motor Car's undercarriage components were observed to be intact and secured in an appropriate manner.

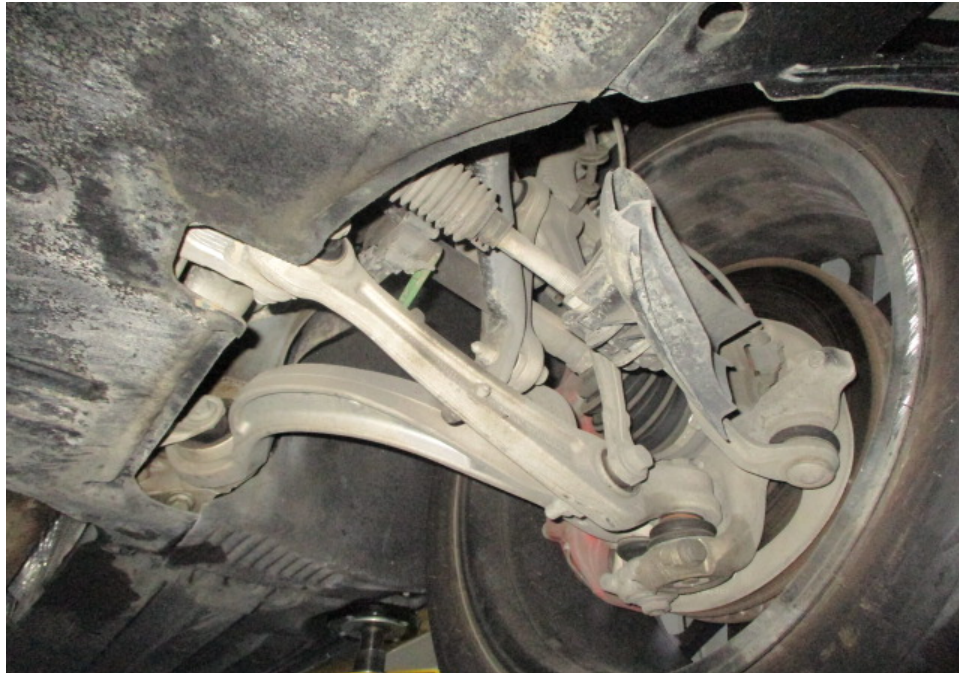
**Photo 22** shows a general view of the control arms and linkages at the front left wheel of the Motor Car. I did not observe any fluid leak and/or fluid stain on the underside of the Motor Car. All of the Motor Car's undercarriage components were observed to be intact and secured in an appropriate manner.

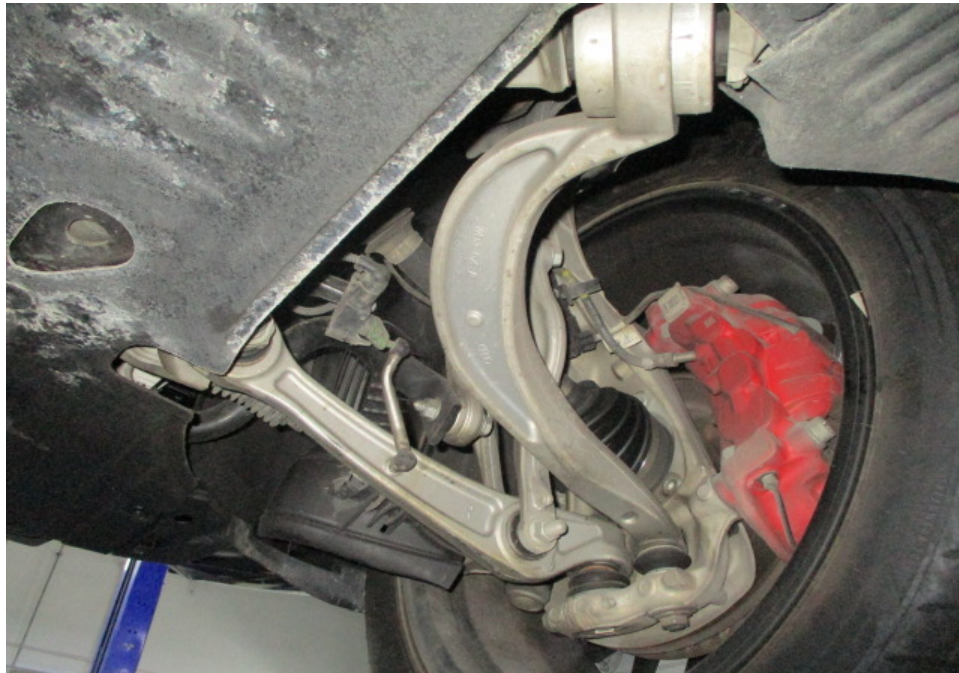
**Photo 23** shows the various undercarriage components at the front right wheel of the Motor Car. The mechanical components, control arms and linkages were all found to be intact and secured in an appropriate manner. I also did not observe any fluid leak and/or fluid stain on the underside of the Motor Car.

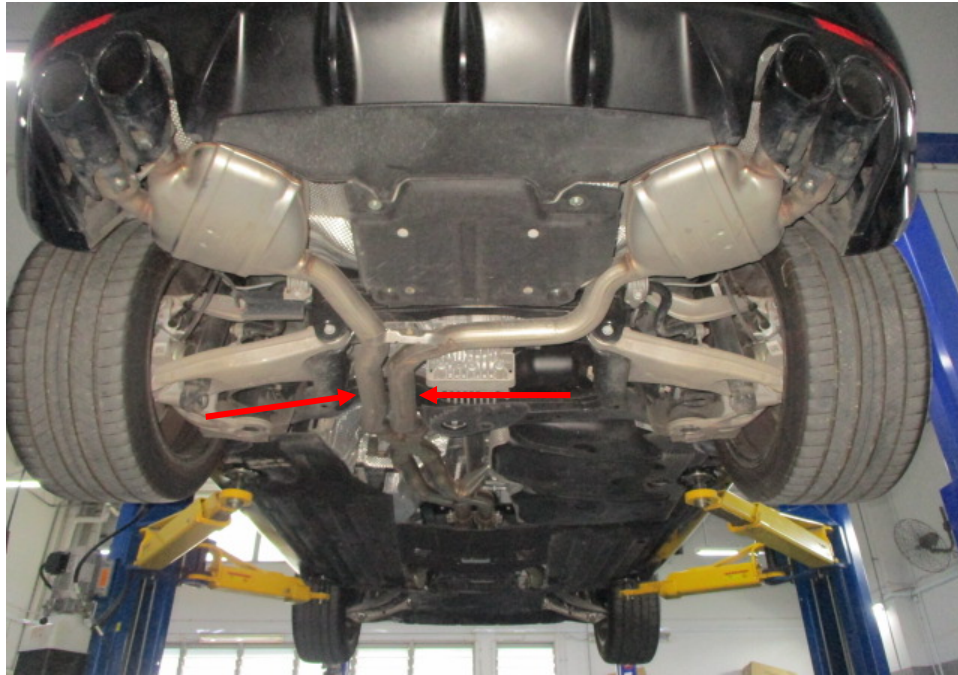
**Photo 24** shows the rear section of the Motor Car's exhaust system. My examination of the Motor Car's exhaust system revealed no sign(s) or indication(s) of any cut or weld marks along its exhaust pipes (arrowed), on its rear mufflers and on its catalytic converters.

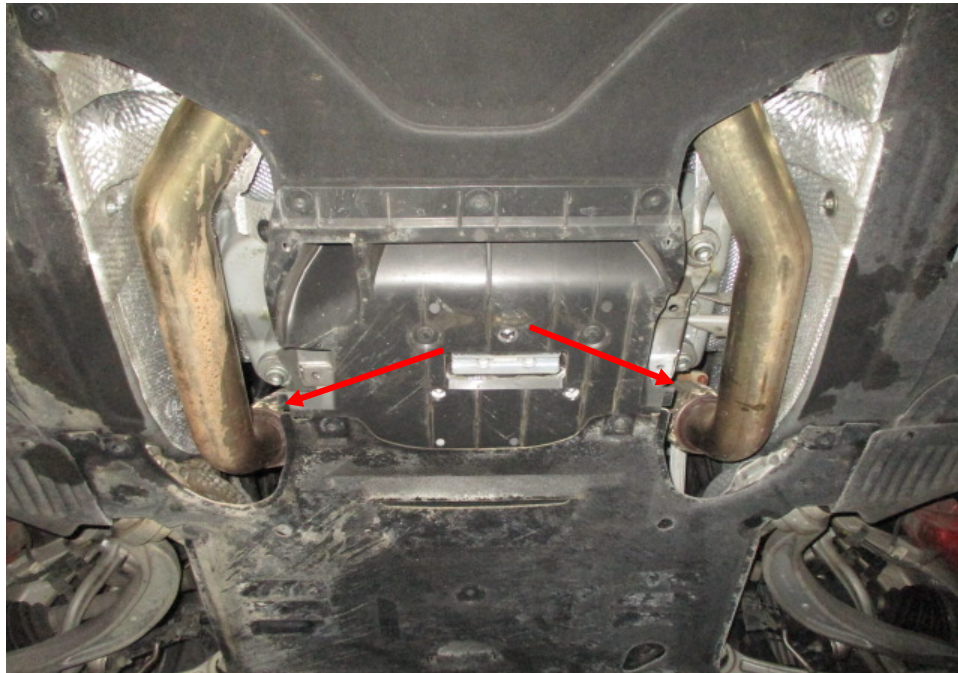
**Photo 25** shows the front section of the Motor Car's exhaust system. My examination of the Motor Car's exhaust system revealed no sign(s) or indication(s) of any cut or weld marks along its exhaust pipes, on its rear mufflers and on its catalytic converters (arrowed).

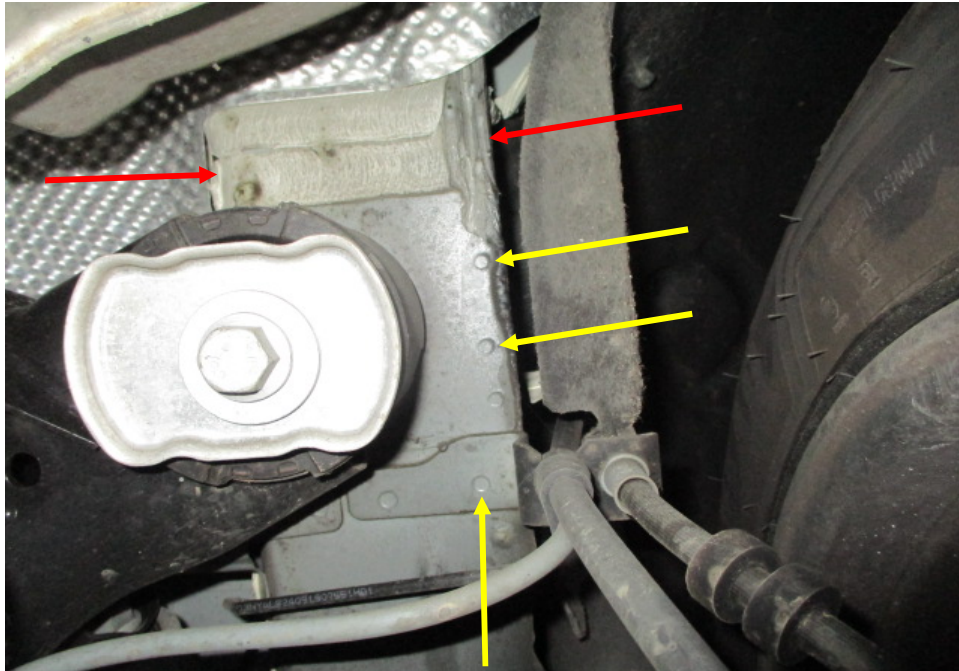
**Photo 26** shows the chassis/structural body at the underside rear right of the Motor Car. I did not find any weld marks other than original spot weld marks (yellow arrow) on the chassis/structural body of the Motor Car. The original factory sealant (red arrow) at the joints along the chassis/structural body was untouched, indicating no work was done on the chassis/structural body of the Motor Car and that the chassis/structural body was originally fitted.

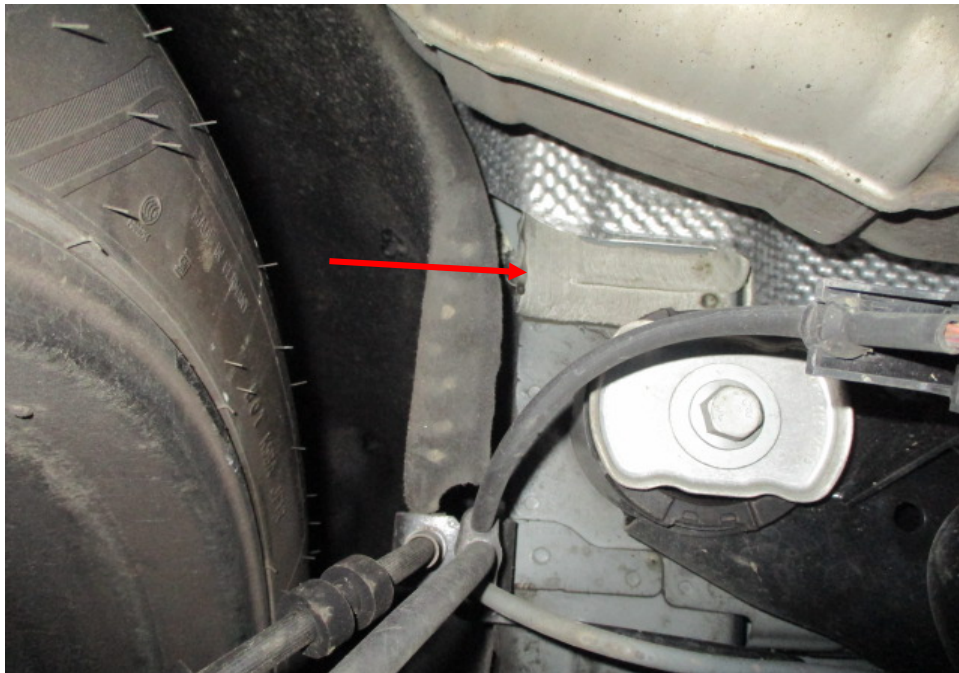
**Photo 27** shows the chassis/structural body at the underside rear left of the Motor Car. The original factory sealant (arrowed) at the joints along the chassis/structural body was observed to be untouched. In general, I had found no work was carried out on the chassis/structural body of the Motor Car. The chassis/structural body of the Motor Car was originally fitted.

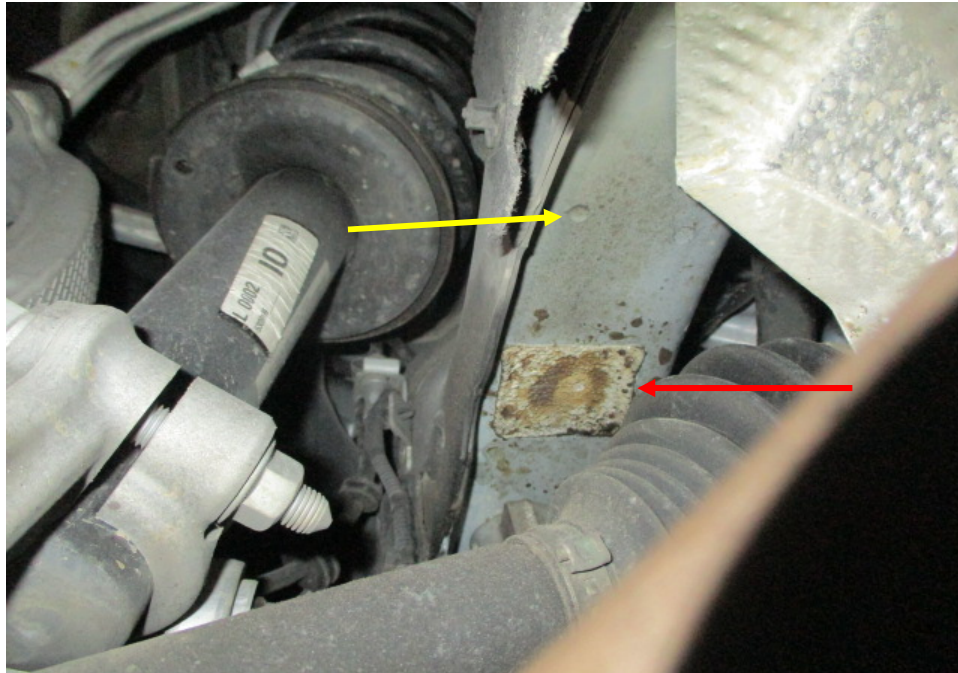
**Photo 28** shows the chassis/structural body at the underside front left of the Motor Car. I did not find any weld marks other than original spot weld marks (yellow arrow) on the chassis/structural body of the Motor Car. The original factory sealant (red arrow) at the joints along the chassis/structural body was untouched, indicating no work was done on the chassis/structural body of the Motor Car and that the chassis/structural body was originally fitted.

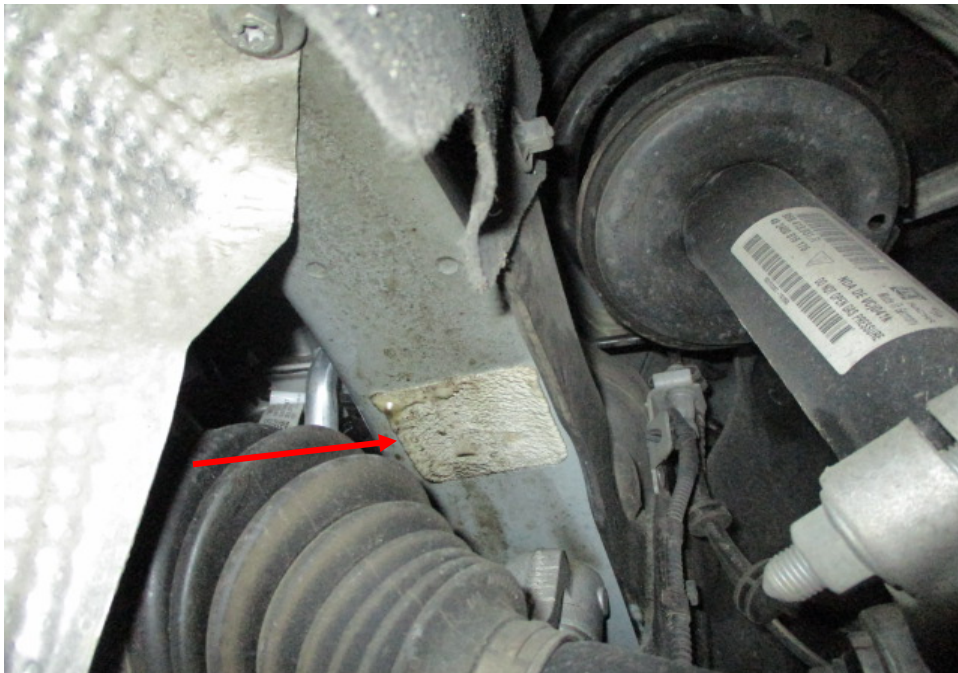
**Photo 29** shows the chassis/structural body at the underside front right of the Motor Car. The original factory sealant (arrowed) at the joints along the chassis/structural body was observed to be untouched. In general, I had found no work was carried out on the chassis/structural body of the Motor Car. The chassis/structural body of the Motor Car was originally fitted.
