Your Ref: Porsche Macan GTS  
(chassis number WP1ZZZ95ZLLB60114)  
Our Ref : CI/TP22002092/D

07 March 2022

**INSPECTION REPORT OF AN UNREGISTERED PORSCHE MACAN GTS  
MOTOR CAR WITH CHASSIS NUMBER WP1ZZZ95ZLLB60114**

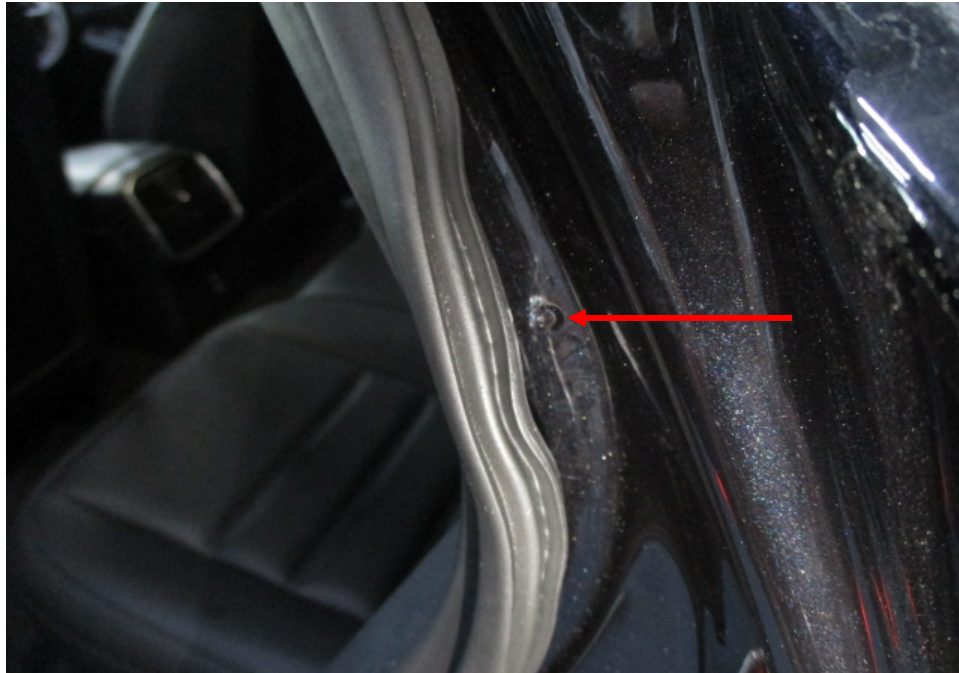
**Photo 30** shows the left side “C” pillar of the Motor Car. I did not find any weld marks other than original spot weld marks (arrowed) on the left side “C” pillar of the Motor Car which, indicates that there was no re-welding works carried out. In general, I had found all the non-detachable body panels of the Motor Car to be originally fitted at the time of my inspection.

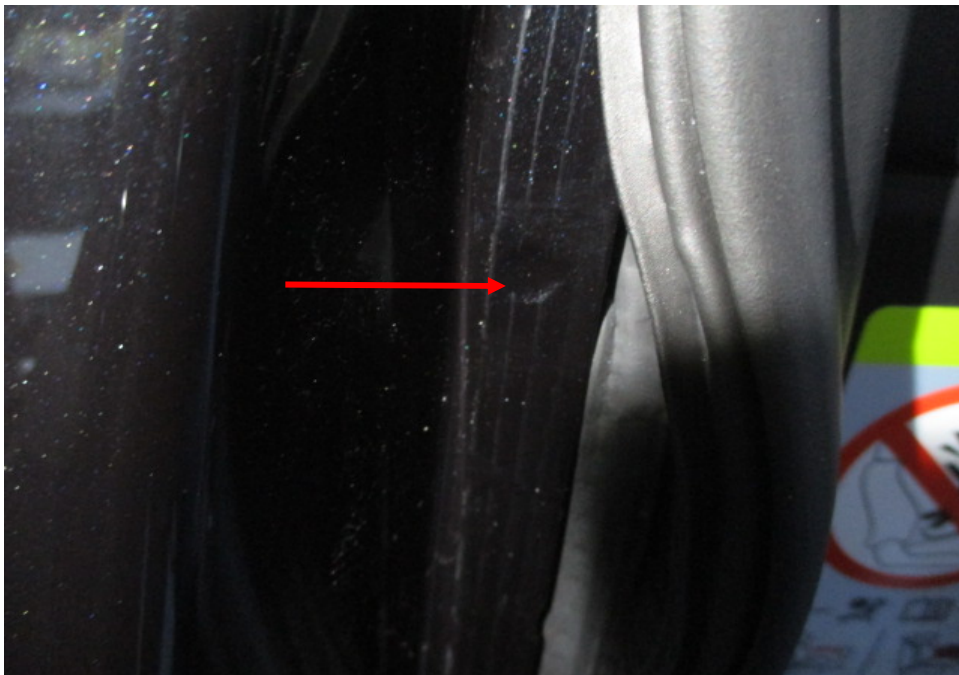
**Photo 31** shows the left side “A” pillar of the Motor Car. I did not find any weld marks other than original spot weld marks (arrowed) on the left side “A” pillar of the Motor Car which, indicates that there was no re-welding works carried out. In general, I had found all the non-detachable body panels of the Motor Car to be originally fitted at the time of my inspection.

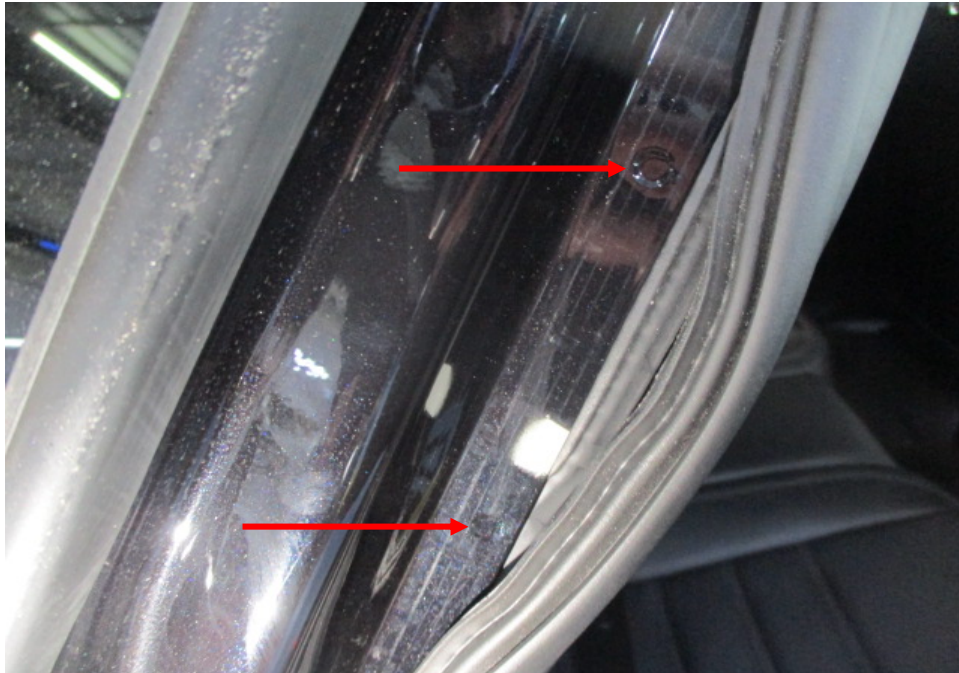
**Photo 32** shows the right side "C" pillar of the Motor Car. I did not find any weld marks other than original spot weld marks (arrowed) on the right side "C" pillar of the Motor Car which, indicates that there was no re-welding works carried out. In general, I had found all the non-detachable body panels of the Motor Car to be originally fitted at the time of my inspection.
