Your Ref : 0782500600SG
Our Ref : CI/AIG22002145/P

30th March 2022

**AUTOMOBILE TECHNICAL INVESTIGATION REPORT OF ACCIDENT
INVOLVING SMY 5960K AND SMR 1253G ON 30 JANURAY 2022**

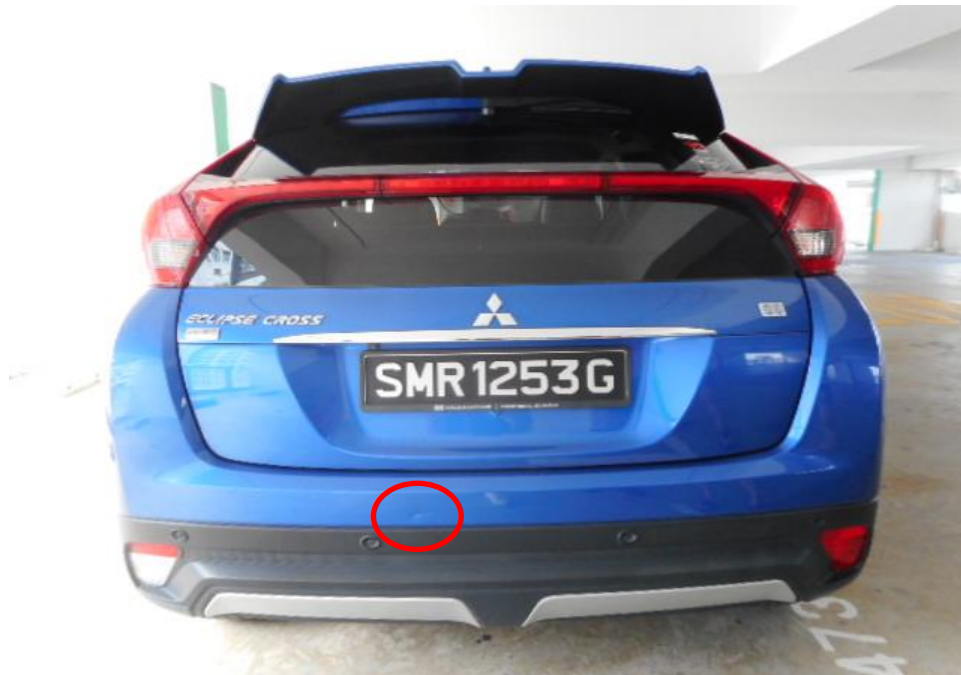
Photo 1 shows the general view of the rear portion of Third Party at the time of inspection. The rear bumper had been damaged. It was also noted that there were paint scratch marks (circled) on the rear bumper of Third Party.

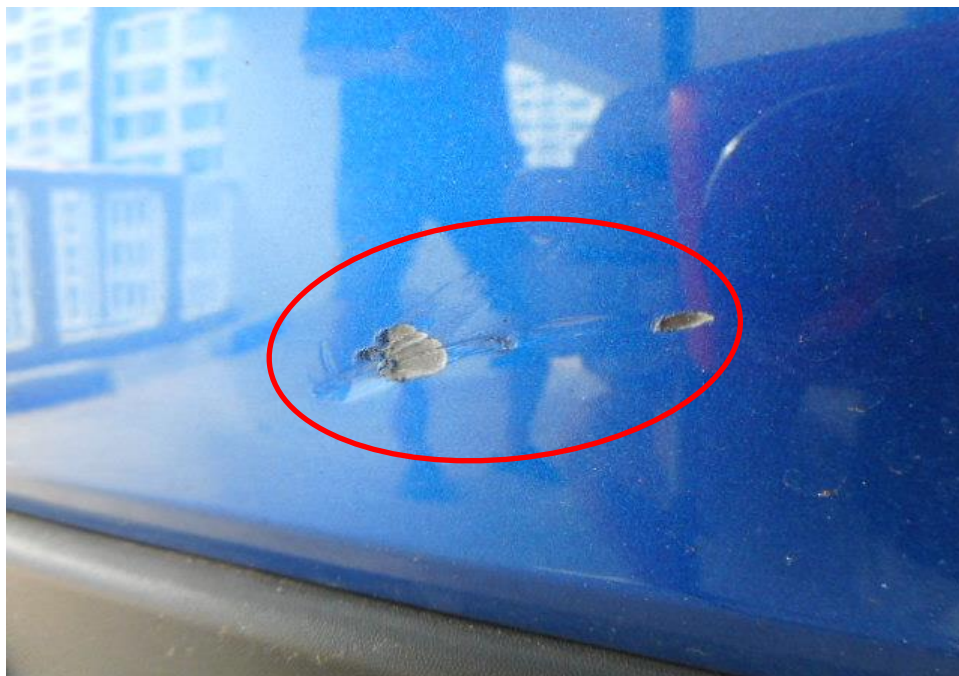
Photo 2 shows a close up view of the rear portion of the Third Party. We noted that there were paint scratch and dent marks the rear bumper with horizontal indentation from the right to the left which had resulted in the accumulation of blue paint of Third Party vehicle color on the rear bumper (circled).

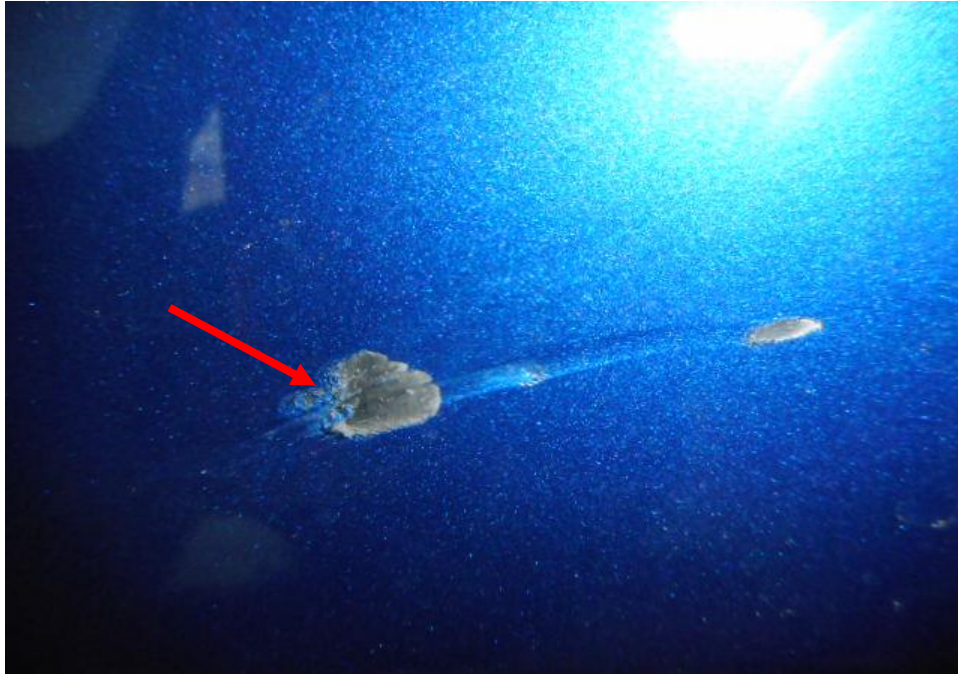
Photo 3 shows a close up view of the rear portion of the Third Party. We noted that there were paint scratch and dent marks the rear bumper with horizontal indentation from the right to the left which had resulted in the accumulation of blue paint (arrowed) of Third Party vehicle color on the rear bumper (circled).

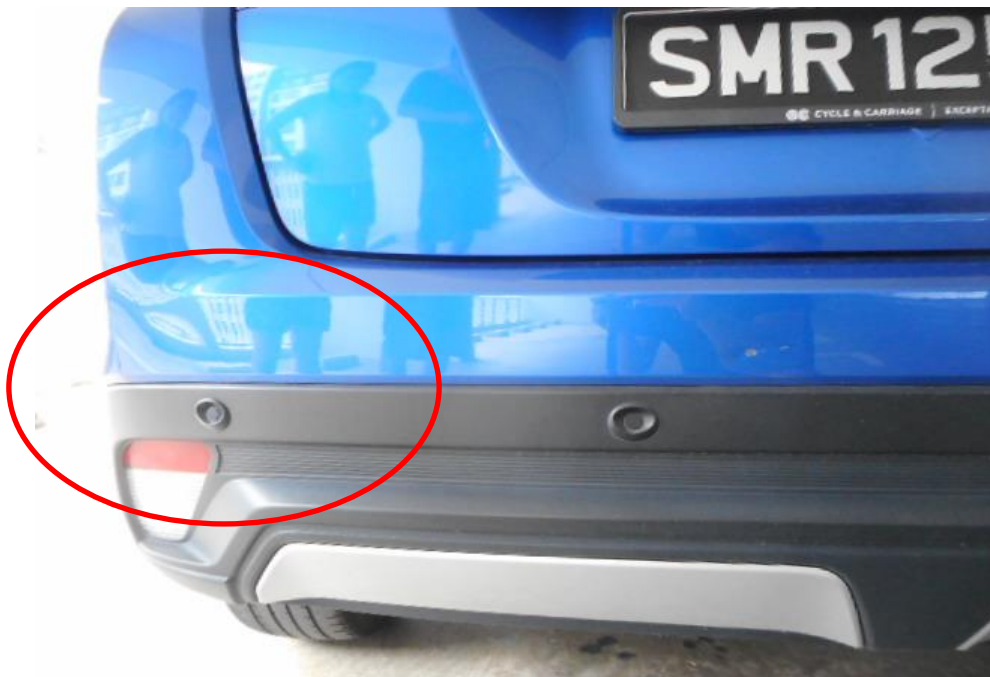
Photo 4 shows a close up view of the rear portion of the Third Party. We note that there was neither dislodgement nor misalignment of the rear bumper at the rear portion (circled) of Third Party.

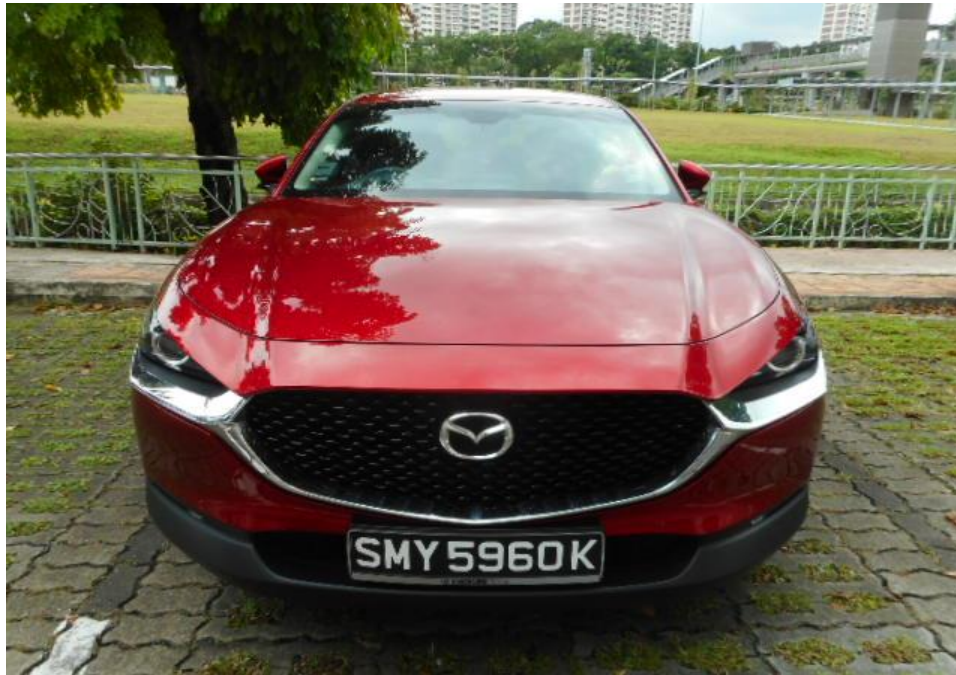
Photo 5 shows the general view of the front portion of Insured at the time of our inspection.

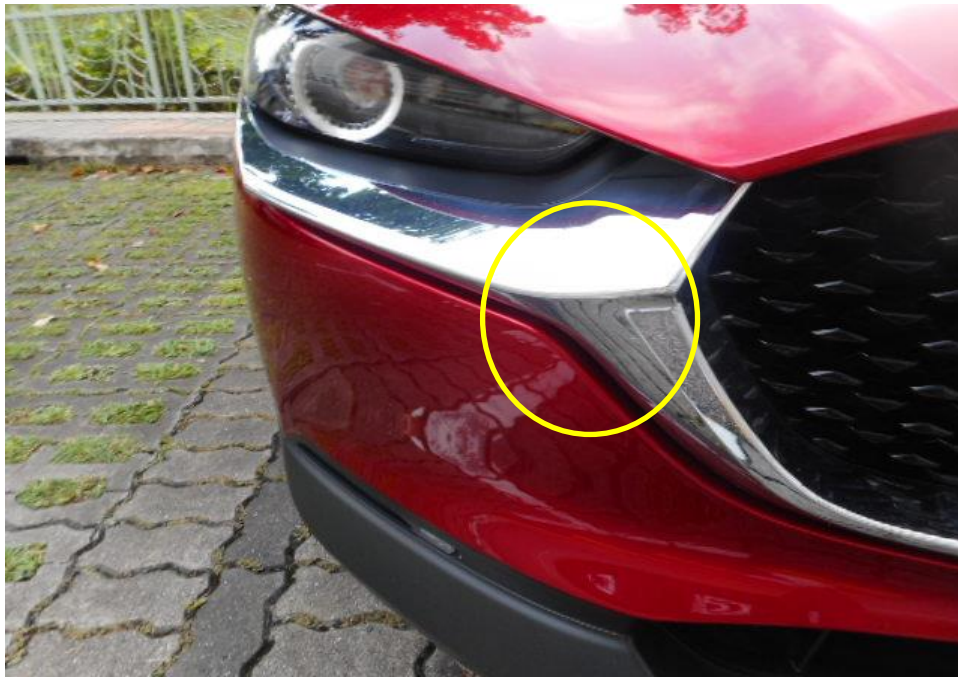
Photo 6 shows a close up view of the front portion of the Insured. We observed that there were no scratches or paint transfer marks on its front chrome and body panel portion of the Insured and that there was neither dislodgement nor misalignment of the front bumper at the front right portion (circled) of Insured.

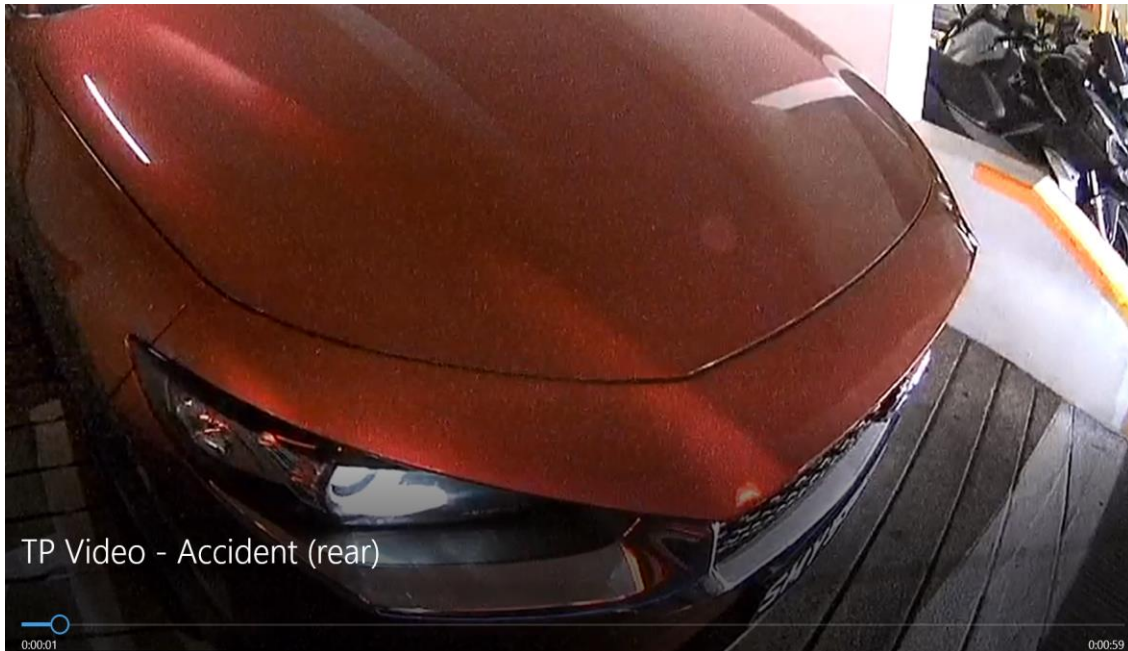
Screenshot 1 shows at the 1 second mark of the video recording, we had noted that Insured was queuing behind the Third Party and started moving forward towards the rear of the Third Party.

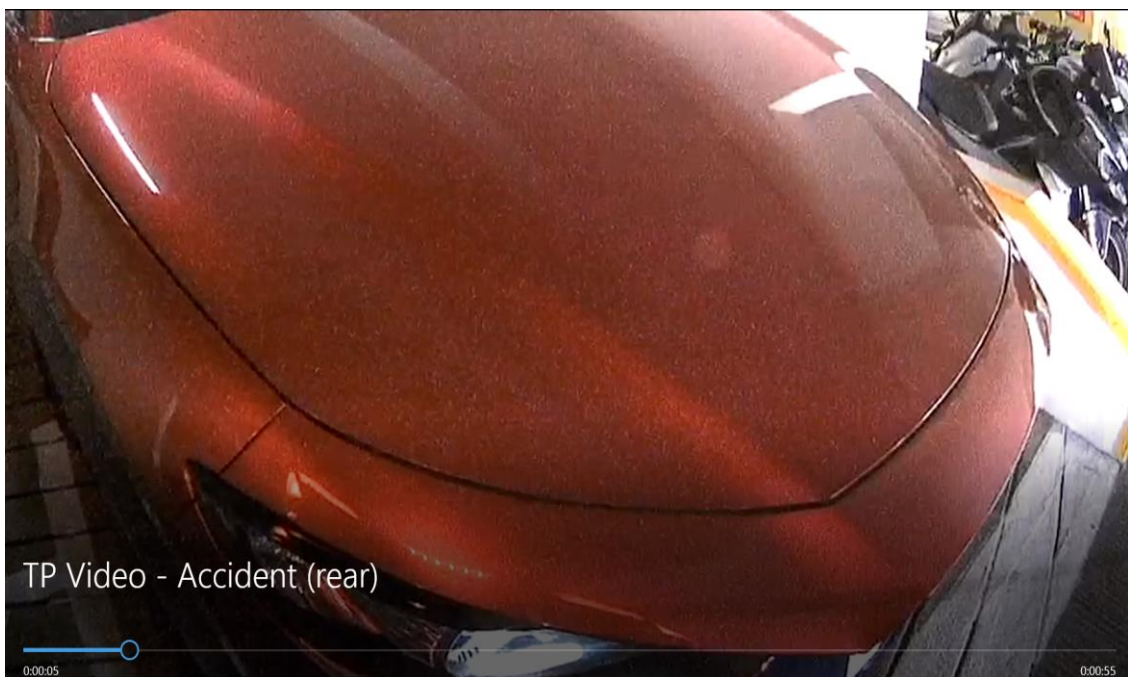
Screenshot 2 shows at the 5 second mark of the video recording, we had noted that Insured was queuing behind the Third Party and started moving forward towards the rear of the Third Party. However, one would have to view the recordings to see and hear the movements and audio warnings.

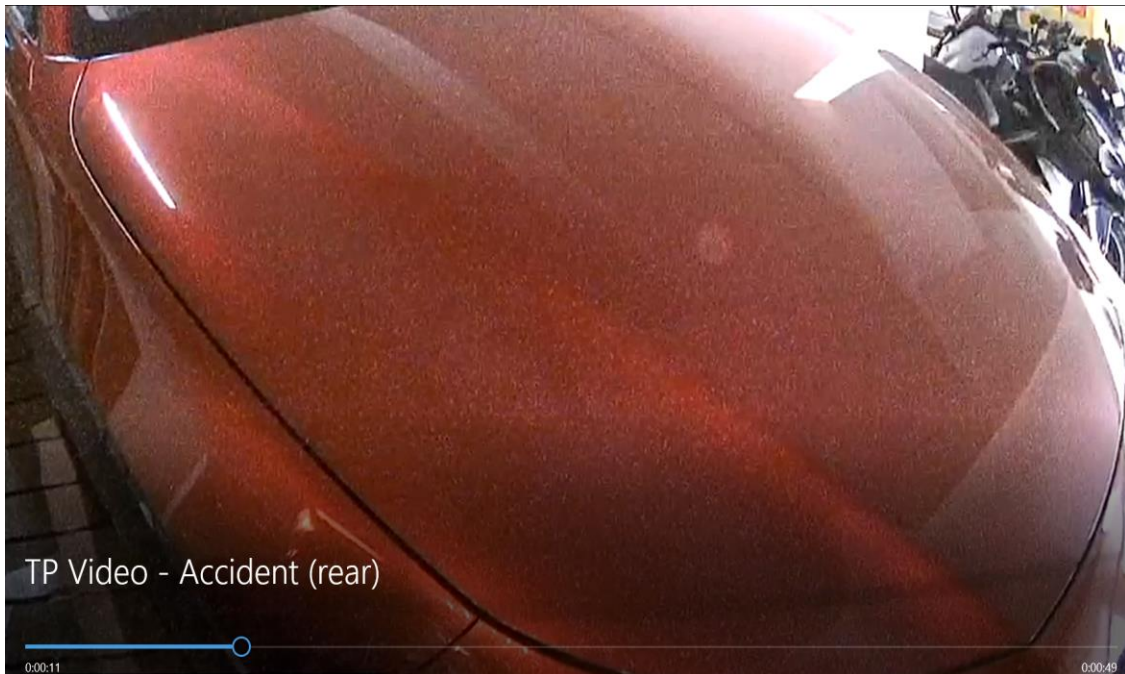
Screenshot 3 shows from the 6 to 11 second mark the rear collision warning system had activated in the Third Party vehicle and at the 11 second mark the Insured had come to a halt. However, one would have to view the recordings to see and hear the movements and audio warnings.

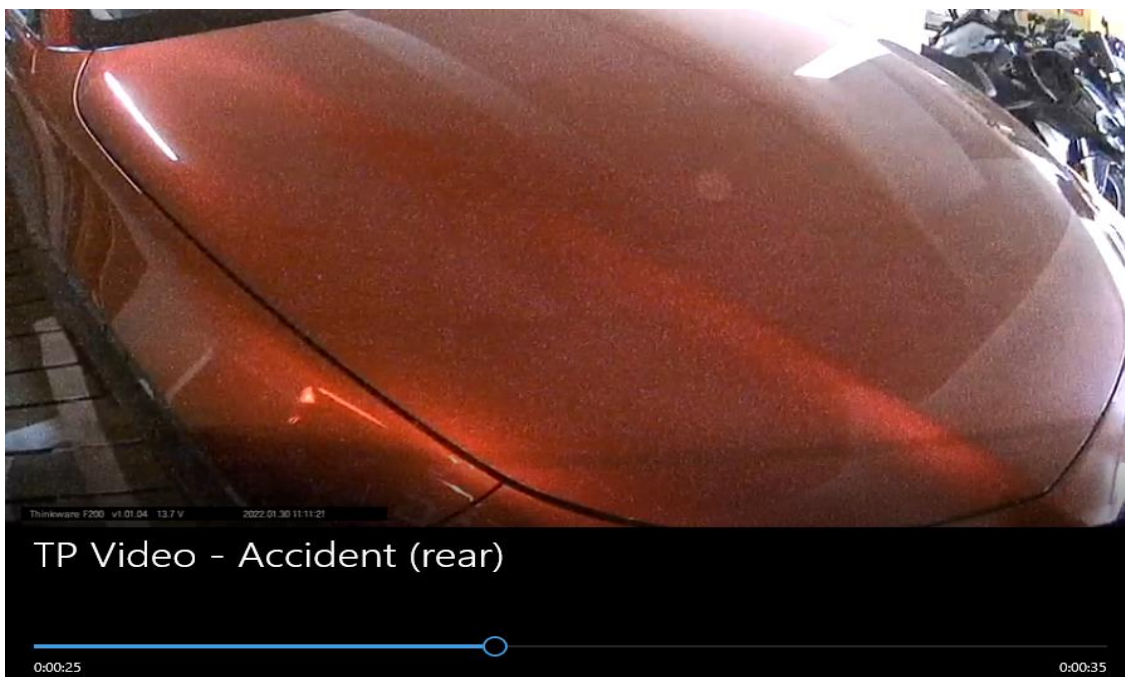
Screenshot 4 shows from the 12 to 24 second mark insured vehicle had started to inch forward and there was a thud sound at the 25 second mark and this is where the said collision might have taken place. However, one would have to view the recordings to see and hear the movements and audio warnings.

14. The video footage provided to me appears to indicate that there was contact between the Insured Vehicle and the Third Party Vehicle. The thud like sound and the conversation thereafter between the occupants on board the Third Party Vehicle, which were both recorded audibly by the recording devices that were mounted on the Third Party Vehicle, support the occurrence of a contact.

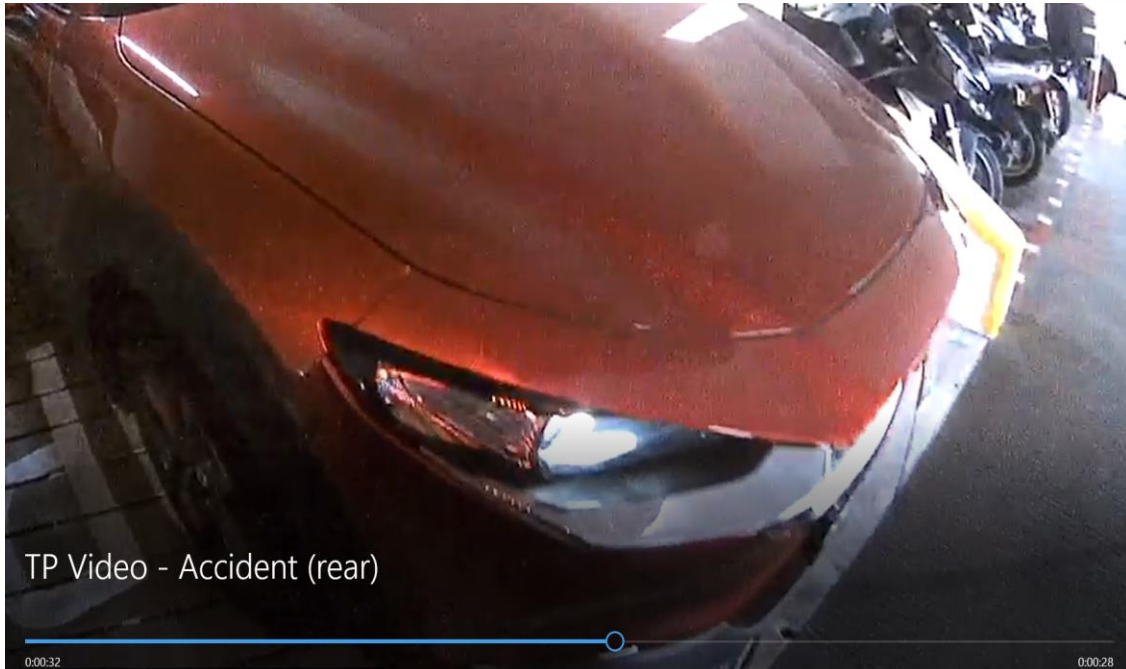
Screenshot 5 shows at the 32 second mark Third Party had started to move off afterwards. However, one would have to view the recordings to see and hear the movements and audio warnings.

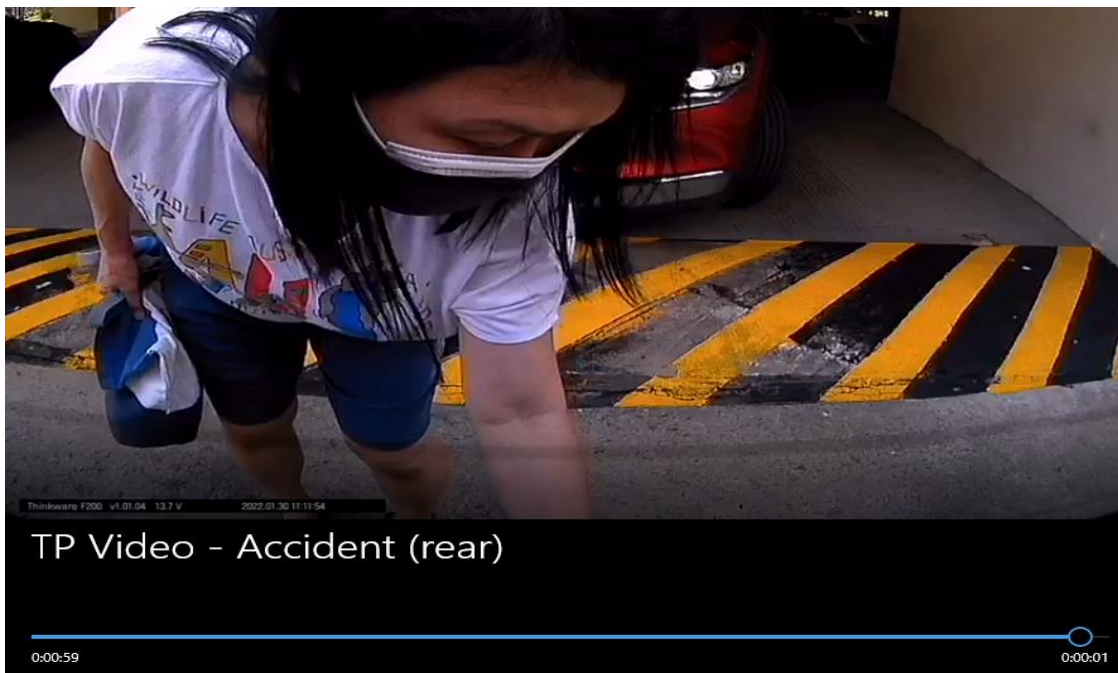
Screenshot 6 shows at the 59 second mark the passenger had alighted to inspect the Third Party vehicle. However, one would have to view the recordings to see and hear the movements and audio warnings.

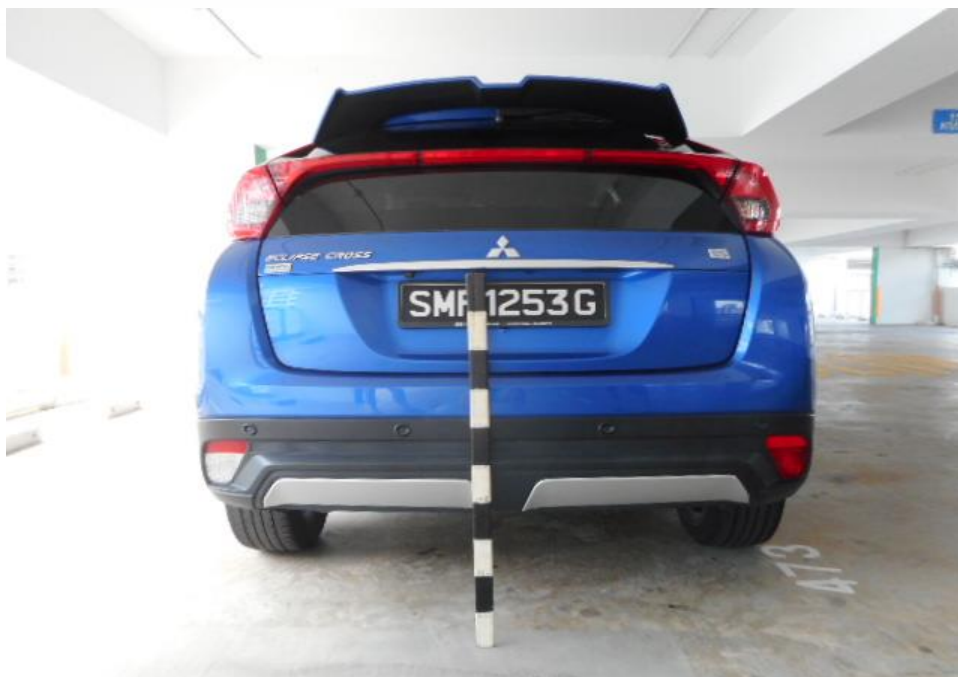
Photo 7 shows the general view of the height measurement being conducted on the rear portion of Third Party. The height above ground level of where the damages were found to the rear bumper of the Third Party was at 64cm to 65cm.

- a) the height above ground level of the range of damages (which included the paint scratched marks on the rear portion rear bumper of Third Party) was measured to be approximately at 64cm to 65cm;

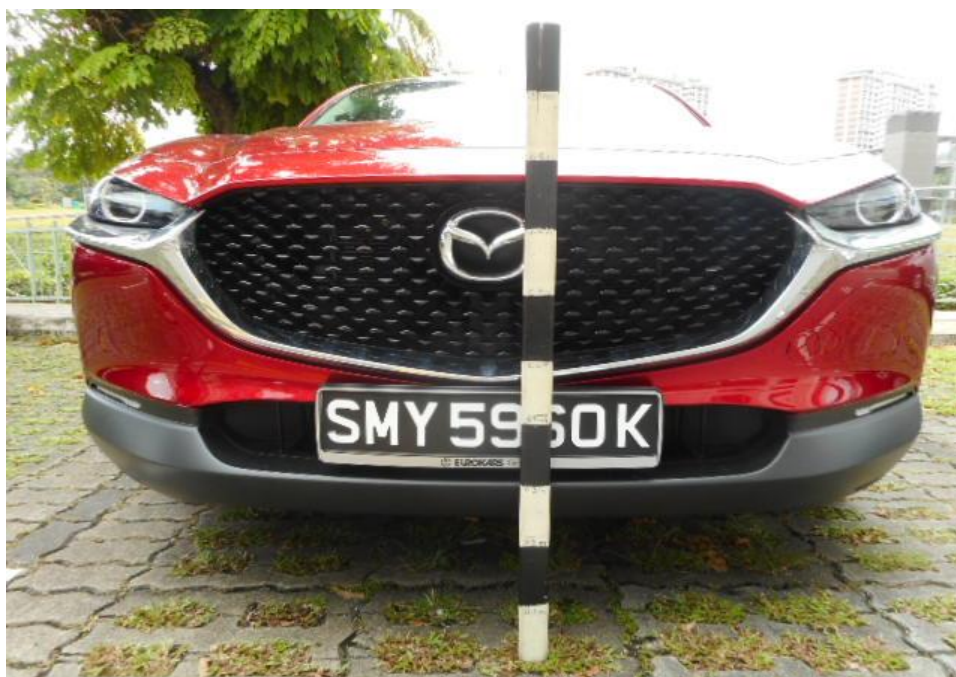
Photo 8 shows a general view of the height measurement being conducted on the front portion of Insured. The front right chrome and body panels was measured to be between 65cm above ground level.

- b) the height above ground level we observed the front portion, front right chrome and body panels at 65cm respectively on the Insured;
- c) The height measurements appear to suggest that there was possible contact between the rear portion of Third Party and the front right portion of Insured. The damage observed on the rear portion of Third Party was a result of this contact and correspond to the damage observed on the front portion of the Insured.

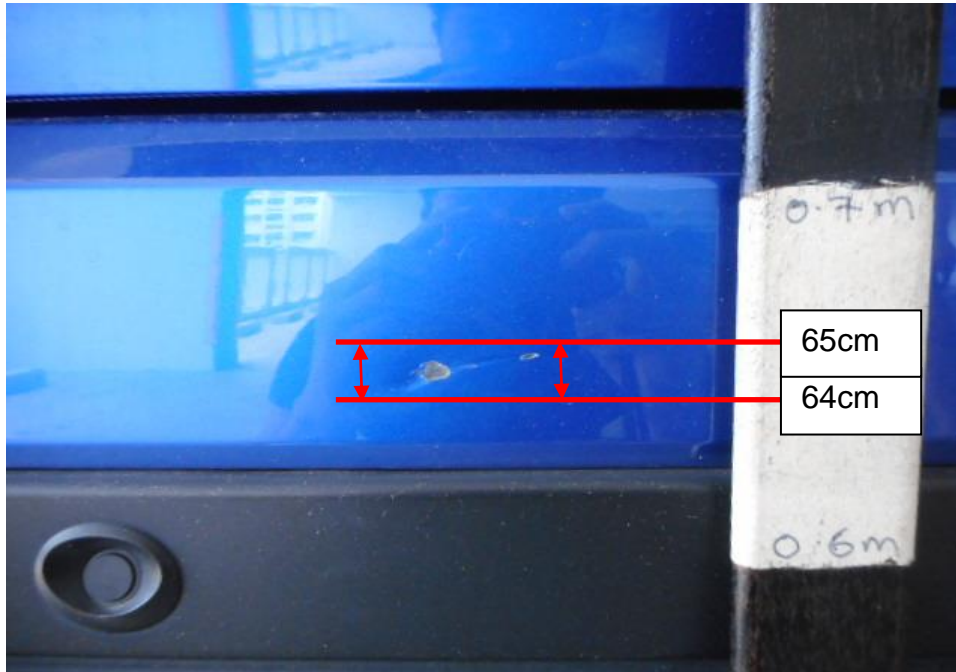
Photo 9 shows the close up view of the height measurement being conducted on the rear portion of Third Party. The height above ground level of where the damages were found to the rear bumper of the Third Party was at 64 to 65cm.

- d) The height measurements appear to support the findings of possible contact between the rear of the Third Party and the front right portion of the Insured because the point of contact to the rear of the Third Party would have been from the front right chrome and body panel of the Insured given that this was the most protruded body part at the front right portion of the Insured as per our discussions set out in paragraph 15, and also the height above ground level had corresponded to the height above ground level of the paint scratch and dent marks found on the rear bumper of the Third Party.

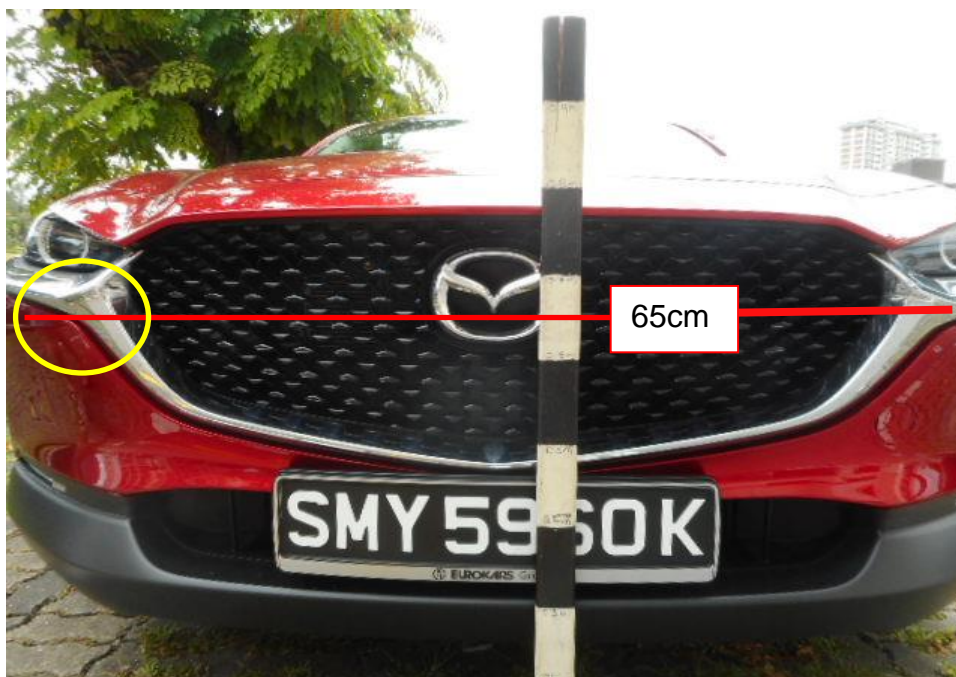
Photo 10 shows the close up view of the height measurement being conducted on the front portion of Insured. The front right chrome and body panels (circled) was measured to be between 65cm above ground level.
