Your Ref: C100014085/CD
Our Ref : CI/AGI22002146/P

9th March 2022

**TECHNICAL INVESTIGATION REPORT OF INSURED VEHICLE SKA 5551H
INVOLVED IN AN ACCIDENT ON 25 FEBRUARY 2022**

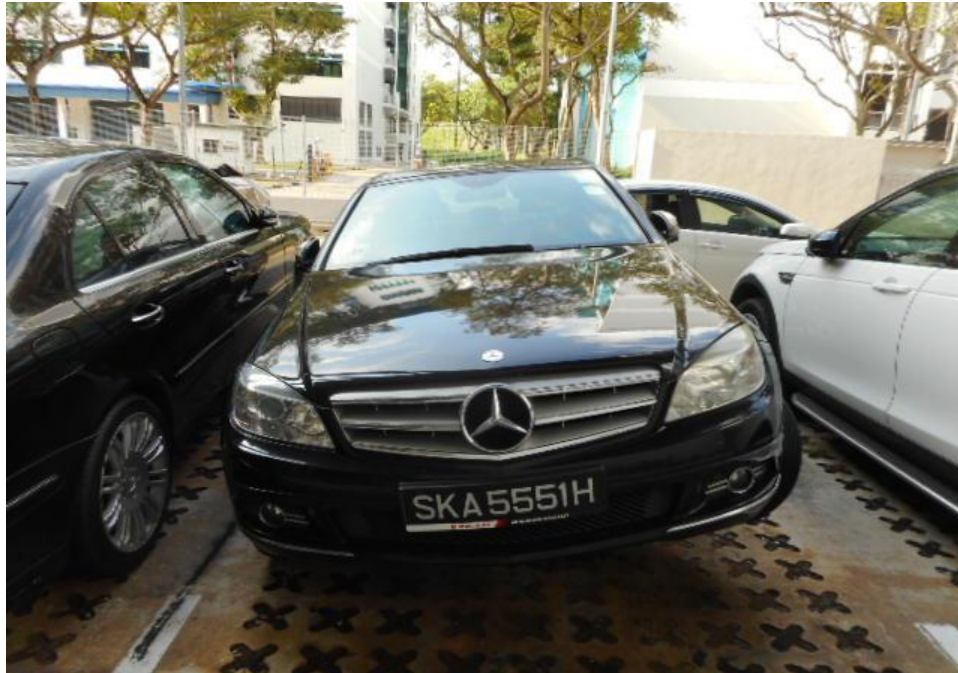
5. The Insured vehicle was observed to have sustained impact damages on its front portion. Its front and rear bumper were amongst the exterior body parts which were observed to have been damaged as a result of the accident. See photo 1 – 4 below.

Photo 1 shows the general view of the front portion of the Insured vehicle at the time of my inspection its front portion was observed to be affected by the accident. Its front bumper was damaged as a result of the accident.

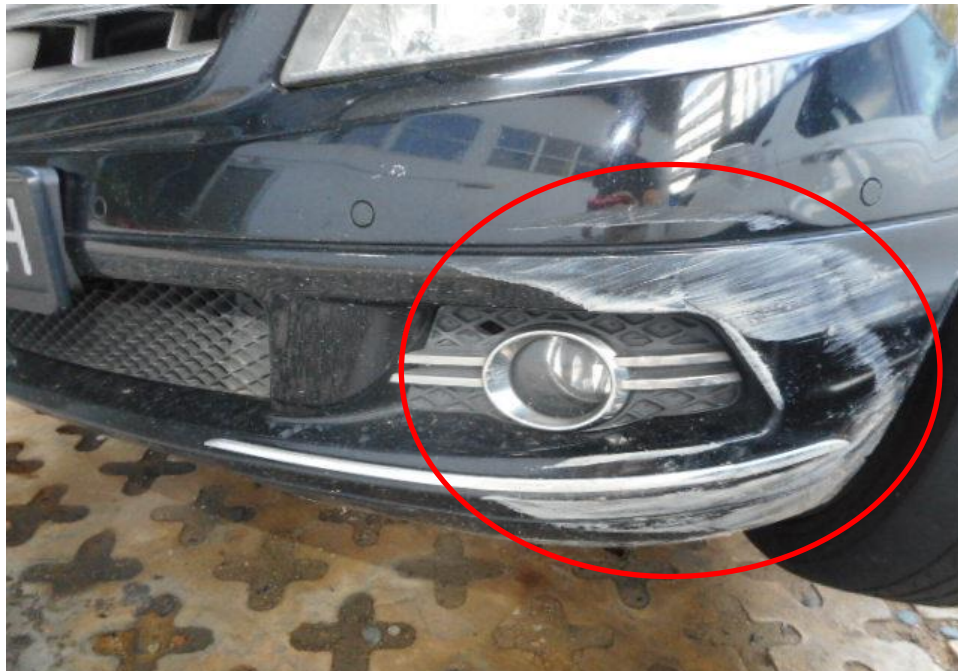
Photo 2 shows the close up view of the front portion of the Insured vehicle at the time of my inspection its front portion was observed to be affected by the accident. Its front bumper (circled) was damaged as a result of the accident.

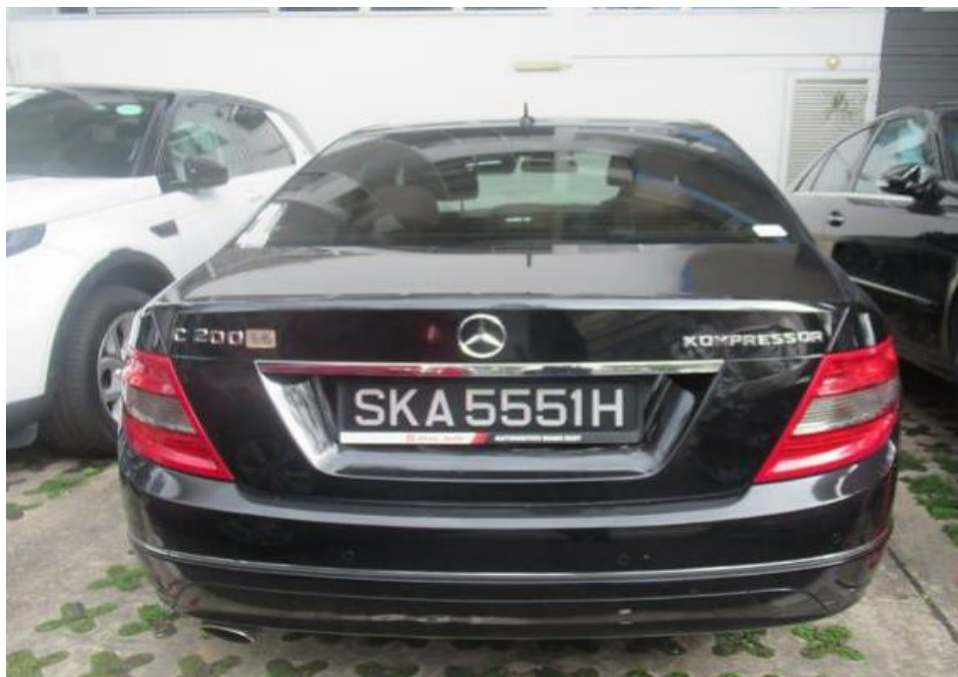
Photo 3 shows the general view of the rear portion of the Insured vehicle at the time of my inspection its rear portion was observed to be affected by the accident. Its rear bumper was damaged as a result of the accident.

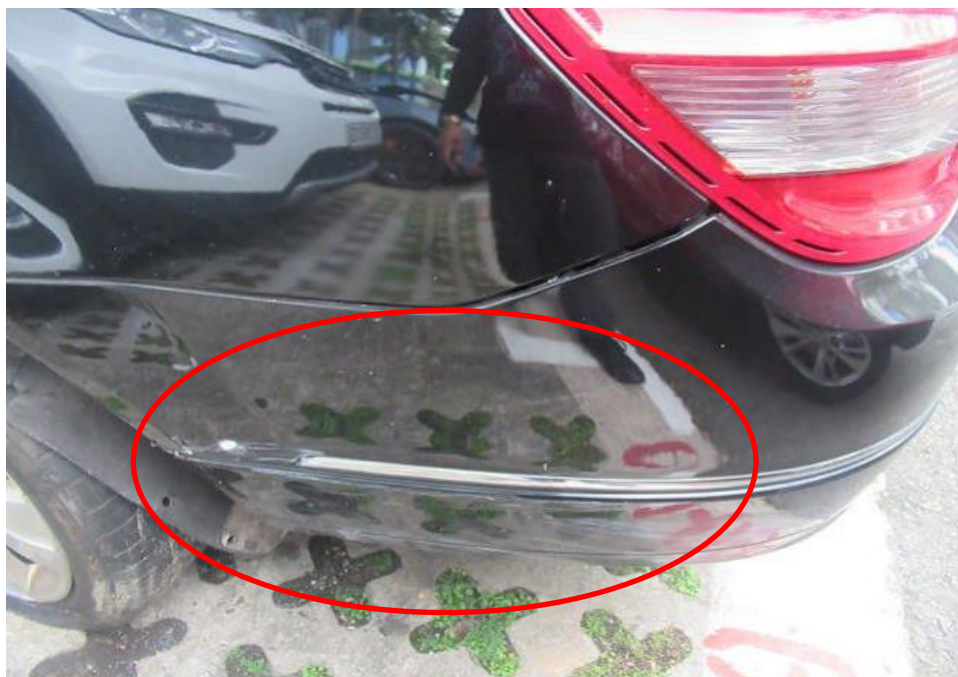
Photo 4 shows the close up view of the rear portion of the Insured vehicle at the time of my inspection its rear portion was observed to be affected by the accident. Its rear bumper (circled) was damaged as a result of the accident.

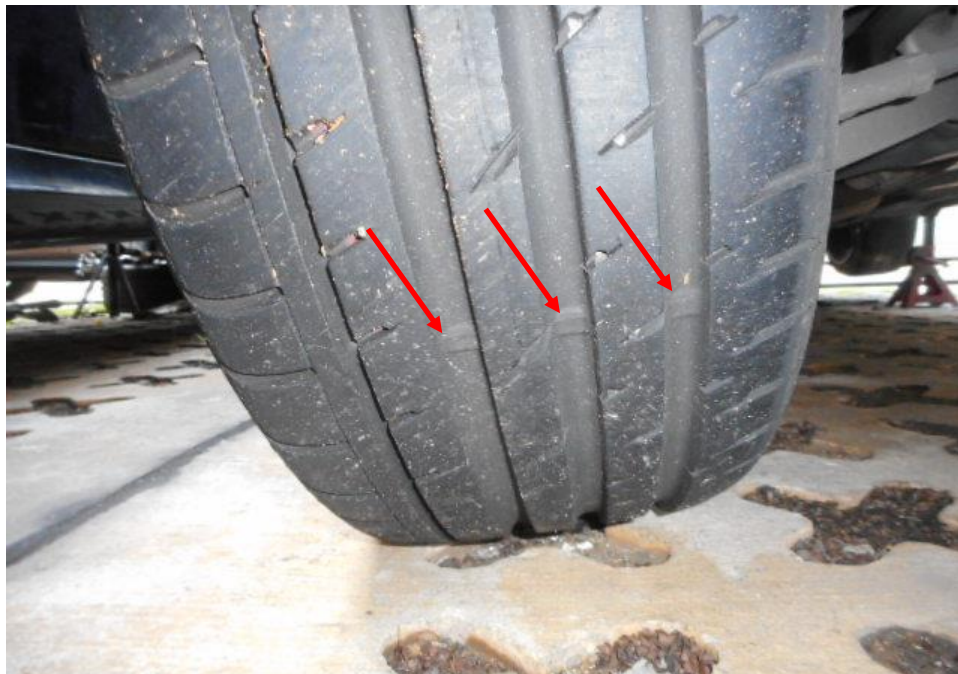
6. The front right and left tyres of the Insured vehicle was found to be in serviceable condition. The pattern of the tread was generally still visible. The tyre wear indicators, normally built into the groove of the tread pattern, were also observed to be not flushed with the tread pattern. The remaining depth of the tread was measured to be approximately 2.4mm to 7mm. See photo 5 - 8

Photo 5 shows the front right tyre of the of the Insured Vehicle, which was observed to be in serviceable condition with remaining tread depth of approximately 7mm. The pattern of the tread was generally still visible. The tyre wear indicators (arrowed), normally built into the groove of the tread pattern, and were also observed to be not flushed with the tread pattern.

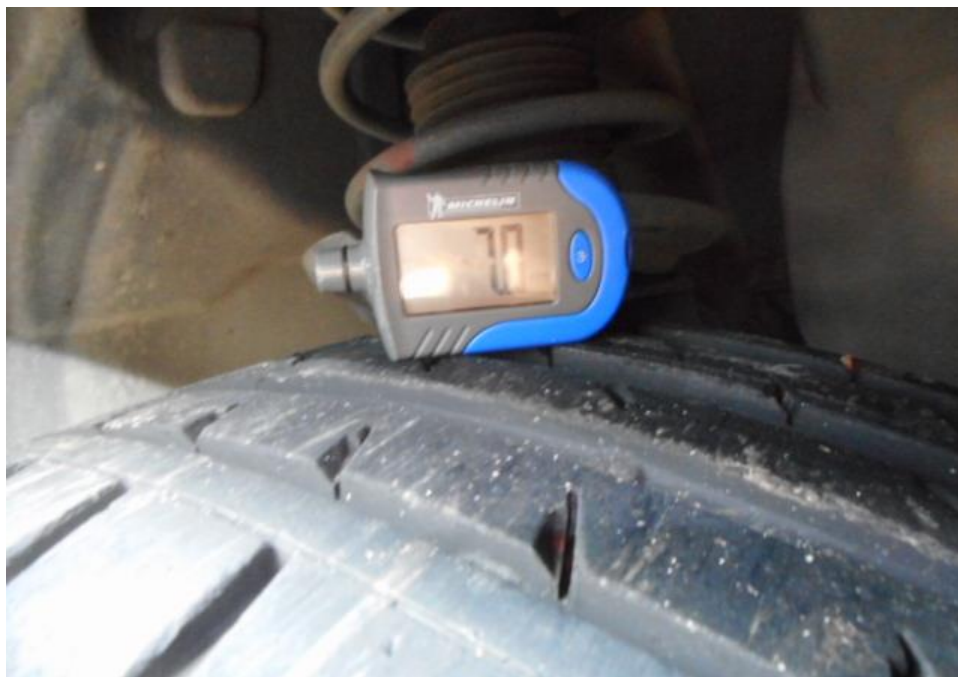
Photo 6 shows measurements being conducted on the remaining tread depth of the front right tyre of the Insured vehicle. The remaining tread depth was measured to be approximately 7mm.

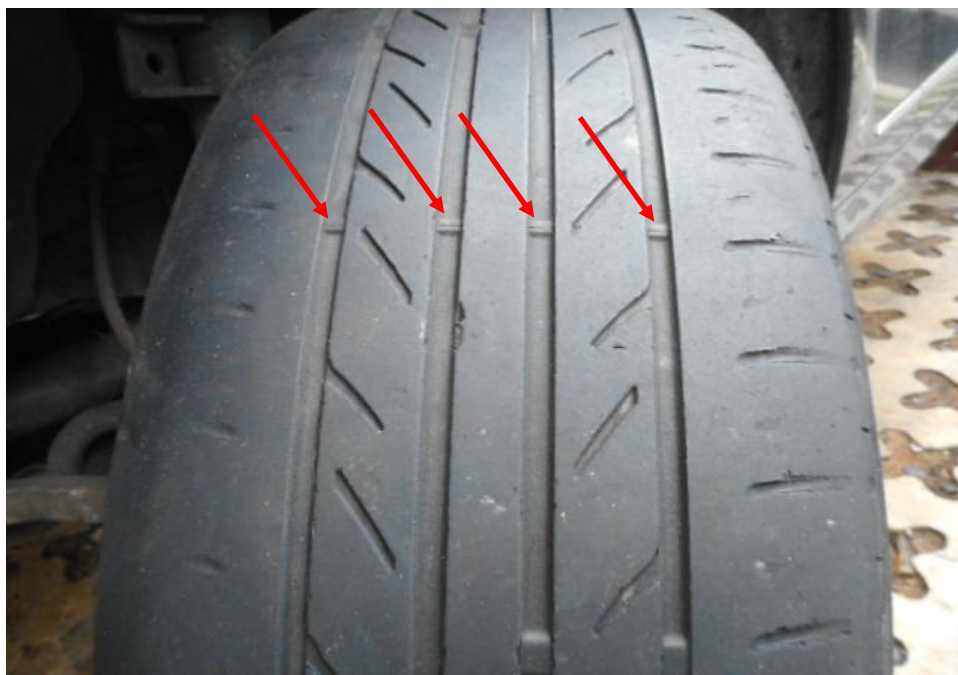
Photo 7 shows the condition of the front left tyre of the Insured vehicle, which was observed to be in serviceable condition with remaining tread depth of approximately 2.4mm. The pattern of the tread was generally still visible. The tyre wear indicators (arrowed), normally built into the groove of the tread pattern, and were also observed to be not flushed with the tread pattern.

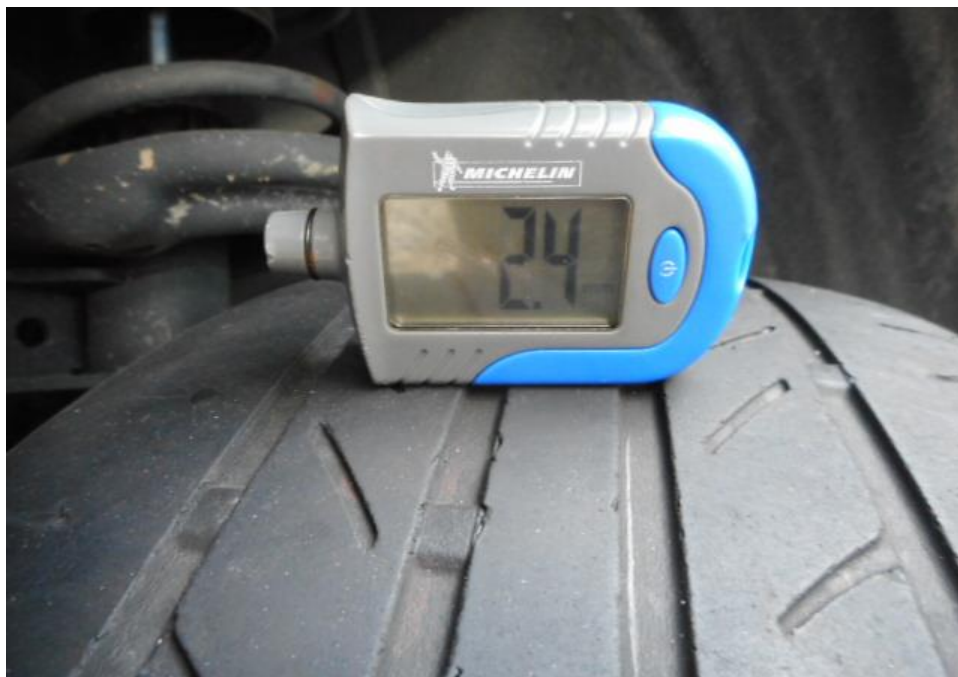
Photo 8 shows measurements being conducted on the remaining tread depth of the front left tyre of the Insured vehicle. The remaining tread depth was measured to be approximately 2.4mm.

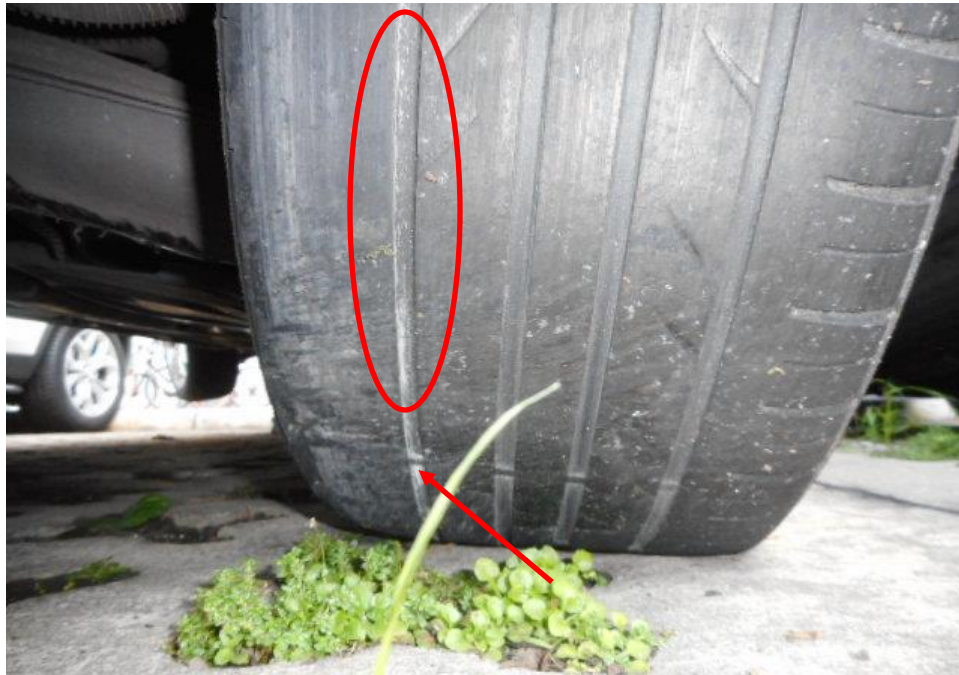
7. Upon examination of the rear right and left tyres of the Insured vehicle, we had observed that the rubber at the inner side of the tread was partially worn. The pattern at some areas at the inner side of the tread was vaguely visible due to worn rubber however the reinforcing belts that are found within the tyre were not exposed at the time of our inspection. The pattern at the inner side of the tread was also observed to be flushed with the tyre wear indicator. The remaining tread depth of the rear right and rear left tyres was measured to be approximately 0.3mm to 1.7mm. See photos 9 - 19 below.

Photo 9 shows the rear right tyre of the Insured vehicle at the time of our inspection. The rubber at the inner side of the tread (circled) was partially worn. The pattern at some areas on the inner side of the tread was vaguely visible due to worn rubber and flushed with the tyre wear indicator (arrowed) however the reinforcing belts that are found within the tyre were not exposed at the time of our inspection.

8. In general, having physically inspected the Insured vehicle, we are of view that the condition of the rear right tyre was slightly within the requirements. However, the rear left tyre of the Insured vehicle was not within the requirements of SECTION 109(f) CAP 276 of THE MOTOR VEHICLES (CONSTRUCTION AND USE) RULES, 1974, 1978 OF THE ROAD TRAFFIC ACT. Under this section it states that “no person shall use, or cause or permit to be used on a road any motor vehicle or trailer, a wheel of which is fitted with a pneumatic tyre, where the tyre is fitted to the wheel of any other motor vehicle or any trailer, the tread pattern (excluding any tie-bar) of the tyre does not have a depth of at least one millimetre throughout at least 75% of the breadth of the tread and round the entire outer circumference of the tyre.

9. The condition of the rear right and left tyres of the Insured vehicle would have also likely affected the road worthiness of the Insured Vehicle as the traction/frictional grip between the Insured Vehicle and the road surface would have been lessen, especially during wet weather condition, when travelling at high speed or cruising speed, cornering and braking amongst others.

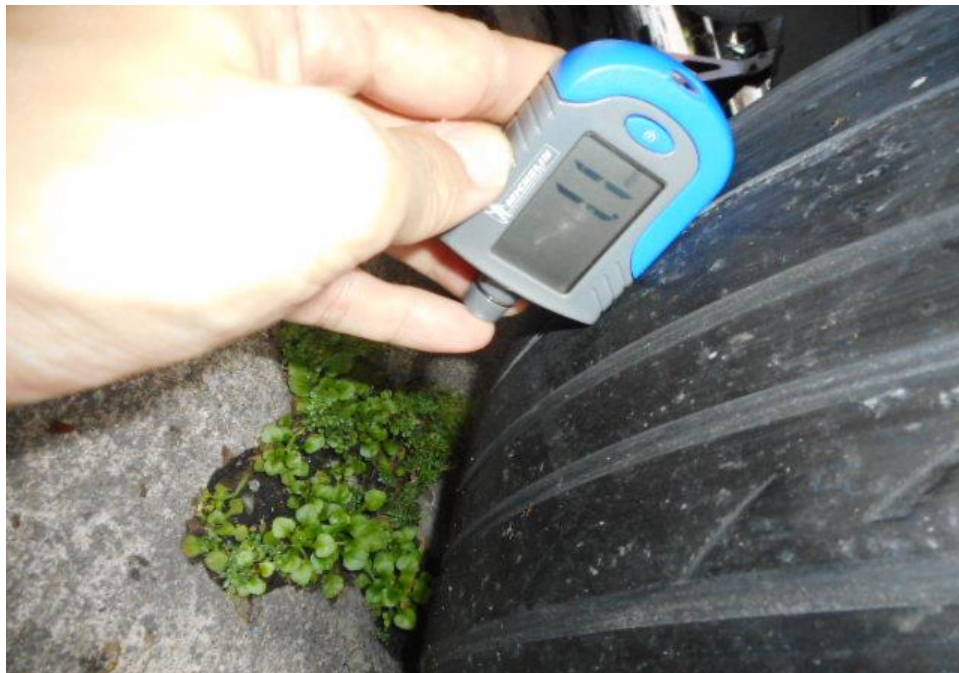
Photo 11 shows measurements being conducted on the inner to outer side of the tread on the rear right tyre of the Insured vehicle. The remaining tread depth was measured to be approximately 1.1mm.

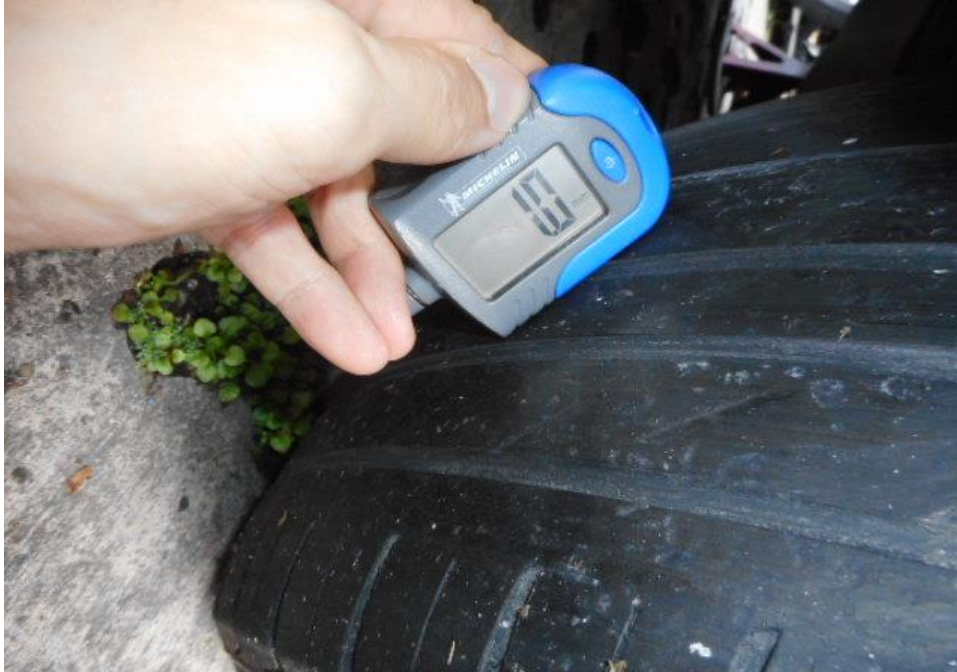
Photo 12 shows measurements being conducted on the outer side of the tread on the rear right tyre of the Insured vehicle. The remaining tread depth was measured to be approximately 1mm.

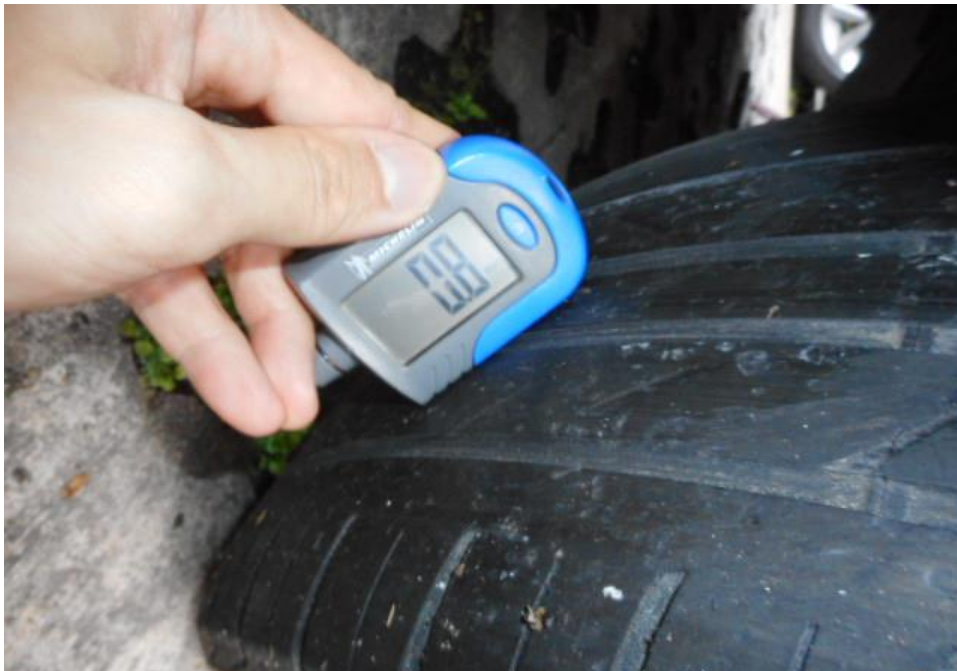
Photo 13 shows measurements being conducted on the outer side of the tread on the rear right tyre of the Insured vehicle. The remaining tread depth was measured to be approximately 0.8mm.

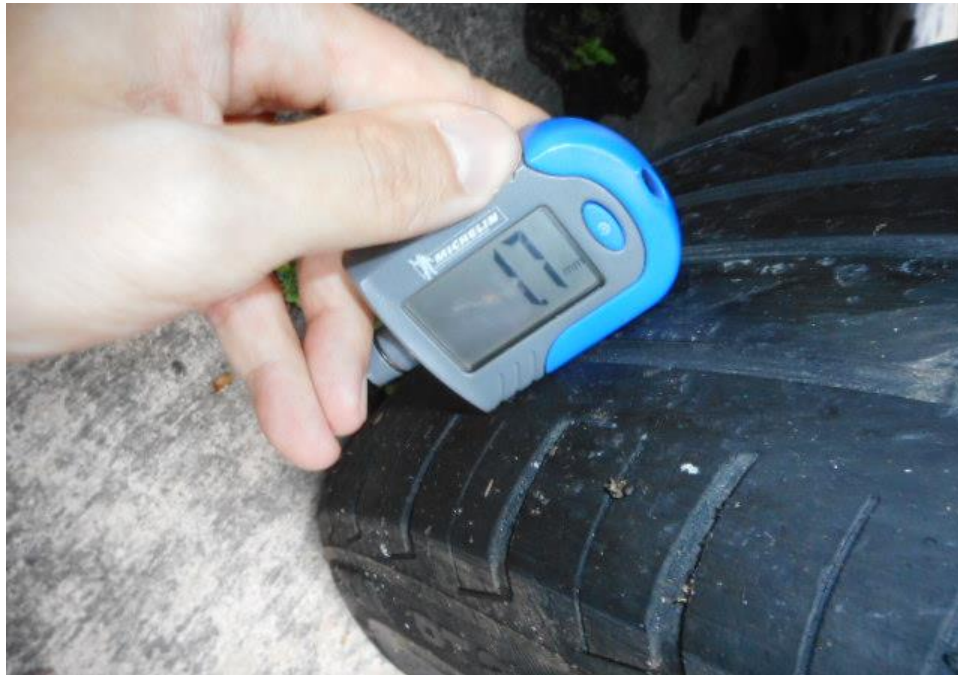
Photo 14 shows measurements being conducted on the outer side of the tread on the rear right tyre of the Insured vehicle. The remaining tread depth was measured to be approximately 1.7mm.

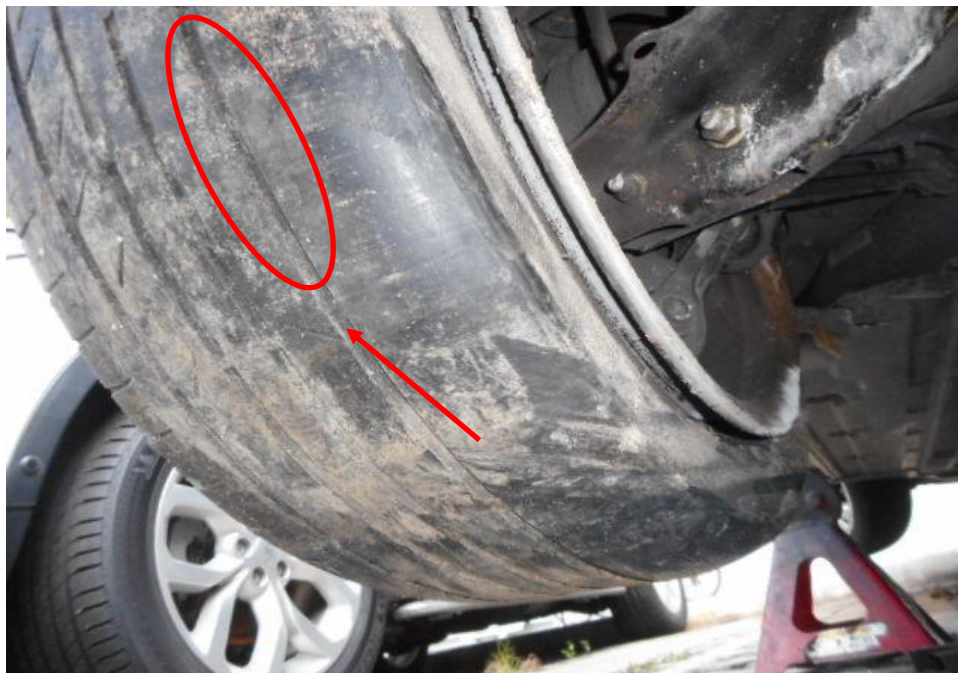
Photo 15 shows the rear left tyre of the Insured vehicle at the time of our inspection. The rubber at the inner side of the tread (circled) was partially worn. The pattern at some areas on the inner side of the tread was vaguely visible due to worn rubber and flushed with the tyre wear indicator (arrowed) however the reinforcing belts that are found within the tyre were not exposed at the time of our inspection.

10. Given the circumstances of accident and wet road surface condition as reported in the Singapore Accident Statement SA1922310005, I am of the view that the condition of the rear right and left tyres of the Insured vehicle would have affected the expulsion of water from its tyres in a wet weather condition. Considering that the Insured vehicle was negotiating the left bent, the traction/frictional grip between the Insured vehicle and the road surface would have been lesser causing the Insured vehicle to go into an uncontrolled spin.

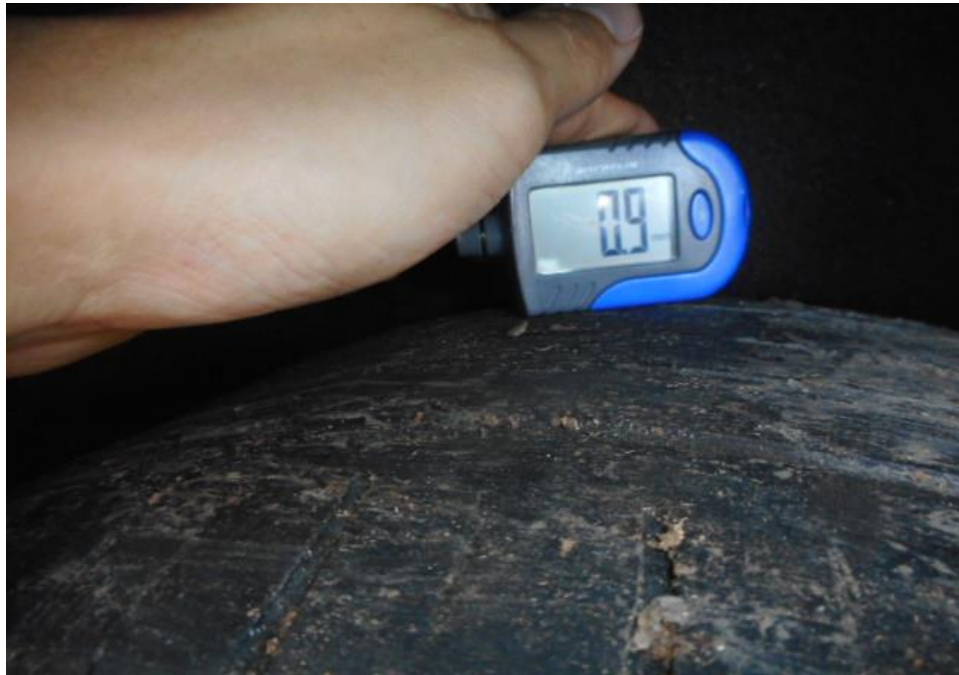
Photo 16 shows measurements being conducted on the inner to outer side of the tread on the rear left tyre of the Insured vehicle. The remaining tread depth was measured to be approximately 0.9mm.

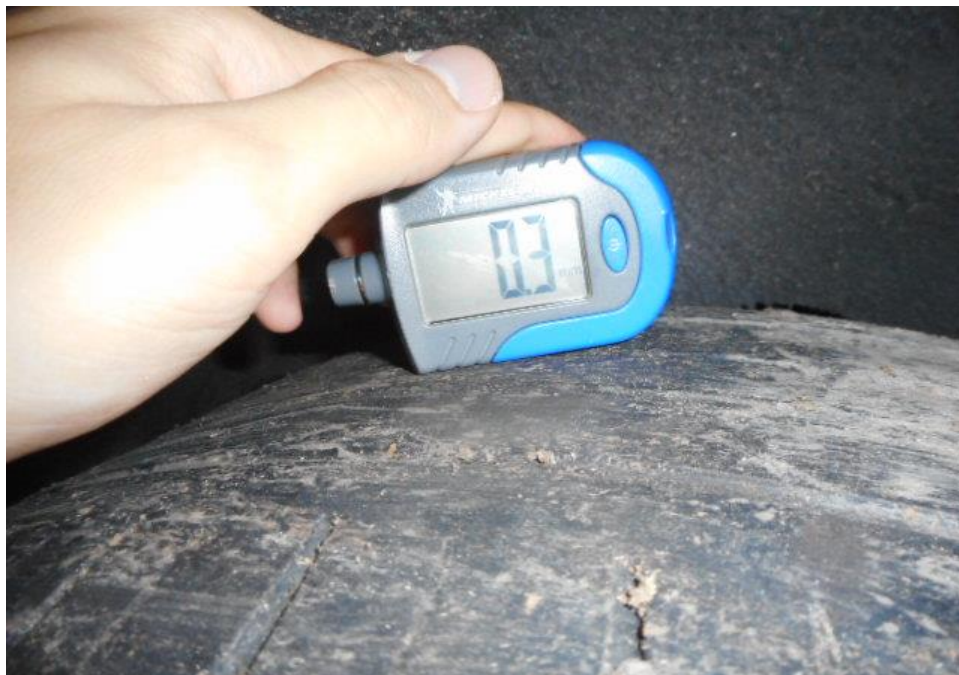
Photo 17 shows measurements being conducted on the inner to outer side of the tread on the rear left tyre of the Insured vehicle. The remaining tread depth was measured to be approximately 0.3mm.

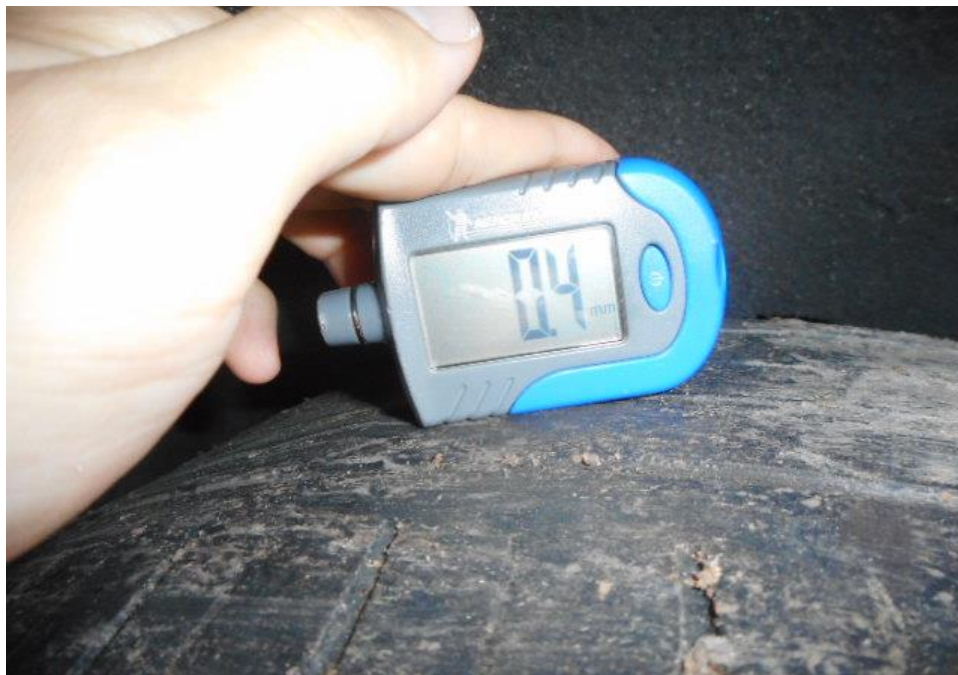
Photo 18 shows measurements being conducted on the inner to outer side of the tread on the rear left tyre of the Insured vehicle. The remaining tread depth was measured to be approximately 0.4mm.

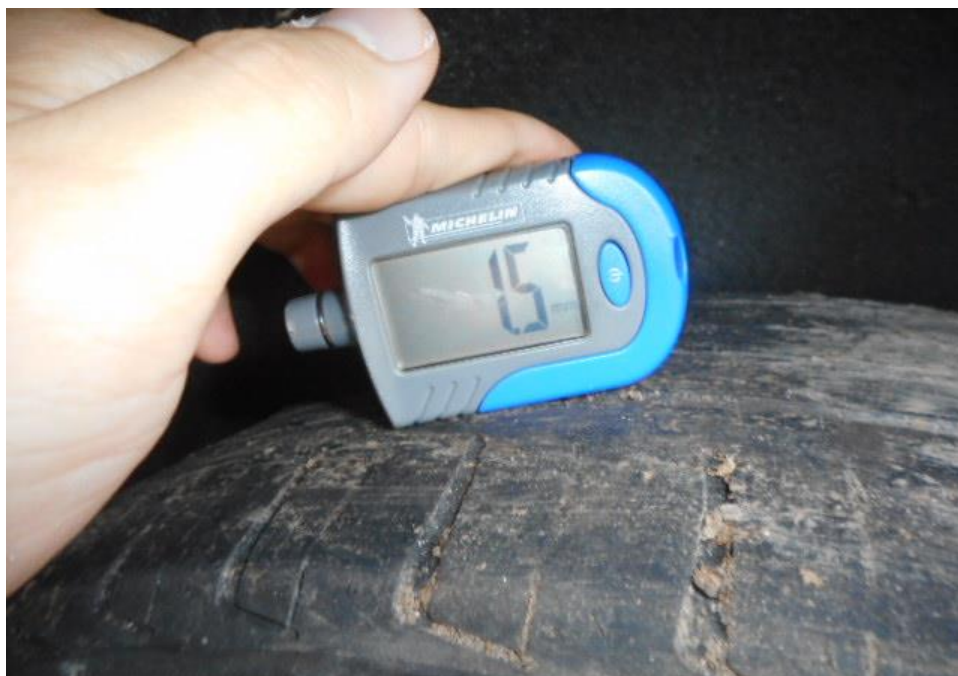
Photo 19 shows measurements being conducted on the inner to outer side of the tread on the rear left tyre of the Insured vehicle. The remaining tread depth was measured to be approximately 1.5mm.
