Your Ref : 6838593563SG  
Our Ref : CI/AIG22002313/D

22 March 2022

**AUTOMOBILE TECHNICAL INVESTIGATION REPORT OF INCIDENT INVOLVING SMA 5189Y AND SJG 6036C ON 17 OCTOBER 2021**

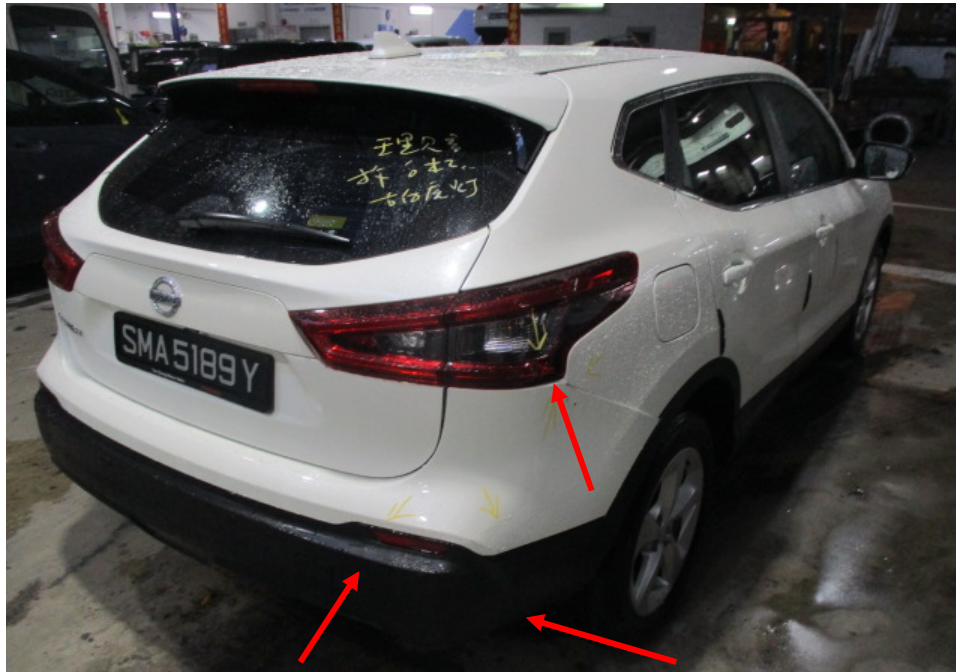
10. The rear bumper was seen to be distorted with a vertical indentation at the area below the rear bumper right reflector. The lower right corner area of the rear bumper was also dented/distorted. The rear right taillamp was cracked at the area adjacent to where the rear bumper aligns with the rear right fender. Overall, the aforesaid damages are all damages that arose from direct contact with an object(s). See photo 1 – 4 below.

**Photo 1** shows the rear right portion of the Third Party Vehicle at the time of physical inspection by LKK Auto Consultants Pte Ltd. The Third Party Vehicle was observed to have sustained damage that was confined to its rear right portion. Direct contact damage was seen at 3 areas at the rear right portion. The rear bumper was distorted with a vertical indentation below the rear bumper right reflector; the lower right corner of the rear bumper was dented/distorted; the rear right taillamp was cracked at the area where the rear bumper aligns with the rear right fender. The aforesaid damage areas are highlighted by the red arrows with close up shown in the below photographs.

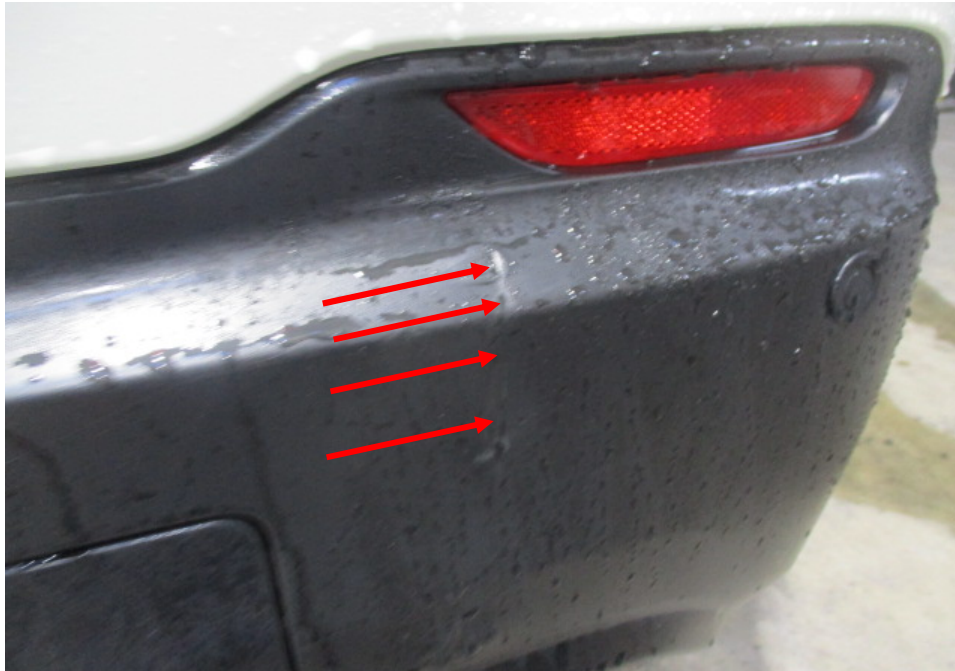
**Photo 2** shows a close up view of the vertical indentation (arrowed) that was seen on the rear bumper of the Third Party Vehicle at the time of physical inspection by LKK Auto Consultants Pte Ltd. This was at the area below the rear bumper right reflector. This damage arose from direct contact with an object(s).

22. Earlier in paragraph 10, I had discussed on the physical damage of the Third Party Vehicle. Following my comments at paragraph 20 above, the distortion with a vertical indention at the area below the Third Party Vehicle's rear bumper right reflector (refer to photograph 2 above) does not seem to be related to this particular incident as the area of this damage was not at the side profile of the Third Party Vehicle. However, the dent/distortion at the lower right corner area of the rear bumper and the crack at the rear right taillamp (refer to photograph 3 & 4 above) are possibly a result of this incident.

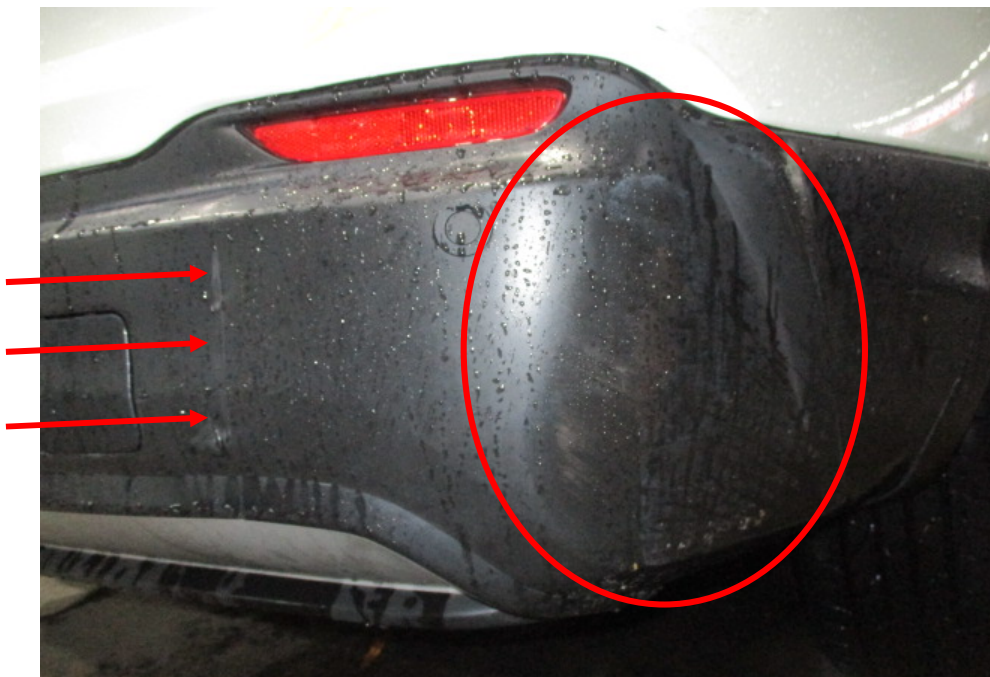
**Photo 3** shows a close up view of the dent/distortion (circled) that was seen on the lower right corner area of the Third Party Vehicle's rear bumper at the time of physical inspection by LKK Auto Consultants Pte Ltd. The vertical indentation at the area below the rear bumper right reflector is also highlighted by the rear arrows. Both these damages arose from direct contact with an object(s).

26. Basing on the height measurements that I had carried out, the dent/distortion at the lower right corner of the Third Party Vehicle's rear bumper was likely to be caused by contact with the Insured Vehicle. The crack to the rear right taillamp of the Third Party Vehicle is not related to this particular incident. In this aspect, using the Vehicle Inspection Report of the Third Party Vehicle by C L Appraiser Pte Ltd that was attached in the Letter of Demand, a reasonable cost of repair to reinstate the Third Party Vehicle is \$850/-. Refer to table below for breakdown of this \$850/-.

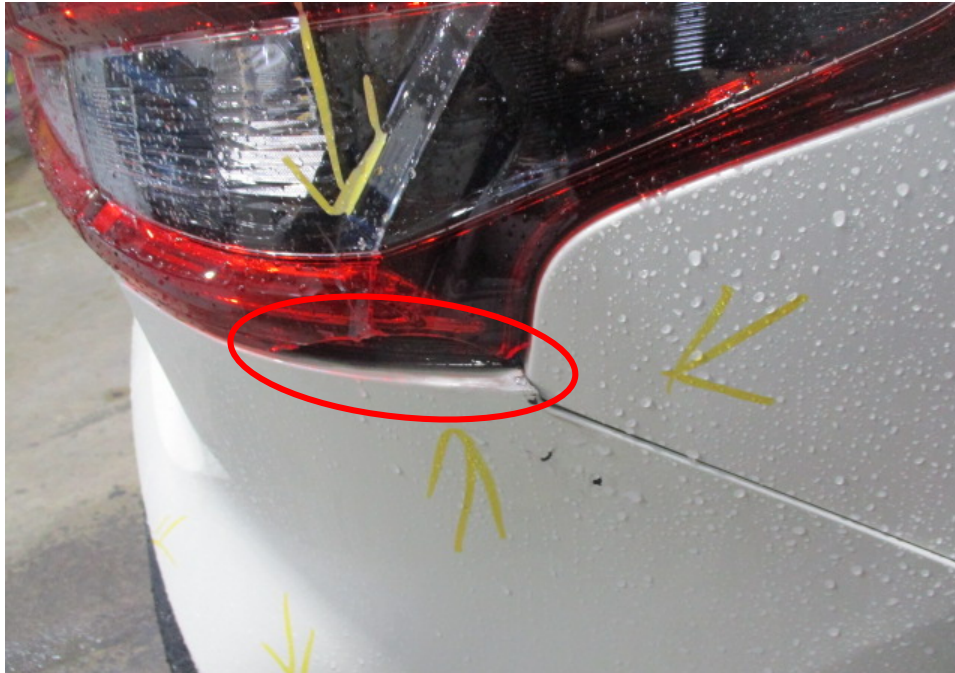
**Photo 4** shows a close up view of the crack (circled) that was seen on the Third Party Vehicle's rear right taillamp at the time of physical inspection by LKK Auto Consultants Pte Ltd. The crack was observed to be at the area where the rear bumper aligns with the rear right fender. This damage arose from direct contact with an object(s).

25. As for the crack to the Third Party Vehicle's rear right taillamp, the height (93cm) above ground level of this damage do not fall within any body part of the Insured Vehicle; and it is unlikely to be related to this incident. The height (67cm) above ground level of the relatively faint grazed marks that was found on the upper left corner area of the Insured Vehicle's front bumper (refer to photograph 6 above) also do not fall within the height above ground level of any damaged parts and/or damaged area of the Third Party Vehicle. These grazed marks are hence also unlikely to be related to this incident. See photo 16 below.

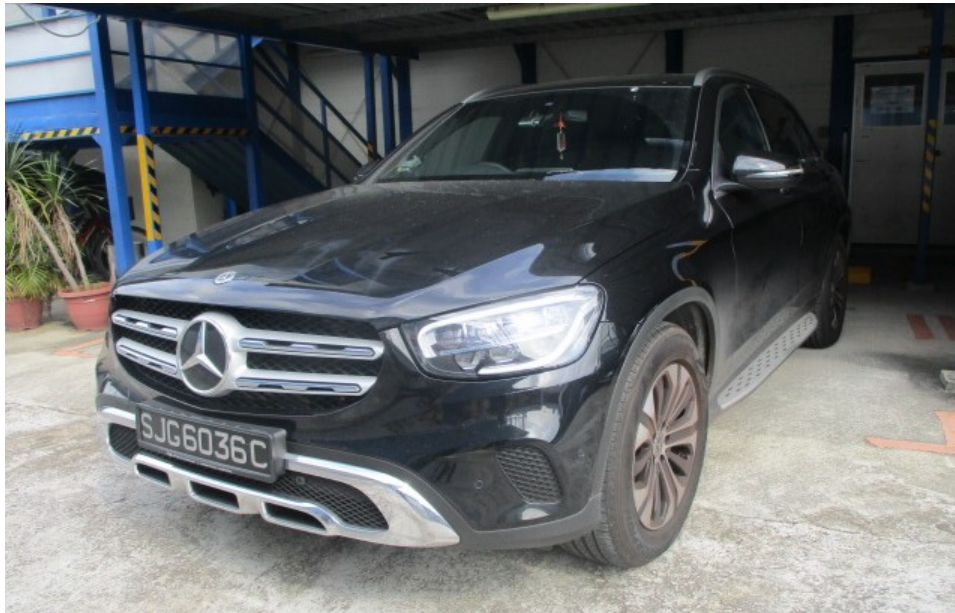
**Photo 5** shows a general view of the front left portion of the Insured Vehicle at the time of my physical inspection on 12 January 2022. My inspection had primarily focused on the front left portion of the Insured Vehicle as the contact with Third Party Vehicle, if any, would have occurred at the front left portion of the Insured Vehicle.

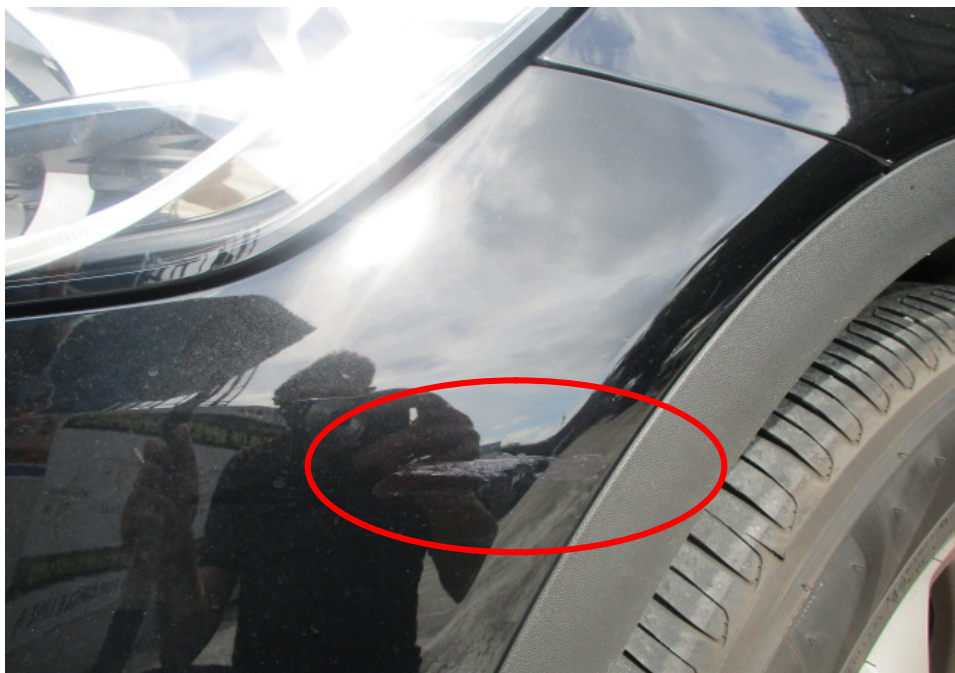
**Photo 6** shows the relatively faint grazed marks (circled) that I had observed on the upper left corner area of the Insured Vehicle's front bumper.

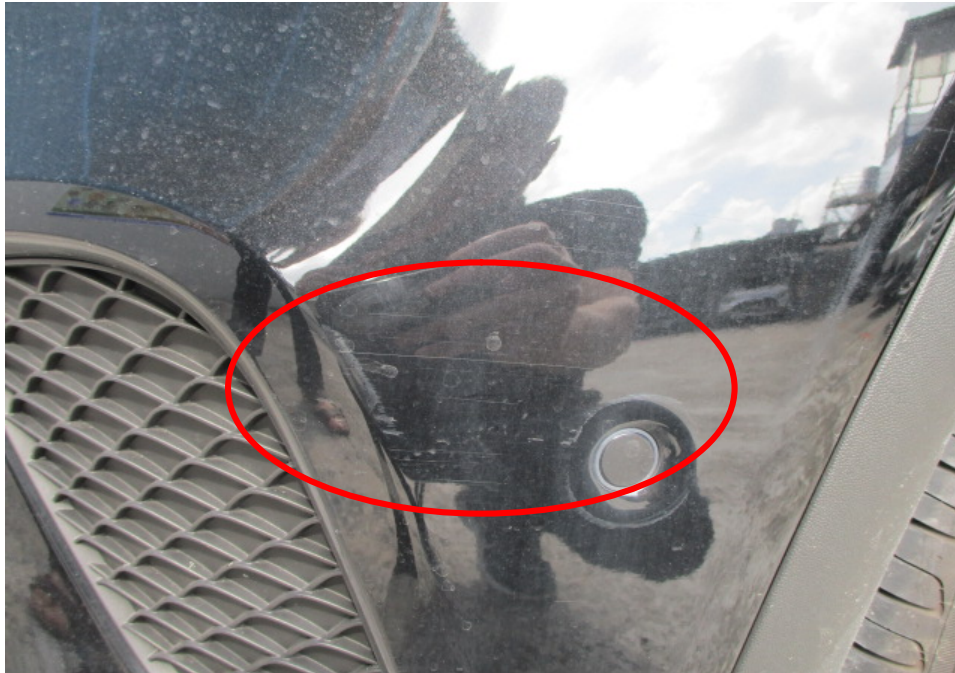
**Photo 7** shows the relatively faint grazed marks (circled) that I had observed on the lower left corner area of the Insured Vehicle's front bumper.

24. Comparing the height of 42cm to 60cm and 93cm above ground level with the side profile of the Insured Vehicle's front right portion, I note that the height (51cm) above ground level of the relatively faint grazed marks that I had found on the lower left corner area of the Insured Vehicle's front bumper, when I had physically inspected the Insured Vehicle on 12 January 2022 (refer to photograph 7 above), was within the height range of the dent/distortion at the lower right corner of the Third Party Vehicle's rear bumper.

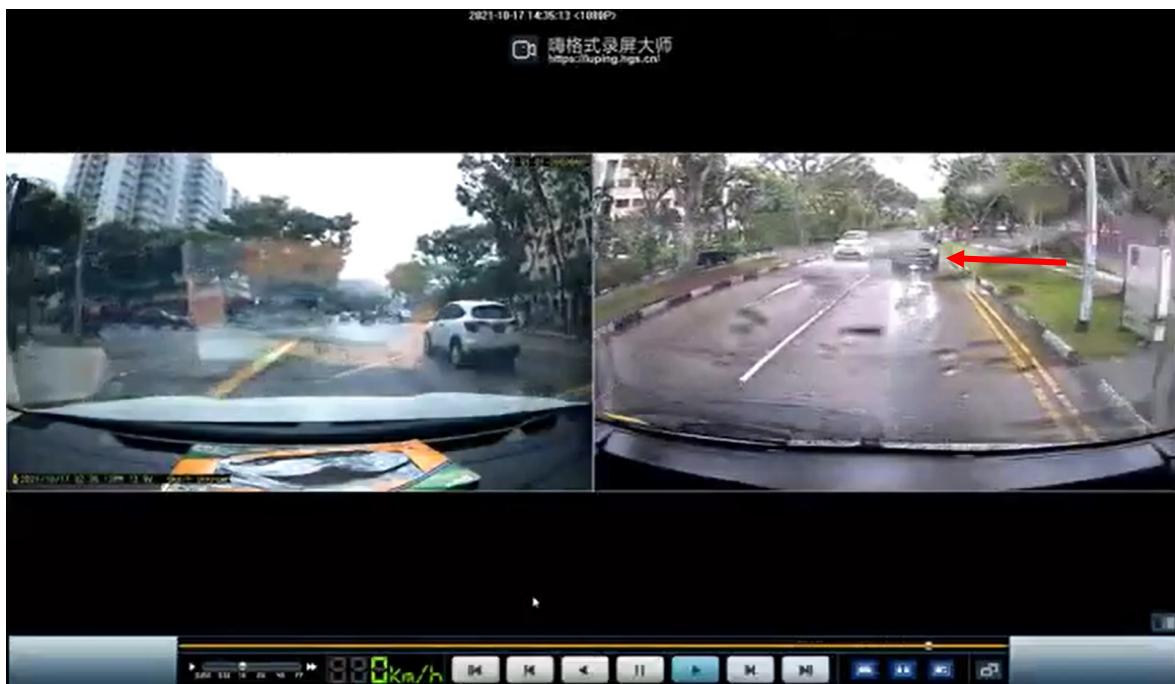
**Photo 8** shows screenshot extracted from the video footage showing the front view and rear view of the Third Party Vehicle's perspective. The Third Party Vehicle was seen making a left turn at a signalized T-junction. The Insured Vehicle (arrowed) was travelling behind the Third Party Vehicle on the same lane.

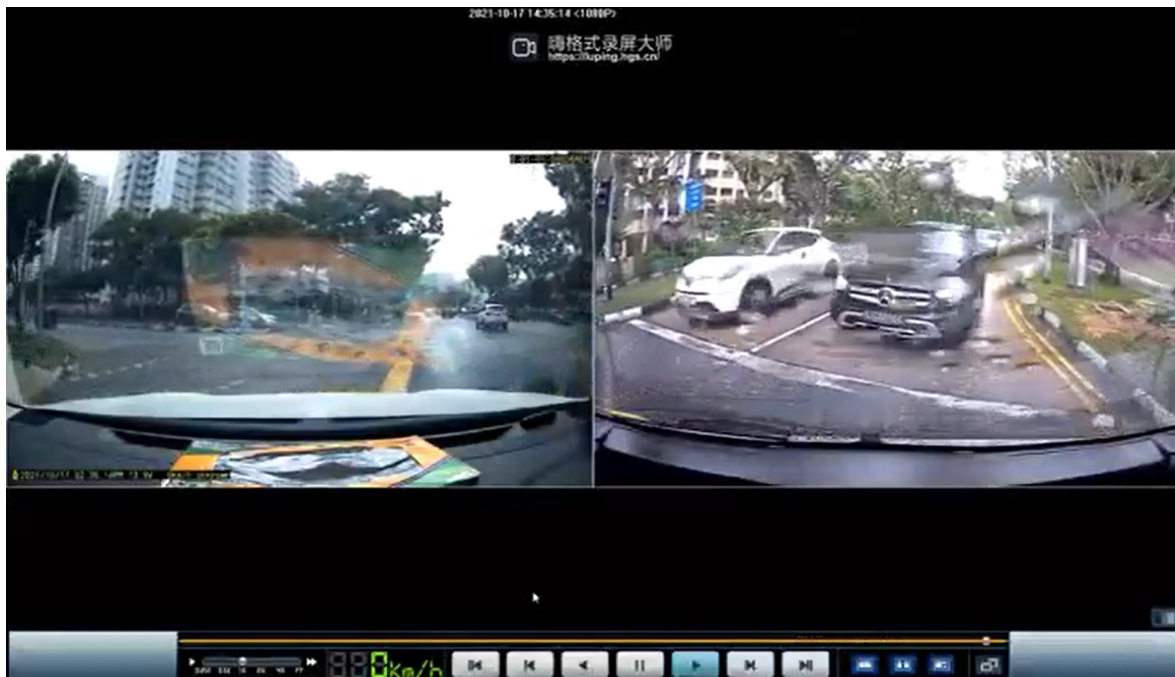
**Photo 9** shows screenshot extracted from the video footage showing the front view and rear view of the Third Party Vehicle's perspective. This was at the time just before the Third Party Vehicle had stopped to give way to a cyclist who was cycling along the pedestrian crossing, across the roadway that the Third Party Vehicle was turning into. The Third Party Vehicle was stopped in an angled position typically seen when vehicles execute a left turn at a T-junction. Its rear right portion was seen to have extended out onto the extreme left lane that it was initially travelling on.

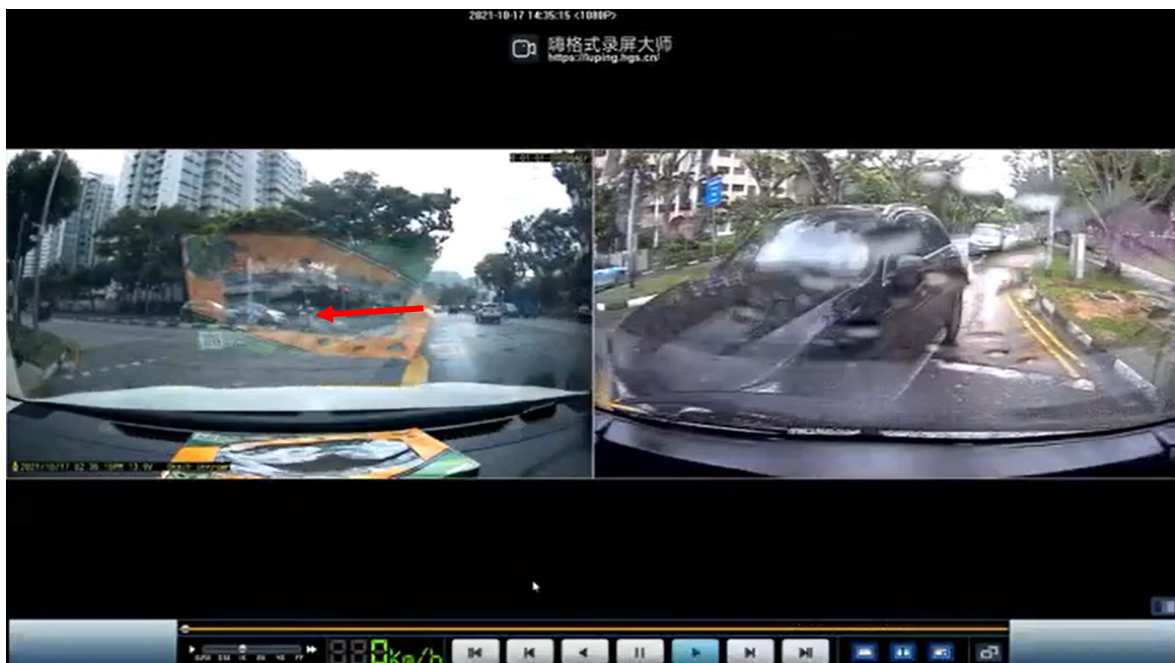
**Photo 10** shows screenshot extracted from the video footage showing the front view and rear view of the Third Party Vehicle's perspective. This was at the time just before the Insured Vehicle had come to a complete stop. The cyclist cycling across the roadway is highlighted by the red arrow.

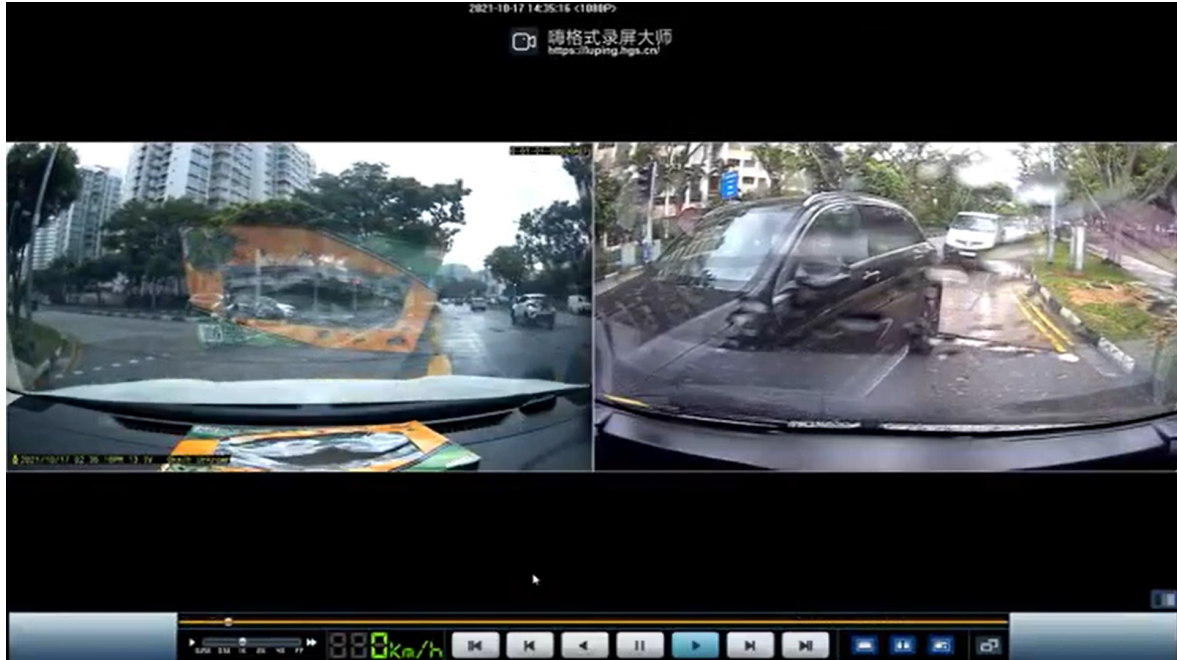
**Photo 11** shows screenshot extracted from the video footage showing the front view and rear view of the Third Party Vehicle's perspective. This was at the time when the Insured Vehicle had come to a complete stop. As seen from the video footage, the Insured Vehicle had stopped with its front left portion in close proximity to the rear right portion of the Third Party Vehicle. Almost simultaneously at this point, a female on board the Third Party Vehicle can be heard asking "*what happened*" in Mandarin, which appears to be in response to a thud like sound captured by the recording devices. This was at the 7 second mark of the video footage.

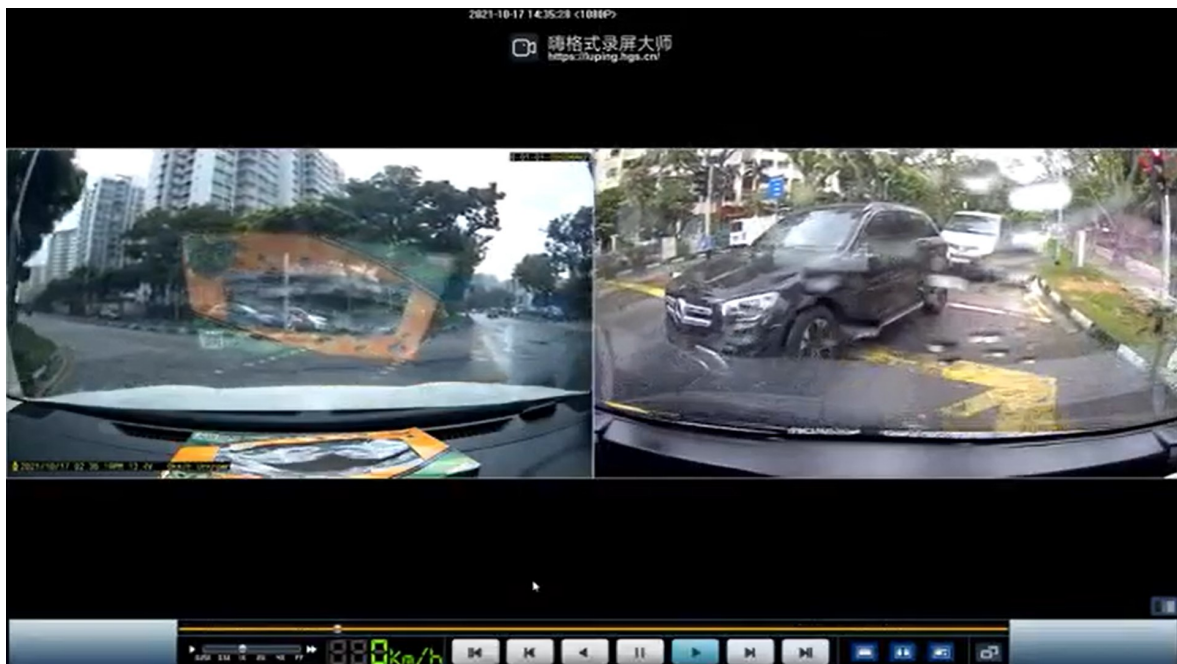
**Photo 12** shows screenshot extracted from the video footage showing the front view and rear view of the Third Party Vehicle's perspective. This was at the time when the Third Party Vehicle started to move off to complete its intended left turn.

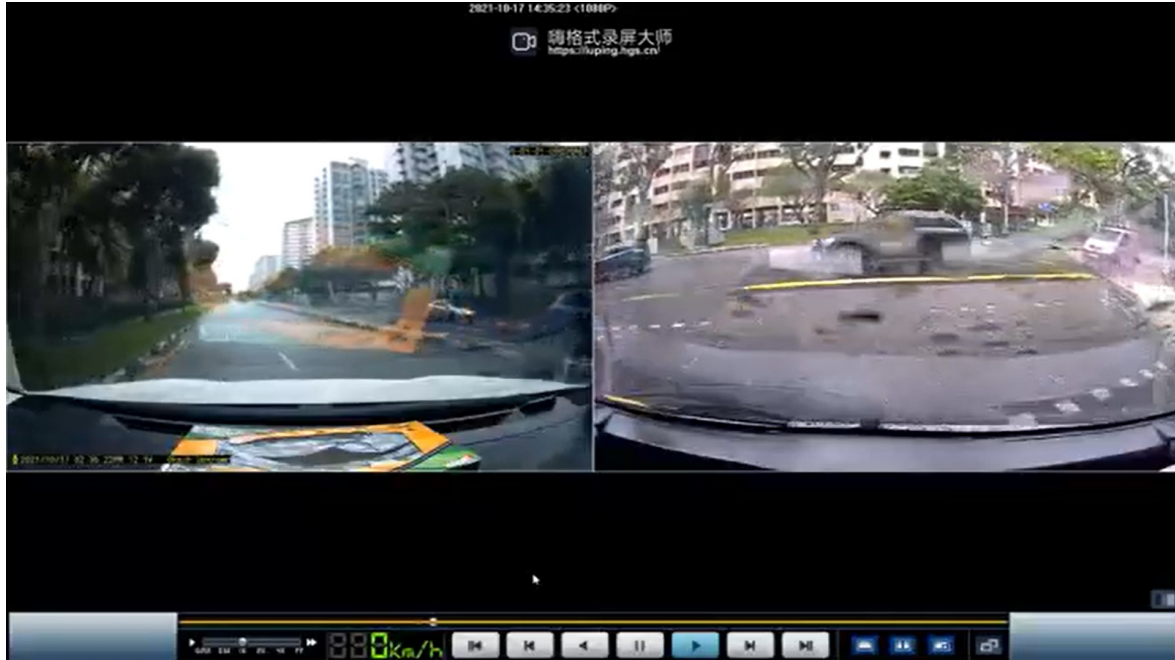
**Photo 13** shows screenshot extracted from the video footage showing the front view and rear view of the Third Party Vehicle's perspective. As seen from the video footage, the Third Party Vehicle turned left while the Insured Vehicle drove straight. I note from the video footage that the conversation between the occupants on board the Third Party Vehicle after it had completed its left turn was centered on whether the Insured Vehicle had contacted onto the Third Party Vehicle.

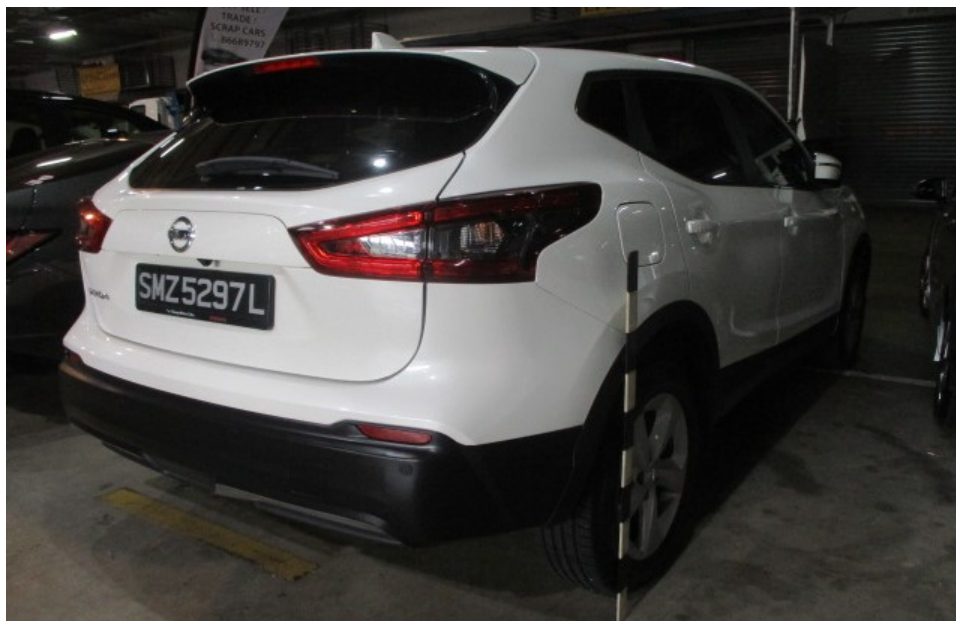
**Photo 14** shows height measurement being carried out at the rear right, side profile of a similar make and model vehicle as the Third Party Vehicle.

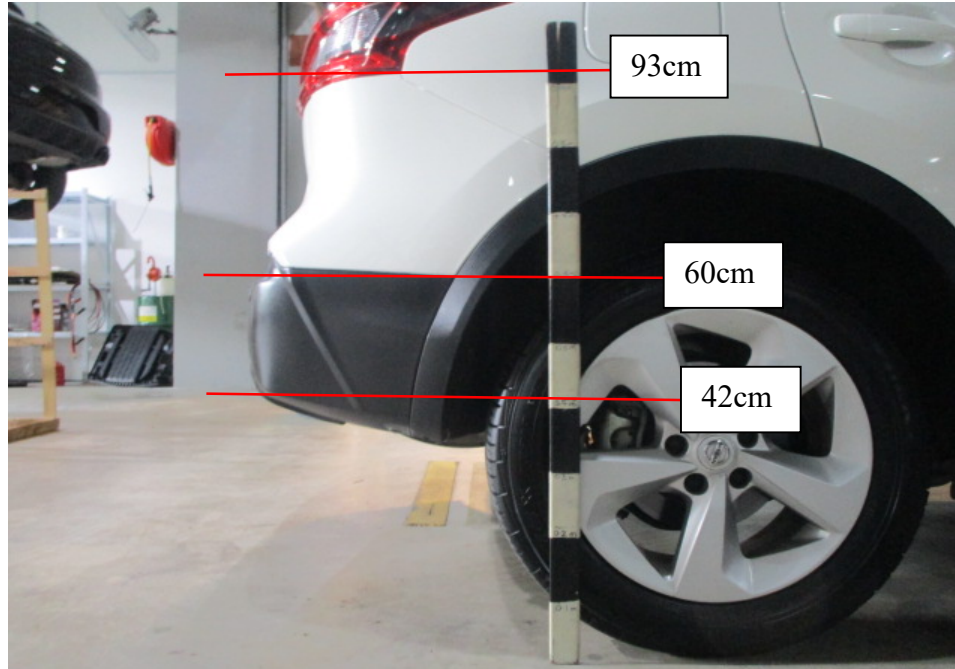
**Photo 15** shows height measurement being carried out at the rear right, side profile of a similar make and model vehicle as the Third Party Vehicle. The height of the dent/distortion at the lower right corner area of the Third Party Vehicle's rear bumper (refer to photograph 3 above) was measured to be 42cm to 60cm above ground level. The crack at the rear right taillamp (refer to photograph 4 above) of the Third Party Vehicle was 93cm above ground level.

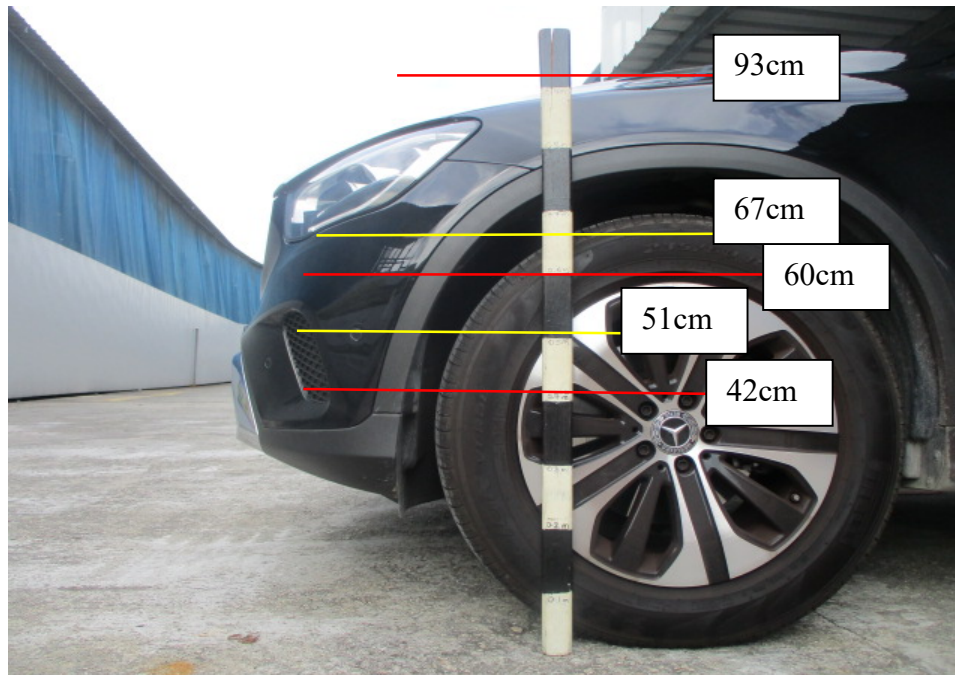
**Photo 16** shows height measurement being carried out at the side profile of the Insured Vehicle, at its front left portion. This was at the time of my physical inspection on 12 January 2022. Comparing the height above ground level of the damaged rear bumper (42cm to 60cm) and cracked rear right taillamp (93cm) of the Third Party Vehicle, I note that the height (51cm) above ground level of the relatively faint grazed marks that I had found on the lower left corner area of the Insured Vehicle's front bumper when I had physically inspected the Insured Vehicle on 12 January 2022 (refer to photograph 7 above), was within the height range of the dent/distortion at the lower right corner of the Third Party Vehicle's rear bumper. As for the crack to the Third Party Vehicle's rear right taillamp, the height (93cm) above ground level of this damage do not fall within any body part of the Insured Vehicle.
