Your Ref: SNC 6872D
Our Ref : CI/III22002331/P

**TECHNICAL INVESTIGATION REPORT OF WARRANTY CLAIM INVOLVING
THE INSURED VEHICLE SNC 6872D ON 8th March 2022**

Vehicle Registration No.	: SNC 66872D
Make / Model	: MERCEDES BENZ E200 AVG (R18 LED)
Chassis No	: WDD2130422A222869
Year of Registration	: APR 2017
Mileage	: 146,926KM

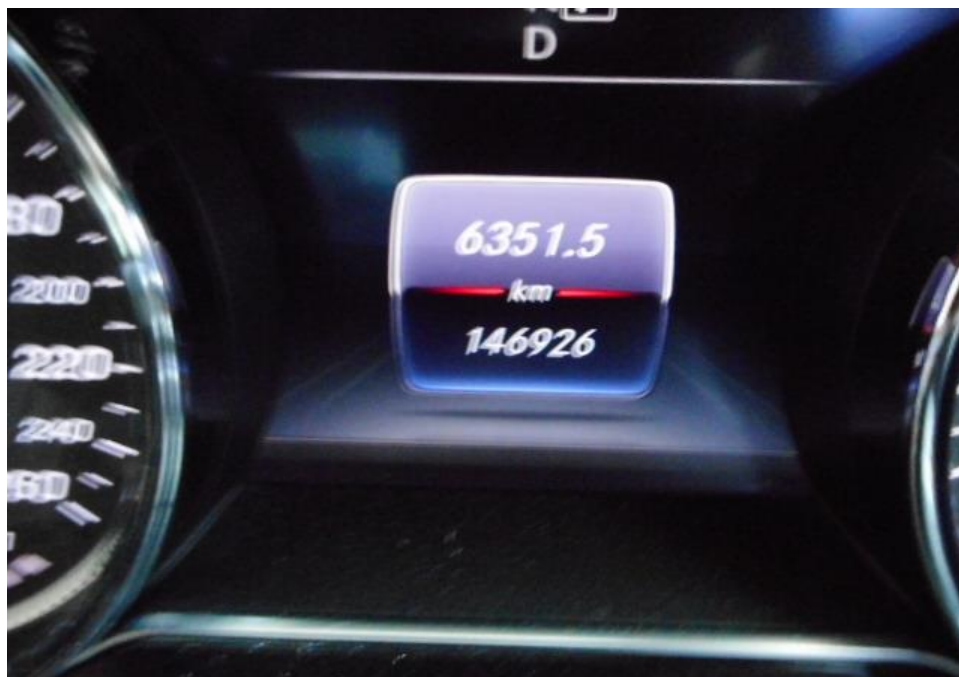
Photo 1 shows the mileage of the Insured Vehicle recorded at the time inspection at 146,926KM

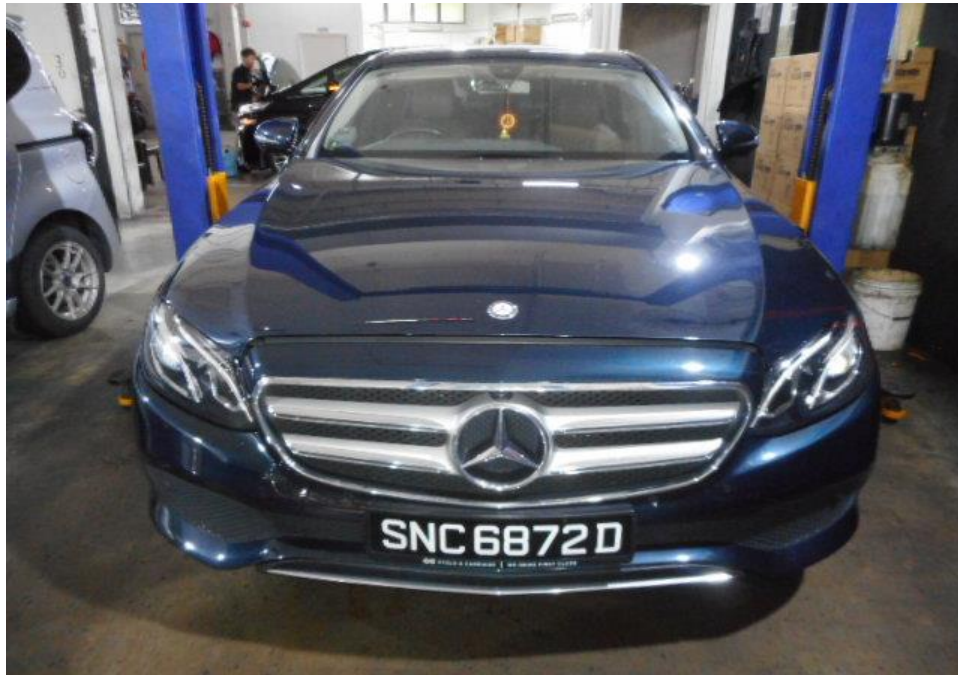
Photo 2 shows the general view of the front portion of the Insured Vehicle at the time of our inspection. The Insured Vehicle is observed to be unaffected by any signs of accident.

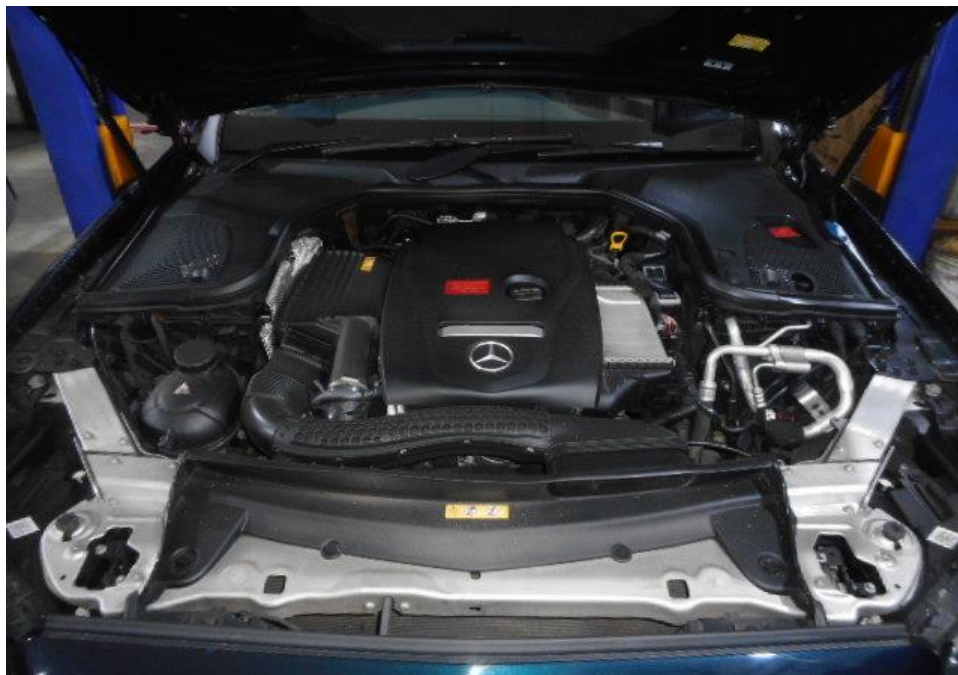
Photo 3 shows the general view of the engine portion of the Insured Vehicle at the time of our inspection. The engine compartment is observed to be unaffected by any signs of accident.

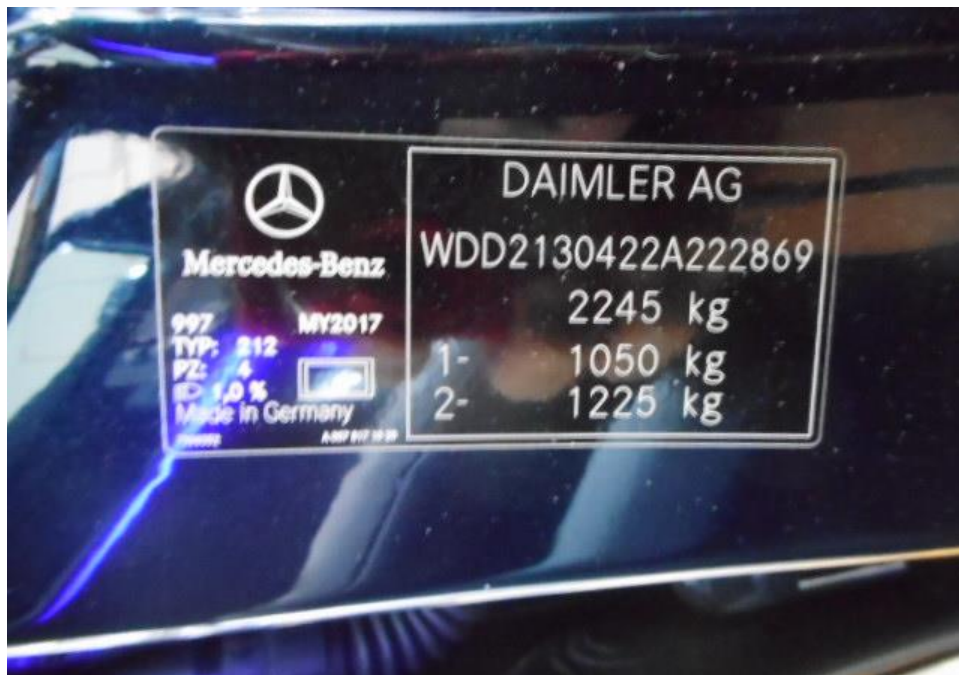
Photo 4 shows the chassis number of the Insured Vehicle at the time of our inspection.

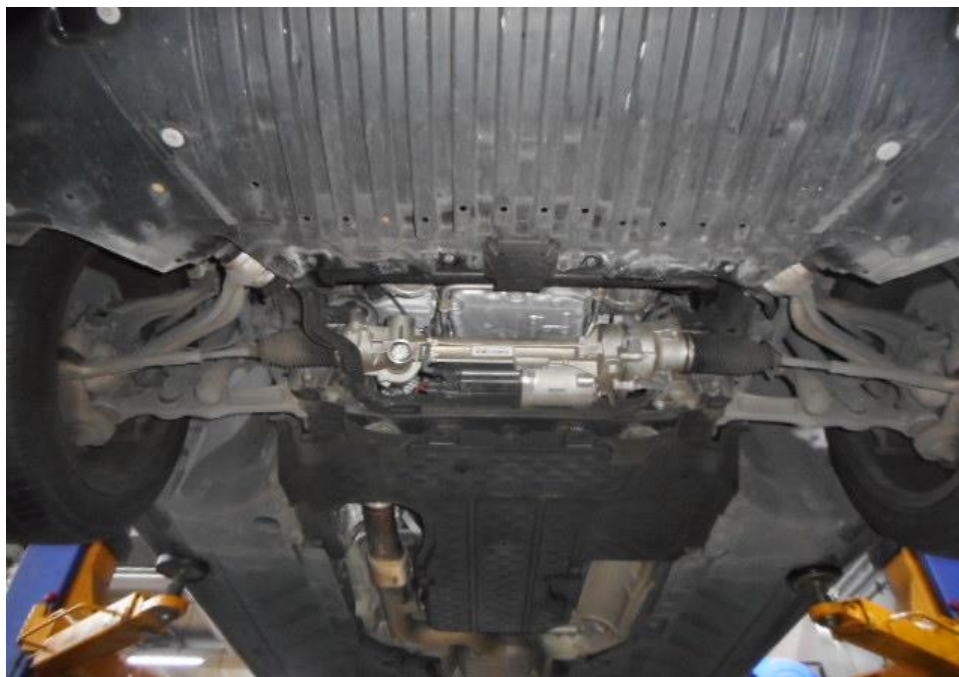
Photo 5 shows the general view of the engine underside portion of the Insured Vehicle at the time of our inspection. The engine underside compartment is observed to be unaffected and by any signs of accident.

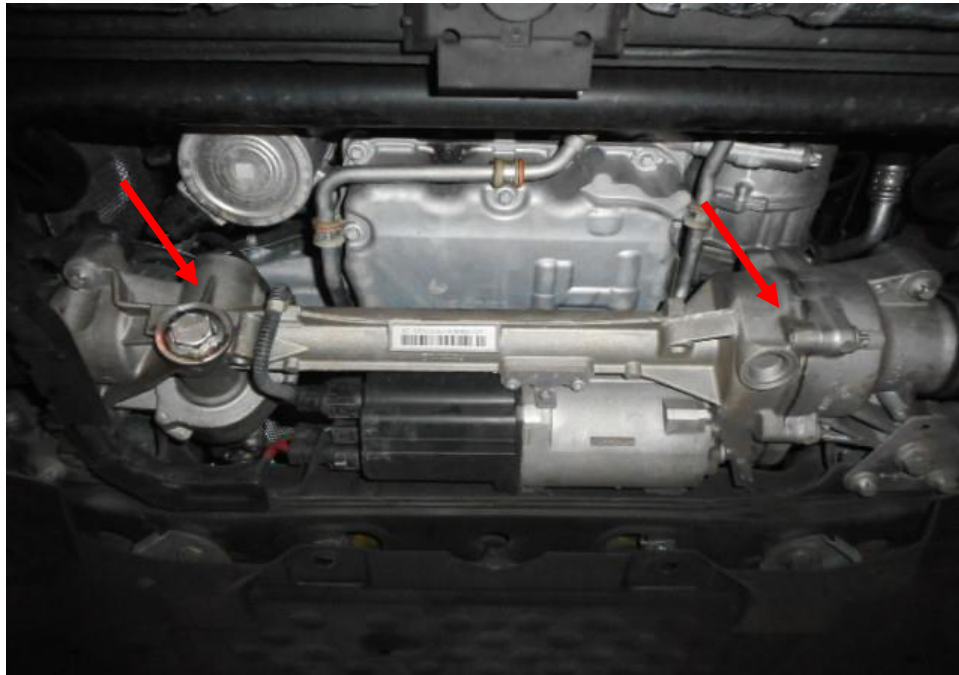
5. The complaint on the Insured Vehicle was noted be to knocking noise from steering rack and pinion when turning the steering wheel and when the vehicle is driving over bumps and uneven road surfaces. There is a recommendation by the workshop to replace the steering rack and pinion unit. The vehicle was observed to be unaffected by any signs of accident.

Photo 6 shows the close up view of the power steering portion of the Insured Vehicle at the time of our inspection. The Electronic Power Steering unit and its steering rack and pinion component is observed to be unaffected and by any signs of accident.

8. We did not find any evidence which had suggested that the cause of abnormalities to the Insured Vehicle was due to poor maintenance and/or recurring problem.
9. The recommendation to replace the Power steering rack and pinion unit at \$4,670.55 is justifiable as all the relevant checks has been conducted.

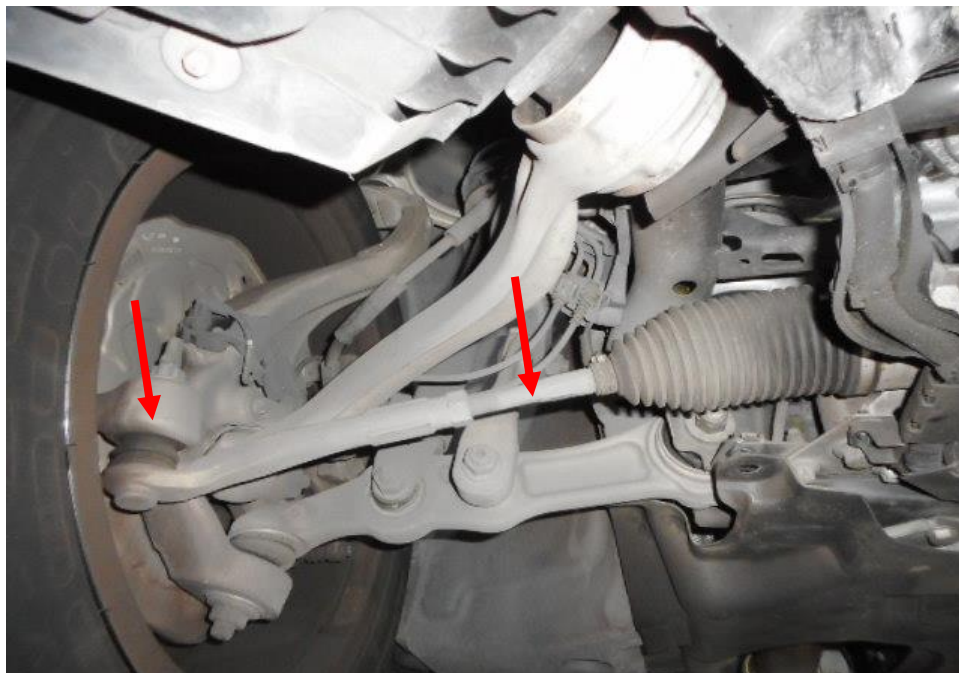
Photo 7 shows the close up view of the front left wheel of the Insured Vehicle at the time of our inspection. The steering tie rod (arrowed) is observed to be unaffected and by any signs of accident.

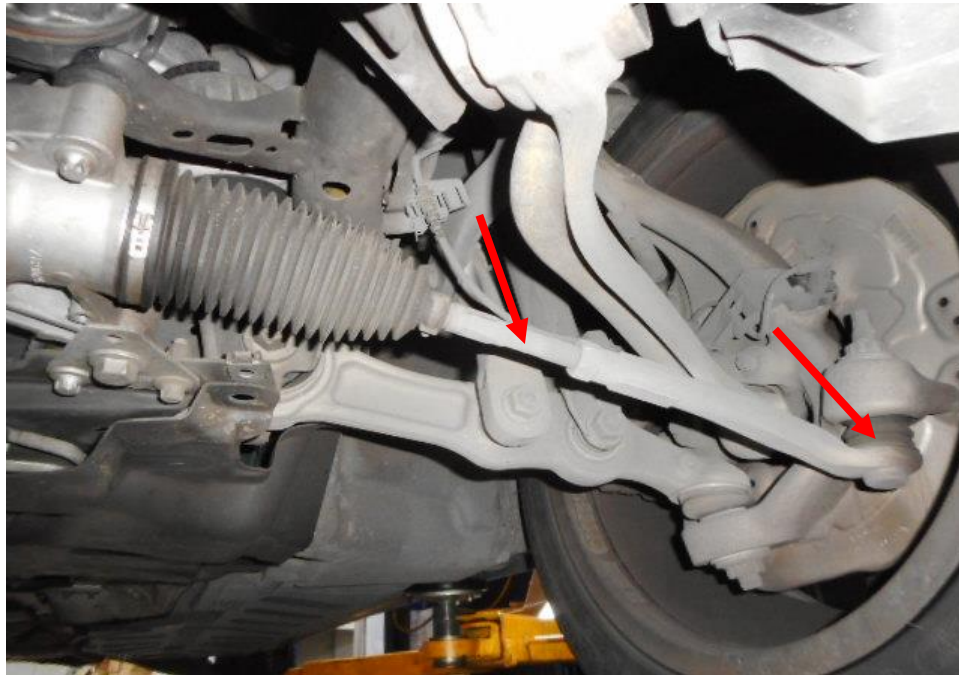
Photo 8 shows the close up view of the front right wheel of the Insured Vehicle at the time of our inspection. The steering tie rod (arrowed) is observed to be unaffected and by any signs of accident.

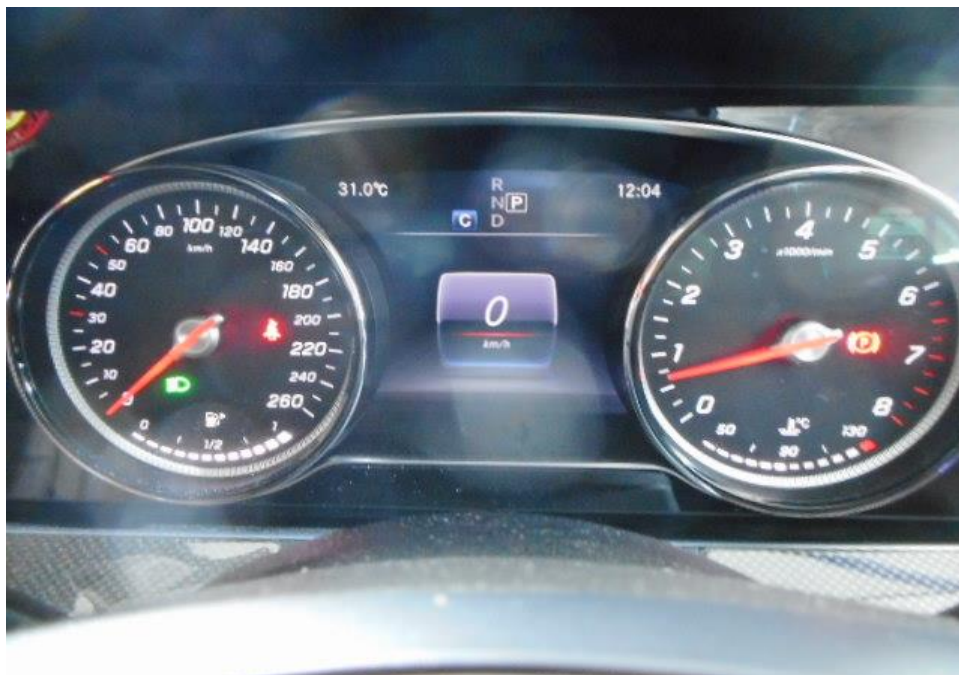
Photo 9 shows the conducted ECU diagnosis of the Insured Vehicle at the time of our inspection. There was no electronic error on the Electronic Power Steering of the Insured Vehicle.
