You're Ref: TP/IP/02286/2022
Our Ref: CI/TPD22002401/P

General Investigation Team

MECHANICAL INSPECTION REPORT OF MOTOR CAR SKH 4566K

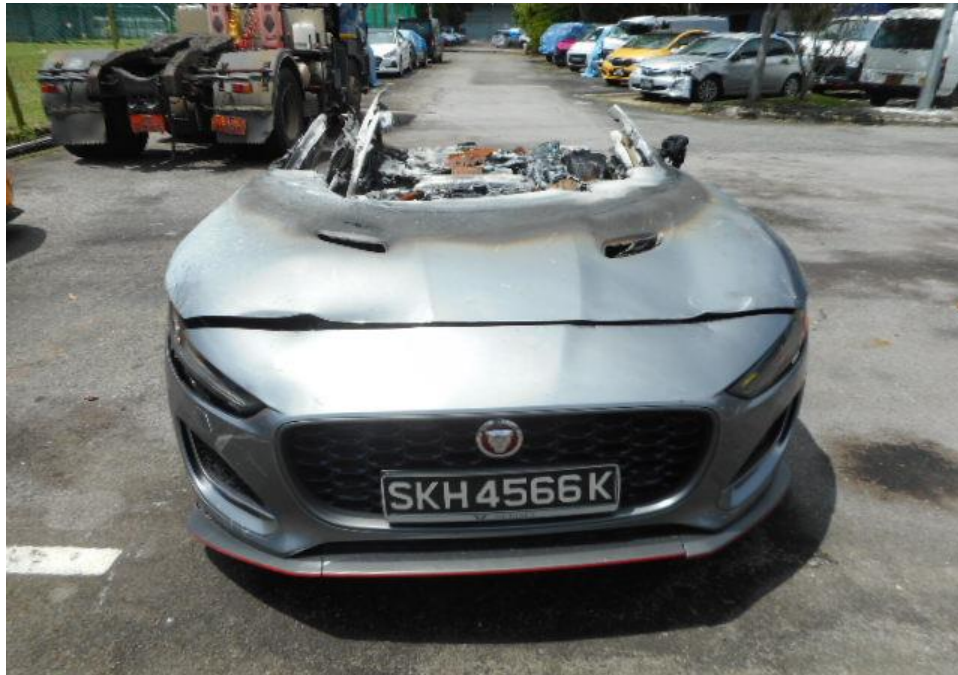
Photo 1 shows a general view of the Motor Car's front body at the time of my inspection. The front of the Motor Car was observed to not sustain any physical damages.

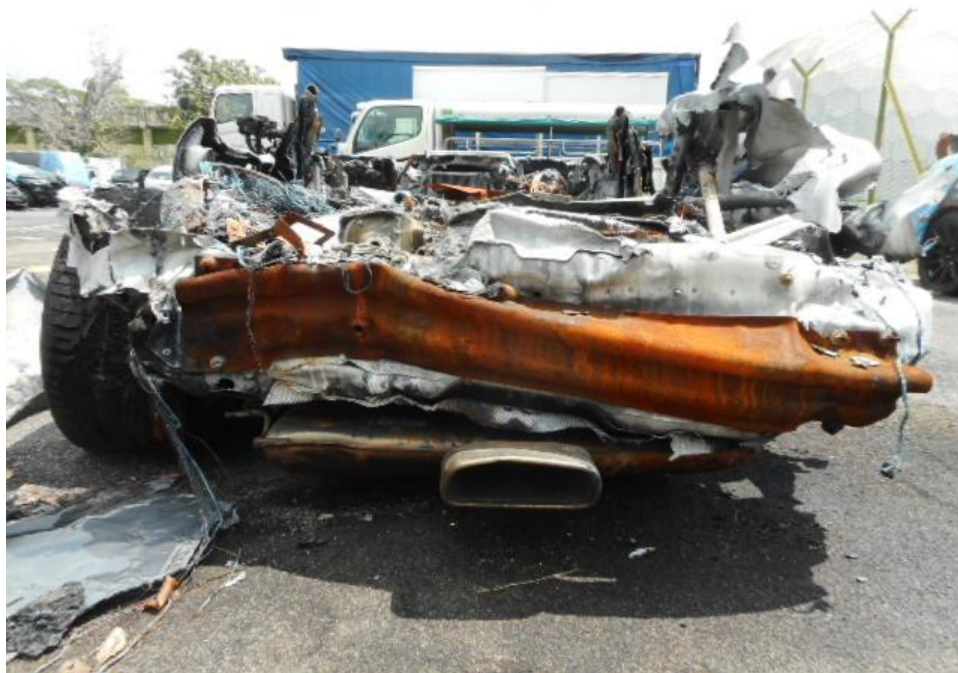
Photo 2 shows the general view of the rear portion of the Motor Car at the time of our inspection. The Motor Car was observed to have sustained physical damage at its rear portion. Its rear left bumper portion was observed to have been damaged as a result of the road traffic accident. The fire had also affect the rear of the Motor car.

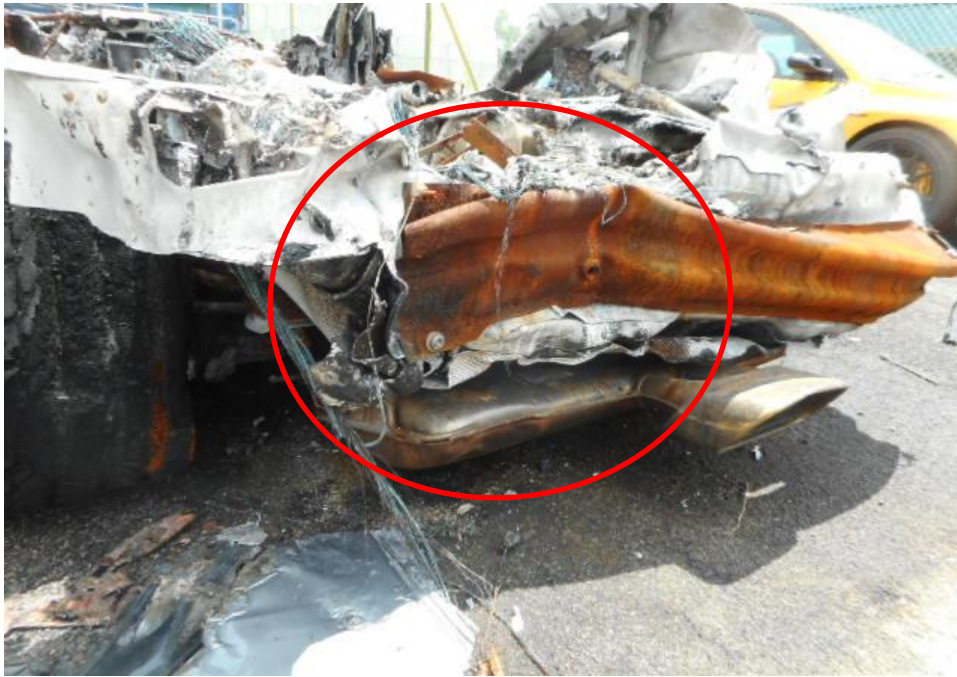
Photo 3 shows the close up view of the rear portion of the Motor Car at the time of our inspection. The Motor Car was observed to have sustained physical damage at its rear portion. Its rear left bumper portion (circled) was observed to have been damaged as a result of the road traffic accident. The fire had also affect the rear of the Motor car.

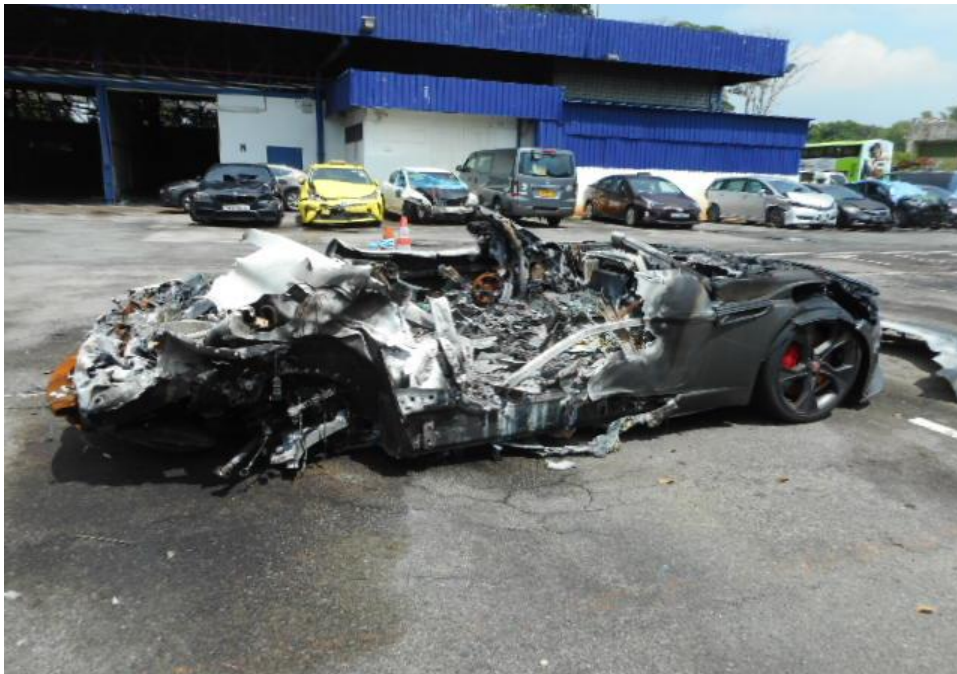
Photo 4 shows the general view of the right portion of the Motor Car at the time of our inspection. The Motor Car was observed to have sustained physical damage at its right portion. Its right body panel and right rear fender portion was observed to have been damaged as a result of the road traffic accident. The fire had also affect the right of the Motor car.

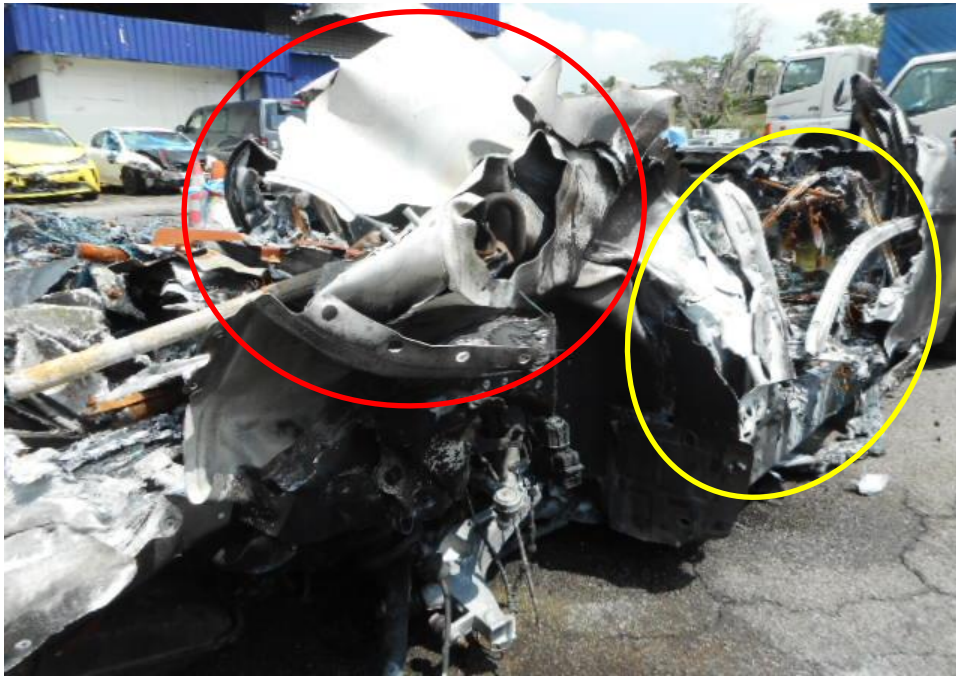
Photo 5 shows the close up view of the rear portion of the Motor Car at the time of our inspection. The Motor Car was observed to have sustained physical damage at its right portion. Its right body panel (yellow circle) and right rear fender (red circle) portion was observed to have been damaged as a result of the road traffic accident. The fire had also affect the right of the Motor car.

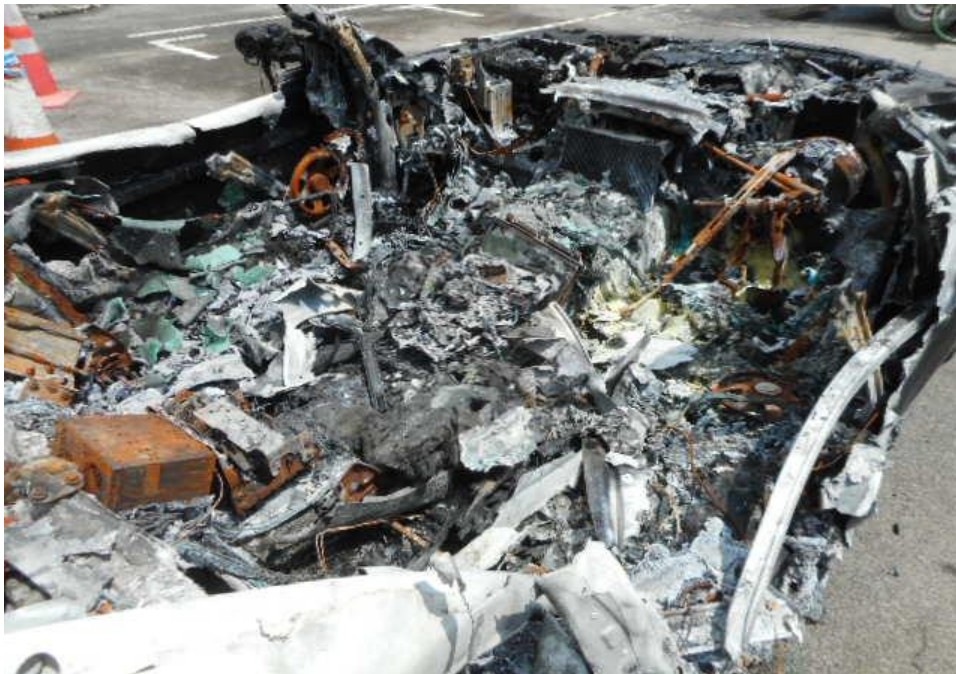
Photo 6 shows the general view of the interior compartment of the Motor Car at the time of our inspection. Its interior compartment was completely burnt as a result of the fire.

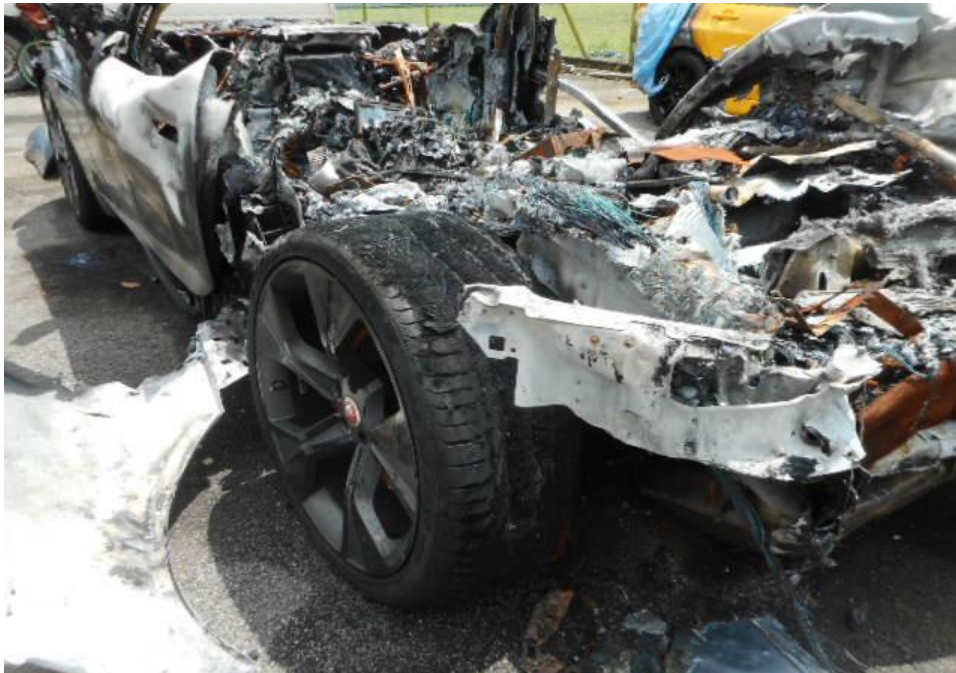
6. Based on the circumstances for this particular case, the fire appears to have originated from the rear left of the Motor Car, somewhere around the rear left and spread to the front of the Motor Car. This can be determined basing on the area where the extent of fire damage was most severe, the circumstances of the fires' origin at the material time of incident and also the high heat intensity burn marks (whitish burn marks) that were found on the exterior surface of its rear left chassis portion.

7. These whitish burn marks are a result of exposure to prolong heat intensity. Rust would normally start to develop around these areas soon after a fire as the prolonged exposure to high heat intensity usually causes the bare steel/metal material of the body parts to be exposed to natural environmental condition. The rust that had developed on the vehicle components, in the immediate vicinity of where these whitish burn marks were found, would also support our findings of where the fire had affected the Motor Car. See photo 7 and 8 below.

Photo 7 shows the exterior of the rear left portion of the Motor Car at the time of our inspection. The high heat intensity burn marks (whitish burn marks) and rust that had development found on the exterior surface indicates that the fire had originated from the rear left portion of the Motor Car.

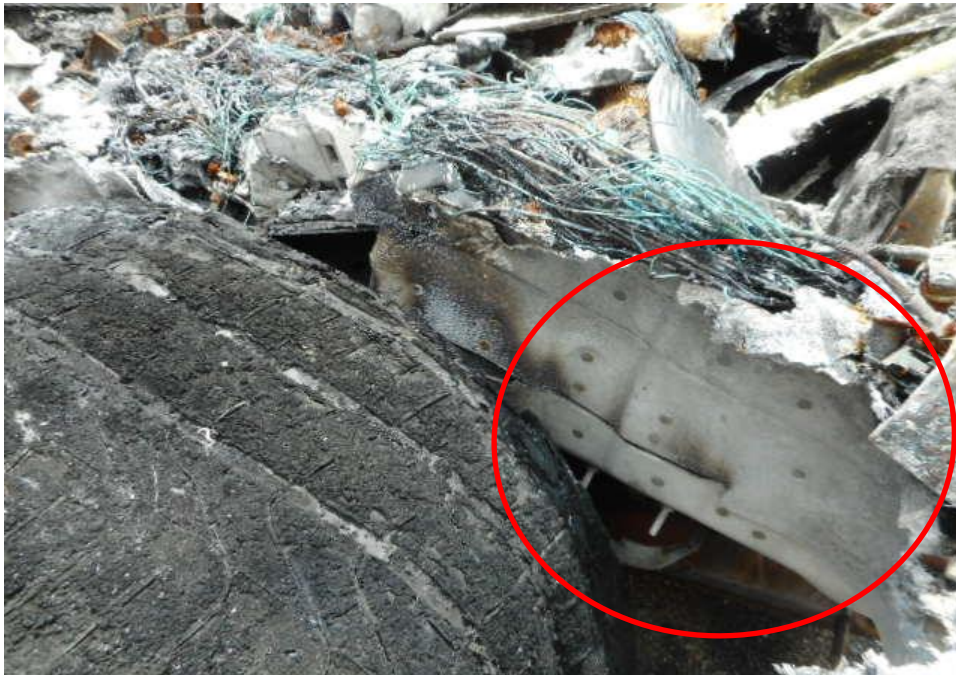
Photo 8 shows the exterior of the rear left portion of the Motor Car at the time of our inspection. The high heat intensity burn marks (whitish burn marks) and rust that had development found on the exterior surface (circled) indicates that the fire had originated from the rear left portion of the Motor Car.

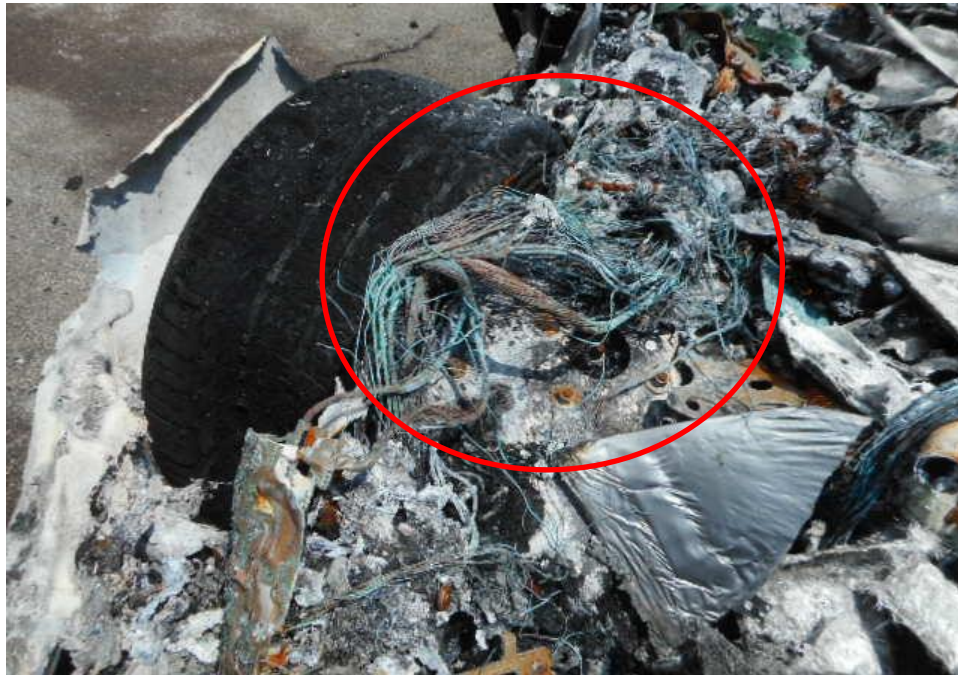
8. Upon closer examination of the rear left portion of the Motor Car which was where the fire had started, we had found traces of greenish residue on the main wirings harnesses leading to the electrical components of the Motor Car. The wirings were original wirings fitted from the manufacturer. The presence of greenish residue indicates internal heating of copper wires, a sign of an electrical short circuit occurring. The greenish residue is normally left behind from the oxidation as a result of chemical reaction involving the copper wires. This physical evidence would then appear to suggest that the cause of fire to the Motor Car could have possibly been due to electrical in nature. See photos 9 - 11 below.

Photo 9 shows a general view of the original wiring harness in the rear left interior compartment. The original wiring harness (circled) was observed with greenish residue on the surface. The presence of greenish residue indicates internal heating of copper wires, a sign of an electrical short circuit occurring. The greenish residue is normally left behind from oxidation as a result of chemical reaction involving the copper wires.

14. We are in view, that the cause of fire to the Motor Car was due to the impact from the accident when had damaged the original wiring harnesses wirings and electrical components located at the rear left portion of the Motor Car causing an electrical short circuit during the towing journey by the tow truck to the Traffic Police Vehicle pound.

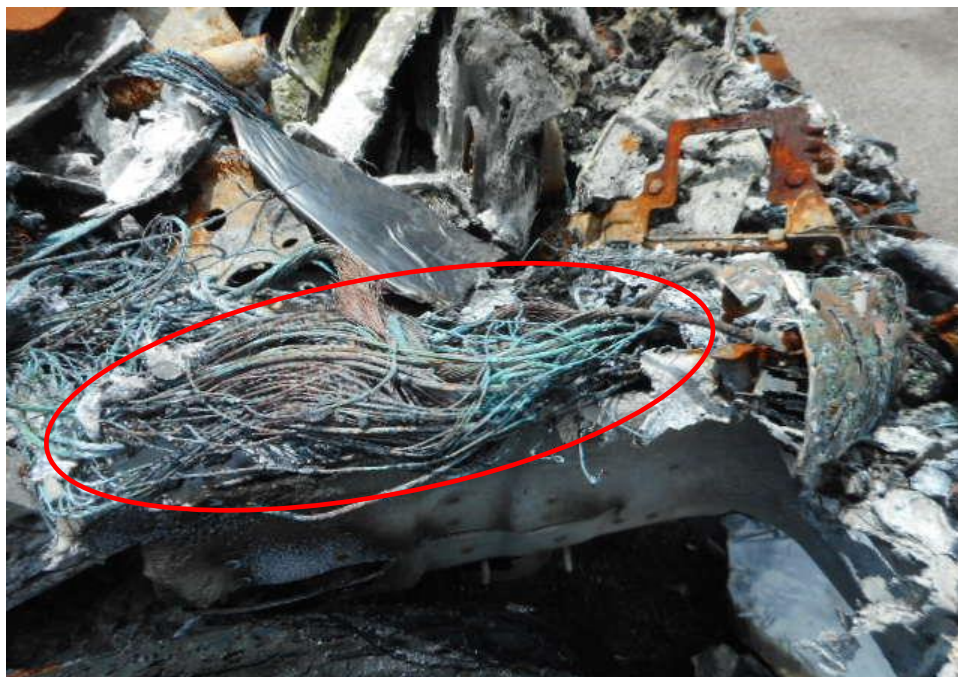
Photo 10 shows a close up view of the original wiring harness in rear left interior compartment. The original wiring harness (circled) was observed with greenish residue on the surface. The presence of greenish residue indicates internal heating of copper wires, a sign of an electrical short circuit occurring. The greenish residue is normally left behind from oxidation as a result of chemical reaction involving the copper wires.

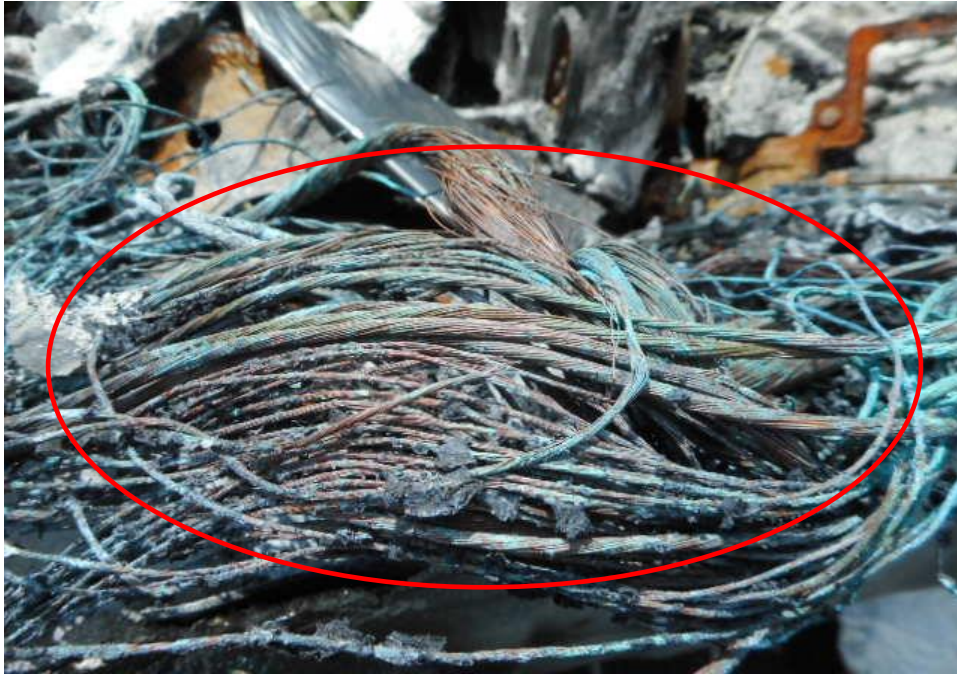
Photo 11 shows a close up view of the original wiring harness in the rear left interior compartment. The original wiring harness (circled) was observed with greenish residue on the surface. The presence of greenish residue indicates internal heating of copper wires, a sign of an electrical short circuit occurring. The greenish residue is normally left behind from oxidation as a result of chemical reaction involving the copper wires.

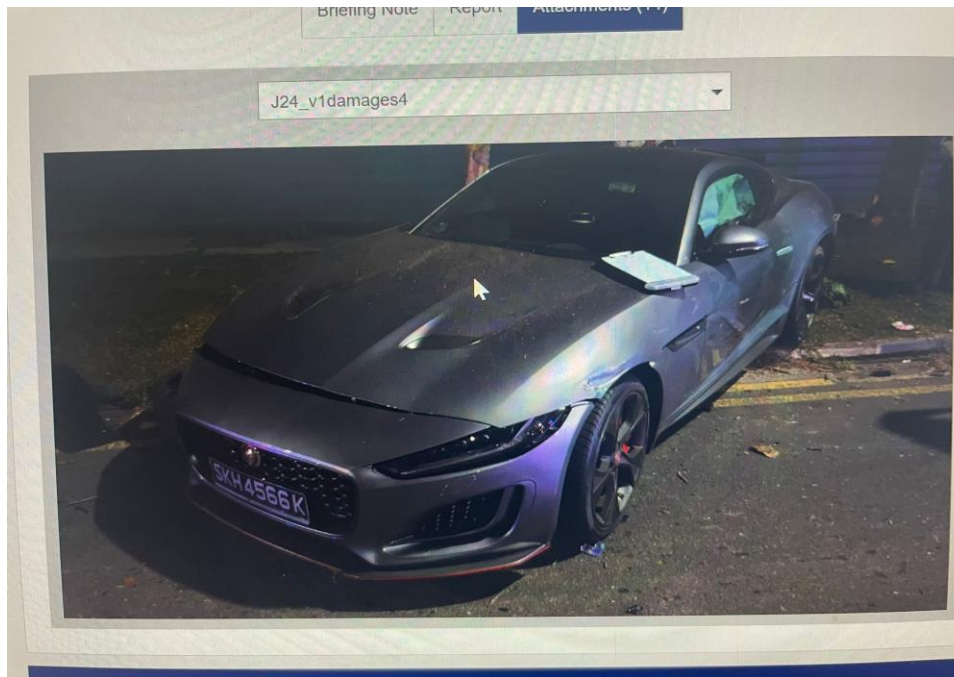
Photo 12 shows the front portion of the Motor Car at the time of incident scene. The front portion did not sustain major damages from the impact of the incident. In general, the information that could be gathered from this photograph had corresponded to our findings on the Motor Car during our inspection.

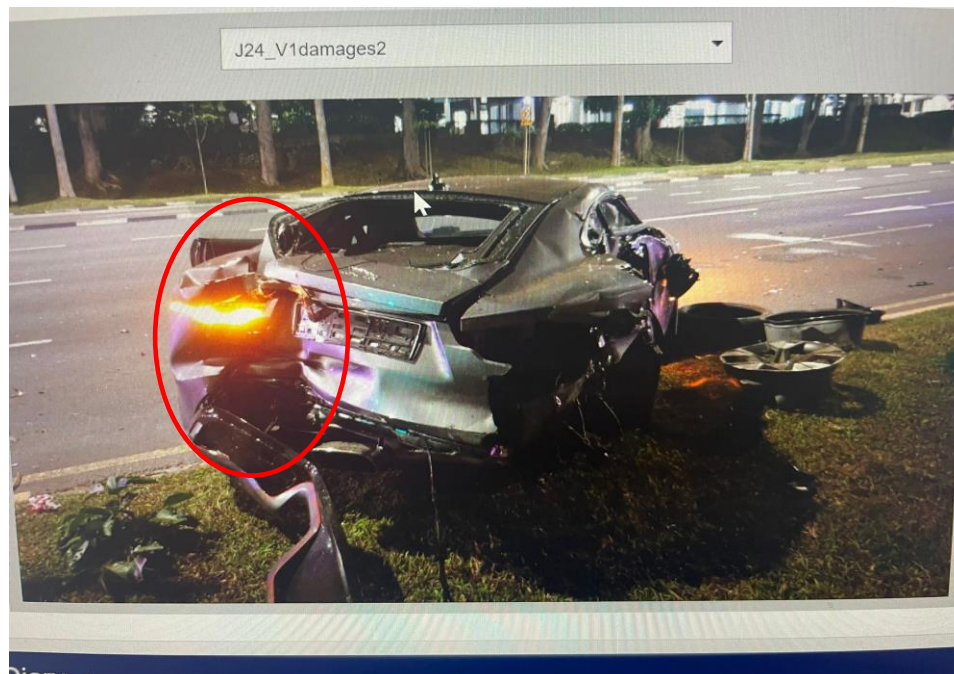
Photo 13 shows the rear left portion of the Motor Car at the time of incident scene. The rear left portion had sustained dent damages from the impact of the incident. In general, the information that could be gathered from this photograph had corresponded to our findings on the Motor Car during our inspection.
