Your Ref: TP/IP/02918/2022
Our Ref: CI/TPD22002406/P

21st March 2022

MECHANICAL INSPECTION REPORT OF MOTOR VAN PA 7894X

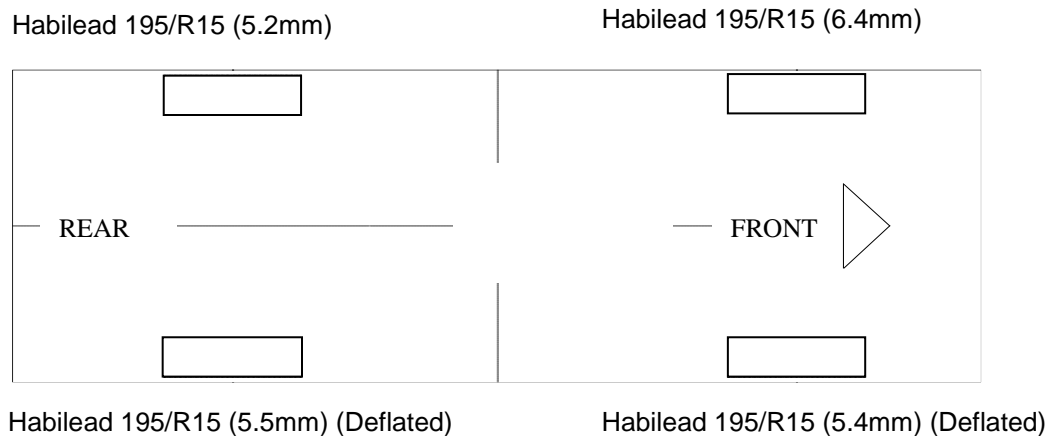
6. The condition of the Motor Van's both right front and rear was observed to be deflated due to the result of the accident. However, the left front and rear tyres was observed to be in serviceable condition. I did not find any tear, cut or burst mark(s) on the outer and the inner sidewalls as well as across the tread of the 4 tyres. The left front and rear tyres were observed to be sufficiently inflated for vehicular operation. The tyre brand, tyre size and remaining tread depth of the 4 tyres were recorded as follows:-

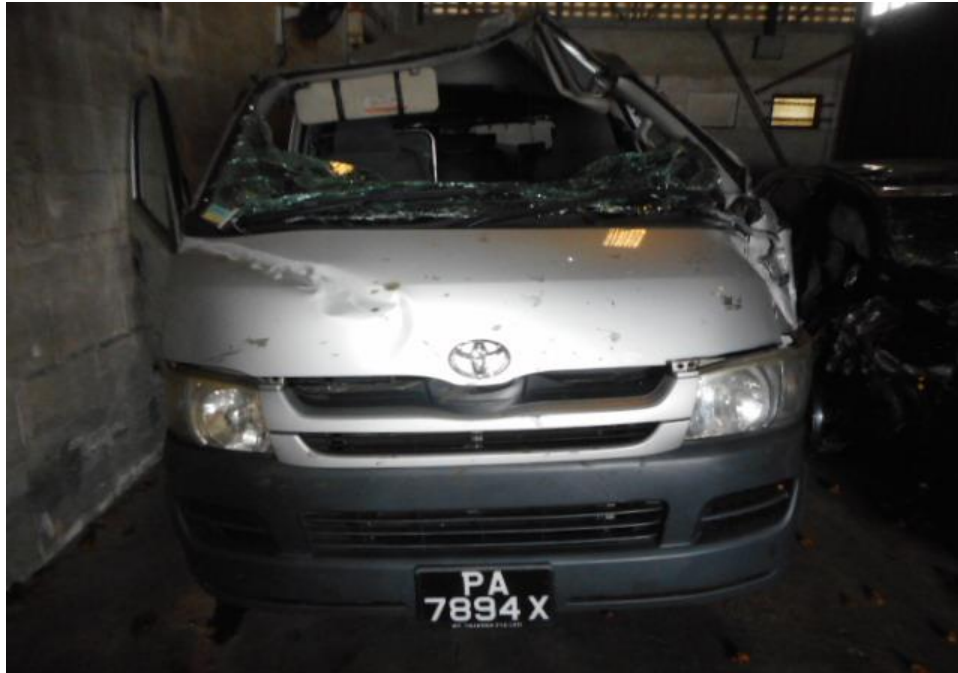
4. The mileage of the Motor Van at the time of my inspection was not recorded as the dashboard of the Motor Van was damaged as a result of the accident.
5. The Motor Van was observed to have sustained damage all around, front windscreen, front cabin, front body panel, front left and right door. Its left and right body panel as well as its rear door and rear windscreen was damaged as a result of the accident.

Photo 1 shows a general view of the front portion of the Motor Van at the time of our inspection. The Motor Van was observed sustained damage all around, front windscreen, front cabin, front body panel, front left and right door. Its left and right body panel as well as its rear door and rear windscreen was damaged as a result of the accident.

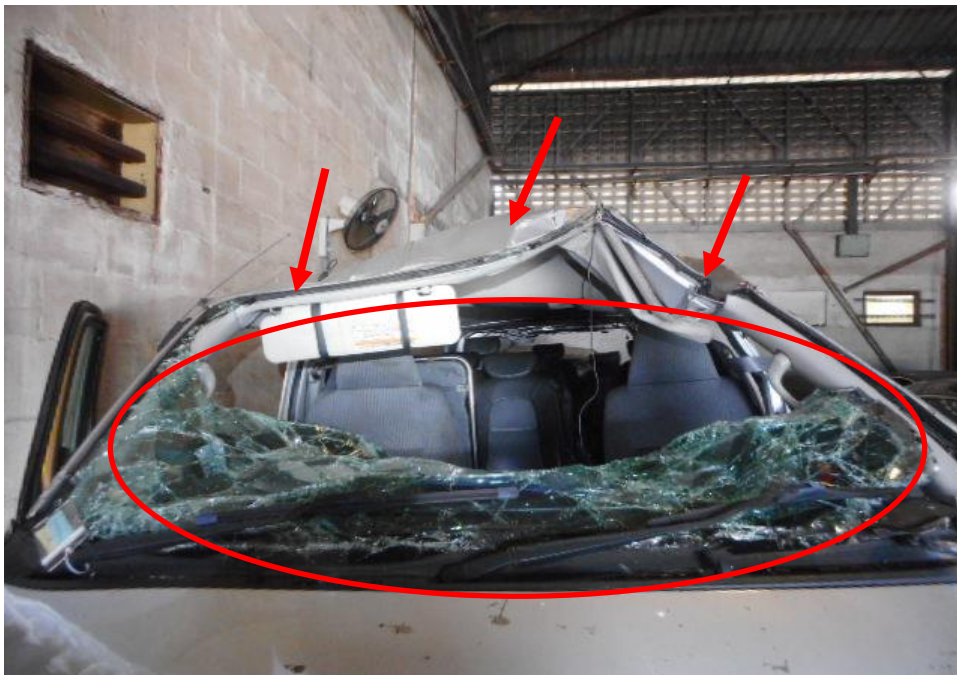
Photo 2 shows the close up view of the front portion of the Motor Van at the time of our inspection. The Motor Van was observed to have sustained major damages to its front windscreen (circled) and its front cabin (arrowed) that was crushed due to the accident's impact.

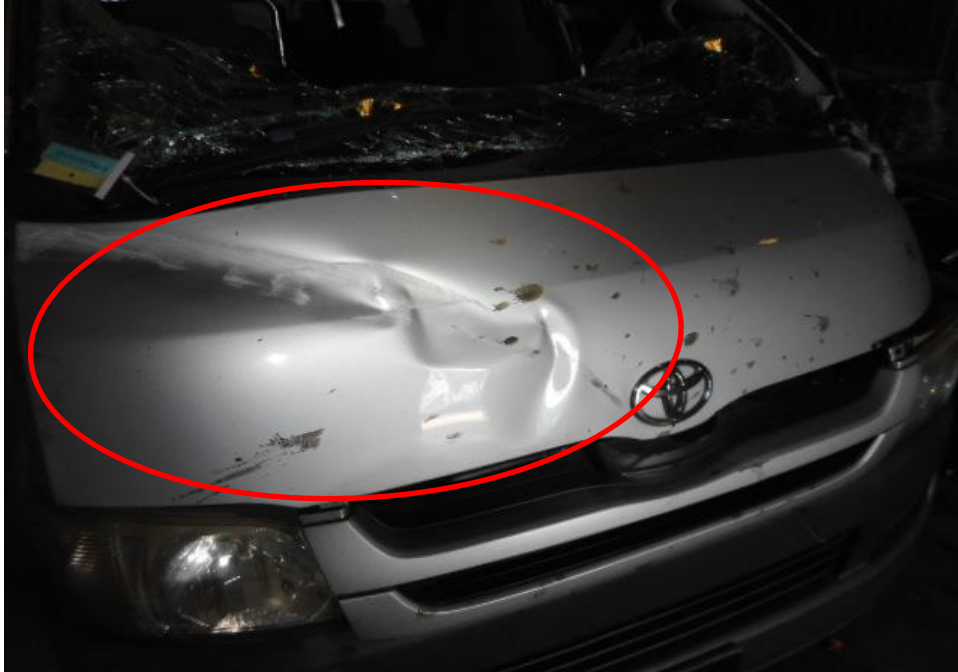
Photo 3 shows the close up view of the front portion of the Motor Van at the time of our inspection. The Motor Van was observed to have sustained major damages to its front body panel (circled) that was damaged as a result of the accident's impact.

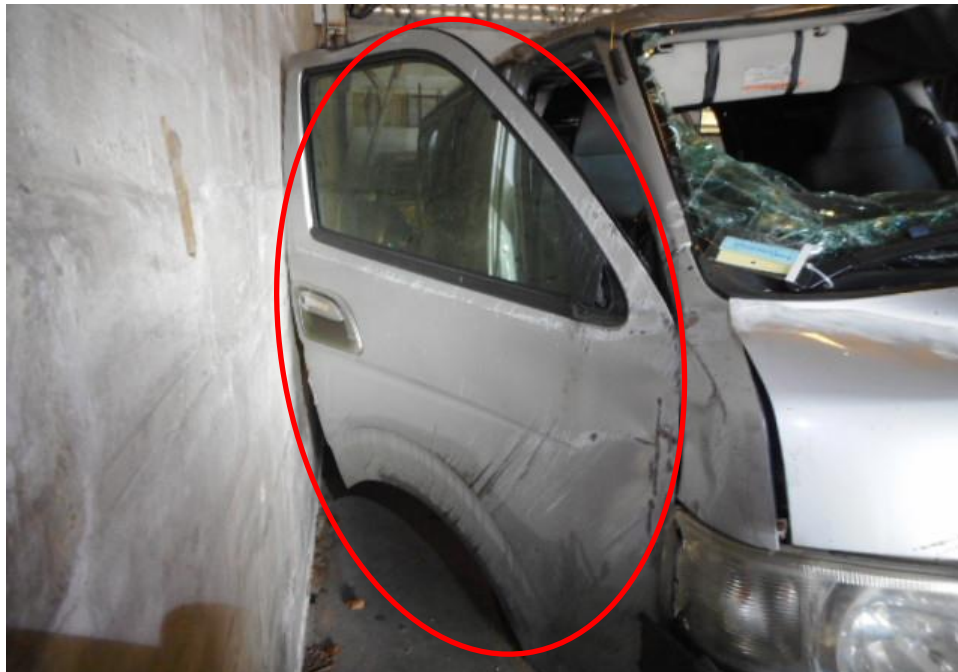
Photo 4 shows the close up view of the right door of the Motor Van at the time of our inspection. The Motor Van was observed to have sustained damages to its right door (circled) as a result of the accident.

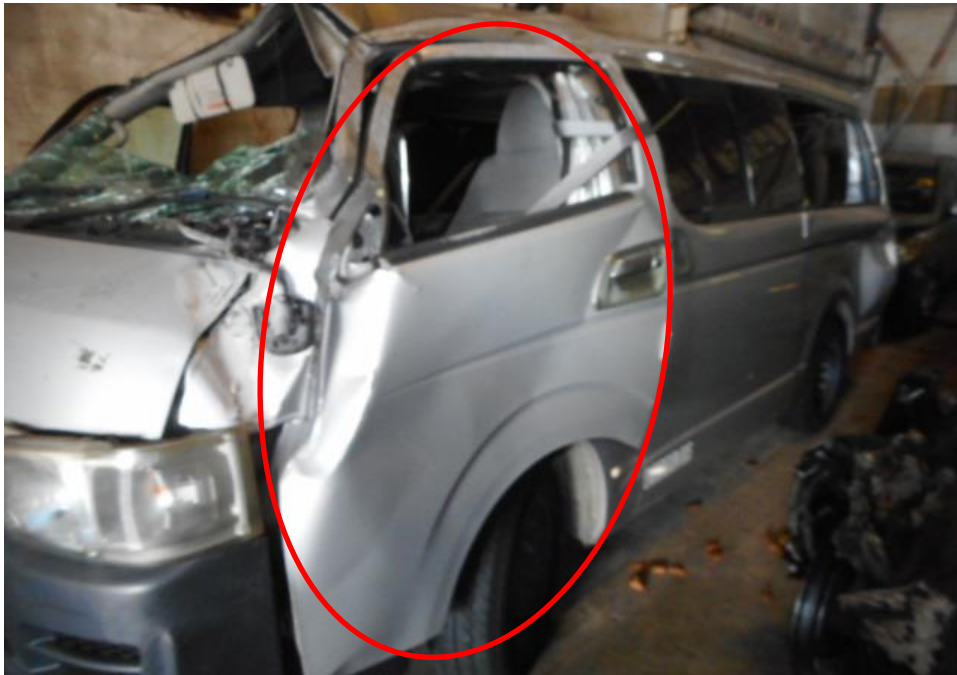
Photo 5 shows the close up view of the left door of the Motor Van at the time of our inspection. The Motor Van was observed to have sustained damages to its left door (circled) as a result of the accident.

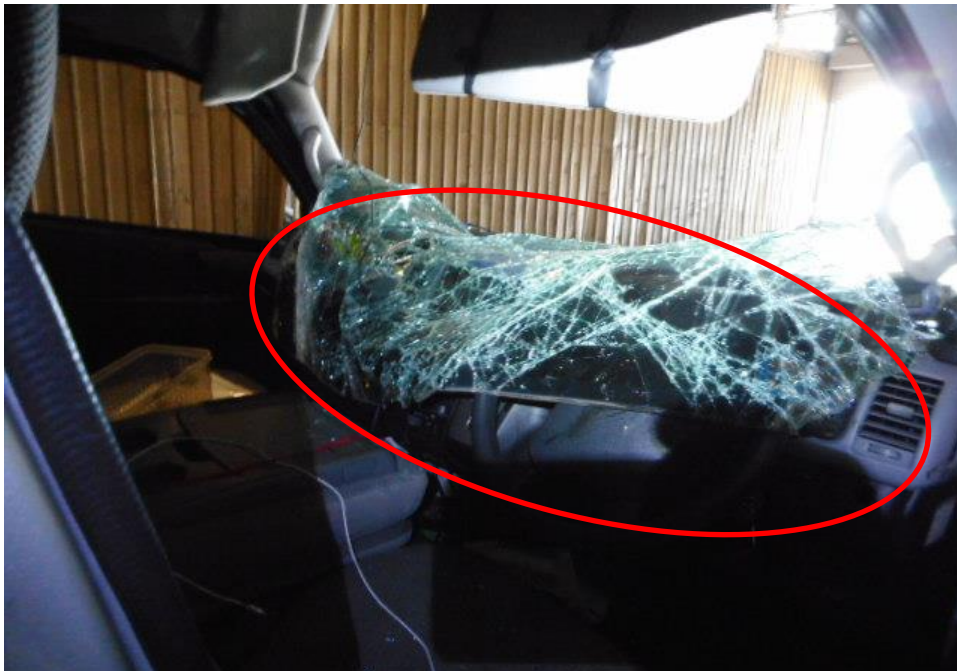
Photo 6 shows the close up view of the interior cabin of the Motor Van. It was observed to have sustained extensive induced damages to the dashboard (circled)

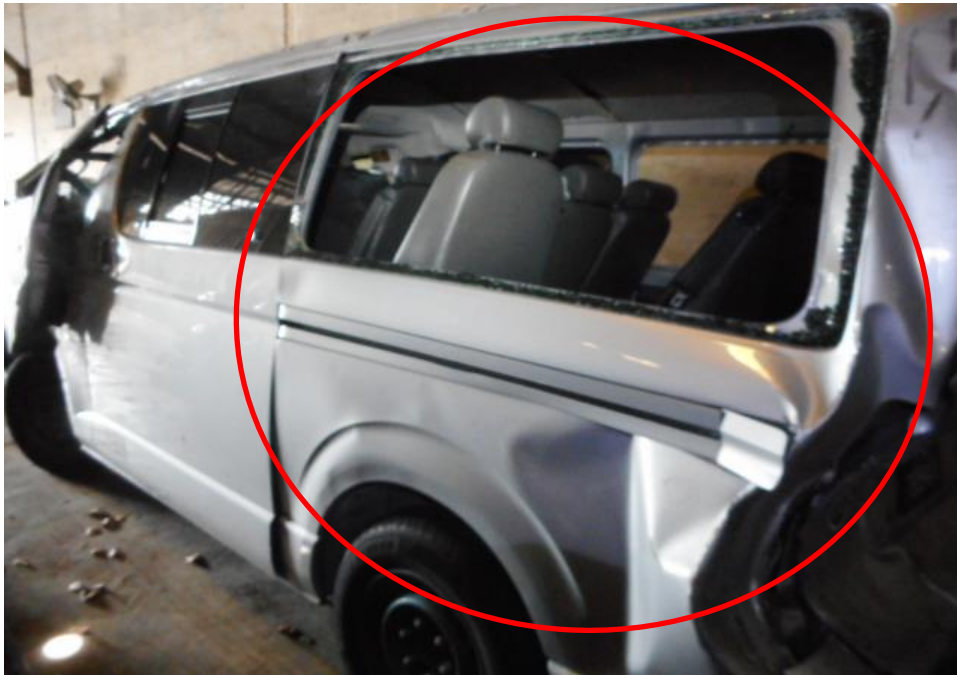
Photo 7 shows a general view of the Motor Van's left body at the time of my inspection. The left portion of the Motor Van was observed to have been affected by the accident. Its body panels (circled) was damaged as a result of the accident.

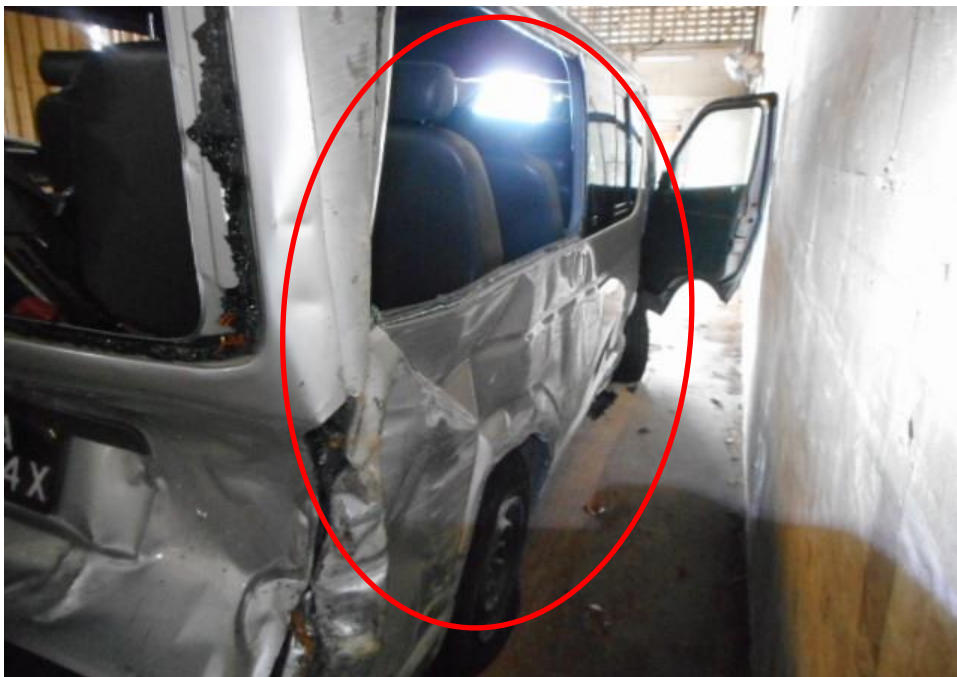
Photo 8 shows a general view of the Motor Van's right body at the time of my inspection. The right portion of the Motor Van was observed to have been affected by the accident. Its body panels (circled) was damaged as a result of the accident.

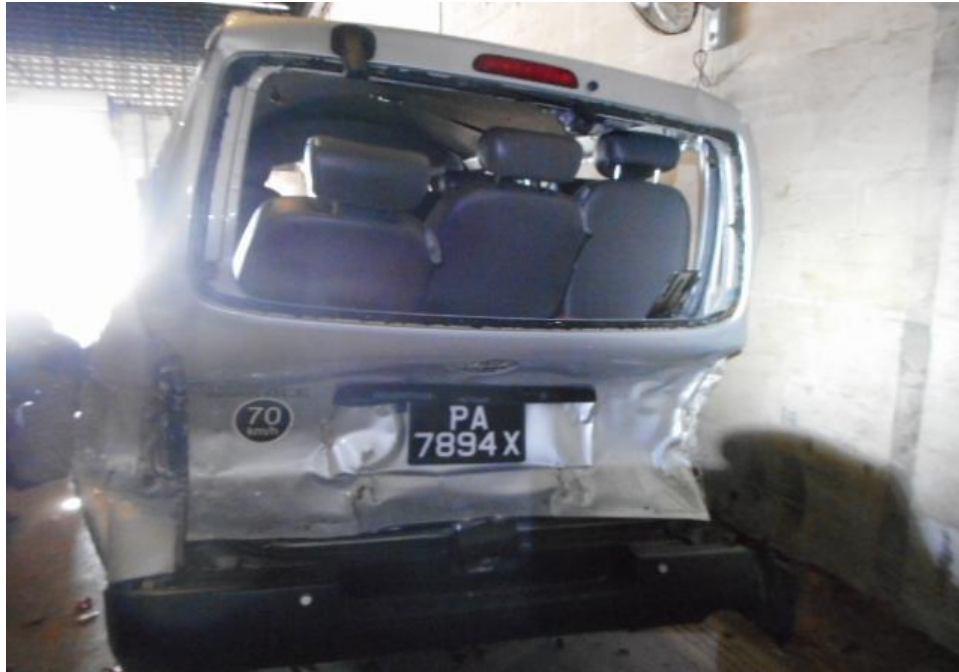
Photo 9 shows the general view of the Motor Van's rear body at the time of my inspection. The rear portion of the Motor Van was observed to have been affected by the accident. Its rear door and windscreen (circled) was damaged as a result of the accident.

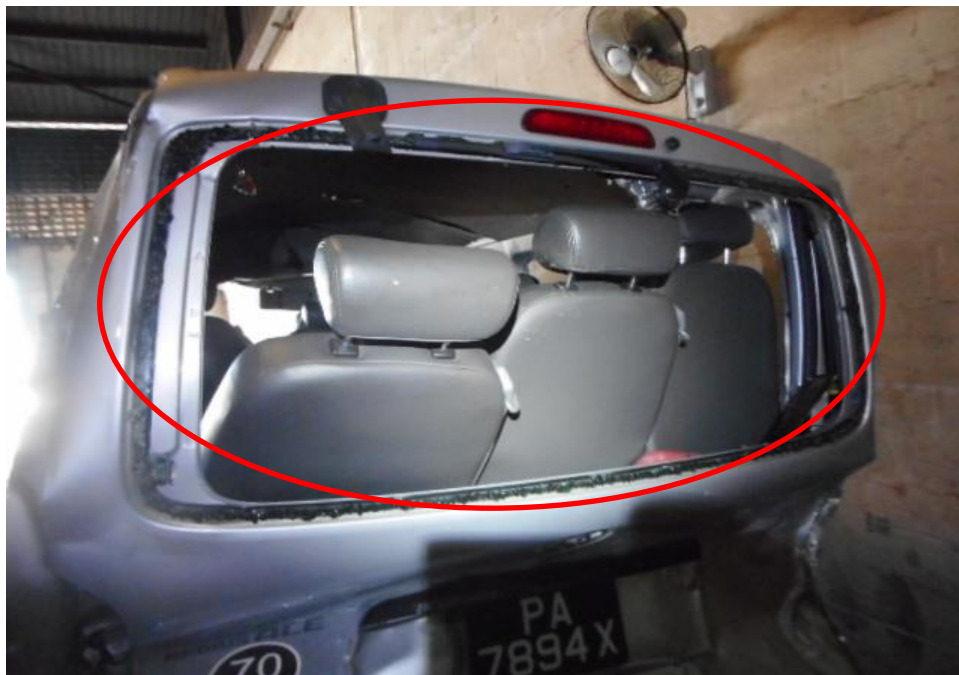
Photo 10 shows the general view of the Motor Van's rear body at the time of my inspection. The rear portion of the Motor Van was observed to have been affected by the accident. Its windscreen (circled) was damaged as a result of the accident.

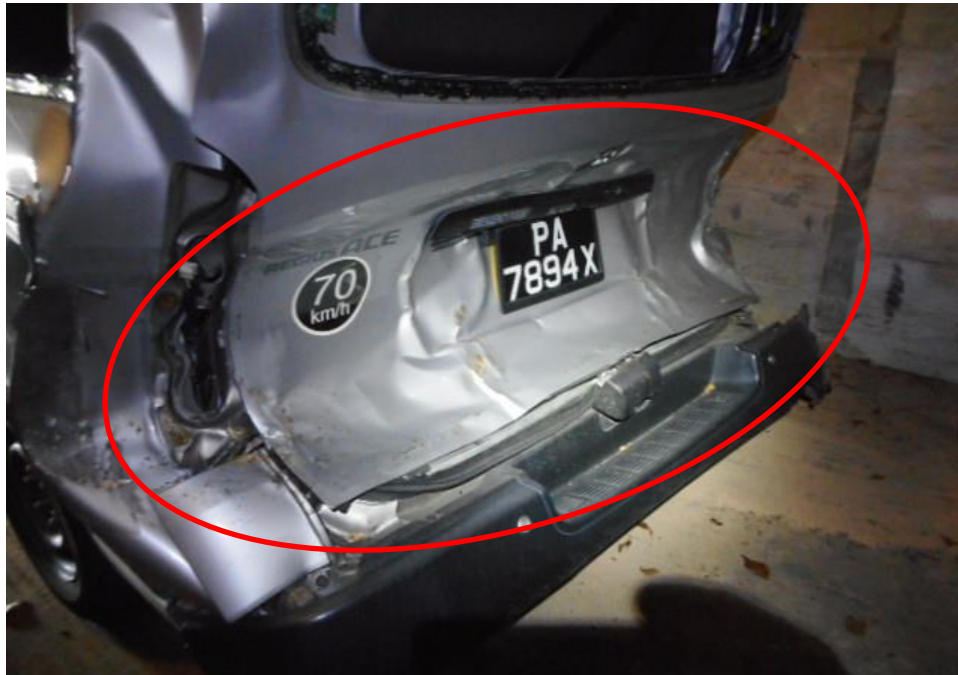
Photo 11 shows the general view of the Motor Van's rear body at the time of my inspection. The rear portion of the Motor Van was observed to have been affected by the accident. Its rear door (circled) was damaged as a result of the accident.

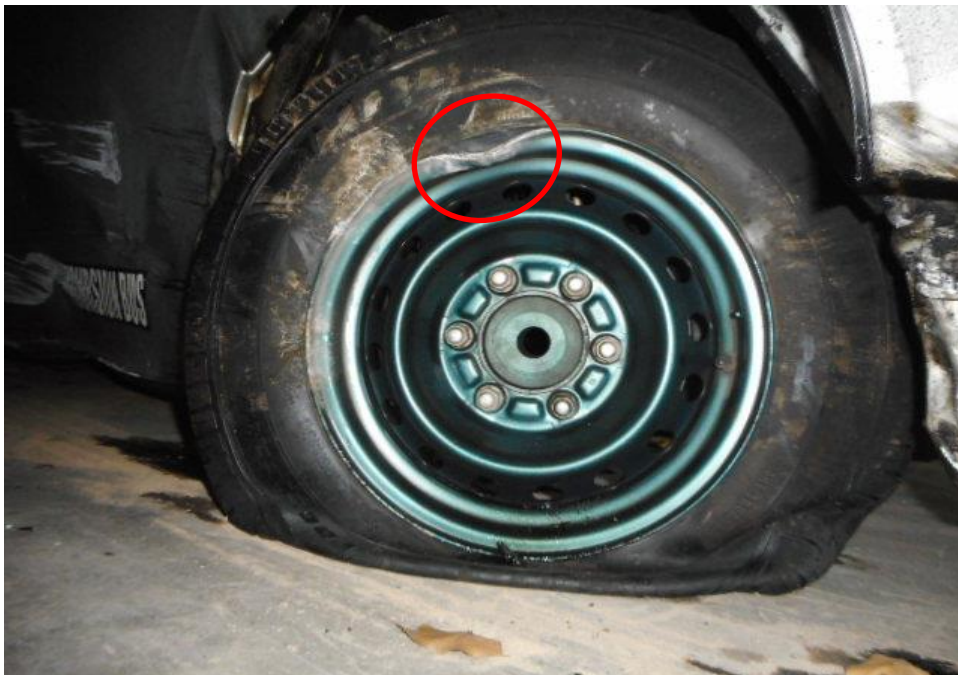
7. The right front and rear wheel rims was damaged as a result of the accident. However, other 2 tyres were observed to be wrapped around standard steel wheel rims were found to be without any damages. See photo 1 - 15 below.

Photo 12 shows the condition of the front right tyre of the Motor Van, which was observed to be in unserviceable condition with remaining tread depth of approximately 5.4mm. The steel wheel rim, was observed damage (circled) and the tyre was deflated as a result of the accident.

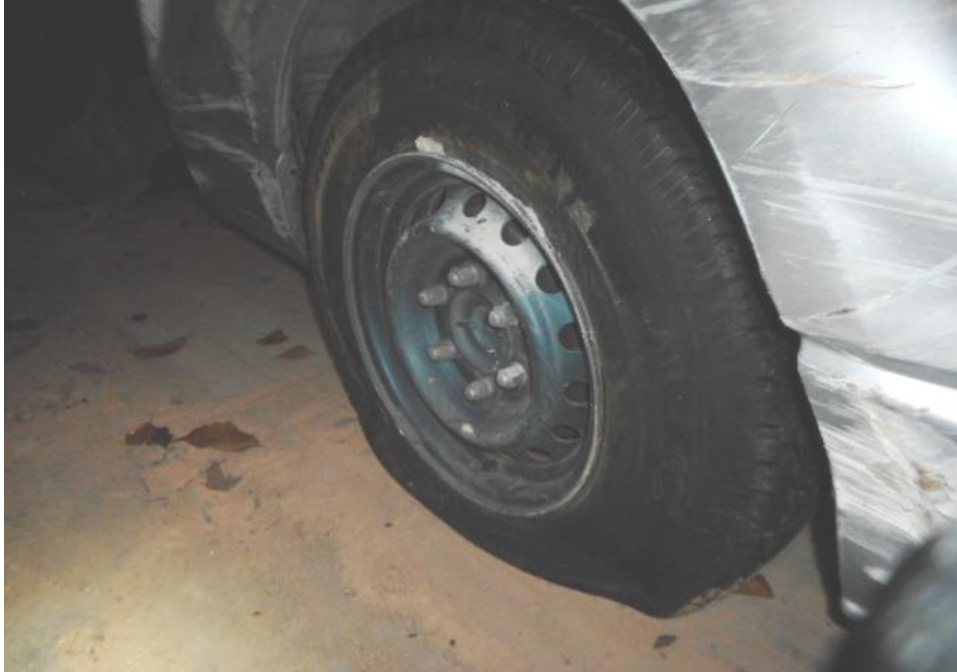
Photo 13 shows the condition of the rear right tyres of the Motor Van, which was observed to be in unserviceable condition with remaining tread depth of approximately 5.5mm. The steel wheel rim, was observed damage (circled) and the tyre was deflated as a result of the accident.

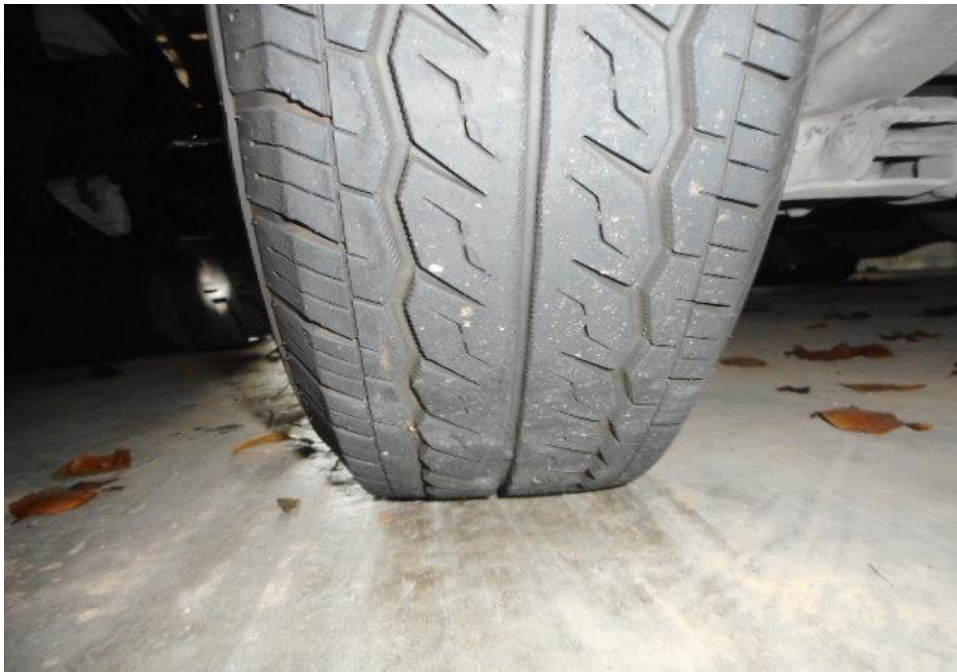
Photo 14 shows the condition of the rear left tyres of the Motor Van, which were observed to be in serviceable condition with remaining, tread depth of approximately 5.2mm. See above.

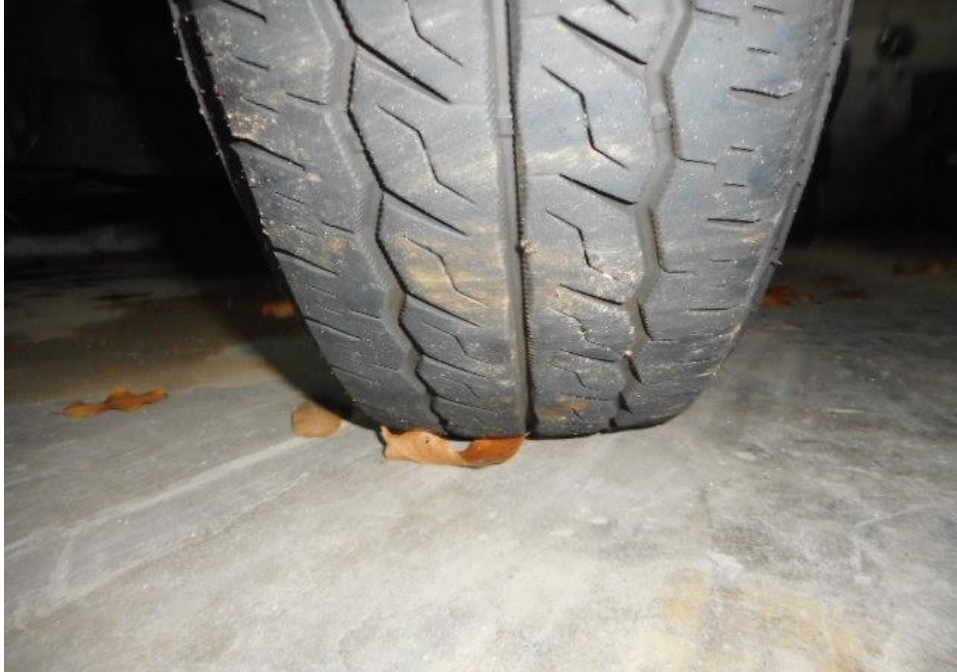
Photo 15 shows the condition of the front left tyre of the Motor Van, which were observed to be in serviceable condition with remaining, tread depth of approximately 6.4mm. See above.

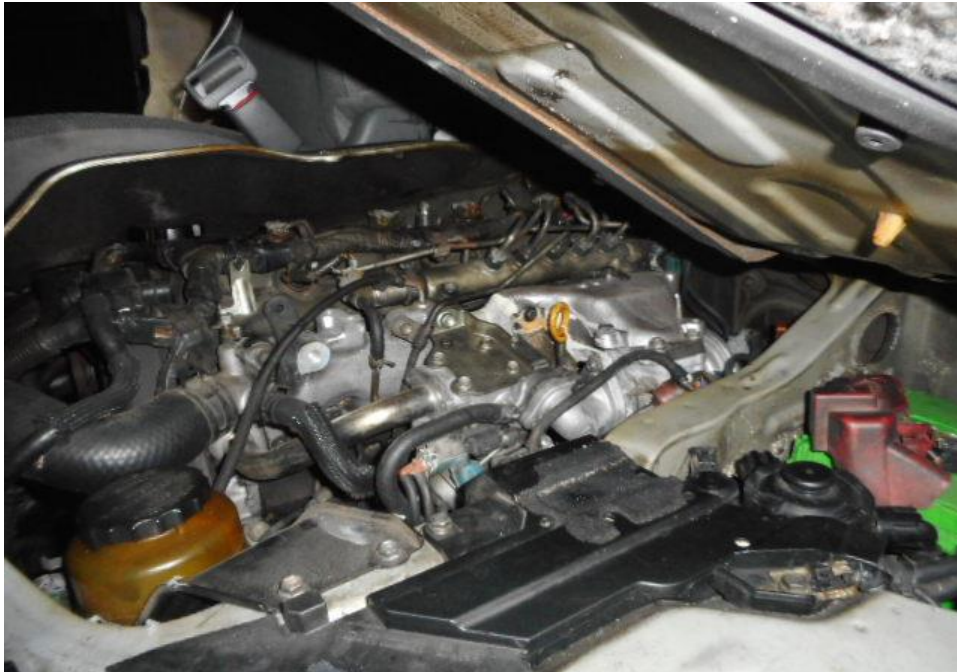
Photo 16 shows a general view of the Motor Van's engine compartment, which was accessed by lifting the front cabin of the Motor Van. The various parts and components inside the engine compartment were unaffected by the accident. There was also no sign(s) or indication(s) of fresh fluid leakage and/or fluid stain within the engine compartment

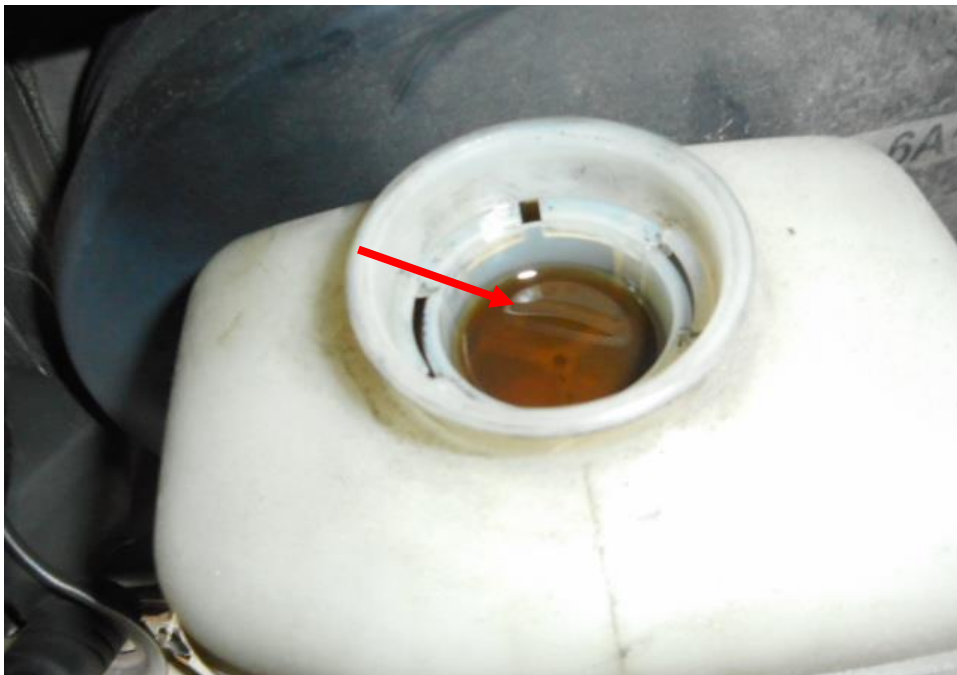
Photo 17 shows the brake fluid reservoir of the Motor Van at the time of my inspection. The brake fluid was observed to be of sufficient level (arrowed) and without any visible contamination.

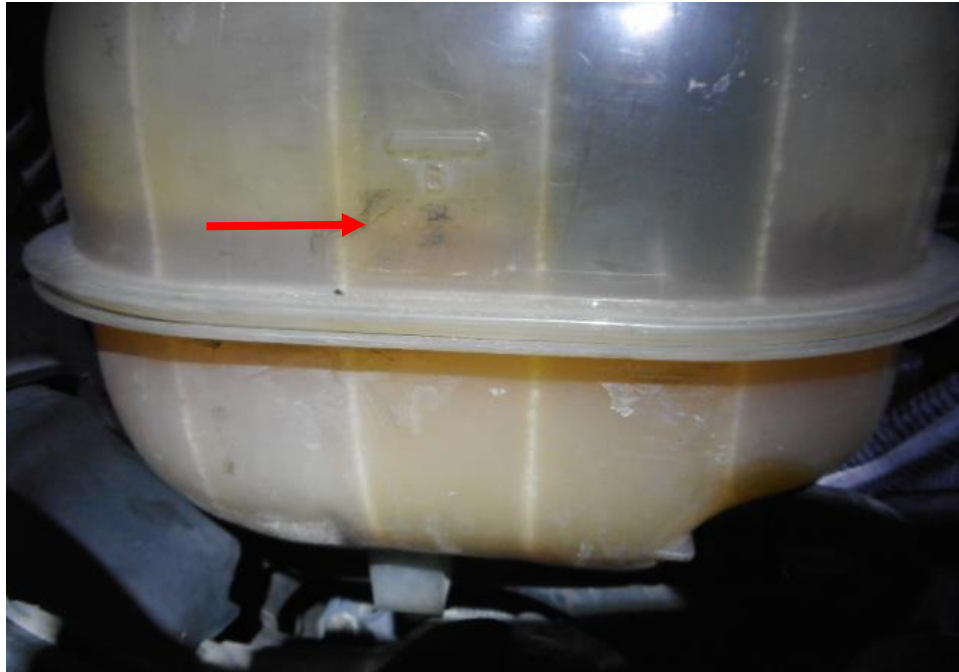
Photo 18 shows the engine coolant of the Motor Van at the time of my inspection. The engine coolant was observed to be of sufficient level and without any visible contamination.

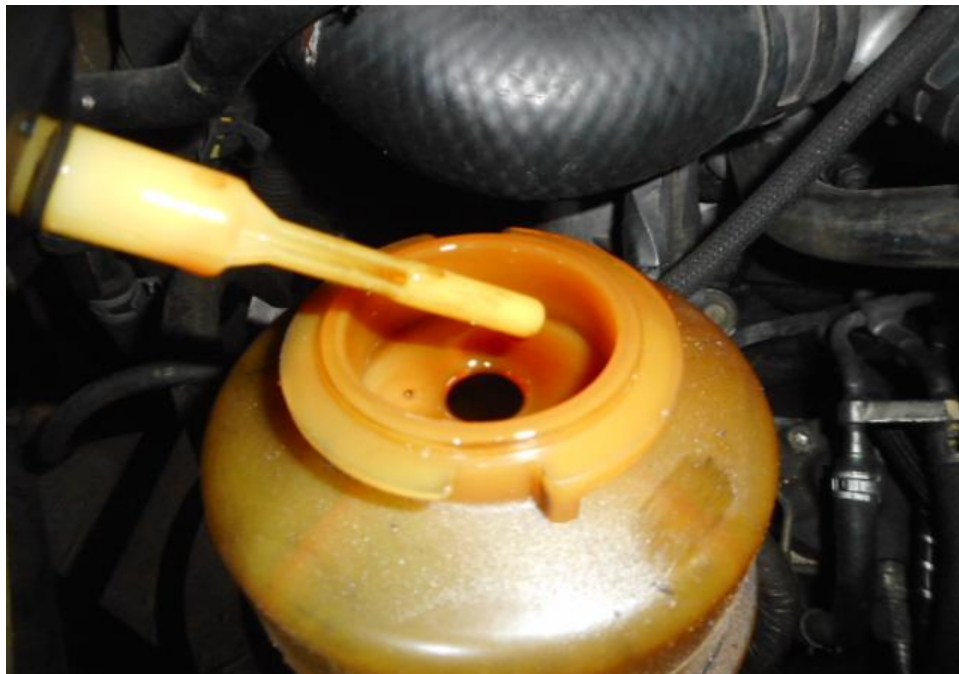
Photo 19 shows the power steering fluid dip stick of the Motor Van at the time of my inspection. The steering fluid was observed to be of sufficient level and without any visible contamination.

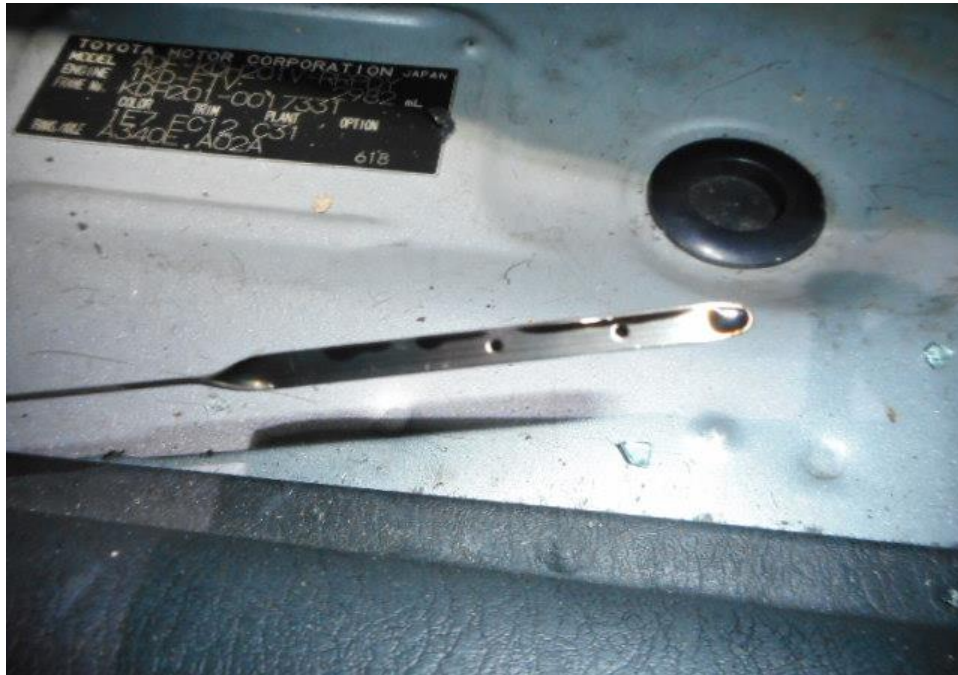
8. Upon examination of the Motor Van's engine compartment, I had observed all the parts and components inside the engine compartment to be intact and unaffected by the accident. The engine coolant, brake fluid, and power steering fluid were all found to be of sufficient level for operating purposes. Visually, there was also no contamination found to these fluids. However, the engine oil was observed to be insufficient due to a leakage as a result of the accident. See photos 16- 21 below.

Photo 20 shows the engine oil dip stick of the Motor Van at the time of my inspection. The engine oil was observed to be of insufficient level due to a leakage as a result of the accident.

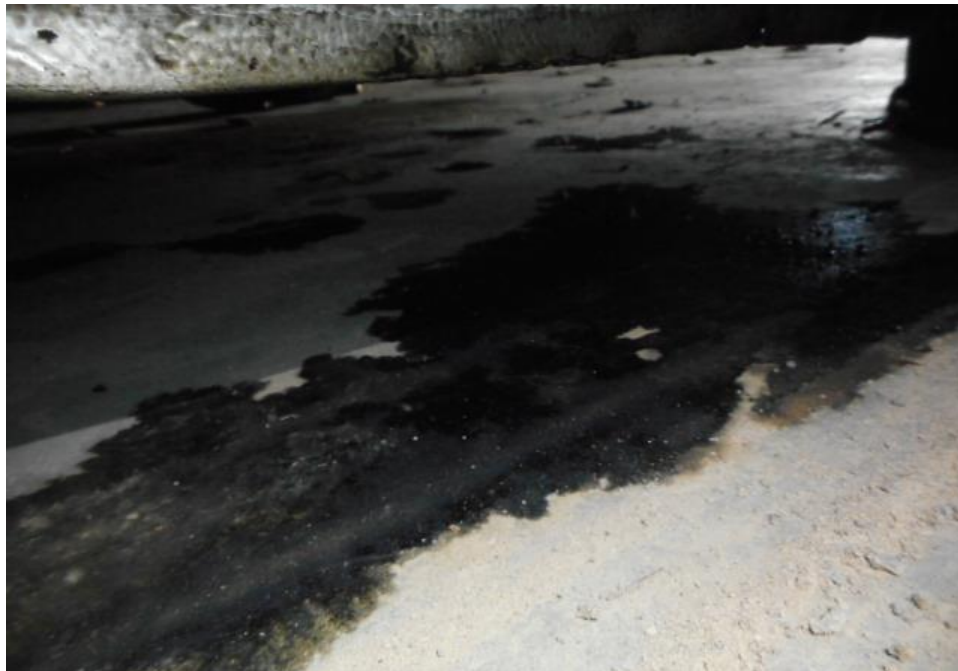
Photo 21 shows the undercarriage of the Motor Van, at the area where the engine housing and transmission housing are located. I have found engine oil leakage and fluid stain(s) on the underside of the Motor Van as a result of the accident.

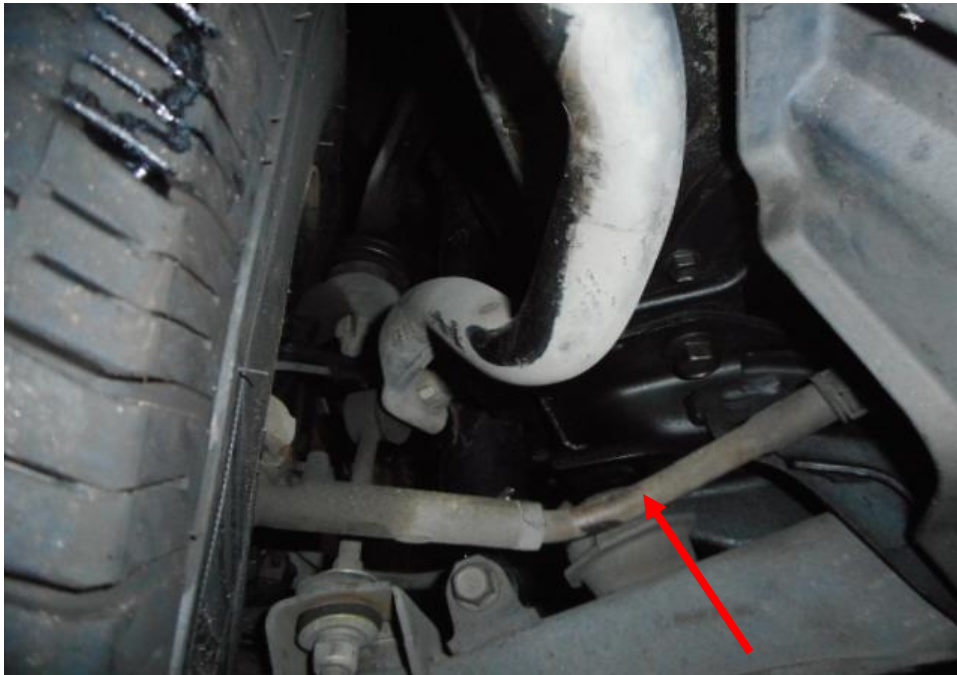
9. Static braking and steering tests was not conducted on the Motor Van as the braking and steering controls in the cabin had sustain damage as the result of the accident. Our visual inspection of the mechanical components of the Motor Van's observed that its undercarriage braking system components was intact. However, the front right steering components had been damaged as a result of the accident. See photo 22 - 27 below.

Photo 22 shows the various undercarriage components at the front right wheel of the Motor Van, in particular the steering tie rod (arrowed) were found to be bent as a result of the accident.

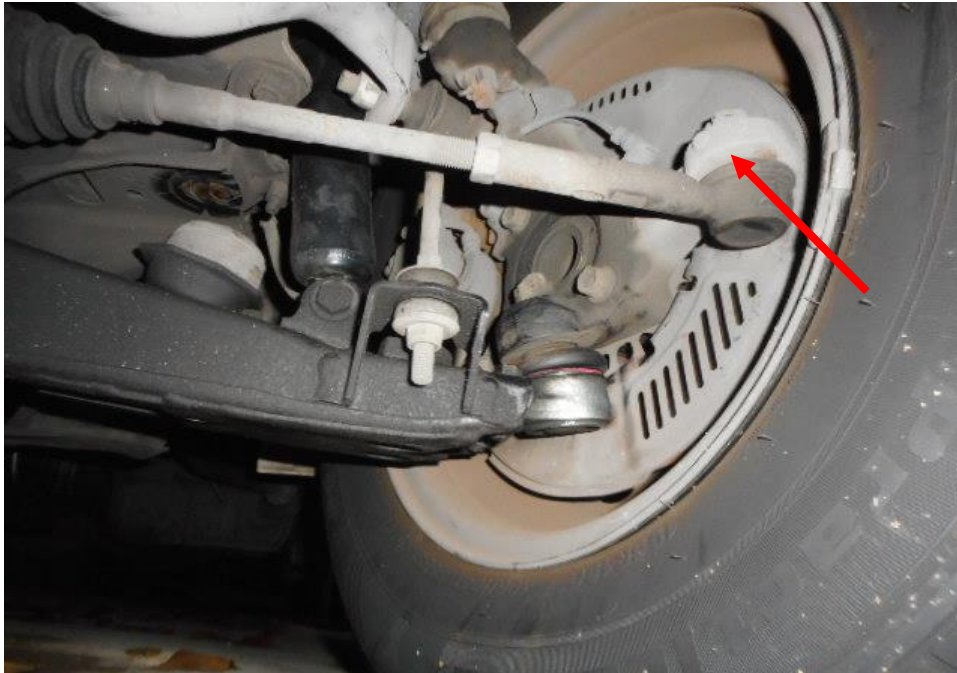
Photo 23 shows the various undercarriage components at the front left wheel of the Motor Van, in particular the steering tie rod end and ball joints (arrowed) were observed to be intact. There was also no sign of fluid stain observed on the various undercarriage components at the front right wheel of the Motor Van.

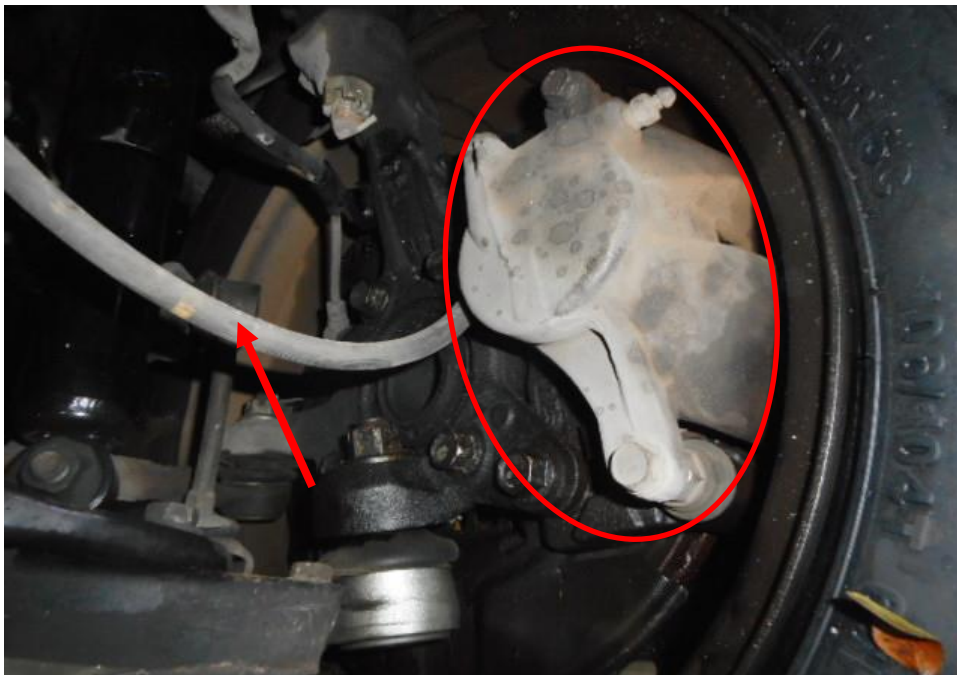
Photo 24 shows the various undercarriage components at the front right wheel of the Motor Van, in particular the brake hose (arrowed) and callipers (circled). The various undercarriage components of the Motor Van were all found to be intact without any visible damage. There was also no sign of fluid stain(s) observed on the various undercarriage components.

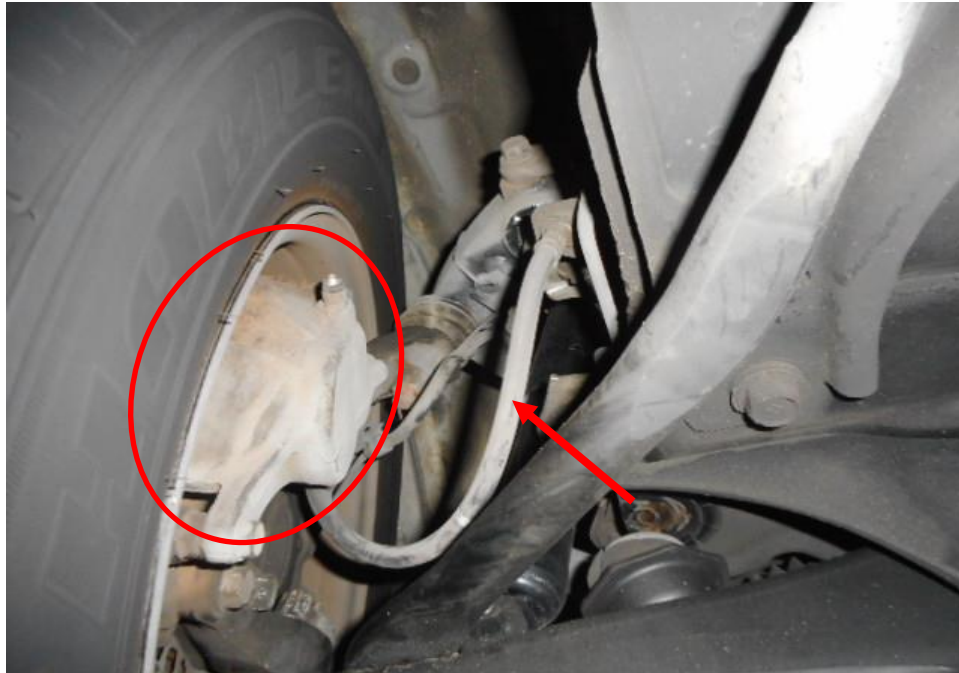
Photo 25 shows the various undercarriage components at the front left wheel of the Motor Van, in particular the brake hose (arrowed) and callipers (circled). The various undercarriage components of the Motor Van were all found to be intact without any visible damage. There was also no sign of fluid stain(s) observed on the various undercarriage components.

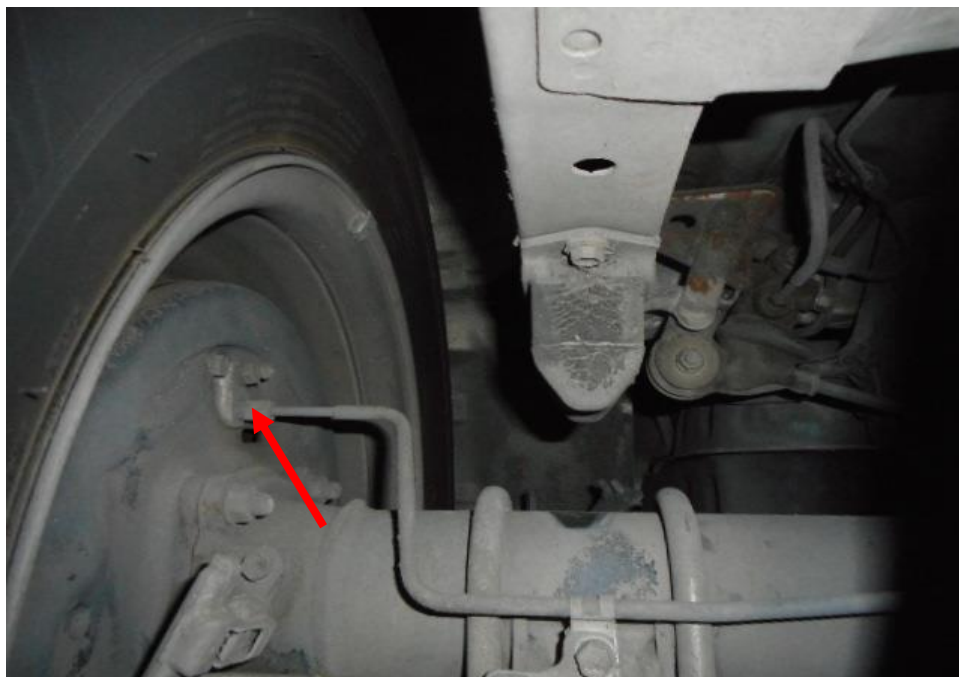
Photo 26 shows the various undercarriage components at the rear left wheel of the Motor Van, in particular the brake hose and drum brake (arrowed). The various undercarriage components of the Motor Van were all found to be intact without any visible damage. There was also no sign of fluid stain(s) observed on the various undercarriage components.

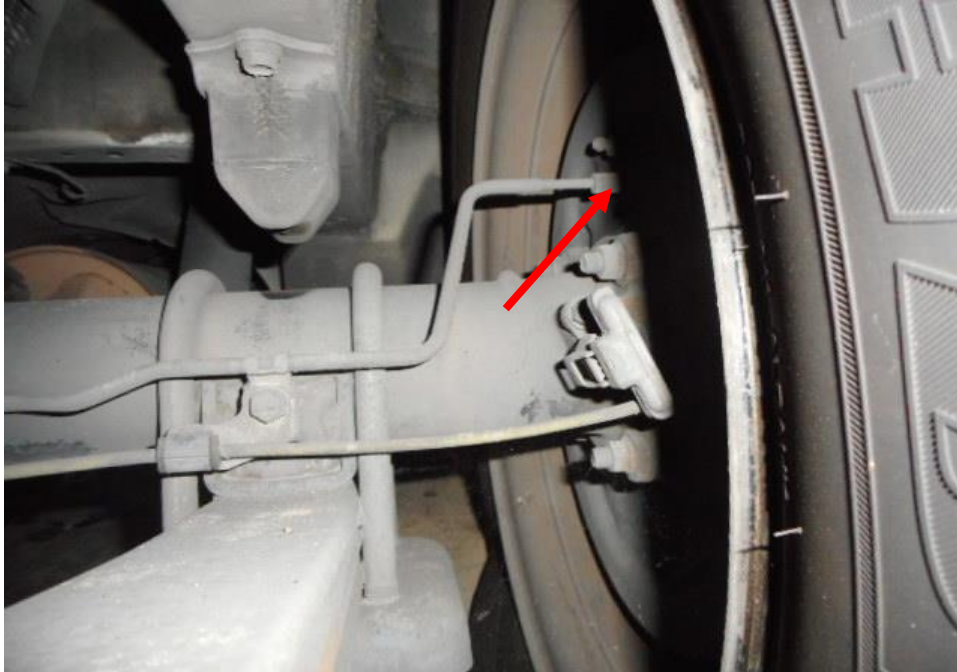
Photo 27 shows the various undercarriage components at the rear right wheel of the Motor Van, in particular the brake hose and drum brake (arrowed). The various undercarriage components of the Motor Van were all found to be intact without any visible damage. There was also no sign of fluid stain(s) observed on the various undercarriage components.
