Your Ref: TP/IP/04581/2022
Our Ref : CI/TPD22002407/P

Fatal Accident Investigation Team

MECHANICAL INSPECTION REPORT OF MOTOR LORRY GBA 3054X

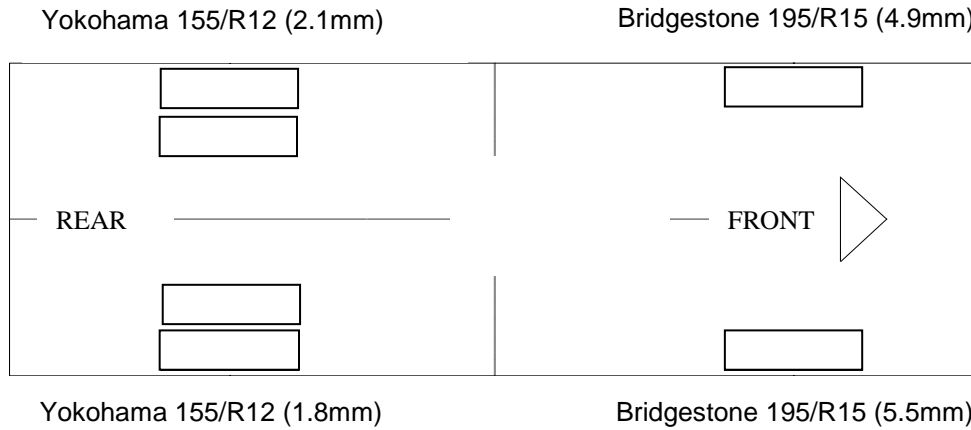
6. The 6 tyres of the Motor Lorry were observed to be in serviceable condition and sufficiently inflated for vehicular operation. I did not find any tear, cut or burst mark(s) on the outer and the inner sidewalls as well as across the tread of the 6 tyres. The tyre brand, tyre size and remaining tread depth of the 6 tyres of the Motor Lorry were recorded as follows:-

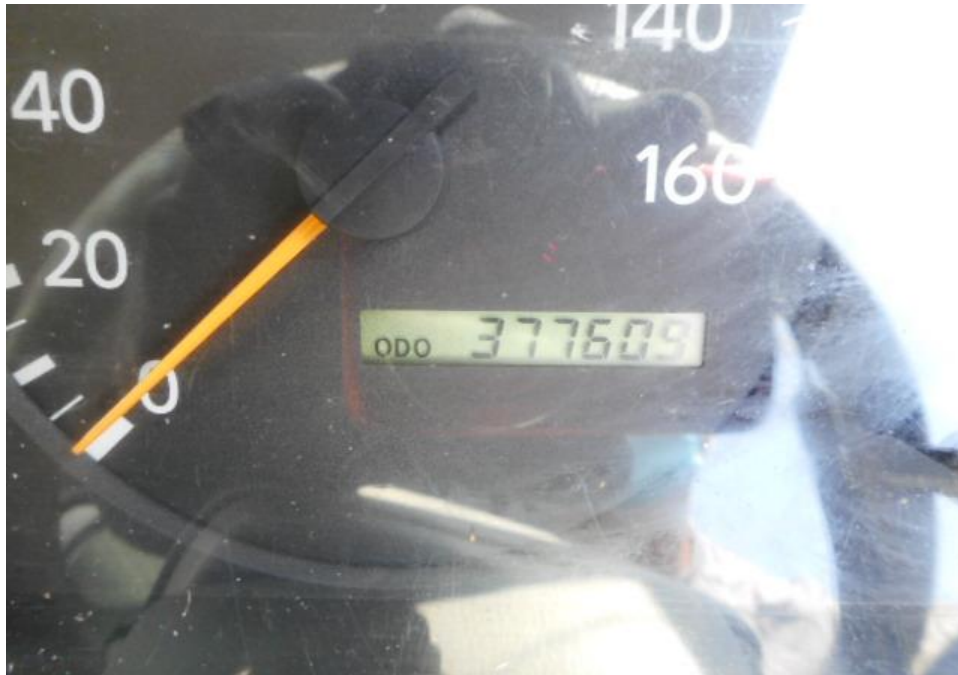
Photo 1 shows a general view of the instrument cluster of the Motor Lorry at the time of my inspection. The mileage of the Motor Lorry was 377,609 km

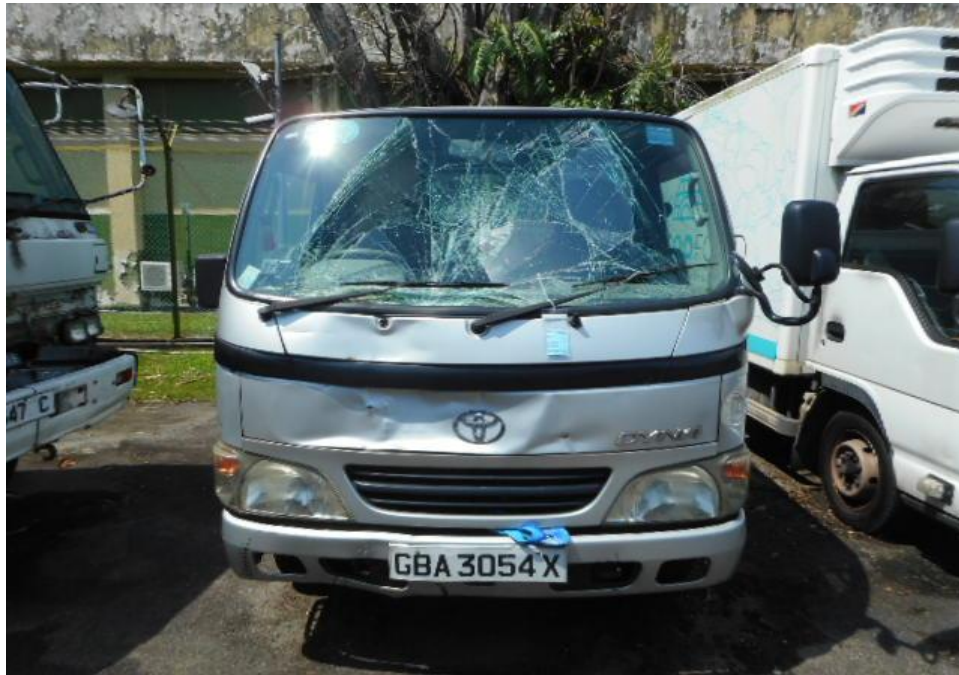
4. The mileage of the Motor Lorry at the time of my inspection was 377,609km.
5. The Motor Lorry was observed to sustained damage at its front portion. Its front windscreen, front body panel as well its front bumper were damage at the time of my inspection as a result of the accident.

Photo 2 shows a general view of the Motor Lorry's frontal portion at the time of my inspection. It appeared to have sustained damage at its front portion. Its front windscreen, front body panel as well as its front bumper were damaged at the time of my inspection as a result of the accident.

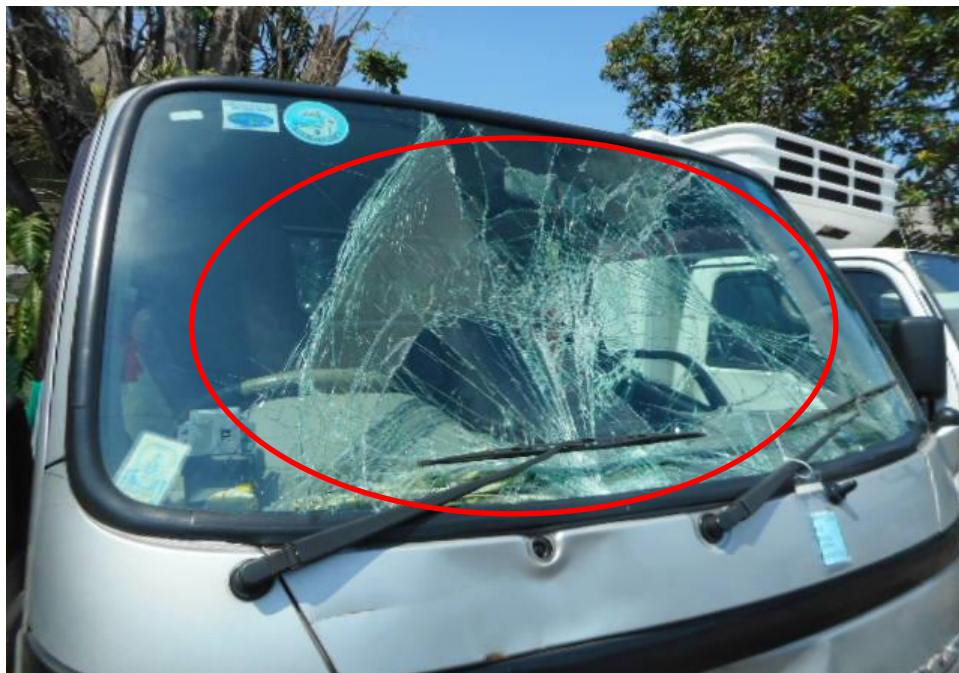
Photo 3 shows a close up view of the Motor Lorry's front portion at the time of my inspection. Its front windscreen (circled) was damaged at the time of my inspection as a result of the accident.

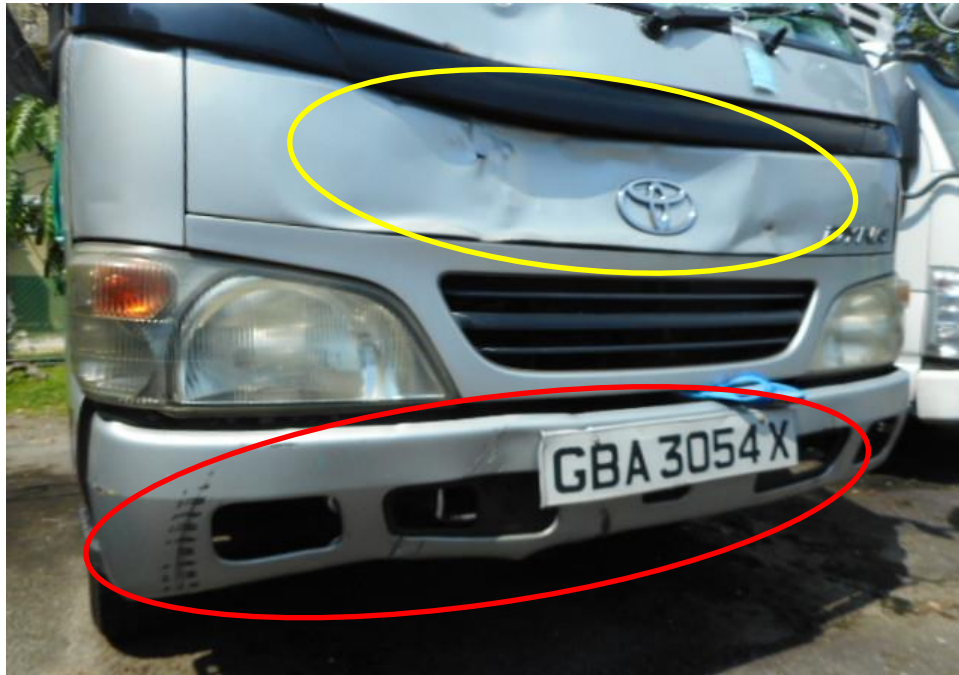
Photo 4 shows a close up view of the Motor Lorry's front portion at the time of my inspection. Its front bumper (red circle) and front body panel (yellow circle) was damage at the time of my inspection as a result of the accident.

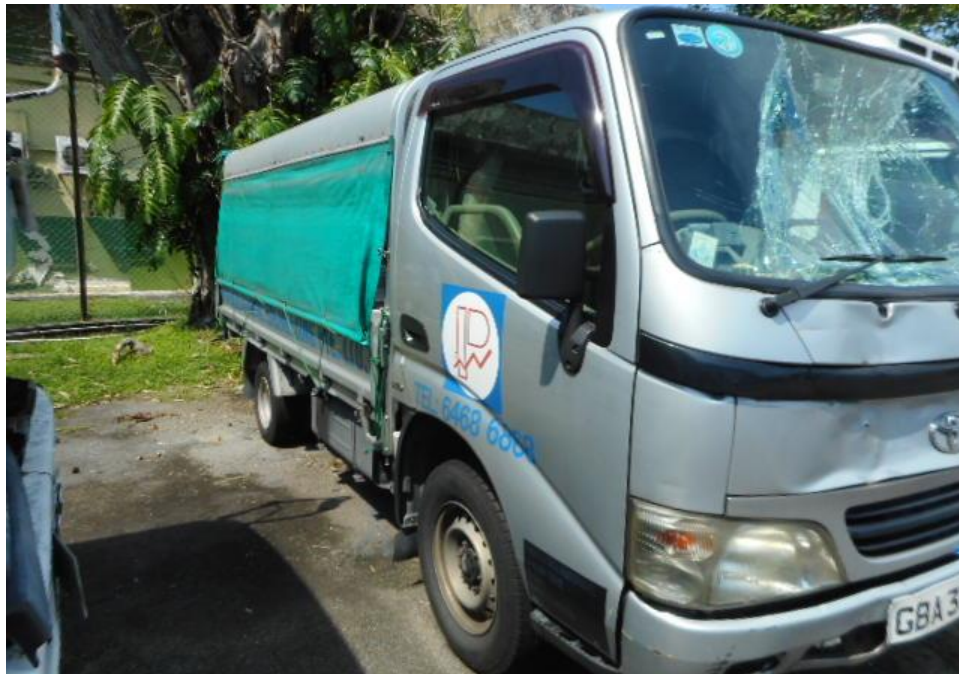
Photo 5 shows a general view of the right body of the Motor Lorry at the time of my inspection. The Motor Lorry was observed to be intact and unaffected by the accident.

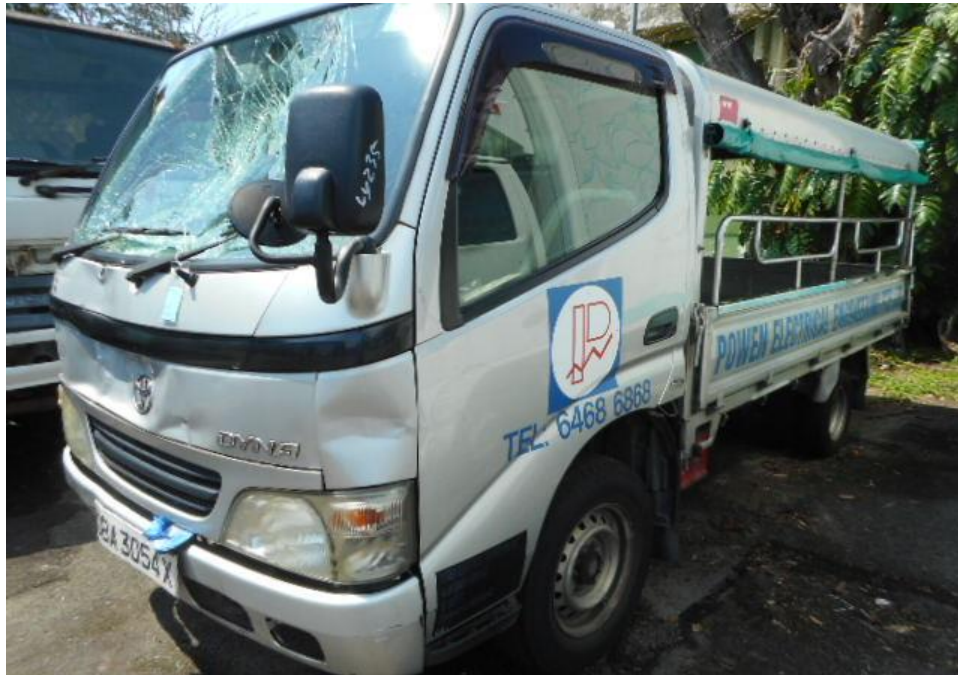
Photo 6 shows a general view of the left body of the Motor Lorry at the time of my inspection. The Motor Lorry was observed to be intact and unaffected by the accident.

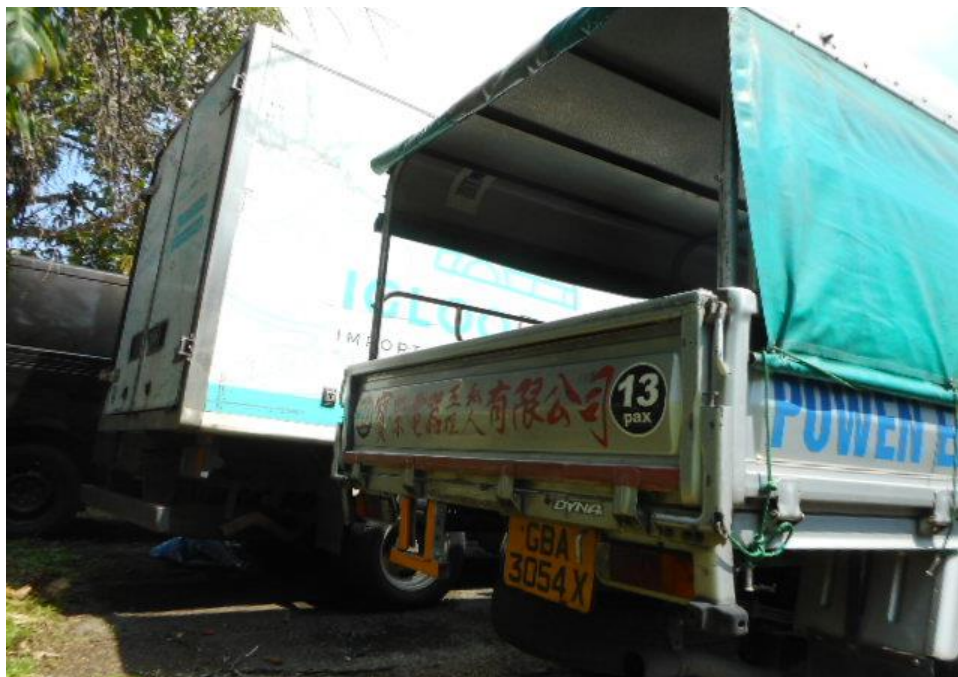
Photo 7 shows a general view of the rear body of the Motor Lorry at the time of my inspection. The Motor Lorry was observed to be intact and unaffected by the accident.

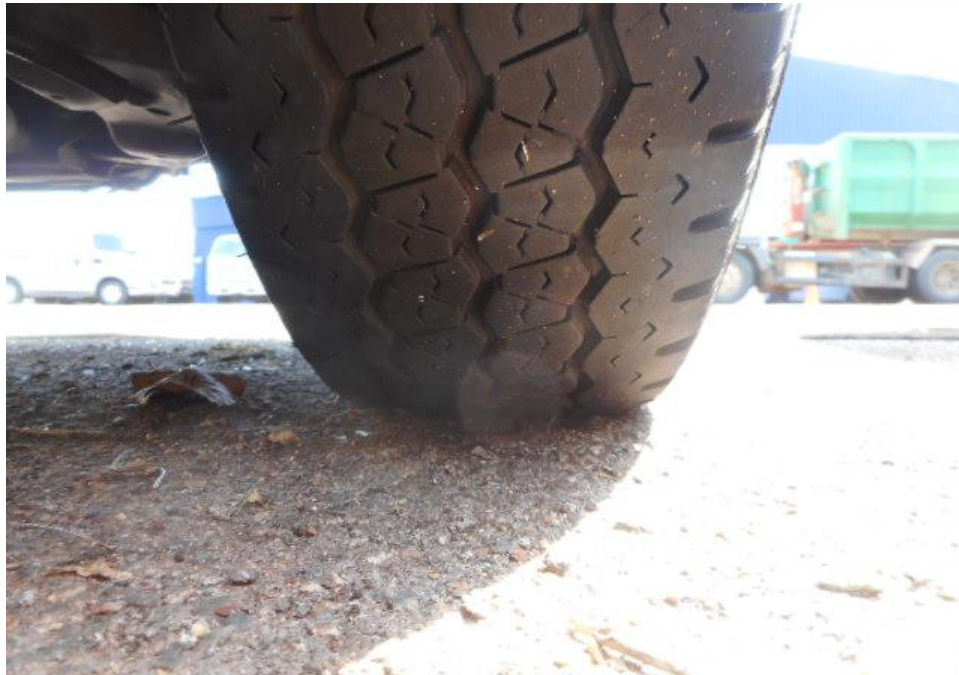
Photo 8 shows the condition of the front right tyre of the Motor Lorry, which was observed to be in serviceable condition with remaining tread depth of approximately 5.5mm. The tyre, which was wrapped around standard steel wheel rim, was also observed to be sufficiently inflated for vehicular operation. There was no tear, cut or burst mark(s) on the outer and the inner sidewalls as well as across the tread of the 6 tyres that were fitted on the Motor Lorry.

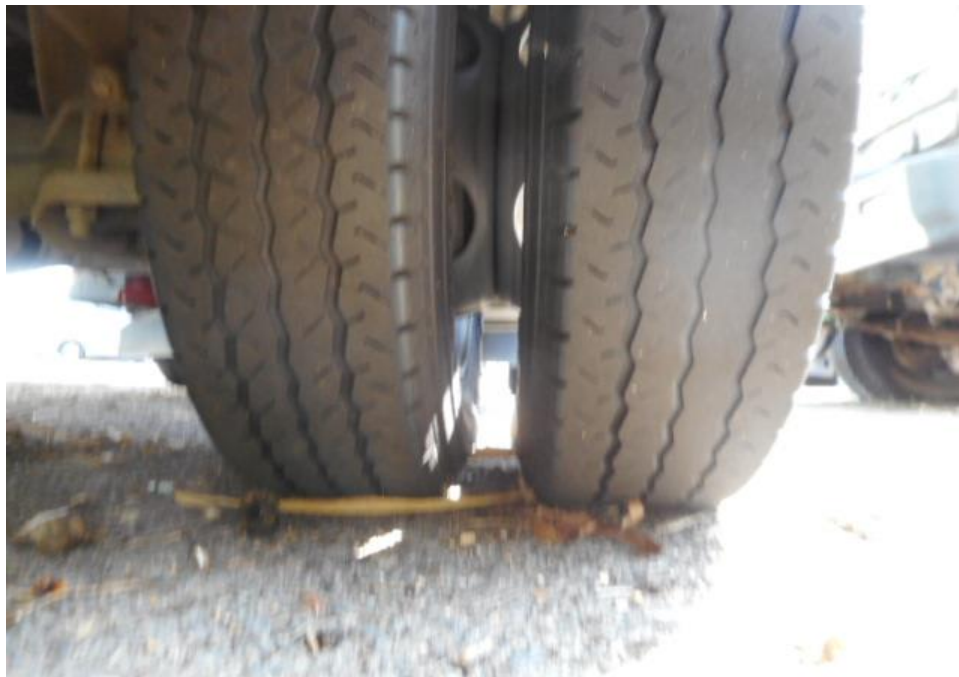
Photo 9 shows the condition of the rear right tyre of the Motor Lorry, which was observed to be in serviceable condition with remaining tread depth of approximately 1.8mm. The tyre, which was wrapped around standard steel wheel rim, it was observed to be sufficiently inflated for vehicular operation.

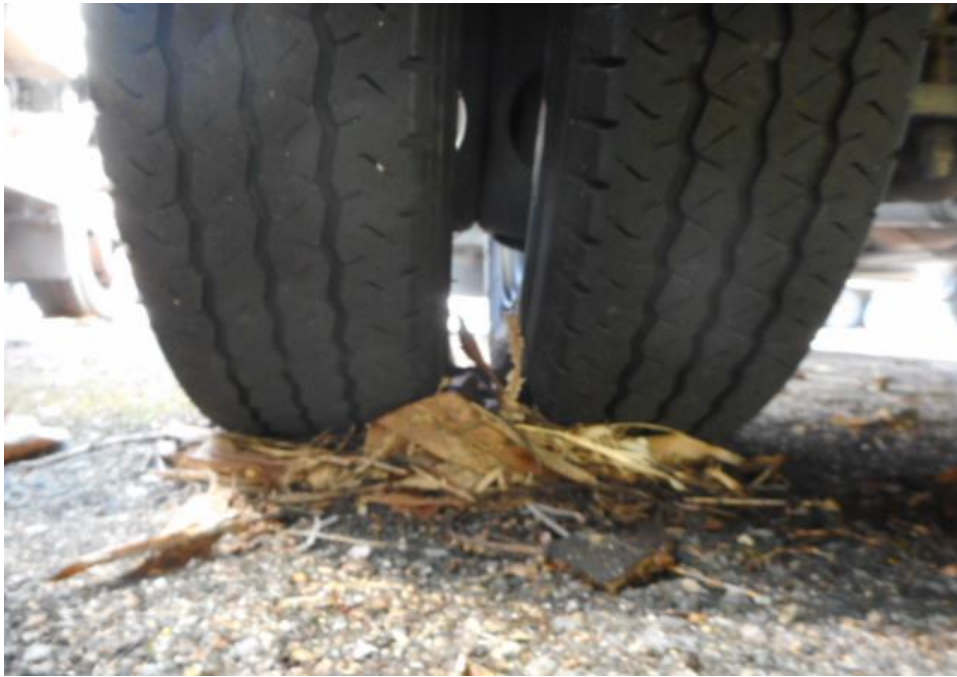
Photo 10 shows the condition of the rear left tyres of the Motor Lorry, which was observed to be in serviceable condition with remaining tread depth of approximately 2.1mm. The tyres, which were wrapped around standard steel wheel rim, were also observed to be sufficiently inflated for vehicular operation.

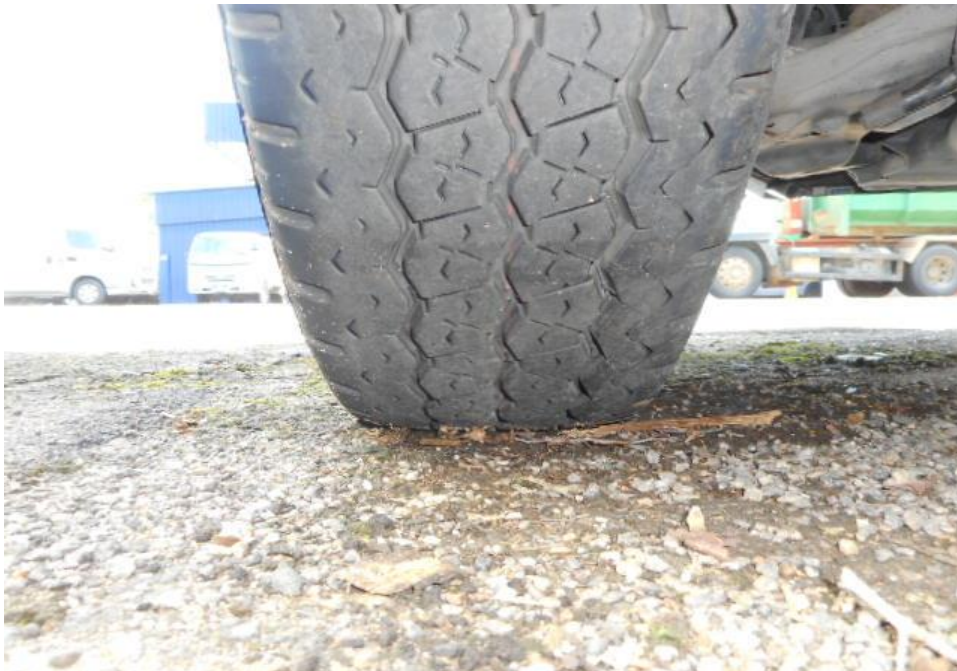
Photo 11 shows the condition of the rear right tyres of the Motor Lorry, which were observed to be in serviceable condition with remaining, tread depth of approximately 4.9mm. There was also no tear, cut or burst mark(s) on the outer and the inner sidewalls as well as across the tread of the 6 tyres that were fitted on the Motor Lorry.

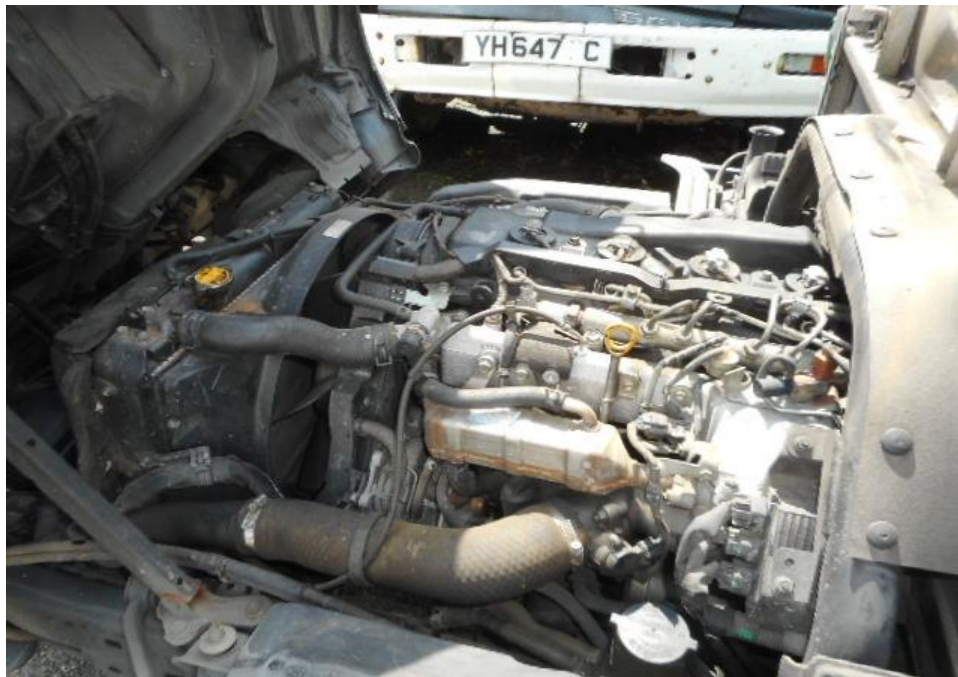
Photo 12 shows a general view of the Motor Lorry's engine compartment, which was accessed by lifting the front cabin of the Motor Lorry. The various parts and components inside the engine compartment were unaffected by the accident. There was also no sign(s) or indication(s) of fresh fluid leakage and/or fluid stain within the engine compartment

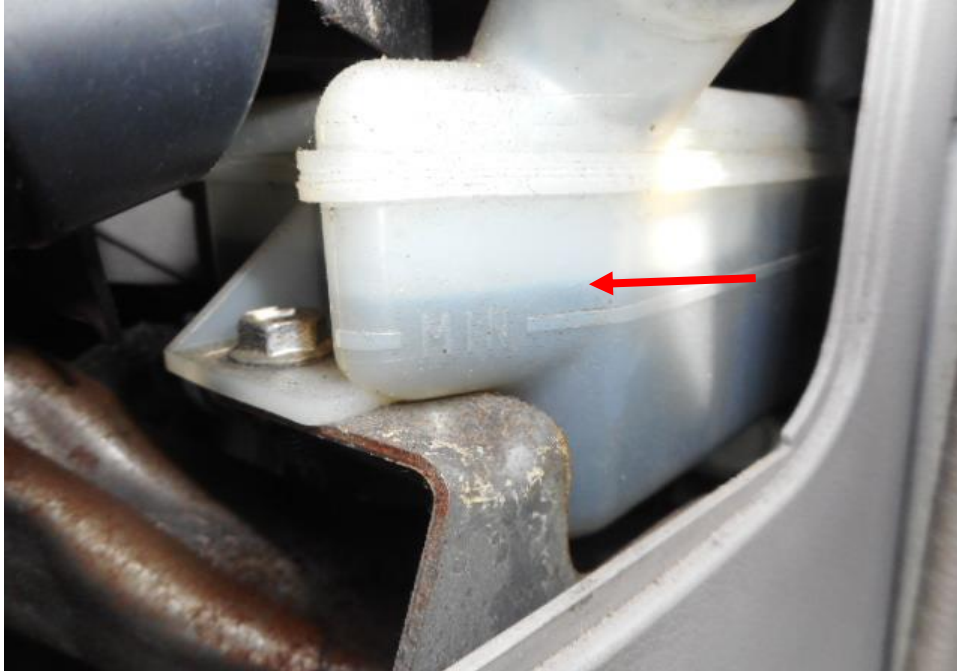
Photo 13 shows the brake fluid reservoir of the Motor Lorry at the time of my inspection. The brake fluid was observed to be of sufficient level (arrowed) and without any visible contamination.

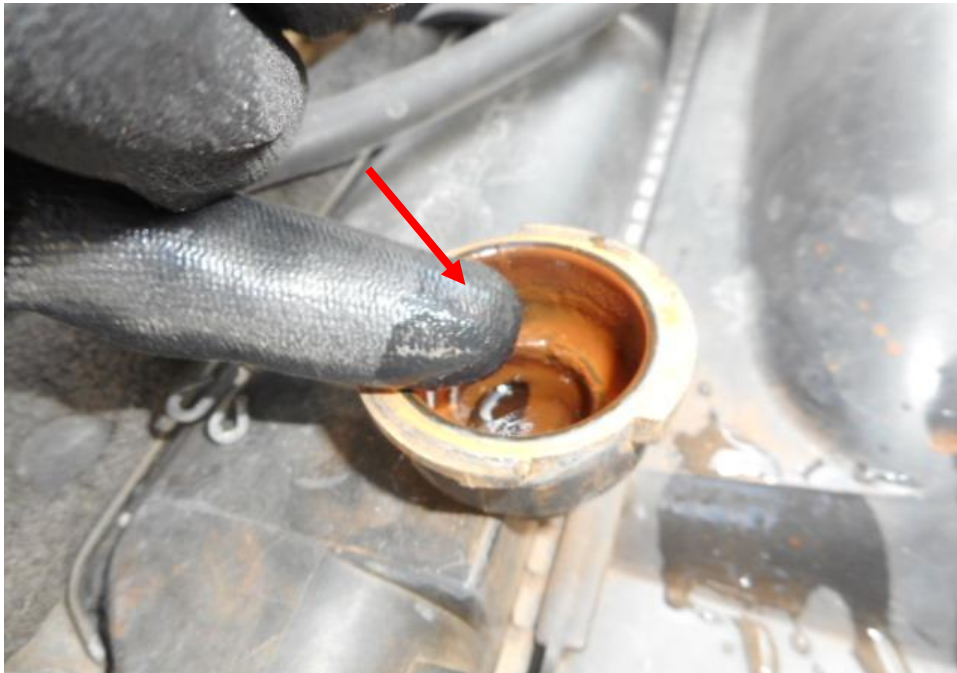
Photo 14 shows the engine coolant reservoir of the Motor Lorry at the time of my inspection. The engine coolant was observed to be of sufficient level (arrowed) and without any visible contamination.

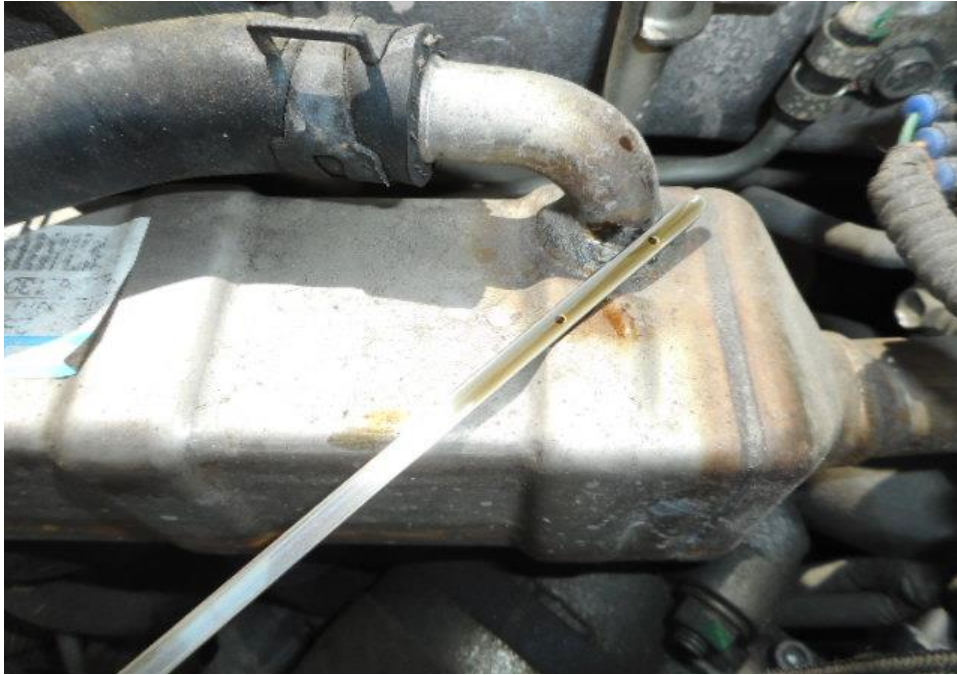
Photo 15 shows the engine oil dip stick of the Motor Lorry at the time of my inspection. The engine oil was observed to be of sufficient level and without any visible contamination.

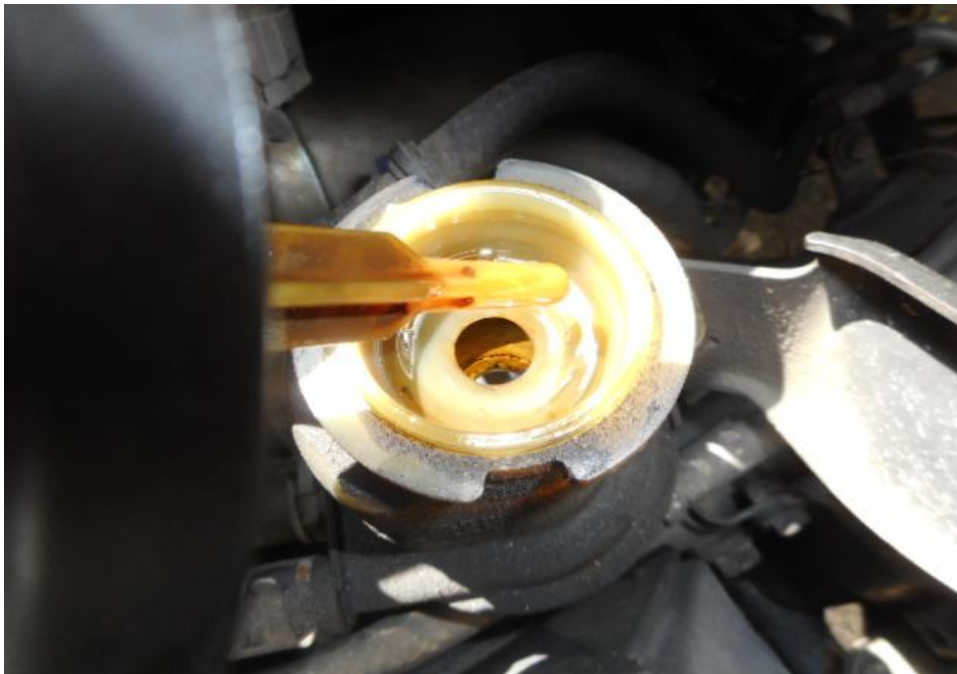
Photo 16 shows the power steering fluid reservoir of the Motor Lorry at the time of my inspection. The power steering fluid was observed to be of sufficient level and without any visible contamination.

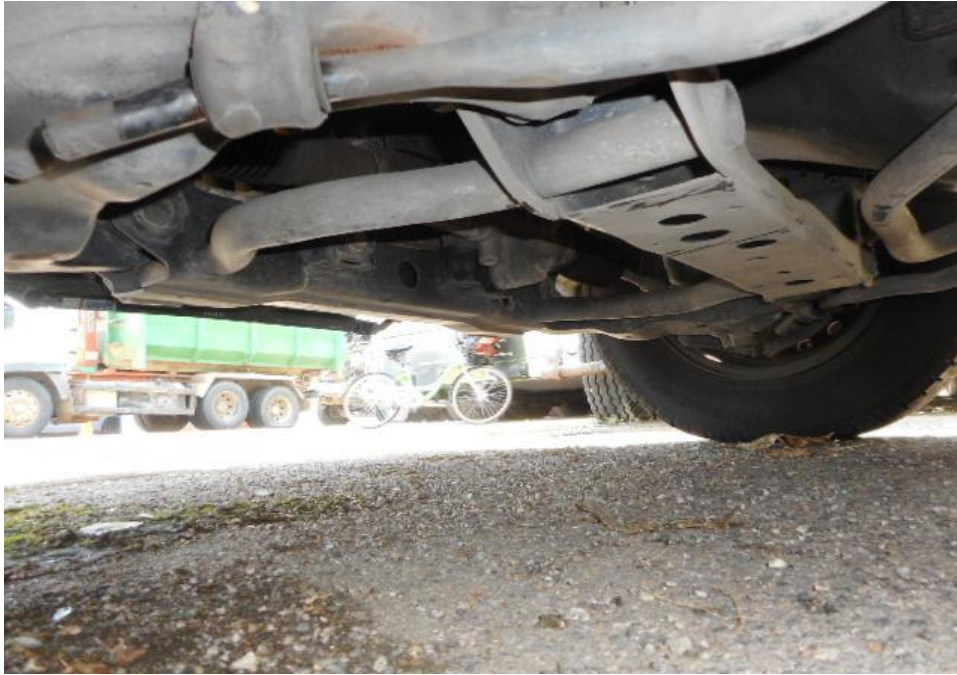
Photo 17 shows the undercarriage of the Motor Lorry, at the area where the engine housing and transmission housing are located. I did not find any sign(s) or indication(s) of fluid leak and/or fluid stain(s) on the underside of the Motor Lorry.

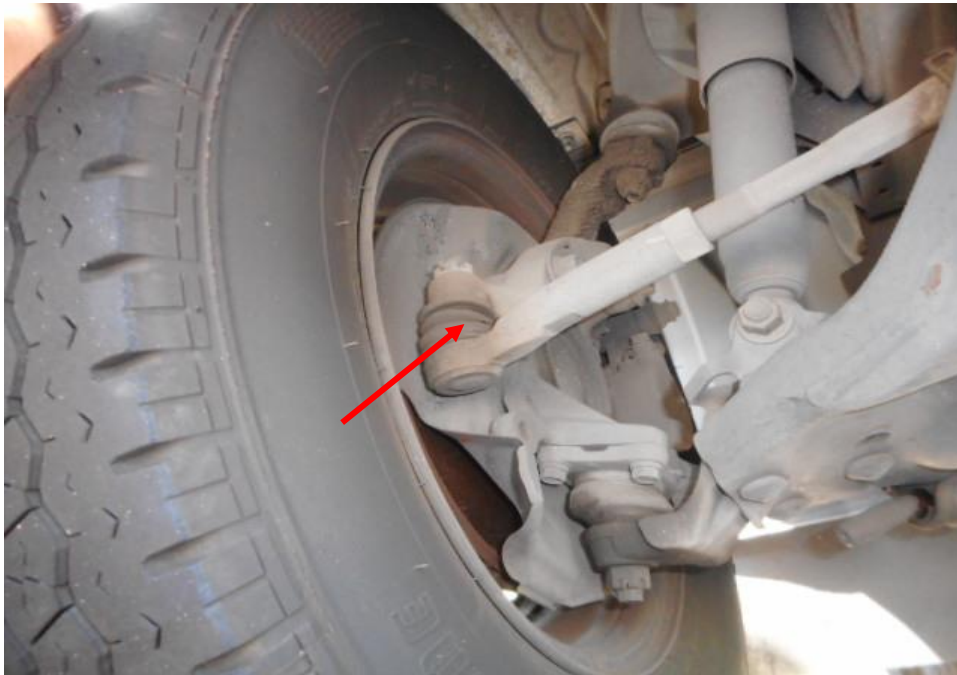
Photo 18 shows the various undercarriage components at the front right wheel of the Motor Lorry, in particular the steering tie rod end (arrowed). The various steering components were all found to be intact, suggesting that the steering system of the Motor Lorry was likely to be in serviceable condition at the material time of accident. There was also no sign of fluid stain(s) observed on the various undercarriage components.

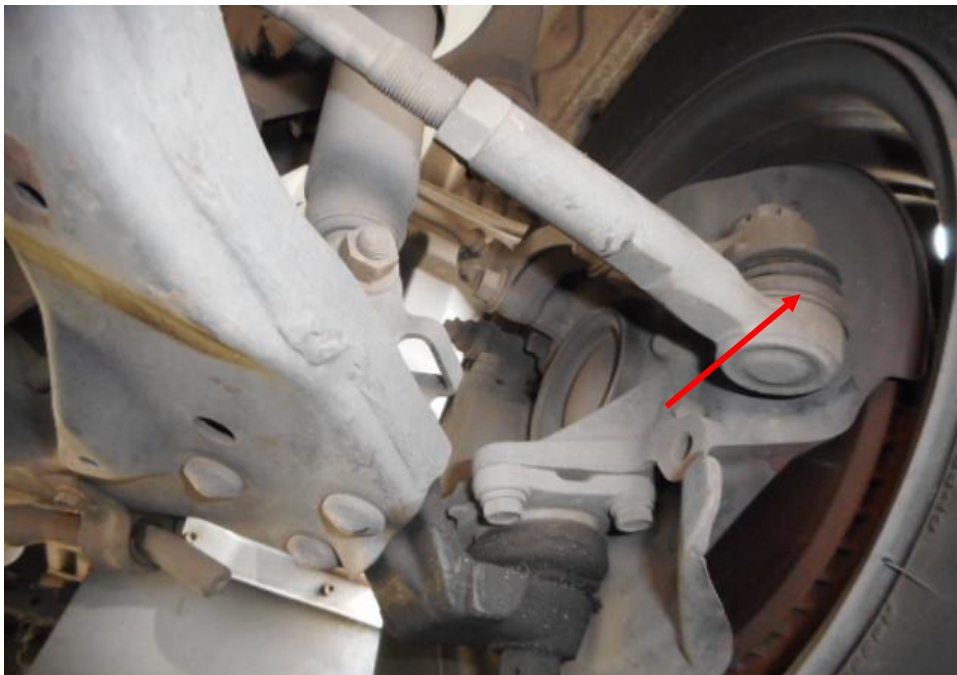
Photo 19 shows the various undercarriage components at the front left wheel of the Motor Lorry, in particular the steering tie rod end (arrowed). The various undercarriage components of the Motor Lorry were all found to be intact without any visible damage. There was also no sign of fluid stain(s) observed on the various undercarriage components.

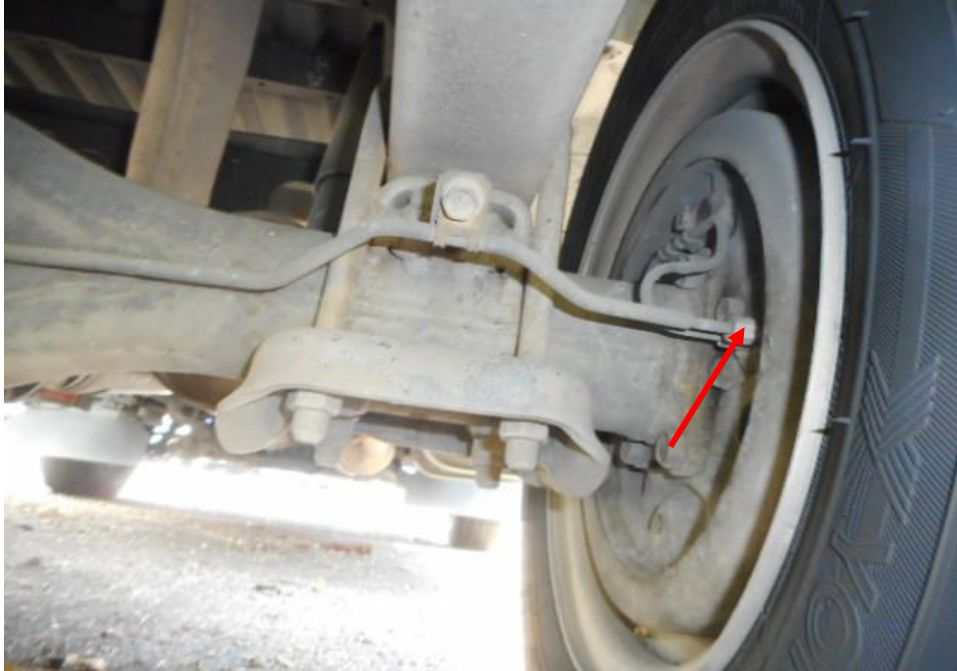
Photo 20 shows the brake pipe (arrowed) at the rear right wheel of the Motor Lorry. I did not observe any leakage of brake fluid at the time of my inspection of the Motor Lorry. My static tests of the Motor Lorry's braking system, along with my visual examination of the various mechanical components in the braking system, had indicated that there was no internal leakage of pressure/vacuum. Hence the braking system of the Motor Lorry was likely to be in serviceable condition at the material time of accident.

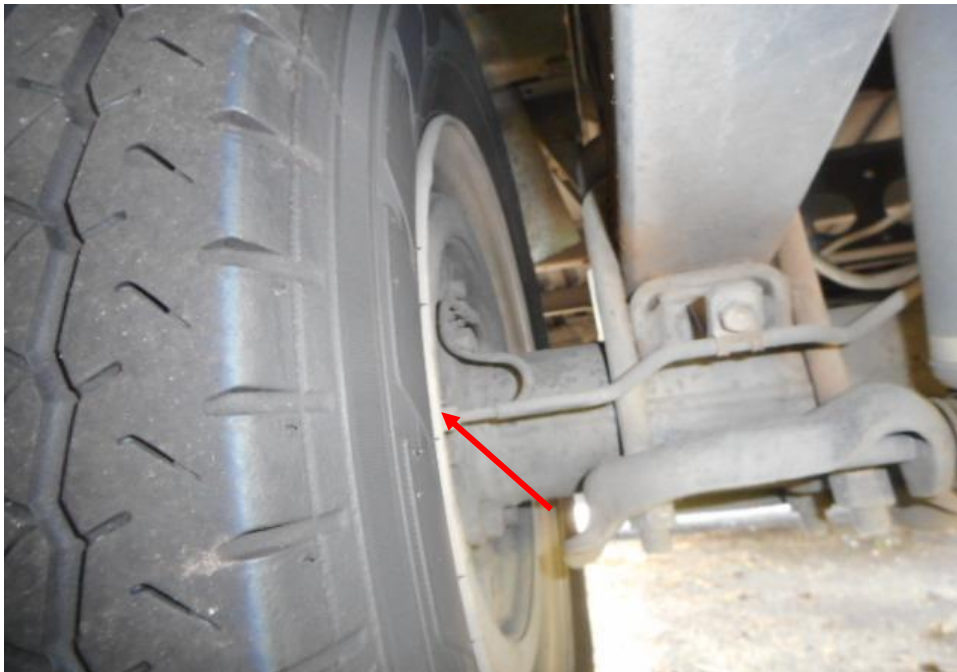
Photo 21 shows the brake pipe (arrowed) at the rear left wheel of the Motor Lorry. I did not observe any leakage of brake fluid at the time of my inspection of the Motor Lorry. My static tests of the Motor Lorry's braking system, along with my visual examination of the various mechanical components in the braking system had indicated that there was no internal leakage of pressure/vacuum. Hence the braking system of the Motor Lorry was likely to be in serviceable condition at the material time of accident.

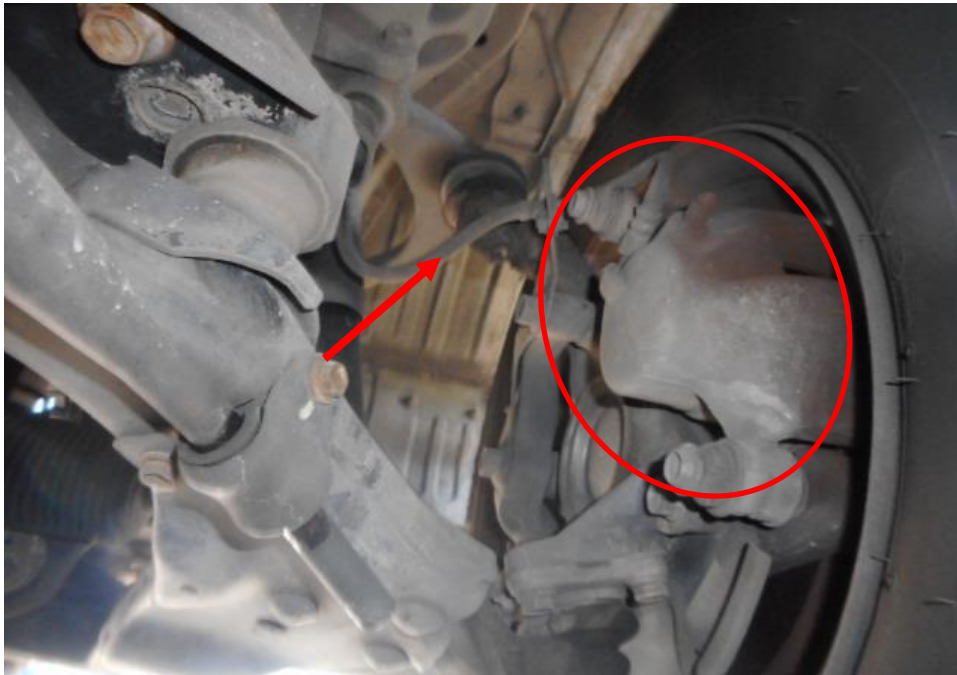
Photo 22 shows the brake hose/pipe (arrowed) at the front right wheel of the Motor Lorry. No leakage of brake fluid was observed. Visual examination of the various components of the braking system like the brake caliper (circled), brake booster, brake pedal etc had revealed all to be intact and without visible damage at the time of accident. There was also no sign of fluid stain(s) observed on the various undercarriage components.

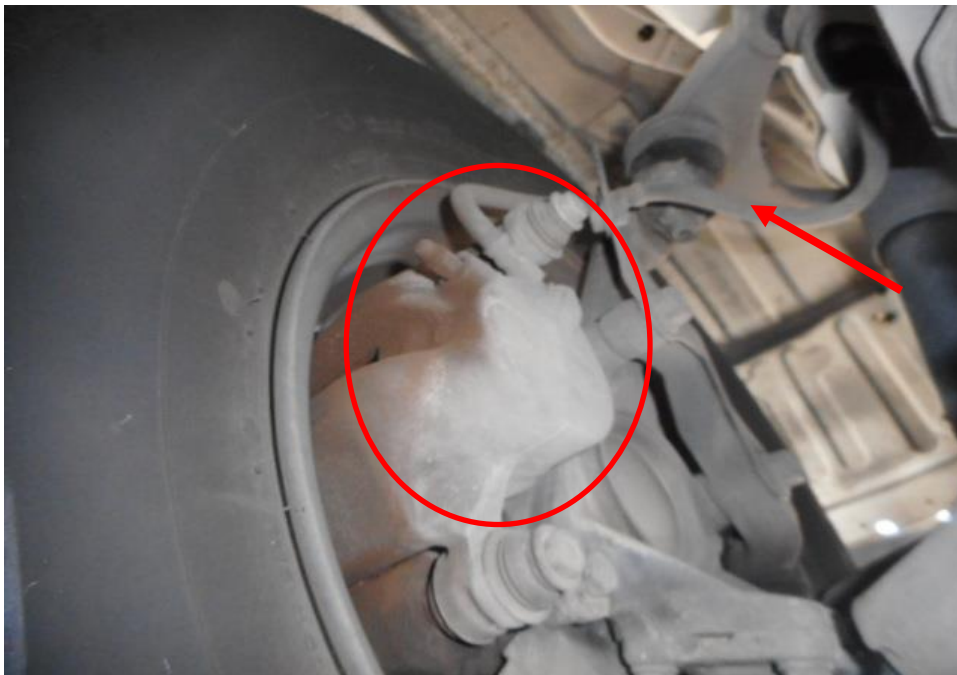
Photo 23 shows the brake hose/pipe (arrowed) at the front left wheel of the Motor Lorry. No leakage of brake fluid was observed. Visual examination of the various components of the braking system like the brake caliper (circled), brake booster, brake pedal etc had revealed all to be intact and without visible damage at the time of accident. There was also no sign of fluid stain(s) observed on the various undercarriage components.
