You're Ref: TP/IP/00600/2022  
Our Ref: CI/TPD22002409/P

**Fatal Accident Investigation Team**

**MECHANICAL INSPECTION REPORT OF MOTOR CAR SJD 5744P**

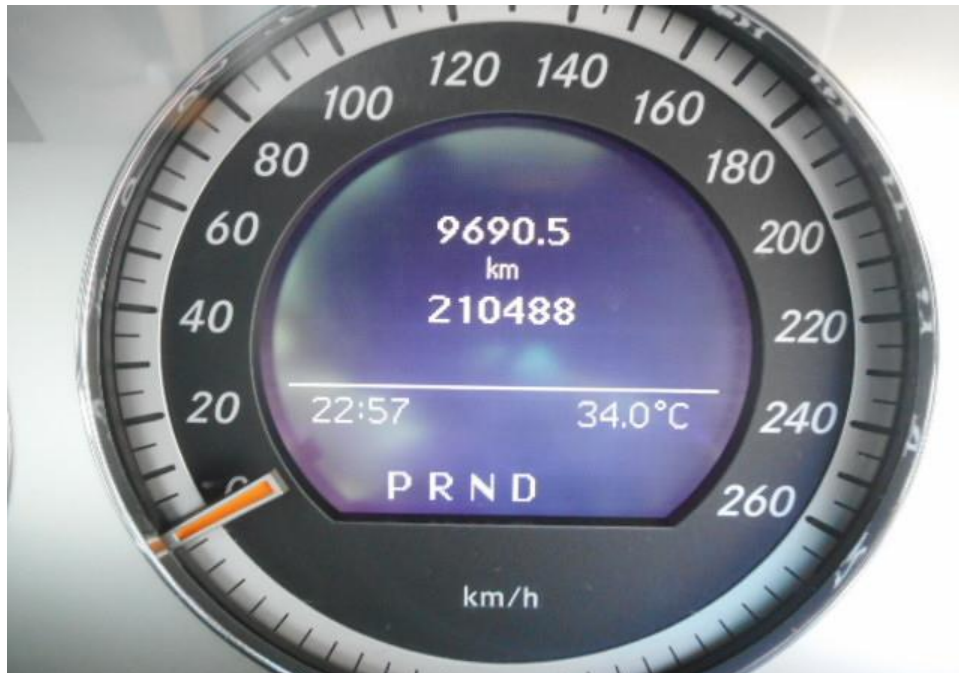
**Photo 1** shows the mileage of the Motor Car at the time of my inspection. The mileage observed was 210,488km.

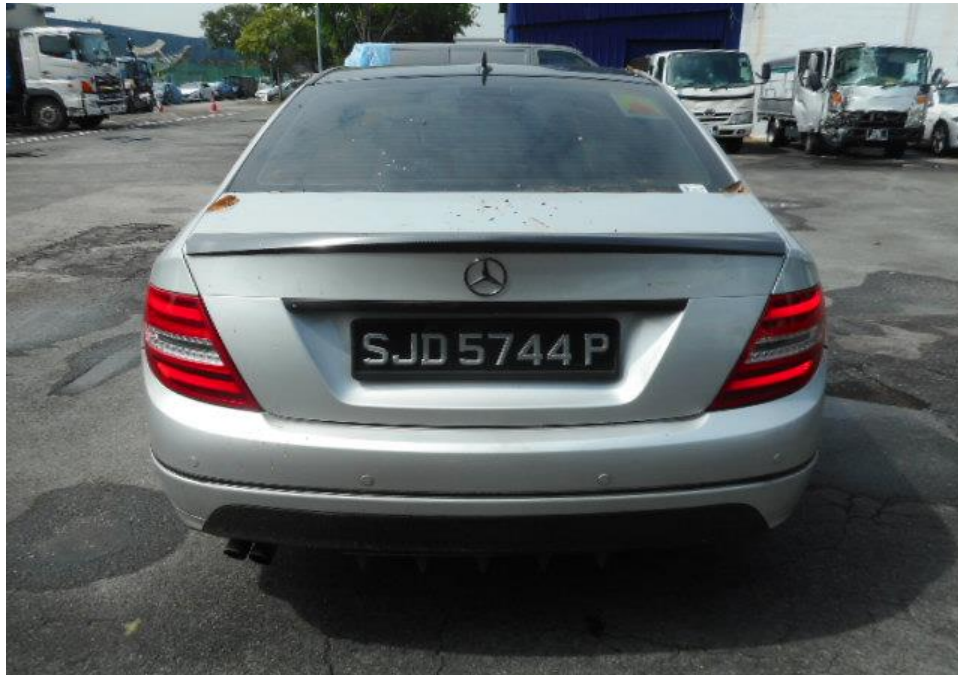
**Photo 2** shows the general view of the Motor Car's rear body at the time of my inspection. The Motor Car rear was observed to be unaffected by the accident.

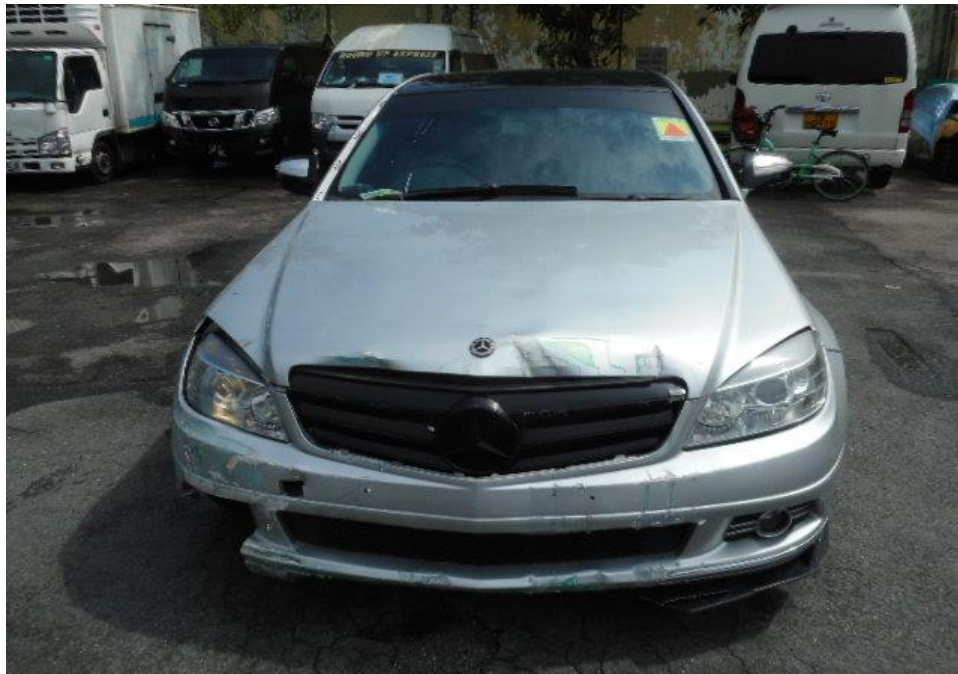
4. The mileage of the Motor Car at the time of my inspection was 210,488km.
5. The Motor Car was observed to have sustained damage at its front portion. Its front bonnet, front bumper as well as its front grille were amongst the body parts that were damaged as a result of the accident.

**Photo 3** shows a general view of the Motor Car's front body at the time of my inspection. The Motor Car was observed to have sustained damage at its front portion. Its front bonnet, front bumper as well as its front grille were amongst the body parts that were damaged as a result of the accident.

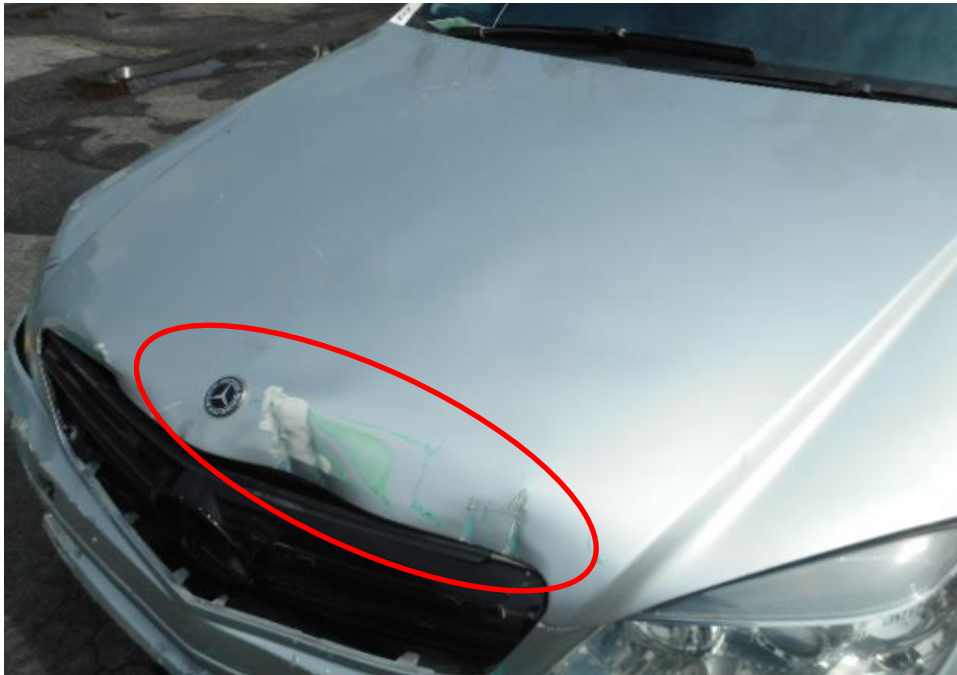
**Photo 4** shows a close up view of the Motor Car's front body at the time of my inspection. The front portion of the Motor Car was observed to have sustained damage. Its front bonnet (circled) was the body parts that were damaged as a result of the accident.

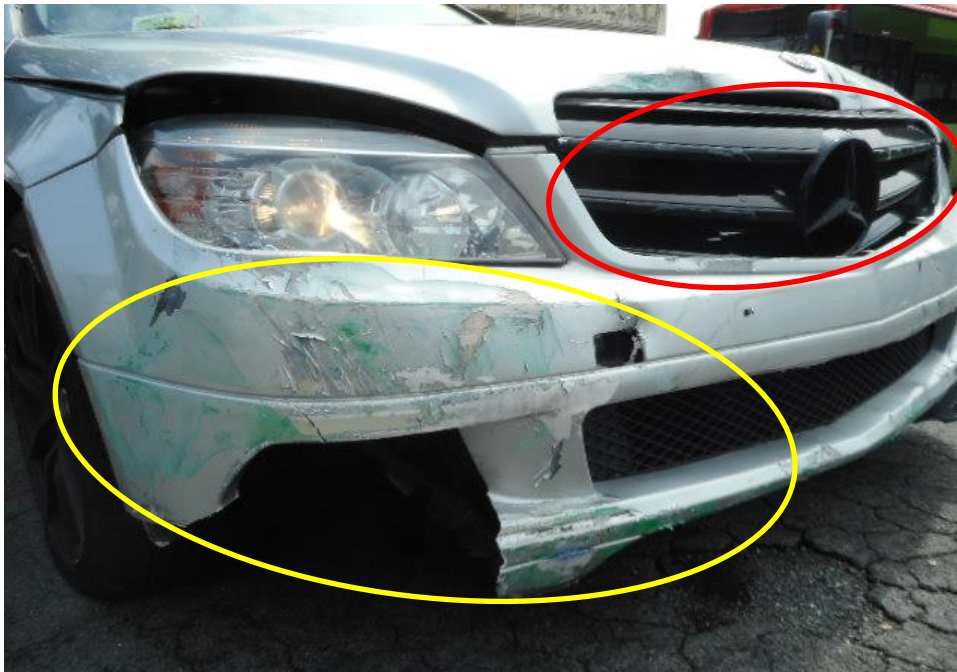
**Photo 5** shows a close up view of the Motor Car's front body at the time of my inspection. The front portion of the Motor Car was observed to have sustained damage. Its front bumper (yellow circle) and front grille (red circle) was the body parts that were damaged as a result of the accident.

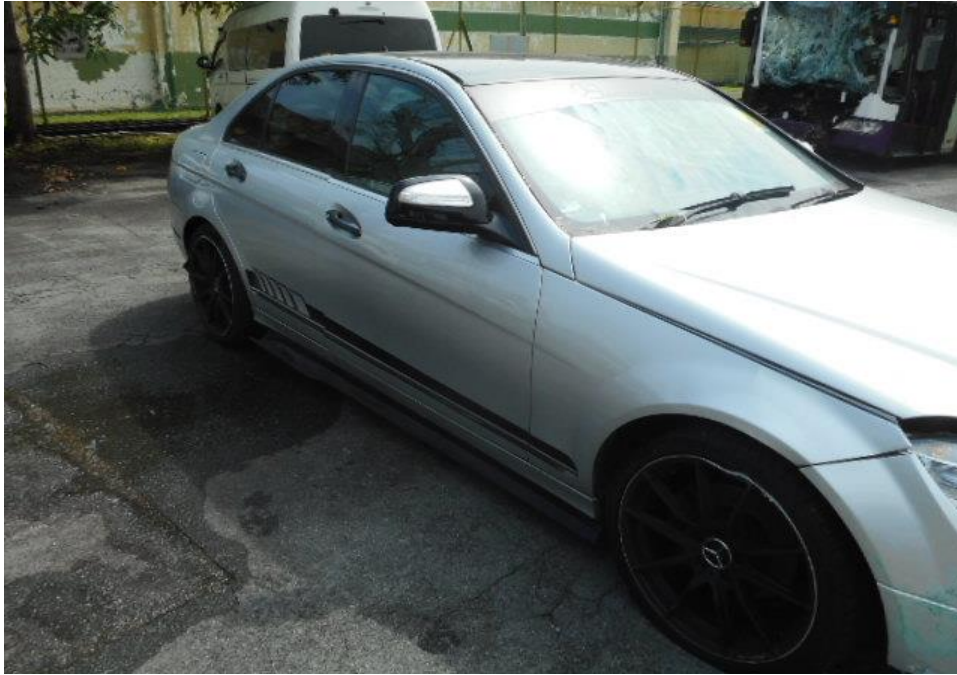
**Photo 6** shows a general view of the Motor Car's right body at the time of my inspection. The right portion of the Motor Car was observed to have been unaffected by the accident.

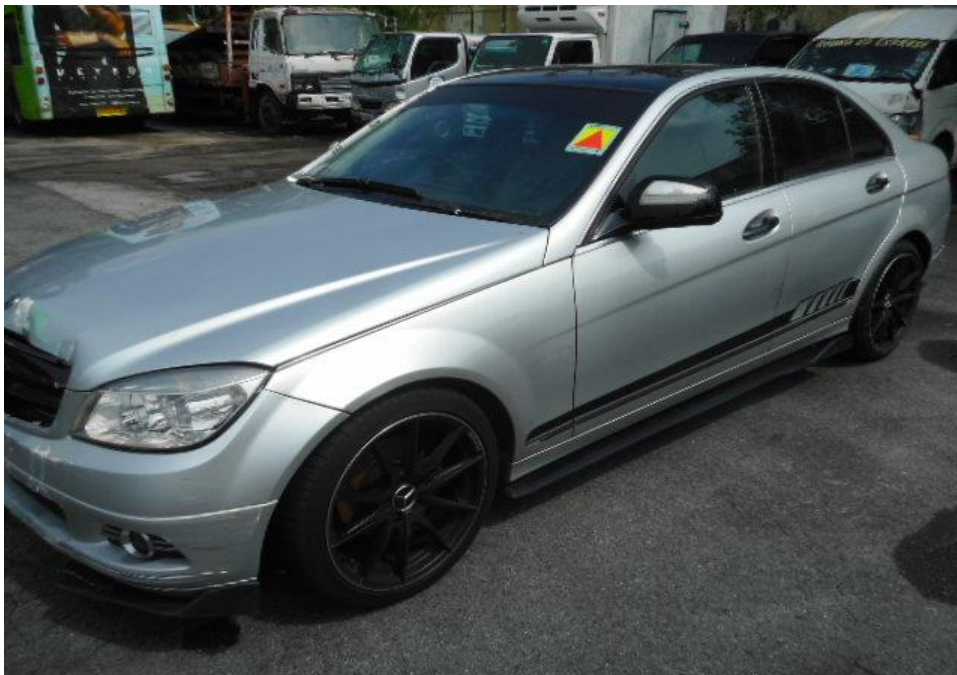
**Photo 7** shows a general view of the Motor Car's left body at the time of my inspection. The left portion of the Motor Car was observed to have been unaffected by the accident.

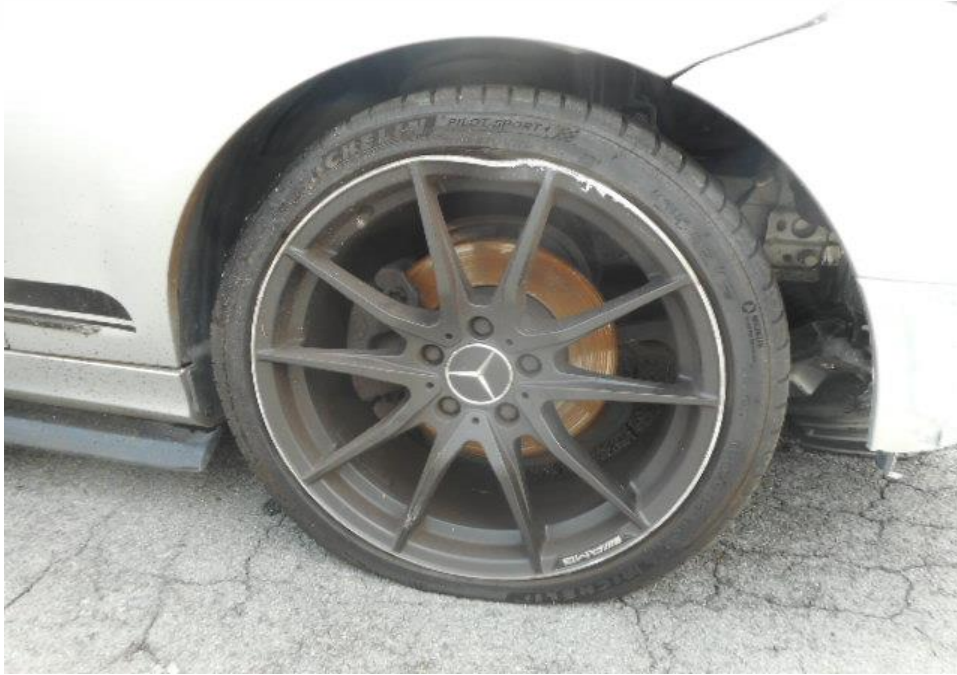
**Photo 8** shows the condition of the front right tyre of the Motor Car, which was observed to be in serviceable condition with remaining tread depth of approximately 4.9mm. The tyre was sufficiently inflated for vehicular operation with no tear, cut or burst mark(s) on the outer and the inner sidewalls as well as across the tread. However, the wheel rim was observed to be damaged as a result of the accident.

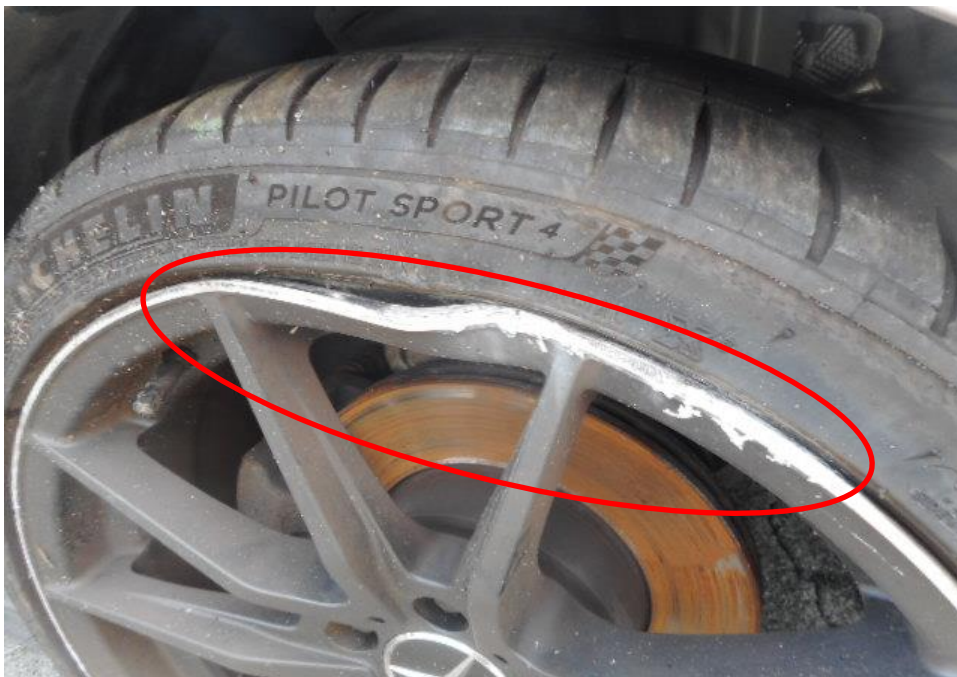
7. The front right wheel rim was observed to be damaged as a result of the accident. However, all the 4 tyres and other 3 wheel rims were observed to be wrapped around standard alloy wheel rims that were found to be without any damage. See photo 1 – 12 below.

**Photo 9** shows the close up condition of the front right tyre wheel rim (circled) of the Motor Car which was observed to be damaged as a result of the accident.

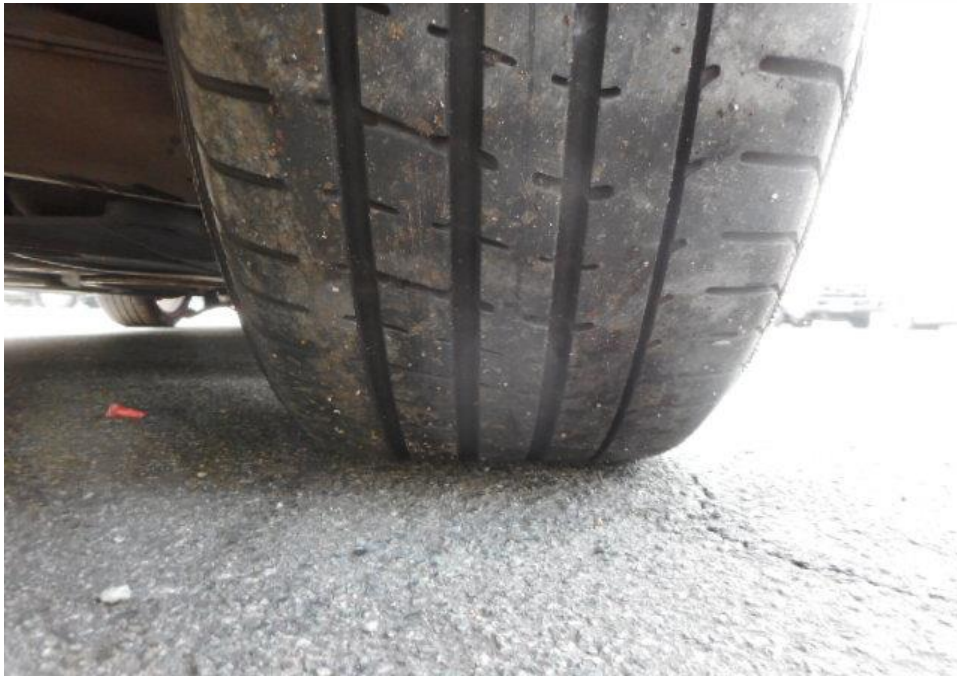
**Photo 10** shows the condition of the rear right tyre of the Motor Car, which was observed to be in serviceable condition with remaining tread depth of approximately 4.4mm. The tyre was also observed to be sufficiently inflated for vehicular operation with no tear, cut or burst mark(s).

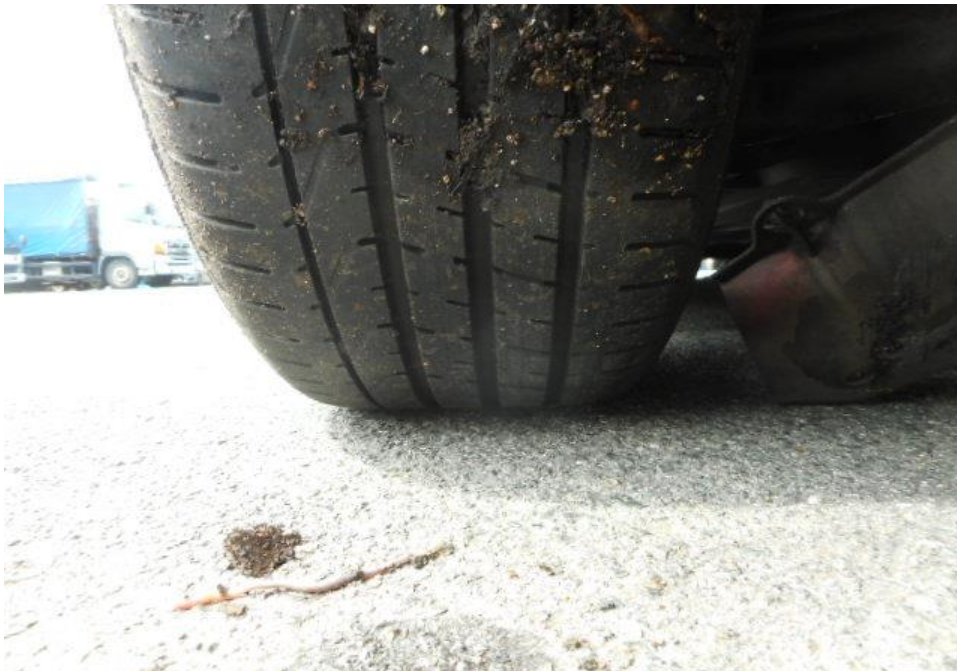
**Photo 11** shows the condition of the rear left tyre of the Motor Car, which was observed to be in serviceable condition with remaining tread depth of approximately 4.9mm. The tyre, which was wrapped around steel wheel rim, was also observed to be sufficiently inflated for vehicular operation. The 4 tyres of the Motor Car were wrapped around standard steel wheel rims.

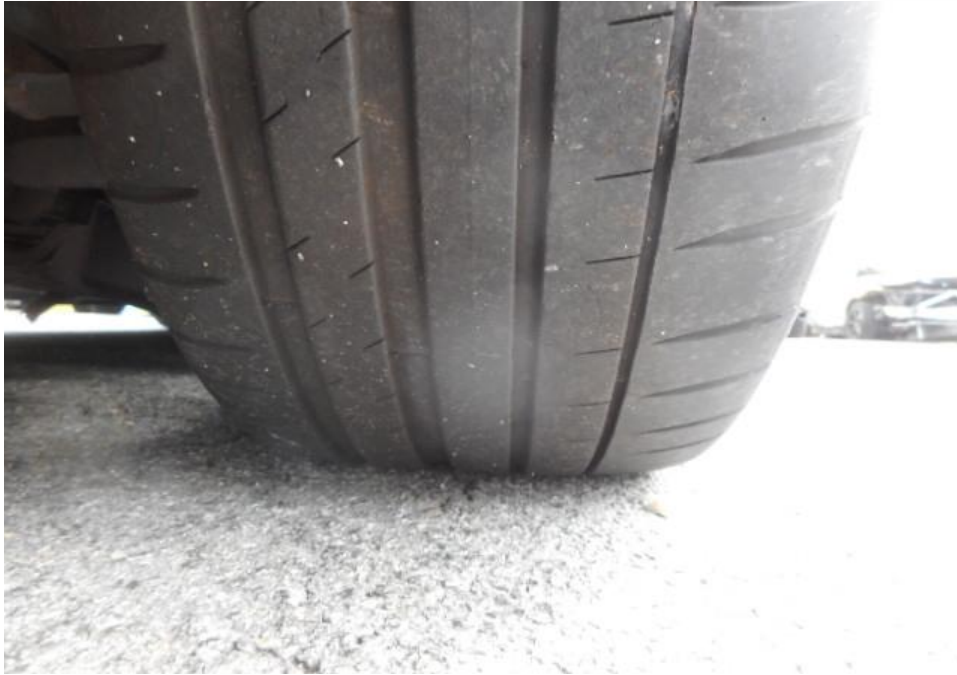
**Photo 12** shows the condition of the front left tyre of the Motor Car, which was observed to be in serviceable condition with remaining tread depth of approximately 4.7mm. There was also no tear, cut or burst mark(s) on the outer and the inner sidewalls as well as across the tread of the Motor Car's 4 tyres.

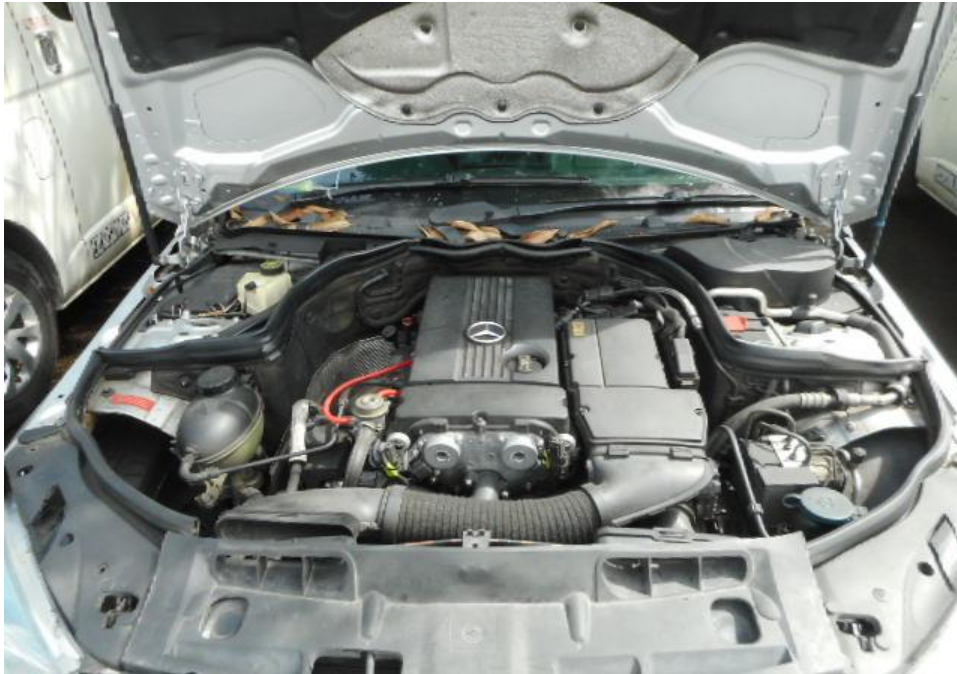
**Photo 13** shows a general view of the Motor Car's engine compartment. The various parts and components inside the engine compartment were unaffected by the accident. There was also no sign(s) or indication(s) of fluid leakage and/or fluid stain within the engine compartment.

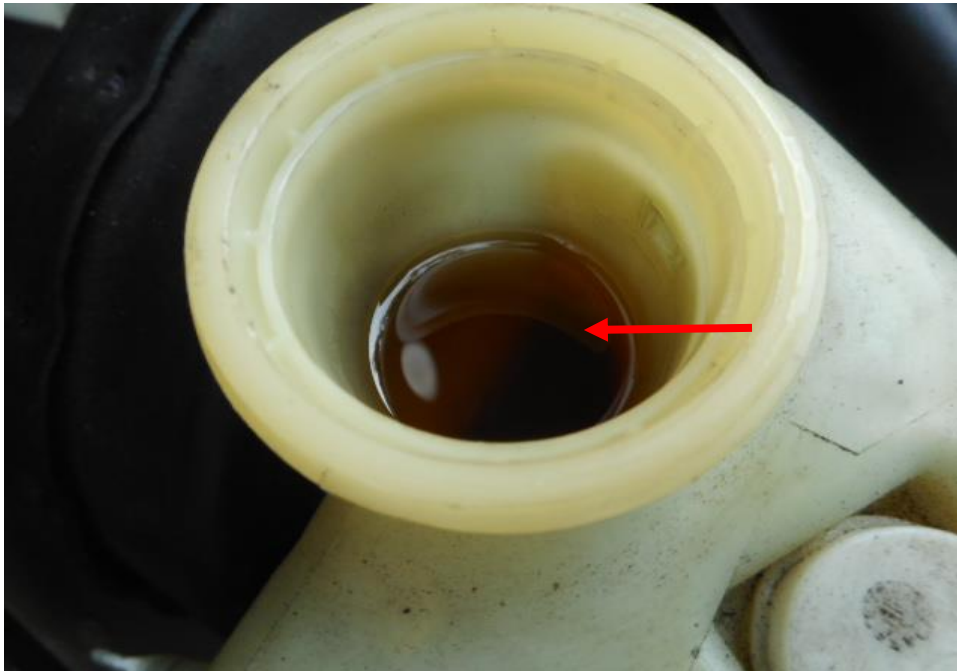
**Photo 14** shows the brake fluid reservoir of the Motor Car at the time of my inspection. The brake fluid was observed to be of sufficient level (arrowed) and without any visible contamination.

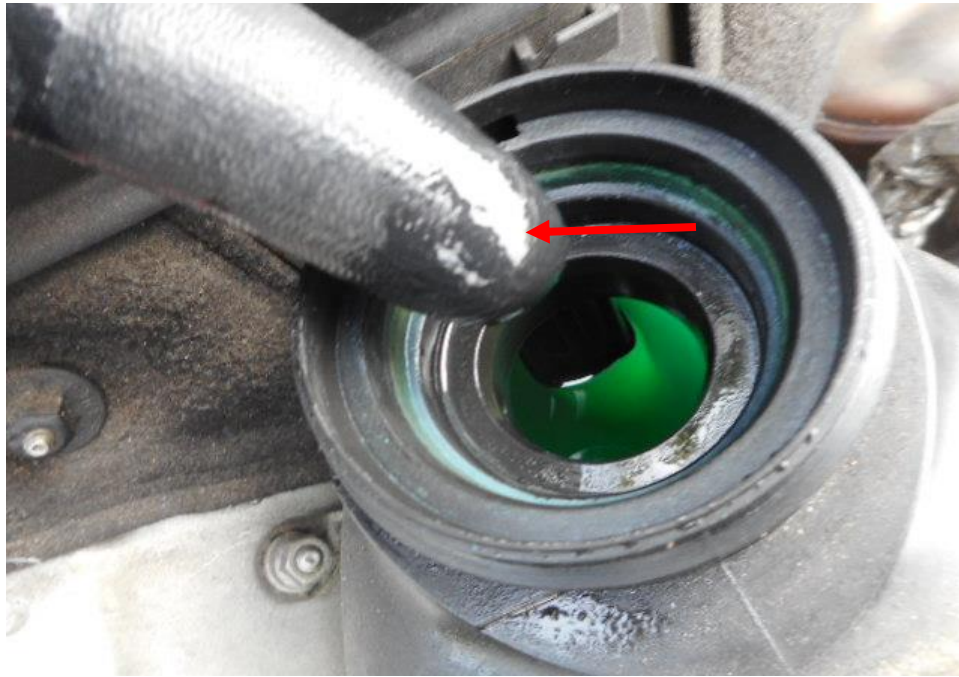
**Photo 15** shows checks being carried out to the engine coolant of the Motor Car at the time of my inspection. The engine coolant was observed to be of sufficient level (arrowed) and without any visible contamination.

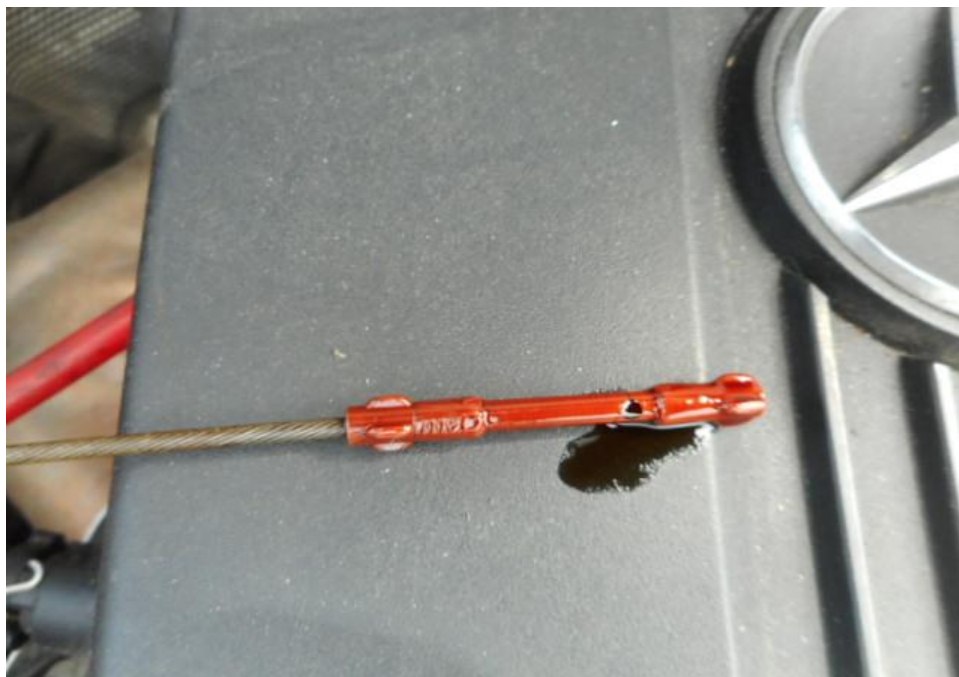
**Photo 16** shows the engine oil dipstick of the Motor Car at the time of my inspection. The engine oil was observed to be of sufficient level and without any visible contamination.

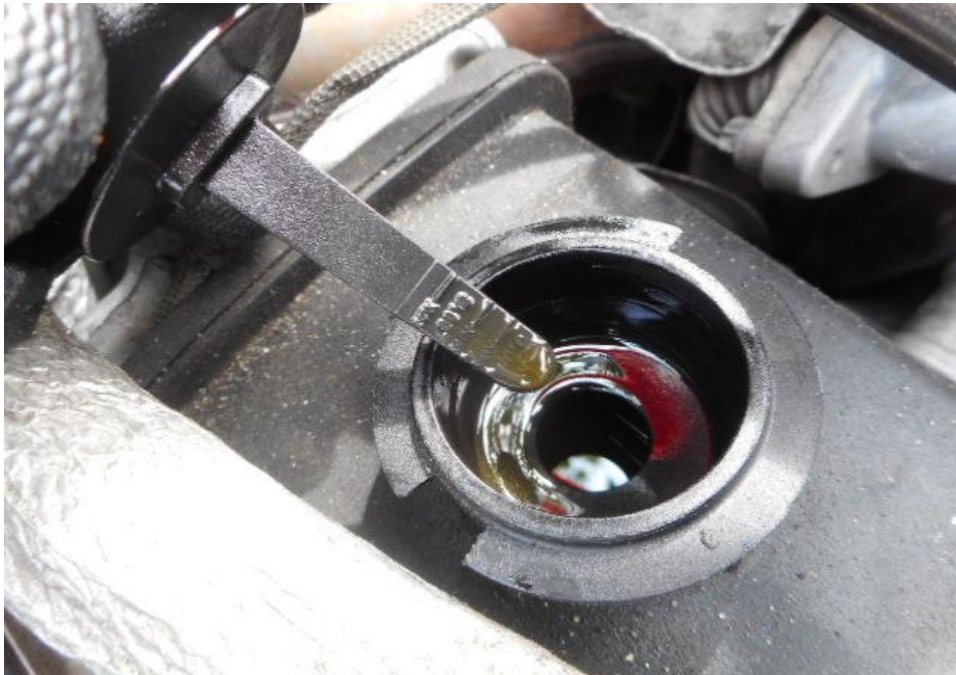
**Photo 17** shows the power steering fluid dipstick of the Motor Car at the time of my inspection. The steering fluid was observed to be of sufficient level and without any visible contamination.

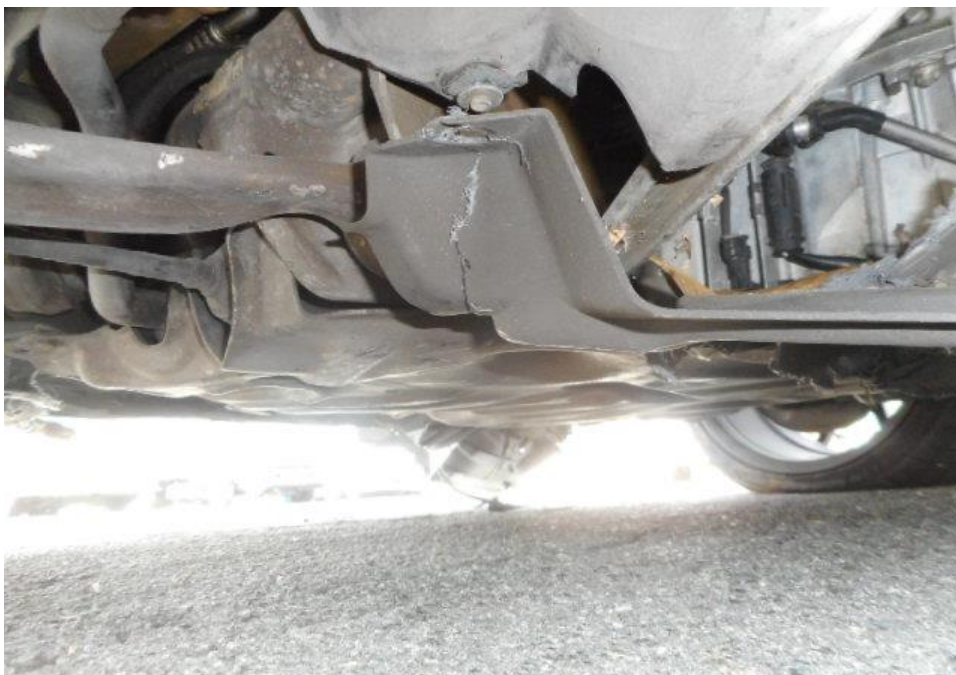
**Photo 18** shows the undercarriage of the Motor Car, at the area where the engine housing and transmission housing are located. I did not find any sign(s) or indication(s) of fluid leak and/or fluid stain(s) on the underside of the Motor Car.

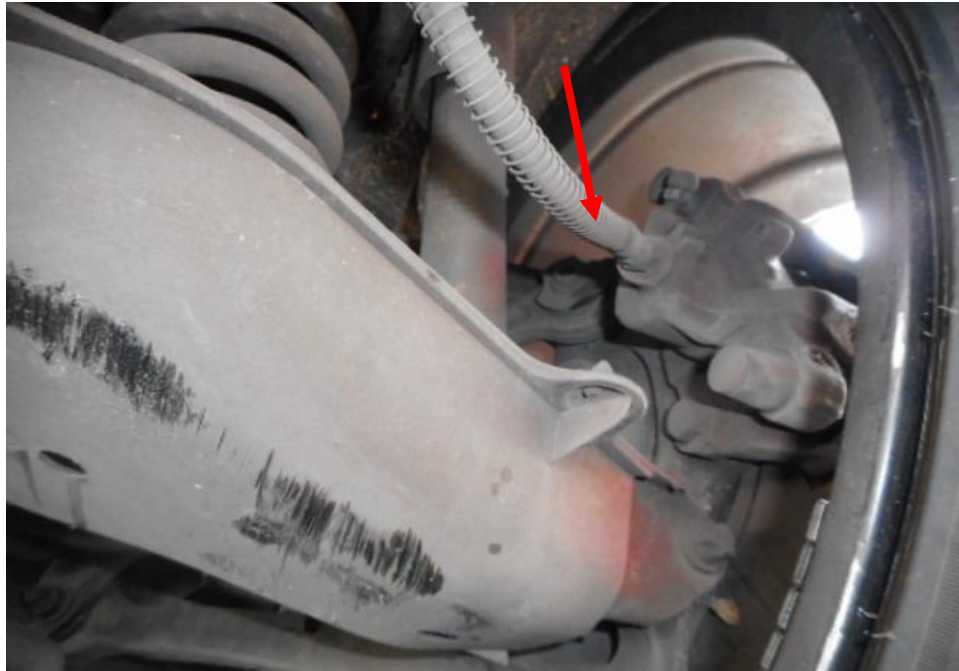
**Photo 19** shows the brake hose/pipe (arrowed) at the rear right wheel of the Motor Car. No leakage of brake fluid was observed. Visual examination of the various components of the braking system like the drum brake, brake booster, brake pedal etc. had revealed all to be intact and without visible damage.

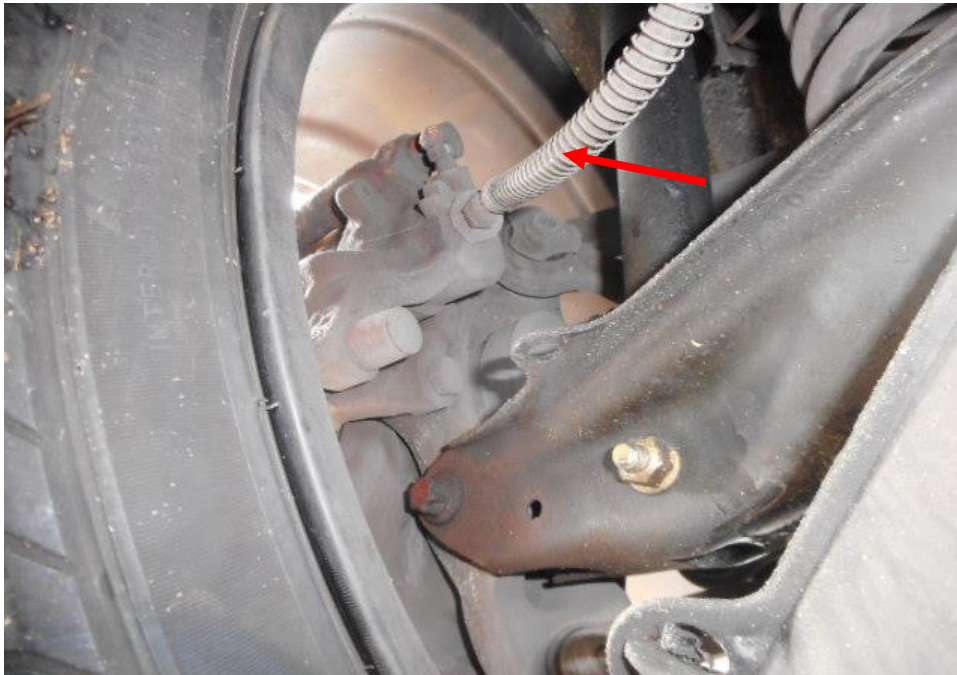
**Photo 20** shows the brake hose/pipe (arrowed) at the rear left wheel of the Motor Car. I did not observe any leakage of brake fluid at the time of my inspection of the Motor Car. Static tests of the Motor Car's braking system had indicated that there was no internal leakage of pressure/vacuum. The undercarriage components of the Motor Car were also all found to be intact and without any visible damage.

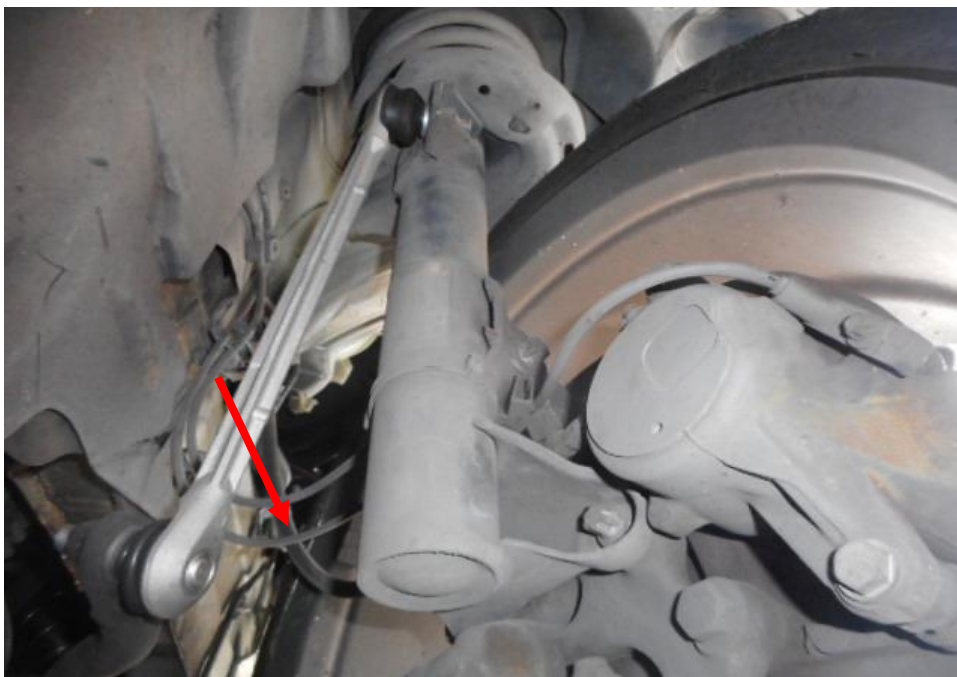
**Photo 21** shows the brake hose/pipe (arrowed) at the front right wheel of the Motor Car. I did not observe any leakage of brake fluid at the time of my inspection of the Motor Car. Static tests of the Motor Car's braking system had indicated that there was no internal leakage of pressure/vacuum. The undercarriage components of the Motor Car were also all found to be intact and without any visible damage.

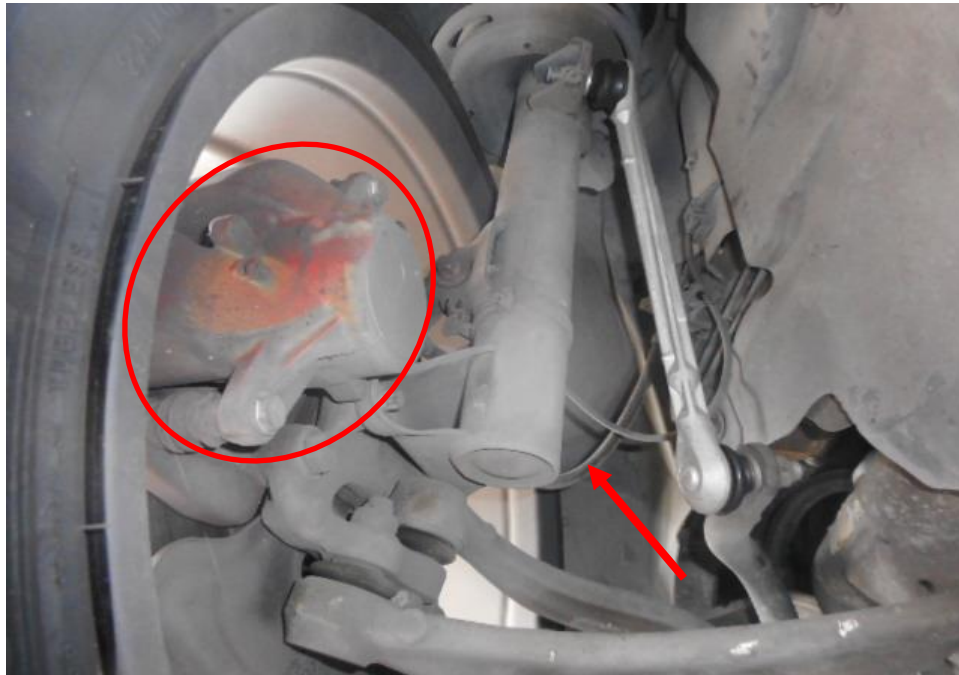
**Photo 22** shows the brake hose/pipe (arrowed) at the front left wheel of the Motor Car. No leakage of brake fluid was observed. Visual examination of the various components of the braking system like the brake caliper (circled), brake booster, brake pedal etc had revealed all to be intact and without visible damage.

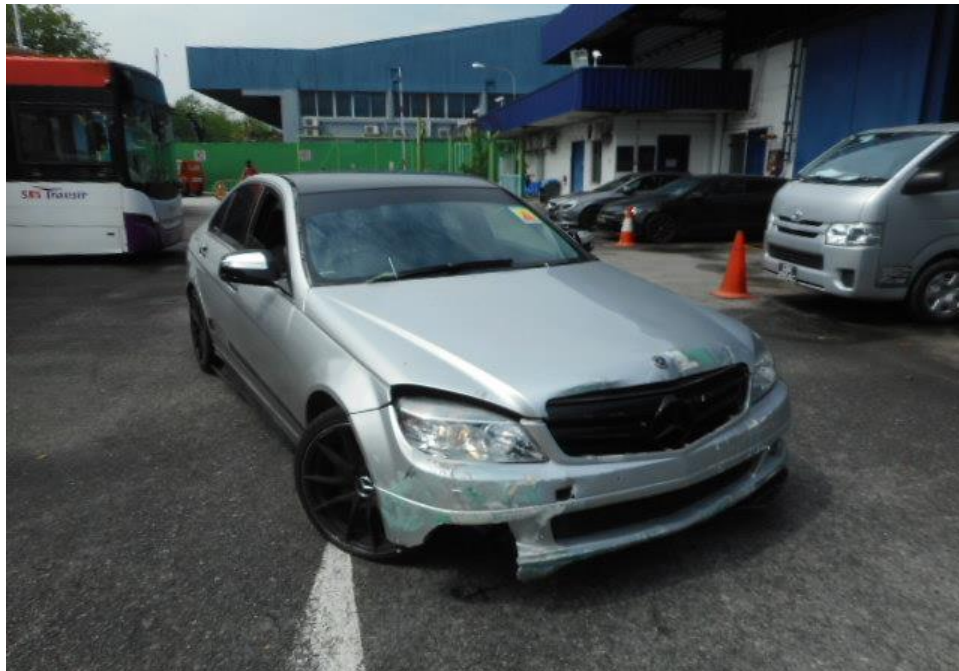
**Photo 23** shows the front right wheel of the Motor Car turned to its full left. During my steering system test, I did not experience any abnormal free play and/or resistance when I had turned the steering wheel towards the left and right. This would suggest that the steering system of the Motor Car was likely to be in serviceable condition at the material time of accident.

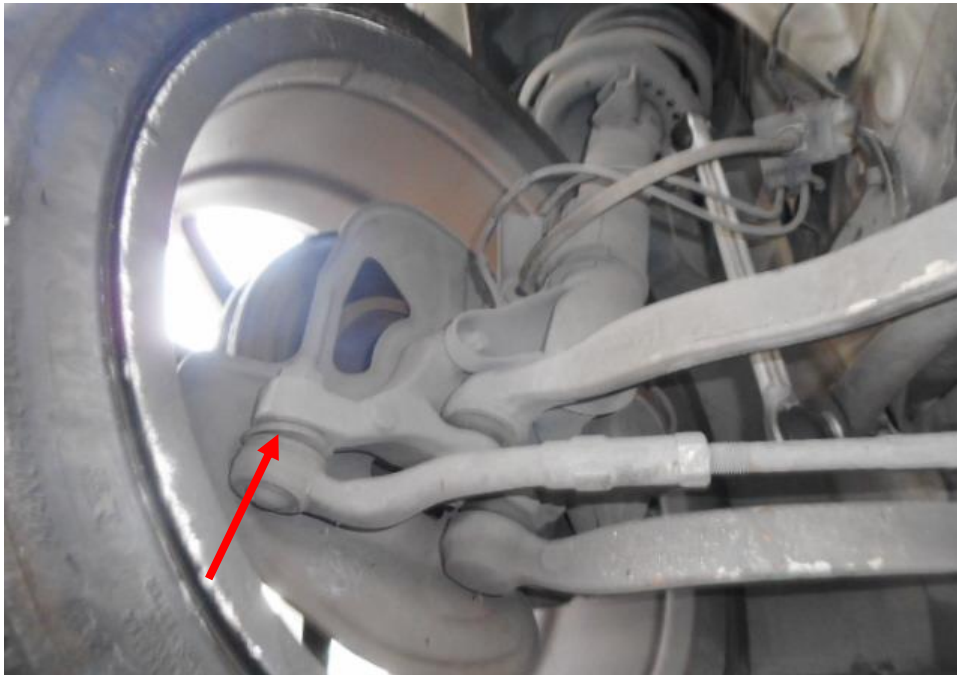
**Photo 24** shows the various undercarriage components at the front right wheel of the Motor Car, in particular the steering tie rod (red arrow). The various steering components were all found to be intact, suggesting that the steering system of the Motor Car was likely to be in serviceable condition at the material time of accident. There was also no sign of fluid stain observed on the various undercarriage components at the front right wheel of the Motor Car.

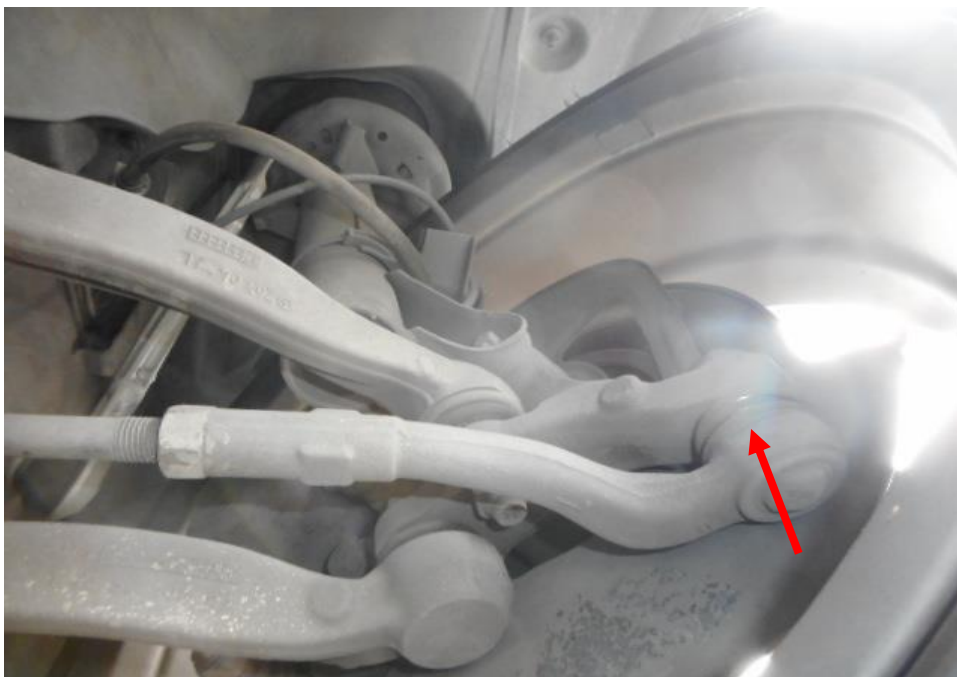
**Photo 25** shows the various undercarriage components at the front left wheel of the Motor Car, which had included the steering tie rod (red arrow). The various undercarriage components of the Motor Car were all found to be intact without any visible damage.

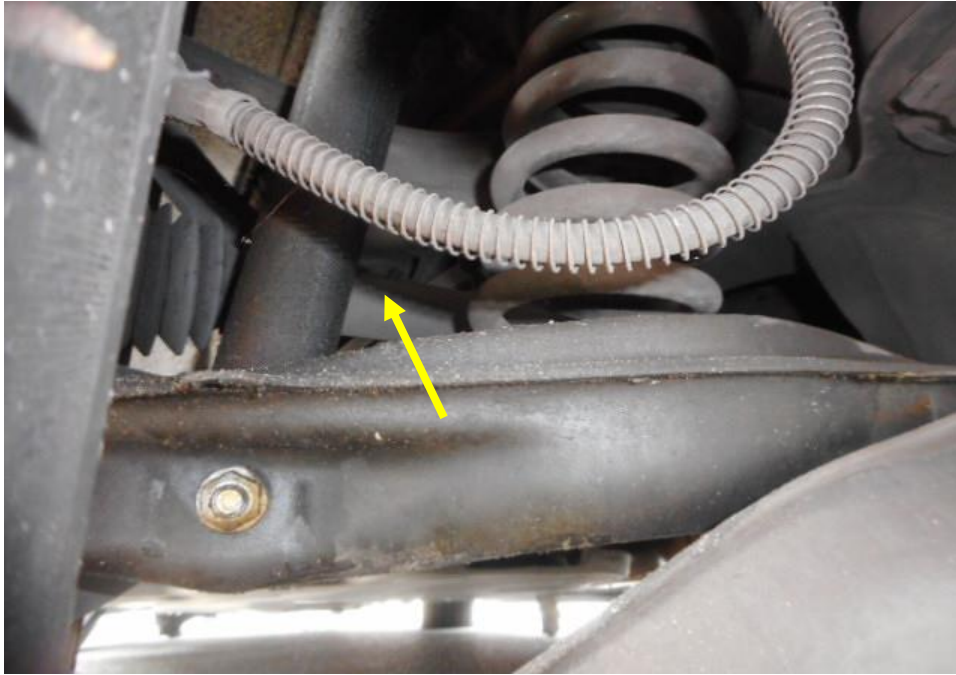
**Photo 26** shows the various undercarriage components at the rear left wheel of the Motor Car, in particular the drive shaft (arrowed). The components were all found to be intact, suggesting that the steering system of the Motor Car was likely to be in serviceable condition at the material time of accident. There was also no sign of fluid stain observed on the various undercarriage components at the front right wheel of the Motor Car.

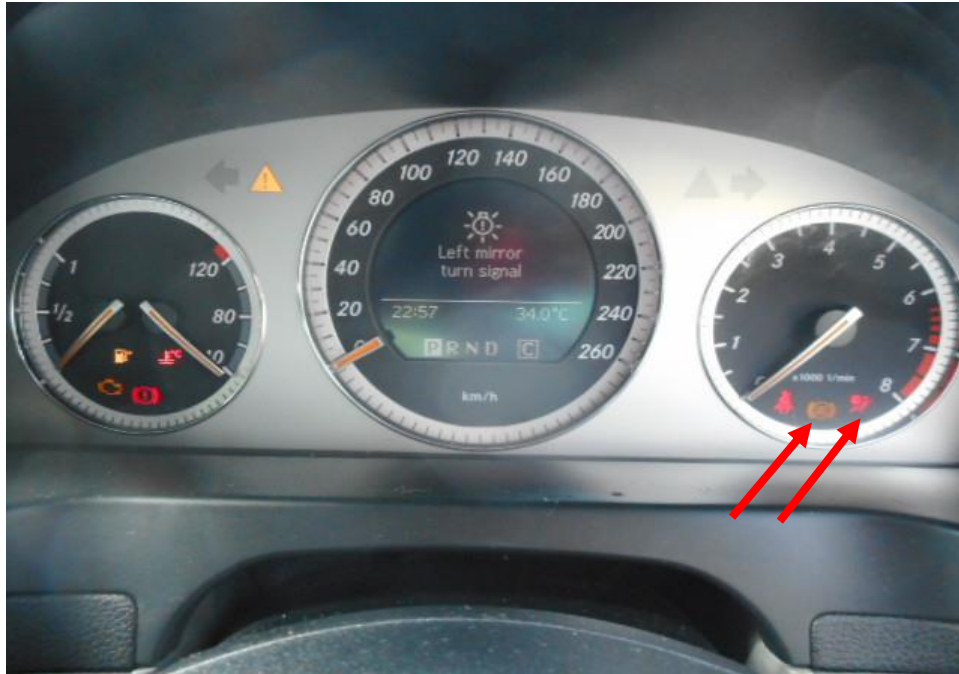
**Photo 27** shows the warning light for Anti-Lock Brake System (ABS), and Supplemental Restraint System (SRS) (arrowed) appearing on the instrument panel of the Motor Car during the self-test of its various electronic operating systems when its engine was cranked.

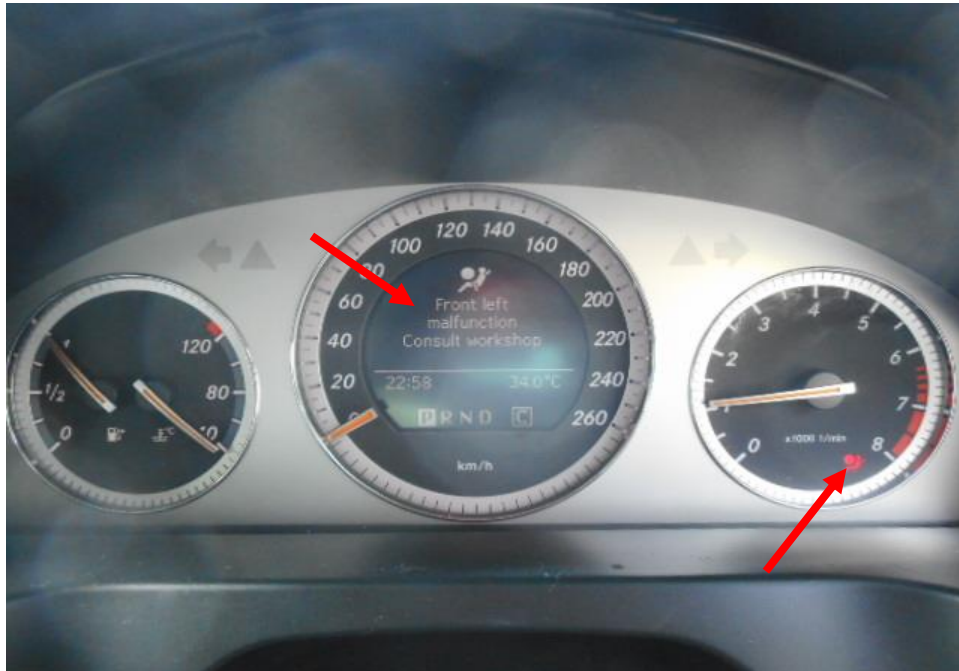
**Photo 28** shows only the Supplemental Restraint System (SRS) remained illuminated up, the fault was a pre-existing fault. There was no other warning lights illuminated on the instrument panel of the Motor Car after the engine was cranked. This would suggest that there was no abnormality to the electronic operating system of the Motor Car, like the ABS and etc.
