You're Ref: TP/IP/04558/2022
Our Ref: CI/TPD22002410/P

Fatal Accident Investigation Team

MECHANICAL INSPECTION REPORT OF MOTOR CAR SMR 1137J

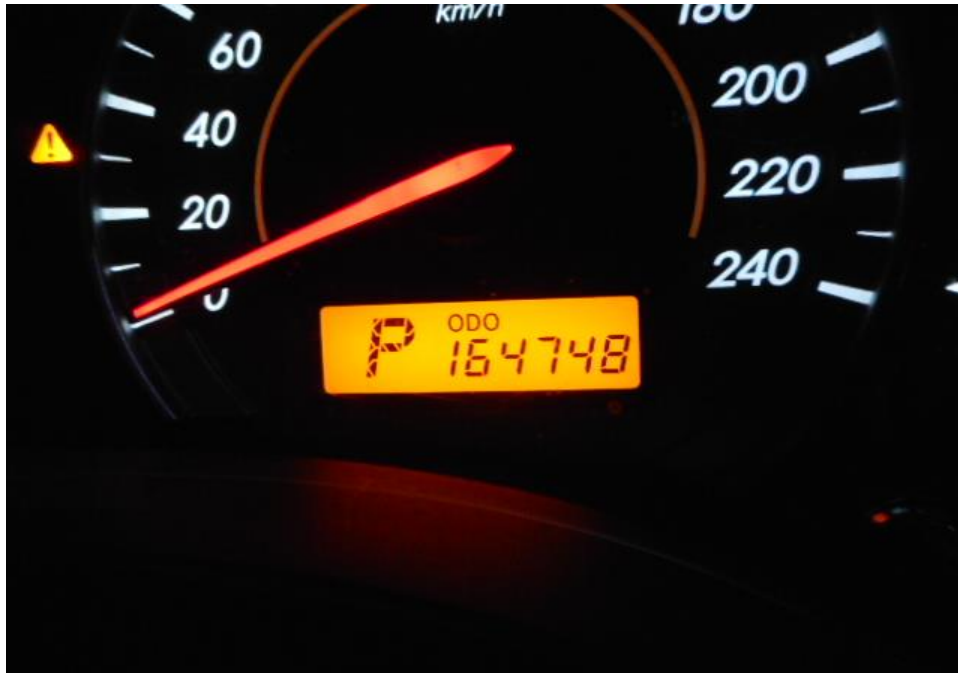
Photo 1 shows the mileage of the Motor Car at the time of my inspection. The mileage observed was 164,748km.

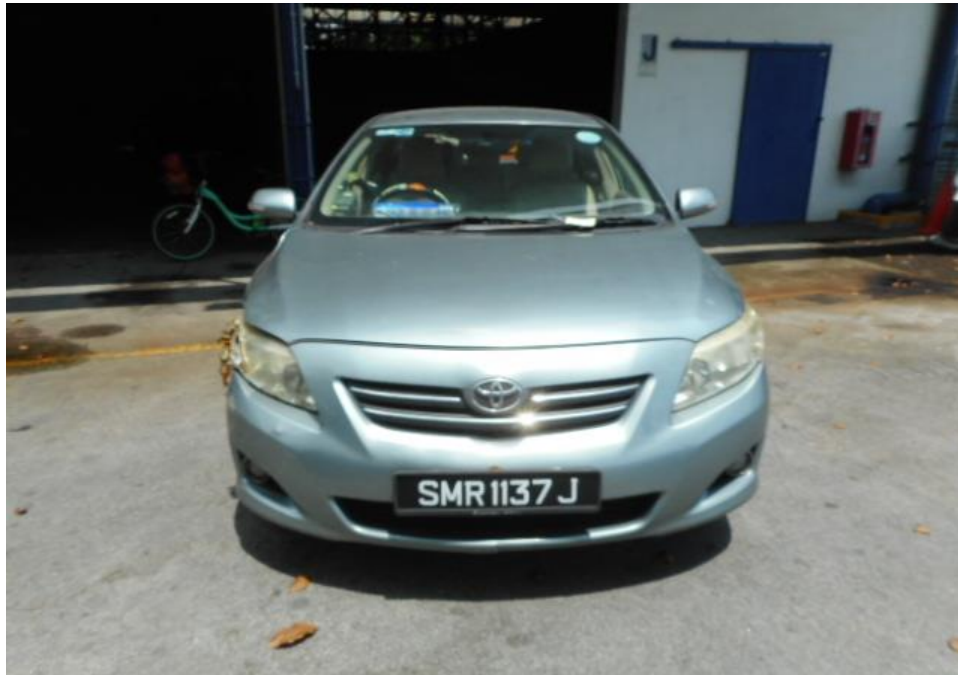
4. The mileage of the Motor Car at the time of my inspection was 164,748km.
5. The Motor Car was observed to have sustained damage at its front and left portion. Its front bumper, front right headlamp as well as its front right fender were amongst the body parts that were damaged as a result of the accident.

Photo 2 shows a general view of the Motor Car's front body at the time of my inspection. The Motor Car was observed to have sustained damage at its front and left portion. Its front bumper, front right headlamp as well as its front right fender were amongst the body parts that were damaged as a result of the accident.

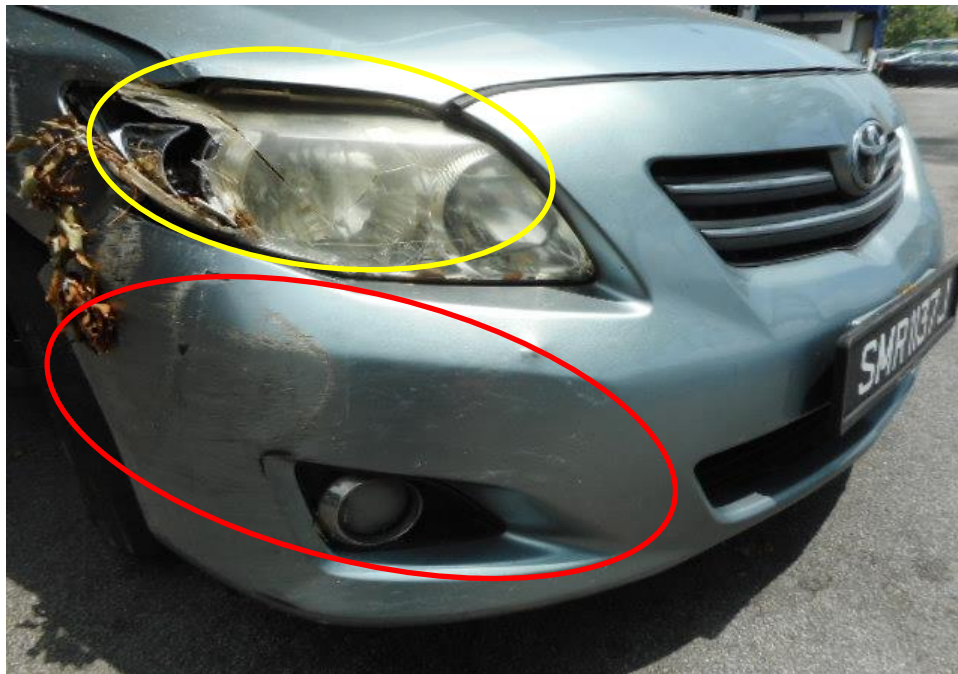
Photo 3 shows a close up view of the Motor Car's front body at the time of my inspection. The front portion of the Motor Car was observed to have sustained damage. Its front bumper (red circle) and front right headlamp (yellow circle) was the body parts that were damaged as a result of the accident.

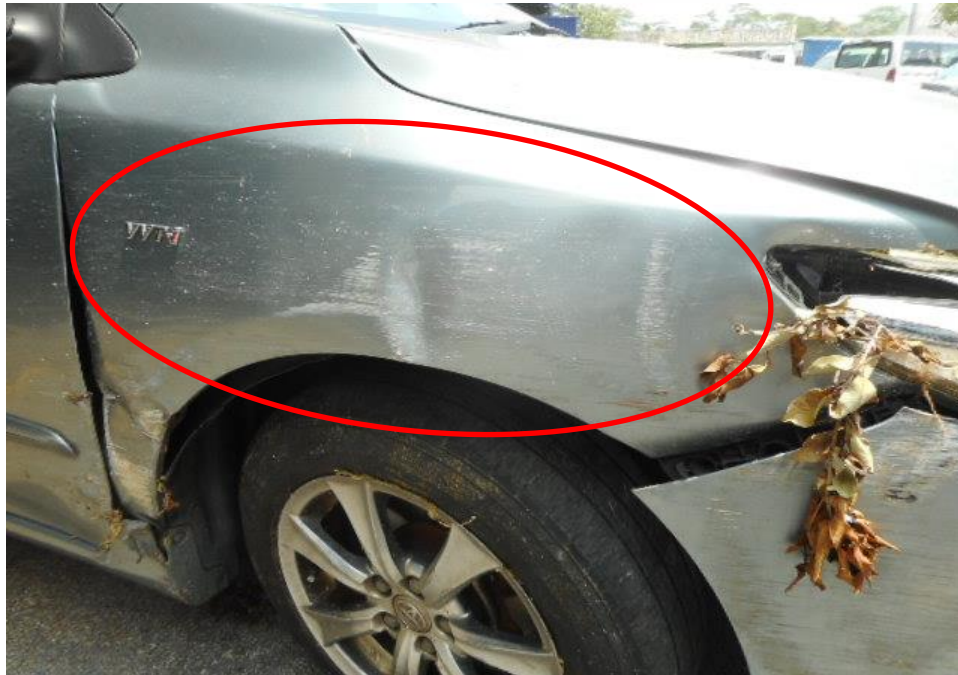
Photo 4 shows a close up view of the Motor Car's front body at the time of my inspection. The front portion of the Motor Car was observed to have sustained damage. Its front right fender (circled) was the body parts that were damaged as a result of the accident.

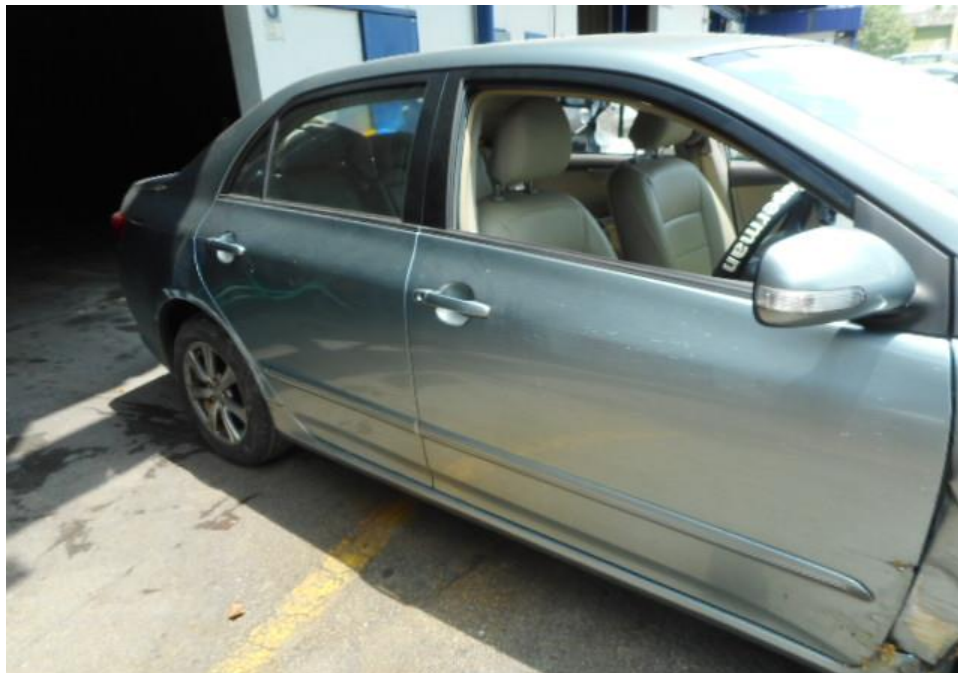
Photo 5 shows a general view of the Motor Car's right body at the time of my inspection. The right portion of the Motor Car was observed to have been unaffected by the accident.

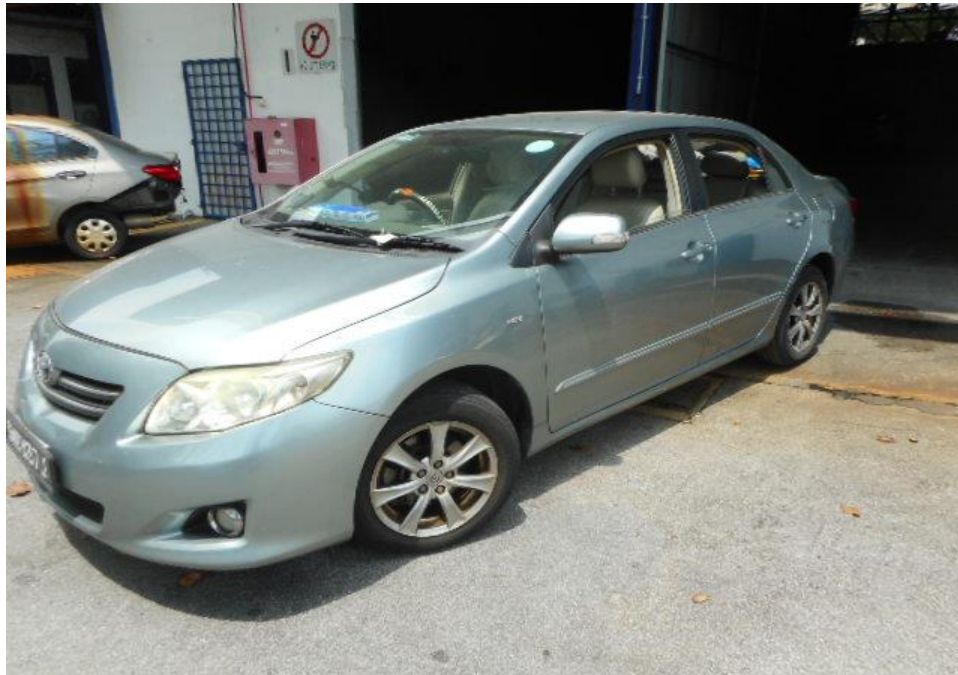
Photo 6 shows a general view of the Motor Car's left body at the time of my inspection. The left portion of the Motor Car was observed to have been unaffected by the accident.

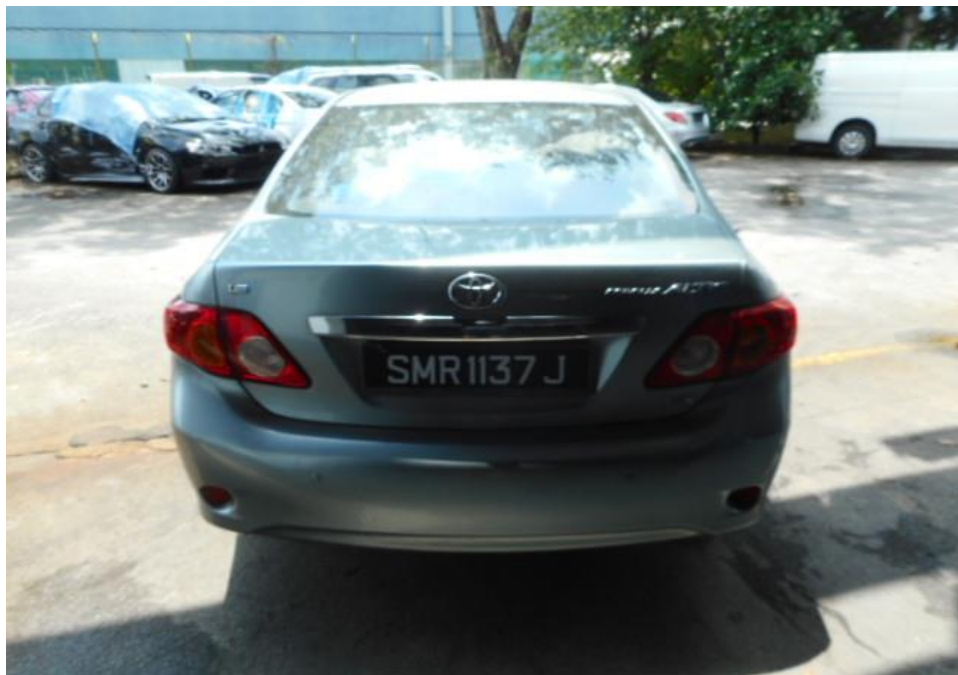
Photo 7 shows the general view of the Motor Car's rear body at the time of my inspection. The Motor Car rear was observed to be unaffected by the accident.

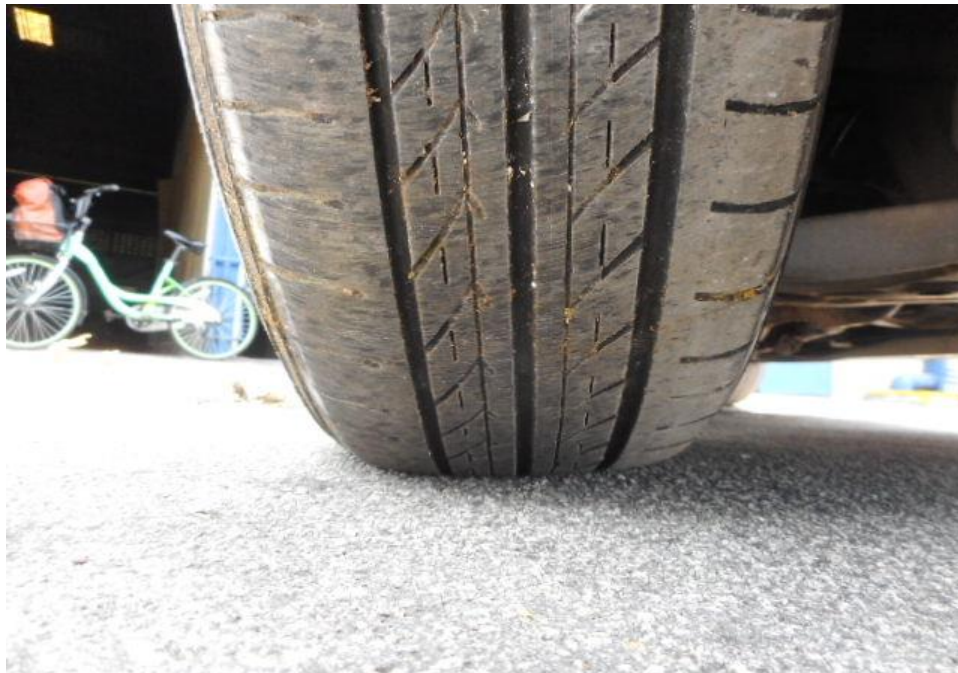
Photo 8 shows the condition of the front right tyre of the Motor Car, which was observed to be in serviceable condition with remaining tread depth of approximately 3.4mm. The tyre was sufficiently inflated for vehicular operation with no tear, cut or burst mark(s) on the outer and the inner sidewalls as well as across the tread. The 4 tyres of the Motor Car were wrapped around standard steel wheel rims without any damage.

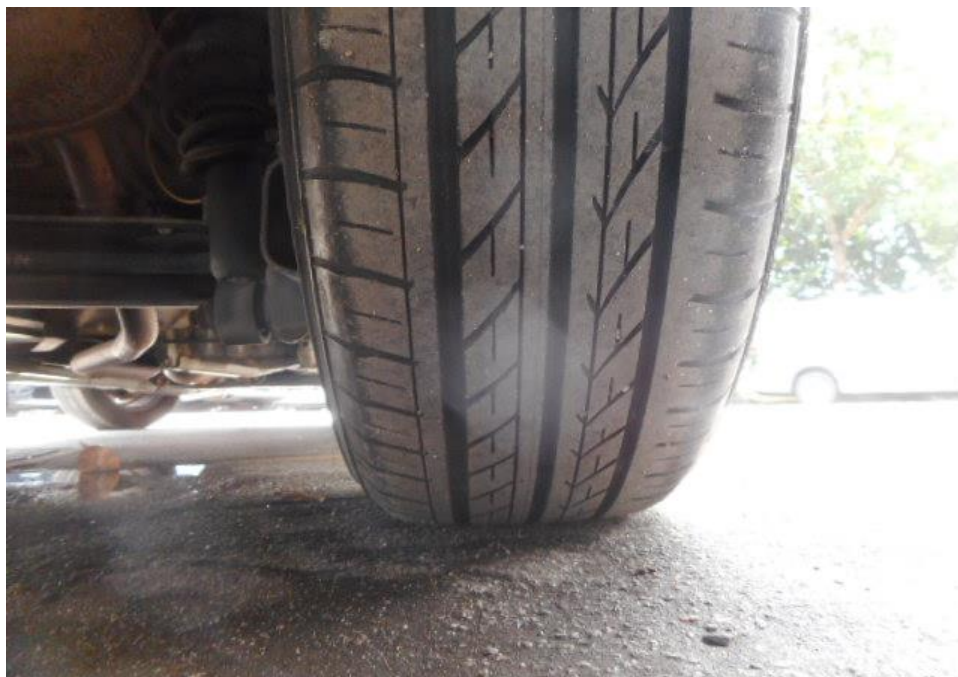
Photo 9 shows the condition of the rear right tyre of the Motor Car, which was observed to be in serviceable condition with remaining tread depth of approximately 4.2mm. The tyre was also observed to be sufficiently inflated for vehicular operation with no tear, cut or burst mark(s).

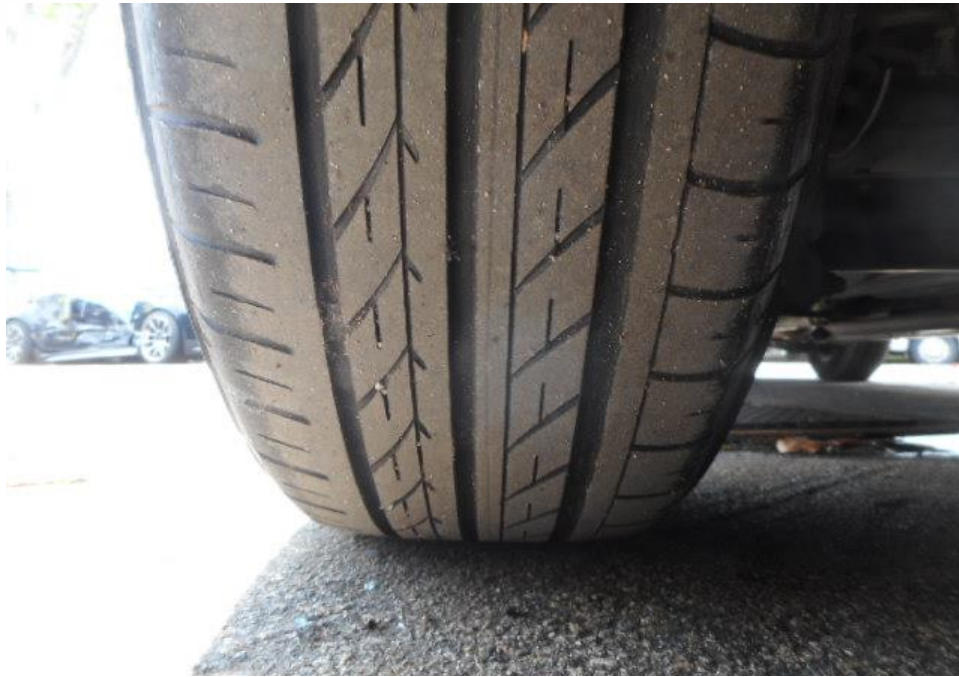
Photo 10 shows the condition of the rear left tyre of the Motor Car, which was observed to be in serviceable condition with remaining tread depth of approximately 3.8mm. The tyre, which was wrapped around steel wheel rim, was also observed to be sufficiently inflated for vehicular operation. The 4 tyres of the Motor Car were wrapped around standard steel wheel rims.

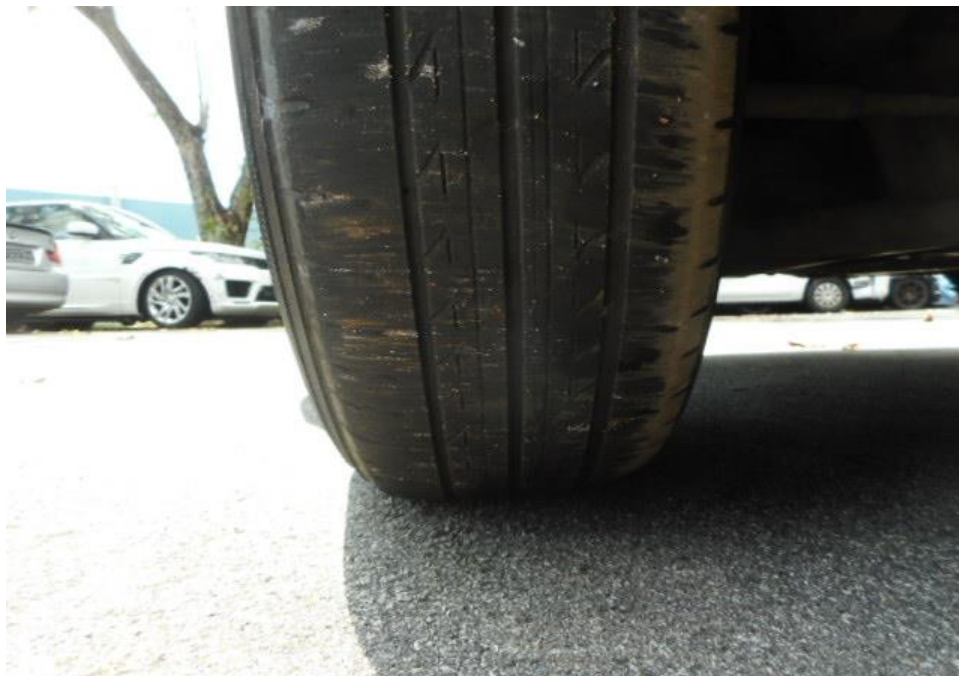
Photo 11 shows the condition of the front left tyre of the Motor Car, which was observed to be in serviceable condition with remaining tread depth of approximately 3mm. There was also no tear, cut or burst mark(s) on the outer and the inner sidewalls as well as across the tread of the Motor Car's 4 tyres.

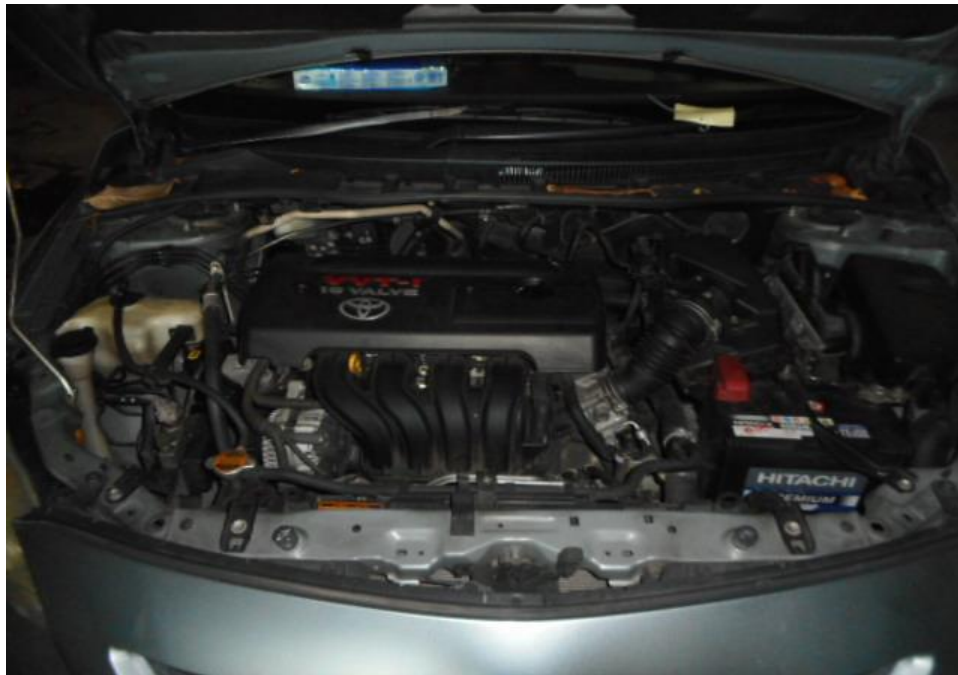
Photo 12 shows a general view of the Motor Car's engine compartment. The various parts and components inside the engine compartment were unaffected by the accident. There was also no sign(s) or indication(s) of fluid leakage and/or fluid stain within the engine compartment.

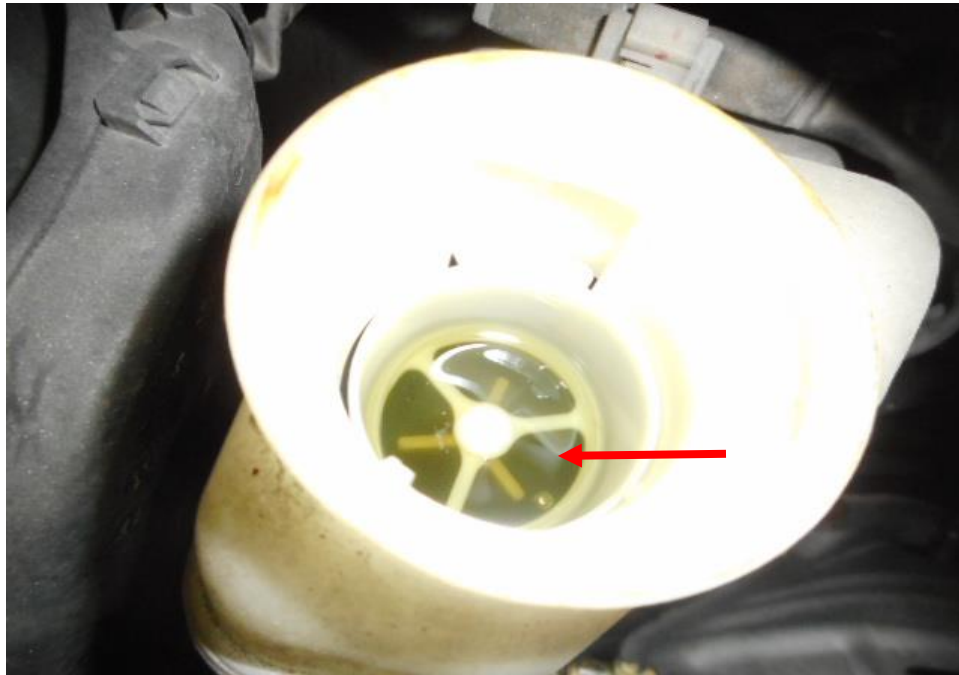
Photo 13 shows the brake fluid reservoir of the Motor Car at the time of my inspection. The brake fluid was observed to be of sufficient level (arrowed) and without any visible contamination.

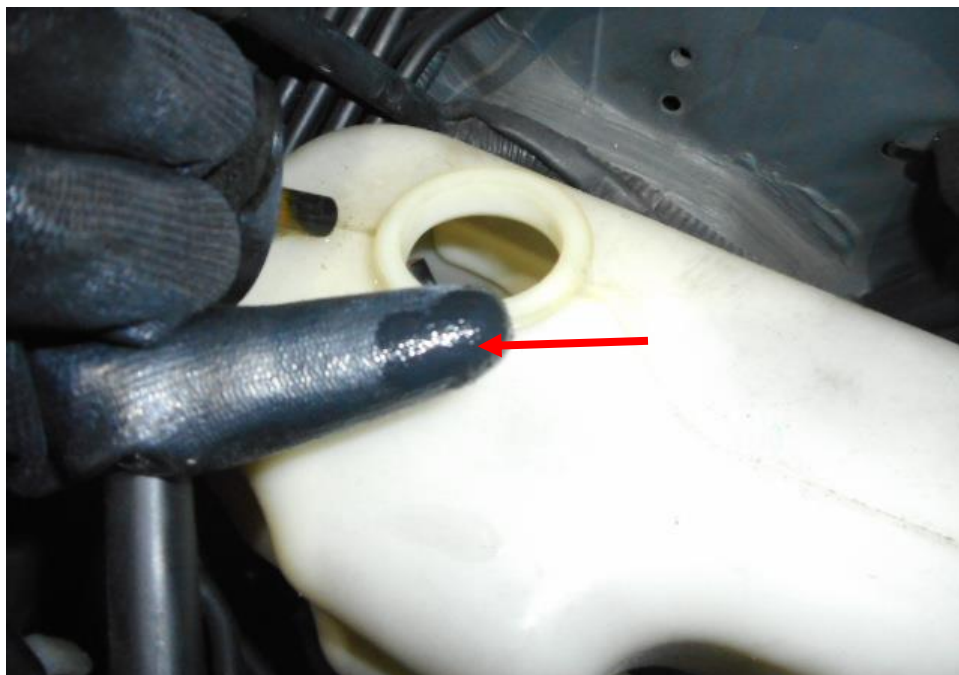
Photo 14 shows checks being carried out to the engine coolant of the Motor Car at the time of my inspection. The engine coolant was observed to be of sufficient level (arrowed) and without any visible contamination.

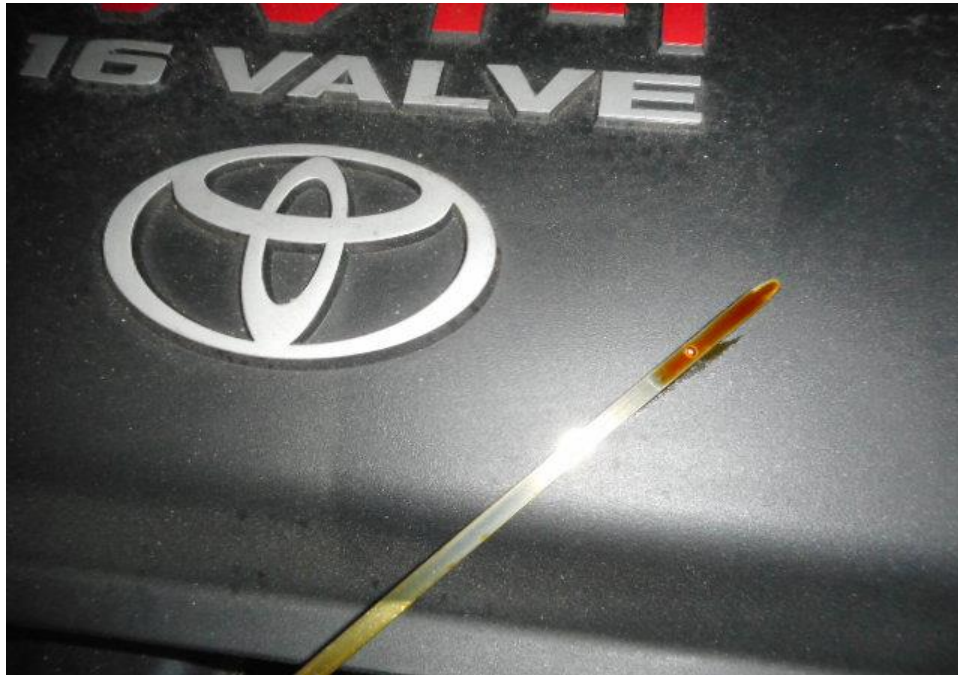
Photo 15 shows the engine oil dipstick of the Motor Car at the time of my inspection. The engine oil was observed to be of sufficient level and without any visible contamination.

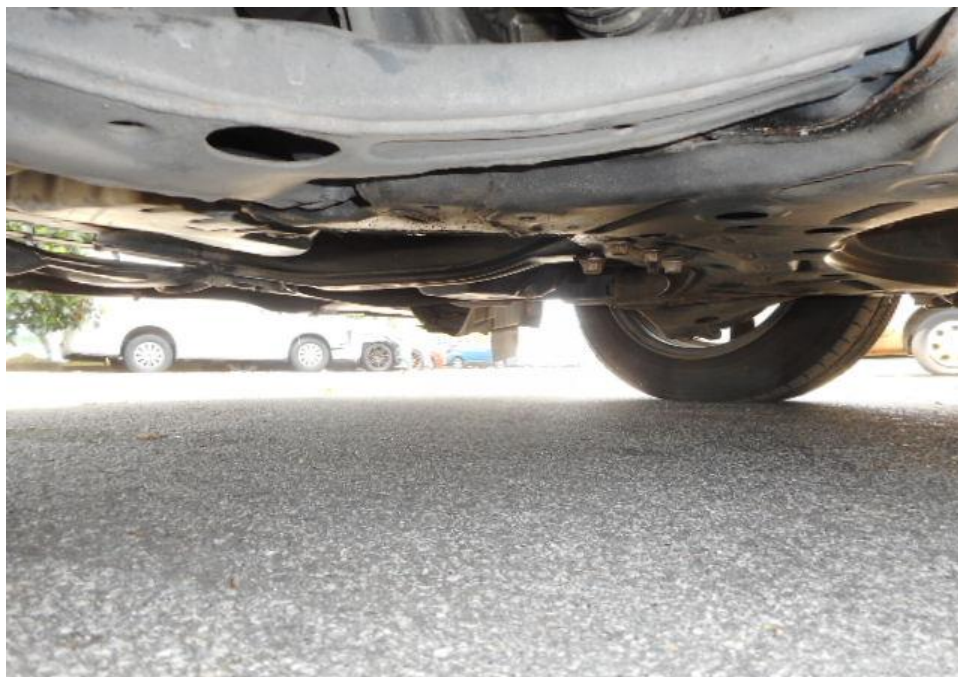
Photo 16 shows the undercarriage of the Motor Car, at the area where the engine housing and transmission housing are located. I did not find any sign(s) or indication(s) of fluid leak and/or fluid stain(s) on the underside of the Motor Car.

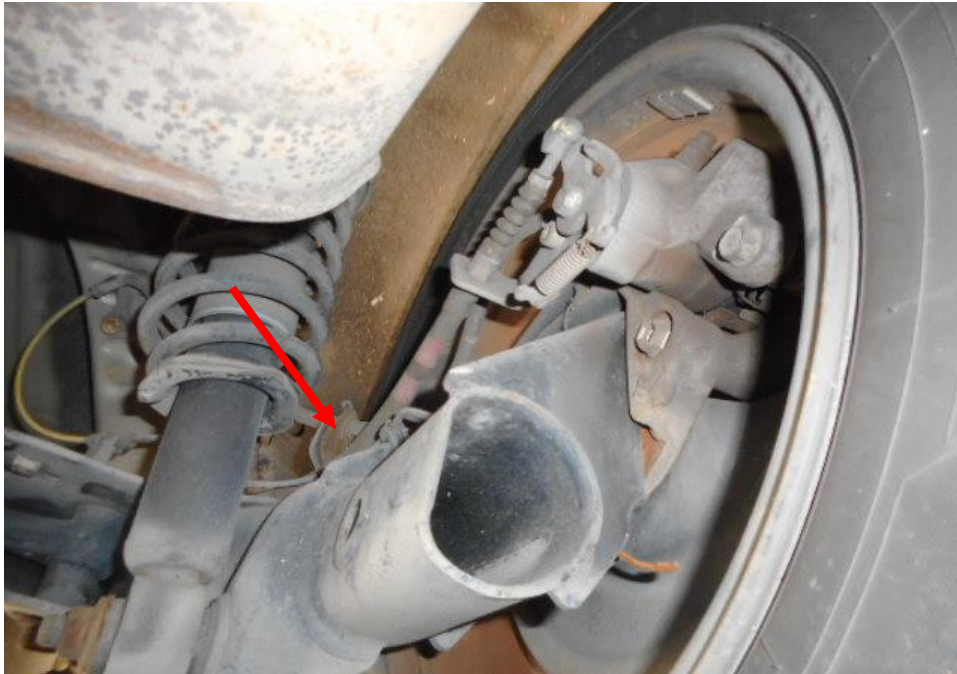
Photo 17 shows the brake hose/pipe (arrowed) at the rear right wheel of the Motor Car. No leakage of brake fluid was observed. Visual examination of the various components of the braking system like the drum brake, brake booster, brake pedal etc. had revealed all to be intact and without visible damage.

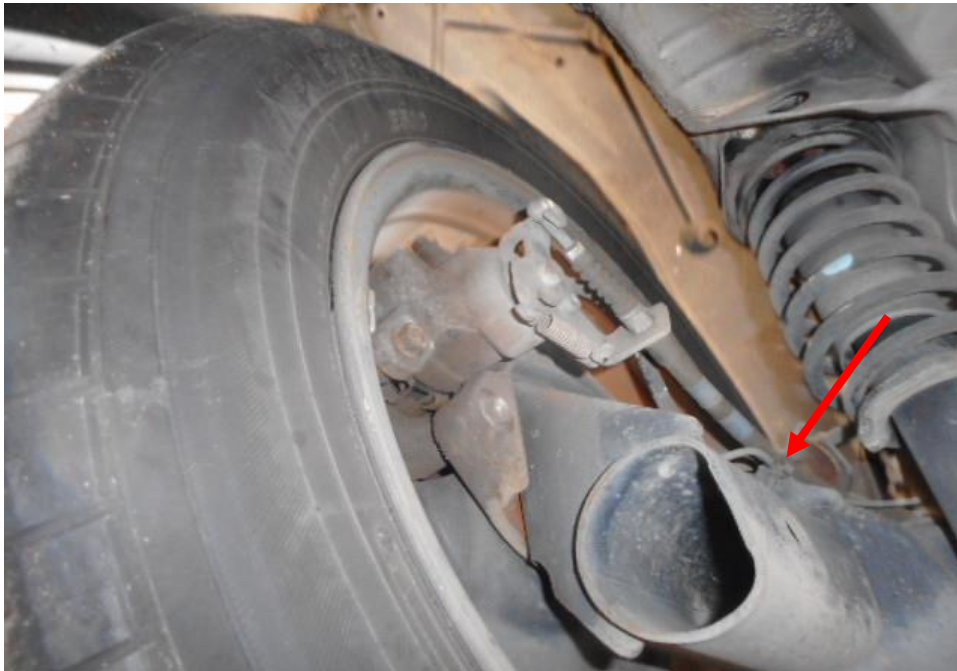
Photo 18 shows the brake hose/pipe (arrowed) at the rear left wheel of the Motor Car. I did not observe any leakage of brake fluid at the time of my inspection of the Motor Car. Static tests of the Motor Car's braking system had indicated that there was no internal leakage of pressure/vacuum. The undercarriage components of the Motor Car were also all found to be intact and without any visible damage.

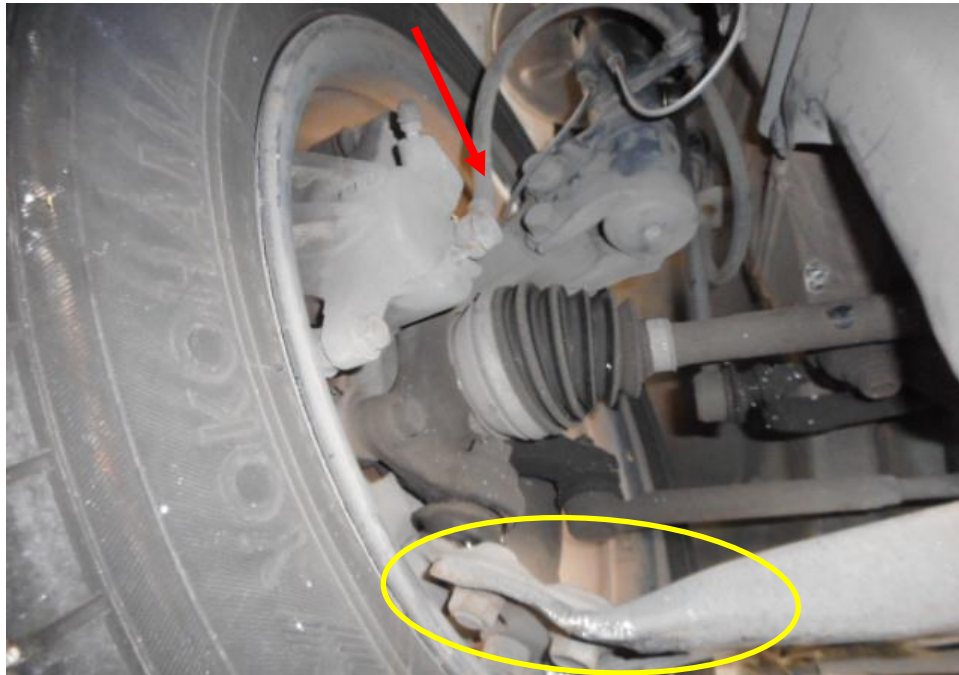
Photo 19 shows the brake hose/pipe (arrowed) at the front right wheel of the Motor Car. I did not observe any leakage of brake fluid at the time of my inspection of the Motor Car. Static tests of the Motor Car's braking system had indicated that there was no internal leakage of pressure/vacuum. I observed that the front right lower arm (circled) was damaged and bent as a result of the accident.

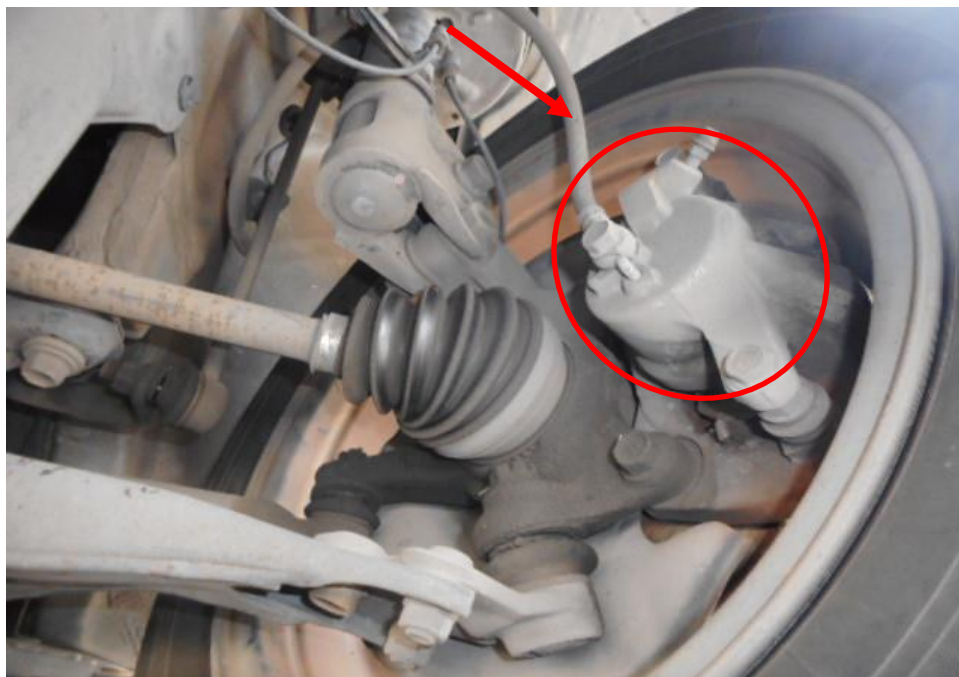
Photo 20 shows the brake hose/pipe (arrowed) at the front left wheel of the Motor Car. No leakage of brake fluid was observed. Visual examination of the various components of the braking system like the brake caliper (circled), brake booster, brake pedal etc had revealed all to be intact and without visible damage.

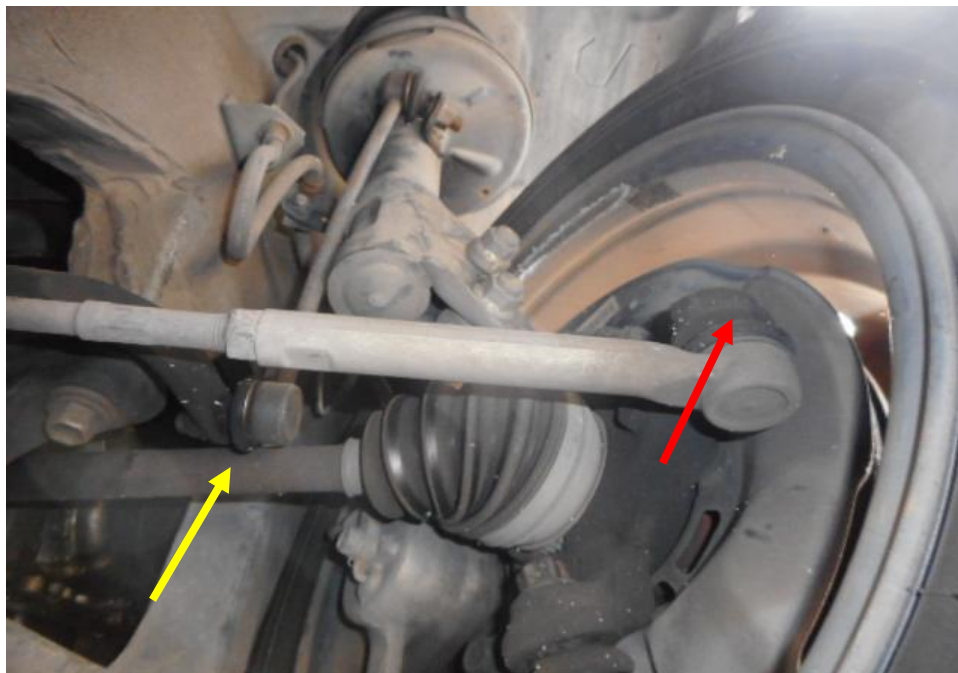
Photo 22 shows the various undercarriage components at the front right wheel of the Motor Car, in particular the steering tie rod (red arrow) and drive shaft (yellow arrow). The various steering components were all found to be intact, suggesting that the steering system of the Motor Car was likely to be in serviceable condition at the material time of accident. There was also no sign of fluid stain observed on the various undercarriage components at the front right wheel of the Motor Car.

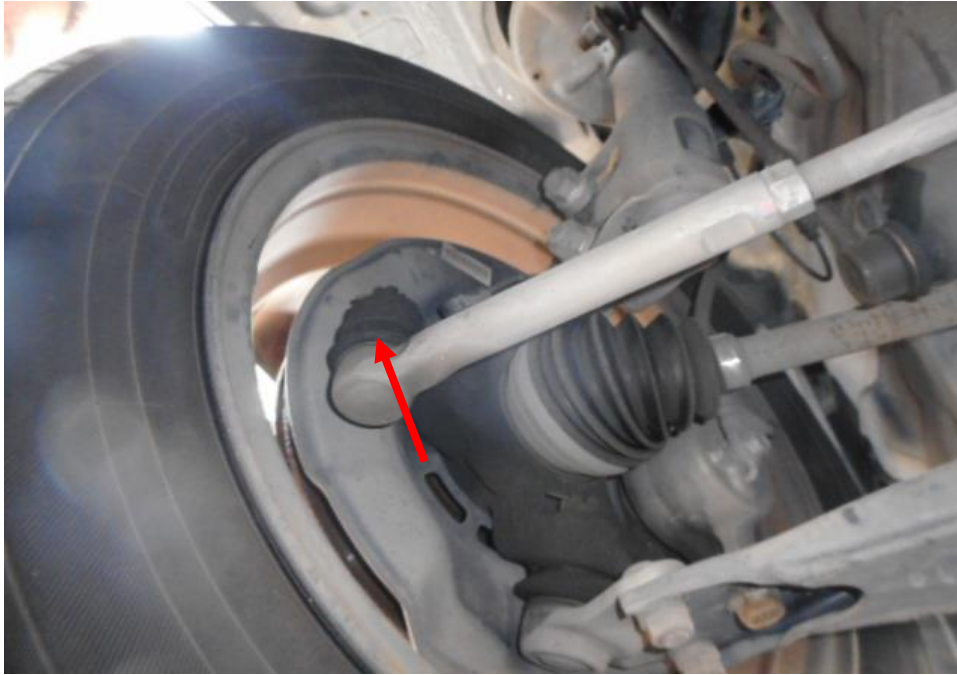
Photo 23 shows the various undercarriage components at the front left wheel of the Motor Car, which had included the steering tie rod (red arrow). The various undercarriage components of the Motor Car were all found to be intact without any visible damage.

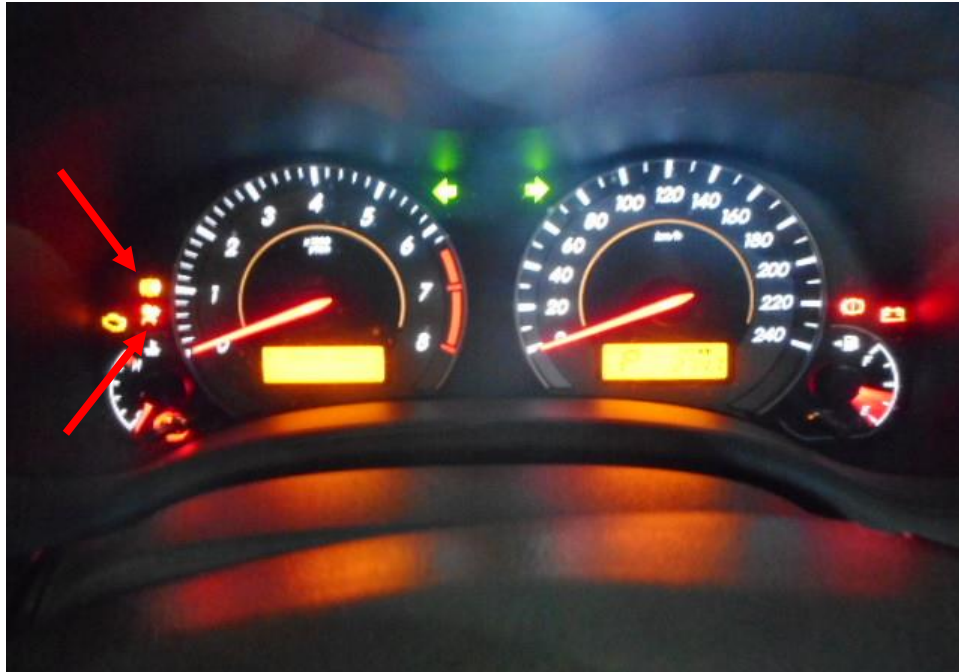
Photo 24 shows the warning light for Anti-Lock Brake System (ABS) and Supplemental Restraint System (SRS) (arrowed) appearing on the instrument panel of the Motor Car during the self-test of its various electronic operating systems when its engine was cranked.

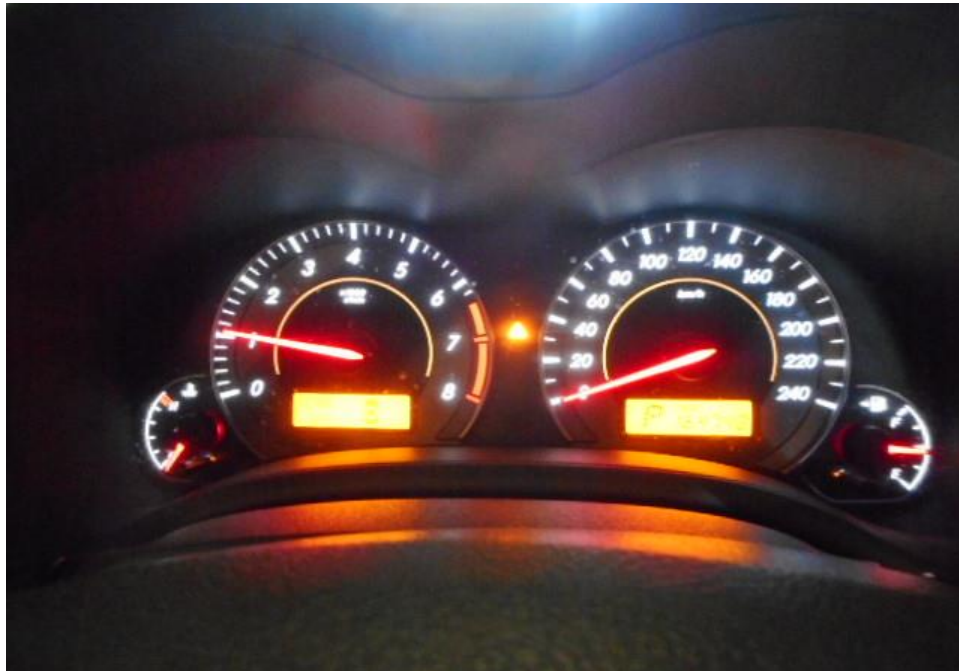
13. The Motor Car's automatic self-test of the functionality of its electronic operating systems like the Anti-Lock Brake System (ABS) and Supplemental Restraint System (SRS) during cranking of the engine had indicated that the system were in working condition and without abnormality. This can be established from the warning lights disappearing from the instrument panel after the self-test. See photo 24 & 25 below.

Photo 25 shows no warning lights illuminated on the instrument panel of the Motor Car after the engine was cranked. This would suggest that there was no abnormality to the electronic operating system of the Motor Car, like the ABS and SRS etc.
