Your Ref: TP/IP/05094/2022  
Our Ref : CI/TPD22002413/P

17<sup>th</sup> March 2022

**Fatal Accident Investigation Team**

**MECHANICAL INSPECTION REPORT OF TIPPER TRUCK, XE 507U**

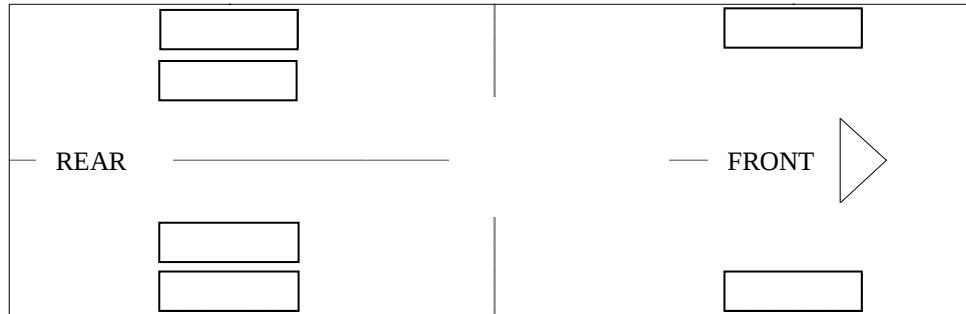
6. The 2 front tyres and 4 rear tyres of the Tipper Truck were observed to be in serviceable condition and sufficiently inflated for vehicular operation. I did not find any tear, cut or burst mark(s) on the outer and the inner sidewalls as well as across the tread of the 6 tyres of the Tipper Truck. The tyre brand, tyre size and remaining tread depth of the 6 tyres of the Tipper Truck were recorded as follows:-

Helloway 295/80R22.5 (14.4mm)

Safe king 295/80R22.5 (11.3mm)

Helloway 295/80 R22.5 (14.1mm)

Safe king 295/80R22.5 (11.7mm)

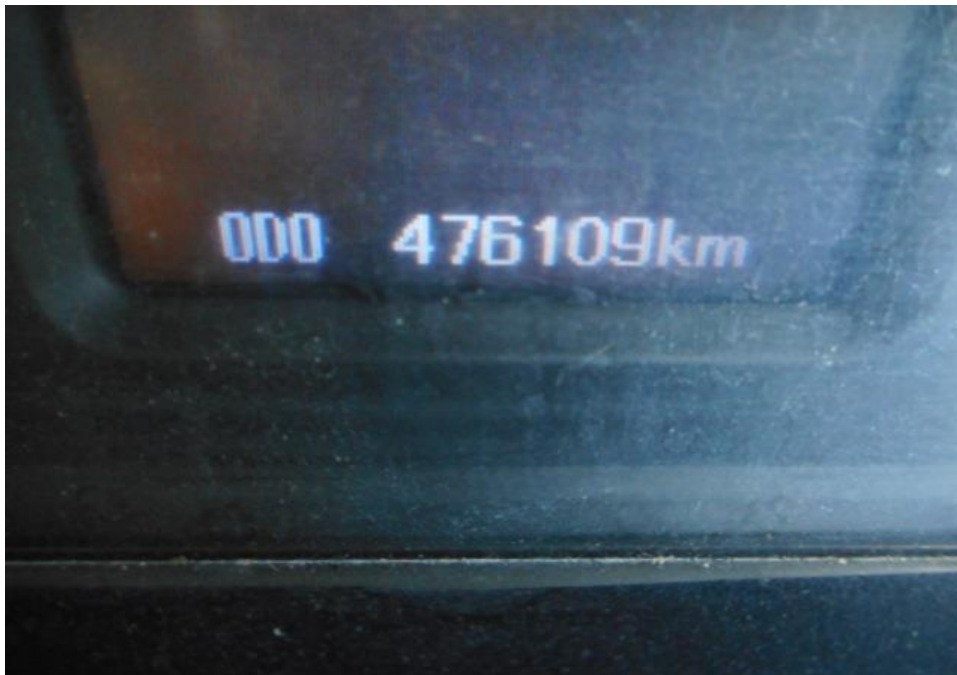
**Photo 1** shows a general view of the instrument cluster of the Tipper Truck at the time of my inspection. The mileage of the Tipper Truck was 476,109km

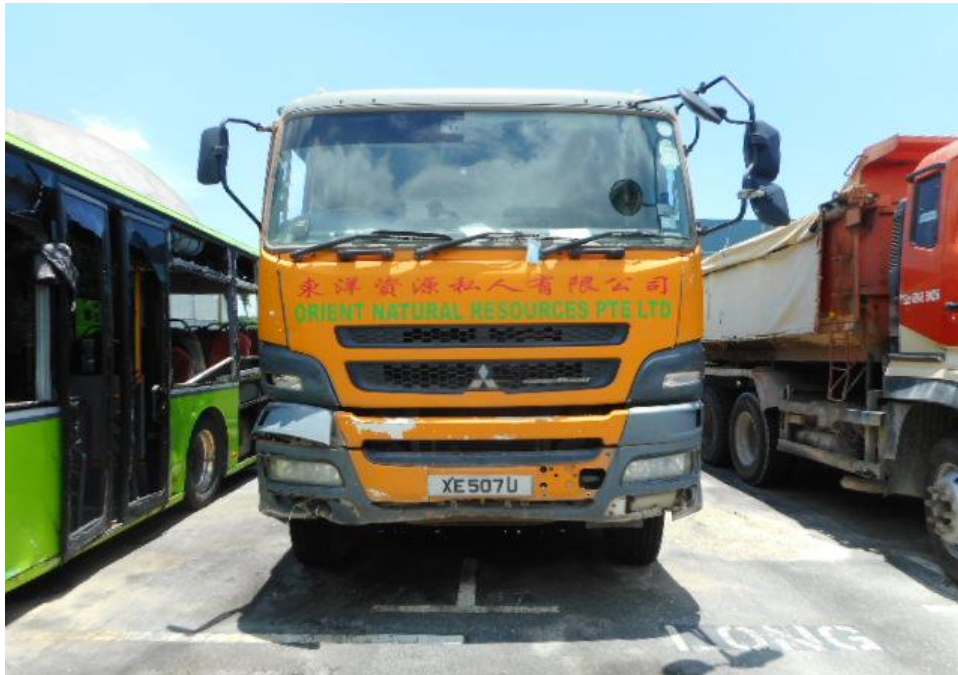
4. The mileage of the Tipper Truck at the time of my inspection was 476,109km.
5. The Tipper Truck was observed to have sustained damage at its front portion. Its front bumper and front right headlamp was amongst the body parts that were damaged as a result of the accident.

**Photo 2** shows a general view of the front body of the Tipper Truck at the time of my inspection. The front portion of the Tipper Truck was observed to sustained damage at the time of inspection. Its front bumper and front right headlamp was amongst the body parts that were damaged as a result of the accident.

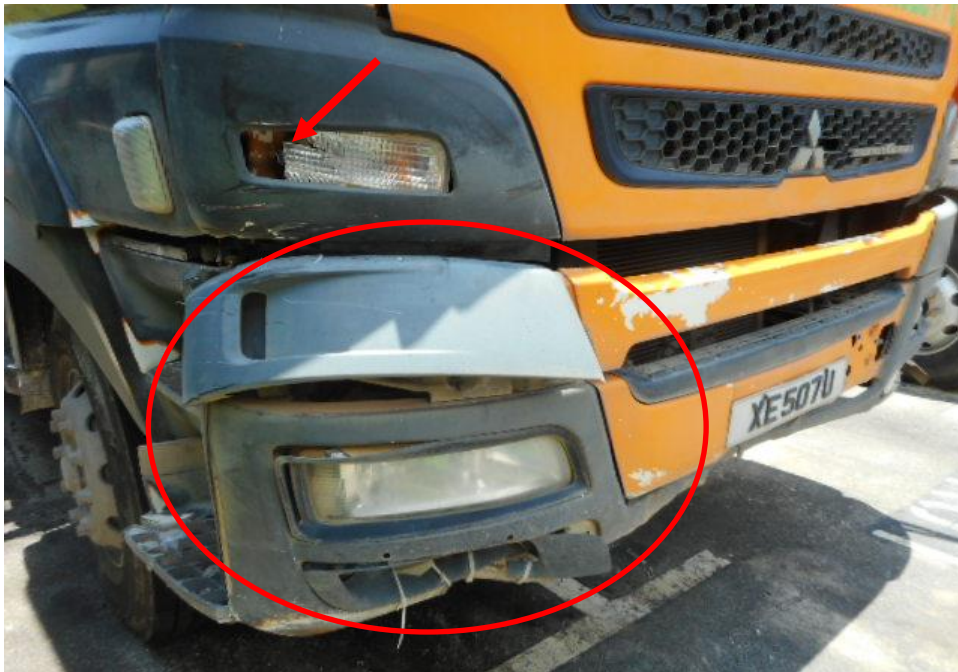
**Photo 3** shows a close up view of the right body of the Tipper Truck at the time of my inspection. The front portion of the Tipper Truck was observed to sustained damage at the time of inspection. Its front bumper (circled) and front right headlamp (arrowed) was amongst the body parts that were damaged as a result of the accident.

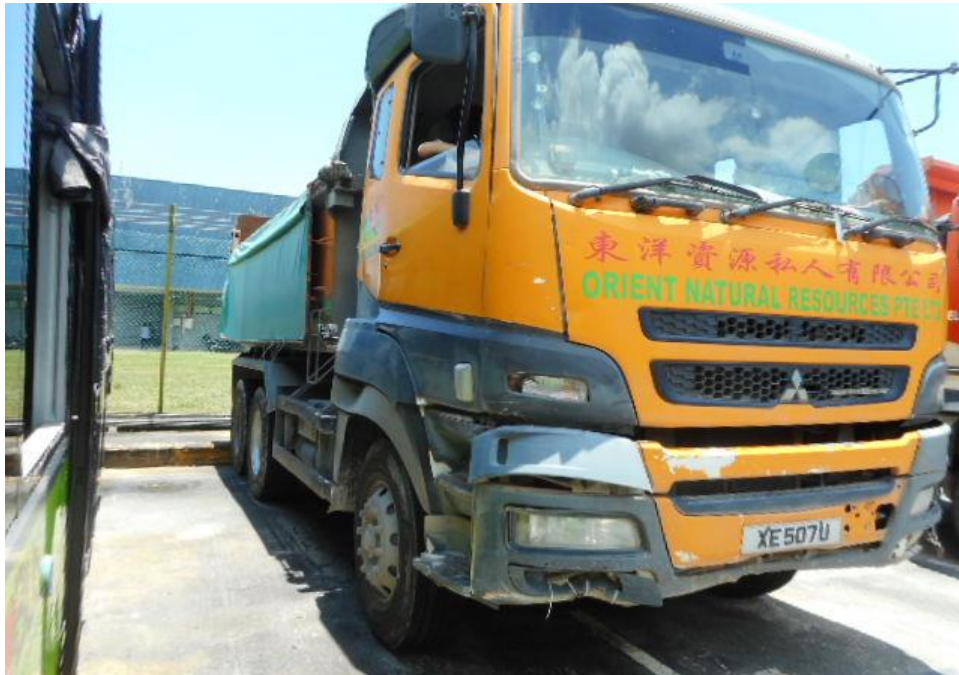
**Photo 4** shows a general view of the right body of the Tipper Truck at the time of my inspection. The right portion of the Tipper Truck was observed to be intact and unaffected by the accident.

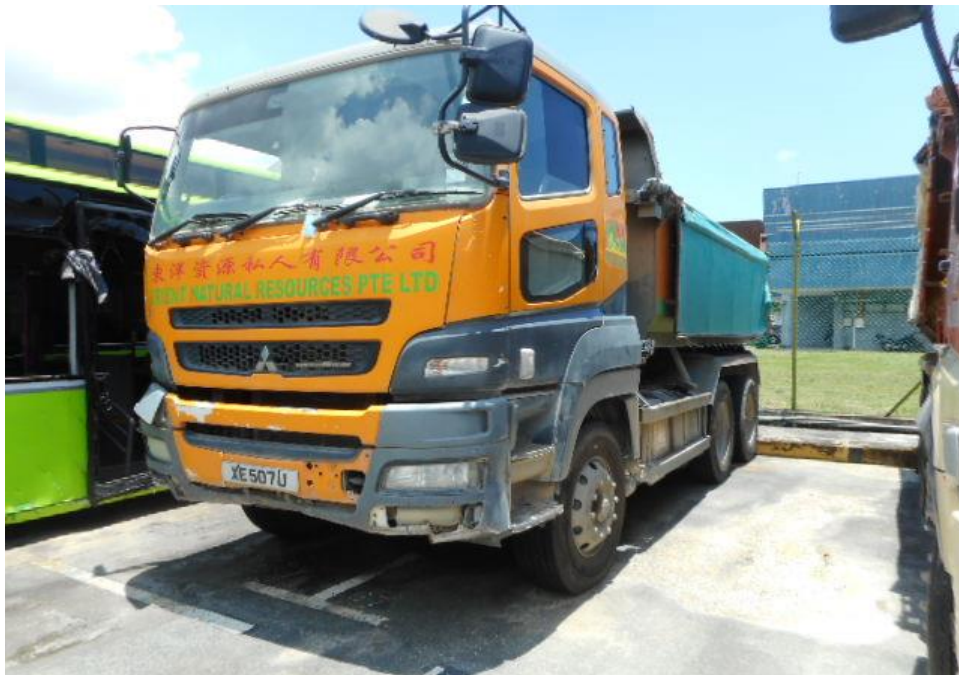
**Photo 5** shows a general view of the left body of the Tipper Truck at the time of my inspection. The left portion of the Tipper Truck was observed to be intact and unaffected by the accident.

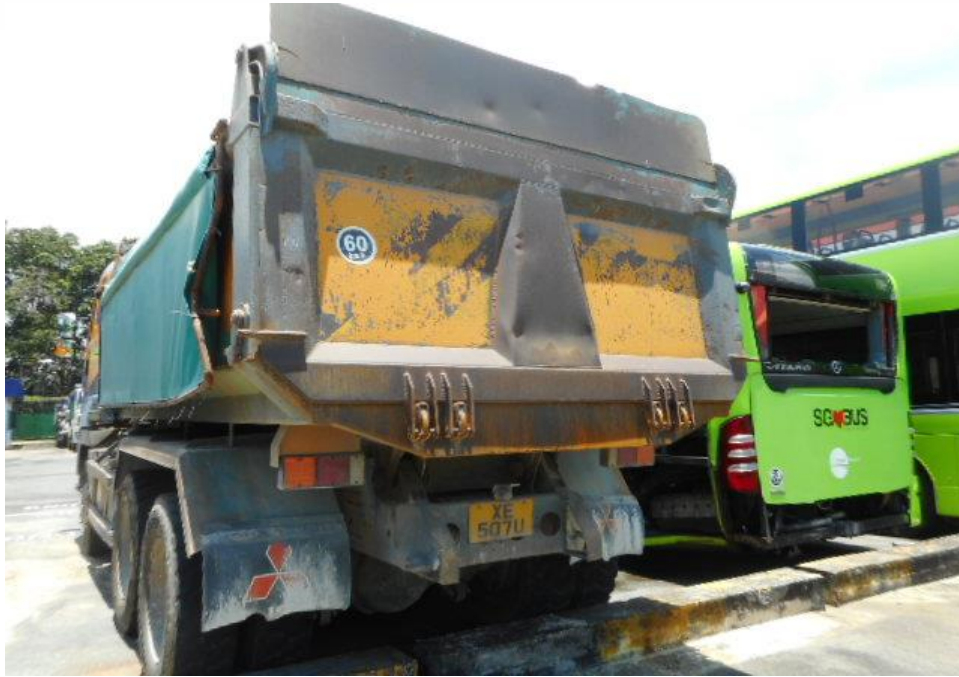
**Photo 6** shows a general view of the Tipper Truck's rear body at the time of my inspection. The rear of the Tipper Truck was observed to be intact and unaffected by the accident.

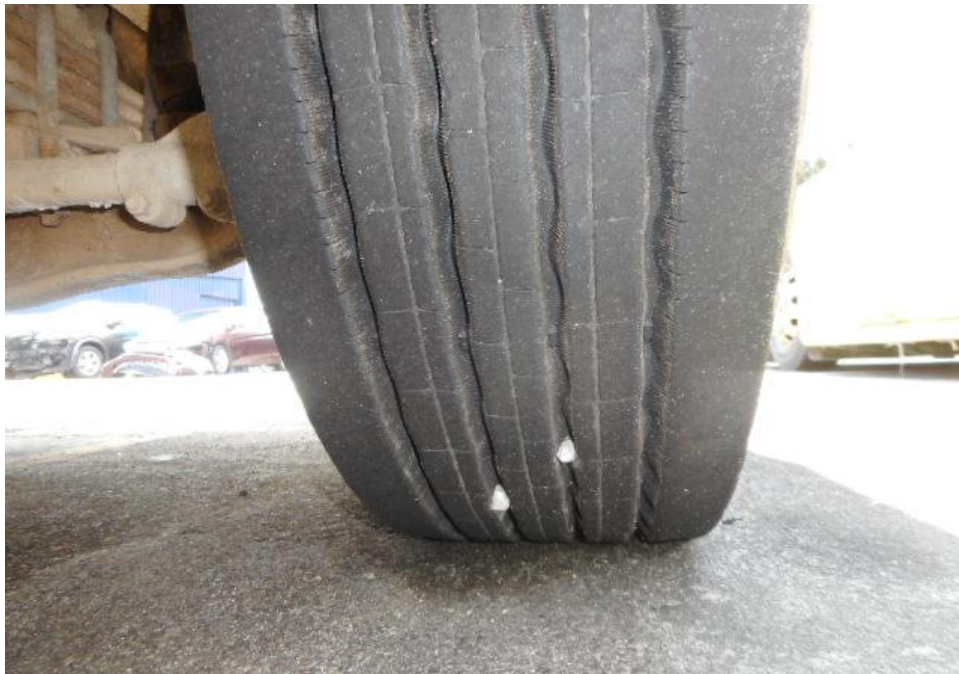
**Photo 7** shows the condition of the front right tyre of the Tipper Truck, which was observed to be in serviceable condition with remaining tread depth of approximately 11.7mm. The tyre, which was wrapped around standard steel wheel rim, was also observed to be sufficiently inflated for vehicular operation. There was no tear, cut or burst mark(s) on the outer and the inner sidewalls as well as across the tread of the 6 tyres that were fitted on the Tipper Truck.

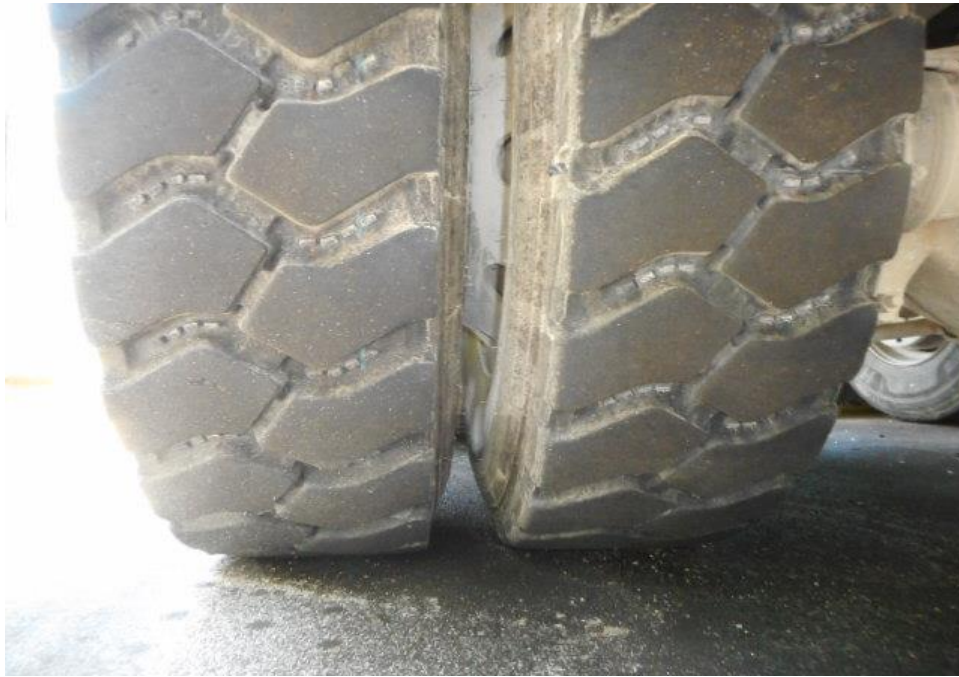
**Photo 8** shows the condition of the rear right tyre of the Tipper Truck, which was observed to be in serviceable condition with remaining tread depth of approximately 14.1mm. The tyre, which was wrapped around standard steel wheel rim, was also observed to be sufficiently inflated for vehicular operation.

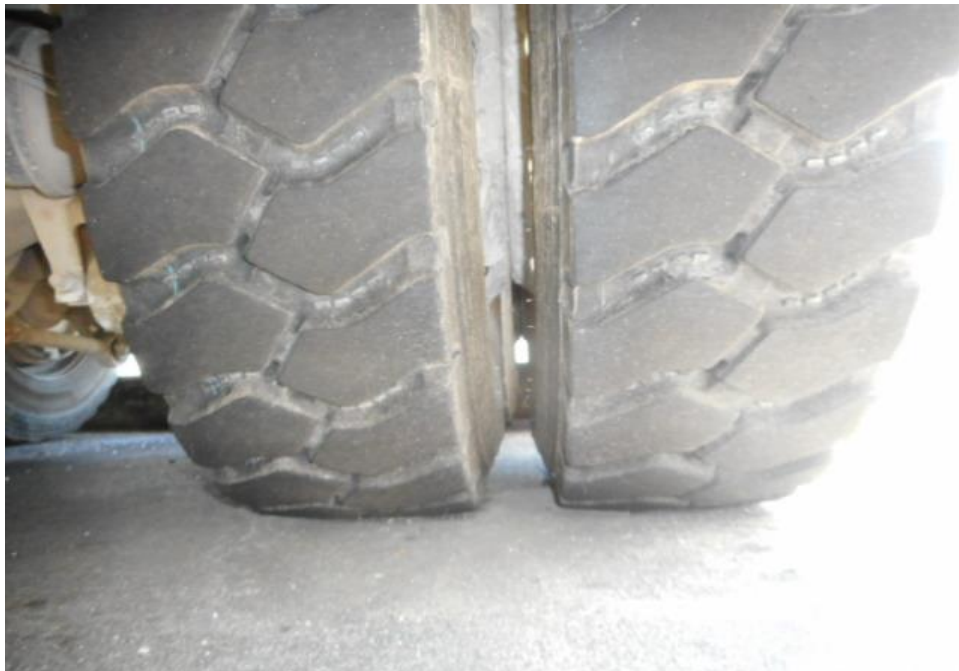
**Photo 9** shows the condition of the rear left tyres of the Tipper Truck, which was observed to be in serviceable condition with remaining tread depth of approximately 14.4mm. The tyres, which were wrapped around standard steel wheel rim, were also observed to be sufficiently inflated for vehicular operation. There was also no damage found on all 6 steel wheel rims of the Tipper Truck.

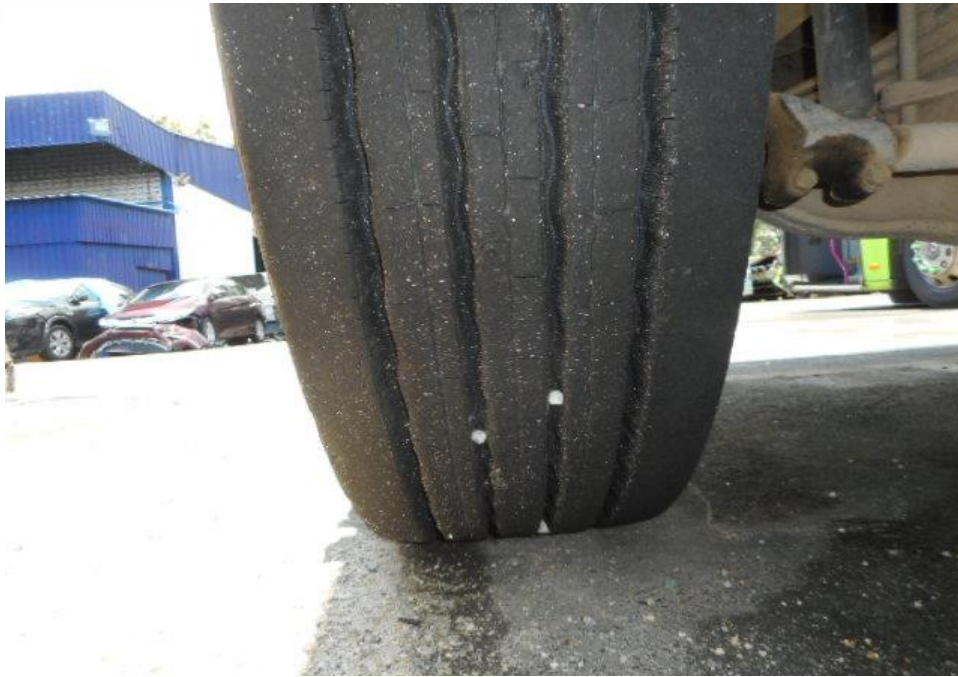
**Photo 10** shows the condition of the front left tyres of the Tipper Truck, which were observed to be in serviceable condition with remaining tread depth of approximately 11.3mm. There was also no tear, cut or burst mark(s) on the outer and the inner sidewalls as well as across the tread of the 6 tyres that were fitted on the Tipper Truck.

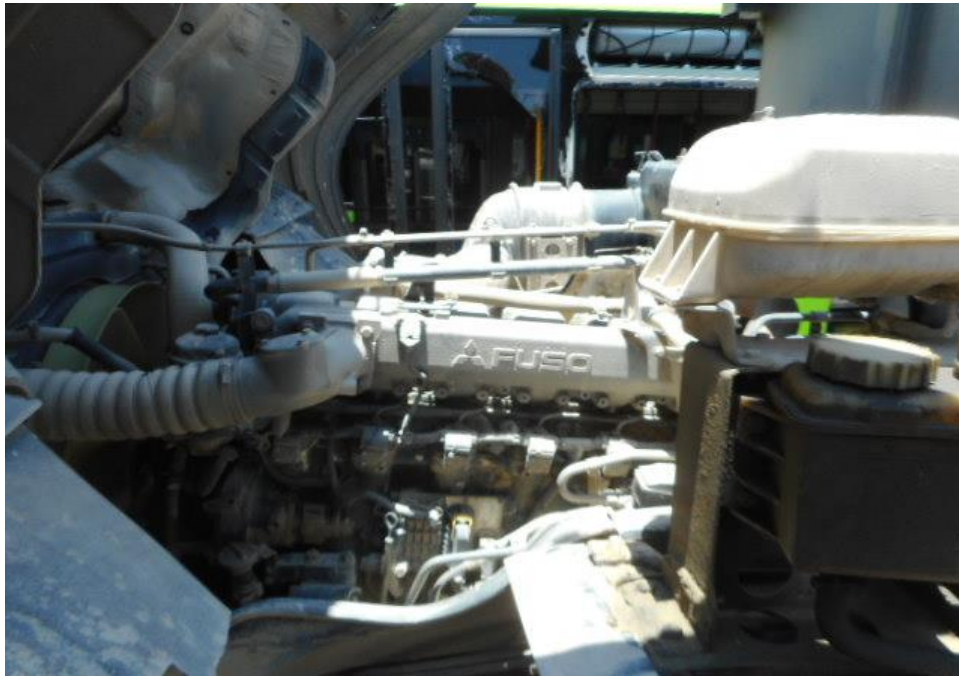
**Photo 11** shows a general view of the Tipper Truck's engine compartment, which was accessed by lifting the front cabin of the Tipper Truck. The various parts and components inside the engine compartment were unaffected by the accident. There was also no sign(s) or indication(s) of fresh fluid leakage and/or fluid stain within the engine compartment

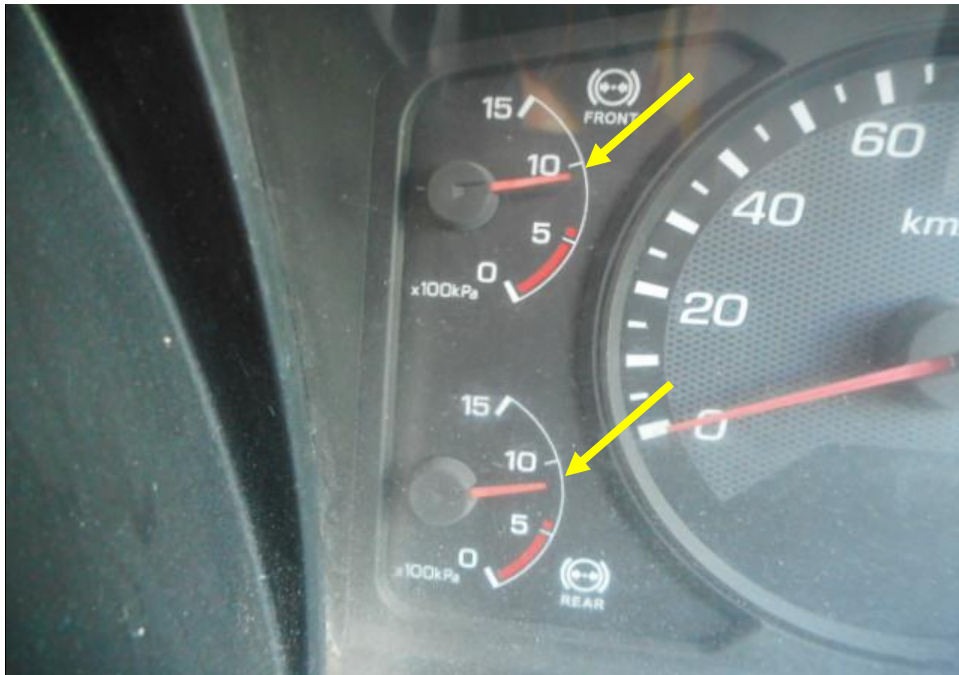
**Photo 12** shows the air in the air brake cylinders of the Tipper Truck at the time of my inspection. The air in the cylinder was observed to be of sufficient level & serviceable at the time of the accident.

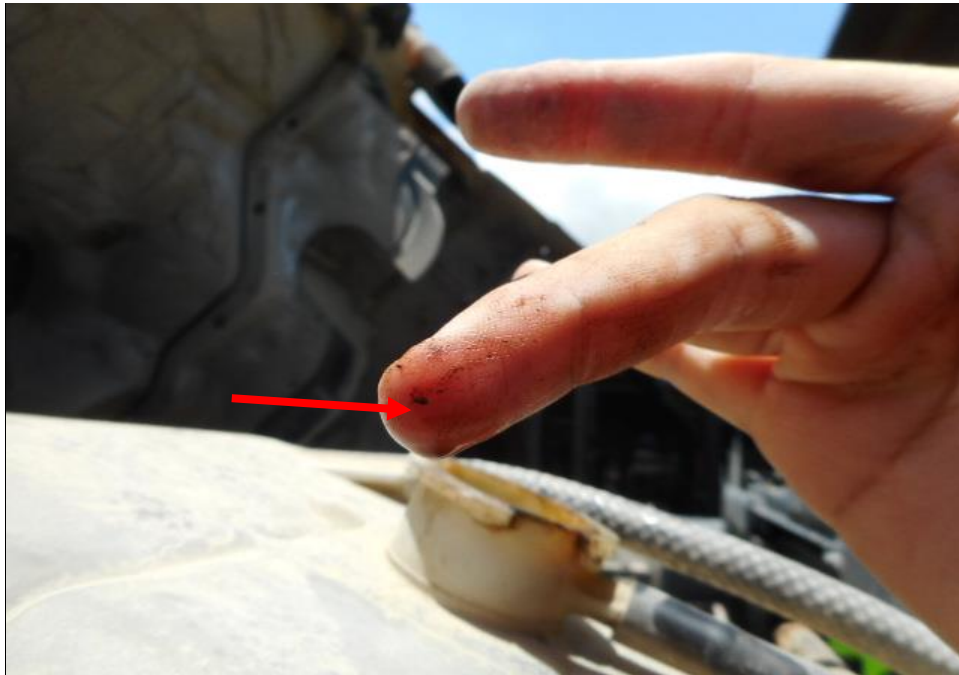
**Photo 13** shows the engine coolant reservoir of the Tipper Truck at the time of my inspection. The engine coolant was observed to be of sufficient level (arrowed) and without any visible contamination.

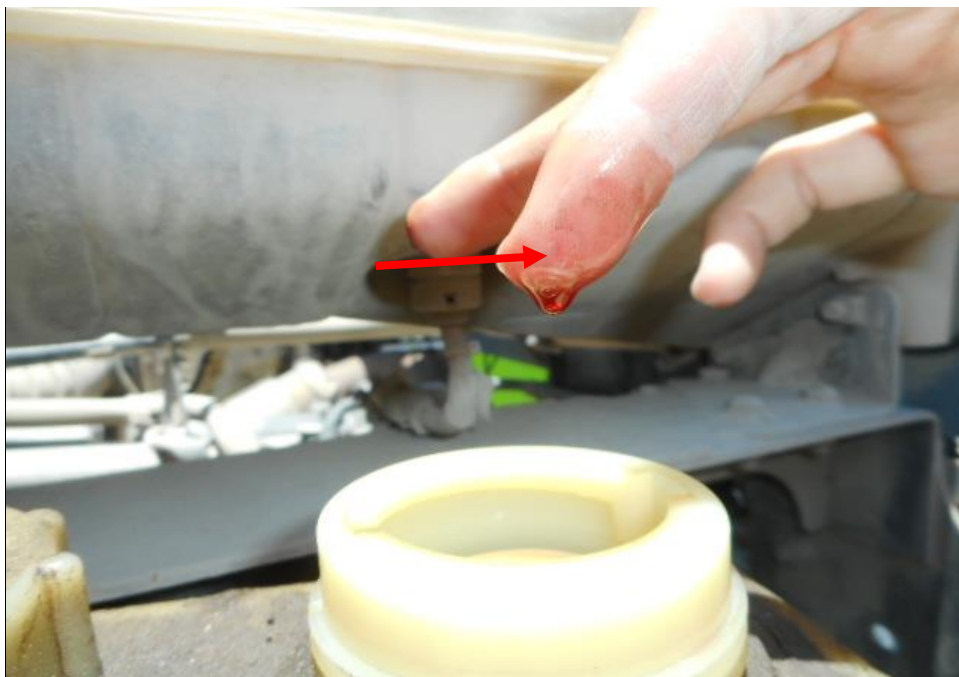
**Photo 14** shows the power steering fluid reservoir of the Tipper Truck at the time of my inspection. The power steering fluid was observed to be of sufficient level (arrowed) and without any visible contamination.

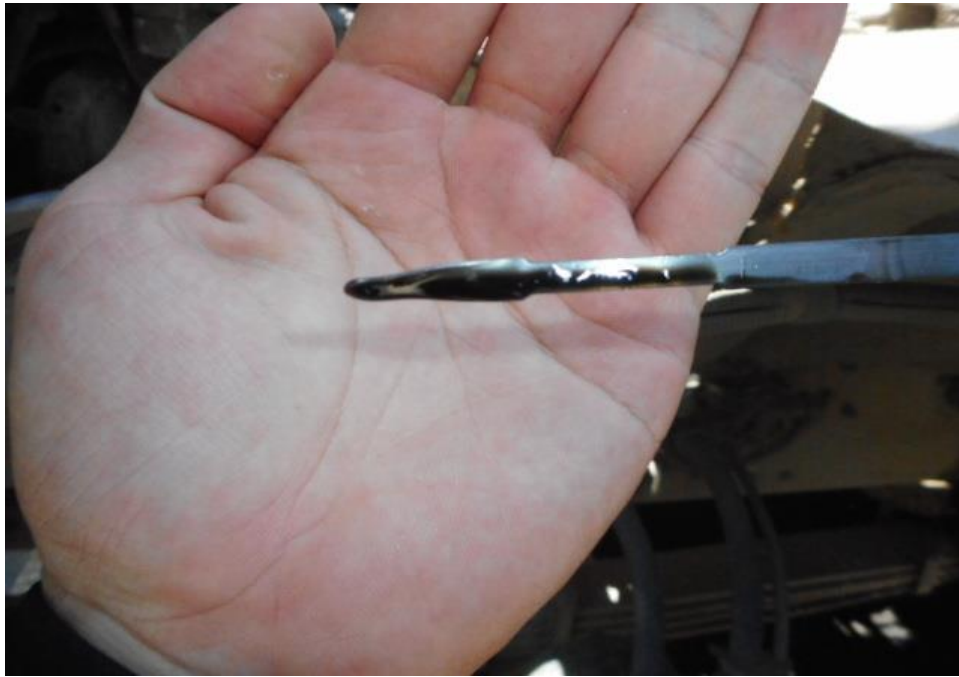
**Photo 15** shows the engine oil dip stick of the Tipper Truck at the time of my inspection. The engine oil was observed to be of insufficient level at the time of our inspection.

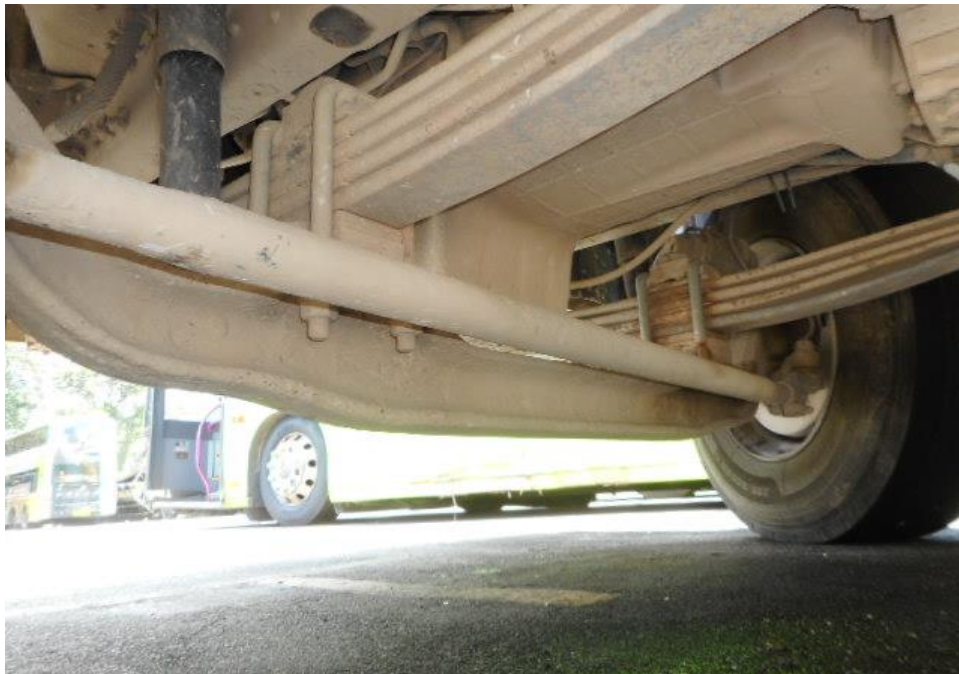
**Photo 16** shows the undercarriage of the Tipper Truck, at the area where the engine housing located. I did not find any sign(s) or indication(s) of fluid leak, however old fluid stain(s) was observed on the underside of the Tipper Truck.

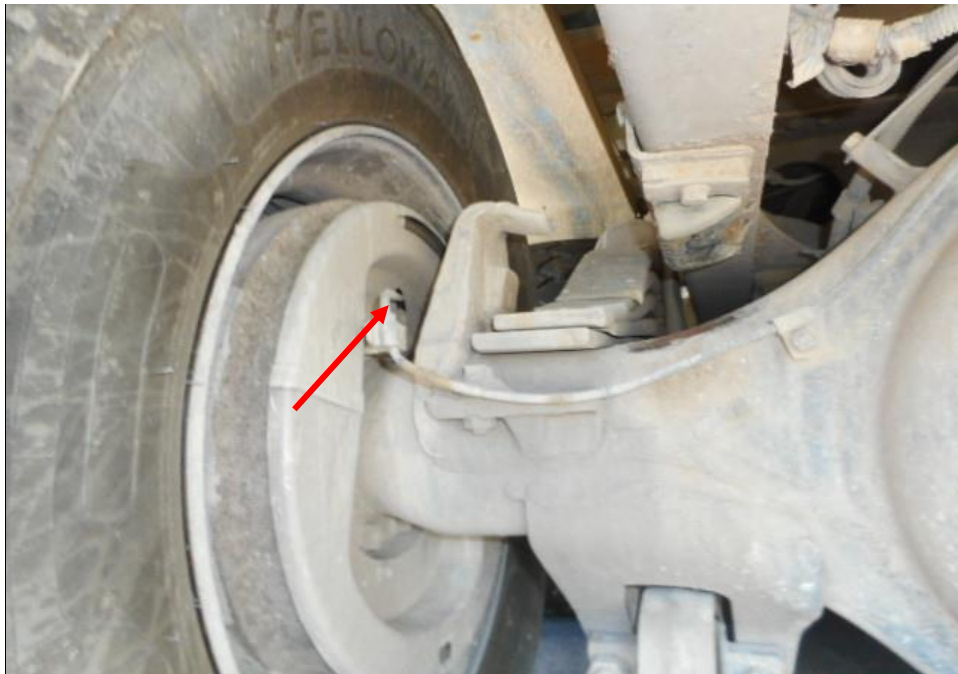
**Photo 17** shows the brake pipe (arrowed) at the rear right wheel of the Tipper Truck. I did not observe any leakage of brake fluid at the time of my inspection of the Tipper Truck. My static tests of the Tipper Truck's braking system, along with my visual examination of the various mechanical components in the braking system, had indicated that there was no internal leakage of pressure/vacuum. Hence the braking system of the Tipper Truck was likely to be in serviceable condition at the material time of accident.

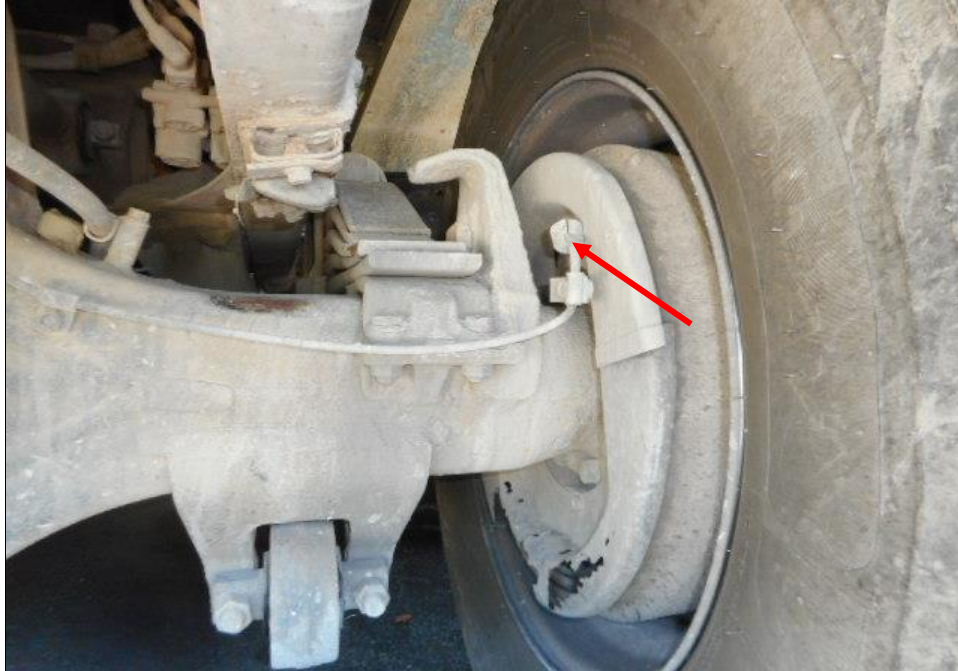
**Photo 18** shows the brake pipe (arrowed) at the rear left wheel of the Tipper Truck. I did not observe any leakage of brake fluid at the time of my inspection of the Tipper Truck. My static tests of the Tipper Truck's braking system, along with my visual examination of the various mechanical components in the braking system, had indicated that there was no internal leakage of pressure/vacuum. Hence the braking system of the Tipper Truck was likely to be in serviceable condition at the material time of accident.

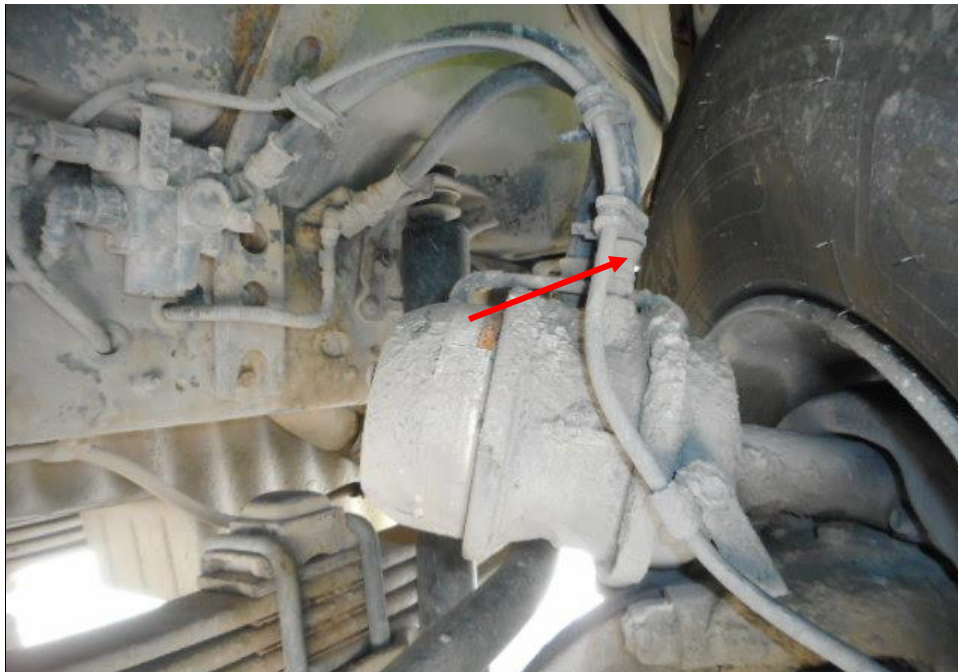
**Photo 19** shows the brake pipe (arrowed) at the front right wheel of the Tipper Truck. I did not observe any leakage of brake fluid at the time of my inspection of the Tipper Truck. My static tests of the Tipper Truck's braking system, along with my visual examination of the various mechanical components in the braking system, had indicated that there was no internal leakage of pressure/vacuum. Hence the braking system of the Tipper Truck was likely to be in serviceable condition at the material time of accident.

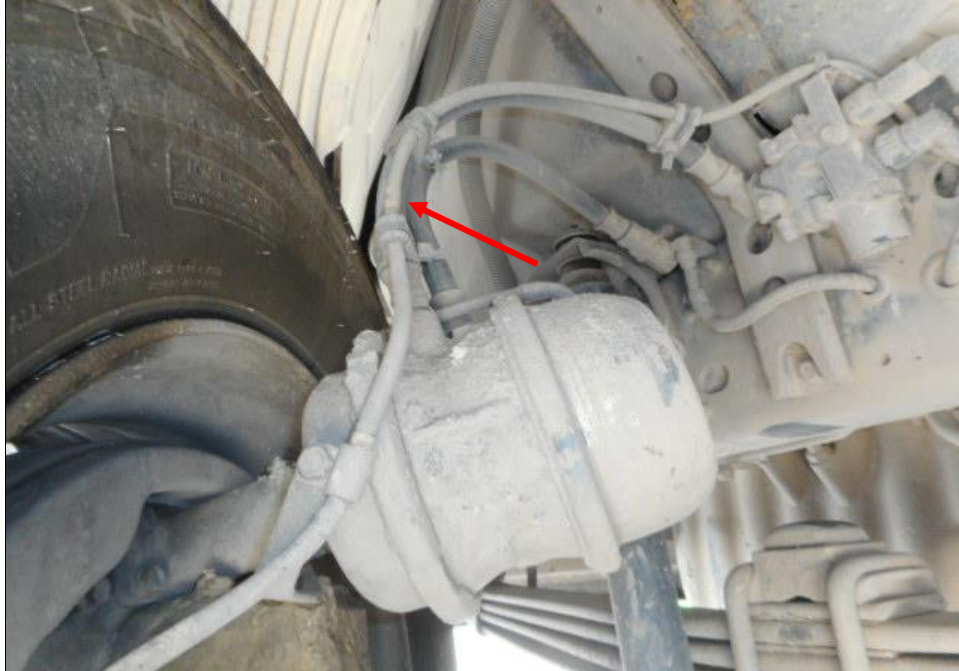
**Photo 20** shows the brake pipe (arrowed) at the front left wheel of the Tipper Truck. I did not observe any leakage of brake fluid at the time of my inspection of the Tipper Truck. My static tests of the Tipper Truck's braking system, along with my visual examination of the various mechanical components in the braking system had indicated that there was no internal leakage of pressure/vacuum. Hence the braking system of the Tipper Truck was likely to be in serviceable condition at the material time of accident.

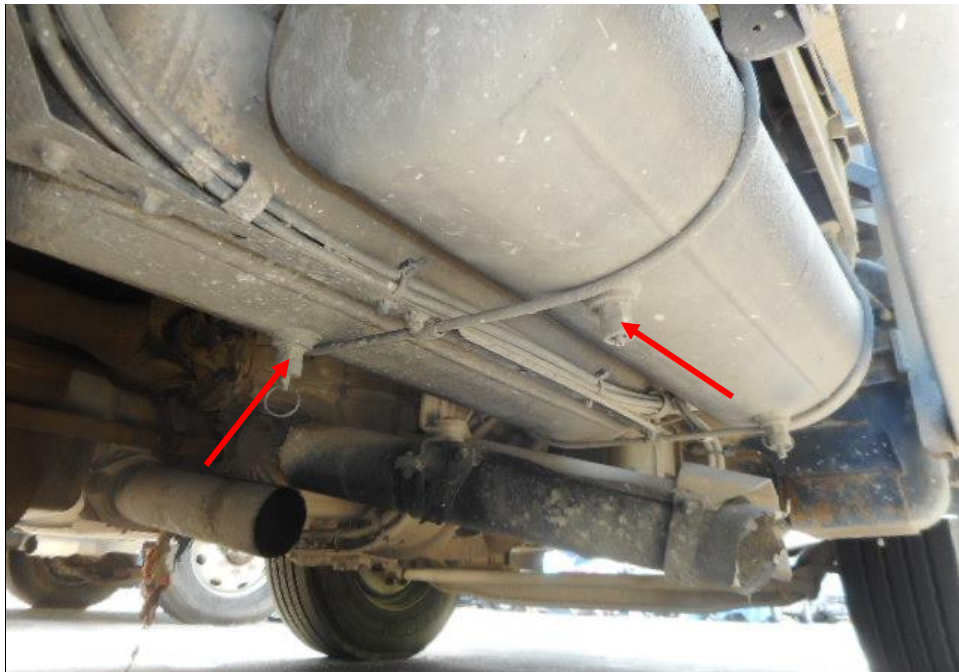
**Photo 21** shows the air brake cylinders (arrowed) at the undercarriage of the Tipper Truck. I did not observe any leakage of air brake fluid at the time of my inspection of the Tipper Truck. My static tests of the Tipper Truck's braking system, along with my visual examination of the various mechanical components in the braking system had indicated that there was no internal leakage of pressure/vacuum. Hence the braking system of the Tipper Truck was likely to be in serviceable condition at the material time of accident.

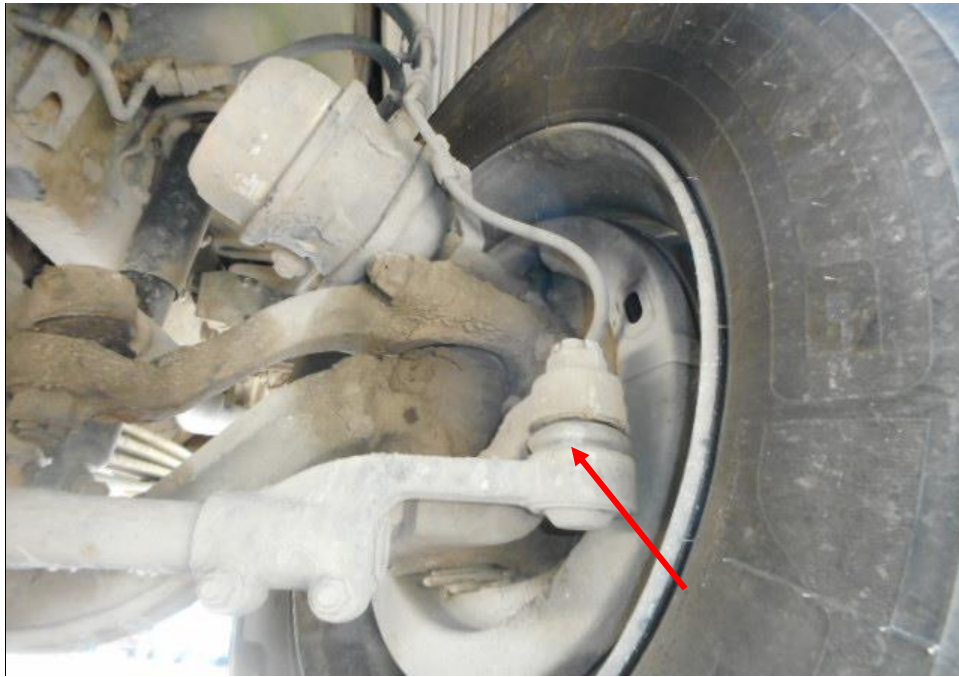
**Photo 22** shows the various undercarriage components at the front right wheel of the Tipper Truck, in particular the steering tie rod end (arrowed). The various steering components were all found to be intact, suggesting that the steering system of the Tipper Truck was likely to be in serviceable condition at the material time of accident. There was also no sign of fluid stain(s) observed on the various undercarriage components.

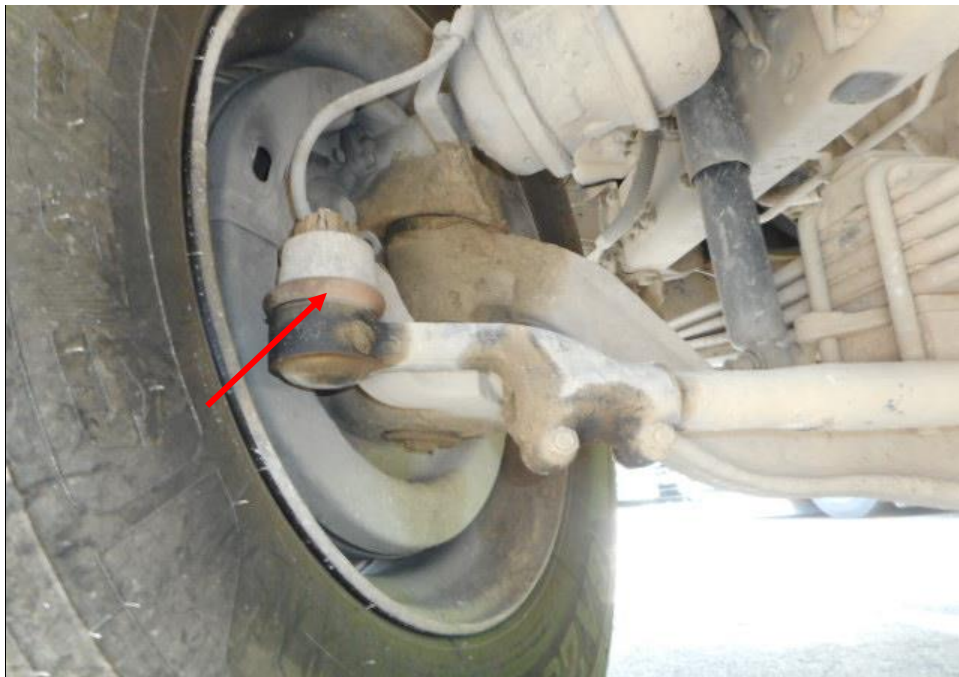
**Photo 23** shows the various undercarriage components at the front left wheel of the Tipper Truck, in particular the steering tie rod end (arrowed). The various undercarriage components of the Tipper Truck were all found to be intact without any visible damage. There was also no sign of fluid stain(s) observed on the various undercarriage components.

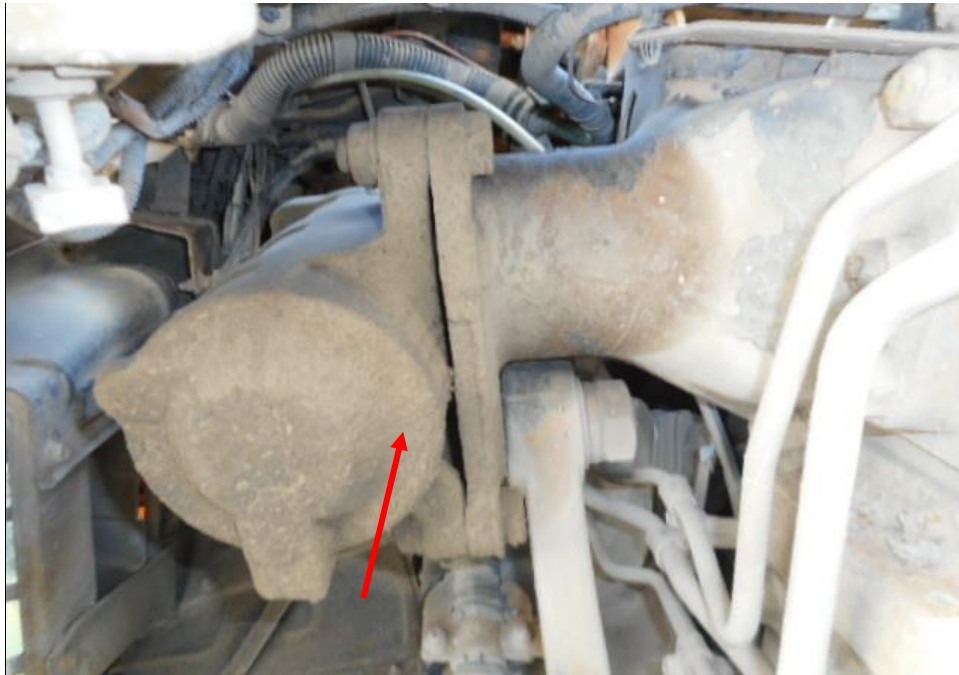
**Photo 24** shows the steering box component (arrowed) at the undercarriage of the Tipper Truck was found to be intact without any visible damage. There was also no sign of fluid stain(s) observed on the various undercarriage components.

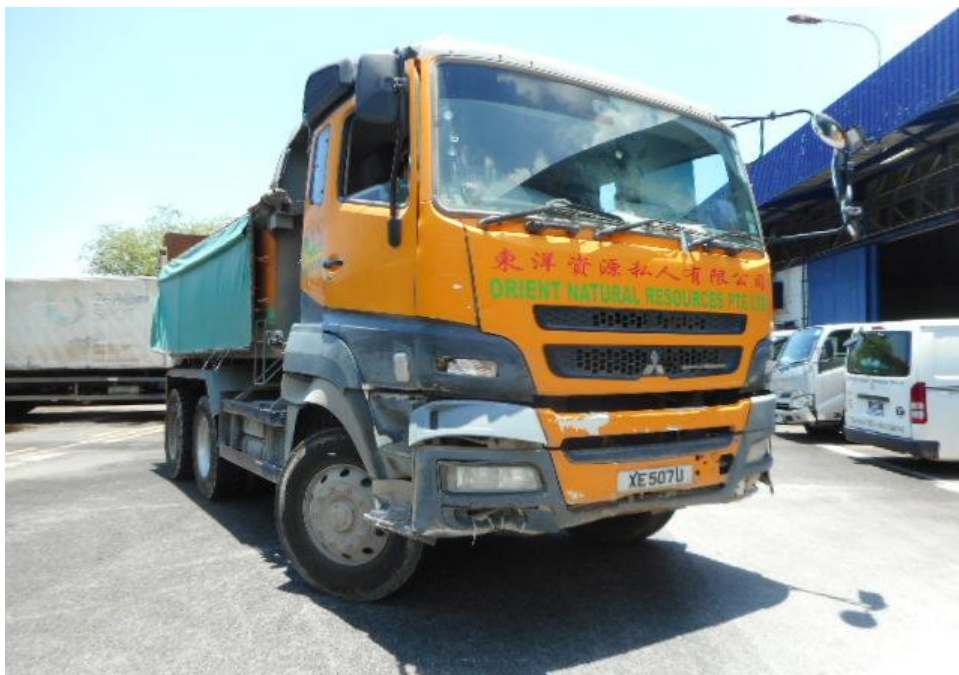
**Photo 25** shows the front right wheel of the Tipper Truck turned to its full left. During my steering system test, I did not experience any abnormal free play and/or resistance when I had turned the steering wheel towards full left and full right. This would suggest that the steering system of the Tipper Truck was likely to be in serviceable condition at the material time of accident.

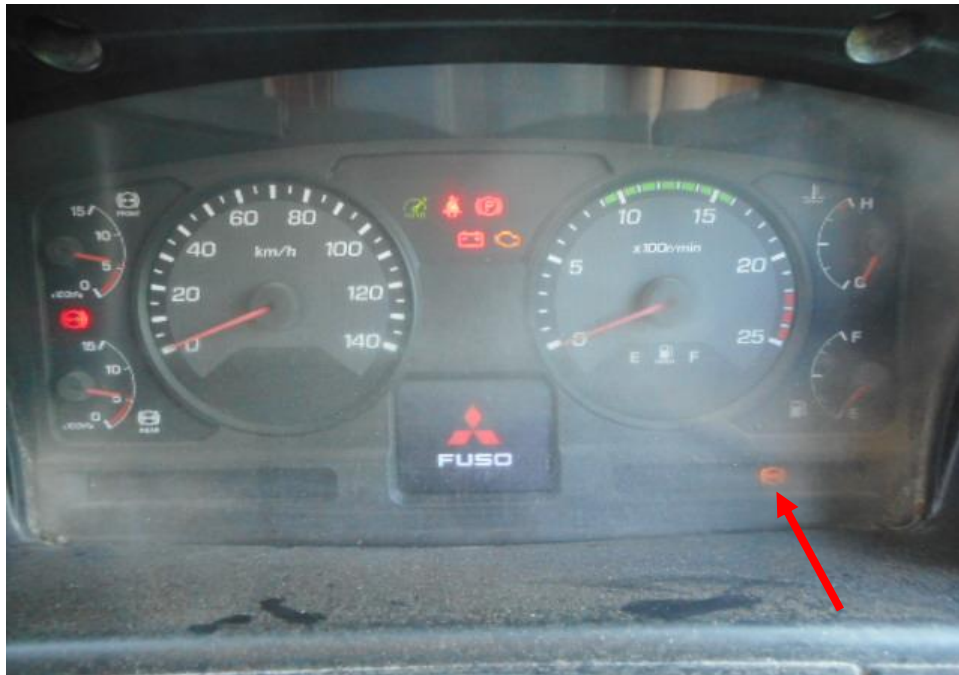
**Photo 26** shows the warning light for Anti-Lock Brake System (ABS) (arrowed) appearing on the instrument panel of the Tipper Truck during the self-test of its various electronic operating systems when its engine was cranked.

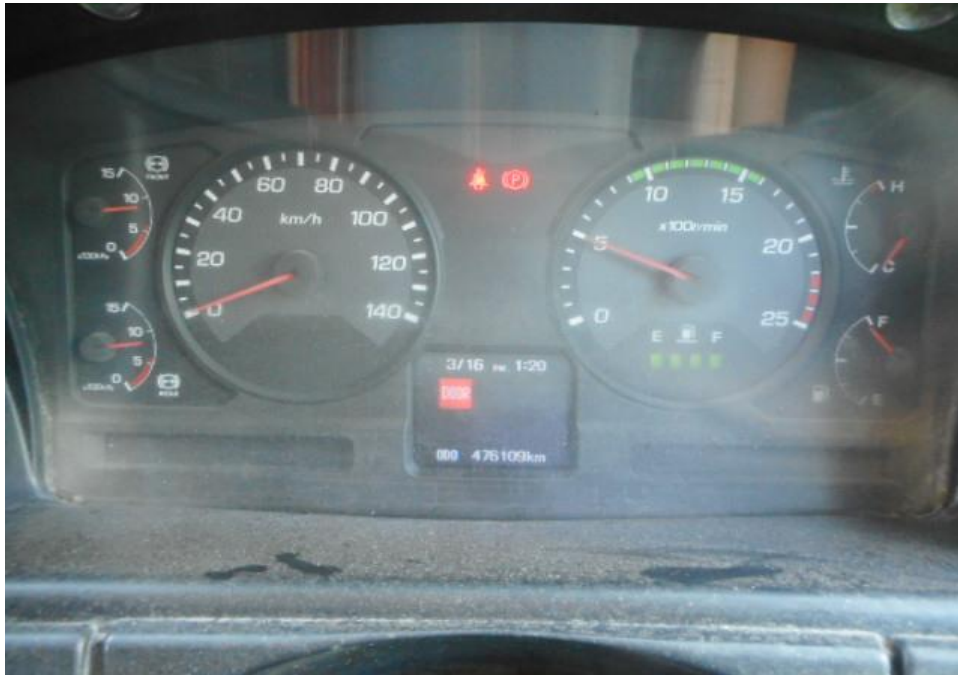
**Photo 27** shows no warning lights illuminated on the instrument panel of the Tipper Truck after the engine was cranked. This would suggest that there was no abnormality to the electronic operating system of the Tipper Truck, like the ABS, and etc.
