Your Ref: 2022 22004226/SL
Our Ref : CS6/AIS22002476/P

**TECHNICAL INVESTIGATION REPORT OF ACCIDENT INCIDENT INVOLVING
THE INSURED VEHICLE SND 6030L ON 11th March 2022**

Vehicle Registration No.	: SND 6030L
Make / Model	: BMW M135i 5DR AT ABS D/AIRBAG HID
Chassis No	: WBA1B72090J778695
Year of Registration	: 04 MAR 2014
Mileage	: 102,475KM

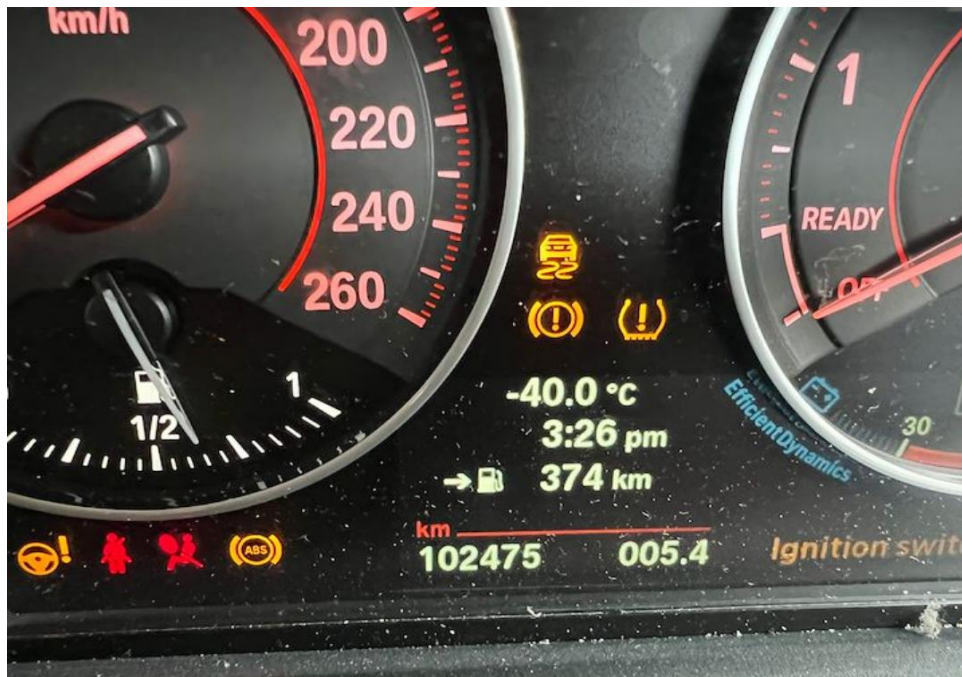
Photo 1 shows the mileage of the Insured Vehicle at the time of our inspection at 102,475km.

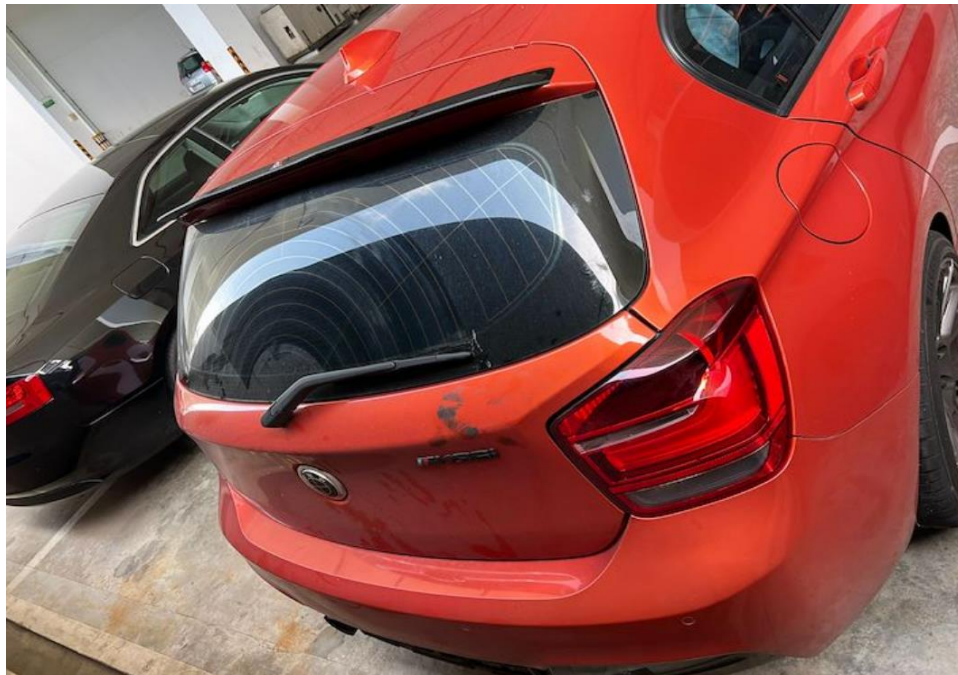
Photo 2 shows the general view of the rear portion of the Insured Vehicle at the time of our inspection. Its rear portion was not affected by the accident.

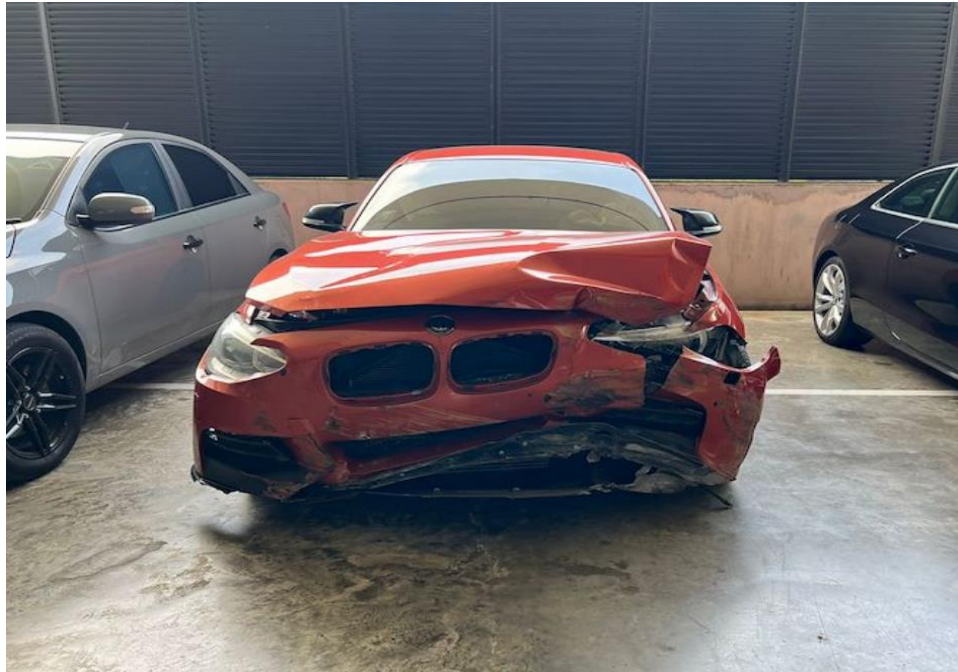
Photo 3 shows the general view of the front portion of the Insured Vehicle at the time of our inspection. Its front bonnet, front left headlamp and front bumper, was amongst the body parts that were damaged as a result of the accident.

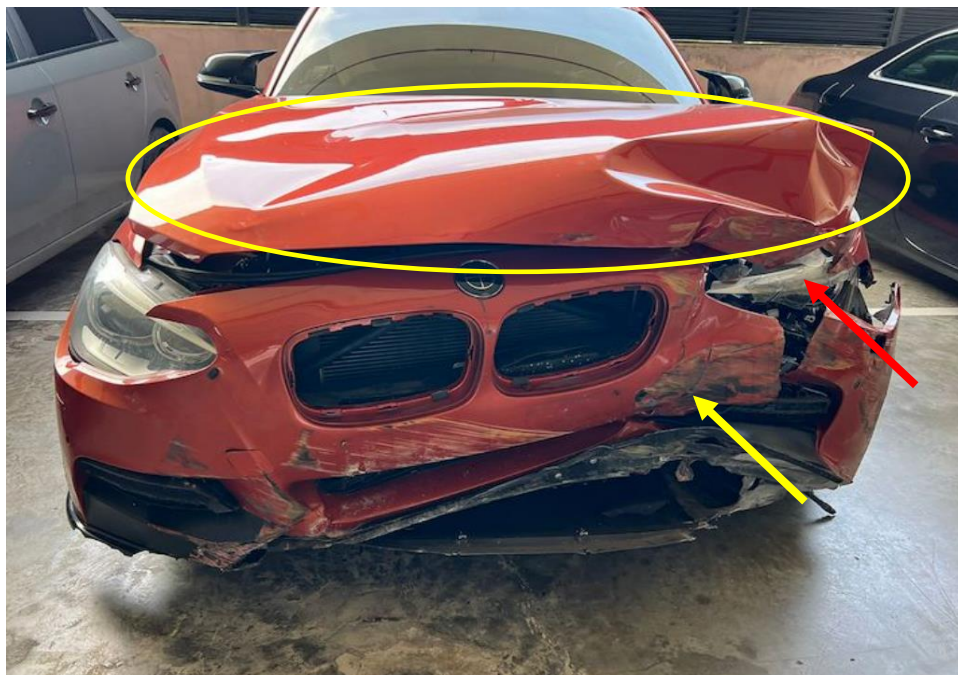
Photo 4 shows the close up view of the front portion of the Insured Vehicle at the time of our inspection. Its front bonnet (circled), front left headlamp (red arrow), front bumper (yellow arrow), was the body parts that were damaged as a result of the accident.

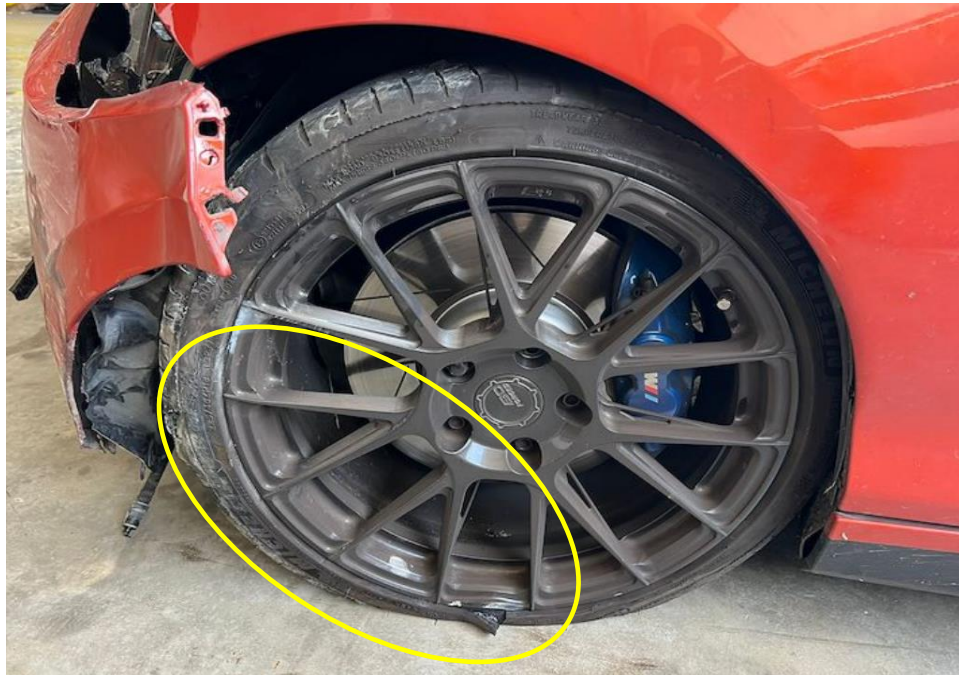
Photo 5 shows the close up view of the front left tyre of the Insured Vehicle at the time of our inspection. Its front left tyre and wheel rim (circled) were damaged as a result of the accident.

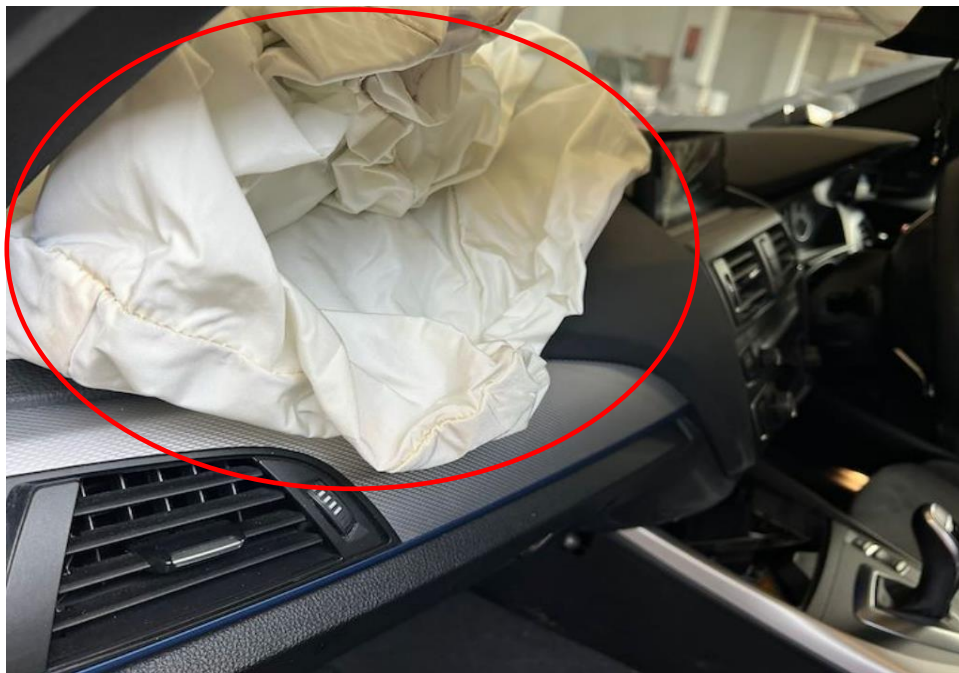
Photo 6 shows the close up view of the interior portion of the Insured Vehicle at the time of our inspection. Its airbag's deployed (circled) as a result of the accident.

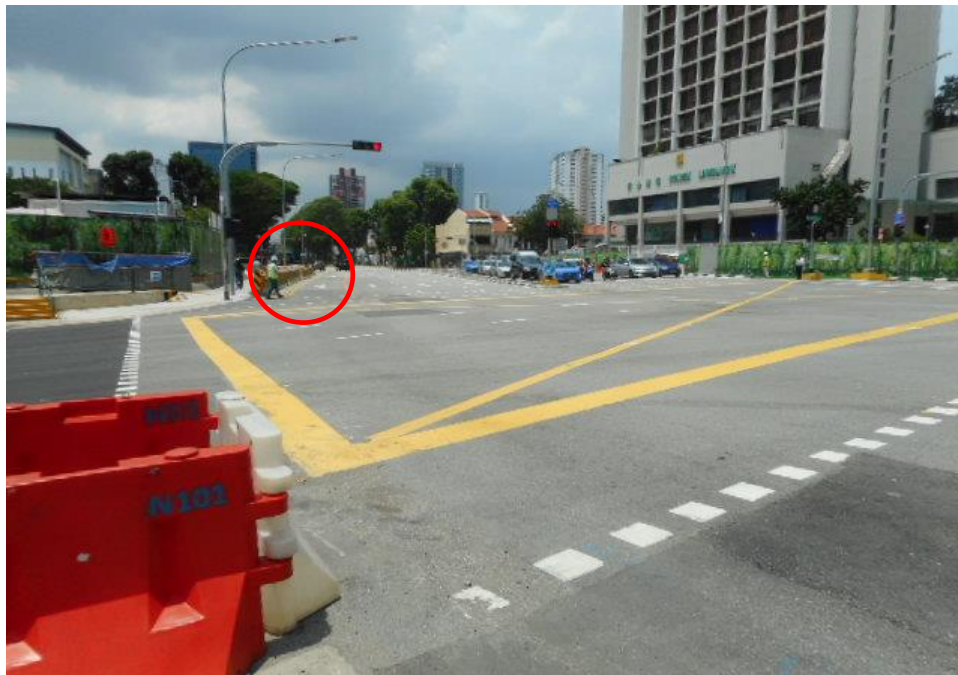
Photo 7 shows location of where the Insured Vehicle was involved in the accident (circled) which is located opposite Golden Landmark building along Victoria street road. In general, the information that could be gathered from this photograph had corresponded to the events that were related to us by Mr Lau, location when the accident happened.

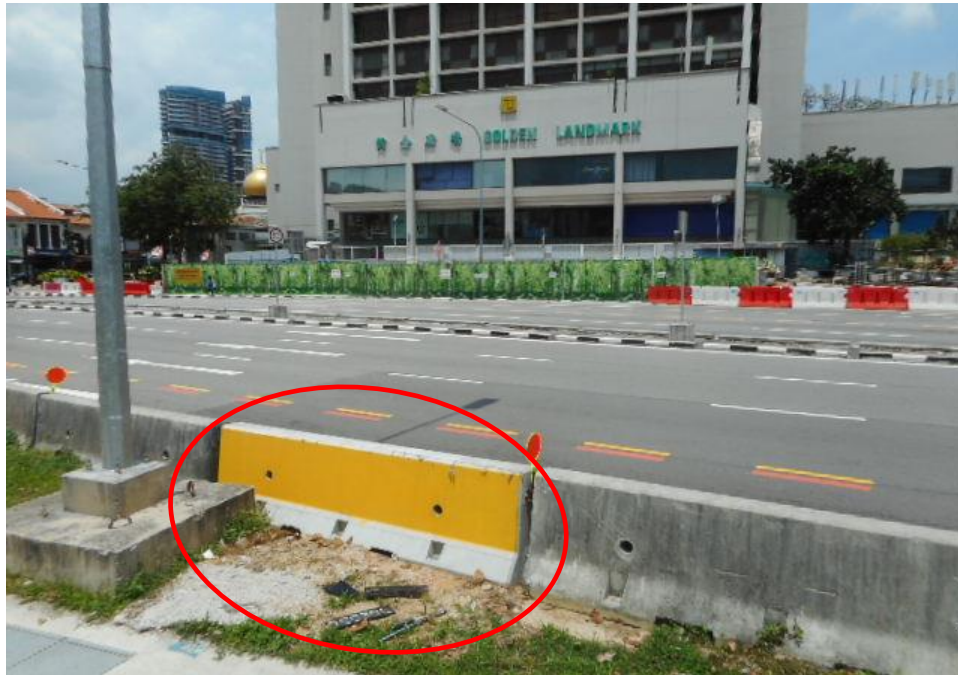
Photo 8 shows the general location of where the Insured Vehicle was involved in the accident which is located opposite Golden Landmark building along Victoria street road as we observed that there was a new and different coloured concrete barrier as compared to the other concrete barriers that was placed there and also damaged Insured Vehicle parts on the surrounding ground (circled). In general, the information that could be gathered from this photograph had corresponded to the events that were related to us by Mr Lau, location when the accident happened.

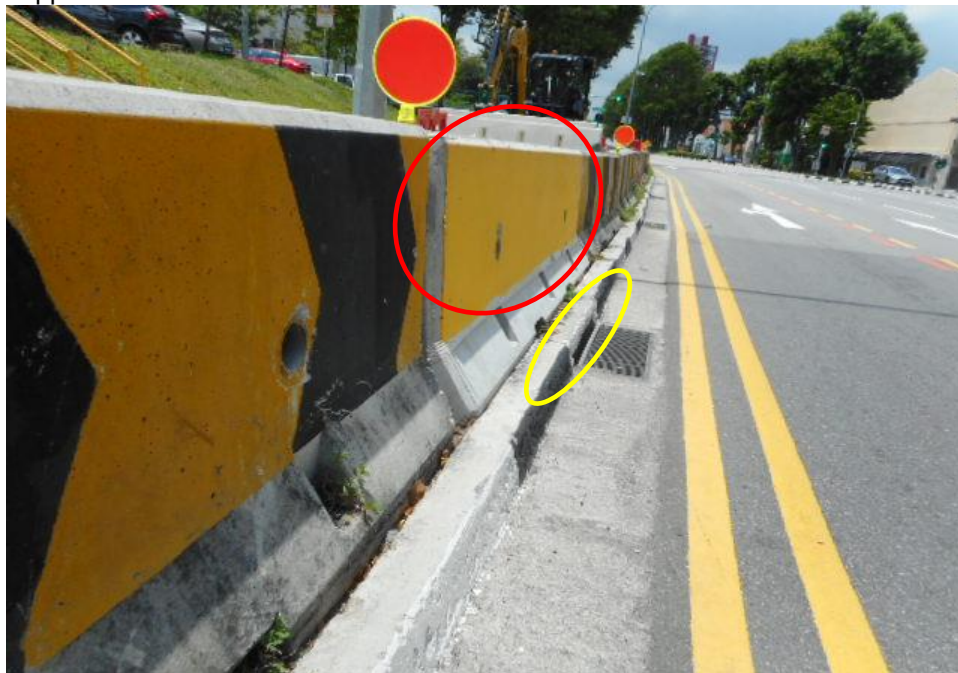
Photo 9 shows general view of where the Insured Vehicle mounted the curb (yellow circle), and the concrete barrier (red circle) opposite Golden Landmark building along Victoria street road. In general, the information that could be gathered from this photograph had corresponded to the events that were related to us by Mr Lau, location when the accident happened.

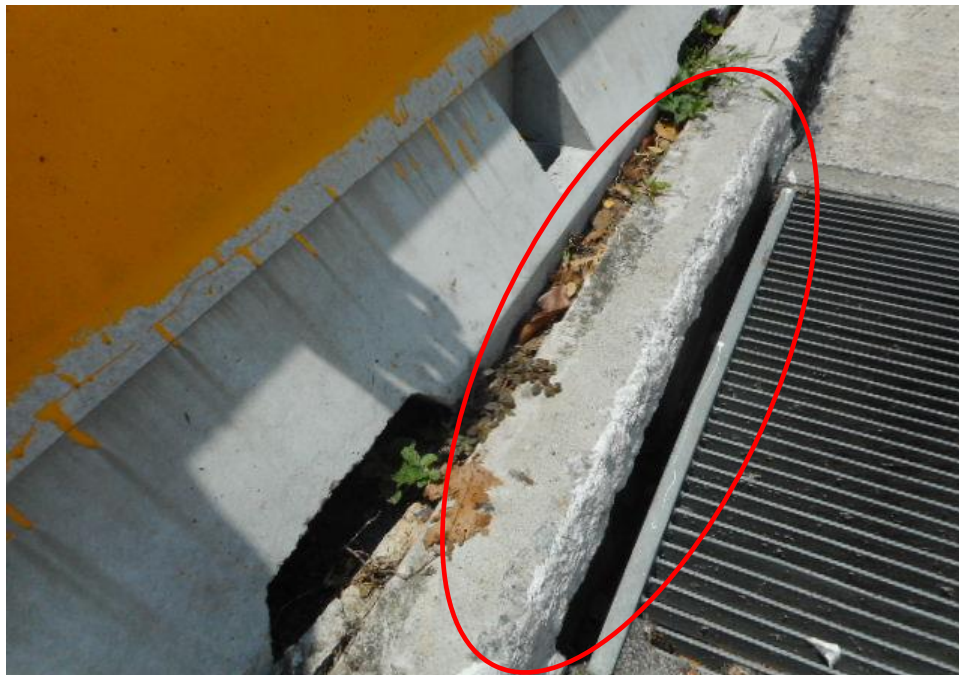
Photo 10 shows the close up view of the curb side, the curb had suffer damaged as a result of the Insured Vehicle mounting it (circled). In general, the information that could be gathered from this photograph had corresponded to the events that were related to us by Mr Lau, location when the accident happened.

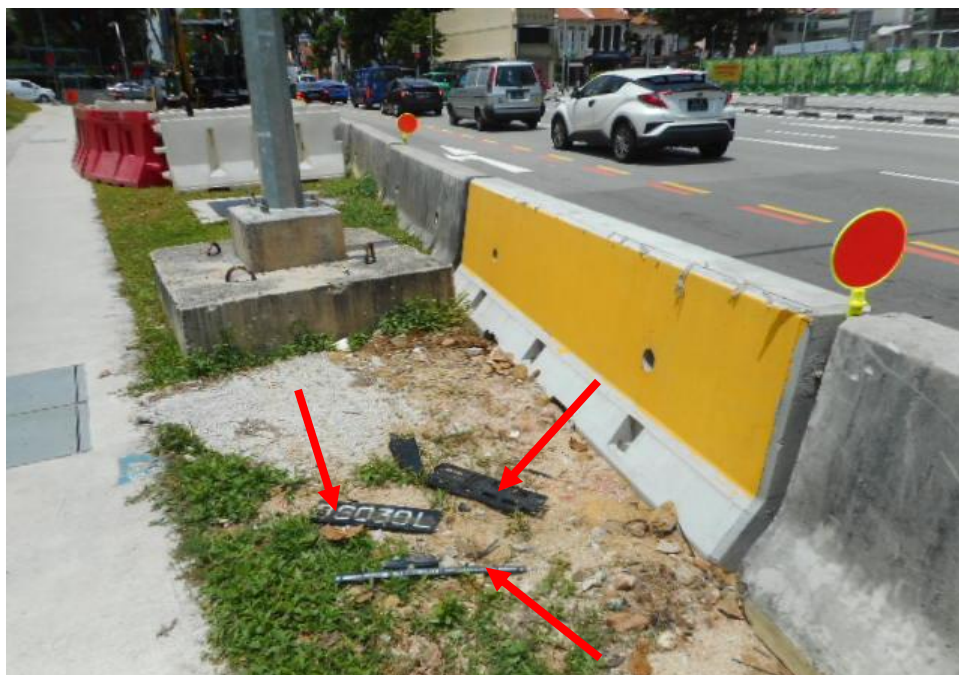
Photo 11 shows the grass patch area, where we observed broken pieces of number plate from the Insured Vehicle after the accident (arrowed). In general, the information that could be gathered from this photograph had corresponded to the events that were related to us by Mr Lau, location when the accident happened.

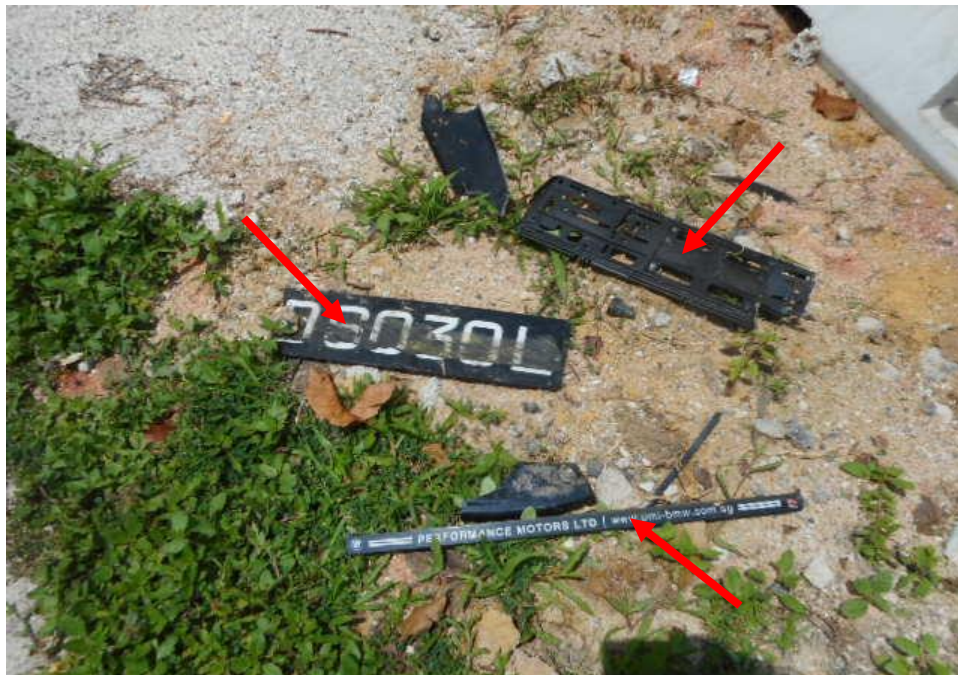
Photo 12 shows the close up view of the grass patch, we had observed multiple remains of the Insured Vehicle's number plate (arrowed). In general, the information that could be gathered from this photograph had corresponded to the events that were related to us by Mr Lau, location when the accident happened.
