Photographs of the Accident Vehicle

MID 59061

Report No. T/20211110/2033

REPORT OF A TRAFFIC ACCIDENT

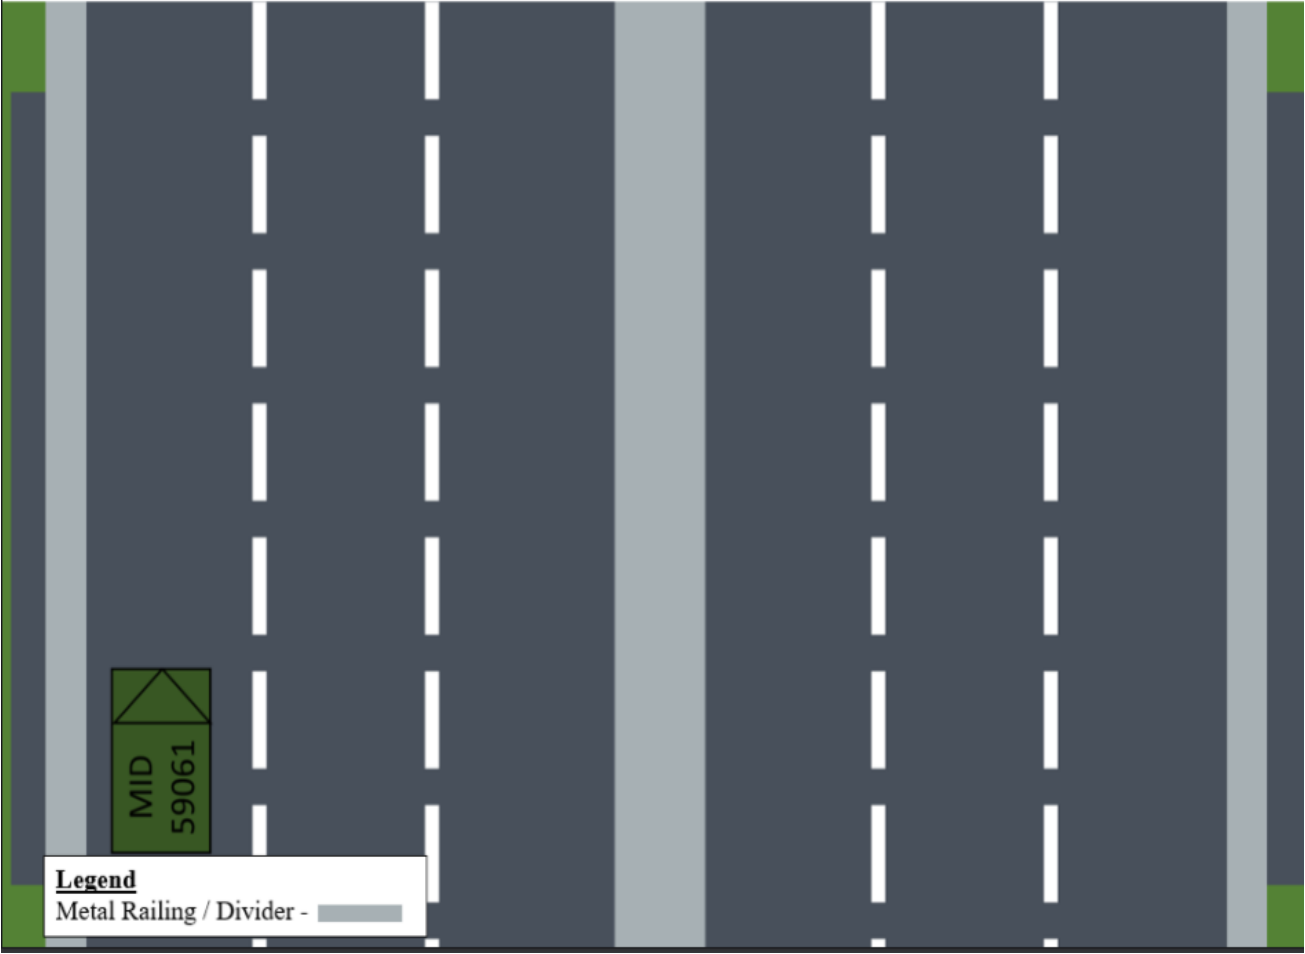
Slide 5

Schematic Diagram of Incident

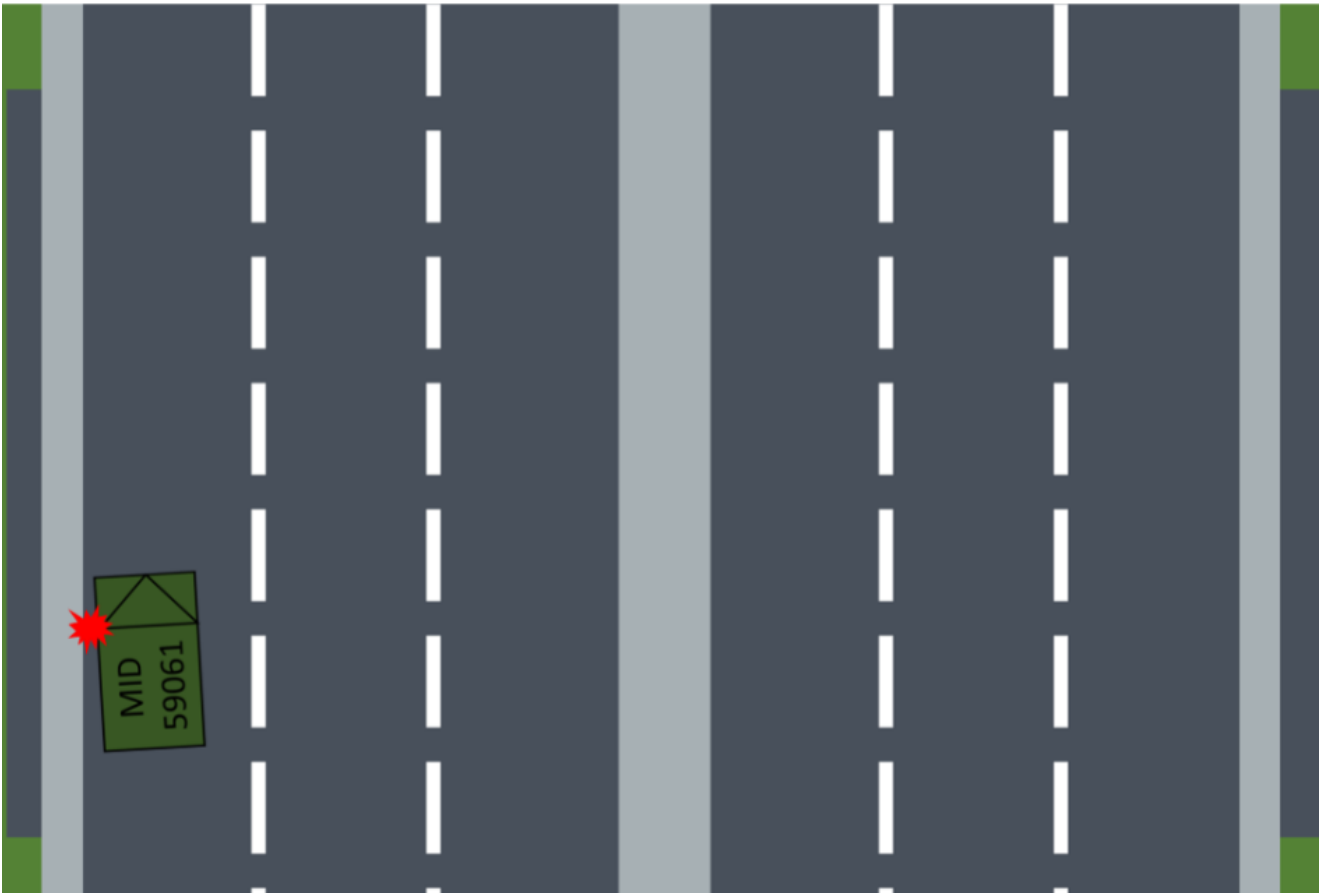
Slide 6

Schematic Diagram of Incident

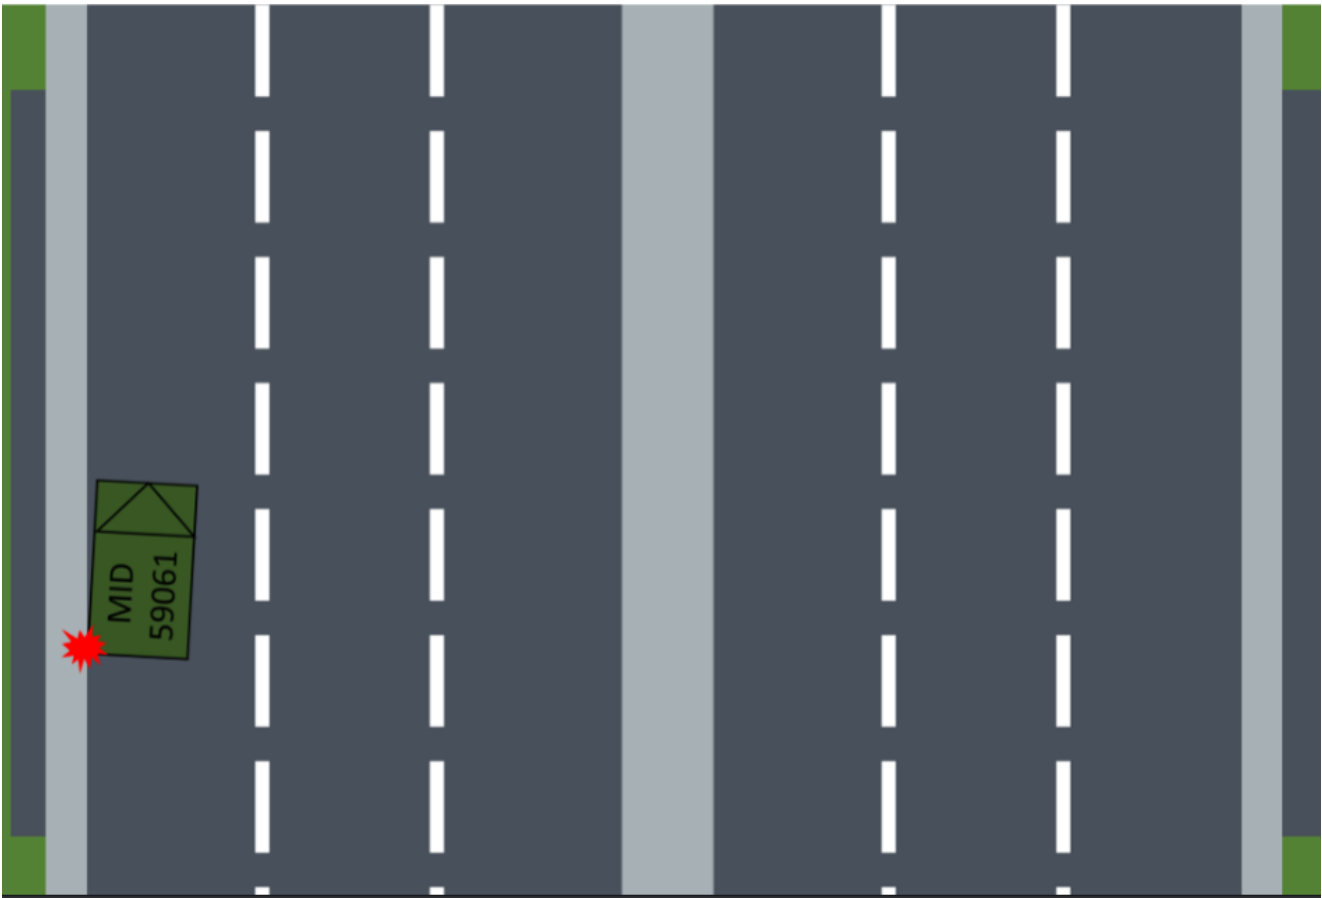
Slide 7

Schematic Diagram of Incident

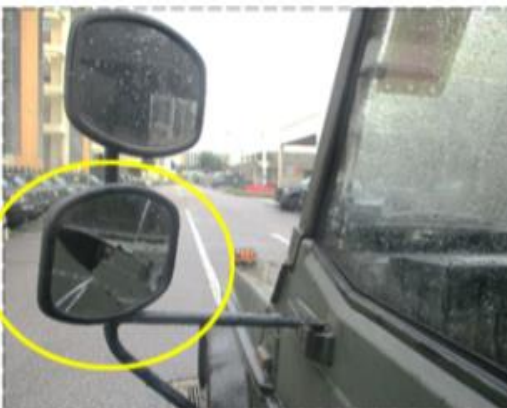
Damage Assessment:
Left blind-spot mirror cracked.

After coming into contact with the railing, I realised the ^{left} blind spot mirror was cracked. I deciphered that the highway had no road shoulder on the travelling lane and the main ^{left side} mirror was still intact. Moreover, I asked the driver if he was able to continue, which he said he was. Given the driver agreed to continue, said he was able to continue, the expressway was not a safe to stop and the vehicle was operable, I decided to continue the journey to PLC.

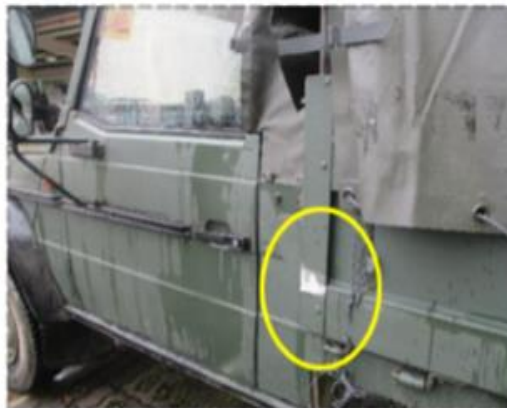
Damage Assessment:
Left front of the
vehicle sideboard scratched.

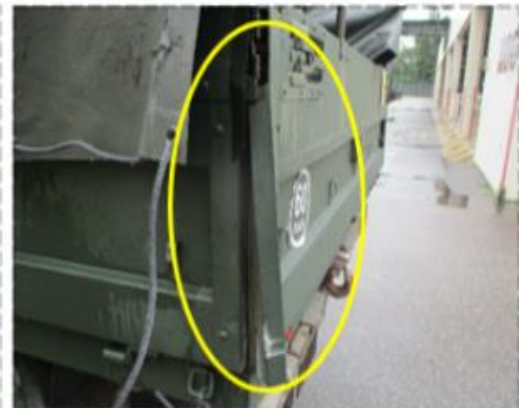
Damage Assessment:
Left side of the
vehicle tailboard was dented.

Upon reaching PLC, we conducted a thorough check ^{on the} of the MB290 (S9061 MID). ~~we~~ Aside from the crack in the blind spot mirror, we discovered that the left side of the tailboard sustained a dent and scratch marks.
