**Memorandum for Billing for Accident Recoveries**

**Facilities Management Fault Report Form**

LOYANG AVENUE, Pole No: 82, Pole Slanting, calling from tp. report sl damage due to accident. uprooted. - slanting against the tree. lp 82. posing danger. location; Loyang ave towards telok paku road. vehicle; saf vehicle vehicle , 34699MID. report; G/20211111/0047

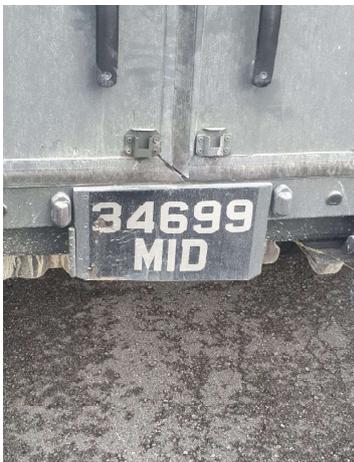
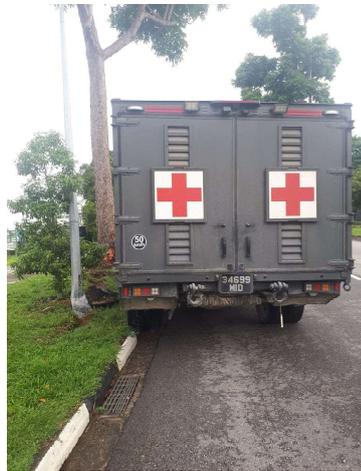
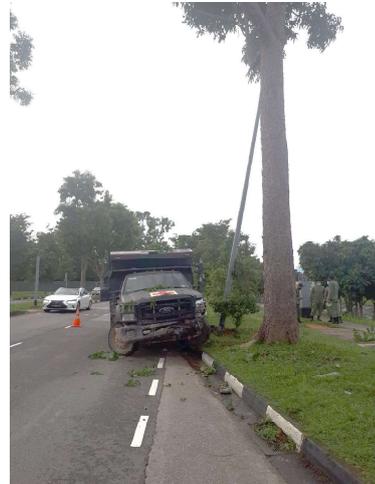
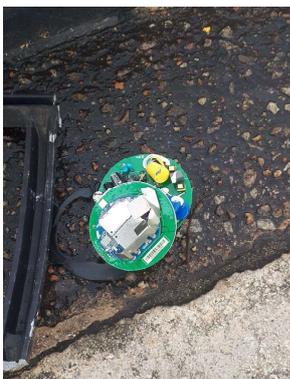
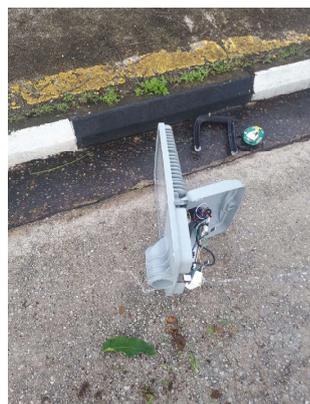
LOCATION : LOYANG AVE  
LP ID : LP NO 82  
BEFORE PHTOS

Checked and found 10m pole, 2m single arm, 1 no 139W LED lantern, control node and cut out damaged at LP82 (Loyang Avenue) due to hit by vehicle no - 34699MID. Replacement of 10m pole, 2m single arm, 1 no 139W LED lantern with control node and cut out at LP82 (Loyang Avenue) due to accident pole.
