Your Ref: Porsche Macan GTS
(chassis number WP1ZZZ95ZLLB62049)
Our Ref : CI/TP22002878/D

INSPECTION REPORT OF AN UNREGISTERED PORSCHE MACAN GTS MOTOR CAR WITH CHASSIS NUMBER WP1ZZZ95ZLLB62049

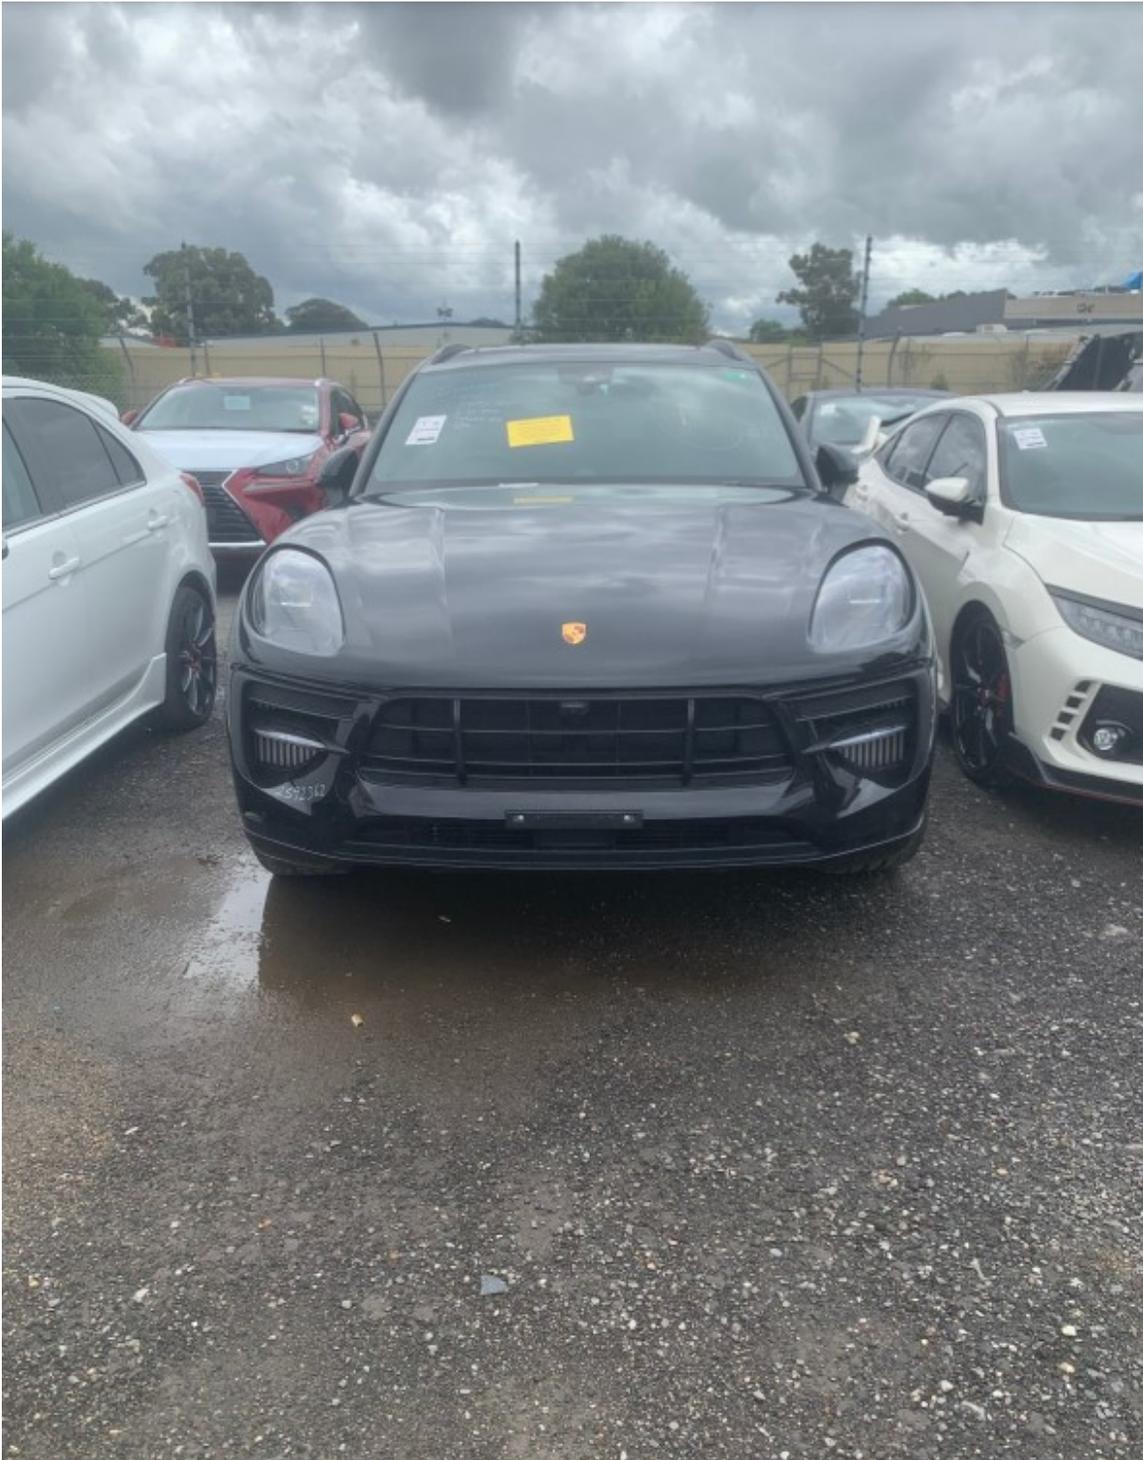
Photo 1 shows the frontal body of the Motor Car (photograph provided to me). The photographs provided to me had showed damage along the left side portion of the Motor Car (refer to photograph 2 & 3 below). Apart for the left side portion, there was no physical damage observed to other areas of the Motor Car.

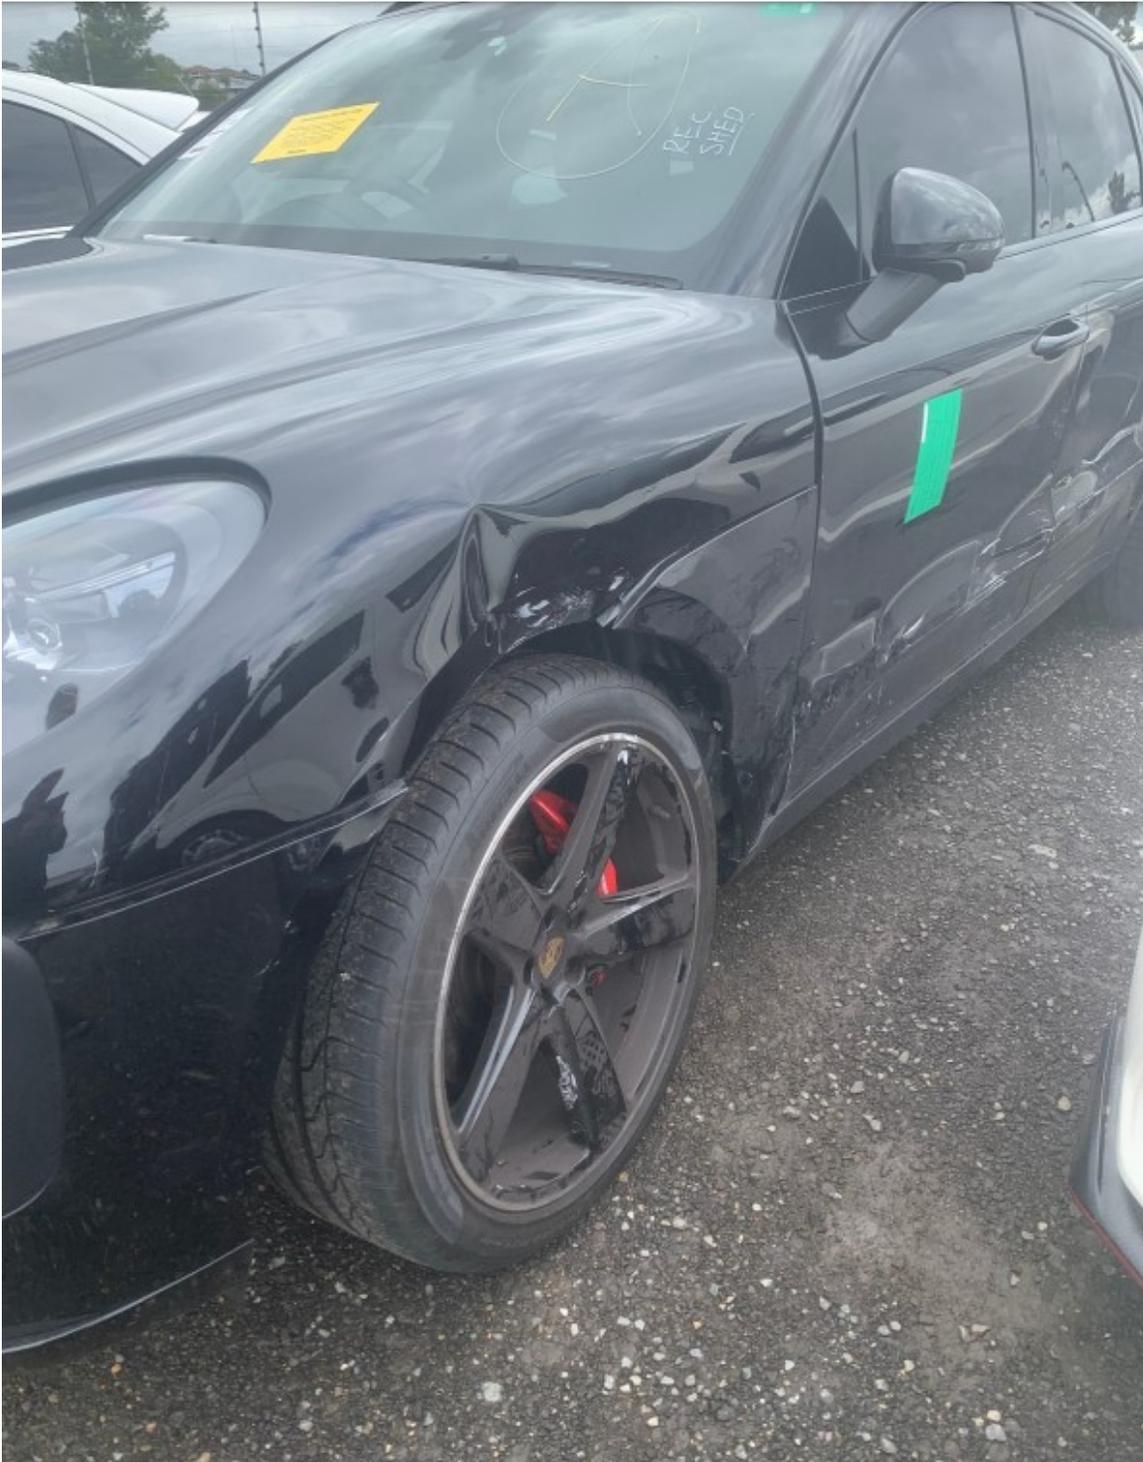
Photo 2 shows the left side front body of the Motor Car (photograph provided to me). The photographs provided to me had showed damage along the left side portion of the Motor Car. The front bumper, front bonnet, front left wheel rim, front left fender, front left door and front left door lower protector were amongst the body parts that were observed to have been damaged.

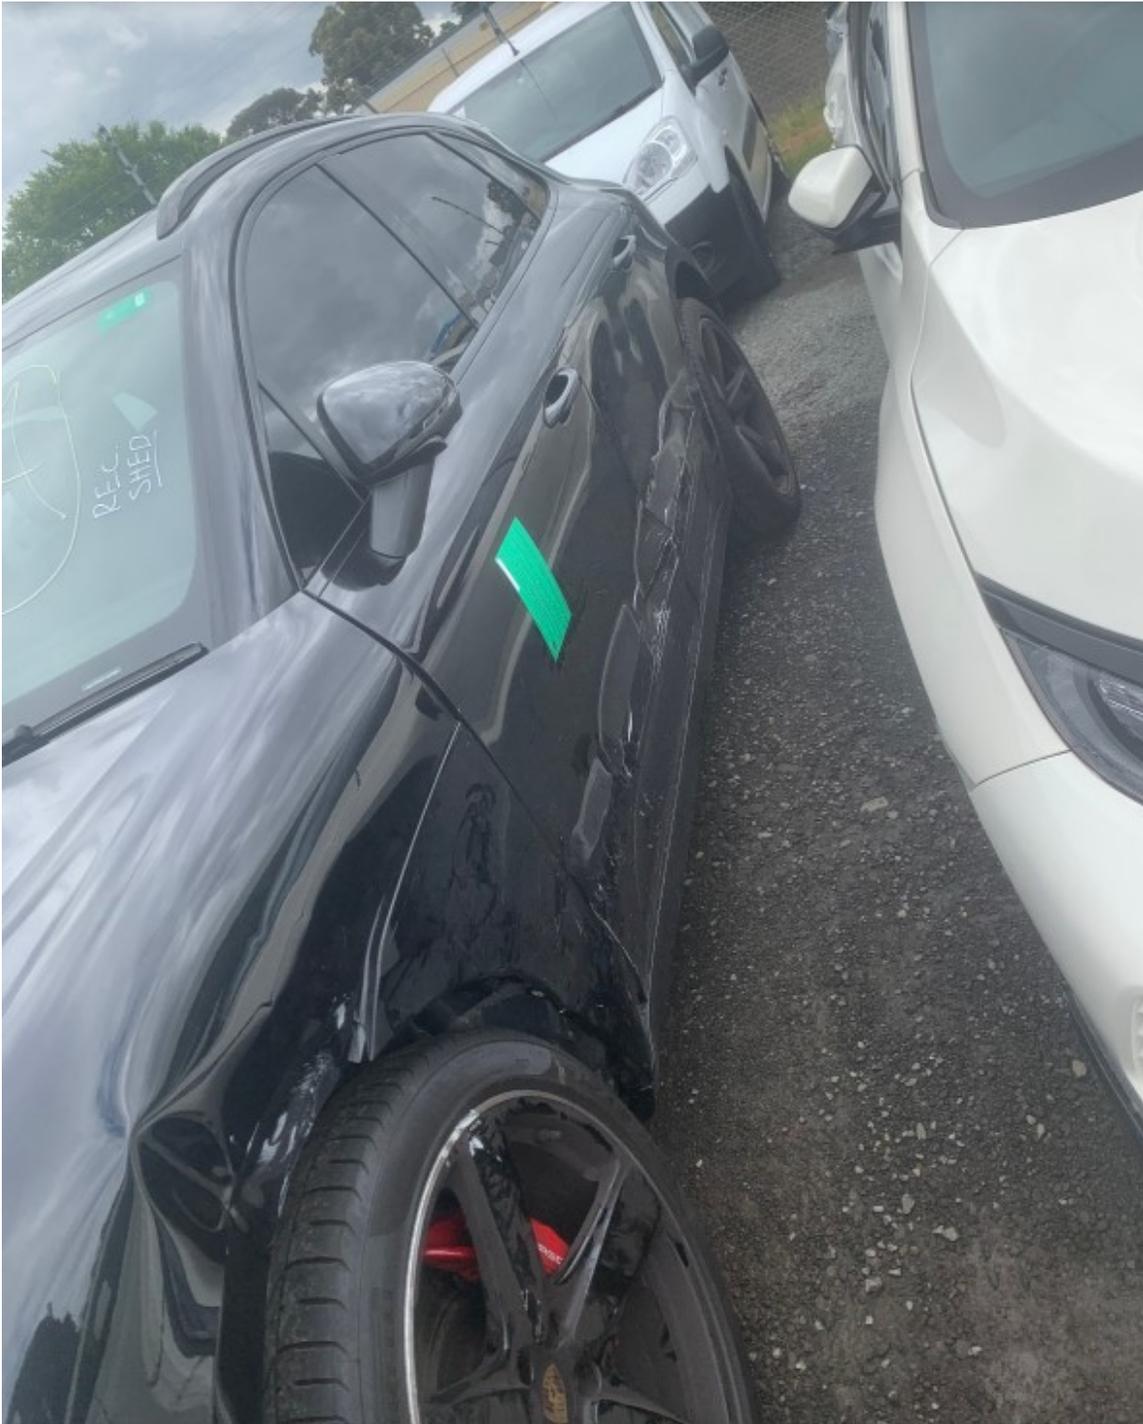
Photo 3 shows the left side body of the Motor Car (photograph provided to me). The photographs provided to me had showed damage along the left side portion of the Motor Car. The front bonnet, front left wheel rim, front left fender, front left door, front left door lower protector, rear left door, rear left door lower protector and rear left fender were amongst the body parts that were observed to have been damaged.

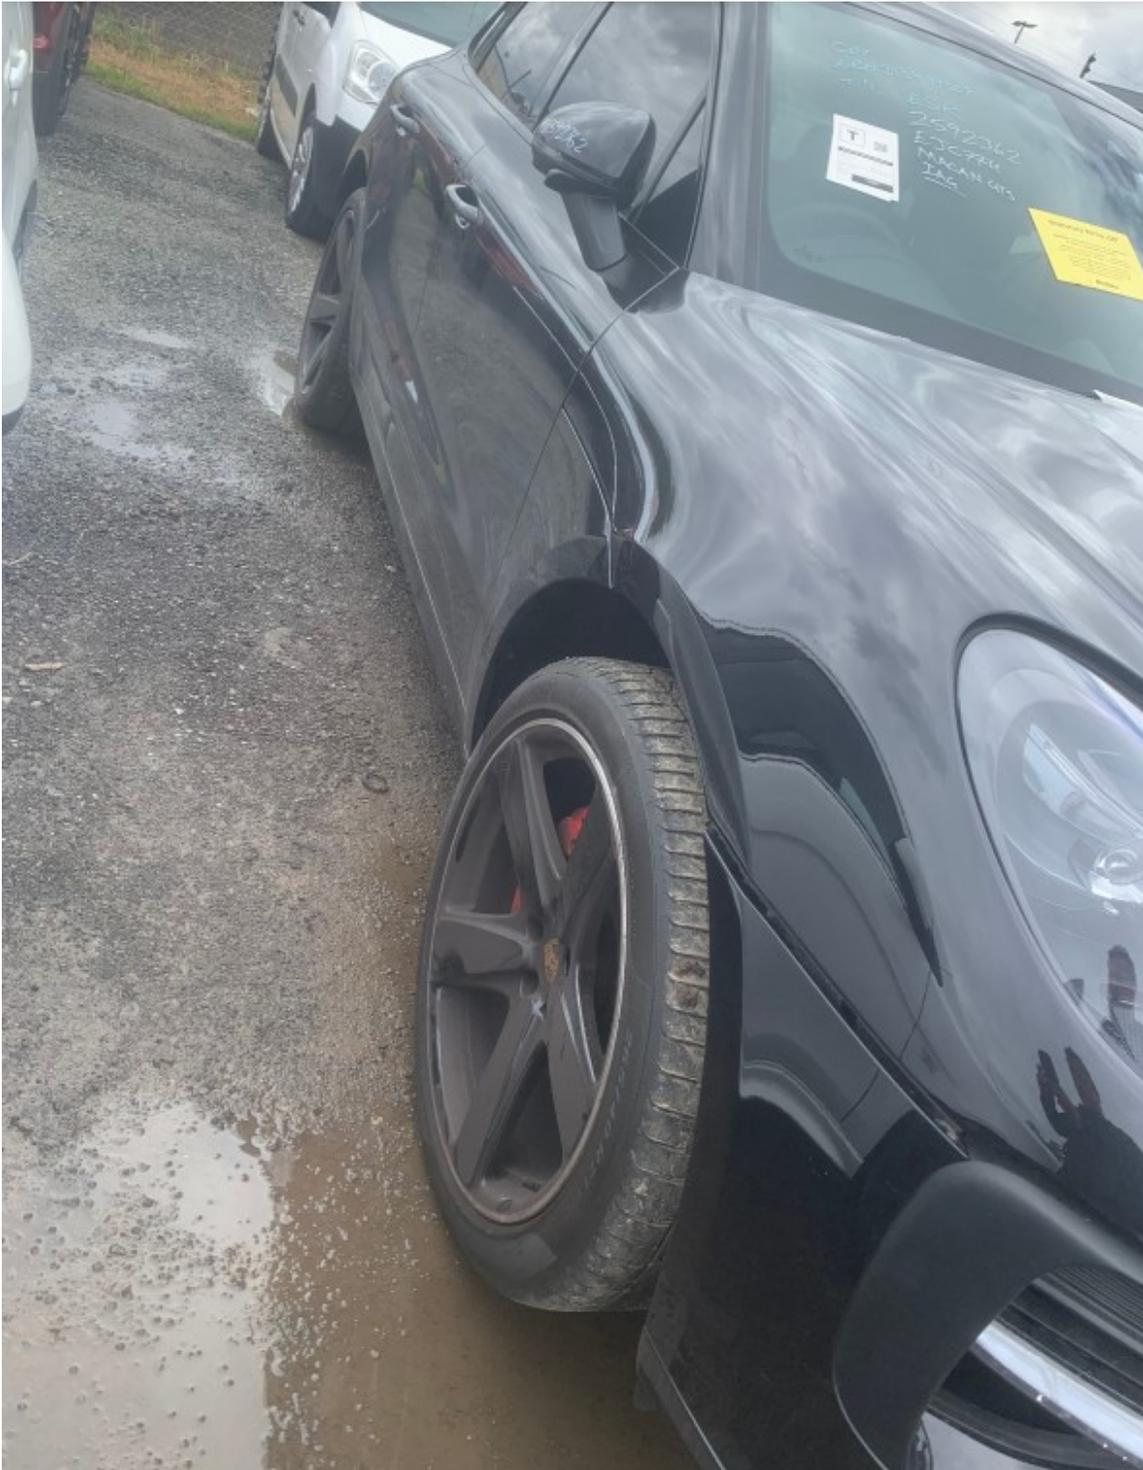
Photo 4 shows the right side body of the Motor Car (photograph provided to me). Apart for the left side portion, there was no physical damage observed to other areas of the Motor Car.

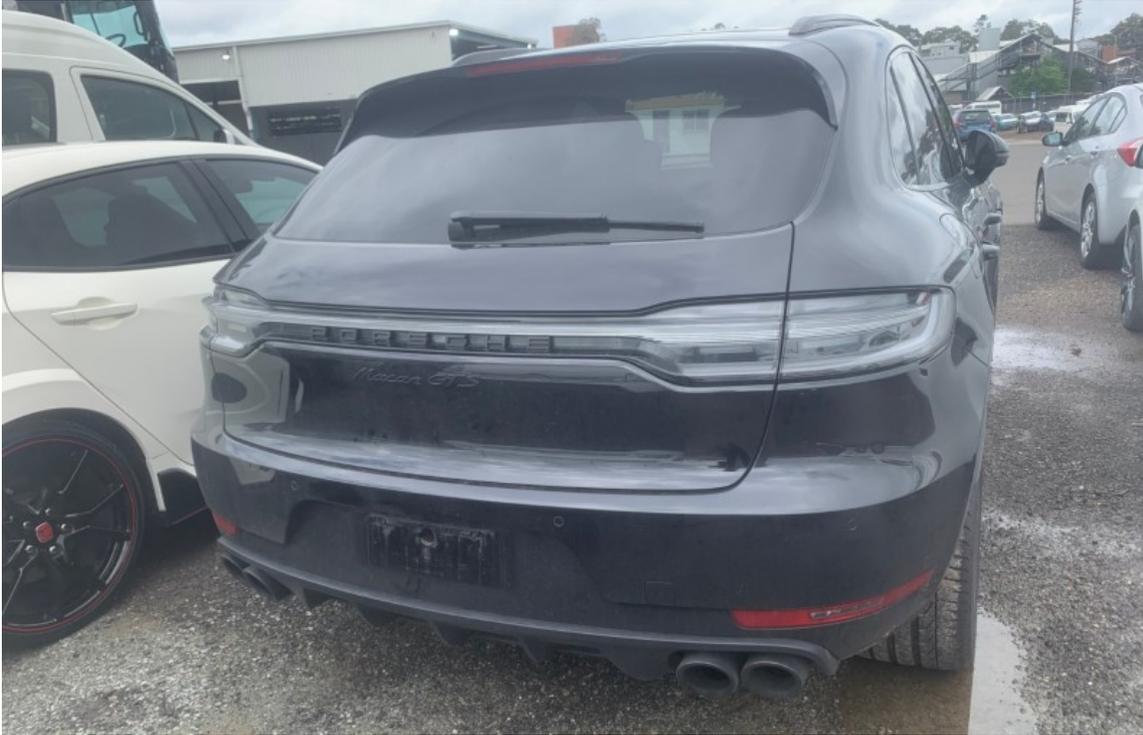
Photo 5 shows the rear body of the Motor Car (photograph provided to me). Apart for the left side portion, there was no physical damage observed to other areas of the Motor Car.

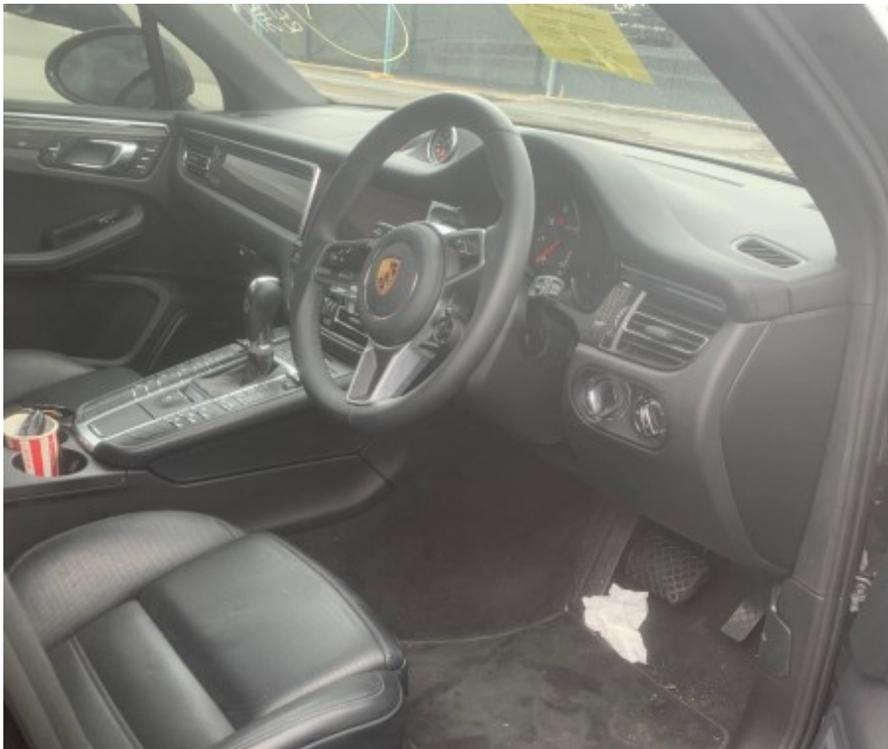
Photo 6 shows the interior compartment of the Motor Car (photograph provided to me). The various parts and components within the interior compartment were all intact and unaffected. The airbag(s) was not deployed as seen from the photographs that were provided to me.

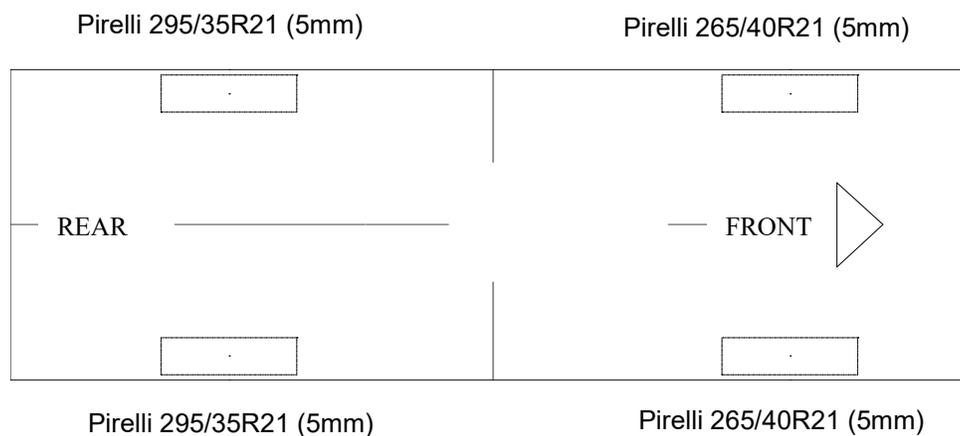
8. The Motor Car was fitted with 21inch sport wheel rims that were wrapped with tyres that were observed to be of serviceable condition. The tyres were also sufficiently inflated for vehicular operation. The tyre brand, tyre size and approximate remaining tread depth of the 4 tyres of the Motor Car were recorded as follows: -

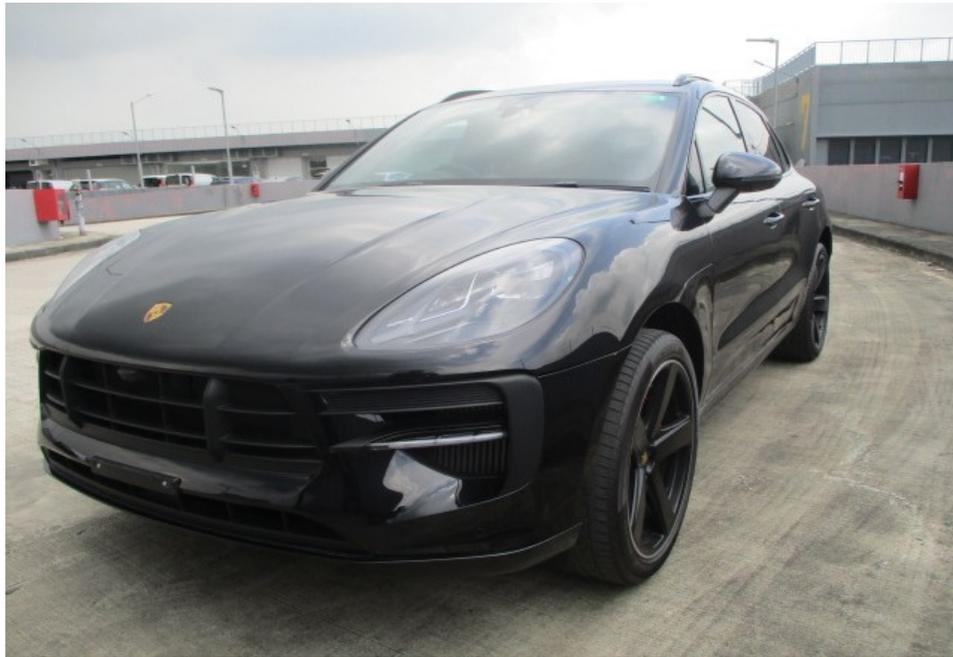
Photo 7 shows a general view of the front left body of the Motor Car at the time of my inspection. The Motor Car was observed to be in a relatively good general condition with no loose exterior fittings observed. The body parts along the left side portion of the Motor Car were visually examined and it was observed that the repair/restoration works carried out to the damaged area of the Motor Car (refer to photograph 2 & 3 above) were reasonably adequate and in order.

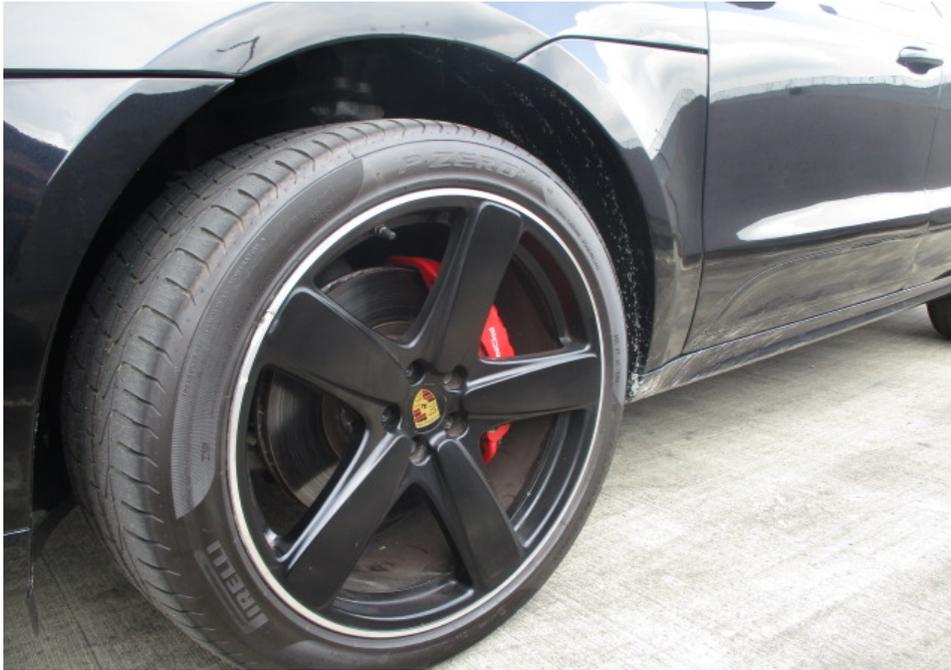
Photo 8 shows a closer view of the Motor Car's front bumper, front bonnet, front left fender and front left wheel rim. The body parts along the left side portion of the Motor Car were visually examined and it was observed that the repair/restoration works carried out to the damaged area of the Motor Car (refer to photograph 2 & 3 above) were reasonably adequate and in order.

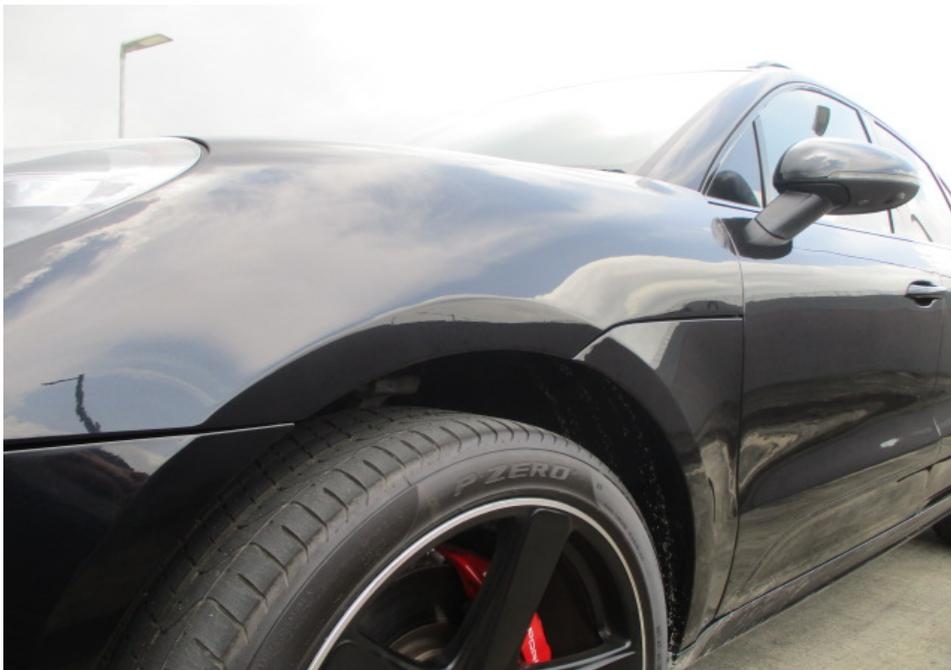
Photo 9 shows a closer view of the Motor Car's front bumper, front bonnet and front left fender. The body parts along the left side portion of the Motor Car were visually examined and it was observed that the repair/restoration works carried out to the damaged area of the Motor Car (refer to photograph 2 & 3 above) were reasonably adequate and in order.

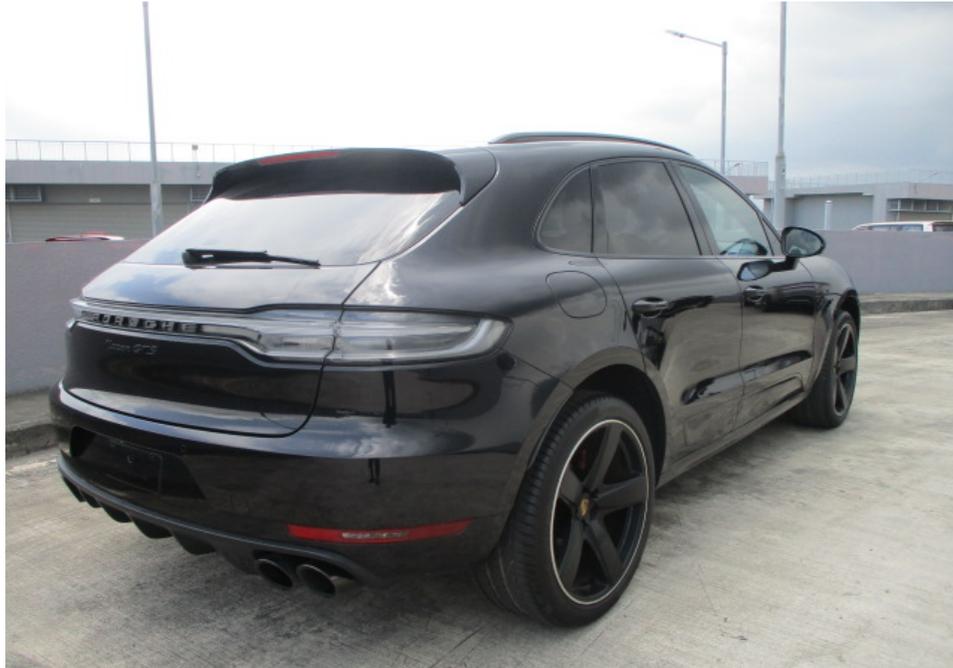
Photo 12 shows a general view of the rear right body of the Motor Car at the time of my inspection. The Motor Car was observed to be in a relatively good general condition with no loose exterior fittings observed. The mileage of the Motor Car recorded at the time of my inspection was 14,582km.

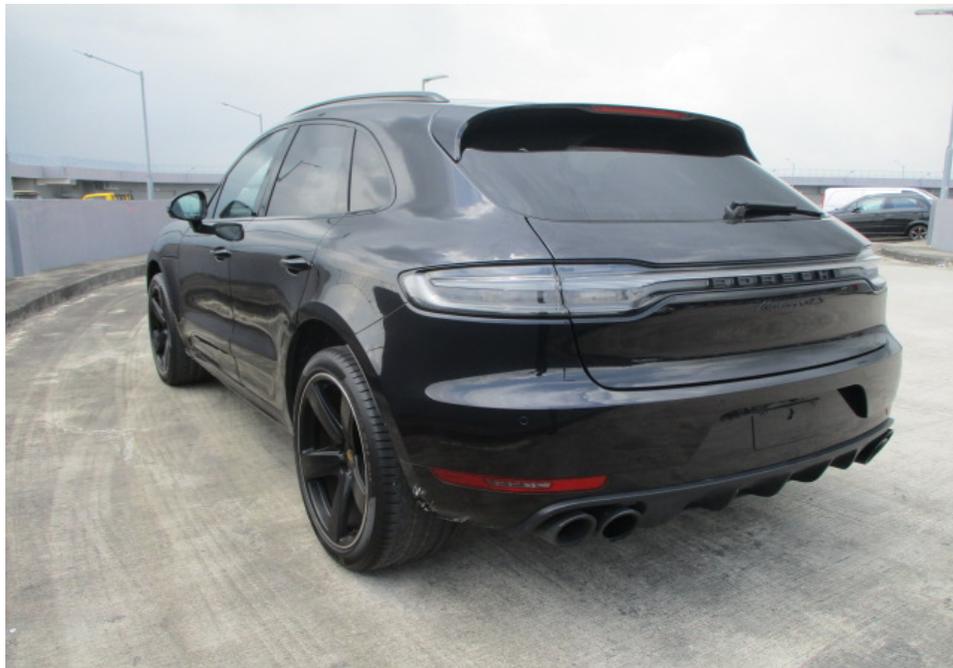
Photo 13 shows a general view of the rear left body of the Motor Car at the time of my inspection. The Motor Car was observed to be in a relatively good general condition with no loose exterior fittings observed. The body parts along the left side portion of the Motor Car were visually examined and it was observed that the repair/restoration works carried out to the damaged area of the Motor Car (refer to photograph 2 & 3 above) were reasonably adequate and in order.

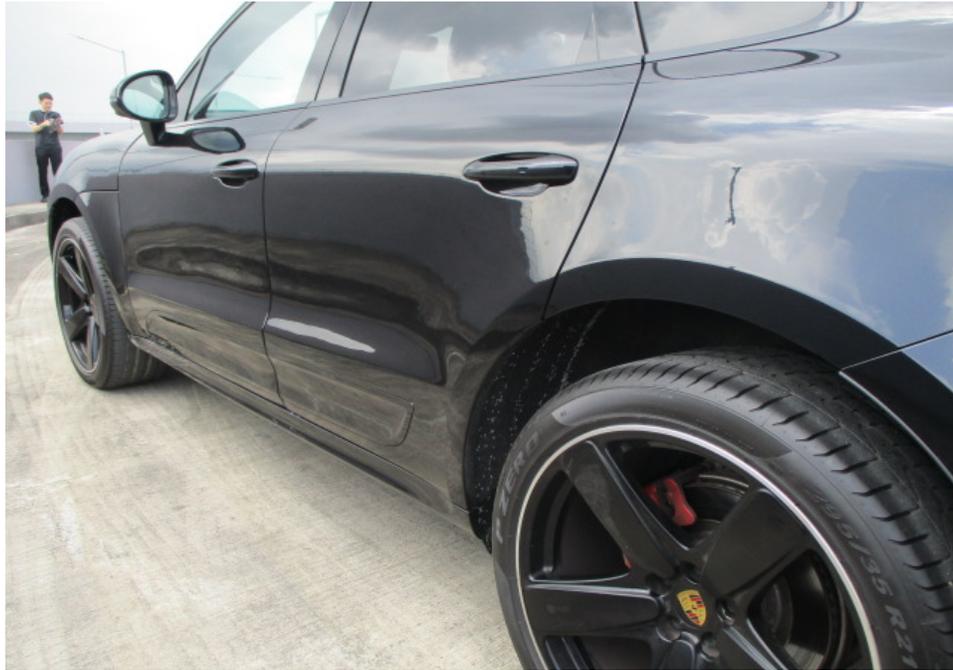
Photo 14 shows a closer view of the Motor Car's rear left fender, rear left door, rear left door lower protector, front left door and front left door lower protector. The body parts along the left side portion of the Motor Car were visually examined and it was observed that the repair/restoration works carried out to the damaged area of the Motor Car (refer to photograph 2 & 3 above) were reasonably adequate and in order.

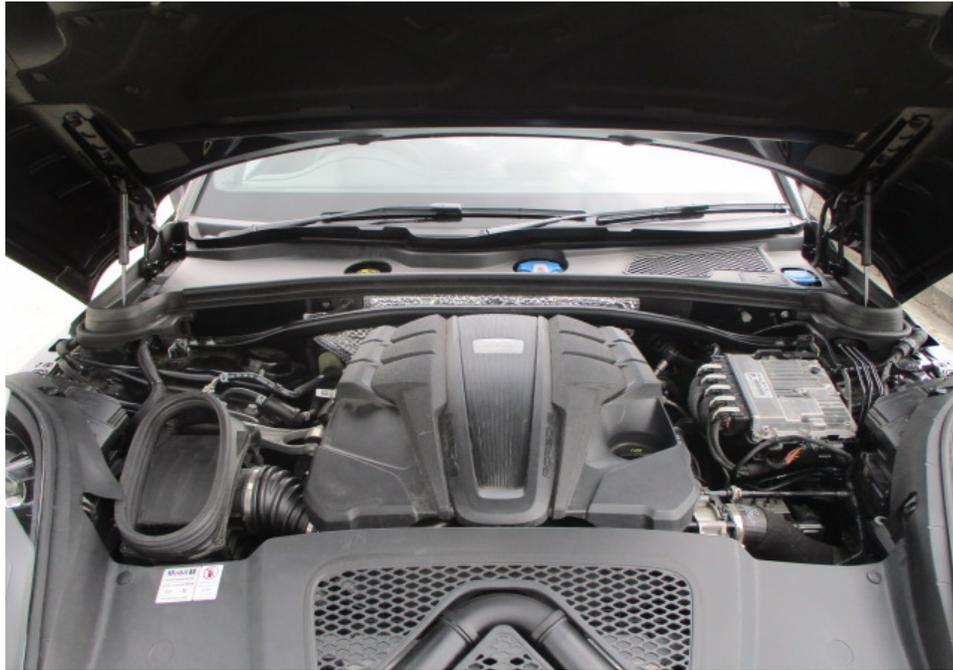
Photo 16 shows a general view of the engine compartment of the Motor Car at the time of my inspection. The various parts and components inside the engine compartment were all observed to be intact and properly fitted. There was also no sign(s) or indication(s) of fluid leak and/or fluid stain found inside the engine compartment.

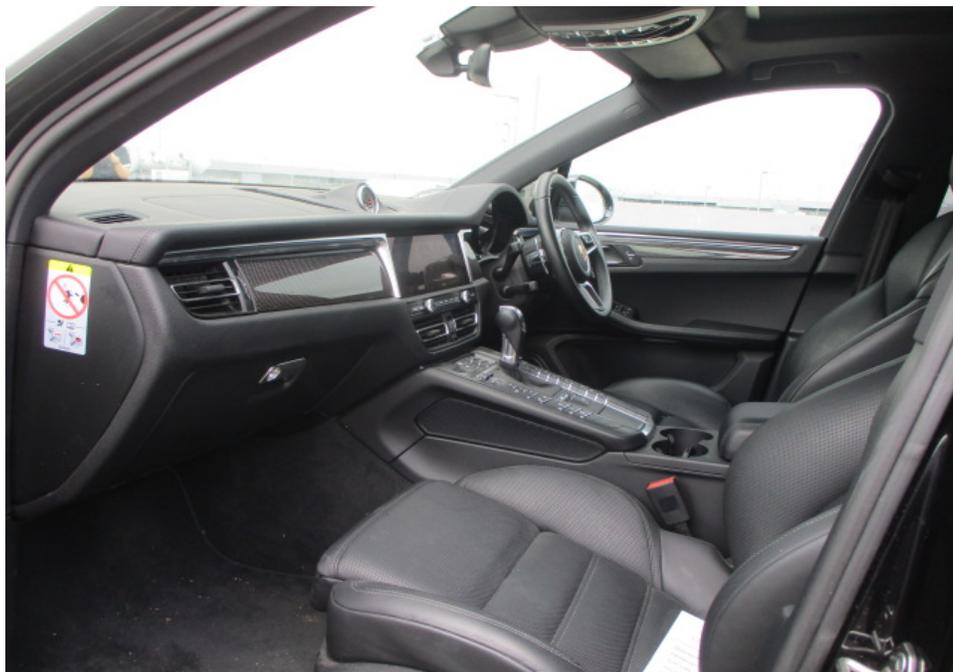
Photo 17 shows the interior compartment of the Motor Car at the time of my inspection. The various parts and components, trims, carpet, and upholstery inside the interior compartment were all observed to be intact and properly fitted.

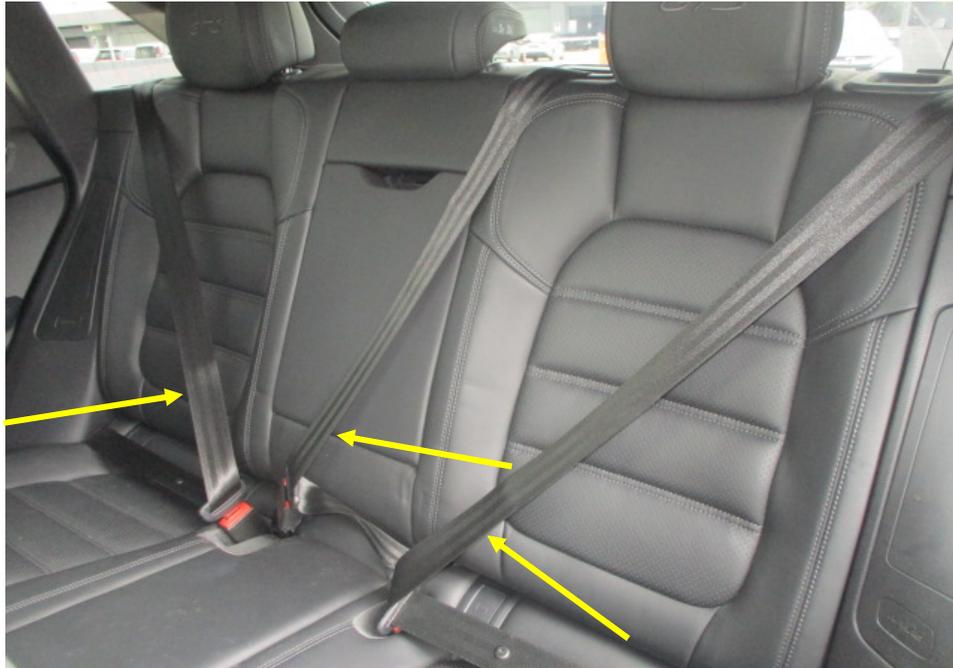
Photo 18 shows the rear seats of the Motor Car. All the seats of the Motor Car were secured via seat rails to the floorboard. They were also fitted with a retractable seat belt reel and a pre-tensioner. The seat belts (arrowed) were tested and were able to be fastened into the respective pre-tensions that were fitted on the side of each individual seat.

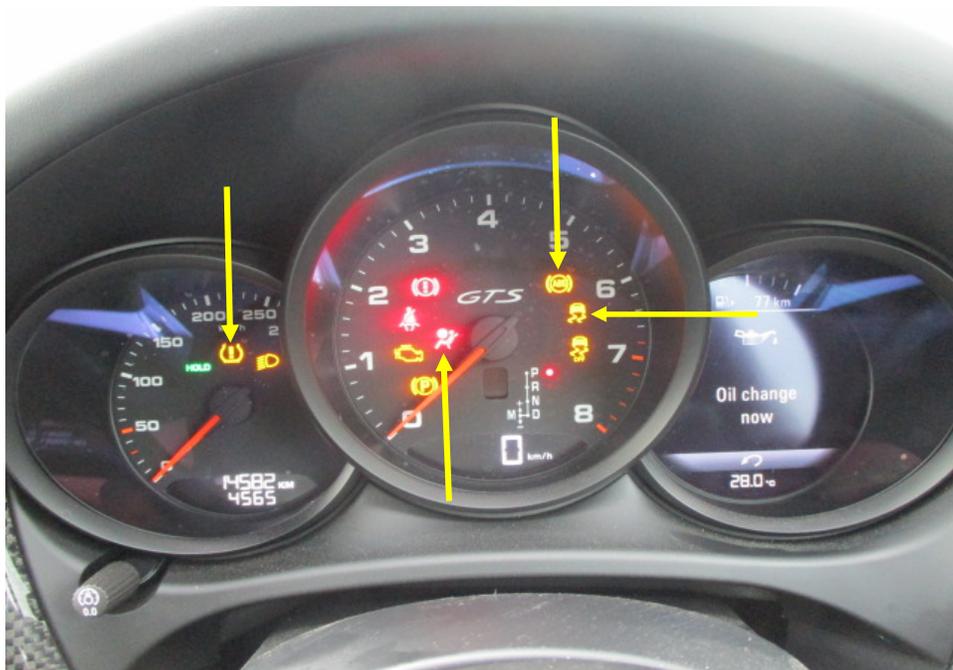
Photo 19 shows the warning lights for the various electronic safety features appearing on the instrument panel of the Motor Car during its self-test when the engine is cranked, in particular the ABS, SRS, TPM and TCS lights (arrowed).

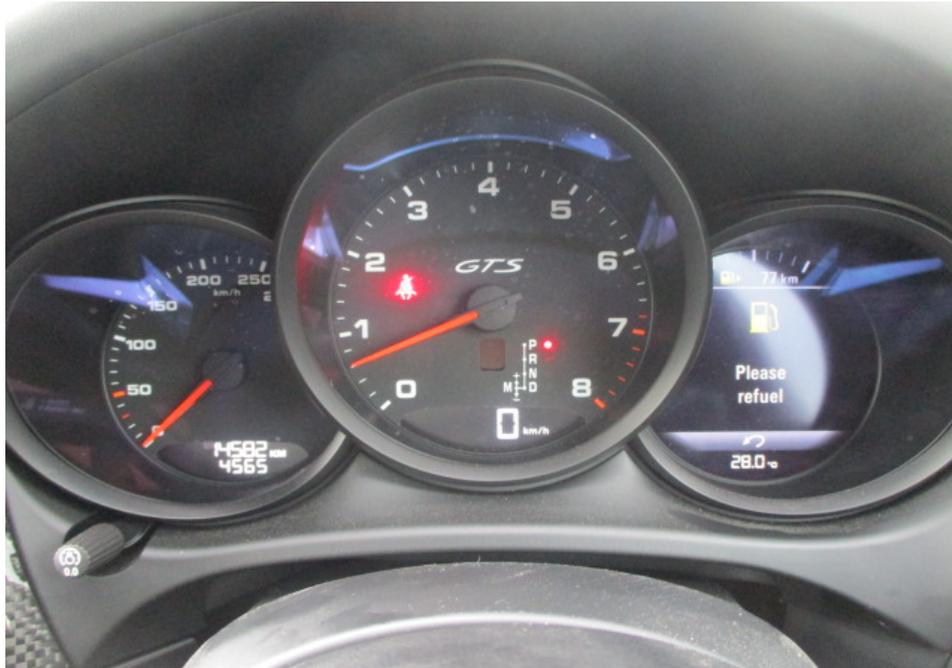
Photo 20 shows the respective warning lights no longer illuminated, indicating that there is no fault detected to the ABS, SRS, TPM and TCS systems of the Motor Car during the self-test. These electronic systems were hence in working condition at the time of my inspection.

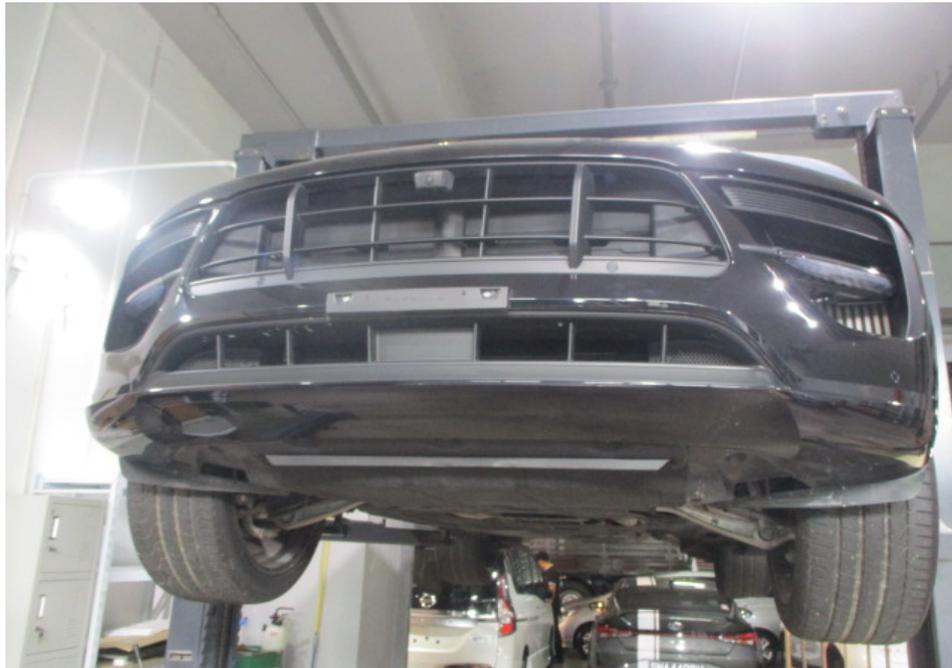
Photo 21 shows the Motor Car hoisted up for checks on its undercarriage. There was no sign(s) or indication(s) of fluid leakage and/or fluid stain(s) on the underside of the Motor Car. The undercarriage components of the Motor Car were also all observed to be intact and secured in an appropriate manner.

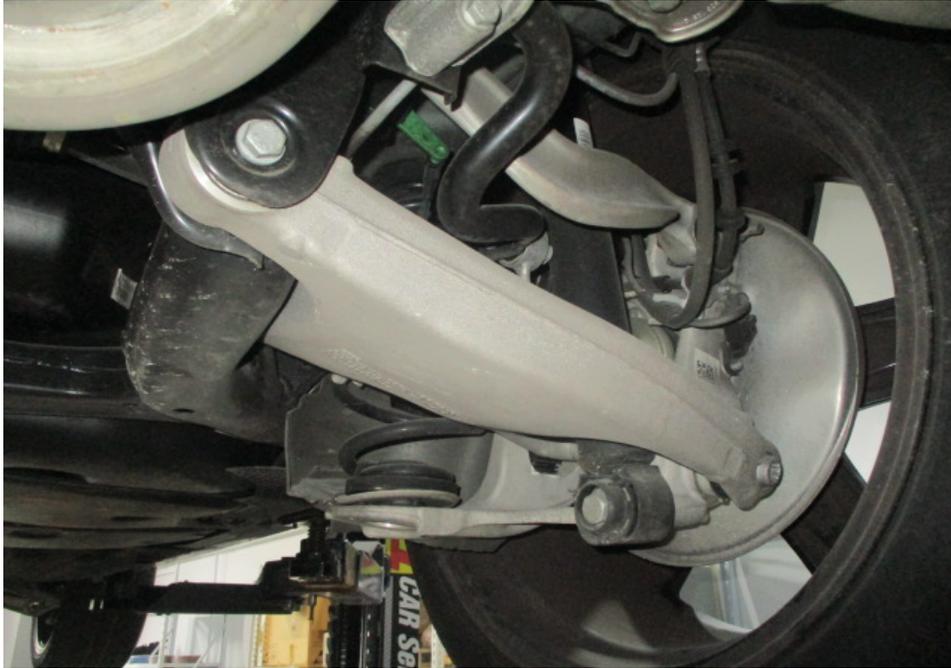
Photo 22 shows a general view of the control arms and linkages at the rear right wheel of the Motor Car. I did not observe any fluid leak and/or fluid stain on the underside of the Motor Car. All of the Motor Car's undercarriage components were observed to be intact and secured in an appropriate manner.

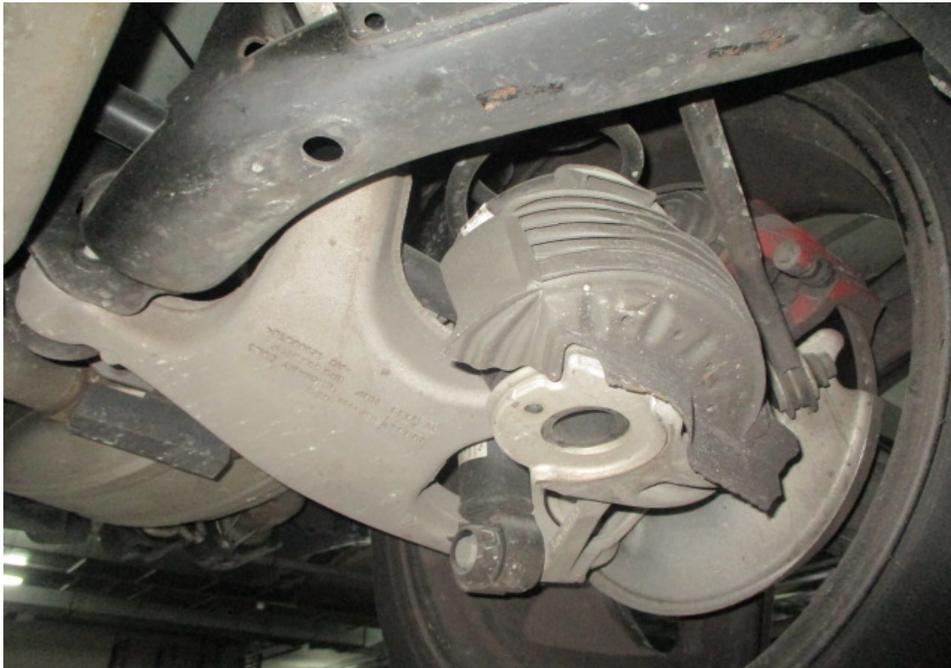
Photo 23 shows a general view of the control arms and linkages at the rear left wheel of the Motor Car. I did not observe any fluid leak and/or fluid stain on the underside of the Motor Car. All of the Motor Car's undercarriage components were observed to be intact and secured in an appropriate manner.

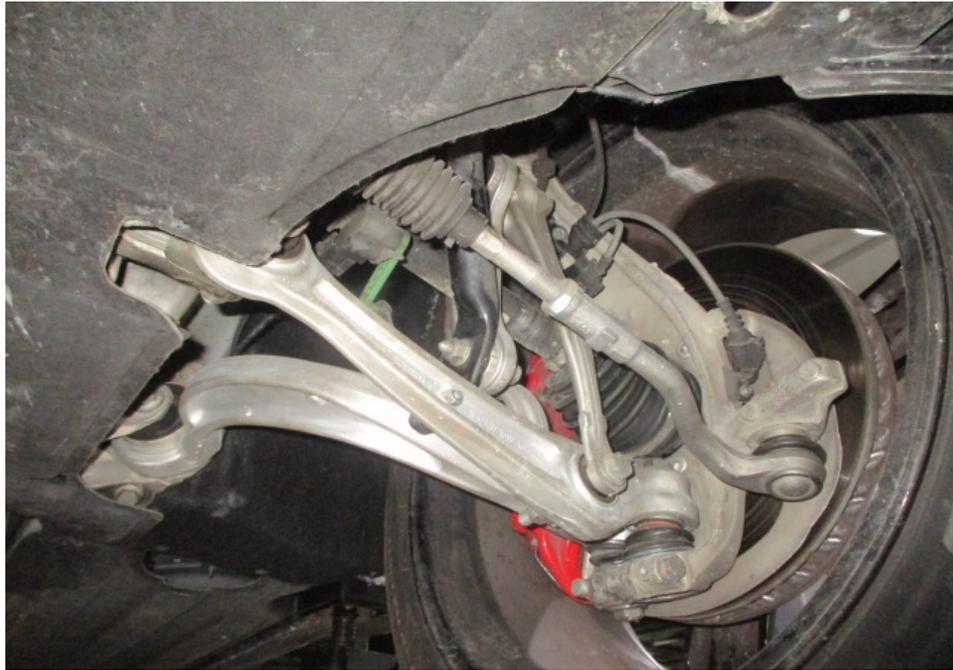
Photo 24 shows the various undercarriage components at the front left wheel of the Motor Car. The mechanical components, control arms and linkages were all found to be intact and secured in an appropriate manner.

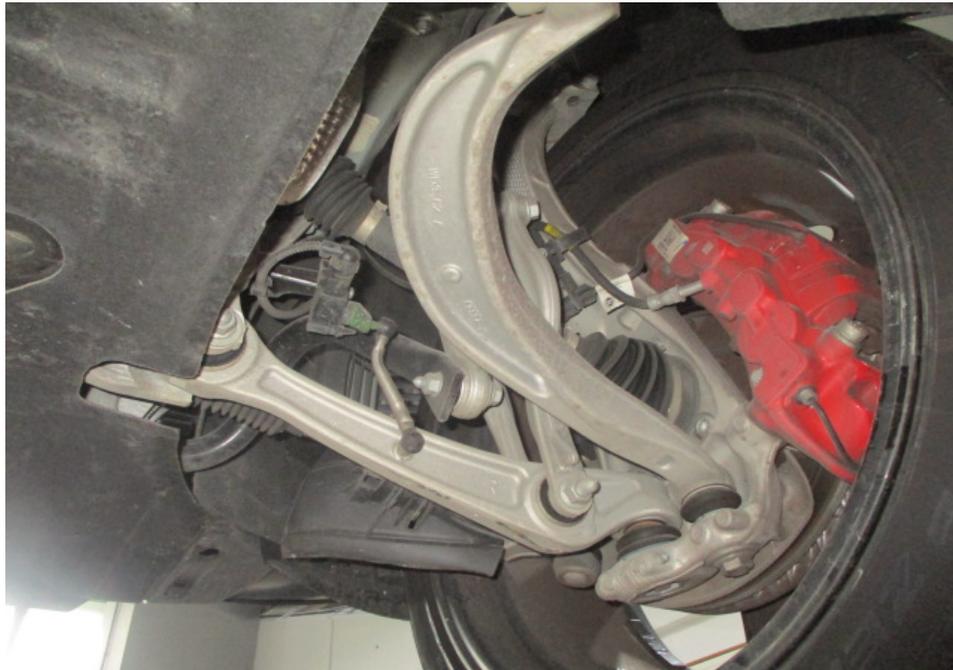
Photo 25 shows the various undercarriage components at the front right wheel of the Motor Car. The mechanical components, control arms and linkages were all found to be intact and secured in an appropriate manner. I also did not observe any fluid leak and/or fluid stain on the underside of the Motor Car.

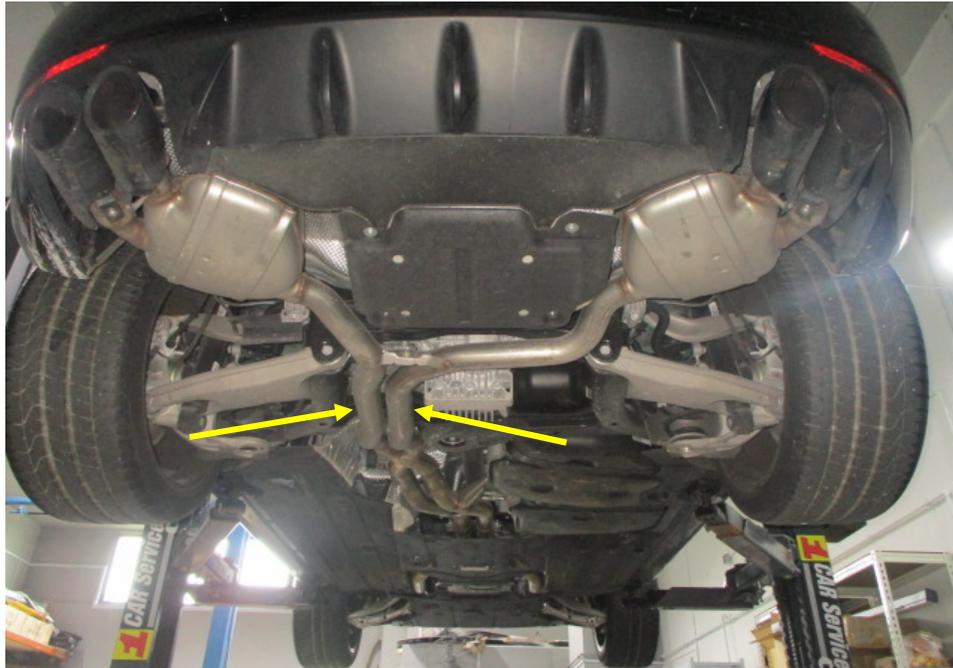
Photo 26 shows the rear section of the Motor Car's exhaust system. My examination of the Motor Car's exhaust system revealed no sign(s) or indication(s) of any cut or weld marks along its exhaust pipes (arrowed), on its rear mufflers and on its catalytic converters.

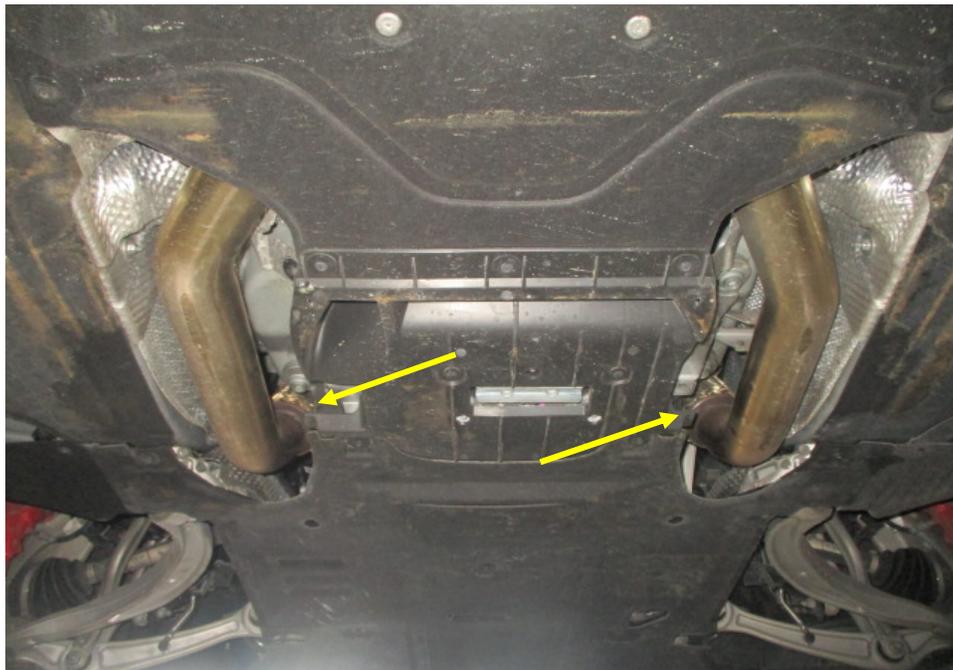
Photo 27 shows the front section of the Motor Car's exhaust system. My examination of the Motor Car's exhaust system revealed no sign(s) or indication(s) of any cut or weld marks along its exhaust pipes, on its rear mufflers, and on its catalytic converters (arrowed).

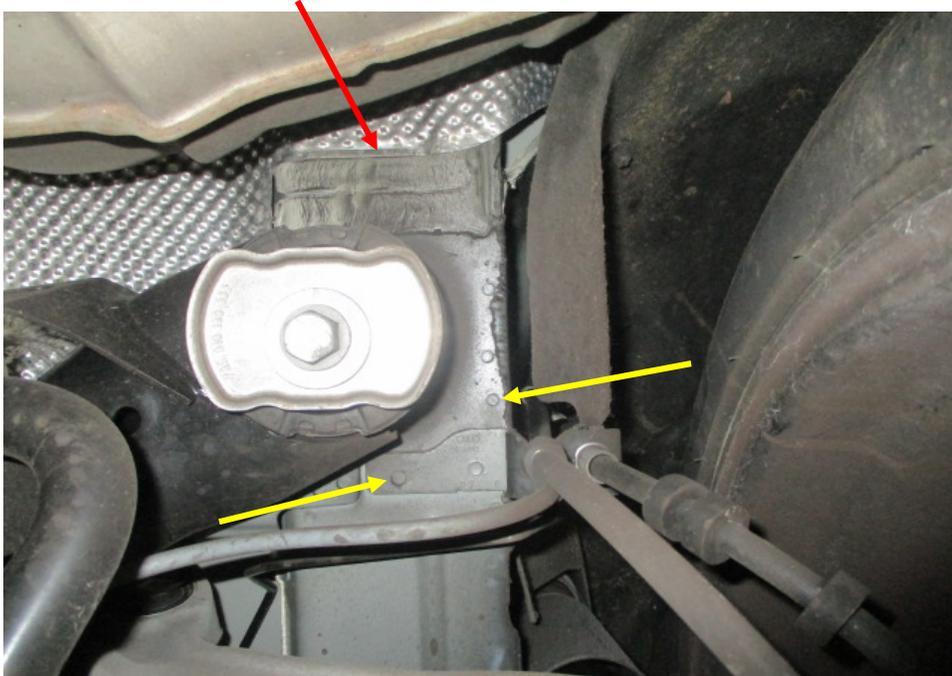
Photo 28 shows the chassis/structural body at the underside rear right of the Motor Car. I did not find any weld marks other than original spot weld marks (yellow arrow) on the chassis/structural body of the Motor Car. The original factory sealant (red arrow) at the joints along the chassis/structural body was untouched, indicating no work was done on the chassis/structural body of the Motor Car and that the chassis/structural body was originally fitted.
