Your Ref: Porsche Macan GTS
(chassis number WP1ZZZ95ZLLB62049)
Our Ref : CI/TP22002878/D

INSPECTION REPORT OF AN UNREGISTERED PORSCHE MACAN GTS MOTOR CAR WITH CHASSIS NUMBER WP1ZZZ95ZLLB62049

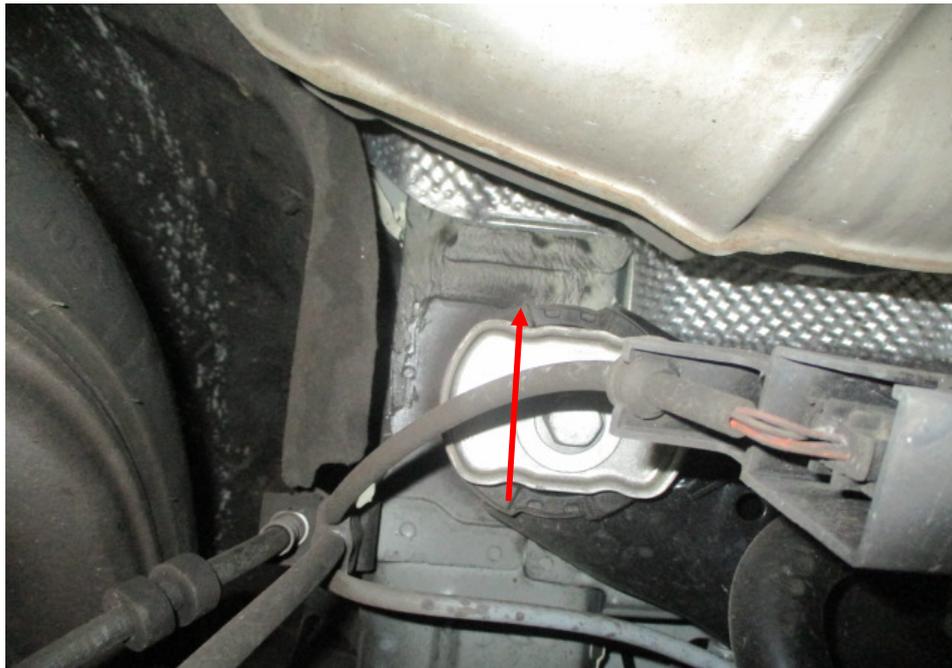
Photo 29 shows the chassis/structural body at the underside rear left of the Motor Car. The original factory sealant (arrowed) at the joints along the chassis/structural body was observed to be untouched. In general, I had found no work was carried out on the chassis/structural body of the Motor Car. The chassis/structural body of the Motor Car was originally fitted.

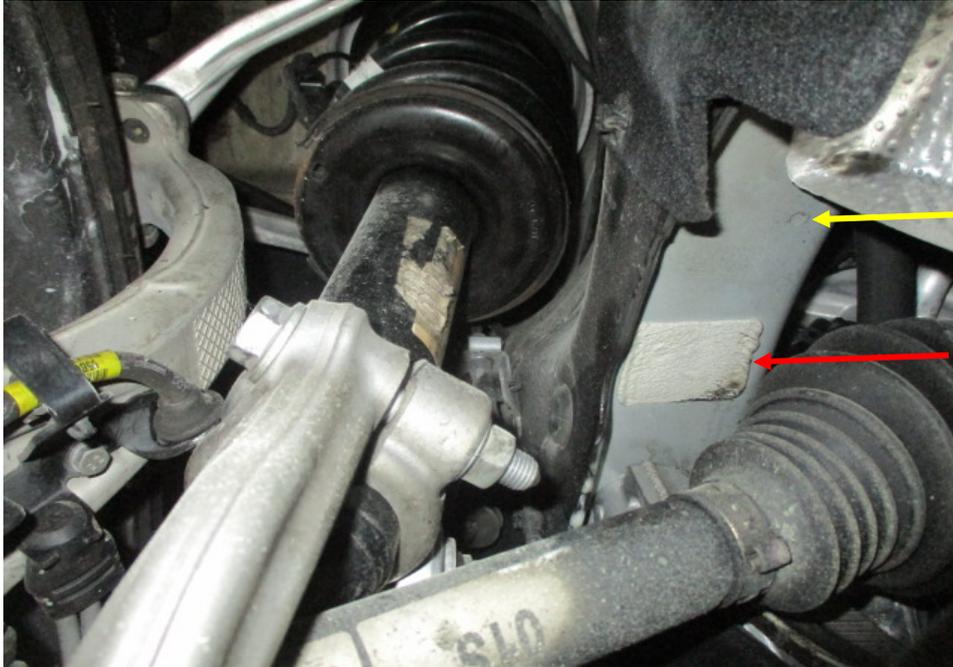
Photo 30 shows the chassis/structural body at the underside front left of the Motor Car. I did not find any weld marks other than original spot weld marks (yellow arrow) on the chassis/structural body of the Motor Car. The original factory sealant (red arrow) at the joints along the chassis/structural body was untouched, indicating no work was done on the chassis/structural body of the Motor Car and that the chassis/structural body was originally fitted.

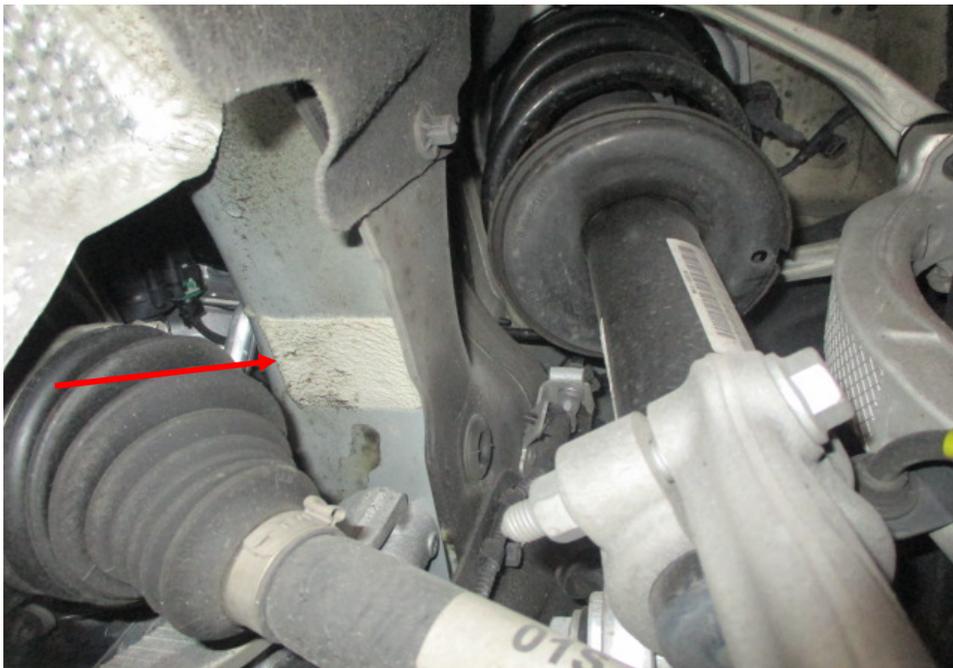
Photo 31 shows the chassis/structural body at the underside front right of the Motor Car. The original factory sealant (arrowed) at the joints along the chassis/structural body was observed to be untouched. In general, I had found no work was carried out on the chassis/structural body of the Motor Car. The chassis/structural body of the Motor Car was originally fitted.

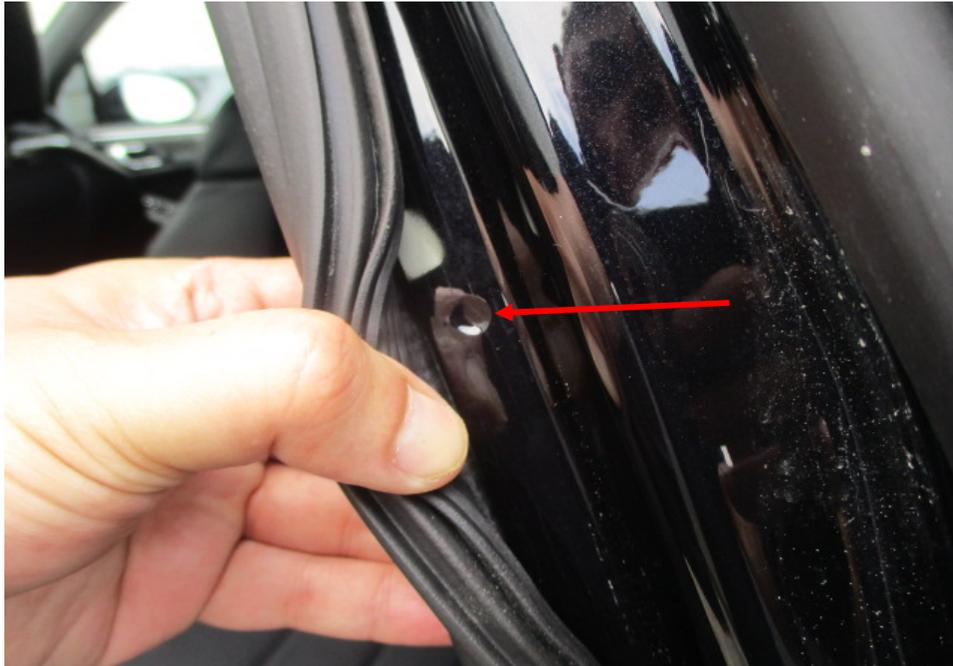
Photo 32 shows the left side “C” pillar of the Motor Car. I did not find any weld marks other than original spot weld marks (arrowed) on the left side “C” pillar of the Motor Car which, indicates that there was no re-welding works carried out. In general, I had found all the non-detachable body panels of the Motor Car to be originally fitted at the time of my inspection.

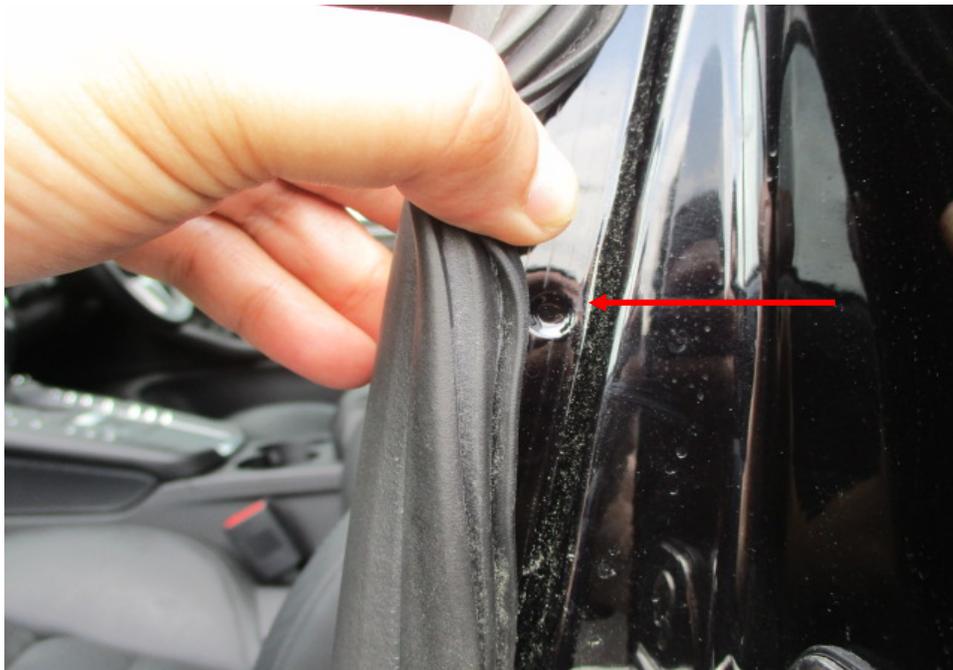
Photo 33 shows the left side “B” pillar of the Motor Car. I did not find any weld marks other than original spot weld marks (arrowed) on the left side “B” pillar of the Motor Car which, indicates that there was no re-welding works carried out. In general, I had found all the non-detachable body panels of the Motor Car to be originally fitted at the time of my inspection.

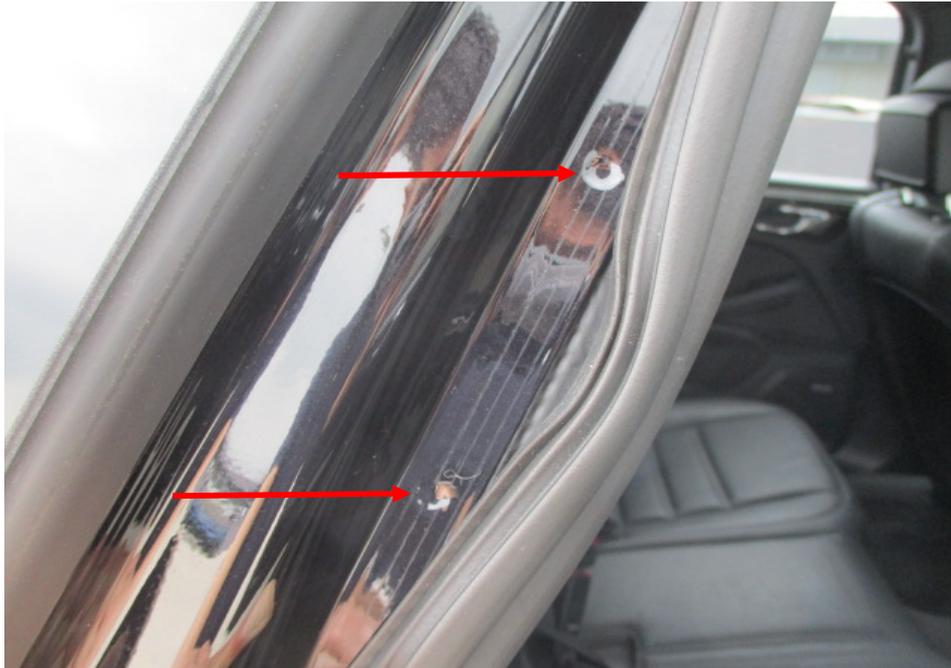
Photo 34 shows the right side “C” pillar of the Motor Car. I did not find any weld marks other than original spot weld marks (arrowed) on the right side “C” pillar of the Motor Car which, indicates that there was no re-welding works carried out. In general, I had found all the non-detachable body panels of the Motor Car to be originally fitted at the time of my inspection.
