Your Ref: Porsche Panamera
(chassis number WP0ZZZ97ZML115109)
Our Ref : CI/TP22002880/D

28 March 2022

**INSPECTION REPORT OF AN UNREGISTERED PORSCHE PANAMERA
MOTOR CAR WITH CHASSIS NUMBER WP0ZZZ97ZML115109**

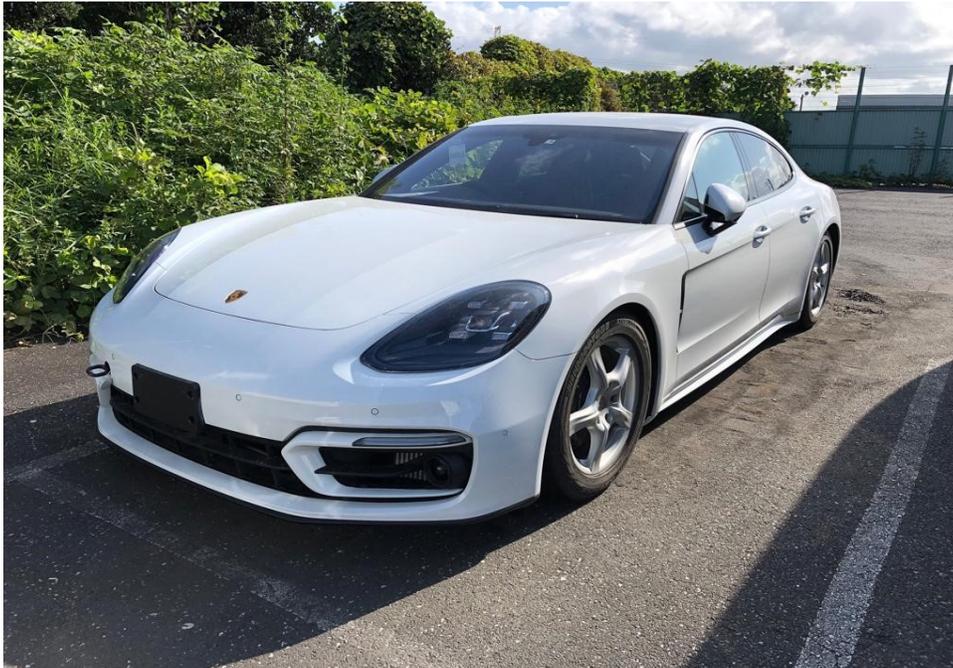
Photo 1 shows the front left body of the Motor Car (photograph provided to me). There was no physical damage seen to the Motor Car from the photographs that were provided to me. The airbag(s) was also not deployed.

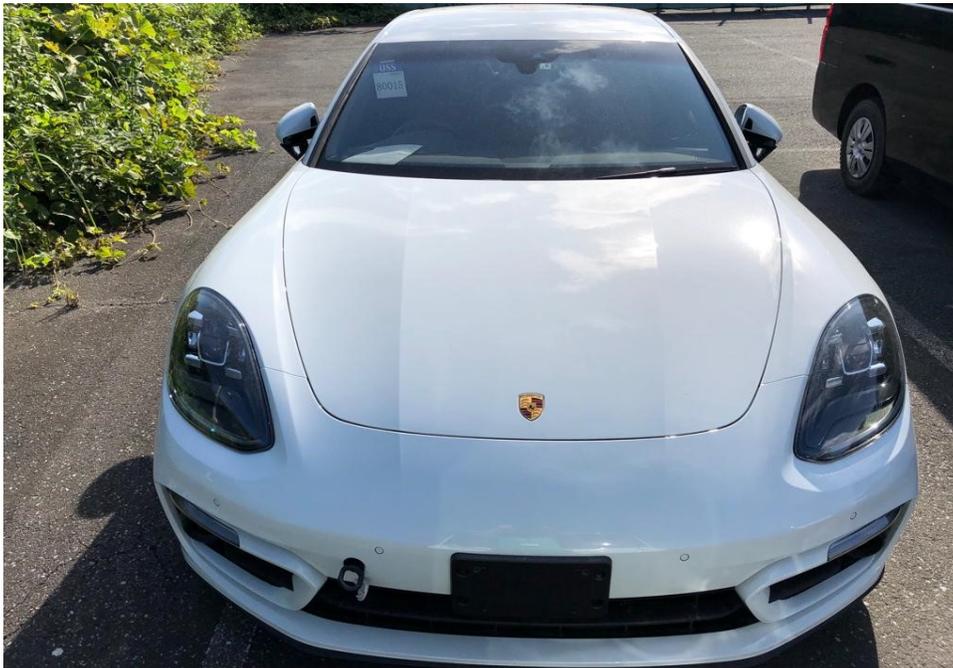
Photo 2 shows the frontal body of the Motor Car (photograph provided to me). There was no physical damage seen to the Motor Car from the photographs that were provided to me. The airbag(s) was also not deployed.

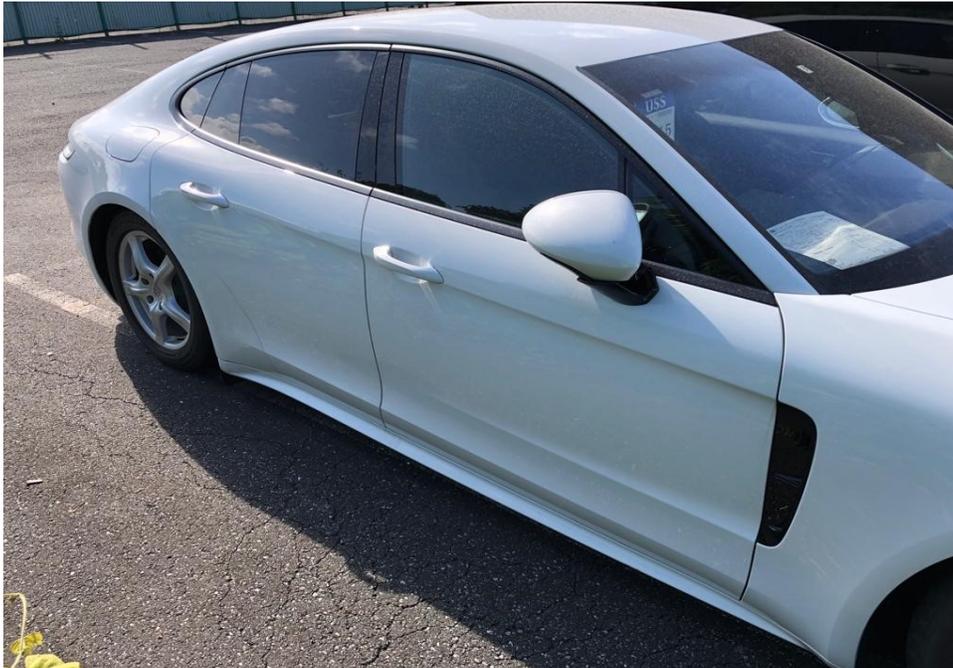
Photo 3 shows the right side body of the Motor Car (photograph provided to me). There was no physical damage seen to the Motor Car from the photographs that were provided to me. The airbag(s) was also not deployed.

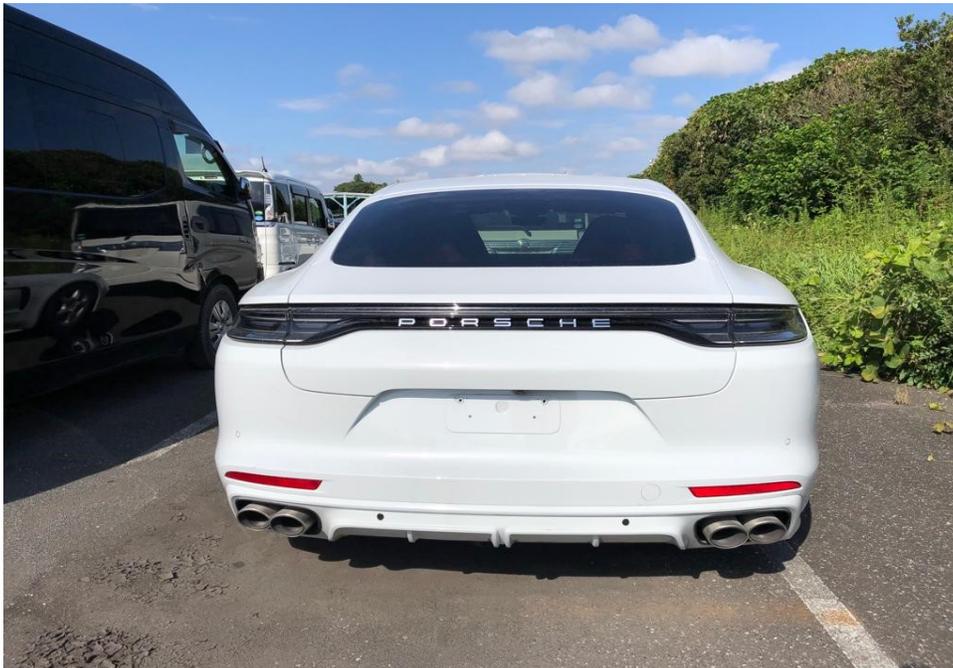
Photo 4 shows the rear body of the Motor Car (photograph provided to me). There was no physical damage seen to the Motor Car from the photographs that were provided to me.

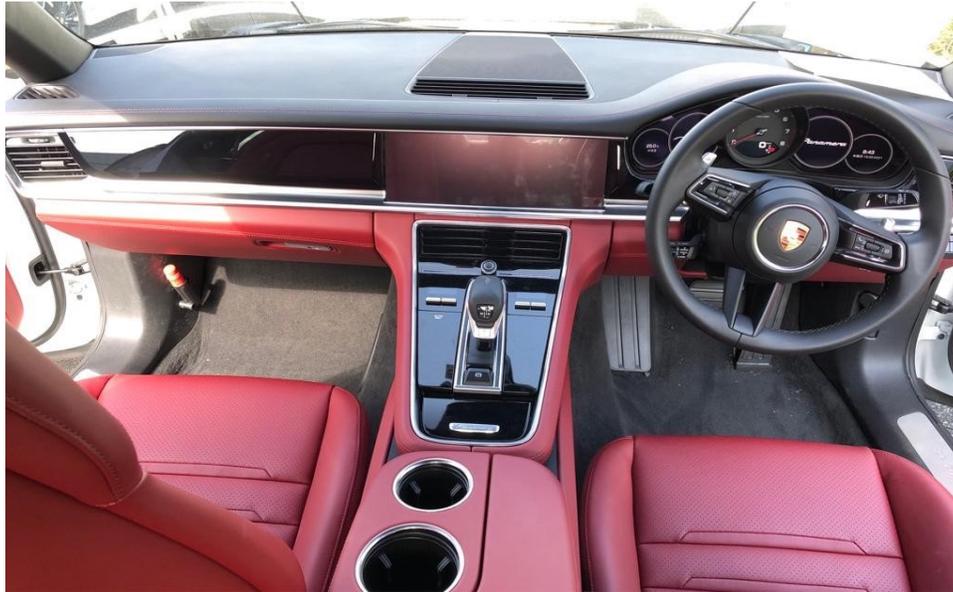
Photo 5 shows the interior compartment of the Motor Car (photograph provided to me). The various parts and components within the interior compartment were all intact and unaffected. The airbag(s) was not deployed as seen from the photographs that were provided to me.

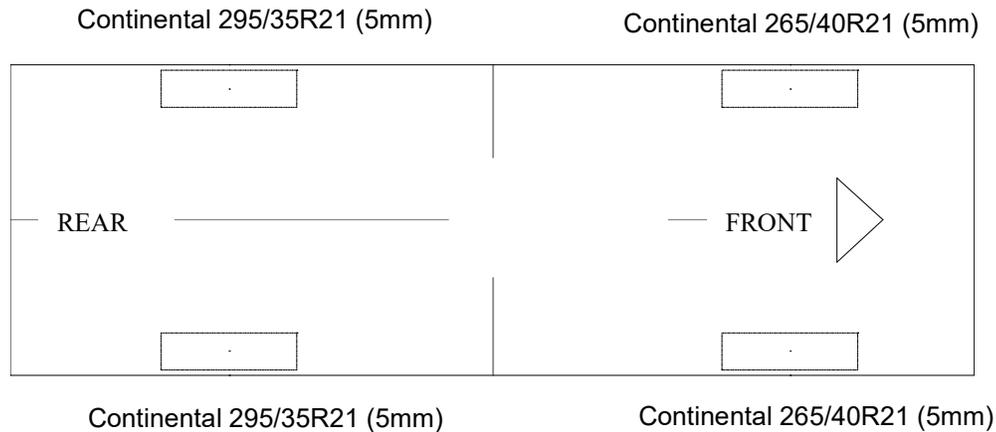
7. It was fitted with 21inch sport wheel rims that were wrapped with tyres that were observed to be of serviceable condition. The tyres were also sufficiently inflated for vehicular operation. The tyre brand, tyre size and approximate remaining tread depth of the 4 tyres of the Motor Car were recorded as follows: -

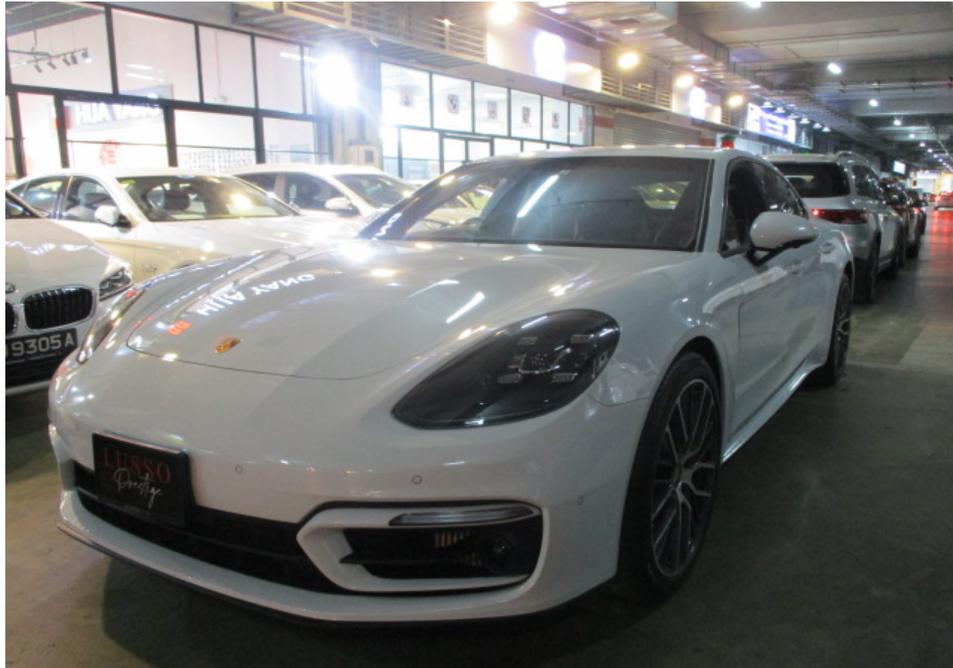
Photo 6 shows a general view of the front left body of the Motor Car at the time of my inspection. The Motor Car was observed to be in a relatively good general condition with no loose exterior fittings observed. The mileage of the Motor Car recorded at the time of my inspection was 1,991km.

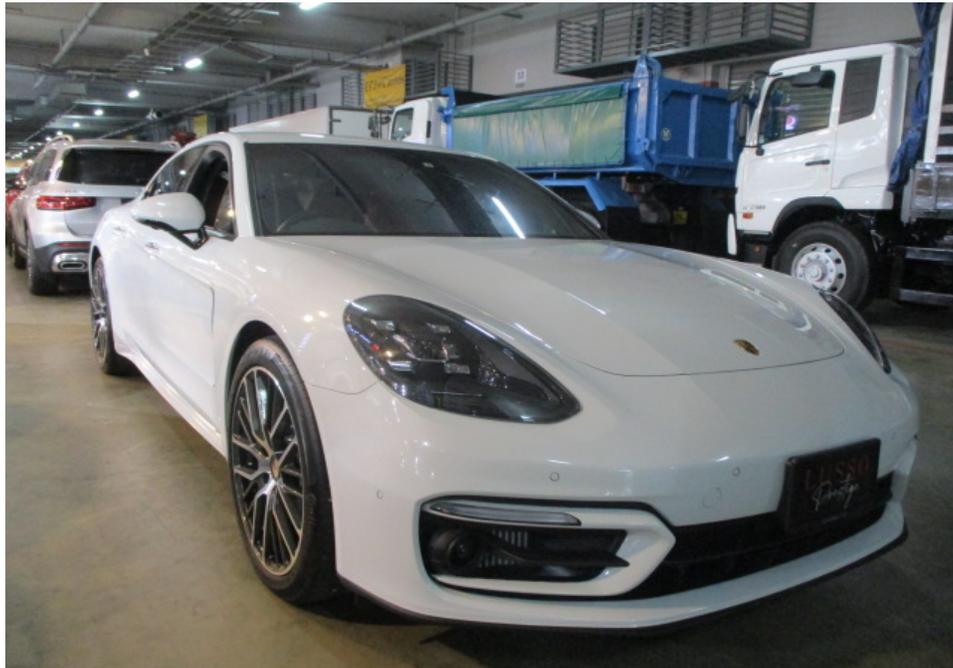
Photo 7 shows a general view of the front right body of the Motor Car at the time of my inspection. The Motor Car was observed to be in a relatively good general condition with no loose exterior fittings observed. The mileage of the Motor Car recorded at the time of my inspection was 1,991km.

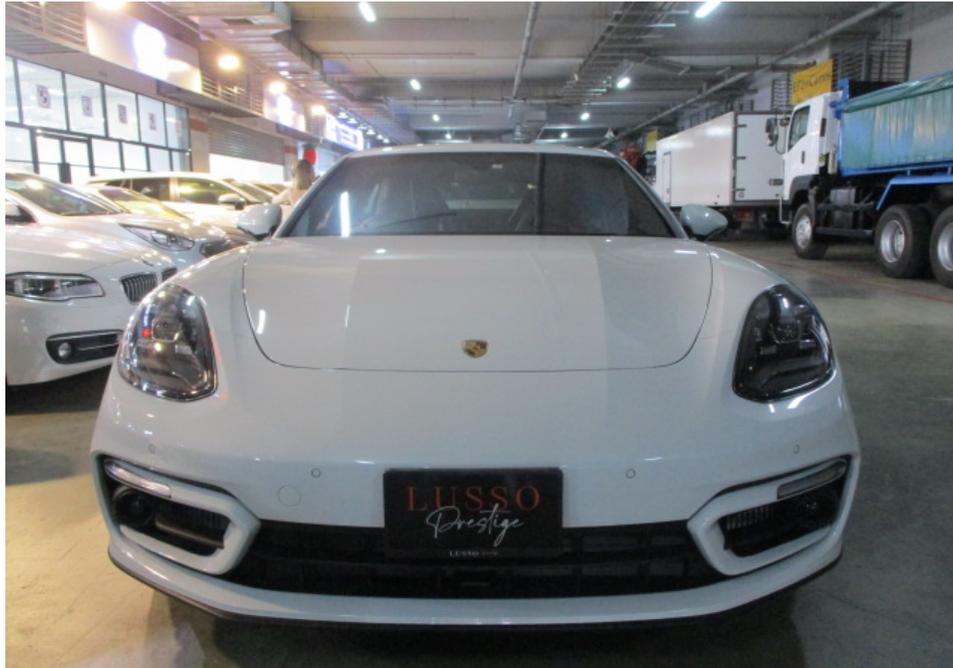
Photo 8 shows a general view of the frontal body of the Motor Car at the time of my inspection. The Motor Car was observed to be in a relatively good general condition with no loose exterior fittings observed. The mileage of the Motor Car recorded at the time of my inspection was 1,991km.

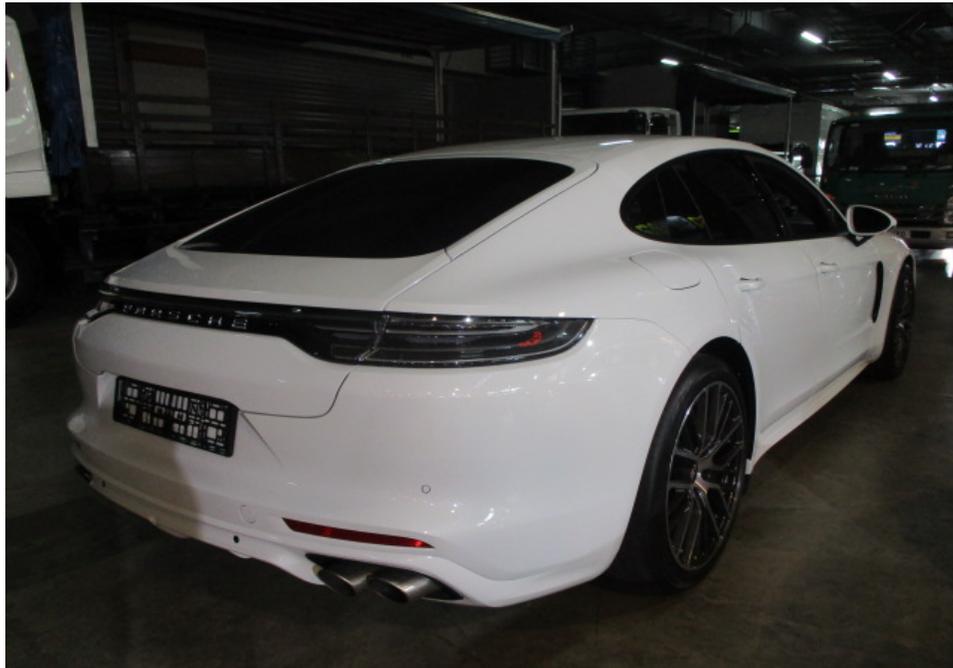
Photo 9 shows a general view of the rear right body of the Motor Car at the time of my inspection. The Motor Car was observed to be in a relatively good general condition with no loose exterior fittings observed. The mileage of the Motor Car recorded at the time of my inspection was 1,991km.

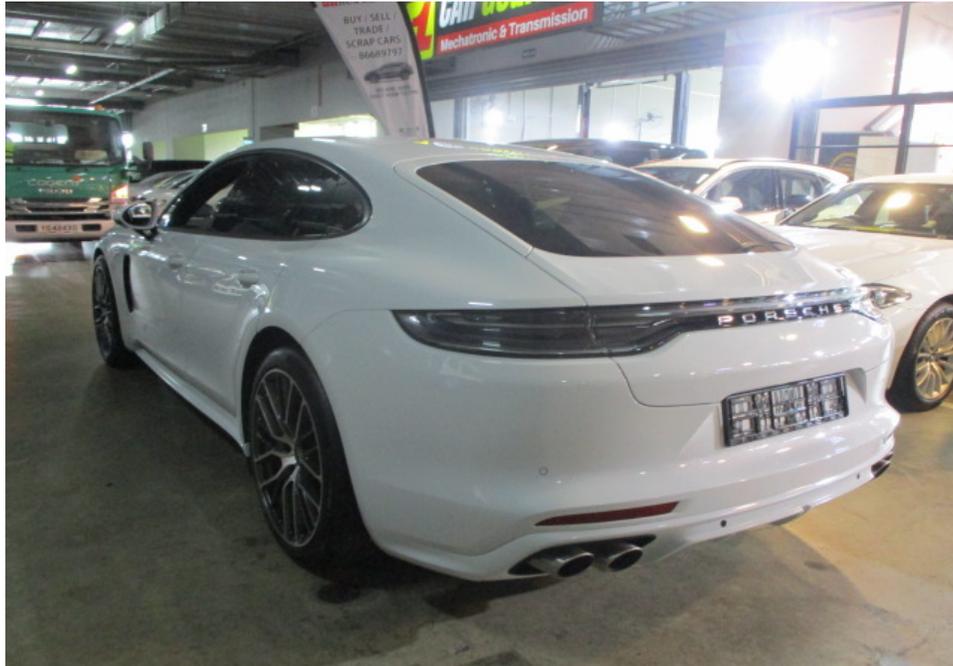
Photo 10 shows a general view of the rear left body of the Motor Car at the time of my inspection. The Motor Car was observed to be in a relatively good general condition with no loose exterior fittings observed. The mileage of the Motor Car recorded at the time of my inspection was 1,991km.

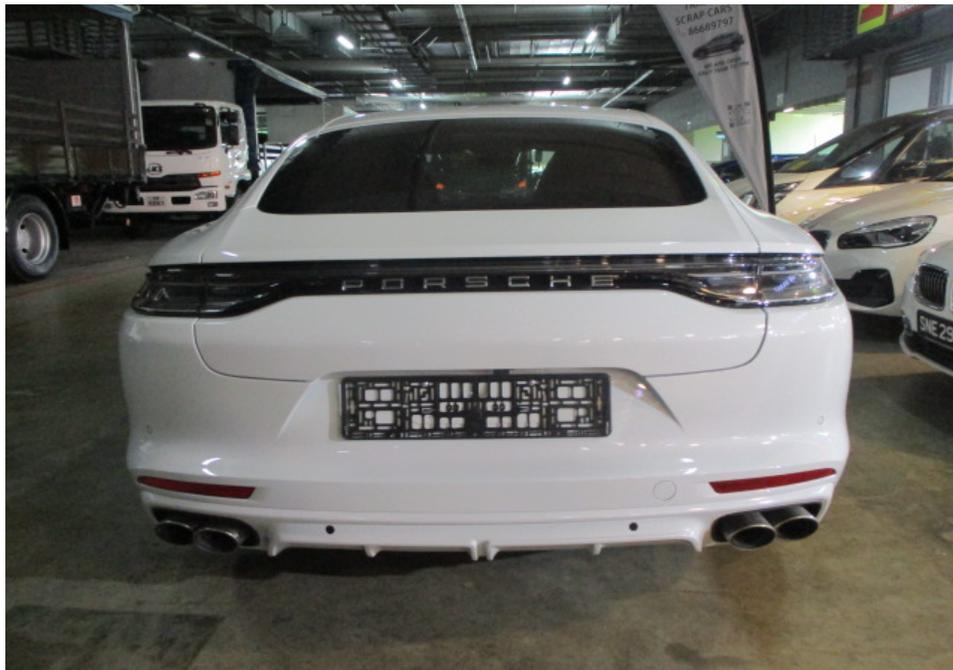
Photo 11 shows a general view of the rear body of the Motor Car at the time of my inspection. The Motor Car was observed to be in a relatively good general condition with no loose exterior fittings observed. The mileage of the Motor Car recorded at the time of my inspection was 1,991km.

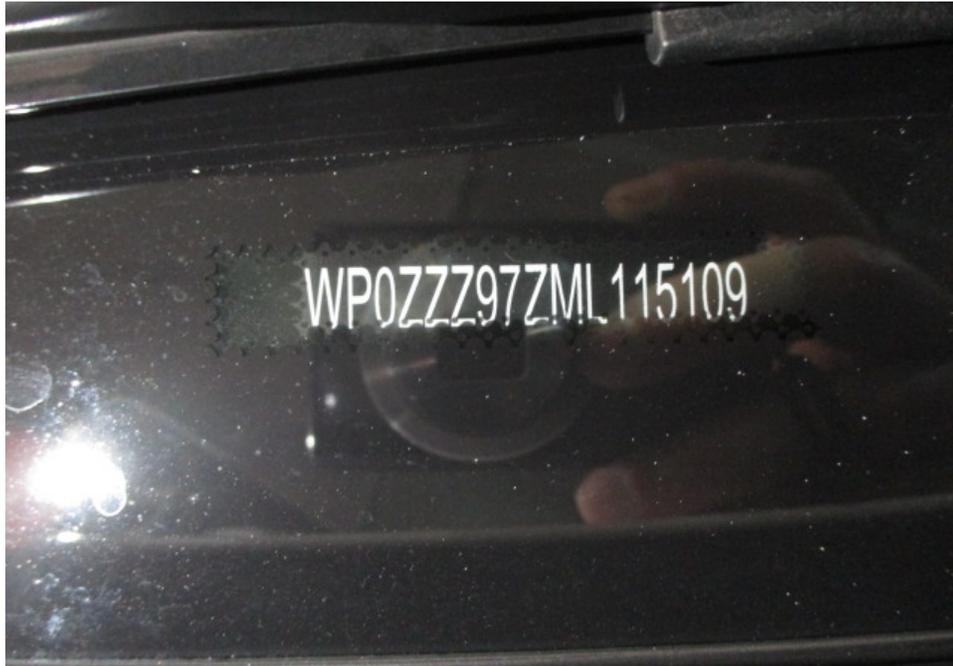
Photo 12 shows the chassis number of the Motor Car. The chassis number recorded was WP0ZZZ97ZML115109.

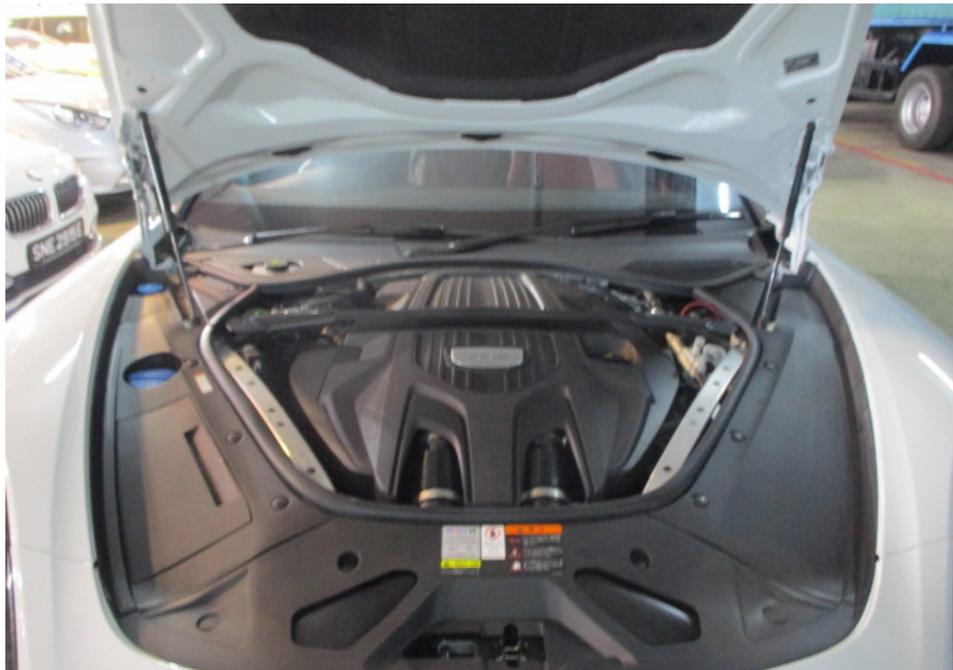
13. My examination of the engine compartment of the Motor Car revealed that the various parts and components inside the engine compartment were all intact and properly fitted. The engine oil, brake fluid and engine coolant were all found to be of sufficient level for operating purposes. Visually, there was also no contamination found to these fluids.

Photo 13 shows a general view of the engine compartment of the Motor Car at the time of my inspection. The various parts and components inside the engine compartment were all observed to be intact and properly fitted. There was also no sign(s) or indication(s) of fluid leak and/or fluid stain found inside the engine compartment.

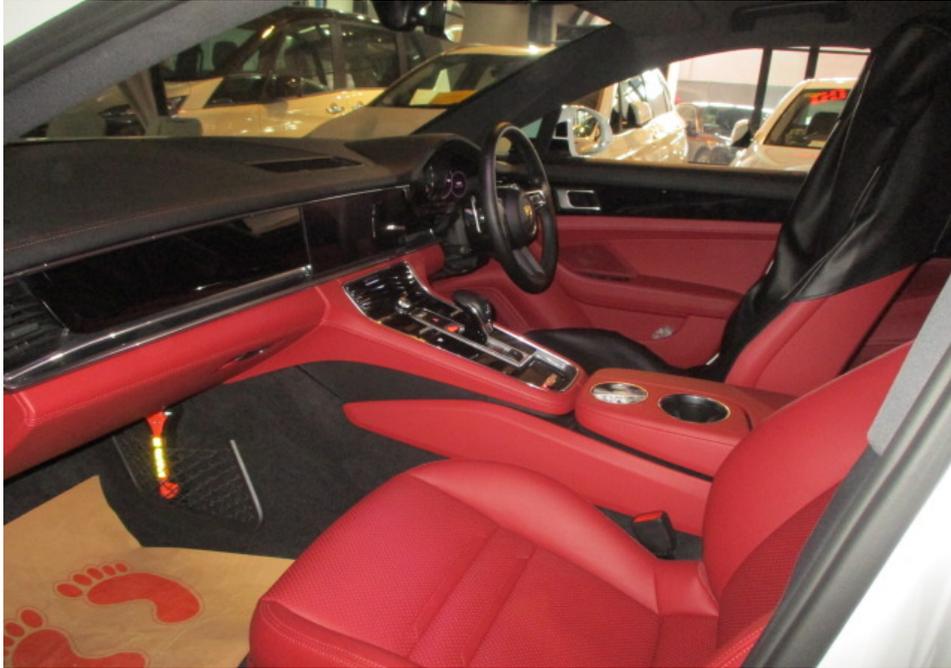
Photo 14 shows the interior compartment of the Motor Car at the time of my inspection. The various parts and components, trims, carpet, and upholstery inside the interior compartment were all observed to be intact and properly fitted.

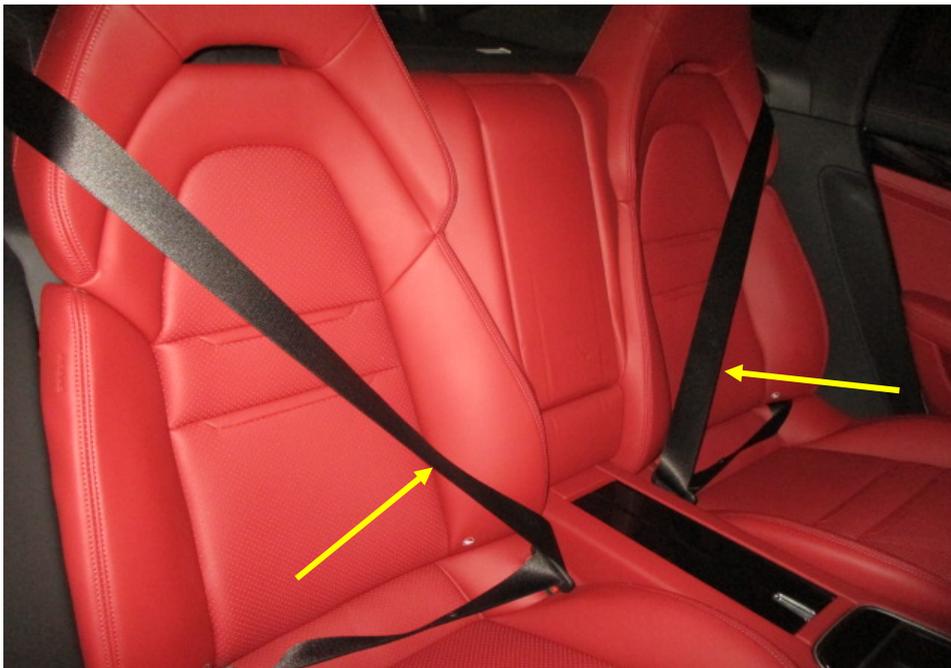
11. The seats of the Motor Car were found to be secured to the floorboard of the Motor Car via seat rails bolted onto the floorboard. Retractable seat belt reels and pre-tensioners were fitted on all seats of the Motor Car. The seat belts were tested and were able to be fastened securely into the respective pre-tensioners that were fixed to the side of all the seats.

Photo 15 shows the rear seats of the Motor Car. All the seats of the Motor Car were secured via seat rails to the floorboard. They were also fitted with a retractable seat belt reel and a pre-tensioner. The seat belts (arrowed) were tested and were able to be fastened into the respective pre-tensions that were fitted on the side of each individual seat.

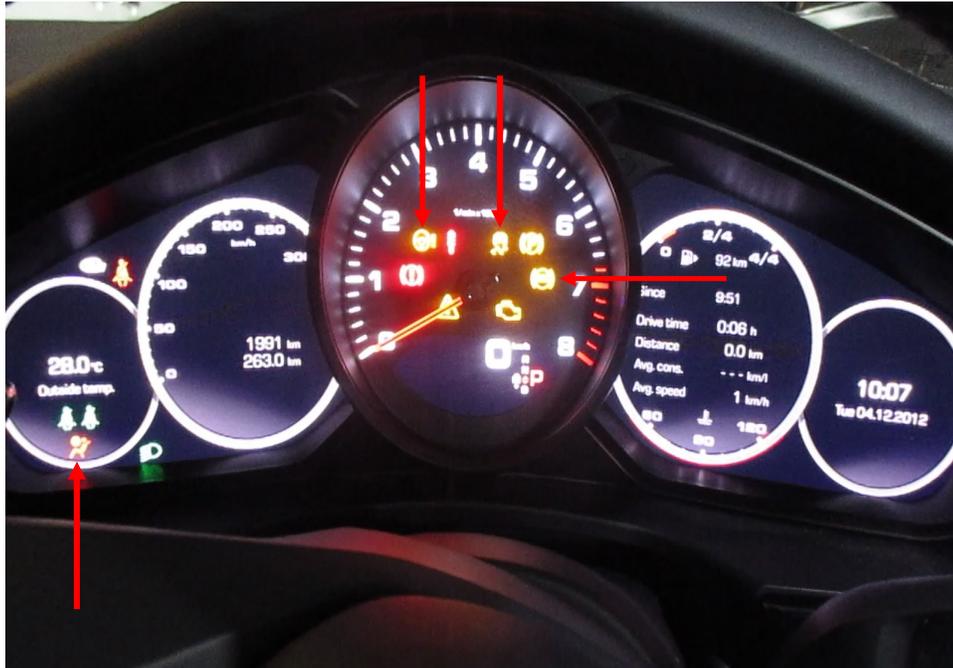
Photo 16 shows the warning lights for the various electronic safety features appearing on the instrument panel of the Motor Car during its self-test when the engine is cranked, in particular the ABS, SRS, EPS and TCS lights (arrowed).

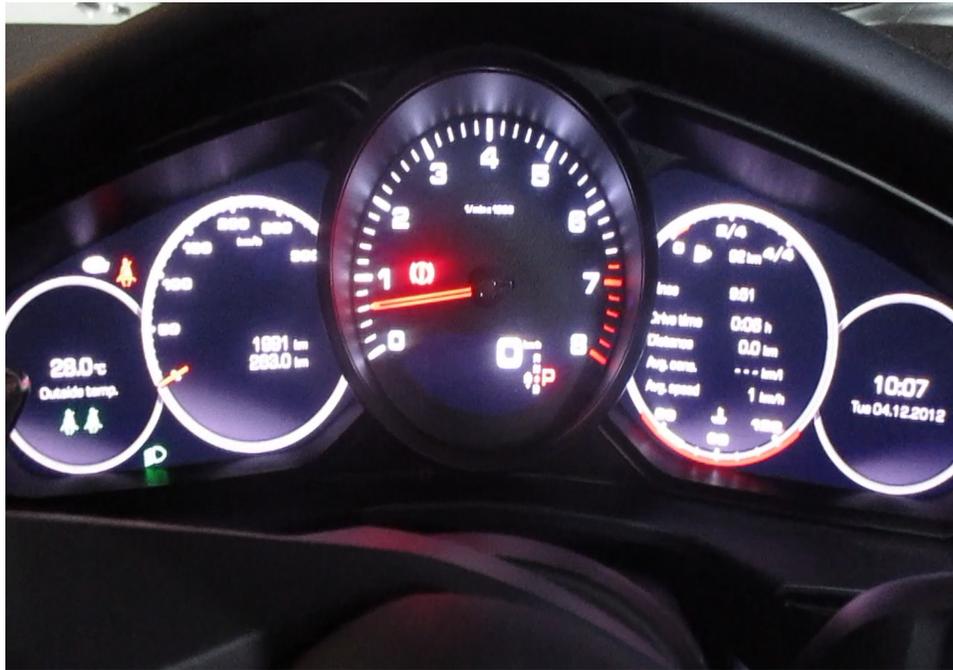
12. The Motor Car's automatic self-test of the functionality of its various electronic safety features like the Anti-Lock Brake System (ABS), Supplemental Restraint System (SRS), Electric Power Steering (EPS) and Traction Control System (TCS) during cranking of the engine had indicated that these electronic systems were in working condition. This was determined from the respective warning lights disappearing from the instrument panel after the self-test.

Photo 17 shows the respective warning lights no longer illuminated, indicating that there is no fault detected to the ABS, SRS, EPS and TCS systems of the Motor Car during the self-test. These electronic systems were hence in working condition at the time of my inspection.

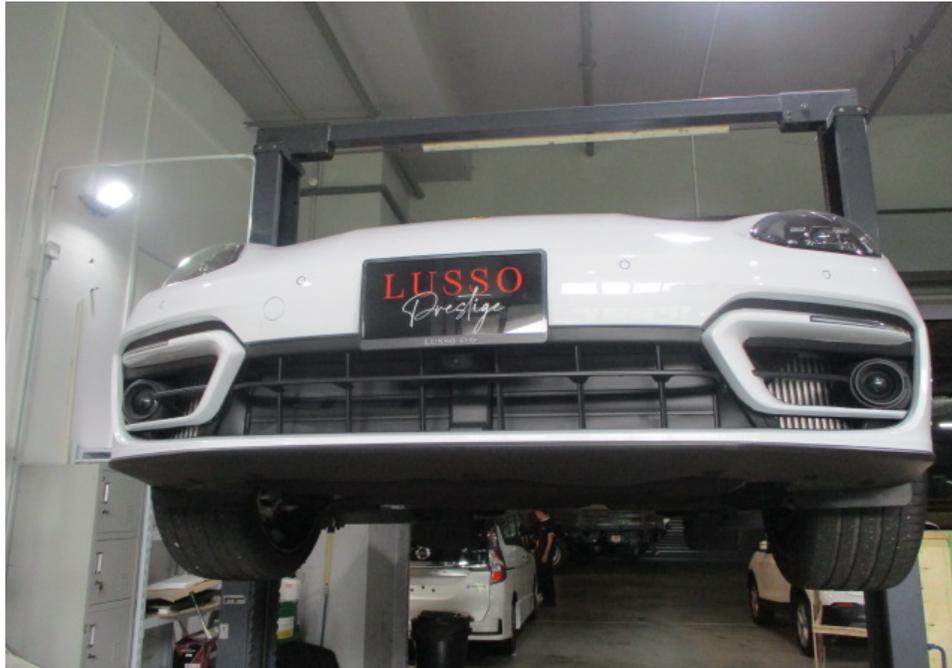
14. My checks on the underside of the Motor Car revealed no sign(s) or indication(s) of fluid leakage and/or fluid stain(s). The engine block and automatic transmission assembly were both secured properly. All undercarriage components of the Motor Car were also observed to be intact and secured in an appropriate manner.

Photo 18 shows the Motor Car hoisted up for checks on its undercarriage. There was no sign(s) or indication(s) of fluid leakage and/or fluid stain(s) on the underside of the Motor Car. The undercarriage components of the Motor Car were also all observed to be intact and secured in an appropriate manner.

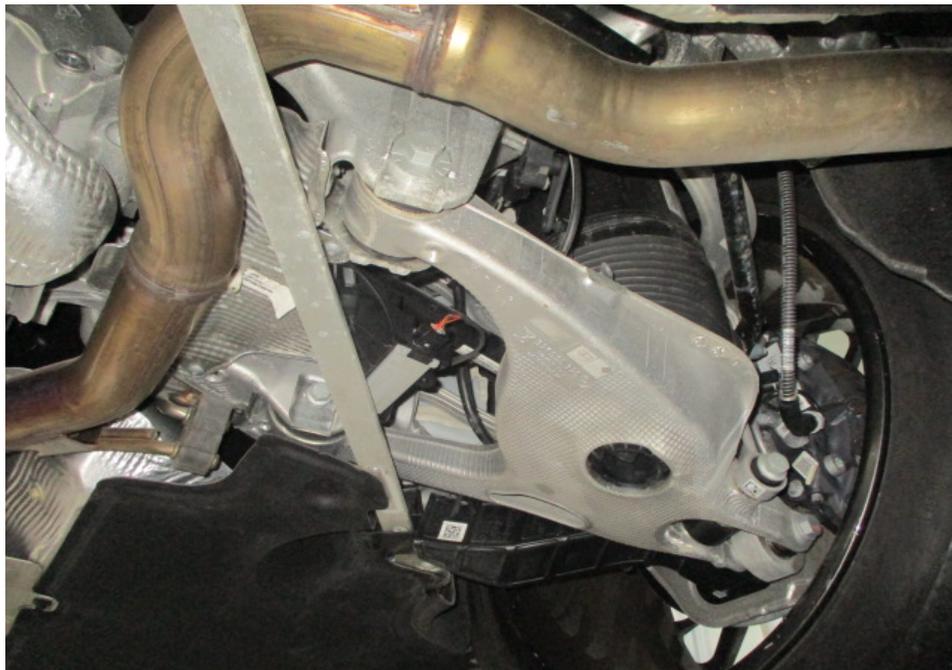
Photo 19 shows a general view of the control arms and linkages at the rear right wheel of the Motor Car. I did not observe any fluid leak and/or fluid stain on the underside of the Motor Car. All of the Motor Car's undercarriage components were observed to be intact and secured in an appropriate manner.

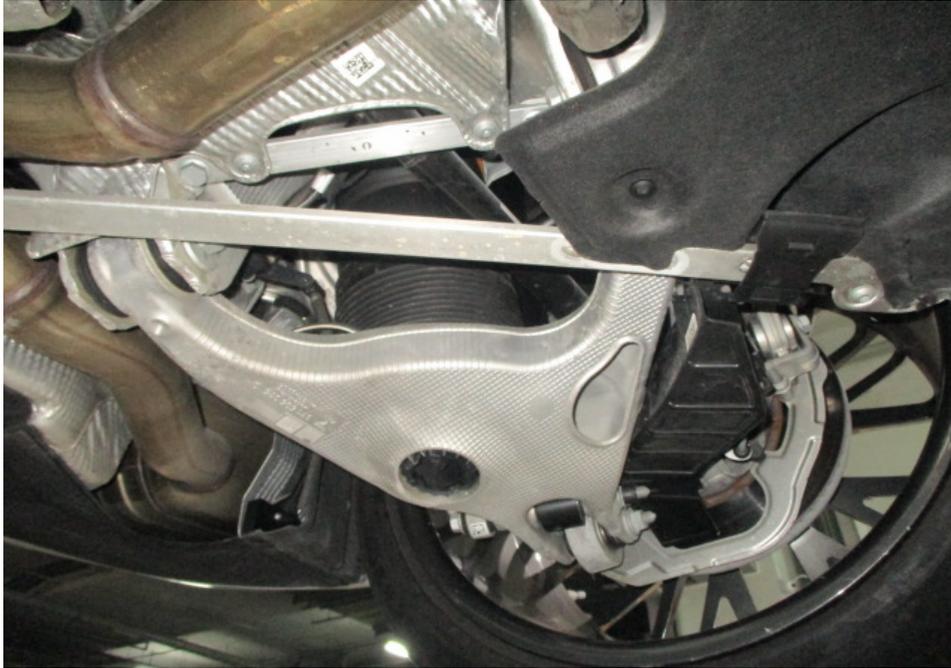
Photo 20 shows a general view of the control arms and linkages at the rear left wheel of the Motor Car. I did not observe any fluid leak and/or fluid stain on the underside of the Motor Car. All of the Motor Car's undercarriage components were observed to be intact and secured in an appropriate manner.

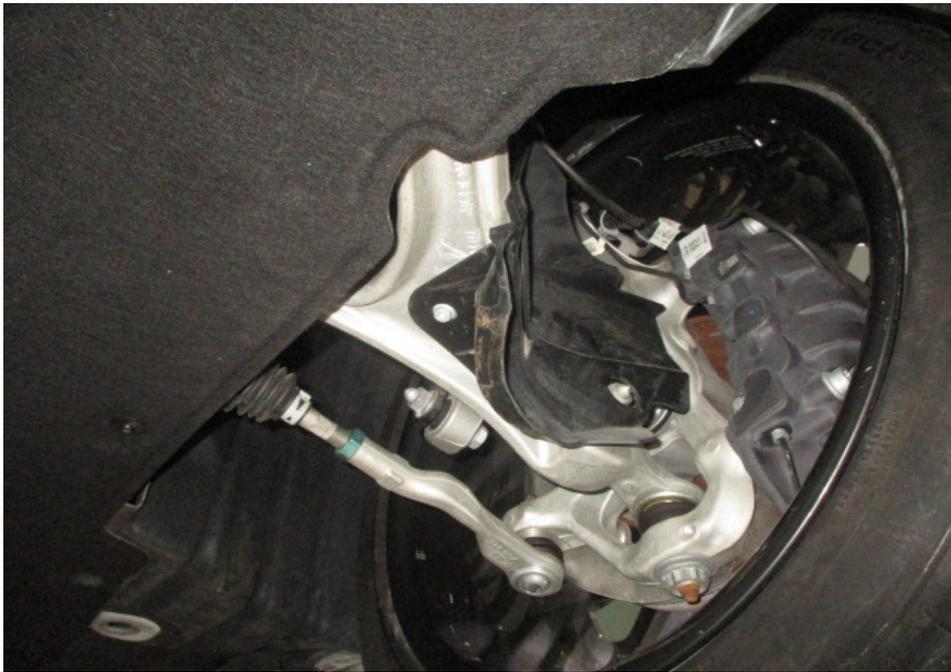
Photo 21 shows the various undercarriage components at the front left wheel of the Motor Car. The mechanical components, control arms and linkages were all found to be intact and secured in an appropriate manner.

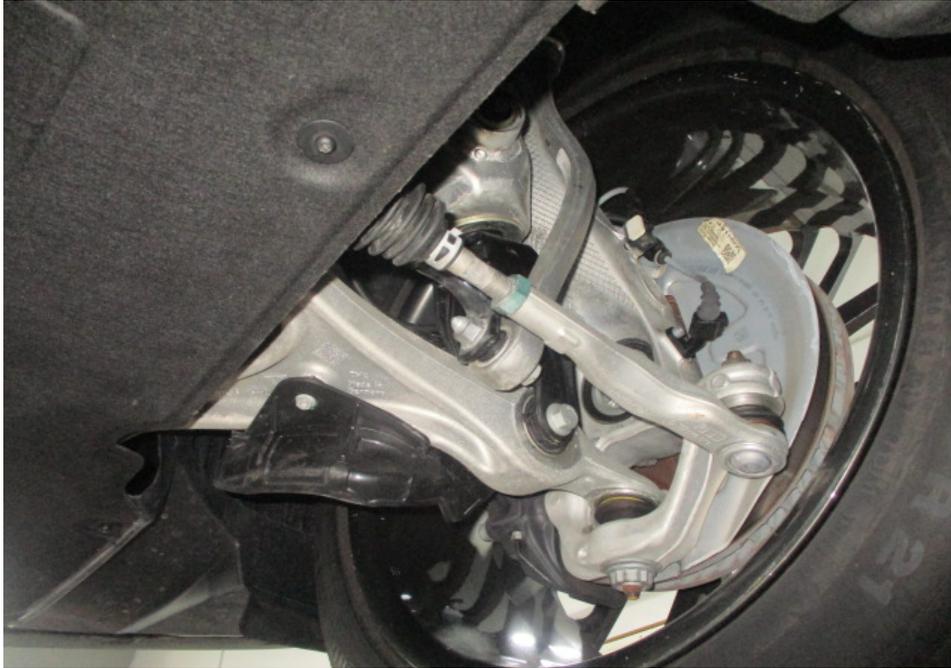
Photo 22 shows the various undercarriage components at the front right wheel of the Motor Car. The mechanical components, control arms and linkages were all found to be intact and secured in an appropriate manner. I also did not observe any fluid leak and/or fluid stain on the underside of the Motor Car.

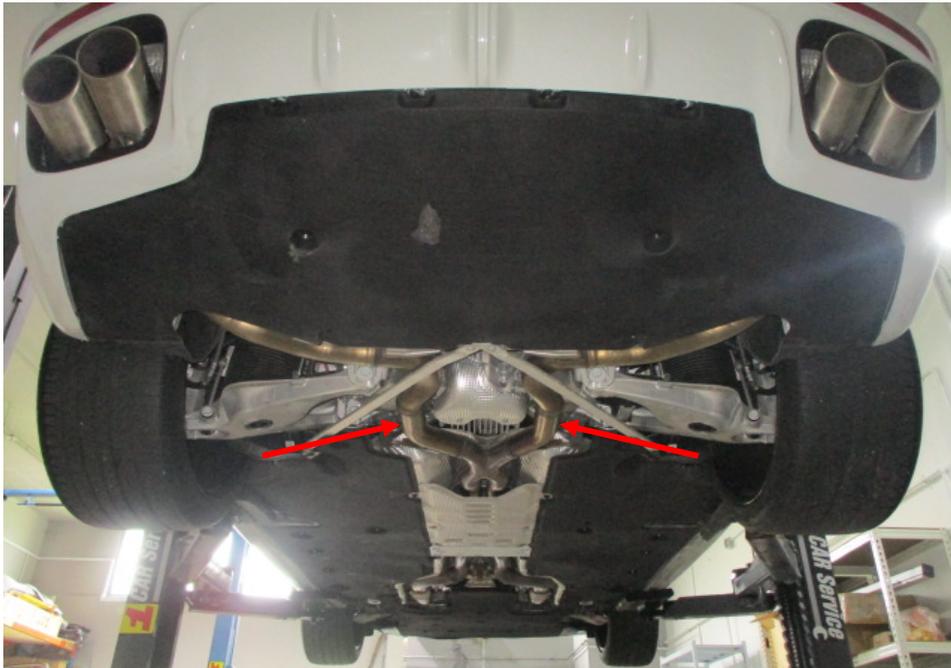
Photo 23 shows the rear section of the Motor Car's exhaust system. My examination of the Motor Car's exhaust system revealed no sign(s) or indication(s) of any cut or weld marks along its exhaust pipes (arrowed), on its rear mufflers and on its catalytic converters.

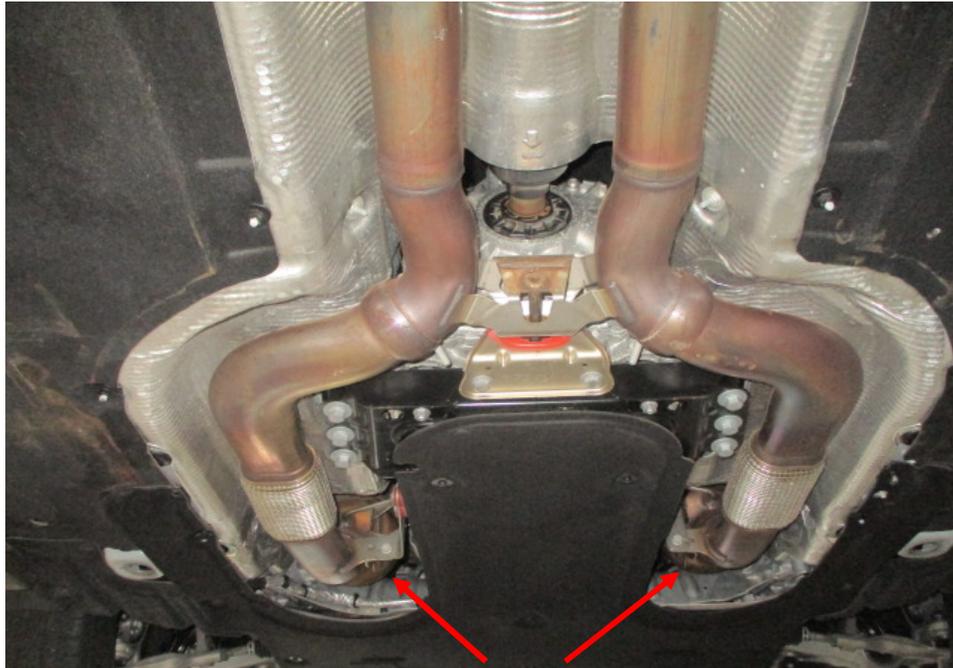
Photo 24 shows the front section of the Motor Car's exhaust system. My examination of the Motor Car's exhaust system revealed no sign(s) or indication(s) of any cut or weld marks along its exhaust pipes, on its rear mufflers and on its catalytic converters (arrowed).

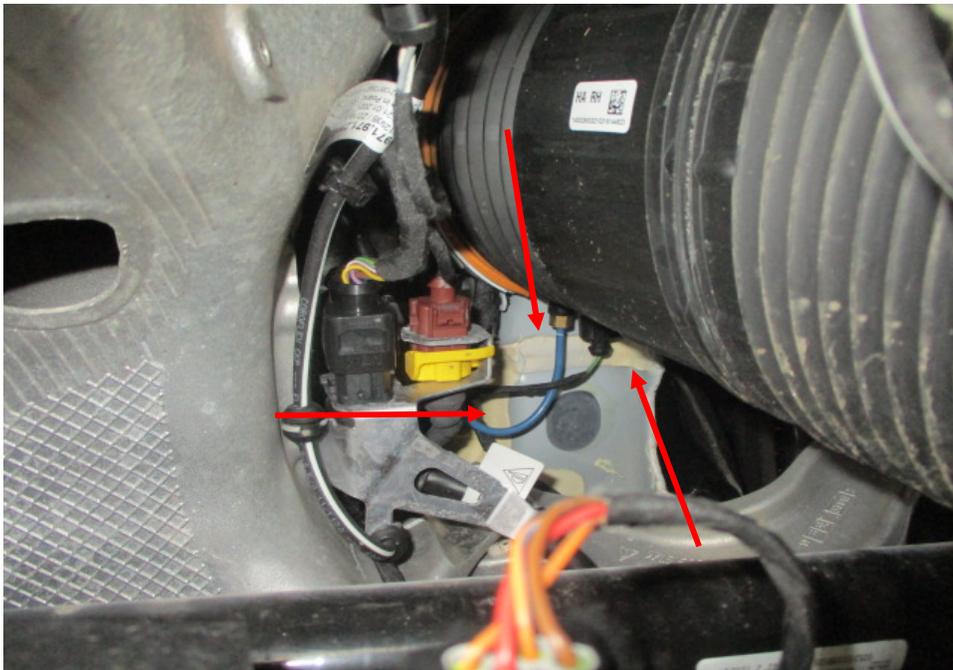
10. Visually, I did not find any weld marks, other than the original spot weld marks, on the chassis/structural body of the Motor Car. The original factory sealant at the joints along the chassis/structural body was also untouched, again indicating that no replacement of the chassis/structural body was carried out; and that the chassis/structural body was originally fitted.

Photo 25 shows the chassis/structural body at the underside rear right of the Motor Car. I did not find any weld marks other than original spot weld marks on the chassis/structural body of the Motor Car. The original factory sealant (arrowed) at the joints along the chassis/structural body was untouched, indicating no work was done on the chassis/structural body of the Motor Car and that the chassis/structural body was originally fitted.

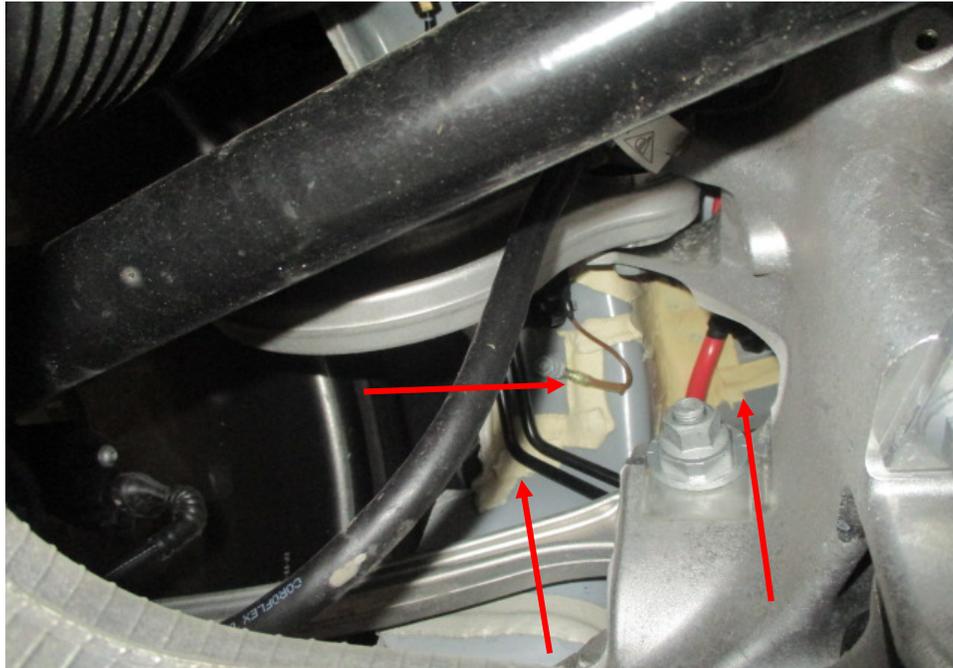
Photo 26 shows the chassis/structural body at the underside rear left of the Motor Car. The original factory sealant (arrowed) at the joints along the chassis/structural body was observed to be untouched. In general, I had found no work was carried out on the chassis/structural body of the Motor Car. The chassis/structural body of the Motor Car was originally fitted.

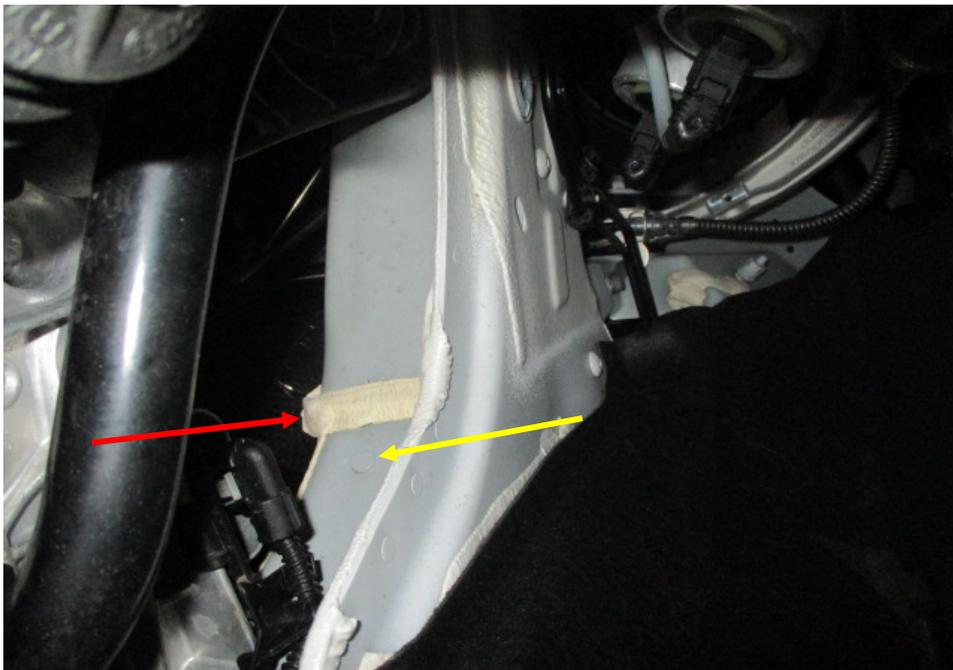
Photo 27 shows the chassis/structural body at the underside front left of the Motor Car. I did not find any weld marks other than original spot weld marks (yellow arrow) on the chassis/structural body of the Motor Car. The original factory sealant (red arrow) at the joints along the chassis/structural body was untouched, indicating no work was done on the chassis/structural body of the Motor Car and that the chassis/structural body was originally fitted.

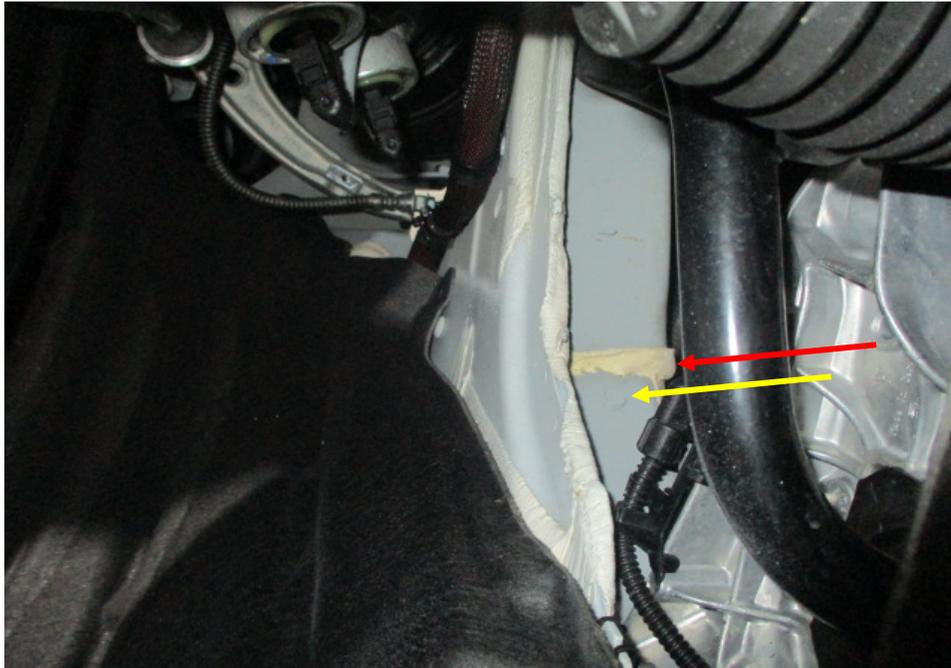
Photo 28 shows the chassis/structural body at the underside front right of the Motor Car. I did not find any weld marks other than original spot weld marks (yellow arrow) on the chassis/structural body of the Motor Car. The original factory sealant (red arrow) at the joints along the chassis/structural body was untouched, indicating no work was done on the chassis/structural body of the Motor Car and that the chassis/structural body was originally fitted.
