Your Ref: 800SWAISCL20220073SL
Our Ref : CS4/AIS22002915/N

Allianz Insurance Singapore Pte. Ltd.

**TECHNICAL INVESTIGATION REPORT OF FIRE INCIDENT INVOLVING THE
MOTOR VEHICLE YN 5916E ON 19 MARCH 2022**

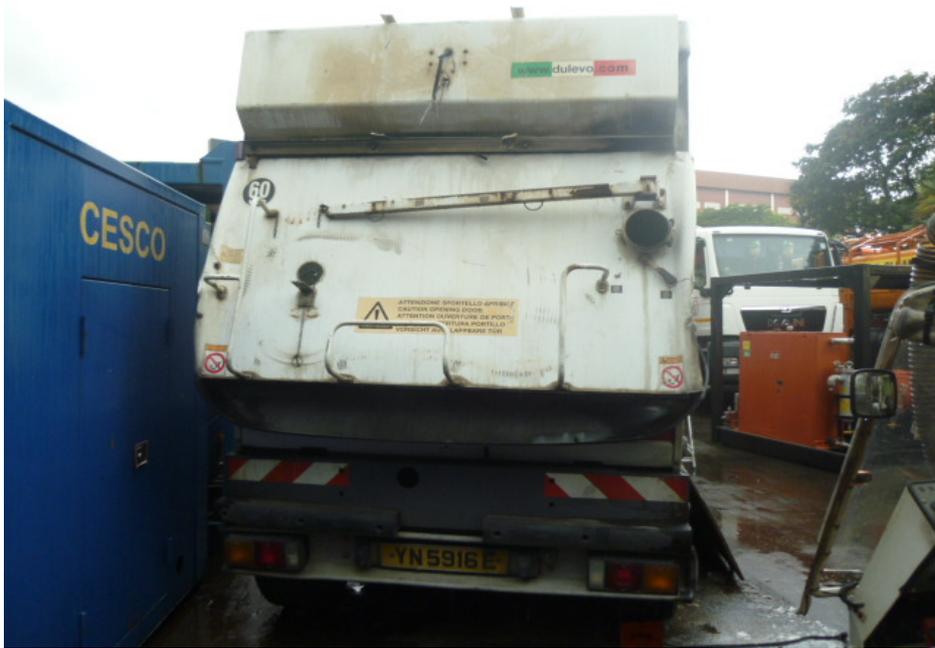
Photo 1 shows a general view of the rear portion of the Insured Vehicle. The rear portion was observed to be relatively unaffected by the fire.

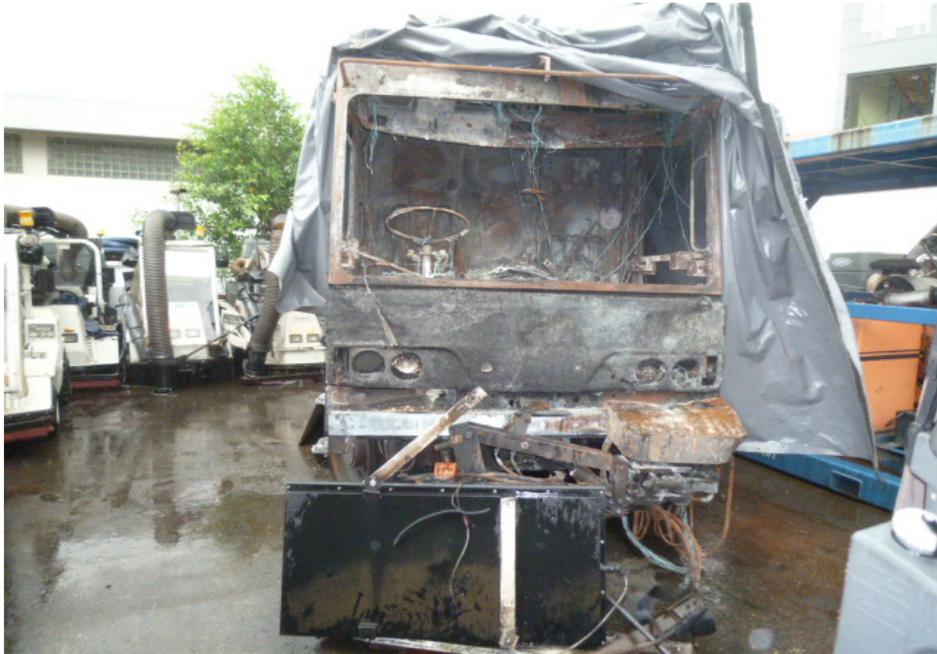
5. The Insured Vehicle was observed to have sustained extensive fire damage at its frontal portion. The body panels at the frontal portion and the undercarriage components at the front underside were found to have been burnt to char. Parts inside the interior compartment were also observed to be completely burnt, leaving charred skeletal remains. The engine and transmission of the Insured Vehicle were also affected.

Photo 2 shows a general view of the frontal portion of the Insured Vehicle at the time of our inspection. The Insured Vehicle was observed to have sustained extensive fire damage at its frontal portion. The body panels at the frontal portion and the undercarriage components at the front underside were found to have been burnt to char.

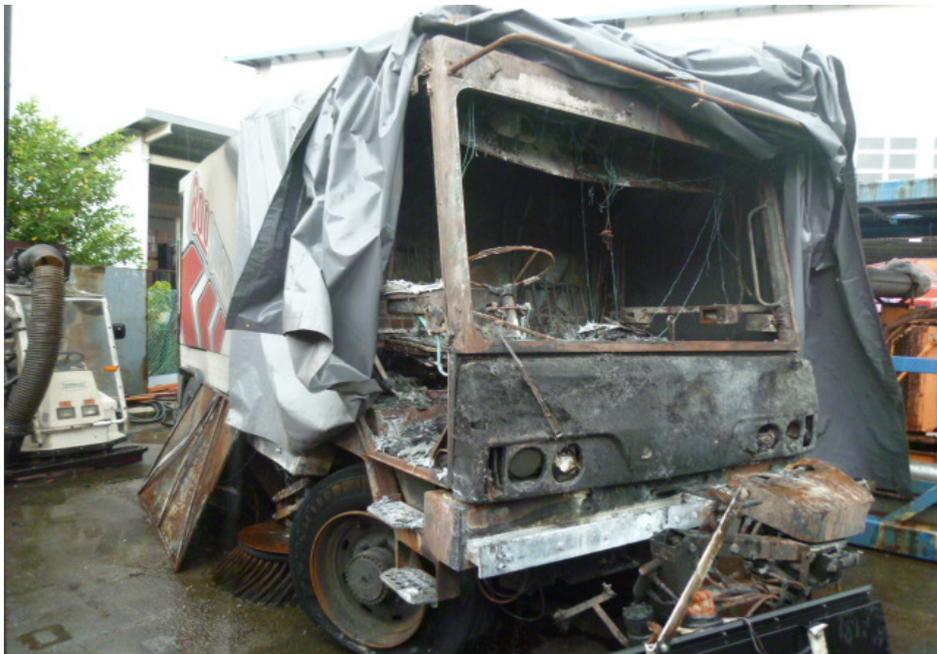
Photo 3 shows a general view of the right frontal body of the Insured Vehicle at the time of inspection. The Insured Vehicle was observed to have sustained extensive fire damage at its frontal portion. The body panels at the frontal portion were found to have been burnt to char.

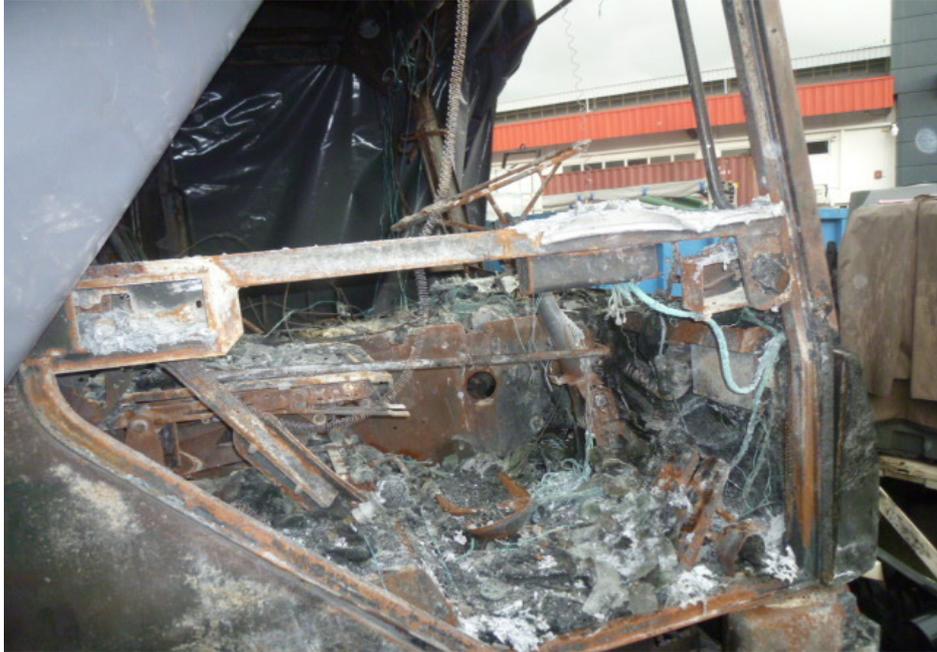
Photo 4 shows the interior compartment of the Insured Vehicle. All the parts inside the interior compartment were found to be burnt and/or melted. Its front seats, roof upholstery, carpet and various trims were all burnt and/or melted as a result of the fire

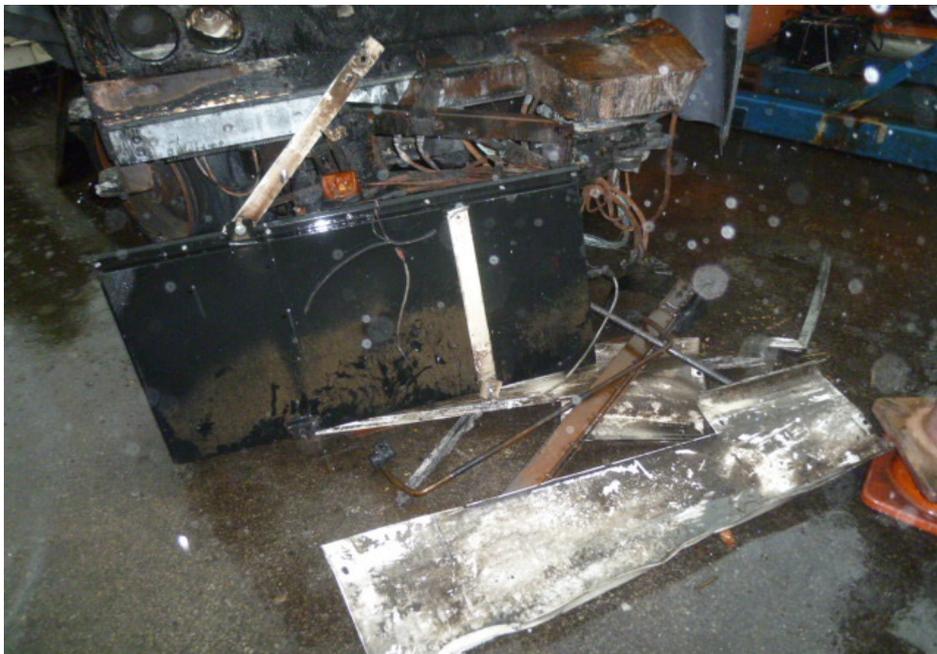
Photo 5 shows the underside of the Insured Vehicle, at its frontal area. The various undercarriage components at the front underside of the Insured Vehicle were observed to be affected. This had included components of the braking system and steering system.

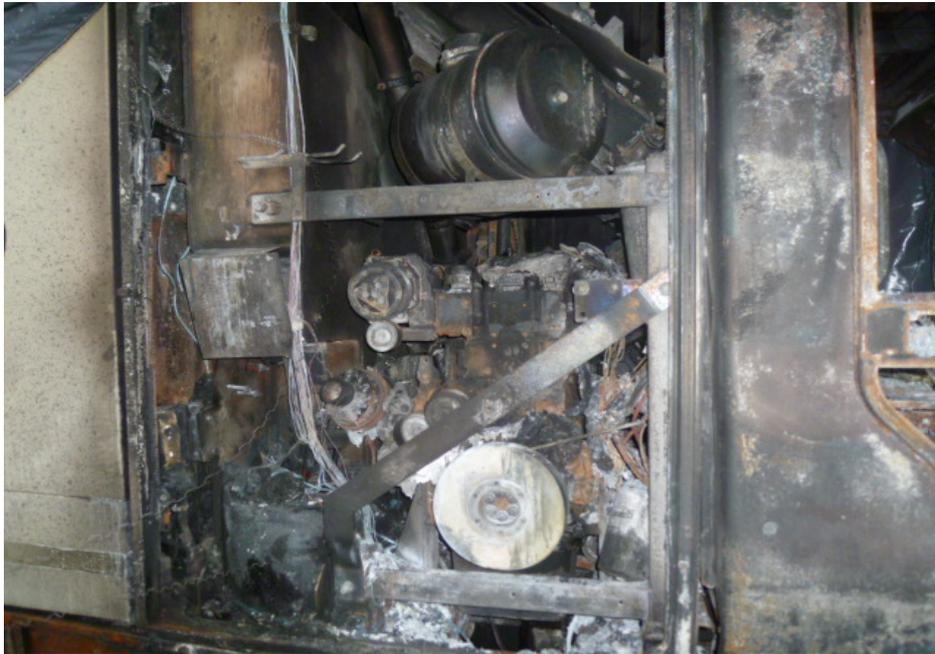
Photo 6 shows the engine compartment, which was located at the back of the Insured Vehicle's front cabin. The various parts and components within the engine compartment of the Insured Vehicle were all affected by the fire. This had included the engine of the Insured Vehicle.

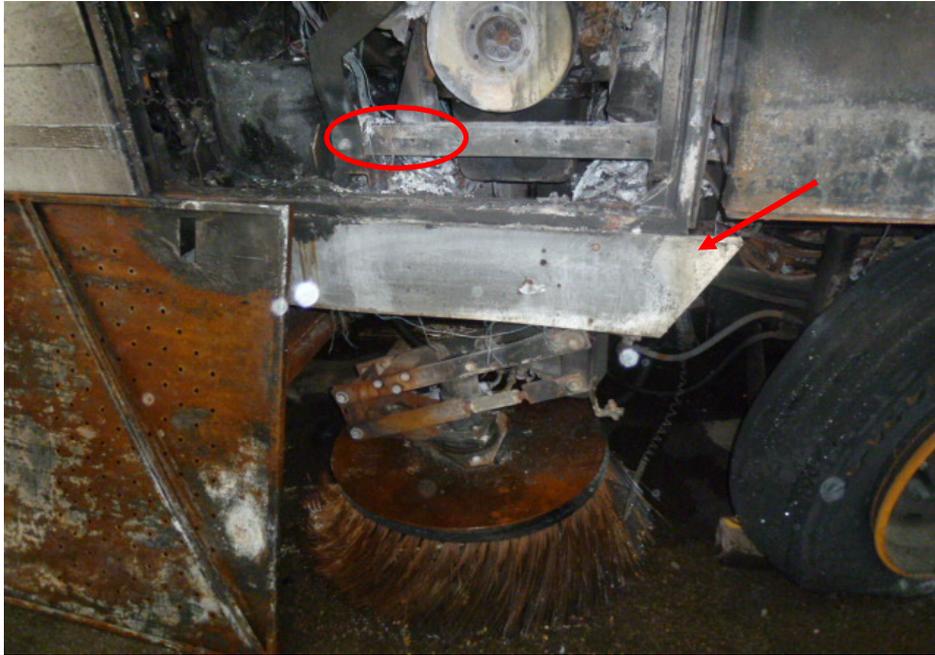
8. For this particular case, the fire appears to have originated from the right centre portion of the Insured Vehicle, which houses the engine. This can be determined from the burn pattern and the high heat intensity burn marks (whitish burn marks) found on the right centre portion of the Insured Vehicle and also the rust that had developed at the areas around the engine compartment.
9. The whitish burn marks are a result of exposure to prolonged heat intensity. Rust would normally start to develop around these areas soon after a fire as prolonged exposure to high heat intensity usually causes steel/metal material body parts to be exposed to natural environmental condition. Hence the rust that had developed around the engine compartment of the Insured Vehicle is an indication that the fire to the Insured Vehicle had originated from the engine compartment. See photo 7 below.

Photo 7 shows the engine compartment of the Insured Vehicle where the burn pattern and whitish burn marks were found (arrowed). Such whitish burn marks are a result of exposure to prolonged heat intensity, which had caused the steel/metal material of the engine compartment to be exposed to natural environmental condition. Hence the rust that had developed around the engine compartment of the Insured Vehicle (circled) is an indication that the fire to the Insured Vehicle had originated from the engine compartment.

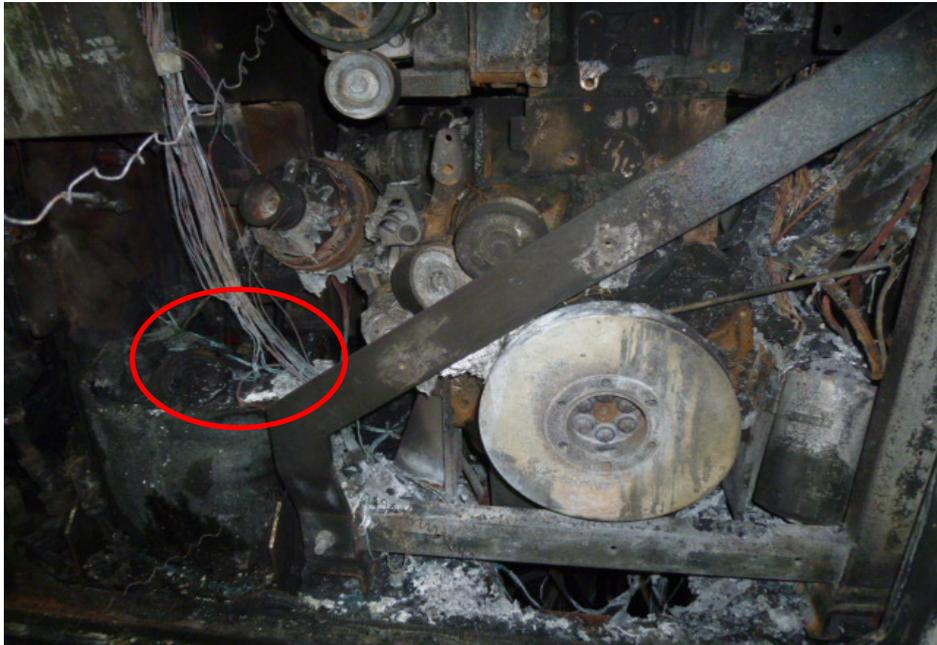
10. Upon closer examination around the areas in closest proximity to the engine compartment which was where the fire to the Insured Vehicle had likely started, we had found several stretches of burnt wirings with greenish residue. These wirings were original factory fitted wirings around the engine compartment. The presence of greenish residue indicates internal heating of copper wires, a sign of an electrical short circuit occurring. The greenish residue is normally left behind from oxidation as a result of chemical reaction involving the copper wires. This physical evidence would appear to suggest that the cause of fire to the Insured Vehicle could have possibly been due to electrical in nature. See photos 8 - 11 below.

Photo 8 shows upon closer examination around the areas in closest proximity to the engine compartment which was where the fire to the Insured Vehicle had likely started, we had found several stretches of burnt wirings with greenish residue. These wirings were original factory fitted wirings around the engine compartment. The presence of such greenish residue suggests occurrence of an electrical short circuit. The greenish residue is normally left behind from oxidation as a result of chemical reaction involving the copper wires.

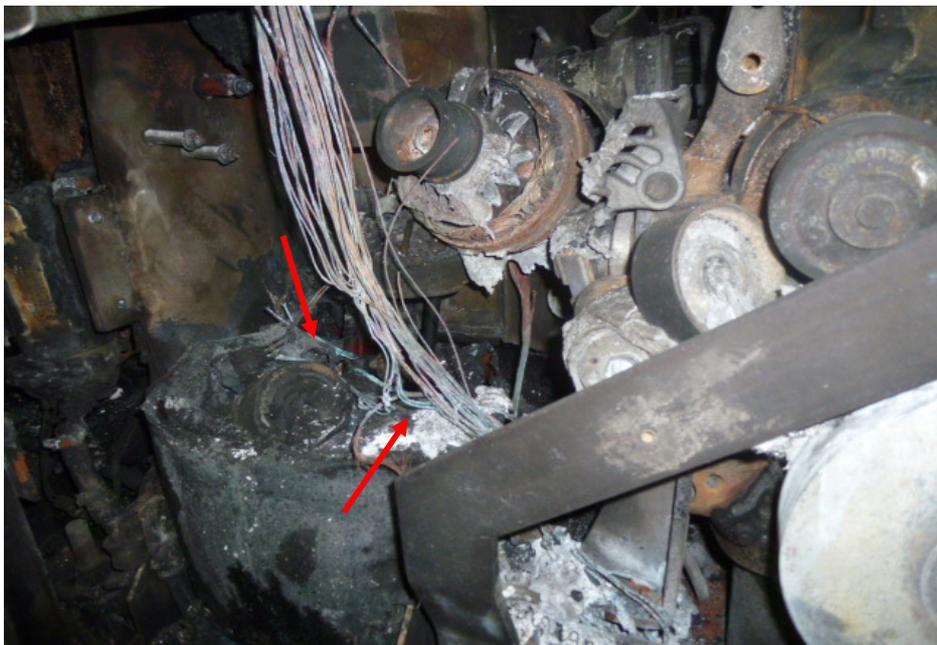
Photo 9 shows a closer view of the several original factory fitted wirings around the engine compartment with greenish residue (arrowed). The presence of such greenish residue suggests occurrence of an electrical short circuit.

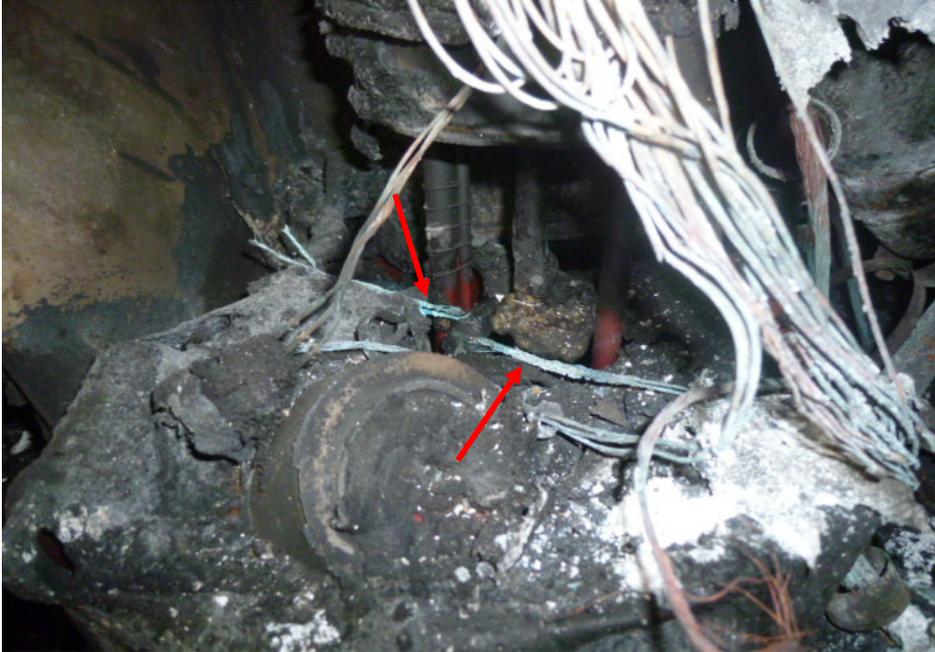
Photo 10 shows a closer view of the several original factory fitted wirings around the engine compartment with greenish residue (arrowed). The presence of such greenish residue suggests occurrence of an electrical short circuit.

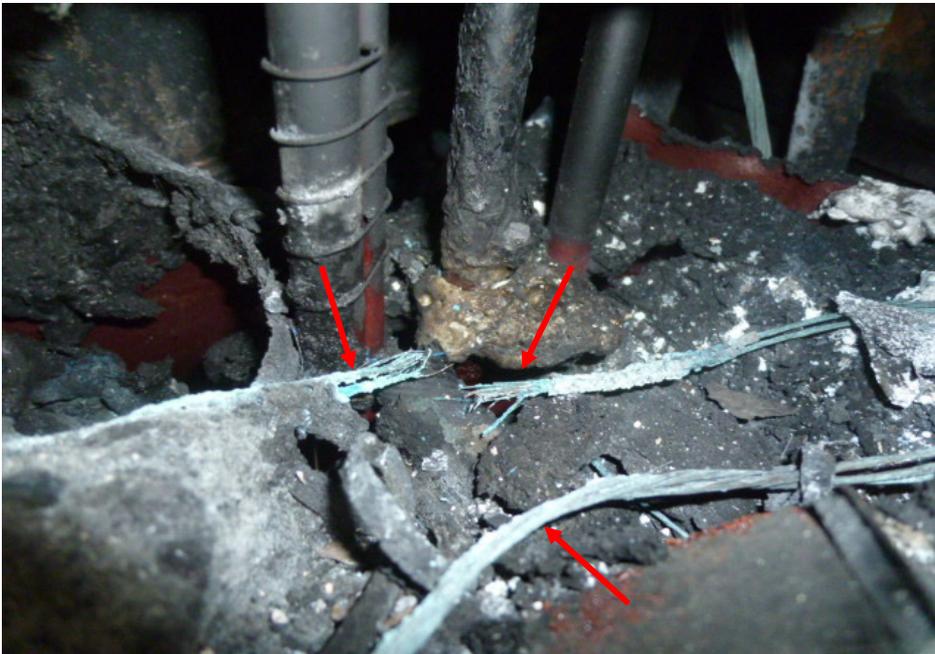
Photo 11 shows a close up view of the several original factory fitted wirings around the engine compartment with greenish residue (arrowed). The presence of such greenish residue suggests occurrence of an electrical short circuit.

28. Having investigated and technically analysed the damages of burnt nature to the Insured Vehicle, we are of the view that the cause of fire to the Insured Vehicle was of electrical in nature. For this particular case, the fire had originated along the original factory fitted wirings inside the engine compartment, somewhere around the right centre portion of the Insured Vehicle.

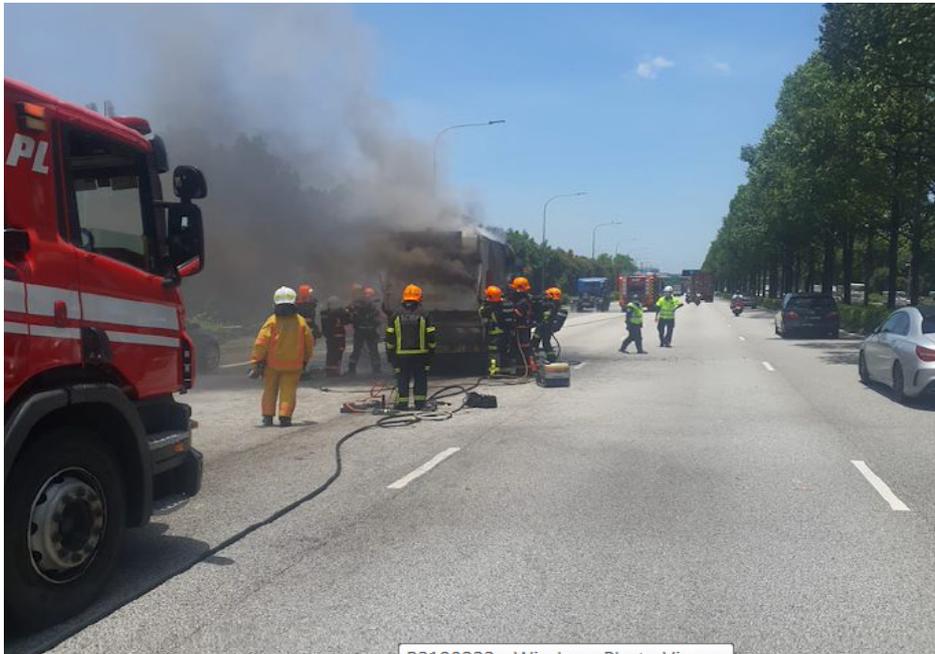
Photo 12 shows the SCDF attending to the fire.

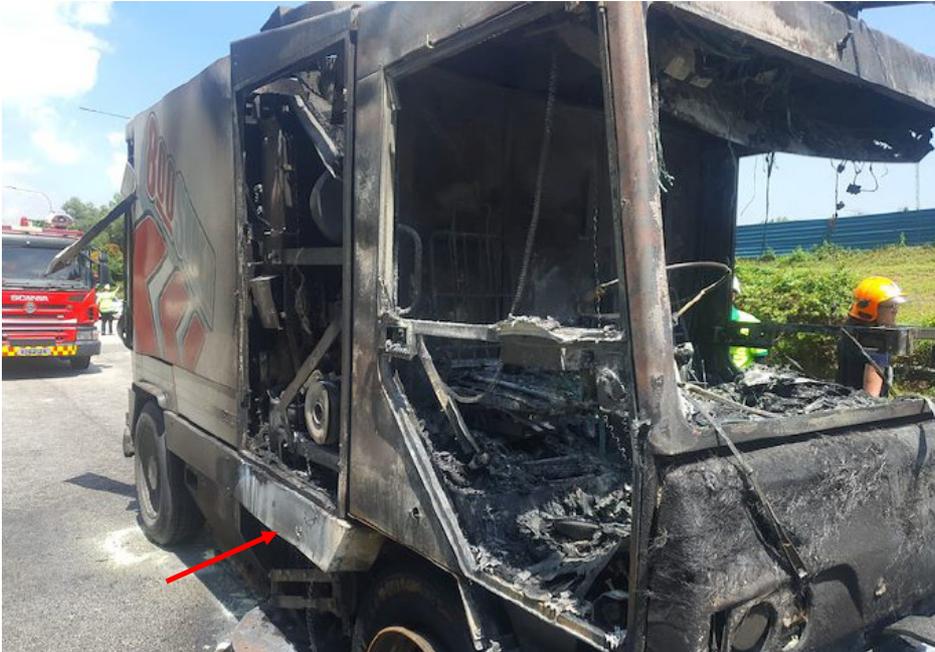
Photo 13 shows the Insured Vehicle after the fire was extinguished. In general, the information gathered from this photograph had corresponded to Mr Lee's statement, which is the fire had started from the engine compartment (arrowed).
