**TECHNICAL INVESTIGATION REPORT OF WARRANTY CLAIM INVOLVING  
THE INSURED VEHICLE SCN 3883P ON 25<sup>th</sup> March 2022**

Vehicle Registration No.	: SCN 3883P
Make / Model	: FORD MUSTANG 2.3 ECOBOOST (A)
Chassis No	: 1FA6P8LH3J5152306
Year of Registration	: APR 2020
Mileage	: 25,693KM

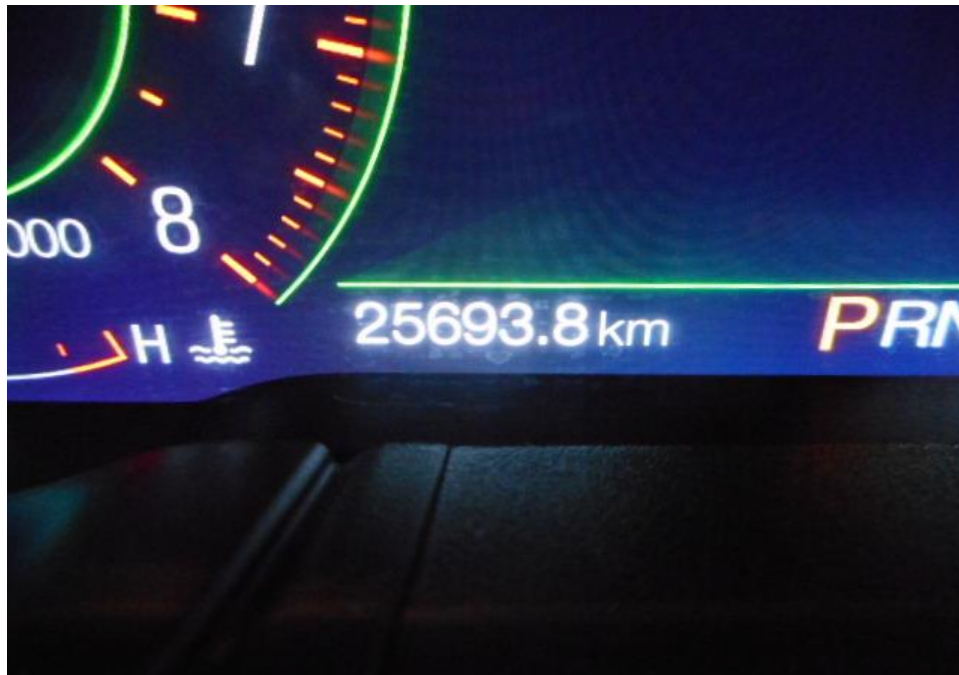
**Photo 1** shows the mileage of the Insured Vehicle recorded at the time inspection at 25,693KM

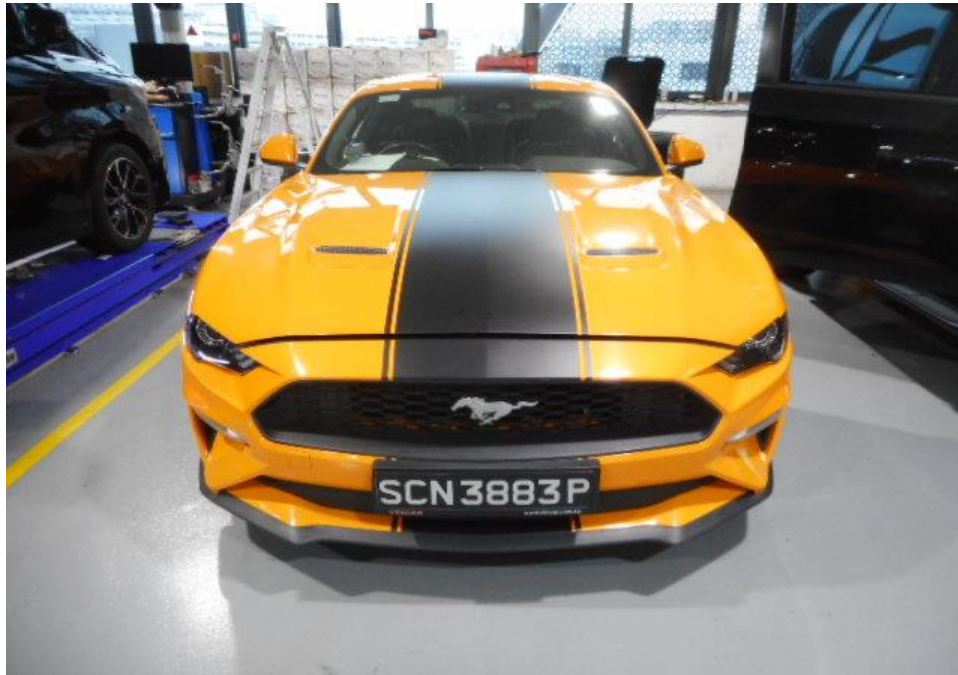
**Photo 2** shows the general view of the front portion of the Insured Vehicle at the time of our inspection. The Insured Vehicle is observed to be unaffected by any signs of accident.

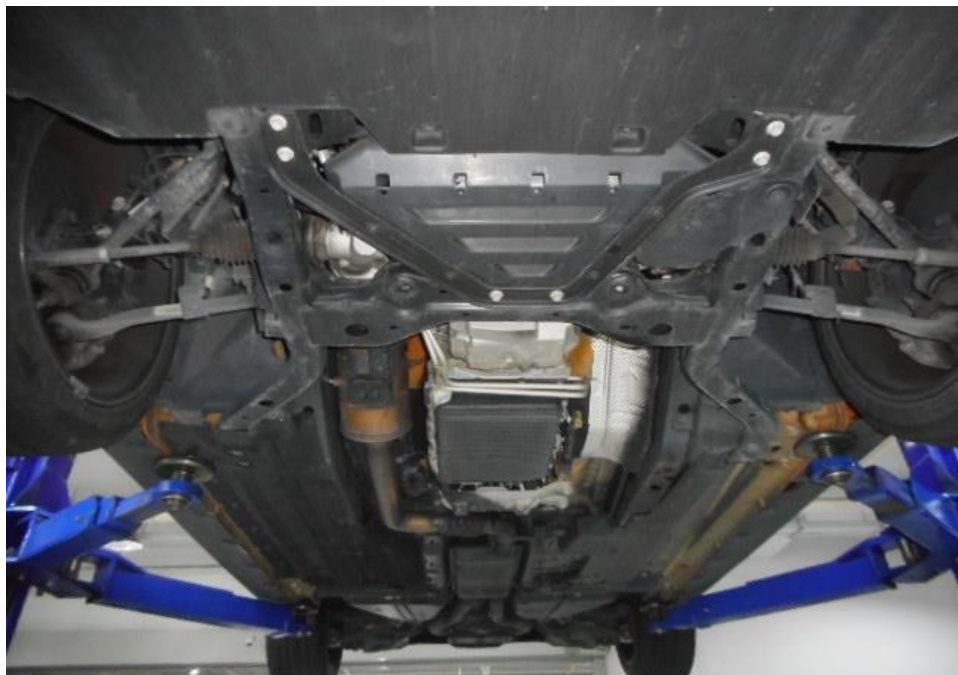
**Photo 3** shows the general view of the undercarriage portion of the Insured Vehicle at the time of our inspection. The undercarriage compartment is observed to be unaffected by any signs of accident.

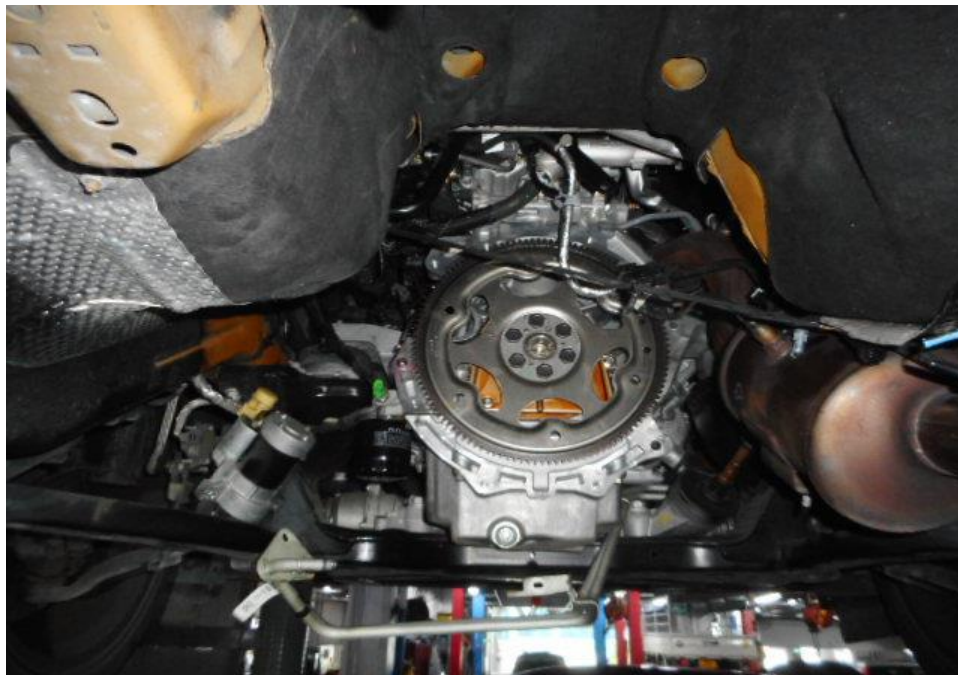
**Photo 4** shows the general view of the gearbox underside portion of the Insured Vehicle at the time of our inspection. The gearbox underside compartment is observed to be unaffected and by any signs of accident.

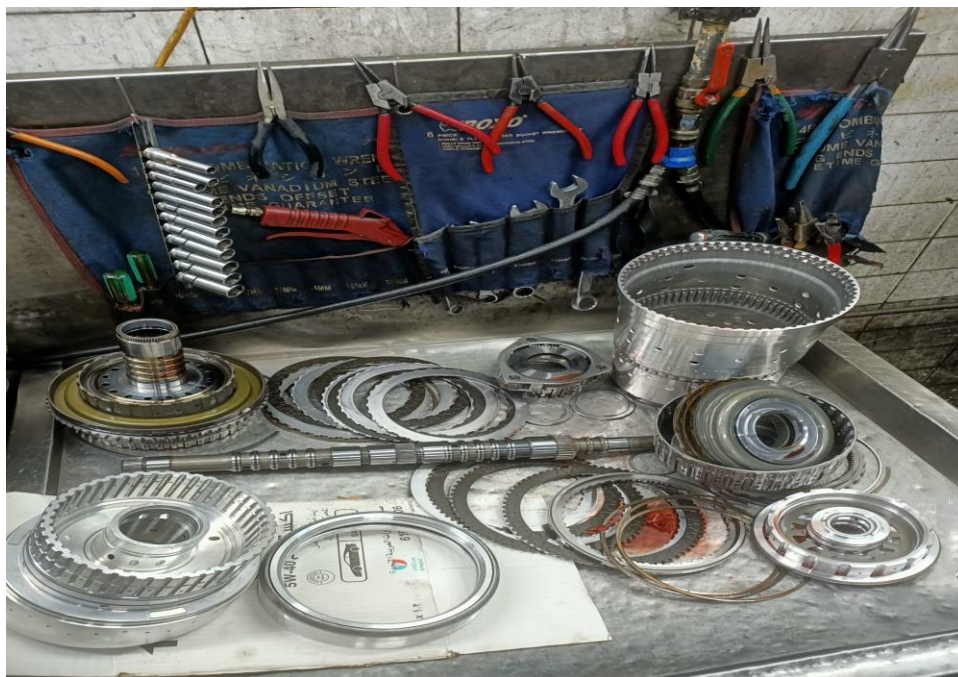
**Photo 5** shows the general view of inside the gearbox unit of the Insured Vehicle at the time of our inspection. The components in the gearbox unit is observed to be unaffected and by any signs of accident.

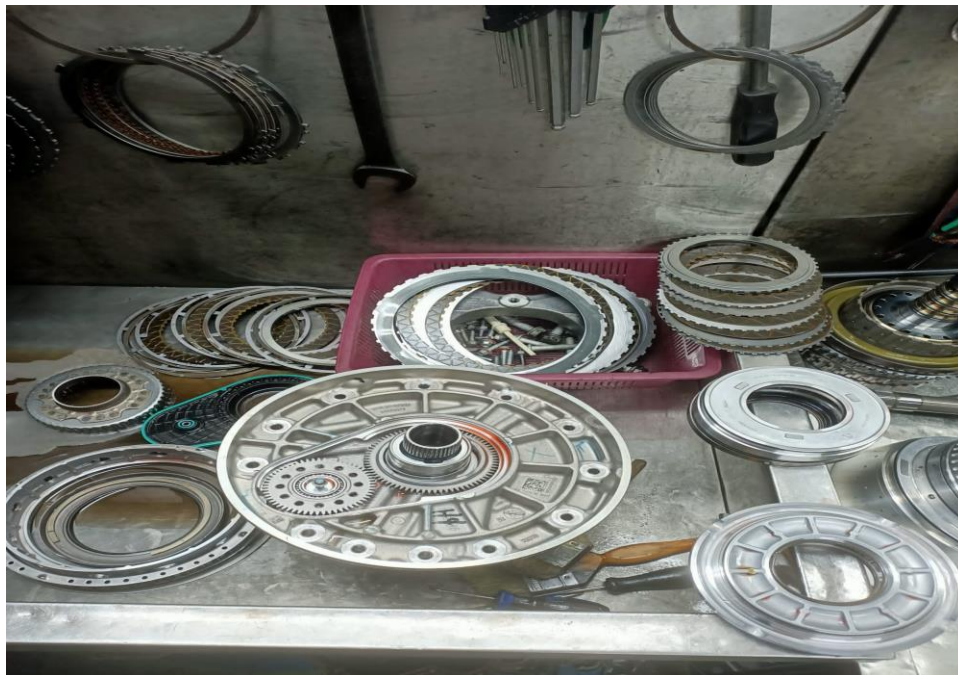
6. Prior to our inspection, the workshop had informed us that they had already conducted checks and upon dismantling the gearbox unit they have found free play to the gear, shafts, clutches from these components in the gearbox unit of the Insured Vehicle and agreed that the complained problem is from these components in the gearbox unit See photos 1 – 9 below.

**Photo 6** shows the general view of inside the gearbox unit of the Insured Vehicle at the time of our inspection. The gears, shafts and clutches components in the gearbox unit is observed to be unaffected and by any signs of accident.

8. We did not find any evidence which had suggested that the cause of abnormalities to the Insured Vehicle was due to poor maintenance and/or recurring problem.
9. The recommendation to replace the gearbox unit at \$6,710 as stated in the quotation is justifiable as all the relevant checks has been conducted to the Insured Vehicle.

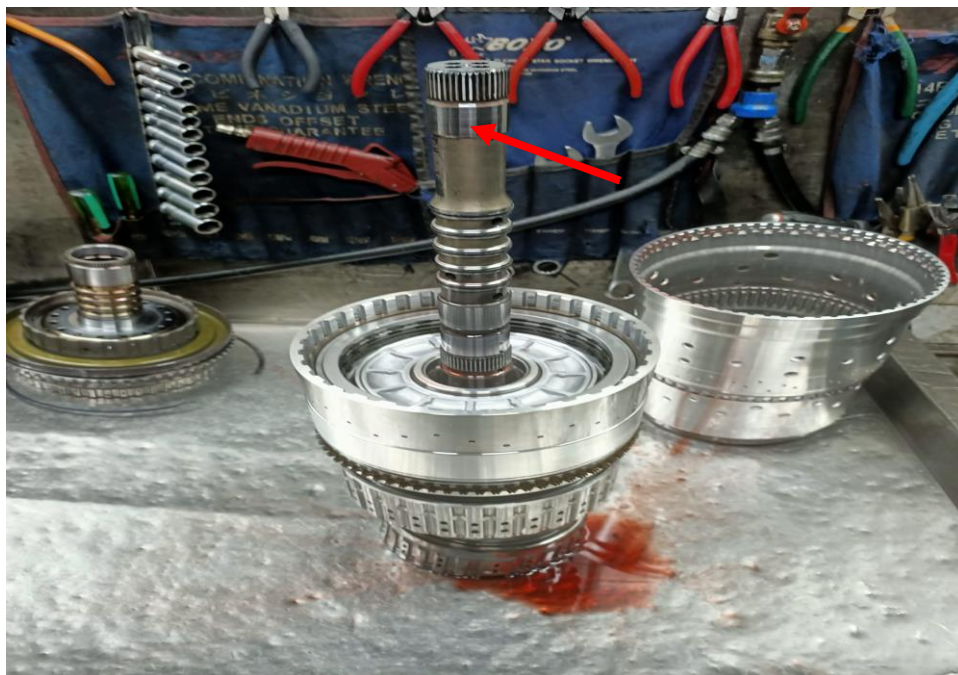
**Photo 7** shows the close up view of inside the gearbox unit of the Insured Vehicle at the time of our inspection. The shafts component (arrowed) in the gearbox unit is observed to be unaffected and by any signs of accident.

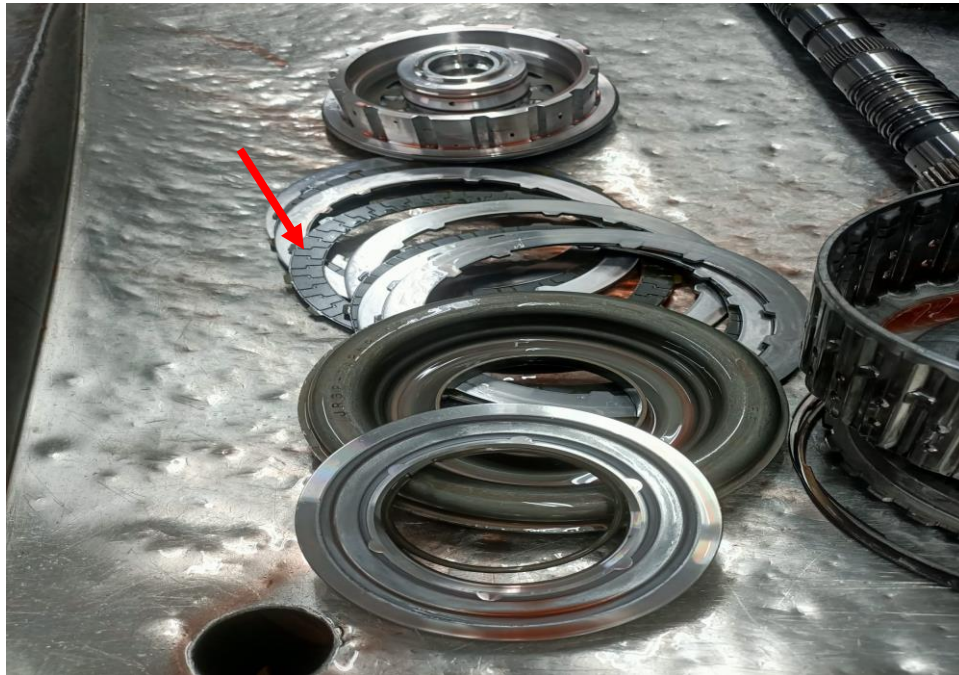
**Photo 8** shows the close up view of inside the gearbox unit of the Insured Vehicle at the time of our inspection. The clutch (arrowed) component in the gearbox unit is observed to be unaffected and by any signs of accident.

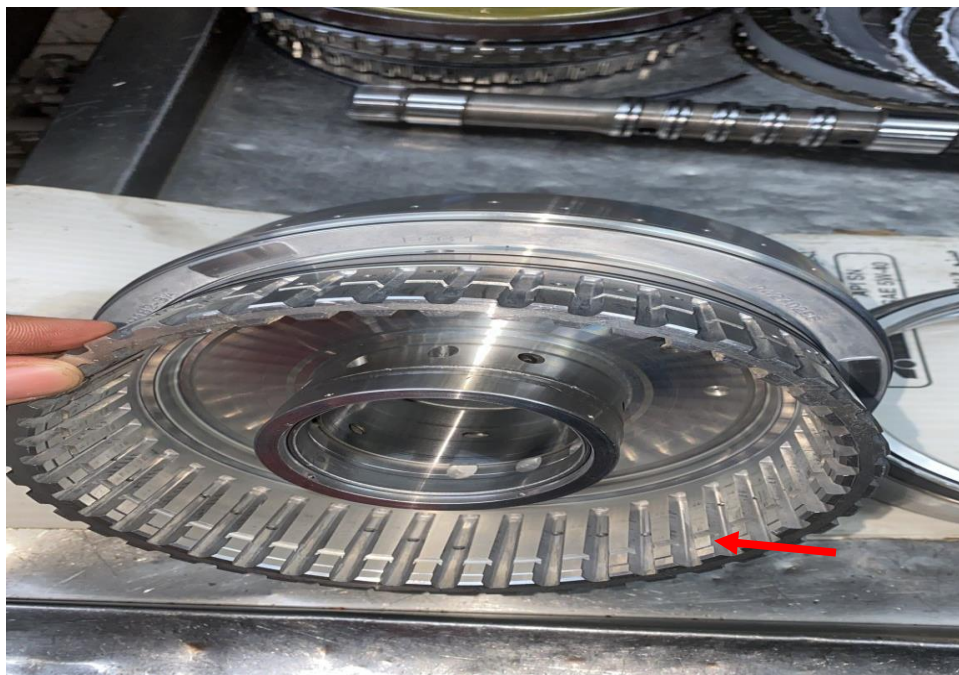
**Photo 9** shows the close up view of inside the gearbox unit of the Insured Vehicle at the time of our inspection. The gears component (arrowed) in the gearbox unit is observed to be unaffected and by any signs of accident.
