Your Ref: Mercedes Benz GLC 300  
(chassis number WDC2533842F682195)  
Our Ref : CI/TP22002984/D

30 March 2022

**INSPECTION REPORT OF AN UNREGISTERED MERCEDES BENZ GLC 300  
MOTOR CAR WITH CHASSIS NUMBER WDC2533842F682195**

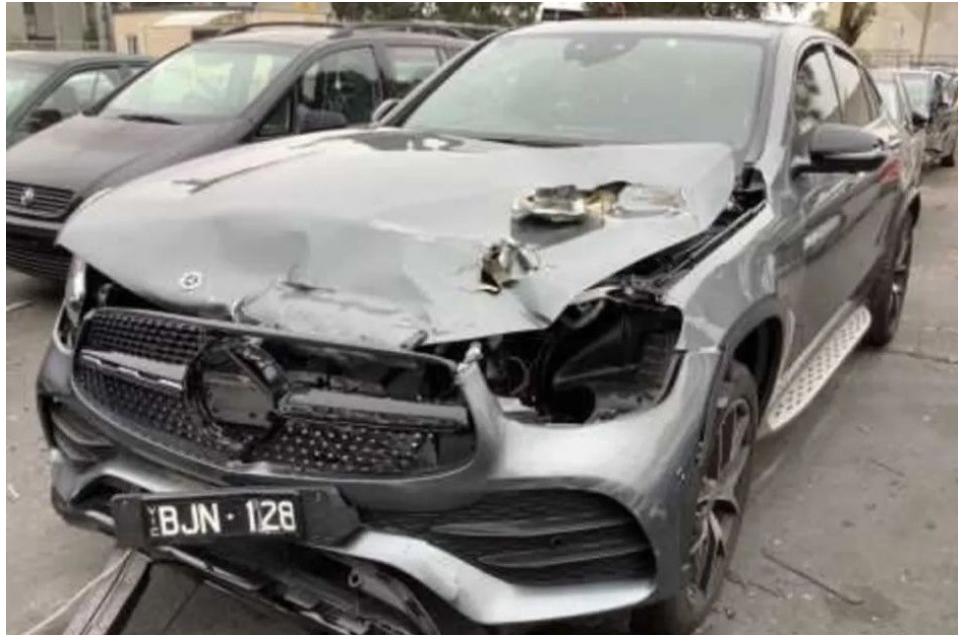
**Photo 1** shows the front left body of the Motor Car (photograph provided to me). The Motor Car was observed to have sustained damage at its frontal portion. The front bumper, front bumper left lower grille, front bumper centre lower grille, front bumper number plate garnish, front bumper sensors, front bonnet, front bonnet hinges, radiator grille, radiator grille emblem, front left headlamp and front left fender were amongst the body parts that were observed to have been damaged. The airbag(s) appears to be not deployed as seen from the photographs that were provided to me.

22. The body parts at the frontal portion of the Motor Car were visually examined and it was noted that the repair/restoration works carried out to the damaged area of the Motor Car (refer to photograph 1 & 2 above) were reasonably adequate and in order.

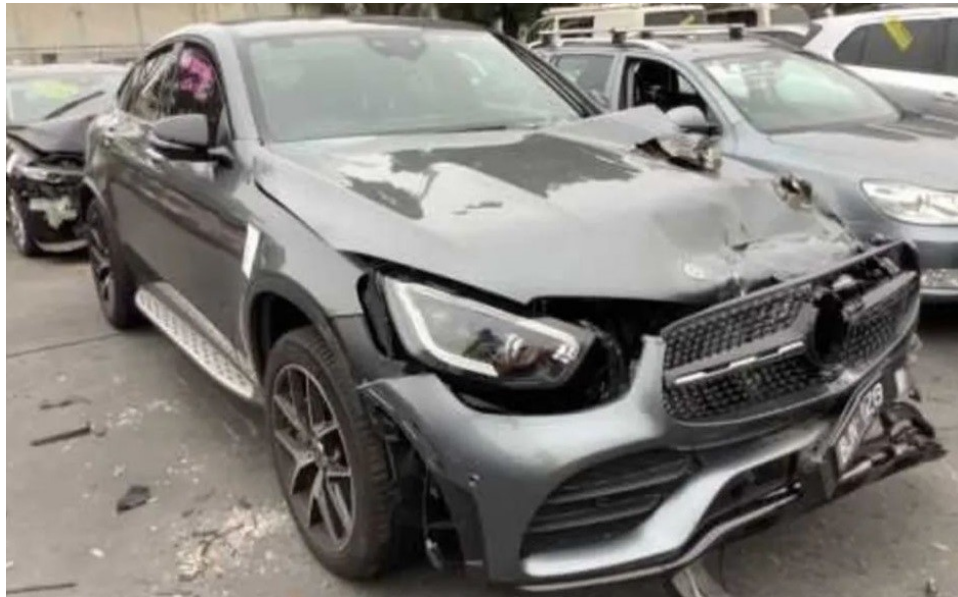
**Photo 2** shows the front right body of the Motor Car (photograph provided to me). The Motor Car was observed to have sustained damage at its frontal portion. The front bumper, front bumper right lower grille, front bumper centre lower grille, front bumper lower lip, front bonnet, radiator grille and front right headlamp were amongst the body parts that were observed to have been damaged. The airbag(s) appears to be not deployed as seen from the photographs that were provided to me.

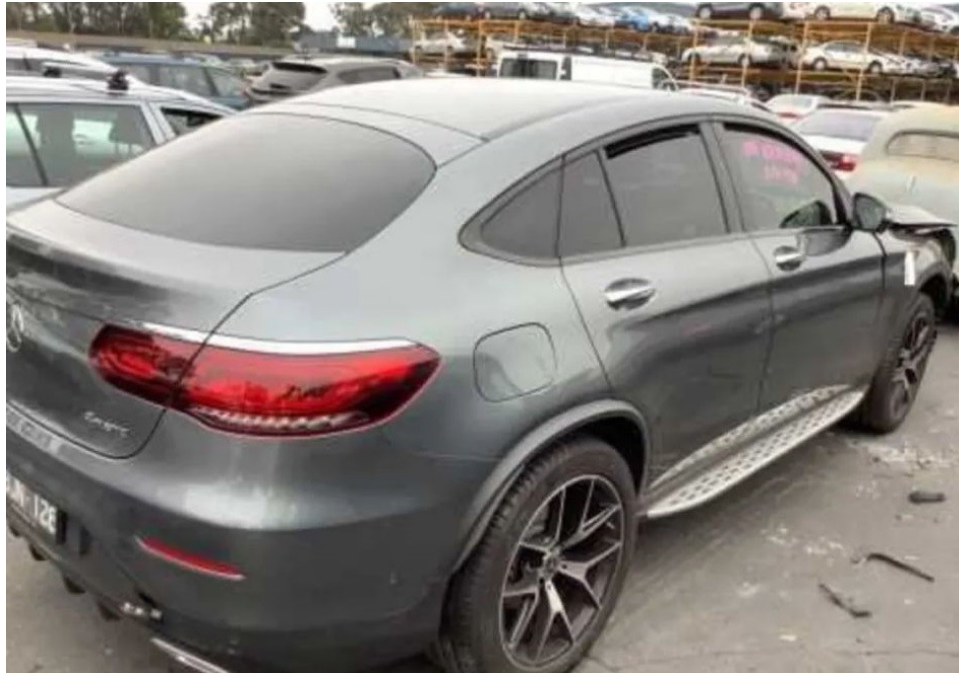
**Photo 3** shows the rear right body of the Motor Car (photograph provided to me). Apart for the frontal portion, there was no physical damage observed to other areas of the Motor Car. The airbag(s) appears to be not deployed as seen from the photographs that were provided to me.

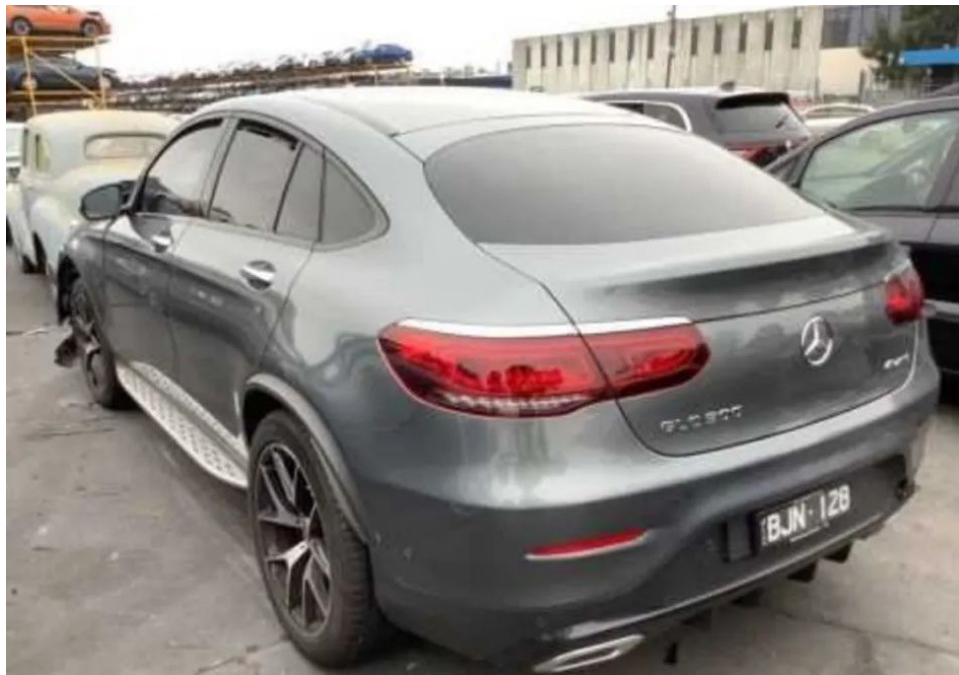
**Photo 4** shows the rear left body of the Motor Car (photograph provided to me). Apart for the frontal portion, there was no physical damage observed to other areas of the Motor Car.

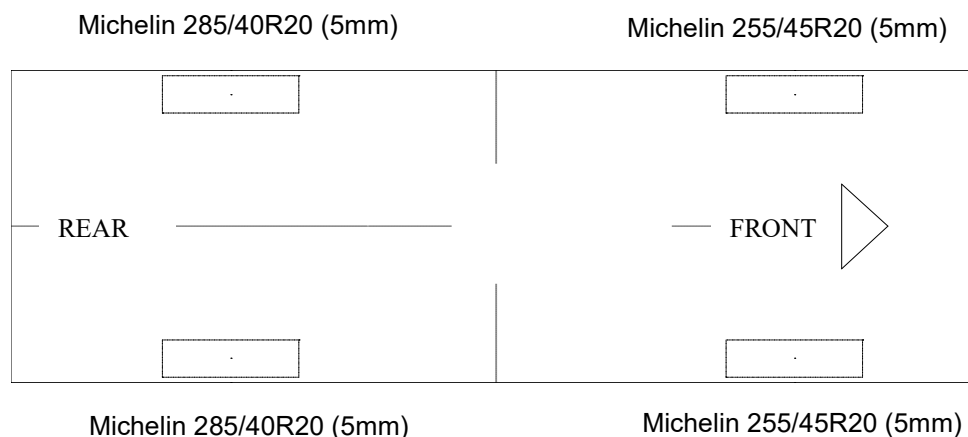
8. The Motor Car was fitted with 20inch sport wheel rims that were wrapped with tyres that were observed to be of serviceable condition. The tyres were also sufficiently inflated for vehicular operation. The tyre brand, tyre size and approximate remaining tread depth of the 4 tyres of the Motor Car were recorded as follows: -

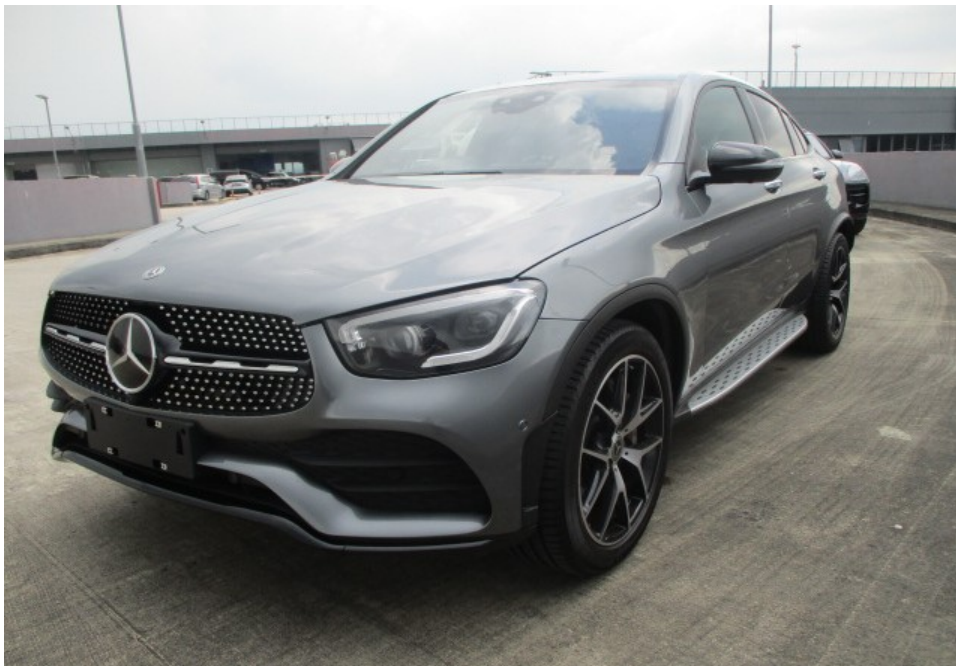
**Photo 5** shows a general view of the front left body of the Motor Car at the time of my inspection. The Motor Car was observed to be in a relatively good general condition with no loose exterior fittings observed. The body parts at the frontal portion of the Motor Car were visually examined and it was observed that the repair/restoration works carried out to the damaged area of the Motor Car (refer to photograph 1 & 2 above) were reasonably adequate and in order.

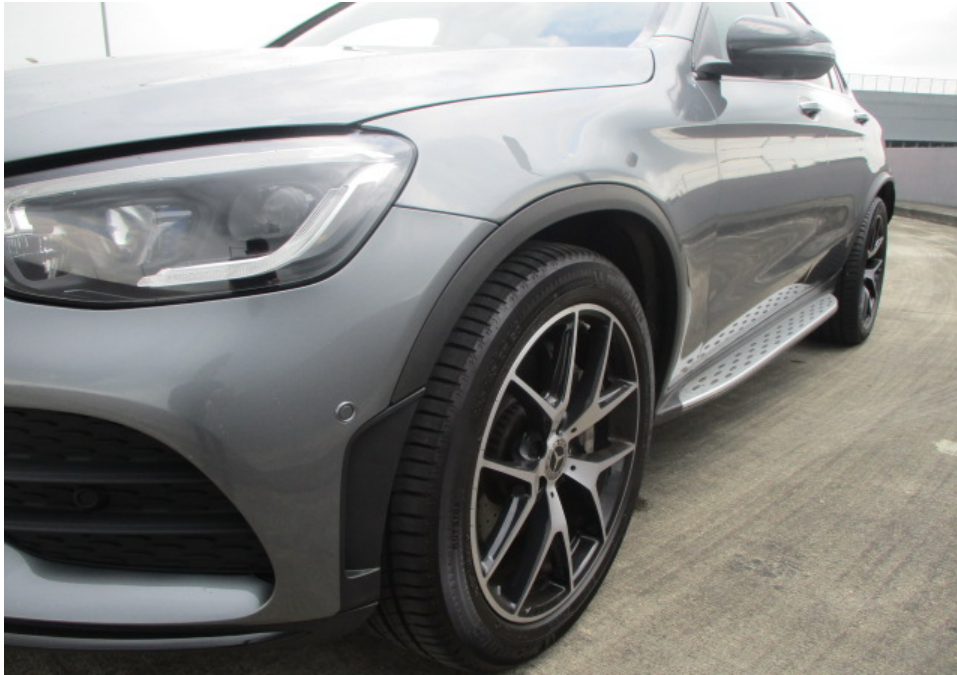
**Photo 6** shows a closer view of the Motor Car's front bumper, front bumper left corner garnish, front left fender, front left fender wheel arc garnish and front left headlamp. The body parts at the frontal portion of the Motor Car were visually examined and it was observed that the repair/restoration works carried out to the damaged area of the Motor Car (refer to photograph 1 & 2 above) were reasonably adequate and in order.

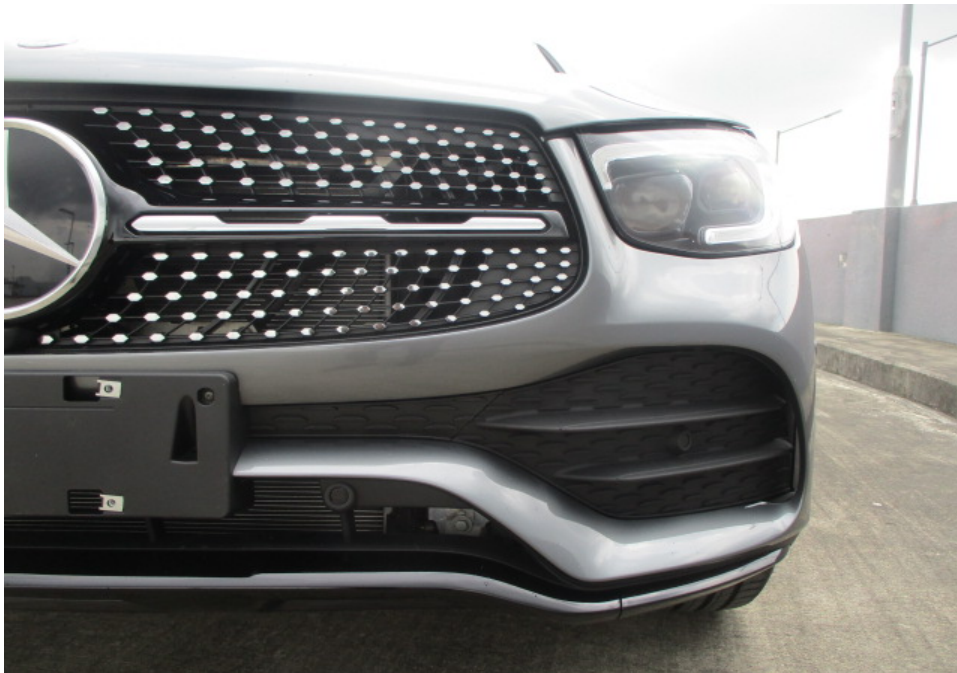
**Photo 7** shows a closer view of the Motor Car's front bumper, front bumper left lower grille, front bumper lower lip and radiator grille. The body parts at the frontal portion of the Motor Car were visually examined and it was observed that the repair/restoration works carried out to the damaged area of the Motor Car (refer to photograph 1 & 2 above) were reasonably adequate and in order.

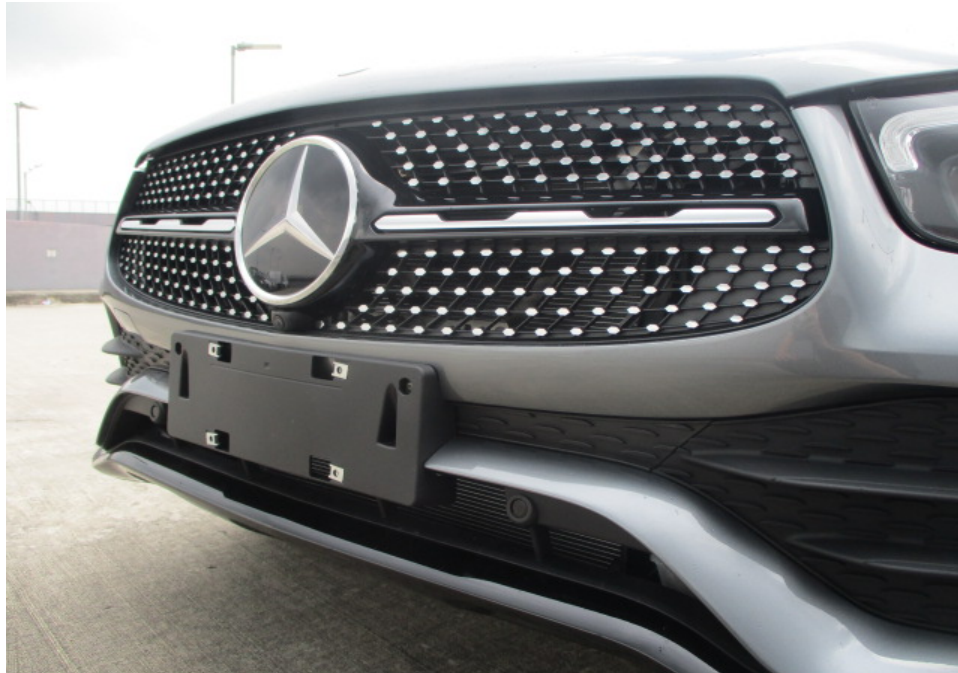
**Photo 8** shows a closer view of the Motor Car's front bumper, front bumper sensors, front bumper number plate garnish, front bumper centre lower grille and radiator grille. The body parts at the frontal portion of the Motor Car were visually examined and it was observed that the repair/restoration works carried out to the damaged area of the Motor Car (refer to photograph 1 & 2 above) were reasonably adequate and in order.

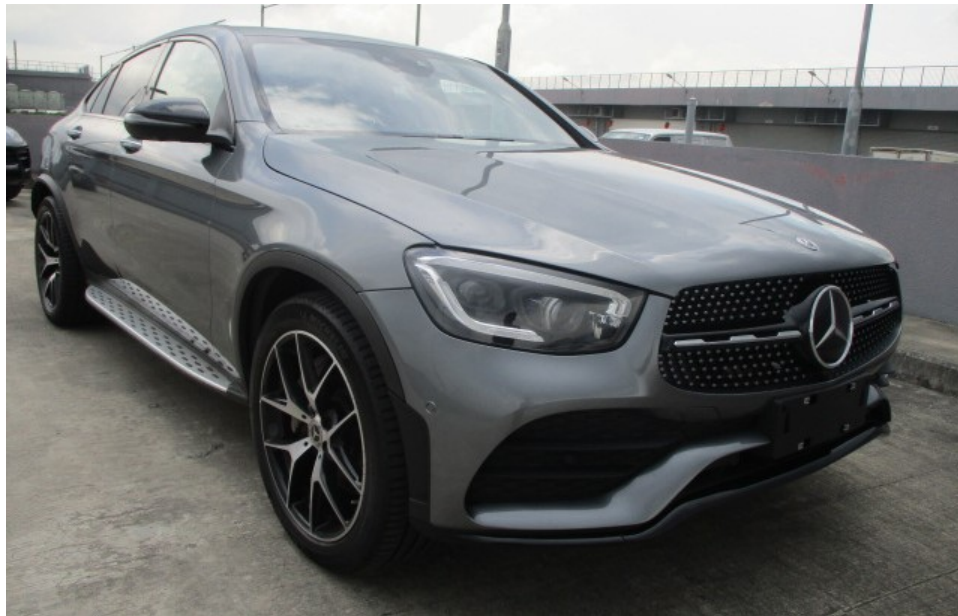
**Photo 9** shows a general view of the front right body of the Motor Car at the time of my inspection. The Motor Car was observed to be in a relatively good general condition with no loose exterior fittings observed. The body parts at the frontal portion of the Motor Car were visually examined and it was observed that the repair/restoration works carried out to the damaged area of the Motor Car (refer to photograph 1 & 2 above) were reasonably adequate and in order.

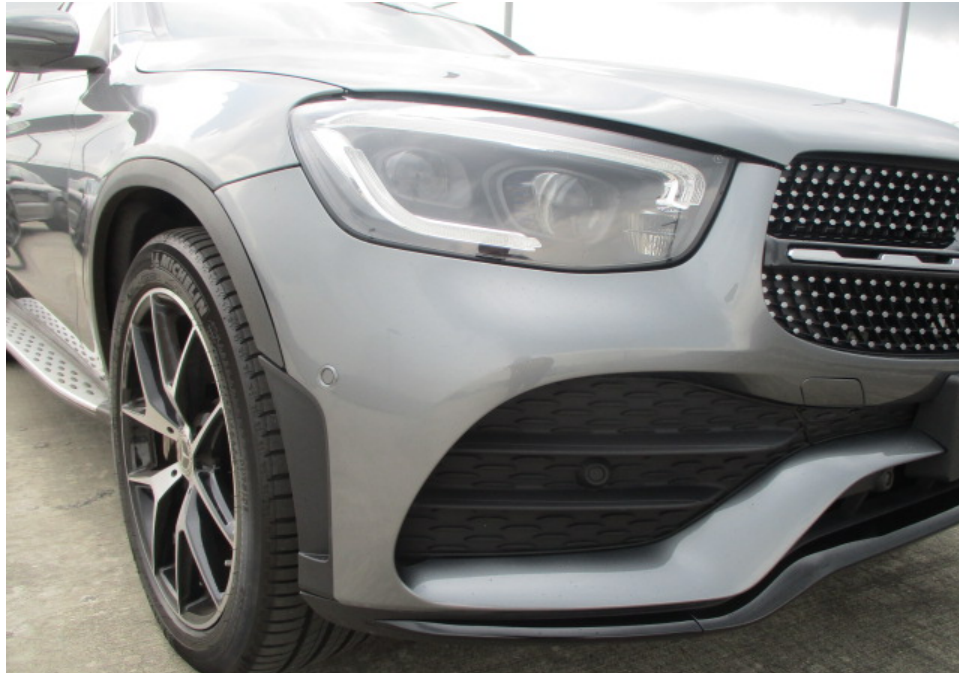
**Photo 10** shows a closer view of the Motor Car's front bumper, front bumper right lower grille, front bumper right corner garnish, front bumper right sensor, front right fender wheel arc garnish and front right headlamp. The body parts at the frontal portion of the Motor Car were visually examined and it was observed that the repair/restoration works carried out to the damaged area of the Motor Car (refer to photograph 1 & 2 above) were reasonably adequate and in order.

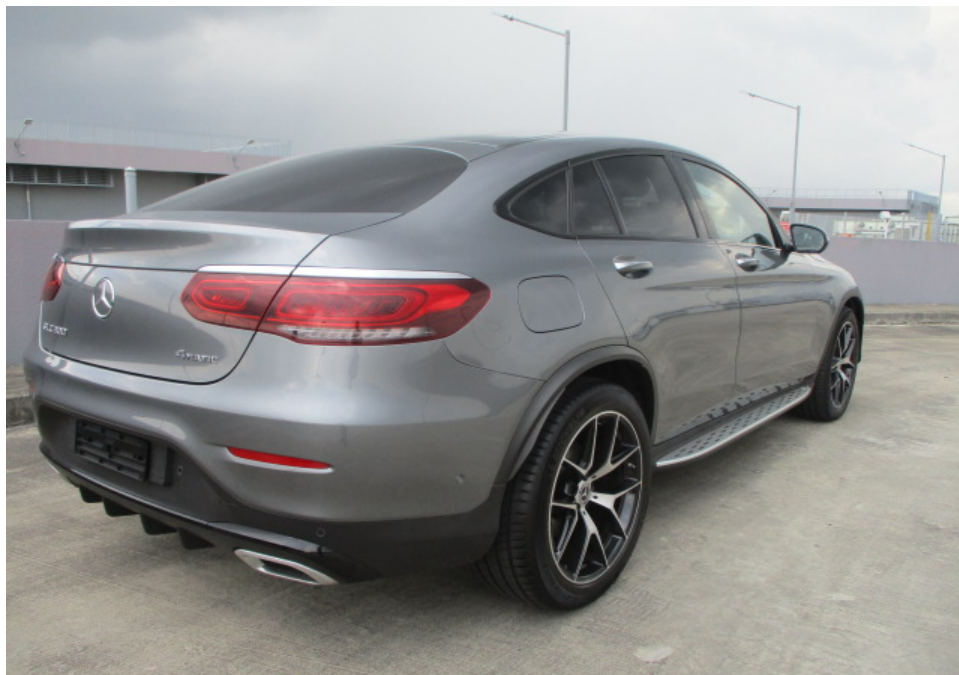
**Photo 11** shows a general view of the rear right body of the Motor Car at the time of my inspection. The Motor Car was observed to be in a relatively good general condition with no loose exterior fittings observed. The mileage of the Motor Car recorded at the time of my inspection was 4,412km.

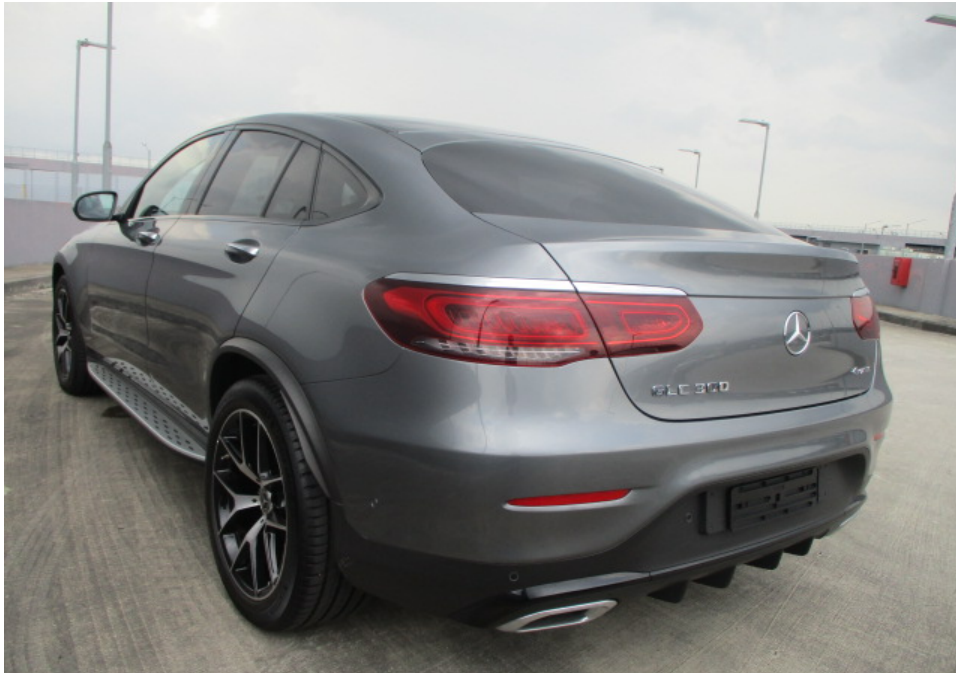
**Photo 12** shows a general view of the rear left body of the Motor Car at the time of my inspection. The Motor Car was observed to be in a relatively good general condition with no loose exterior fittings observed. The mileage of the Motor Car recorded at the time of my inspection was 4,412km.

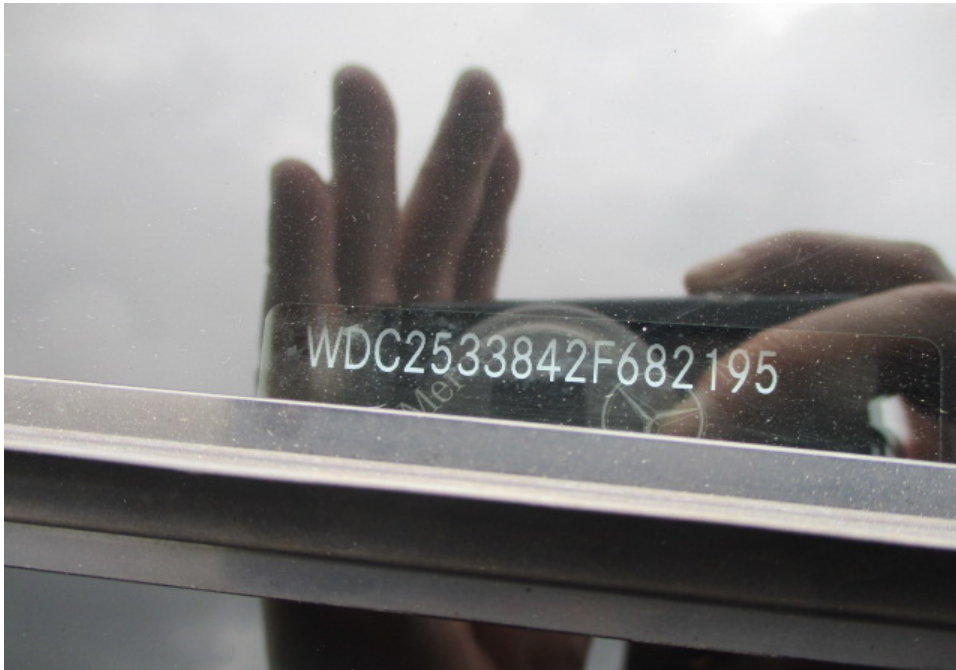
**Photo 13** shows the chassis number of the Motor Car. The chassis number recorded was WDC2533842F682195.

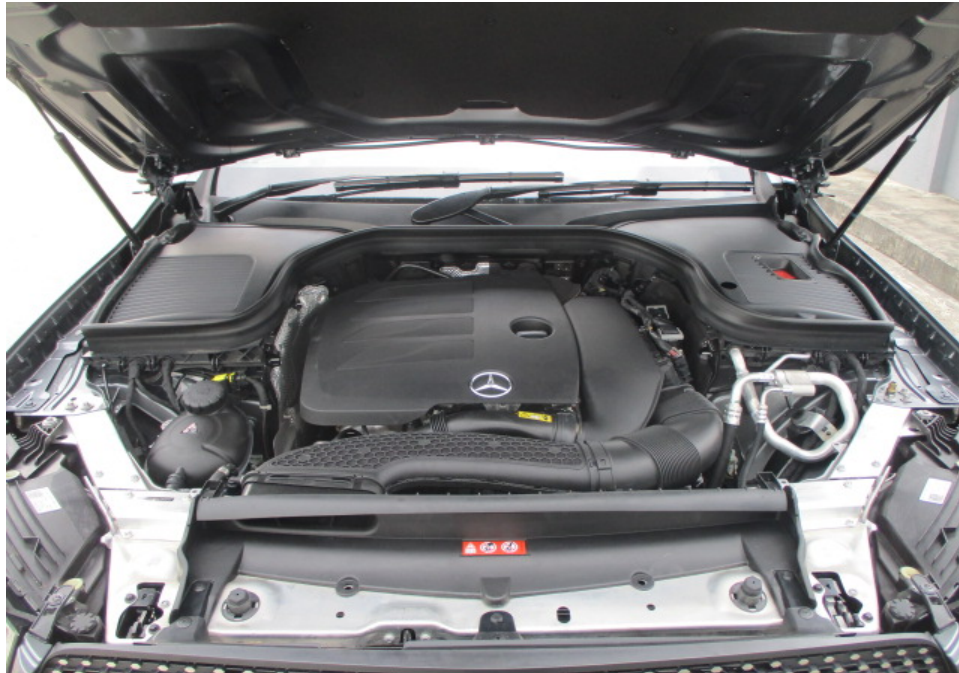
**Photo 14** shows a general view of the engine compartment of the Motor Car at the time of my inspection. The various parts and components inside the engine compartment were all observed to be intact and properly fitted. There was also no sign(s) or indication(s) of fluid leak and/or fluid stain found inside the engine compartment.

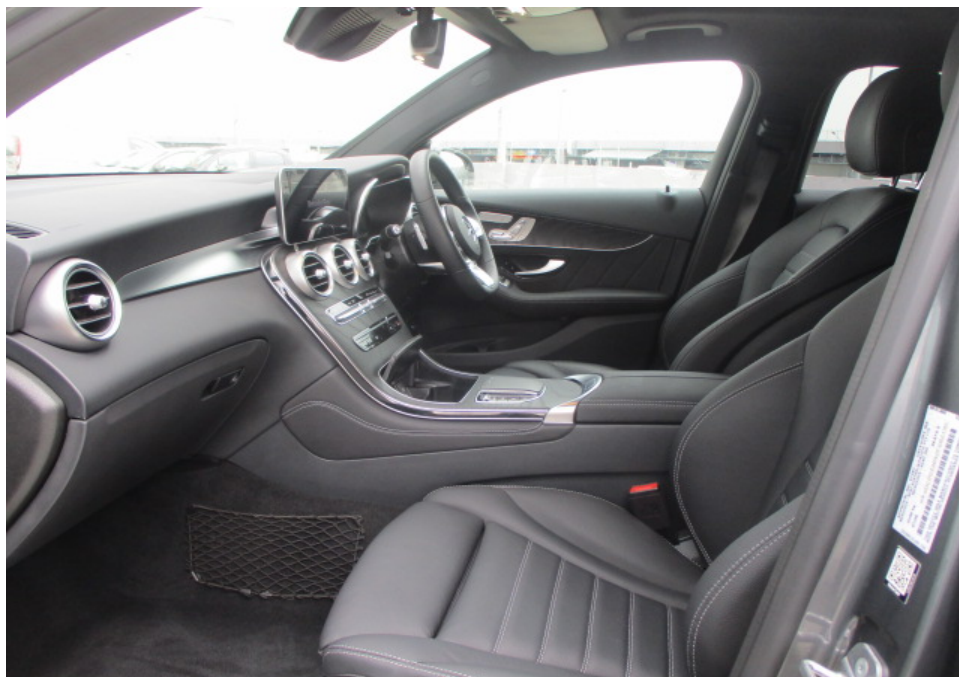
**Photo 15** shows the interior compartment of the Motor Car at the time of my inspection. The various parts and components, trims, carpet, and upholstery inside the interior compartment were all observed to be intact and properly fitted.

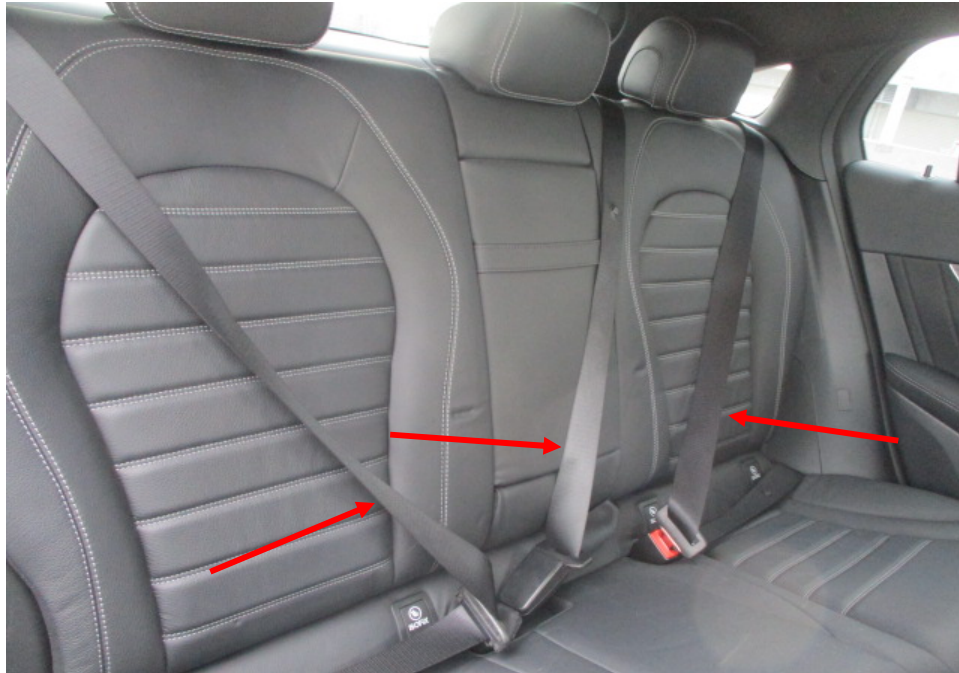
**Photo 16** shows the rear seats of the Motor Car. All the seats of the Motor Car were secured via seat rails to the floorboard. They were also fitted with a retractable seat belt reel and a pre-tensioner. The seat belts (arrowed) were tested and were able to be fastened into the respective pre-tensions that were fitted on the side of each individual seat.

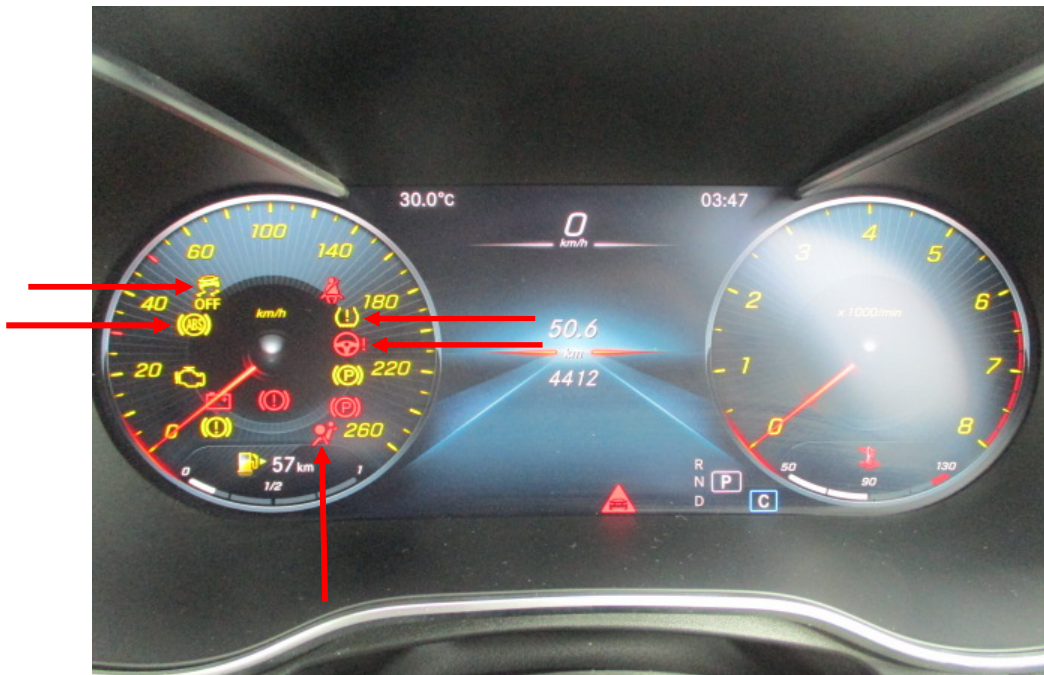
**Photo 17** shows the warning lights for the various electronic safety features appearing on the instrument panel of the Motor Car during its self-test when the engine is cranked, in particular the ABS, SRS, EPS, TPM and TCS lights (arrowed).

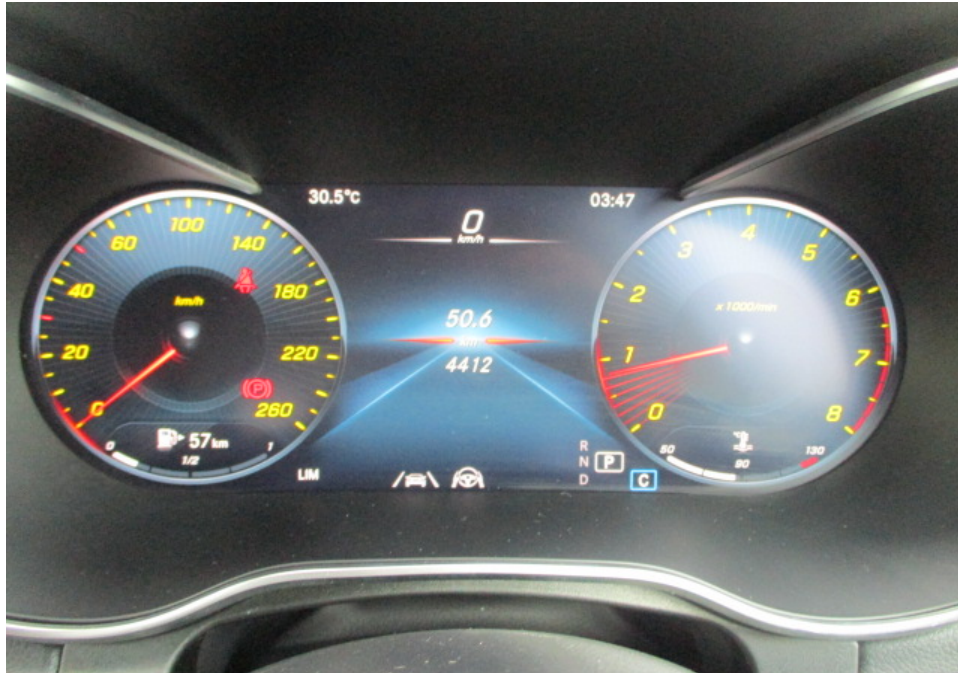
**Photo 18** shows the respective warning lights no longer illuminated, indicating that there is no fault detected to the ABS, SRS, EPS, TPM and TCS systems of the Motor Car during the self-test. These electronic systems were hence in working condition at the time of my inspection.

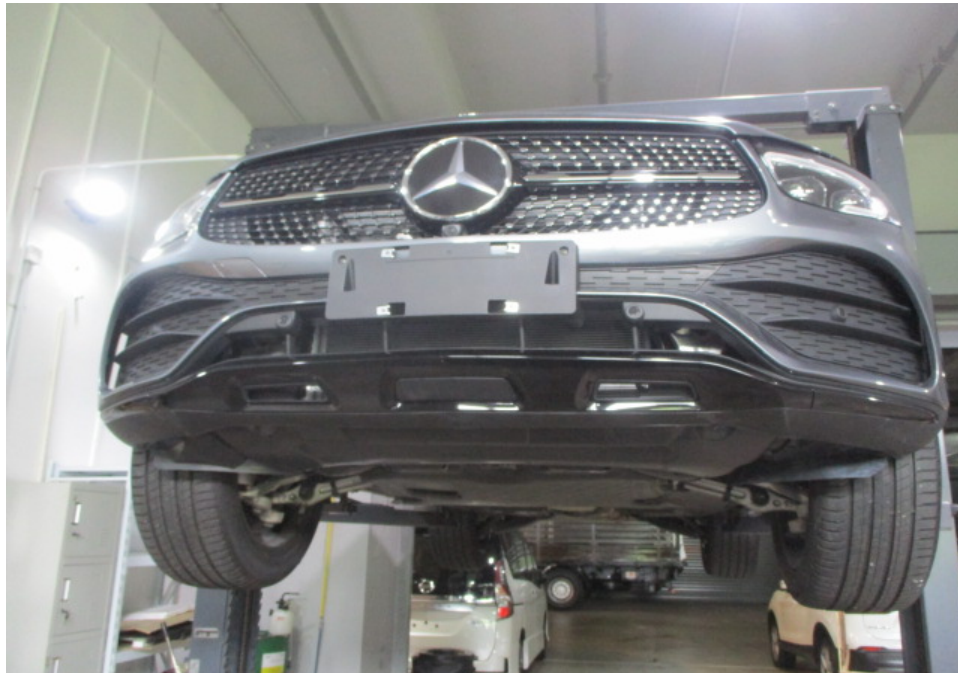
**Photo 19** shows the Motor Car hoisted up for checks on its undercarriage. There was no sign(s) or indication(s) of fluid leakage and/or fluid stain(s) on the underside of the Motor Car. The undercarriage components of the Motor Car were also all observed to be intact and secured in an appropriate manner.

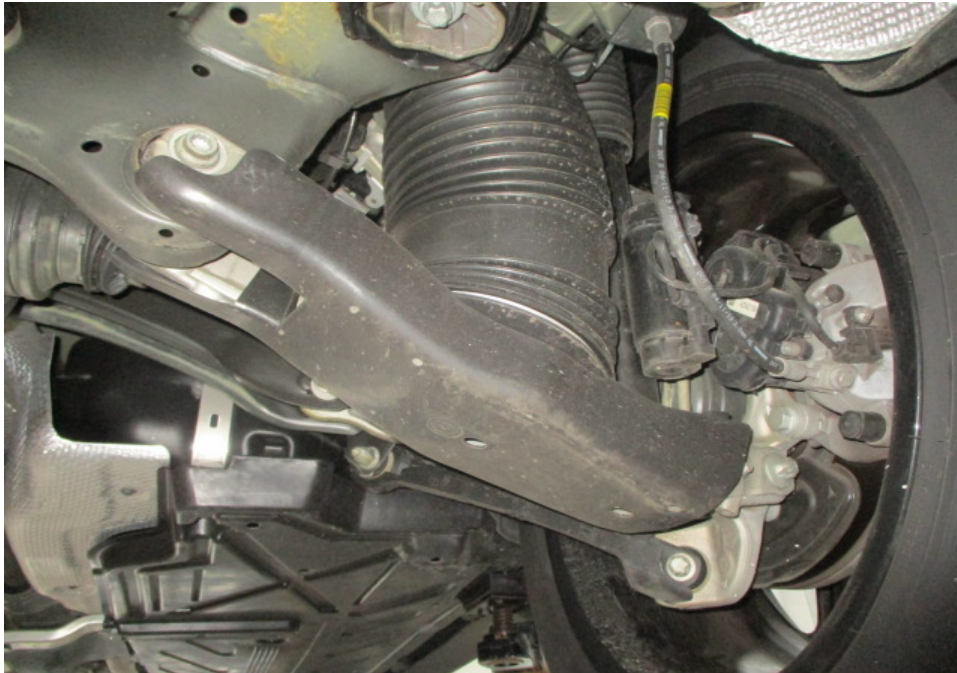
**Photo 20** shows a general view of the control arms and linkages at the rear right wheel of the Motor Car. I did not observe any fluid leak and/or fluid stain on the underside of the Motor Car. All of the Motor Car's undercarriage components were observed to be intact and secured in an appropriate manner.

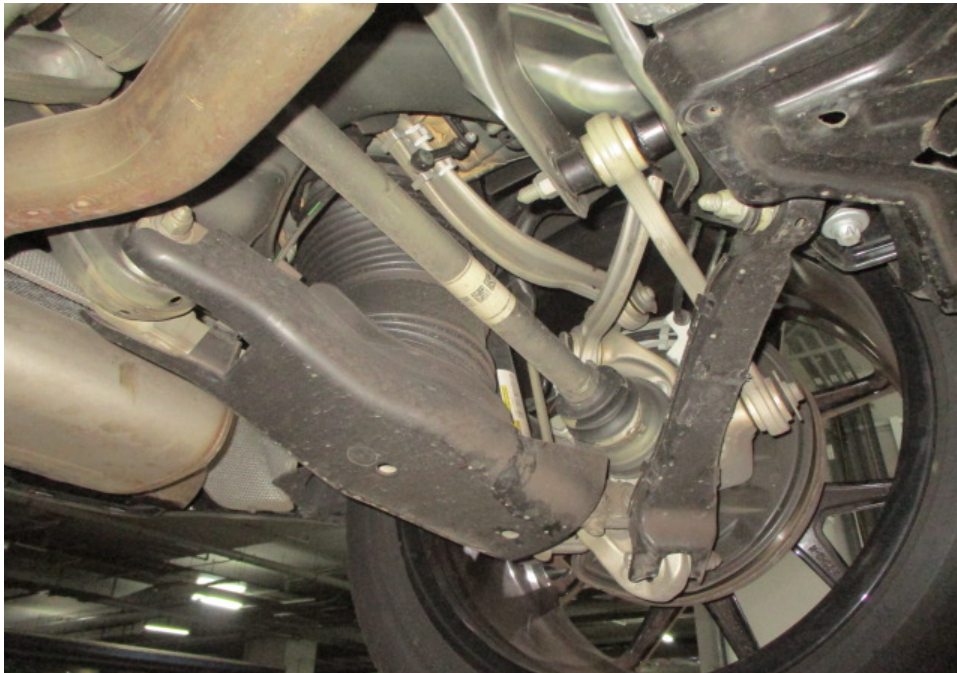
**Photo 21** shows a general view of the control arms and linkages at the rear left wheel of the Motor Car. I did not observe any fluid leak and/or fluid stain on the underside of the Motor Car. All of the Motor Car's undercarriage components were observed to be intact and secured in an appropriate manner.

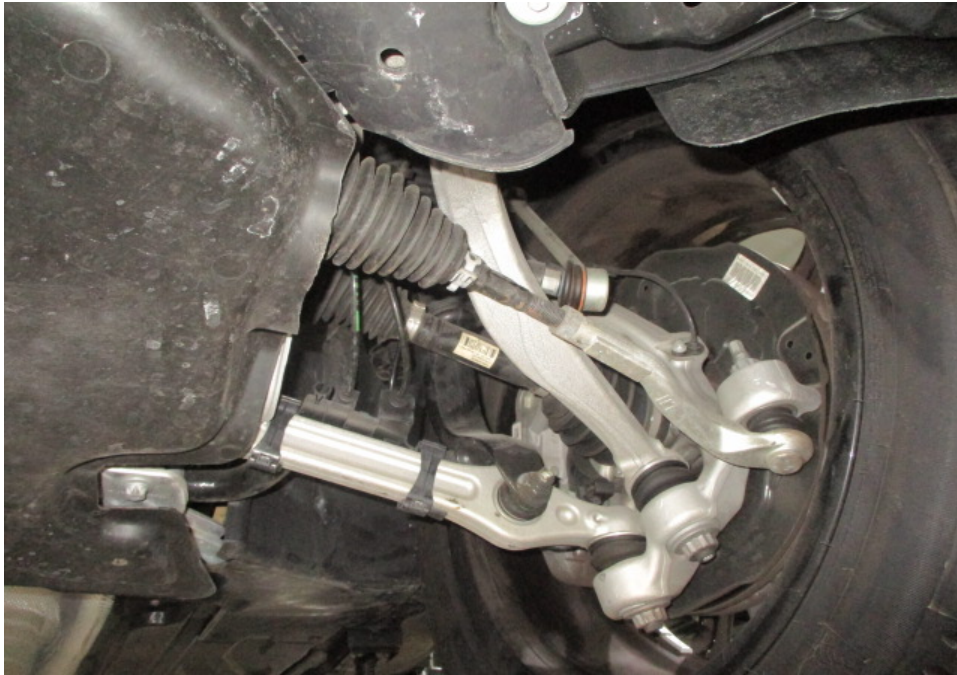
**Photo 22** shows the various undercarriage components at the front left wheel of the Motor Car. The mechanical components, control arms and linkages were all found to be intact and secured in an appropriate manner.

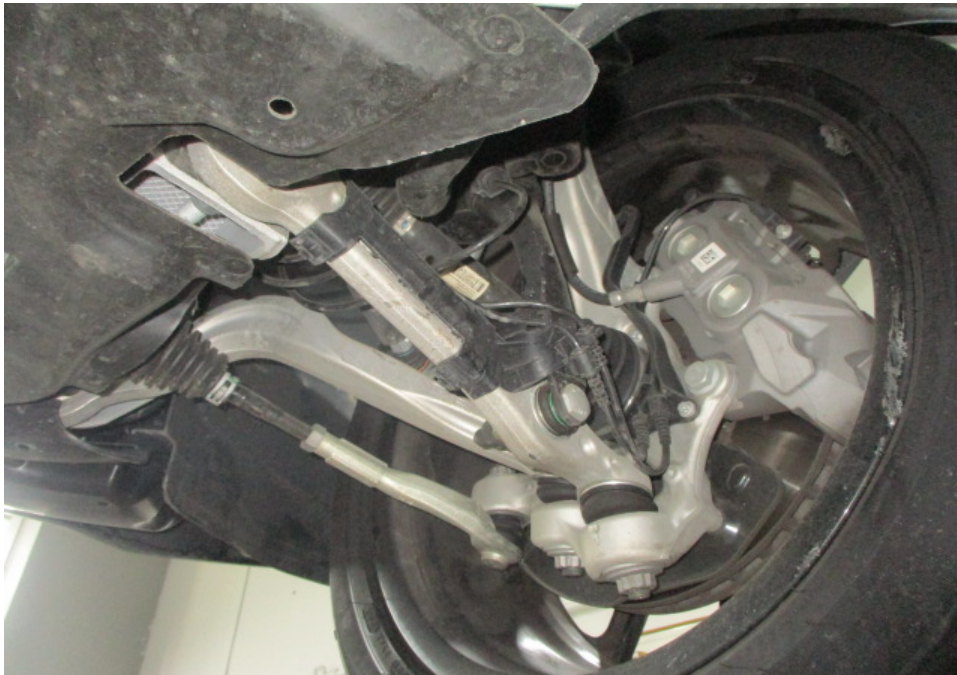
**Photo 23** shows the various undercarriage components at the front right wheel of the Motor Car. The mechanical components, control arms and linkages were all found to be intact and secured in an appropriate manner. I also did not observe any fluid leak and/or fluid stain on the underside of the Motor Car.

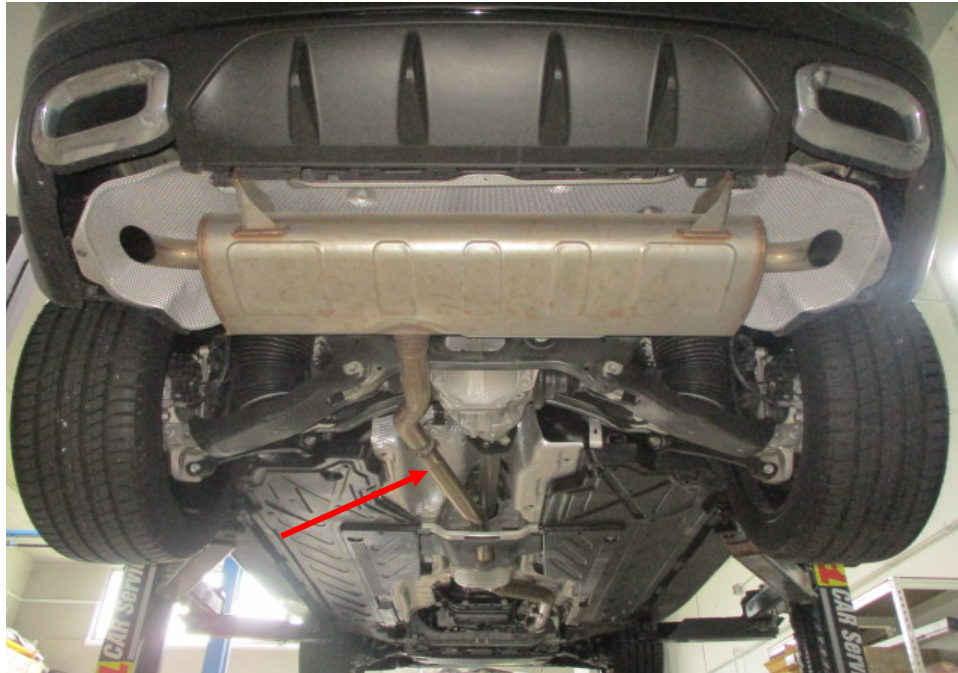
**Photo 24** shows the rear section of the Motor Car's exhaust system. My examination of the Motor Car's exhaust system revealed no sign(s) or indication(s) of any cut or weld marks along its exhaust pipes (arrowed), on its rear muffler, on its centre resonator box and on its catalytic converter.

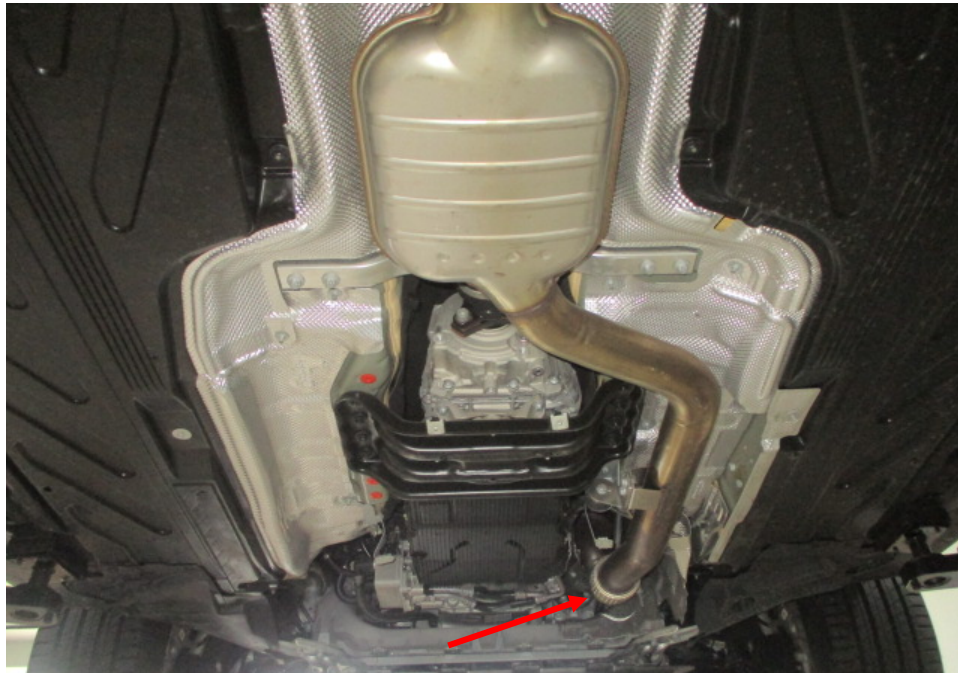
**Photo 25** shows the front section of the Motor Car's exhaust system. My examination of the Motor Car's exhaust system revealed no sign(s) or indication(s) of any cut or weld marks along its exhaust pipes, on its rear muffler, on its centre resonator box and on its catalytic converter (arrowed).

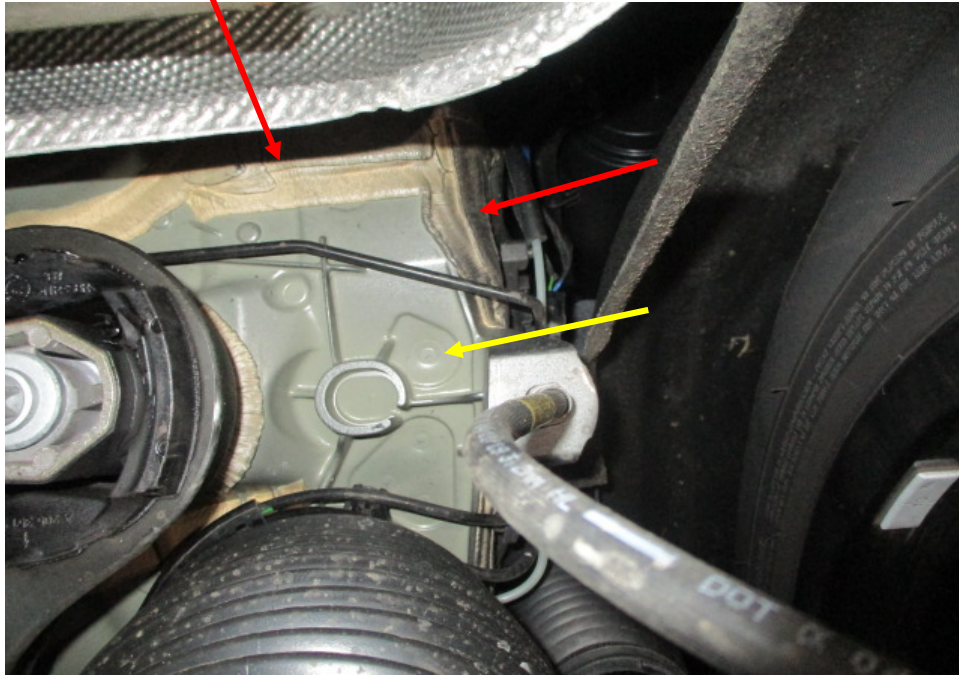
**Photo 26** shows the chassis/structural body at the underside rear right of the Motor Car. I did not find any weld marks other than original spot weld marks (yellow arrow) on the chassis/structural body of the Motor Car. The original factory sealant (red arrow) at the joints along the chassis/structural body was untouched, indicating no work was done on the chassis/structural body of the Motor Car and that the chassis/structural body was originally fitted.

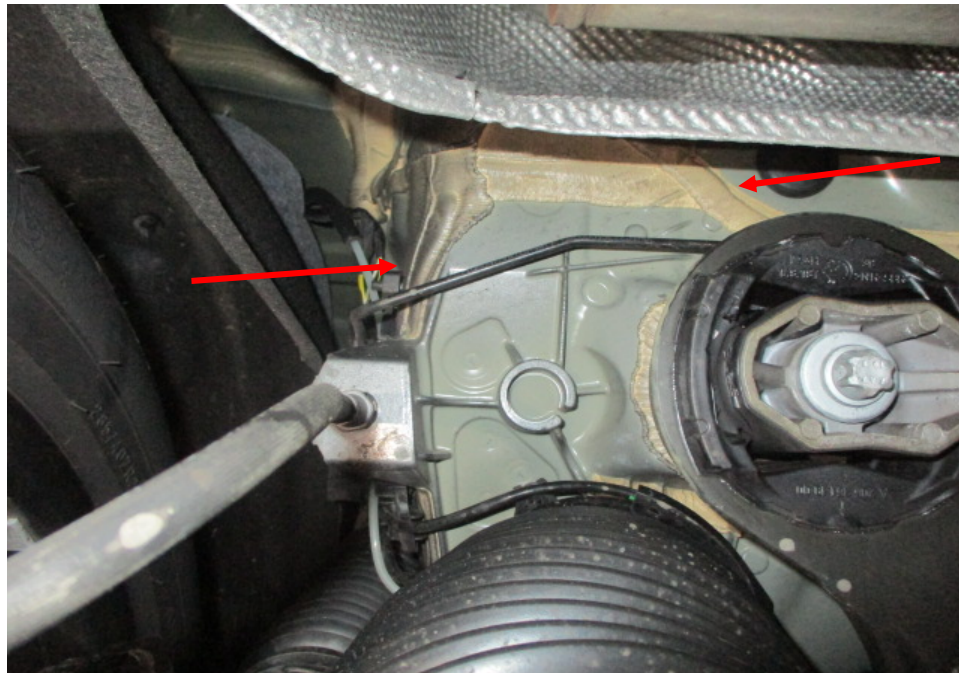
**Photo 27** shows the chassis/structural body at the underside rear left of the Motor Car. The original factory sealant (arrowed) at the joints along the chassis/structural body was observed to be untouched. In general, I had found no work was carried out on the chassis/structural body of the Motor Car. The chassis/structural body of the Motor Car was originally fitted.

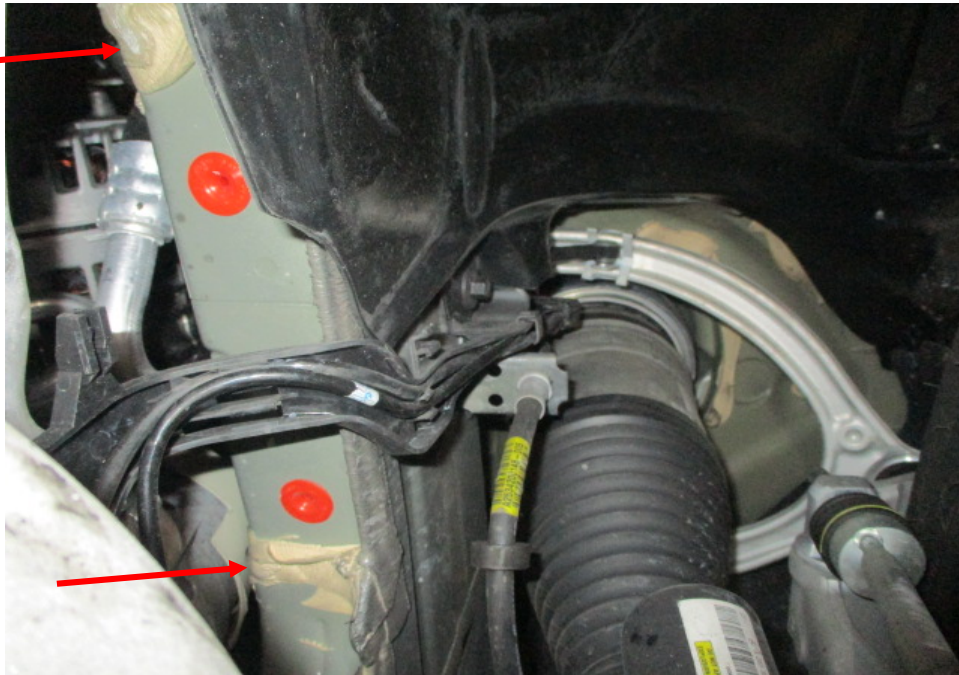
**Photo 28** shows the chassis/structural body at the underside front left of the Motor Car. I did not find any weld marks other than original spot weld marks on the chassis/structural body of the Motor Car. The original factory sealant (arrowed) at the joints along the chassis/structural body was untouched, indicating no work was done on the chassis/structural body of the Motor Car and that the chassis/structural body was originally fitted.

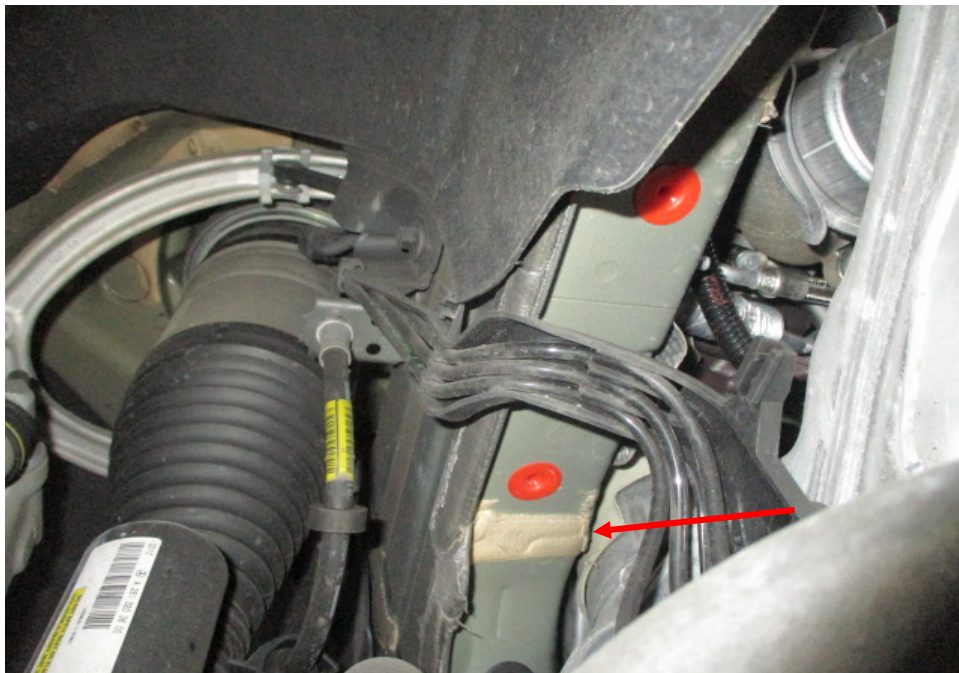
**Photo 29** shows the chassis/structural body at the underside front right of the Motor Car. The original factory sealant (arrowed) at the joints along the chassis/structural body was observed to be untouched. In general, I had found no work was carried out on the chassis/structural body of the Motor Car. The chassis/structural body of the Motor Car was originally fitted.

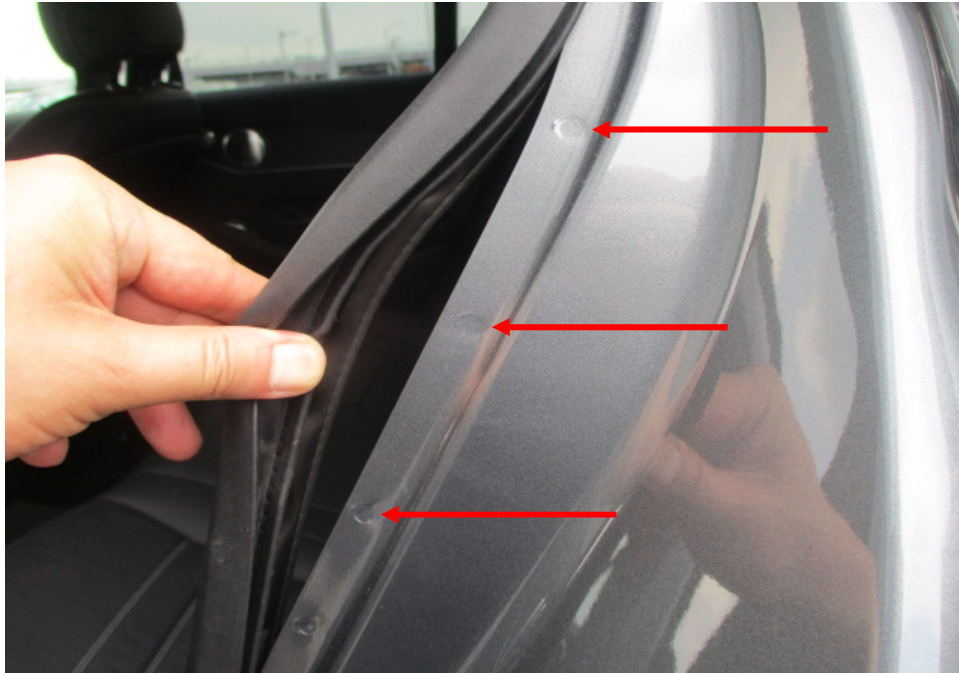
**Photo 30** shows the left side “C” pillar of the Motor Car. I did not find any weld marks other than original spot weld marks (arrowed) on the left side “C” pillar of the Motor Car which, indicates that there was no re-welding works carried out. In general, I had found all the non-detachable body panels of the Motor Car to be originally fitted at the time of my inspection.
