Your Ref: Mercedes Benz GLC 300  
(chassis number WDC2533842F682195)  
Our Ref : CI/TP22002984/D

30 March 2022

**INSPECTION REPORT OF AN UNREGISTERED MERCEDES BENZ GLC 300  
MOTOR CAR WITH CHASSIS NUMBER WDC2533842F682195**

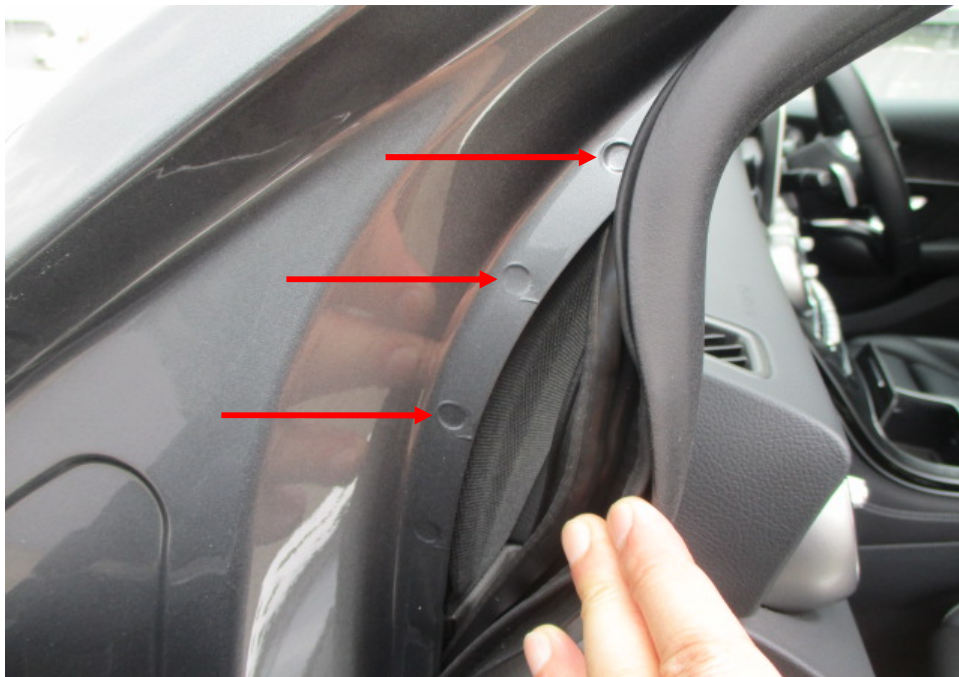
**Photo 31** shows the left side “A” pillar of the Motor Car. I did not find any weld marks other than original spot weld marks (arrowed) on the left side “A” pillar of the Motor Car which, indicates that there was no re-welding works carried out. In general, I had found all the non-detachable body panels of the Motor Car to be originally fitted at the time of my inspection.

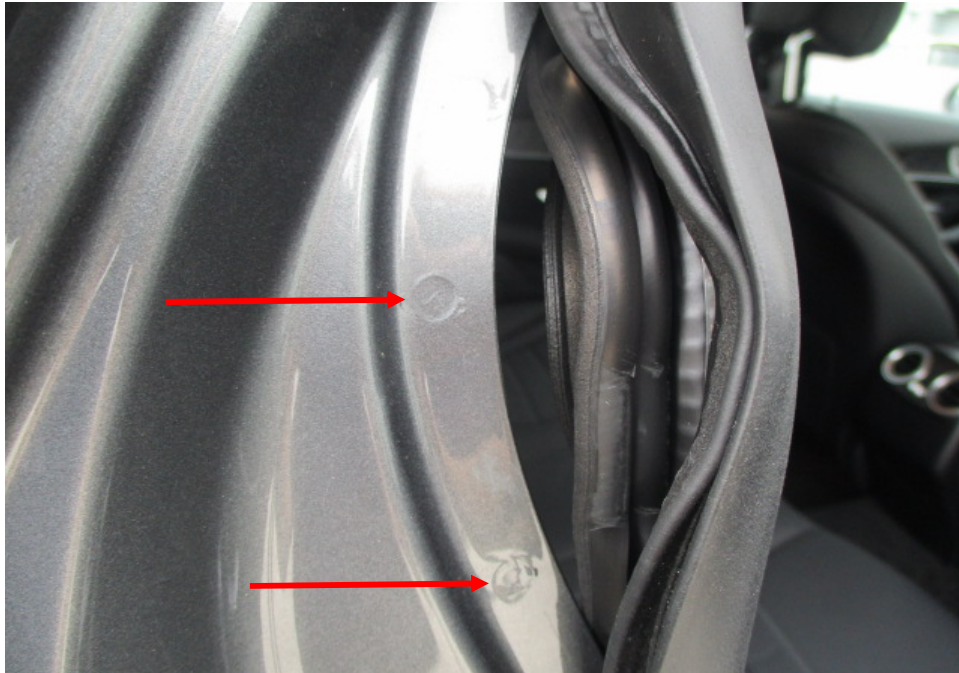
**Photo 32** shows the right side “C” pillar of the Motor Car. I did not find any weld marks other than original spot weld marks (arrowed) on the right side “C” pillar of the Motor Car which, indicates that there was no re-welding works carried out. In general, I had found all the non-detachable body panels of the Motor Car to be originally fitted at the time of my inspection.
