Your Ref: Porsche Panamera  
(chassis number WP0ZZZ97ZKL170075)  
Our Ref : CI/TP22002985/D

31 March 2022

**INSPECTION REPORT OF AN UNREGISTERED PORSCHE PANAMERA  
MOTOR CAR WITH CHASSIS NUMBER WP0ZZZ97ZKL170075**

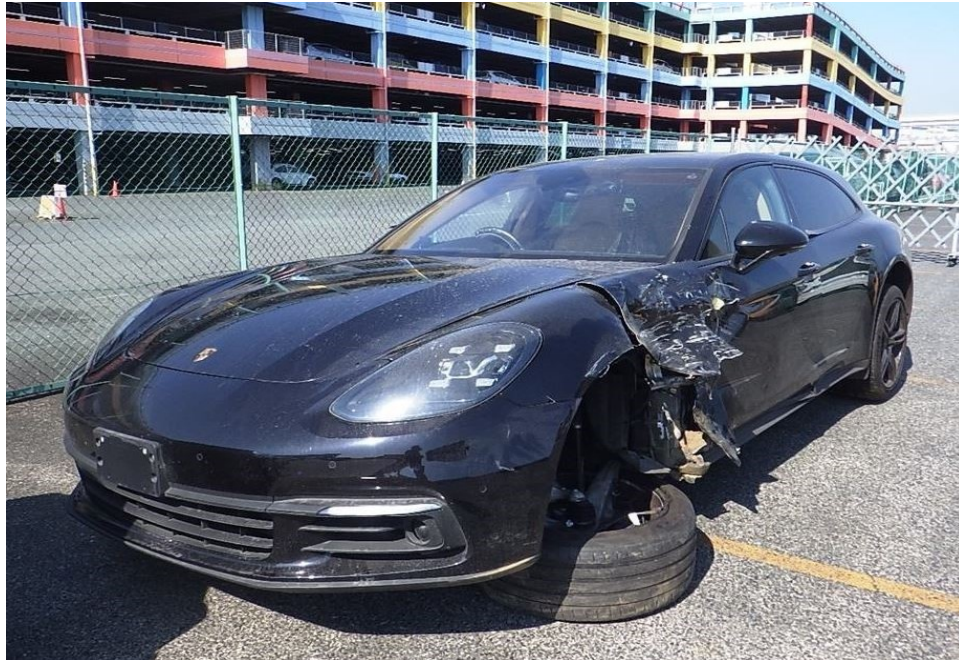
3. The photographs provided to me had showed damage to the left side front portion and right side front portion of the Motor Car. Body parts damaged at the left side front portion include the front left fender, front left door, front left wheel rim and left side rocker panel garnish amongst others. The undercarriage parts at the front left wheel like the front left knuckle arm, front left lower arm, front left upper arm, front left shock absorber and front left steering tie rod end amongst others, were also likely to be damaged given that the front left wheel was seen to be dislodged from the Motor Car.

**Photo 1** shows the front left body of the Motor Car (photograph provided to me). The photographs provided to me had showed damage to the left side front portion of the Motor Car. The front left fender, front left door, front left wheel rim and left side rocker panel garnish were amongst the body parts that were observed to have been damaged. The undercarriage parts at the front left wheel were also likely to have been damaged given that the front left wheel was seen to be dislodged from the Motor Car.

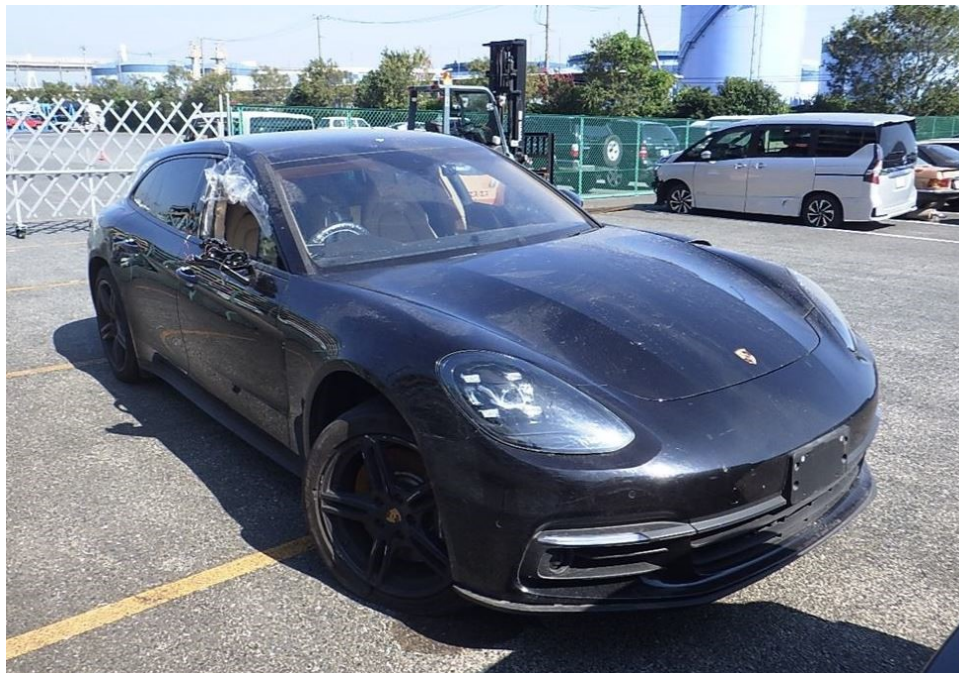
4. As for the right side front portion, I had observed damage to the Motor Car's front right door, front right door glass window and right side wing mirror amongst others.

**Photo 2** shows the front right body of the Motor Car (photograph provided to me). Apart for the left side front portion, I had also observed damage to the right side front portion of the Motor Car. The front right door, front right door glass window and right side wing mirror amongst others were observed to have been damaged.

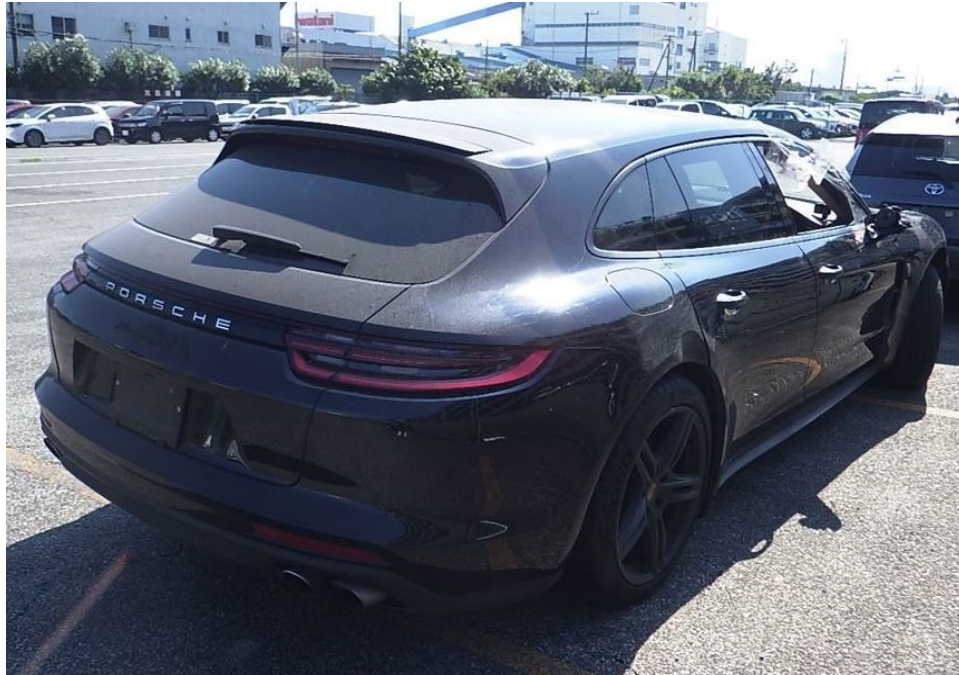
**Photo 3** shows the rear right body of the Motor Car (photograph provided to me). There was no physical damage seen to the Motor Car's rear portion.

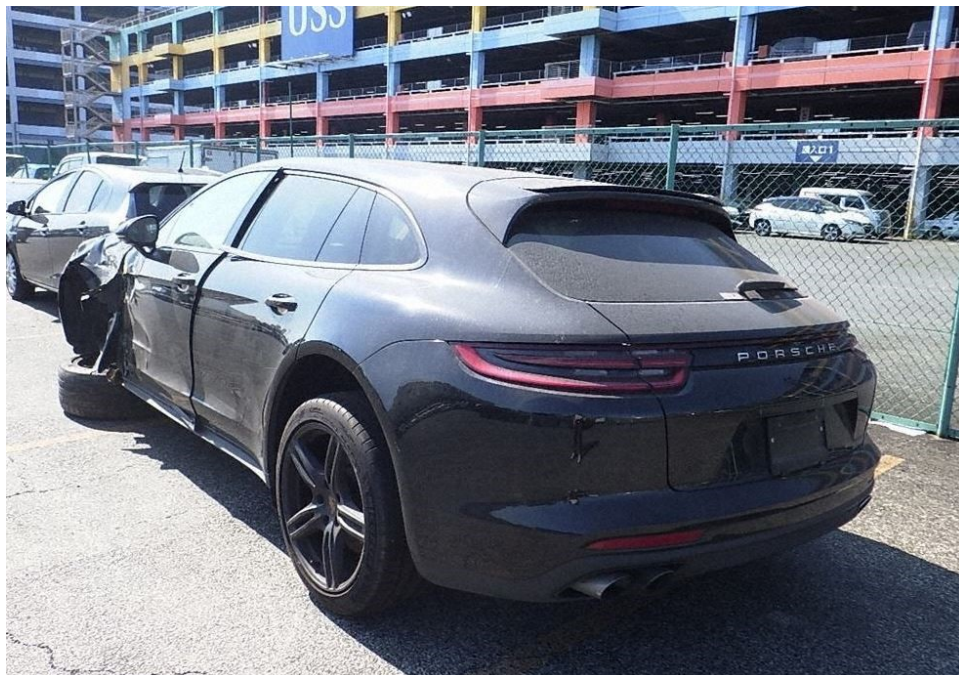
**Photo 4** shows the rear left body of the Motor Car (photograph provided to me). There was no physical damage seen to the Motor Car's rear portion.

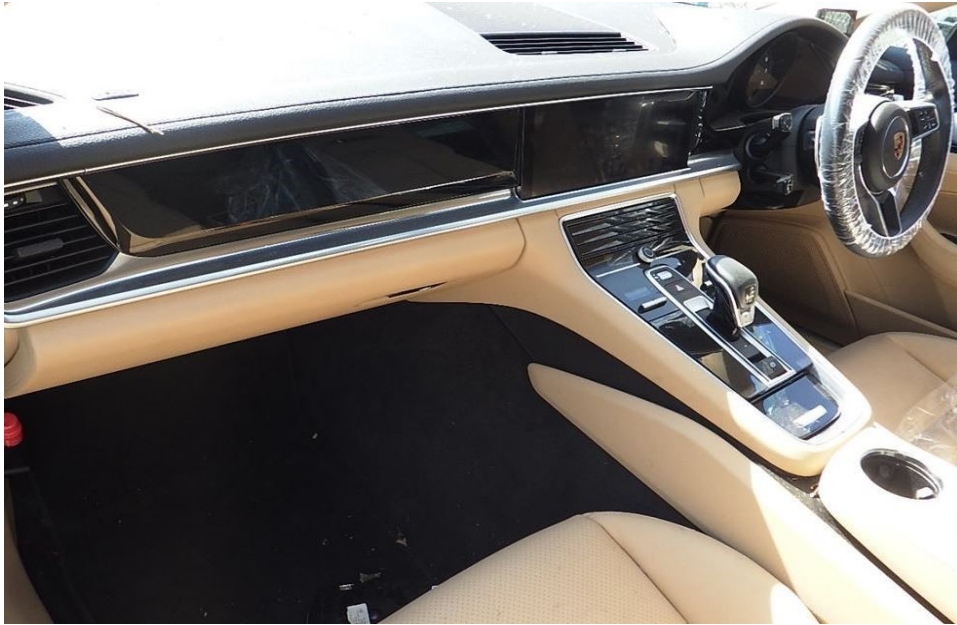
**Photo 5** shows the interior compartment of the Motor Car (photograph provided to me). The various parts and components within the interior compartment were all intact and unaffected. The airbag(s) was not deployed as seen from the photographs that were provided to me.

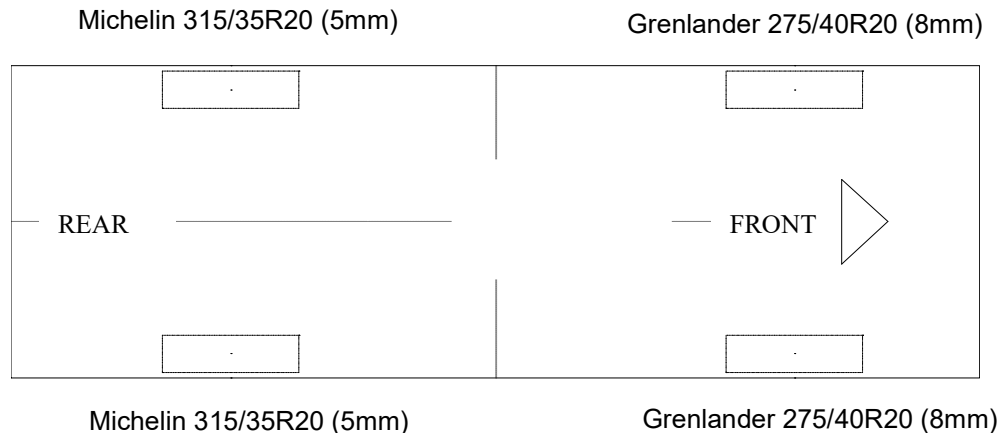
9. It was fitted with 20inch sport wheel rims that were wrapped with tyres that were observed to be of serviceable condition. The tyres were also sufficiently inflated for vehicular operation. The tyre brand, tyre size and approximate remaining tread depth of the 4 tyres of the Motor Car were recorded as follows: -

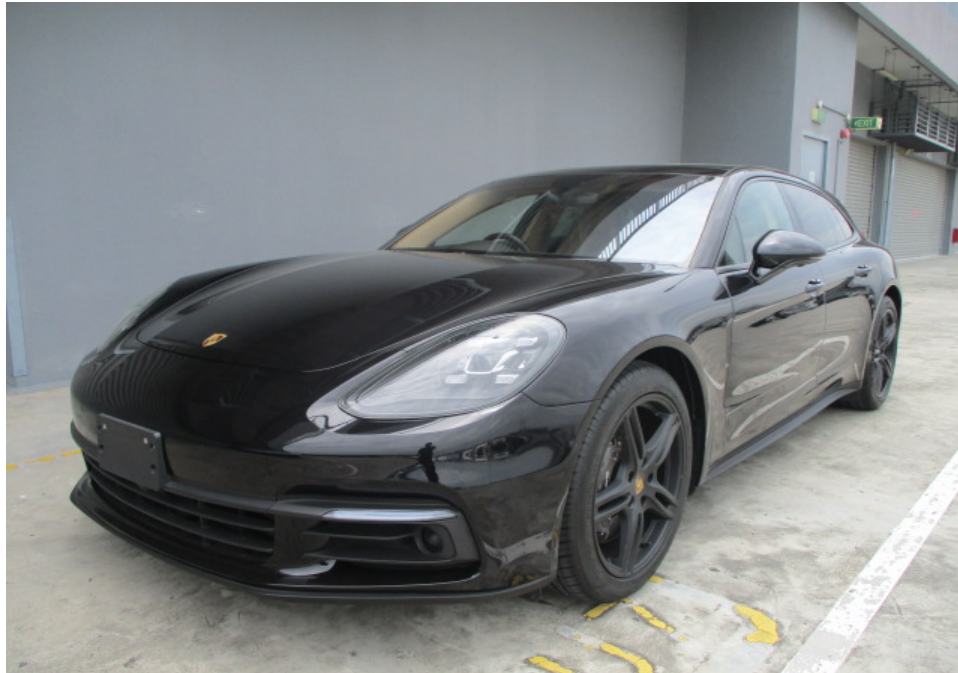
**Photo 6** shows a general view of the front left body of the Motor Car at the time of my inspection. The Motor Car was observed to be in a relatively good general condition with no loose exterior fittings observed. The body parts at the left side front portion of the Motor Car were visually examined and it was observed that the repair/restoration works carried out to the damaged area of the Motor Car (refer to photograph 1 above) were reasonably adequate and in order.

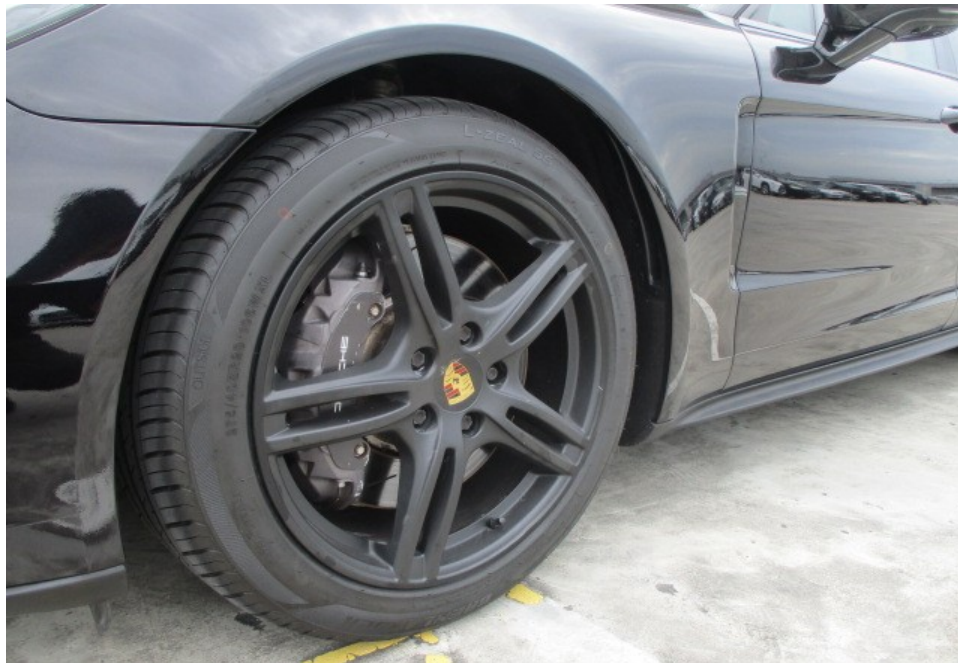
**Photo 7** shows a closer view of the Motor Car's front left fender, front left wheel rim and front left door. The body parts at the left side front portion of the Motor Car were visually examined and it was observed that the repair/restoration works carried out to the damaged area of the Motor Car (refer to photograph 1 above) were reasonably adequate and in order.

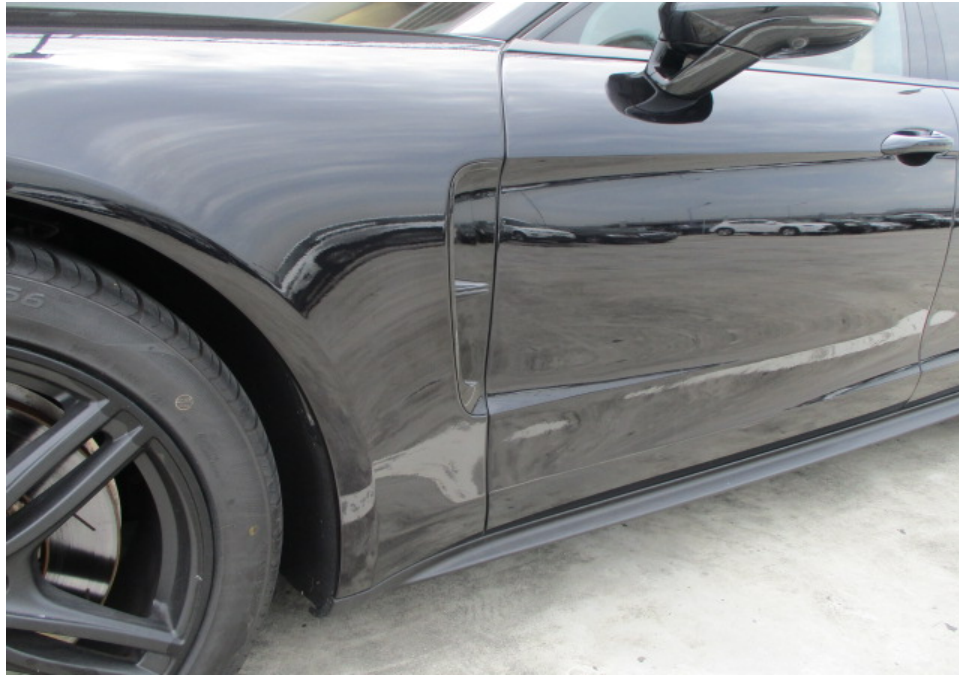
**Photo 8** shows a closer view of the Motor Car's front left fender, front left door and left side rocker panel garnish. The body parts at the left side front portion of the Motor Car were visually examined and it was observed that the repair/restoration works carried out to the damaged area of the Motor Car (refer to photograph 1 above) were reasonably adequate and in order.

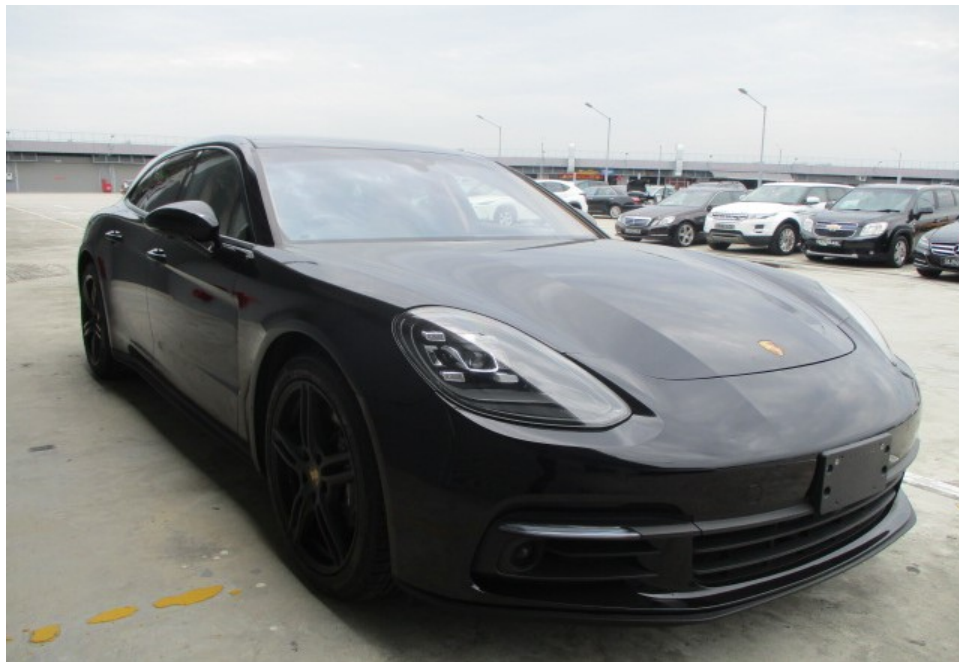
**Photo 9** shows a general view of the front right body of the Motor Car at the time of my inspection. The Motor Car was observed to be in a relatively good general condition with no loose exterior fittings observed. The body parts at the right side front portion of the Motor Car were visually examined and it was observed that the repair/restoration works carried out to the damaged area of the Motor Car (refer to photograph 2 above) were reasonably adequate and in order.

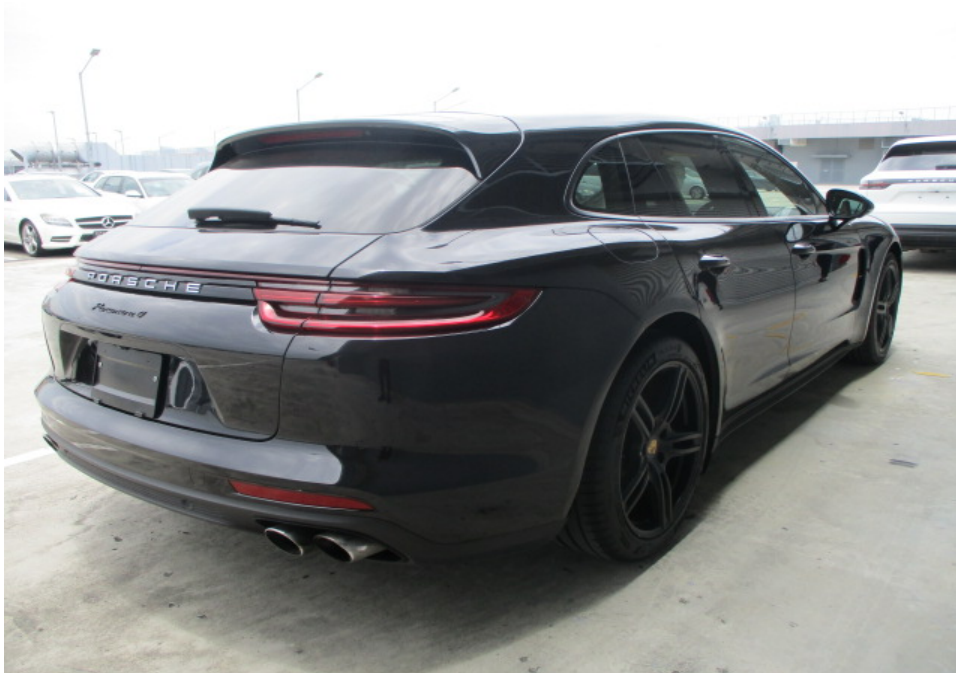
**Photo 10** shows a general view of the rear right body of the Motor Car at the time of my inspection. The Motor Car was observed to be in a relatively good general condition with no loose exterior fittings observed. The mileage of the Motor Car recorded at the time of my inspection was 38,971km.

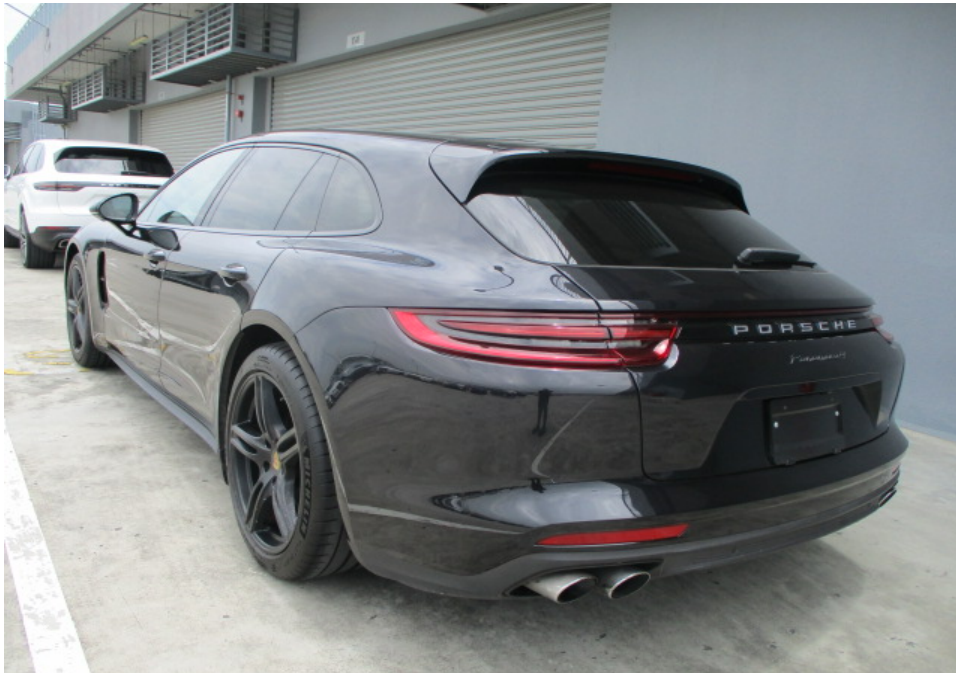
**Photo 11** shows a general view of the rear left body of the Motor Car at the time of my inspection. The Motor Car was observed to be in a relatively good general condition with no loose exterior fittings observed. The mileage of the Motor Car recorded at the time of my inspection was 38,971km.

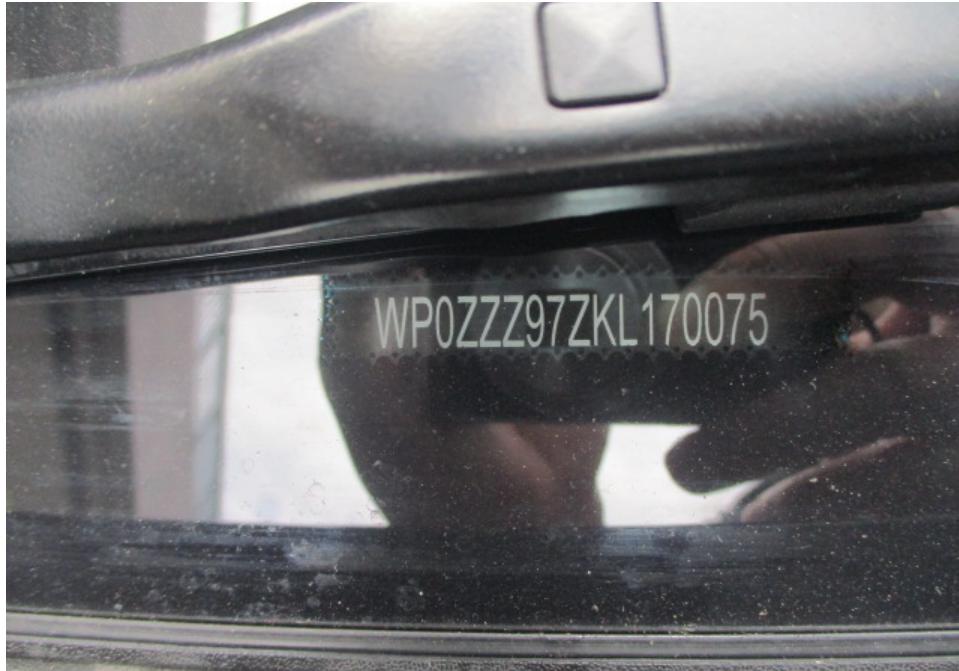
**Photo 12** shows the chassis number of the Motor Car. The chassis number recorded was WP0ZZZ97ZKL170075.

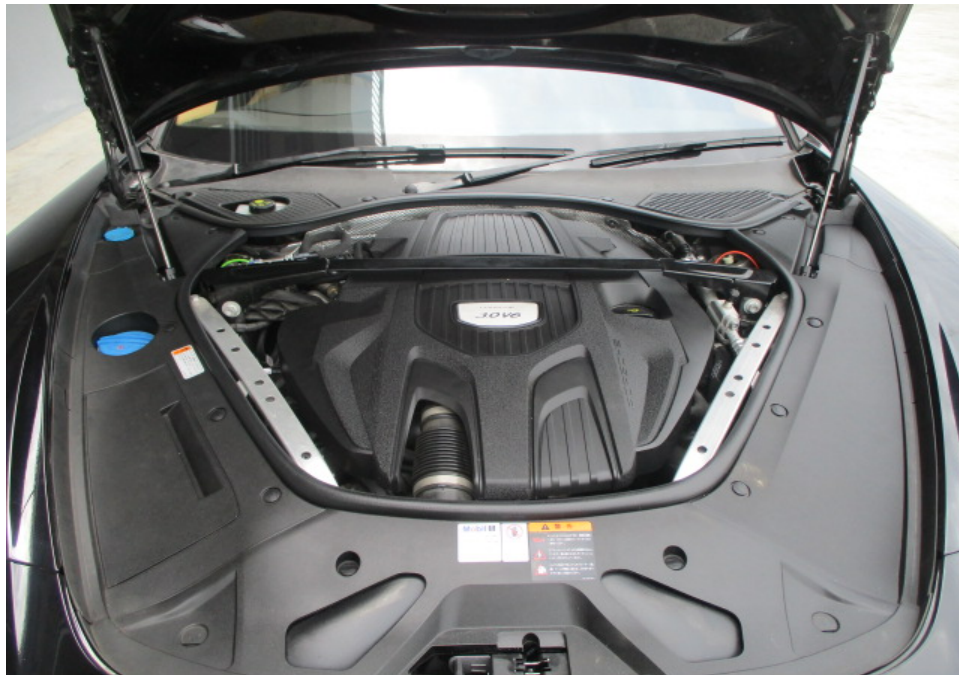
**Photo 13** shows a general view of the engine compartment of the Motor Car at the time of my inspection. The various parts and components inside the engine compartment were all observed to be intact and properly fitted. There was also no sign(s) or indication(s) of fluid leak and/or fluid stain found inside the engine compartment.

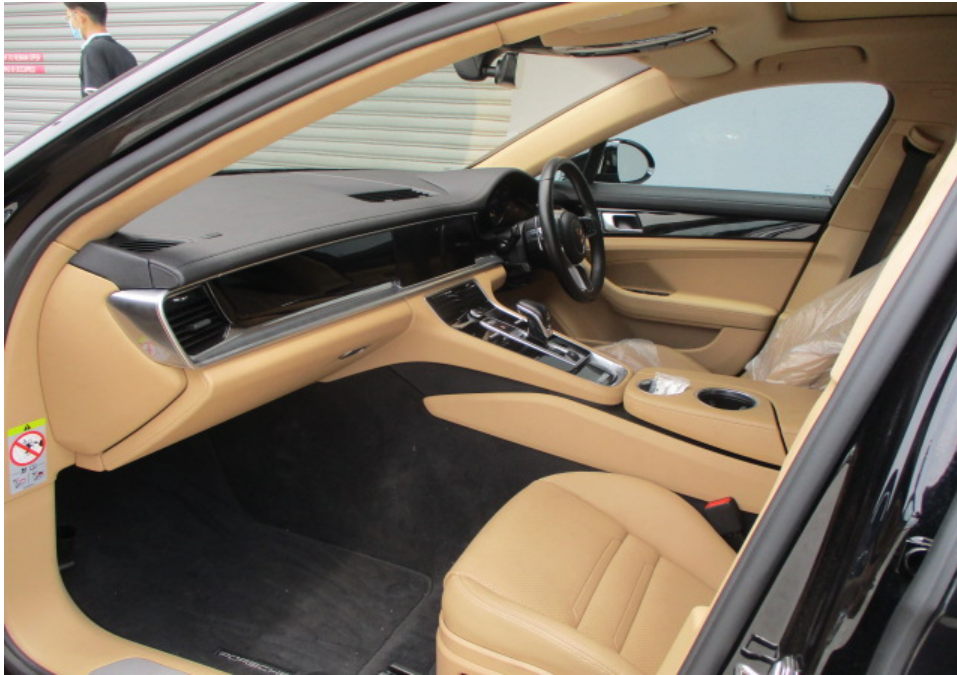
**Photo 14** shows the interior compartment of the Motor Car at the time of my inspection. The various parts and components, trims, carpet, and upholstery inside the interior compartment were all observed to be intact and properly fitted.

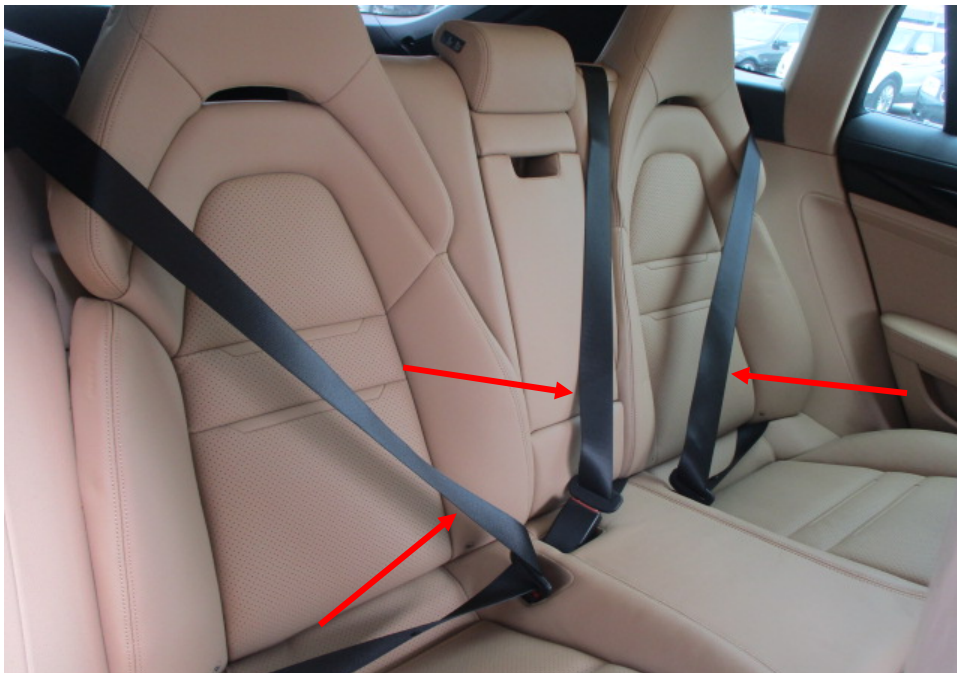
**Photo 15** shows the rear seats of the Motor Car. All the seats of the Motor Car were secured via seat rails to the floorboard. They were also fitted with a retractable seat belt reel and a pre-tensioner. The seat belts (arrowed) were tested and were able to be fastened into the respective pre-tensions that were fitted on the side of each individual seat.

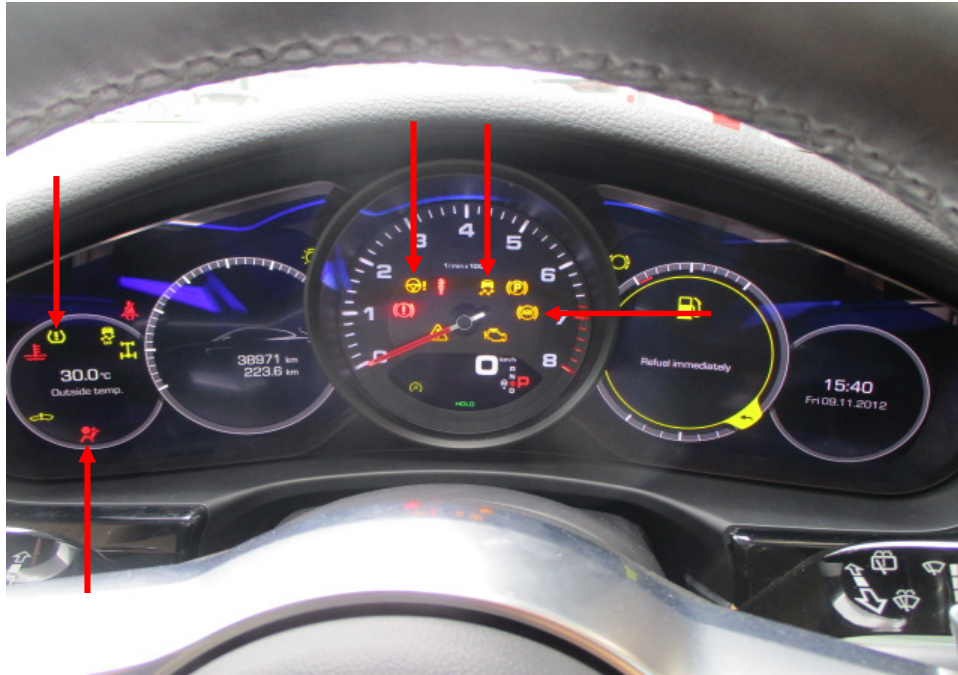
**Photo 16** shows the warning lights for the various electronic safety features appearing on the instrument panel of the Motor Car during its self-test when the engine is cranked, in particular the ABS, SRS, EPS, TPM and TCS lights (arrowed).

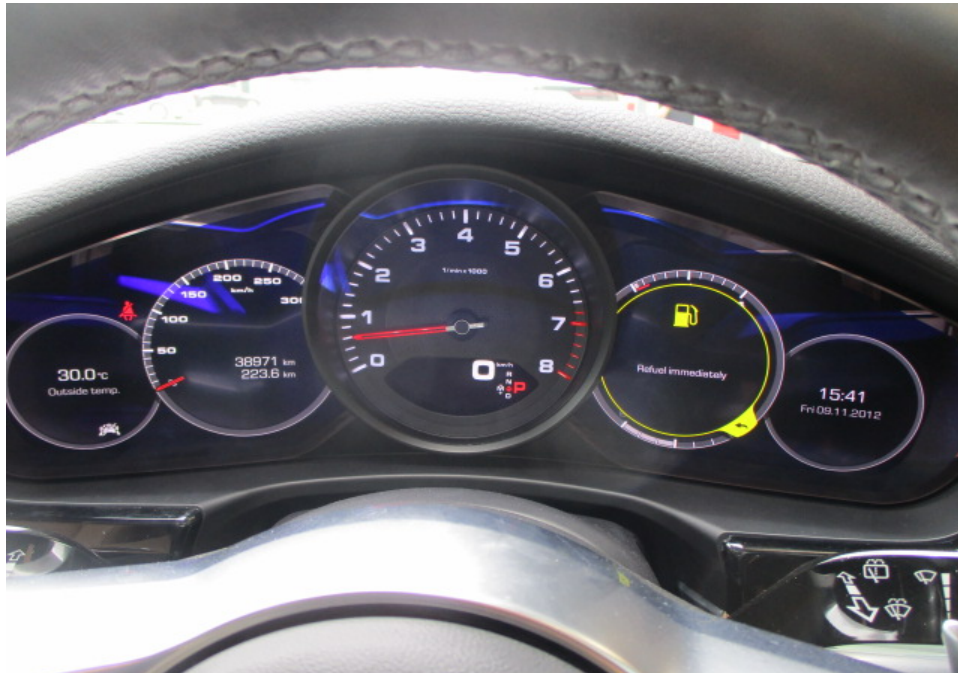
**Photo 17** shows the respective warning lights no longer illuminated, indicating that there is no fault detected to the ABS, SRS, EPS, TPM and TCS systems of the Motor Car during the self-test. These electronic systems were hence in working condition at the time of my inspection.

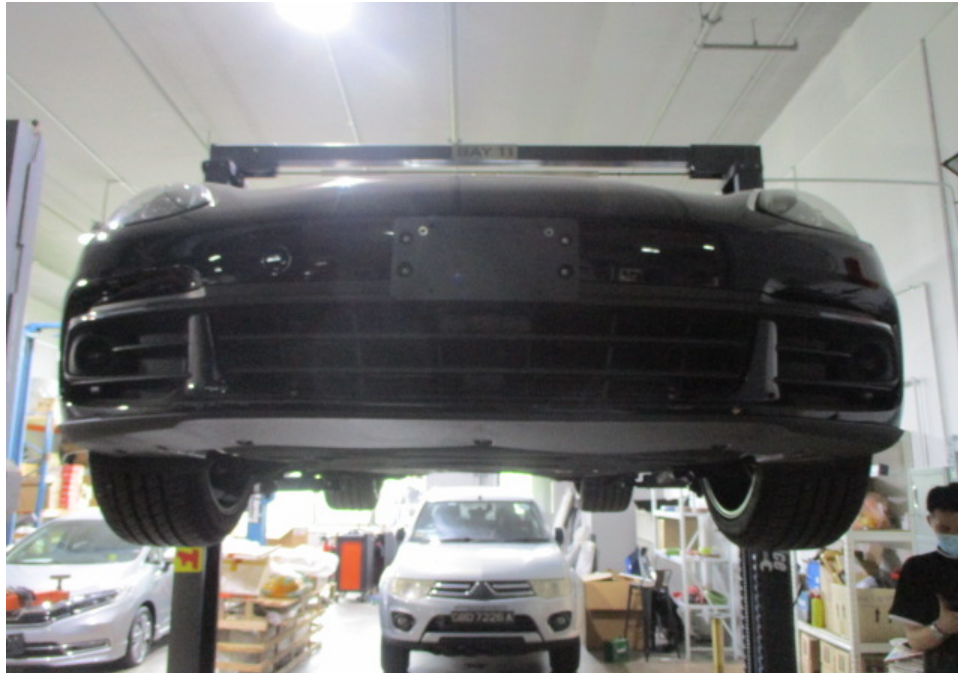
**Photo 18** shows the Motor Car hoisted up for checks on its undercarriage. There was no sign(s) or indication(s) of fluid leakage and/or fluid stain(s) on the underside of the Motor Car. The undercarriage components of the Motor Car were also all observed to be intact and secured in an appropriate manner.

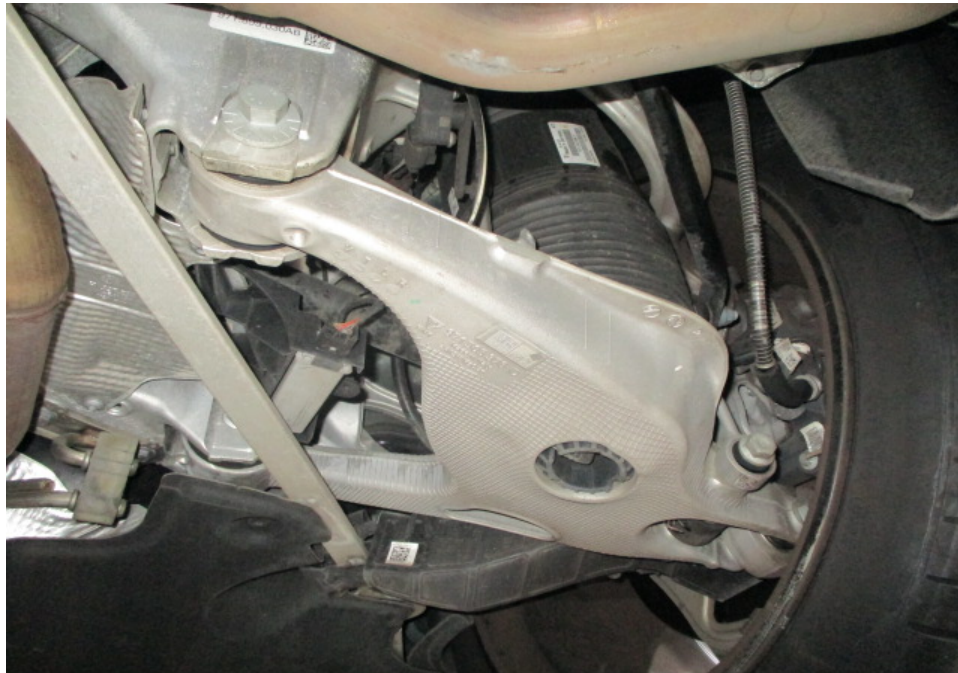
**Photo 19** shows a general view of the control arms and linkages at the rear right wheel of the Motor Car. I did not observe any fluid leak and/or fluid stain on the underside of the Motor Car. All of the Motor Car's undercarriage components were observed to be intact and secured in an appropriate manner.

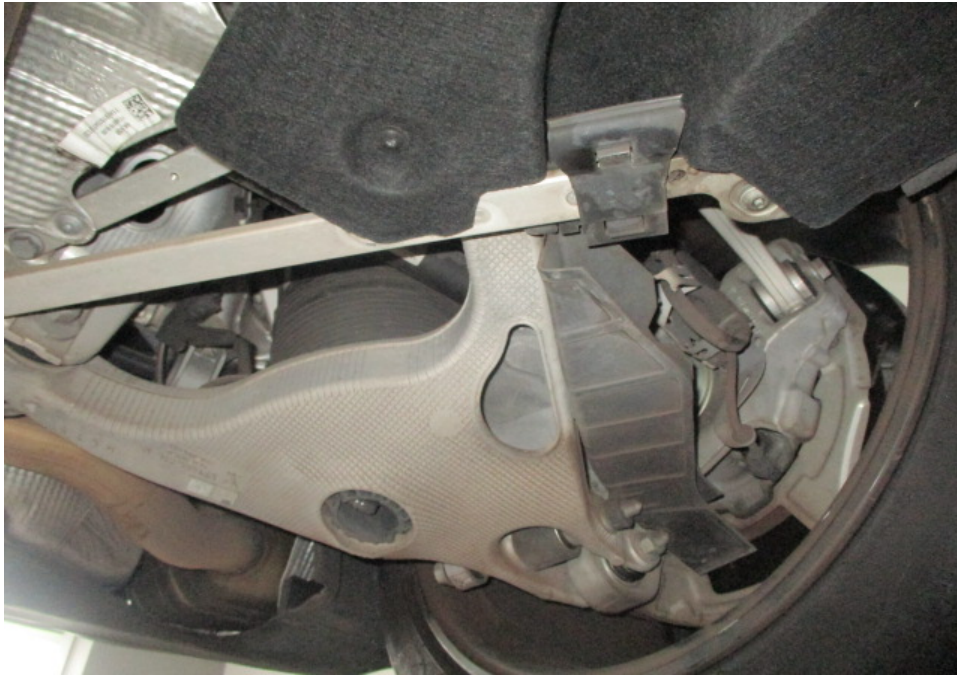
**Photo 20** shows a general view of the control arms and linkages at the rear left wheel of the Motor Car. I did not observe any fluid leak and/or fluid stain on the underside of the Motor Car. All of the Motor Car's undercarriage components were observed to be intact and secured in an appropriate manner.

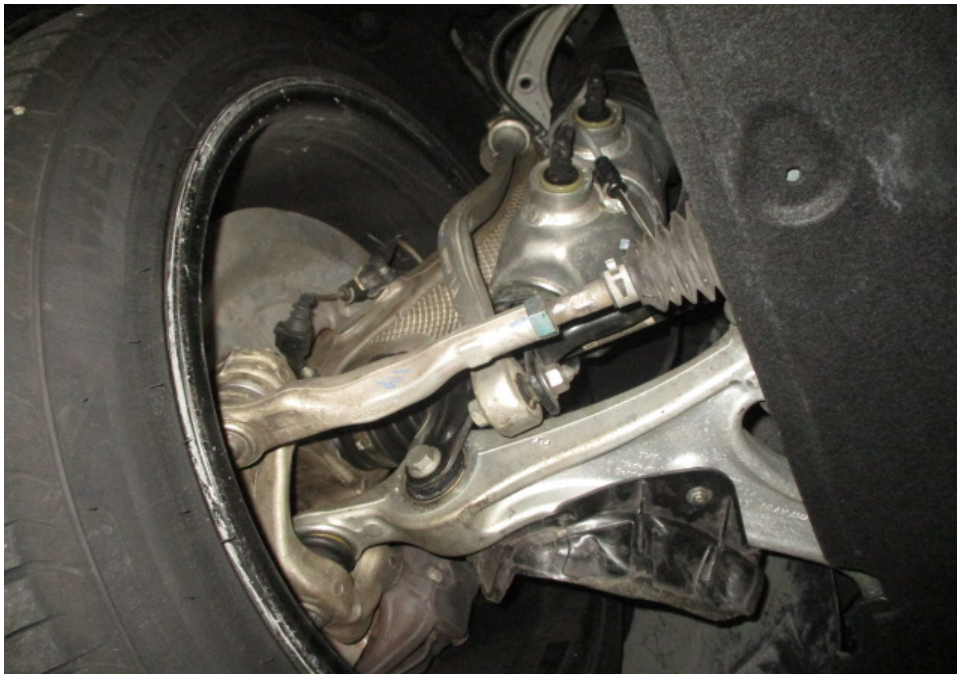
**Photo 21** shows the various undercarriage components at the front left wheel of the Motor Car. The mechanical components, control arms and linkages were all found to be intact and secured in an appropriate manner.

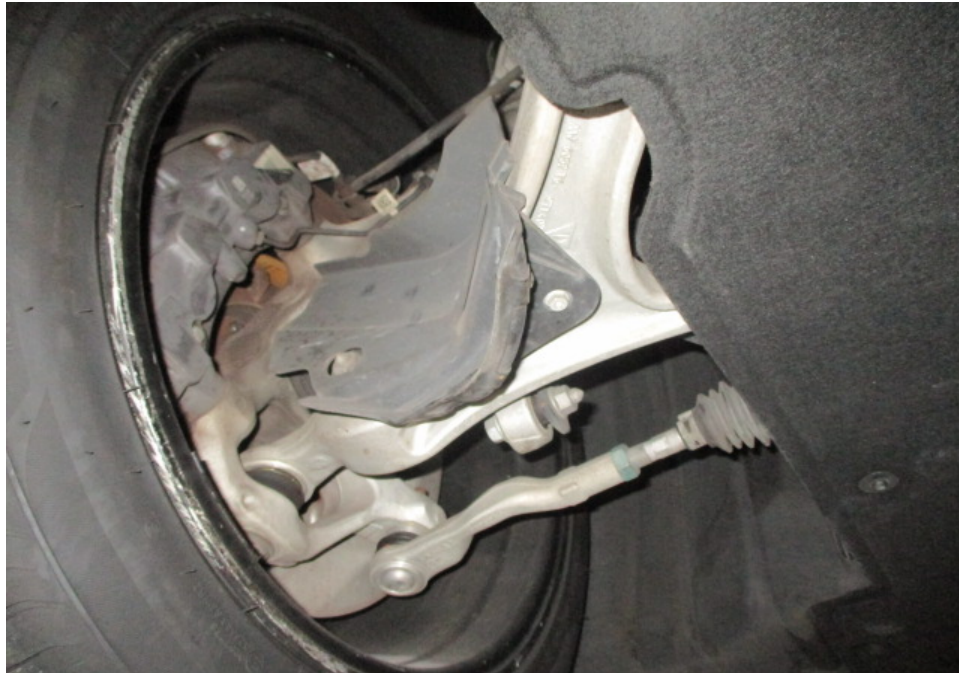
**Photo 22** shows the various undercarriage components at the front right wheel of the Motor Car. The mechanical components, control arms and linkages were all found to be intact and secured in an appropriate manner. I also did not observe any fluid leak and/or fluid stain on the underside of the Motor Car.

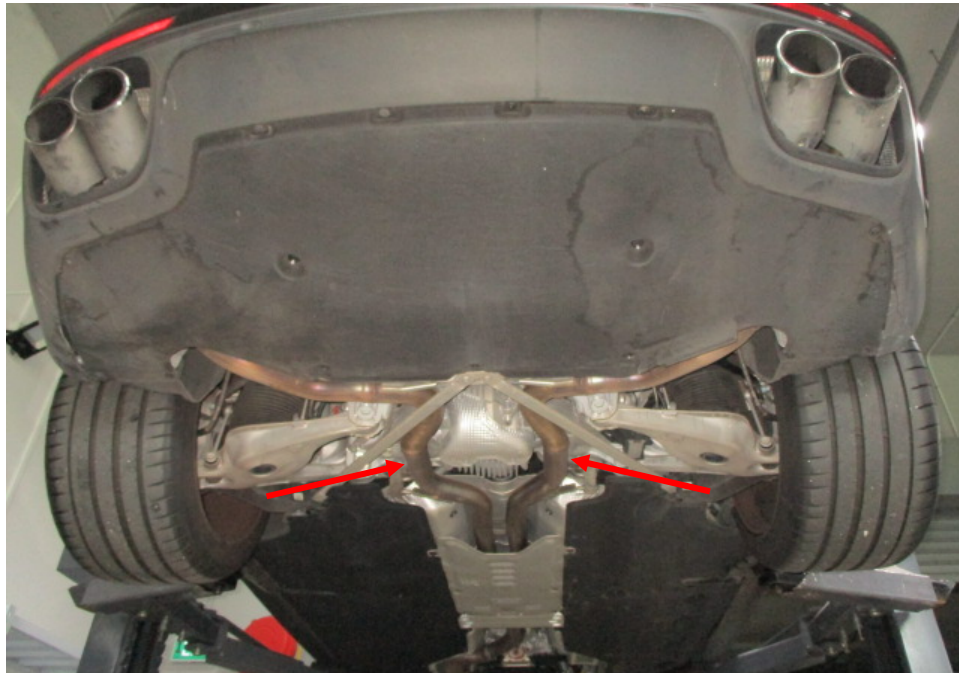
**Photo 23** shows the rear section of the Motor Car's exhaust system. My examination of the Motor Car's exhaust system revealed no sign(s) or indication(s) of any cut or weld marks along its exhaust pipes (arrowed), on its rear mufflers and on its catalytic converter.

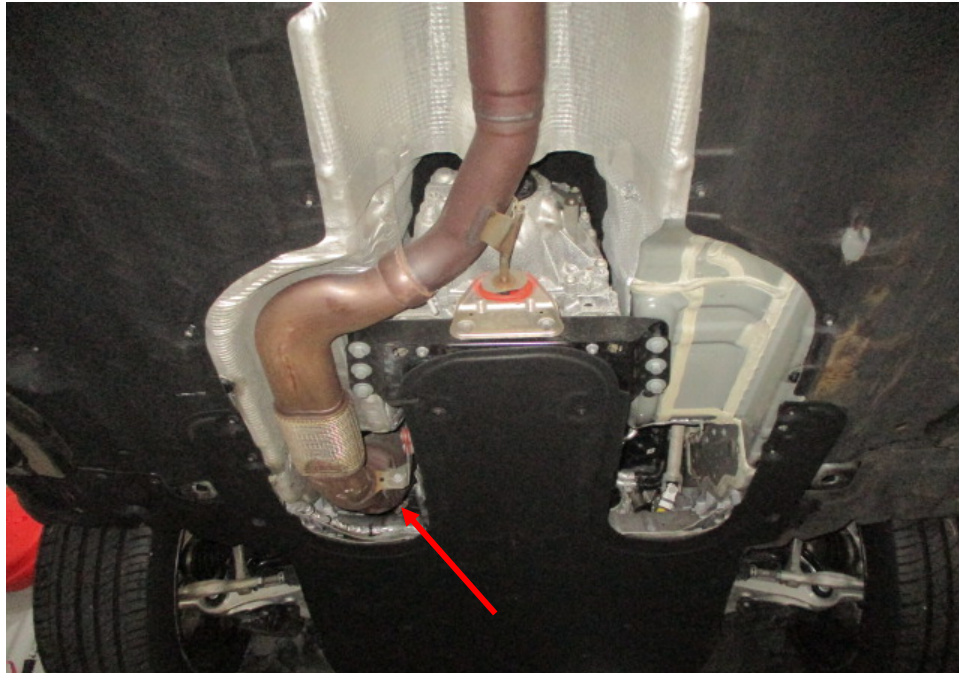
**Photo 24** shows the front section of the Motor Car's exhaust system. My examination of the Motor Car's exhaust system revealed no sign(s) or indication(s) of any cut or weld marks along its exhaust pipes, on its rear mufflers and on its catalytic converter (arrowed).

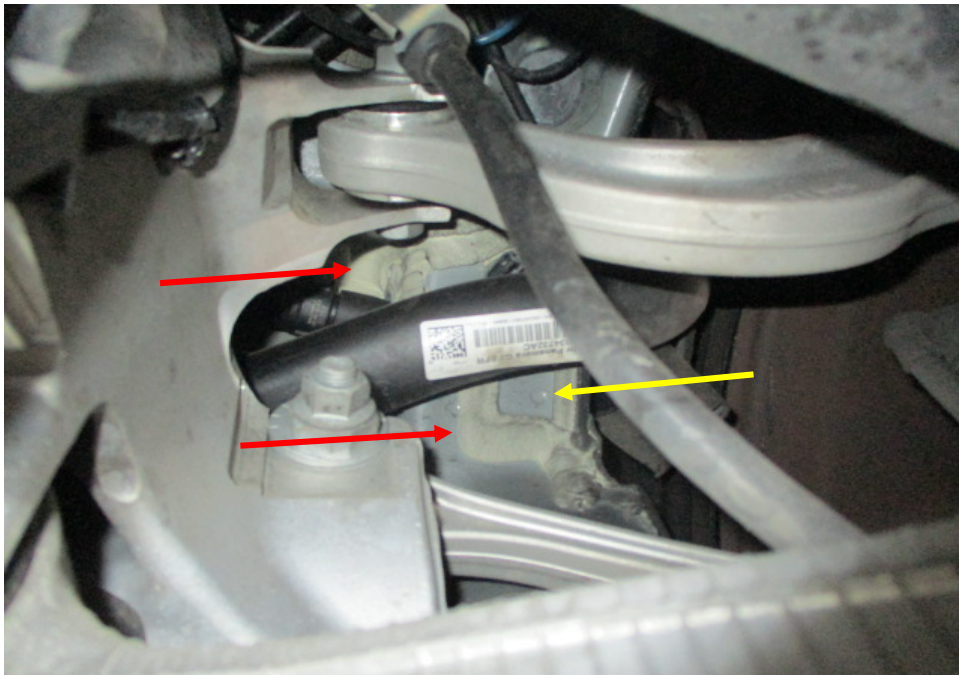
**Photo 25** shows the chassis/structural body at the underside rear right of the Motor Car. I did not find any weld marks other than original spot weld marks (yellow arrow) on the chassis/structural body of the Motor Car. The original factory sealant (red arrow) at the joints along the chassis/structural body was untouched, indicating no work was done on the chassis/structural body of the Motor Car and that the chassis/structural body was originally fitted.

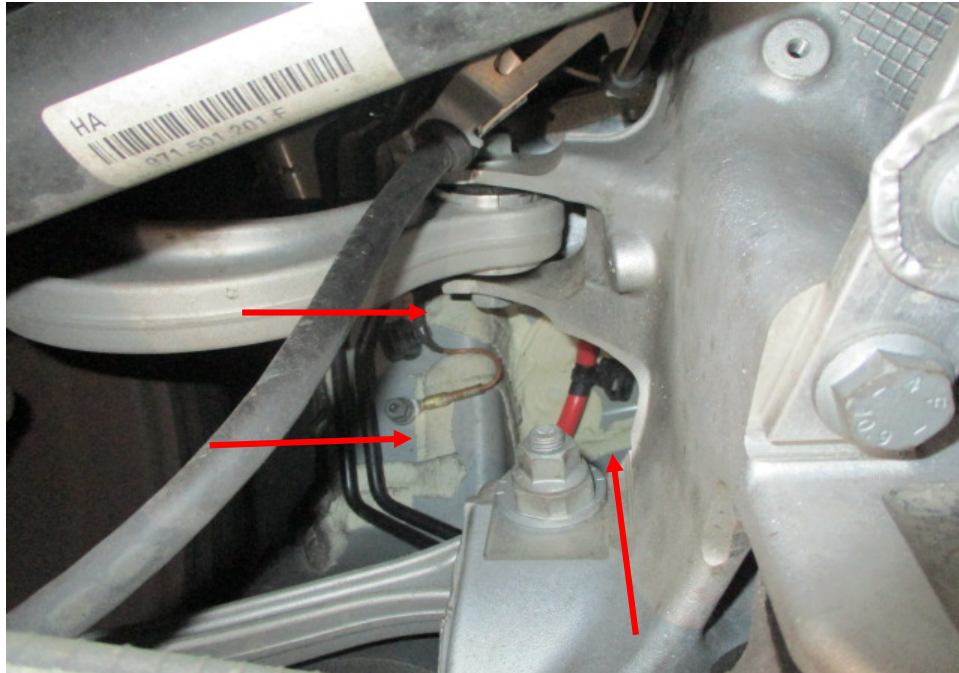
**Photo 26** shows the chassis/structural body at the underside rear left of the Motor Car. The original factory sealant (arrowed) at the joints along the chassis/structural body was observed to be untouched. In general, I had found no work was carried out on the chassis/structural body of the Motor Car. The chassis/structural body of the Motor Car was originally fitted.

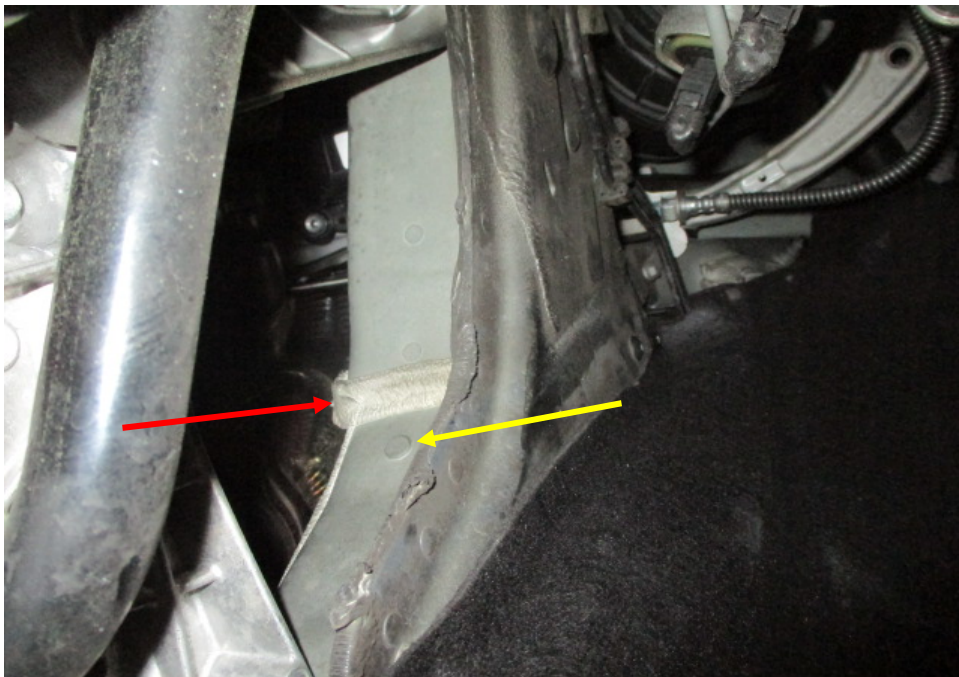
**Photo 27** shows the chassis/structural body at the underside front left of the Motor Car. I did not find any weld marks other than original spot weld marks (yellow arrow) on the chassis/structural body of the Motor Car. The original factory sealant (red arrow) at the joints along the chassis/structural body was untouched, indicating no work was done on the chassis/structural body of the Motor Car and that the chassis/structural body was originally fitted.

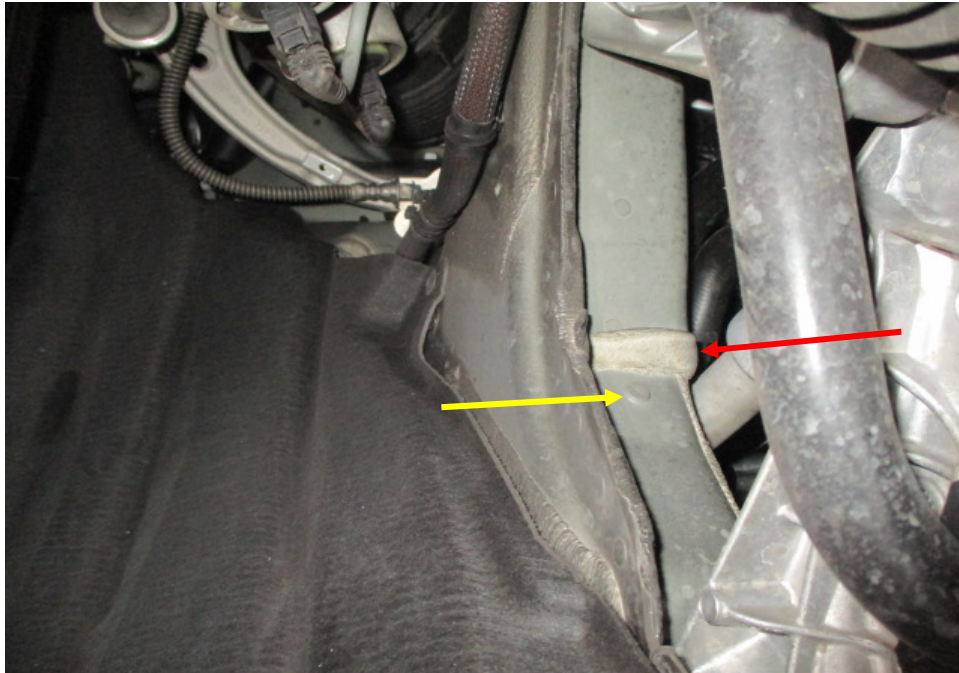
**Photo 28** shows the chassis/structural body at the underside front right of the Motor Car. I did not find any weld marks other than original spot weld marks (yellow arrow) on the chassis/structural body of the Motor Car. The original factory sealant (red arrow) at the joints along the chassis/structural body was untouched, indicating no work was done on the chassis/structural body of the Motor Car and that the chassis/structural body was originally fitted.
