Your Ref : 2212658304SG  
Our Ref : CI/AIG22003024/N

**M/s AIG Asia Pacific Insurance Pte. Ltd.**

**TECHNICAL INVESTIGATION REPORT OF FIRE INCIDENT INVOLVING THE  
INSURED VEHICLE SLR 7575A ON 15 MARCH 2022**

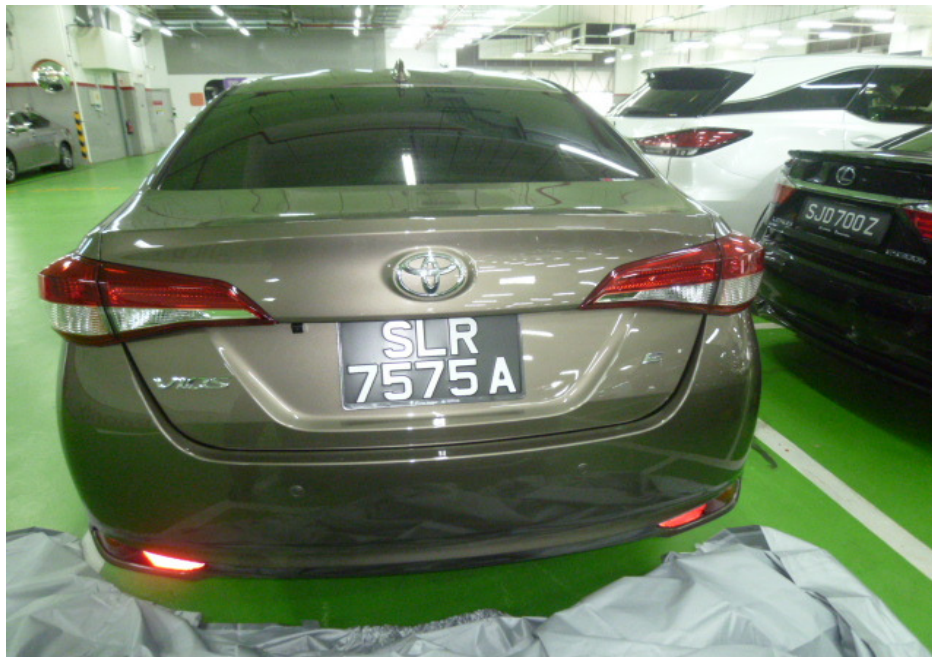
**Photo 1** shows the general view of the rear portion of the Insured Vehicle at the time of our inspection. The rear portion of the Insured Vehicle was relatively unaffected by the fire.

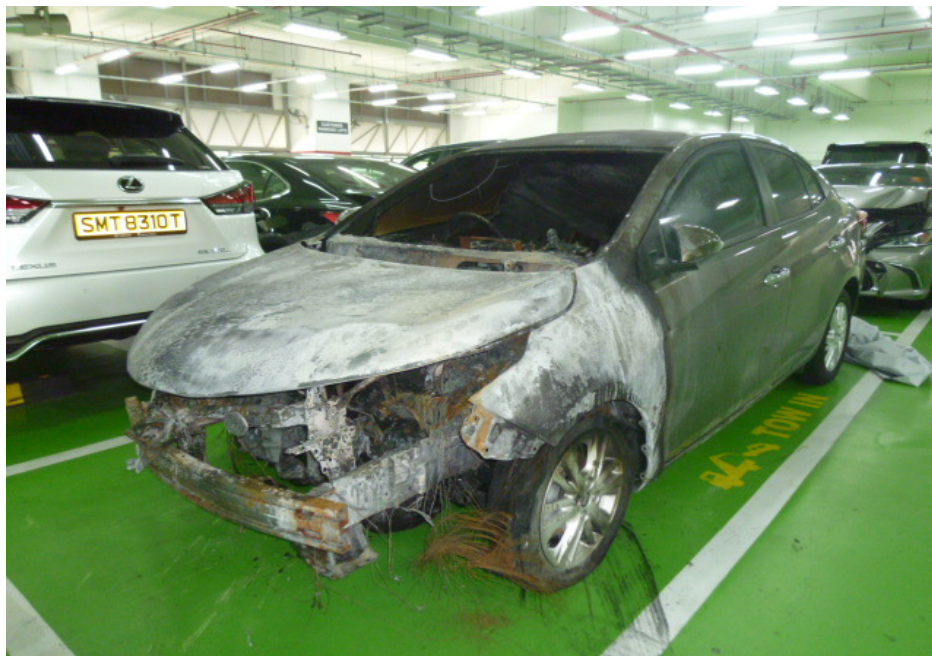
**Photo 2** shows the closer view of the left front body of the Insured Vehicle at the time of our inspection. The fire damage to the Insured Vehicle was confined to its frontal portion. Its front windscreen, front bumper, front bonnet, front support panel, front grille, left headlamp, left front wheel rim, left front fender and left front tyre were amongst the body parts that were found to have been affected by the fire.

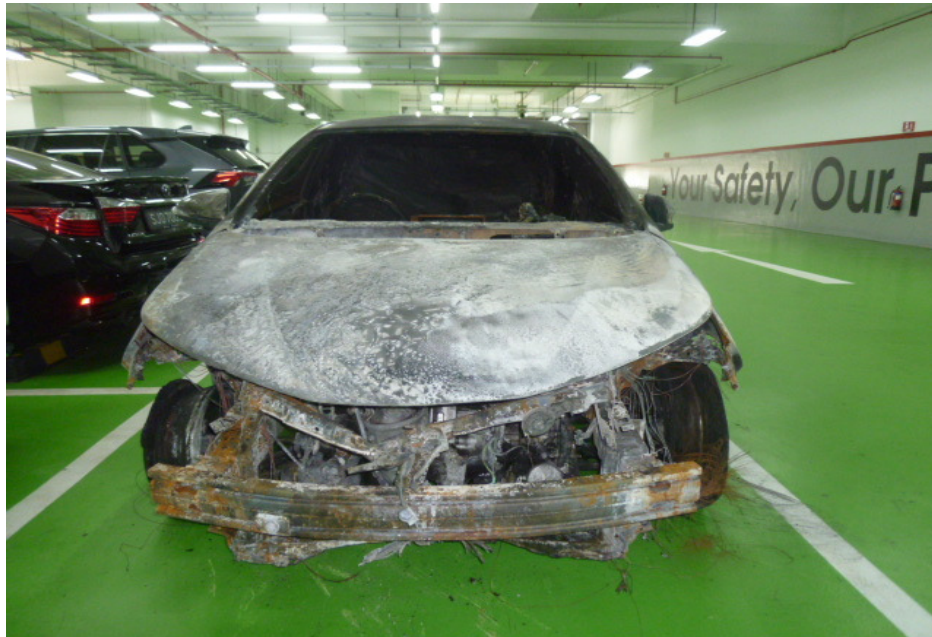
**Photo 3** shows the general view of the frontal portion of the Insured Vehicle at the time of our inspection. The fire damage to the Insured Vehicle was confined to its frontal portion. The entire engine compartment of the Insured Vehicle was observed to be severely burnt while the interior compartment was observed to be severely affected by the fire.

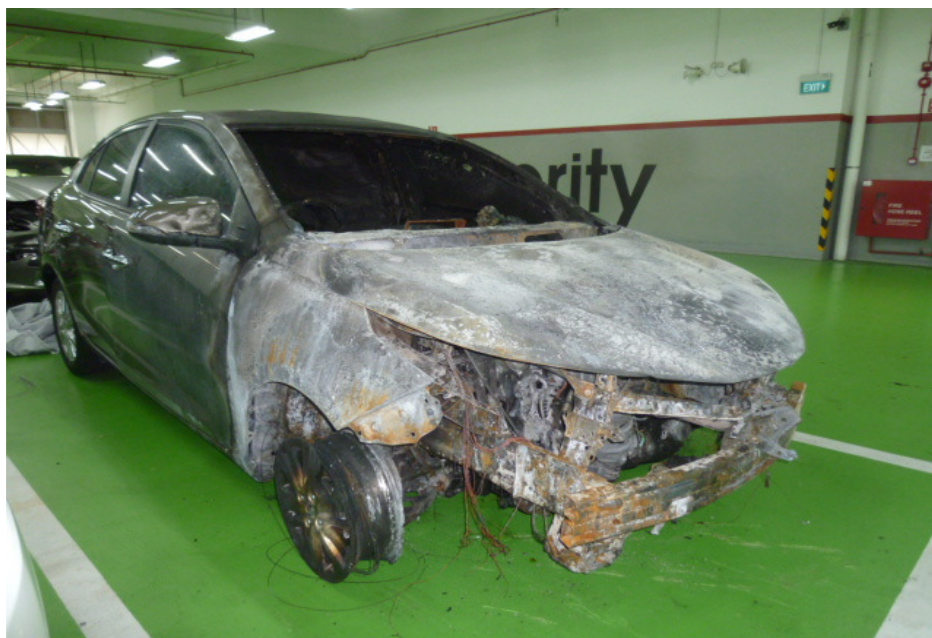
**Photo 4** shows the closer view of the right front body of the Insured Vehicle at the time of our inspection. The fire damage to the Insured Vehicle was confined to its frontal portion. Its front windscreen, front bumper, front bonnet, front support panel, front grille, right headlamp, right front wheel rim, right front fender and right front tyre were amongst the body parts that were found to have been affected by the fire.

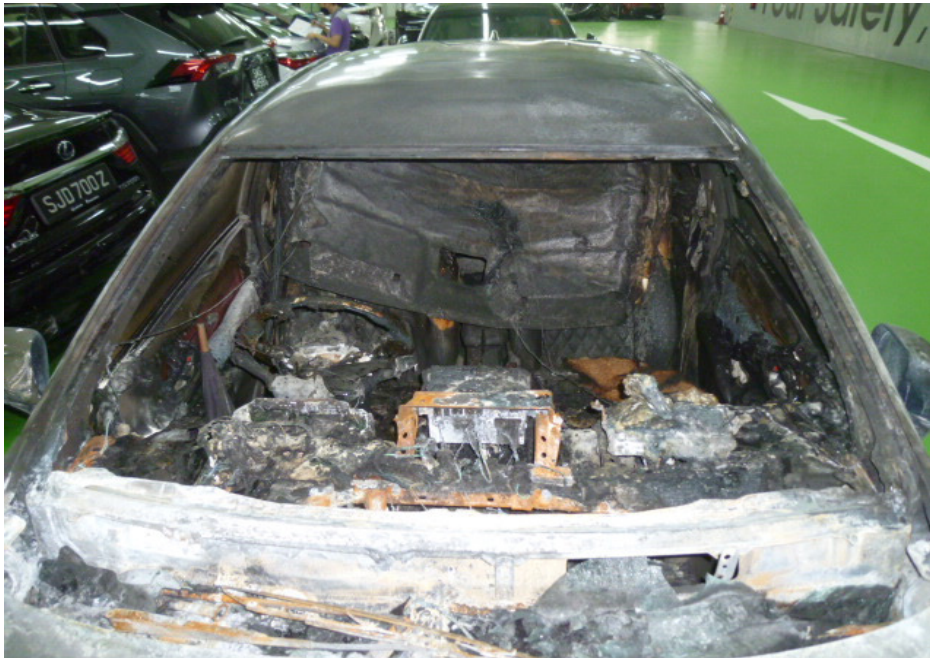
**Photo 5** shows the general view of the front windscreen of the Insured Vehicle at the time of our inspection. The fire damage to the front windscreen was extensive.

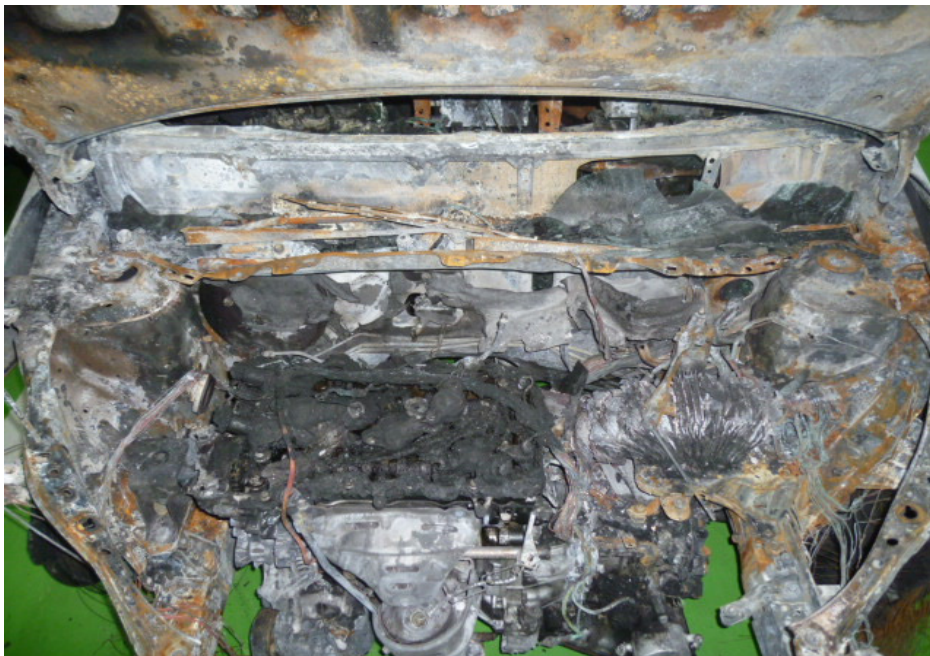
**Photo 6** shows the engine compartment of the Insured Vehicle at the time of our inspection. The entire engine compartment of the Insured Vehicle was observed to be severely burnt. Most of the parts inside the engine compartment were found to be burnt and/or melted as a result of the fire.

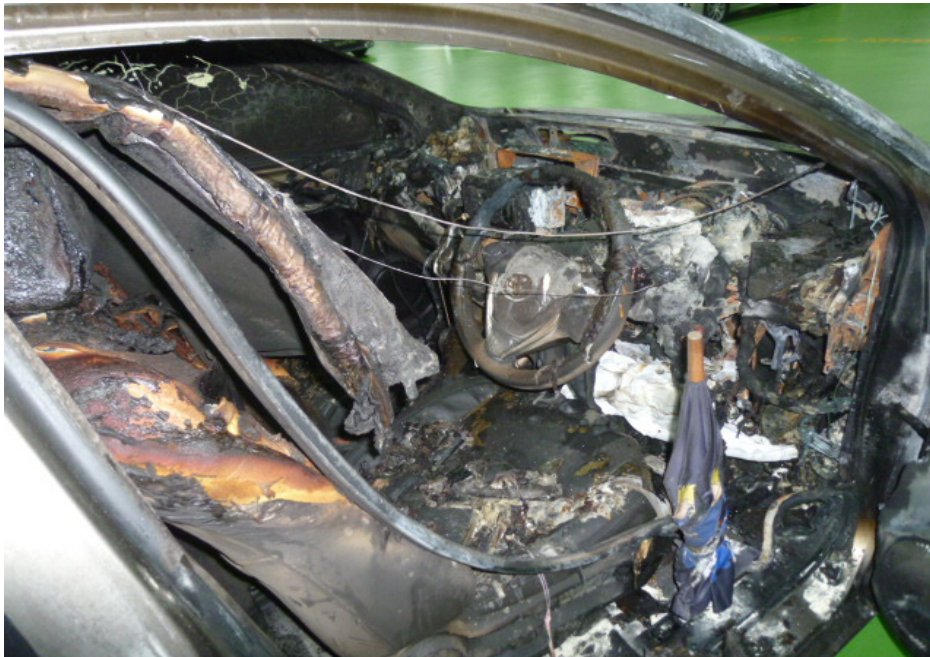
**Photo 7** shows the interior compartment of the Insured Vehicle, which was severely affected by the fire.

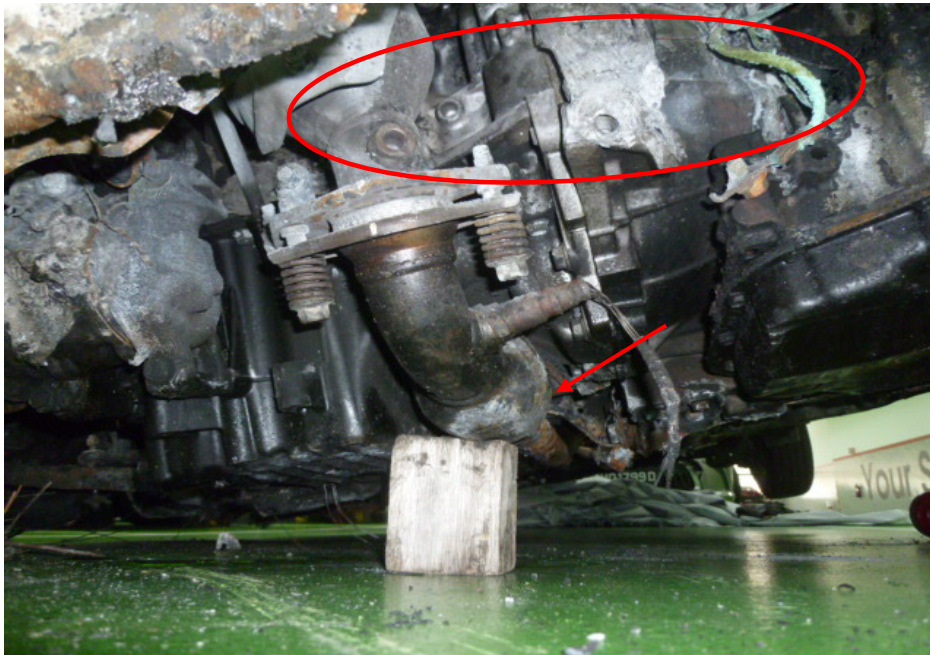
8. Based on the circumstances for this particular case, the fire appears to have originated from the exterior portion of the front undercarriage of the Insured Vehicle, somewhere around the engine compartment. This can be determined basing on the area where the extent of fire damage was most severe, the circumstances of the fires' origin at the material time of incident and also the high heat intensity burn marks (whitish burn marks) that were found on the exterior surface of the undercarriage. These whitish burn marks are a result of exposure to prolong heat intensity. Rust would normally start to develop around these areas soon after a fire as the prolonged exposure to high heat intensity usually causes the bare steel/metal material of the body parts to be exposed to natural environmental condition. The rust that had developed around the front undercarriage, in the immediate vicinity of where these whitish burn marks were found, would also support our findings of where the fire to the Insured Vehicle had originated. See photos 8 & 9 below.

**Photo 8** shows the fire damage at the exterior portion of the front undercarriage of the Insured Vehicle. The high heat intensity burn marks (whitish burn marks) found on the exterior surface of its engine components (circled) and rust that had developed on the front undercarriage (arrowed) indicates that the fire to the Insured Vehicle had originated from the exterior of the Insured Vehicle.

15. Having investigated and technically analysed the damages of burnt nature to the Insured Vehicle, we are of the view that the cause of fire to the Insured Vehicle was likely due to external factor from the cardboard box that was stuck under the front undercarriage of the Insured Vehicle.
16. The cause of fire being due to the cardboard box is also supported by our examination of the incident scene photographs where we had found the remnants of the cardboard box and foam padding which were pulled out from the front undercarriage of the Insured Vehicle by firefighters after the fire was extinguished.
17. There was no modification(s) or additional electronic and/or electrical component(s) fitted on the Insured Vehicle at the time of our inspection of the Insured Vehicle.

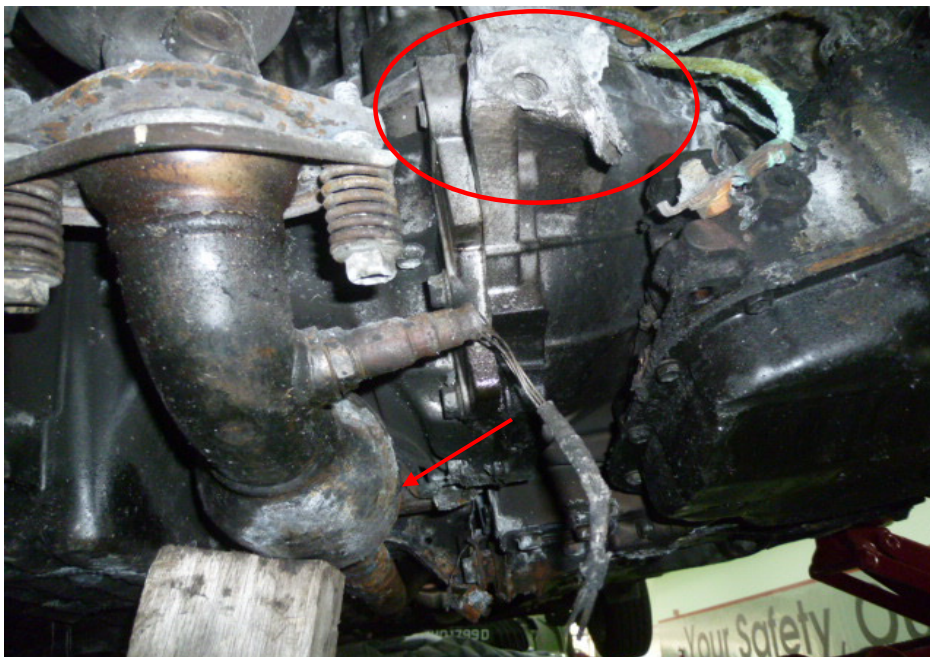
**Photo 9** shows a closer view of the high heat intensity burn marks (whitish burn marks) found on the exterior surface of its engine components (circled) and rust that had developed on the front undercarriage (arrowed) indicating that the fire to the Insured Vehicle had originated from the exterior of the Insured Vehicle.

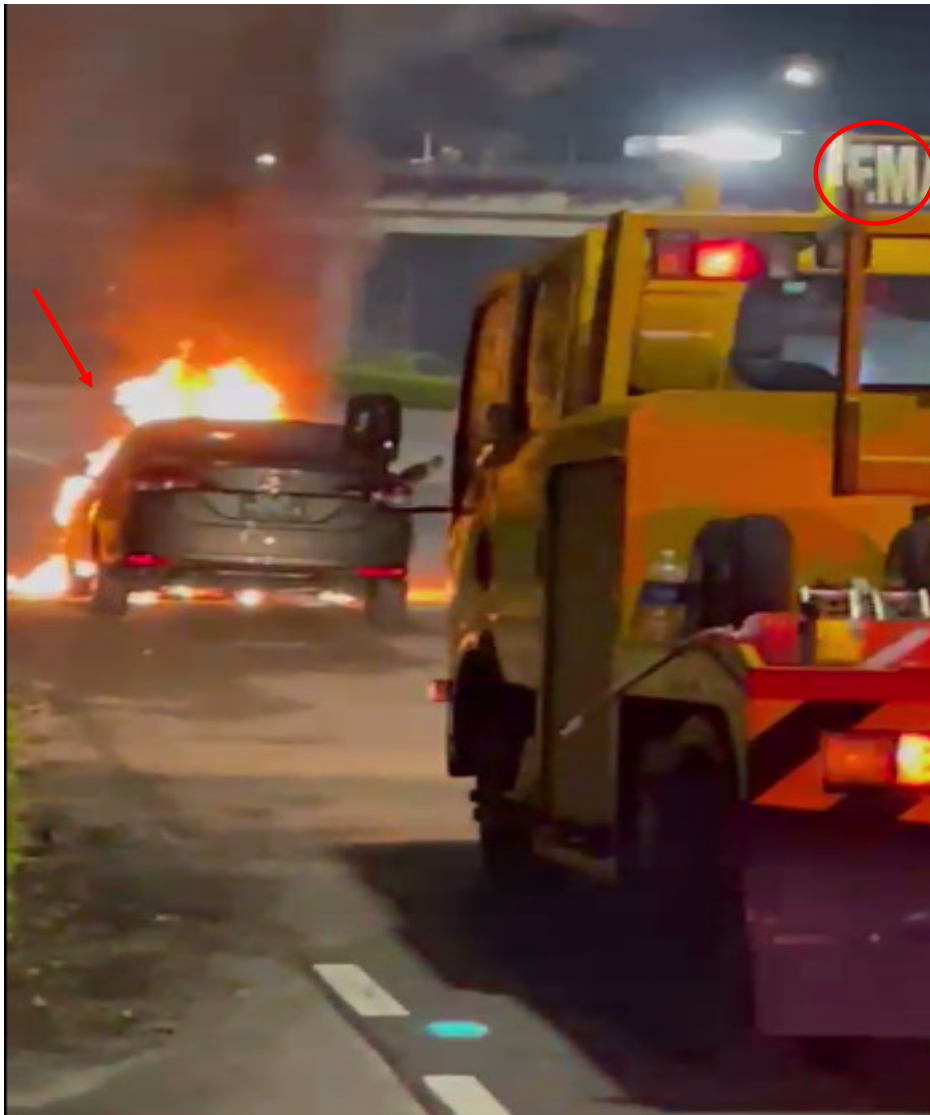
**Photo 10** shows the Insured Vehicle on fire before the arrival of the SCDF. In general, the information that could be gathered from this photograph had corresponded to the events that were related to us by Ms Ng which is the fire had started from the frontal portion of the Insured Vehicle (arrowed) and that EMAS Recovery Services were first to arrive at the incident scene (circled).

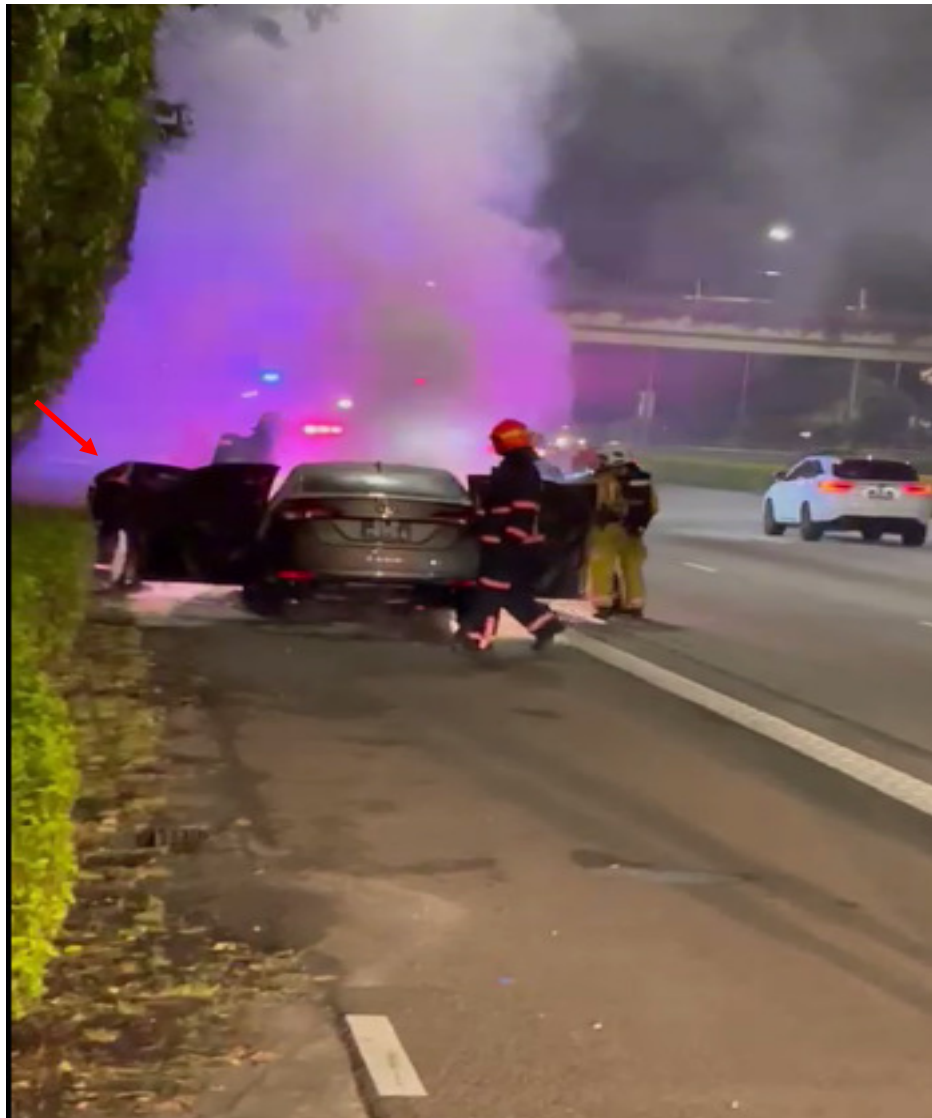
**Photo 11** shows the SCDF conducting preliminary investigations after putting out the fire on the Insured Vehicle. In general, the information that could be gathered from this photograph had corresponded to the events that were related to us by Ms Ng which is the fire had started from the front undercarriage of the Insured Vehicle (arrowed).

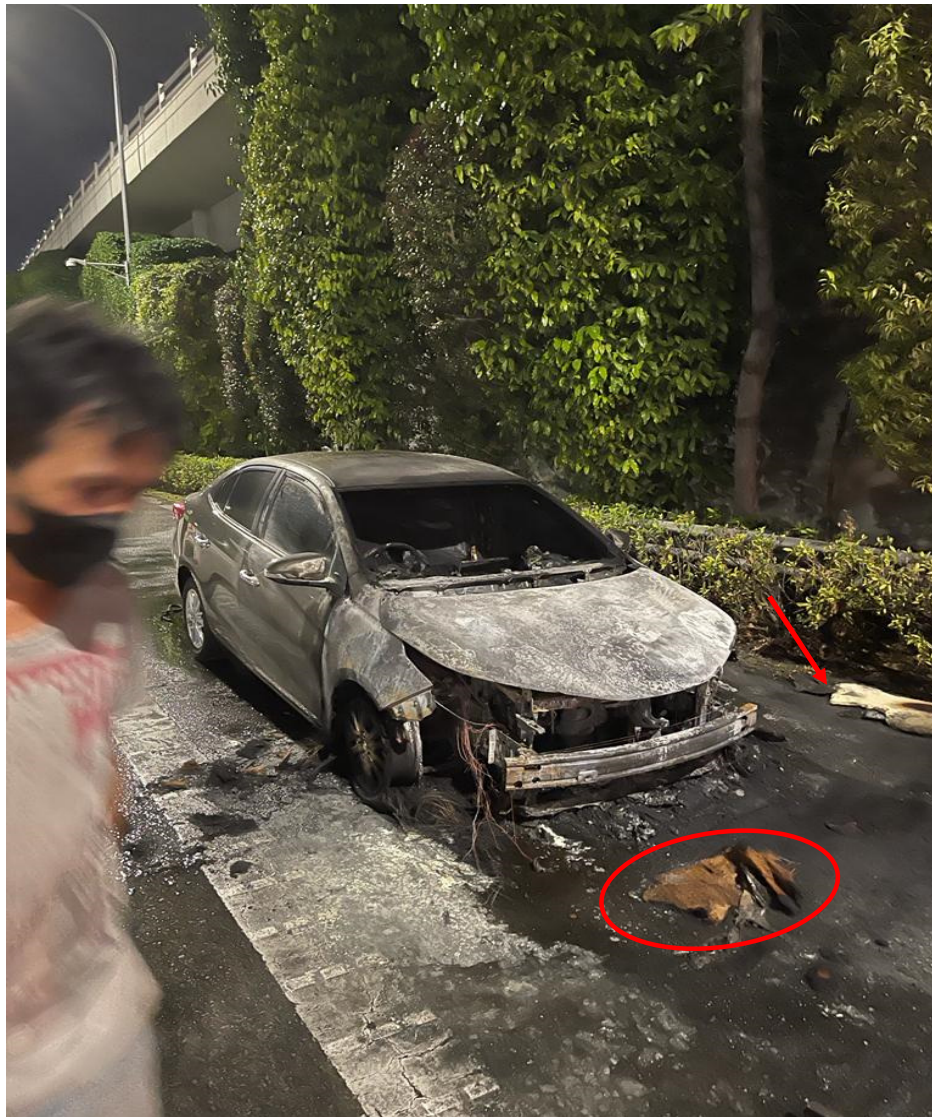
13. Our closer examination of these photographs revealed that remnants of the cardboard box and foam padding were pulled out from the front undercarriage of the Insured Vehicle by firefighters after the fire was put out. Apart from the aforesaid, there was no further notable information that could be gathered from these photographs. See photos 10 - 12 below.

**Photo 12** shows the Insured Vehicle at the incident location after the fire was extinguished by the SCDF. Ms Ng mentioned that remnants of the cardboard box (circled) and foam padding (arrowed) were pulled from the front undercarriage of the Insured Vehicle by firefighters during their preliminary investigation. The extent of damage and burn pattern to the Insured Vehicle was also observed to be similar to what we had observed during our physical inspection of the Insured Vehicle.
