Your Ref: BMW 840i  
(chassis number WBAGV22080CG15788)  
Our Ref : CI/TP22003034/D

01 April 2022

**INSPECTION REPORT OF AN UNREGISTERED BMW 840i MOTOR CAR  
WITH CHASSIS NUMBER WBAGV22080CG15788**

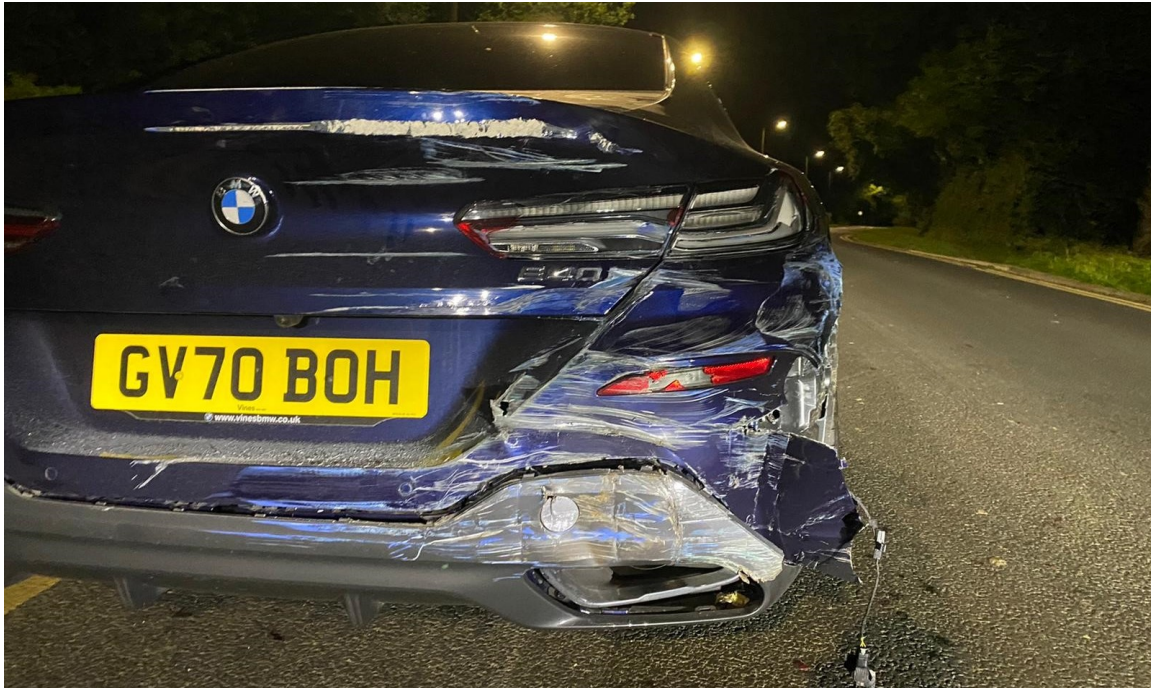
**Photo 1** shows the rear right body of the Motor Car (photograph provided to me). The photographs provided to me had showed damage to the rear right portion of the Motor Car. The rear bumper, rear bumper lower cover, rear bumper tow hook cover, rear bumper sensors, rear bumper right reflector, rear right exhaust chrome garnish, rear bootlid, rear right bootlid lamp and rear right taillamp were amongst the body parts that were observed to have been damaged.

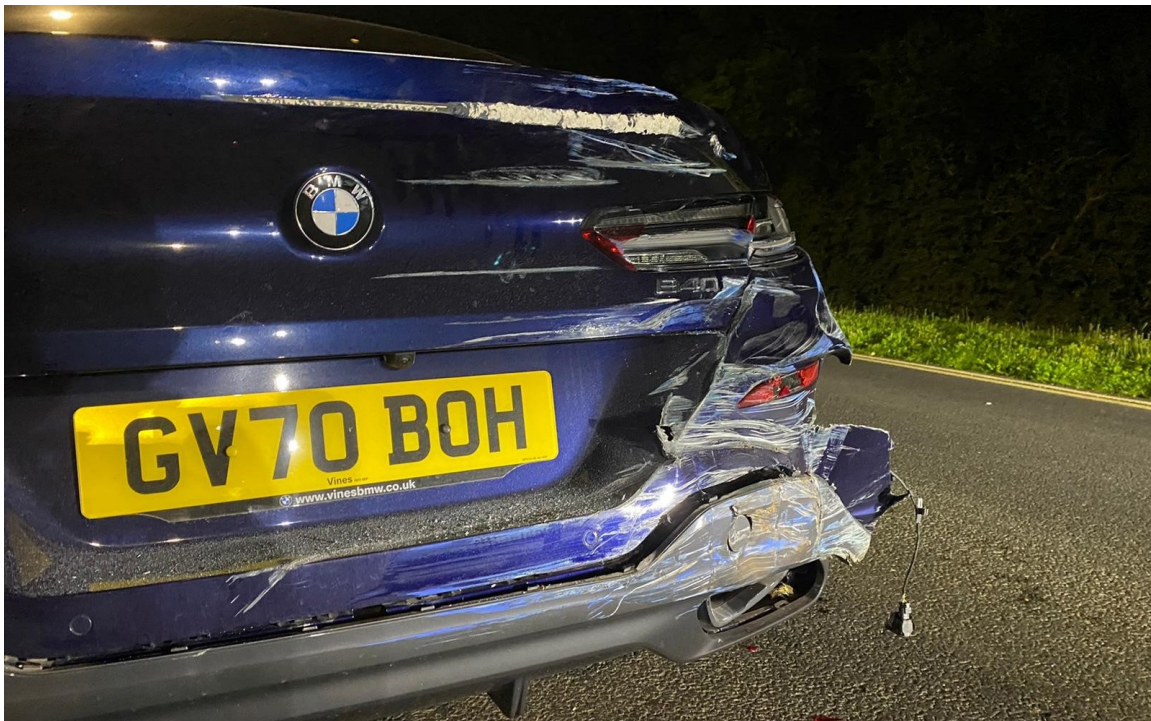
**Photo 2** shows another view of the damage at the rear right portion of the Motor Car (photograph provided to me). The rear bumper, rear bumper lower cover, rear right exhaust chrome garnish, rear bootlid and rear right bootlid lamp were amongst the body parts that were observed to have been damaged.

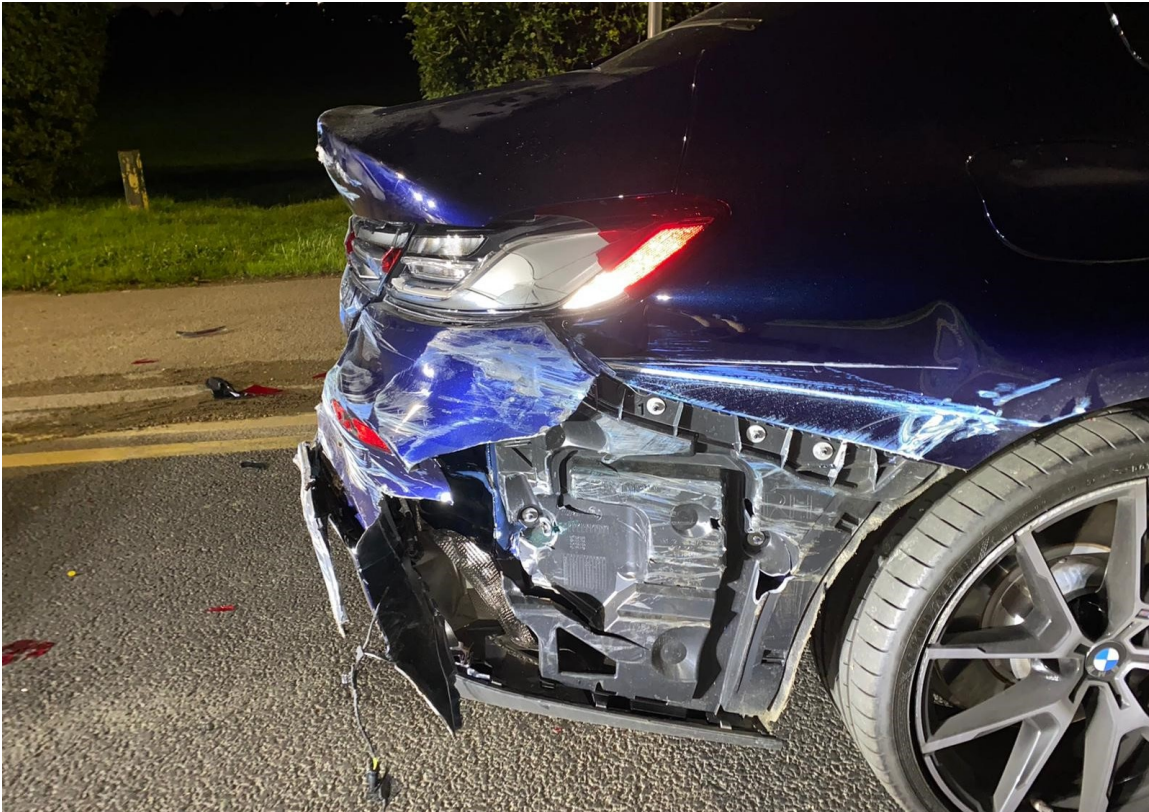
**Photo 3** shows the right side rear portion of the Motor Car (photograph provided to me). The rear bumper, rear bumper lower cover, rear bumper sensors, rear bumper right corner air vent, rear bumper right bracket, rear right exhaust heat shield, rear right taillamp and rear right fender were amongst the body parts that were observed to have been damaged.

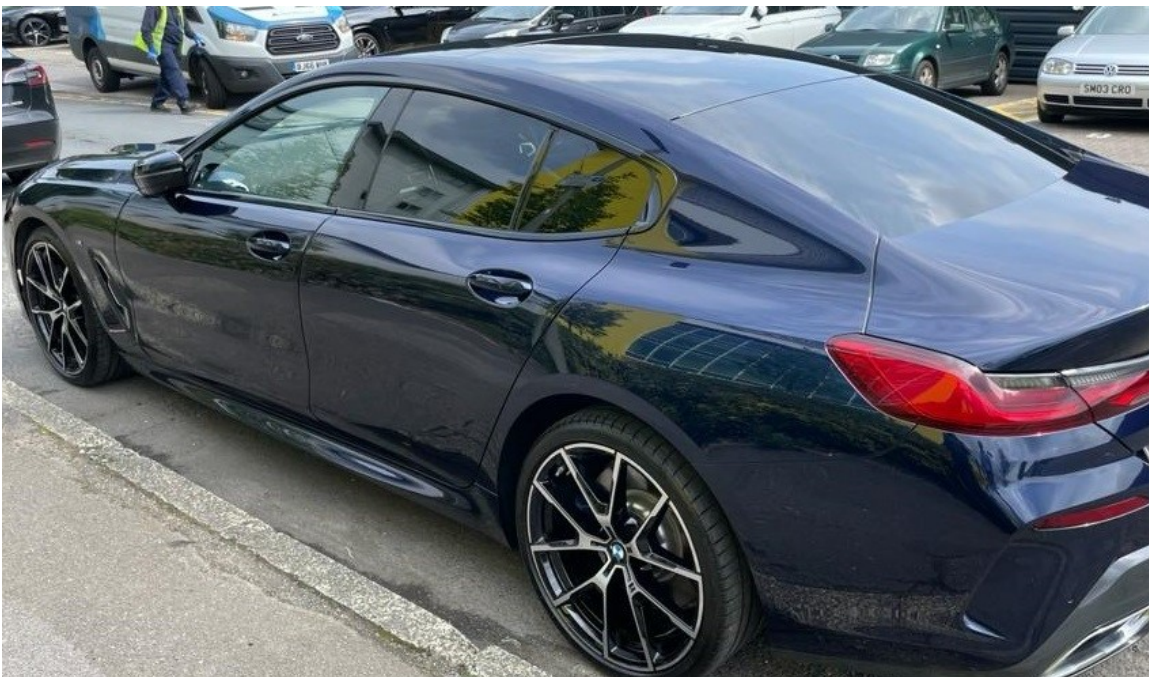
**Photo 4** shows the left side body of the Motor Car (photograph provided to me). Apart for the rear right portion, there was no physical damage observed to other areas of the Motor Car.

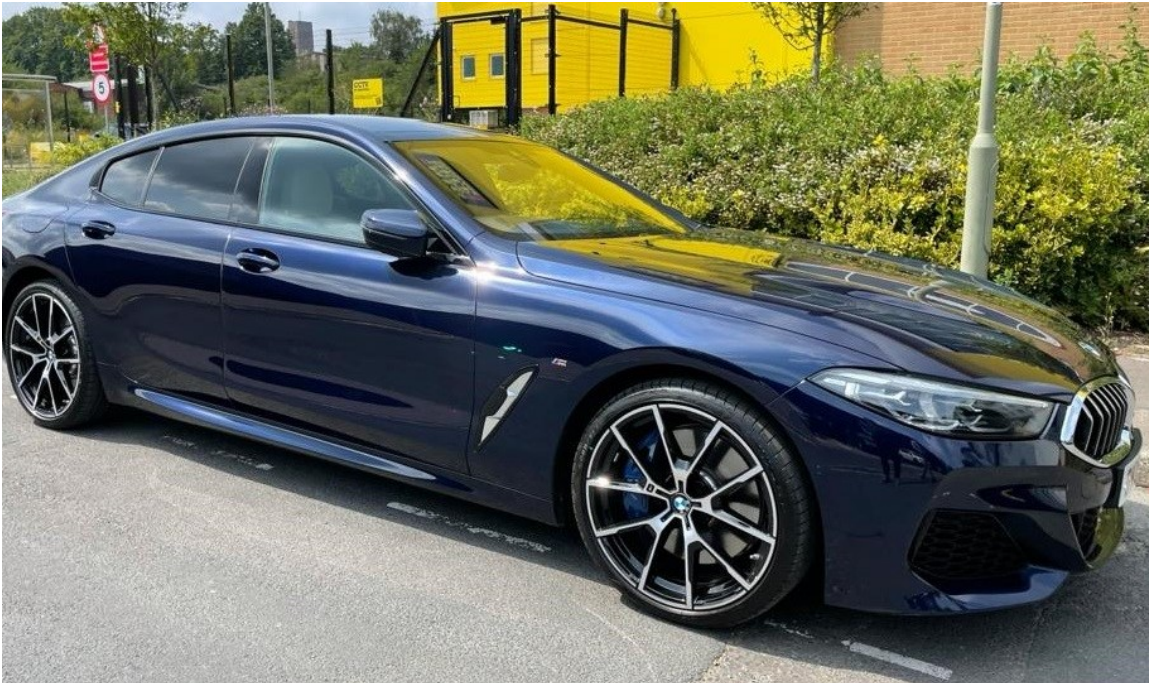
**Photo 5** shows the right side body of the Motor Car (photograph provided to me). Apart for the rear right portion, there was no physical damage observed to other areas of the Motor Car. The airbag(s) appears to have been not deployed as seen from the photographs that were provided to me.

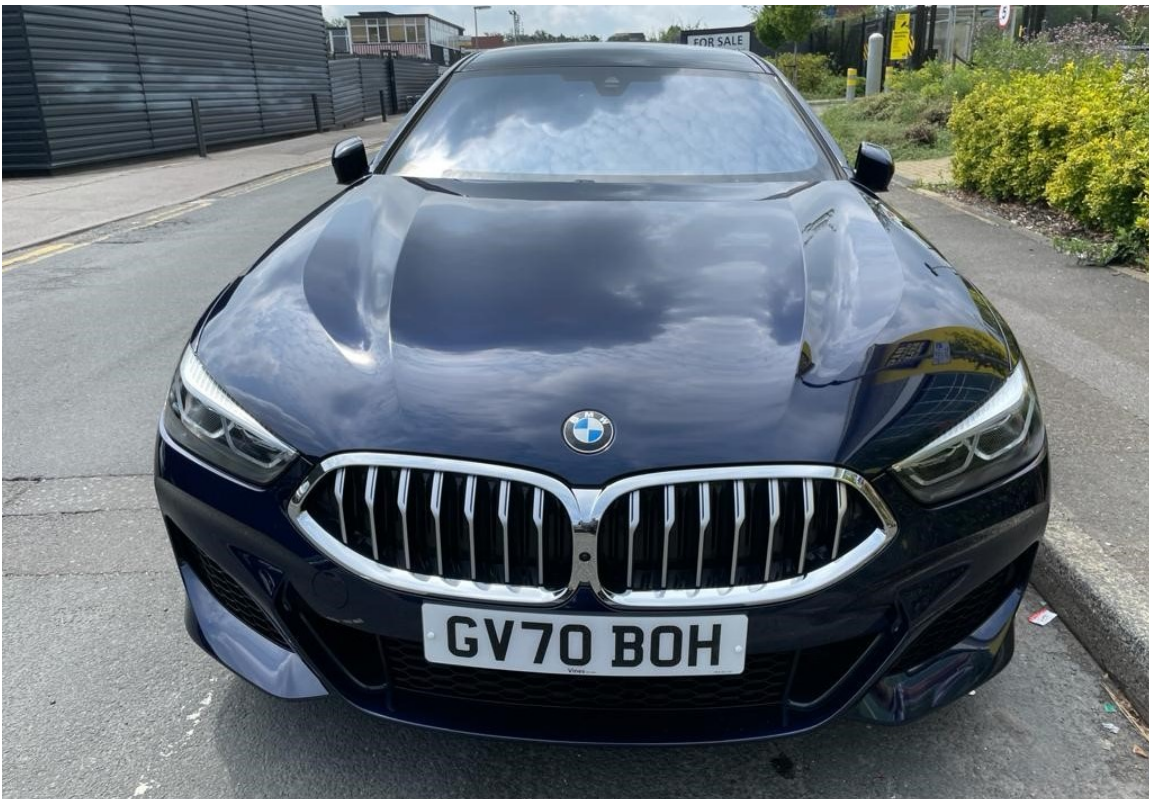
**Photo 6** shows the frontal portion of the Motor Car (photograph provided to me). Apart for the rear right portion, there was no physical damage observed to other areas of the Motor Car.

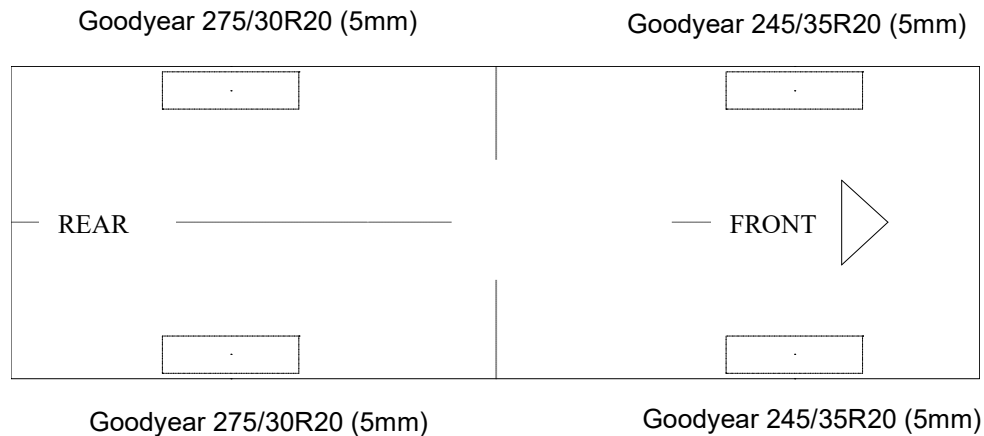
8. It was fitted with 20inch sport wheel rims that were wrapped with tyres that were observed to be of serviceable condition. The tyres were also sufficiently inflated for vehicular operation. The tyre brand, tyre size and approximate remaining tread depth of the 4 tyres of the Motor Car were recorded as follows: -

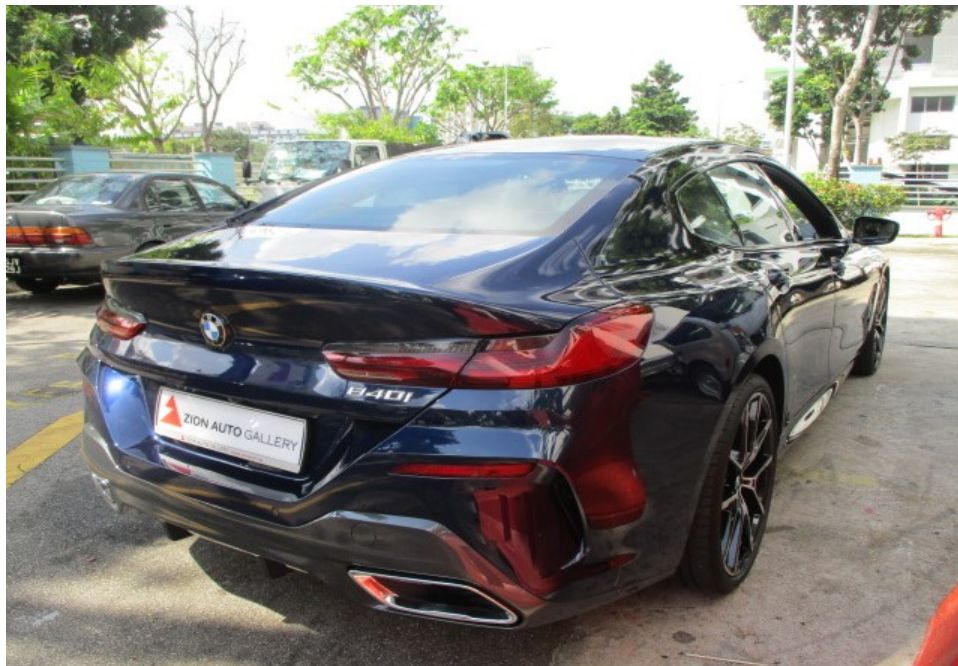
**Photo 7** shows a general view of the rear right body of the Motor Car at the time of my inspection. The Motor Car was observed to be in a relatively good general condition with no loose exterior fittings observed. The body parts at the rear right portion of the Motor Car were visually examined and it was observed that the repair/restoration works carried out to the damaged area of the Motor Car (refer to photograph 1 - 3 above) were reasonably adequate and in order.

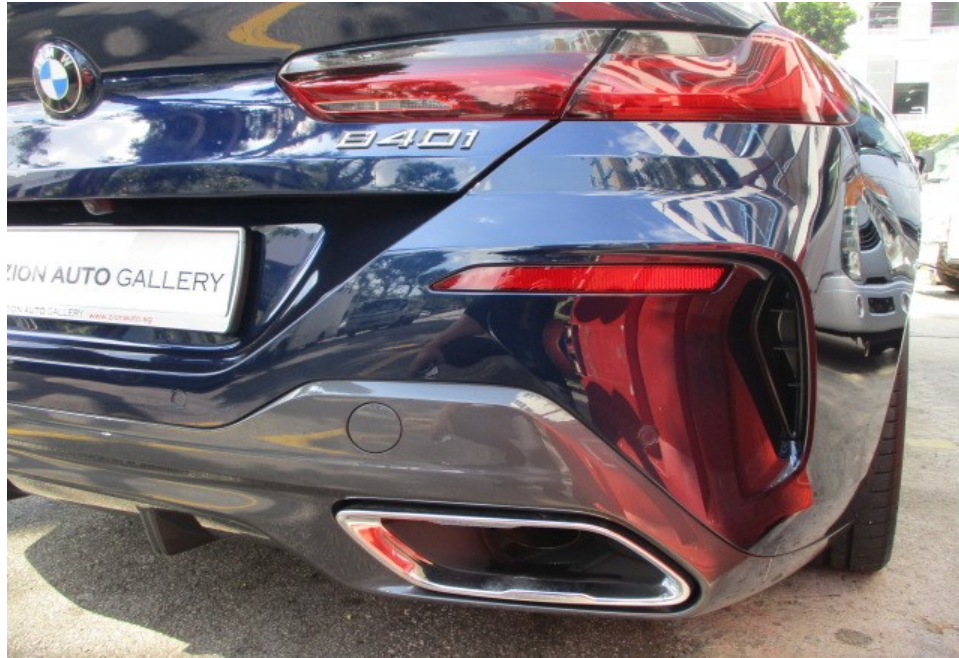
**Photo 8** shows a closer view of the Motor Car's rear bumper, rear bumper lower cover, rear bumper tow hook cover, rear bumper right reflector and rear right exhaust chrome garnish at the time of my inspection. The body parts at the rear right portion of the Motor Car were visually examined and it was observed that the repair/restoration works carried out to the damaged area of the Motor Car (refer to photograph 1 - 3 above) were reasonably adequate and in order.

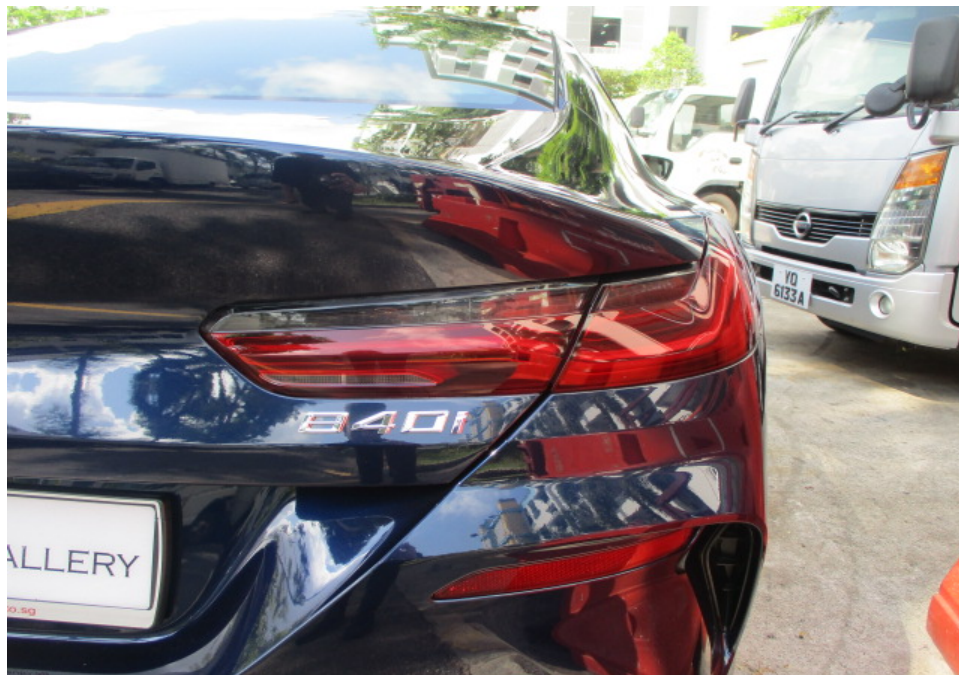
**Photo 9** shows a closer view of the Motor Car's rear bootlid, rear right bootlid lamp and rear right taillamp at the time of my inspection. The body parts at the rear right portion of the Motor Car were visually examined and it was observed that the repair/restoration works carried out to the damaged area of the Motor Car (refer to photograph 1 - 3 above) were reasonably adequate and in order.

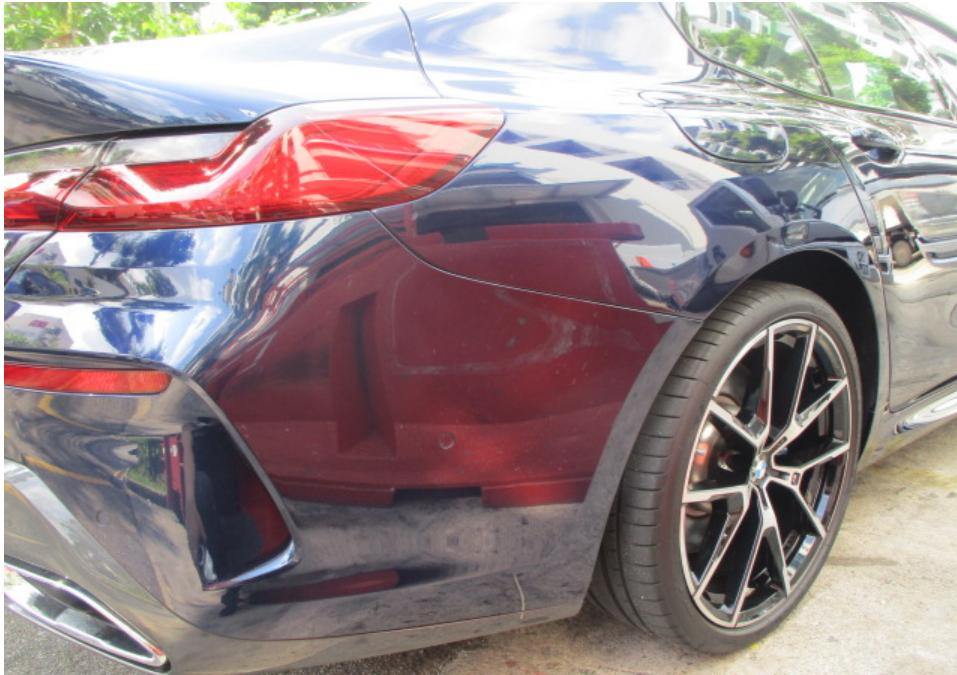
**Photo 10** shows a closer view of the Motor Car's rear bumper, rear right taillamp and rear right fender at the time of my inspection. The body parts at the rear right portion of the Motor Car were visually examined and it was observed that the repair/restoration works carried out to the damaged area of the Motor Car (refer to photograph 1 - 3 above) were reasonably adequate and in order.

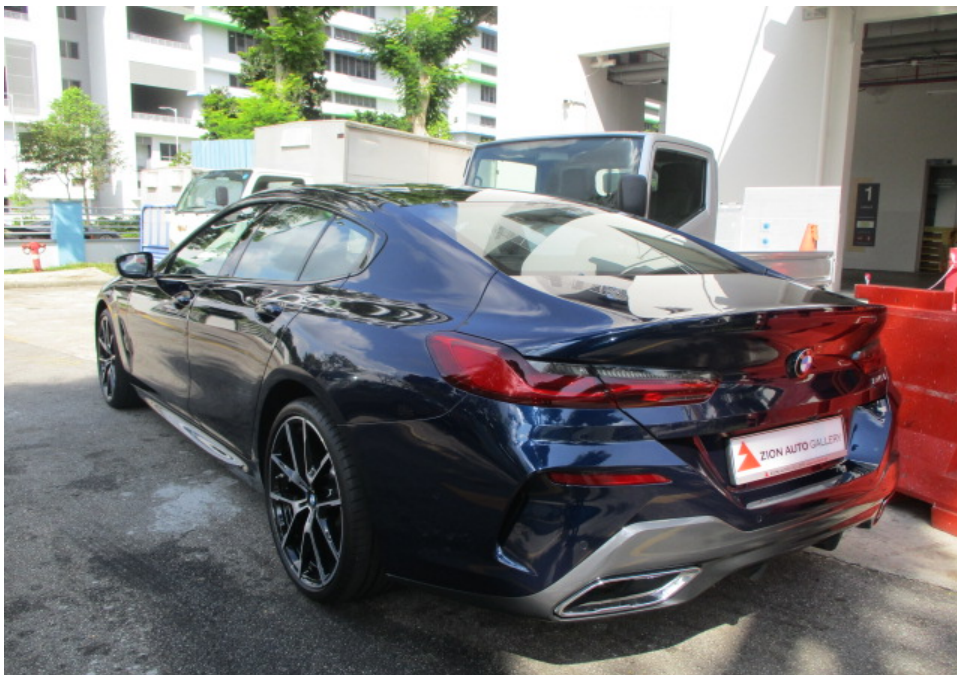
**Photo 11** shows a general view of the rear left body of the Motor Car at the time of my inspection. The Motor Car was observed to be in a relatively good general condition with no loose exterior fittings observed. The mileage of the Motor Car recorded at the time of my inspection was 4,051km.

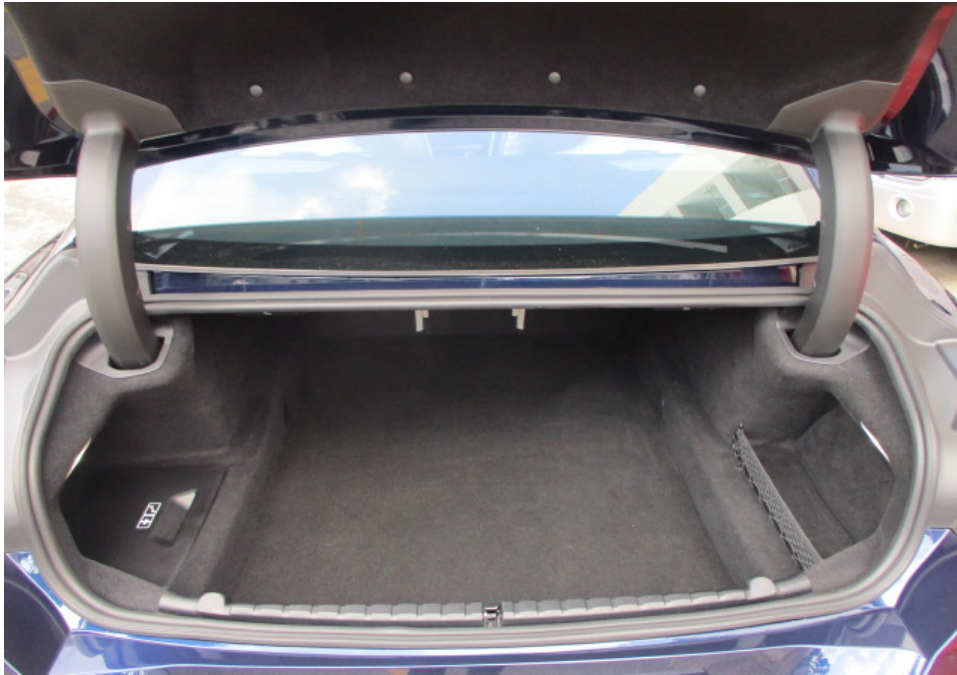
**Photo 12** shows a general view of the Motor Car's rear boot compartment at the time of my inspection. All inner trims, garnishes and upholstery etc were observed to be properly fitted.

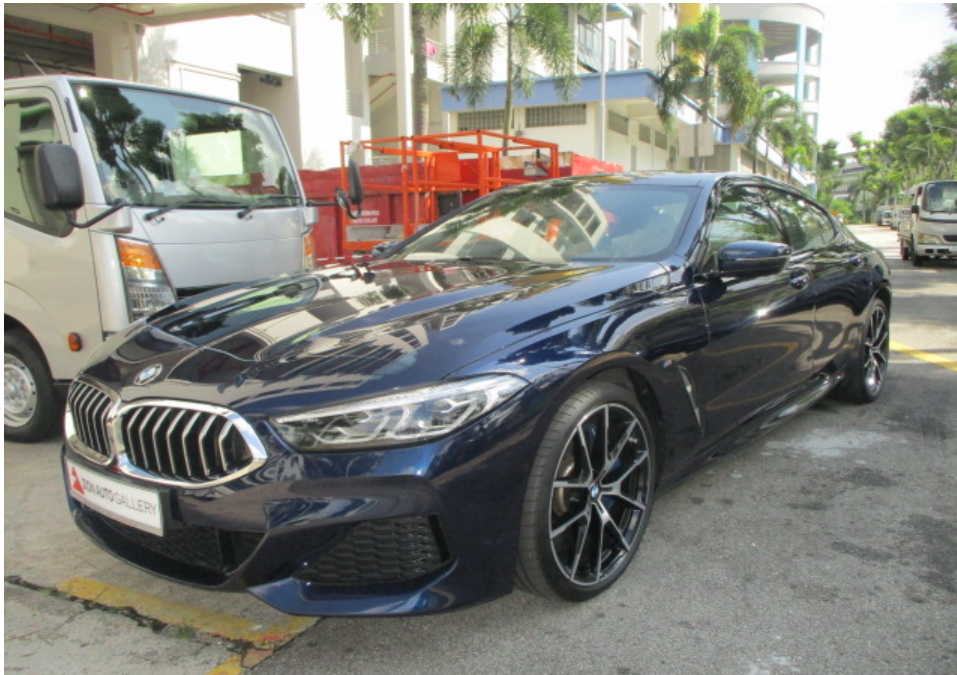
**Photo 13** shows a general view of the front left body of the Motor Car at the time of my inspection. The Motor Car was observed to be in a relatively good general condition with no loose exterior fittings observed. The mileage of the Motor Car recorded at the time of my inspection was 4,051km.

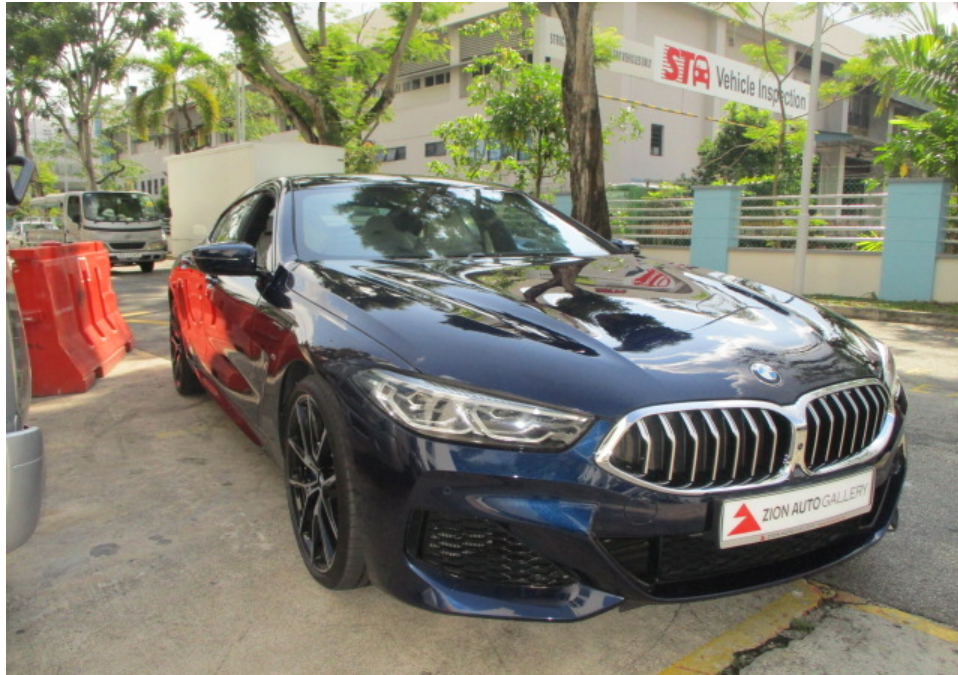
**Photo 14** shows a general view of the front right body of the Motor Car at the time of my inspection. The Motor Car was observed to be in a relatively good general condition with no loose exterior fittings observed. The mileage of the Motor Car recorded at the time of my inspection was 4,051km.

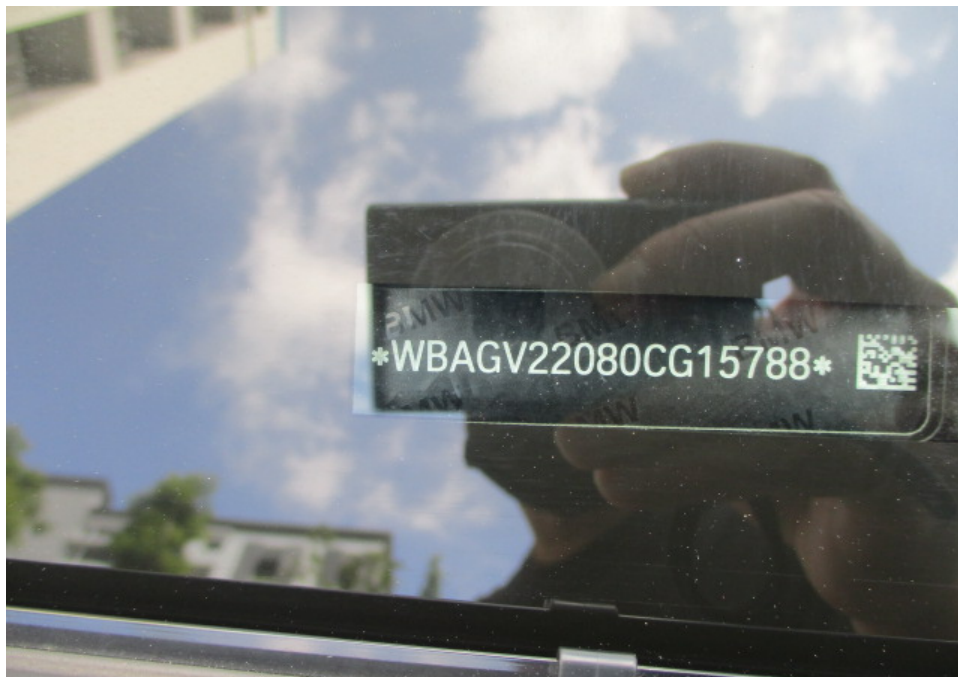
**Photo 15** shows the chassis number of the Motor Car. The chassis number recorded was WBAGV22080CG15788.

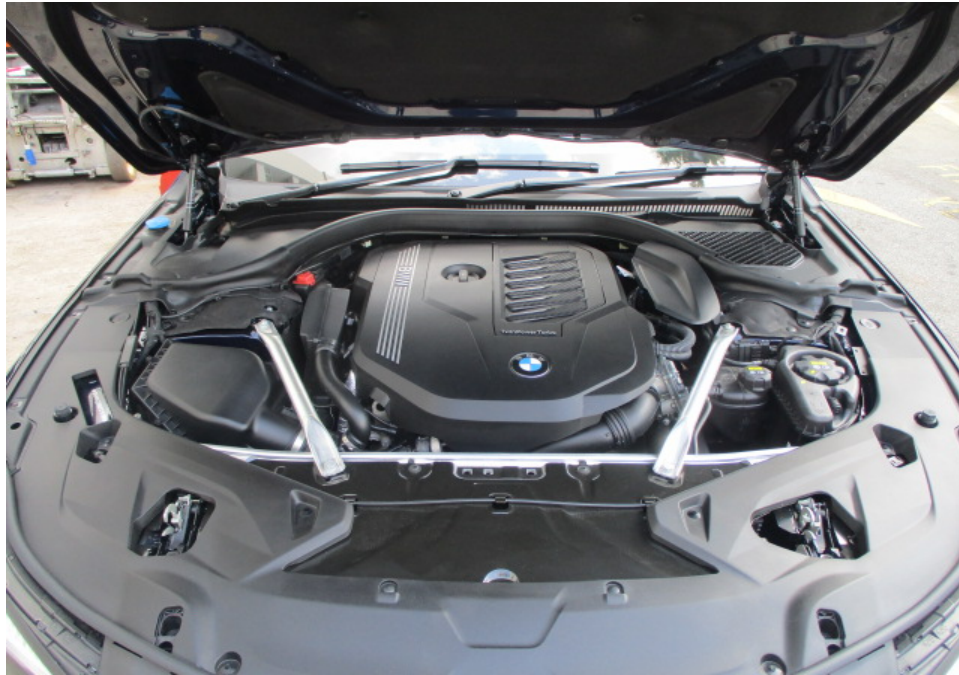
**Photo 16** shows a general view of the engine compartment of the Motor Car at the time of my inspection. The various parts and components inside the engine compartment were all observed to be intact and properly fitted. There was also no sign(s) or indication(s) of fluid leak and/or fluid stain found inside the engine compartment.

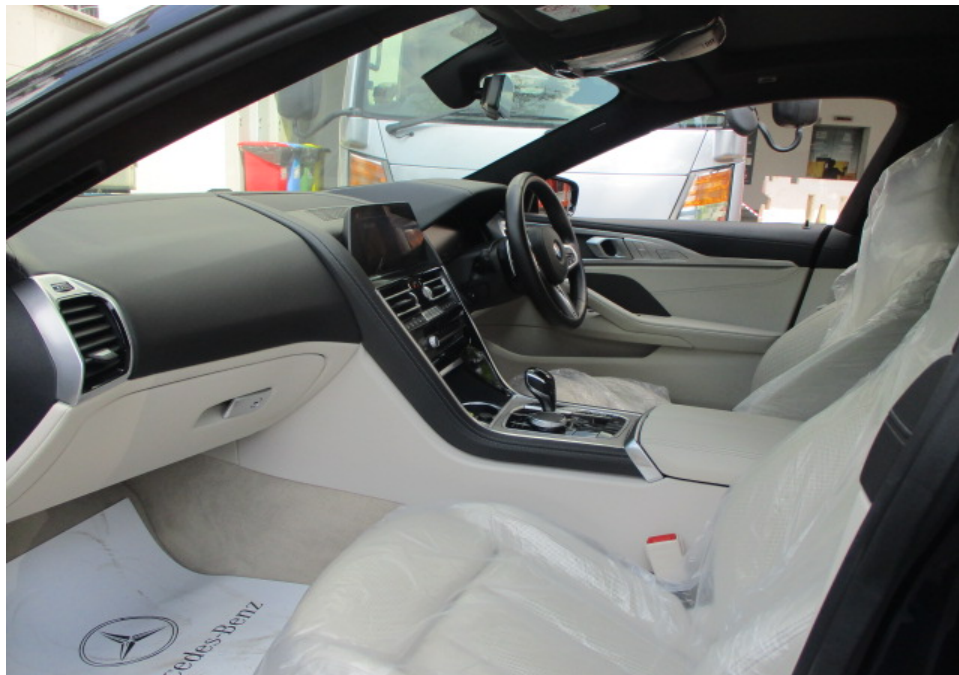
**Photo 17** shows the interior compartment of the Motor Car at the time of my inspection. The various parts and components, trims, carpet, and upholstery inside the interior compartment were all observed to be intact and properly fitted.

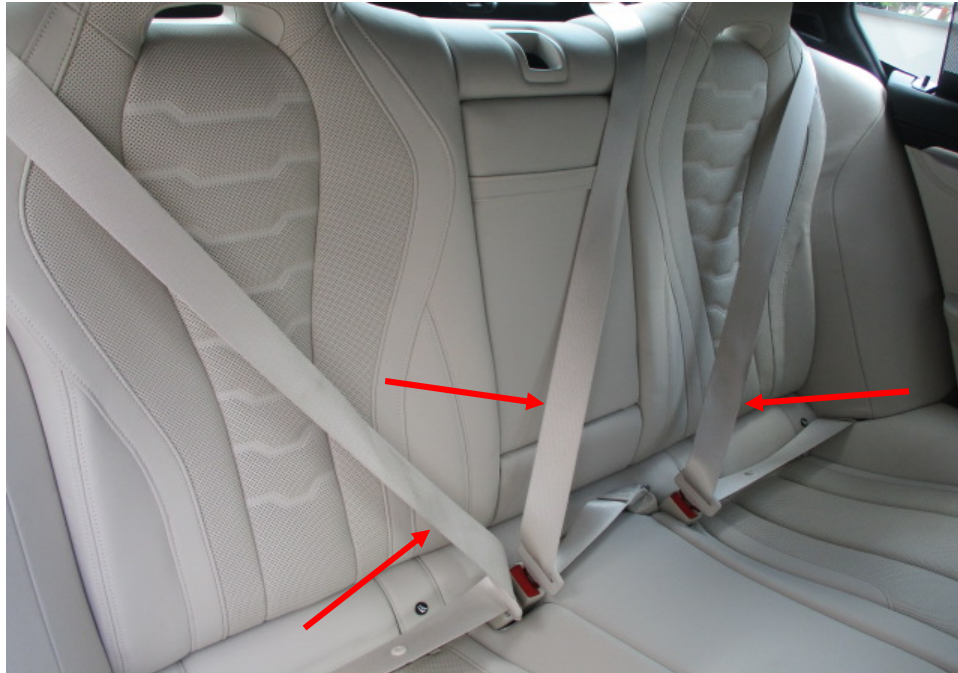
**Photo 18** shows the rear seats of the Motor Car. All the seats of the Motor Car were secured via seat rails to the floorboard. They were also fitted with a retractable seat belt reel and a pre-tensioner. The seat belts (arrowed) were tested and were able to be fastened into the respective pre-tensions that were fitted on the side of each individual seat.

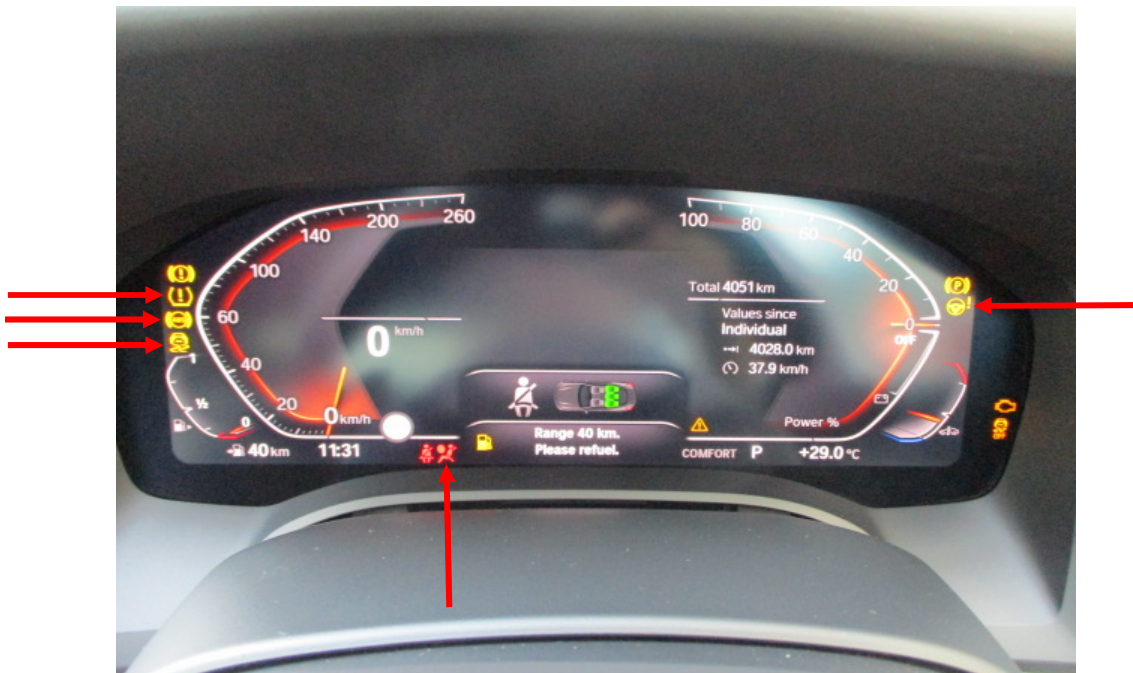
**Photo 19** shows the warning lights for the various electronic safety features appearing on the instrument panel of the Motor Car during its self-test when the engine is cranked, in particular the ABS, SRS, IAS, TPM and DSC lights (arrowed).

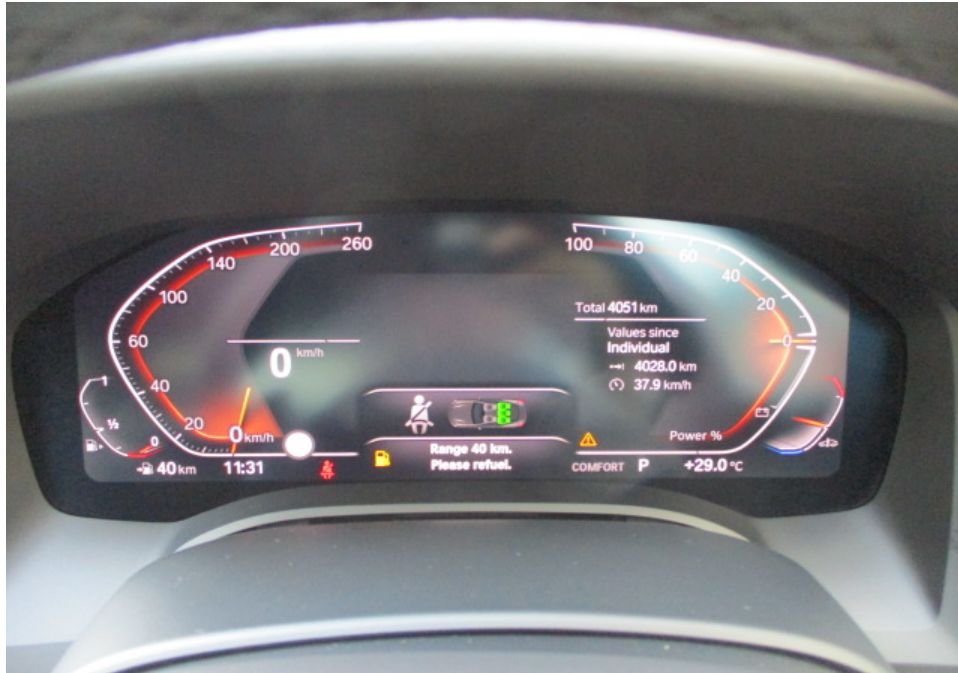
**Photo 20** shows the respective warning lights no longer illuminated, indicating that there is no fault detected to the ABS, SRS, IAS, TPM and DSC systems of the Motor Car during the self-test. These electronic systems were hence in working condition at the time of my inspection.

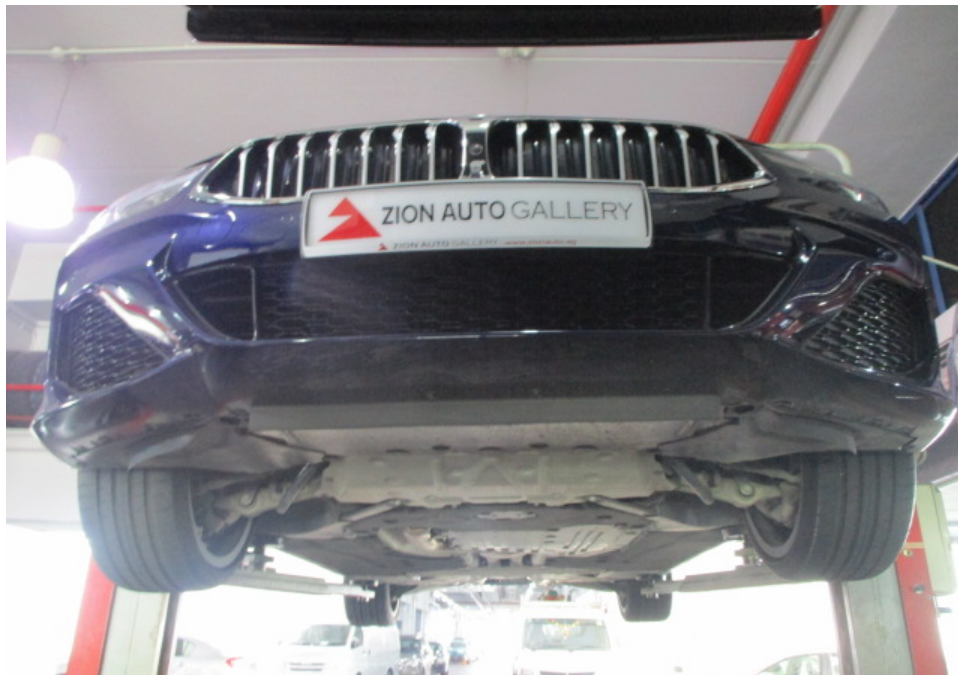
**Photo 21** shows the Motor Car hoisted up for checks on its undercarriage. There was no sign(s) or indication(s) of fluid leakage and/or fluid stain(s) on the underside of the Motor Car. The undercarriage components of the Motor Car were also all observed to be intact and secured in an appropriate manner.

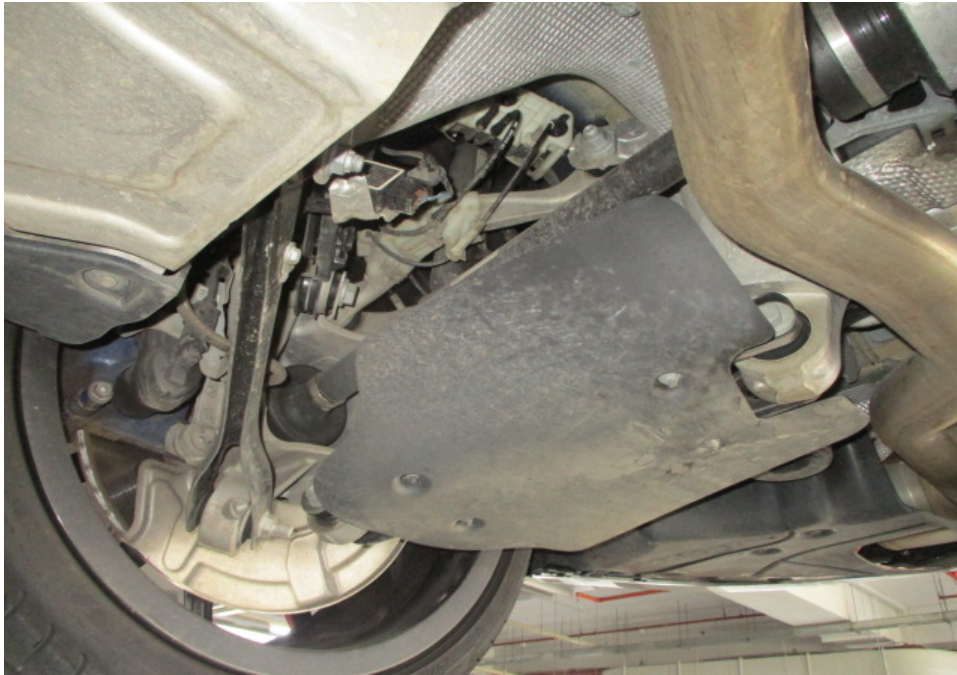
**Photo 22** shows a general view of the control arms and linkages at the rear right wheel of the Motor Car. I did not observe any fluid leak and/or fluid stain on the underside of the Motor Car. All of the Motor Car's undercarriage components were observed to be intact and secured in an appropriate manner.

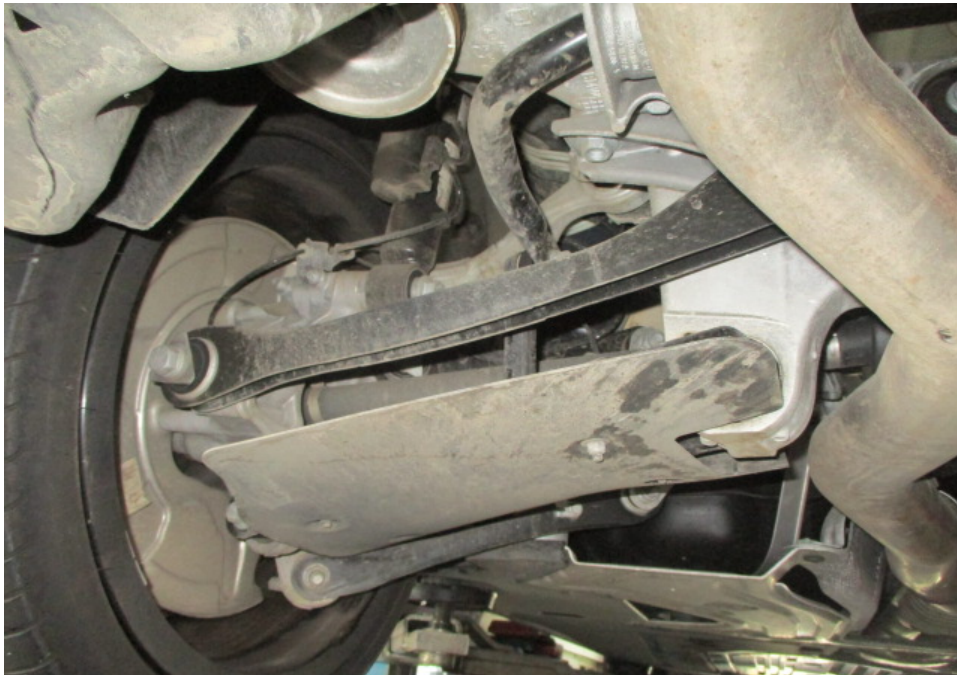
**Photo 23** shows a general view of the control arms and linkages at the rear left wheel of the Motor Car. I did not observe any fluid leak and/or fluid stain on the underside of the Motor Car. All of the Motor Car's undercarriage components were observed to be intact and secured in an appropriate manner.

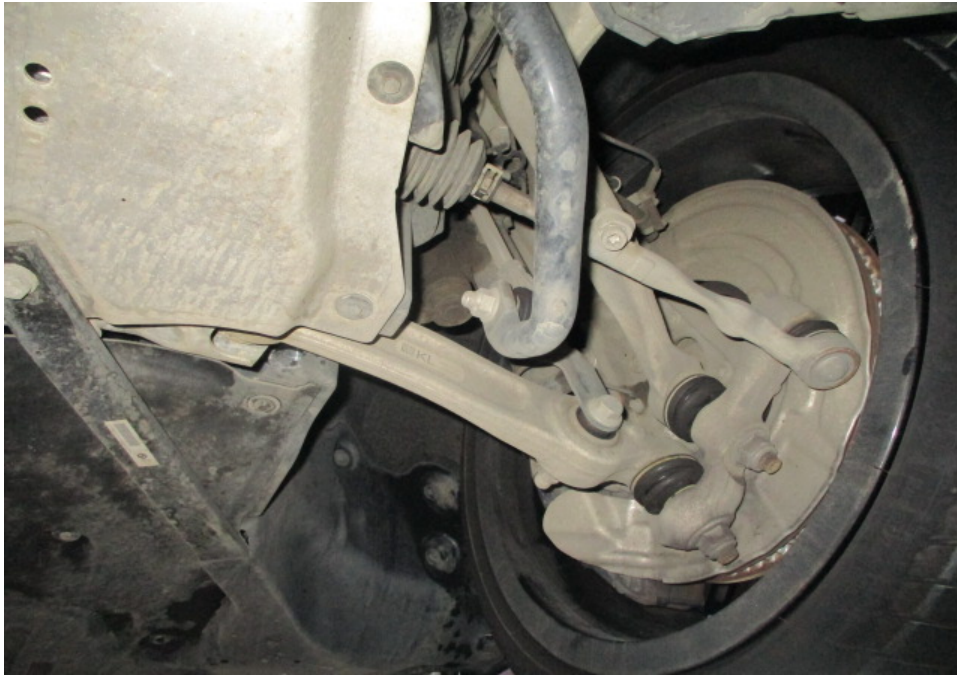
**Photo 24** shows the various undercarriage components at the front left wheel of the Motor Car. The mechanical components, control arms and linkages were all found to be intact and secured in an appropriate manner.

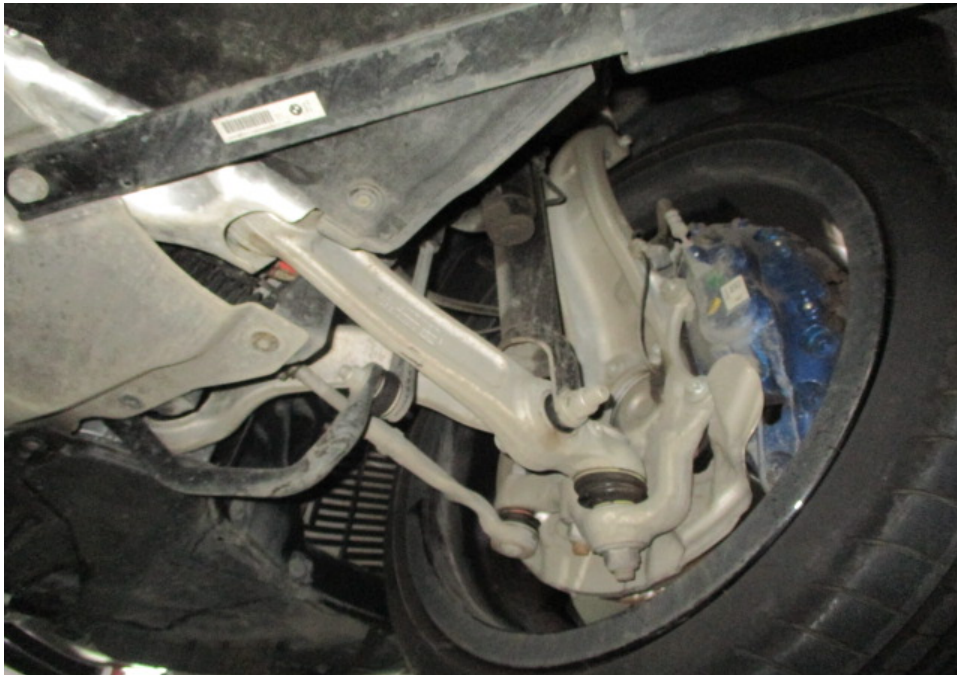
**Photo 25** shows the various undercarriage components at the front right wheel of the Motor Car. The mechanical components, control arms and linkages were all found to be intact and secured in an appropriate manner. I also did not observe any fluid leak and/or fluid stain on the underside of the Motor Car.

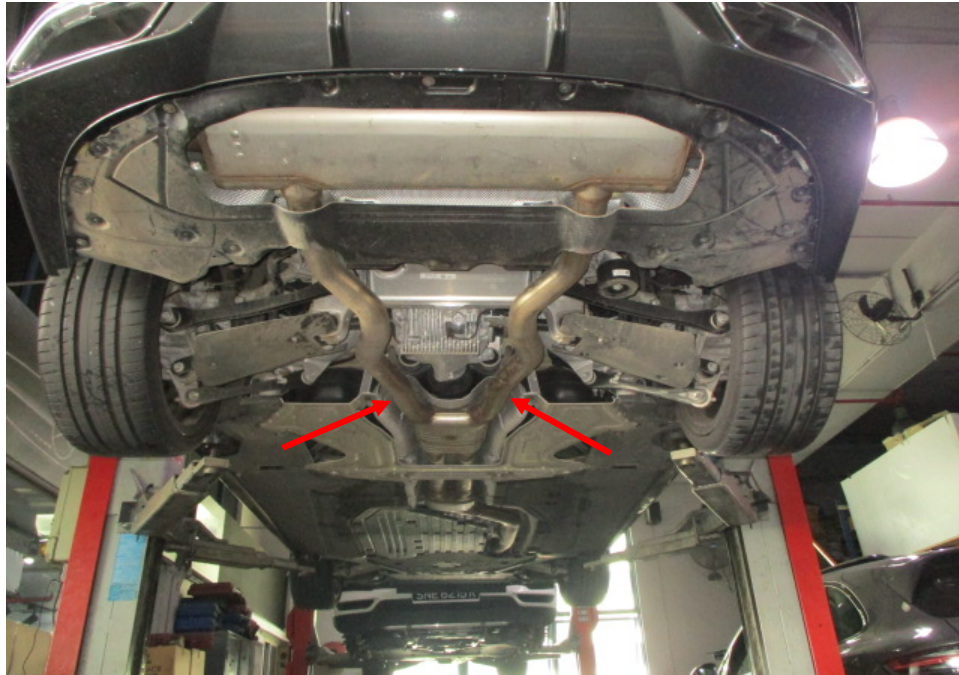
**Photo 26** shows the rear section of the Motor Car's exhaust system. My examination of the Motor Car's exhaust system revealed no sign(s) or indication(s) of any cut or weld marks along its exhaust pipes (arrowed), on its rear muffler, on its centre resonator boxes and on its catalytic converter.

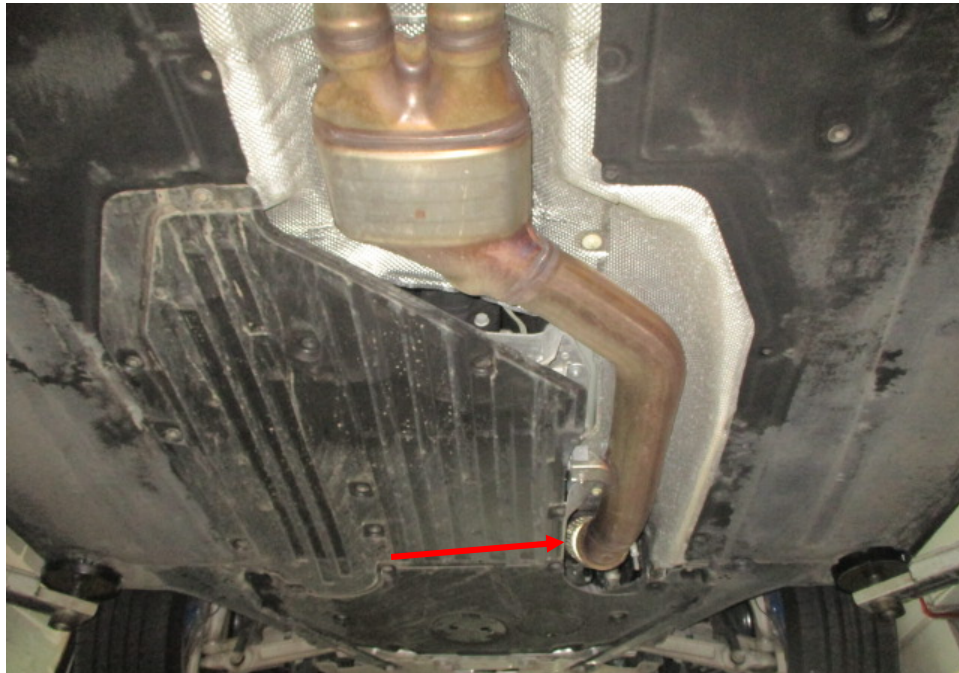
**Photo 27** shows the front section of the Motor Car's exhaust system. My examination of the Motor Car's exhaust system revealed no sign(s) or indication(s) of any cut or weld marks along its exhaust pipes, on its rear muffler, on its centre resonator boxes and on its catalytic converter (arrowed).

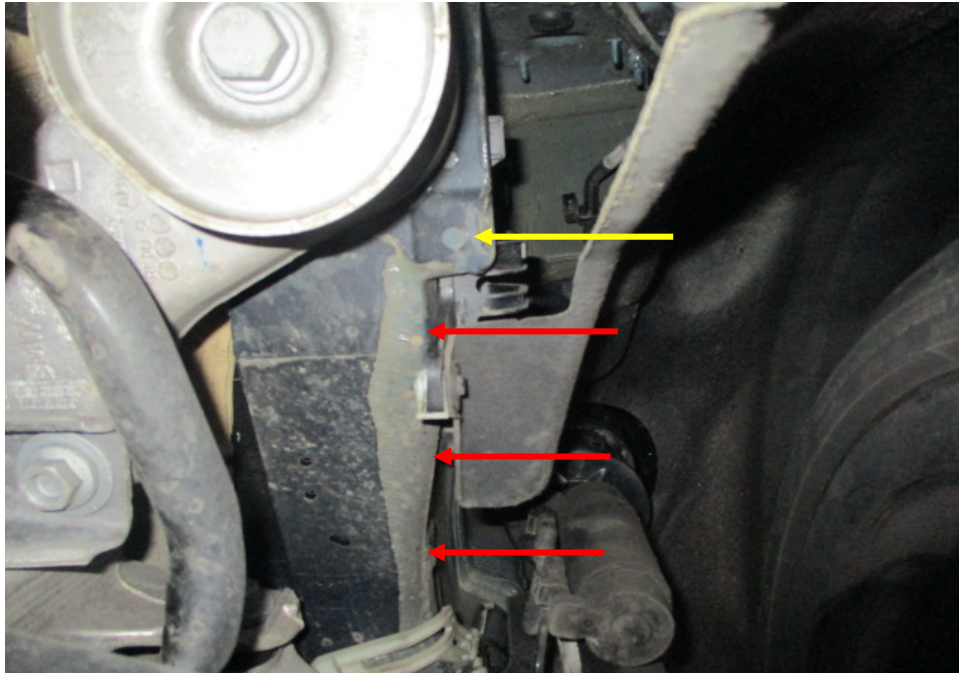
**Photo 28** shows the chassis/structural body at the underside rear right of the Motor Car. I did not find any weld marks other than original spot weld marks (yellow arrow) on the chassis/structural body of the Motor Car. The original factory sealant (red arrow) at the joints along the chassis/structural body was untouched, indicating no work was done on the chassis/structural body of the Motor Car and that the chassis/structural body was originally fitted.

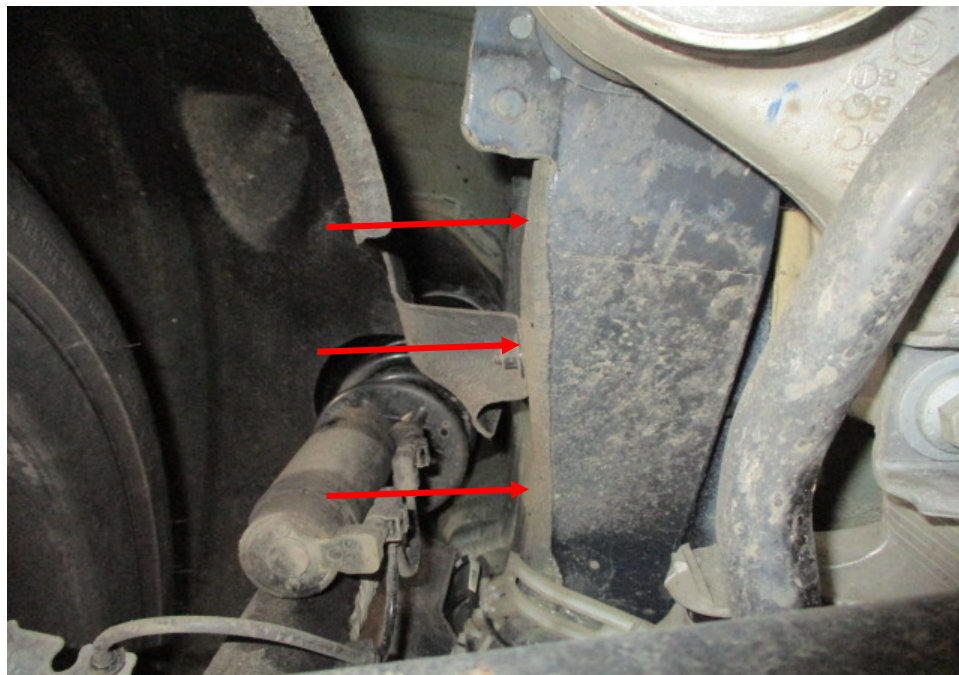
**Photo 29** shows the chassis/structural body at the underside rear left of the Motor Car. The original factory sealant (arrowed) at the joints along the chassis/structural body was observed to be untouched. In general, I had found no work was carried out on the chassis/structural body of the Motor Car. The chassis/structural body of the Motor Car was originally fitted.
