Your Ref: BMW 840i  
(chassis number WBAGV22080CG15788)  
Our Ref : CI/TP22003034/D

01 April 2022

**INSPECTION REPORT OF AN UNREGISTERED BMW 840i MOTOR CAR  
WITH CHASSIS NUMBER WBAGV22080CG15788**

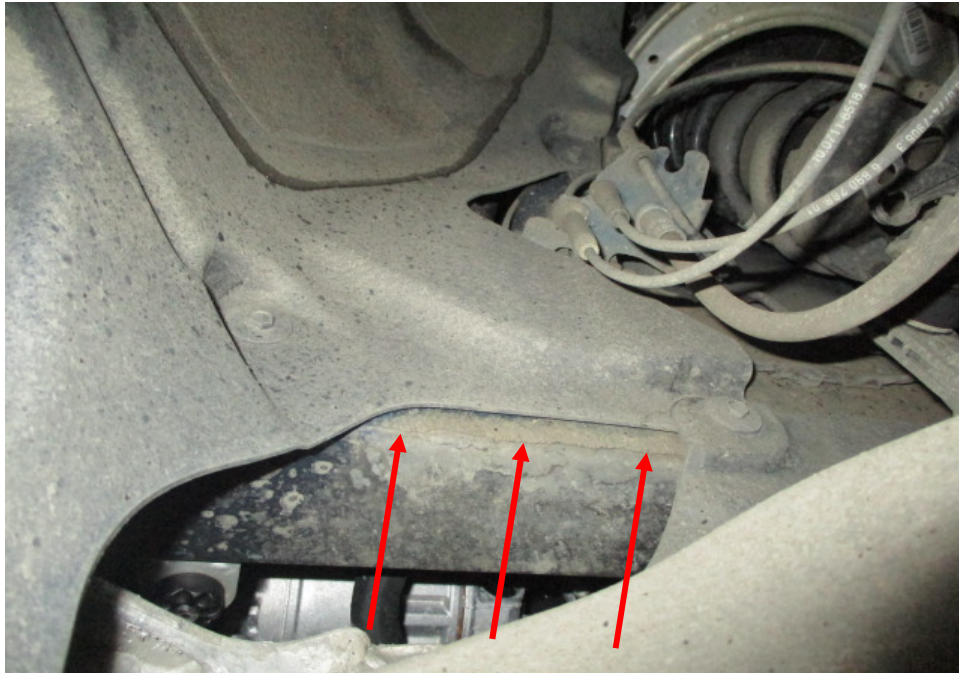
**Photo 30** shows the chassis/structural body at the underside front left of the Motor Car. The original factory sealant (arrowed) at the joints along the chassis/structural body was observed to be untouched. In general, I had found no work was carried out on the chassis/structural body of the Motor Car. The chassis/structural body of the Motor Car was originally fitted.

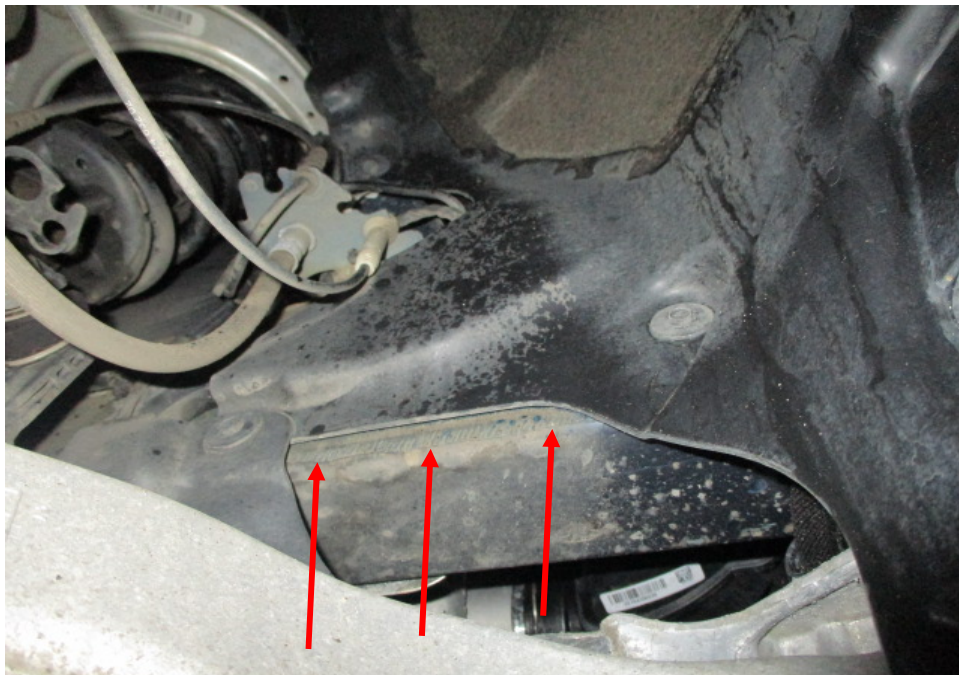
**Photo 31** shows the chassis/structural body at the underside front right of the Motor Car. The original factory sealant (arrowed) at the joints along the chassis/structural body was observed to be untouched. In general, I had found no work was carried out on the chassis/structural body of the Motor Car. The chassis/structural body of the Motor Car was originally fitted.

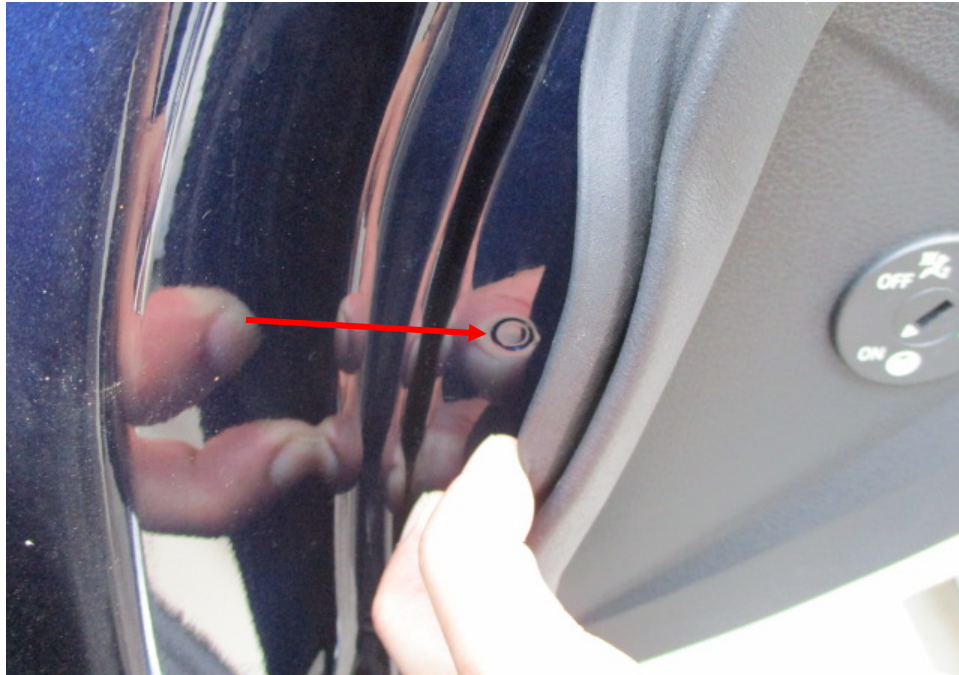
**Photo 32** shows the left side "A" pillar of the Motor Car. I did not find any weld marks other than original spot weld marks (arrowed) on the left side "A" pillar of the Motor Car which, indicates that there was no re-welding works carried out. In general, I had found all the non-detachable body panels of the Motor Car to be originally fitted at the time of my inspection.

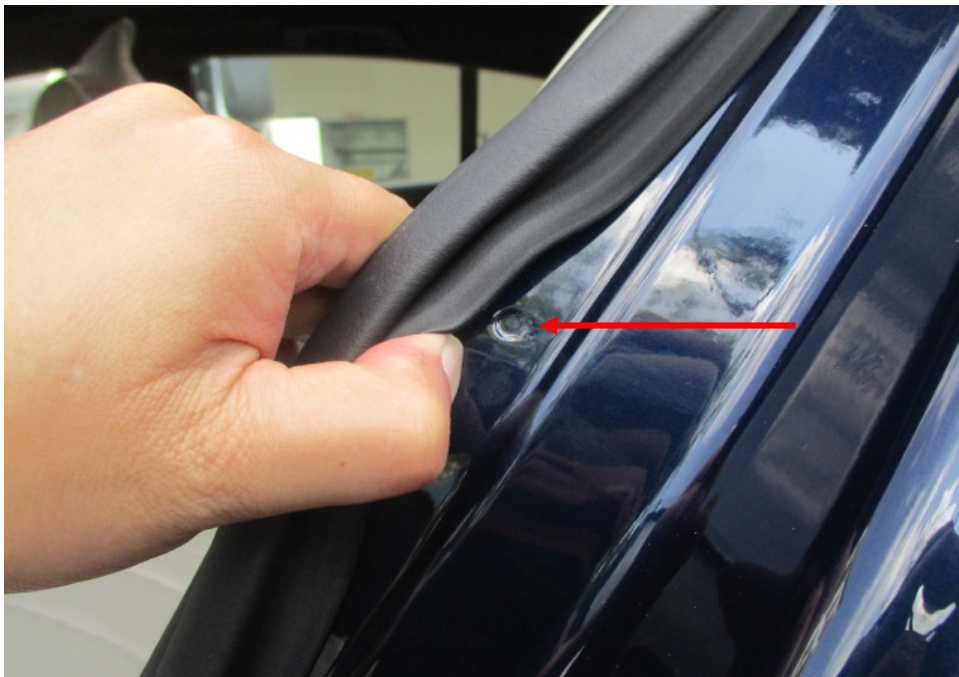
**Photo 33** shows the left side "C" pillar of the Motor Car. I did not find any weld marks other than original spot weld marks (arrowed) on the left side "C" pillar of the Motor Car which, indicates that there was no re-welding works carried out. In general, I had found all the non-detachable body panels of the Motor Car to be originally fitted at the time of my inspection.

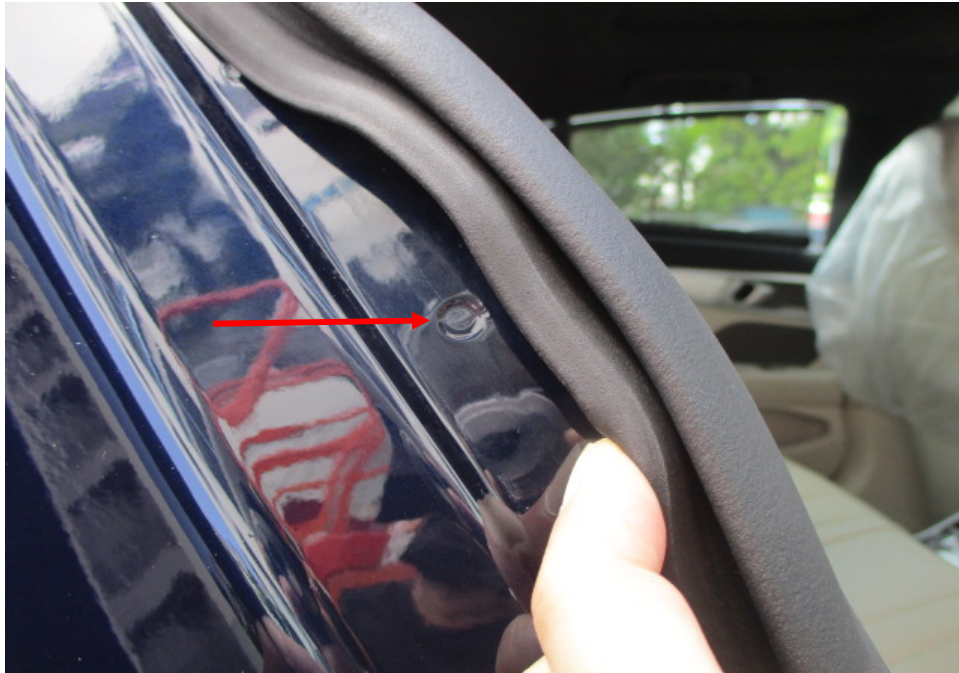
**Photo 34** shows the right side "C" pillar of the Motor Car. I did not find any weld marks other than original spot weld marks (arrowed) on the right side "C" pillar of the Motor Car which, indicates that there was no re-welding works carried out. In general, I had found all the non-detachable body panels of the Motor Car to be originally fitted at the time of my inspection.
