Your Ref: MTS2022D0001749
Our Ref : CI/III22003041/P

11th April 2022

**TECHNICAL INVESTIGATION REPORT OF WARRANTY CLAIM INVOLVING
THE INSURED VEHICLE SMQ 8426J ON 1st APRIL 2022**

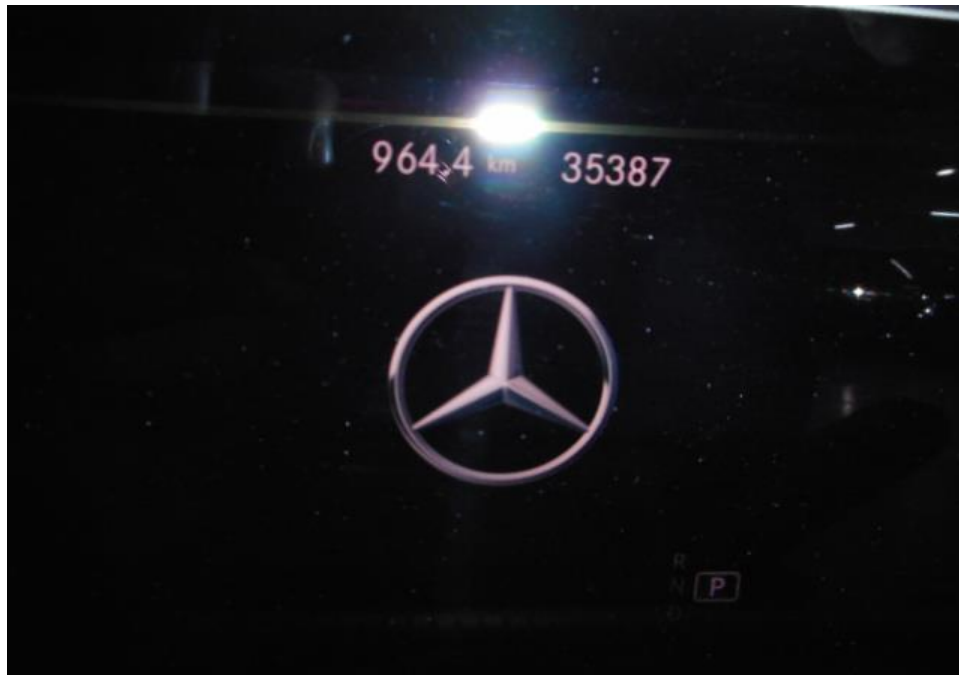
Photo 1 shows the mileage of the Insured Vehicle recorded at the time inspection at 35,387KM

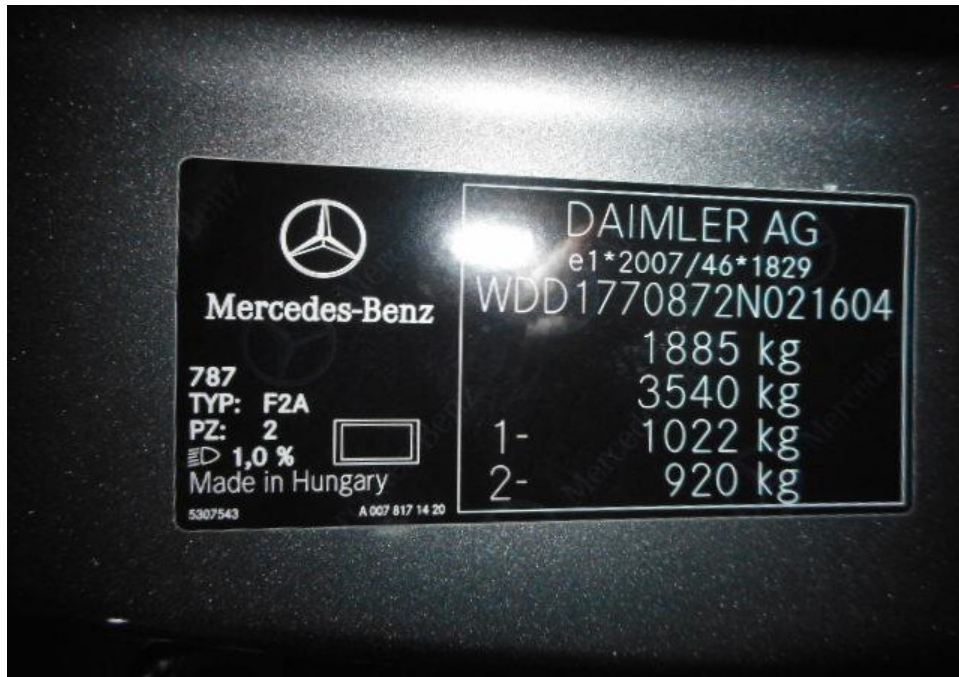
Photo 2 shows the chassis number of the Insured Vehicle at the time of our inspection.

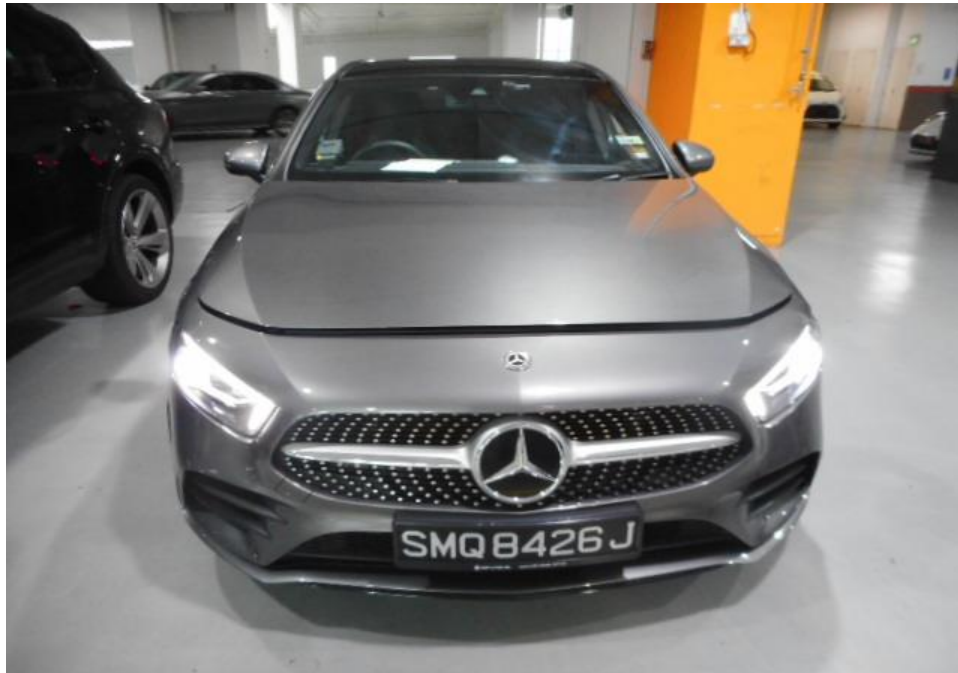
Photo 3 shows the general view of the front portion of the Insured Vehicle at the time of our inspection. The Insured Vehicle is observed to be unaffected by any signs of accident.

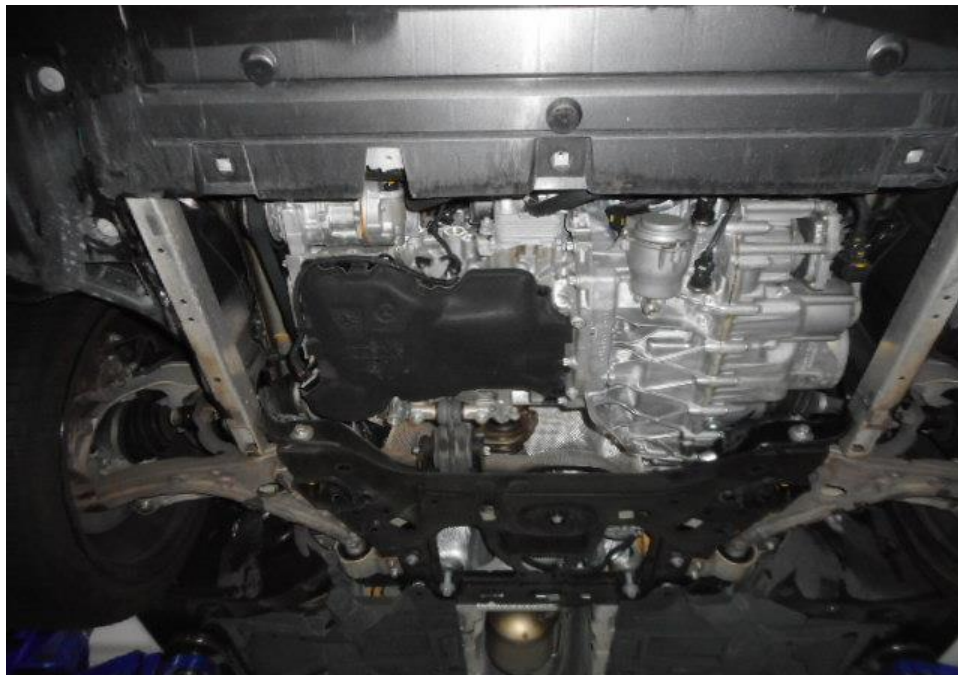
Photo 4 shows the general view of the undercarriage portion of the Insured Vehicle at the time of our inspection. The undercarriage compartment is observed to be unaffected by any signs of accident.

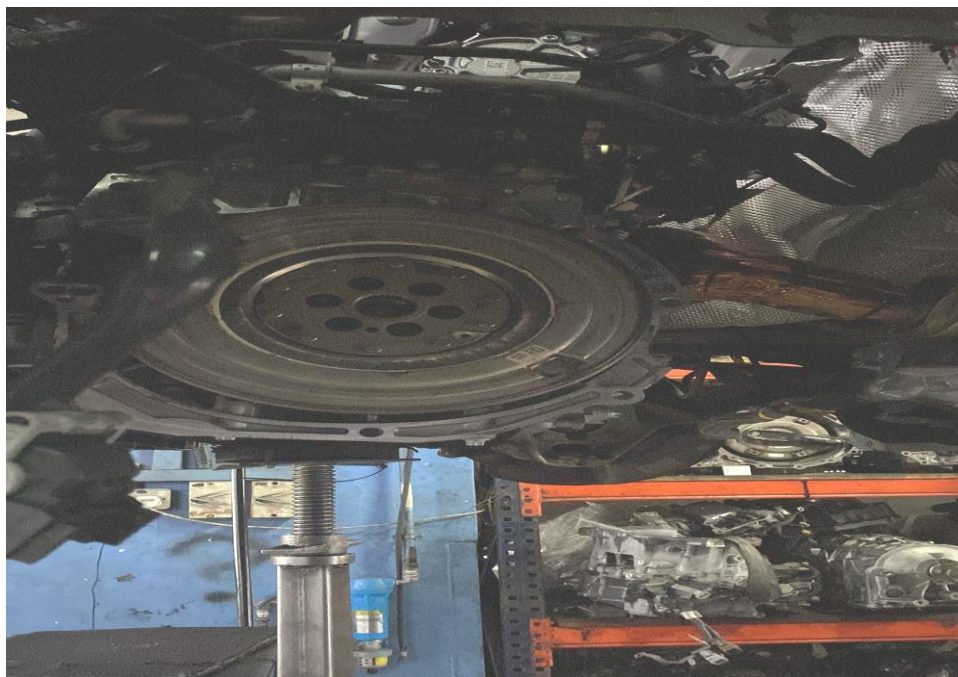
Photo 5 shows the general view of the gearbox underside portion of the Insured Vehicle at the time of our inspection. The gearbox underside compartment is observed to be unaffected and by any signs of accident.

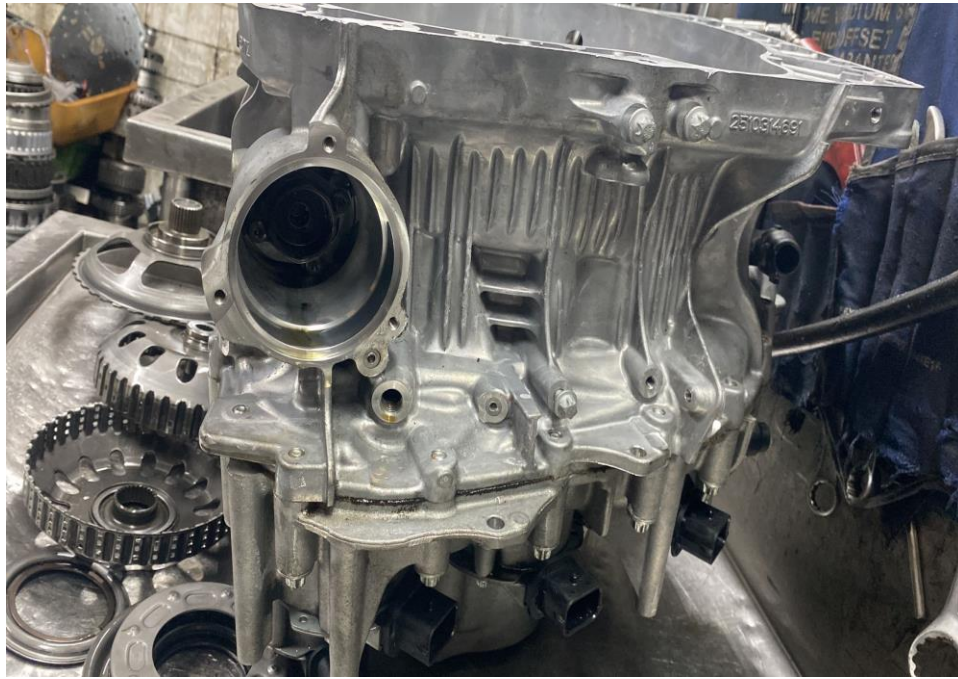
Photo 6 shows the general view of inside the gearbox unit of the Insured Vehicle at the time of our inspection. The components in the gearbox unit is observed to be unaffected and by any signs of accident.

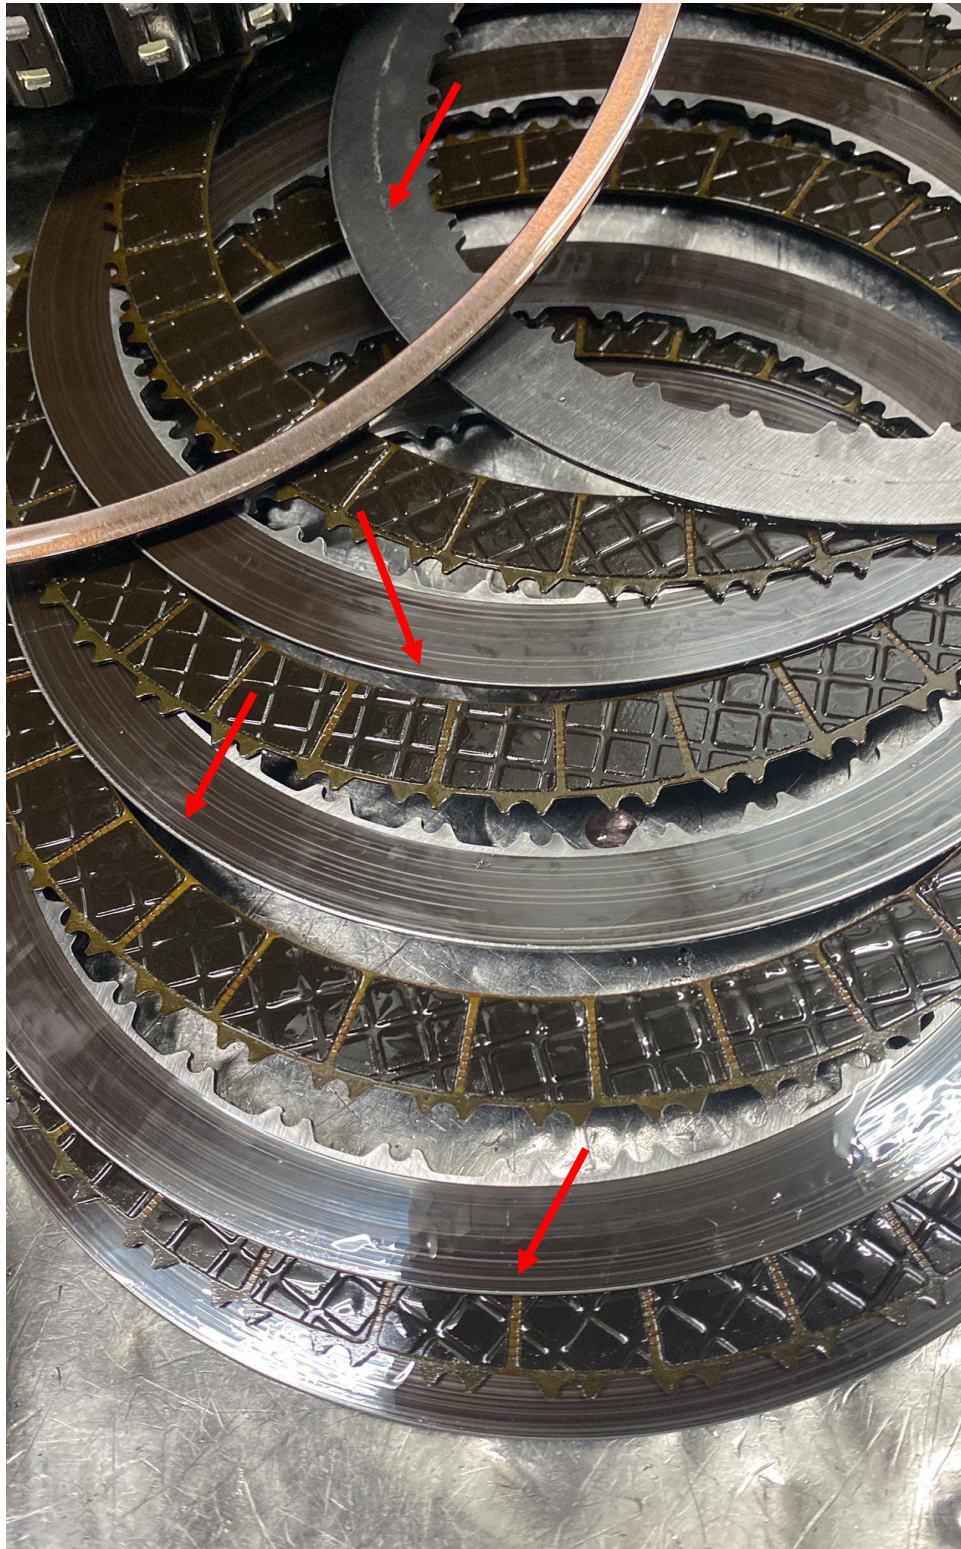
6. Prior to our inspection, the workshop had informed us that they had already conducted checks and upon dismantling the gearbox unit they have found damages to the clutch pack in the gearbox of the Insured Vehicle and agreed that the complained problem is from these components in the gearbox unit See photos 1 – 7 below.

Photo 7 shows the close up view of inside the gearbox unit of the Insured Vehicle at the time of our inspection. The clutch pack (arrowed) component in the gearbox unit is observed to be damaged with scratches on the surface on the clutch packs linings, this is the cause for the complained problems of difficulty in changing gears and the sound coming for the gearbox of the Insured Vehicle.

8. We did not find any evidence which had suggested that the cause of abnormalities to the Insured Vehicle was due to poor maintenance and/or recurring problem.
9. The recommendation to replace the clutches and overhaul the gearbox unit at \$7,150 as stated in the quotation is justifiable as all the relevant checks has been conducted to the Insured Vehicle.
