TP VEHICLE NO : SKR3527C

CLAIM TYPE : PRE-REPAIR SURVEY

PRE-REPAIR SURVEY REPORT

Mercedes-Benz CLA180

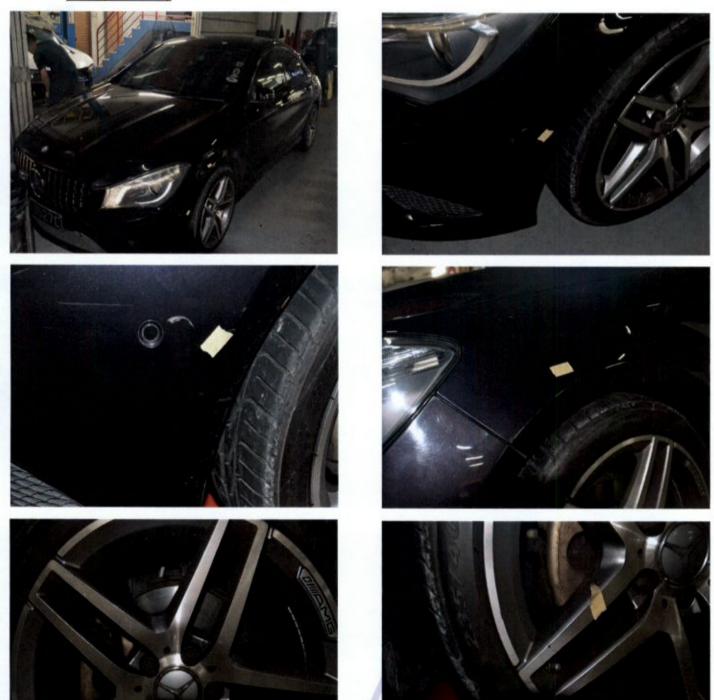
Pre-repair survey

The vehicle sustained damage on the front left portion.

Based on visual survey of the vehicle without any repair estimate provided, we viewed that the repair cost should not be more than \$\$800.00 and could take approximately three (3) working days to complete.
