## AUTOMOBILE INSPECTION REPORT

Assigned By : As above  
Accident Date : 12 December 2021  
Assignment Date : 13 December 2021  
Inspection Date : 13 December 2021  
Our Reference No. : PAS/NPA/220118/TP

Registration No. : SJX 1771 G  
Make/Model : MERCEDES BENZ C200 CGI AMG  
Yr of Manuf/Regn : 20 Jun 2017  
Carrying Capacity : 4 Seater  
Chassis No. : WDD2050422R178395  
Engine No. : 27492030627367  
Colour : Metallic Silver  
Class : Passenger ( Private - Company )

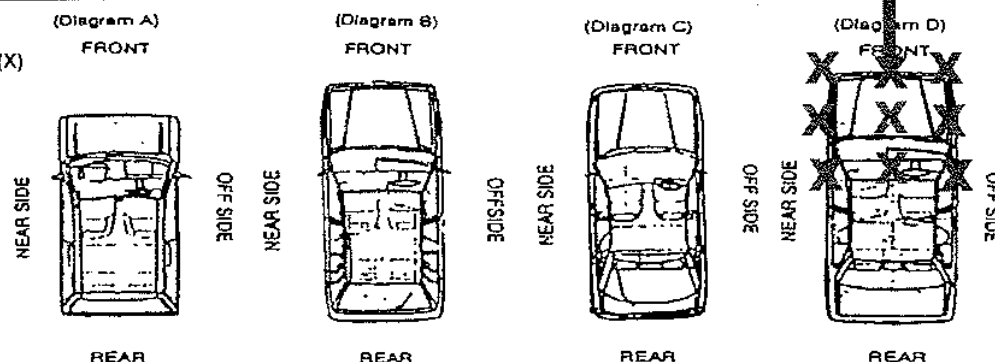
**The vehicle sustained impact On its Front Portion. (see Diagram D)**

Parts damaged were : **The bonnet, front bumper and reinforcement, front support panel, both front chassis and fenders, firewall panel, front lower engine crossmember were dented.**
