Your Ref : 639105  
Our Ref : CI/MSG22003272/D

07 April 2022

**AUTOMOBILE TECHNICAL INVESTIGATION REPORT OF INCIDENT  
INVOLVING SNA 9130C AND SKP 5353J ON 29 NOVEMBER 2021**

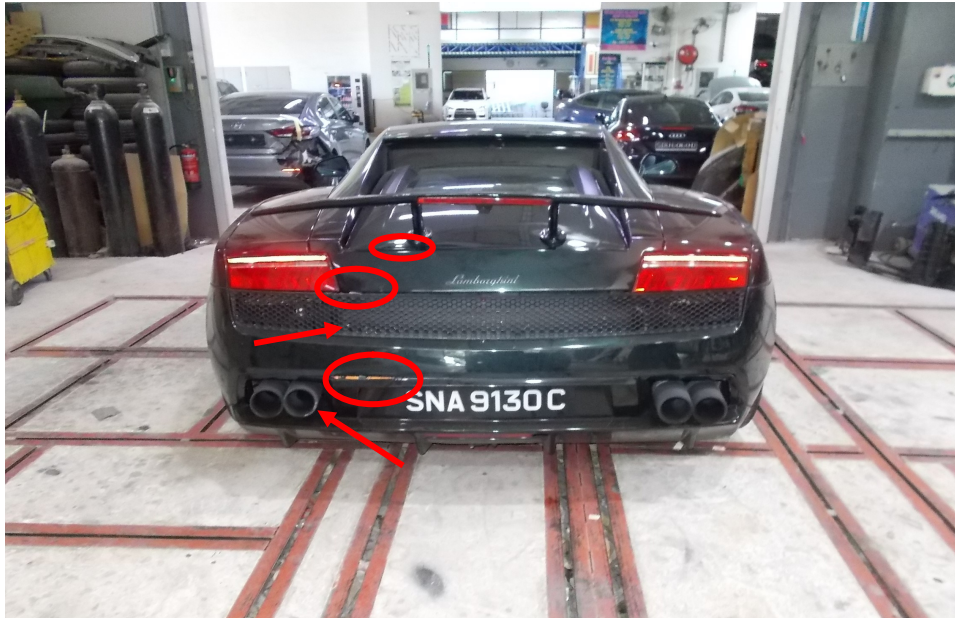
9. The Third Party Vehicle was physically inspected by LKK Auto Consultants Pte Ltd on 30 November 2021. Upon review of the photographs taken, I note that the Third Party Vehicle had sustained damage that was confined to its rear portion, slightly to the left of the centre. The rear bumper, rear bumper lower spoiler, rear bumper grille, rear centre top panel, rear taillamps, rear left exhaust tip and engine hood were amongst the body parts that were damaged. Refer to photo 1 – 8 below for details of the damage.

**Photo 1** shows the rear body of the Third Party Vehicle at the time of physical inspection by LKK Auto Consultants Pte Ltd. The Third Party Vehicle was observed to have sustained damage that was confined to its rear portion, slightly to the left of the centre. Damage was seen on the rear bumper, rear bumper lower spoiler, rear bumper grille, rear left exhaust tip, rear centre top panel, rear taillamps and engine hood. The damage areas are highlighted by the red arrows and red circles with close up shown in the below photographs.

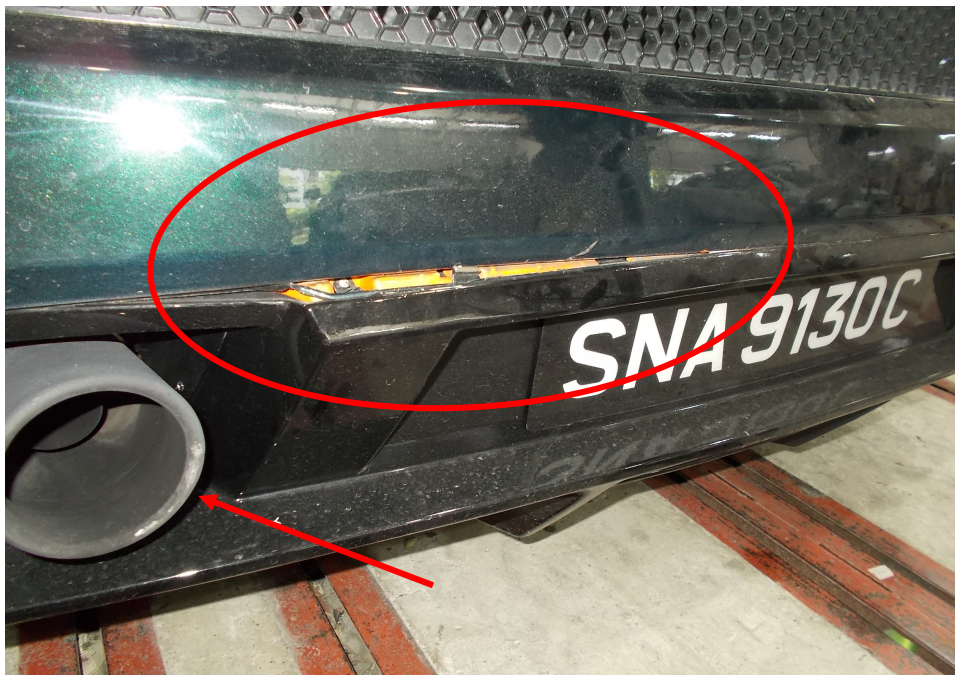
**Photo 2** shows a close up view of the damage to the rear bumper and rear bumper lower spoiler (circled) of the Third Party Vehicle at the time of physical inspection by LKK Auto Consultants Pte Ltd. What appears to be impact marks were also seen to the rear left exhaust tip (arrowed) of the Third Party Vehicle. These damages are a result of direct contact with an object(s).

24. For completeness, the damage that was seen on the rear left lower portion of the Third Party Vehicle, shown in photograph 2 above, was similarly seen on the Third Party Vehicle in the images captured by the recording device after the incident. See photo 19 below, which is a screenshot extracted directly from the video footage showing the Third Party Vehicle driving off after the contact from the Insured Vehicle.

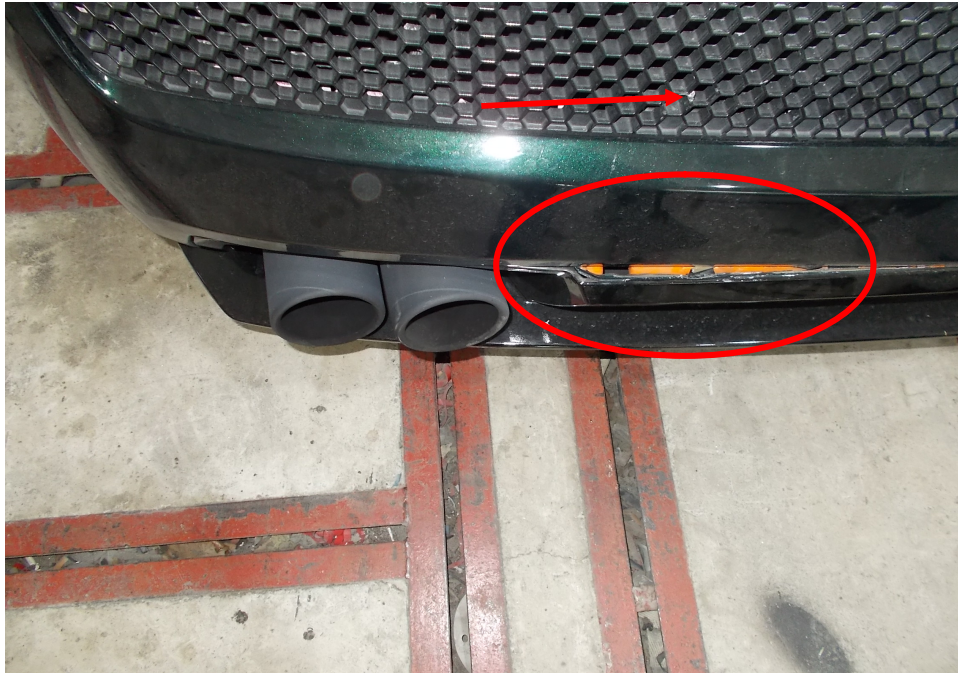
**Photo 3** shows another view of the damage to the Third Party Vehicle's rear bumper and rear bumper lower spoiler (circled) at the time of physical inspection by LKK Auto Consultants Pte Ltd. The damage to the rear bumper grille of the Third Party Vehicle is shown by the red arrow.

21. The photograph taken by the driver of the Insured Vehicle was attached in his Singapore Accident Statement. The photograph had showed the Third Party Vehicle's rear bumper and rear bumper lower spoiler misaligned, which was in the same damage condition as seen in photograph 2 and 3 above. However, upon my close examination of this photograph, I note that the damage to the rear bumper grille, shown in photograph 3 and 4 above, did not exist at the time when the photograph was taken by the driver of the Insured Vehicle. See photo 16 below.

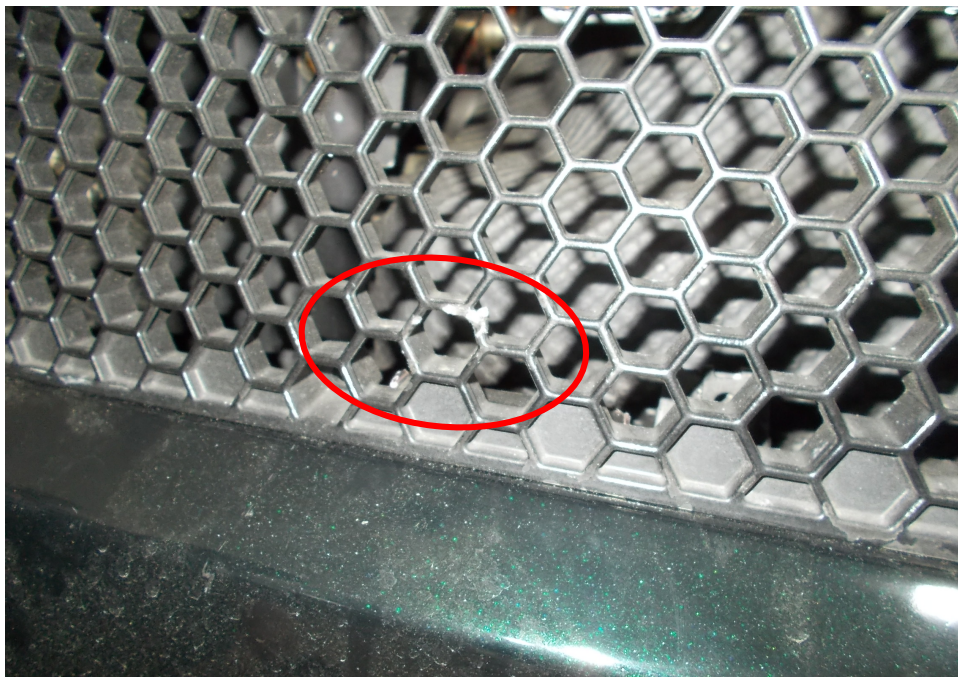
**Photo 4** shows a close up view of the damage (circled) that was seen on the Third Party Vehicle's rear bumper grille at the time of physical inspection by LKK Auto Consultants Pte Ltd. This damage arose from direct contact with an object(s).

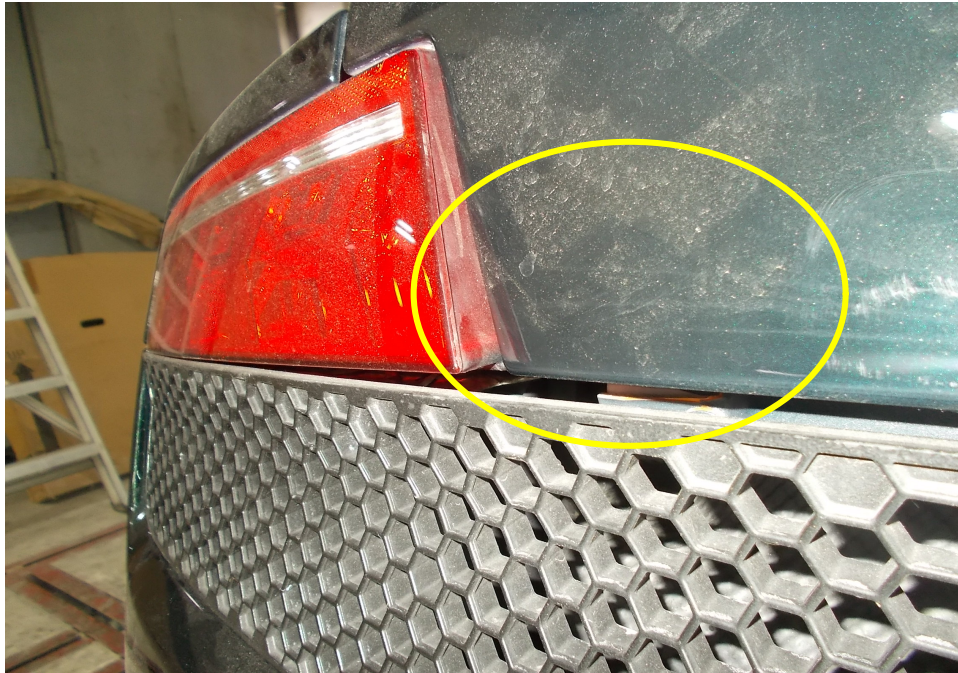
**Photo 5** shows the misalignment between the rear centre top panel and the rear left taillamp of the Third Party Vehicle at the time of physical inspection by LKK Auto Consultants Pte Ltd. The rear centre top panel appears to be bent inwards at the area (circled) adjacent to the rear left taillamp.

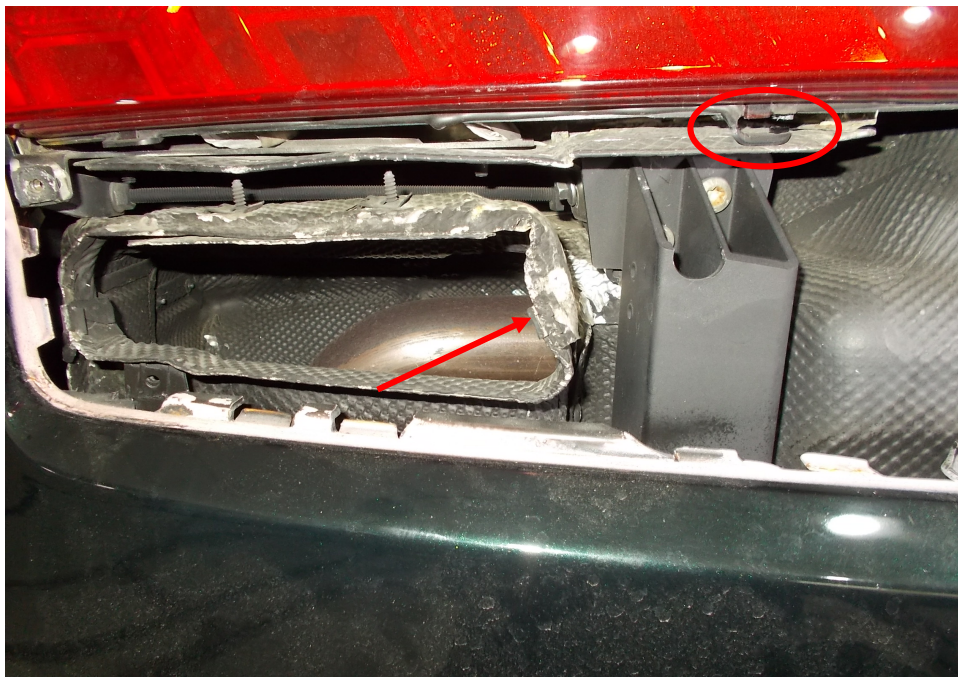
**Photo 6** shows the damage to the rear left taillamp of the Third Party Vehicle at the time of physical inspection by LKK Auto Consultants Pte Ltd. This was after the front bumper grille was removed. The mounting loop of the rear left taillamp was observed to be broken (circled). The heat shield for the rear left exhaust was also observed to be bent (arrowed). These damages are induced damages.

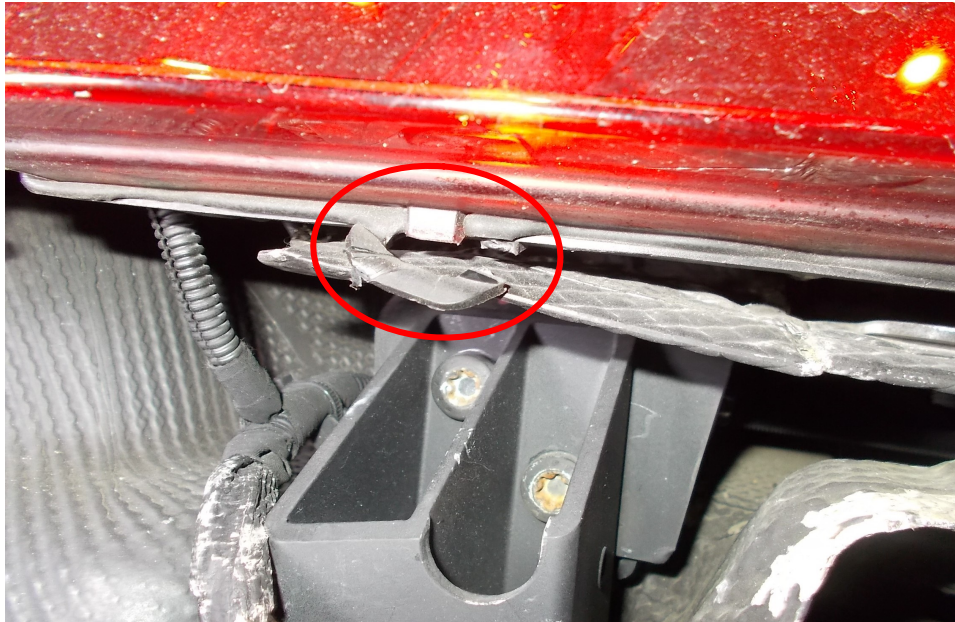
**Photo 7** shows the damage to the rear right taillamp of the Third Party Vehicle at the time of physical inspection by LKK Auto Consultants Pte Ltd. This was after the front bumper grille was removed. The mounting loop of the rear right taillamp was observed to be broken (circled). This damage is an induced damage.

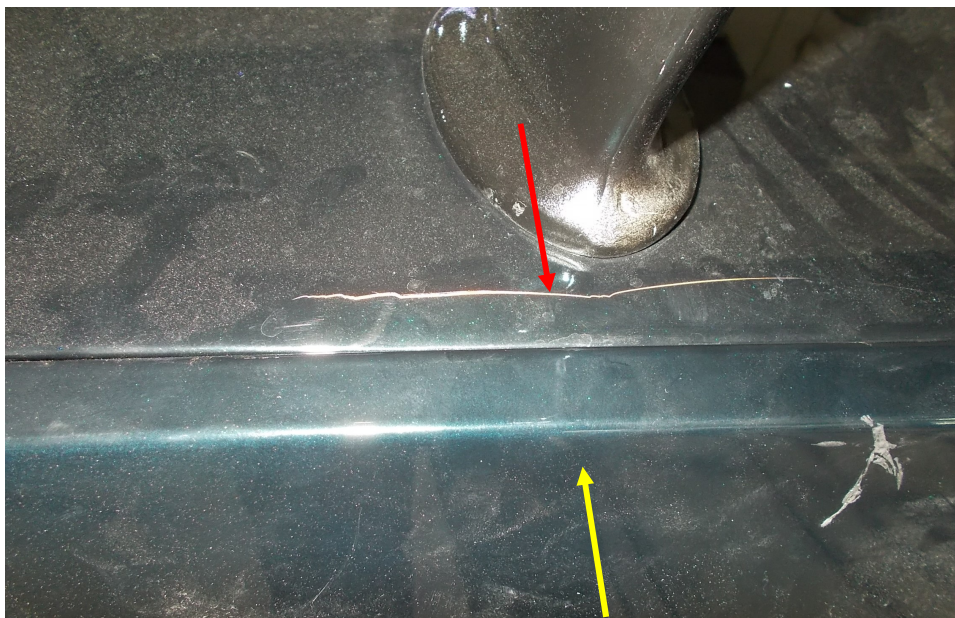
**Photo 8** shows a close up view of the damage that was seen on the Third Party Vehicle's engine hood at the time of physical inspection by LKK Auto Consultants Pte Ltd. Paint crack (red arrow) was observed on the top surface area of the engine hood. This indicates a movement inwards of the rear centre top panel (yellow arrow). In other words, the rear centre panel of the Third Party Vehicle was exposed to a direct impact force that pushed it inwards. The engine hood, which fits above the rear centre top panel, was the resisting influence. This caused the edge of the engine hood to bend, leading to the paint on the top surface of the engine hood to crack. This damage is an induced damage.

22. Also, my analysis of the video footages showing the events after the contact from the Insured Vehicle appears to show no paint crack on the top surface area of the Third Party Vehicle's engine hood immediately after the occurrence of contact from the Insured Vehicle. The paint crack that was shown in photograph 8 above was not seen in the images captured by the recording device. See photo 17 & 18 below, which are screenshots extracted directly from the video footages showing the Third Party Vehicle after the contact from the Insured Vehicle.

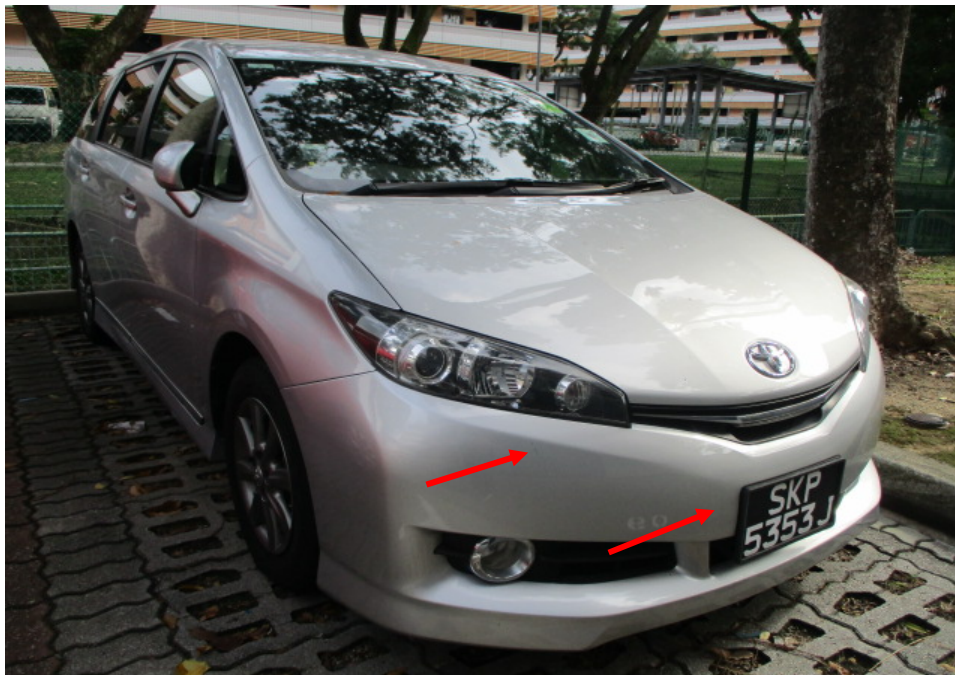
10. For the Insured Vehicle, I had physically inspected it on 17 December 2021. My physical inspection had primarily focused on the front right portion of the Insured Vehicle. This was because the contact, if any, would have occurred at the Insured Vehicle's front right portion, if basing on the events seen in the video footage, which will be discussed upon later in paragraph 15 below.
11. Upon close examination, I had observed a relatively faint grazed mark on the Insured Vehicle's front bumper, at the area below the front right headlamp. A semi-circular imprint mark was also seen on the front bumper, at the area towards the right side of the Insured Vehicle's front number plate. See photo 9 – 11 below.

**Photo 9** shows a general view of the front right body of the Insured Vehicle at the time of my physical inspection on 17 December 2021. My inspection of the Insured Vehicle had primarily focused on its front right portion. This was because the contact, if any, would have occurred at the front right portion of the Insured Vehicle. Upon close examination, I had found a relatively faint grazed mark and a semi-circular imprint mark on the right side of the Insured Vehicle's front bumper, which are highlighted by the red arrows with close up shown in the below photographs.

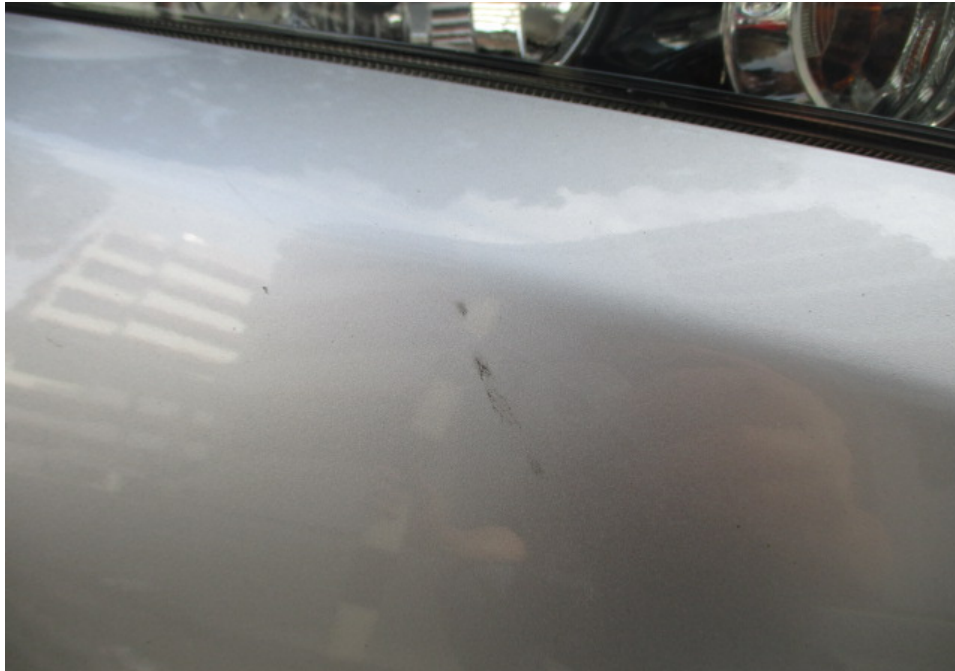
**Photo 10** shows a close up view of the relatively faint grazed mark that I had observed on the Insured Vehicle's front bumper, at the area below the front right headlamp.

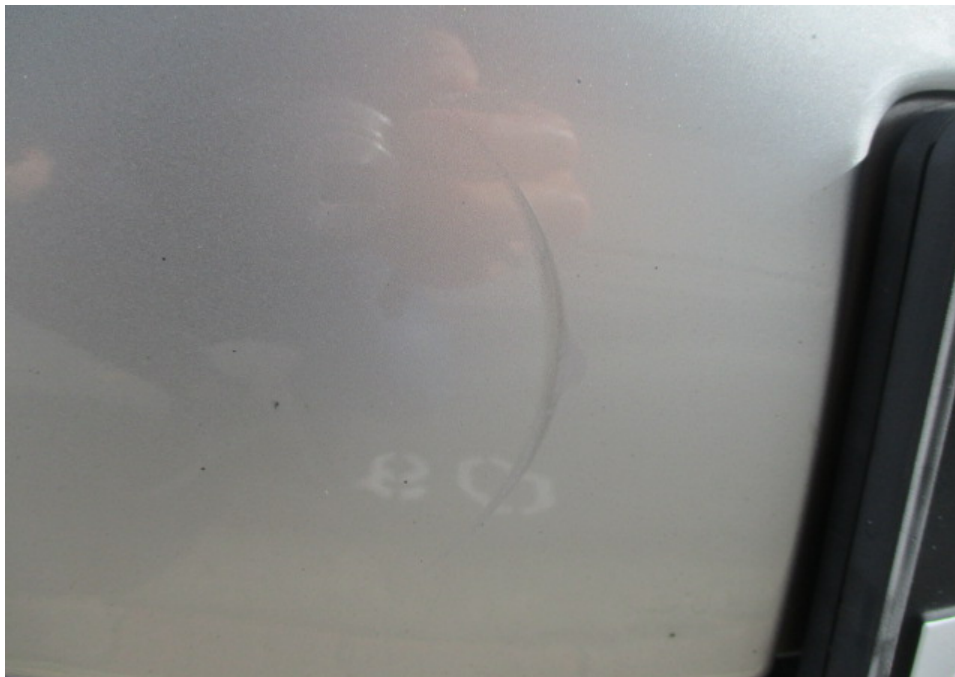
**Photo 11** shows a close up view of the semi-circular imprint mark that was found on the front bumper of the Insured Vehicle, at the area towards the right side of the front number plate.

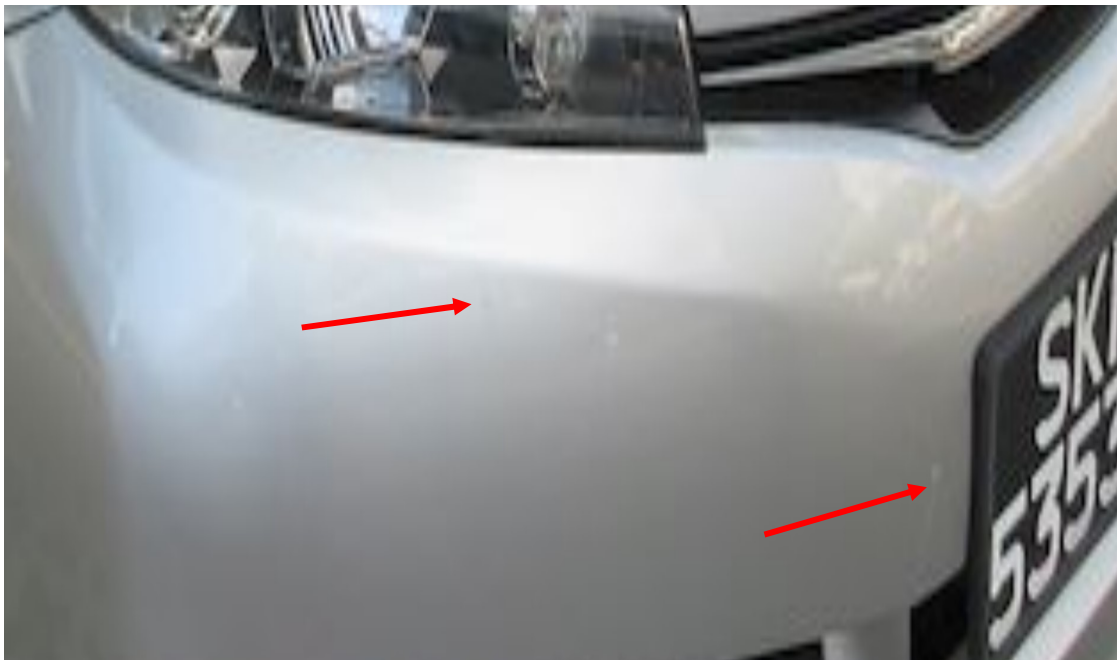
12. For completeness, the damages that I had observed on the front bumper of the Insured Vehicle at the time of my physical inspection on 17 December 2021 were also vaguely seen in the photographs that were attached in the Singapore Accident Statement that was lodged by the driver of the Insured Vehicle. The photographs were taken at the time when the Singapore Accident Statement was lodged on 07 December 2021, about 10 days before my inspection of the Insured Vehicle.
13. Note that the photographs were all general view without any close up view. A zoomed in view of the Insured Vehicle's front left portion, extracted from the set of photographs that were attached in the Singapore Accident Statement lodged by the driver of the Insured Vehicle, is shown below.

**Photo 12** shows a zoomed in view of the relatively faint grazed mark and semi-circular imprint mark on the right side of the Insured Vehicle's front bumper (arrowed). This was at the time when the Singapore Accident Statement was lodged by the driver of the Insured Vehicle on 07 December 2021, which was 10 days before my inspection of the Insured Vehicle on 17 December 2021.

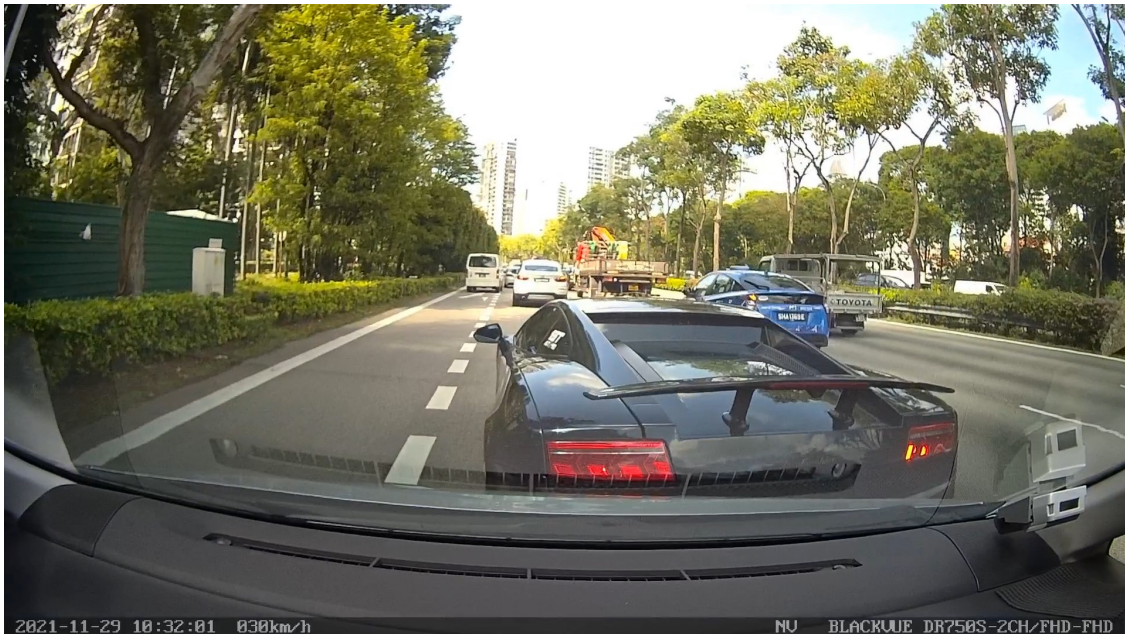
15. Upon analyzing the video footage showing the events before the incident, I note the occurrence of contact between the Insured Vehicle and the Third Party Vehicle at the 10:32:01 time stamp mark. Basing on the positioning of the Insured Vehicle and the Third Party Vehicle, the contact had occurred between the front right portion of the Insured Vehicle and the rear left portion of the Third Party Vehicle. See photo 13 below, which is a screenshot extracted directly from the video footage showing the events before the incident.

**Photo 13** shows screenshot extracted from the video footage that was taken from the recording device that was mounted on the front windscreen of the Insured Vehicle. This was at the 10:32:01 time stamp mark where I note the occurrence of contact between the Insured Vehicle and the Third Party Vehicle. Basing on the positioning of the Insured Vehicle and the Third Party Vehicle at this time stamp, the contact had occurred between the front right portion of the Insured Vehicle and the rear left portion of the Third Party Vehicle.

23. In addition, as seen in photograph 13 above, at the time of contact from the Insured Vehicle, the rear taillamps and rear top panel of the Third Party Vehicle was not obscured from view by the body of the Insured Vehicle. This would indicate that no body part at the frontal portion of the Insured Vehicle had come into direct contact with the rear taillamps and rear top panel of the Third Party Vehicle.

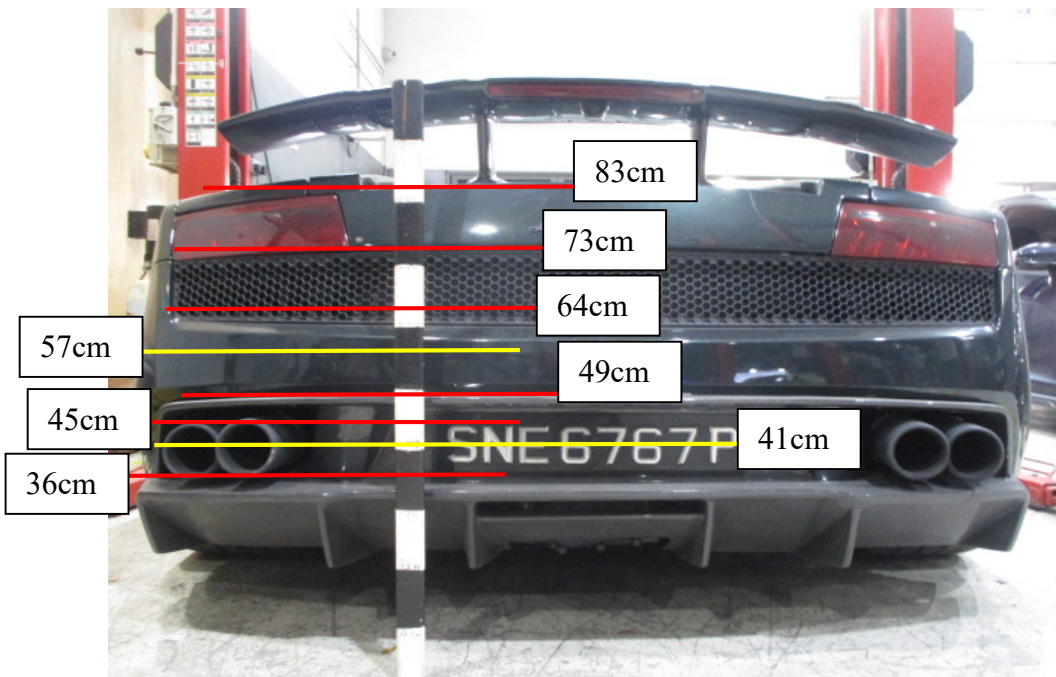
**Photo 14** shows height measurement being carried out to the rear portion of the Third Party Vehicle. This was on 18 February 2022. Basing on the height as shown in the photograph, the damage to the body parts of the Third Party Vehicle (refer to photograph 1 – 8 above) was between 36cm to 83cm above ground level. However, upon comparing the height above ground level of the damage to the Insured Vehicle (refer to photograph 15 below), I note that the damage that are within the height range of 36cm to 57cm above ground level of the Third Party Vehicle are damage that arose from the contact with the Insured Vehicle. Note: red lines are height above ground level of the damage to the Third Party Vehicle and yellow lines are height above ground level of the damage to the Insured Vehicle.

20. In light of the findings from the height measurements that were carried out, it would appear to me that the damage to the body parts of the Third Party Vehicle that are above the height of 57cm above ground level is not related to this particular incident involving the Insured Vehicle. This finding is further supported by the photograph showing the damaged Third Party Vehicle that was taken by the driver of the Insured Vehicle after the incident and; also from the video footage showing the events after the incident.

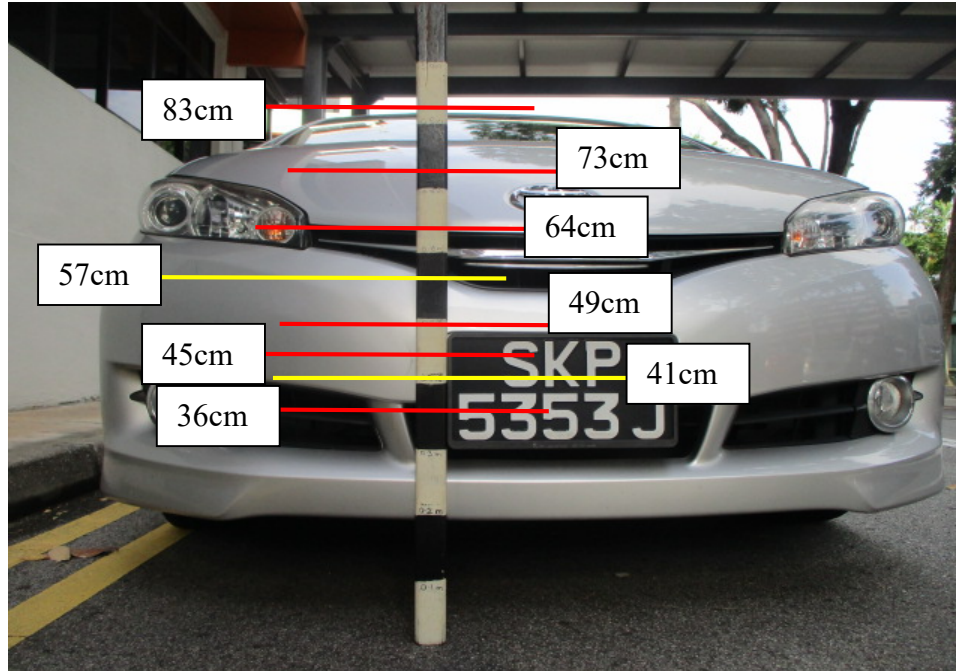
**Photo 15** shows height measurement being carried out to the frontal portion of the Insured Vehicle. This was at the time of my physical inspection on 17 December 2021. The damage to the Insured Vehicle (refer to photograph 9 to 11 above) was between 41cm to 57cm above ground level. Note: red lines are height above ground level of the damage to the Third Party Vehicle and yellow lines are height above ground level of the damage to the Insured Vehicle.

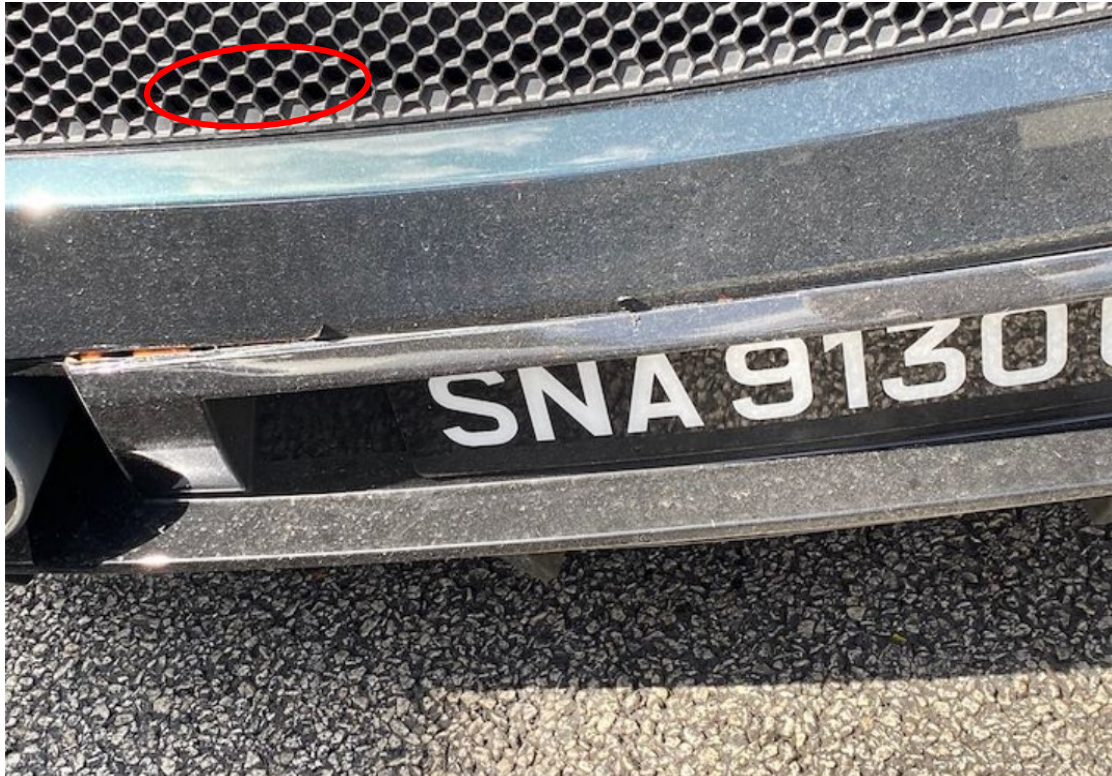
**Photo 16** shows the photograph of the damaged Third Party Vehicle that was taken by the driver of the Insured Vehicle after the incident. The damage to the rear bumper grille, shown in photograph 3 and 4 above, was located around the area highlighted by the red circle. Upon close examination of this photograph, the damage on the Third Party Vehicle's rear bumper grille that was seen in photograph 3 and 4 above, was not seen around the area highlighted by the red circle.

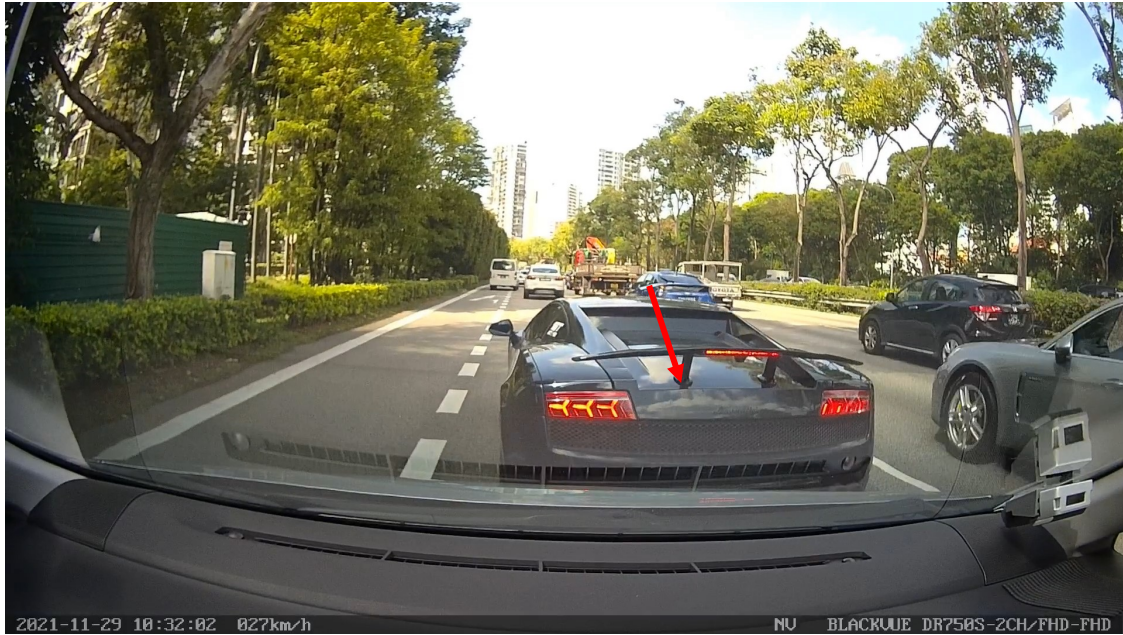
**Photo 17** shows screenshot extracted from the video footage taken from the recording device that was mounted on the front windscreen of the Insured Vehicle. This was at the 10:32:02 time stamp mark, immediately after the occurrence of contact from the Insured Vehicle. The paint crack at the engine hood, shown in photograph 8 above, was located around the area highlighted by the red arrow. Upon close examination of the images captured by the recording device (after the contact had occurred), the paint crack that was shown in photograph 8 above, was not seen around the area highlighted by the red arrow.

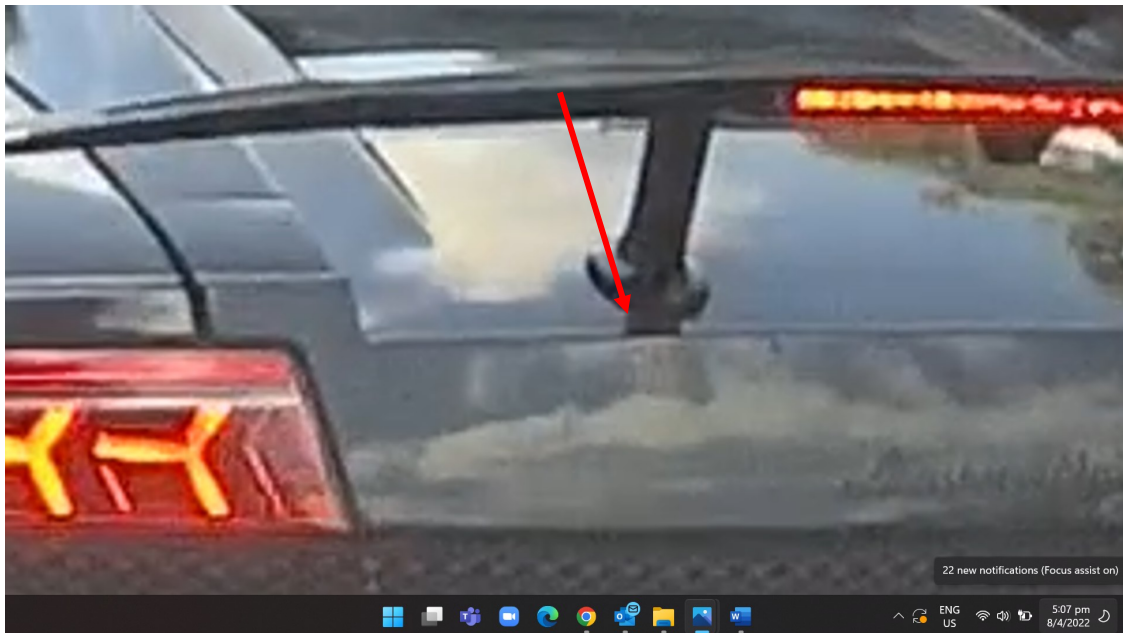
**Photo 18** shows a zoomed in view of photograph 17 above. The paint crack at the engine hood, shown in photograph 8 above, was not seen around the area highlighted by the red arrow. The reflection of the top spoiler stand onto the engine hood was not distorted, which would indicate that there was no crack line(s) on the top surface area of the Third Party Vehicle's engine hood.

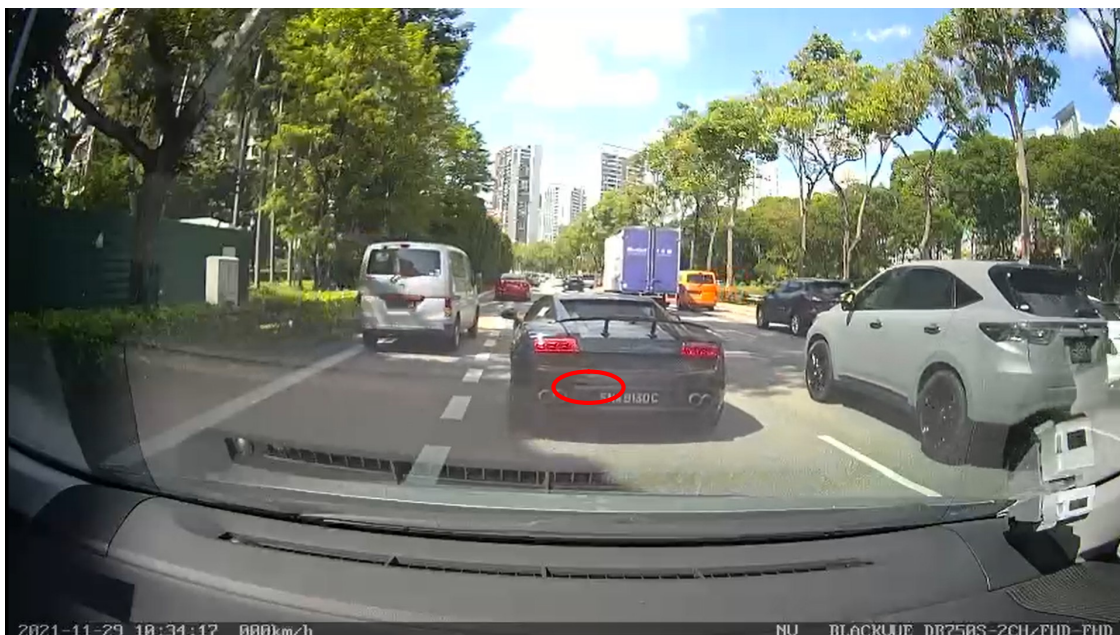
**Photo 19** shows screenshot extracted from the video footage taken from the recording device that was mounted on the front windscreen of the Insured Vehicle. This was at the 10:34:17 time stamp mark, when the Third Party Vehicle was driving off after the incident. The damage that was seen on the rear left lower portion of the Third Party Vehicle, shown in photograph 2 above, was similarly seen on the same area of the Third Party Vehicle (circled) in the images captured by the recording device after the incident. This damage was not seen on the Third Party Vehicle before the contact (refer to photograph 20 to 22 below).

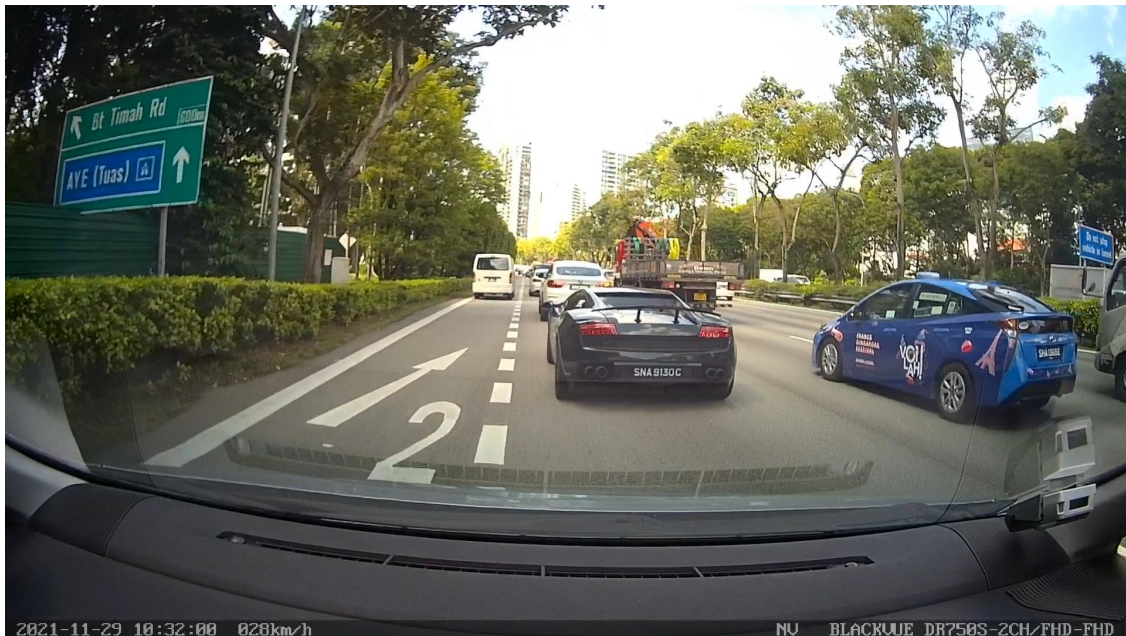
**Photo 20** shows screenshot extracted from the video footage taken from the recording device that was mounted on the front windscreen of the Insured Vehicle. This was at the 10:32:00 time stamp mark, before the occurrence of contact. At this point of the video footage, the Insured Vehicle was seen maneuvering into the extreme left lane of CTE behind the Third Party Vehicle.

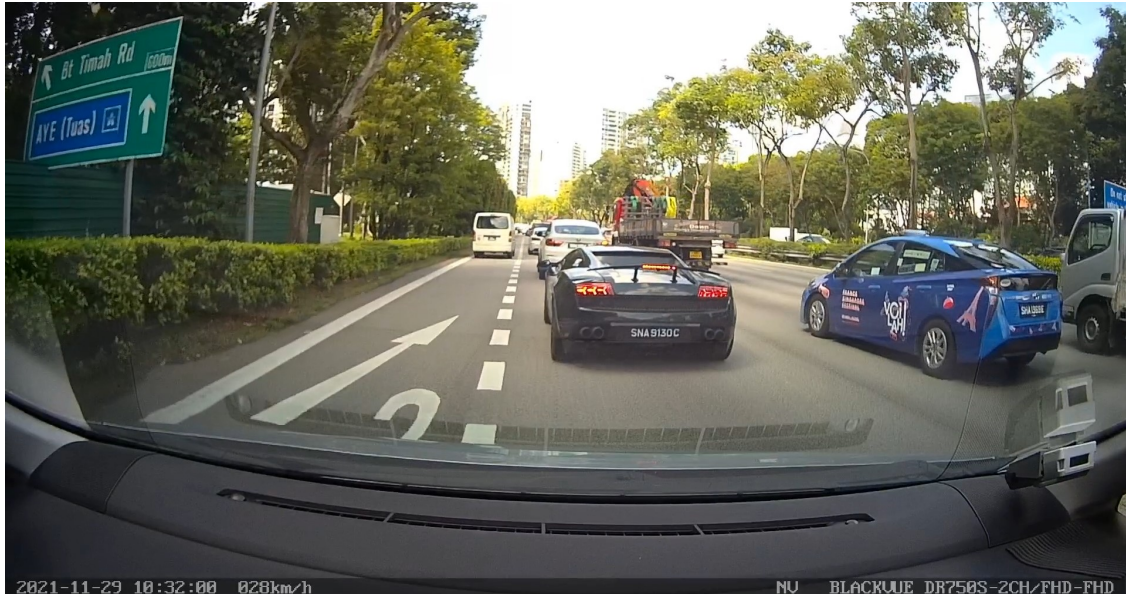
**Photo 21** shows screenshot extracted from the video footage taken from the recording device that was mounted on the front windscreen of the Insured Vehicle. This was at the 10:32:00 time stamp mark, before the occurrence of contact. The Insured Vehicle was seen maneuvering into the extreme left lane of CTE behind the Third Party Vehicle. At this point of the video footage, the brake lights of the Third Party Vehicle illuminated. Note that the brake lights of the white BMW make motor car that was in front of the Third Party Vehicle was not illuminated. The distance between the Third Party Vehicle and the BMW make motor car was also not close to suggest that the Third Party Vehicle was tailgating the BMW make motor car.

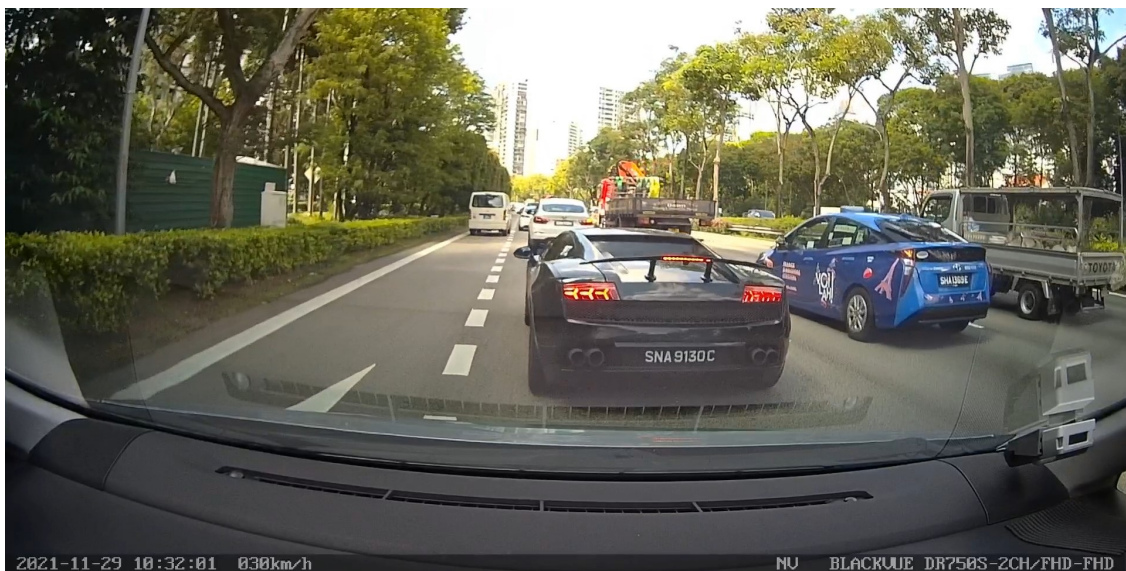
**Photo 22** shows screenshot extracted from the video footage taken from the recording device that was mounted on the front windscreen of the Insured Vehicle. This was at the 10:32:01 time stamp mark, before the occurrence of contact. At this point, the Third Party Vehicle came to a complete stop with the insured Vehicle closing in on the Third Party Vehicle. Note that the brake lights of the white BMW make motor car that was in front of the Third Party Vehicle was still not illuminated and the distance between the Third Party Vehicle and the BMW make motor car was also not close. There appears to be no reasonable cause for the Third Party Vehicle to brake to a complete stop.

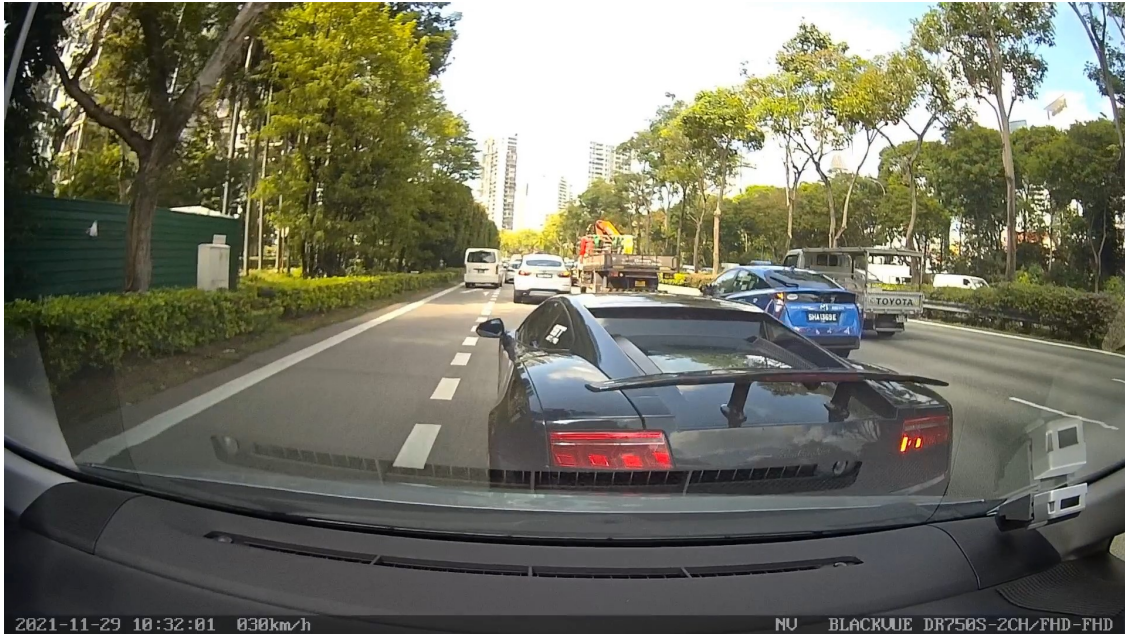
**Photo 23** shows screenshot extracted from the video footage taken from the recording device that was mounted on the front windscreen of the Insured Vehicle. This was at the 10:32:01 time stamp mark, just before the occurrence of contact. At this point of the video footage, the brake lights of the Third Party Vehicle was no longer illuminated. The Third Party Vehicle started to move off slowly just as the contact from the Insured Vehicle occurred. Note the distance between the BMW model motor car and the Third Party Vehicle was relatively wide. There appears to be no reasonable cause for the Third Party Vehicle to brake to a complete stop.
