Your Ref: RT9Foowuvt
Our Ref : CI/III22003353/P

**TECHNICAL INVESTIGATION REPORT OF WARRANTY CLAIM INVOLVING
THE INSURED VEHICLE SDK 8893G ON 6th April 2022**

Vehicle Registration No.	: SDK 8893G
Make / Model	: BMW 320i
Chassis No	: WBA5F72090FH25698
Year of Registration	: DEC 2020
Mileage	: 32,523KM

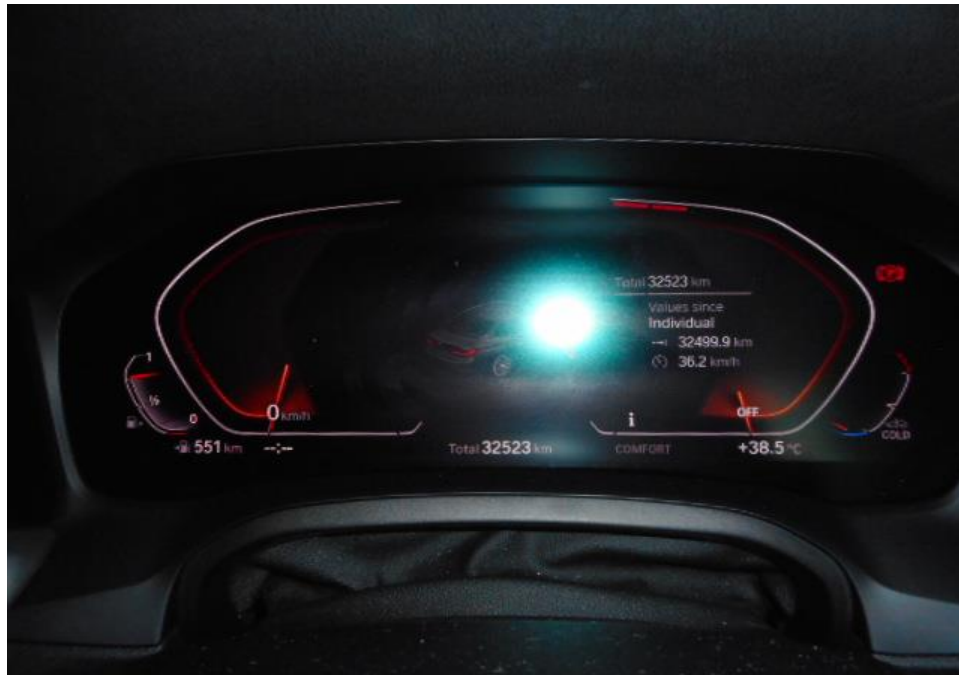
Photo 1 shows the mileage of the Insured Vehicle recorded at the time inspection at 32,523KM

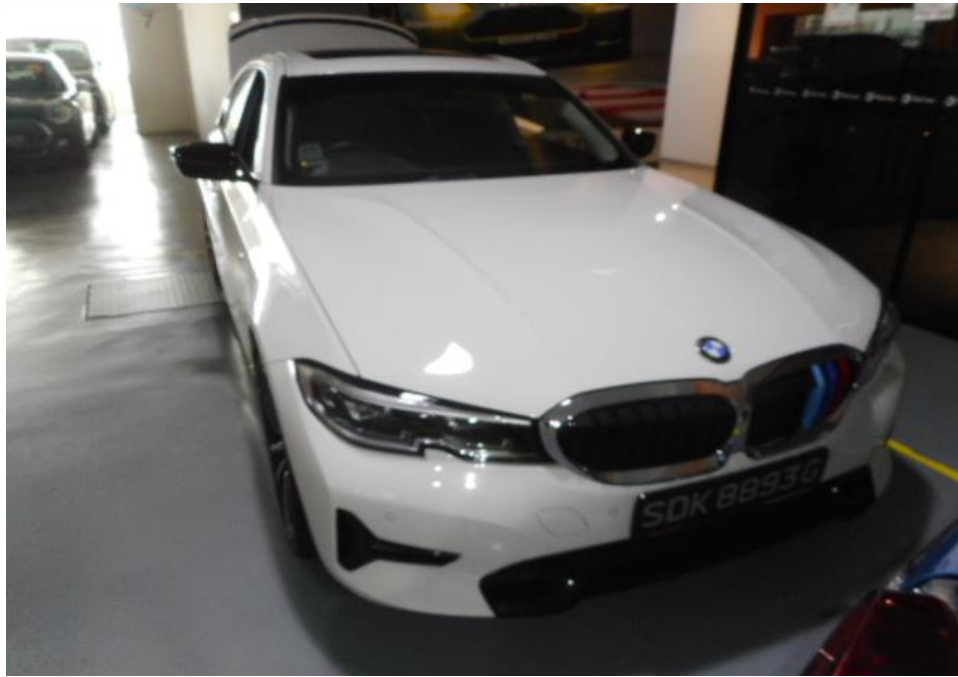
Photo 2 shows the general view of the front portion of the Insured Vehicle at the time of our inspection. The Insured Vehicle is observed to be unaffected by any signs of accident.

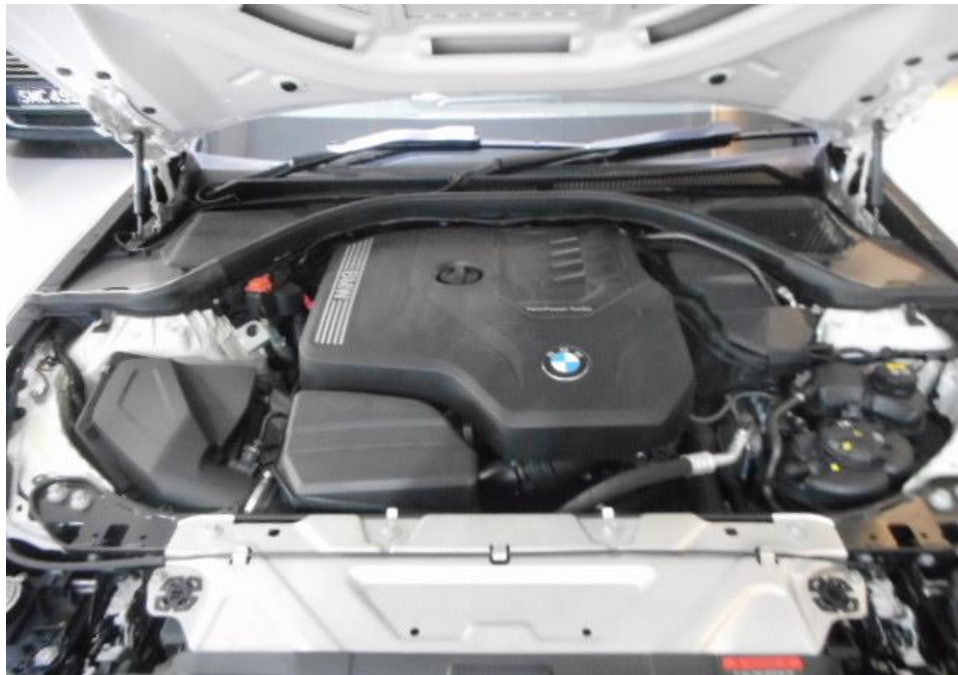
Photo 3 shows the general view of the engine portion of the Insured Vehicle at the time of our inspection. The engine compartment is observed to be unaffected by any signs of accident.

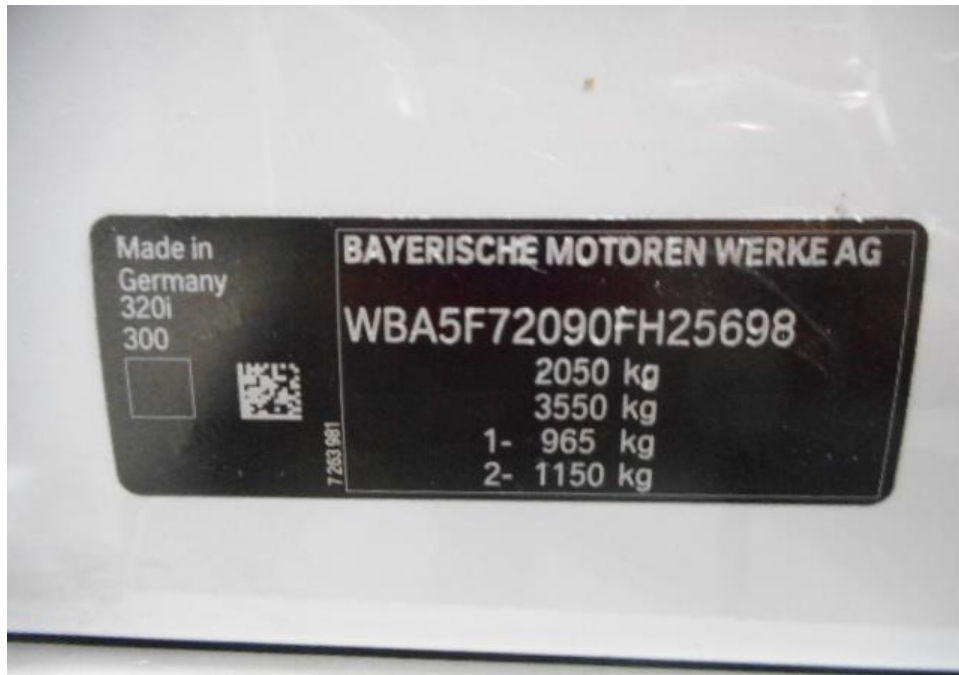
Photo 4 shows the chassis number of the Insured Vehicle at the time of our inspection.

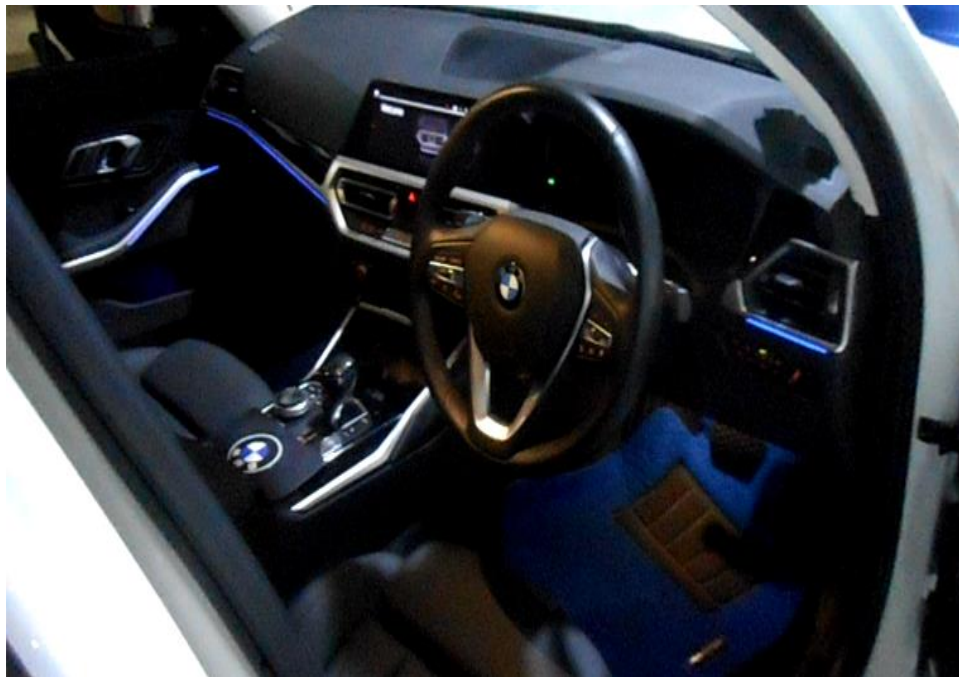
Photo 5 shows the general view of the interior portion of the Insured Vehicle at the time of our inspection. The interior portion is observed to be unaffected and by any signs of accident.

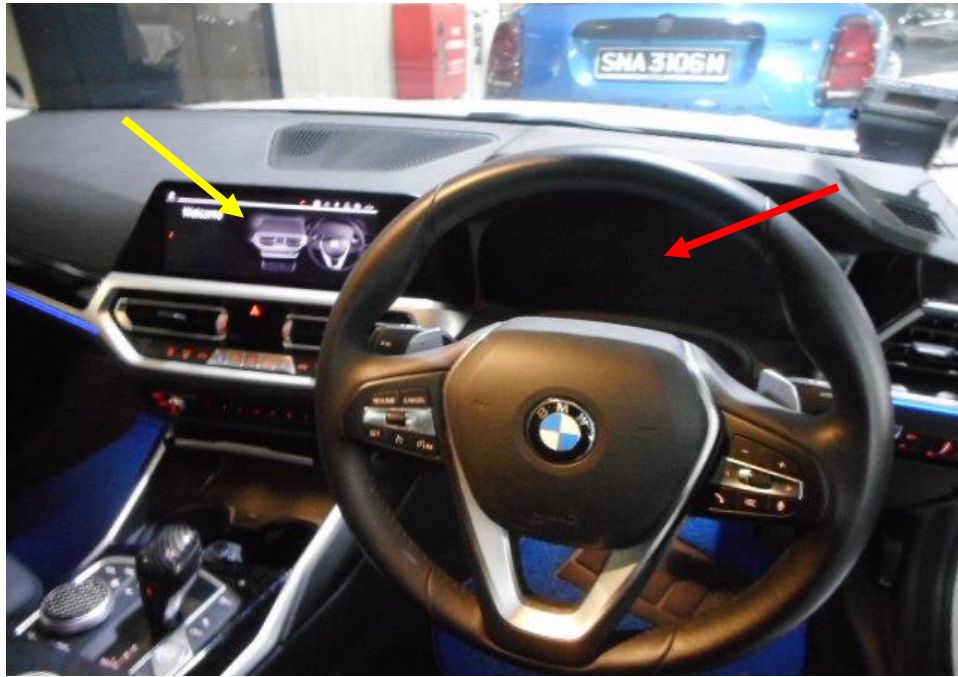
5. The complaint on the Insured Vehicle was noted be that the driver's digital instrument display would turn on and off intermittently but remains off most of the time. There is a recommendation by the workshop to replace the Infotainment control module. The vehicle was observed to be unaffected by any signs of accident.

Photo 6 shows the close up view of the vehicle instrument portion of the Insured Vehicle at the time of our inspection. The driver's instrument display (red arrowed) remained turned off even when the vehicle's engine is turned on as compared to the centre display panel (yellow arrow).

8. We did not find any evidence which had suggested that the cause of abnormalities to the Insured Vehicle was due to poor maintenance and/or recurring problem.
9. The recommendation to replace the Infotainment control module at \$2,750 is justifiable as all the relevant checks has been conducted.
