DAMAGE CONSISTENCY AND RE-INSPECTION REPORT

INSURED VEHICLE : YM 4184L as DV (Defendant Vehicle)

THIRD-PARTY VEHICLE : SFL 928P Replaced with SND 918 R as PV
(Plaintiff Vehicle)

DESCRIPTION : TP VEHICLE ALLEGEDLY DAMAGED BY
INSURED'S TOW TRUCK

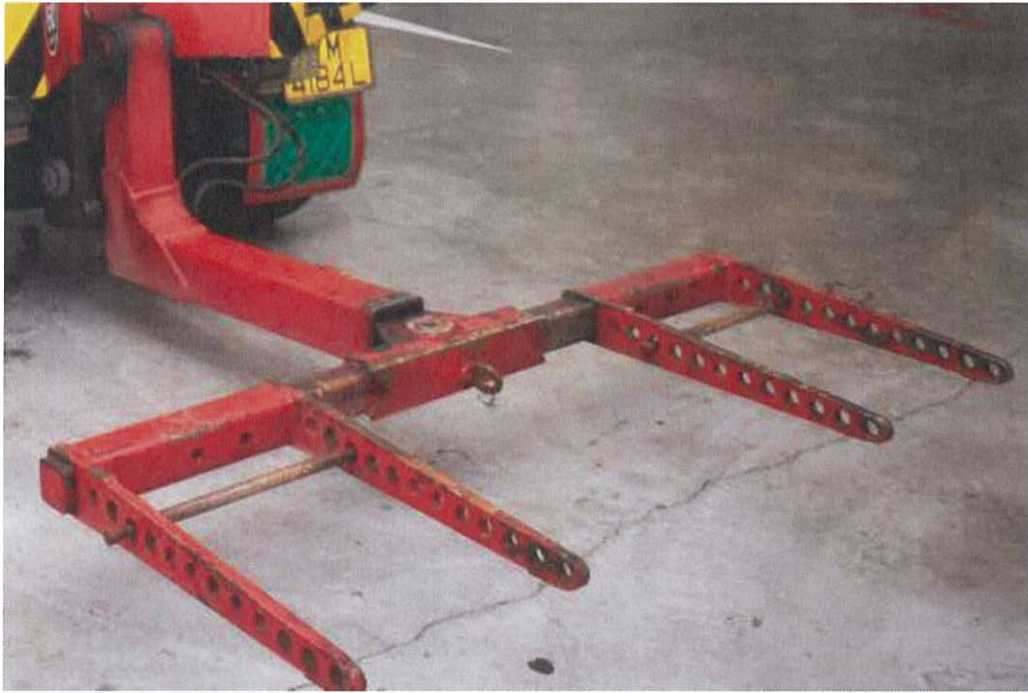
Photo 2 - Taking the measurement of the Tow Truck lifting Equipment

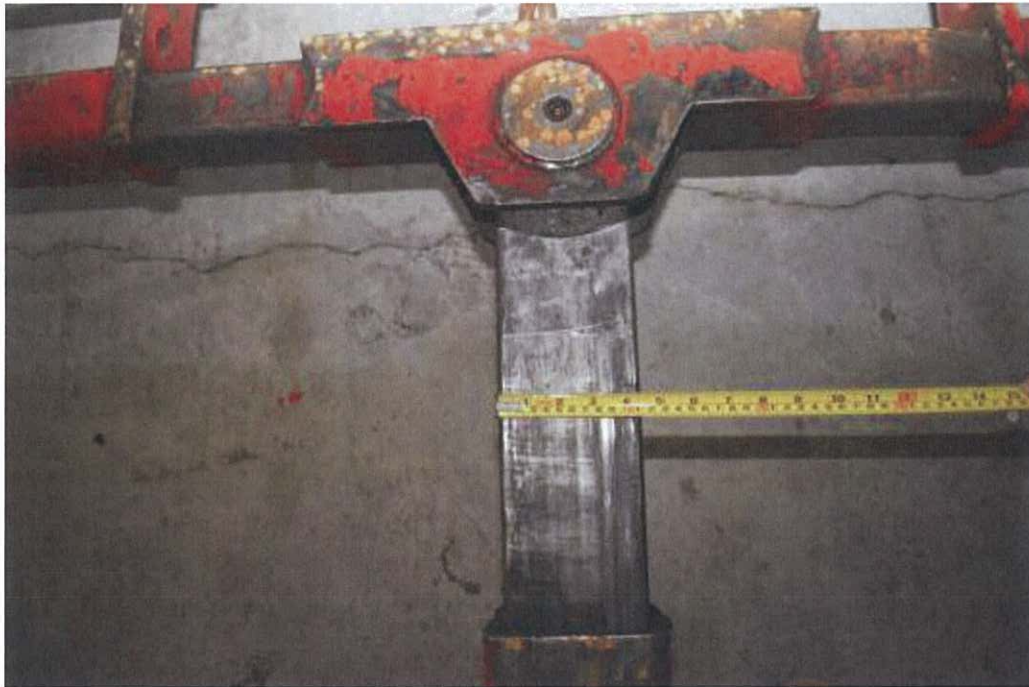
Photo 6 - Measurement on the Tow Truck lifting Inner Boom

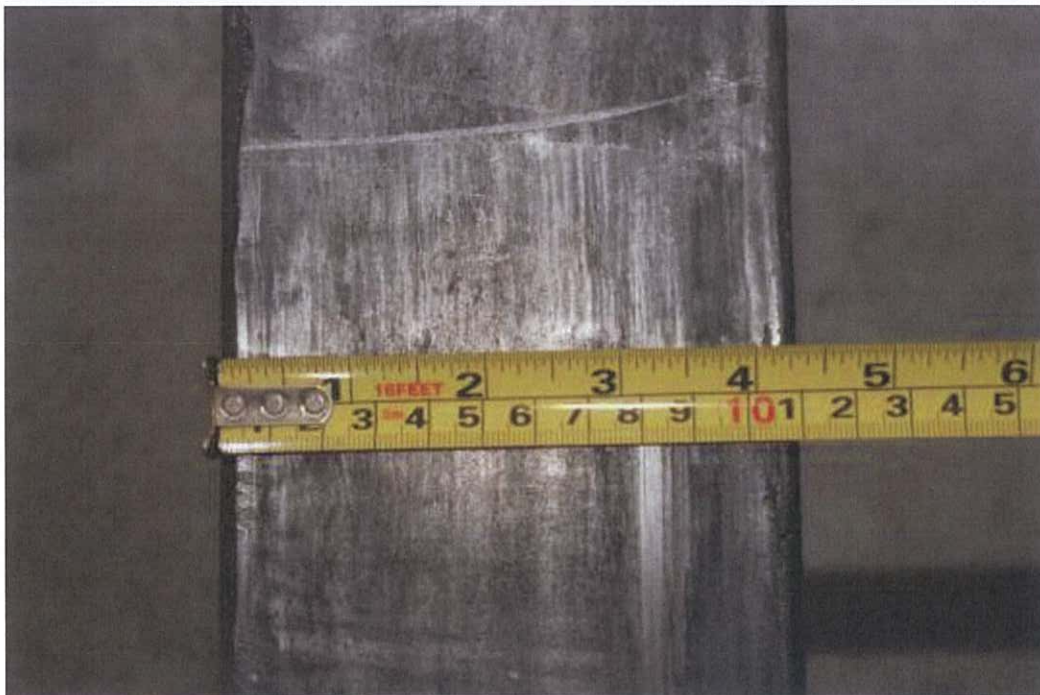
Photo 7 - Measurement on the Tow Truck lifting Inner Boom reads 10.8cm

- (1) From the damage pattern to the Rear Exhaust Muffler of PV, it appears that the dent mark was caused by Tow Truck's Inner Boom. The measurements on the Rear Muffler dent matches with DV Tow Truck lifting Inner Boom. The damage to the Rear Muffler is due to a centered single impact which suggested it could be damaged during the descending and unloading process of DV vehicle. From our understanding, before PV is being lowered onto the ground level, wooden blocks should be used to support both the tyres of PV ensuring the height of PV is being lifted to allow the lifting boom to retract safely into the boom housing. As DV lifting inner boom's Fork can be swivel freely, we rule out damage to PV exhaust muffler caused during the towing process to Carros Centre. As also mentioned in LKK's report (Pg 9 Para 25) No Overlapping Indentation in a single impact and upward impact direction. If it was damaged enroute to Carros, as DV was in motion and the tow boom swivel, damage sustained to the Exhaust Muffler would be multiple dents, cuts, and scratches. Therefore, this is ruled out.

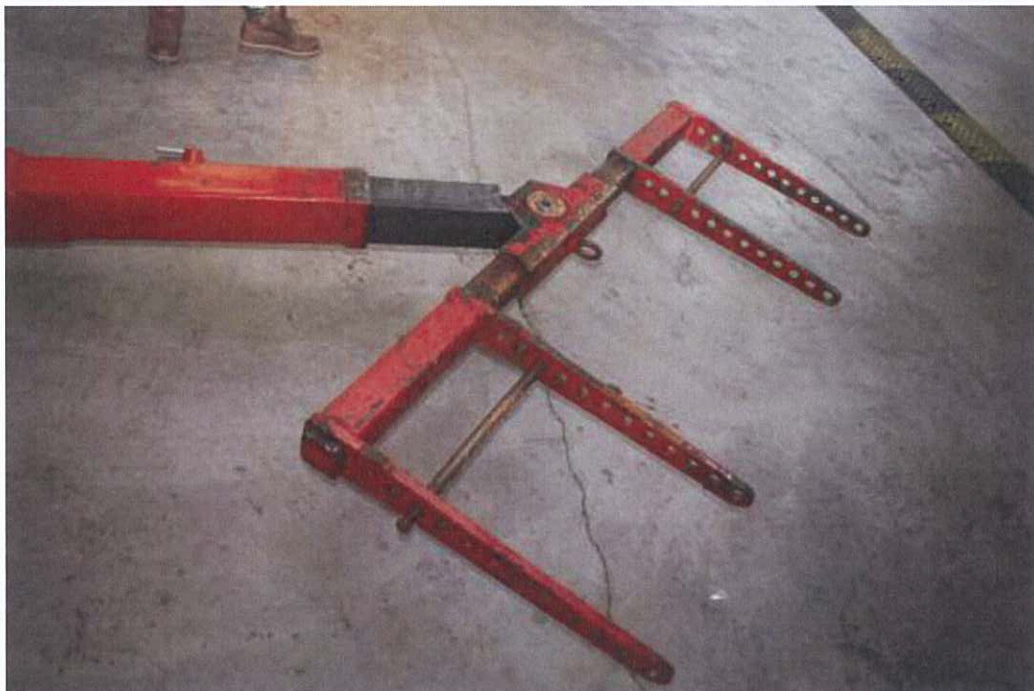
Photo 9- The Underlift fork swiveling to the right

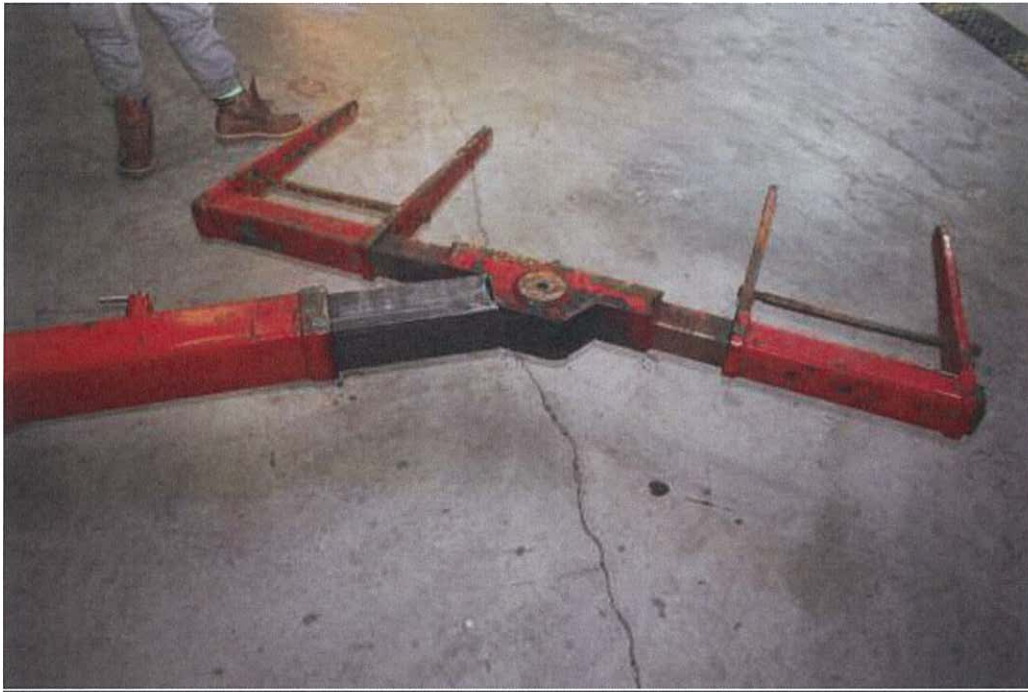
Photo 10 - The Underlift fork swiveling to the left

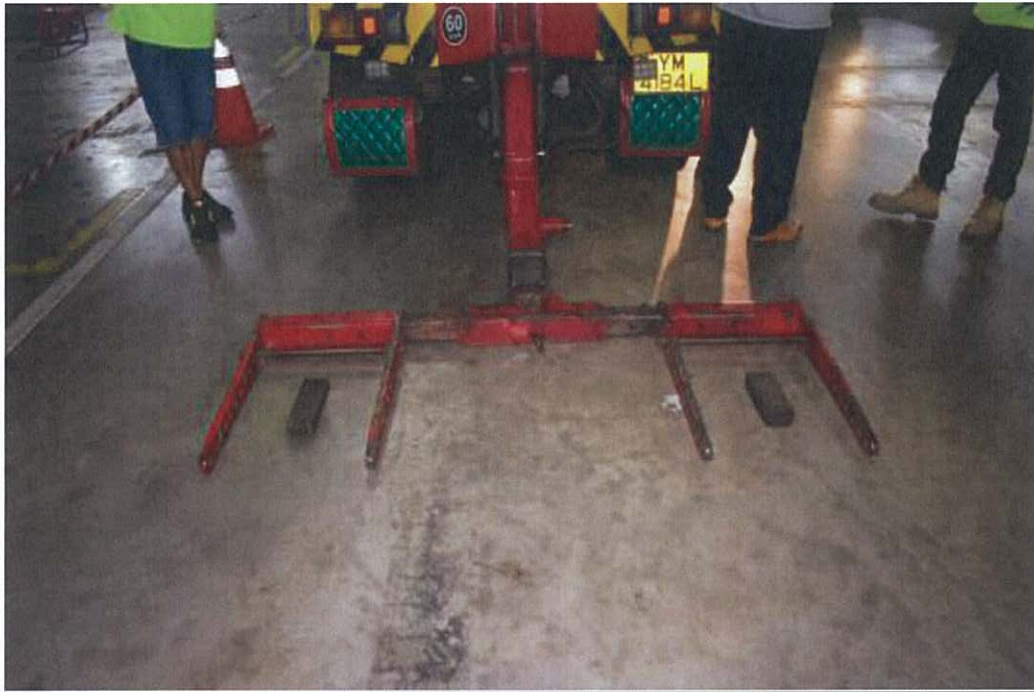
Photo 12 – The proper way to unload a low floor clearance vehicle by using 2 wooden blocks in between each fork

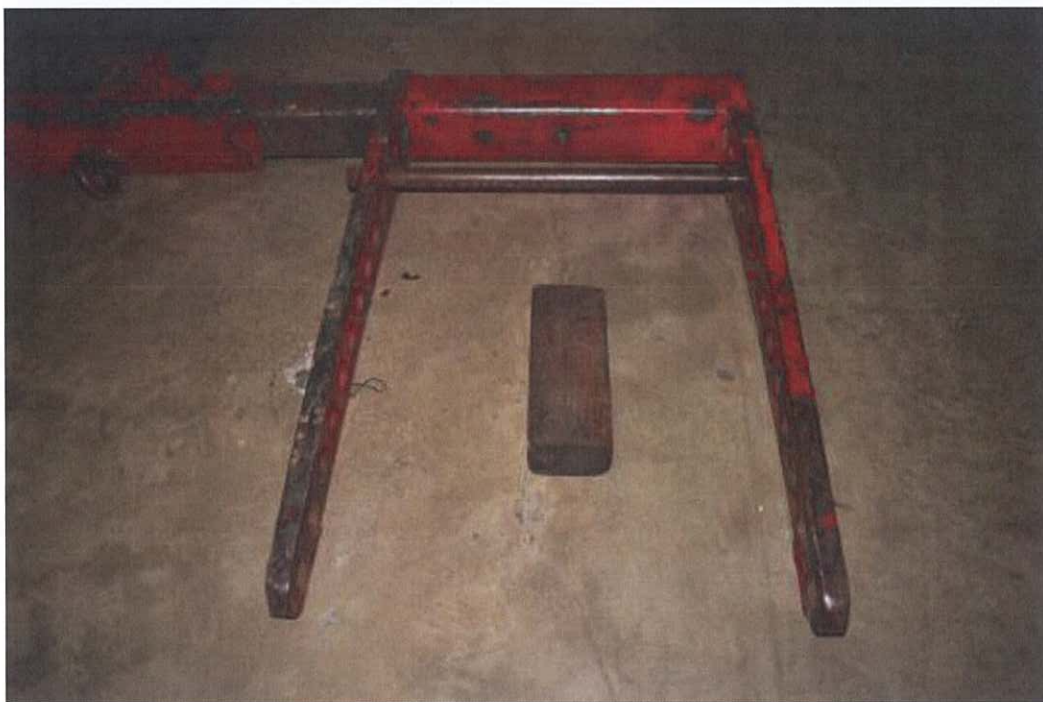
Photo 13 – The proper way to unload a low floor clearance vehicle by using 2 wooden blocks in between each fork

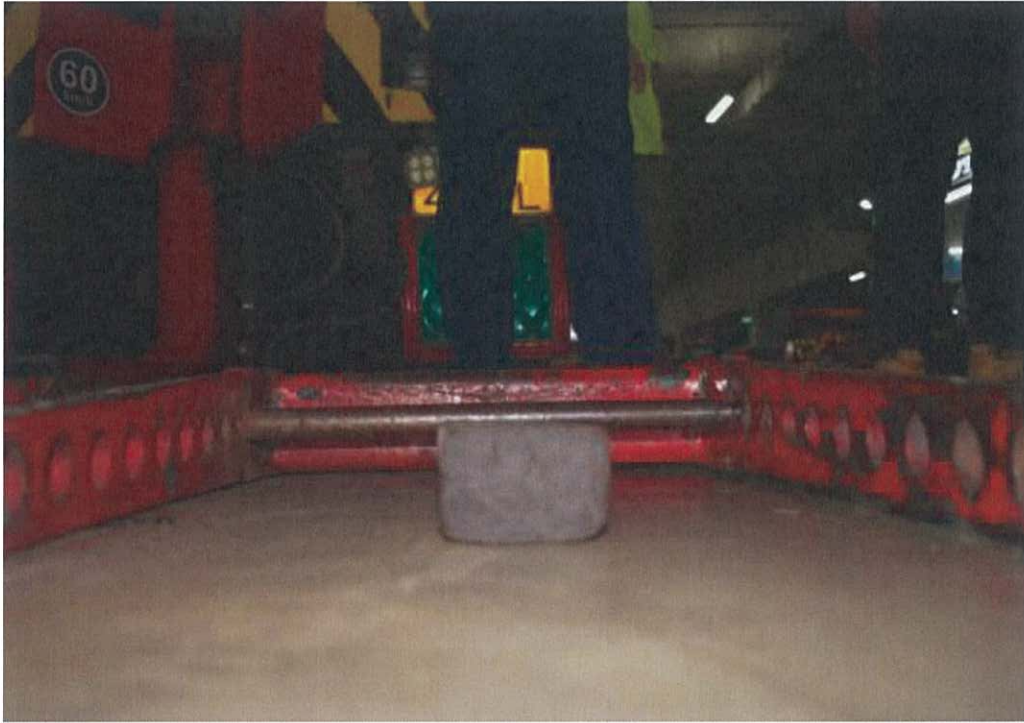
Photo 14 – The proper way to unload a low floor clearance vehicle by using 2 wooden blocks in between each
fork

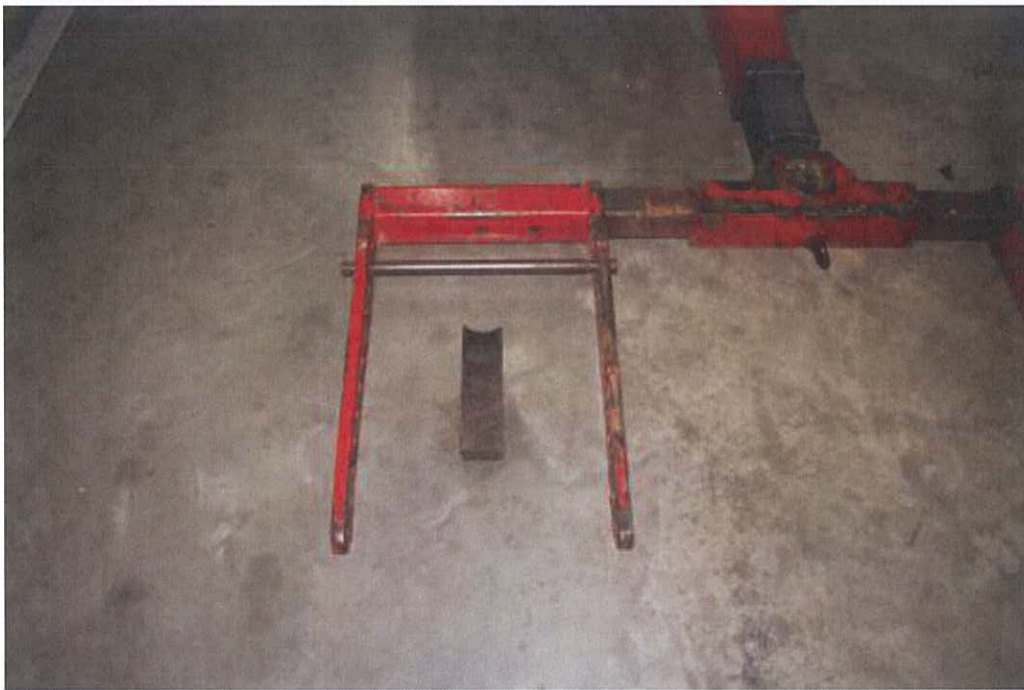
Photo 15 – The proper way to unload a low floor clearance vehicle by using 2 wooden blocks in between each
fork

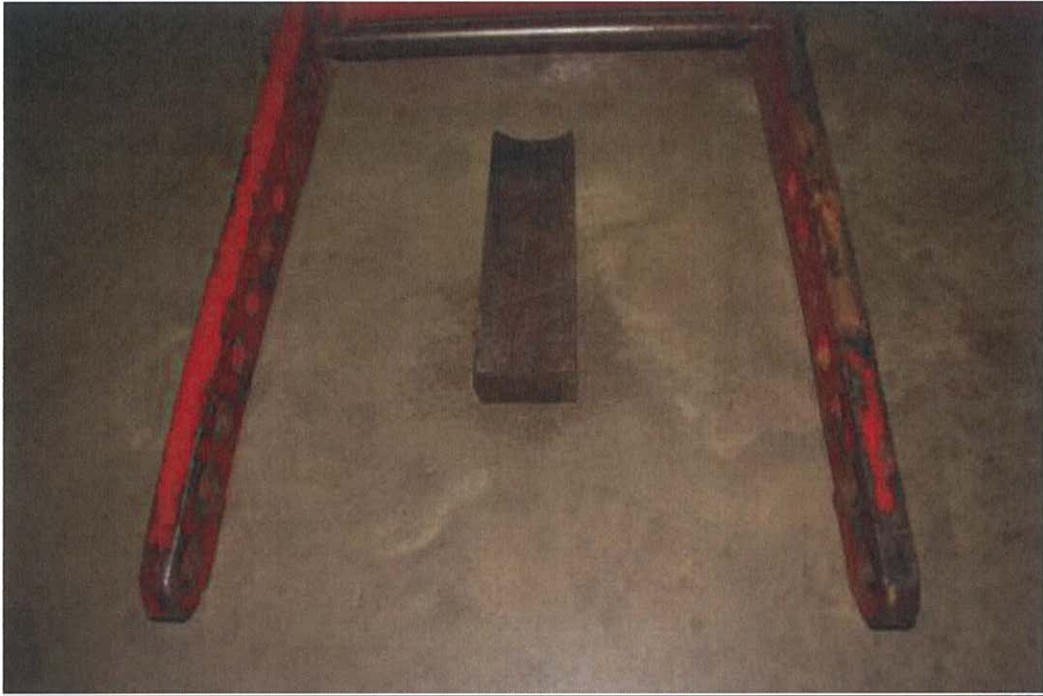
Photo 16 – The proper way to unload a low floor clearance vehicle by using 2 wooden blocks in between each fork

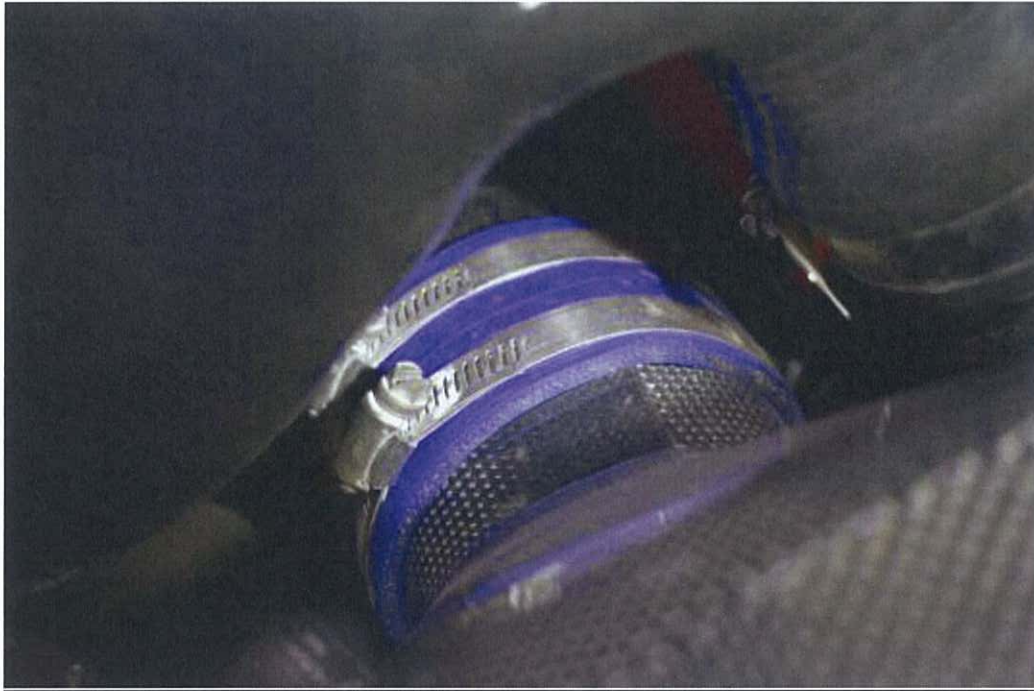
Photo 21 – The Air Duct is secured by hose and clips

- (17) The airduct damaged was not caused by this incident as the engine was not in motion during the process of towing.

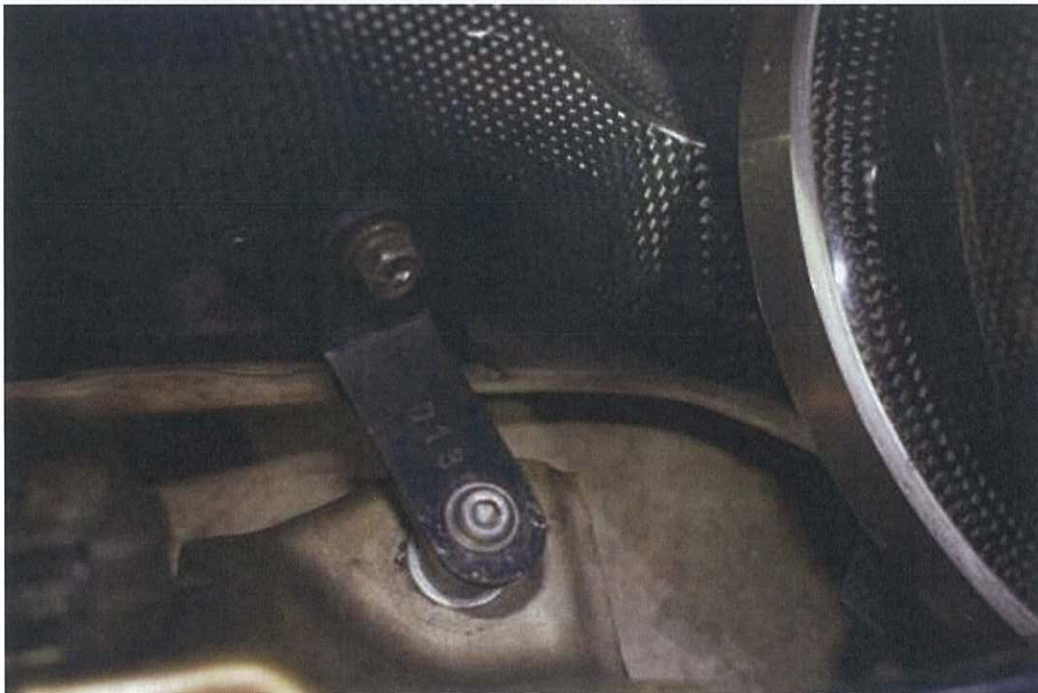
Photo 22 - The Air Duct is secured by a L Bracket

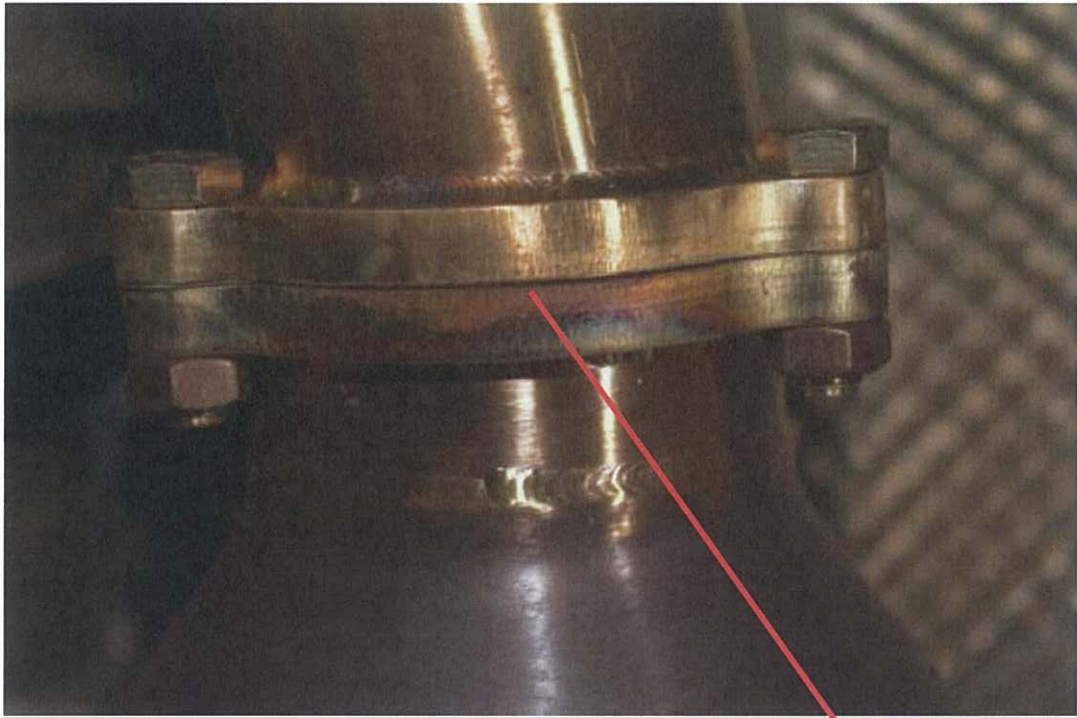
Photo 29 – PV Right Exhaust Muffler to Catalytic Converter Joint with gaps

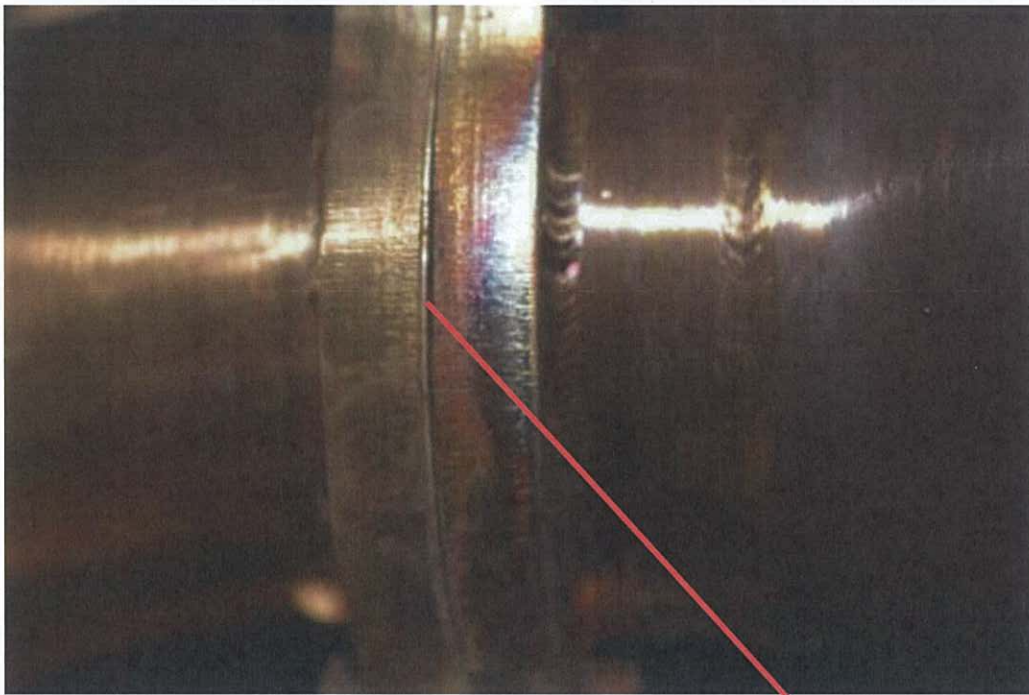
Photo 30 – PV Right Exhaust Muffler to Catalytic Converter Joint with Exhaust Gasket

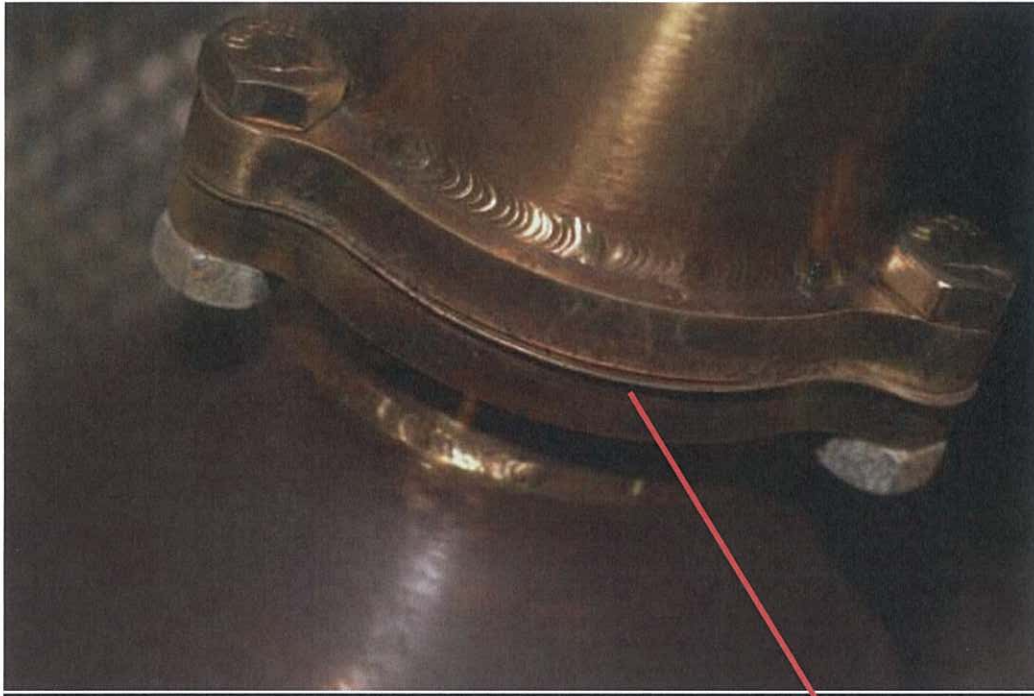
Photo 33 – PV Left Exhaust Muffler to Catalytic Converter Joint with Exhaust Gasket

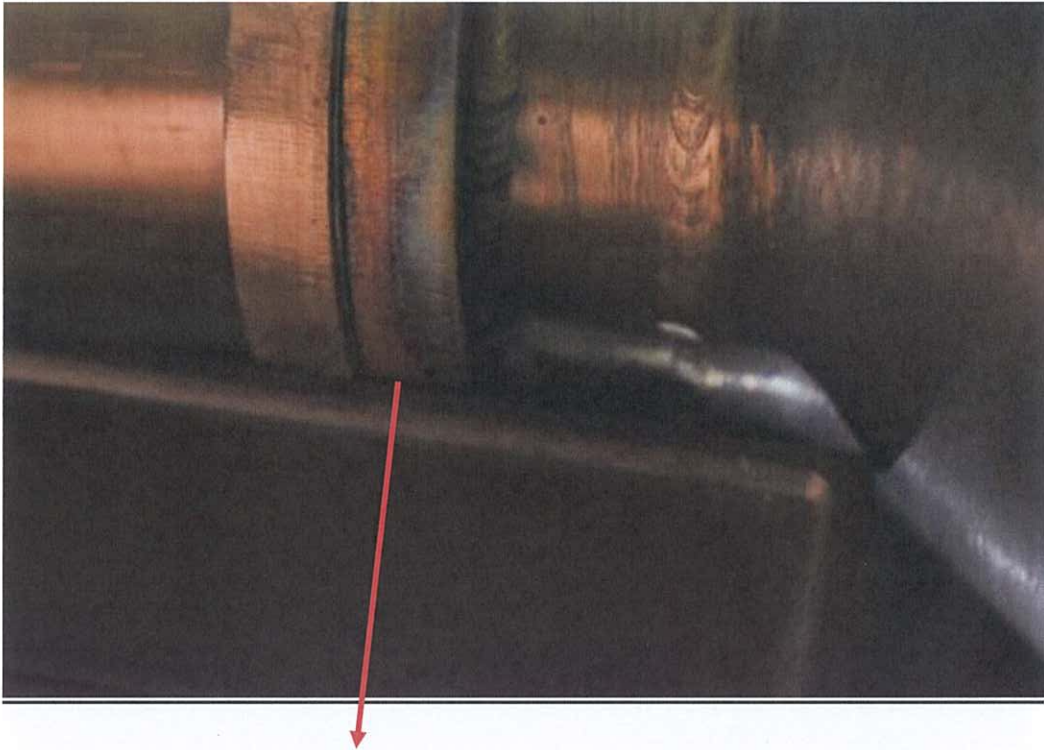
Photo 35 – Uneven & Misaligned Joint of the right Exhaust Muffler to Catalytic Converter

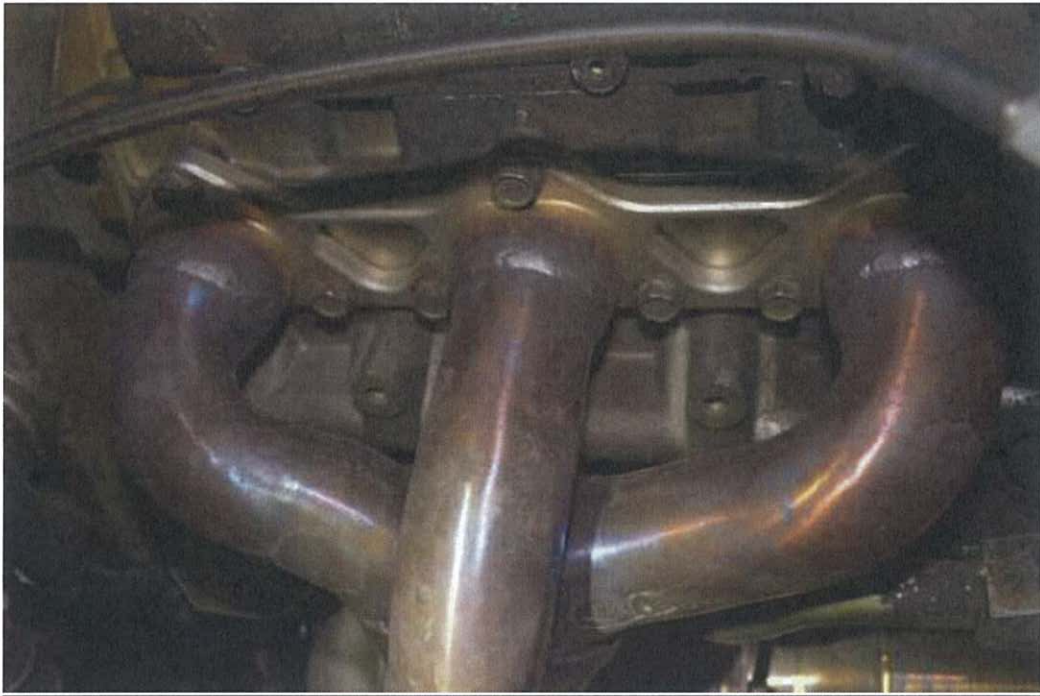
Photo 37 – Right Exhaust Manifold not replaced and untouched rusted bolt

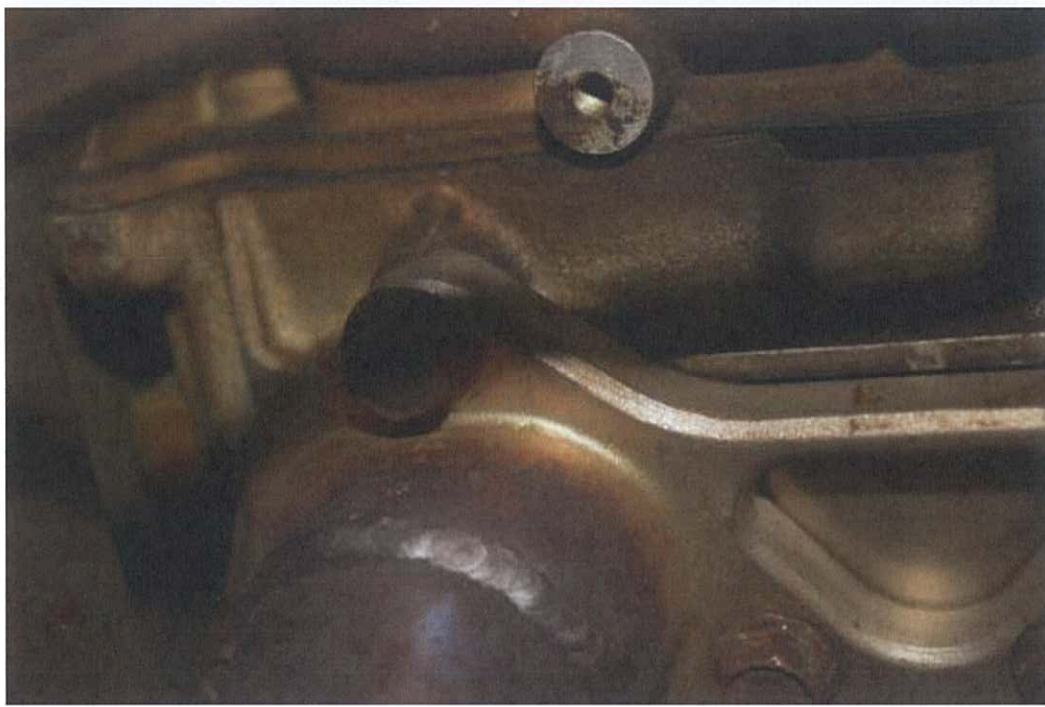
Photo 38 – Right Exhaust Manifold not replaced and untouched rusted bolt

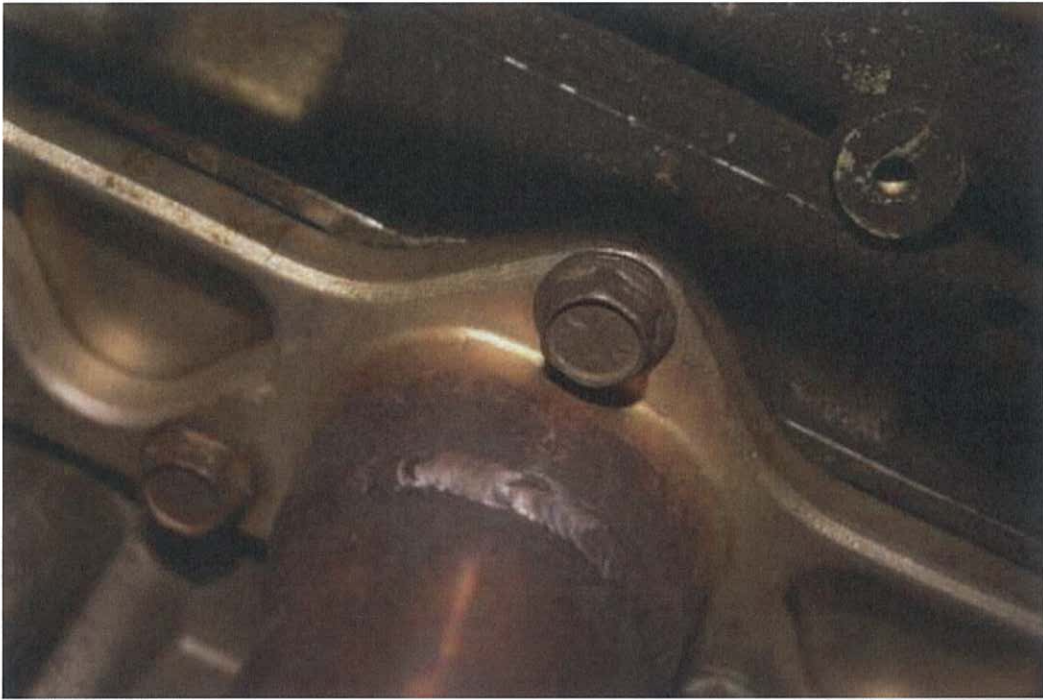
Photo 39 – Right Exhaust Manifold not replaced and untouched rusted bolt

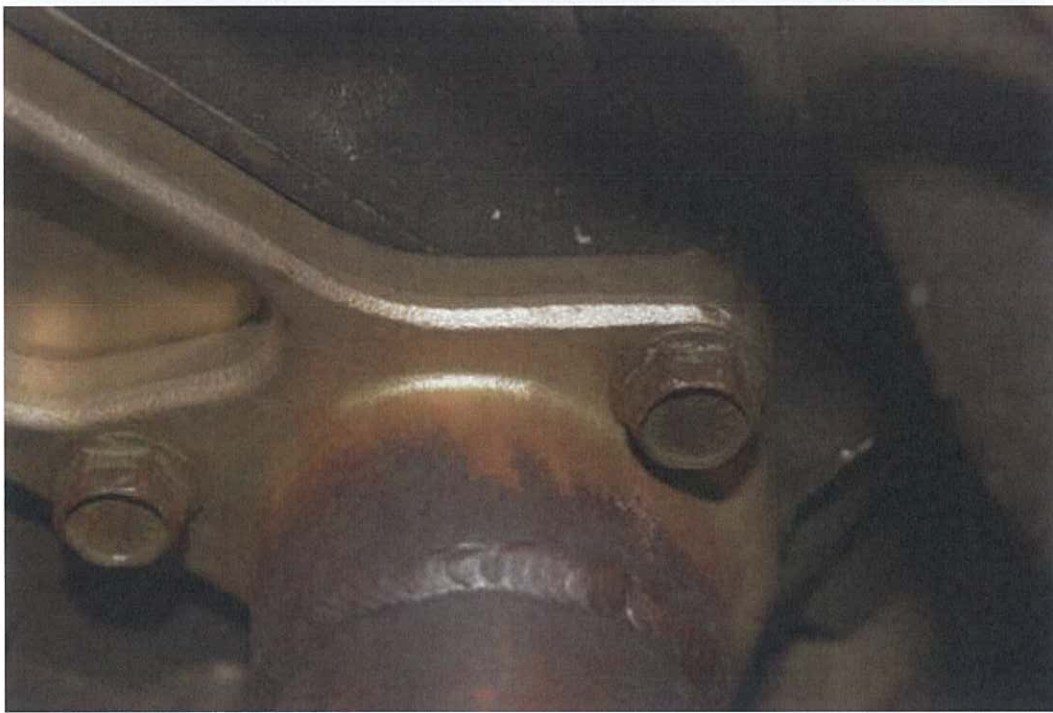
Photo 40 – Right Exhaust Manifold not replaced and untouched rusted bolt

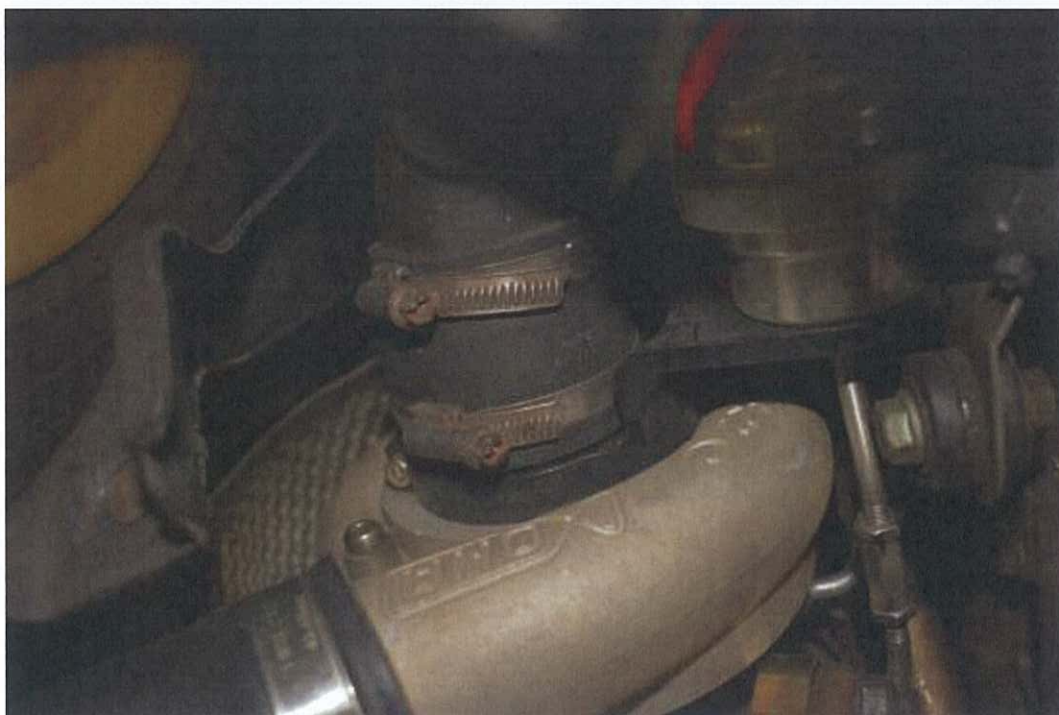
Photo 42 – Right Turbo not replaced -rusty screw and rusty secure bracket. BLACK SOOT MARK SAME AS
LKK REPORT PHOTO 19

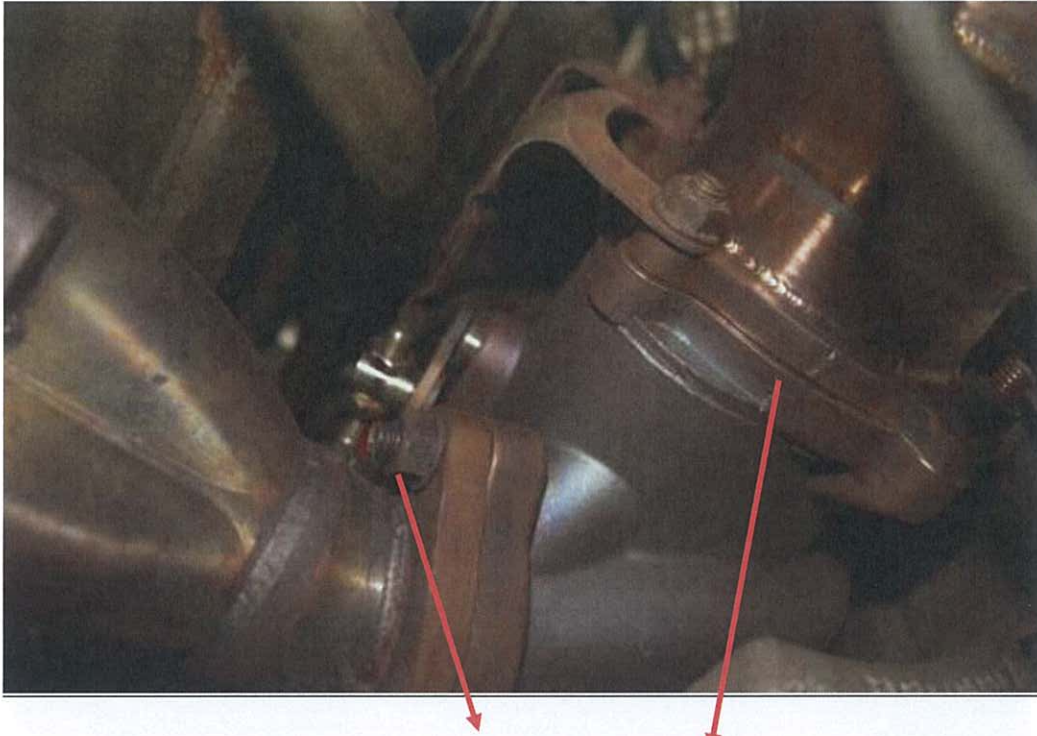
Photo 43 – Right Turbo not replaced, untouched rusted bolt. New exhaust gasket between the turbo and catalytic converter.

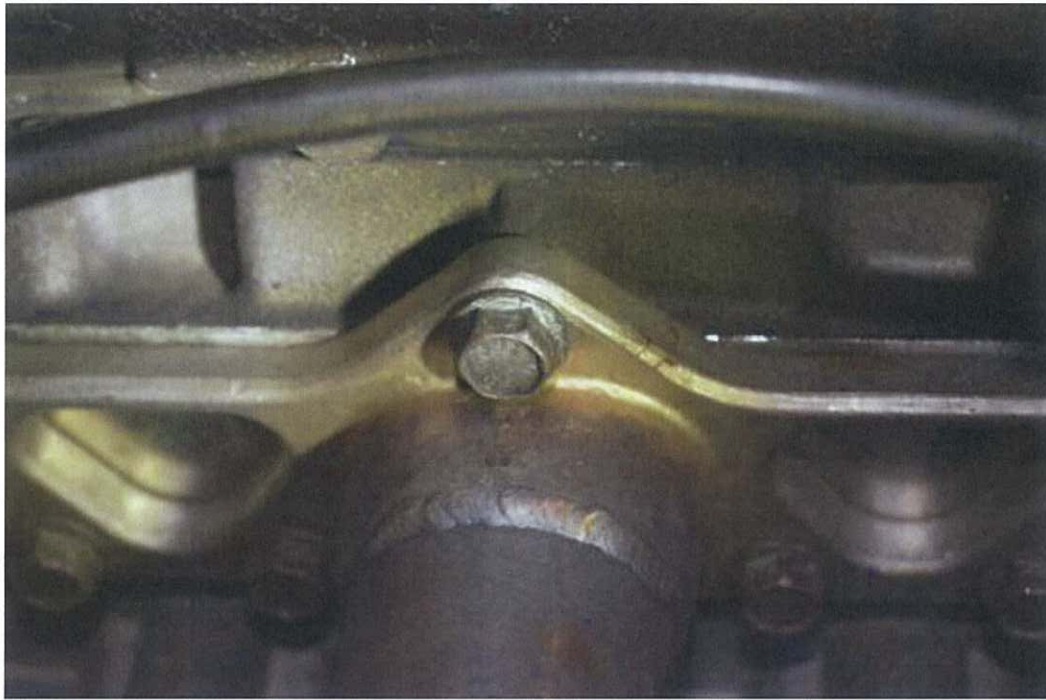
Photo 45 – Left Exhaust Manifold rusty untouched bolt

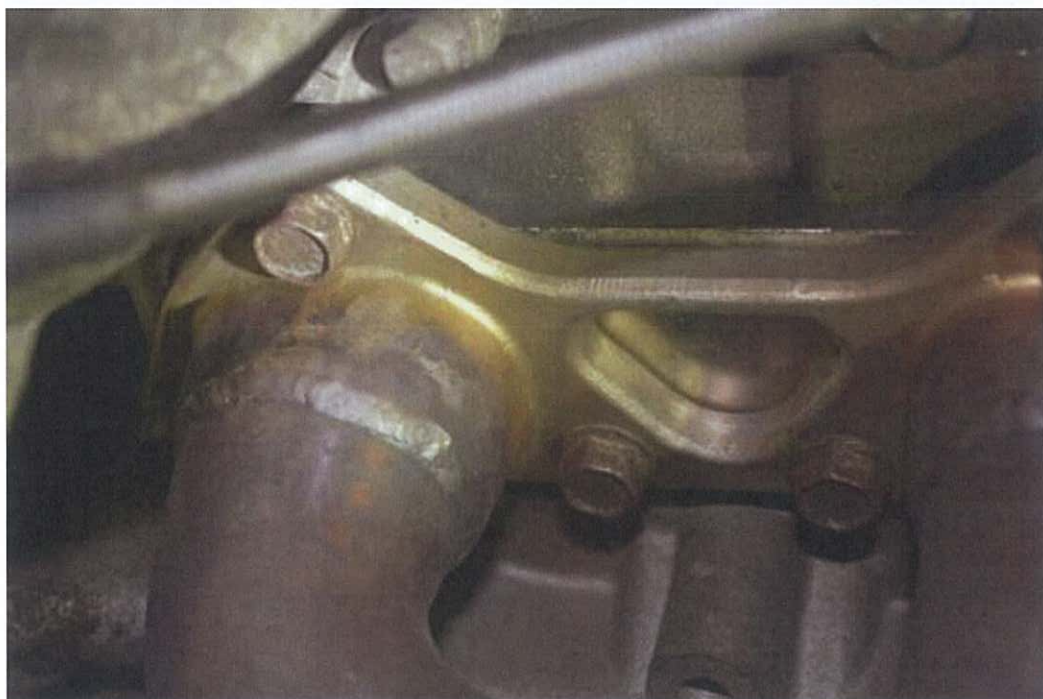
Photo 46 – Left Exhaust Manifold rusted untouched and rusty bolt

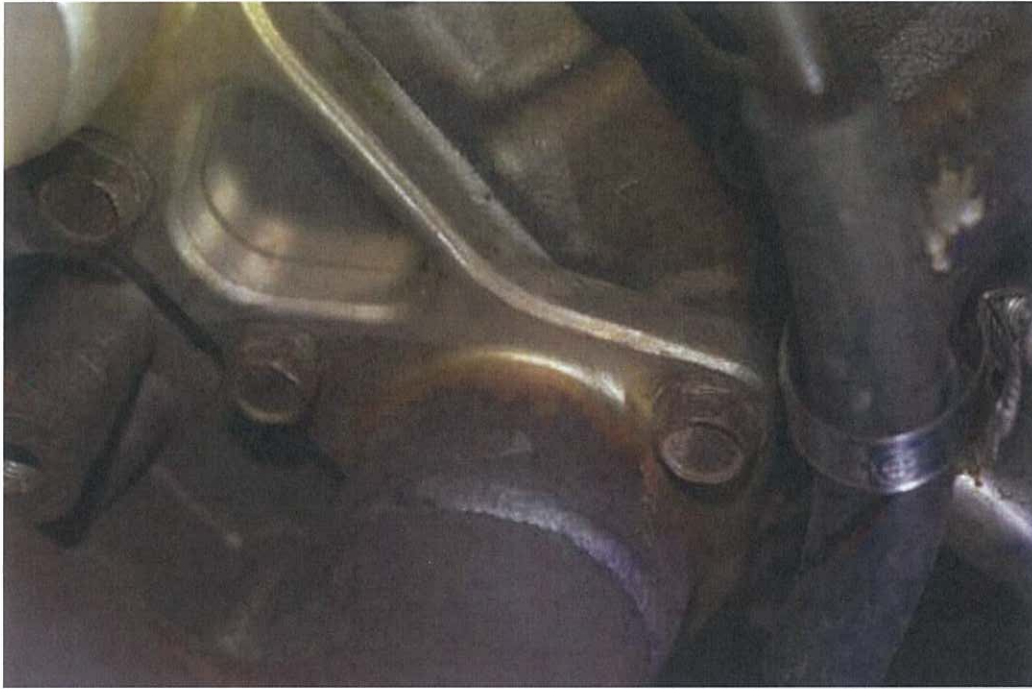
Photo 47 – Left Exhaust Manifold rusty untouched bolt

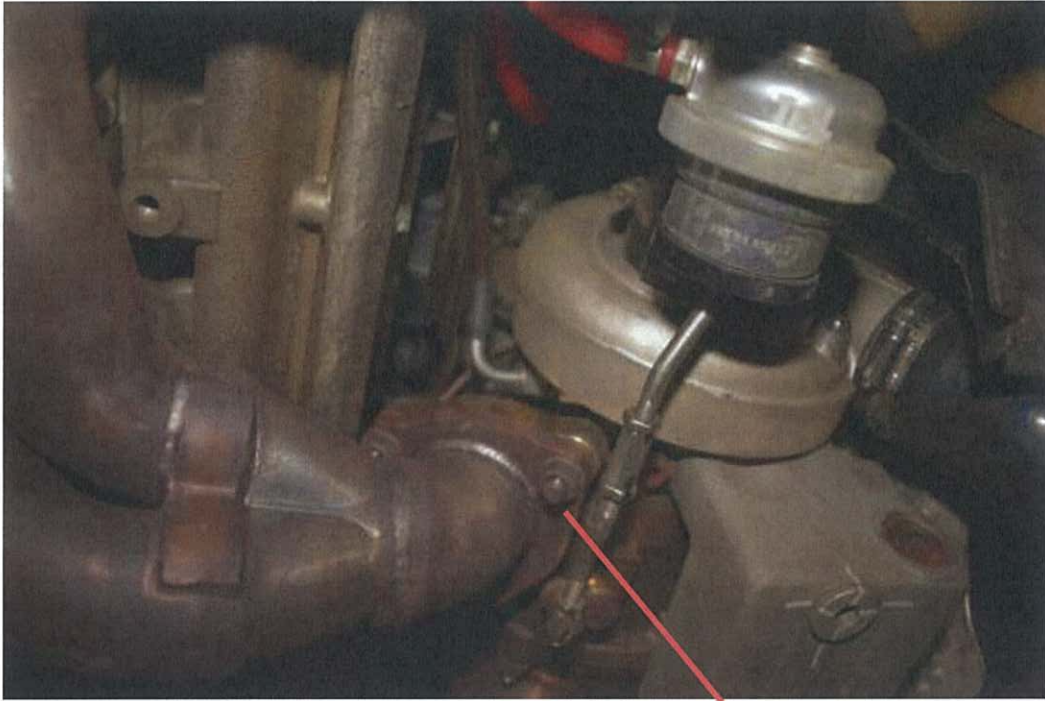
Photo 49 – Left Turbo not replaced, untouched rusty bolt.

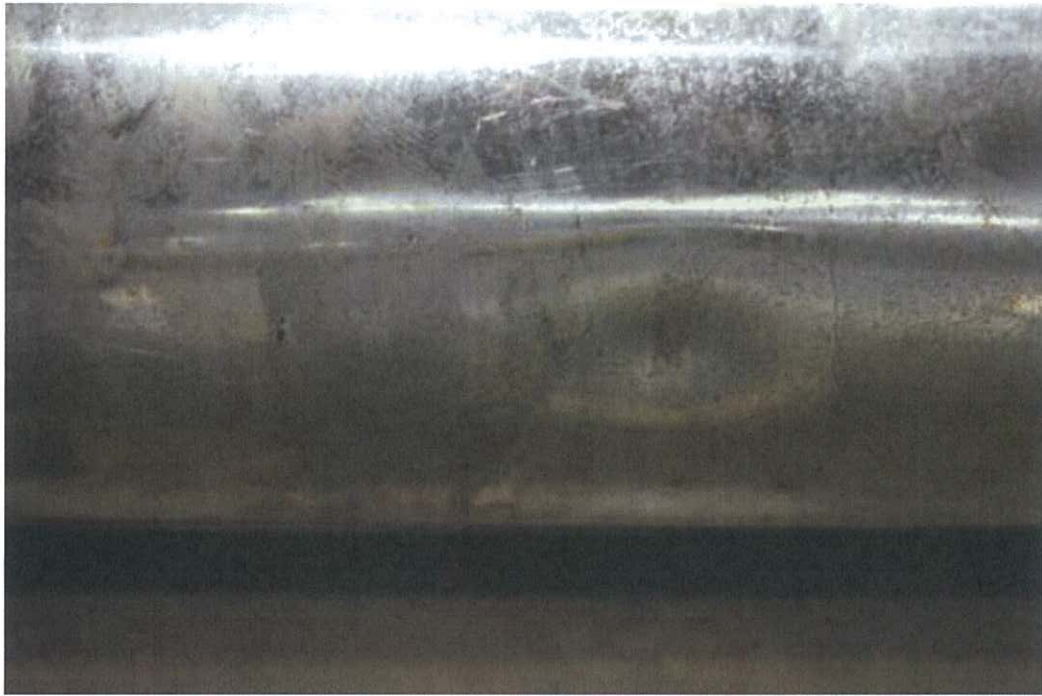
Photo 71 – Rear Exhaust Muffler dent damage, not related to the reported incident

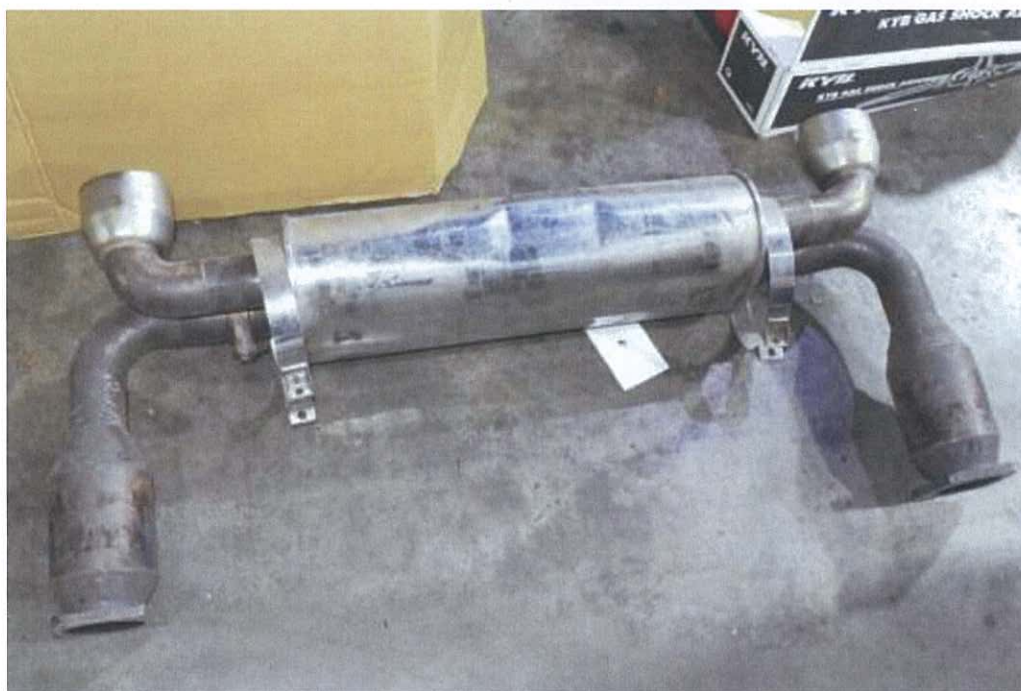
Photo 72- Damaged Exhaust Muffler

During our survey, we observed the damaged pattern on PV dismantled Rear Exhaust Muffler was a single impact dent inward. Based on the measurement of the damaged Rear Muffler, the damages measured by LKK across the dented area is 10.5 Inches. However, LKK did not measure the depth/intrusion of the dent. We did a measurement and found the depth of the dent is merely **5mm**. We also sighted the exhaust muffler had **EXISTING DAMAGES** apart from the dent suffered by the tow boom.

- 1) Rear Exhaust Muffler \$7,790.43.
- 2) Labour charges \$300.00 and one (1) day for repair.
- 3) Please see annex A our survey report.

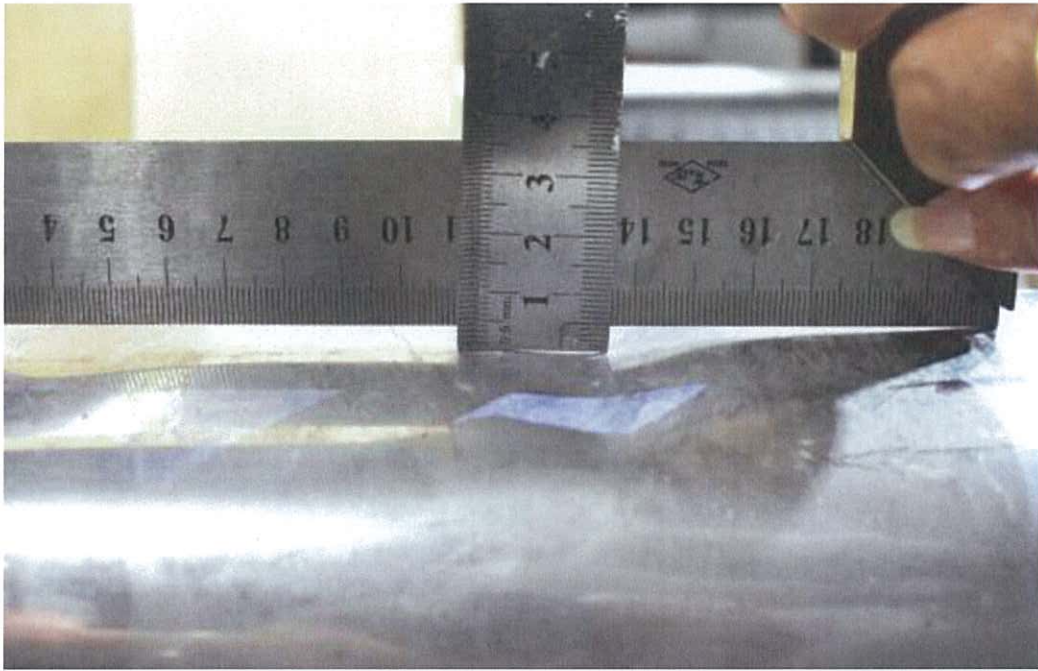
Photo73 – Depth of dent reads at 5mm

- (13) The exhaust muffler of PV did not show any red paint transfer from the outer tow boom.
- (14) From the small dent of 5mm impact on the exhaust muffler, it is impossible that the force be transmitted to other parts of vehicle to cause damage.

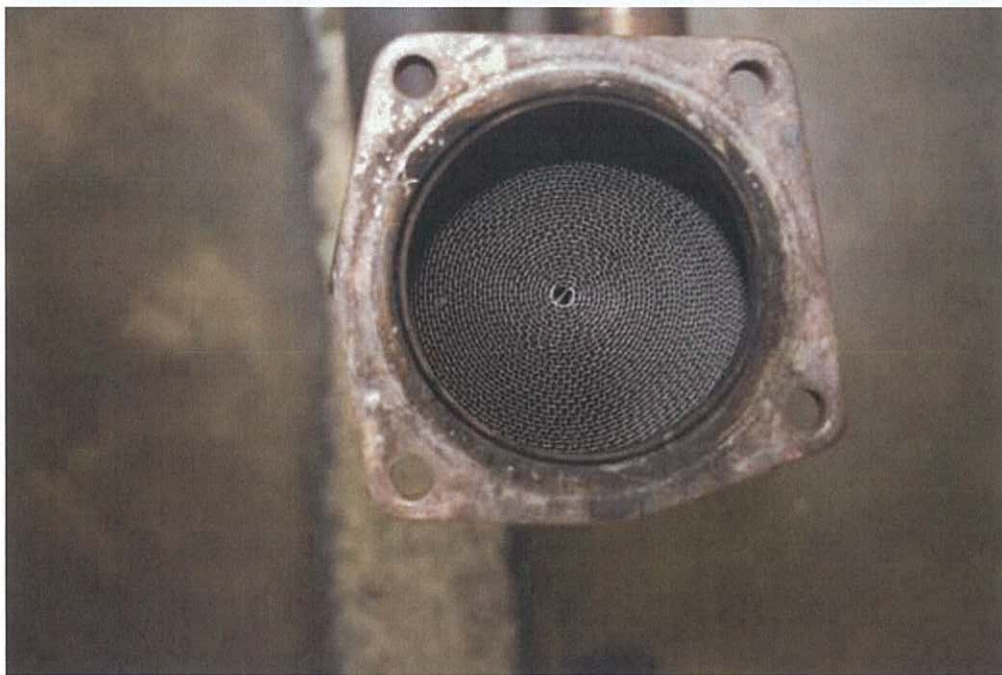
Photo 76 – The honey comb in the Catalytic Convertor is in good condition

- (10) The Turbo unit and the manifold could not be affected or damaged without a strong or direct impact to it.
- (11) We also noticed the Honey Comb inside both the catalytic converters were not affected or damaged at all.
