DAMAGE CONSISTENCY AND RE-INSPECTION REPORT

INSURED VEHICLE : YM 4184L as DV (Defendant Vehicle)

THIRD-PARTY VEHICLE : SFL 928P Replaced with SND 918 R as PV
(Plaintiff Vehicle)

DESCRIPTION : TP VEHICLE ALLEGEDLY DAMAGED BY
INSURED'S TOW TRUCK

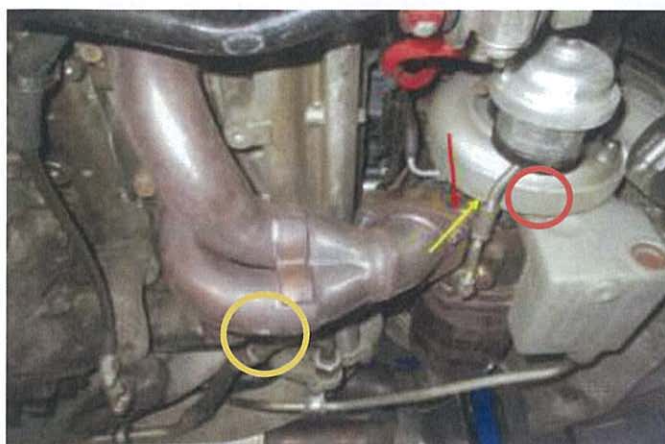
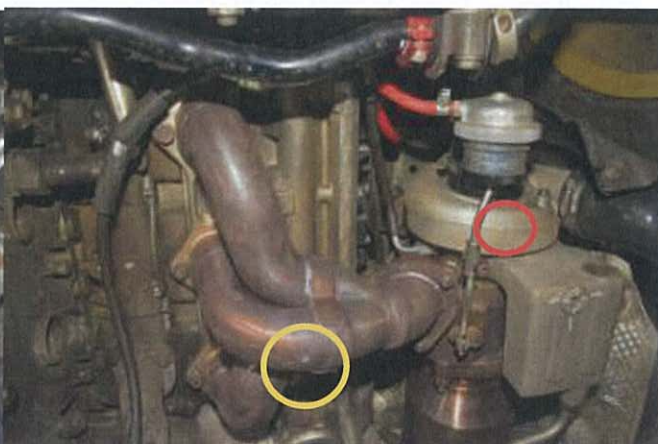
Photo 77 - During our survey, we confirmed the left manifold and left turbo were not replaced.

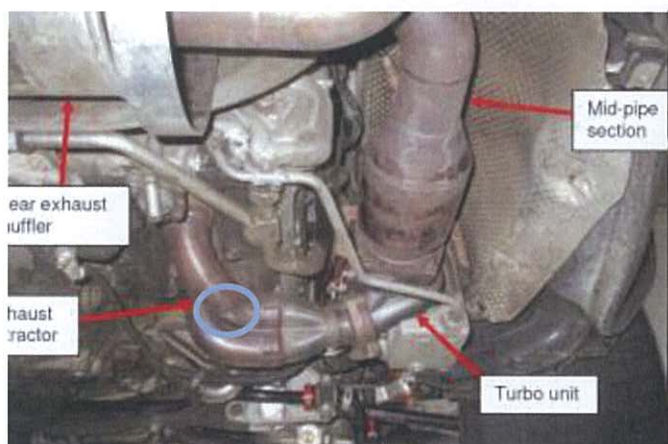
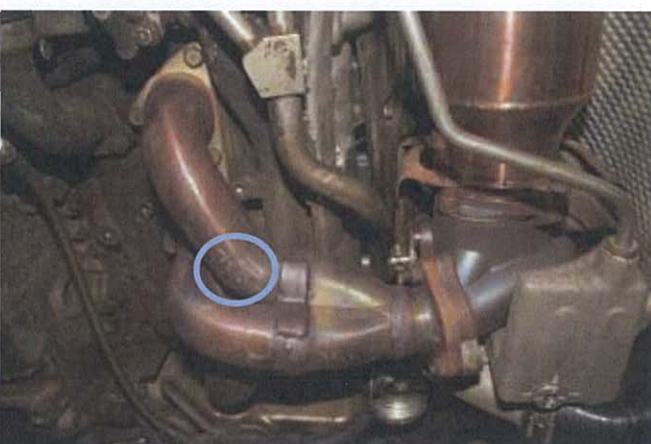
Photo 78 - Same dirt mark on the Right Exhaust Manifold which was not replaced.

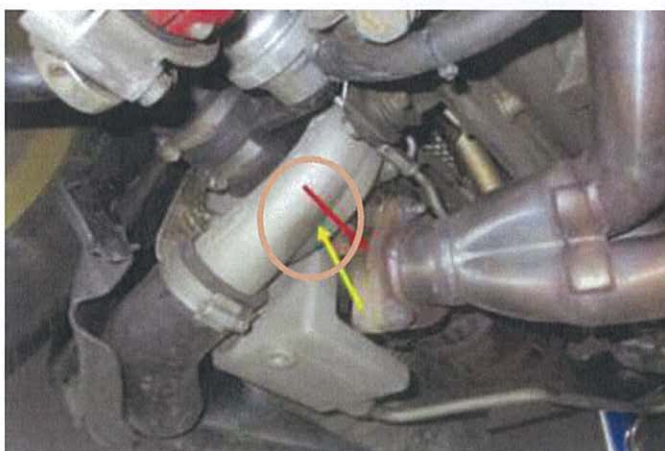
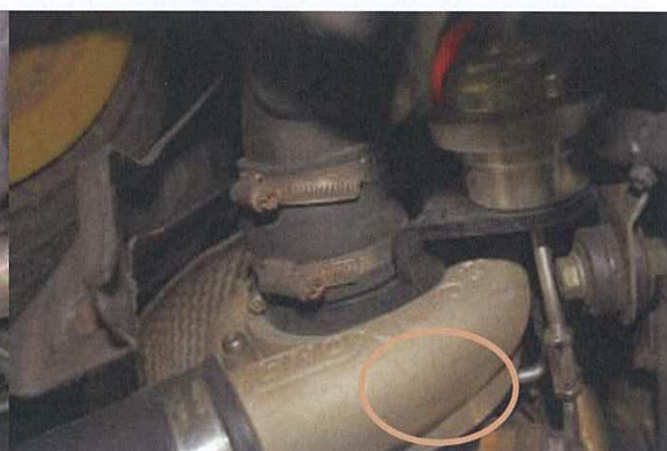
Photo 79 – Same exhaust soot marked on the right turbo which was not replaced

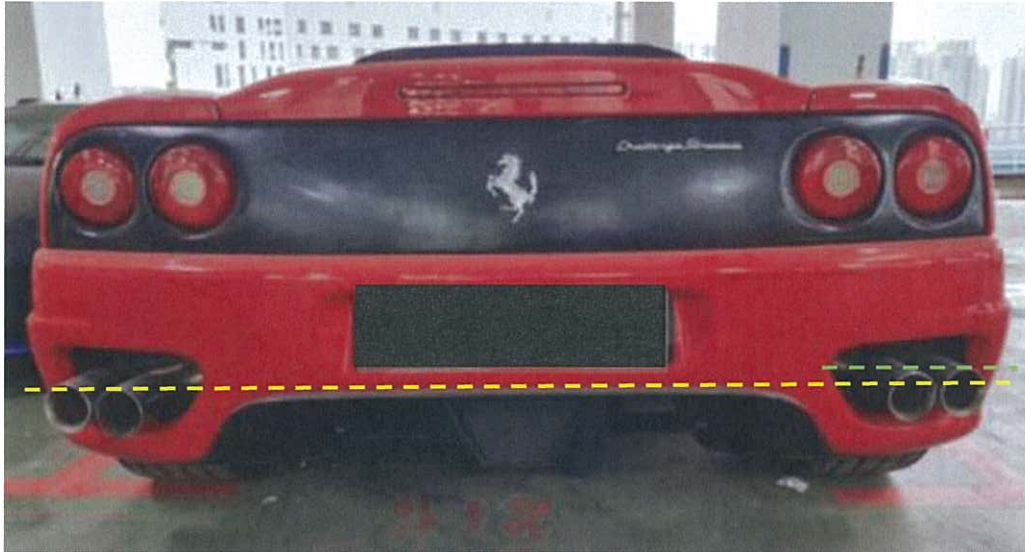
Photo 80 – Height difference indicated in yellow and green lines

- (3) It is not uncommon for the rear exhaust to be of different height. Attached photographs for reference.
- (4) Page 13 and 14 of LKK's report photos 14, 15 and 17 shows Misalignment of the Exhaust Muffler. We do not agree and **Totally Not Consistent** to all the related parts affected by the Exhaust Muffler. LKK commented the impact is upward direction, basing on the **facts and direction of impact**, photo 17 (Red Arrow) pointing, the joining nearer to the Exhaust Muffler would Definitely be **HIGHER** than the joining nearer to the catalytic converter.
