Your Ref: Bentley Continental GT Coupe  
(chassis number SCBCX13S0NC091646)  
Our Ref : CI/TP22003547/D

16 April 2022

**INSPECTION REPORT OF AN UNREGISTERED BENTLEY CONTINENTAL  
GT COUPE MOTOR CAR WITH CHASSIS NUMBER SCBCX13S0NC091646**

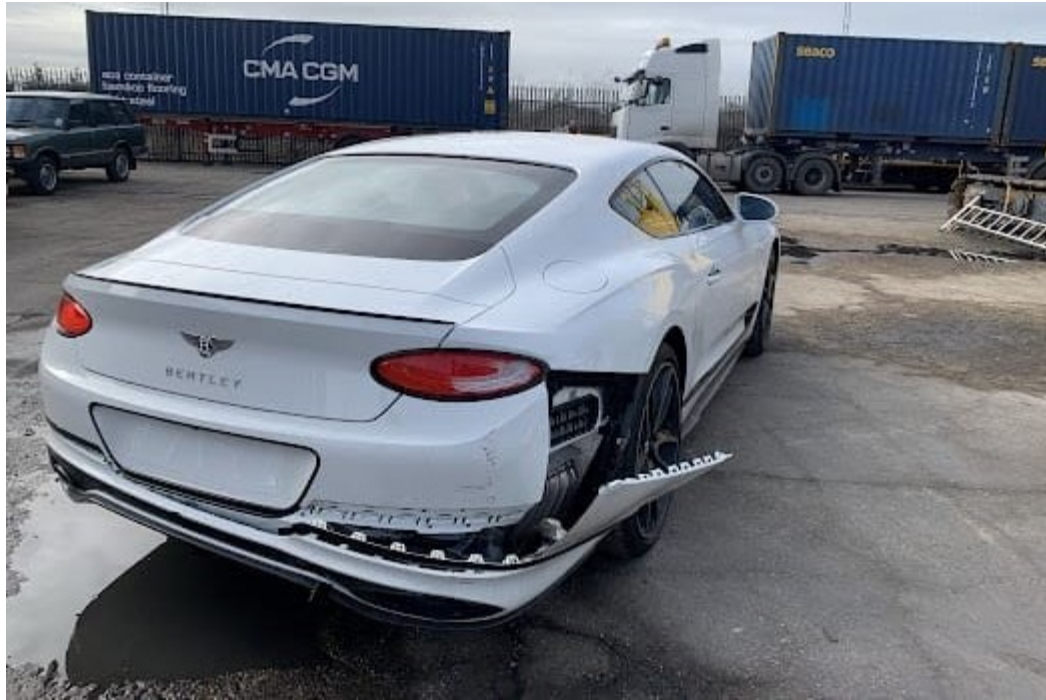
3. The photographs provided to me had showed relatively minor damage to the rear right portion of the Motor Car. The rear bumper and rear right taillamp were observed to have been damaged.
4. Apart for the rear right portion, there was no physical damage observed to other areas of the Motor Car. The airbag(s) was not deployed as seen from the photographs that were provided to me. See photo 1 – 4 below.

**Photo 1** shows the rear right body of the Motor Car (photograph provided to me). The photographs provided to me had showed relatively minor damage to the rear right portion of the Motor Car. The rear bumper and rear right taillamp were observed to have been damaged.

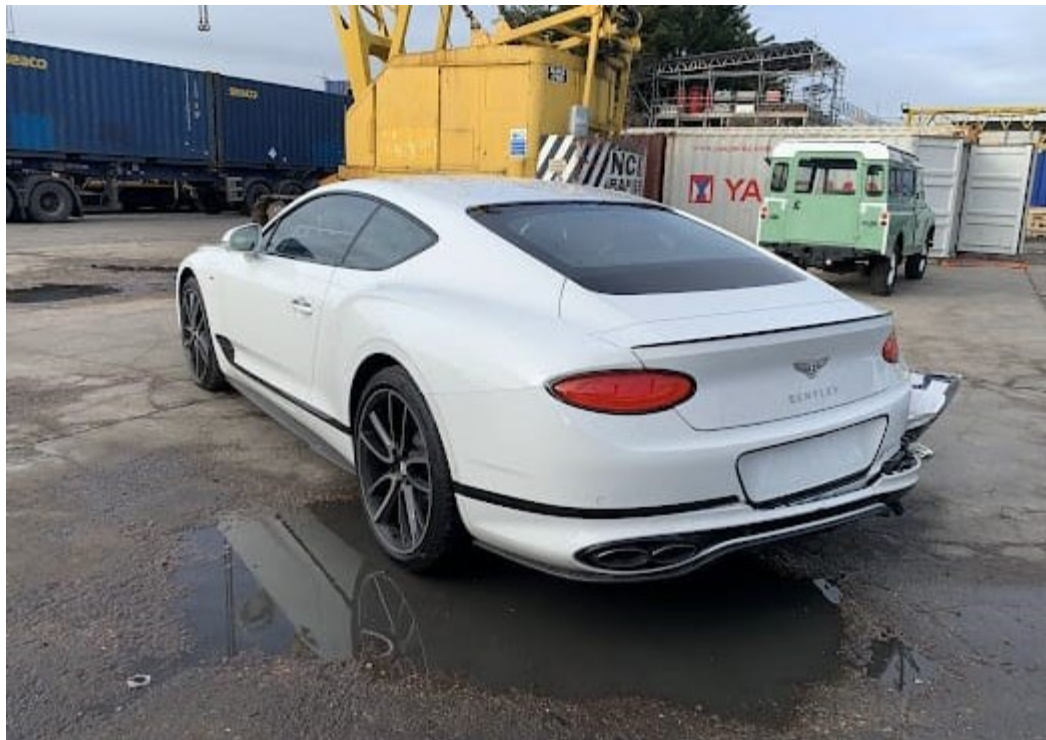
**Photo 2** shows the rear left body of the Motor Car (photograph provided to me). Apart for the rear right portion, there was no physical damage observed to other areas of the Motor Car.

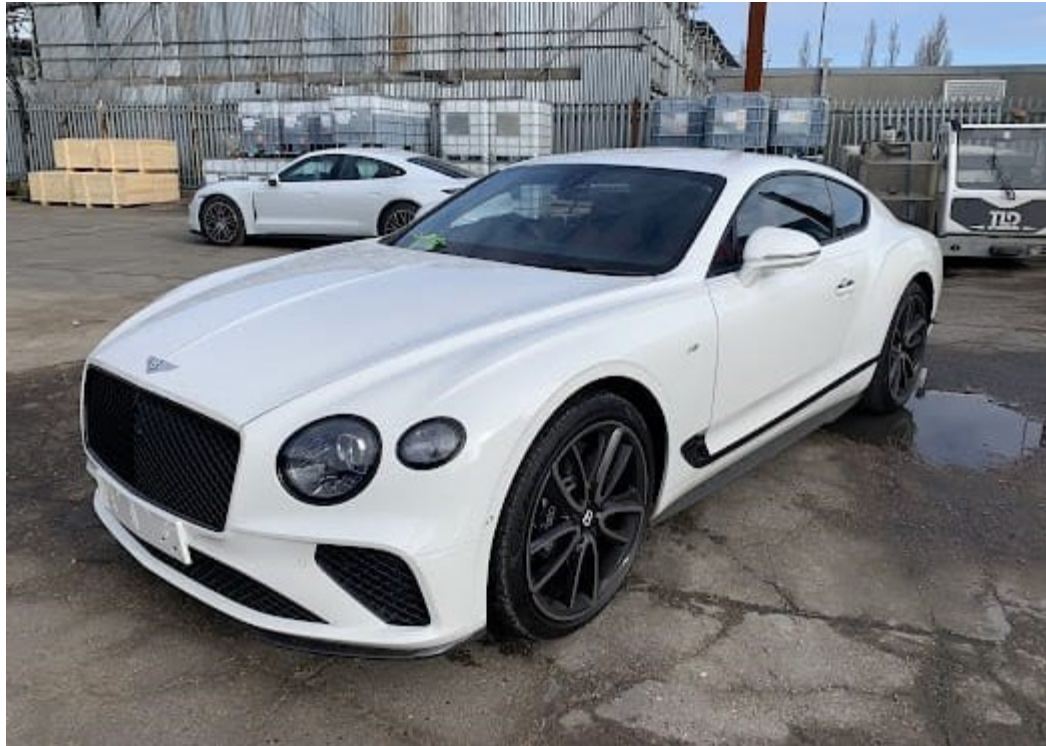
**Photo 3** shows the front left body of the Motor Car (photograph provided to me). Apart for the rear right portion, there was no physical damage observed to other areas of the Motor Car. The airbag(s) appears to have been not deployed as seen from the photographs that were provided to me.

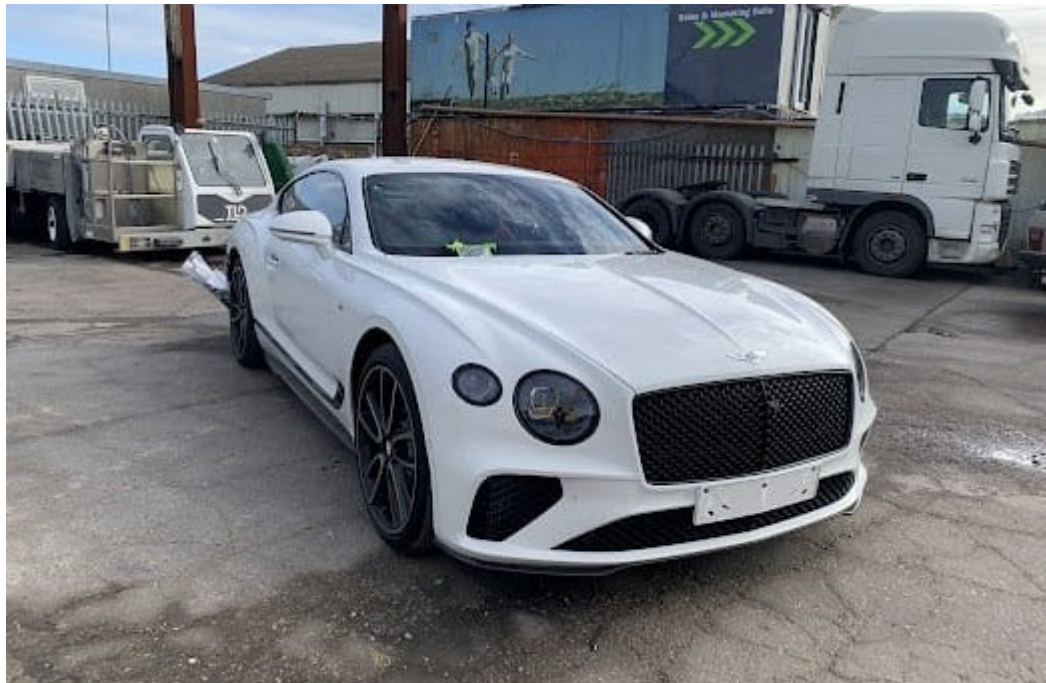
**Photo 4** shows the front right body of the Motor Car (photograph provided to me). Apart for the rear right portion, there was no physical damage observed to other areas of the Motor Car. The airbag(s) appears to have been not deployed as seen from the photographs that were provided to me.

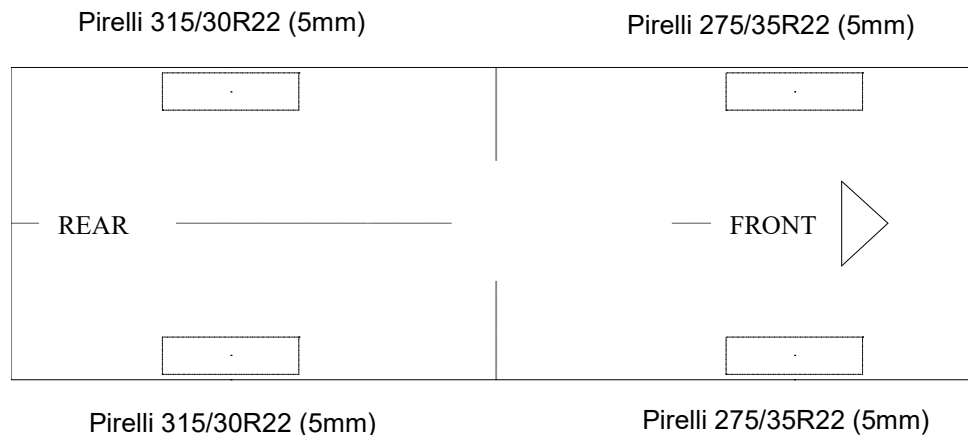
8. It was fitted with 22inch sport wheel rims that were wrapped with tyres that were observed to be of serviceable condition. The tyres were also sufficiently inflated for vehicular operation. The tyre brand, tyre size and approximate remaining tread depth of the 4 tyres of the Motor Car were recorded as follows: -

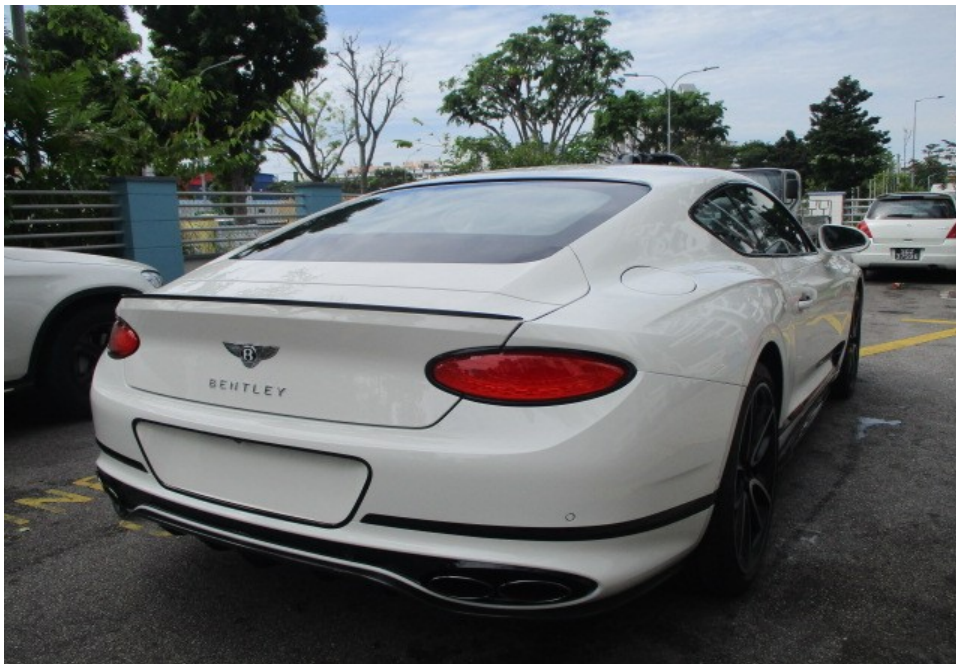
22. The body parts at the rear right portion of the Motor Car were visually examined and it was noted that the repair/restoration works carried out to the damaged area of the Motor Car (refer to photograph 1 above) were reasonably adequate and in order.

**Photo 5** shows a general view of the rear right body of the Motor Car at the time of my inspection. The Motor Car was observed to be in a relatively good general condition with no loose exterior fittings observed. The body parts at the rear right portion of the Motor Car were visually examined and it was observed that the repair/restoration works carried out to the damaged area of the Motor Car (refer to photograph 1 above) were reasonably adequate and in order.

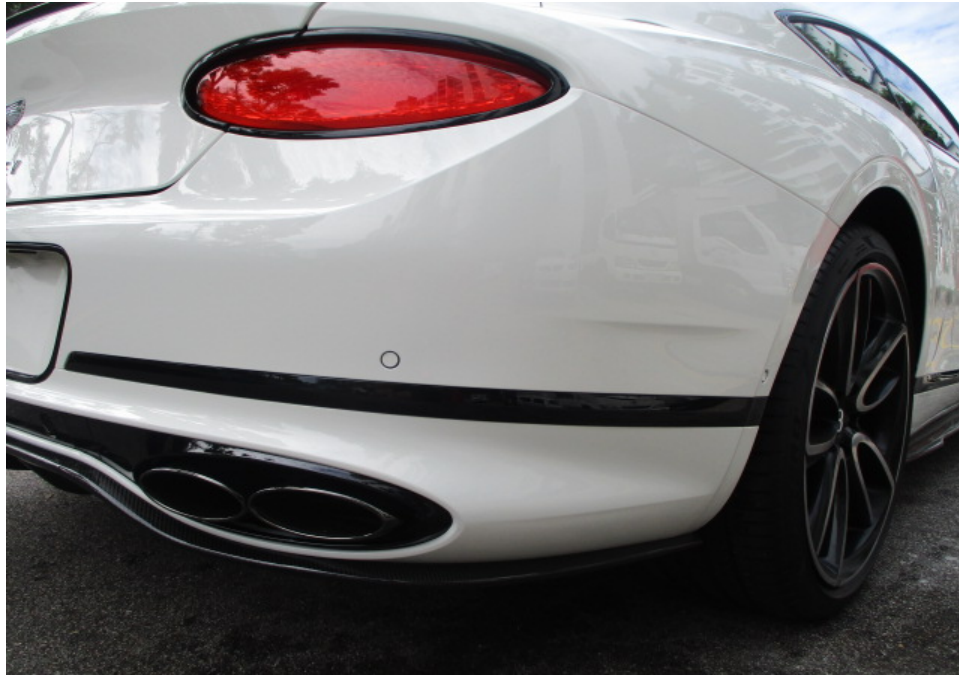
**Photo 6** shows a closer view of the Motor Car's rear bumper, rear bumper right lower moulding and rear bumper sensors at the time of my inspection. The body parts at the rear right portion of the Motor Car were visually examined and it was observed that the repair/restoration works carried out to the damaged area of the Motor Car (refer to photograph 1 above) were reasonably adequate and in order.

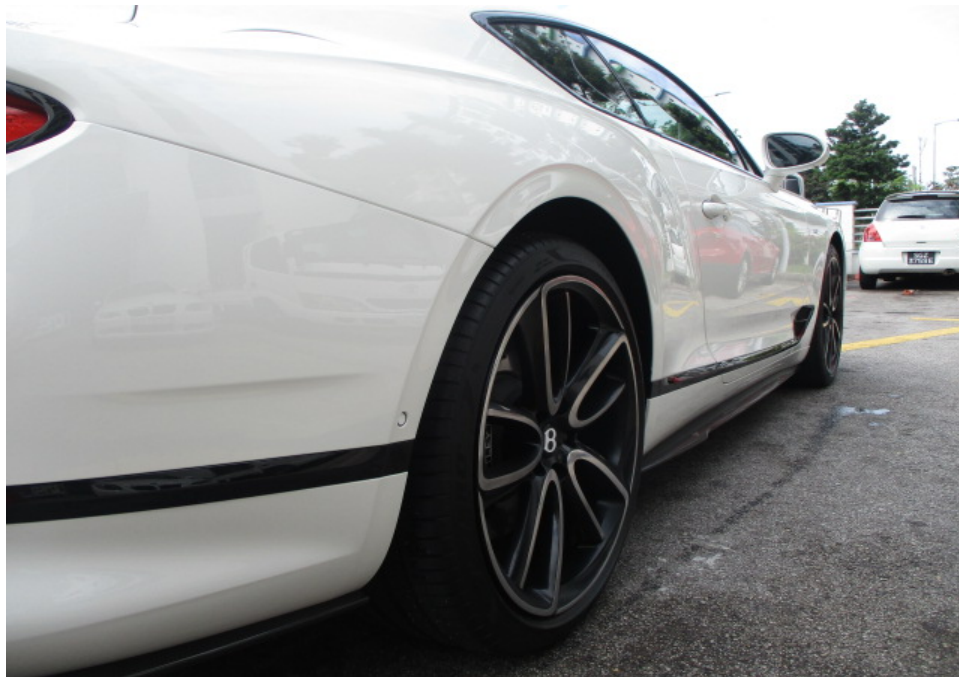
**Photo 7** shows a closer view of the Motor Car's rear bumper, rear right fender and rear right wheel rim at the time of my inspection. The body parts at the rear right portion of the Motor Car were visually examined and it was observed that the repair/restoration works carried out to the damaged area of the Motor Car (refer to photograph 1 above) were reasonably adequate and in order.

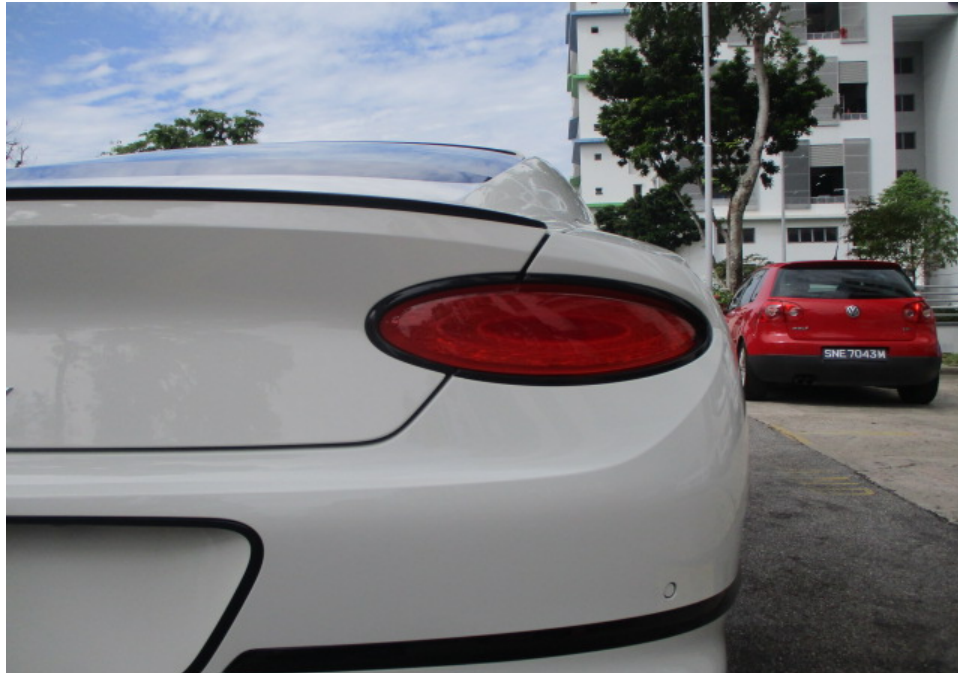
**Photo 8** shows a closer view of the Motor Car's rear bumper, rear bootlid and rear right taillamp at the time of my inspection. The body parts at the rear right portion of the Motor Car were visually examined and it was observed that the repair/restoration works carried out to the damaged area of the Motor Car (refer to photograph 1 above) were reasonably adequate and in order.

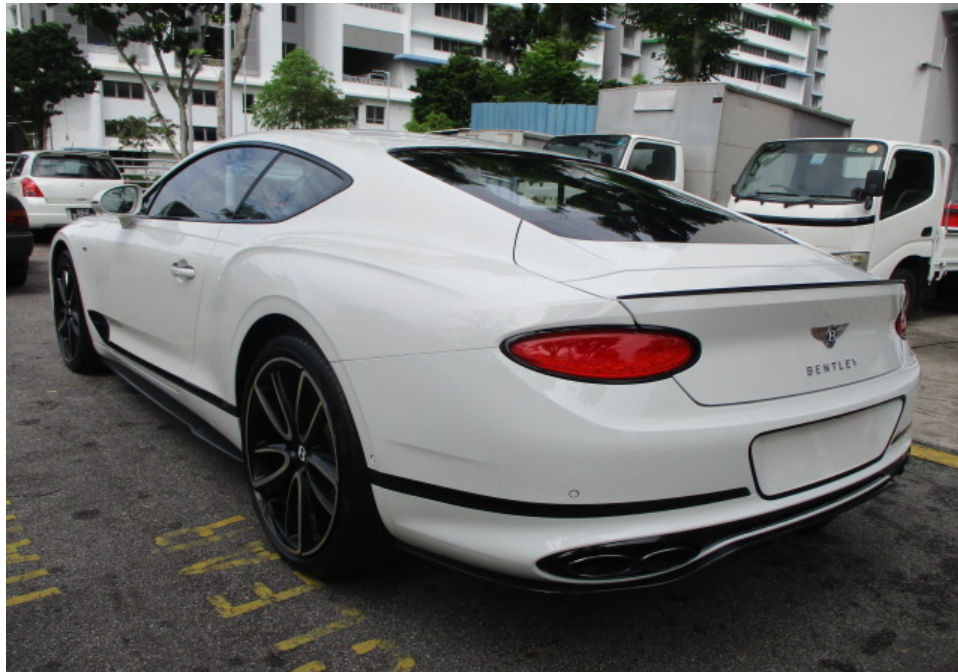
**Photo 9** shows a general view of the rear left body of the Motor Car at the time of my inspection. The Motor Car was observed to be in a relatively good general condition with no loose exterior fittings observed. The mileage of the Motor Car recorded at the time of my inspection was 3,156km.

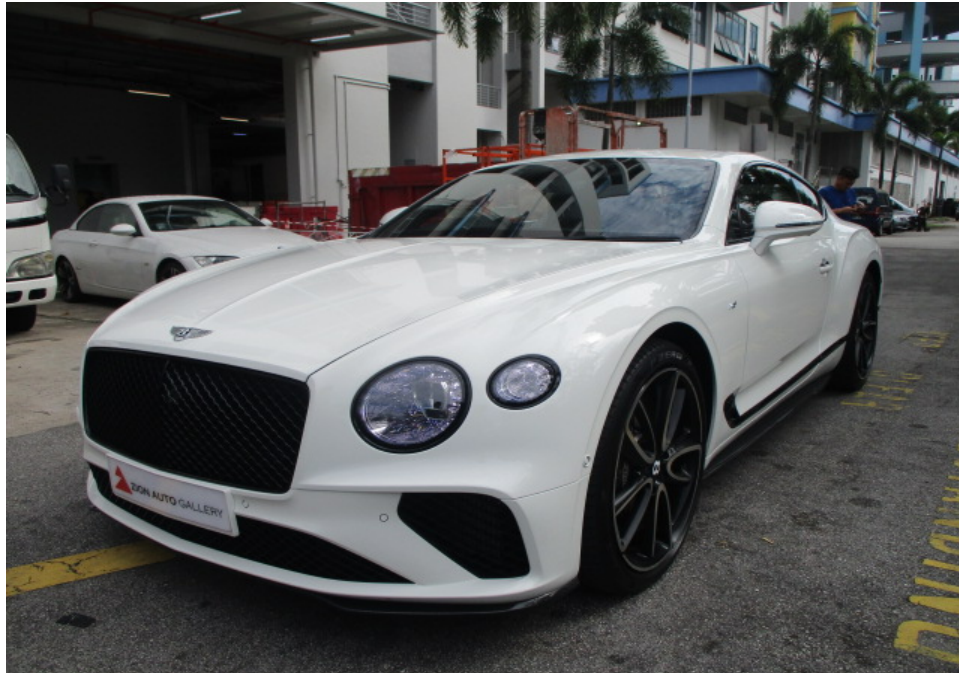
**Photo 10** shows a general view of the front left body of the Motor Car at the time of my inspection. The Motor Car was observed to be in a relatively good general condition with no loose exterior fittings observed. The mileage of the Motor Car recorded at the time of my inspection was 3,156km.

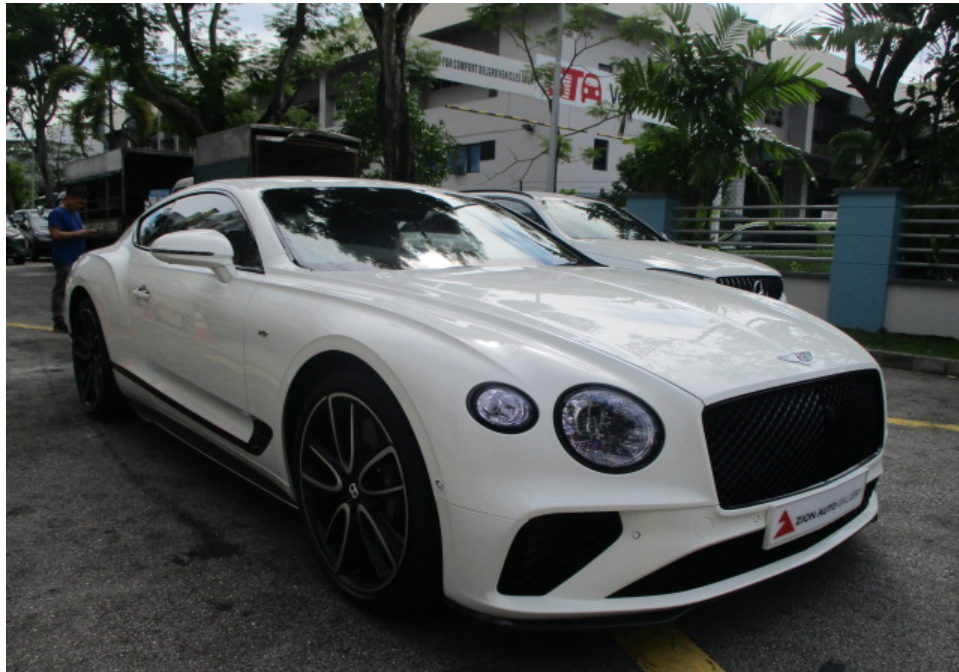
**Photo 11** shows a general view of the front right body of the Motor Car at the time of my inspection. The Motor Car was observed to be in a relatively good general condition with no loose exterior fittings observed. The mileage of the Motor Car recorded at the time of my inspection was 3,156km.

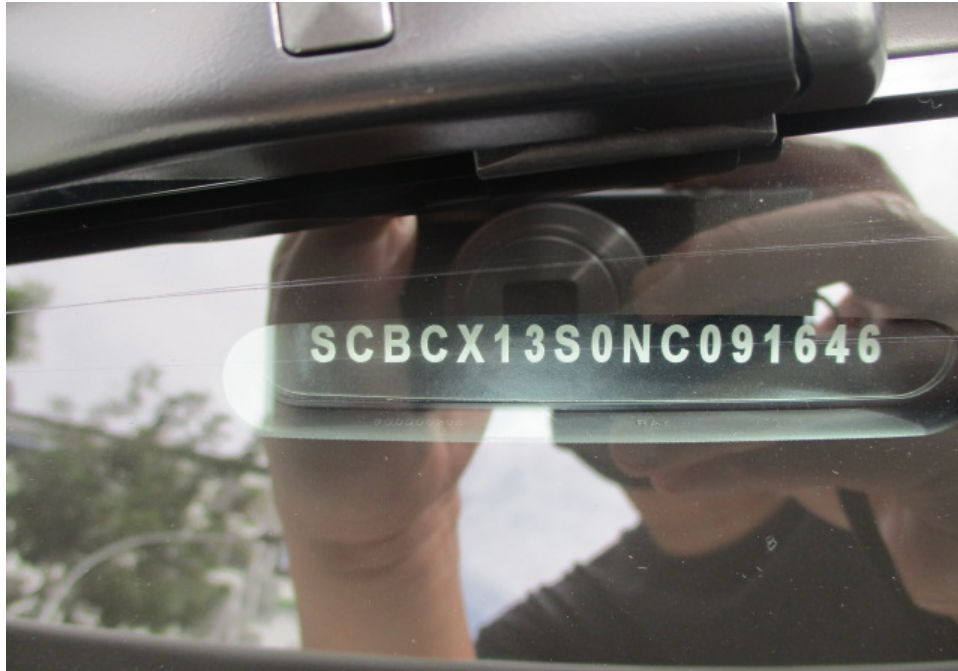
**Photo 12** shows the chassis number of the Motor Car. The chassis number recorded was SCBCX13S0NC091646.

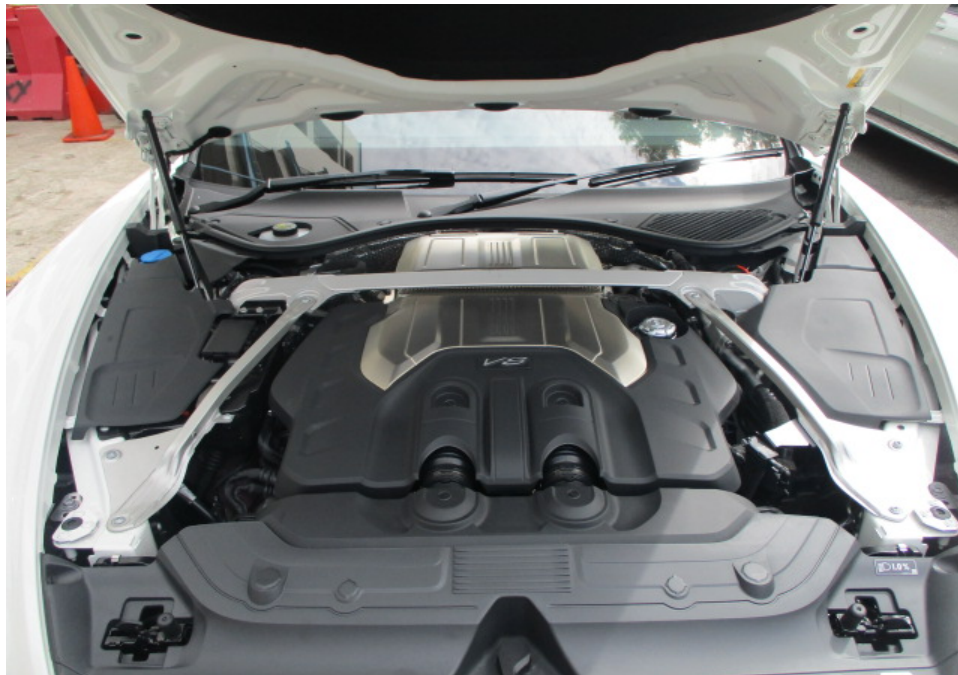
**Photo 13** shows a general view of the engine compartment of the Motor Car at the time of my inspection. The various parts and components inside the engine compartment were all observed to be intact and properly fitted. There was also no sign(s) or indication(s) of fluid leak and/or fluid stain found inside the engine compartment.

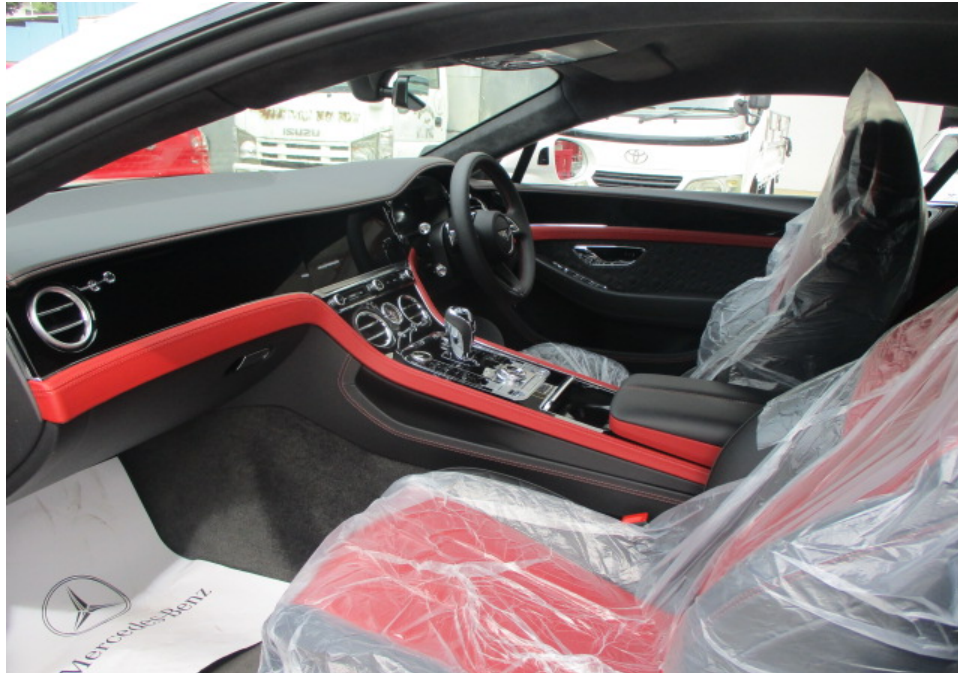
**Photo 14** shows the interior compartment of the Motor Car at the time of my inspection. The various parts and components, trims, carpet, and upholstery inside the interior compartment were all observed to be intact and properly fitted.

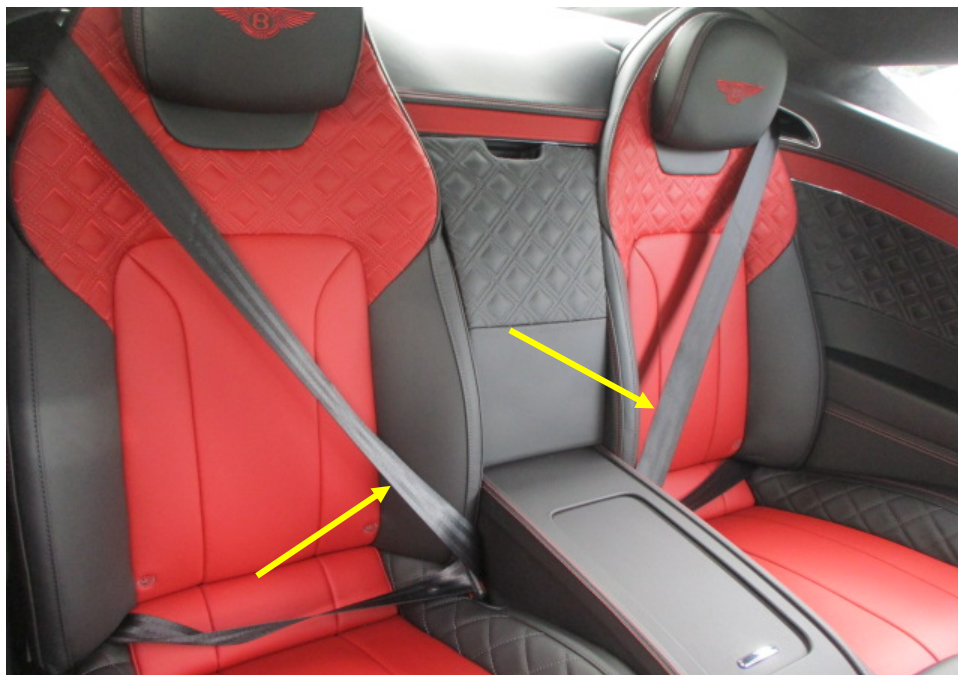
**Photo 15** shows the rear seats of the Motor Car. All the seats of the Motor Car were secured via seat rails to the floorboard. They were also fitted with a retractable seat belt reel and a pre-tensioner. The seat belts (arrowed) were tested and were able to be fastened into the respective pre-tensions that were fitted on the side of each individual seat.

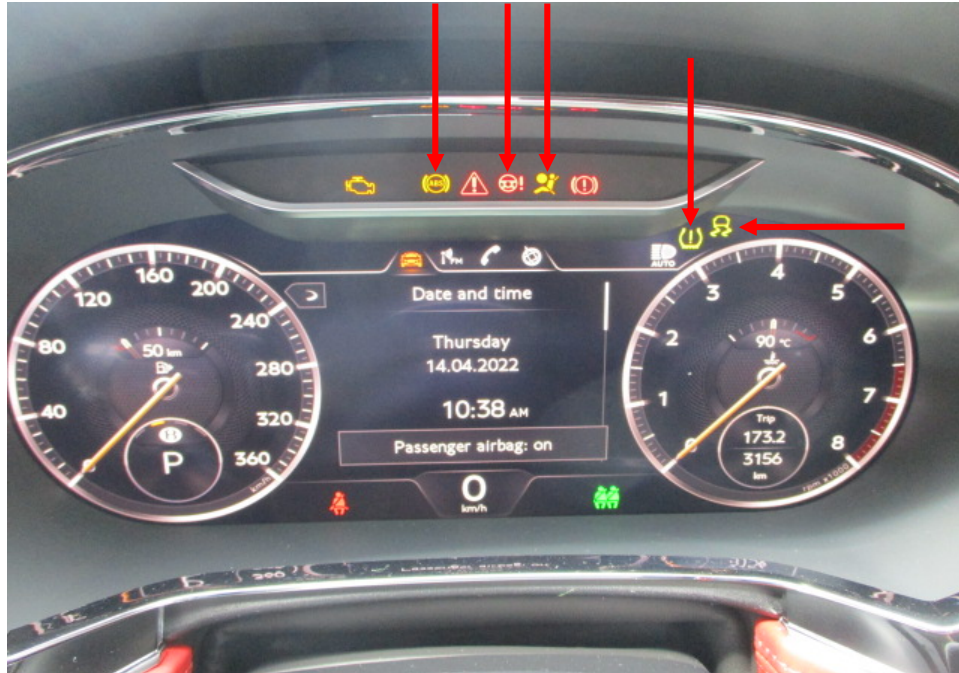
**Photo 16** shows the warning lights for the various electronic safety features appearing on the instrument panel of the Motor Car during its self-test when the engine is cranked, in particular the ABS, SRS, EPS, TPM and TCS lights (arrowed).

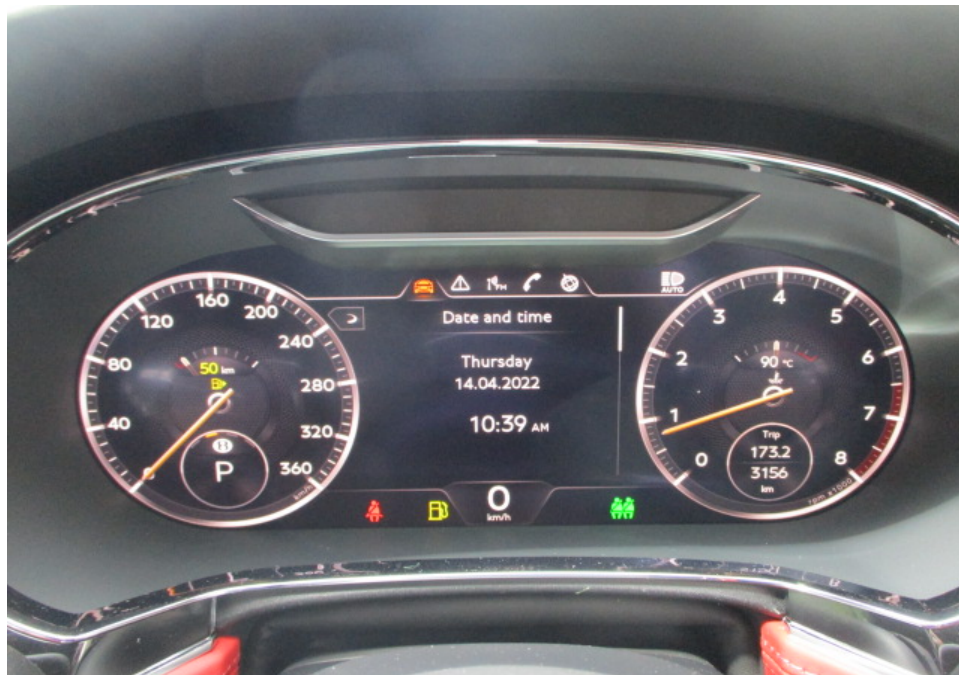
**Photo 17** shows the respective warning lights no longer illuminated, indicating that there is no fault detected to the ABS, SRS, EPS, TPM and TCS systems of the Motor Car during the self-test. These electronic systems were hence in working condition at the time of my inspection.

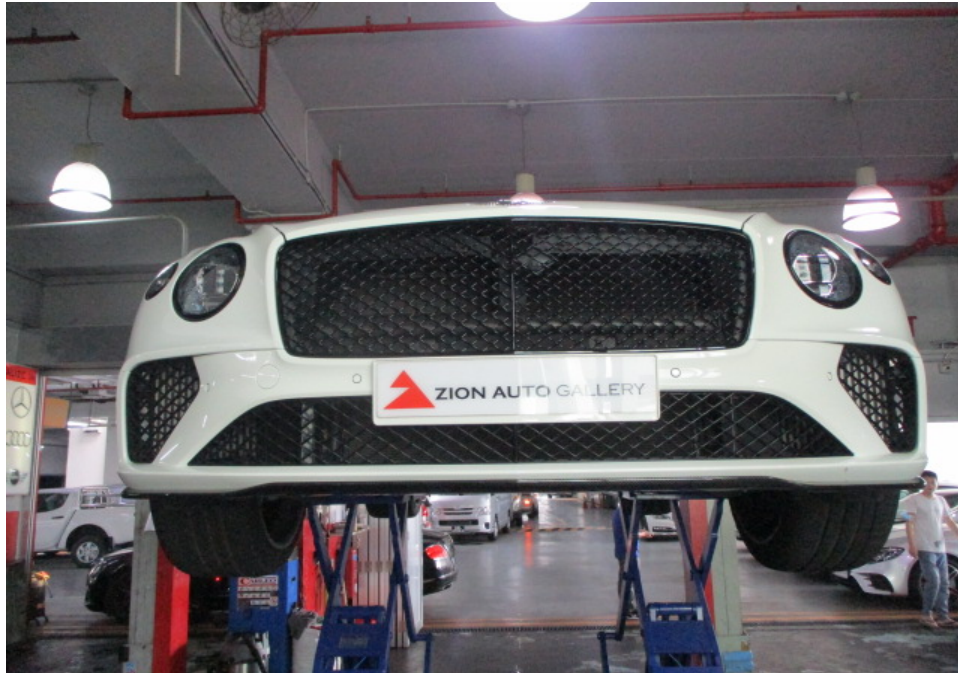
**Photo 18** shows the Motor Car hoisted up for checks on its undercarriage. There was no sign(s) or indication(s) of fluid leakage and/or fluid stain(s) on the underside of the Motor Car. The undercarriage components of the Motor Car were also all observed to be intact and secured in an appropriate manner.

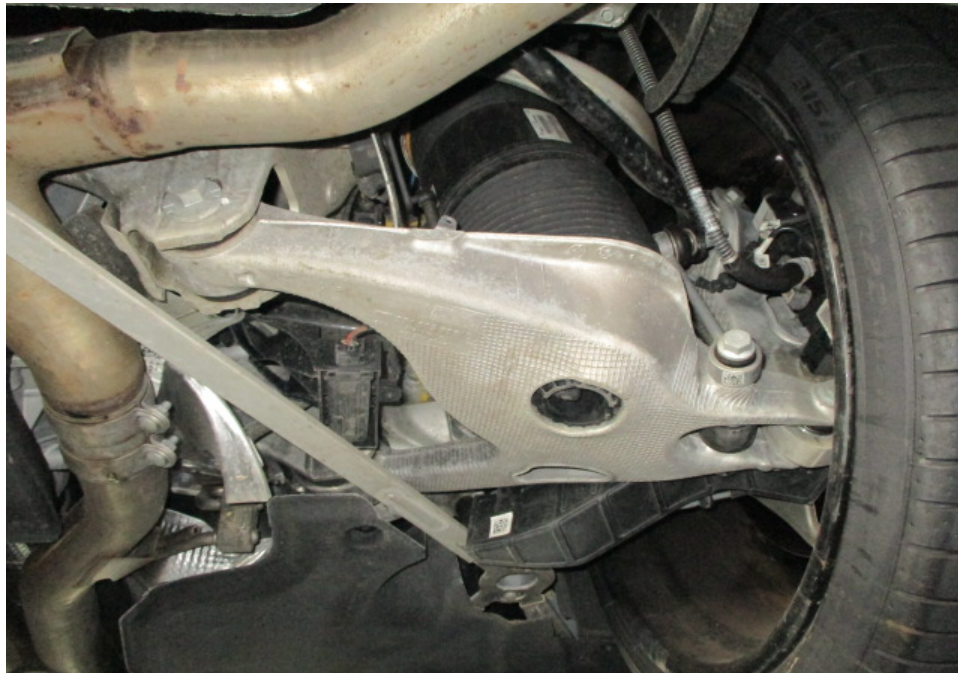
**Photo 19** shows a general view of the control arms and linkages at the rear right wheel of the Motor Car. I did not observe any fluid leak and/or fluid stain on the underside of the Motor Car. All of the Motor Car's undercarriage components were observed to be intact and secured in an appropriate manner.

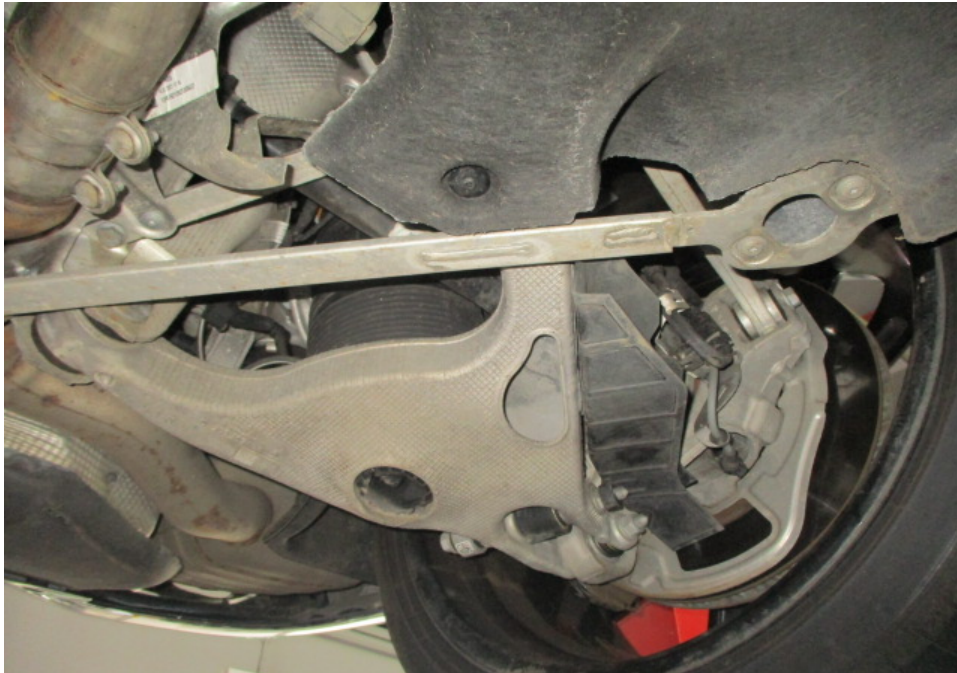
**Photo 20** shows a general view of the control arms and linkages at the rear left wheel of the Motor Car. I did not observe any fluid leak and/or fluid stain on the underside of the Motor Car. All of the Motor Car's undercarriage components were observed to be intact and secured in an appropriate manner.

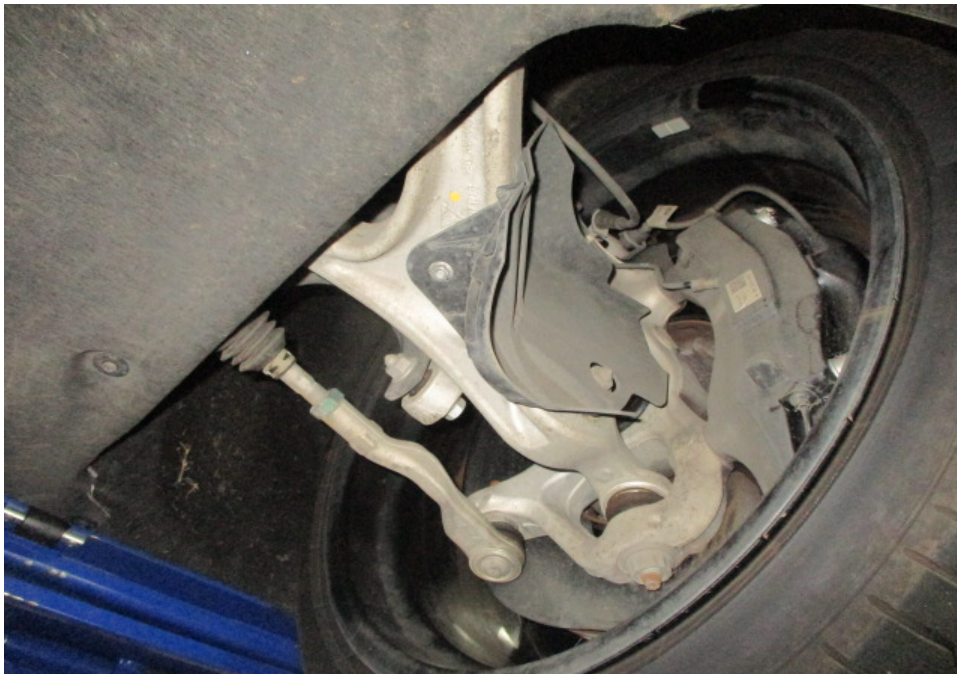
**Photo 21** shows the various undercarriage components at the front left wheel of the Motor Car. The mechanical components, control arms and linkages were all found to be intact and secured in an appropriate manner.

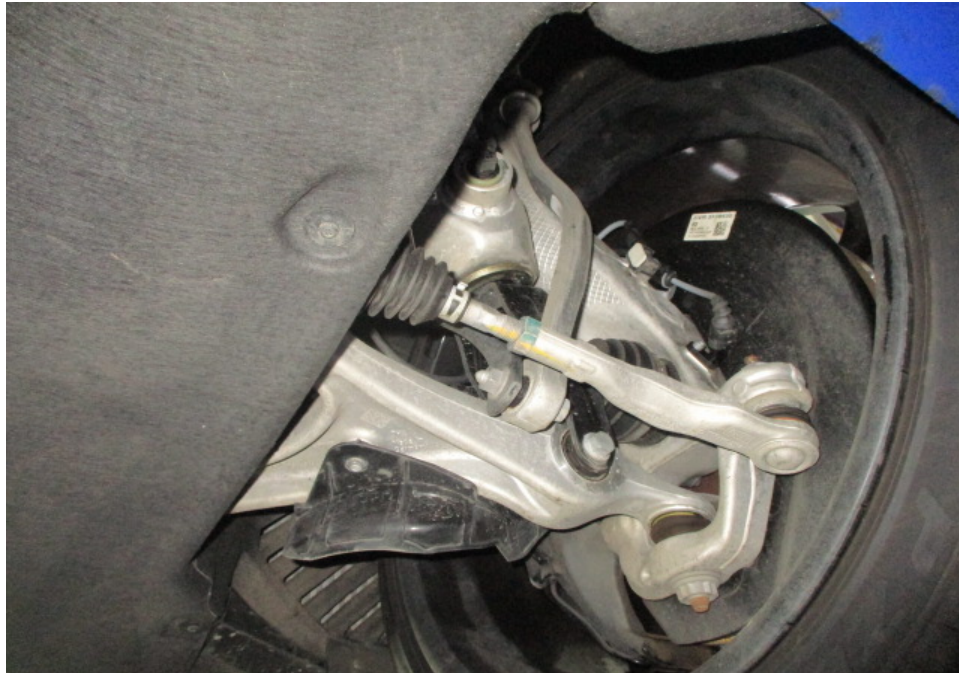
**Photo 22** shows the various undercarriage components at the front right wheel of the Motor Car. The mechanical components, control arms and linkages were all found to be intact and secured in an appropriate manner. I also did not observe any fluid leak and/or fluid stain on the underside of the Motor Car.

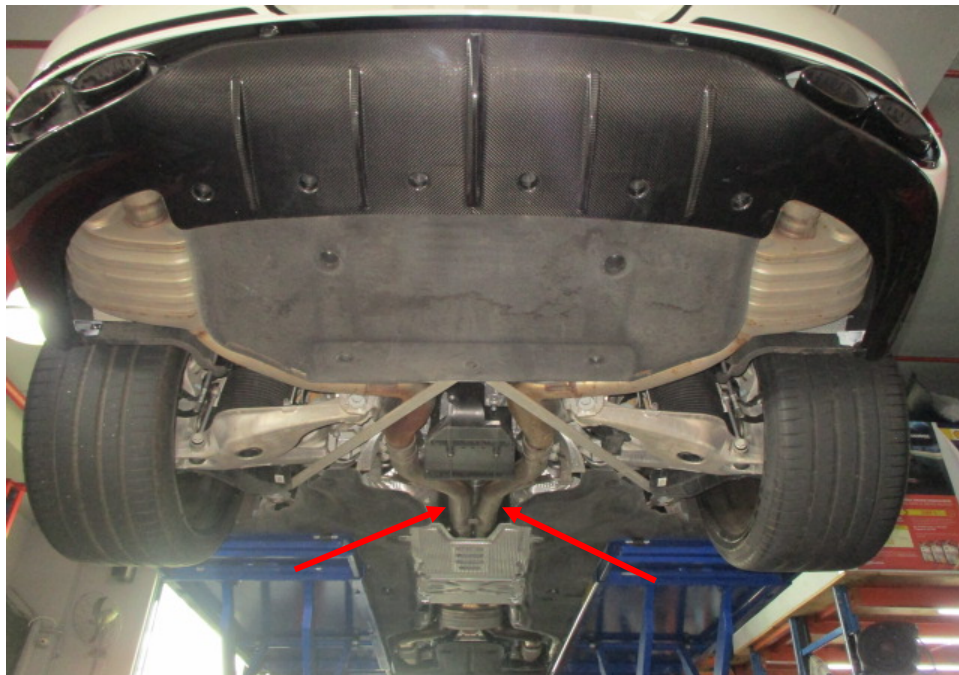
**Photo 23** shows the rear section of the Motor Car's exhaust system. My examination of the Motor Car's exhaust system revealed no sign(s) or indication(s) of any cut or weld marks along its exhaust pipes (arrowed), on its rear mufflers, on its centre resonator box and on its catalytic converters.

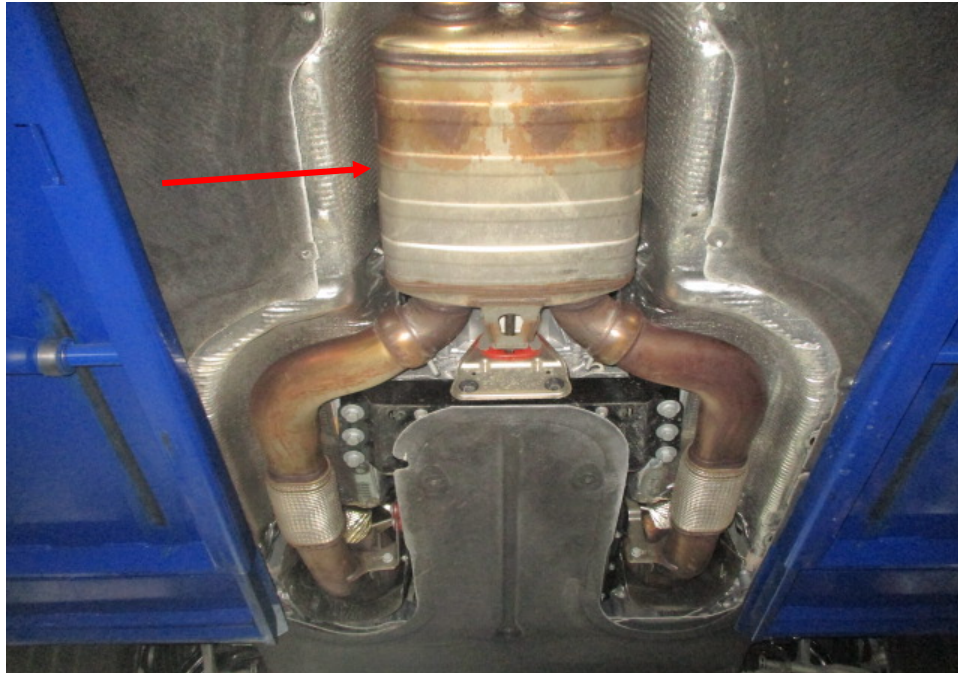
**Photo 24** shows the front section of the Motor Car's exhaust system. My examination of the Motor Car's exhaust system revealed no sign(s) or indication(s) of any cut or weld marks along its exhaust pipes, on its rear mufflers, on its centre resonator box (arrowed) and on its catalytic converters.

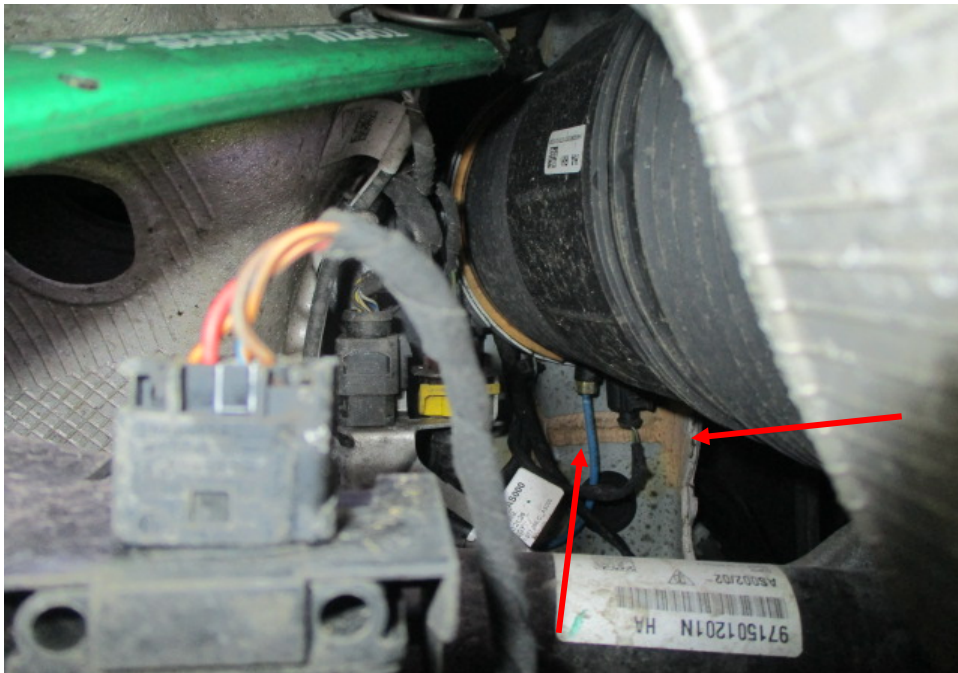
**Photo 25** shows the chassis/structural body at the underside rear right of the Motor Car. I did not find any weld marks other than original spot weld marks on the chassis/structural body of the Motor Car. The original factory sealant (arrowed) at the joints along the chassis/structural body was untouched, indicating no work was done on the chassis/structural body of the Motor Car and that the chassis/structural body was originally fitted.

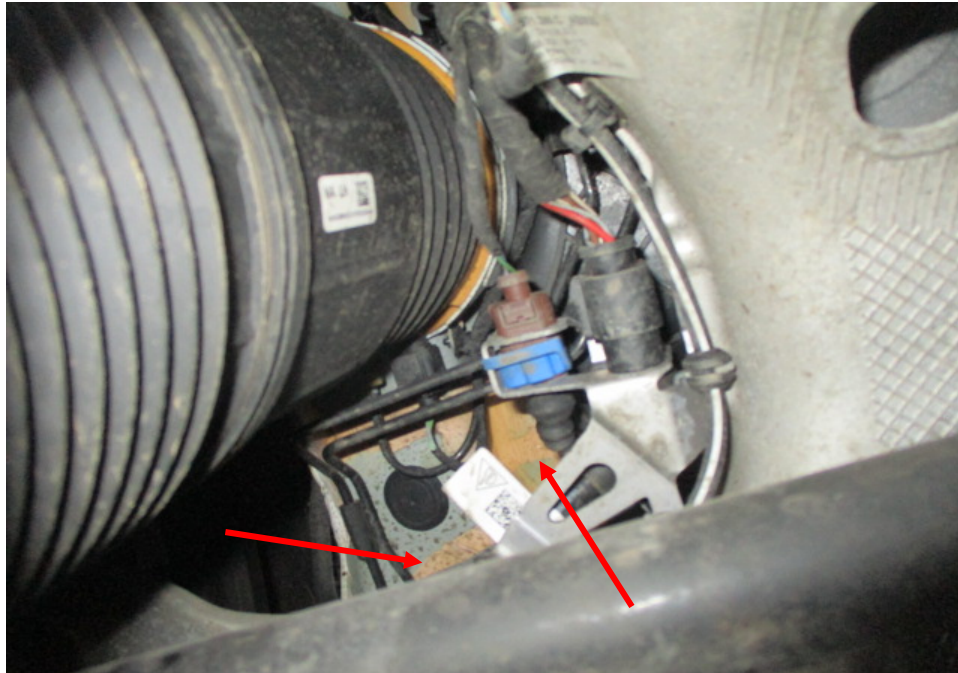
**Photo 26** shows the chassis/structural body at the underside rear left of the Motor Car. The original factory sealant (arrowed) at the joints along the chassis/structural body was observed to be untouched. In general, I had found no work was carried out on the chassis/structural body of the Motor Car. The chassis/structural body of the Motor Car was originally fitted.

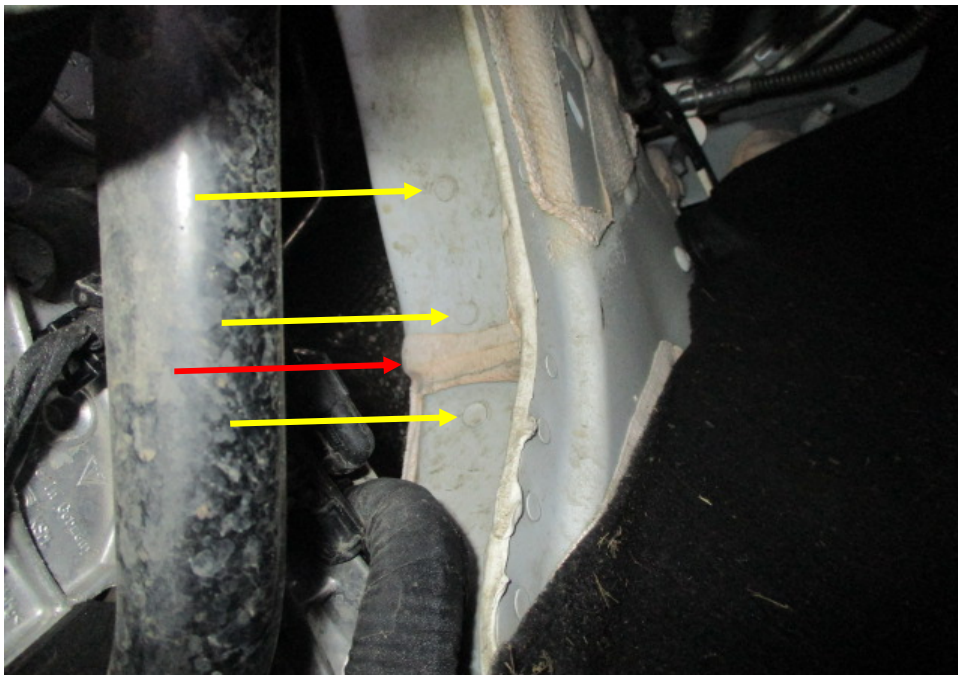
**Photo 27** shows the chassis/structural body at the underside front left of the Motor Car. I did not find any weld marks other than original spot weld marks (yellow arrow) on the chassis/structural body of the Motor Car. The original factory sealant (red arrow) at the joints along the chassis/structural body was untouched, indicating no work was done on the chassis/structural body of the Motor Car and that the chassis/structural body was originally fitted.

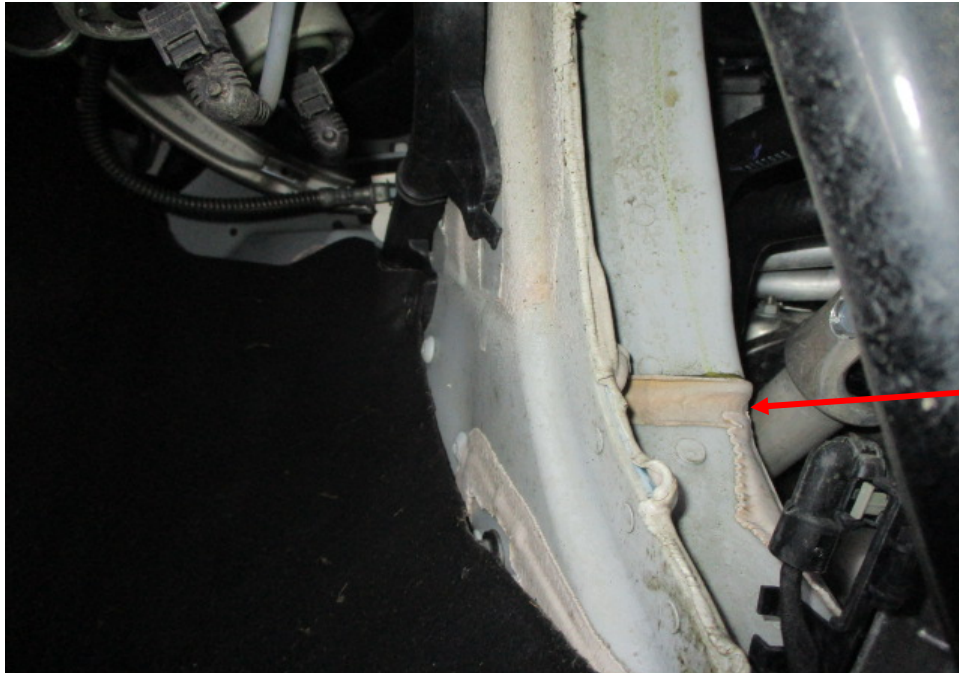
**Photo 28** shows the chassis/structural body at the underside front right of the Motor Car. The original factory sealant (arrowed) at the joints along the chassis/structural body was observed to be untouched. In general, I had found no work was carried out on the chassis/structural body of the Motor Car. The chassis/structural body of the Motor Car was originally fitted.
