Your Ref: BMW 740Li
(chassis number WBA7T22060CF65429)
Our Ref : CI/TP22003548/D

15 April 2022

**INSPECTION REPORT OF AN UNREGISTERED BMW 740Li MOTOR CAR
WITH CHASSIS NUMBER WBA7T22060CF65429**

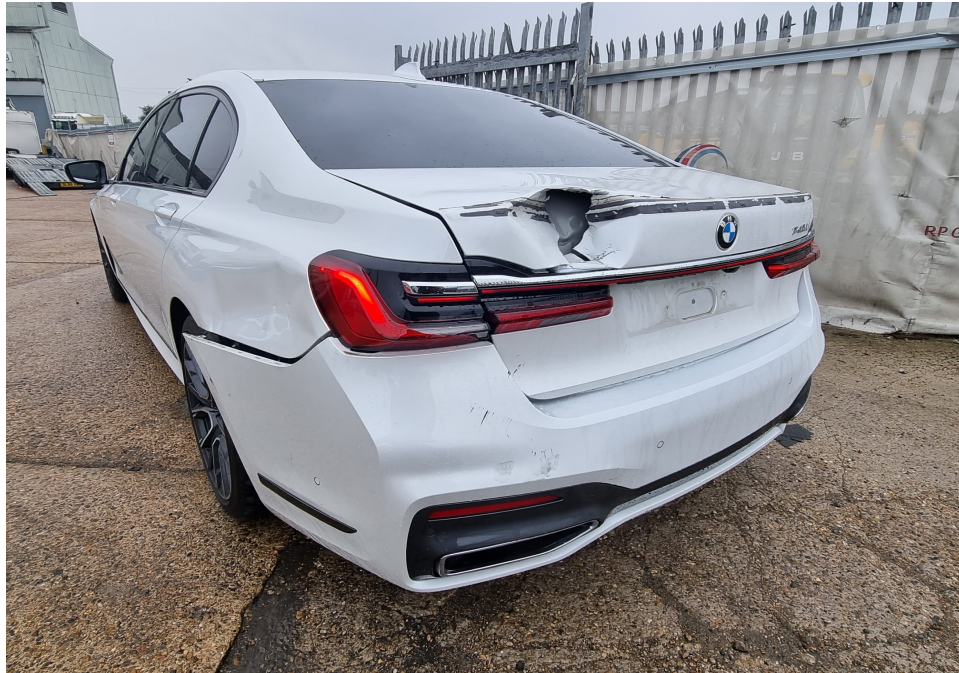
3. The photographs provided to me had showed damage to the rear left portion of the Motor Car. Body parts damaged include the rear bumper, rear bootlid, rear bootlid chrome moulding, rear bootlid top spoiler, rear left taillamp and rear left fender amongst others.
4. Apart for the rear left portion, there was no physical damage observed to other areas of the Motor Car. The airbag(s) was not deployed as seen from the photographs that were provided to me. See photo 1 – 5 below.

Photo 1 shows the rear left body of the Motor Car (photograph provided to me). The photographs provided to me had showed damage to the rear left portion of the Motor Car. The rear bumper, rear bootlid, rear bootlid chrome moulding, rear bootlid top spoiler, rear left taillamp and rear left fender were amongst the body parts that were observed to have been damaged.

22. The body parts at the rear left portion of the Motor Car were visually examined and it was noted that the repair/restoration works carried out to the damaged area of the Motor Car (refer to photograph 1 above) were reasonably adequate and in order.

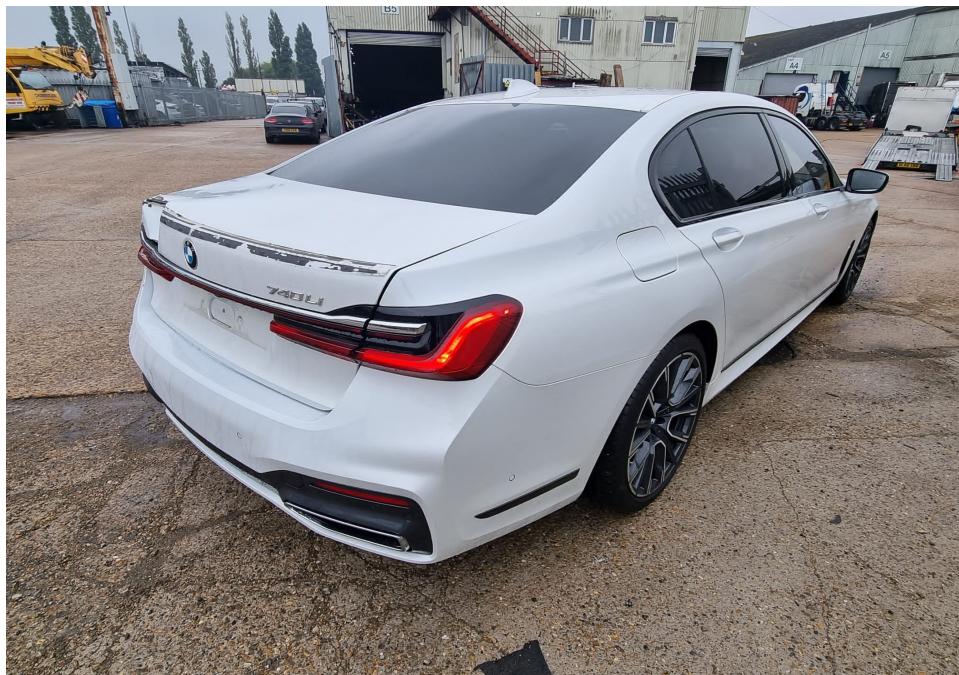
Photo 2 shows the rear right body of the Motor Car (photograph provided to me). Apart for the rear left portion, there was no physical damage observed to other areas of the Motor Car.

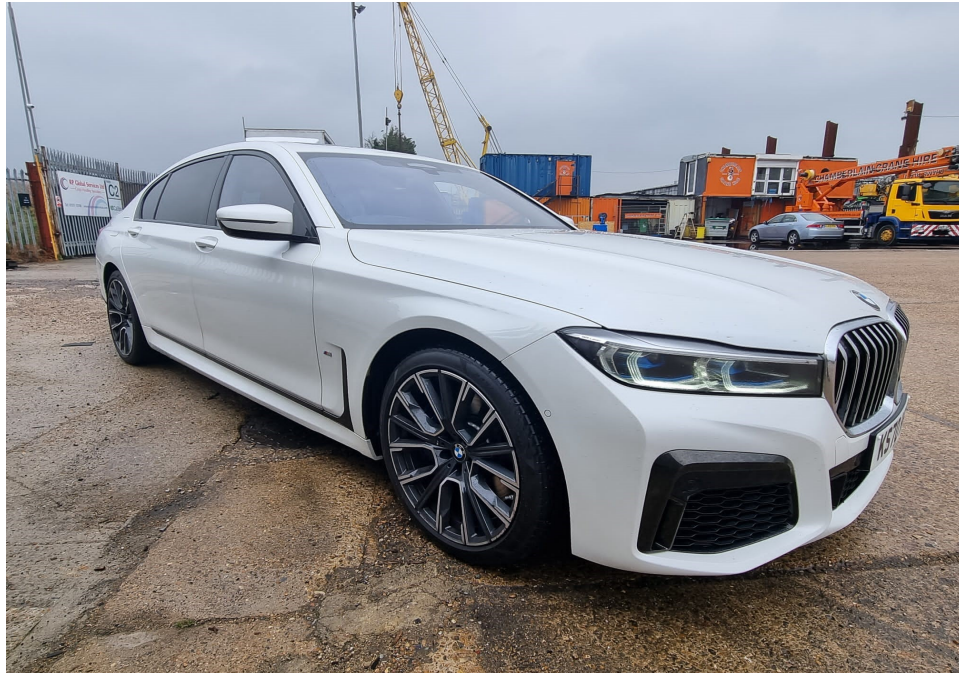
Photo 3 shows the right side body of the Motor Car (photograph provided to me). Apart for the rear left portion, there was no physical damage observed to other areas of the Motor Car. The airbag(s) appears to have been not deployed as seen from the photographs that were provided to me.

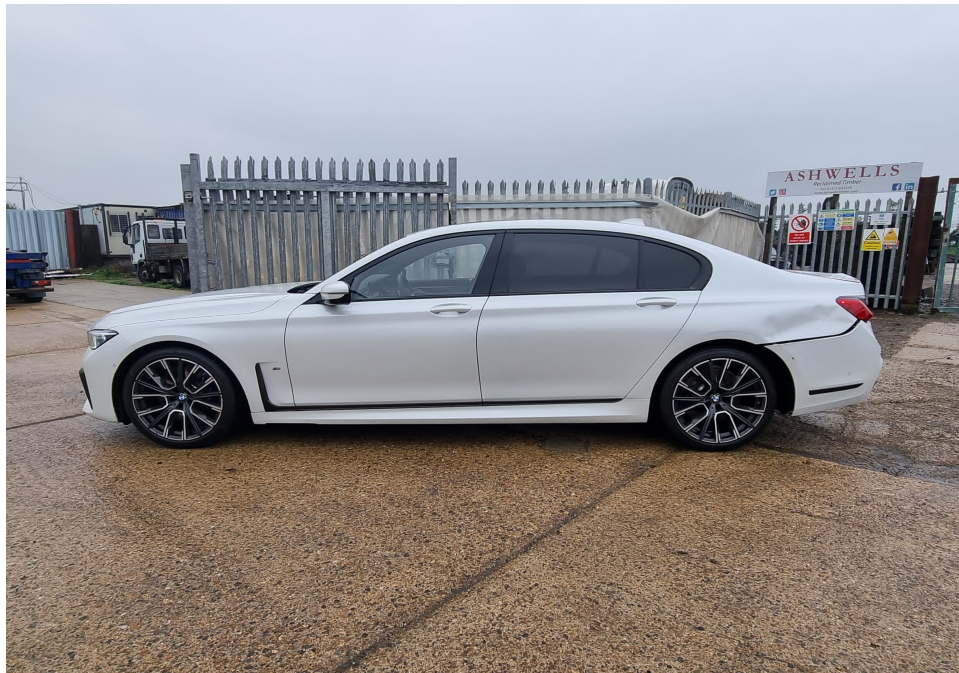
Photo 4 shows the left side body of the Motor Car (photograph provided to me). Apart for the rear left portion, there was no physical damage observed to other areas of the Motor Car. The airbag(s) appears to have been not deployed as seen from the photographs that were provided to me.

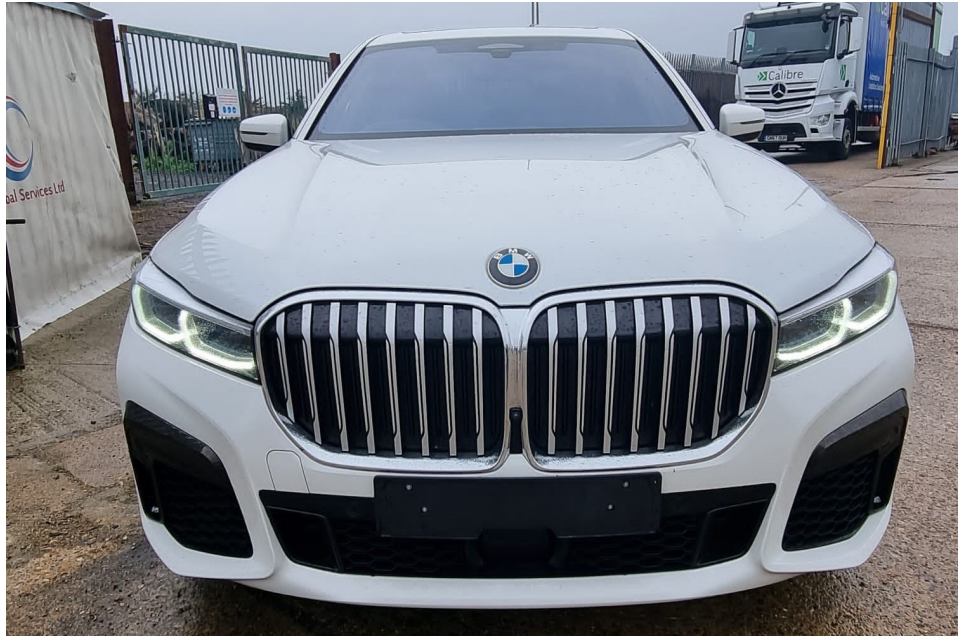
Photo 5 shows the frontal body of the Motor Car (photograph provided to me). Apart for the rear left portion, there was no physical damage observed to other areas of the Motor Car. The airbag(s) appears to have been not deployed as seen from the photographs that were provided to me.

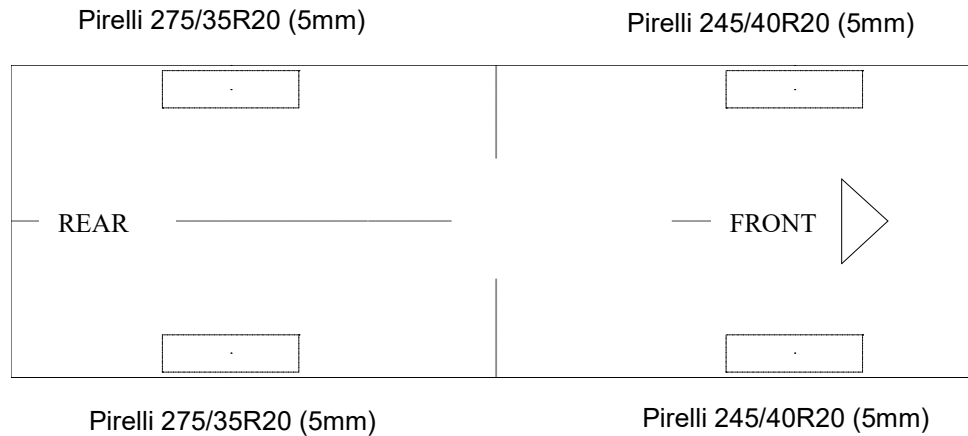
8. It was fitted with 20inch sport wheel rims that were wrapped with tyres that were observed to be of serviceable condition. The tyres were also sufficiently inflated for vehicular operation. The tyre brand, tyre size and approximate remaining tread depth of the 4 tyres of the Motor Car were recorded as follows: -

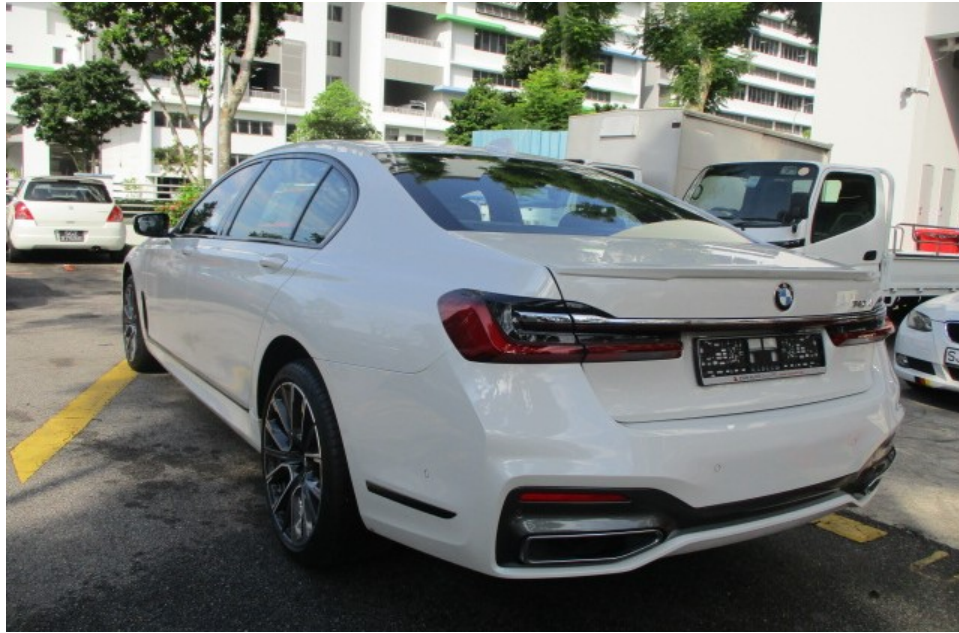
Photo 6 shows a general view of the rear left body of the Motor Car at the time of my inspection. The Motor Car was observed to be in a relatively good general condition with no loose exterior fittings observed. The body parts at the rear left portion of the Motor Car were visually examined and it was observed that the repair/restoration works carried out to the damaged area of the Motor Car (refer to photograph 1 above) were reasonably adequate and in order.

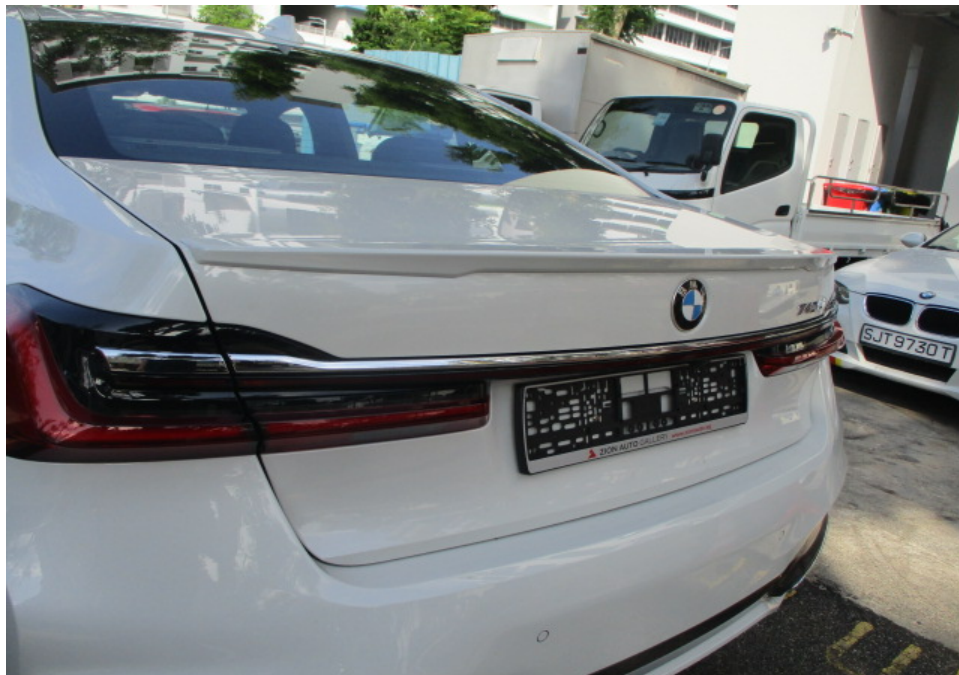
Photo 7 shows a closer view of the Motor Car's rear bootlid, rear bootlid chrome moulding, rear bootlid top spoiler and rear left bootlid lamp at the time of my inspection. The body parts at the rear left portion of the Motor Car were visually examined and it was observed that the repair/restoration works carried out to the damaged area of the Motor Car (refer to photograph 1 above) were reasonably adequate and in order.

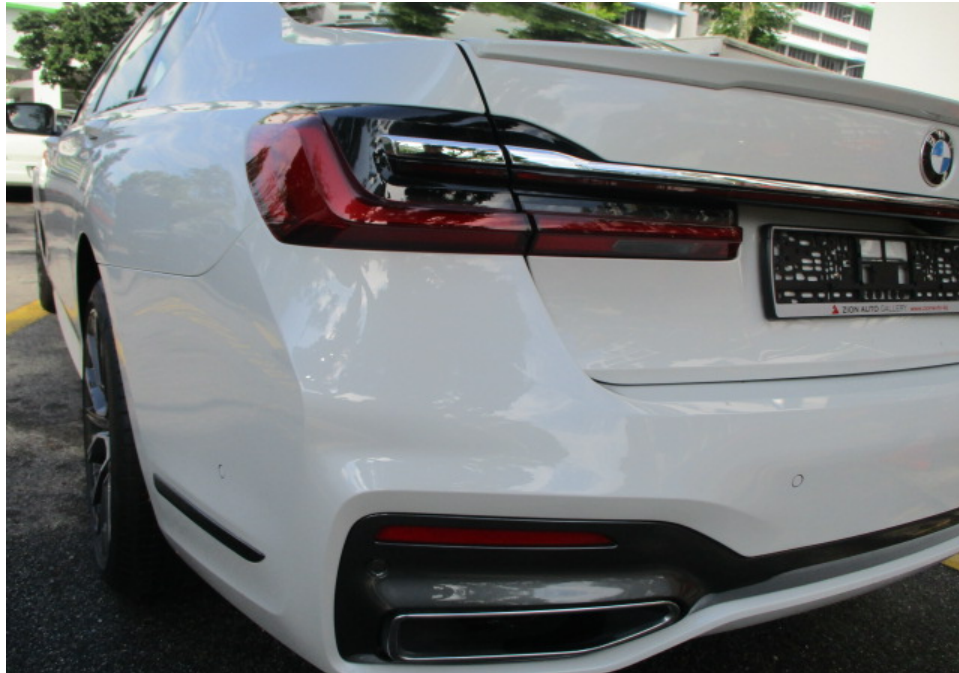
Photo 8 shows a closer view of the Motor Car's rear bumper, rear bootlid, rear bootlid chrome moulding and rear left taillamp at the time of my inspection. The body parts at the rear left portion of the Motor Car were visually examined and it was observed that the repair/restoration works carried out to the damaged area of the Motor Car (refer to photograph 1 above) were reasonably adequate and in order.

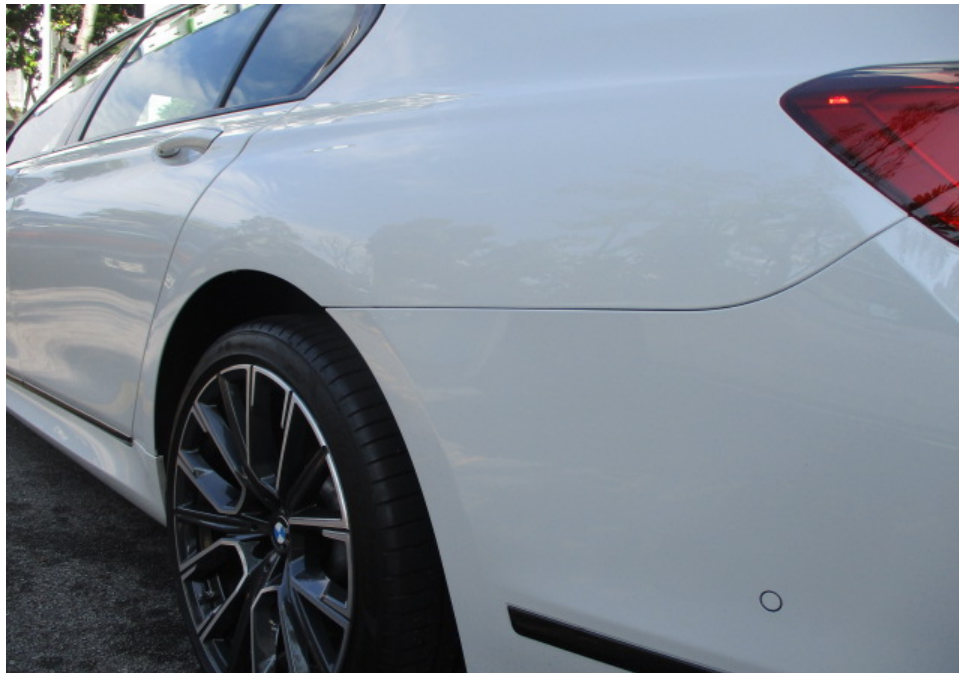
Photo 9 shows a closer view of the Motor Car's rear bumper, rear left fender and rear left wheel rim at the time of my inspection. The body parts at the rear left portion of the Motor Car were visually examined and it was observed that the repair/restoration works carried out to the damaged area of the Motor Car (refer to photograph 1 above) were reasonably adequate and in order.

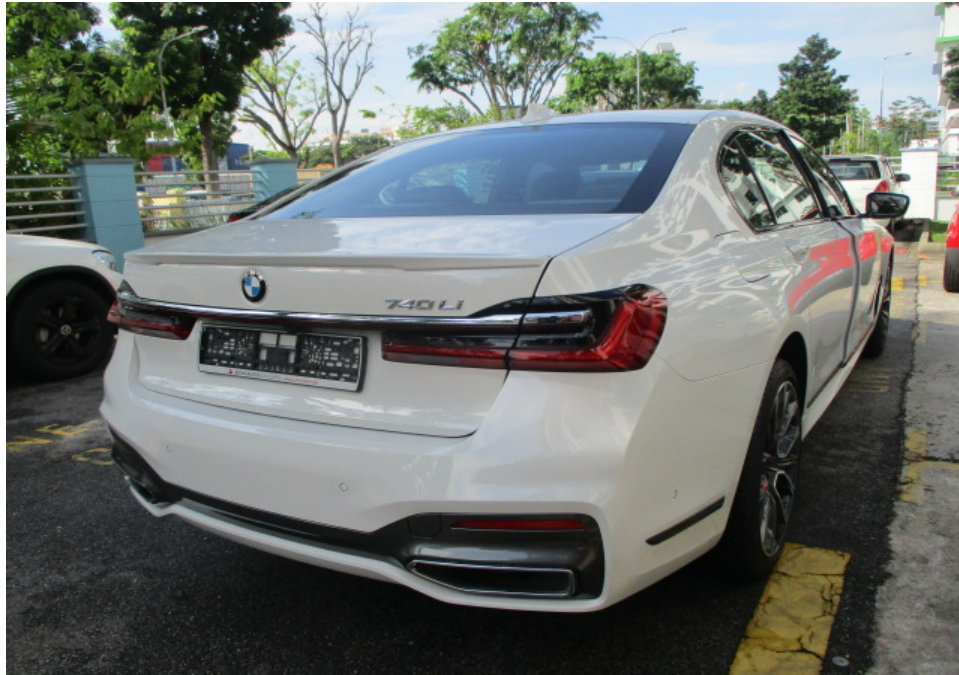
Photo 10 shows a general view of the rear right body of the Motor Car at the time of my inspection. The Motor Car was observed to be in a relatively good general condition with no loose exterior fittings observed. The mileage of the Motor Car recorded at the time of my inspection was 4,107km.

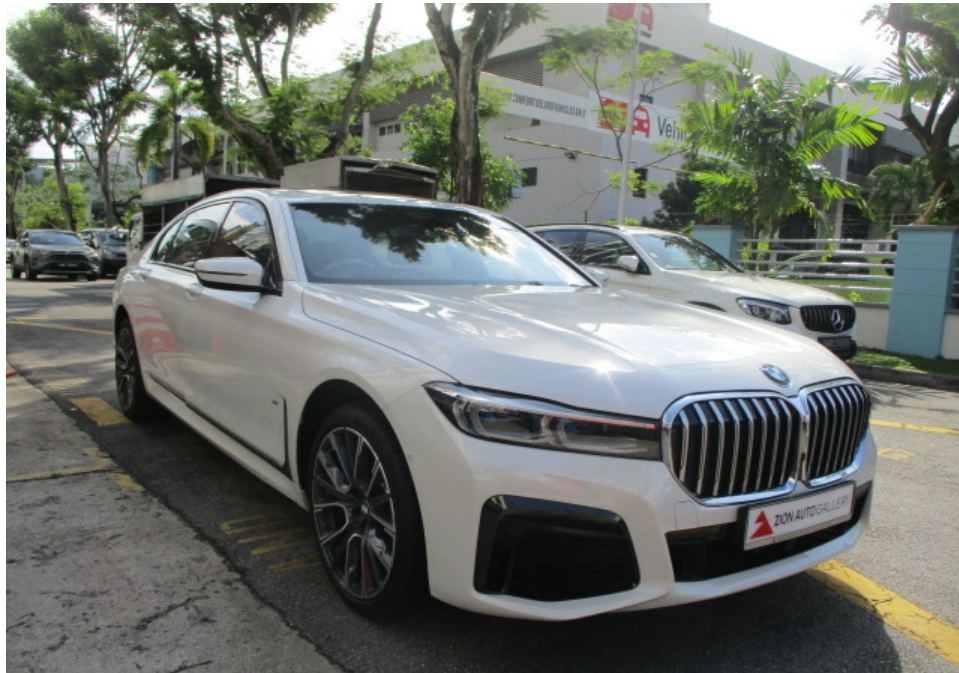
Photo 11 shows a general view of the front right body of the Motor Car at the time of my inspection. The Motor Car was observed to be in a relatively good general condition with no loose exterior fittings observed. The mileage of the Motor Car recorded at the time of my inspection was 4,107km.

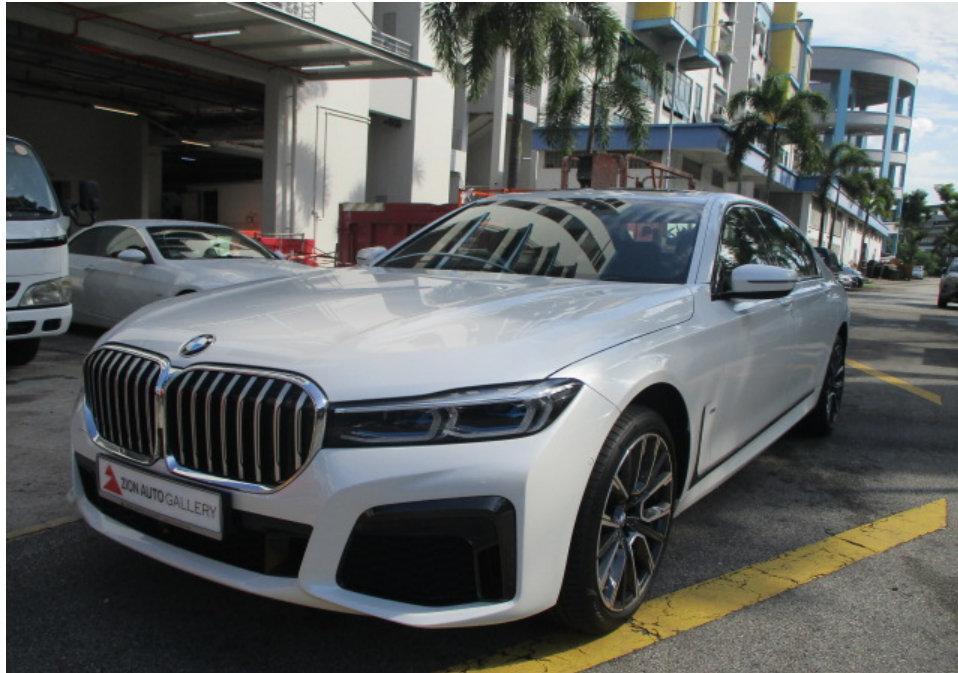
Photo 12 shows a general view of the front left body of the Motor Car at the time of my inspection. The Motor Car was observed to be in a relatively good general condition with no loose exterior fittings observed. The mileage of the Motor Car recorded at the time of my inspection was 4,107km.

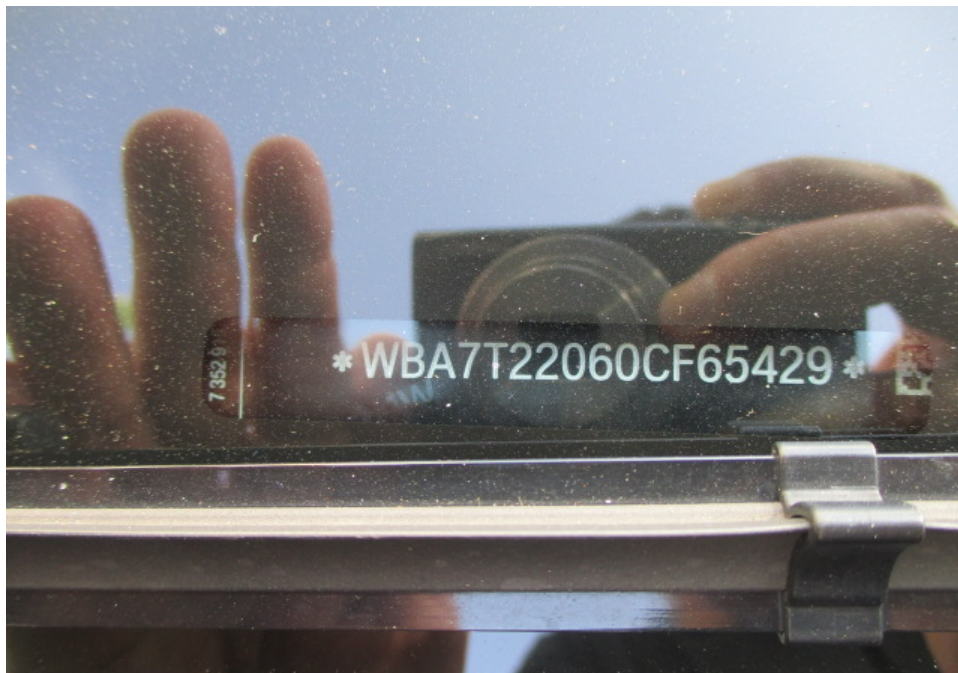
Photo 13 shows the chassis number of the Motor Car. The chassis number recorded was WBA7T22060CF65429.

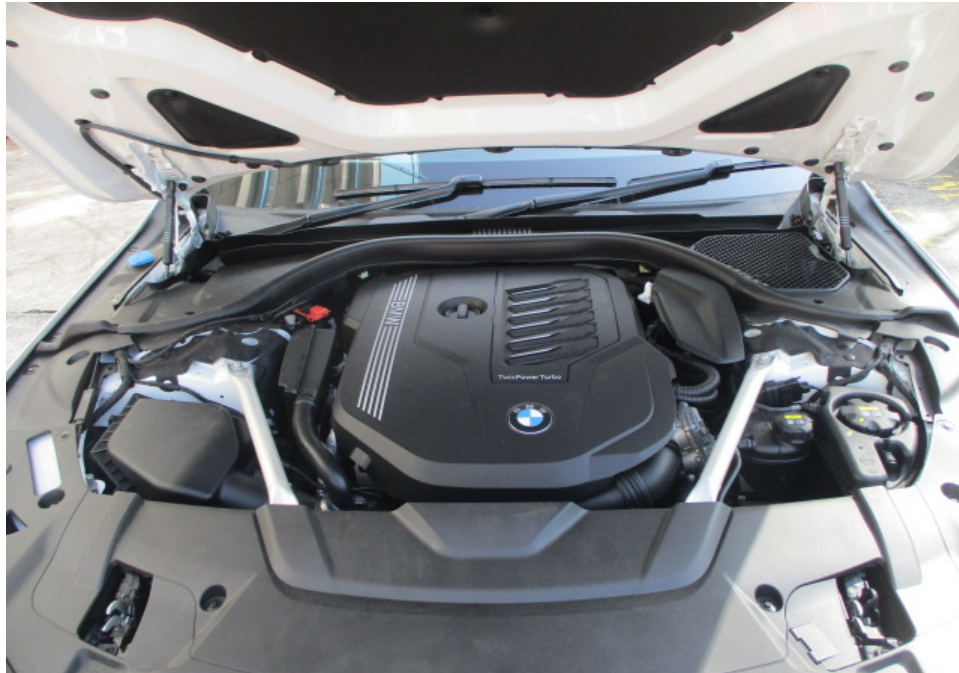
Photo 14 shows a general view of the engine compartment of the Motor Car at the time of my inspection. The various parts and components inside the engine compartment were all observed to be intact and properly fitted. There was also no sign(s) or indication(s) of fluid leak and/or fluid stain found inside the engine compartment.

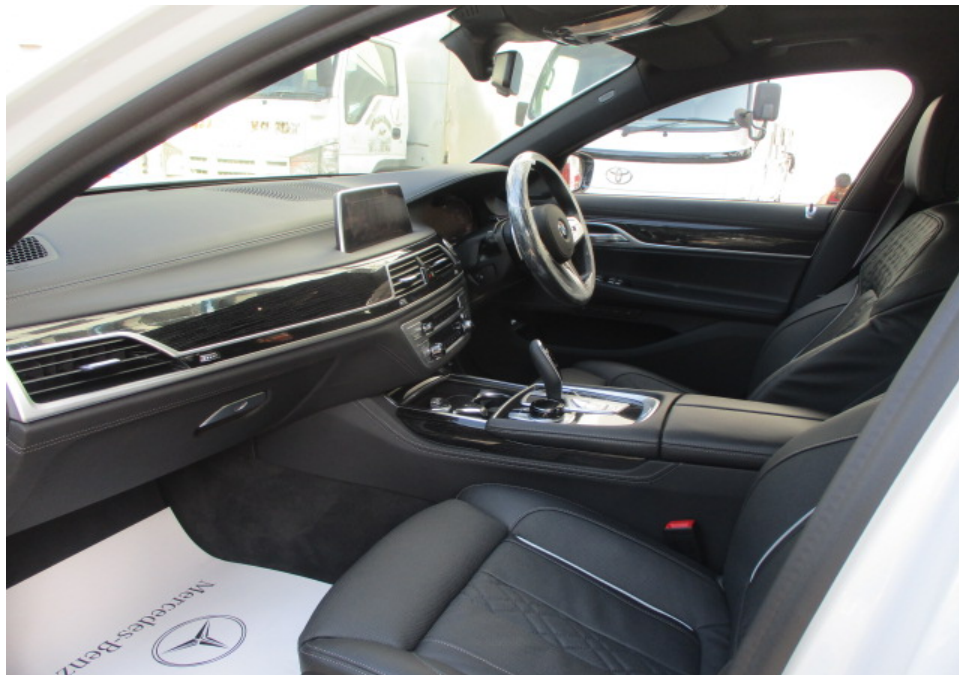
Photo 15 shows the interior compartment of the Motor Car at the time of my inspection. The various parts and components, trims, carpet, and upholstery inside the interior compartment were all observed to be intact and properly fitted.

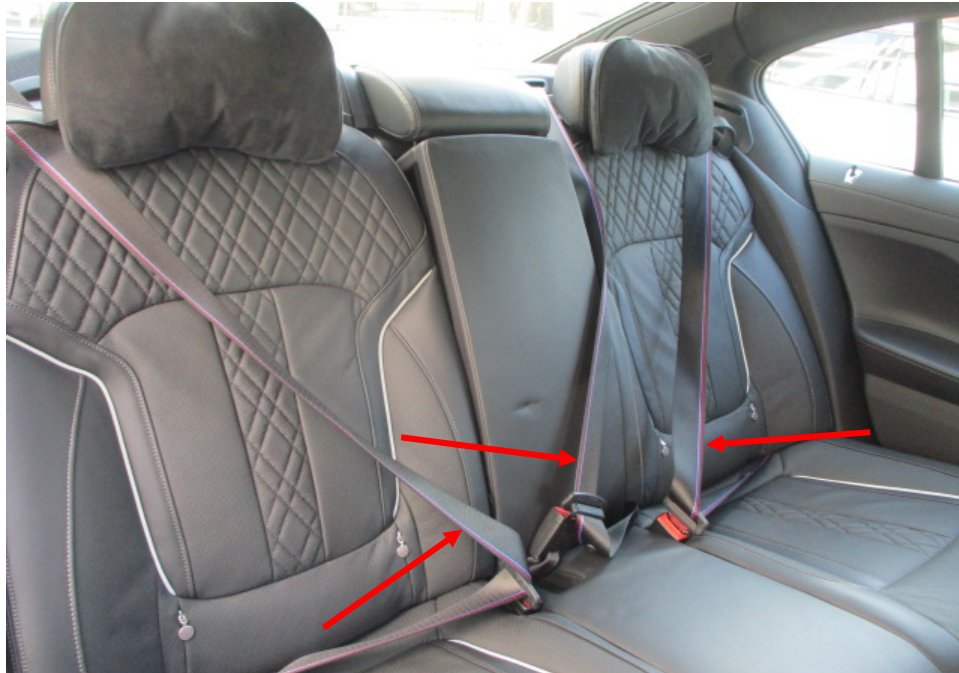
Photo 16 shows the rear seats of the Motor Car. All the seats of the Motor Car were secured via seat rails to the floorboard. They were also fitted with a retractable seat belt reel and a pre-tensioner. The seat belts (arrowed) were tested and were able to be fastened into the respective pre-tensions that were fitted on the side of each individual seat.

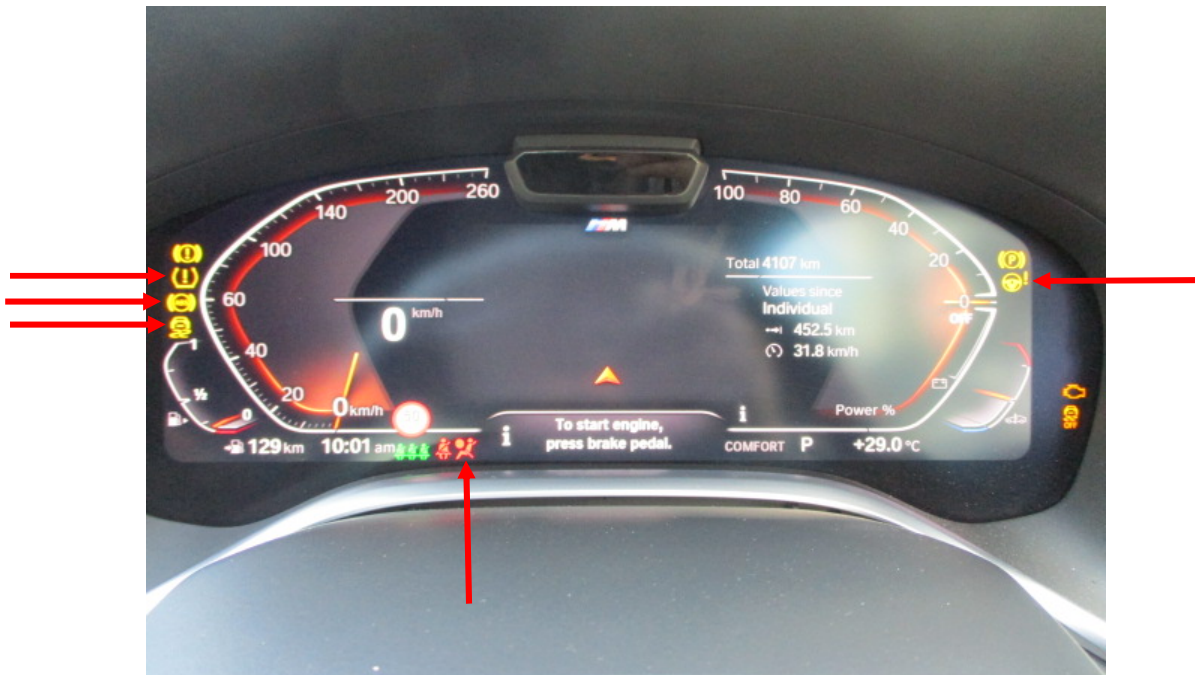
Photo 17 shows the warning lights for the various electronic safety features appearing on the instrument panel of the Motor Car during its self-test when the engine is cranked, in particular the ABS, SRS, IAS, TPM and DSC lights (arrowed).

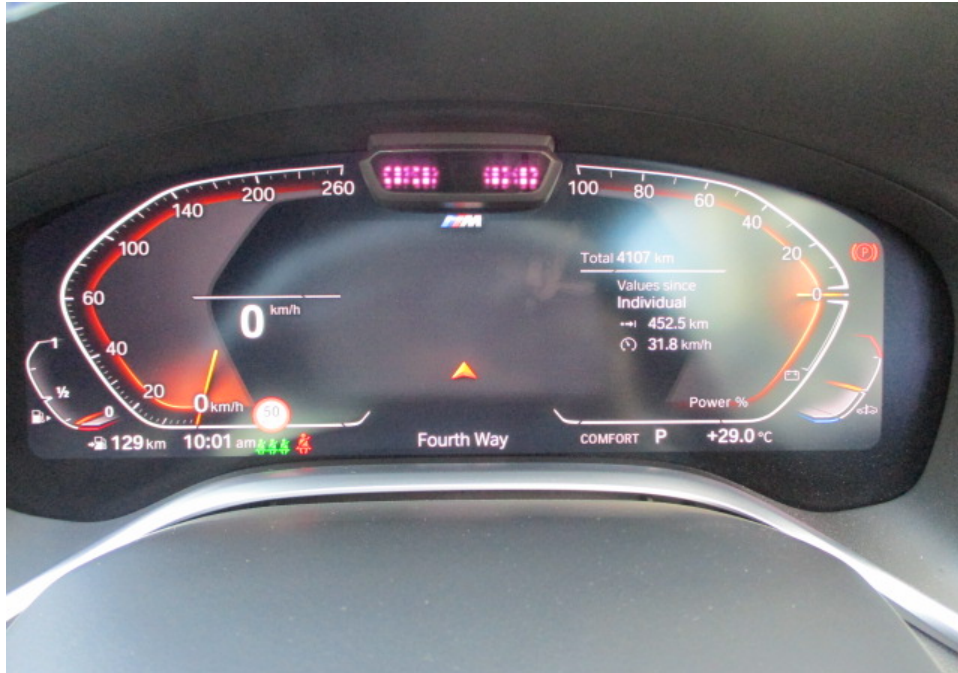
Photo 18 shows the respective warning lights no longer illuminated, indicating that there is no fault detected to the ABS, SRS, IAS, TPM and DSC systems of the Motor Car during the self-test. These electronic systems were hence in working condition at the time of my inspection.

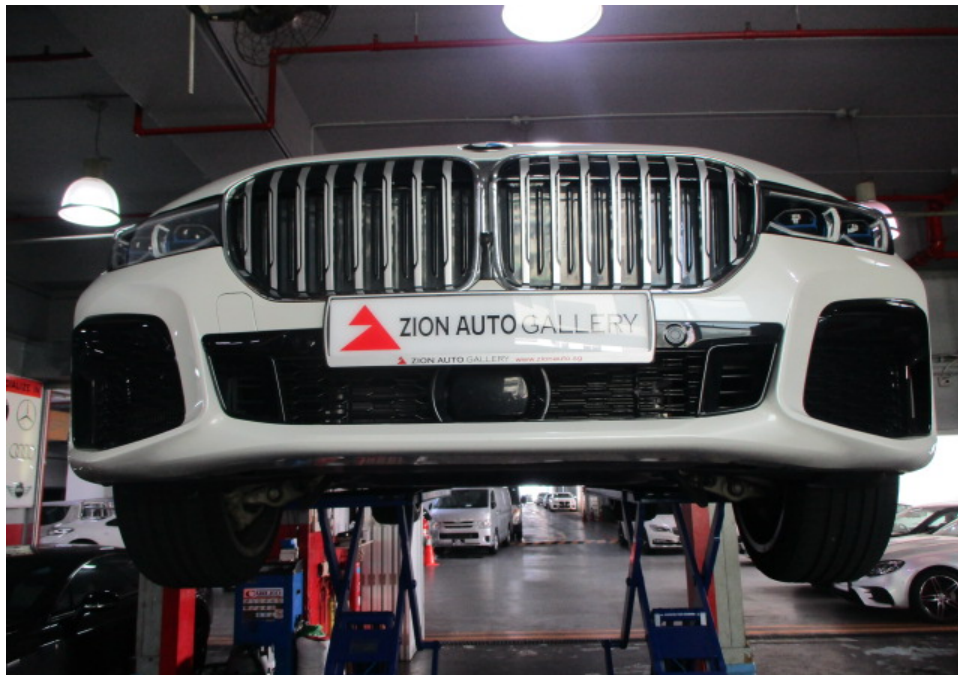
Photo 19 shows the Motor Car hoisted up for checks on its undercarriage. There was no sign(s) or indication(s) of fluid leakage and/or fluid stain(s) on the underside of the Motor Car. The undercarriage components of the Motor Car were also all observed to be intact and secured in an appropriate manner.

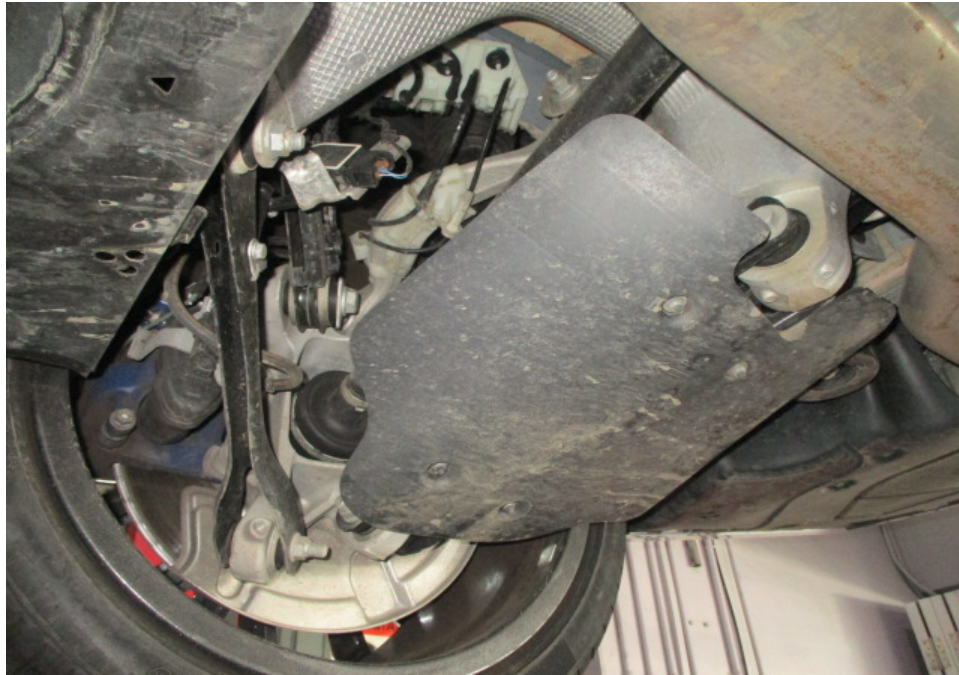
Photo 20 shows a general view of the control arms and linkages at the rear right wheel of the Motor Car. I did not observe any fluid leak and/or fluid stain on the underside of the Motor Car. All of the Motor Car's undercarriage components were observed to be intact and secured in an appropriate manner.

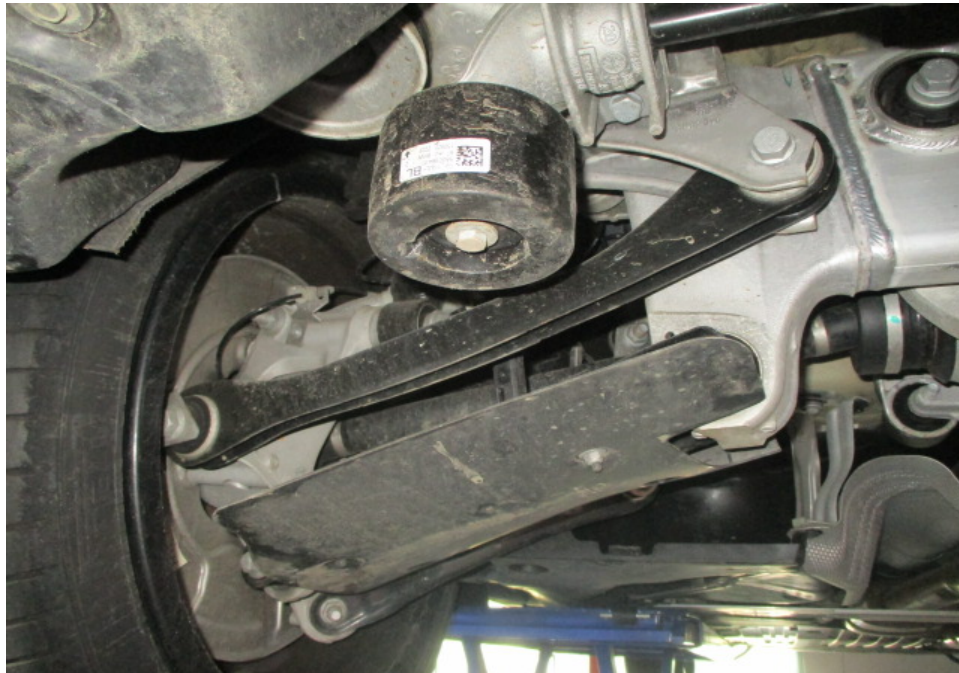
Photo 21 shows a general view of the control arms and linkages at the rear left wheel of the Motor Car. I did not observe any fluid leak and/or fluid stain on the underside of the Motor Car. All of the Motor Car's undercarriage components were observed to be intact and secured in an appropriate manner.

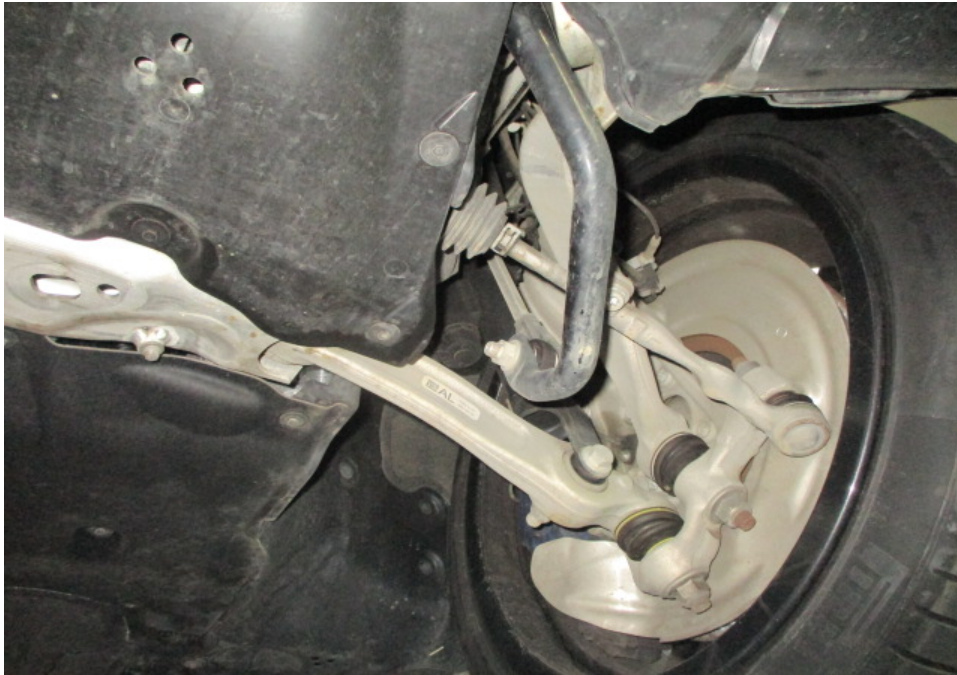
Photo 22 shows the various undercarriage components at the front left wheel of the Motor Car. The mechanical components, control arms and linkages were all found to be intact and secured in an appropriate manner.

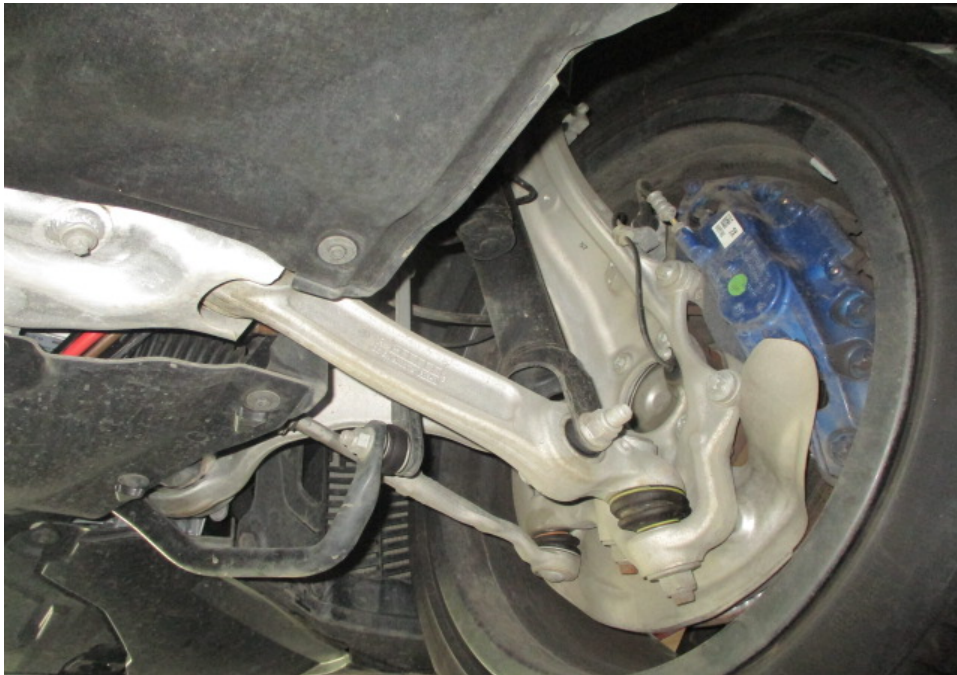
Photo 23 shows the various undercarriage components at the front right wheel of the Motor Car. The mechanical components, control arms and linkages were all found to be intact and secured in an appropriate manner. I also did not observe any fluid leak and/or fluid stain on the underside of the Motor Car.

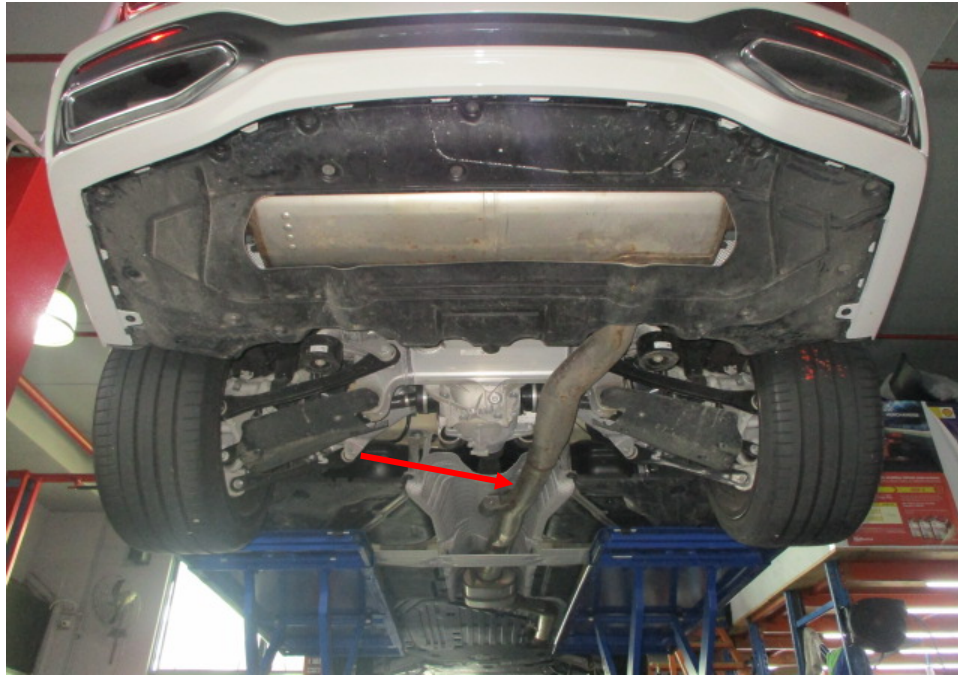
Photo 24 shows the rear section of the Motor Car's exhaust system. My examination of the Motor Car's exhaust system revealed no sign(s) or indication(s) of any cut or weld marks along its exhaust pipes (arrowed), on its rear muffler, on its centre resonator box and on its catalytic converter.

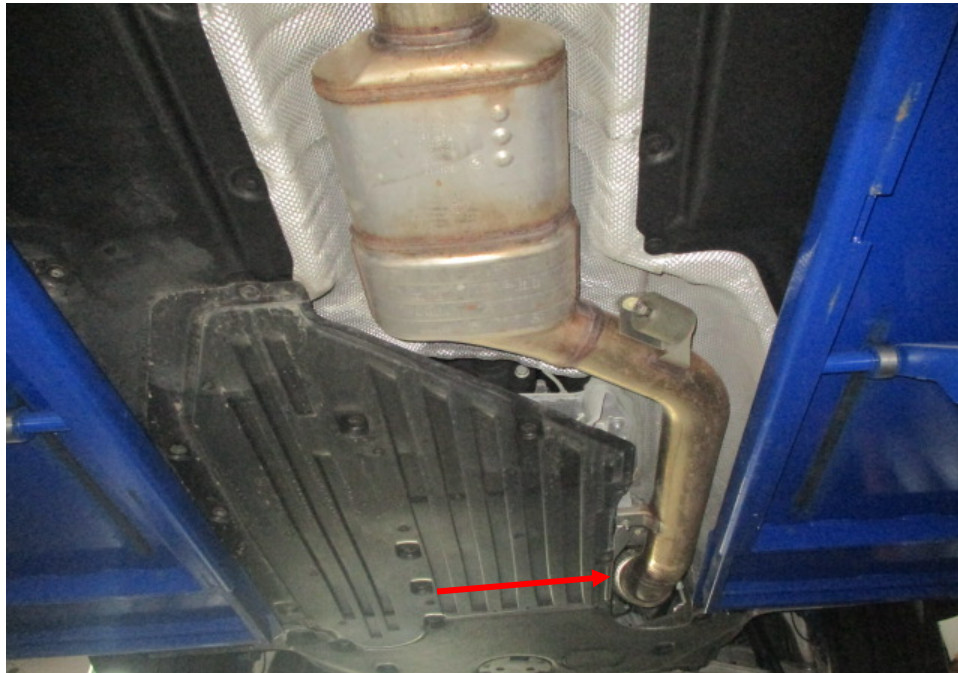
Photo 25 shows the front section of the Motor Car's exhaust system. My examination of the Motor Car's exhaust system revealed no sign(s) or indication(s) of any cut or weld marks along its exhaust pipes, on its rear muffler, on its centre resonator box and on its catalytic converter (arrowed).

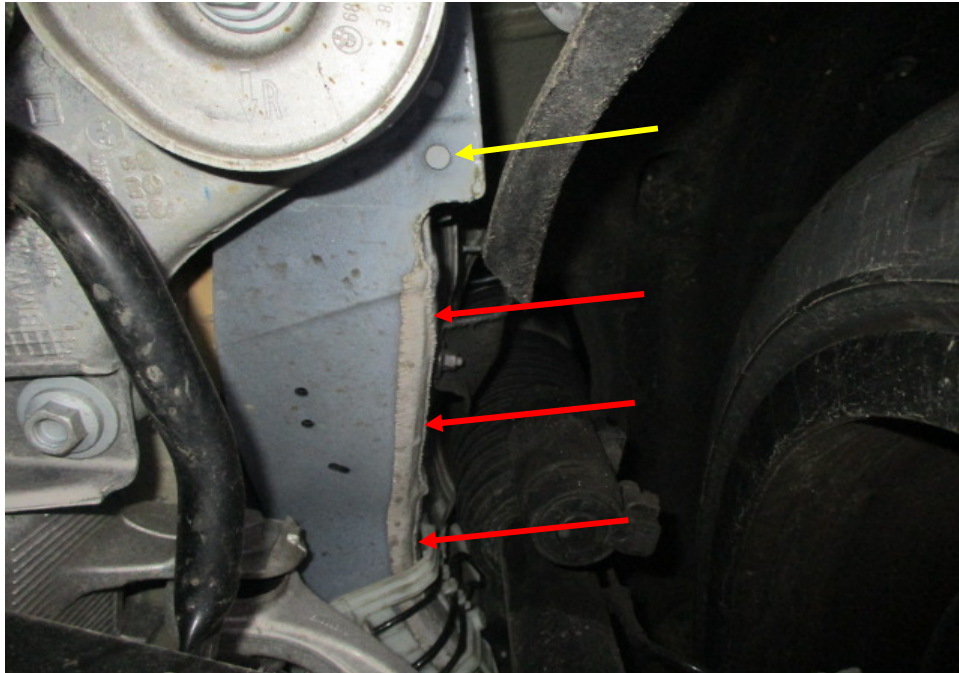
Photo 26 shows the chassis/structural body at the underside rear right of the Motor Car. I did not find any weld marks other than original spot weld marks (yellow arrow) on the chassis/structural body of the Motor Car. The original factory sealant (red arrow) at the joints along the chassis/structural body was untouched, indicating no work was done on the chassis/structural body of the Motor Car and that the chassis/structural body was originally fitted.

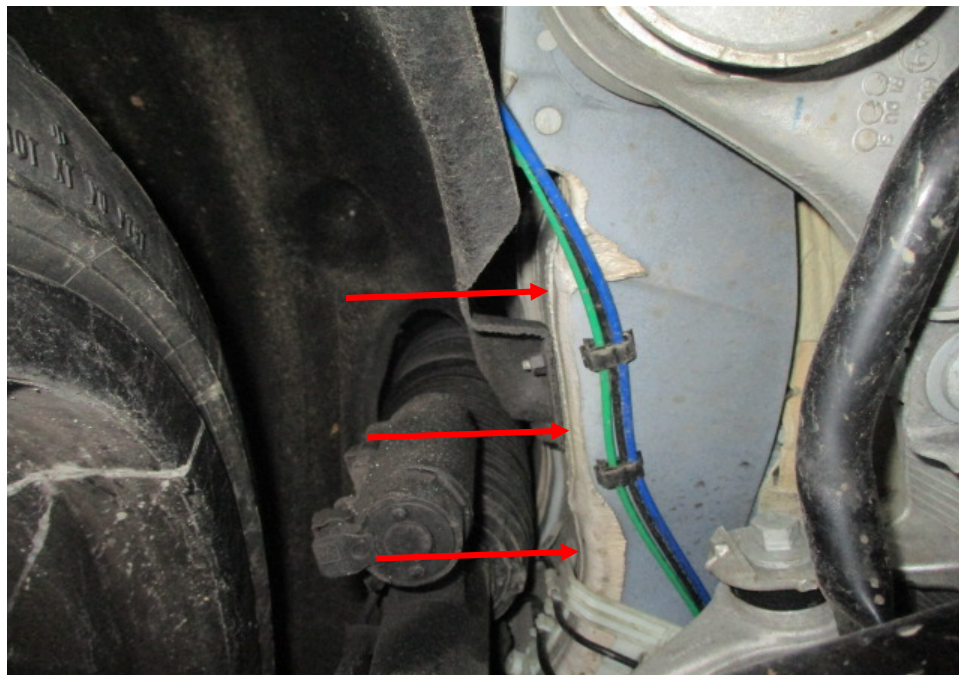
Photo 27 shows the chassis/structural body at the underside rear left of the Motor Car. The original factory sealant (arrowed) at the joints along the chassis/structural body was observed to be untouched. In general, I had found no work was carried out on the chassis/structural body of the Motor Car. The chassis/structural body of the Motor Car was originally fitted.

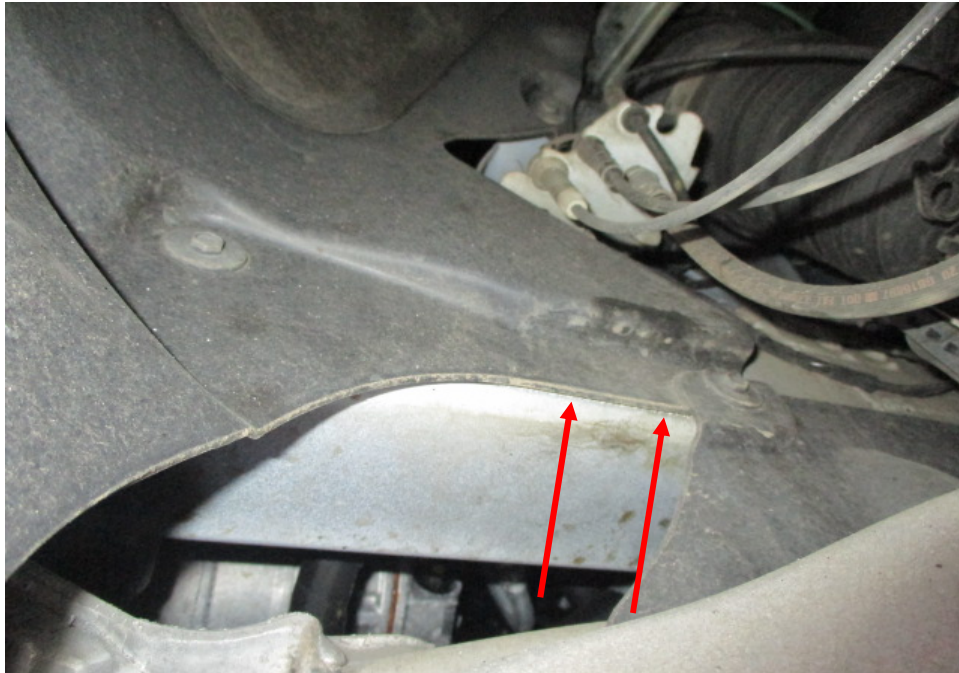
Photo 28 shows the chassis/structural body at the underside front left of the Motor Car. The original factory sealant (arrowed) at the joints along the chassis/structural body was observed to be untouched. In general, I had found no work was carried out on the chassis/structural body of the Motor Car. The chassis/structural body of the Motor Car was originally fitted.

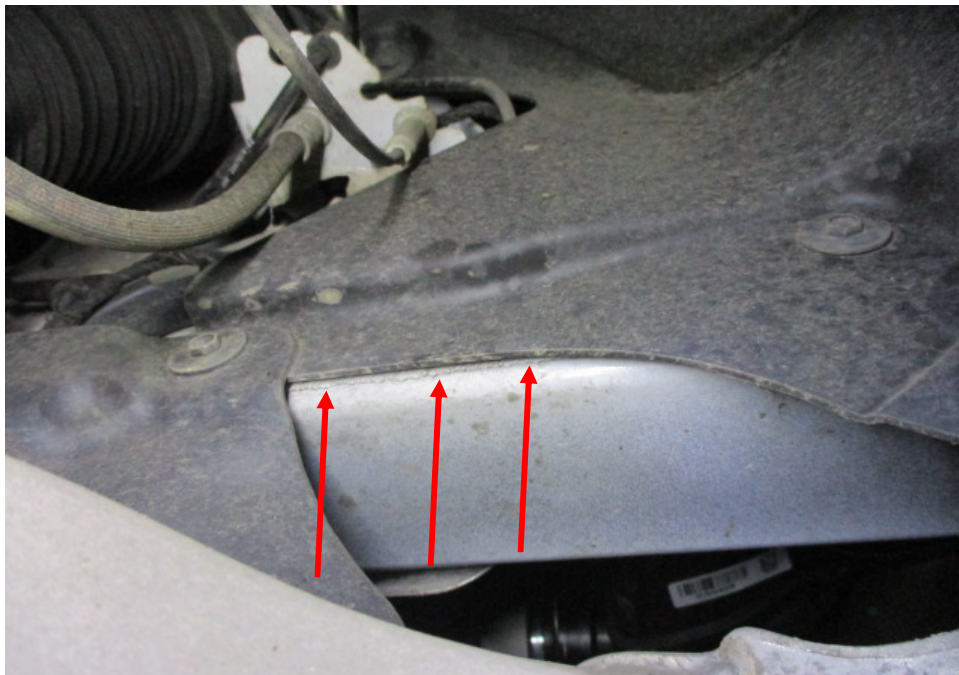
Photo 29 shows the chassis/structural body at the underside front right of the Motor Car. The original factory sealant (arrowed) at the joints along the chassis/structural body was observed to be untouched. In general, I had found no work was carried out on the chassis/structural body of the Motor Car. The chassis/structural body of the Motor Car was originally fitted.

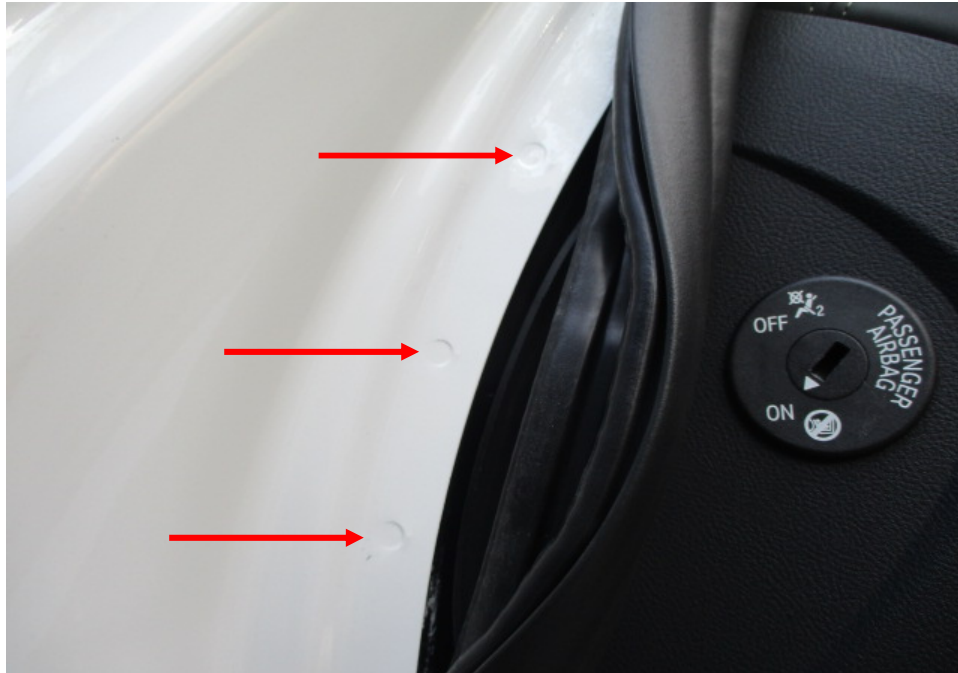
Photo 30 shows the left side “A” pillar of the Motor Car. I did not find any weld marks other than original spot weld marks (arrowed) on the left side “A” pillar of the Motor Car which, indicates that there was no re-welding works carried out. In general, I had found all the non-detachable body panels of the Motor Car to be originally fitted at the time of my inspection.
