Your Ref: BMW 740Li
(chassis number WBA7T22060CF65429)
Our Ref : CI/TP22003548/D

15 April 2022

**INSPECTION REPORT OF AN UNREGISTERED BMW 740Li MOTOR CAR
WITH CHASSIS NUMBER WBA7T22060CF65429**

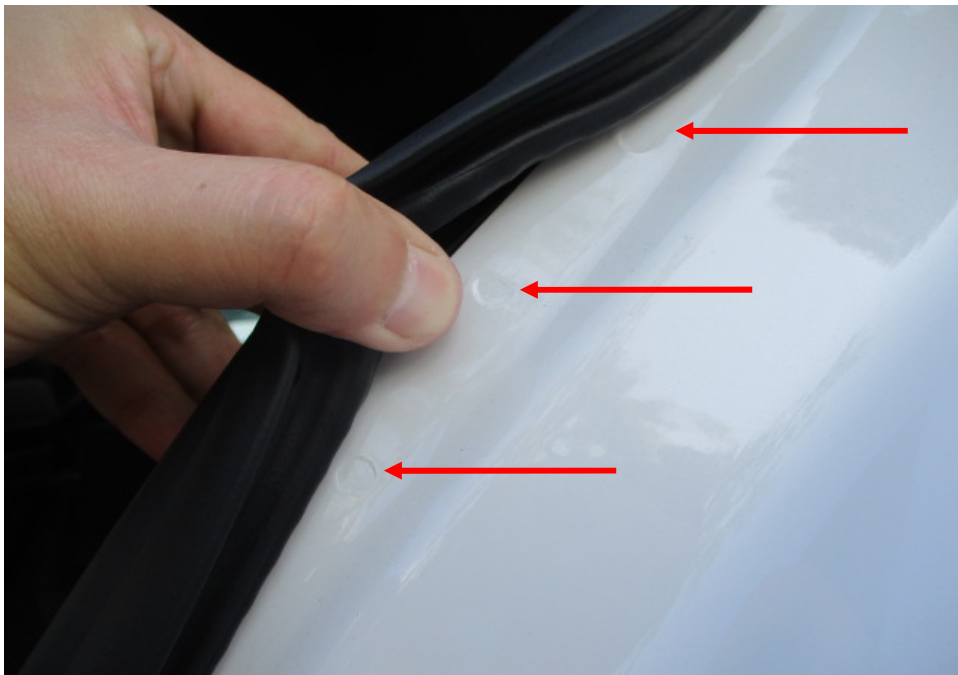
Photo 31 shows the left side “C” pillar of the Motor Car. I did not find any weld marks other than original spot weld marks (arrowed) on the left side “C” pillar of the Motor Car which, indicates that there was no re-welding works carried out. In general, I had found all the non-detachable body panels of the Motor Car to be originally fitted at the time of my inspection.

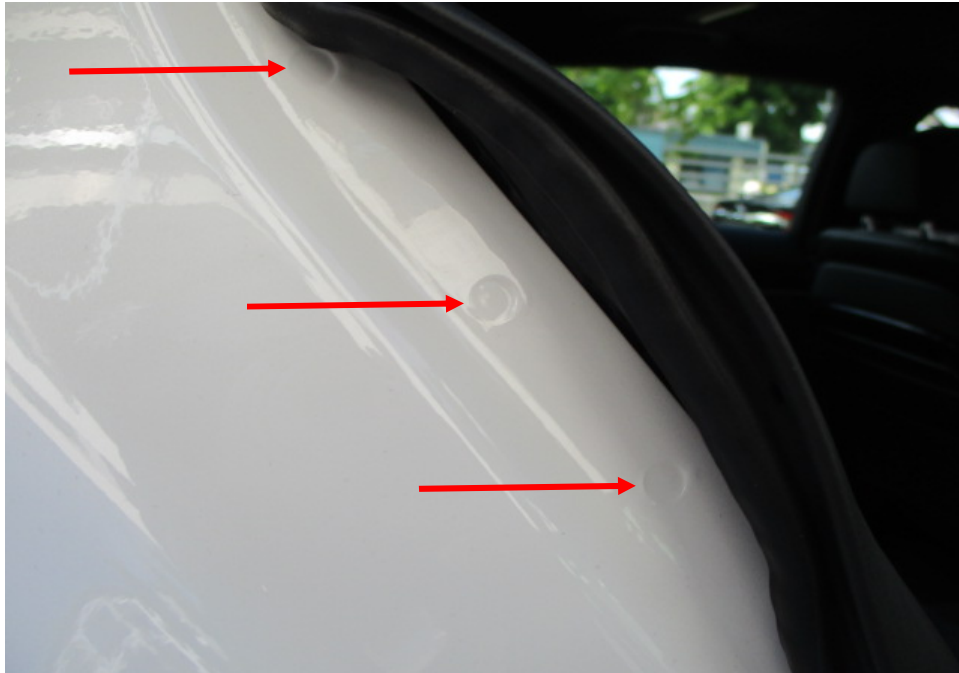
Photo 32 shows the right side "C" pillar of the Motor Car. I did not find any weld marks other than original spot weld marks (arrowed) on the right side "C" pillar of the Motor Car which, indicates that there was no re-welding works carried out. In general, I had found all the non-detachable body panels of the Motor Car to be originally fitted at the time of my inspection.
