Your Ref: Porsche 911 Carrera
(chassis number WP0ZZZ99ZLS220125)
Our Ref : CI/TP22003549/D

INSPECTION REPORT OF AN UNREGISTERED PORSCHE 911 CARRERA MOTOR CAR WITH CHASSIS NUMBER WP0ZZZ99ZLS220125

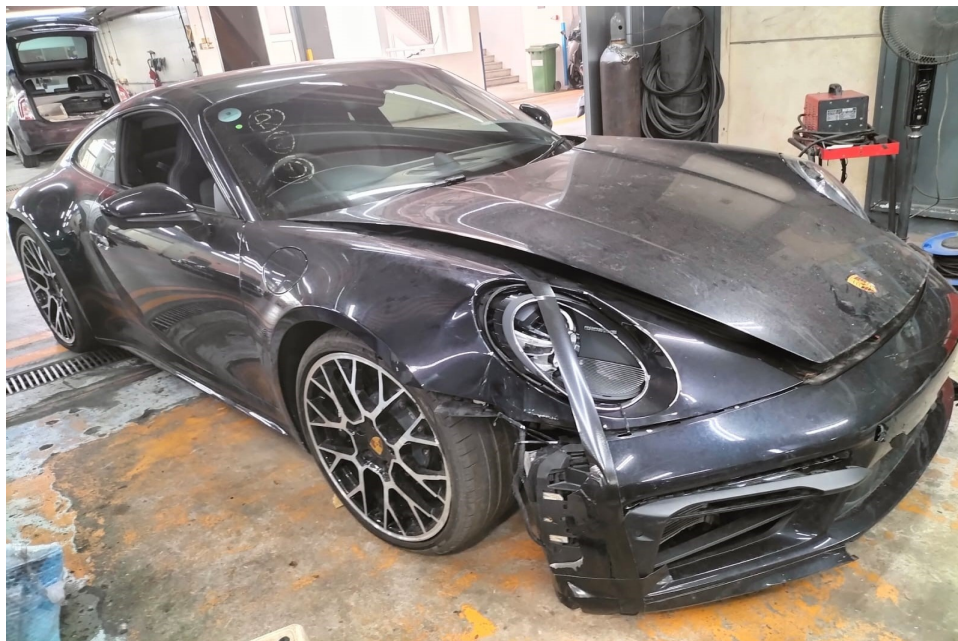
3. The photographs provided to me had showed damage to the front right portion of the Motor Car. The front bumper, front bumper lower moulding, front bumper right bracket, front bumper right lower grille, front right fender, front right fender inner shield, front right wheel rim, front right headlamp, front right radiator, right signal lamp and front bonnet were amongst the body parts that were observed to have been damaged.

Photo 1 shows the front right body of the Motor Car (photograph provided to me). The photographs provided to me had showed damage to the front right portion of the Motor Car. The front bumper, front bumper lower moulding, front bumper right bracket, front bumper right lower grille, front right fender, front right fender inner shield, front right wheel rim, front right headlamp, front right radiator, right signal lamp and front bonnet were amongst the body parts that were observed to have been damaged.

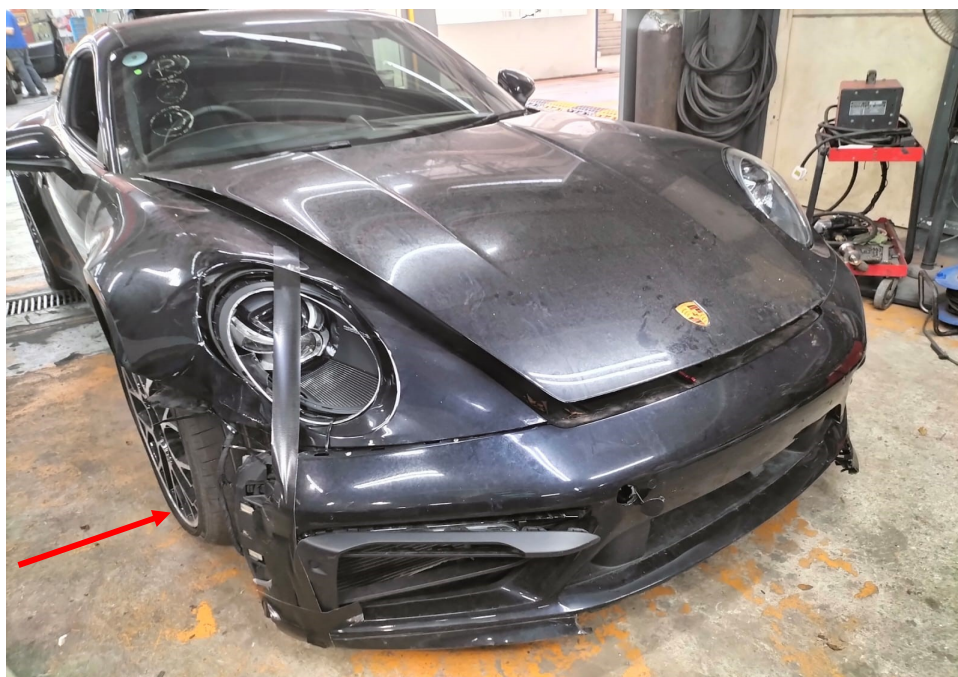
4. The orientation of the front right wheel and front left wheel suggest damage to the front right undercarriage parts of the Motor Car. The undercarriage parts that may possibly be damage include the front right lower arm, front right steering tie rod and front right shock absorber amongst others.

Photo 2 shows another view of the damage at the front right body of the Motor Car (photograph provided to me). The front right wheel (arrowed) and front left wheel (refer to photograph 3 below) were both orientated in a slightly inward direction, which suggests damage to the Motor Car's front right undercarriage parts.

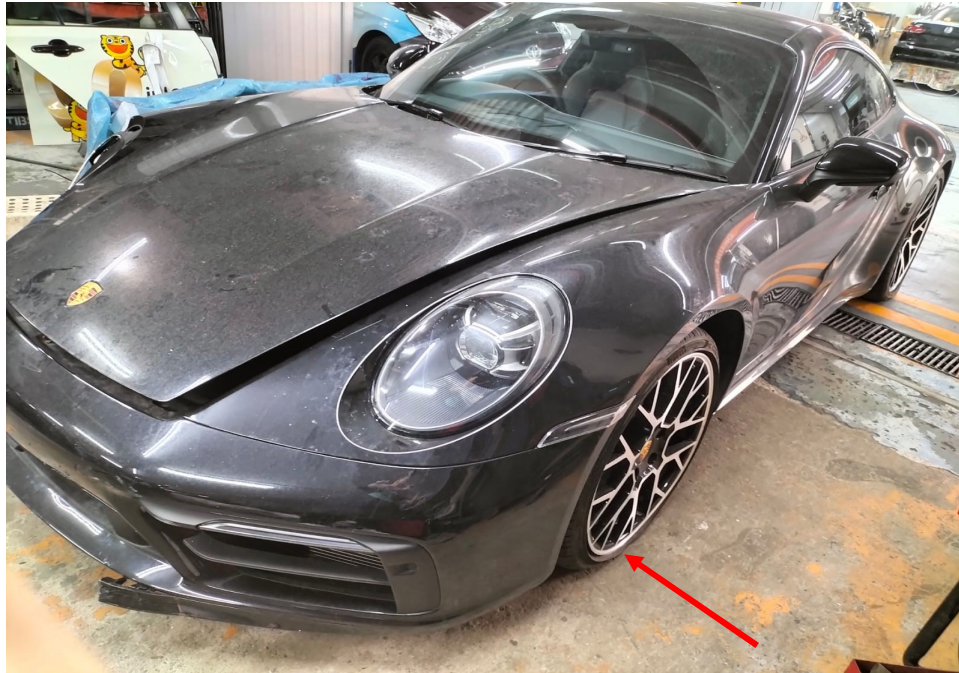
Photo 3 shows the front left body of the Motor Car (photograph provided to me). Apart for the front right portion, there was no physical damage observed to other areas of the Motor Car. The front left wheel (arrowed) and front right wheel (refer to photograph 2 above) were both orientated in a slightly inward direction, which suggests damage to the Motor Car's front right undercarriage parts.

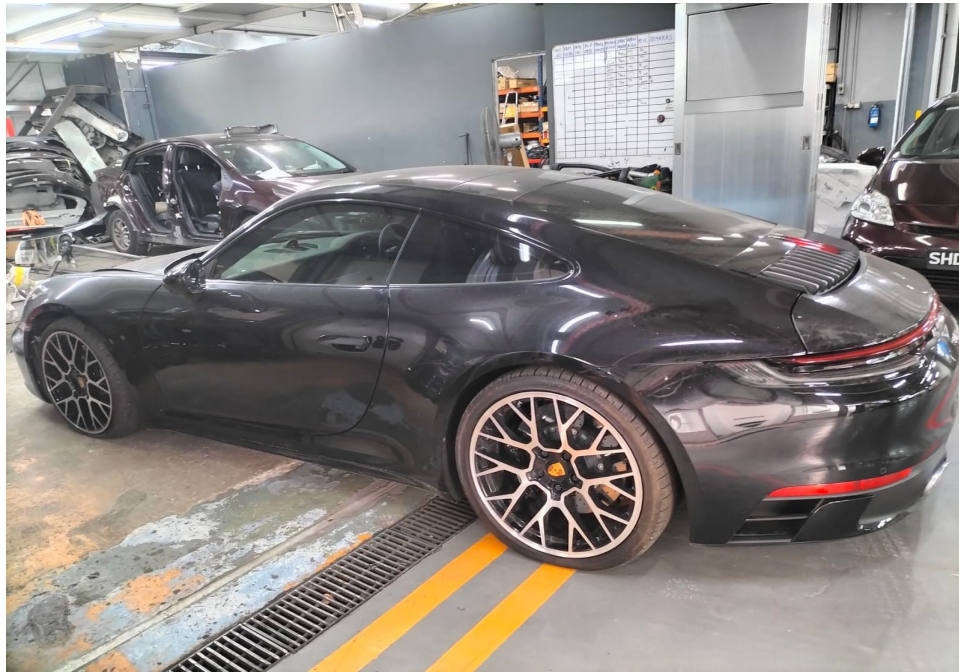
Photo 4 shows the left side body of the Motor Car (photograph provided to me). Apart for the front right portion, there was no physical damage observed to other areas of the Motor Car. The airbag(s) was not deployed as seen from the photographs that were provided to me.

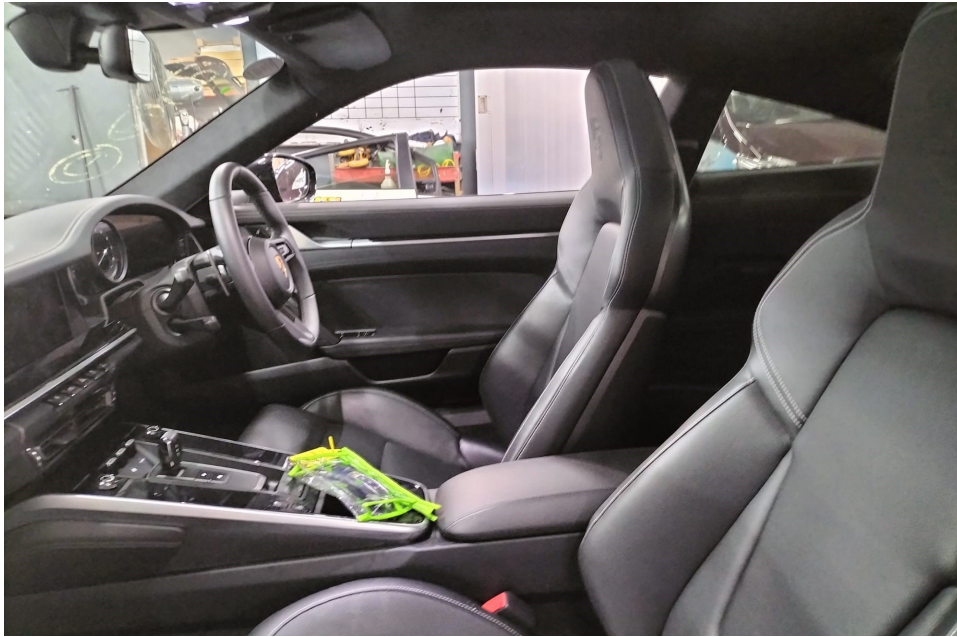
Photo 5 shows the interior compartment of the Motor Car (photograph provided to me). The various parts and components within the interior compartment were all intact and unaffected. The airbag(s) was not deployed as seen from the photographs that were provided to me.

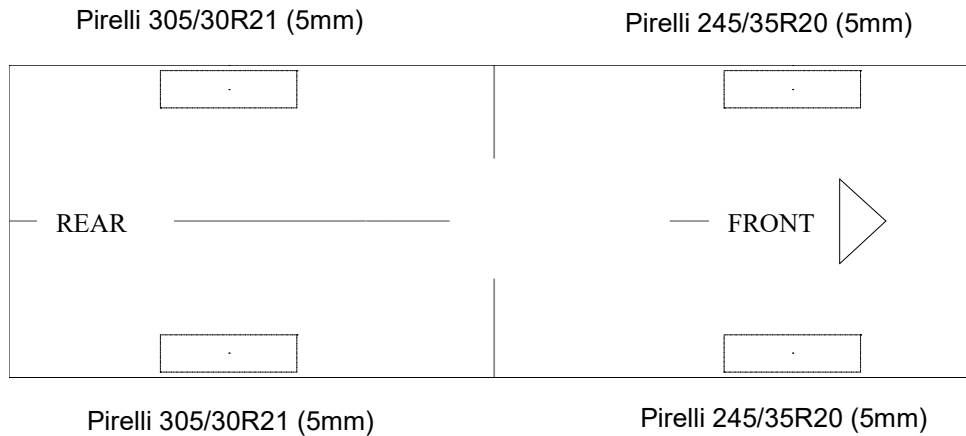
9. It was fitted with 20inch (front) and 21inch (rear) sport wheel rims that were wrapped with tyres that were observed to be of serviceable condition. The tyres were also sufficiently inflated for vehicular operation. The tyre brand, tyre size and approximate remaining tread depth of the 4 tyres of the Motor Car were recorded as follows: -

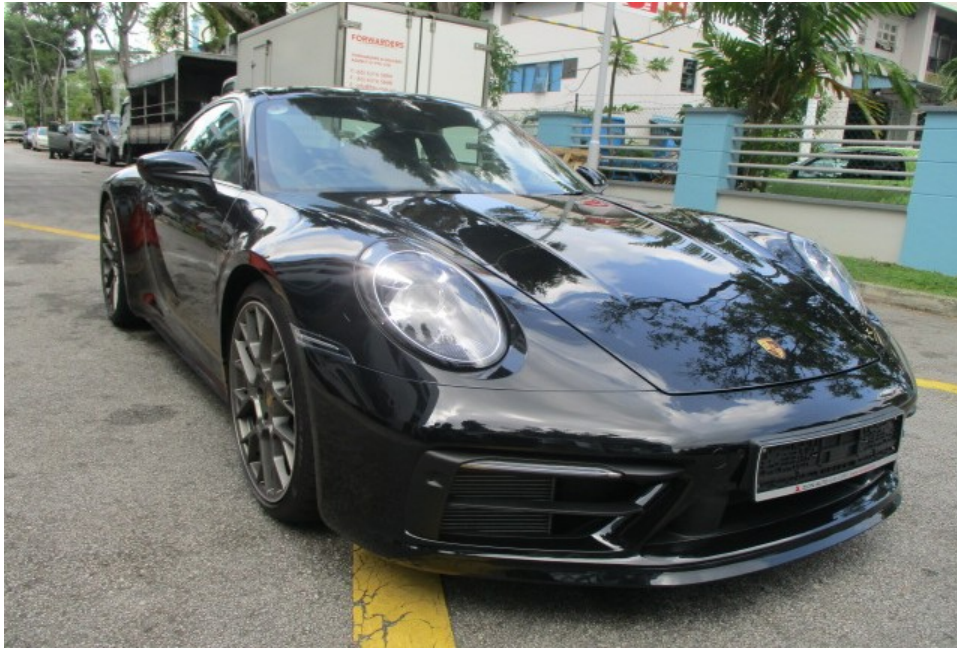
23. The body parts at the front right portion and the undercarriage parts at the front right wheel of the Motor Car were visually examined and it was noted that the repair/restoration works carried out to the damaged area of the Motor Car (refer to photograph 1 & 2 above) were reasonably adequate and in order.

Photo 6 shows a general view of the front right body of the Motor Car at the time of my inspection. The Motor Car was observed to be in a relatively good general condition with no loose exterior fittings observed. The body parts at the front right portion of the Motor Car were visually examined and it was observed that the repair/restoration works carried out to the damaged area of the Motor Car (refer to photograph 1 & 2 above) were reasonably adequate and in order.

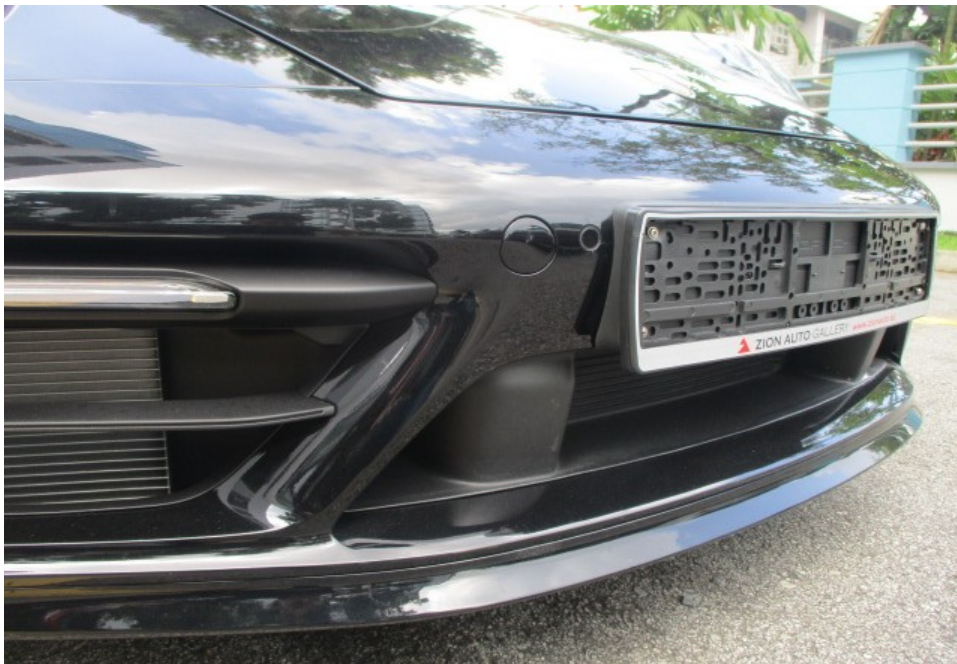
Photo 7 shows a closer view of the Motor Car's front bumper, front bumper lower moulding and front bumper tow hook cover at the time of my inspection. The body parts at the front right portion of the Motor Car were visually examined and it was observed that the repair/restoration works carried out to the damaged area of the Motor Car (refer to photograph 1 & 2 above) were reasonably adequate and in order.

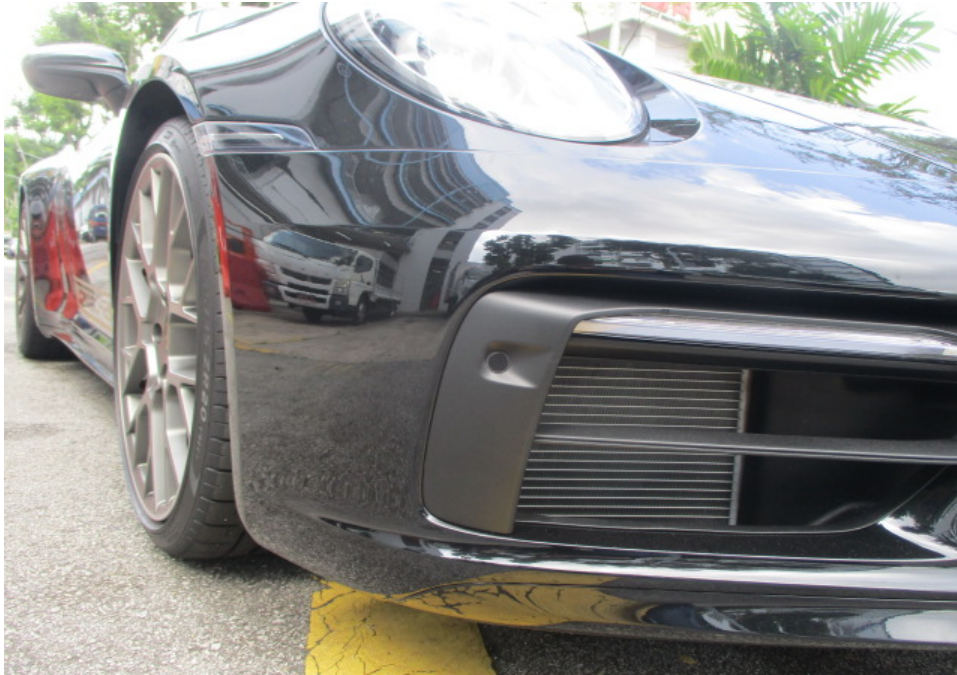
Photo 8 shows a closer view of the Motor Car's front bumper, front bumper right sensor, front bumper right lower grille, front right day light and front right radiator at the time of my inspection. The body parts at the front right portion of the Motor Car were visually examined and it was observed that the repair/restoration works carried out to the damaged area of the Motor Car (refer to photograph 1 & 2 above) were reasonably adequate and in order.

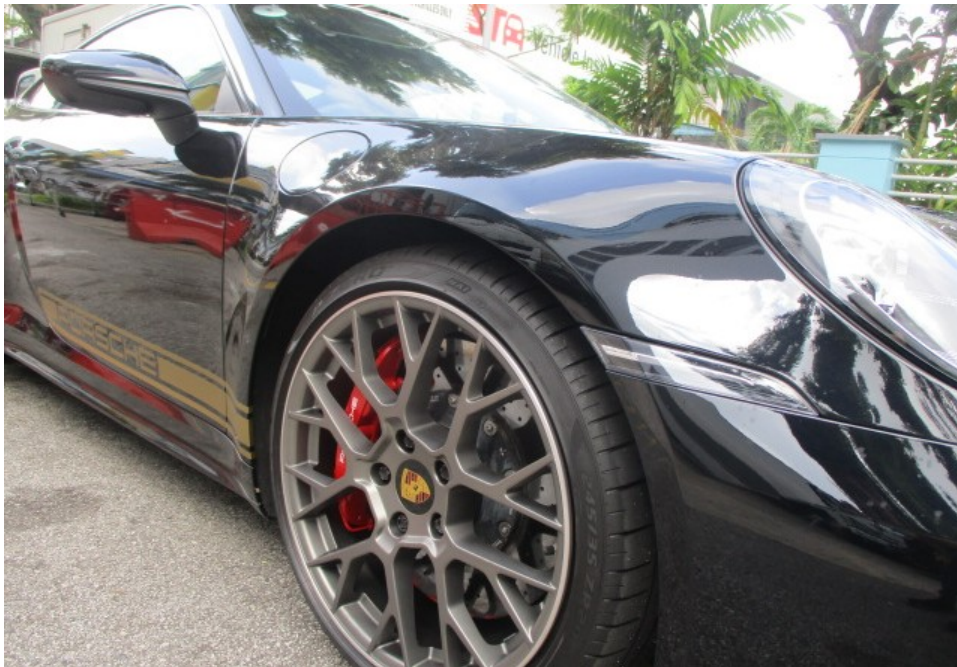
Photo 9 shows a closer view of the Motor Car's front right wheel rim, front right fender and right signal lamp at the time of my inspection. The body parts at the front right portion of the Motor Car were visually examined and it was observed that the repair/restoration works carried out to the damaged area of the Motor Car (refer to photograph 1 & 2 above) were reasonably adequate and in order.

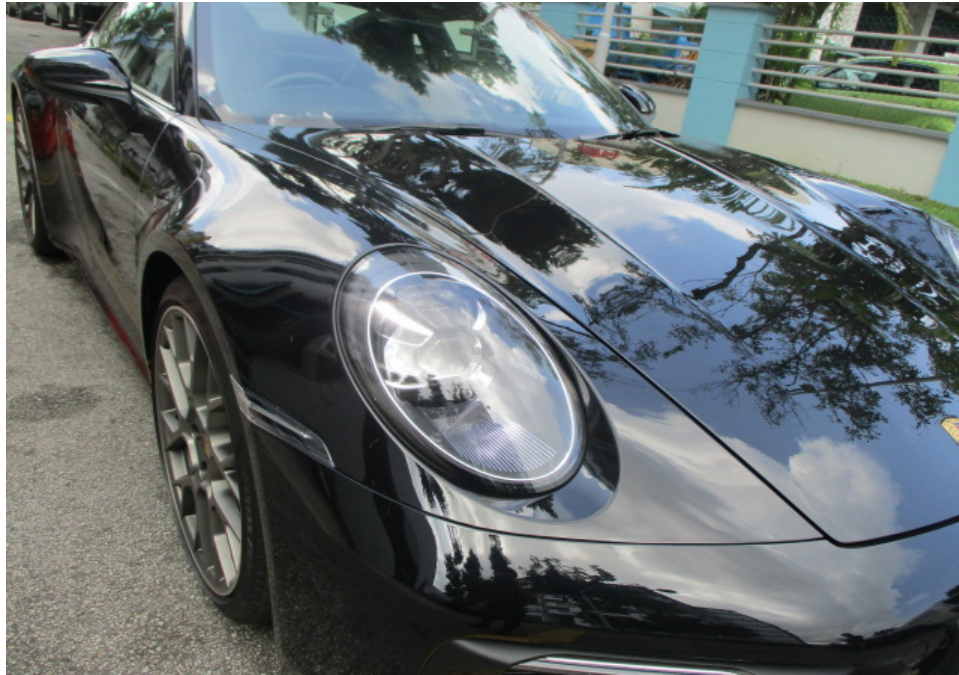
Photo 10 shows a closer view of the Motor Car's front right headlamp, front right fender and front bonnet at the time of my inspection. The body parts at the front right portion of the Motor Car were visually examined and it was observed that the repair/restoration works carried out to the damaged area of the Motor Car (refer to photograph 1 & 2 above) were reasonably adequate and in order.

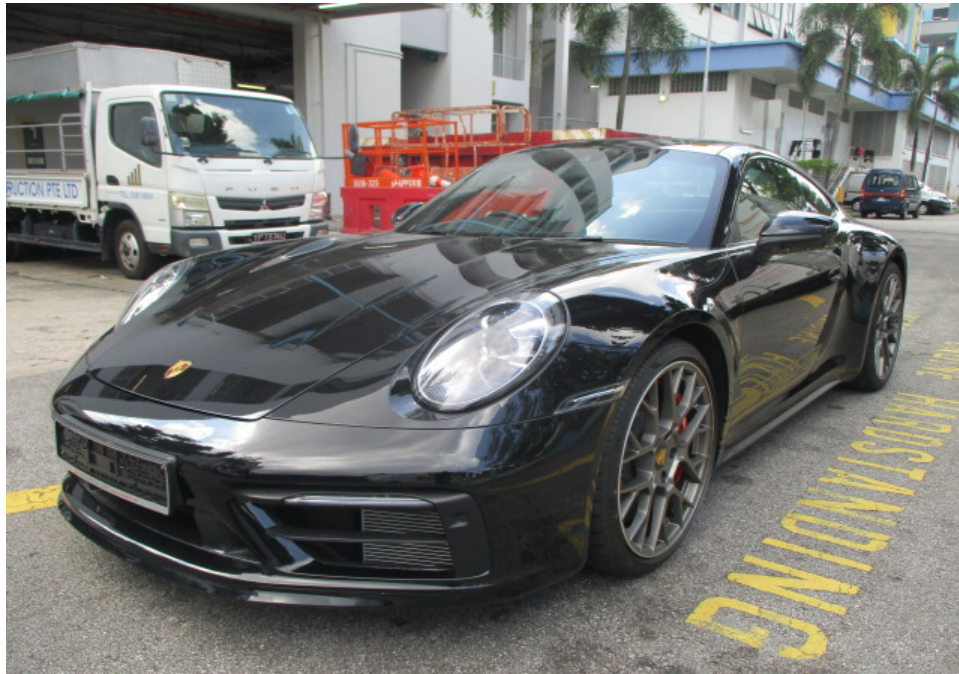
Photo 11 shows a general view of the front left body of the Motor Car at the time of my inspection. The Motor Car was observed to be in a relatively good general condition with no loose exterior fittings observed. The mileage of the Motor Car recorded at the time of my inspection was 17,290km.

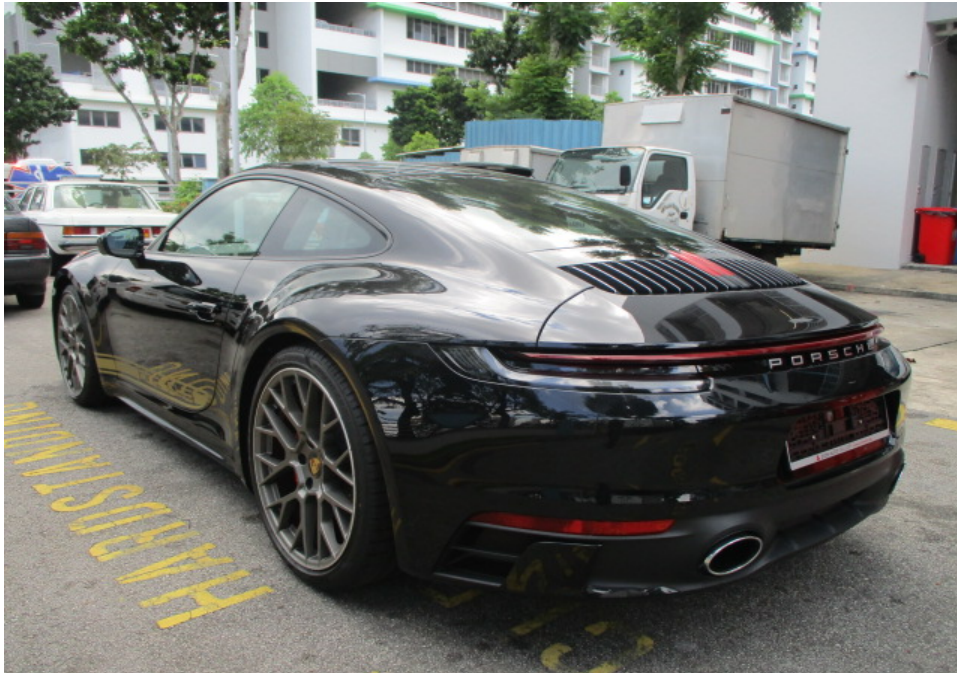
Photo 12 shows a general view of the rear left body of the Motor Car at the time of my inspection. The Motor Car was observed to be in a relatively good general condition with no loose exterior fittings observed. The mileage of the Motor Car recorded at the time of my inspection was 17,290km.

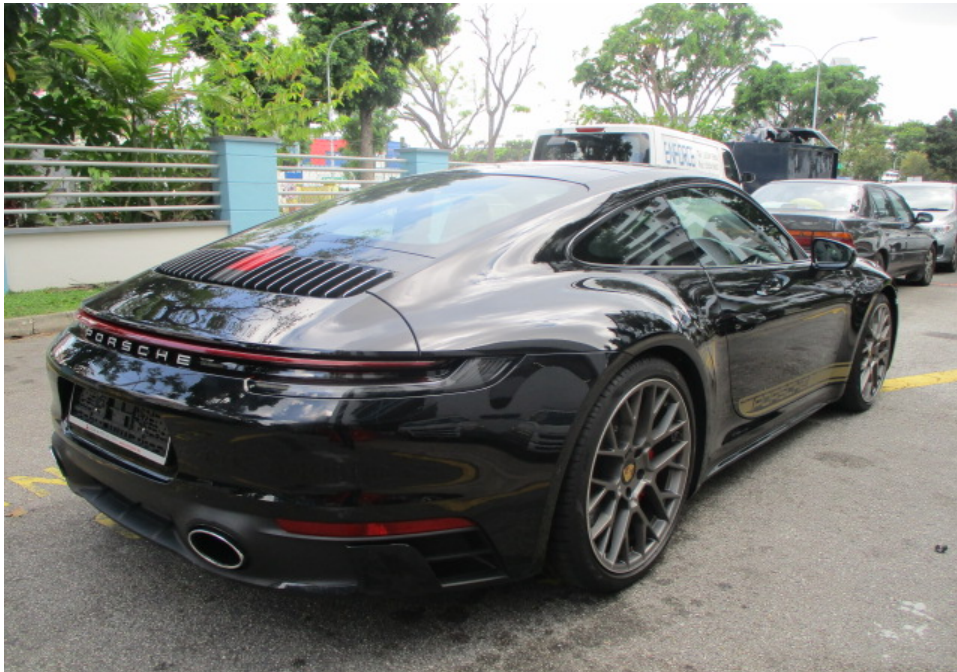
Photo 13 shows a general view of the rear right body of the Motor Car at the time of my inspection. The Motor Car was observed to be in a relatively good general condition with no loose exterior fittings observed. The mileage of the Motor Car recorded at the time of my inspection was 17,290km.

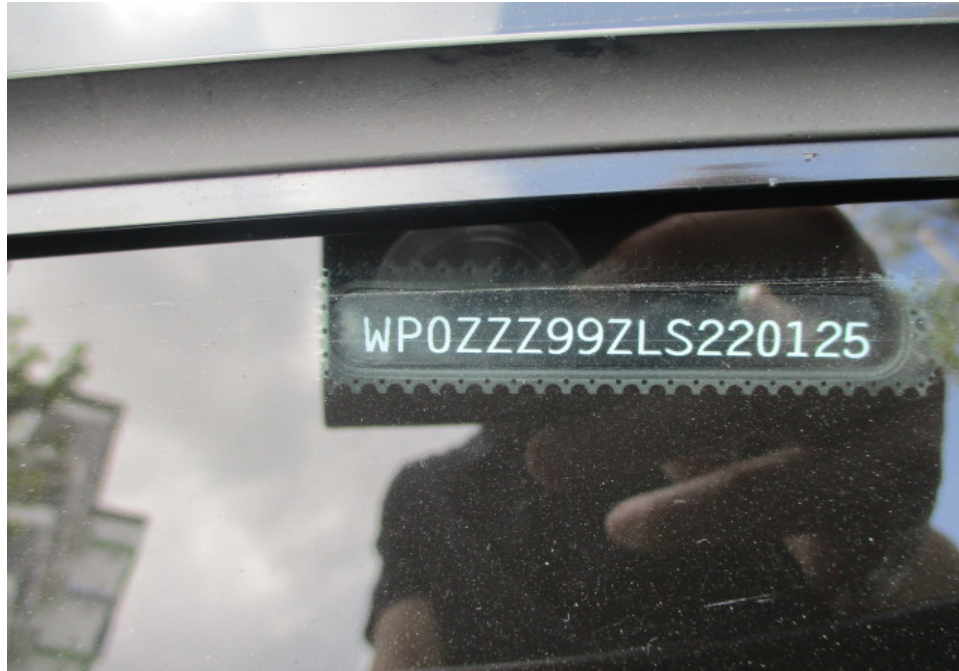
Photo 14 shows the chassis number of the Motor Car. The chassis number recorded was WP0ZZZ99ZLS220125.

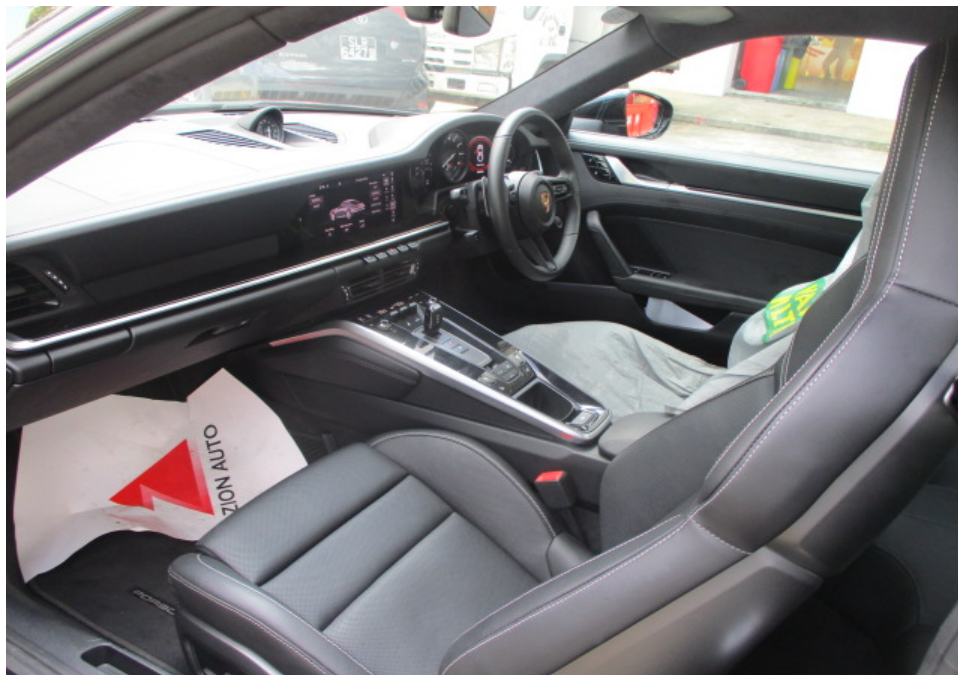
Photo 15 shows the interior compartment of the Motor Car at the time of my inspection. The various parts and components, trims, carpet, and upholstery inside the interior compartment were all observed to be intact and properly fitted.

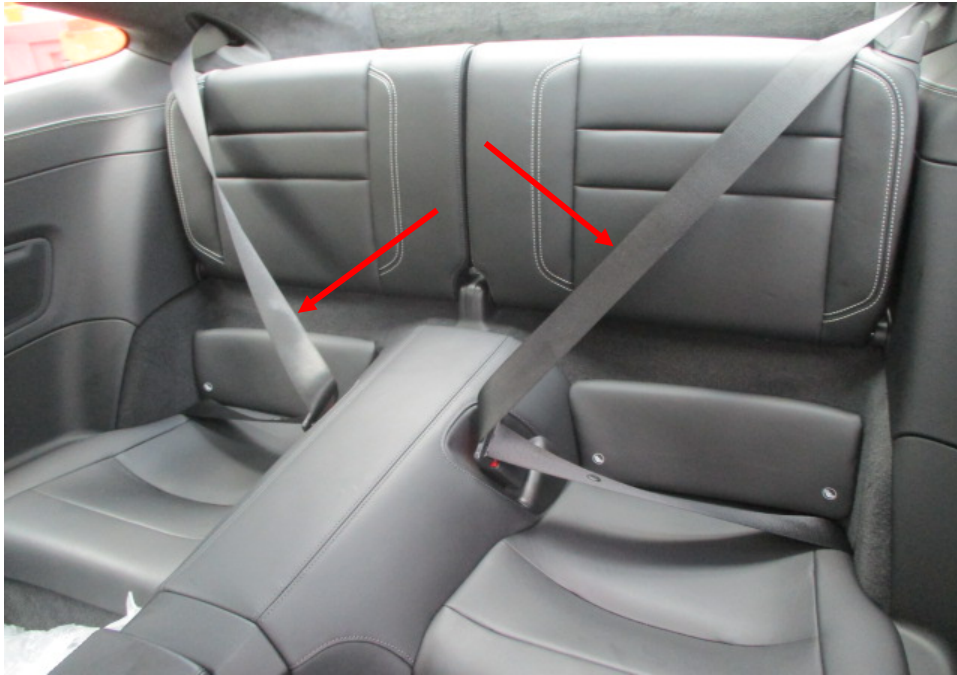
Photo 16 shows the rear seats of the Motor Car. All the seats of the Motor Car were secured via seat rails to the floorboard. They were also fitted with a retractable seat belt reel and a pre-tensioner. The seat belts (arrowed) were tested and were able to be fastened into the respective pre-tensions that were fitted on the side of each individual seat.

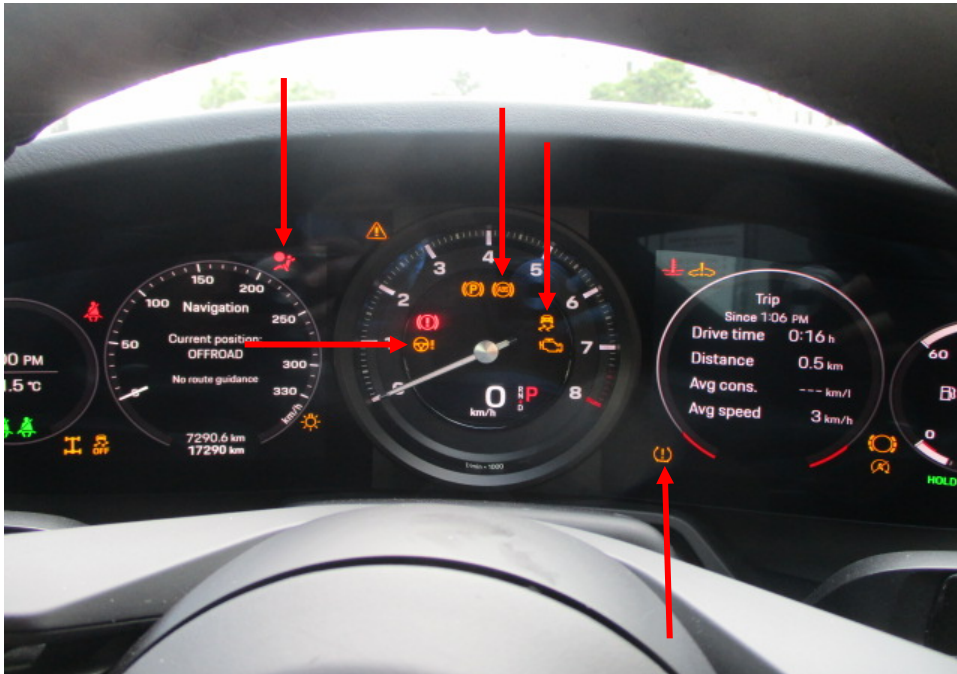
Photo 17 shows the warning lights for the various electronic safety features appearing on the instrument panel of the Motor Car during its self-test when the engine is cranked, in particular the ABS, SRS, EPS, TPM and TCS lights (arrowed).

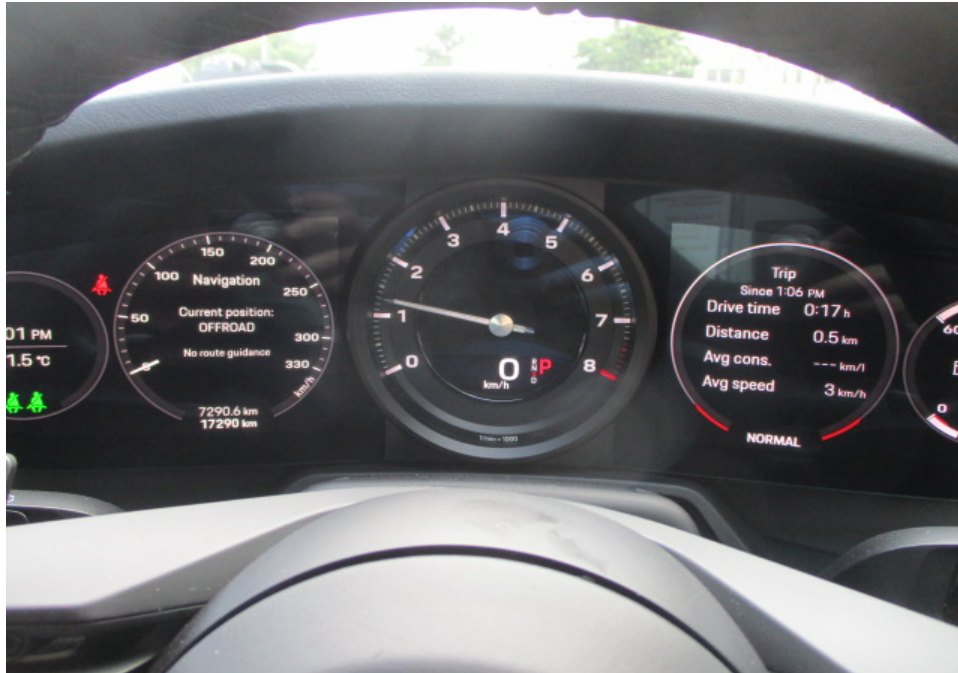
Photo 18 shows the respective warning lights no longer illuminated, indicating that there is no fault detected to the ABS, SRS, EPS, TPM and TCS systems of the Motor Car during the self-test. These electronic systems were hence in working condition at the time of my inspection.

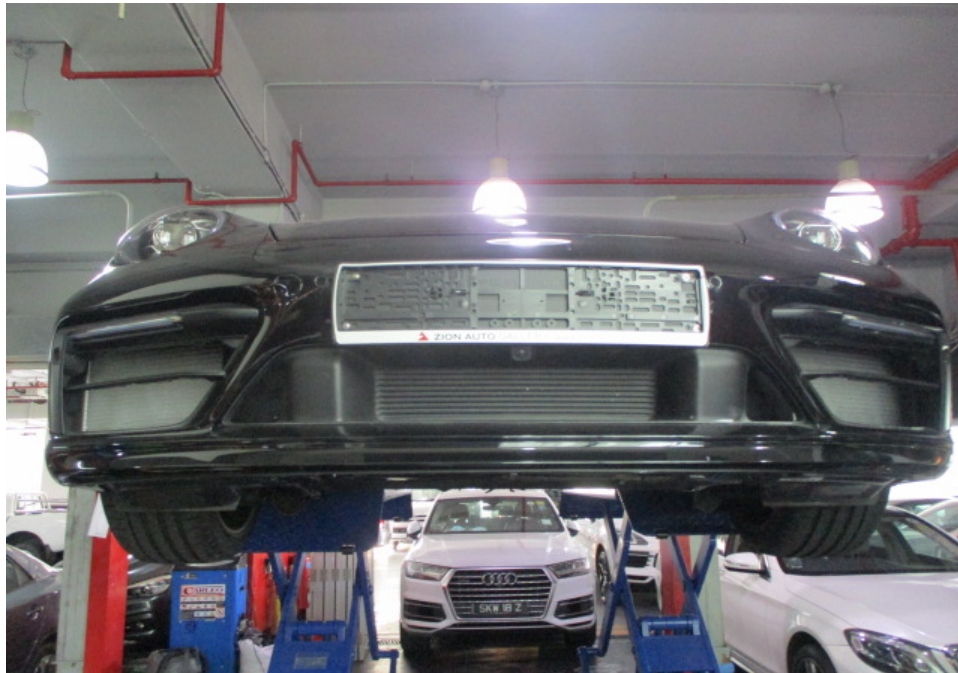
Photo 19 shows the Motor Car hoisted up for checks on its undercarriage. There was no sign(s) or indication(s) of fluid leakage and/or fluid stain(s) on the underside of the Motor Car. The undercarriage components of the Motor Car were also all observed to be intact and secured in an appropriate manner.

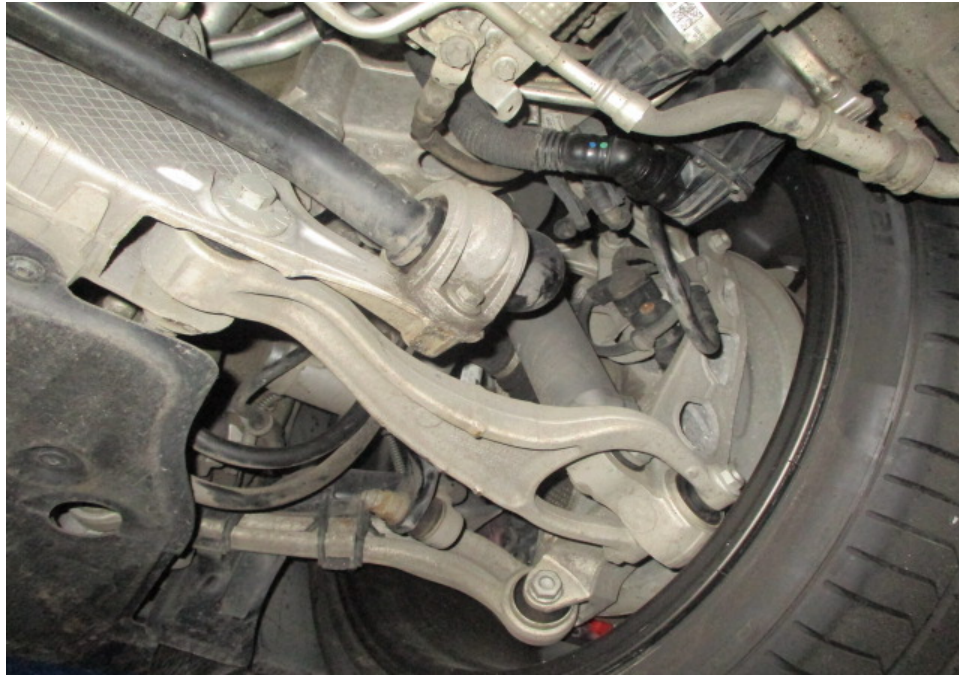
Photo 20 shows a general view of the control arms and linkages at the rear right wheel of the Motor Car. I did not observe any fluid leak and/or fluid stain on the underside of the Motor Car. All of the Motor Car's undercarriage components were observed to be intact and secured in an appropriate manner.

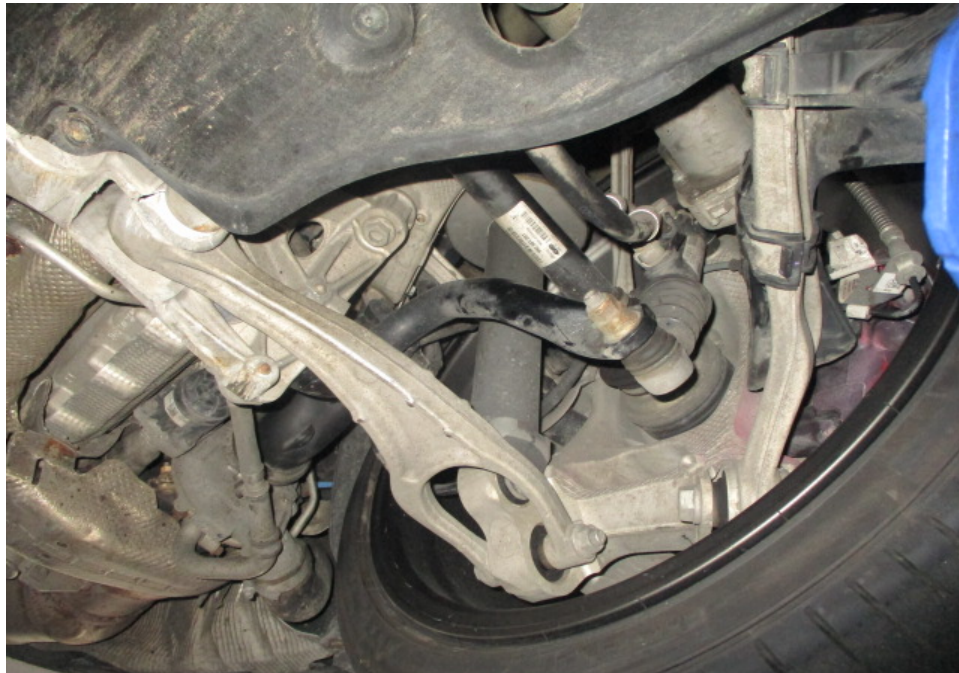
Photo 21 shows a general view of the control arms and linkages at the rear left wheel of the Motor Car. I did not observe any fluid leak and/or fluid stain on the underside of the Motor Car. All of the Motor Car's undercarriage components were observed to be intact and secured in an appropriate manner.

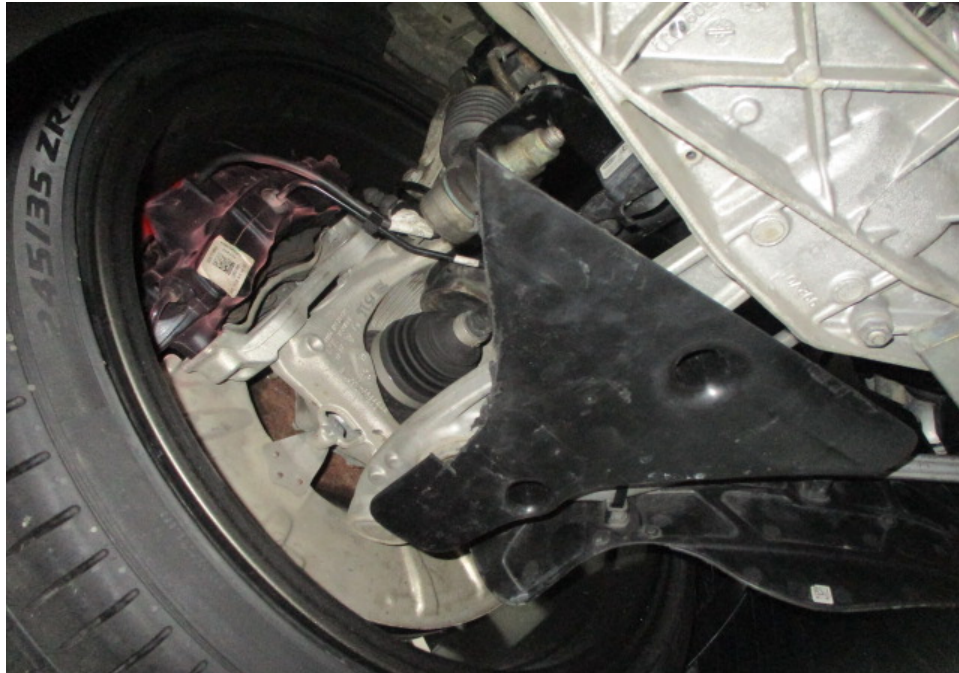
Photo 22 shows the various undercarriage components at the front left wheel of the Motor Car. The mechanical components, control arms and linkages were all found to be intact and secured in an appropriate manner.

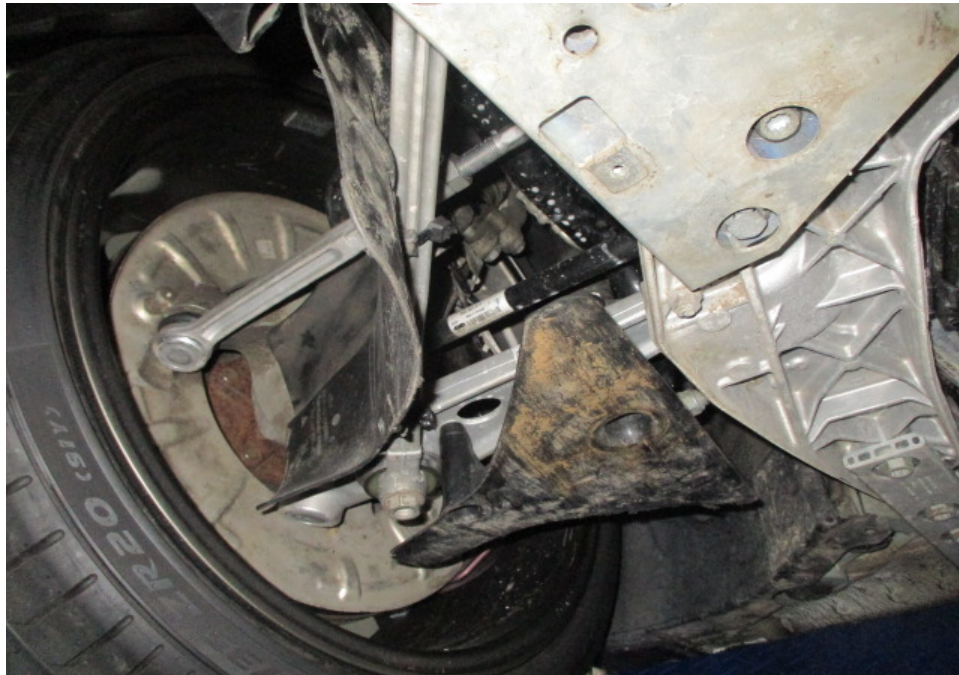
Photo 23 shows the various undercarriage components at the front right wheel of the Motor Car. The mechanical components, control arms and linkages were all found to be intact and secured in an appropriate manner. I also did not observe any fluid leak and/or fluid stain on the underside of the Motor Car.

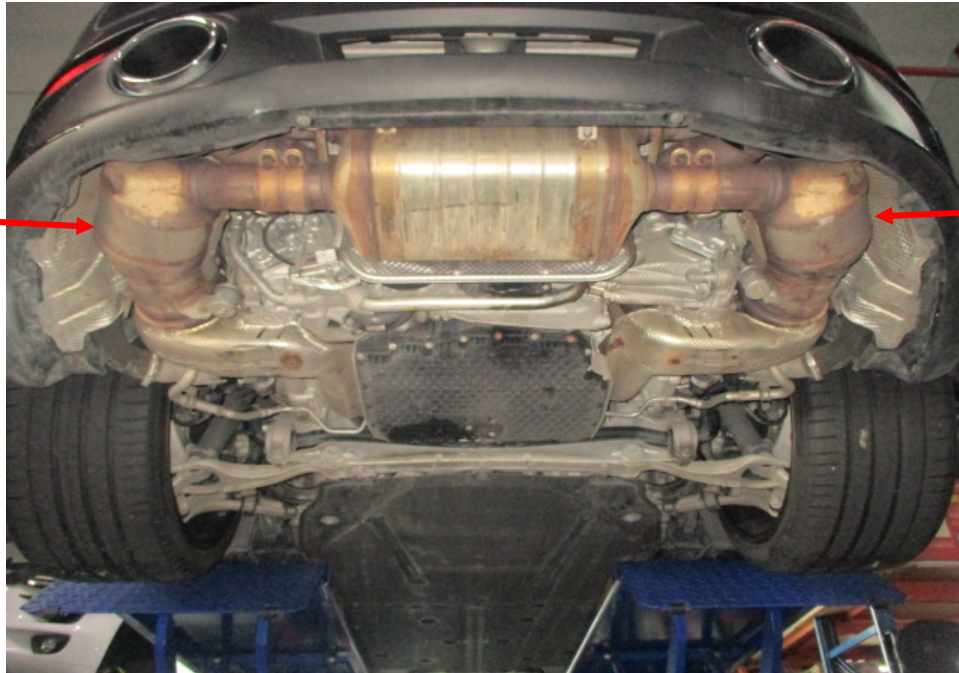
Photo 24 shows the Motor Car's exhaust system. My examination of the Motor Car's exhaust system revealed no sign(s) or indication(s) of any cut or weld marks along its exhaust pipes, on its catalytic converters (arrowed) and on its rear muffler.

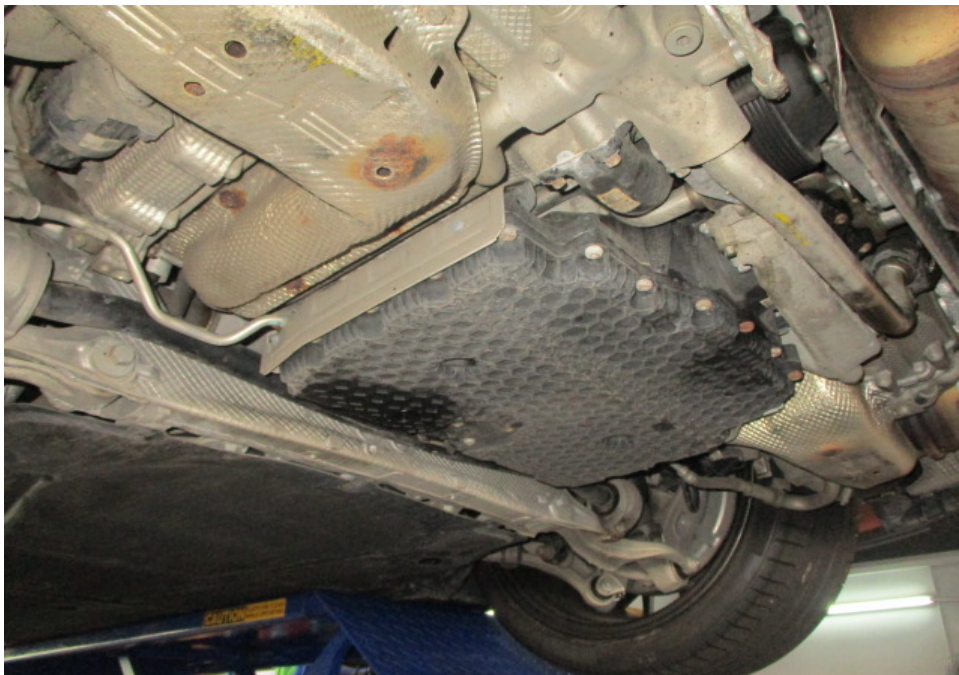
Photo 25 shows a general view of the Motor Car's engine compartment. The engine compartment was at the rear underside of the Motor Car. The various parts and components inside the engine compartment were all observed to be intact and properly fitted. There was also no sign(s) or indication(s) of fluid leak and/or fluid stain found inside the engine compartment.

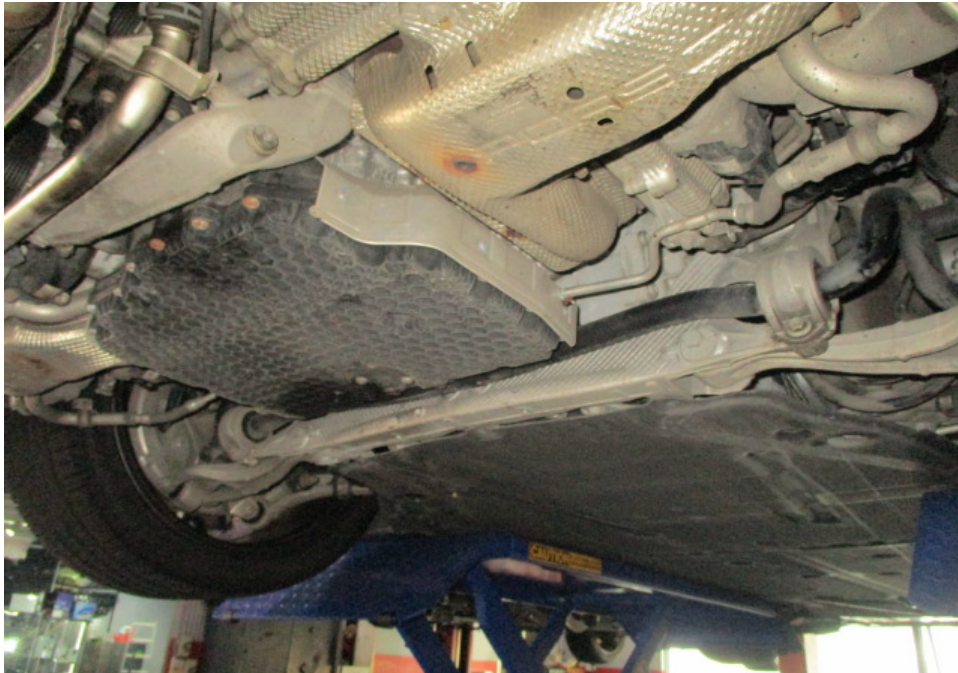
Photo 26 shows another view of the Motor Car's engine compartment. The engine compartment was at the rear underside of the Motor Car. The various parts and components inside the engine compartment were all observed to be intact and properly fitted. There was also no sign(s) or indication(s) of fluid leak and/or fluid stain found inside the engine compartment.

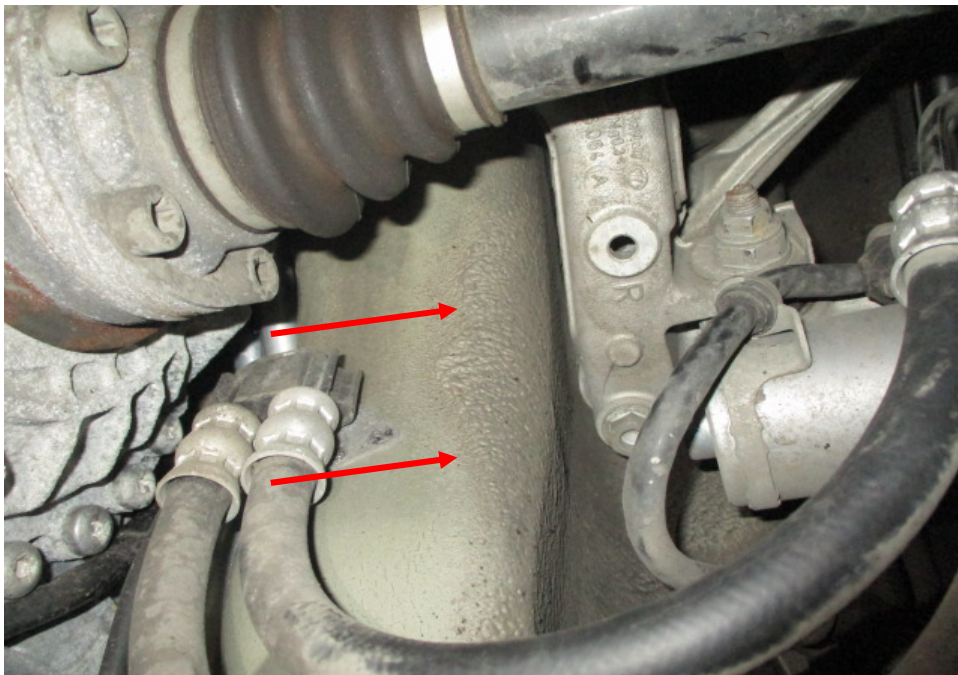
Photo 27 shows the chassis/structural body at the underside rear right of the Motor Car. I did not find any weld marks other than original spot weld marks on the chassis/structural body of the Motor Car. The original factory sealant (arrowed) at the joints along the chassis/structural body was untouched, indicating no work was done on the chassis/structural body of the Motor Car and that the chassis/structural body was originally fitted.

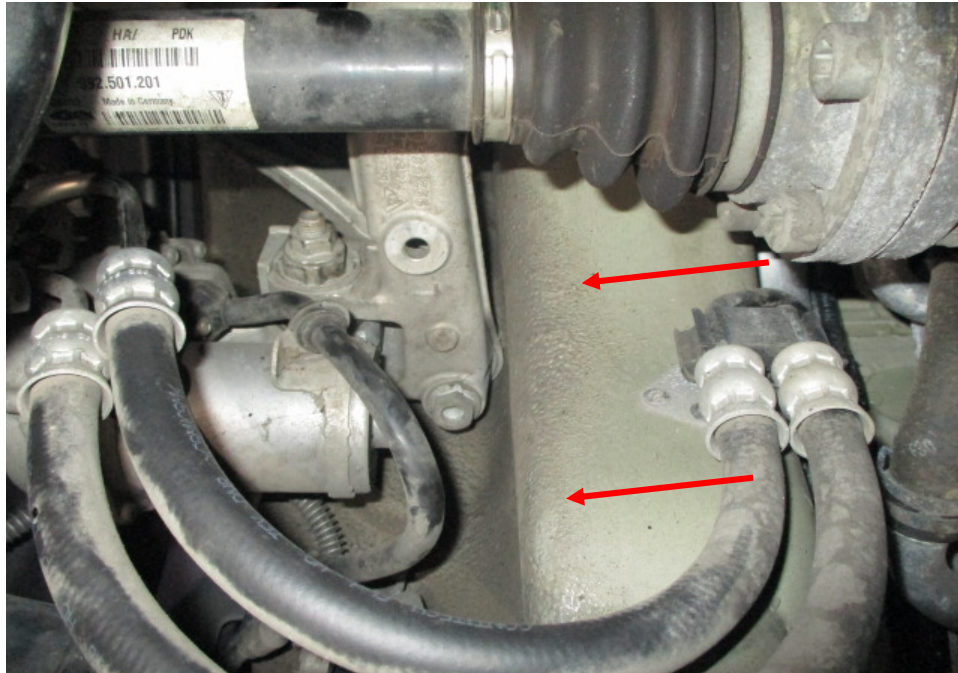
Photo 28 shows the chassis/structural body at the underside rear left of the Motor Car. The original factory sealant (arrowed) at the joints along the chassis/structural body was observed to be untouched. In general, I had found no work was carried out on the chassis/structural body of the Motor Car. The chassis/structural body of the Motor Car was originally fitted.

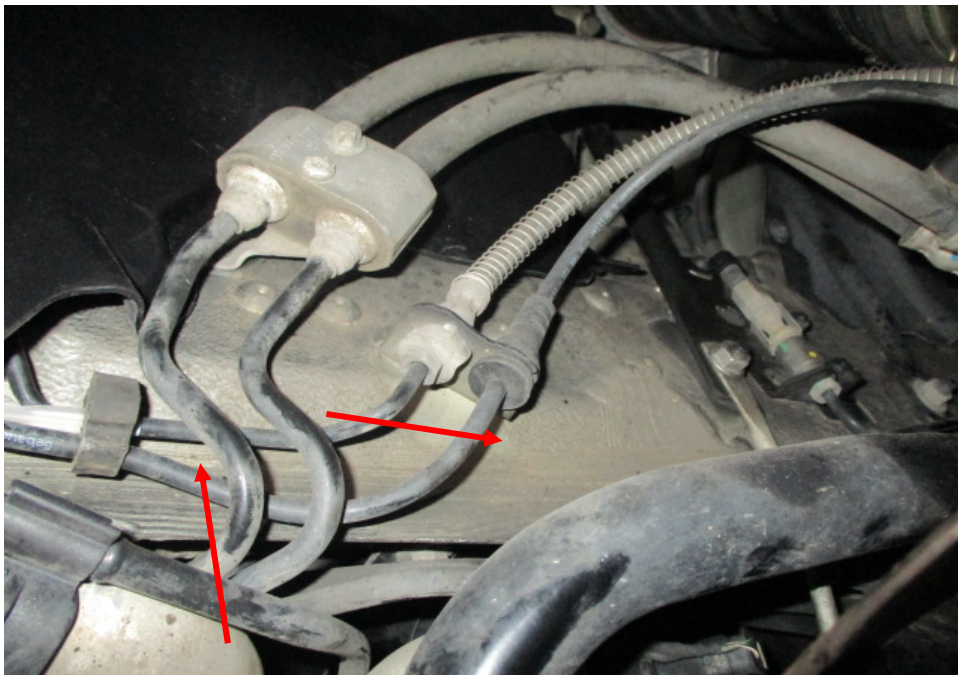
Photo 29 shows the chassis/structural body at the underside front left of the Motor Car. I did not find any weld marks other than original spot weld marks on the chassis/structural body of the Motor Car. The original factory sealant (arrowed) at the joints along the chassis/structural body was untouched, indicating no work was done on the chassis/structural body of the Motor Car and that the chassis/structural body was originally fitted.

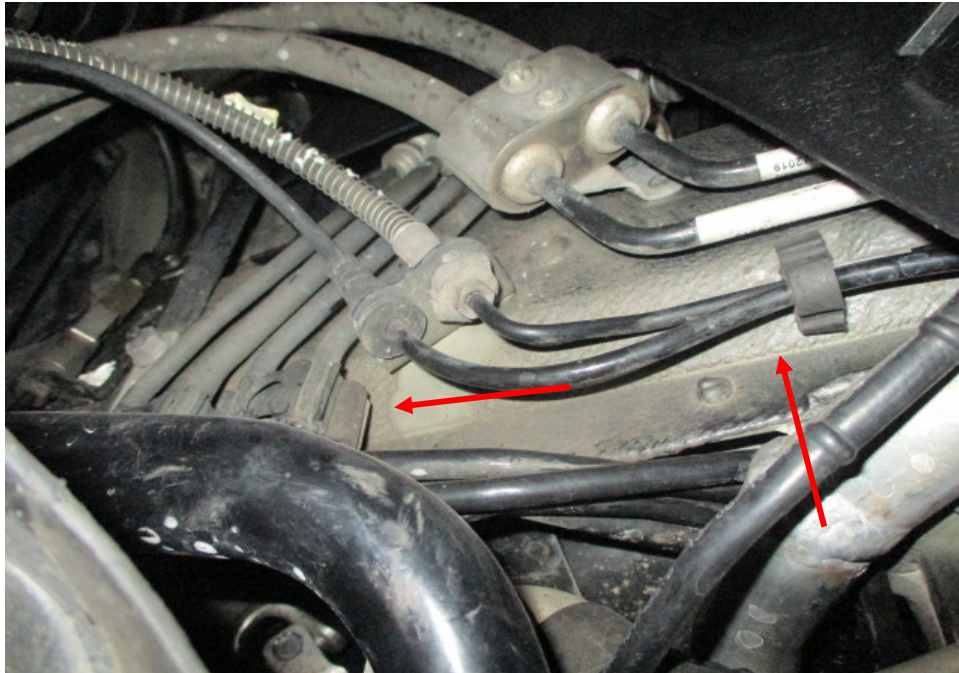
Photo 30 shows the chassis/structural body at the underside front right of the Motor Car. The original factory sealant (arrowed) at the joints along the chassis/structural body was observed to be untouched. In general, I had found no work was carried out on the chassis/structural body of the Motor Car. The chassis/structural body of the Motor Car was originally fitted.
