Your Ref: TP/IP/05637/2021  
Our Ref : CI/TPD22003611/P

**General Investigation Team**

**MECHANICAL INSPECTION REPORT OF MOTOR VAN GBC 4328P**

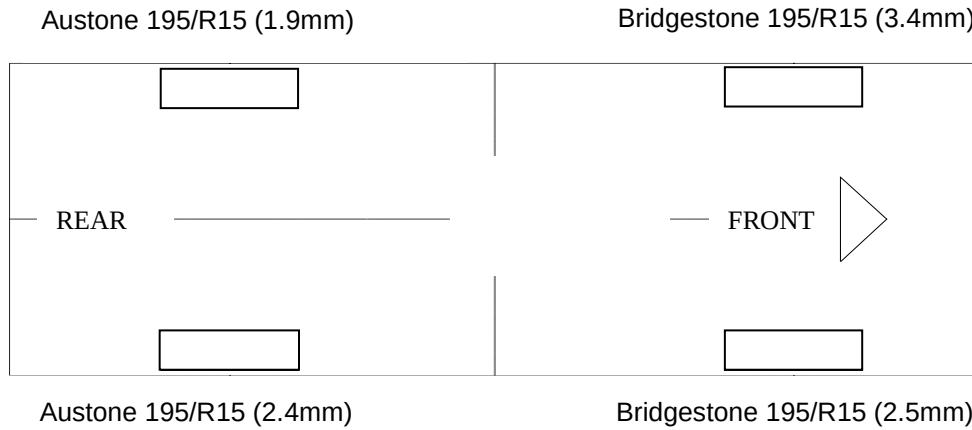
6. The front right tyre was observed to be deflated as a result of the accident. However, the other 3 tyres of the Motor Van were observed to be in serviceable condition and sufficiently inflated for vehicular operation. I did not find any tear, cut or burst mark(s) on the outer and the inner sidewalls as well as across the tread of the 4 tyres. The tyre brand, tyre size and remaining tread depth of the 4 tyres of the Motor Van were recorded as follows: -

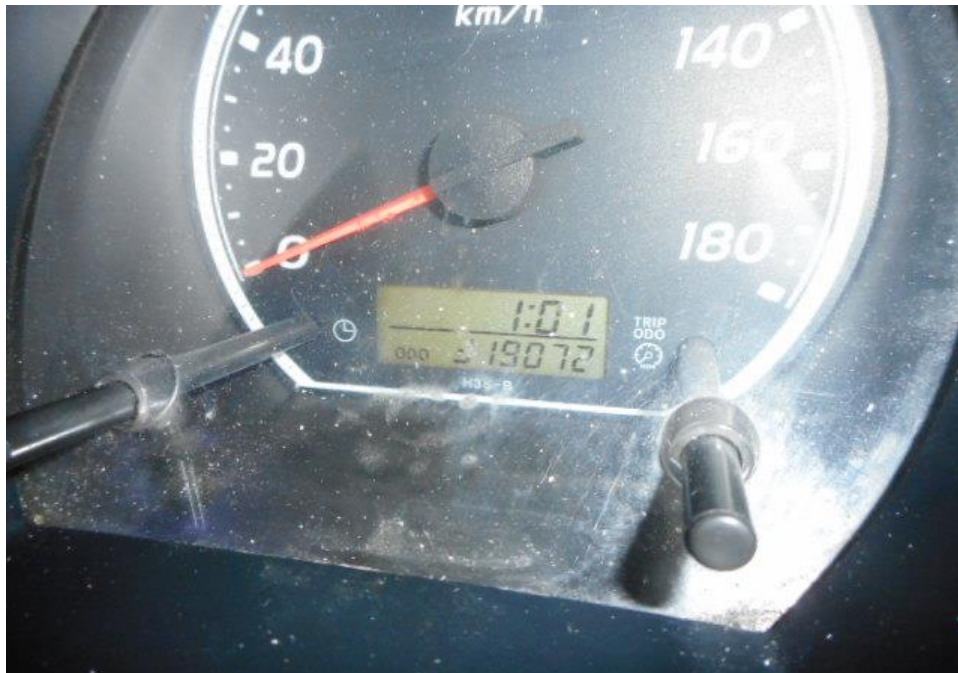
**Photo 1** shows a general view of the instrument cluster of the Motor Van at the time of my inspection. The mileage of the Motor Van was 319,072km

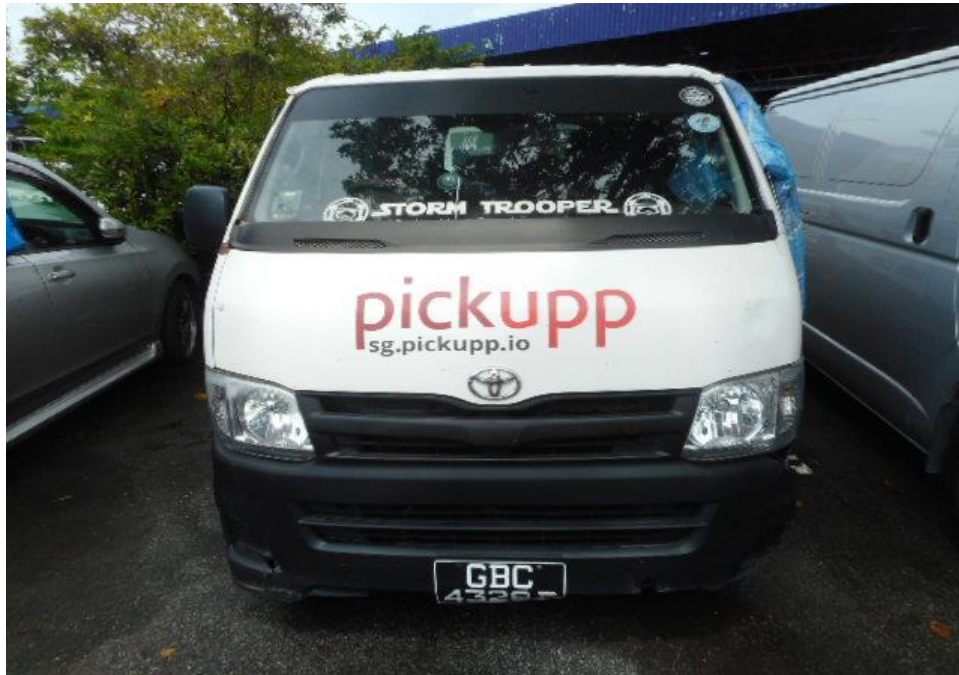
**Photo 2** shows a general view of the Motor Van's frontal portion at the time of my inspection. It appeared to have sustained damage at its frontal portion. Its front body panel and front bumper were also damage at the time of my inspection.

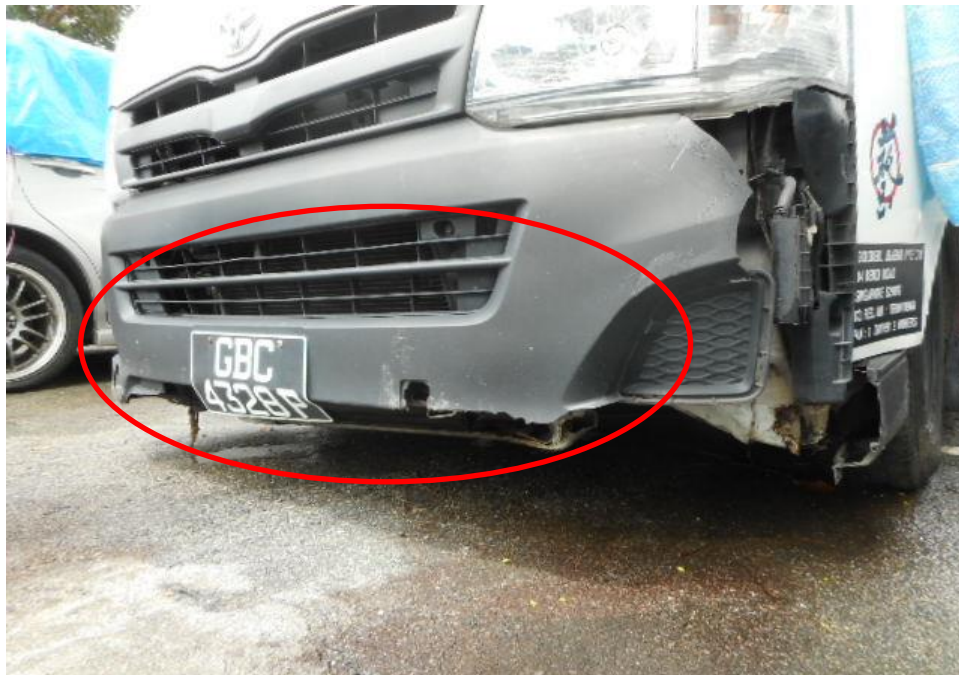
**Photo 3** shows a close up view of the Motor Van's frontal portion at the time of my inspection. It appeared to have sustained damage at its frontal portion. Its front bumper (circled) was damage at the time of my inspection as a result of the accident.

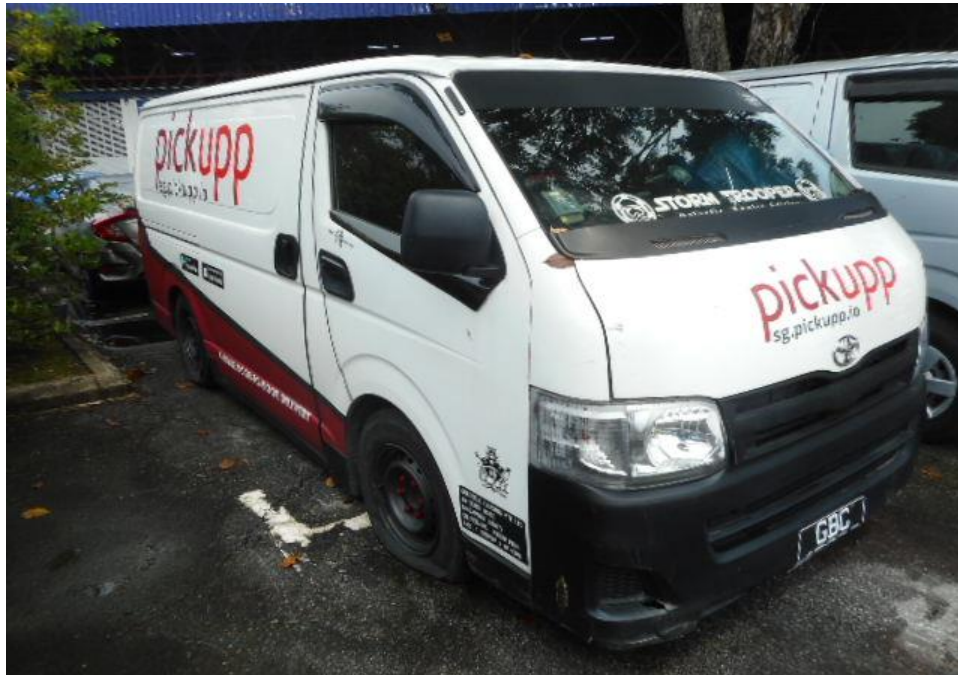
**Photo 4** shows a general view of the right body of the Motor Van at the time of my inspection. The Motor Van was observed to be intact and unaffected by the accident.

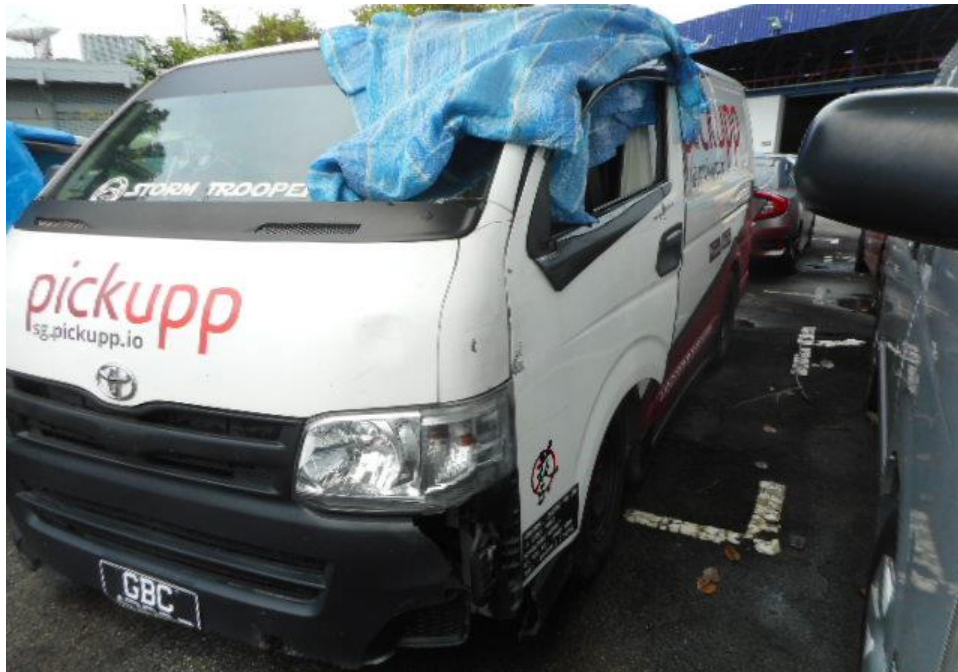
**Photo 5** shows a general view of the left body of the Motor Van at the time of my inspection. The Motor Van was observed to sustained damages to its left door windscreen and left rear view mirror due to the accident.

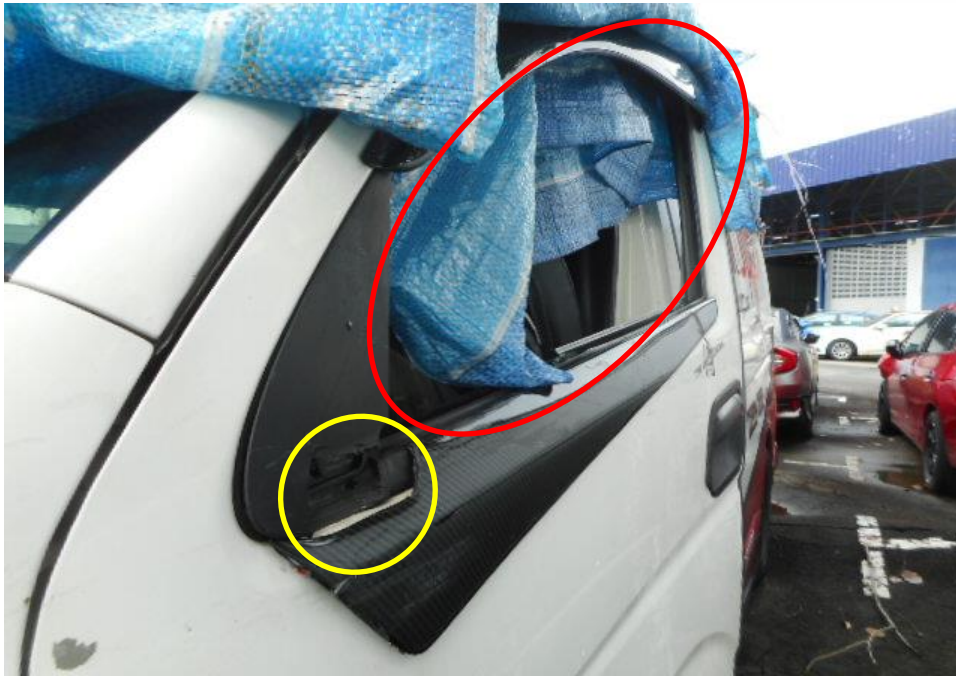
**Photo 6** shows a close up view of the left body of the Motor Van at the time of my inspection. The Motor Van was observed to sustained damages to its left door windscreen (red circle) and left rear view mirror (yellow circle) due to the accident.

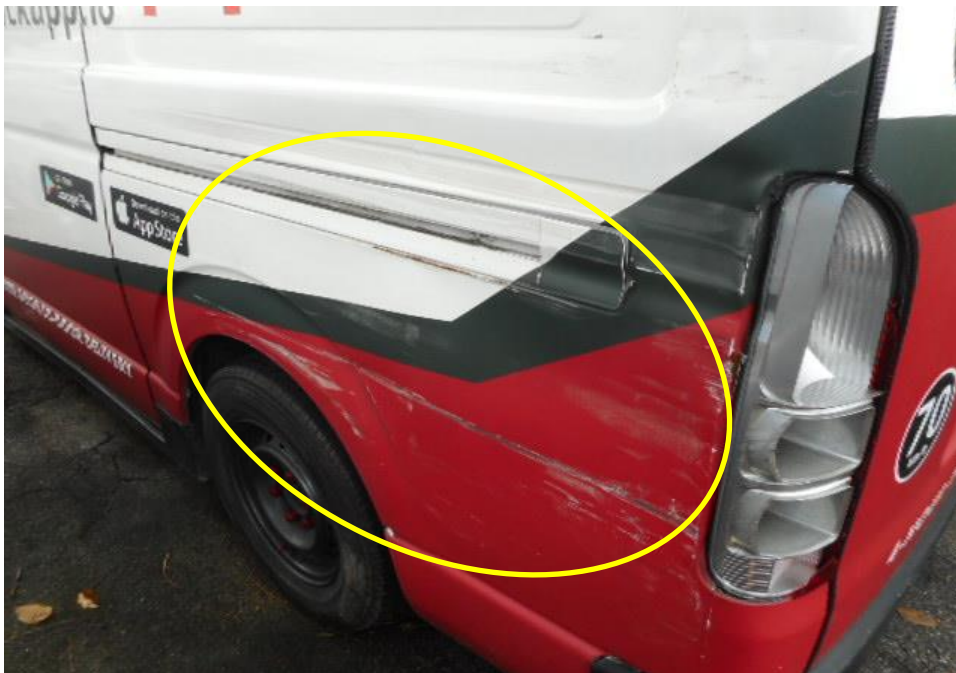
**Photo 7** shows a close up view of the left body of the Motor Van at the time of my inspection. The Motor Van was observed to sustained damages to its left body panel (circled) due to the accident.

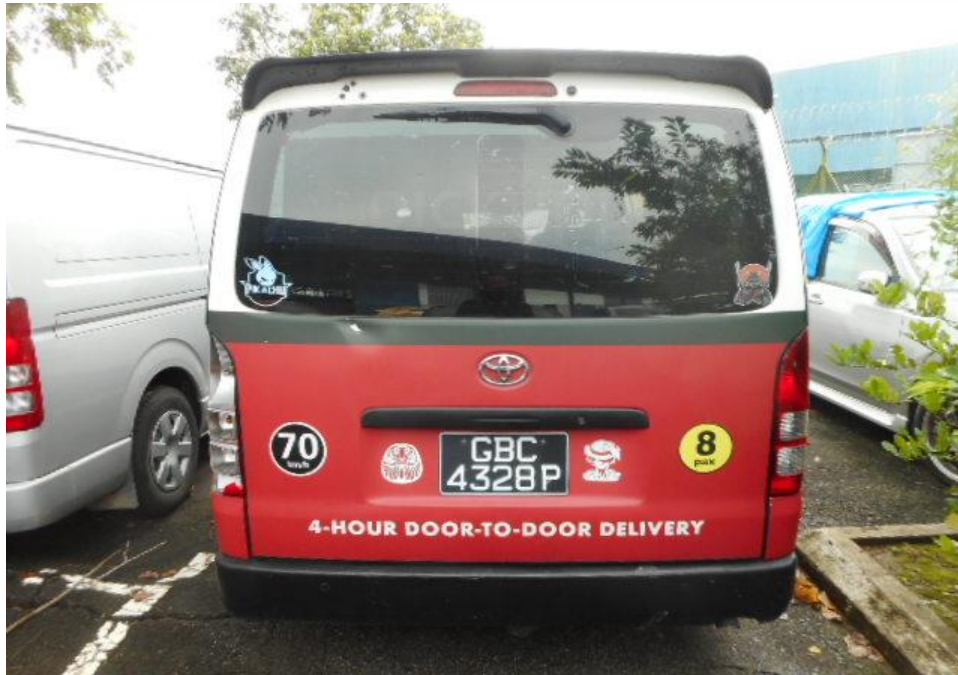
**Photo 8** shows a general view of the rear body of the Motor Van at the time of my inspection. The Motor Van was observed to be intact and unaffected by the accident.

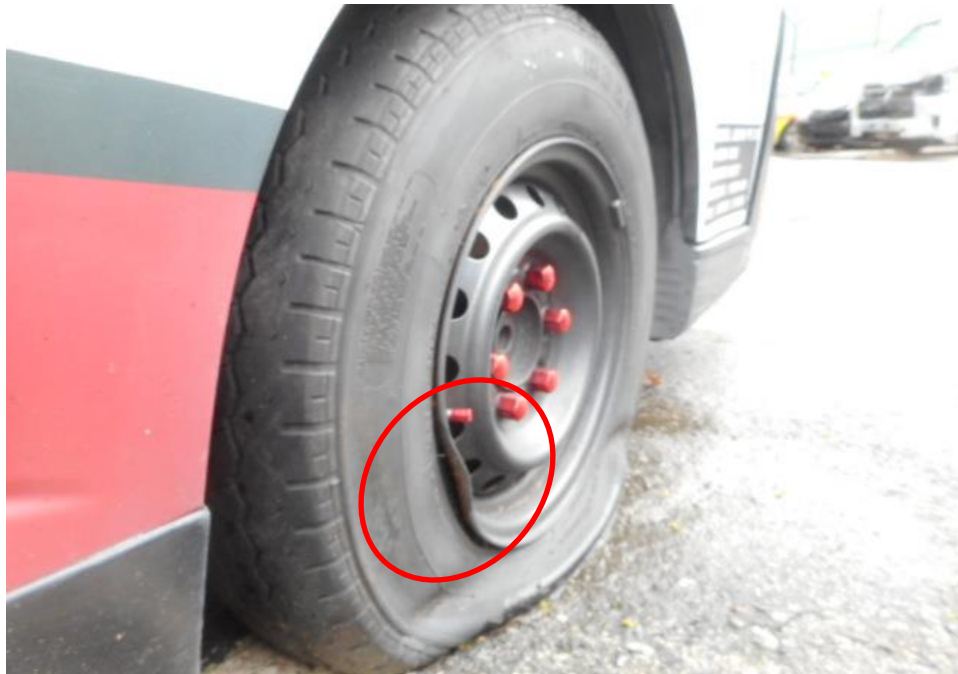
7. The front right tyre rim was observed to sustained damage as a result of the accident. The other 3 tyres were observed to be wrapped around standard steel wheel rims that were found to be without any damage. See photo 1 – 12 below.

**Photo 9** shows the condition of the front right tyre of the Motor Van, which was observed to be deflated as the rim had been damaged (circled) as a result of the accident with remaining tread depth of approximately 3.4mm. The tyre, which was wrapped around standard steel wheel rim, was also observed to be sufficiently inflated for vehicular operation. There was no tear, cut or burst mark(s) on the outer and the inner sidewalls as well as across the tread of the 4 tyres that were fitted on the Motor Van.

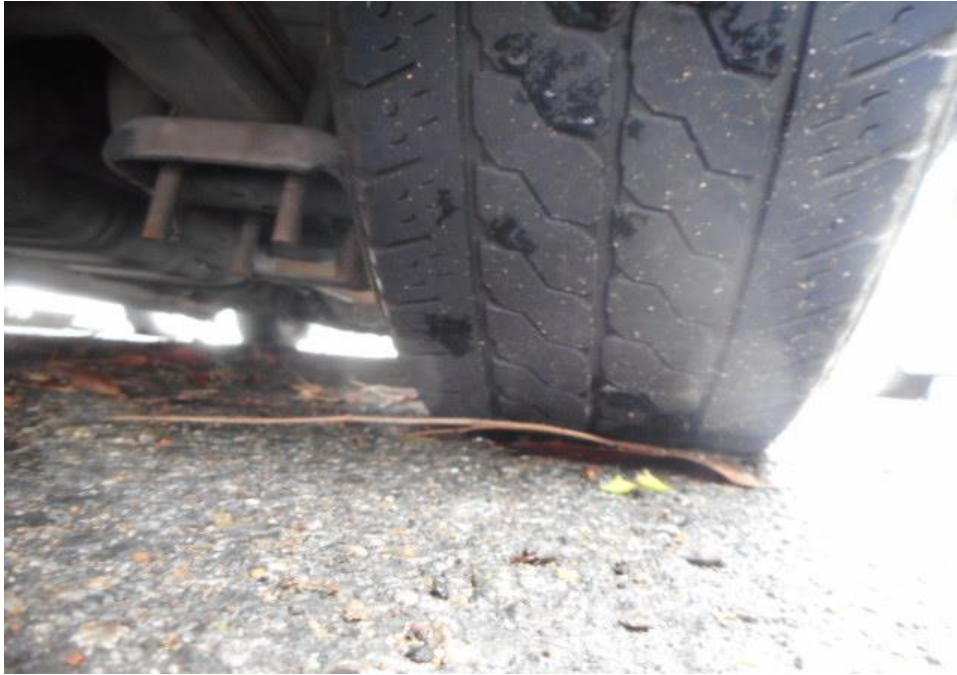
**Photo 10** shows the condition of the rear right tyre of the Motor Van, which was observed to be in serviceable condition with remaining tread depth of approximately 6.4mm. The tyre, which was wrapped around standard steel wheel rim, it was observed to be sufficiently inflated for vehicular operation.

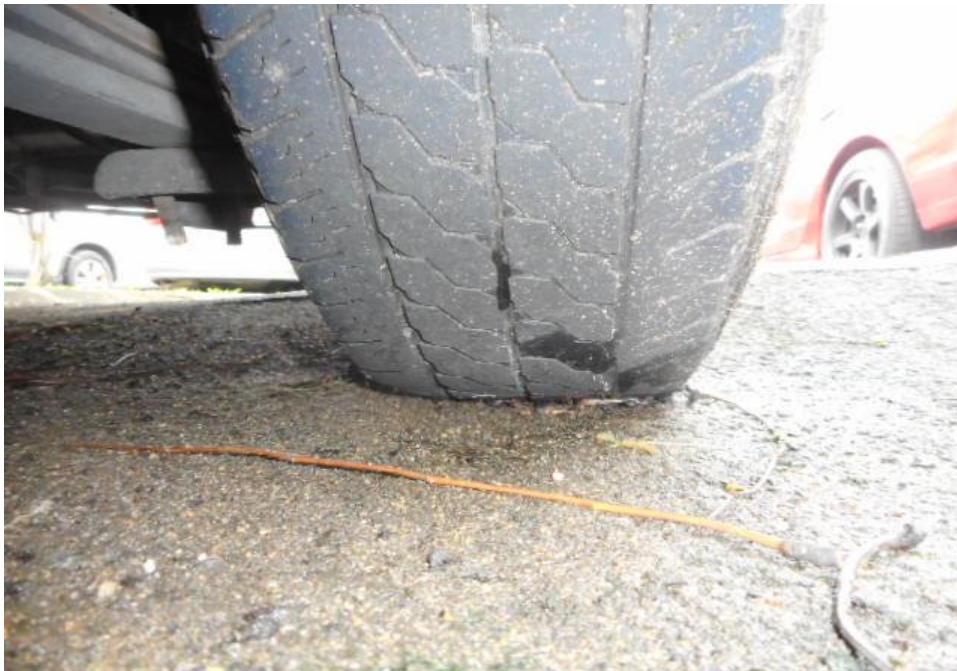
**Photo 11** shows the condition of the rear left tyres of the Motor Van, which was observed to be in serviceable condition with remaining tread depth of approximately 1.9mm. The tyres, which were wrapped around standard steel wheel rim, were also observed to be sufficiently inflated for vehicular operation. There was also no damage found on all 4 steel wheel rims of the Motor Van.

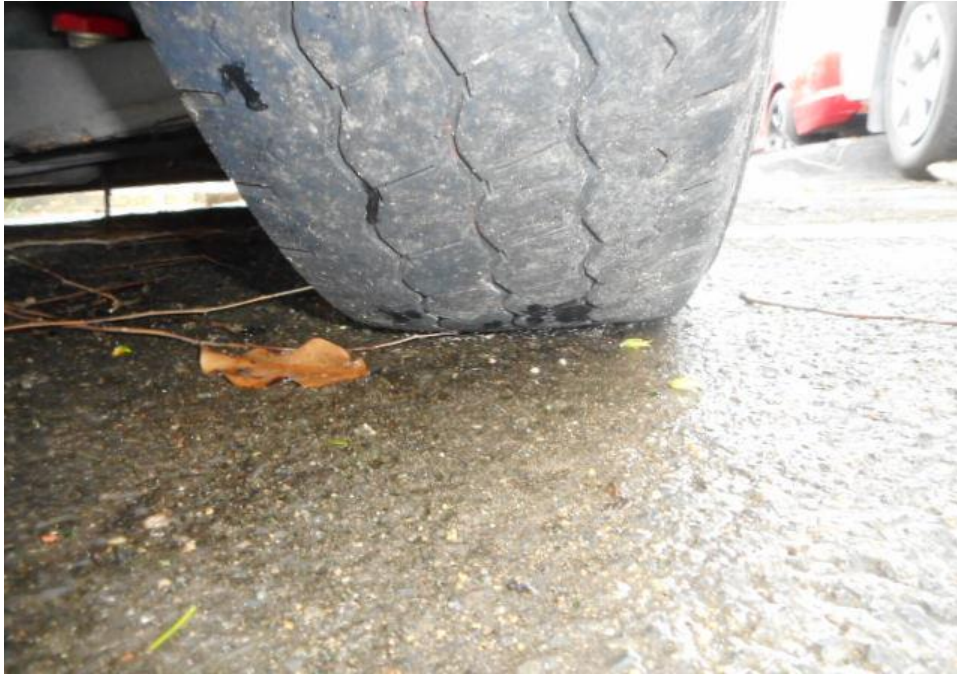
**Photo 12** shows the condition of the rear right tyres of the Motor Van, which were observed to be in serviceable condition with remaining, tread depth of approximately 2.5mm. There was also no tear, cut or burst mark(s) on the outer and the inner sidewalls as well as across the tread of the 4 tyres that were fitted on the Motor Van.

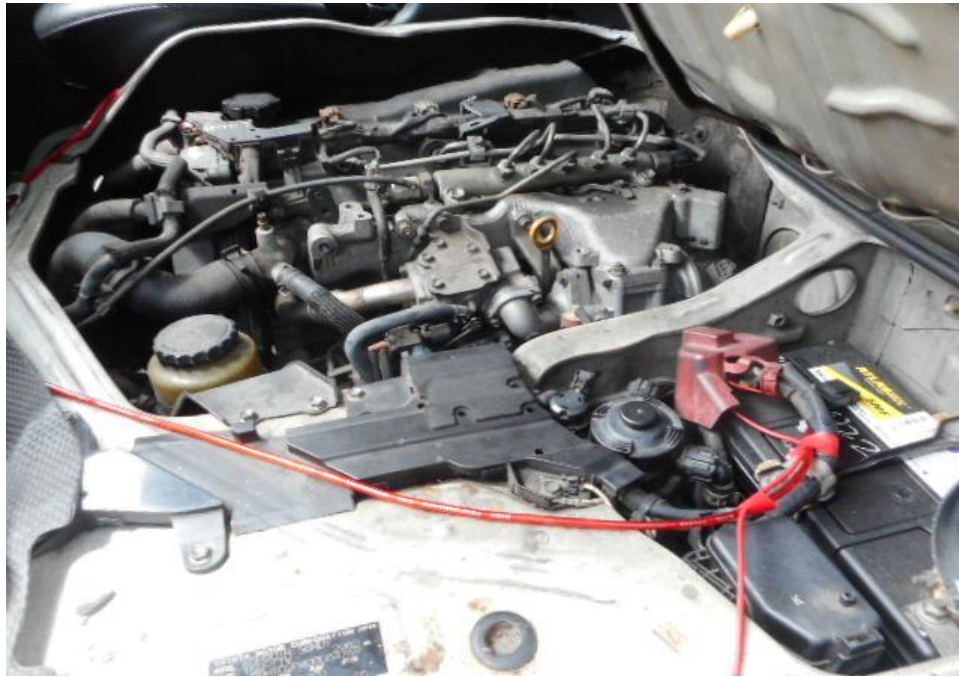
**Photo 13** shows a general view of the Motor Van's engine compartment, which was accessed by lifting the front cabin of the Motor Van. The various parts and components inside the engine compartment were unaffected by the accident. There was also no sign(s) or indication(s) of fresh fluid leakage and/or fluid stain within the engine compartment

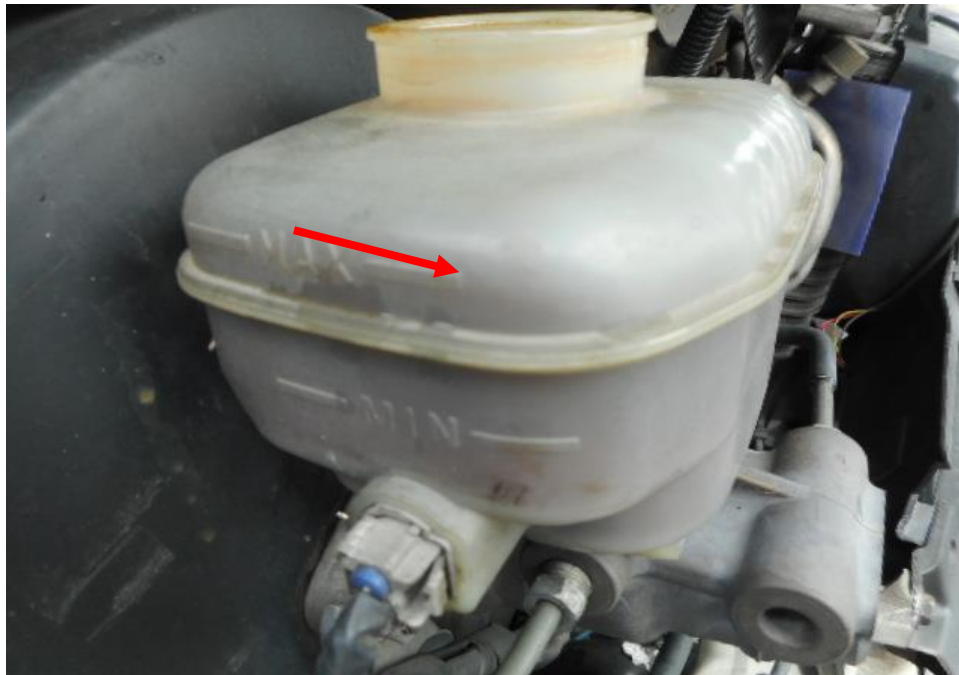
**Photo 14** shows the brake fluid reservoir of the Motor Van at the time of my inspection. The brake fluid was observed to be of sufficient level (arrowed) and without any visible contamination.

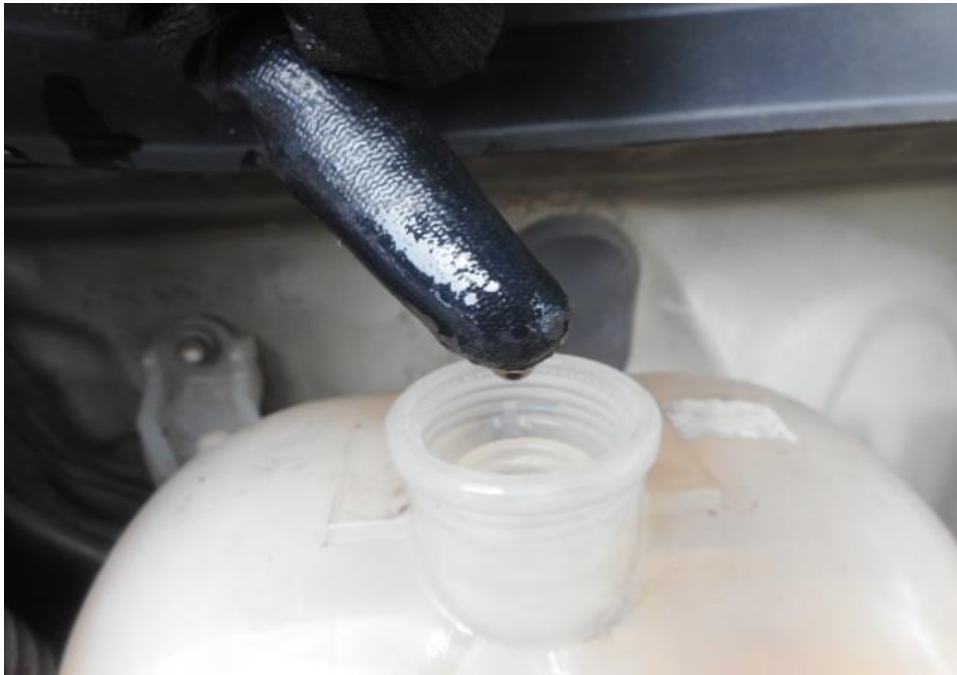
**Photo 15** shows the engine coolant of the Motor Van at the time of my inspection. The engine coolant was observed to be of sufficient level and without any visible contamination.

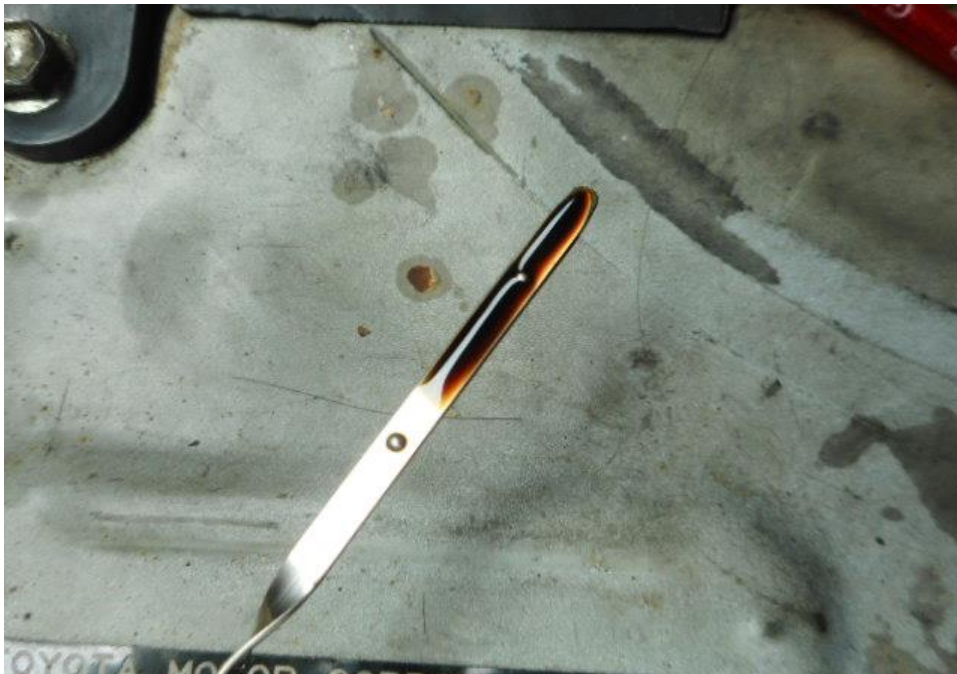
**Photo 16** shows the engine oil dip stick of the Motor Van at the time of my inspection. The engine oil was observed to be of sufficient level and without any visible contamination.

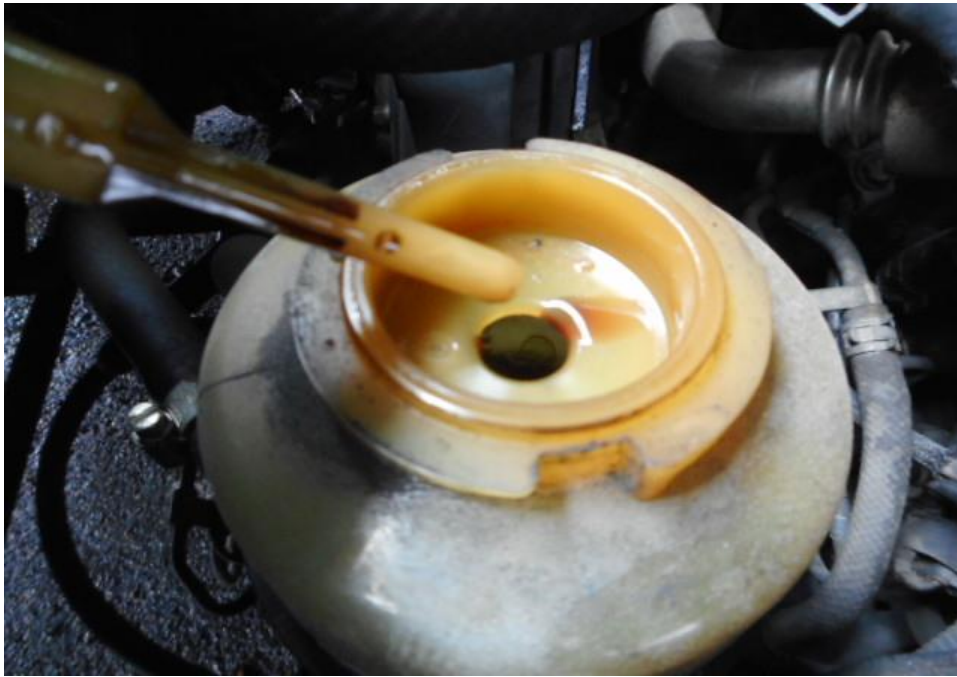
**Photo 17** shows the power steering fluid dip stick of the Motor Van at the time of my inspection. The steering fluid was observed to be of sufficient level and without any visible contamination.

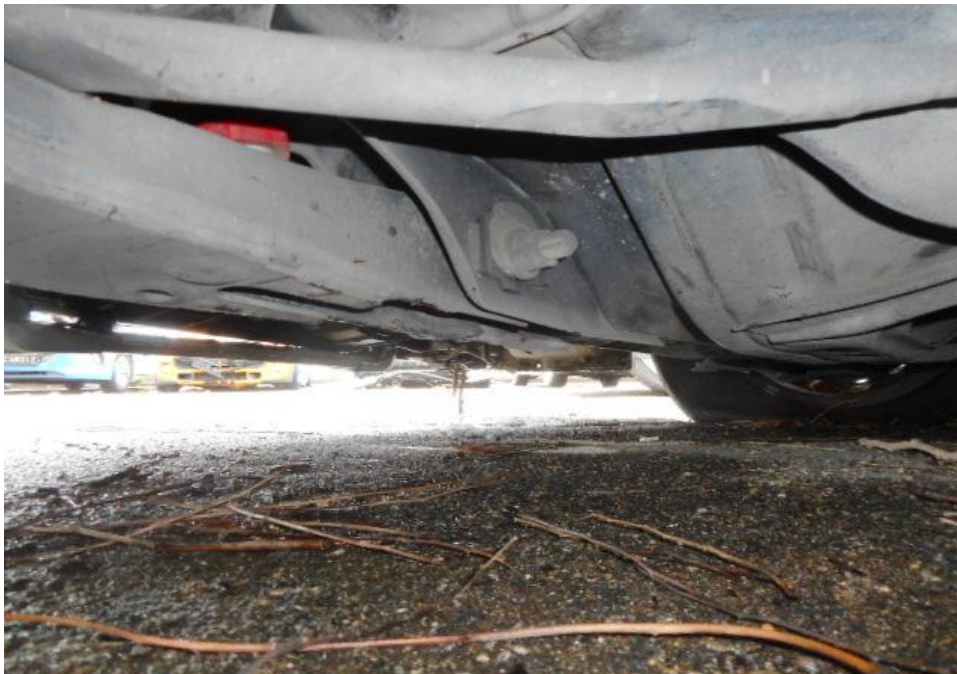
**Photo 18** shows the undercarriage of the Motor Van, at the area where the engine housing and transmission housing are located. I did not find any sign(s) or indication(s) of fluid leak and/or fluid stain(s) on the underside of the Motor Van.

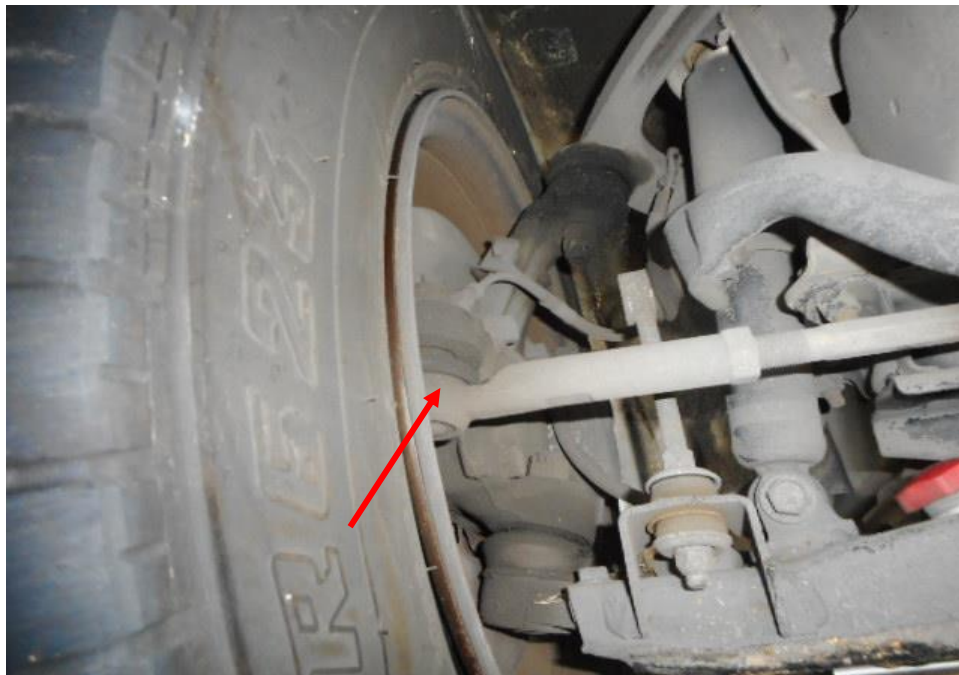
**Photo 19** shows the various undercarriage components at the front right wheel of the Motor Van, in particular the steering tie rod end (arrowed). The various steering components were all found to be intact, suggesting that the steering system of the Motor Van was likely to be in serviceable condition at the material time of accident. There was also no sign of fluid stain(s) observed on the various undercarriage components.

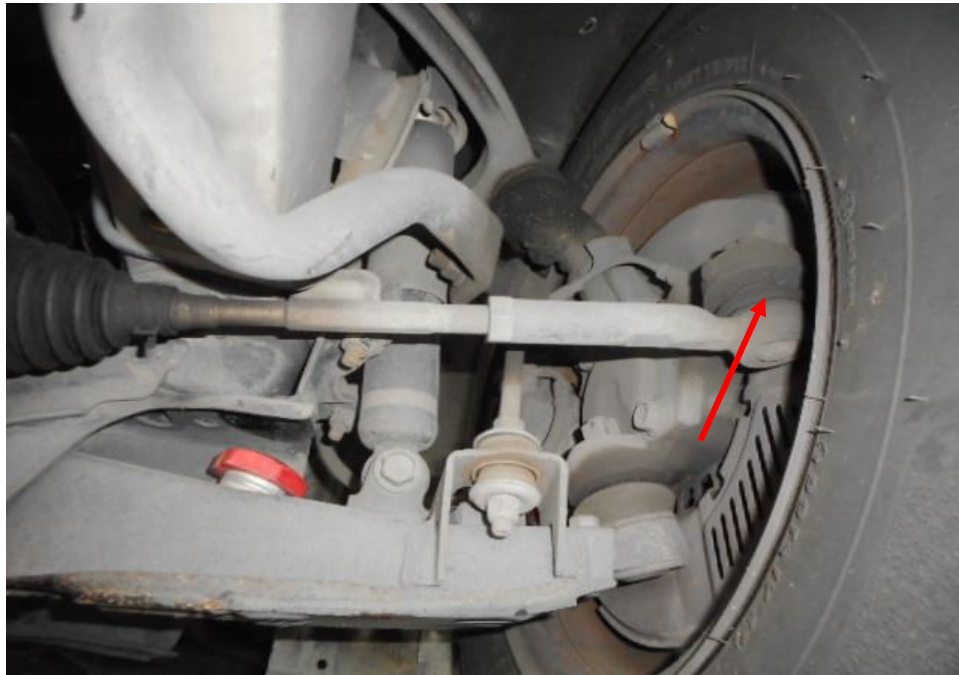
**Photo 20** shows the various undercarriage components at the front left wheel of the Motor Van, in particular the steering tie rod end (arrowed). The various undercarriage components of the Motor Van were all found to be intact without any visible damage. There was also no sign of fluid stain(s) observed on the various undercarriage components.

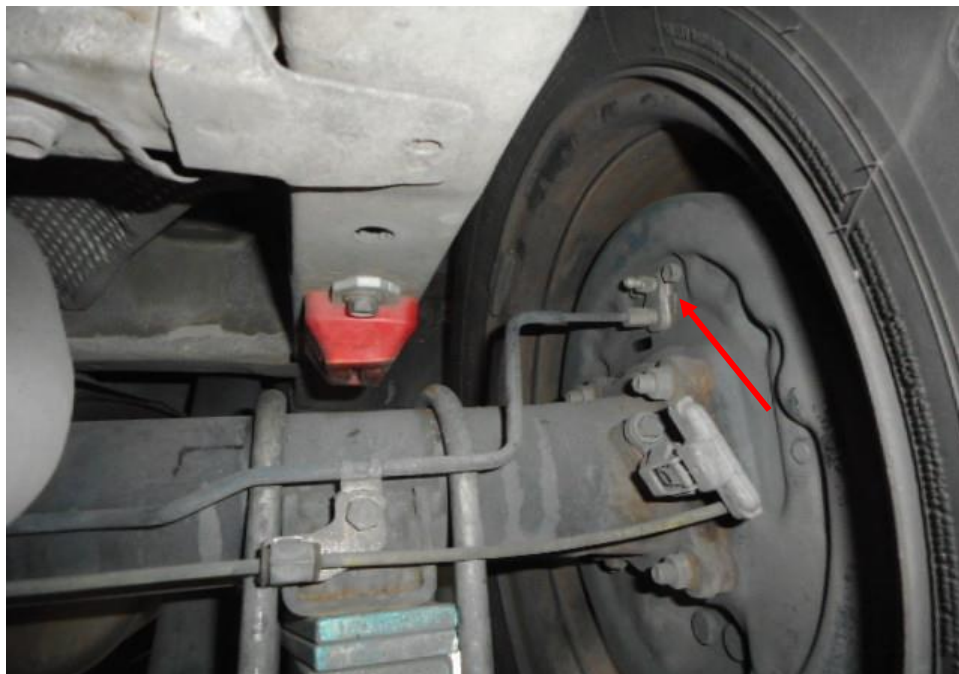
**Photo 21** shows the brake pipe (arrowed) at the rear right wheel of the Motor Van. I did not observe any leakage of brake fluid at the time of my inspection of the Motor Van. My static tests of the Motor Van's braking system, along with my visual examination of the various mechanical components in the braking system, had indicated that there was no internal leakage of pressure/vacuum. Hence the braking system of the Motor Van was likely to be in serviceable condition at the material time of accident.

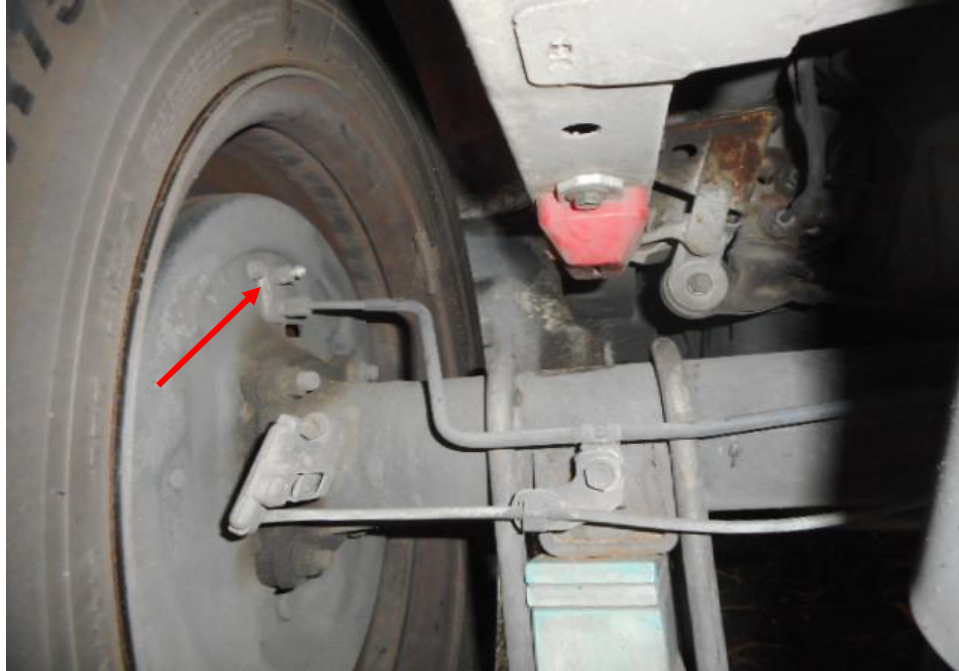
**Photo 22** shows the brake pipe (arrowed) at the rear left wheel of the Motor Van. I did not observe any leakage of brake fluid at the time of my inspection of the Motor Van. My static tests of the Motor Van's braking system, along with my visual examination of the various mechanical components in the braking system had indicated that there was no internal leakage of pressure/vacuum. Hence the braking system of the Motor Van was likely to be in serviceable condition at the material time of accident.

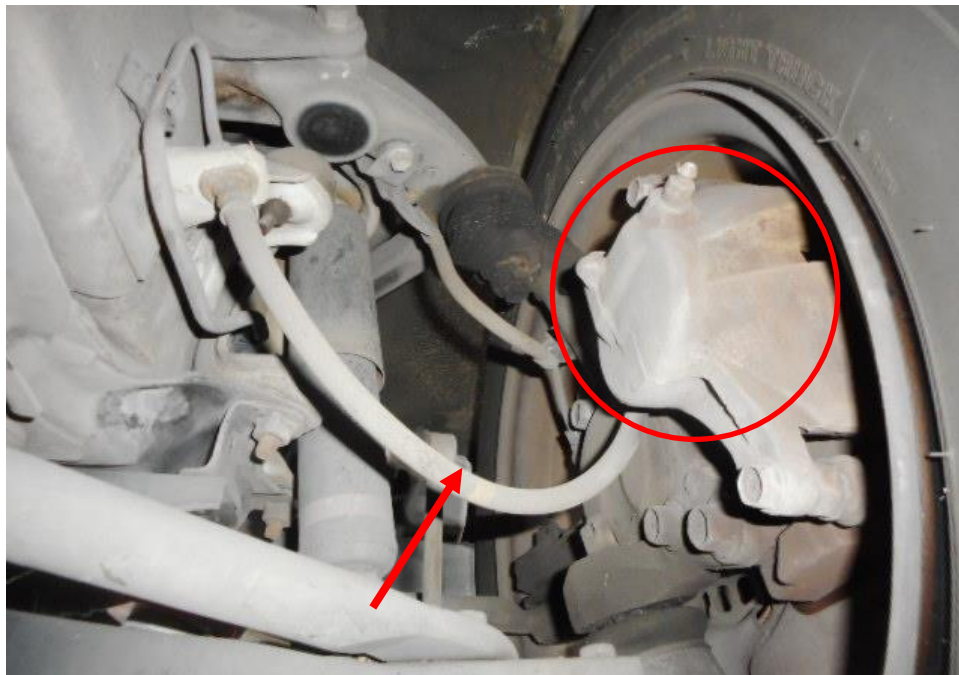
**Photo 23** shows the brake hose/pipe (arrowed) at the front right wheel of the Motor Van. No leakage of brake fluid was observed. Visual examination of the various components of the braking system like the brake caliper (circled), brake booster, brake pedal etc had revealed all to be intact and without visible damage at the time of accident. There was also no sign of fluid stain(s) observed on the various undercarriage components.

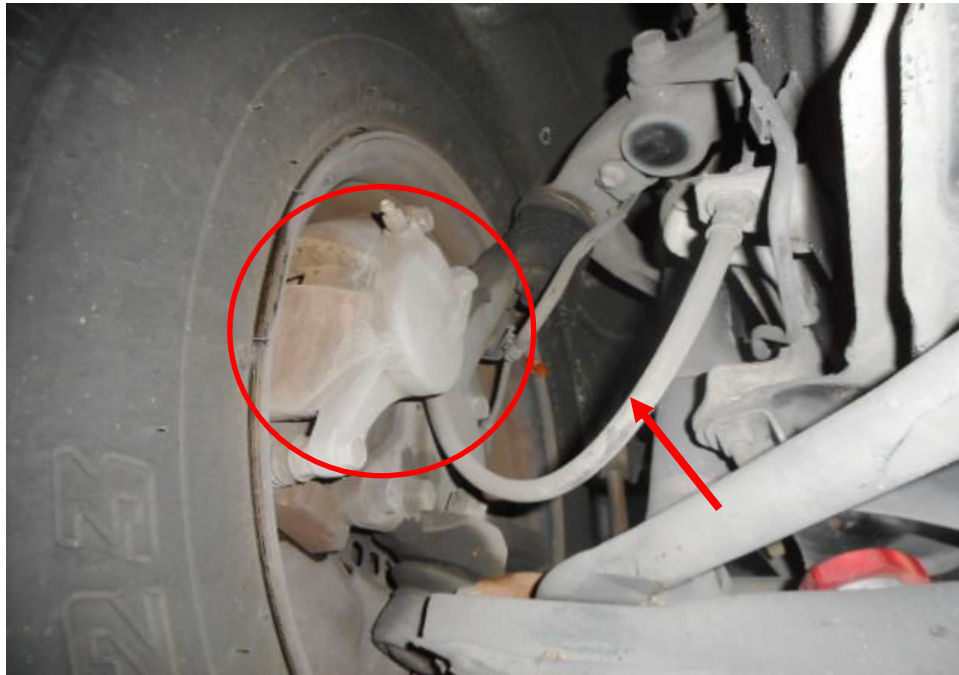
**Photo 24** shows the brake hose/pipe (arrowed) at the front left wheel of the Motor Van. No leakage of brake fluid was observed. Visual examination of the various components of the braking system like the brake caliper (circled), brake booster, brake pedal etc had revealed all to be intact and without visible damage at the time of accident. There was also no sign of fluid stain(s) observed on the various undercarriage components.

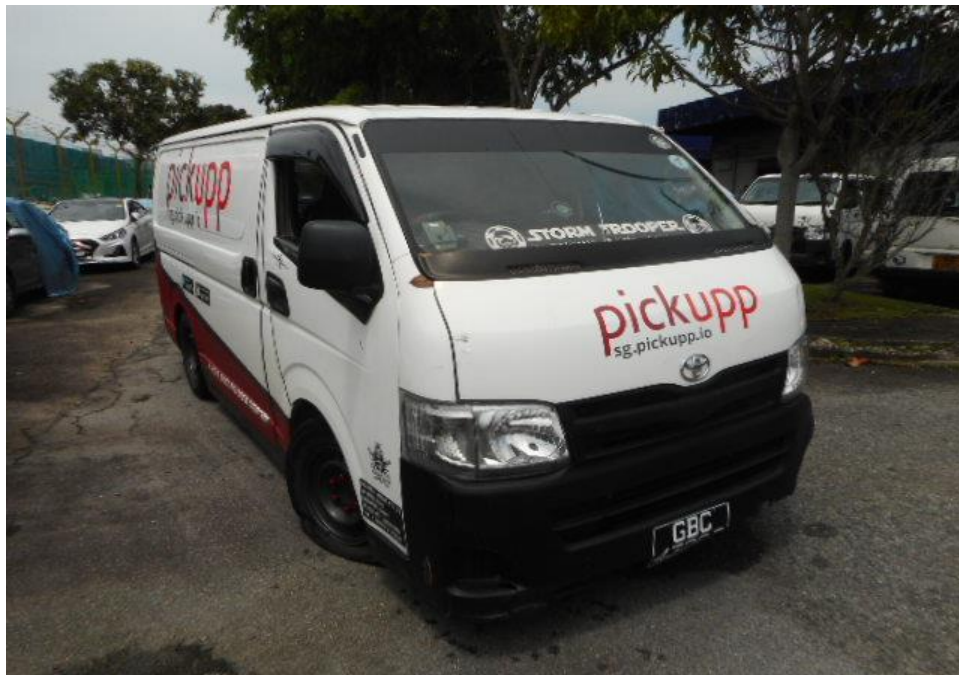
**Photo 25** shows the front right wheel of the Motor Van turned to its full left. During my steering system test, I did not experience any abnormal free play and/or resistance when I had turned the steering wheel towards full left and full right. This would suggest that the steering system of the Motor Van was likely to be in serviceable condition at the material time of accident.

16. The braking system was also found to be in working condition as the Motor Van was able to slow down and come to a complete stop upon depressing of the brake pedal. However, during the operational test the brake pedal had to be depressed all the way to the end with extra effort for the brakes to start braking and slowing down the Motor Van. This is a sign that the brake booster is not working well and it might have affected the braking efficiency on the Motor Van. Refer to photo 2 & 25

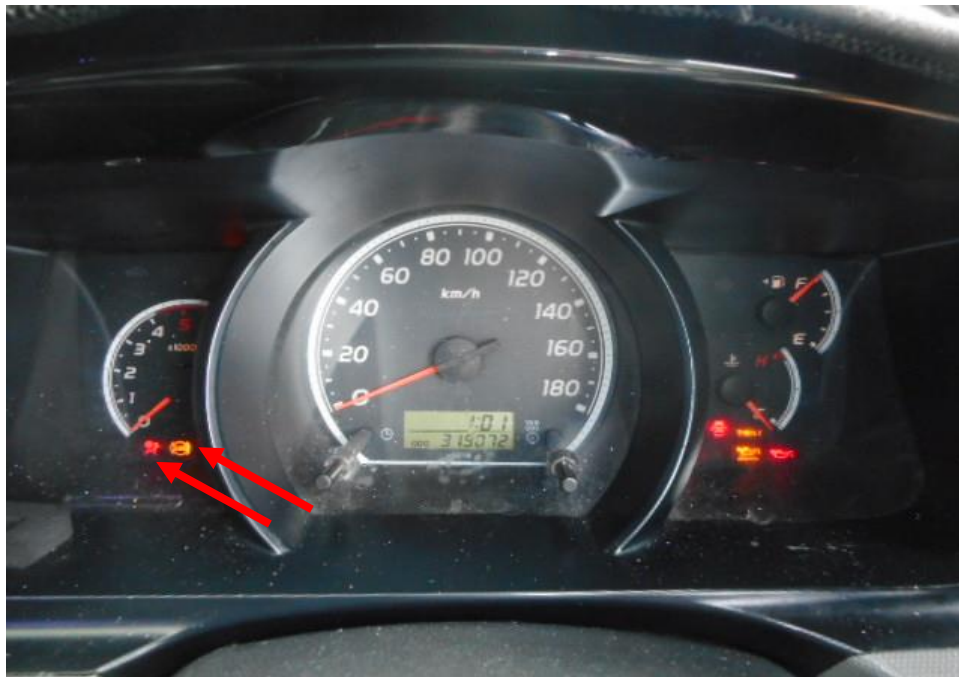
**Photo 26** shows the warning light for Anti-Lock Brake System (ABS) and Supplemental Restraint System (SRS) (arrowed) appearing on the instrument panel of the Motor Van during the self-test of its various electronic operating systems when its engine was cranked.

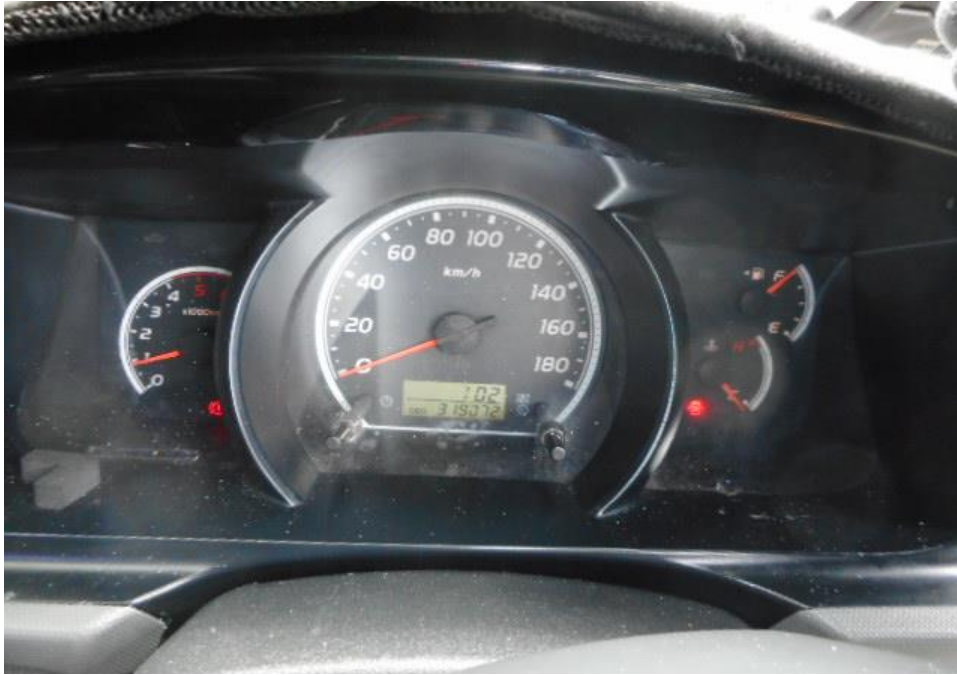
**Photo 27** shows no warning lights illuminated on the instrument panel of the Motor Van after the engine was cranked. This would suggest that there was no abnormality to the electronic operating system of the Motor Van, like the ABS, SRS and etc.
