Your Ref: TP/IP/07242/2022
Our Ref : CI/TPD22003613/P

Fatal Accident Investigation Team

MECHANICAL INSPECTION REPORT OF MOTOR BUS PA 7907T

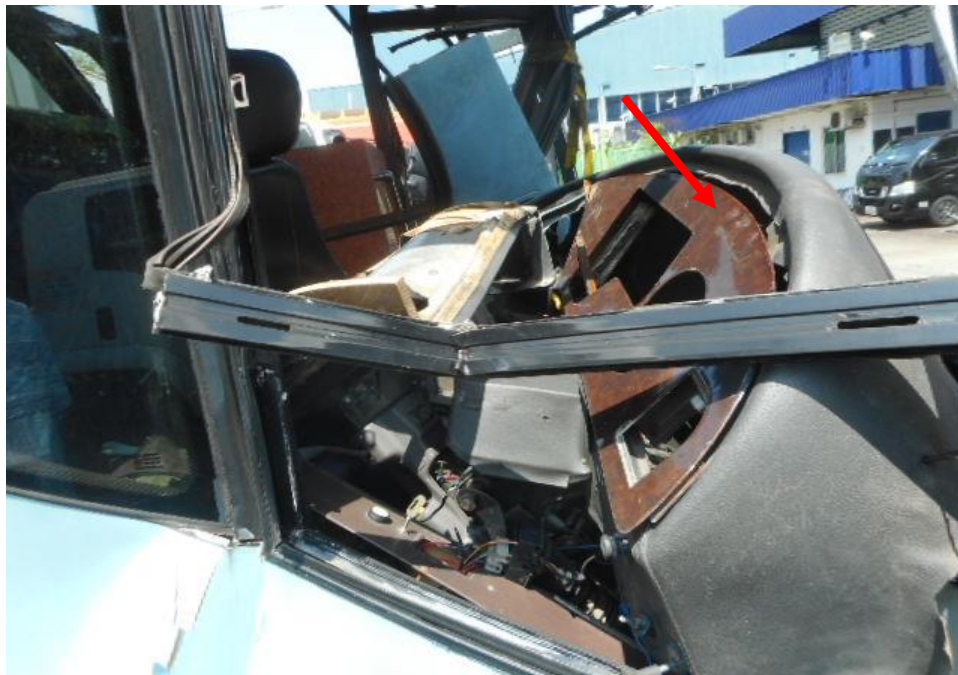
4. The mileage of the Motor Bus at the time of our inspection was not able to be recorded as the whole dashboard including the odometer has been damaged by the accident.
5. The Motor Bus was observed to sustained damage at its front portion. Its front cabin structure, front windscreen, front bumper, front body panel, front door was damaged as a result of the accident.

Photo 1 shows the damaged instrument cluster (arrowed). Therefore no mileage is recorded at the time of our inspection.

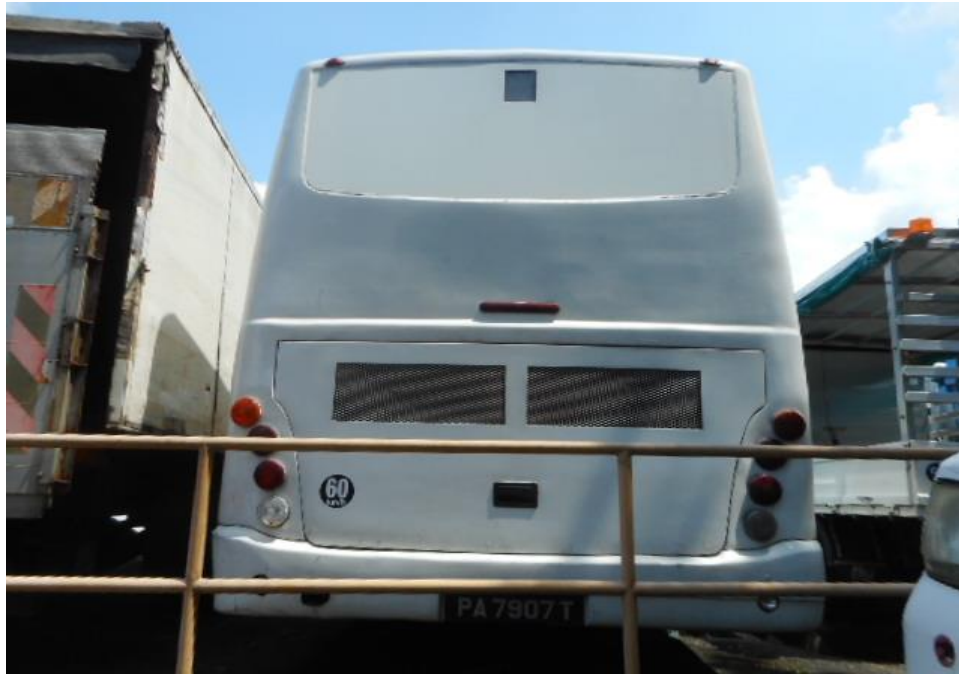
Photo 2 shows a close up view of the rear portion of the Motor Bus at the time of our inspection. The right portion of the Motor Bus was observed to have been unaffected by the accident

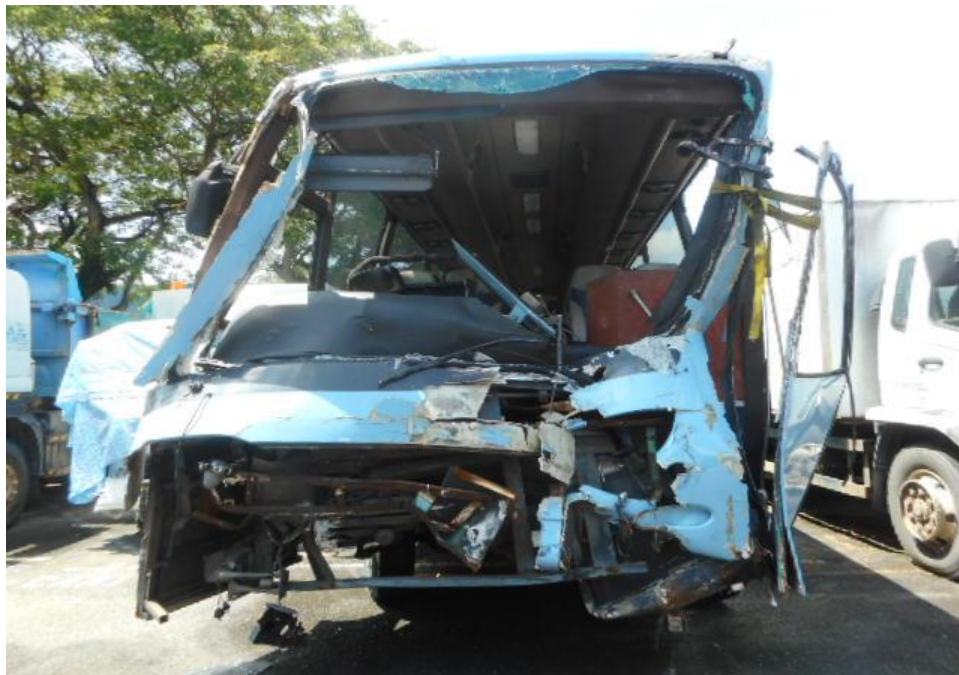
Photo 3 shows a general view of the front body of the Motor Bus at the time of my inspection. The Motor Bus was observed to sustained damage at its front portion. Its front cabin structure, front windscreen, front bumper, front body panel, front door was damaged as a result of the accident.

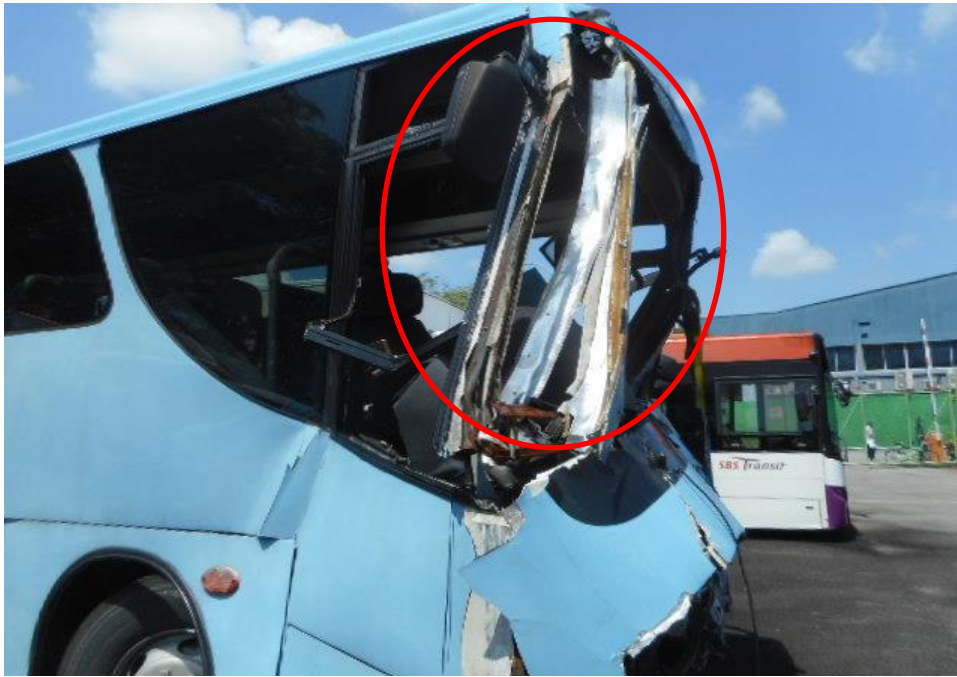
Photo 4 shows a close up view of the front body of the Motor Bus at the time of my inspection. The Motor Bus was observed to sustained damage at its front portion. Its front cabin structure (circled) were damage at the time of my inspection as a result of the accident.

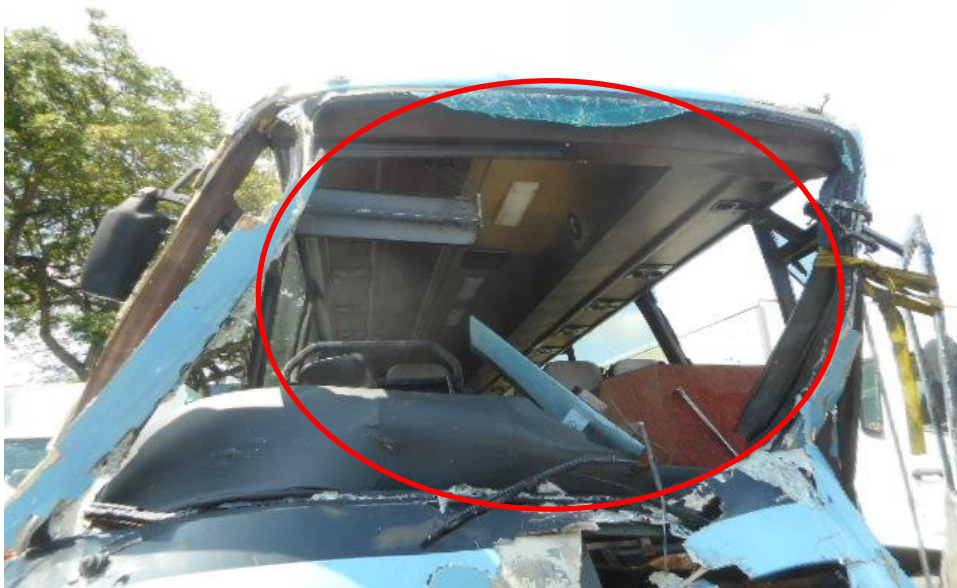
Photo 5 shows a close up view of the front body of the Motor Bus at the time of my inspection. The Motor Bus was observed to sustained damage at its front portion. Its front windscreen (circled) were damage at the time of my inspection as a result of the accident.

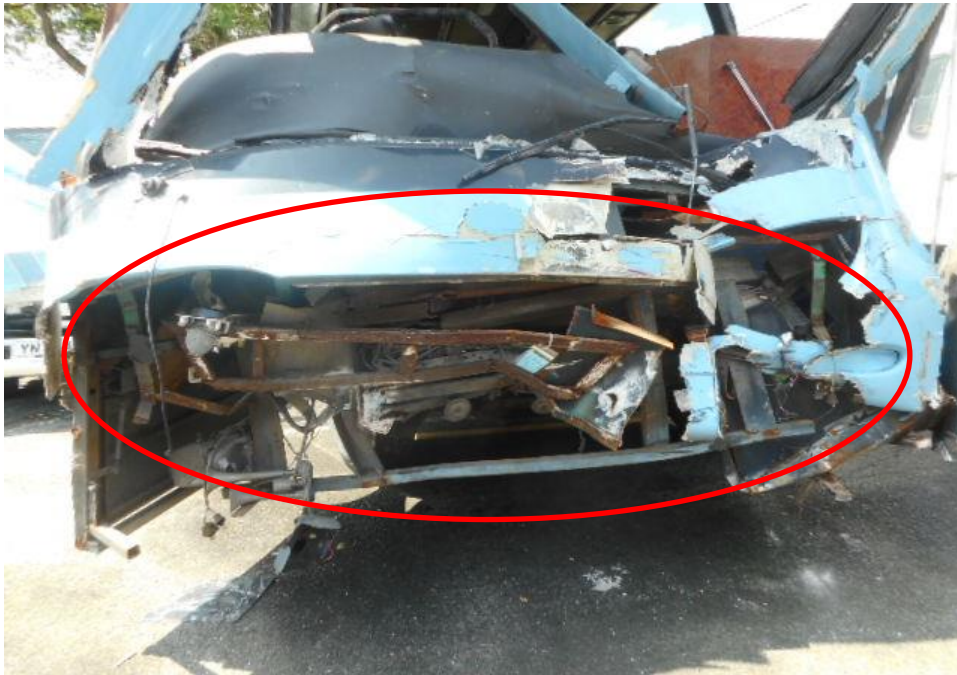
Photo 6 shows a close up view of the front body of the Motor Bus at the time of my inspection. The Motor Bus was observed to sustained damage at its front portion. Its front bumper and front body panel (circled) were damage at the time of my inspection as a result of the accident.

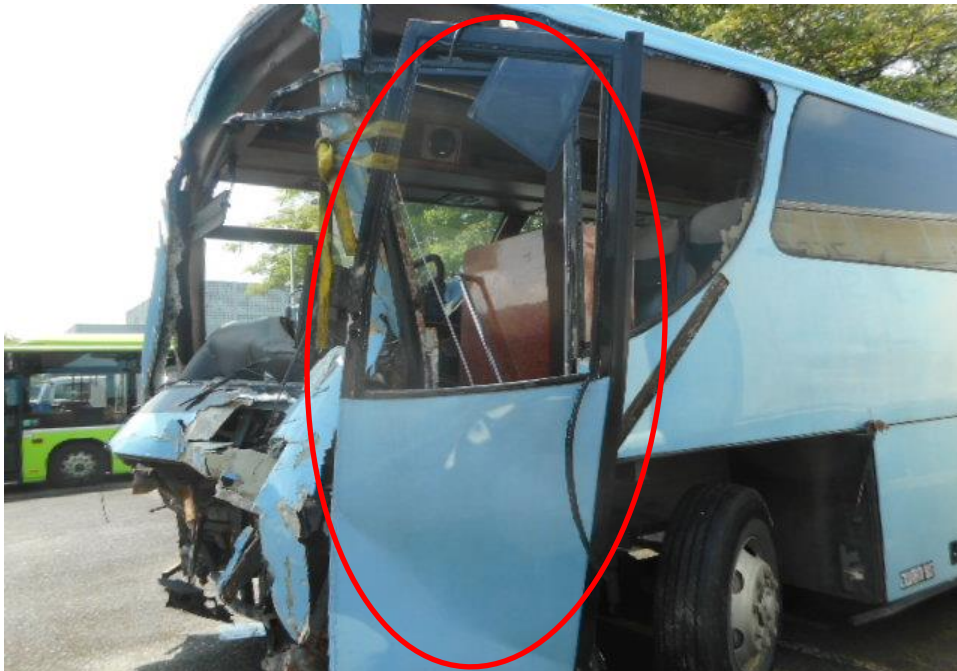
Photo 7 shows a close up of the left body of the Motor Bus at the time of my inspection. The Motor Bus was observed to sustained damage at its front portion. Its front door (circled) were damage at the time of my inspection as a result of the accident.

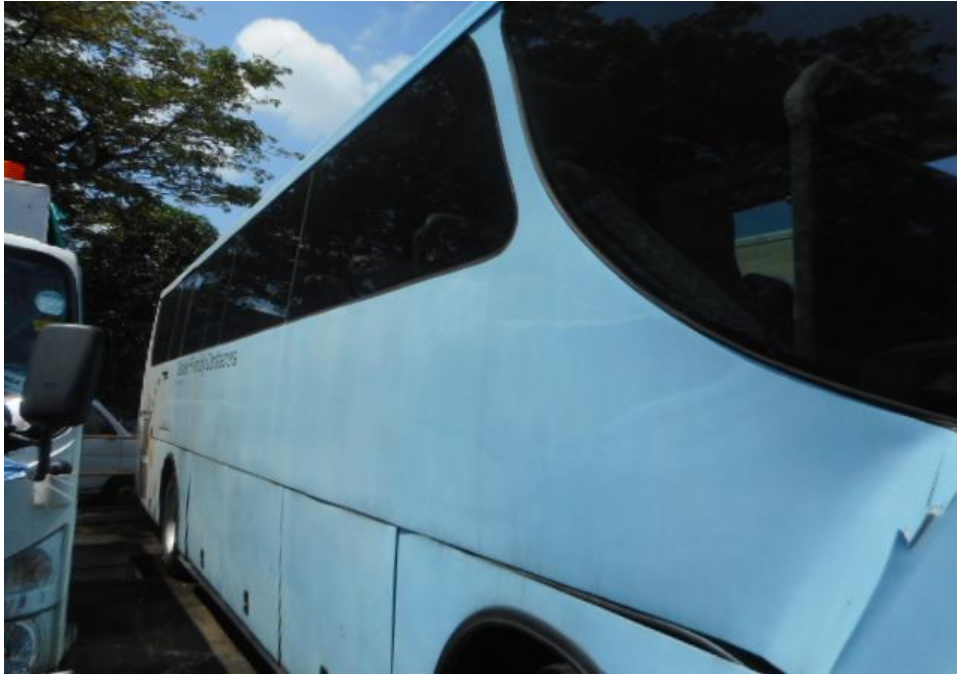
Photo 8 shows a close up view of the right portion of the Motor Bus at the time of our inspection. The right portion of the Motor Bus was observed to have been unaffected by the accident

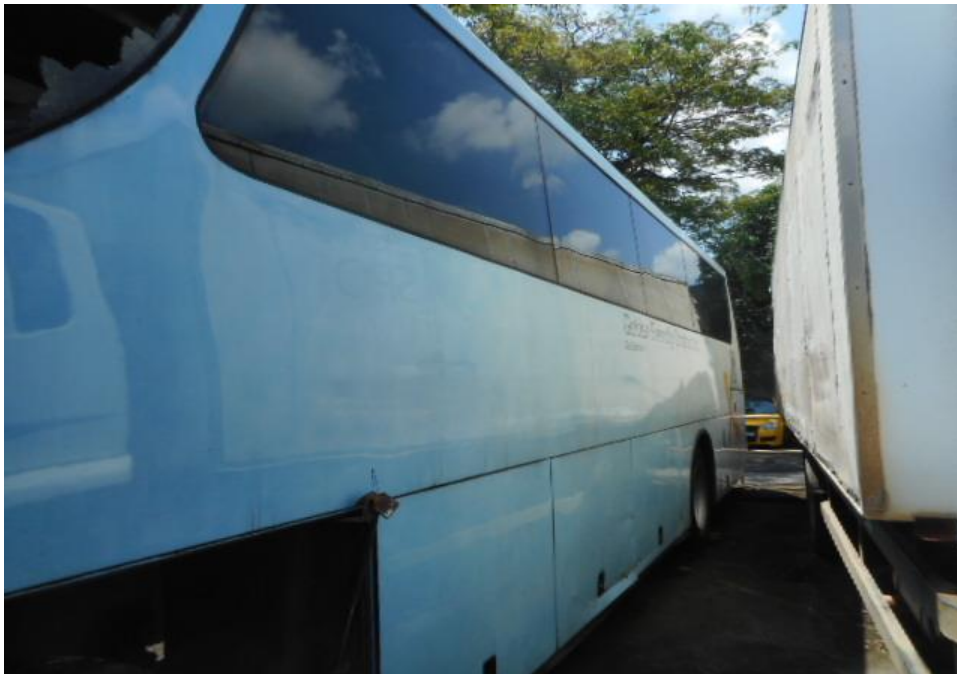
Photo 9 shows a close up view of the left portion of the Motor Bus at the time of our inspection. The left portion of the Motor Bus was observed to have been unaffected by the accident

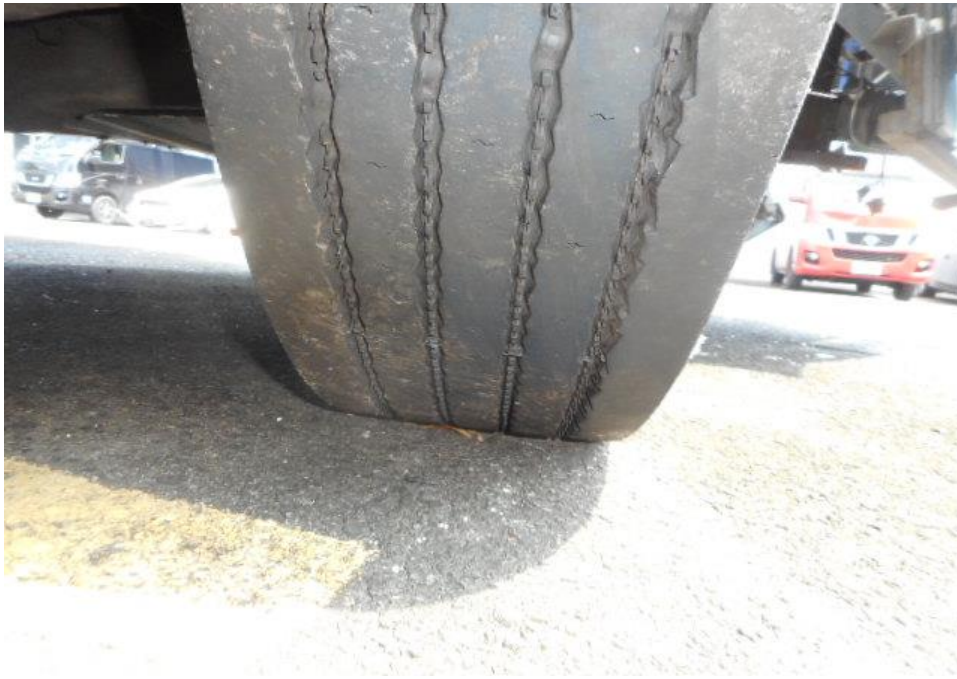
Photo 10 shows the condition of the front right tyre of the Motor Bus, which was observed to be in serviceable condition with remaining tread depth of approximately 5.8mm. The tyre, which was wrapped around standard steel wheel rim, was also observed to be sufficiently inflated for vehicular operation. There was no tear, cut or burst mark(s) on the outer and the inner sidewalls as well as across the tread of the 6 tyres that were fitted on the Motor Bus.

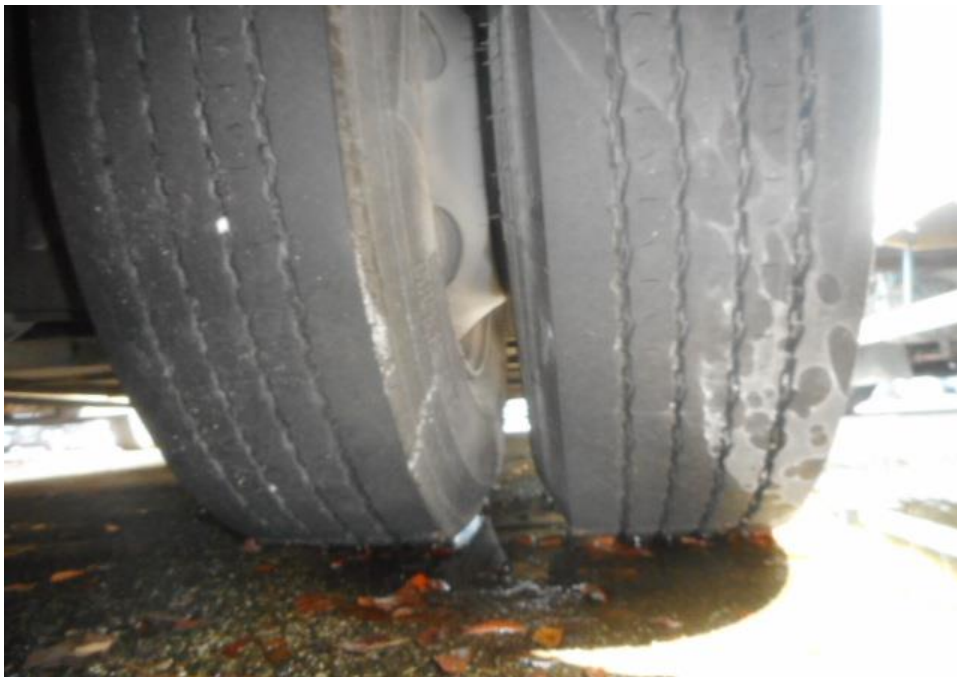
Photo 11 shows the condition of the rear right tyre of the Motor Bus, which was observed to be in serviceable condition with remaining tread depth of approximately 8.9mm. The tyre, which was wrapped around standard steel wheel rim, was also observed to be sufficiently inflated for vehicular operation.

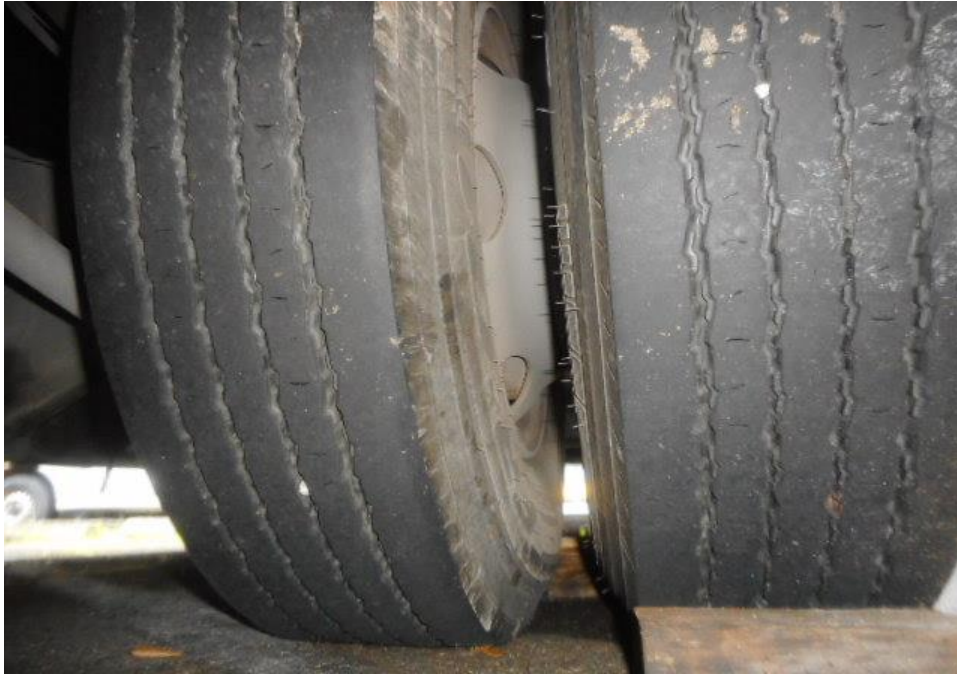
Photo 12 shows the condition of the rear left tyres of the Motor Bus, which was observed to be in serviceable condition with remaining tread depth of approximately 9mm. The tyres, which were wrapped around standard steel wheel rim, were also observed to be sufficiently inflated for vehicular operation. There was also no damage found on all 6 steel wheel rims of the Motor Bus.

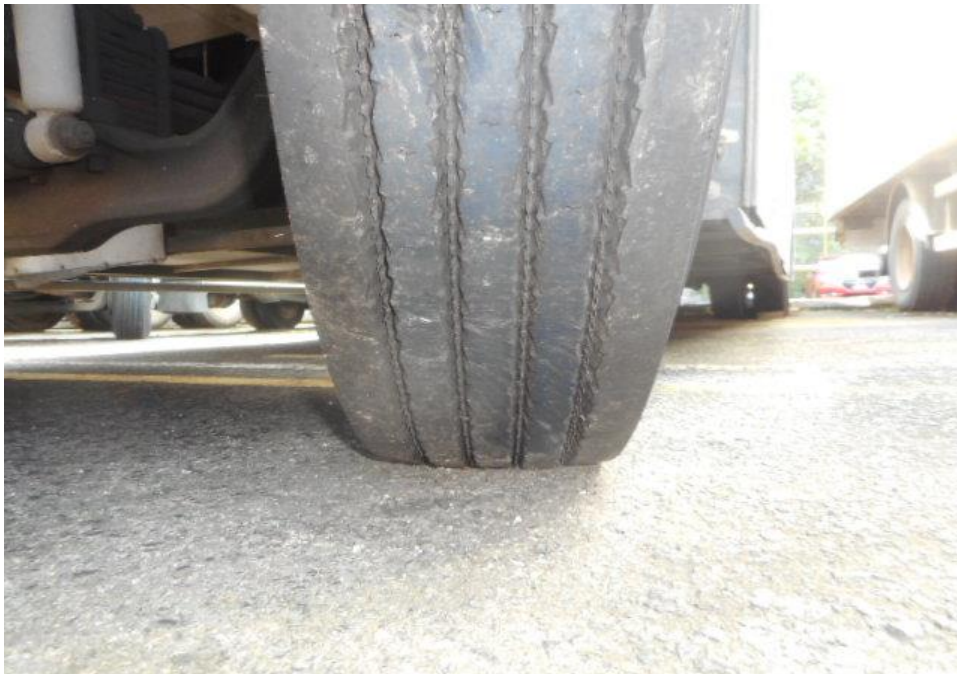
Photo 13 shows the condition of the front left tyres of the Motor Bus, which were observed to be in serviceable condition with remaining tread depth of approximately 10.2mm. There was also no tear, cut or burst mark(s) on the outer and the inner sidewalls as well as across the tread of the 6 tyres that were fitted on the Motor Bus.

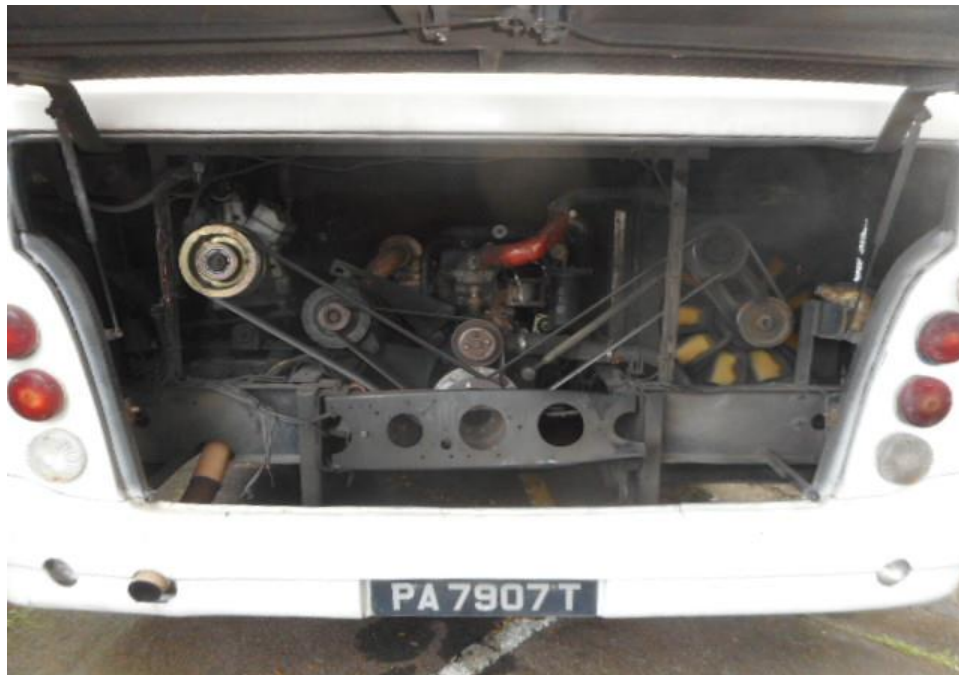
Photo 14 shows a general view of the Motor Bus's engine compartment, which was accessed by lifting the rear of the Motor Bus. The various parts and components inside the engine compartment were unaffected by the accident. There was also no sign(s) or indication(s) of fresh fluid leakage and/or fluid stain within the engine compartment

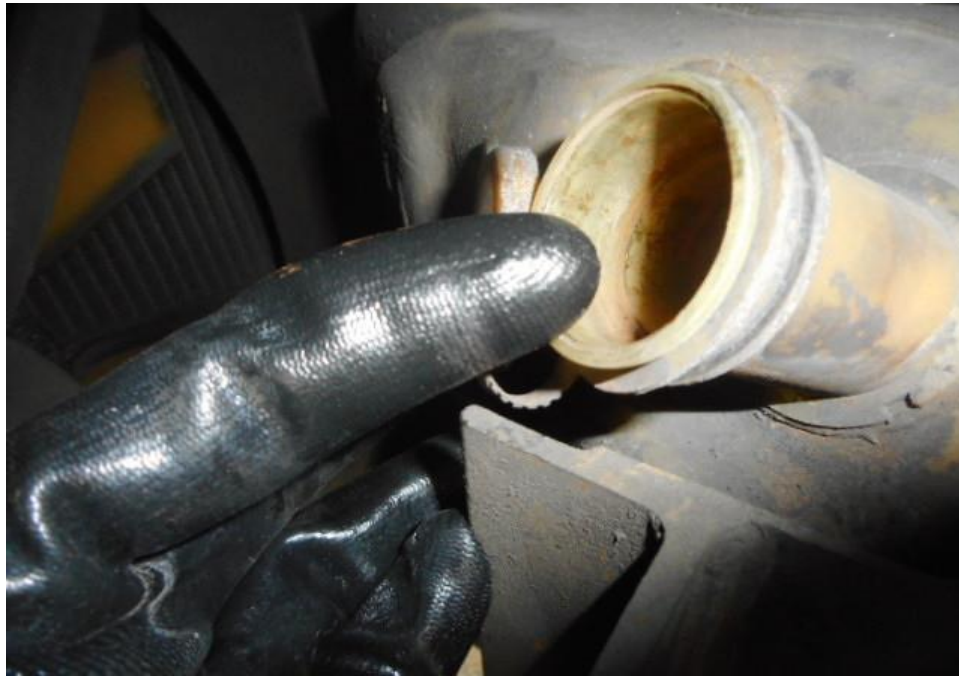
Photo 15 shows the engine coolant reservoir of the Motor Bus at the time of my inspection. The engine coolant was observed to be of insufficient level likely due to a leakage as a result of the accident.

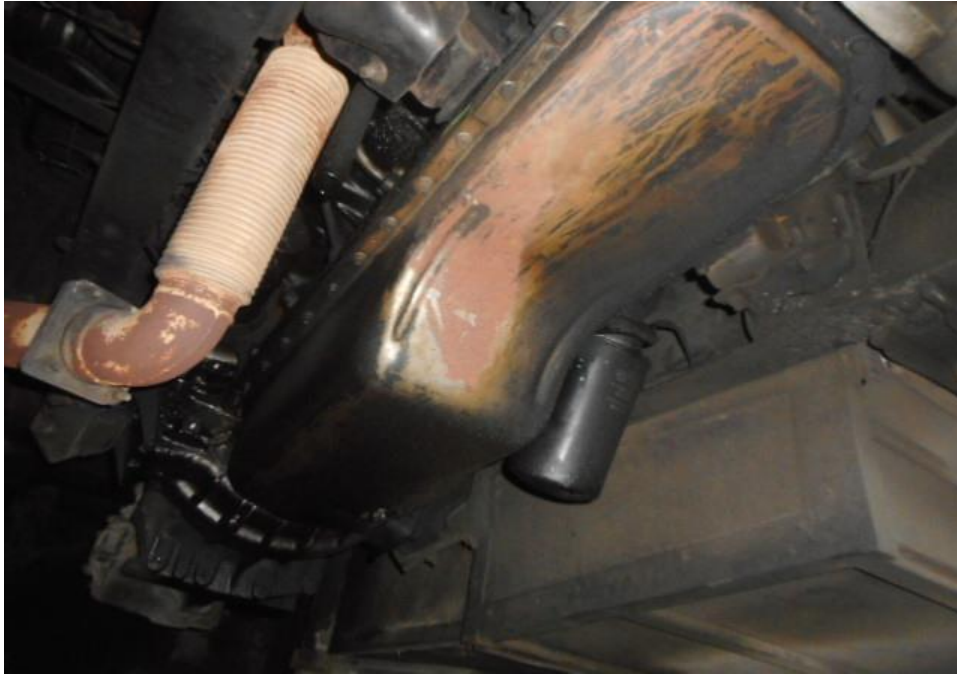
Photo 17 shows the undercarriage of the Motor Bus, at the area where the engine housing and transmission housing are located. I did not find any sign(s) or indication(s) of fluid leak and/or fluid stain(s) on the underside of the Motor Bus.

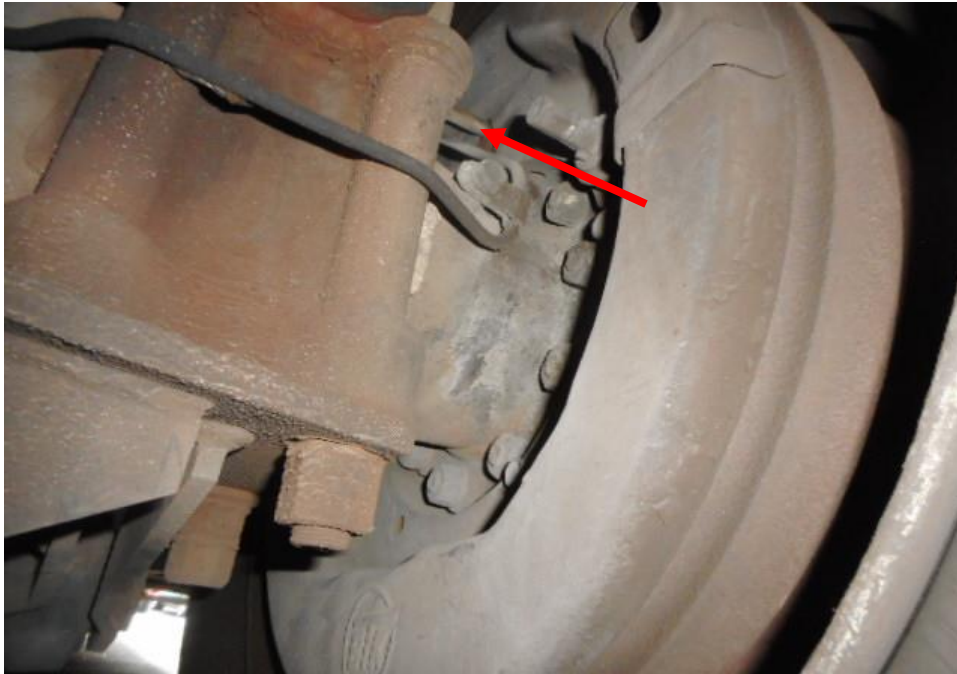
Photo 18 shows the brake pipe (arrowed) at the rear right wheel of the Motor Bus. I did not observe any leakage of brake fluid at the time of my inspection of the Motor Bus. My visual examination of the various mechanical components of the braking system where generally intact and unaffected by the accident.

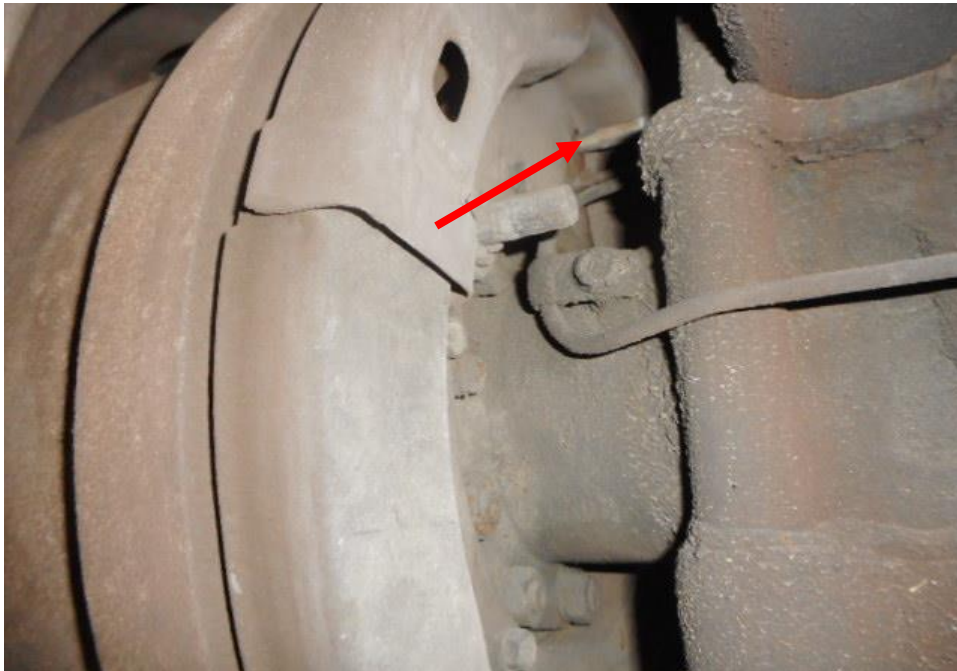
Photo 19 shows the brake pipe (arrowed) at the rear left wheel of the Motor Bus. I did not observe any leakage of brake fluid at the time of my inspection of the Motor Bus. My visual examination of the various mechanical components of the braking system where generally intact and unaffected by the accident.

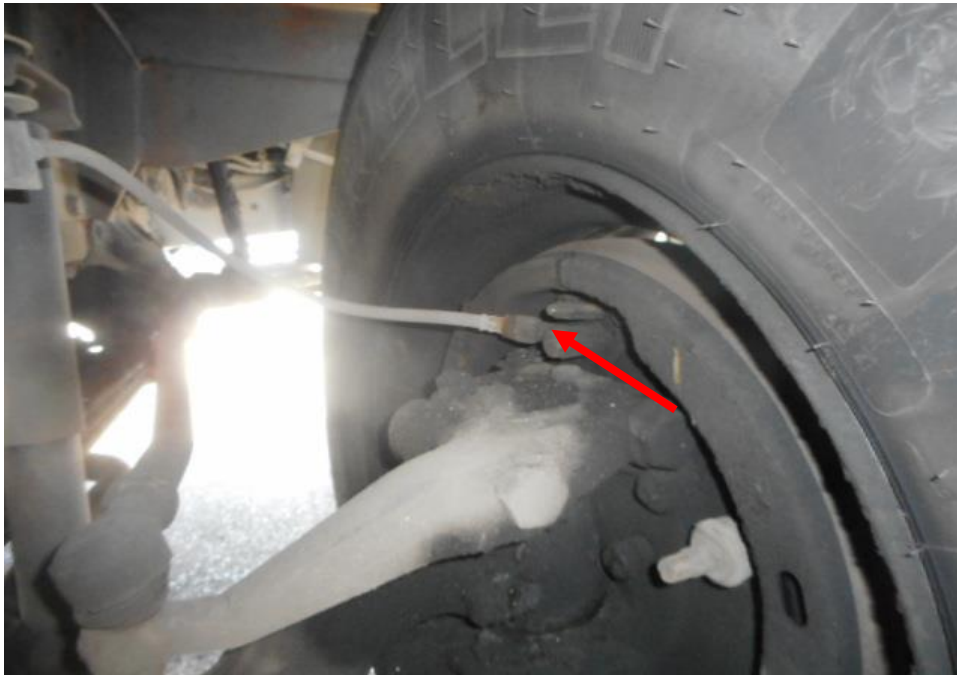
Photo 20 shows the brake pipe (arrowed) at the front right wheel of the Motor Bus. I did not observe any leakage of brake fluid at the time of my inspection of the Motor Bus. My visual examination of the various mechanical components of the braking system where generally intact and unaffected by the accident.

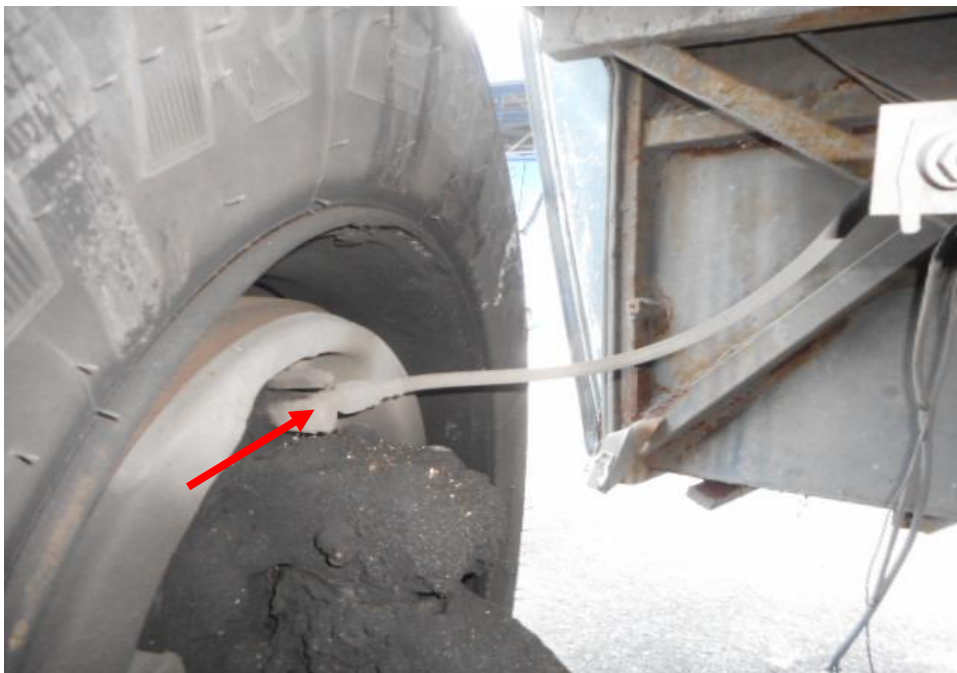
Photo 21 shows the brake pipe (arrowed) at the front left wheel of the Motor Bus. I did not observe any leakage of brake fluid at the time of my inspection of the Motor Bus. My visual examination of the various mechanical components of the braking system where generally intact and unaffected by the accident.

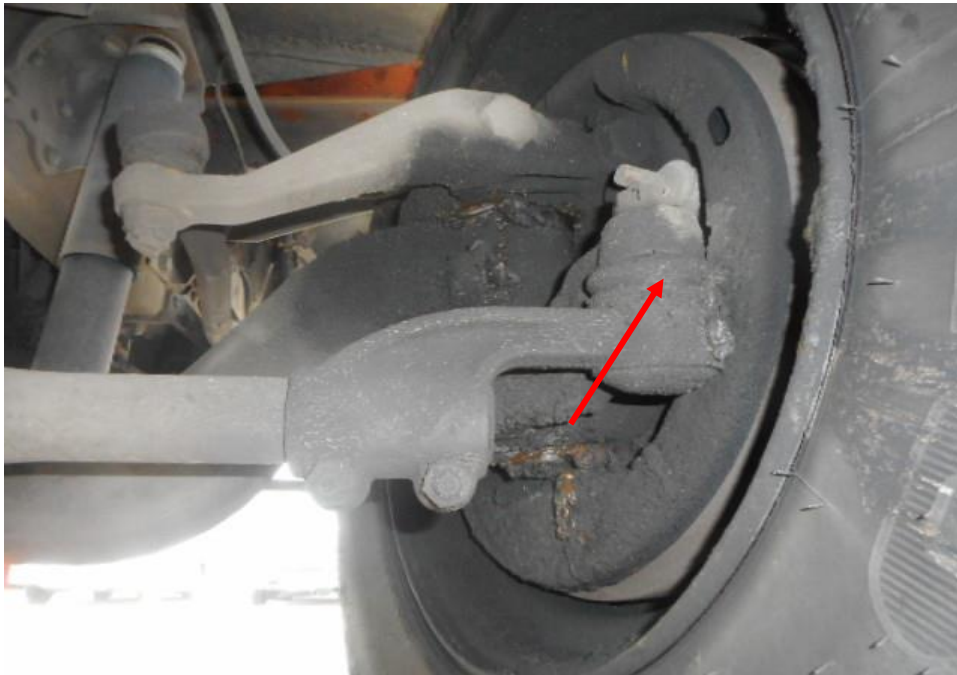
Photo 22 shows the various undercarriage components at the front right wheel of the Motor Bus, in particular the steering tie rod end (arrowed). The various steering components were all found to be intact. There was also no sign of fluid stain(s) observed on the various undercarriage components.

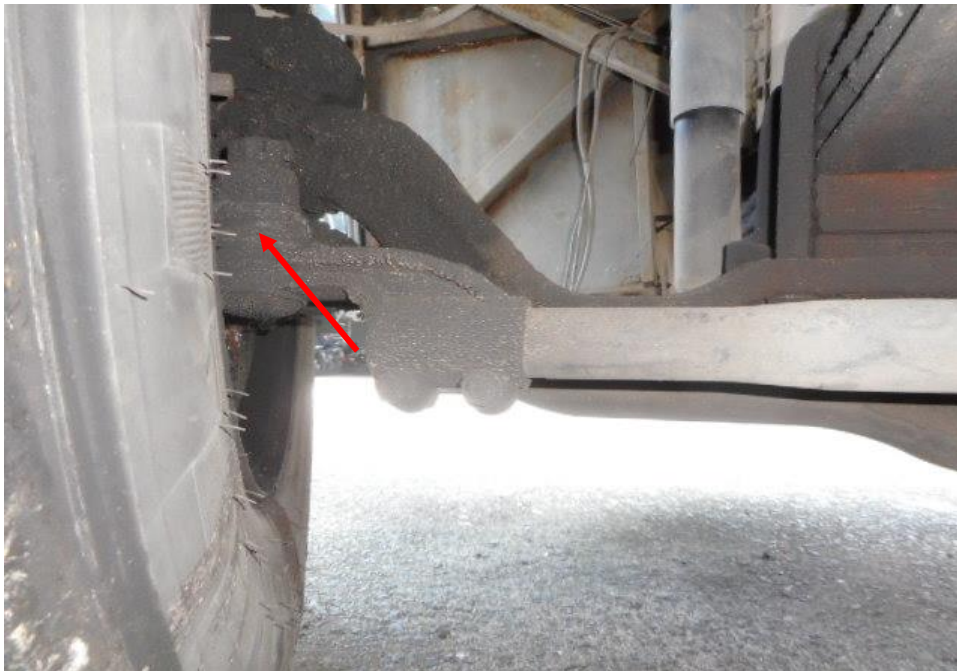
Photo 23 shows the various undercarriage components at the front left wheel of the Motor Bus, in particular the steering tie rod end (arrowed). The various steering components were all found to be intact. There was also no sign of fluid stain(s) observed on the various undercarriage components.

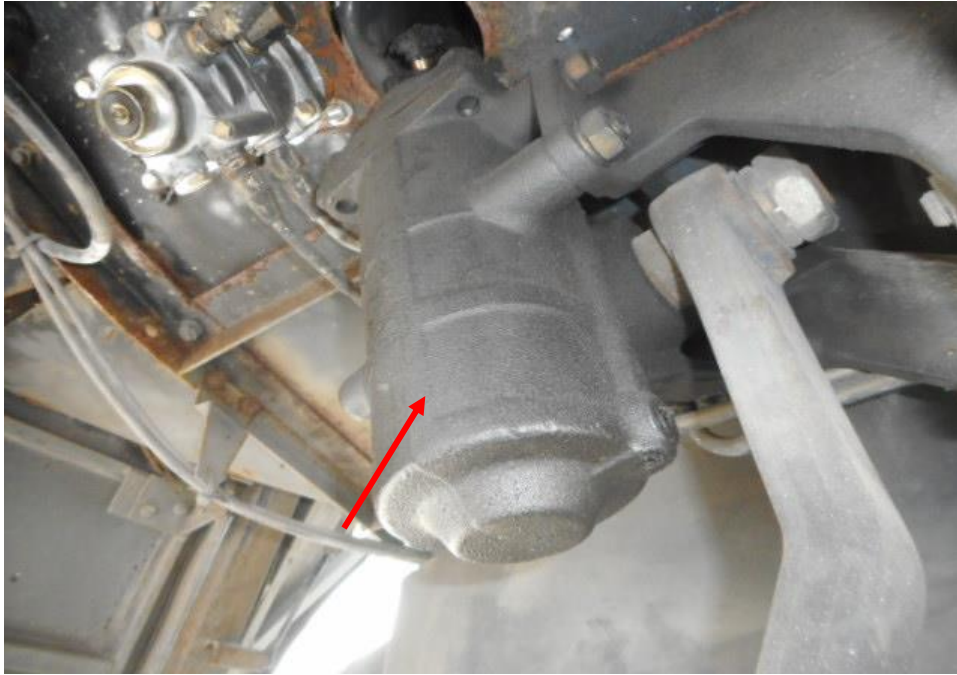
Photo 24 shows the steering box component (arrowed) at the undercarriage of the Motor Bus was found to be intact without any visible damage. There was also no sign of fluid stain(s) observed on the various undercarriage components.
