Your Ref: TP/IP/07242/2022
Our Ref : CI/TPD22003614/P

25th May 2022

MECHANICAL INSPECTION REPORT OF MOTOR BUS PC 9002E

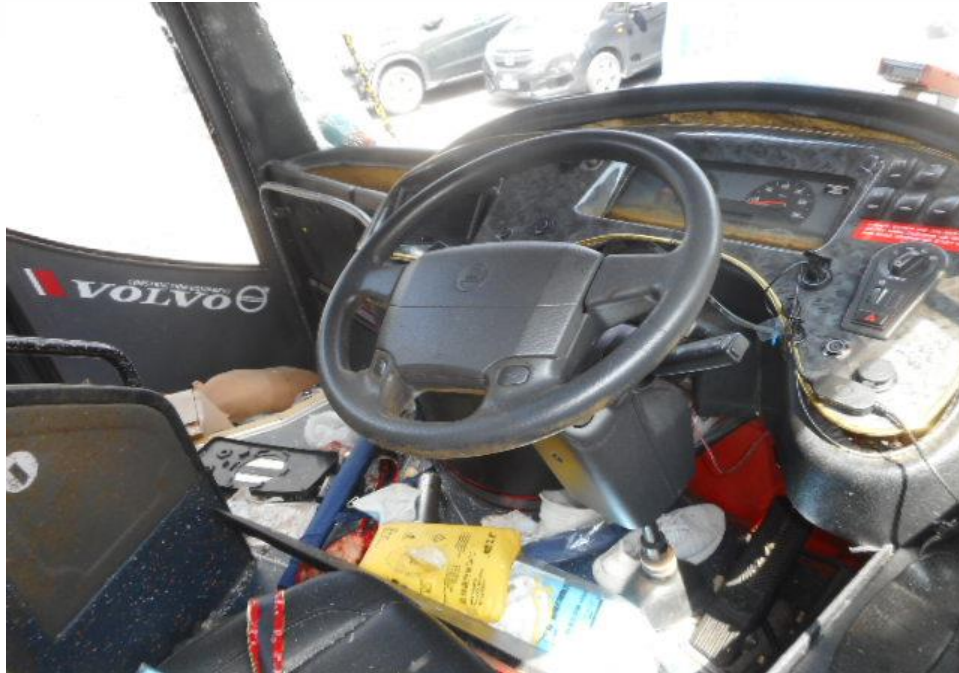
4. The mileage of the Motor Bus at the time of our inspection was not able to be recorded as the whole dashboard including the odometer has been damaged by the accident.
5. The Motor Bus was observed to have sustained damages at its frontal, left and right portion. Its front windscreen, front bumper, front door, right and left body panels as well as its windscreens was observed to be damaged at time of our inspection.

Photo 1 shows the damaged instrument cluster. Therefore no mileage is recorded at the time of our inspection.

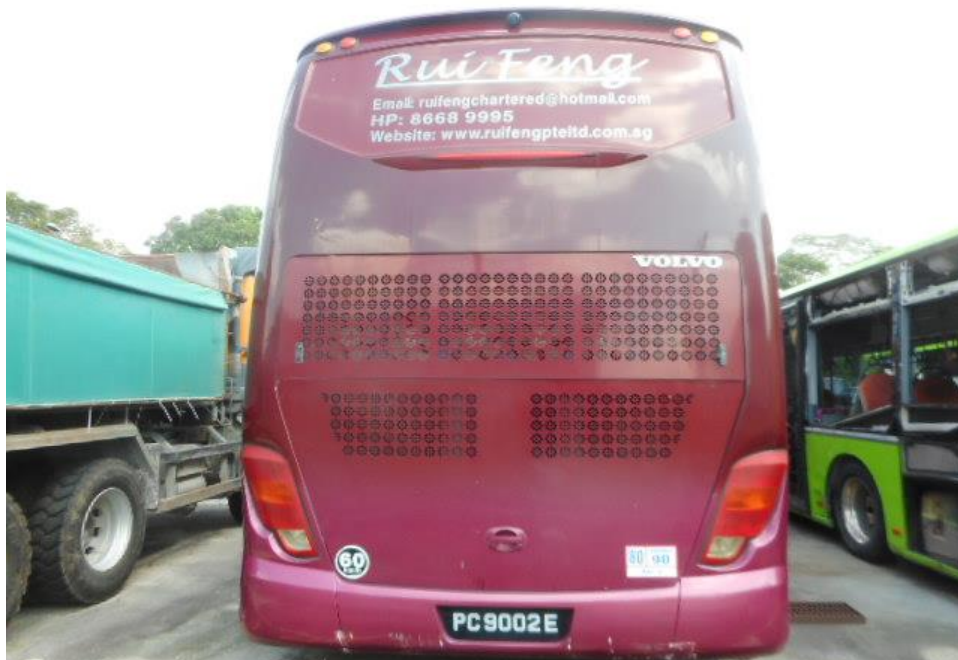
Photo 2 shows a close up view of the rear portion of the Motor Bus at the time of our inspection. The right portion of the Motor Bus was observed to have been unaffected by the accident.

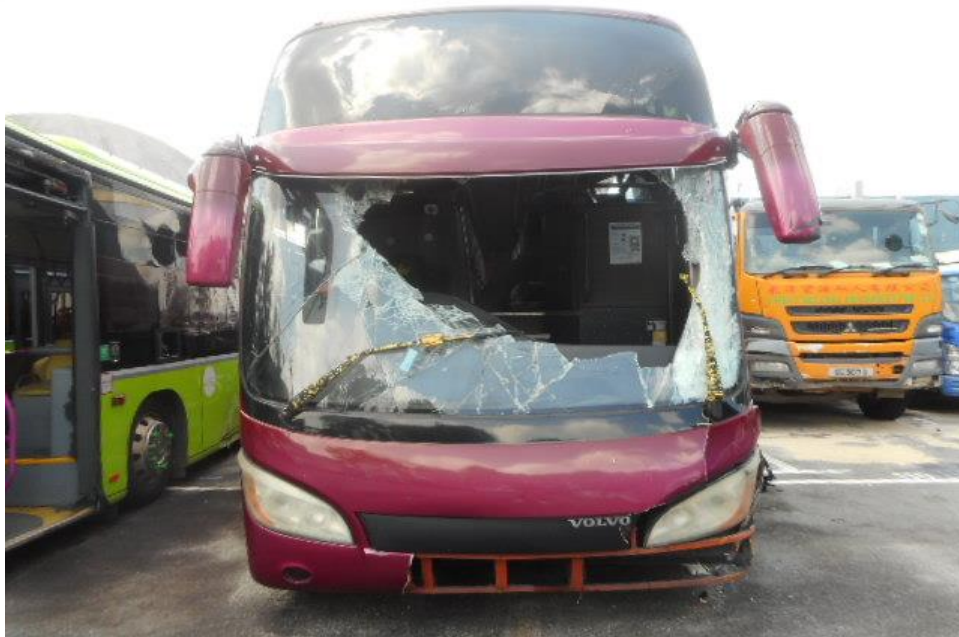
Photo 3 shows a general view of the front body of the Motor Bus at the time of our inspection. The Motor Bus was observed to have sustained damages at its front windscreen, front bumper, front door, right & left body panels as well as its windscreens was observed to be damaged at time of our inspection.

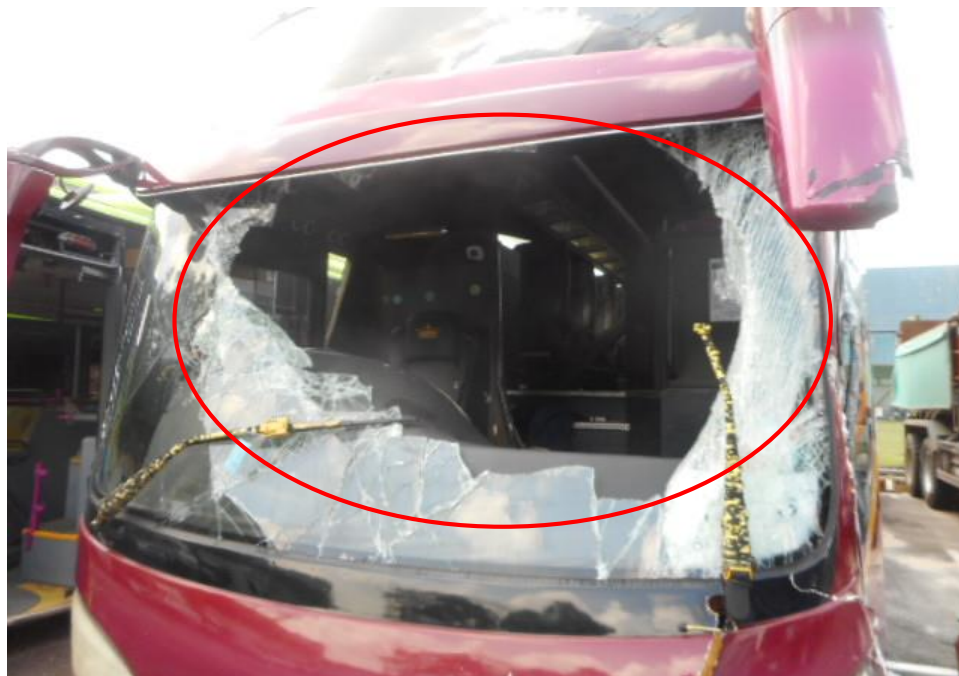
Photo 4 shows a close up view of the front body of the Motor Bus at the time of our inspection. The Motor Bus was observed to have sustained damages at its front windscreen (circled) as a result of the accident.

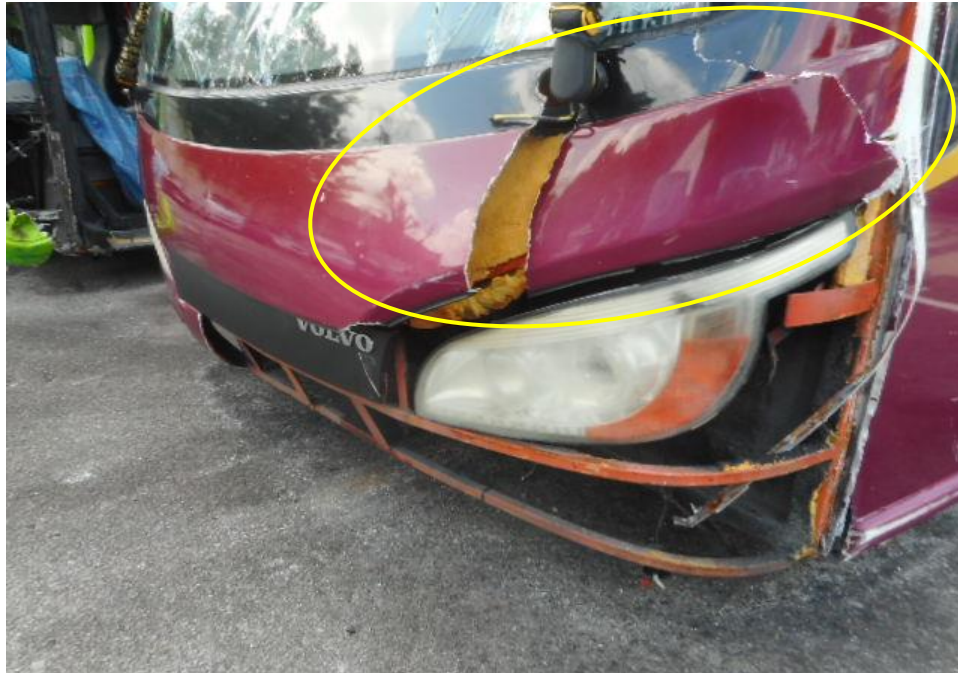
Photo 5 shows a close up view of the front body of the Motor Bus at the time of our inspection. The Motor Bus was observed to have sustained damages at its front bumper (circled) as a result of the accident.

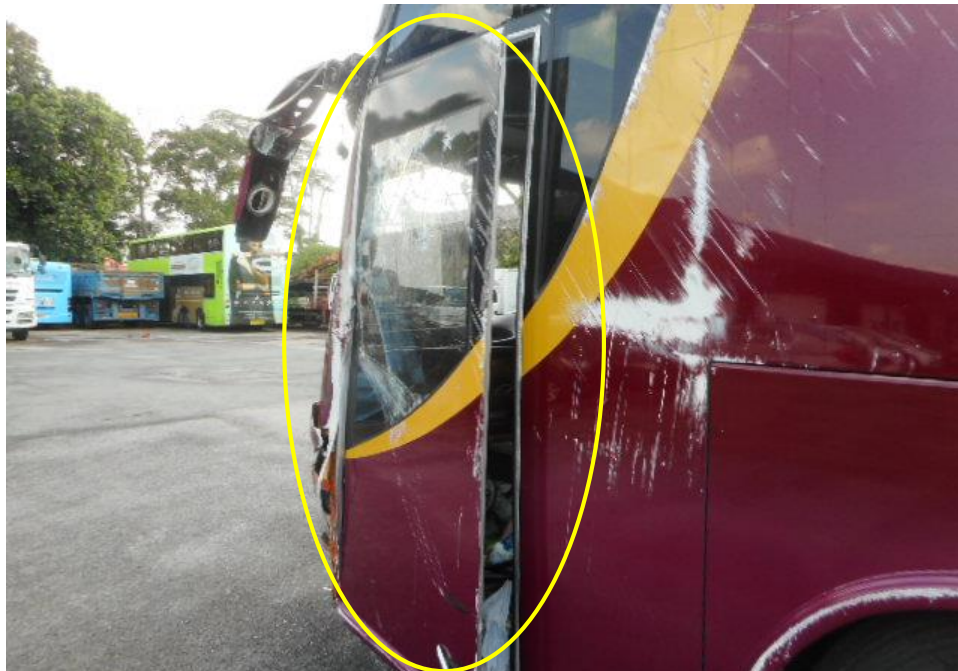
Photo 6 shows a close up view of the front body of the Motor Bus at the time of our inspection. The Motor Bus was observed to have sustained damages at its front door (circled) as a result of the accident.

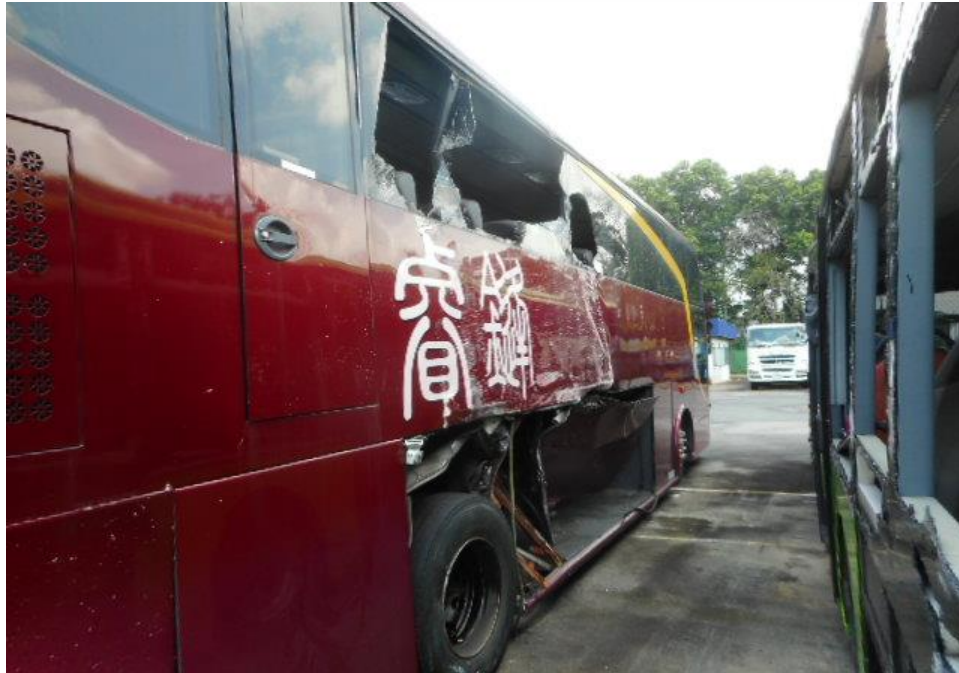
Photo 7 shows a general view of the right side of the Motor Bus at the time of our inspection. The Motor Bus was observed to have sustained damages at its right body panels and windscreens as a result of the accident.

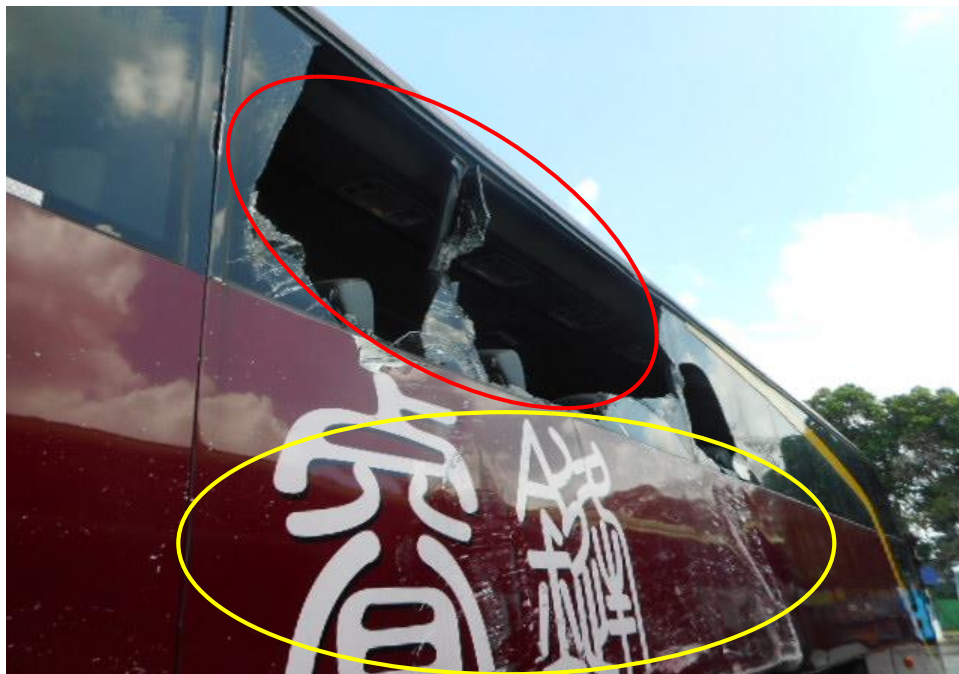
Photo 8 shows a close up view of the right side of the Motor Bus at the time of our inspection. The Motor Bus was observed to have sustained damages at its right body panels (yellow circle) and windscreens (red circle) as a result of the accident.

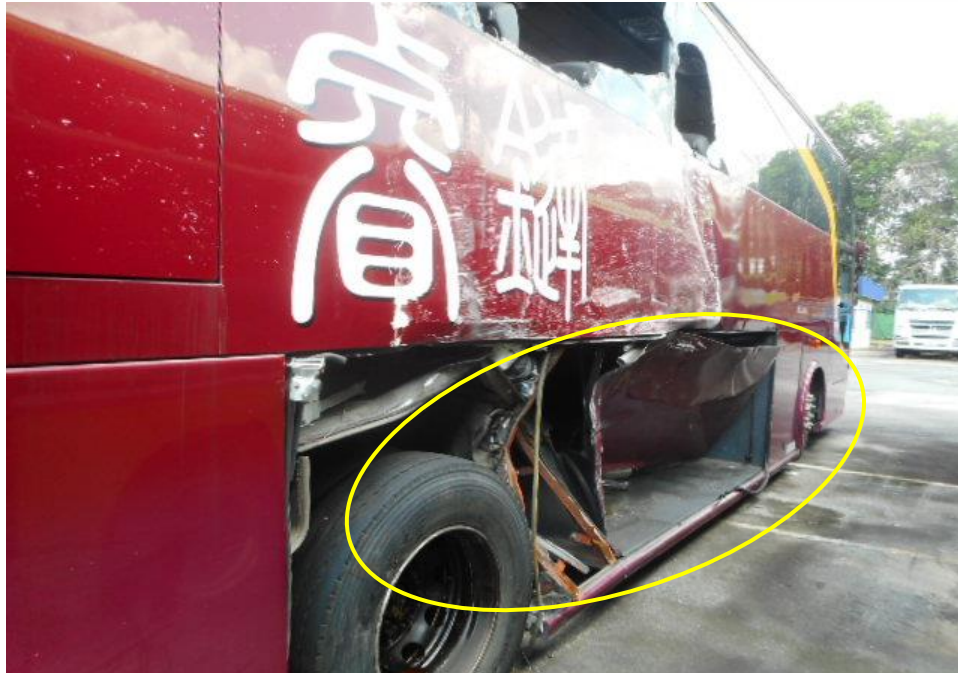
Photo 9 shows a close up view of the right side of the Motor Bus at the time of our inspection. The Motor Bus was observed to have sustained damages at its right body panels (yellow circle) as a result of the accident.

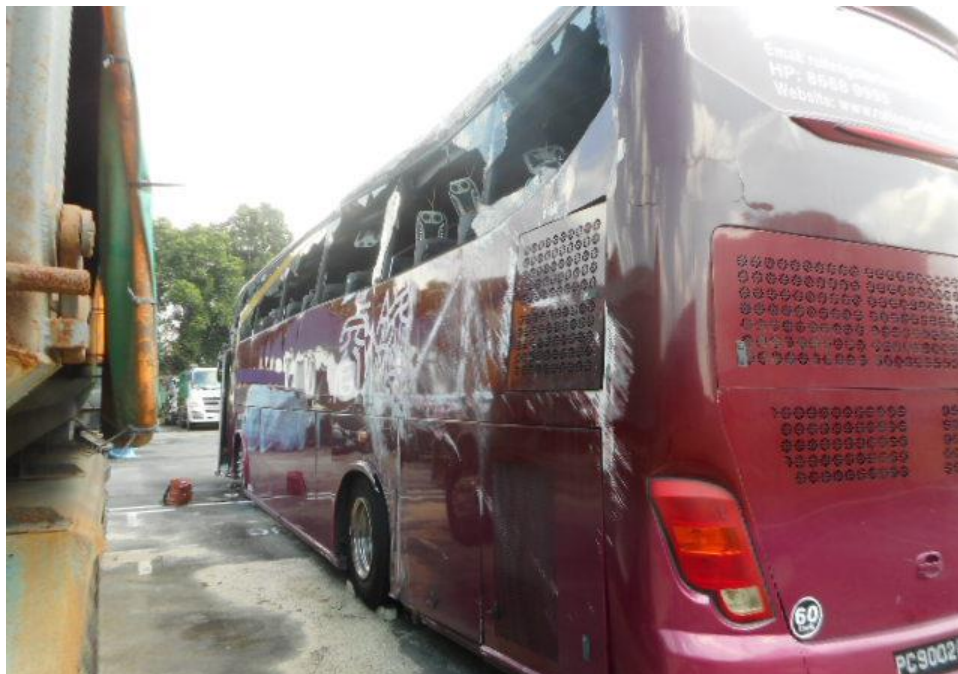
Photo 10 shows a general view of the left side of the Motor Bus at the time of our inspection. The Motor Bus was observed to have sustained damages at its left body panels and windcreens as a result of the accident.

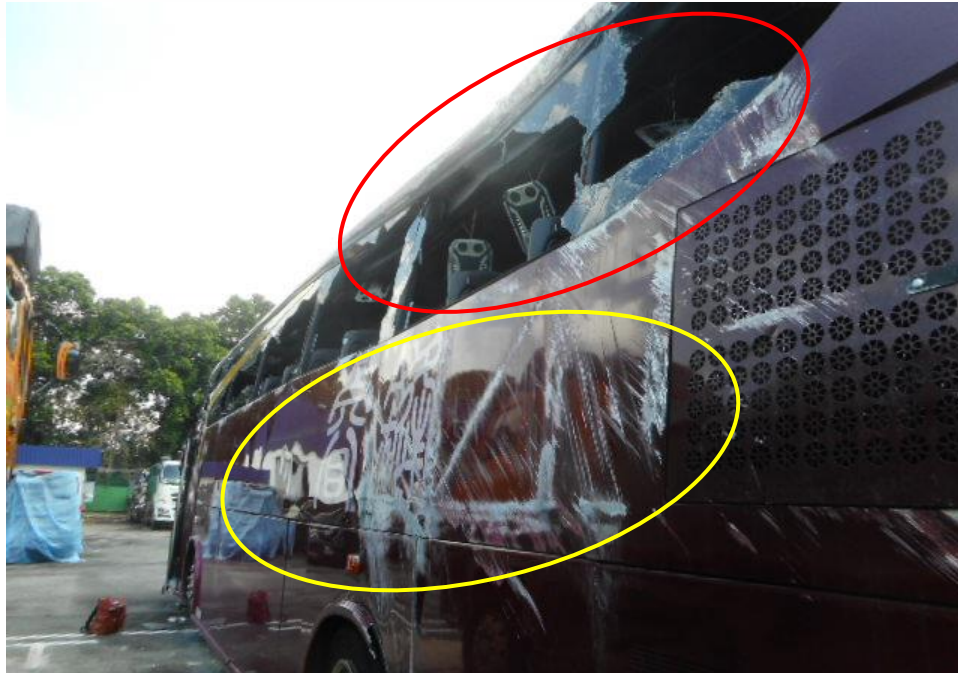
Photo 11 shows a close up view of the left side of the Motor Bus at the time of our inspection. The Motor Bus was observed to have sustained damages at its left body panels (yellow circle) and windscreens (red circle) as a result of the accident.

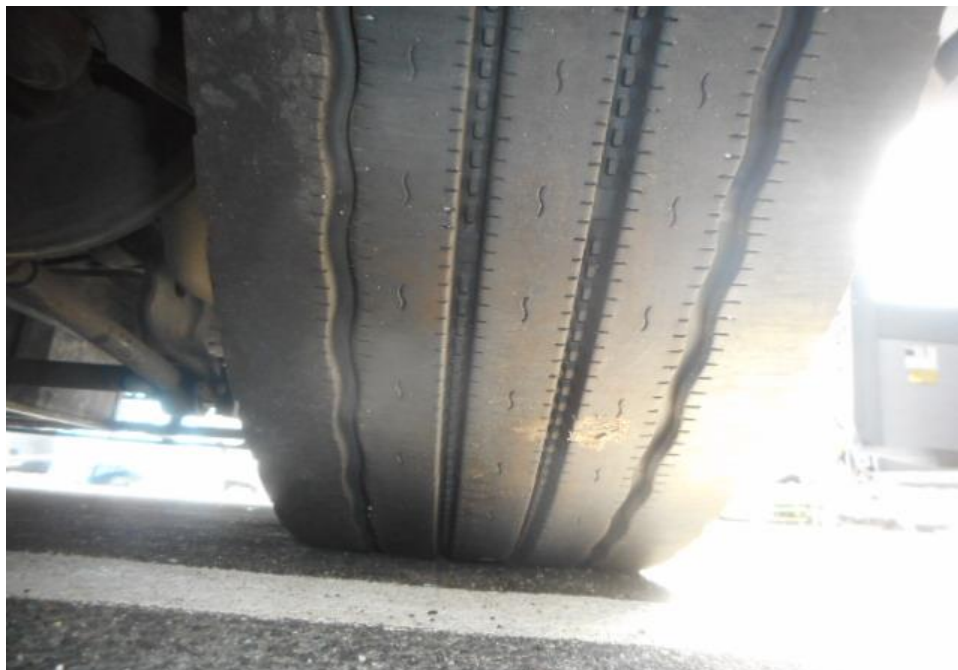
Photo 12 shows the condition of the front right tyre of the Motor Bus, which was observed to be in serviceable condition with remaining tread depth of approximately 11.1mm. The tyre was also observed to be sufficiently inflated for vehicular operation.

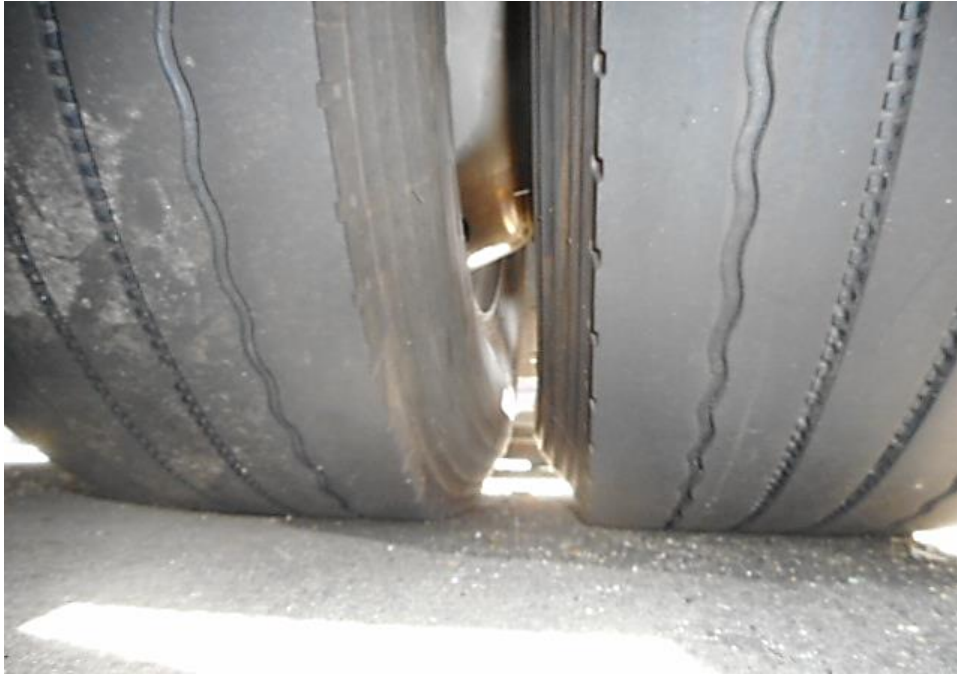
Photo 13 shows the condition of the rear right tyre of the Motor Bus, which was observed to be in serviceable condition with remaining tread depth of approximately 7.8mm. The tyre was also observed to be sufficiently inflated for vehicular operation.

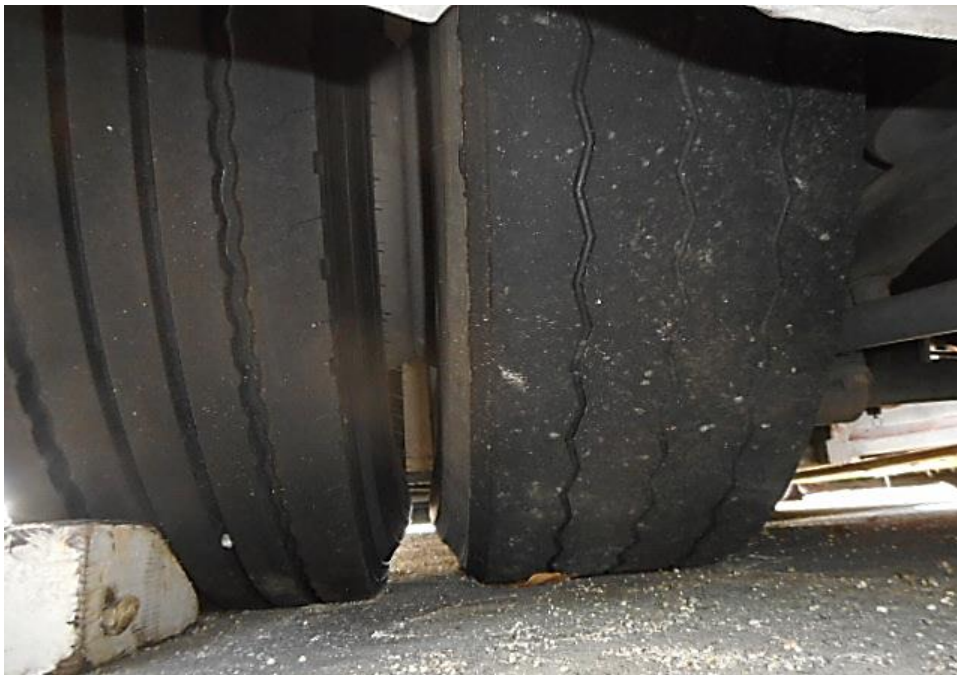
Photo 14 shows the condition of the rear right tyres of the Motor Bus, which were observed to be in serviceable condition with remaining tread depth of approximately 10.5mm. The tyres, which were wrapped around standard alloy wheel rims, were also observed to be sufficiently inflated for vehicular operation.

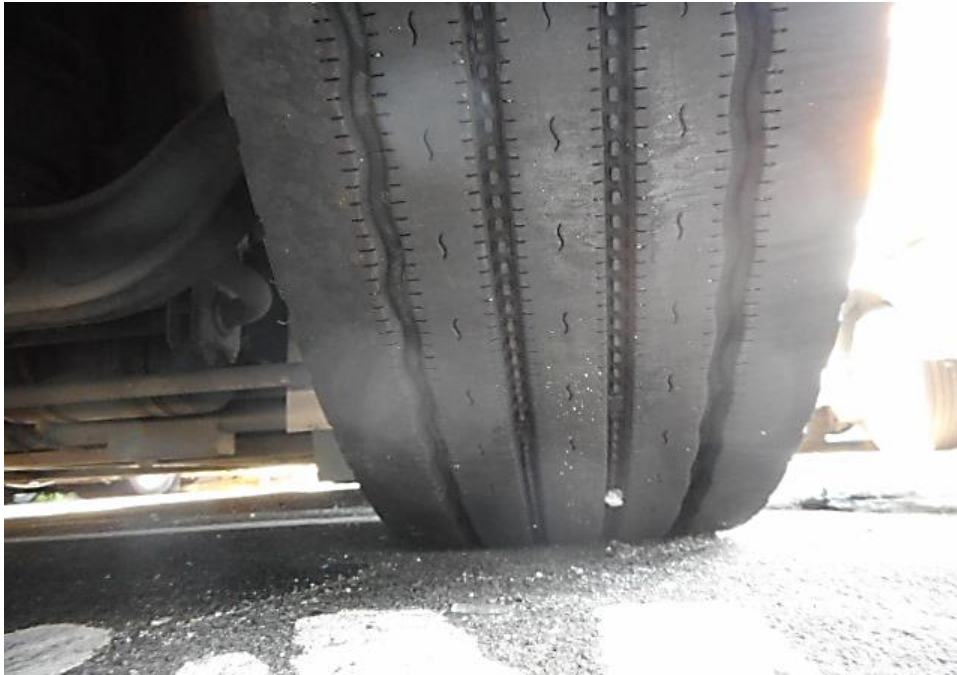
Photo 15 shows the condition of the front left tyre of the Motor Bus, which was observed to be in serviceable condition with remaining tread depth of approximately 13.5mm. The tyre was also observed to be sufficiently inflated for vehicular operation.

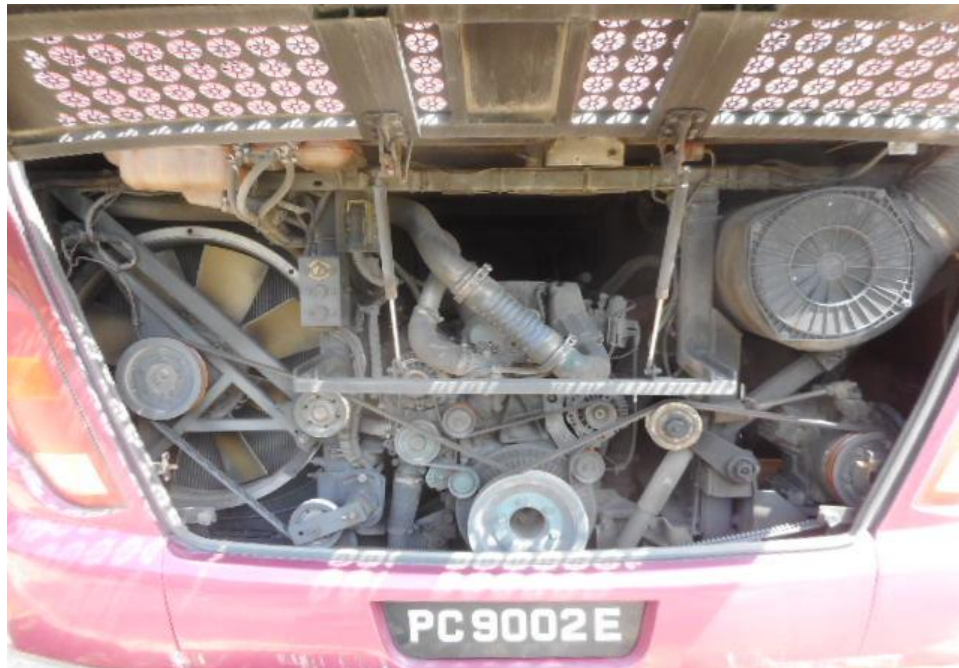
Photo 16 shows a general view of the Motor Bus engine compartment. The various parts and components inside the engine compartment were unaffected by the accident. There was also no sign(s) or indication(s) of fluid leakage and/or fluid stain within the engine compartment.

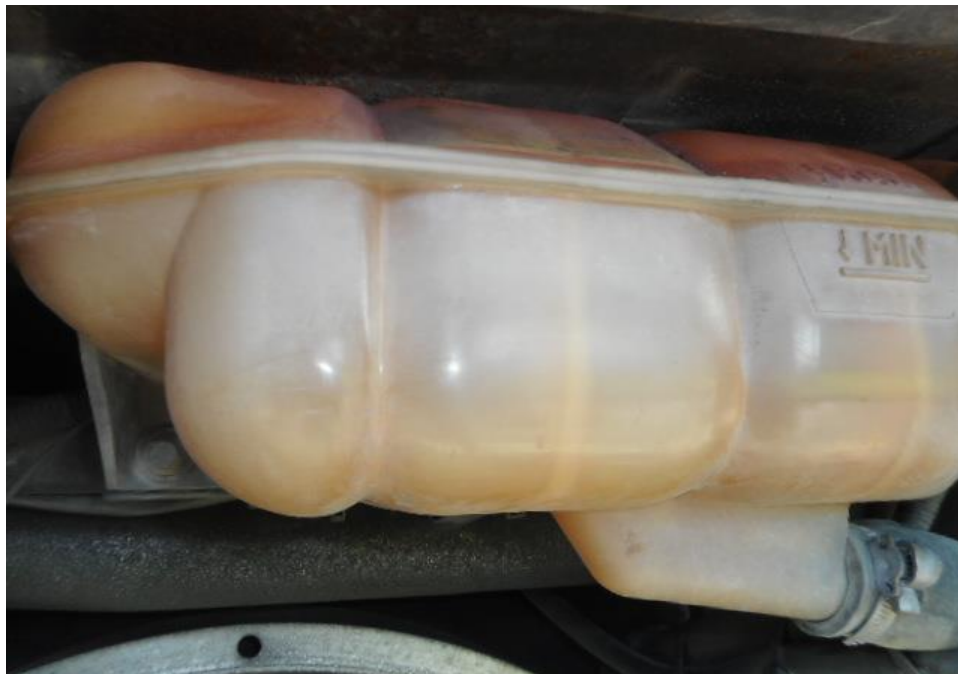
Photo 17 shows checks being carried out to the engine coolant of the Motor Bus at the time of my inspection. The engine coolant was observed to be of insufficient level.

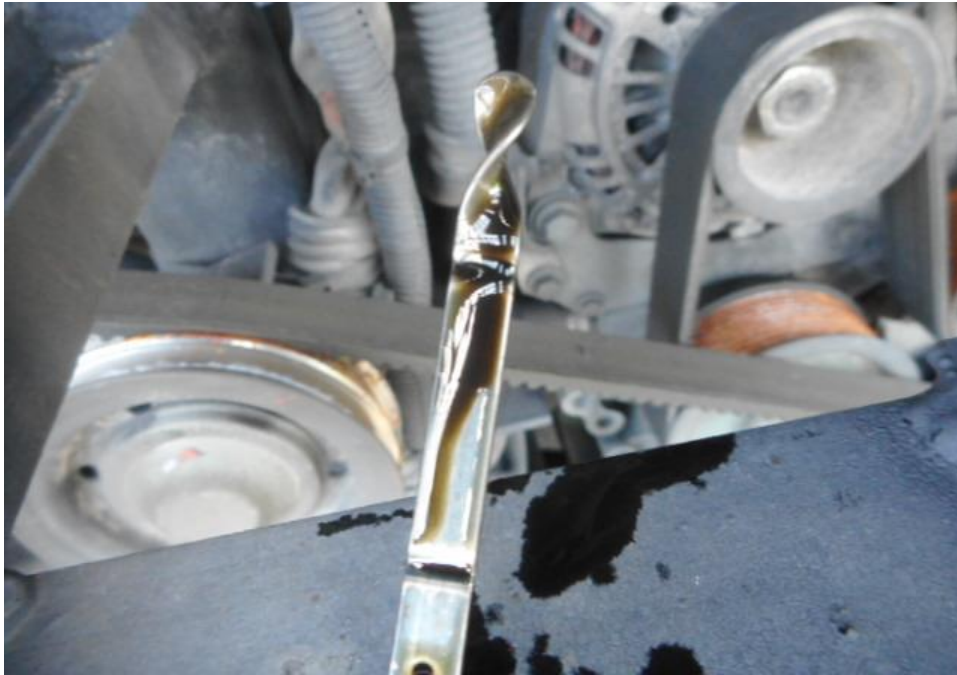
Photo 18 shows the engine oil dipstick of the Motor Bus at the time of my inspection. The engine oil was observed to be of sufficient level and without any visible contamination.

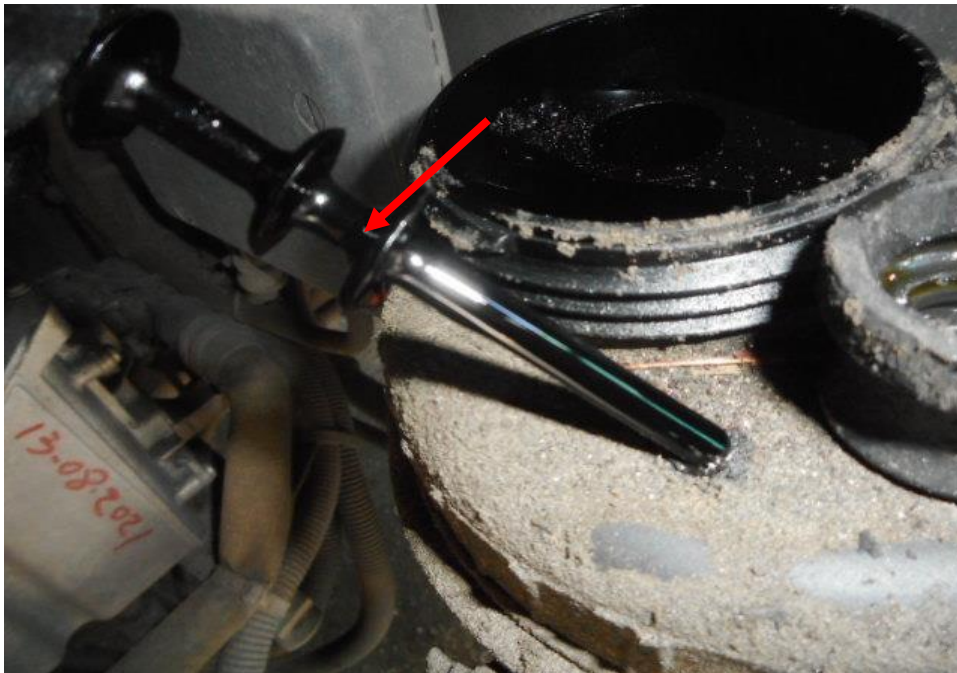
Photo 19 shows the power steering fluid reservoir of the Motor Bus at the time of my inspection. The power steering fluid was observed to be of sufficient level (arrowed) and without any visible contamination.

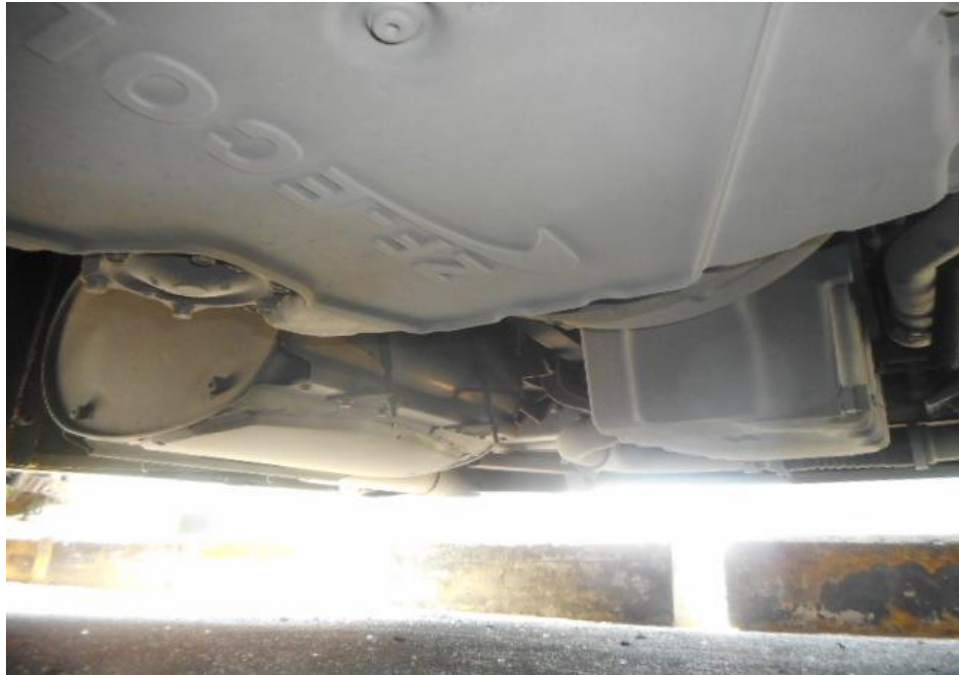
Photo 20 shows the undercarriage of the Motor Bus, at the area where the engine housing and transmission housing are located. I did not find any sign(s) or indication(s) of fluid leak and/or fluid stain(s) on the underside of the Motor Bus.

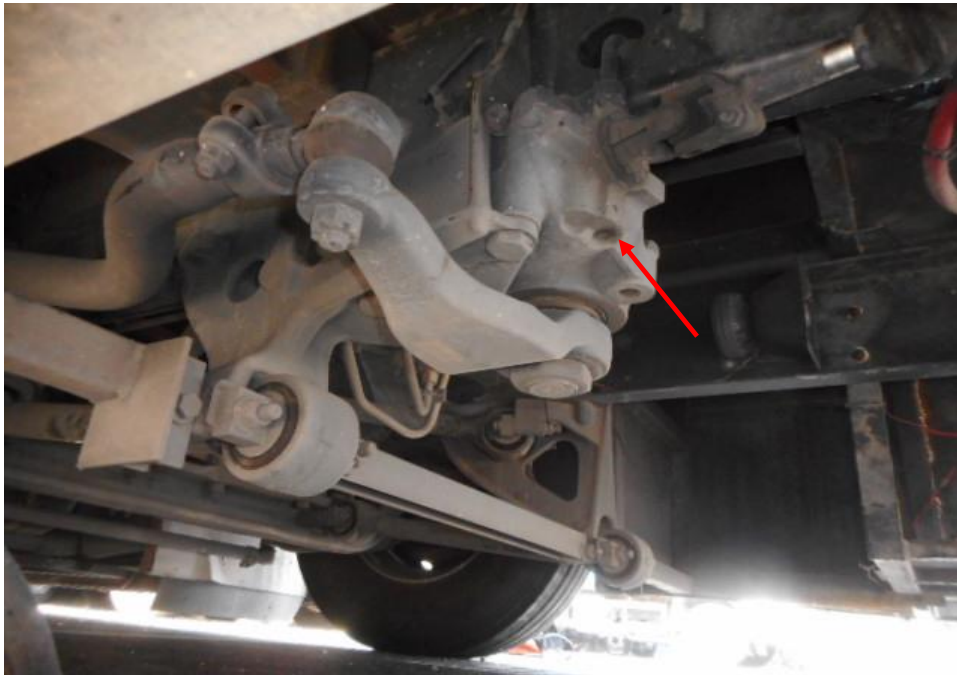
Photo 21 shows the steering box components (arrowed) of the Motor Bus's steering system. The steering system of the Motor Bus shows to be intact and not damaged by the accident.

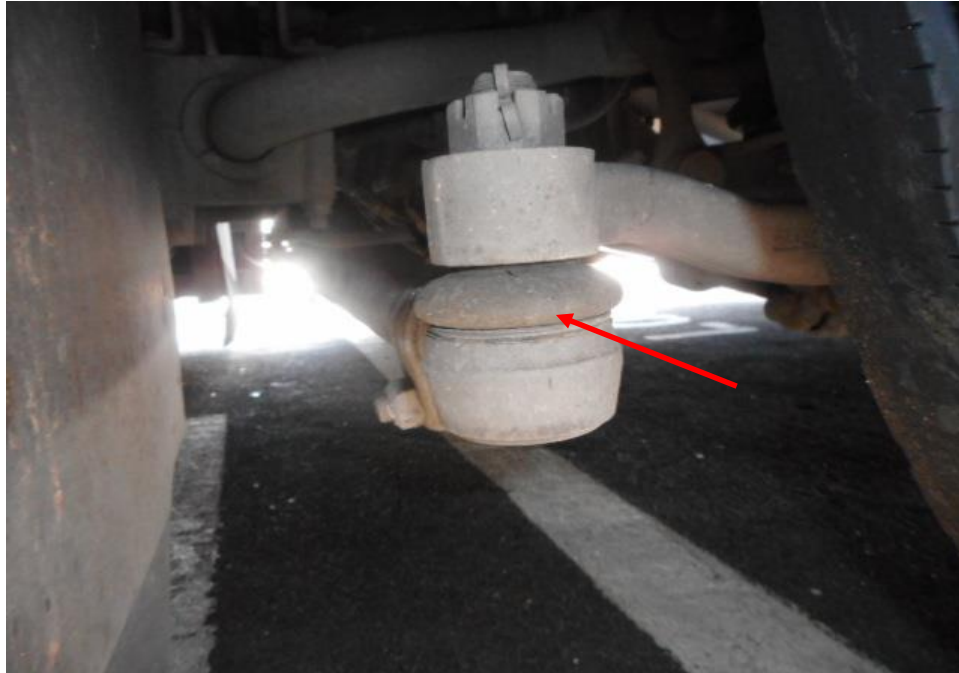
Photo 22 shows the front right wheel components of the front steering system of the Motor Bus. The various undercarriage components of the Motor Bus were all observed to be intact and without any visible damage. This had included the steering rack and steering ball joints (arrowed) of the Motor Bus, which were observed to be securely attached to the front right wheel.

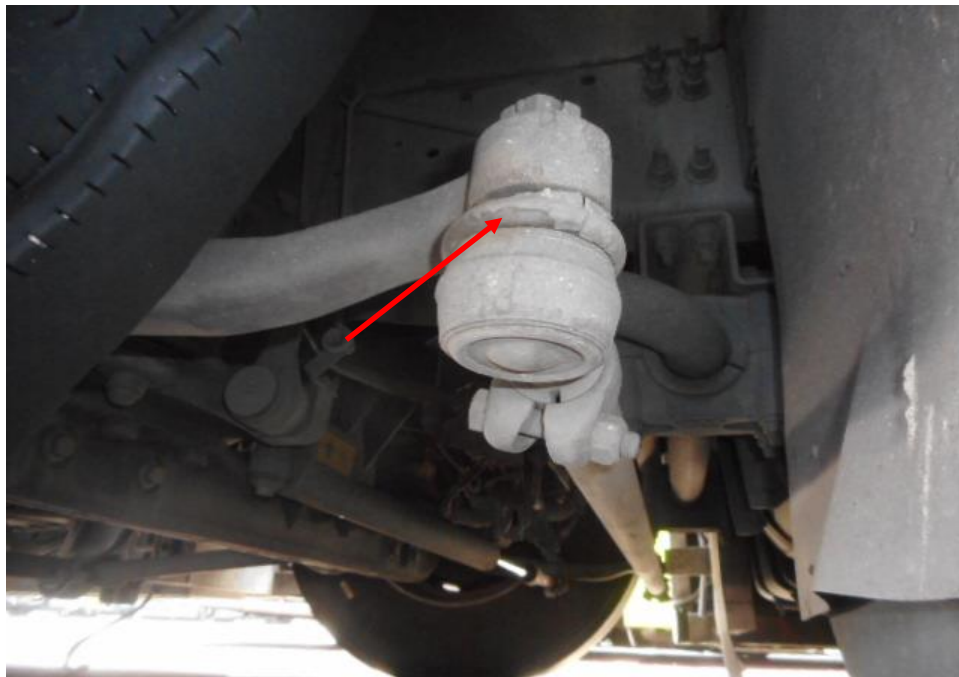
Photo 23 shows the front left wheel components of the front steering system of the Motor Bus. The various undercarriage components of the Motor Bus were all observed to be intact and without any visible damage. This had included the steering rack and steering ball joints (arrowed) of the Motor Bus, which were observed to be securely attached to the front left wheel.

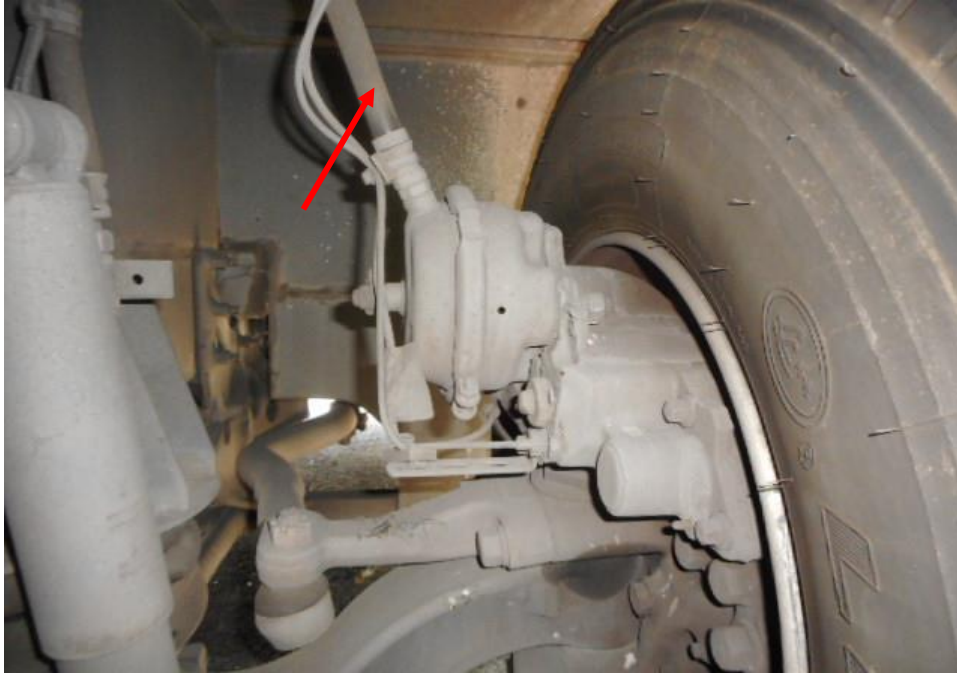
Photo 24 shows the brake pipe (arrowed) at the front right wheel of the Motor Bus. I did not observe any leakage of brake fluid/air at the time of my inspection of the Motor Bus and the various mechanical components was observed to be intact.

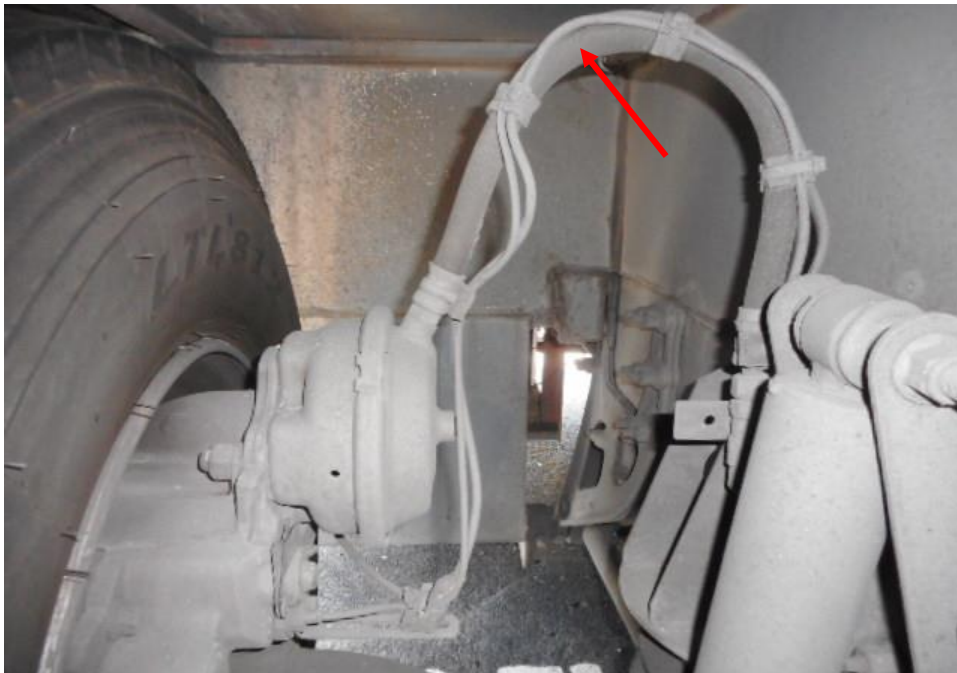
Photo 25 shows the brake pipe (arrowed) at the front left wheel of the Motor Bus. I did not observe any leakage of brake fluid/air at the time of my inspection of the Motor Bus and the various mechanical components was observed to be intact.

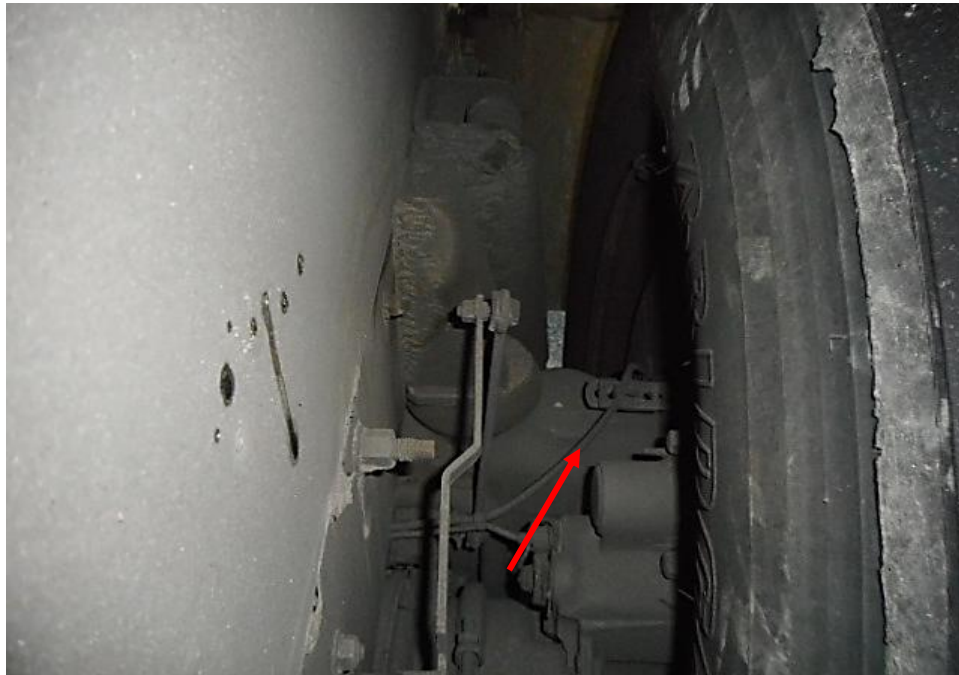
Photo 26 shows the brake pipe (arrowed) at the rear right wheel of the Motor Bus. I did not observe any leakage of brake fluid at the time of my inspection of the Motor Bus and the various mechanical components was observed to be intact.

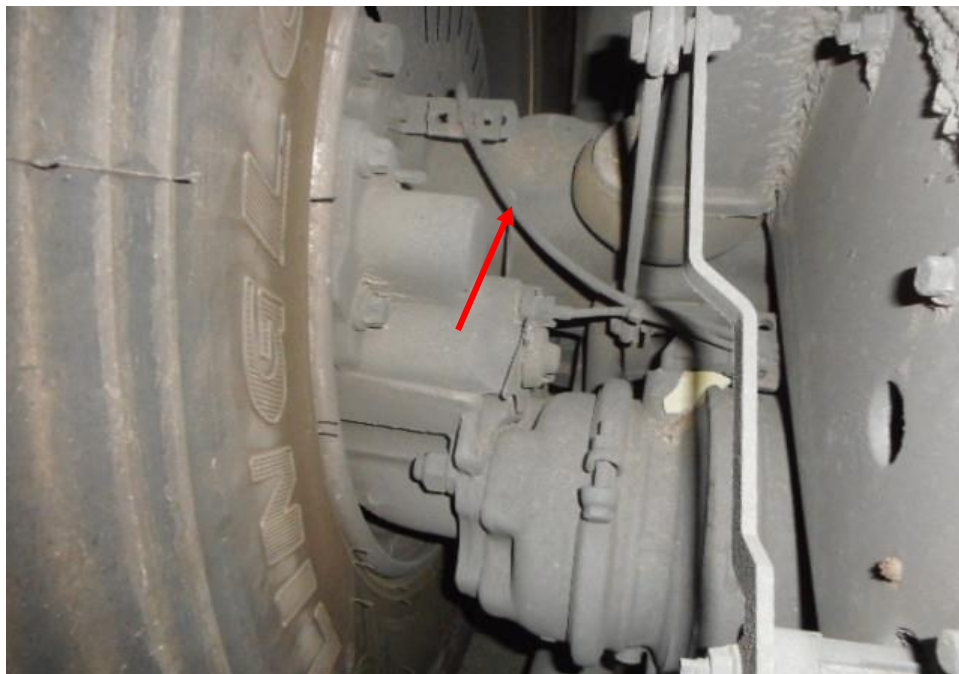
Photo 27 shows the brake pipe (arrowed) at the rear left wheel of the Motor Bus. I did not observe any leakage of brake fluid at the time of my inspection of the Motor Bus and the various mechanical components was observed to be intact.

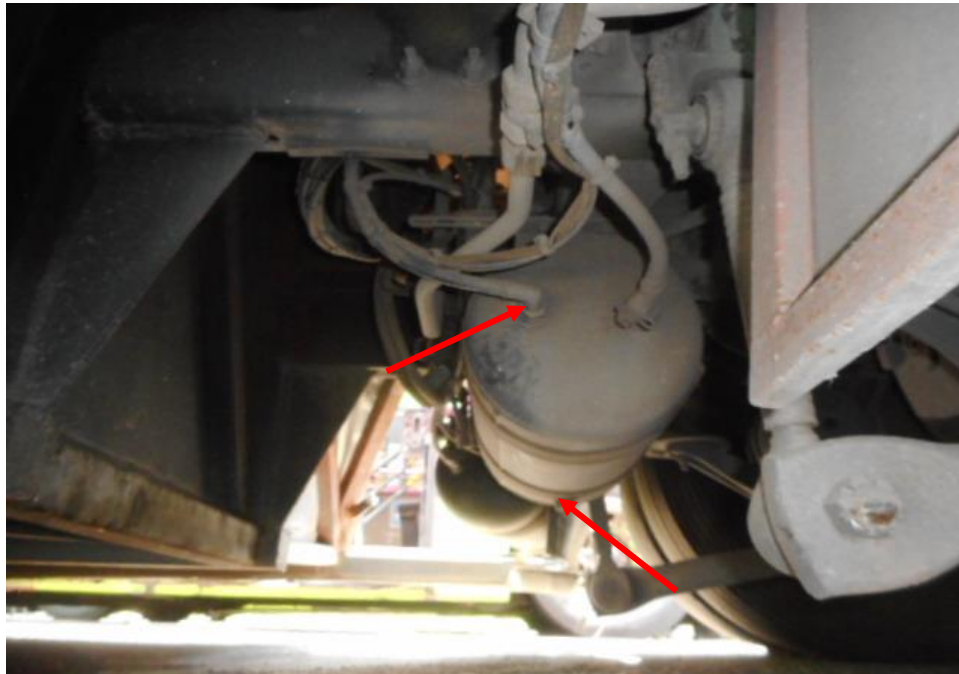
Photo 28 shows the air brake cylinders (arrowed) at the undercarriage of the Motor Bus. I did not observe any leakage of brake fluid at the time of my inspection of the Motor Bus and the various mechanical components was observed to be intact.
