Your Ref: TP/IP/04040/2022
Our Ref : CI/TPD22003616/P

Fatal Accident Investigation Team

MECHANICAL INSPECTION REPORT OF MOTOR BUS SG 5442M

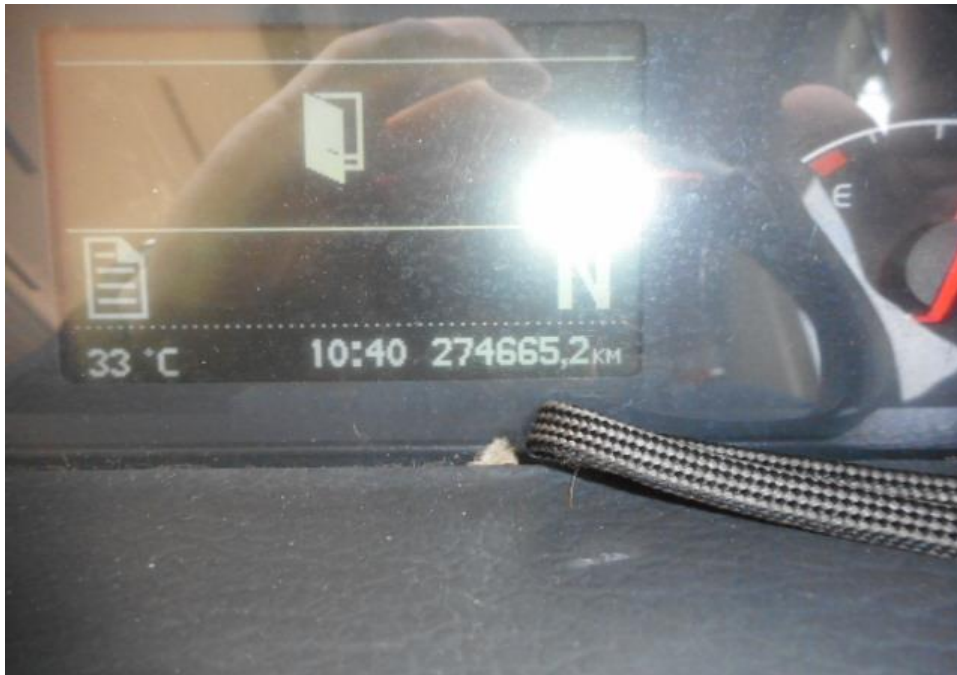
Photo 1 shows a general view of the instrument cluster of the Motor Bus at the time of my inspection. The mileage of the Motor Bus was 274,665km

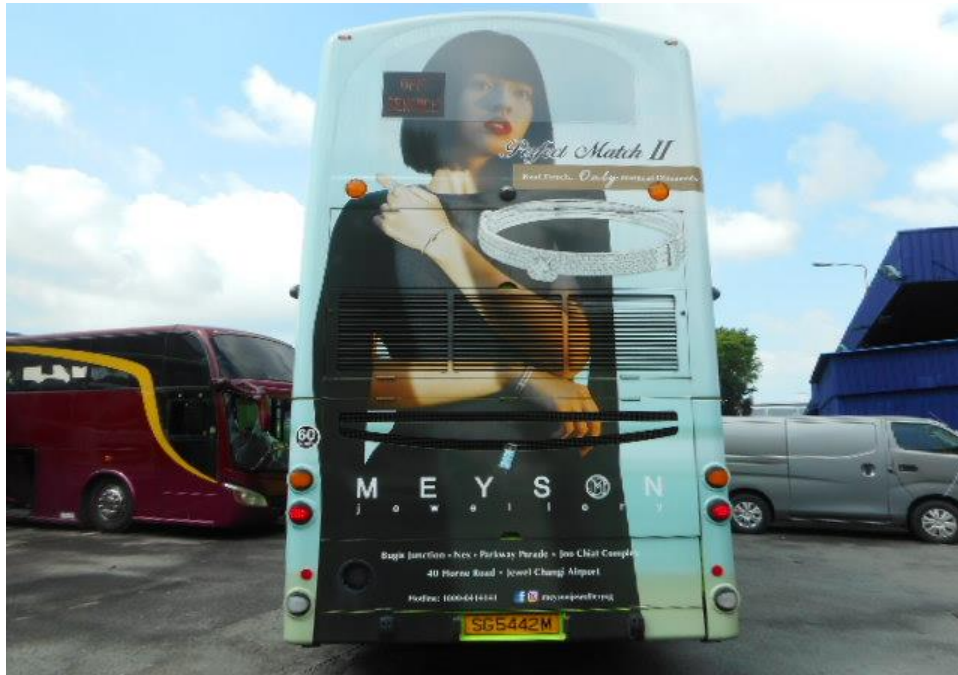
Photo 2 shows a general view of the rear body of the Motor Bus at the time of my inspection. The Motor Bus was observed to be intact and unaffected by the accident.

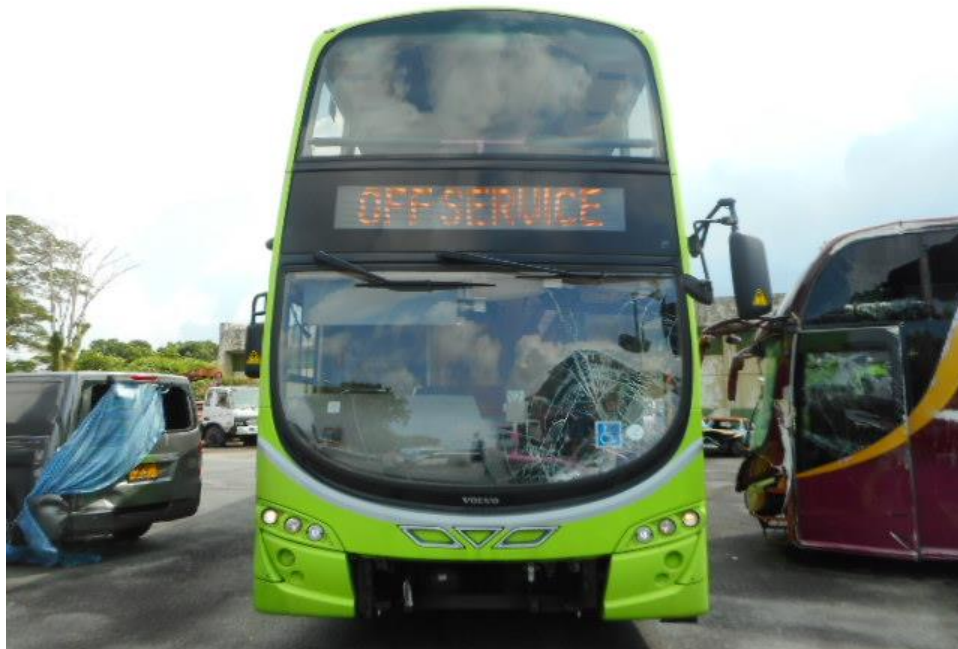
4. The mileage of the Motor Bus at the time of my inspection was 274,665km.
5. The Motor Bus was observed to have sustained damage at its front portion. Its front windscreen was the body part that were damaged as a result of the accident.

Photo 3 shows a general view of the front body of the Motor Bus at the time of my inspection. The Motor Bus was observed to have sustained damages at its front windscreen was observed to be damaged at time of our inspection.

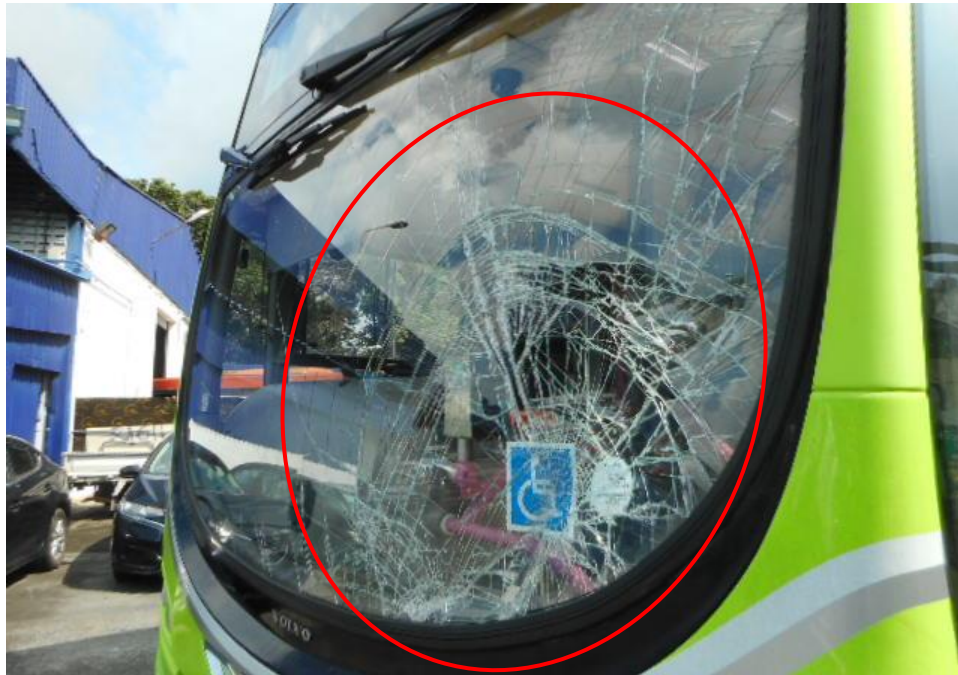
Photo 4 shows a close up view of the front body of the Motor Bus at the time of our inspection. The Motor Bus was observed to have sustained damages at its front windscreen (circled) as a result of the accident.

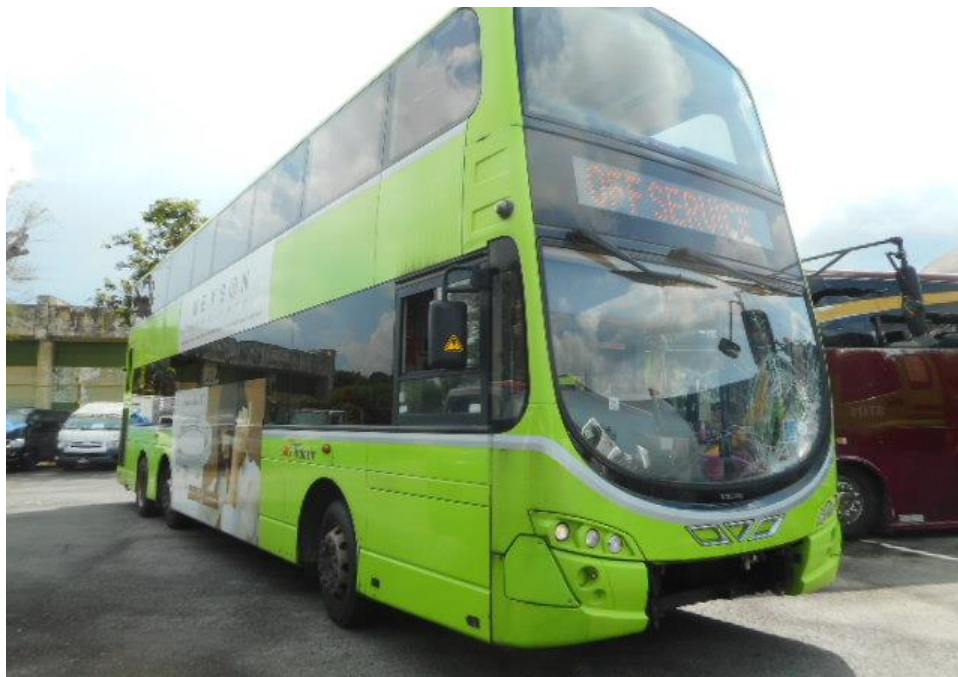
Photo 5 shows a general view of the right body of the Motor Bus at the time of my inspection. The Motor Bus was observed to be intact and unaffected by the accident.

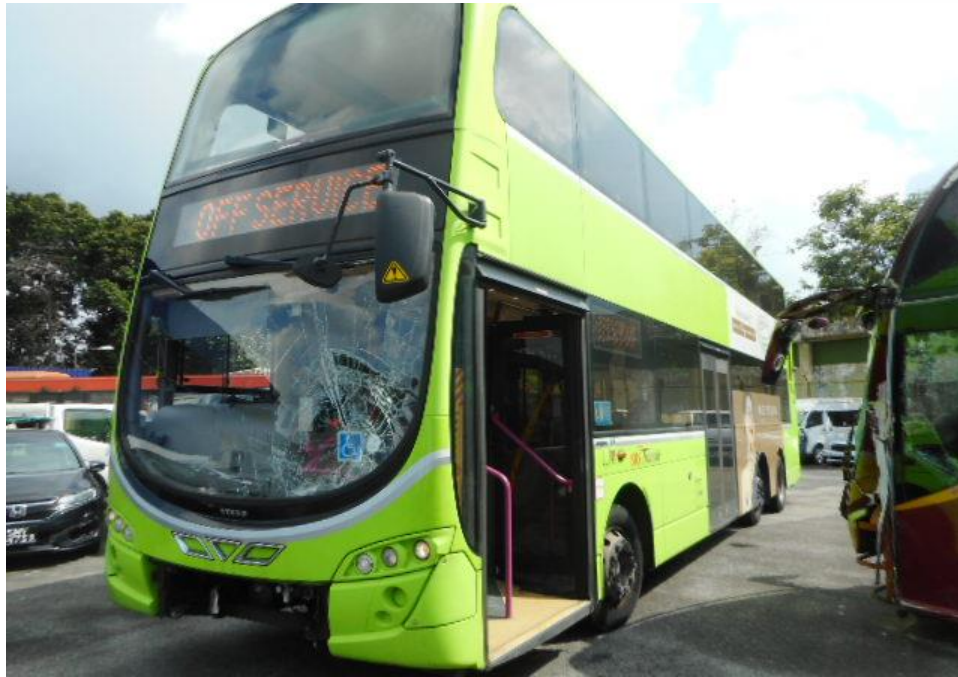
Photo 6 shows a general view of the left body of the Motor Bus at the time of my inspection. The Motor Bus was observed to be intact and unaffected by the accident.

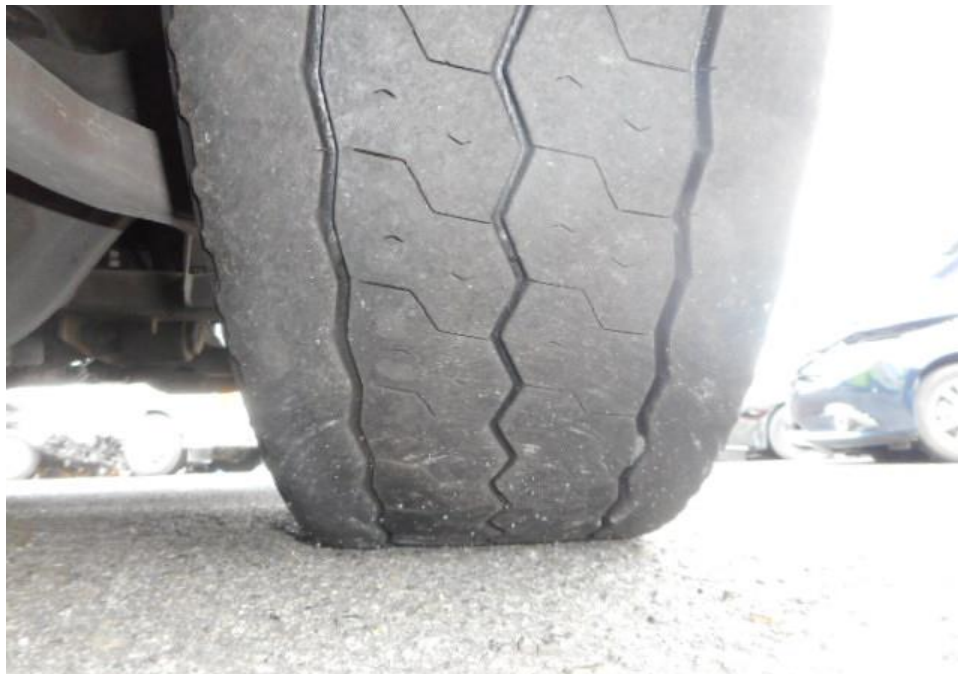
Photo 7 shows the condition of the front right tyre of the Motor Bus, which was observed to be in serviceable condition with remaining tread depth of approximately 8.9mm. The tyre, which was wrapped around standard steel wheel rim, was also observed to be sufficiently inflated for vehicular operation. There was no tear, cut or burst mark(s) on the outer and the inner sidewalls as well as across the tread of the 8 tyres that were fitted on the Motor Bus.

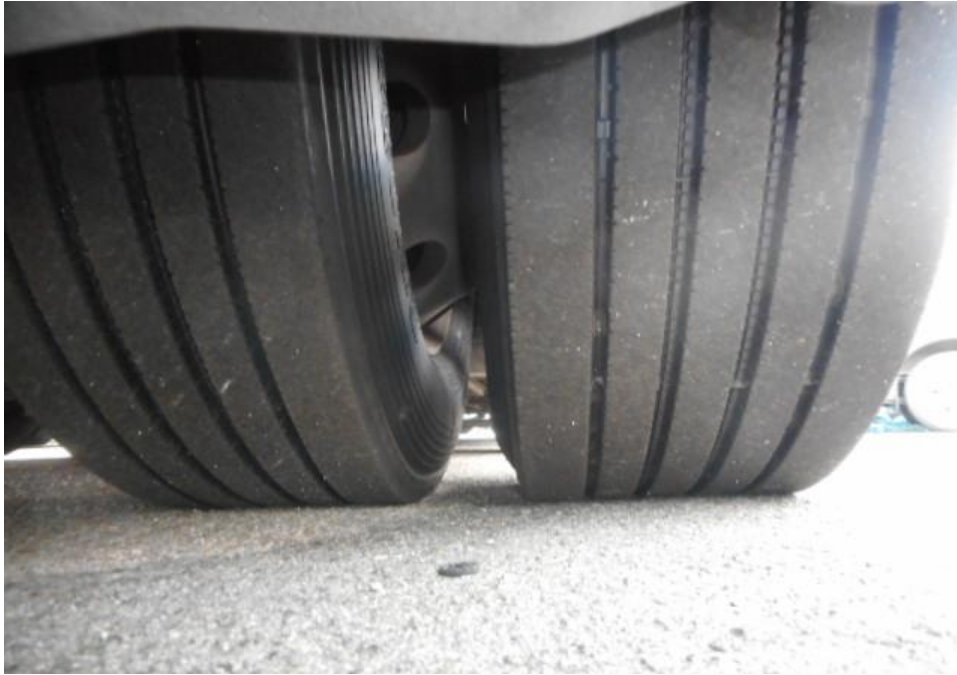
Photo 8 shows the condition of the rear right tyre of the Motor Bus, which was observed to be in serviceable condition with remaining tread depth of approximately 8.9mm. The tyre, which was wrapped around standard steel wheel rim, was also observed to be sufficiently inflated for vehicular operation.

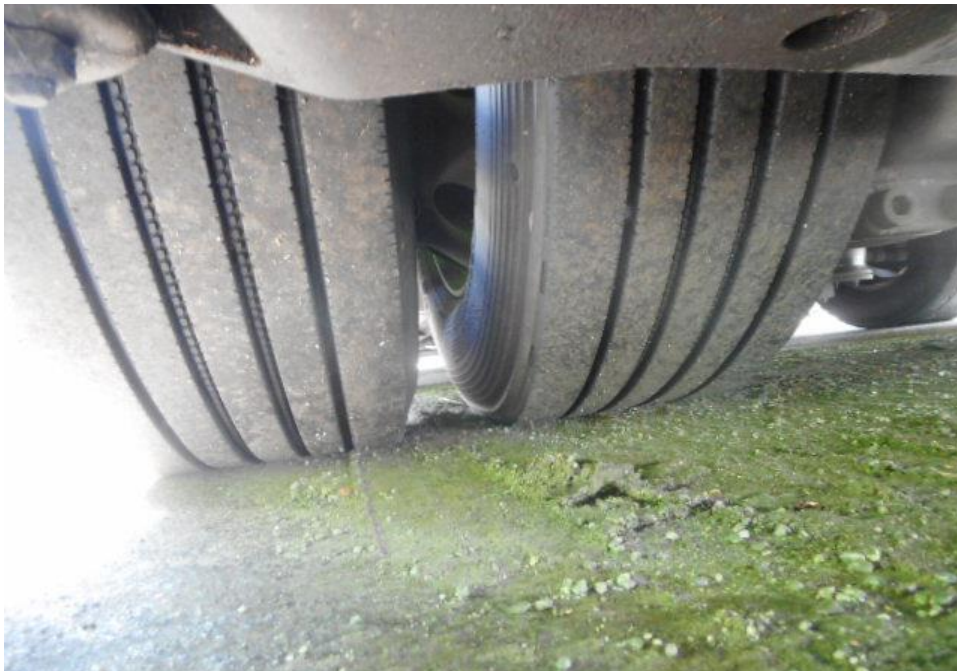
Photo 9 shows the condition of the rear left tyres of the Motor Bus, which was observed to be in serviceable condition with remaining tread depth of approximately 13.8mm. The tyres, which were wrapped around standard steel wheel rim, were also observed to be sufficiently inflated for vehicular operation. There was also no damage found on all 8 steel wheel rims of the Motor Bus.

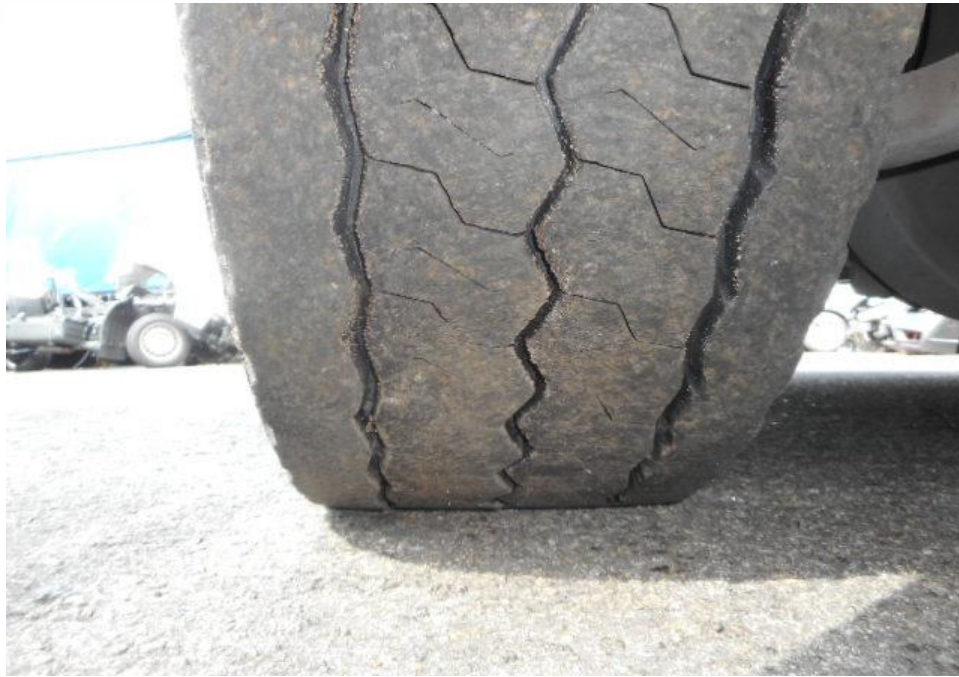
Photo 10 shows the condition of the front left tyres of the Motor Bus, which were observed to be in serviceable condition with remaining tread depth of approximately 13.4mm. There was also no tear, cut or burst mark(s) on the outer and the inner sidewalls as well as across the tread of the 8 tyres that were fitted on the Motor Bus.

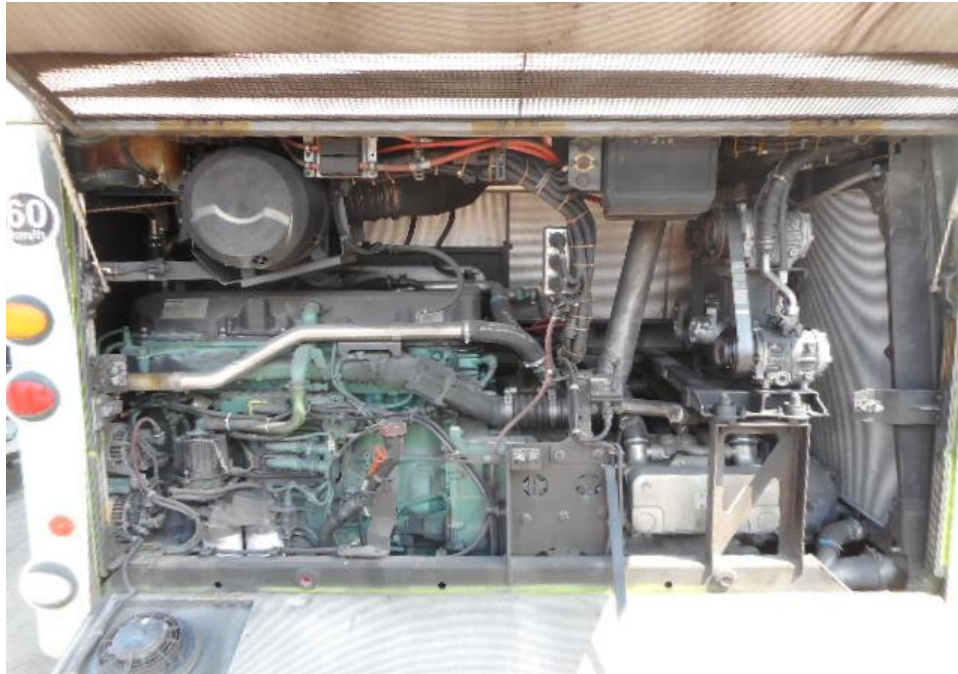
Photo 11 shows a general view of the Motor Bus's engine compartment, which was accessed by lifting the rear of the Motor Bus. The various parts and components inside the engine compartment were unaffected by the accident. There was also no sign(s) or indication(s) of fresh fluid leakage and/or fluid stain within the engine compartment

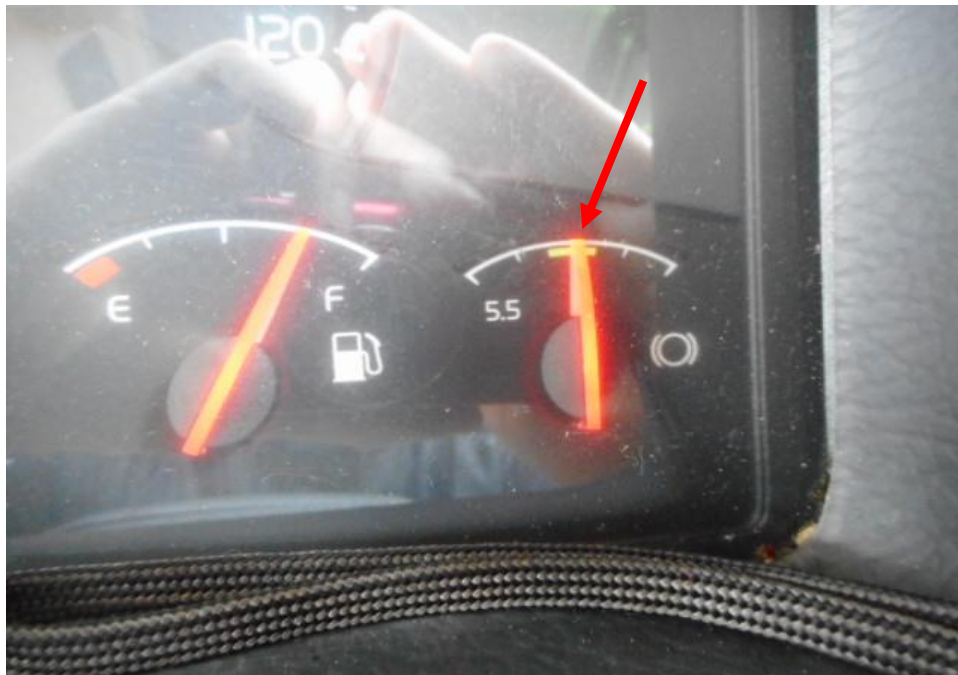
Photo 12 shows the air in the air brake cylinder of the Motor Bus at the time of my inspection. The air in the cylinder was observed to be of sufficient level & serviceable at the time of the accident.

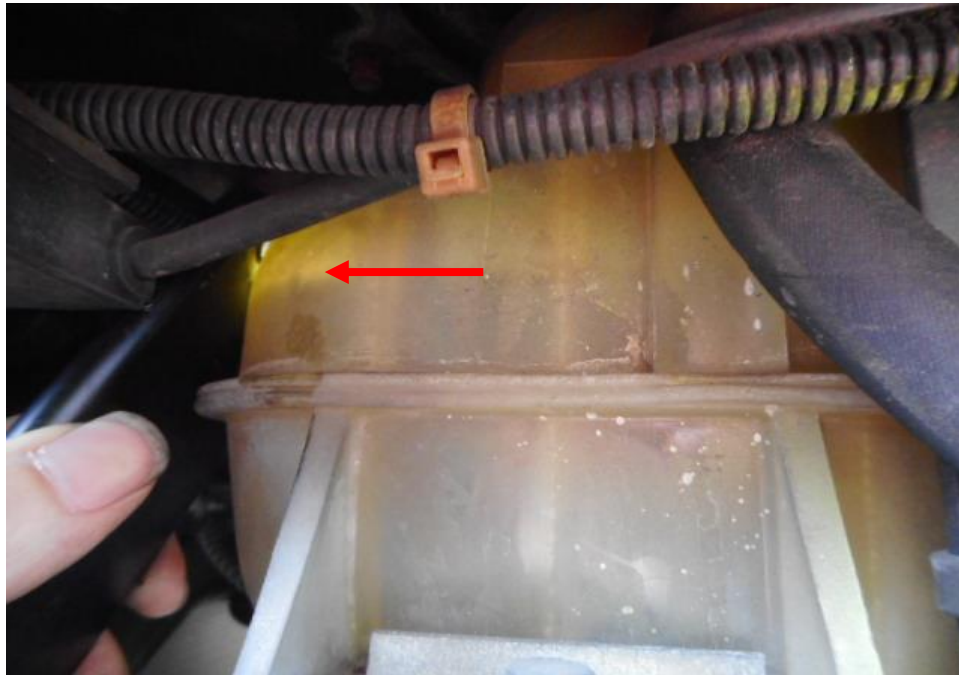
Photo 13 shows the engine coolant reservoir of the Motor Bus at the time of my inspection. The engine coolant was observed to be of sufficient level (arrowed) and without any visible contamination.

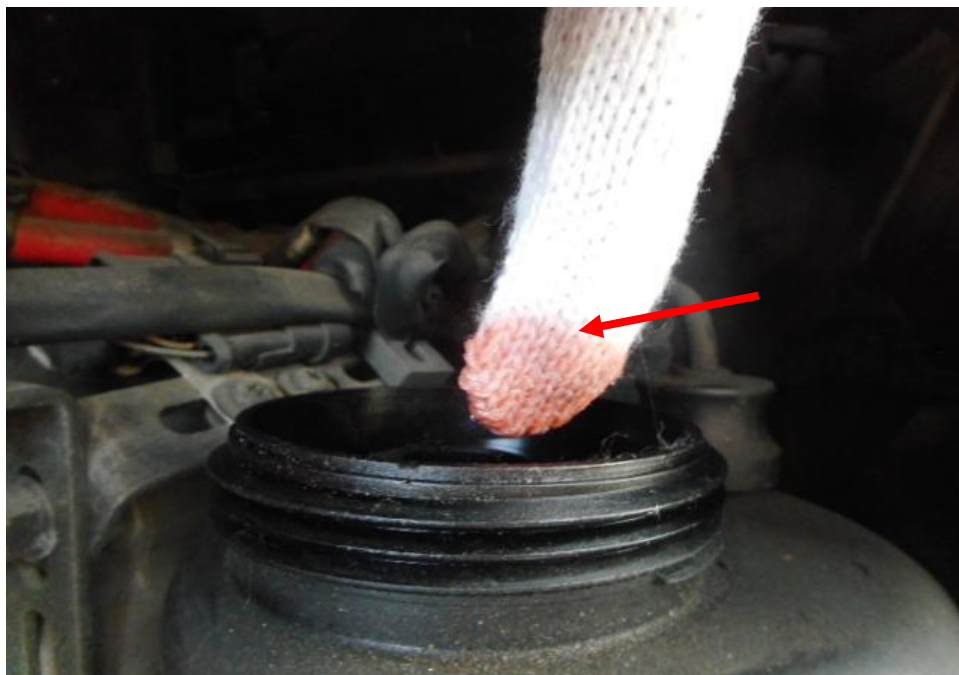
Photo 14 shows the power steering fluid reservoir of the Motor Bus at the time of my inspection. The power steering fluid was observed to be of sufficient level and without any visible contamination.

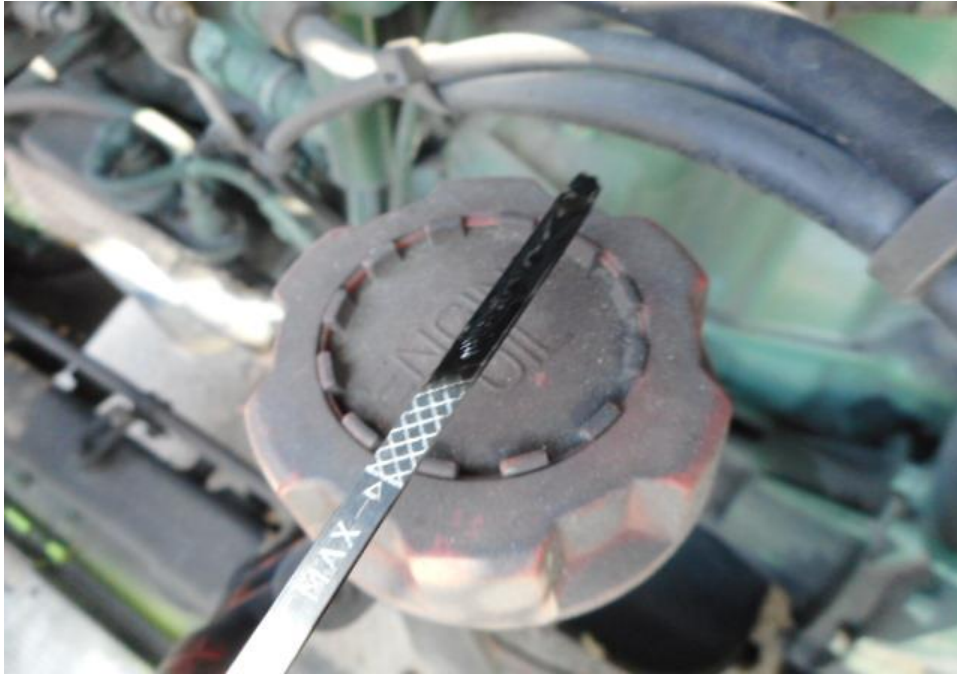
Photo 15 shows the engine oil dip stick system of the Motor Bus at the time of my inspection. The engine oil was observed to be sufficient for operation and without any visible contamination.

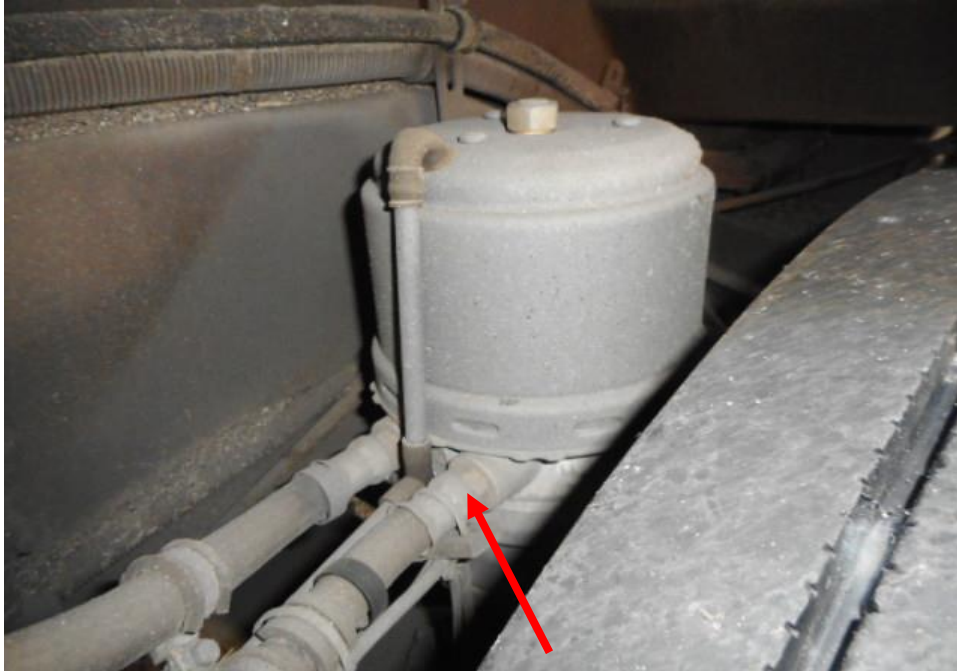
Photo 16 shows the brake pipe (arrowed) at the rear right wheel of the Motor Bus. I did not observe any leakage of brake fluid at the time of my inspection of the Motor Bus. My static tests of the Motor Bus's braking system, along with my visual examination of the various mechanical components in the braking system, had indicated that there was no internal leakage of pressure/vacuum. Hence the braking system of the Motor Bus was likely to be in serviceable condition at the material time of accident.

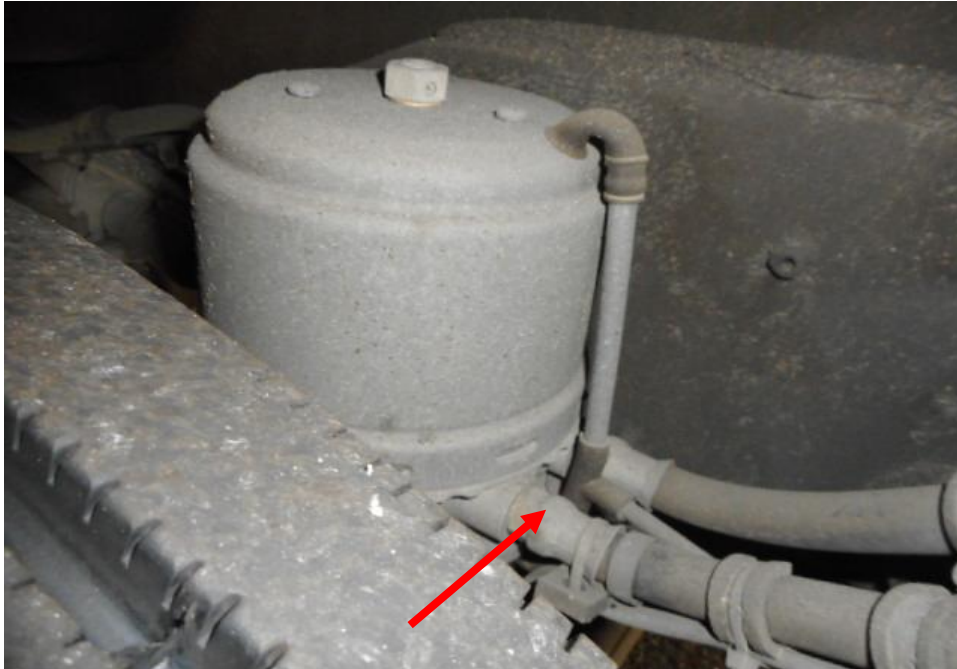
Photo 17 shows the brake pipe (arrowed) at the rear left wheel of the Motor Bus. I did not observe any leakage of brake fluid at the time of my inspection of the Motor Bus. My static tests of the Motor Bus's braking system, along with my visual examination of the various mechanical components in the braking system, had indicated that there was no internal leakage of pressure/vacuum. Hence the braking system of the Motor Bus was likely to be in serviceable condition at the material time of accident.

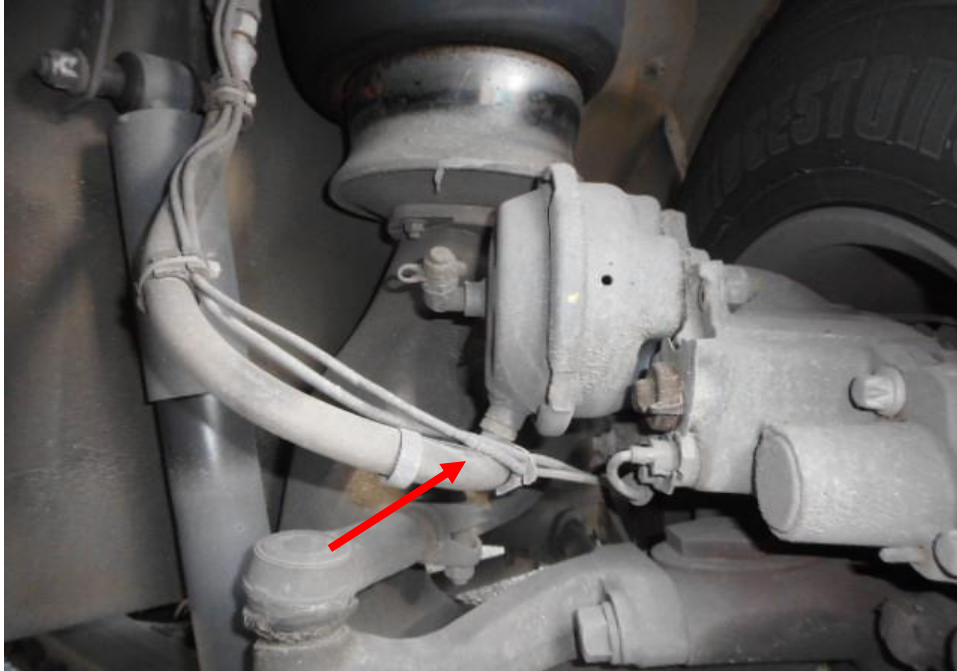
Photo 18 shows the brake pipe (arrowed) at the front right wheel of the Motor Bus. I did not observe any leakage of brake fluid at the time of my inspection of the Motor Bus. My static tests of the Motor Bus's braking system, along with my visual examination of the various mechanical components in the braking system, had indicated that there was no internal leakage of pressure/vacuum. Hence the braking system of the Motor Bus was likely to be in serviceable condition at the material time of accident.

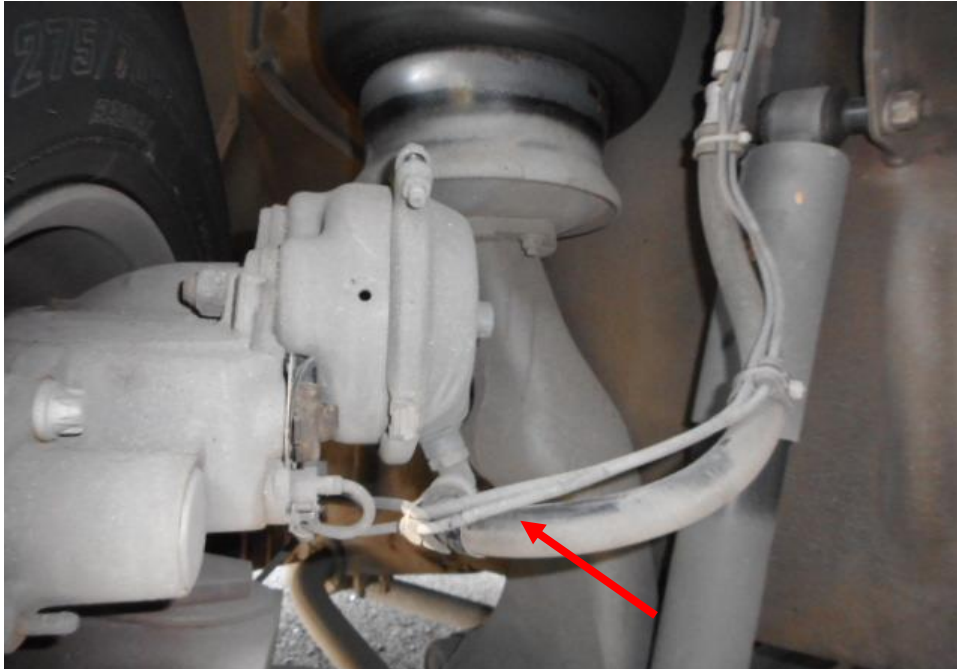
Photo 19 shows the brake pipe (arrowed) at the front left wheel of the Motor Bus. I did not observe any leakage of brake fluid at the time of my inspection of the Motor Bus. My static tests of the Motor Bus's braking system, along with my visual examination of the various mechanical components in the braking system had indicated that there was no internal leakage of pressure/vacuum. Hence the braking system of the Motor Bus was likely to be in serviceable condition at the material time of accident.

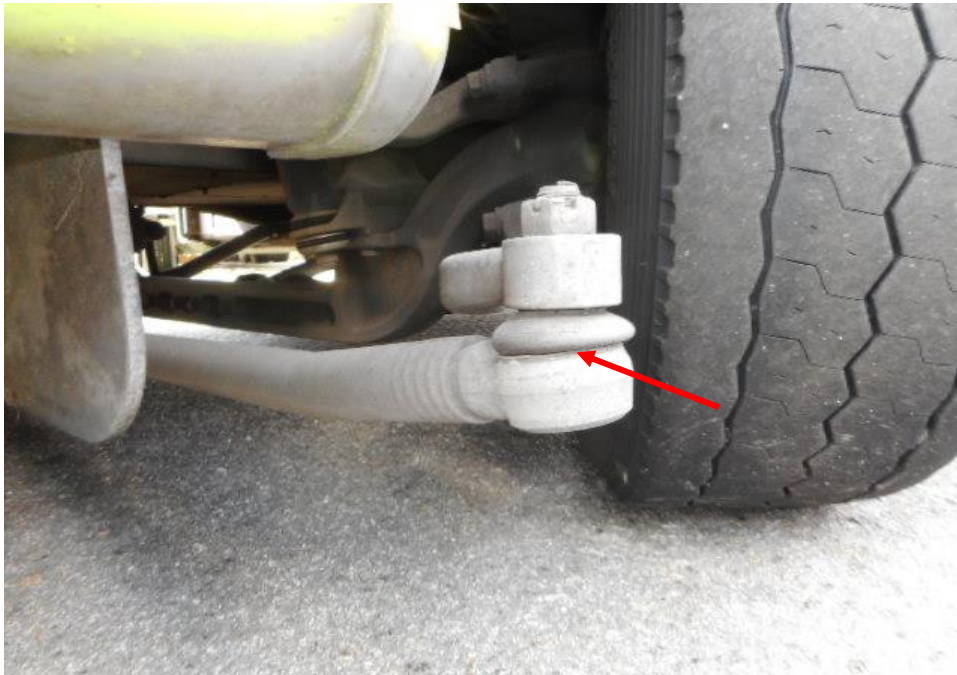
Photo 20 shows the various undercarriage components at the front right wheel of the Motor Bus, in particular the steering tie rod end (arrowed). The various steering components were all found to be intact, suggesting that the steering system of the Motor Bus was likely to be in serviceable condition at the material time of accident. There was also no sign of fluid stain(s) observed on the various undercarriage components.

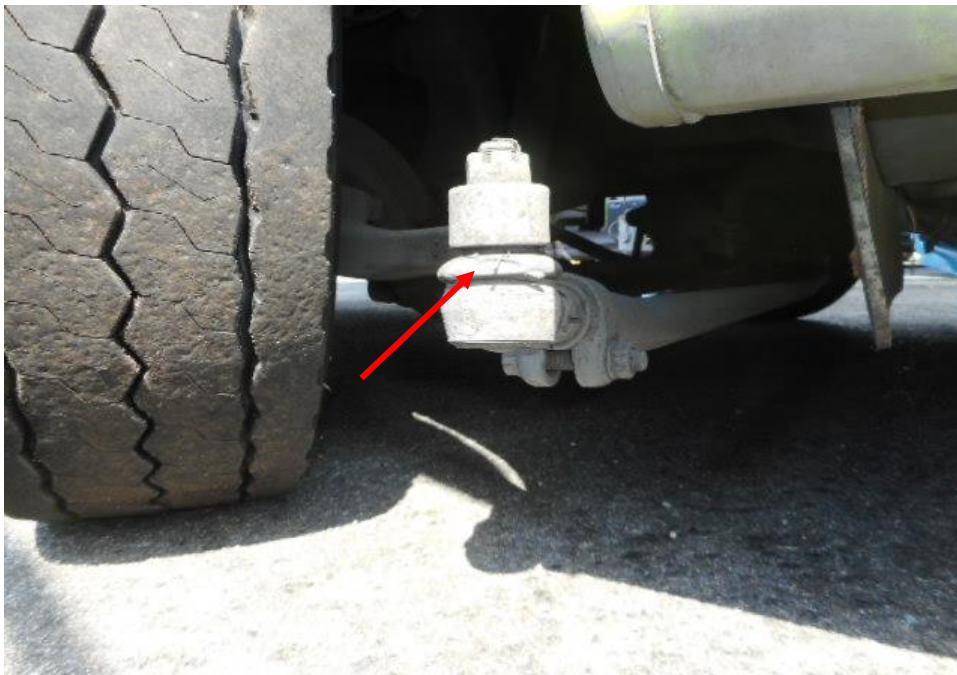
Photo 21 shows the various undercarriage components at the front left wheel of the Motor Bus, in particular the steering tie rod end (arrowed). The various undercarriage components of the Motor Bus were all found to be intact without any visible damage. There was also no sign of fluid stain(s) observed on the various undercarriage components.

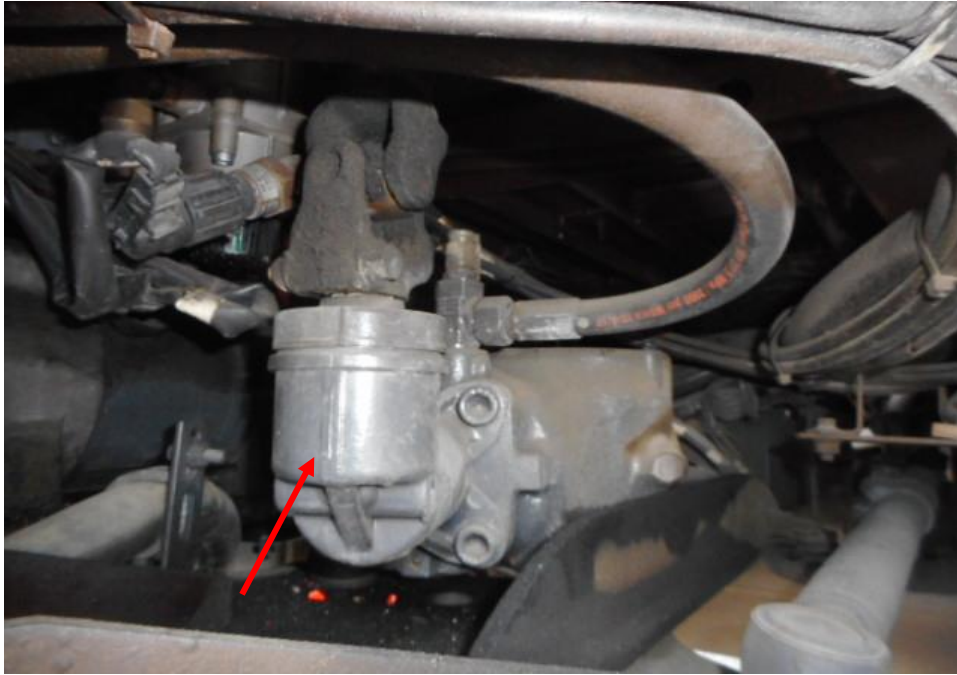
Photo 22 shows the steering box component (arrowed) at the undercarriage of the Motor Bus was found to be intact without any visible damage. There was also no sign of fluid stain(s) observed on the various undercarriage components.

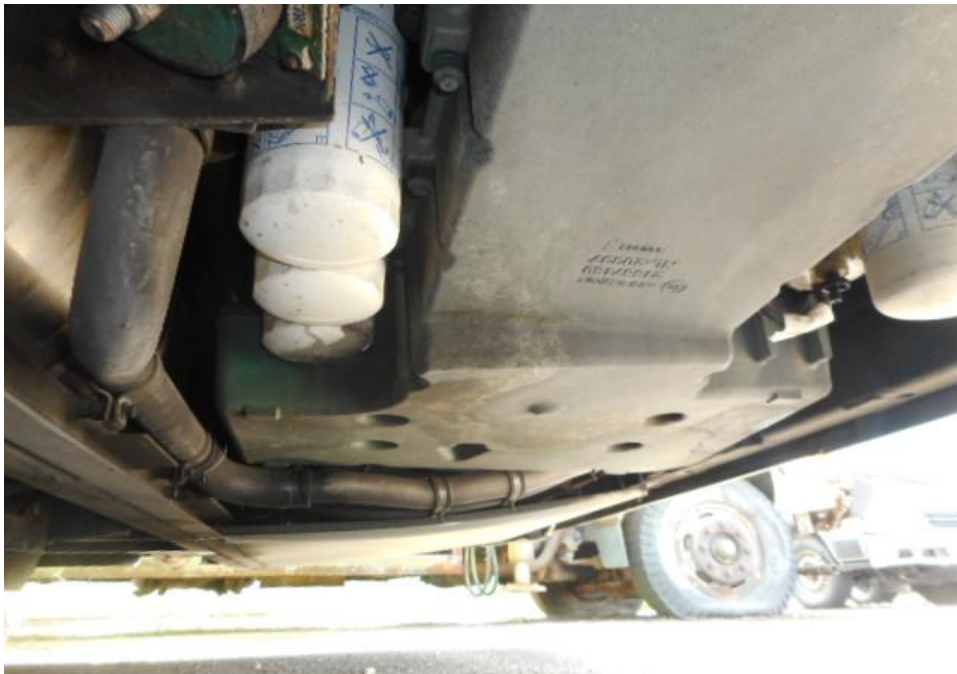
Photo 23 shows the undercarriage of the Motor Bus, at the area where the engine housing and transmission housing are located. I did not find any sign(s) or indication(s) of fluid leak and/or fluid stain(s) on the underside of the Motor Bus.

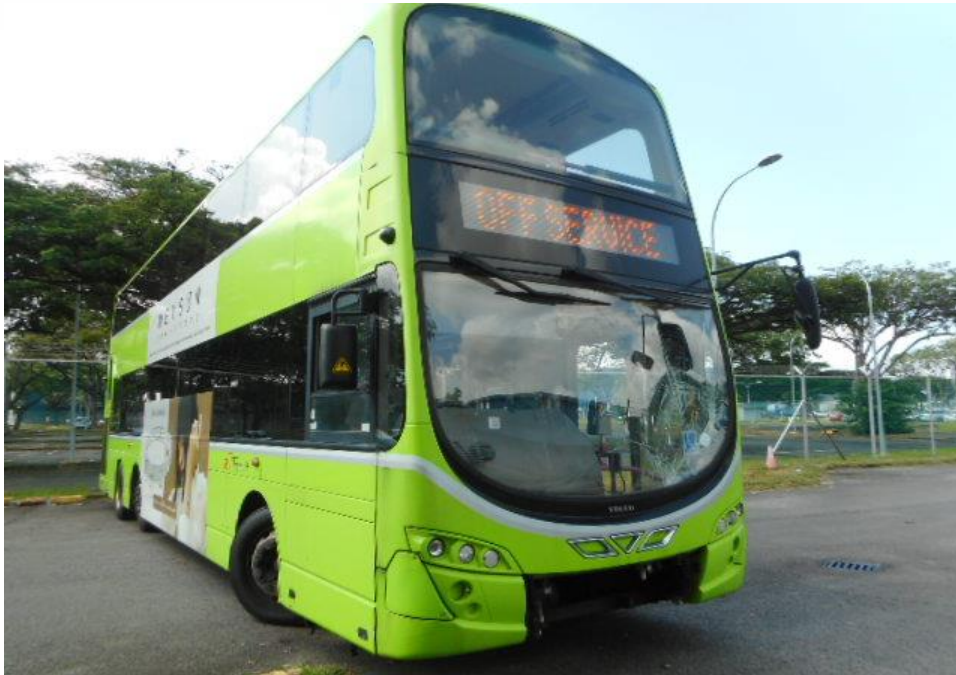
Photo 24 shows the front right wheel of the Motor Bus turned to its full left. During my steering system test, I did not experience any abnormal free play and/or resistance when I had turned the steering wheel towards full left and full right. This would suggest that the steering system of the Motor Bus was likely to be in serviceable condition at the material time of accident.

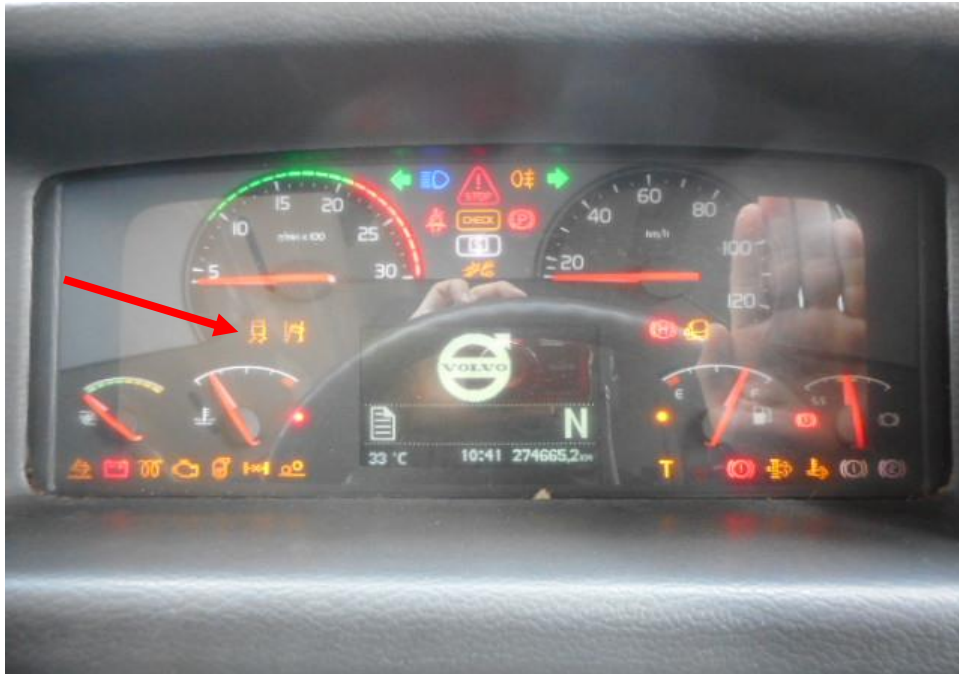
Photo 25 shows the warning light for Traction Control System (TCS) appearing on the instrument panel of the Motor Bus during the self-test of its various electronic operating systems when its engine was cranked.

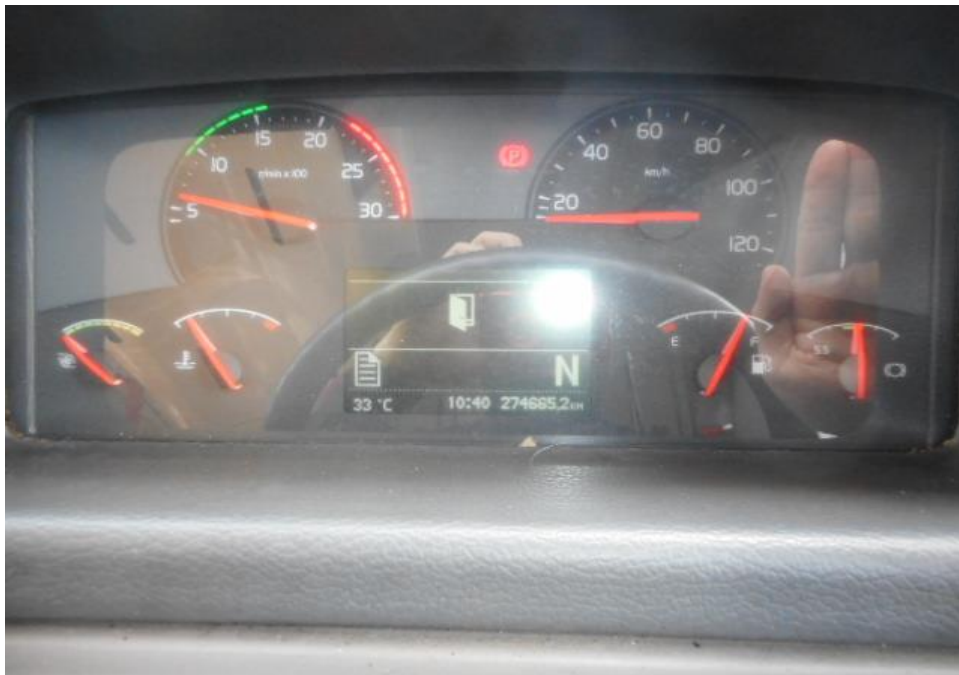
Photo 26 shows no warning lights illuminated on the instrument panel of the Motor Bus after the engine was cranked. This would suggest that there was no abnormality to the various electronic operating systems of the Motor Bus, like the TCS and etc.
